**Flood Control Project Maintenance
Levee Inspections
2020 Channel Summary Report
Overall Unit and Item Ratings**

Truckee River

2020 Channel Inspection Results

Levee Inspection Report By Mile - Channel 2020

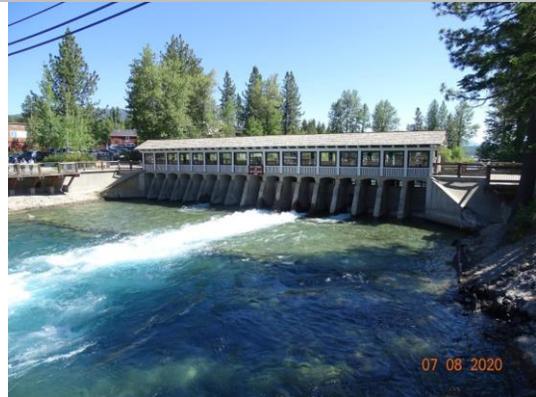
Photo 1 of 1 : CH_2020_NA0045_13_11_20200720_00009.jpg

Check Point / View				
Hwy 89 / Up				
Rating **	A	Issue No.	11	GPS Lat/Long
Issue Type +	Ma	Location *		39.166845 °
Category	Rivers, Channels & Designated Flood			-120.144424 °
Item	Vegetation & Obstructions			
DWR ID	DWR_NA0045_13_c_2012_11			
Action/Comments				
Inspector Comments: Minimal, scattered obstructions or vegetation. The flow is not impeded.

View of the river from Highway 89, looking upstream towards the outlet structure. Summer 2020.

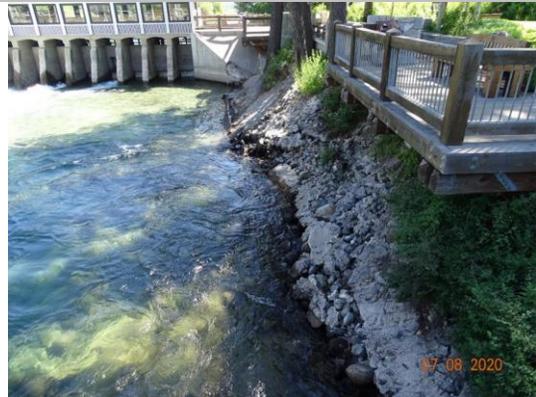
Photo 1 of 2 : CH_2020_NA0045_13_14_20200720_00010.jpg

Check Point / View				
Hwy 89 / Up (cont)				
Rating **	A	Issue No.	14	GPS Lat/Long
Issue Type +	Ma	Location *		39.166845 °
Category	Rivers, Channels & Designated Flood			-120.144424 °
Item	Revetments			
DWR ID	DWR_NA0045_13_c_2012_14			
Action/Comments				
Inspector Comments: Minimal scouring on the left bank that has been stable for the last few inspections.

View of the riprap on the left bank. Summer 2020.

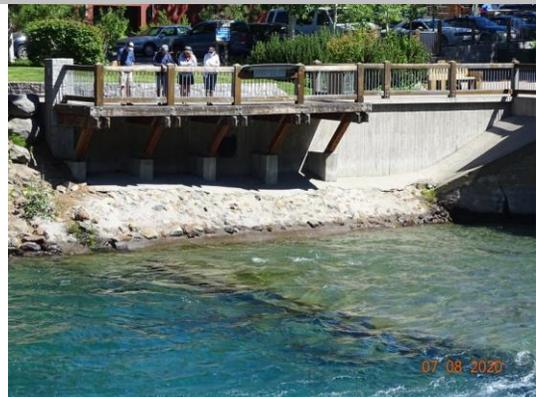
Photo 2 of 2 : CH_2020_NA0045_13_14_20200720_00011.jpg

View of the riprap on the right bank. Summer 2020.

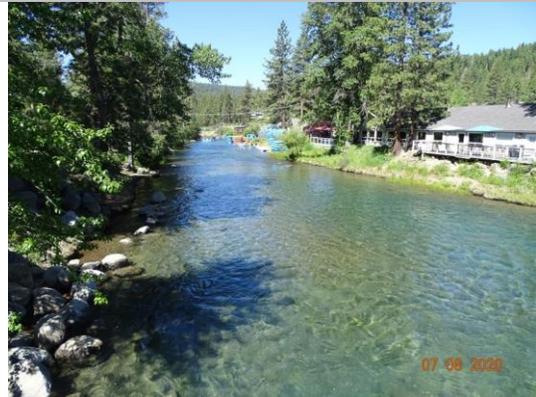
Photo 1 of 1 : CH_2020_NA0045_13_16_20200720_00012.jpg

Check Point / View				
Hwy 89 / Down				
Rating **	A	Issue No.	16	GPS Lat/Long
Issue Type +	Ma	Location *		39.166845 °
Category	Rivers, Channels & Designated Flood			-120.144424 °
Item	Vegetation & Obstructions			
DWR ID	DWR_NA0045_13_c_2012_16			
Action/Comments				
Inspector Comments: Minimal, scattered obstructions or vegetation. The flow is not impeded.

Looking downstream on the Truckee River from Highway 89. Summer 2020.

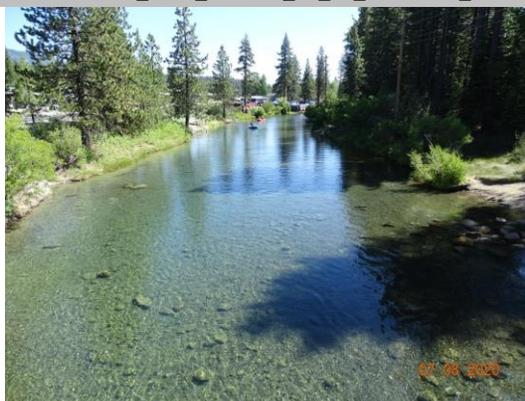
Photo 1 of 1 : CH_2020_NA0045_13_21_20200720_00013.jpg

Check Point / View			
bike bridge / Up			
Rating **	A	Issue No. 21	GPS Lat/Long
Issue Type +	Ma	Location *	39.165170 °
Category	Rivers, Channels & Designated Flood		-120.147590 °
Item	Vegetation & Obstructions		
DWR ID	DWR_NA0045_13_c_2012_21		
Action/Comments			
Inspector Comments: Minimal, scattered obstructions or vegetation. The flow is not impeded.

View of the Truckee River, looking upstream from the bike bridge. Summer 2020.

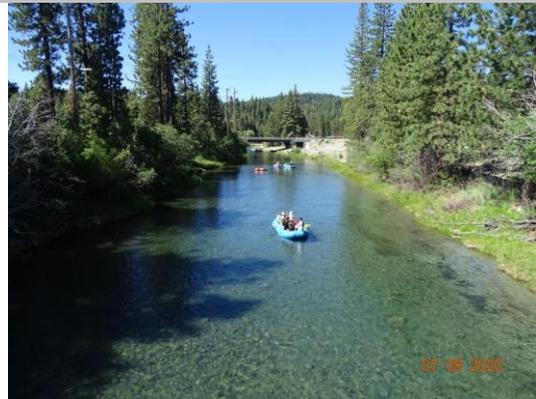
Photo 1 of 2 : CH_2020_NA0045_13_26_20200720_00014.jpg

Check Point / View			
bike bridge / Down			
Rating **	A	Issue No.	26
Issue Type +	Ma	Location *	39.165170 °
Category	Rivers, Channels & Designated Flood		-120.147590 °
Item	Vegetation & Obstructions		
DWR ID	DWR_NA0045_13_c_2012_26		
Action/Comments			
Inspector Comments: Minimal, scattered obstructions or vegetation. The flow is not impeded.

View of the Truckee River, looking downstream from the bike bridge. Summer 2020.

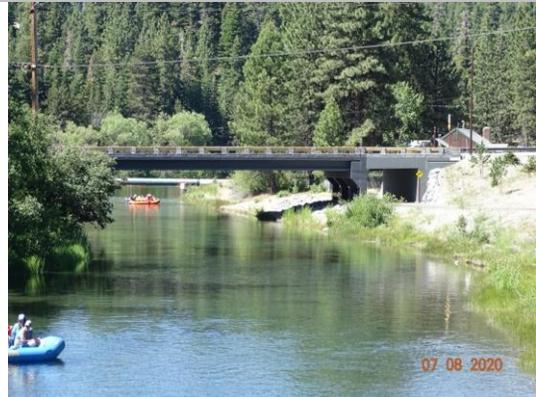
Photo 2 of 2 : CH_2020_NA0045_13_26_20200720_00017.jpg

Check Point / View				
bike bridge / Down (cont)				
Rating **	A	Issue No.	26 (cont)	GPS Lat/Long
Issue Type +	Ma	Location *		39.165170 °
Category	Rivers, Channels & Designated Flood			-120.147590 °
Item	Vegetation & Obstructions			
DWR ID	DWR_NA0045_13_c_2012_26			
Action/Comments				
Inspector Comments: Minimal, scattered obstructions or vegetation. The flow is not impeded.

A new bridge was constructed downstream from the bike bridge. Summer 2020.

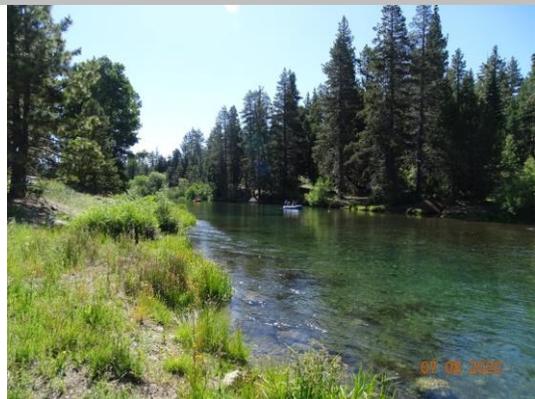
Photo 1 of 1 : CH_2020_NA0045_13_31_20200720_00015.jpg

Check Point / View			
Tahoe City lumber yard / Up			
Rating **	A	Issue No. 31	GPS Lat/Long
Issue Type +	Ma	Location *	39.162480 °
Category	Rivers, Channels & Designated Flood		-120.151900 °
Item	Vegetation & Obstructions		
DWR ID	DWR_NA0045_13_c_2012_31		
Action/Comments			
Inspector Comments: Minimal, scattered obstructions or vegetation. The flow is not impeded.

View of the Truckee River, looking upstream from the Tahoe City Lumber Yard. Summer 2020.

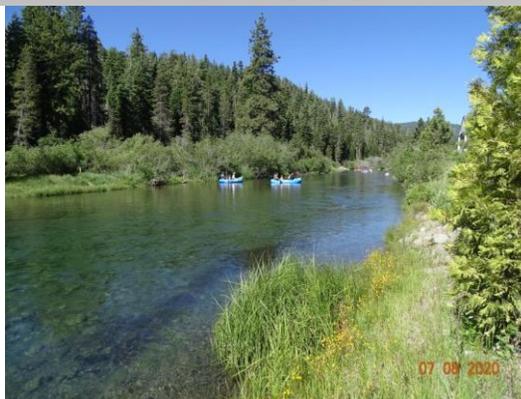
Photo 1 of 1 : CH_2020_NA0045_13_36_20200720_00016.jpg

Check Point / View			
Tahoe City lumber yard / Down			
Rating **	A	Issue No. 36	GPS Lat/Long
Issue Type +	Ma	Location *	39.162480 °
Category	Rivers, Channels & Designated Flood		-120.151900 °
Item	Vegetation & Obstructions		
DWR ID	DWR_NA0045_13_c_2012_36		
Action/Comments			
Inspector Comments: Minimal, scattered obstructions or vegetation. The flow is not impeded.

View of the Truckee River, looking downstream from the Tahoe City Lumber Yard. Summer 2020.
