**Flood Control Project Maintenance
Levee Inspections**
2020 Channel Summary Report
Overall Unit and Item Ratings

DWR Sutter Maintenance Yard

Levee Inspection Report By Mile - Channel 2020

Channel	Channel Length	Inspection Start/End	Inspector
Big Chico Creek	13.00	07/29/2020 07/29/2020	Brooks Weisser

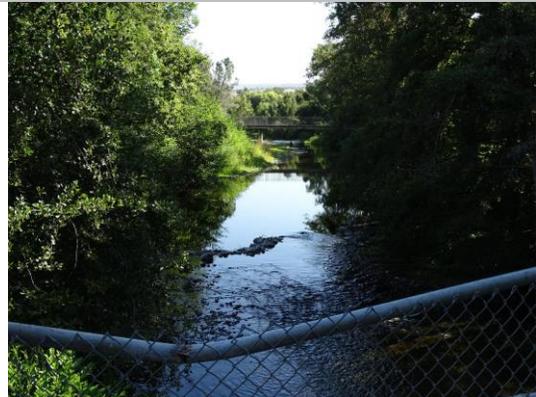
Photo 1 of 1 : CH_2020_NA0060_5_1_20200804_00027.jpg

Check Point / View			
Big Chico Creek Control Structure / Up			
Rating **	A	Issue No.	1
Issue Type +	Ma	Location *	GPS Lat/Long
Category	Rivers, Channels & Designated Flood		39.761840 °
Item	Vegetation & Obstructions		-121.792590 °
DWR ID	DWR_NA0060_5_c_2012_1		
Action/Comments			
Inspector Comments: Minimal, scattered obstructions and vegetation. The flow is not impeded.

View of the channel from the structure facing upstream from the structure, 2020.

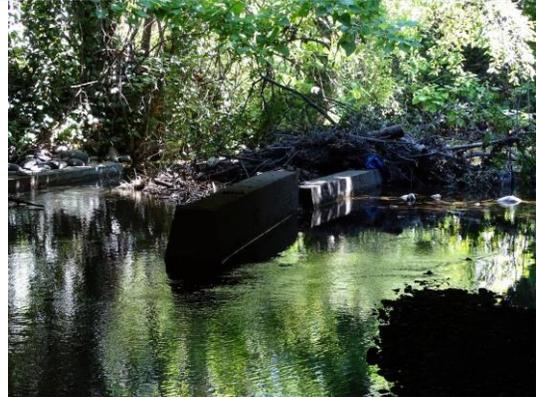
Photo 1 of 1 : CH_2020_NA0060_5_40_20200804_00048.jpg

View of old bridge footing in the channel, 2020.

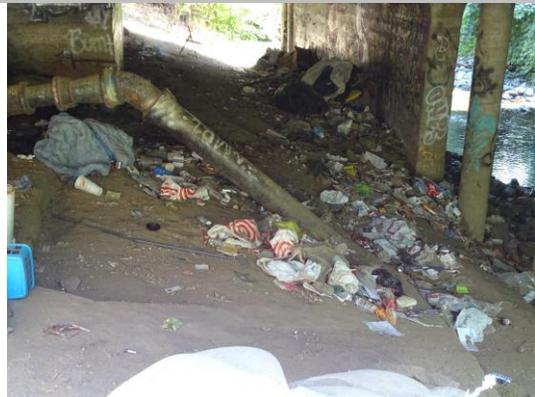
Photo 1 of 1 : CH_2020_NA0060_5_45_20200804_00051.jpg

View of trash and debris from the homeless living under the bridge, 2020.

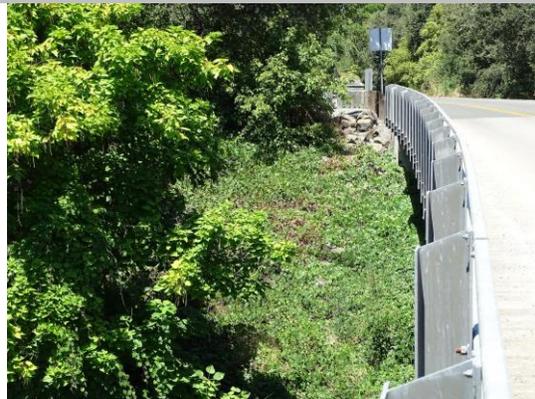
Photo 2 of 2 : CH_2020_NA0060_5_54_20200804_00055.jpg

View of the revetment right bank that is over grown with vegetation, 2020.

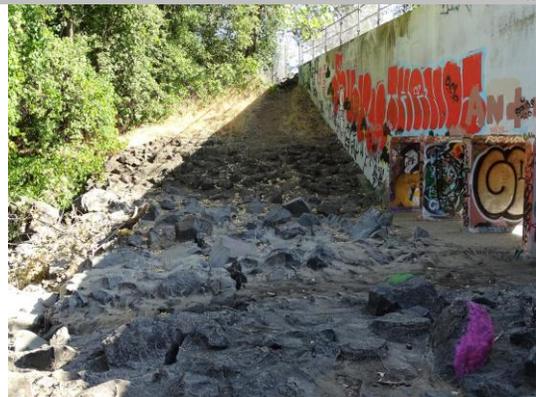
Photo 1 of 2 : CH_2020_NA0060_6_9_20200805_00060.jpg

Rating **	A	Issue No. 9	GPS Lat/Long
Issue Type +	Ma	Location *	39.761590 °
Category	Rivers, Channels & Designated Flood		-121.797320 °
Item	Revetments		
DWR ID	DWR_NA0060_6_c_2012_9		
Action/Comments			
Inspector Comments: Revetment observed at this location is intact, clearly visible, and well maintained.

View of revetment downstream of structure, right bank, 2020.

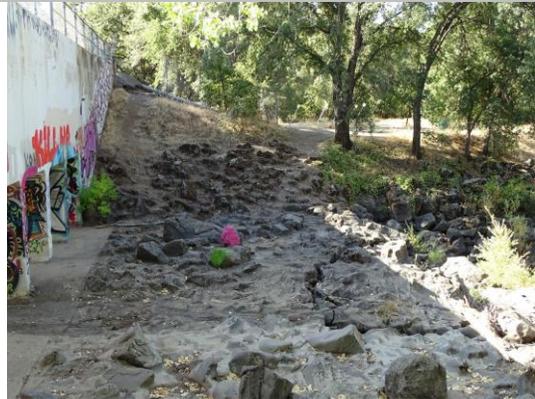
Photo 2 of 2 : CH_2020_NA0060_6_9_20200805_00059.jpg

View of revetment downstream of structure, left bank, 2020.

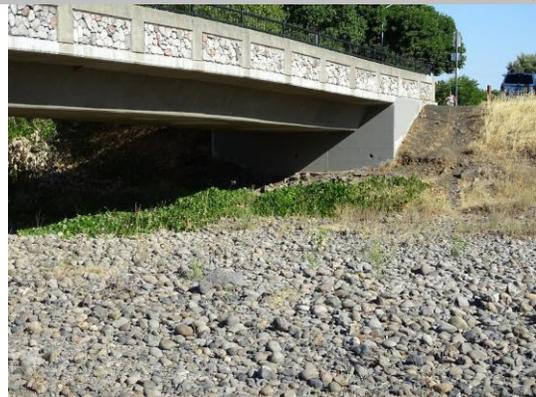
Photo 1 of 2 : CH_2020_NA0060_6_24_20200805_00066.jpg

View looking at the left bank abutment very little revetment remaining, 2020.

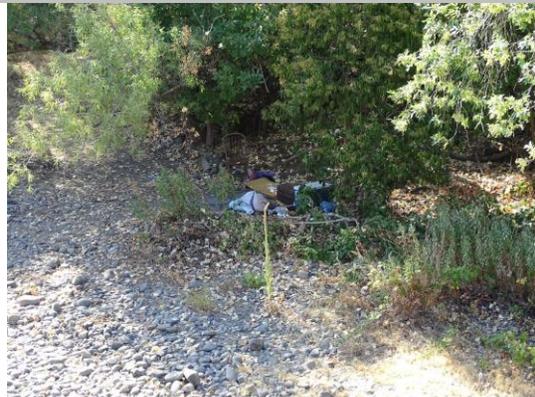
Photo 1 of 5 : CH_2020_NA0060_6_35_20200805_00072.jpg

Debris and trash from campers within the project easement area needs to be removed, 2020.

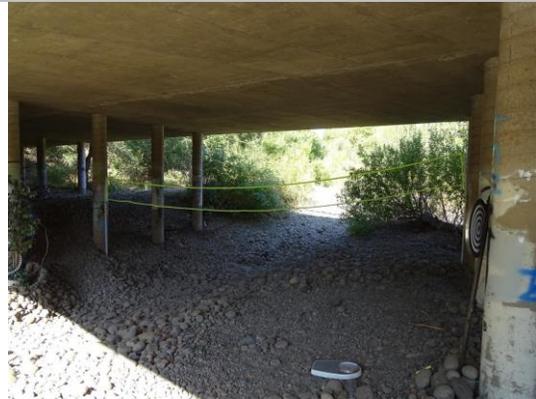
Photo 3 of 5 : CH_2020_NA0060_6_35_20200805_00075.jpg

Debris and trash from campers within the project easement area needs to be removed, 2020.

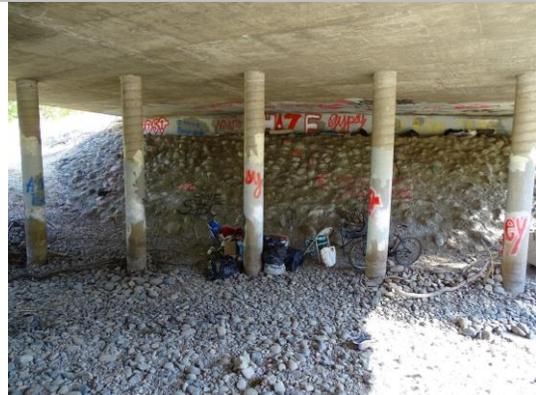
Photo 5 of 5 : CH_2020_NA0060_6_35_20200805_00076.jpg

Debris and trash from campers within the project easement area needs to be removed, 2020.

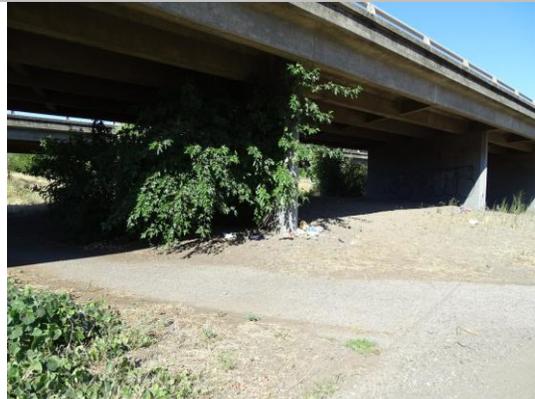
Photo 1 of 1 : CH_2020_NA0060_6_95_20200805_00086.jpg

View of a tree growing near a bridge pier near the left bank, 2020.

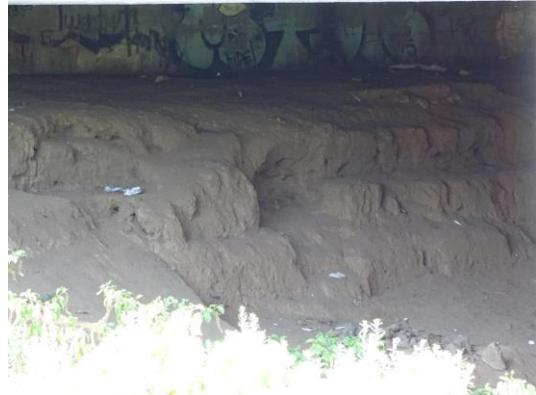
Photo 1 of 1 : CH_2020_NA0060_6_113_20200805_00090.jpg

View of erosion on the left bank looking downstream, 2020.

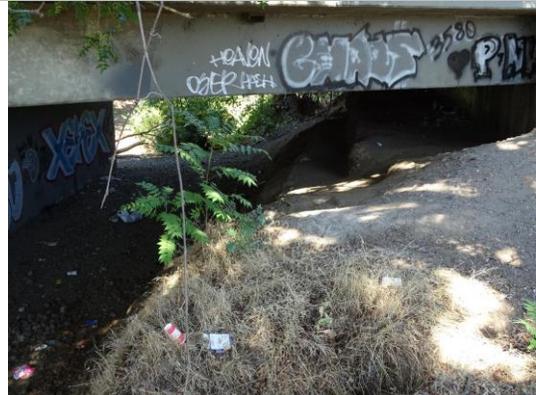
Photo 1 of 1 : CH_2020_NA0060_6_114_20200805_00089.jpg

View looking downstream at the right bank abutment, no revetment observed, 2020.

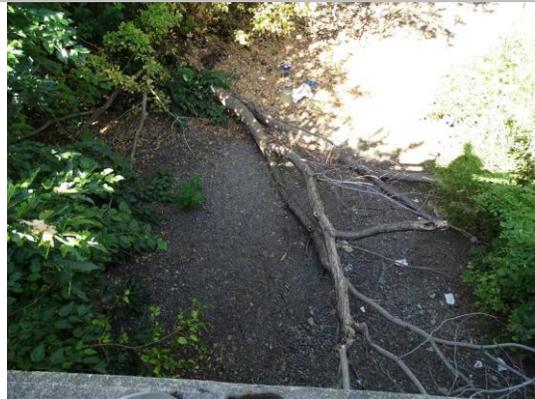
Photo 1 of 1 : CH_2020_NA0060_6_120_20200805_00091.jpg

View of a tree in the channel downstream of the bridge, 2020.

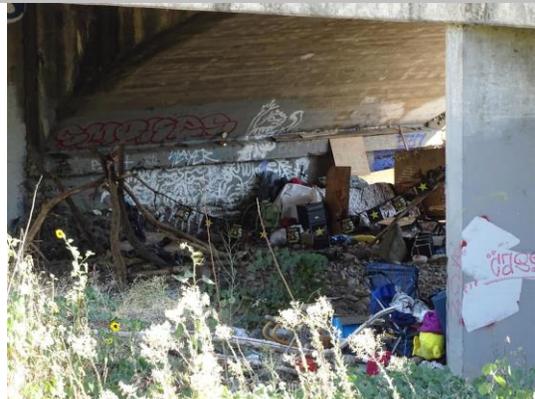
Photo 1 of 2 : CH_2020_NA0060_6_55_20200805_00095.jpg

View of the right bank facing upstream. Large debris and trash piles from campers, 2020.

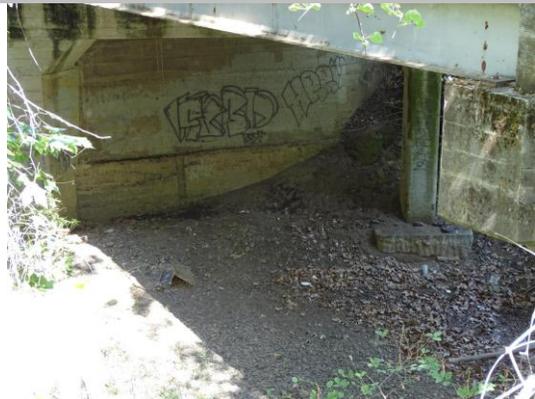
Photo 2 of 2 : CH_2020_NA0060_6_74_20200805_00108.jpg

View of right abutment with no revetment, 2020

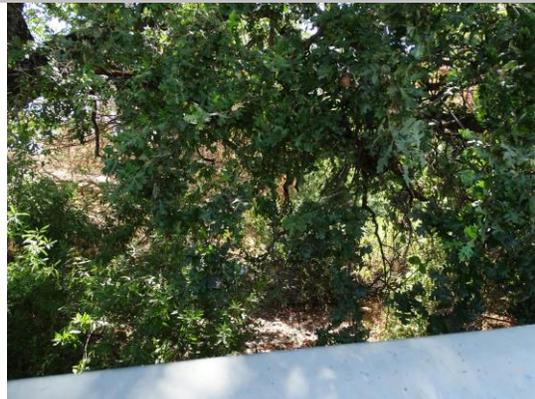
Photo 1 of 1 : CH_2020_NA0060_12_114_20200805_00049.jpg

View looking upstream from the bridge of the overhanging vegetation, 2020.

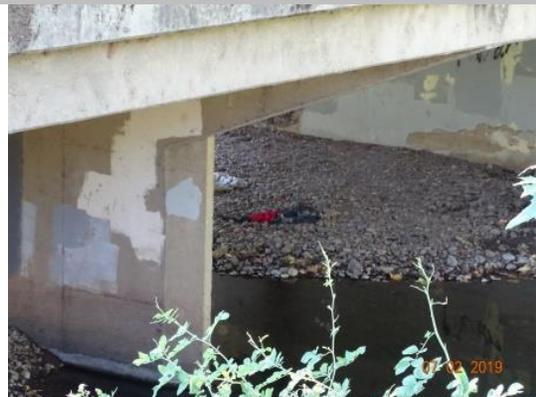
Photo 1 of 2 : CH_2020_NA0060_12_88_20200730_00030.jpg

View of the abutment right bank, no revetment was observed at either side, 2019.

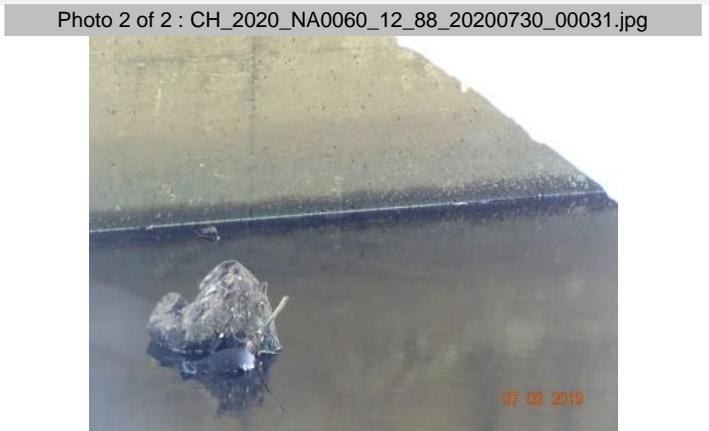
Check Point / View				
Bruce Street / Up (cont)				
Rating **	N	Issue No.	88 (cont)	GPS Lat/Long
Issue Type +	Ma	Location *		39.733204 °
Category	Rivers, Channels & Designated Flood			-121.819610 °
Item	Revetments			
DWR ID	DWR_NA0060_12_c_2015_88			
Action/Comments				
Inspector Comments: No riprap was observed.

View of the abutment left bank, no revetment was observed at either side, 2019.

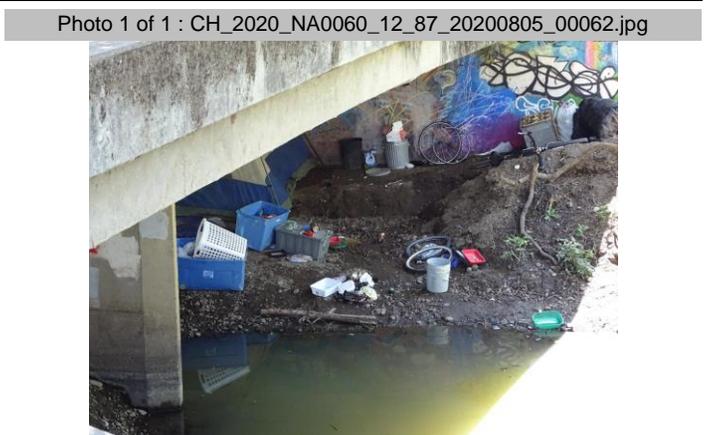
Rating **	M	Issue No.	87	GPS Lat/Long
Issue Type +	Ma	Location *		39.733204 °
Category	Rivers, Channels & Designated Flood			-121.819610 °
Item	Encroachments			
DWR ID	DWR_NA0060_12_c_2015_87			
Action/Comments				
Inspector Comments: Trash and debris left by campers should be removed.

View of trash and debris left by campers, 2020.

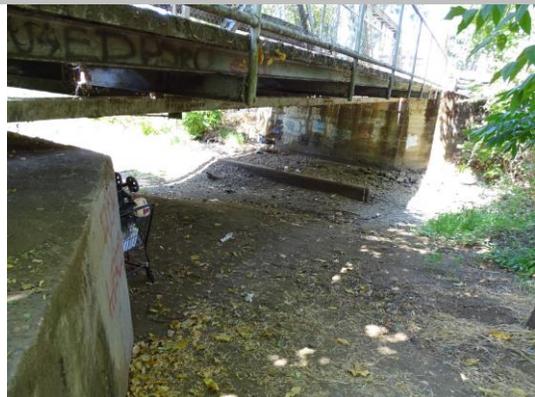
Photo 1 of 2 : CH_2020_NA0060_12_44_20200805_00046.jpg

View of the right bank abutment, no revetment present, 2020.

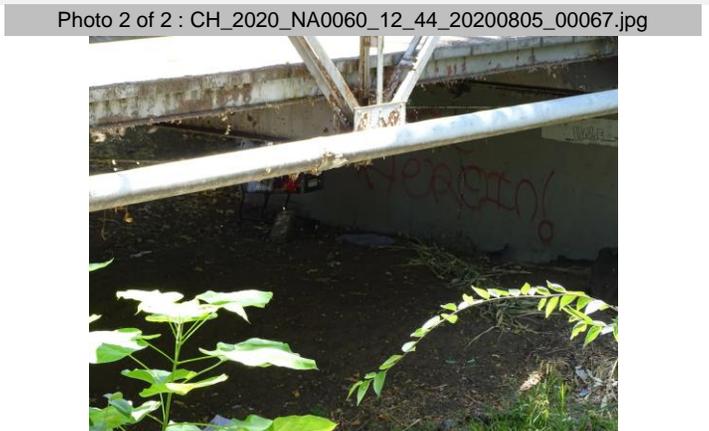
Check Point / View			
Boucher St / Up (cont)			
Rating **	N	Issue No.	44 (cont)
Issue Type +	Ma	Location *	39.730240 °
Category	Rivers, Channels & Designated Flood		-121.823800 °
Item	Revetments		
DWR ID	DWR_NA0060_12_c_2012_44		
Action/Comments			
Inspector Comments: There was no riprap observed at this site.

View of the left bank abutment, no revetment present, 2020

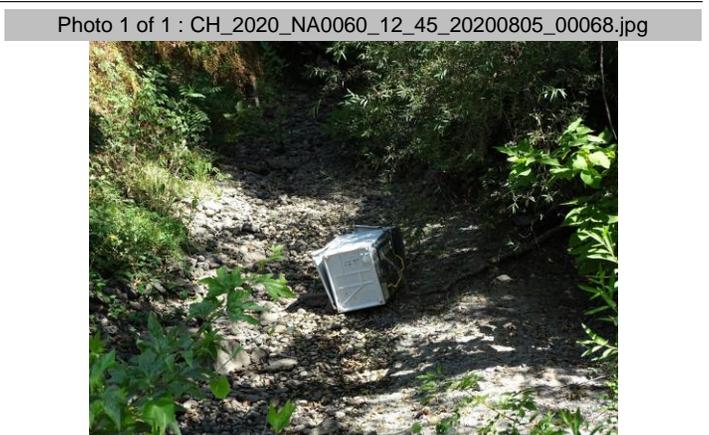
Rating **	A	Issue No.	45
Issue Type +	Ma	Location *	39.730240 °
Category	Rivers, Channels & Designated Flood		-121.823800 °
Item	Encroachments		
DWR ID	DWR_NA0060_12_c_2012_45		
Action/Comments			
Inspector Comments: Debris observed in the channel upstream of the bridge should be removed but will not impede the flow, 2020.

View of debris in the channel upstream of the bridge, 2020.

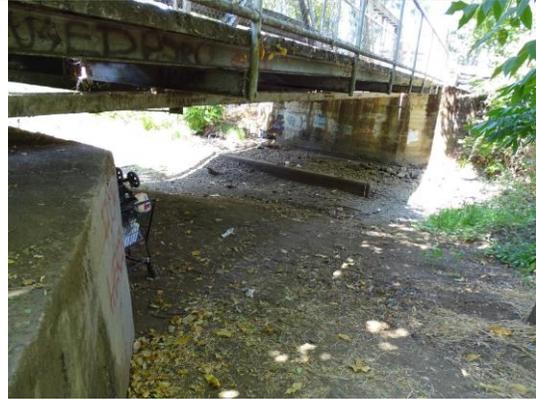
Photo 1 of 1 : CH_2020_NA0060_12_50_20200805_00069.jpg

View of debris and trash left by campers on the left bank, 2020.

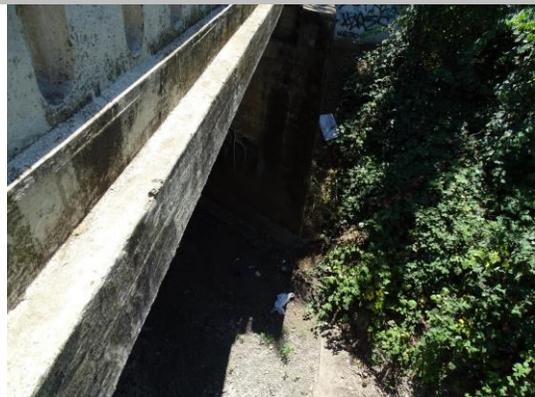
Photo 1 of 2 : CH_2020_NA0060_12_64_20200805_00077.jpg

View of left abutment, no revetment observed, 2020.

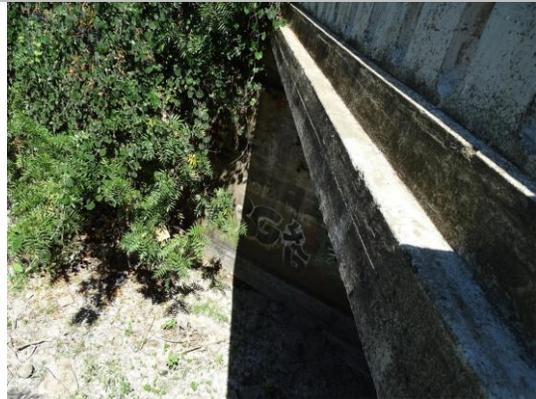
Photo 2 of 2 : CH_2020_NA0060_12_64_20200805_00078.jpg

View of right abutment, no revetment observed, 2020.

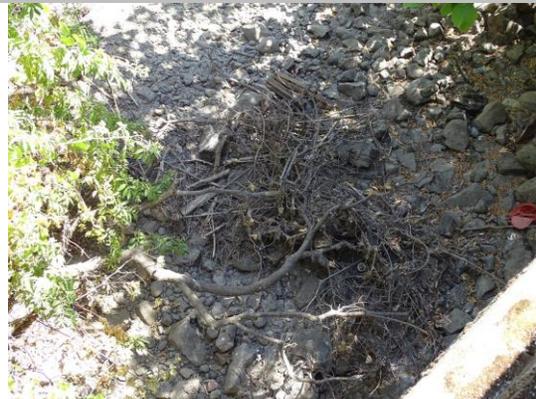
Photo 1 of 1 : CH_2020_NA0060_12_65_20200805_00076.jpg

View of wood debris in channel upstream of the bridge, 2020.

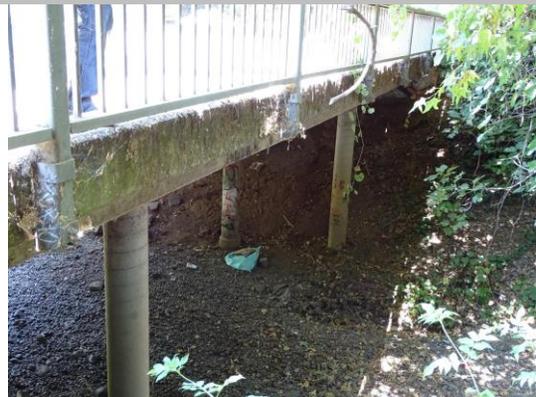
Photo 1 of 2 : CH_2020_NA0060_12_97_20200805_00081.jpg

View of right bank of abutment, no revetment present, 2020.

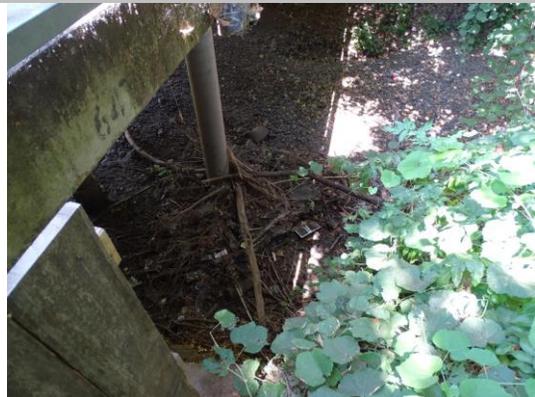
Photo 1 of 1 : CH_2020_NA0060_12_98_20200805_00083.jpg

View of wood debris piled on upstream bridge pier, 2020

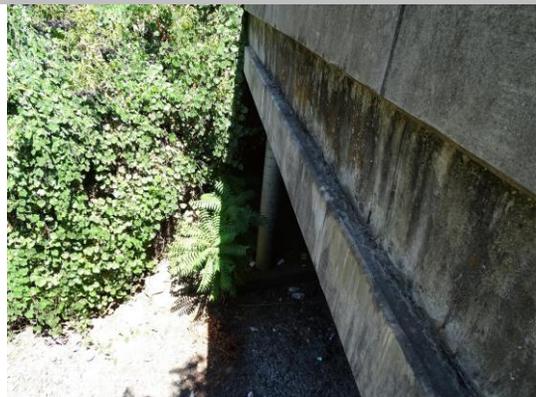
Photo 1 of 2 : CH_2020_NA0060_12_107_20200805_00086.jpg

View of the right bank abutment, revetment present but overgrown, 2020.

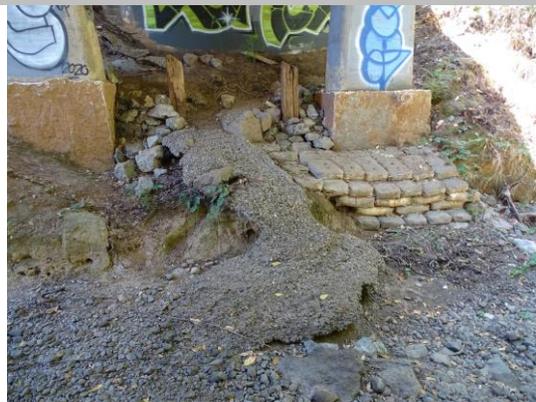
Photo 1 of 1 : CH_2020_NA0060_12_73_20200805_00092.jpg

View of erosion under the sandbag revetment, 2020.

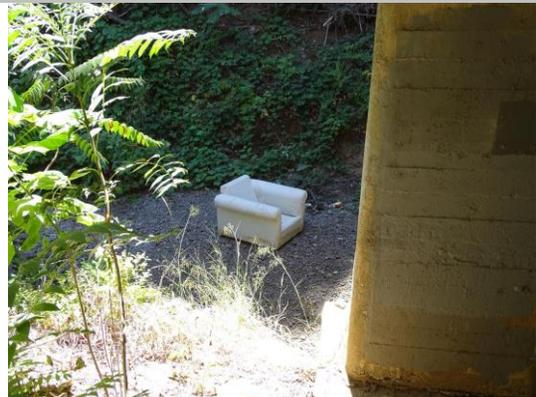
Photo 1 of 1 : CH_2020_NA0060_12_75_20200805_00093.jpg

View of debris in channel upstream of bridge, 2020.
