**Flood Control Project Maintenance**  
**2020 Structure Summary Report**  
**Overall Unit and Item Ratings**

**DWR Sutter Maintenance Yard**

**Butte Slough Drainage Structure**

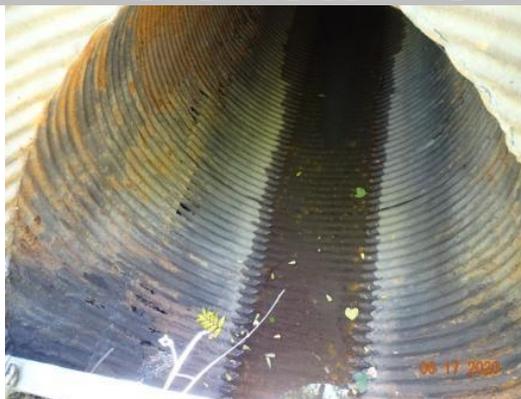
Photo 1 of 1 : ST\_2020\_NA0060\_38\_8\_20200618\_00018.jpg

LM Start	<b>0.00</b>	Rating **	M	Issue No.	<b>8</b>
LM End	<b>0.00</b>	Issue Type +	Ma	Location *	
Category	Structures & Concrete Lined Channels		GPS Latitude/Longitude		
			Start	End	
Item	Culverts: Breaks / Holes / Cracks		39.197288 °	39.197288 °	
			-121.943847 °	-121.943847 °	
DWR ID	DWR_NA0060_38_t_2012_8				
Action/Comments					
Inspector Comments: The visible portion of the culvert shows small holes due to corrosion.

View of the pipe from the landside.

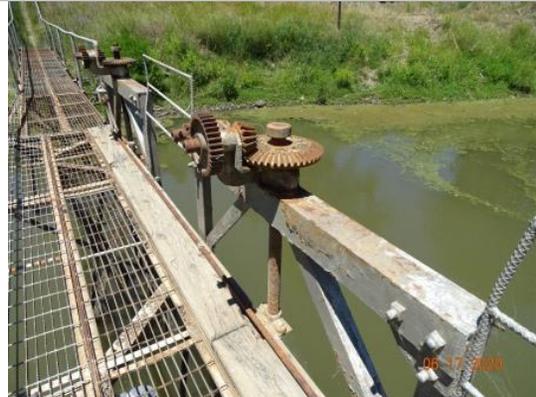
Photo 4 of 8 : ST\_2020\_NA0060\_42\_1\_20200618\_00015.jpg

View of the valve operator with rust on the gears.

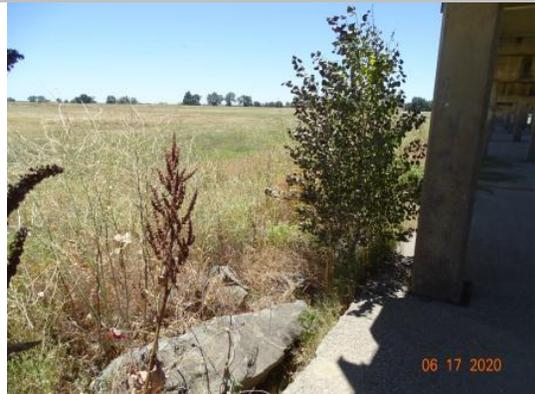
Photo 1 of 1 : ST\_2020\_NA0060\_55\_2\_20200618\_00023.jpg

View of a tree growing along one of the pillars on the downstream side of the weir.

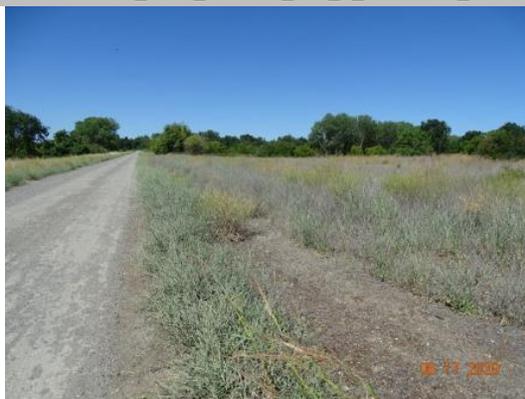
Photo 1 of 2 : ST\_2020\_NA0060\_225\_2\_20200618\_00009.jpg

View of the vegetation on the upstream of the weir.

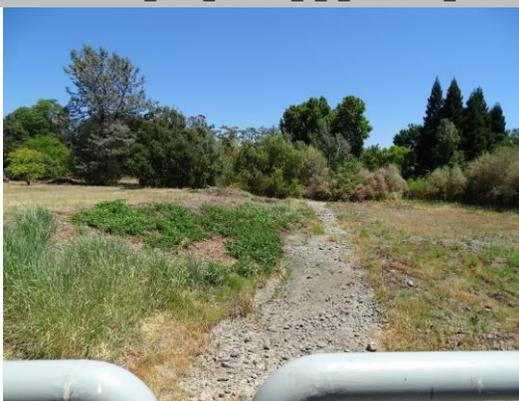
Photo 1 of 3 : ST\_2020\_NA0060\_9\_2\_20200805\_00027.jpg

This is a view looking upstream at the vegetation from the control structure, 2020.

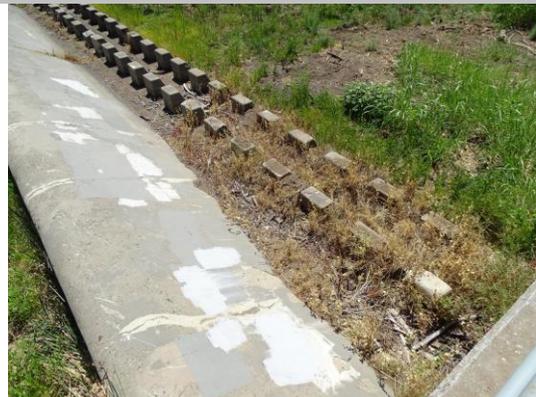
Photo 1 of 1 : ST\_2020\_NA0060\_9\_6\_20200805\_00030.jpg

View of wood debris trapped in the north side of the weir, 2020.

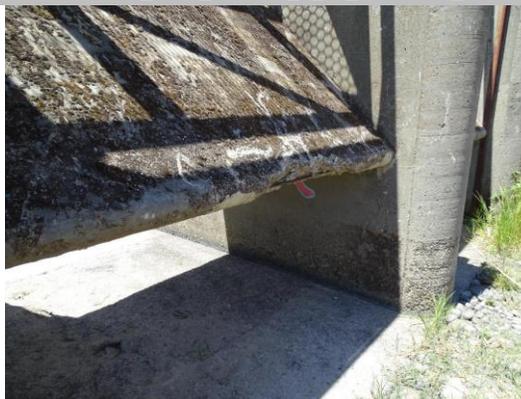
Photo 1 of 1 : ST\_2020\_NA0060\_9\_15\_20200805\_00032.jpg

View of one of the inlets that is showing some wear and spalling and rebar is exposed, 2020.

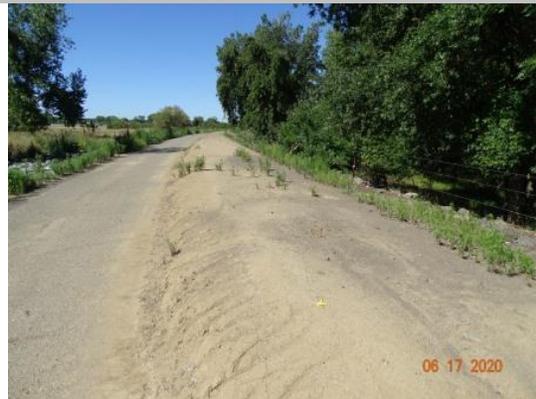
Photo 3 of 3 : ST\_2020\_NA0060\_228\_1\_20200618\_00009.jpg

View of the temporary berm on the upstream side of the overflow structure.

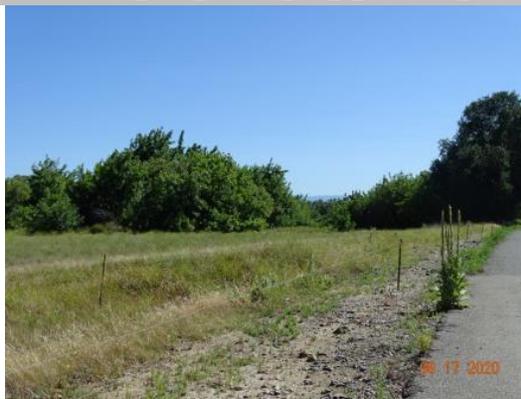
Photo 1 of 1 : ST\_2020\_NA0060\_228\_2\_20200618\_00010.jpg

View of the vegetation on the upstream side of the weir.

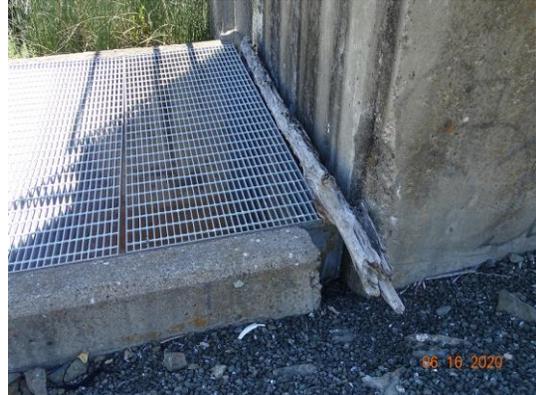
Photo 2 of 2 : ST\_2020\_NA0060\_17\_3\_20200617\_00013.jpg

View of the settlement on the adjacent structure. Summer 2020.

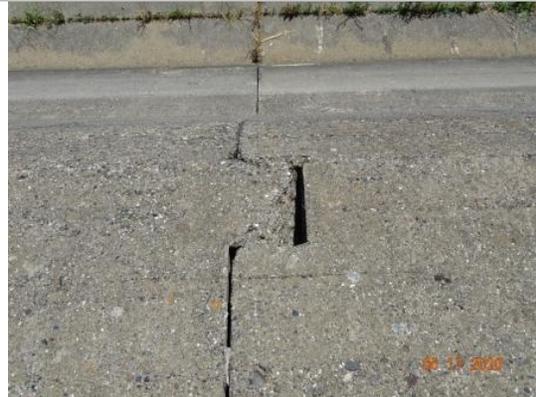
Photo 1 of 2 : ST\_2020\_NA0060\_4\_15\_20200618\_00024.jpg

View of the spalling at one of the joints.

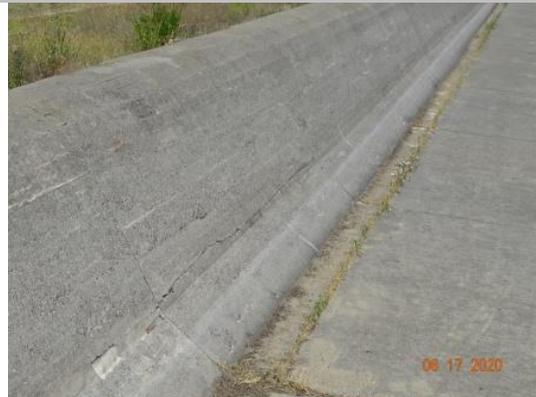
Photo 2 of 2 : ST\_2020\_NA0060\_4\_15\_20200618\_00025.jpg

View of a longitudinal crack along a vertical concrete section.

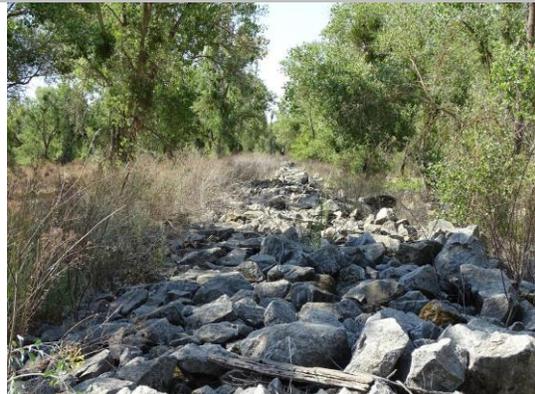
Photo 1 of 3 : ST\_2020\_NA0060\_54\_2\_20200727\_00003.jpg

View of the vegetation that is overgrowing the rock weir looking south, 2020.

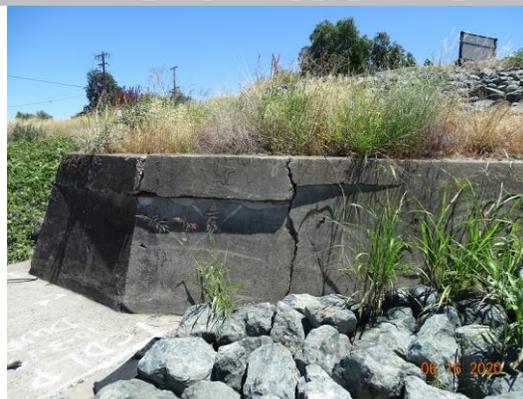
Photo 1 of 3 : ST\_2020\_NA0060\_3\_15\_20200617\_00022.jpg

View of cracks on the south abutment. Summer 2020.

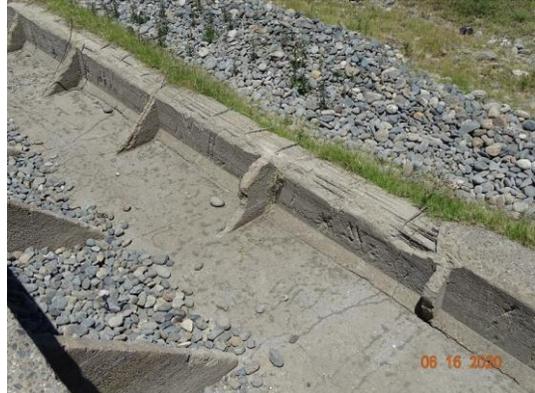
Photo 2 of 3 : ST\_2020\_NA0060\_3\_15\_20200617\_00023.jpg

View of exposed rebar on the still basin. Summer 2020.
