**Flood Control Project Maintenance  
Levee Inspections**

**Maintenance Issue Types Only, Levee Inspection Report By Mile - Fall 2019**

**Reclamation District No. 0001 Union Island**

Waterway	Bank	Unit Miles	Inspection Start/End	Inspector
Unit No. 01 Old River	Right	1.14	11/05/2019 11/05/2019	Alberto De Leon

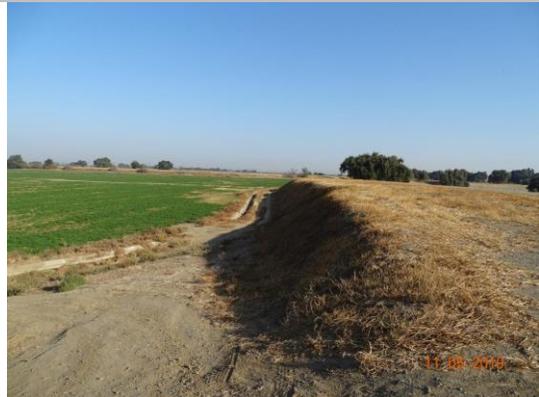
Photo 1 of 1 : FA\_2019\_RD0001\_23\_12\_20191111\_00024.jpg

LM Start	<b>0.25</b>	Rating **	A	Issue No.	<b>12</b>
LM End	<b>0.25</b>	Issue Type +	Ma	Location *	LS
Category	Earthen Levee			GPS Latitude/Longitude	
				Start	End
Item	Vegetation			37.820297°	37.820297°
				-121.378509°	-121.378509°
DWR ID	DWR_RD0001_01_f_2019_12				
Comment Code					
V1 : Control annual grass and weeds on the levee slopes and easements.					
Inspector Comment					
Annual vegetation is well maintained.

View of vegetation on landside slope. Fall 2019
