**Flood Control Project Maintenance
Levee Inspections**

Fall 2019 Levee Maintenance Deficiency Summary Report

Sacramento River Basin

Reclamation District No. 0010 Honcut

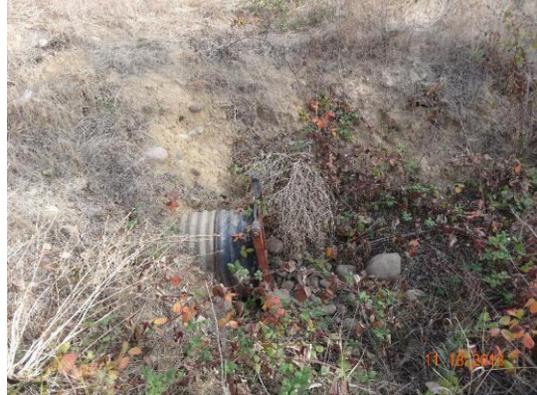
Photo 3 of 3 : UCIP_FA_2019_27791_51504.jpg

Comment Code					
Inspector Comment					
DS_ID:21268 FS_ID:27791 EP_NO: N/A Repair Type: Non-Urgent Crossing Status: Found UCIP Comments: 04/29/2013 Vegetation has been cleared from slope. This crossing is referenced in the USACE Periodic Inspection as item USACE_CESPK_HON1_2013_p_0158. (DWR UCIP - O. Magana) FIELD_STRUCT_DESC: 24-inch corrugated metal gravity drainage pipe through the levee, 30 feet below the crown. Flap gate on the waterside (WS) end. Slide gate on the landside (LS) end. Concrete saddle and apron on the WS. [Additional Reference(s): DWR Levee Log, 2005. USACE Sacramento O&M Manual 151, May 1953, (Station 1+00)]. FS Date: 4/29/2013

View of pipe and flap gate located on waterward side.

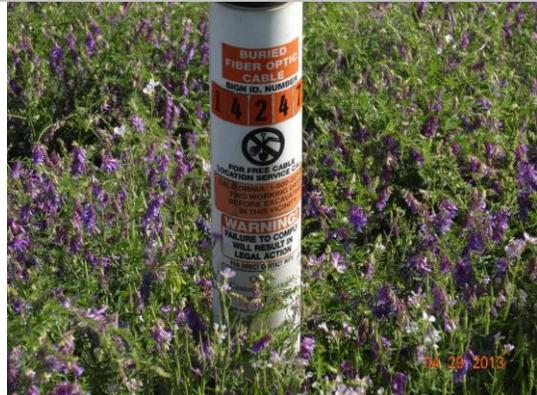
Photo 1 of 2 : UCIP_FA_2019_27712_51365.jpg

LM Start	0.23	Rating **	M	Issue No.	66
LM End	0.23	Issue Type +	En	Location *	
Category	Supplemental			GPS Latitude/Longitude	
				Start	End
Item	DRAFT DWR UCIP Field Study			39.163407 °	39.163407 °
				-121.605645 °	-121.605645 °
DWR ID	24653				
Comment Code					
Inspector Comment					
DS_ID:24653 FS_ID:27712 EP_NO: N/A Repair Type: Non-Urgent Crossing Status: Indicator Found UCIP Comments: 04/29/2013 Need to contact owner--unable to determine if crossing is authorized (no permit found) also need to determine if crossing goes through levee. (DWR UCIP - O. Magana) FIELD_STRUCT_DESC: Fiber optics line markers on the levee slope. Unable to determine if this line goes through the levee. This line was field discovered. FS Date: 4/29/2013

Contact information for buried fiber optic cable.

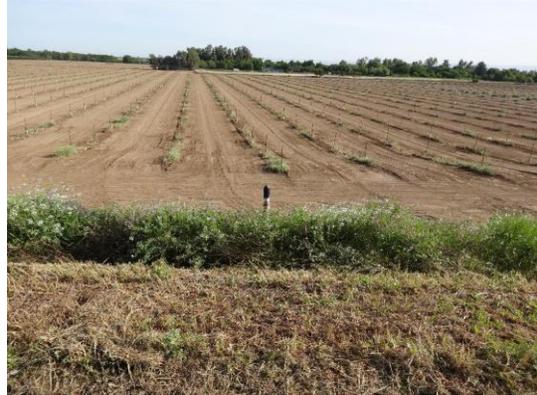
Photo 2 of 2 : UCIP_FA_2019_27712_51364.jpg

LM Start	0.23	Rating **	M	Issue No.	66 (cont)	
LM End	0.23	Issue Type +	En	Location *		
Category	Supplemental			GPS Latitude/Longitude		
				Start	End	
Item	DRAFT DWR UCIP Field Study			39.163407°	39.163407°	
				-121.605645°	-121.605645°	
DWR ID	24653					
Comment Code						
Inspector Comment						
DS_ID:24653 FS_ID:27712 EP_NO: N/A Repair Type: Non-Urgent Crossing Status: Indicator Found UCIP Comments: 04/29/2013 Need to contact owner--unable to determine if crossing is authorized (no permit found) also need to determine if crossing goes through levee. (DWR UCIP - O. Magana) FIELD_STRUCT_DESC: Fiber optics line markers on the levee slope. Unable to determine if this line goes through the levee. This line was field discovered. FS Date: 4/29/2013

Marker visible on landward side.

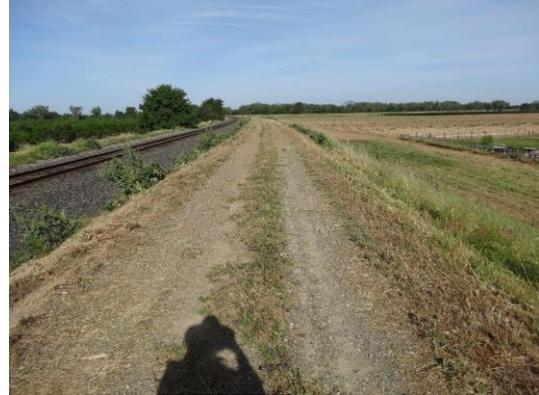
Photo 1 of 3 : UCIP_FA_2019_24806_44540.jpg

Comment Code					
Inspector Comment					
DS_ID:21257 FS_ID:24806 EP_NO: 13015 Repair Type: Non-Urgent Crossing Status: Found UCIP Comments: 04/29/2013 New gravel indicates work was recently completed. Will need to contact owner to obtain information pertaining to work completed. Need to contact owner to determine if crossing is still active and to determine last inspection date. Will need copy of letter showing crossings passed inspection. This crossing is referenced in the USACE Periodic Inspection as item USACE_CESPK_HON1_2013_p_0075. (DWR UCIP - O. Magana) FIELD_STRUCT_DESC: 4-inch steel natural gas pipeline sleeved through an 8-inch pipe through the levee, 30 feet below the crown. Annular space grouted. Cutoff wall on each end within the levee. (Plans to reinforce an existing 4-inch gas main with a parallel 4-inch main through the levee authorized under Permit No. 13015, 1980 - Pacific Gas and Electric Company [PG&E]). [Additional Reference(s): DWR Levee Log, 2005]. FS Date: 4/29/2013

View of levee crown looking upstream.

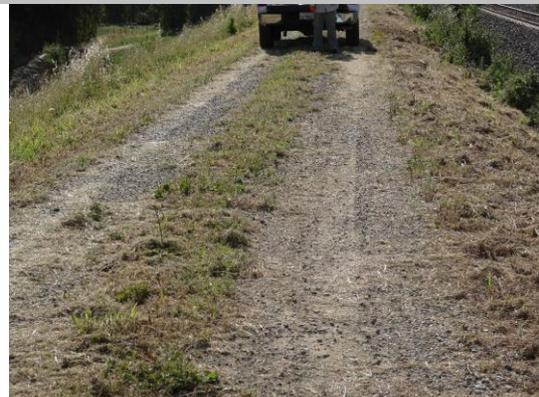
Photo 2 of 3 : UCIP_FA_2019_24806_44541.jpg

View of levee crown looking downstream.

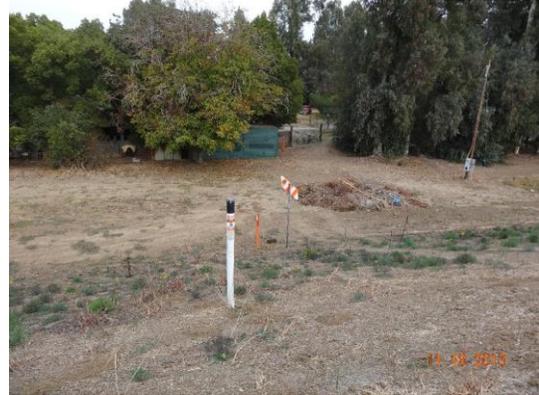
Photo 3 of 3 : UCIP_FA_2019_24806_44543.jpg

Comment Code					
Inspector Comment					
<p>DS_ID:21257 FS_ID:24806 EP_NO: 13015 Repair Type: Non-Urgent Crossing Status: Found UCIP Comments: 04/29/2013 New gravel indicates work was recently completed. Will need to contact owner to obtain information pertaining to work completed. Need to contact owner to determine if crossing is still active and to determine last inspection date. Will need copy of letter showing crossings passed inspection. This crossing is referenced in the USACE Periodic Inspection as item USACE_CESPK_HON1_2013_p_0075. (DWR UCIP - O. Magana) FIELD_STRUCT_DESC: 4-inch steel natural gas pipeline sleeved through an 8-inch pipe through the levee, 30 feet below the crown. Annular space grouted. Cutoff wall on each end within the levee. (Plans to reinforce an existing 4-inch gas main with a parallel 4-inch main through the levee authorized under Permit No. 13015, 1980 - Pacific Gas and Electric Company [PG&E]). [Additional Reference(s): DWR Levee Log, 2005]. FS Date: 4/29/2013</p>

View of landward side--gas marker and conduit line marker.

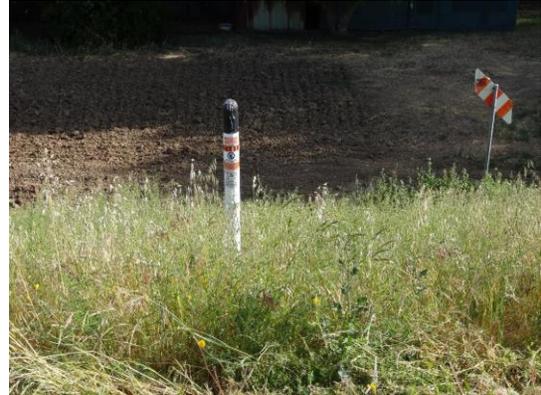
Photo 1 of 2 : UCIP_FA_2019_27713_51366.jpg

LM Start	0.41	Rating **	M	Issue No.	68
LM End	0.41	Issue Type +	En	Location *	
Category	Supplemental			GPS Latitude/Longitude	
				Start	End
Item	DRAFT DWR UCIP Field Study			39.162853°	39.162853°
				-121.602435°	-121.602435°
DWR ID	24654				
Comment Code					
Inspector Comment					
DS_ID:24654 FS_ID:27713 EP_NO: N/A Repair Type: Non-Urgent Crossing Status: Indicator Found UCIP Comments: 04/29/2013 Need to contact owner--unable to determine if crossing is authorized (no permit found) also need to determine if crossing goes through levee. (DWR UCIP - O. Magana) FIELD_STRUCT_DESC: Fiber optics line markers on levee slope. Unable to determine if line goes through the levee. This line was field discovered. FS Date: 4/29/2013

View of landward side--communication line marker.

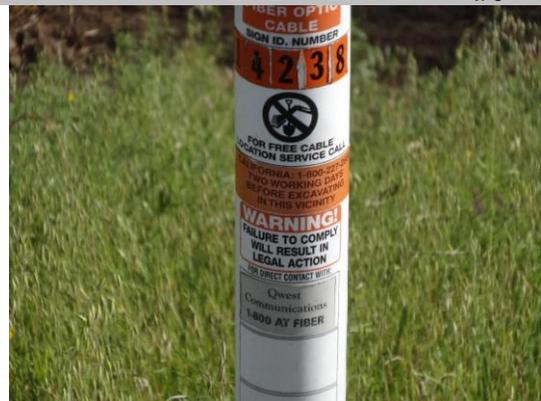
Photo 2 of 2 : UCIP_FA_2019_27713_51367.jpg

Contact information for communication line.

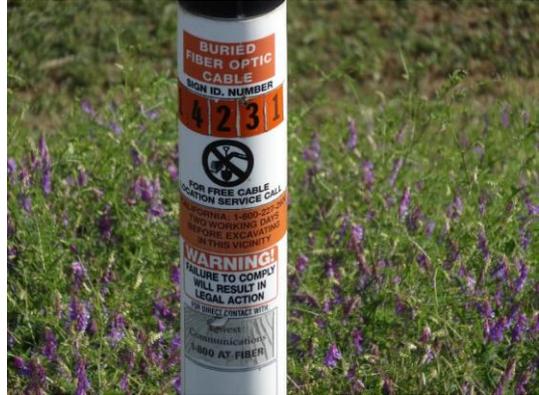
Photo 1 of 2 : UCIP_FA_2019_27710_51361.jpg

LM Start	0.53	Rating **	M	Issue No.	69
LM End	0.53	Issue Type +	En	Location *	
Category	Supplemental			GPS Latitude/Longitude	
				Start	End
Item	DRAFT DWR UCIP Field Study			39.162277°	39.162277°
				-121.600219°	-121.600219°
DWR ID	24655				
Comment Code					
Inspector Comment					
DS_ID:24655 FS_ID:27710 EP_NO: N/A Repair Type: Non-Urgent Crossing Status: Indicator Found UCIP Comments: 04/29/2013 Need to contact owner--unable to determine if crossing is authorized (no permit found) also need to determine if crossing goes through levee. (DWR UCIP - O. Magana) FIELD_STRUCT_DESC: Fiber optics line markers on levee slope. Unable to determine if line goes through the levee. This line was field discovered. FS Date: 4/29/2013

Contact information for fiber optic cable and ID number.

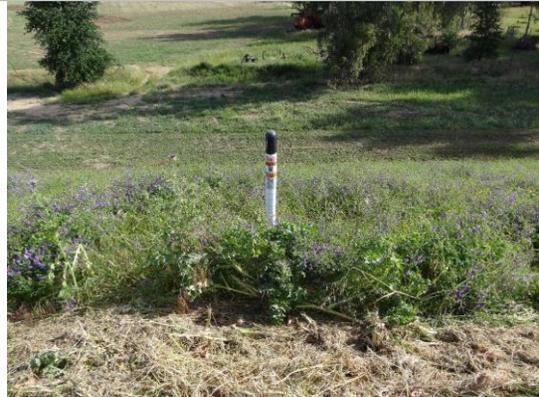
Photo 2 of 2 : UCIP_FA_2019_27710_51360.jpg

View of marker located on landward side.

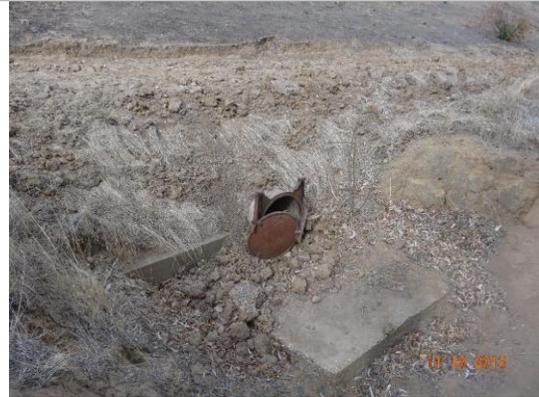
Photo 3 of 3 : UCIP_FA_2019_50058_51414.jpg

Comment Code					
Inspector Comment					
<p>DS_ID:21258 FS_ID:50058 EP_NO: N/A Repair Type: Non-Urgent Crossing Status: Found UCIP Comments: 7/01/2016 Gate has been repaired--WS gate is functional. LS gate still needs new stem for the gate to properly function--stem is bent. USACE's PI issue references permit number 13710 this is incorrect permit is associated with DS_ID 21259 (CLM 0.767). (DWR UCIP - omagana)4/29/2013 Damaged flap gate on waterward side and damaged stem on screw gate on landward side. Need to contact owner to determine if crossing is still active. If crossing is still in use owner will need to address damage on flap gate and screw gate. If crossing is no longer in use owner will need to contact the CVFPB to comply with Title 23. This crossing is referenced in the USACE Periodic Inspection as item USACE_CESPK_HON1_2013_p_0053 and 0057. (DWR UCIP - omagana) FIELD_STRUCT_DESC: 24-inch corrugated metal gravity drainage pipe through the levee, 31 feet below the crown. Two corrugated metal cutoff walls around pipe. Concrete headwall at each end. Flap gate on the waterside (WS) end. Slide gate on the landside (LS) end. Pipe discharges into 6-foot concrete splash apron on the WS. [Additional Reference(s): DWR Levee Log, 2005. USACE Sacramento O&M Manual 151, May 1953, (Station 46+60)]. FS Date: 7/1/2016</p>

Damage flap gate located on WS.

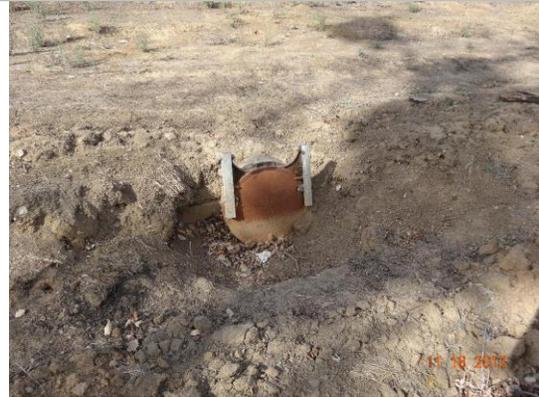
Photo 3 of 3 : UCIP_FA_2019_27748_51451.jpg

Comment Code					
Inspector Comment					
DS_ID:21261 FS_ID:27748 EP_NO: N/A Repair Type: No Action Needed Crossing Status: Found UCIP Comments: 04/29/2013 No signs of damage to levee present during inspection. This crossing is referenced in the USACE Periodic Inspection as item USACE_CESPK_HON1_2013_p_0037 and 0040. (DWR UCIP - O. Magana) FIELD_STRUCT_DESC: 24-inch corrugated metal gravity drainage pipe through the levee, 29.5 feet below the crown. Two corrugated metal cutoff walls around the pipe on each end. Slide gate on the landside (LS) end. Flap gate on the waterside (WS) end. Concrete headwall at the LS toe. [Additional Reference(s): DWR Levee Log, 2005. USACE Sacramento O&M Manual 151, May 1953, (Station 37+66)]. FS Date: 4/29/2013

View of flap gate located on waterward side.

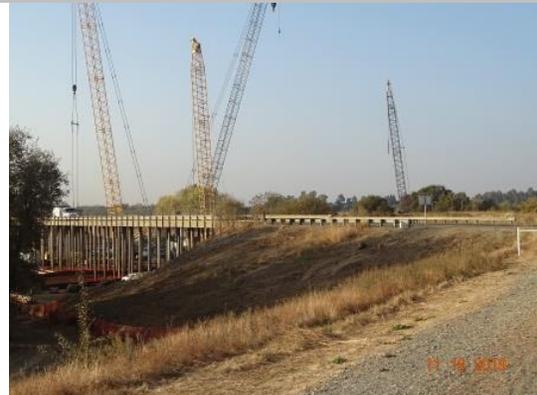
Photo 1 of 2 : FA_2019_RD0010_163_28_20191119_00082.jpg

View looking downstream of the construction of the new Highway 70 Bridge, Fall 2019.

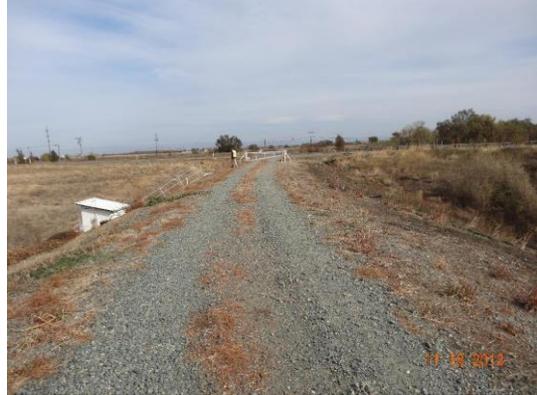
Photo 2 of 3 : UCIP_FA_2019_27725_51387.jpg

Comment Code					
Inspector Comment					
DS_ID:21262 FS_ID:27725 EP_NO: N/A Repair Type: Non-Urgent Crossing Status: Found UCIP Comments: 04/29/2013 Crossing appears not to be in use--need to contact owner. Need to coordinate with owner to determine status of crossing. If crossing is no longer in use owner will need to contact the CVFPB to comply with Title 23. This crossing is referenced in the USACE Periodic Inspection as item USACE_CESPK_HON1_2013_p_0012. (DWR UCIP - O. Magana) FIELD_STRUCT_DESC: 10-inch steel irrigation discharge pipe through the levee, 7.3 feet below the crown. Siphon breaker in a corrugated metal pipe (CMP) riser on the waterside (WS) slope. Pump on the WS berm. Pump not present. Switch house on the WS slope. No switch house present. 24-inch concrete standpipe at the landside (LS) toe. Concrete pad is still present on the WS. [Additional Reference(s): DWR Levee Log, 2005. USACE Sacramento O&M Manual 151, May 1953, (Station 14+82)]. FS Date: 4/29/2013

View of levee crown looking downstream.

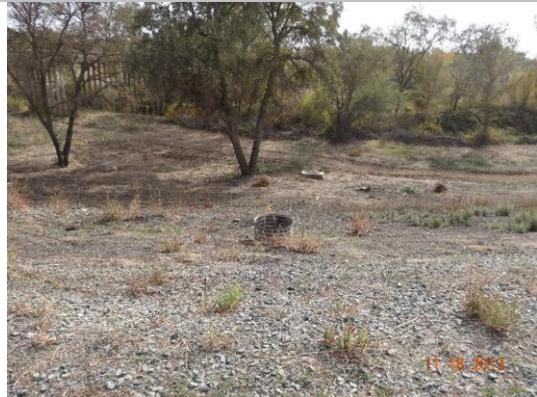
Photo 3 of 3 : UCIP_FA_2019_27725_51384.jpg

View of waterward side-slopes cleared.

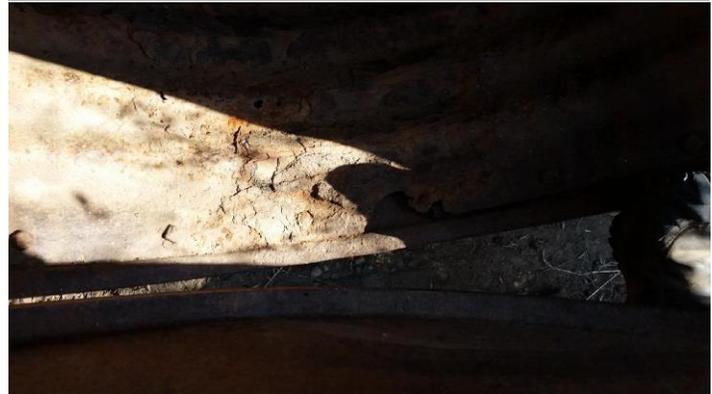
Photo 3 of 3 : UCIP_FA_2019_53136_75321.jpg

Deteriorated pipe wall at the outlet (WS).

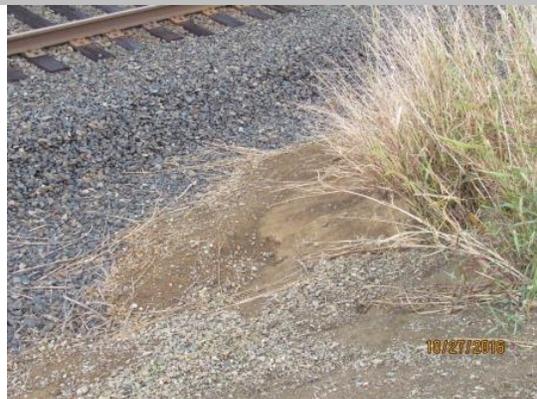
Photo 1 of 1 : FA_2019_RD0010_163_64_20190904_00020.jpg

View of squirrel holes on the landside, no rodent activity was observed.

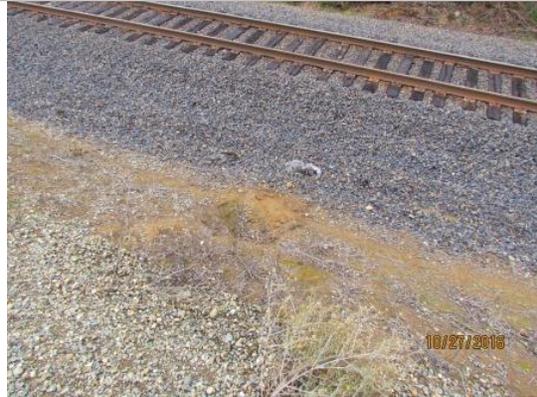
Photo 1 of 1 : FA_2019_RD0010_163_63_20190904_00019.jpg

View of squirrel holes on the landside, no rodent activity was observed.

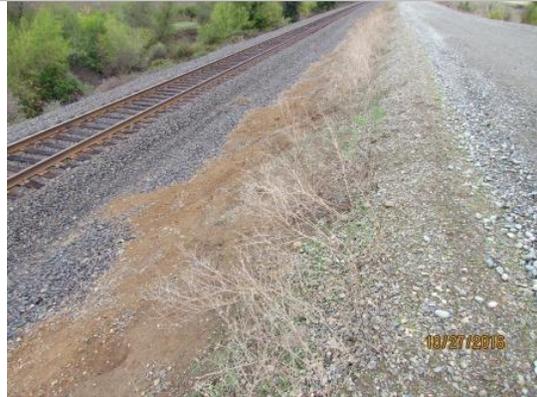
Photo 1 of 1 : FA_2019_RD0010_163_60_20190904_00017.jpg

View of squirrel holes on the landside slope and toe, no rodent activity was observed.

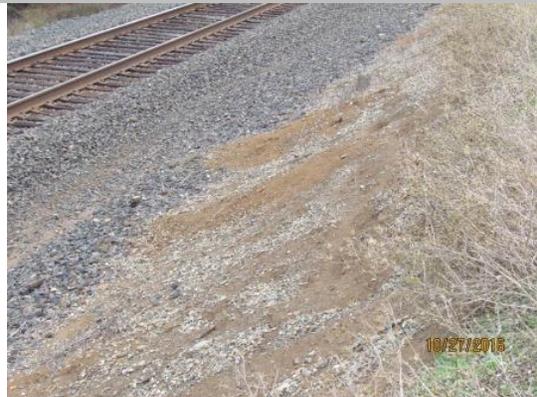
Photo 1 of 1 : FA_2019_RD0010_163_59_20190904_00016.jpg

View of squirrel holes on the landside slope and toe, no rodent activity was observed.

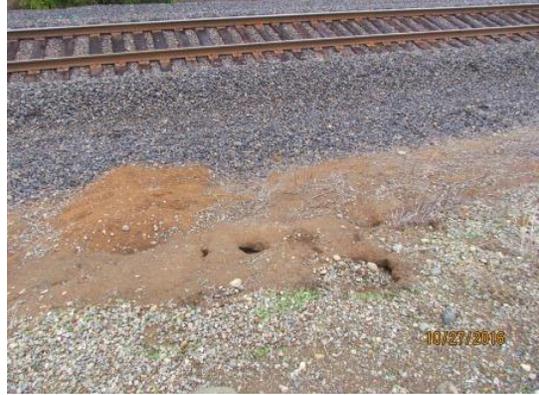
Photo 1 of 1 : FA_2019_RD0010_163_58_20190904_00015.jpg

View of squirrel holes on the landside slope and toe, no rodent activity was observed.

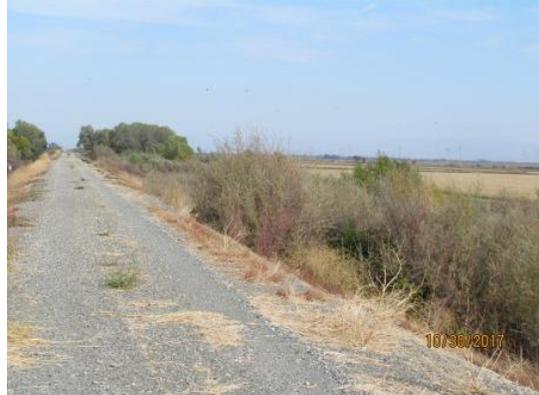
Photo 1 of 1 : FA_2019_RD0010_163_35_20190904_00002.jpg

View looking upstream waterside at Willow Trees that need to be removed.

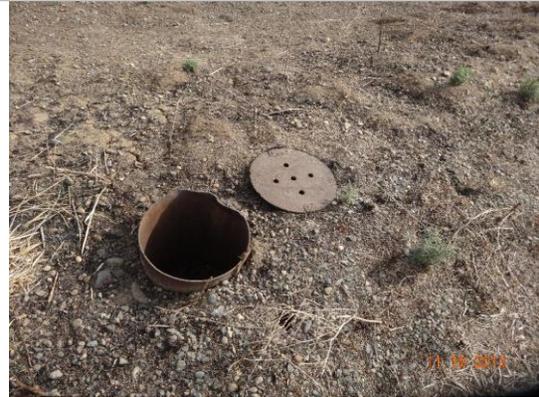
Photo 2 of 3 : UCIP_FA_2019_53137_44605.jpg

View of riser with damage lid located on WS shoulder.

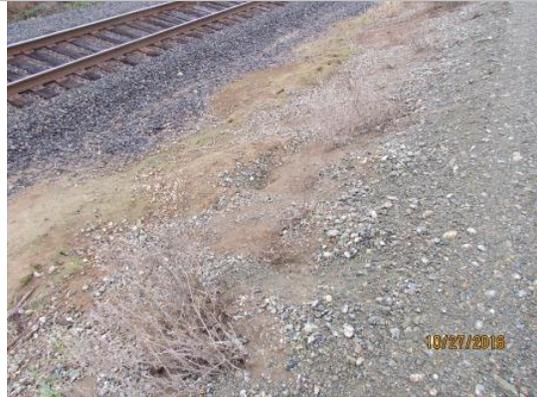
Photo 1 of 1 : FA_2019_RD0010_163_50_20190904_00011.jpg

View of squirrel holes on the landside slope and toe, no rodent activity was observed.

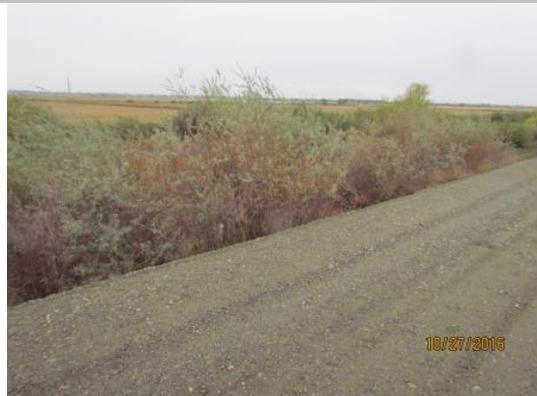
Photo 1 of 1 : FA_2019_RD0010_163_49_20190904_00010.jpg

View of small starter willow trees on the waterside looking upstream.

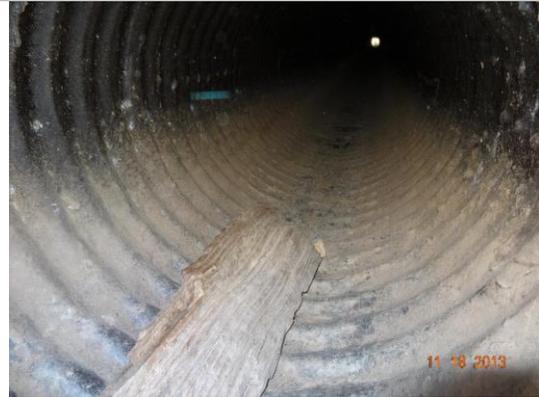
Photo 3 of 3 : UCIP_FA_2019_27747_51443.jpg

Internal view of pipe wall using camera with flash.

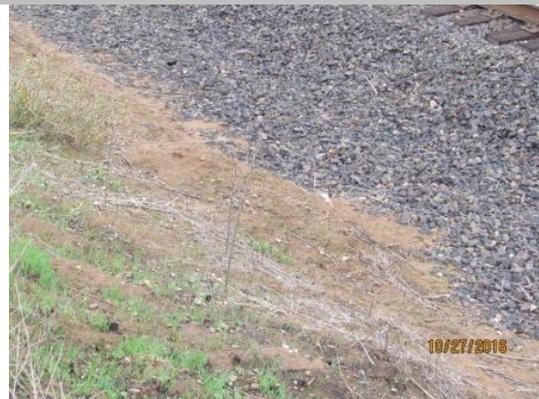
Photo 1 of 1 : FA_2019_RD0010_163_46_20190904_00007.jpg

View of squirrel holes on the landside slope and toe, no rodent activity was observed.

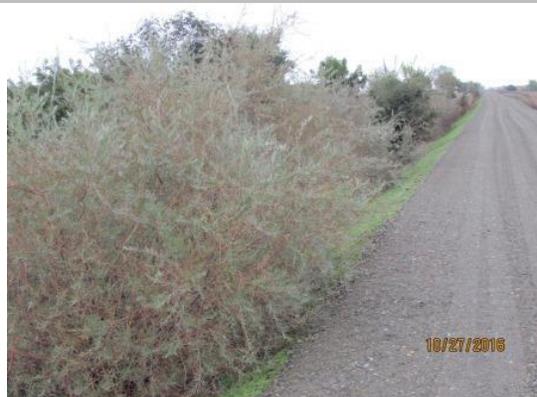
Photo 1 of 1 : FA_2019_RD0010_163_40_20190904_00004.jpg

View of willow trees on the landside slope looking upstream.

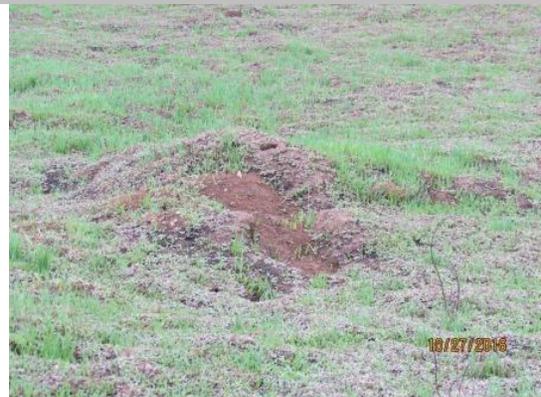
Photo 1 of 1 : FA_2019_RD0010_164_29_20190904_00004.jpg

View of rodent hole that has more than 2 cubic feet of material on the waterside.

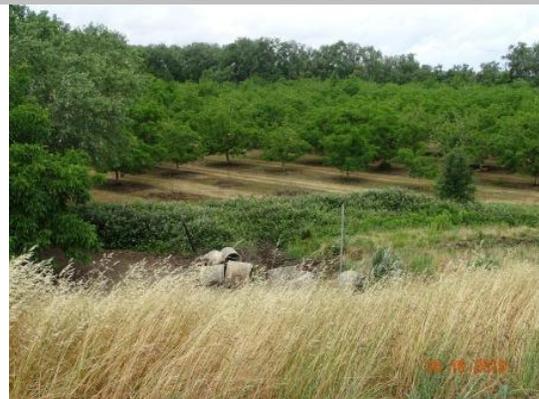
Photo 1 of 1 : FA_2019_RD0010_164_47_20190904_00018.jpg

View looking at the waterside levee toe where debris has been stacked, Spring 2019.

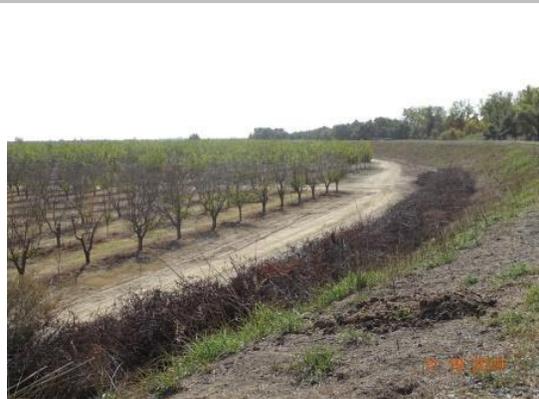
Photo 1 of 1 : FA_2019_RD0010_164_49_20191120_00103.jpg

View looking downstream landside at prunings on levee toe, Fall 2019.

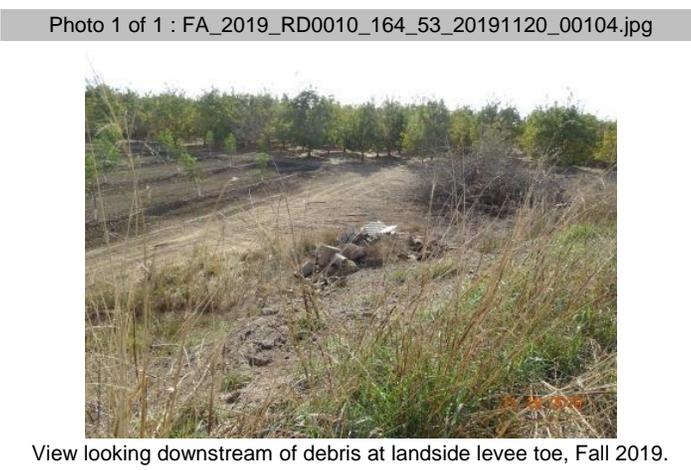
LM Start	7.07	Rating **	M	Issue No.	53
LM End	7.07	Issue Type +	En	Location *	LS
Category	Earthen Levee			GPS Latitude/Longitude	
				Start	End
Item	Encroachments			39.262290 °	39.262290 °
				-121.614390 °	-121.614390 °
DWR ID	DWR_RD0010_02_s_2016_53				
Comment Code					
DE : Debris					
Inspector Comment					
Remove debris from the levee toe, Fall 2019.

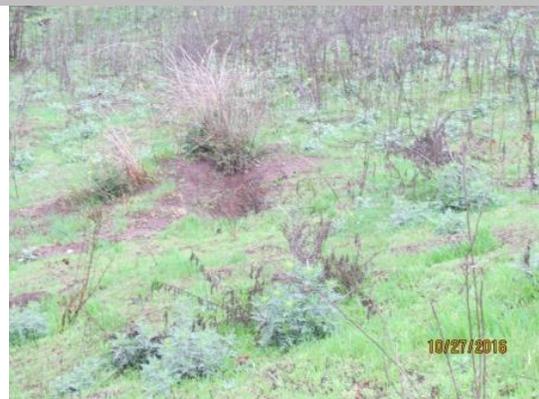
Photo 1 of 1 : FA_2019_RD0010_164_35_20190904_00011.jpg

View of rodent hole on waterside.

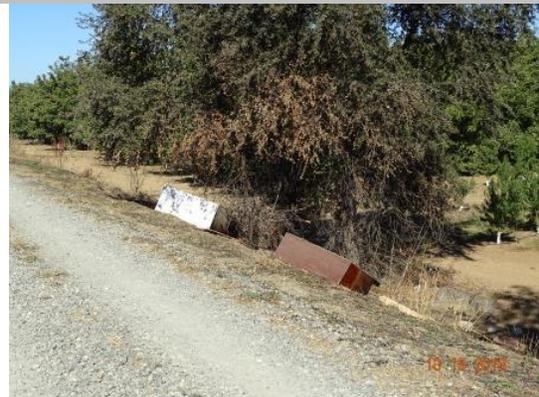
Photo 1 of 1 : FA_2019_RD0010_164_45_20190904_00017.jpg

View looking at the landside levee slope where debris has been dumped.

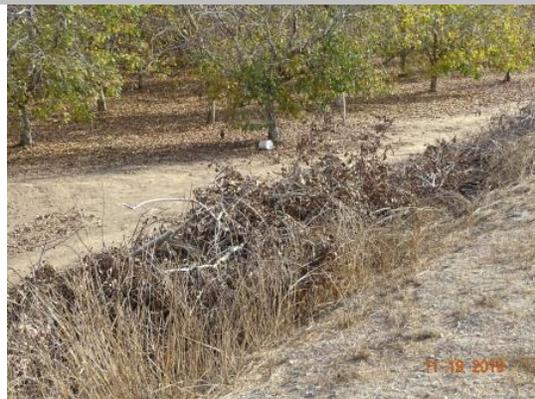
Photo 1 of 1 : FA_2019_RD0010_164_57_20191120_00105.jpg

View looking at the prunings on the landside levee toe, Fall 2019.

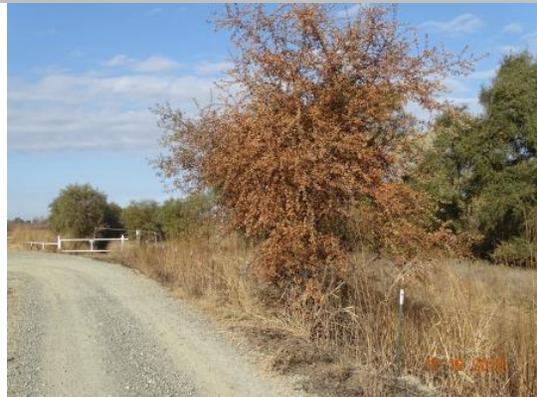
Photo 1 of 1 : FA_2019_RD0010_165_10_20191120_00012.jpg

View looking downstream waterside of a tree that needs to be trimmed for access and visibility, Fall 2019.

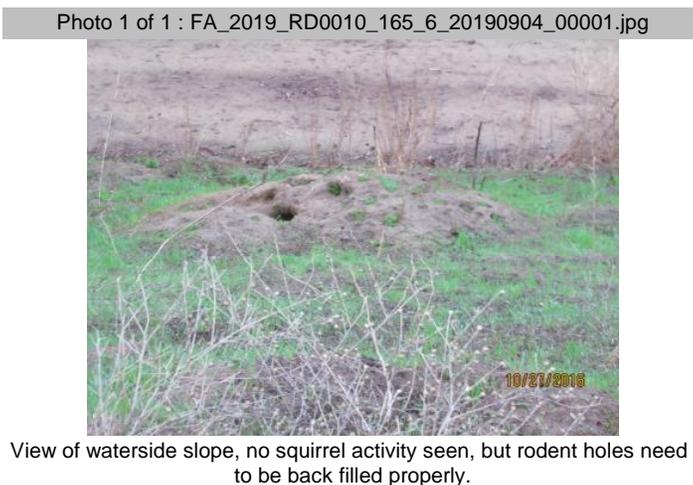
LM Start	1.72	Rating **	M	Issue No.	6
LM End	1.72	Issue Type +	Ma	Location *	WS
Category	Earthen Levee			GPS Latitude/Longitude	
				Start	End
Item	Animal Control			39.303262°	39.303262°
				-121.587680°	-121.587680°
DWR ID	DWR_RD0010_03_f_2016_6				
Comment Code					
A3 : No rodents visible, but rodent burrows visible; need to backfill and compact or grout burrows.					
Inspector Comment					
No squirrel activity seen, but rodent holes need to be back filled properly, Fall 2019.

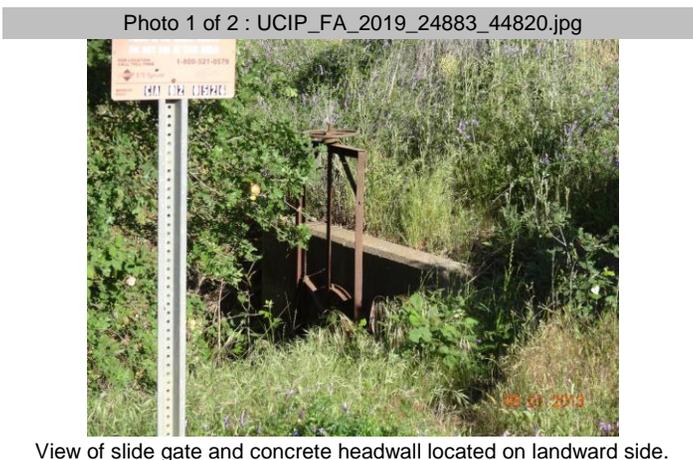
LM Start	2.80	Rating **	M	Issue No.	13
LM End	2.80	Issue Type +	Ma	Location *	
Category	Supplemental			GPS Latitude/Longitude	
				Start	End
Item	DRAFT DWR UCIP LMA Responsibility			39.298561°	39.298561°
				-121.569977°	-121.569977°
DWR ID	21308

Comment Code					
Inspector Comment					
DS_ID:21308 FS_ID:24883 EP_NO: N/A Repair Type: Non-Urgent Crossing Status: Found UCIP Comments: 05/01/2013 Dense vegetation limits the inspector's visibility to identify signs of pipe failure (leaks) along the slope. Recommend removing vegetation along pipe alignment to conduct proper inspection of structure and appurtances. (DWR UCIP - O. Magana) FIELD_STRUCT_DESC: 24-inch corrugated metal gravity drainage pipe through the levee, 12 feet below the crown. Corrugated metal cutoff wall around the pipe at each shoulder. Flap gate on the waterside (WS) end. Slide gate on the landside (LS) end. Concrete headwall at the LS toe. [Additional Reference(s): DWR Levee Log, 2005. USACE Sacramento O&M Manual 151, May 1953, (Station 192+33)]. FS Date: 5/1/2013

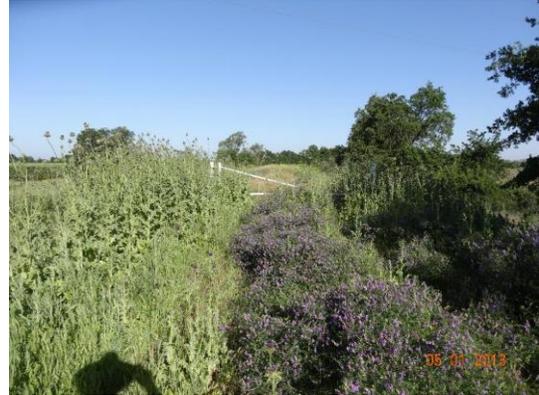
Photo 2 of 2 : UCIP_FA_2019_24883_44821.jpg

View of levee crown--dense vegetation.
