**Flood Control Project Maintenance
Levee Inspections**

Maintenance Issue Types Only, Levee Inspection Report By Mile - Spring 2020

Reclamation District No. 0010 Honcut

Waterway	Bank	Unit Miles	Inspection Start/End	Inspector
Unit No. 01 Simmerly Slough	Right	7.65	04/28/2020 04/28/2020	Sterling York

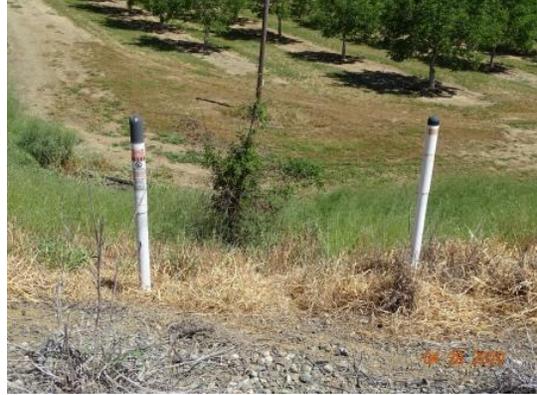
Photo 1 of 1 : SP_2020_RD0010_163_44_20200429_00085.jpg

View looking upstream landside at small starter tree on levee slope, Spring 2020.

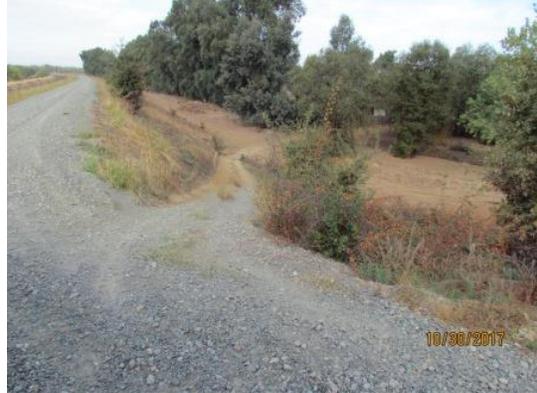
Photo 1 of 1 : SP_2020_RD0010_163_48_20200227_00013.jpg

LM Start	0.72	Rating **	A/W	Issue No.	48
LM End	0.72	Issue Type +	Ma	Location *	LS
Category	Earthen Levee		GPS Latitude/Longitude		
			Start	End	
Item	Slope Stability		39.161198 °	39.161198 °	
			-121.597102 °	-121.597102 °	
DWR ID	DWR_RD0010_01_f_2013_48				
Comment Code					
S3 : Repair the levee slope damaged by vehicle traffic and prevent access where possible.					
Inspector Comment					
Ramp is caused by constant ATV foot traffic use on levee slope, there is no sign of separation, cracking, or caving.

View of the slope stability caused by foot traffic on the landward side of the levee looking downstream.

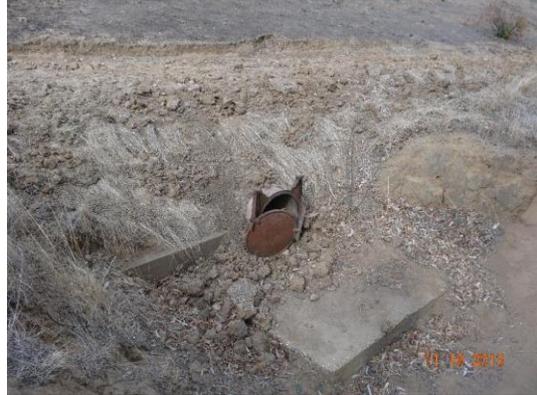
Photo 3 of 3 : UCIP_SP_2020_50058_51414.jpg

Damage flap gate located on WS.

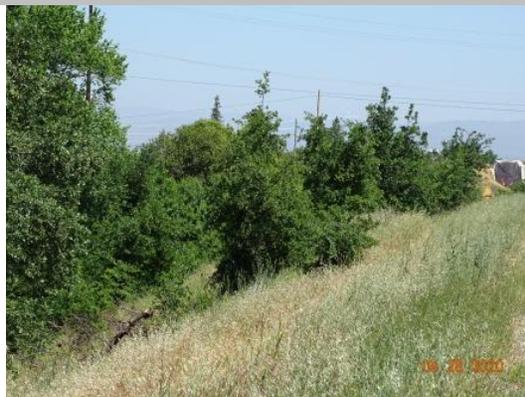
Photo 1 of 1 : SP_2020_RD0010_163_45_20200429_00086.jpg

View looking upstream landside at small starter trees on levee slope, Spring 2020.

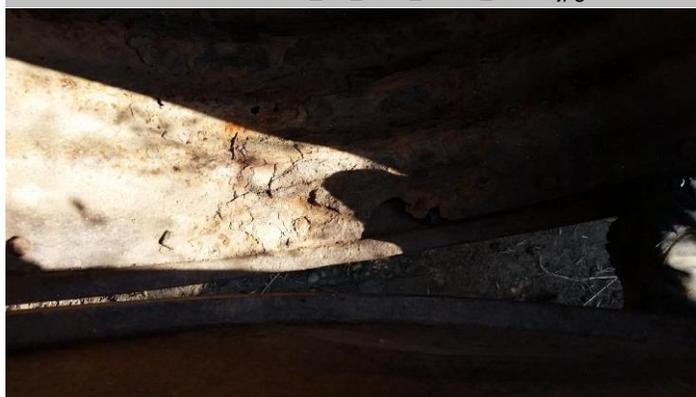
Photo 3 of 3 : UCIP_SP_2020_53136_75321.jpg

Deteriorated pipe wall at the outlet (WS).

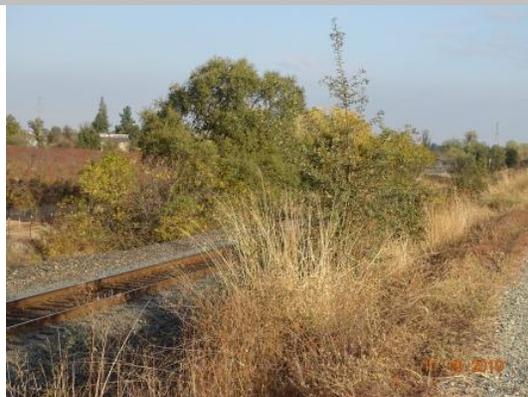
Photo 1 of 1 : SP_2020_RD0010_163_34_20200227_00002.jpg

LM Start	1.65	Rating **	M	Issue No.	34
LM End	1.69	Issue Type +	Ma	Location *	LS
Category	Earthen Levee			GPS Latitude/Longitude	
				Start	End
Item	Trim / Thin Trees			39.169788 °	39.170335 °
				-121.585746 °	-121.585683 °
DWR ID	DWR_RD0010_01_f_2019_34				
Comment Code					
T3 : Trim and thin trees to allow visibility of the ground and room to flood fight.					
Inspector Comment					
Trees with less than 4" diameter at chest height should be removed, Spring 2020.

View looking upstream landside of small starter trees that need to be removed, Fall 2019.

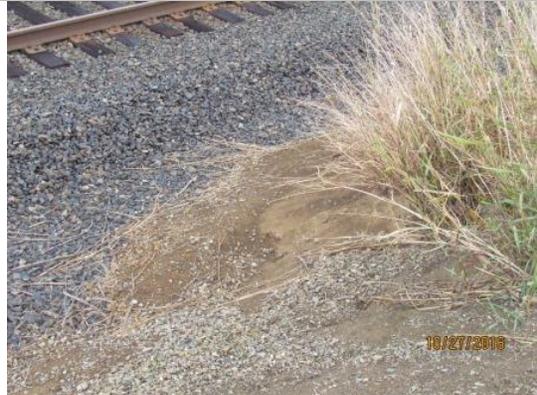
Photo 1 of 1 : SP_2020_RD0010_163_64_20200227_00024.jpg

View of squirrel holes on the landside, no rodent activity was observed.

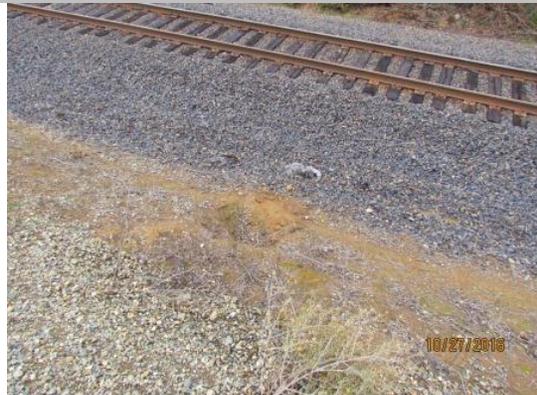
Photo 1 of 1 : SP_2020_RD0010_163_63_20200227_00023.jpg

View of squirrel holes on the landside, no rodent activity was observed.

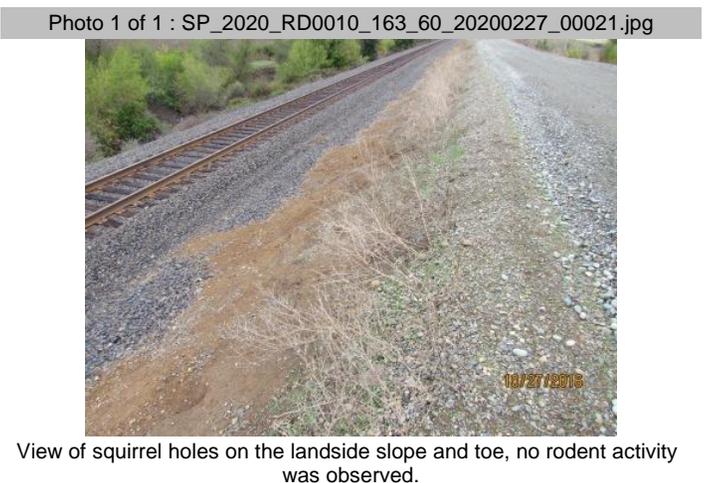
LM Start	2.56	Rating **	M	Issue No.	60
LM End	2.61	Issue Type +	Ma	Location *	LS
Category	Earthen Levee		GPS Latitude/Longitude		
			Start	End	
Item	Animal Control		39.182940 °	39.183721 °	
			-121.584115 °	-121.584019 °	
DWR ID	DWR_RD0010_01_s_2016_60				
Comment Code					
A3 : No rodents visible, but rodent burrows visible; need to backfill and compact or grout burrows.					
Inspector Comment					
Squirrel holes still are visible but there is no sign of activity.

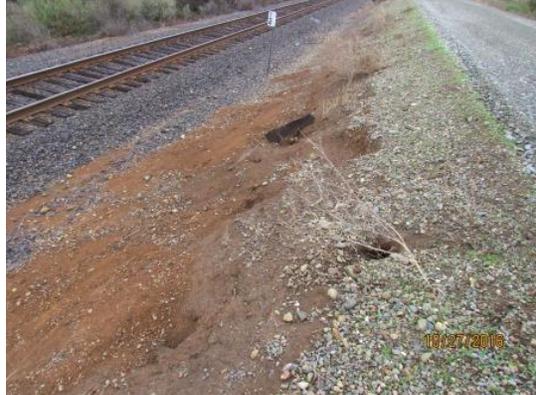
Photo 1 of 1 : SP_2020_RD0010_163_57_20200227_00018.jpg

View of squirrel holes on the landside slope and toe, no rodent activity was observed.

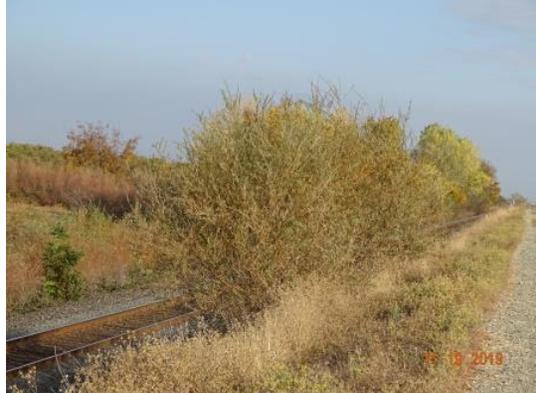
Photo 1 of 1 : SP_2020_RD0010_163_38_20200227_00006.jpg

View looking upstream landside at small starter trees that need to be removed, Fall 2019.

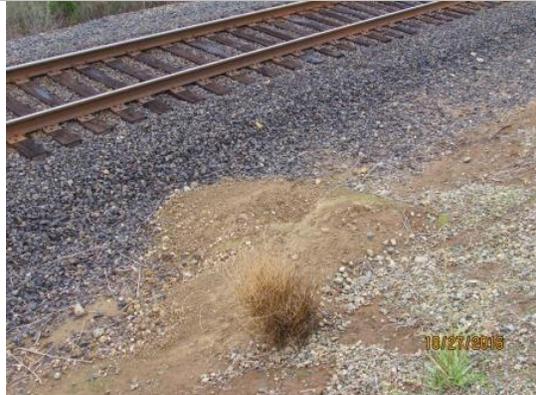
Photo 1 of 1 : SP_2020_RD0010_163_52_20200227_00017.jpg

View of squirrel holes on the landside slope and toe, no rodent activity was observed. Fall 2016.

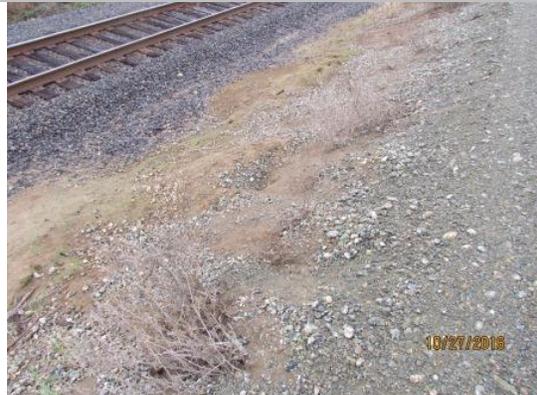
Photo 1 of 1 : SP_2020_RD0010_163_50_20200227_00015.jpg

View of squirrel holes on the landside slope and toe, no rodent activity was observed.

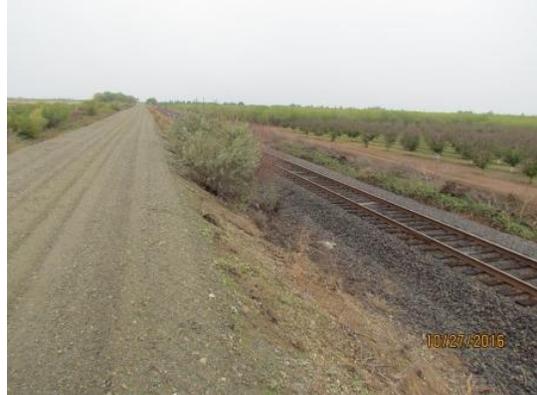
Photo 1 of 1 : SP_2020_RD0010_163_47_20200227_00012.jpg

View of a small willow tree that should be removed on the landside looking downstream.

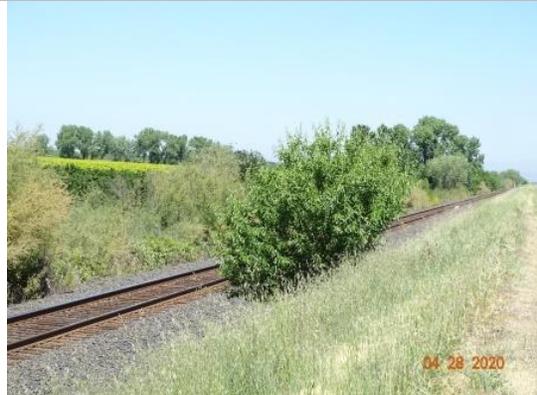
Photo 1 of 1 : SP_2020_RD0010_163_31_20200430_00093.jpg

View looking upstream landside at small starter trees on levee slope, Spring 2020.

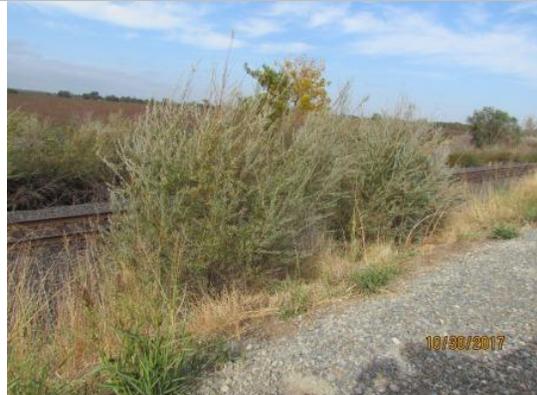
Photo 1 of 1 : SP_2020_RD0010_163_37_20200227_00005.jpg

View of small willow trees on the landside slope looking upstream.

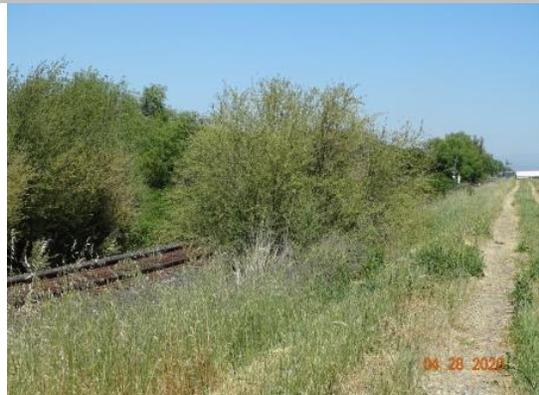
Photo 1 of 1 : SP_2020_RD0010_163_54_20200430_00095.jpg

View looking upstream landside at small starter tree on levee slope, Spring 2020.

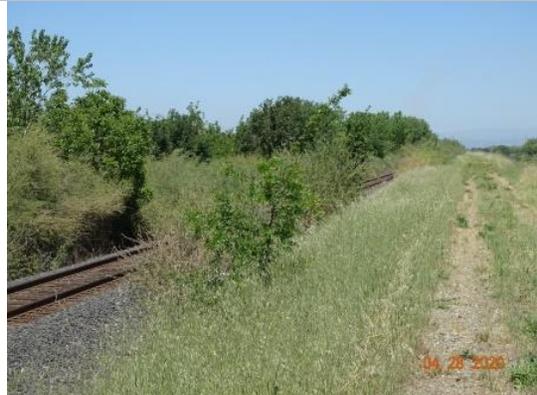
Photo 1 of 1 : SP_2020_RD0010_163_56_20200430_00097.jpg

View looking upstream landside at small starter trees on levee slope, Spring 2020.

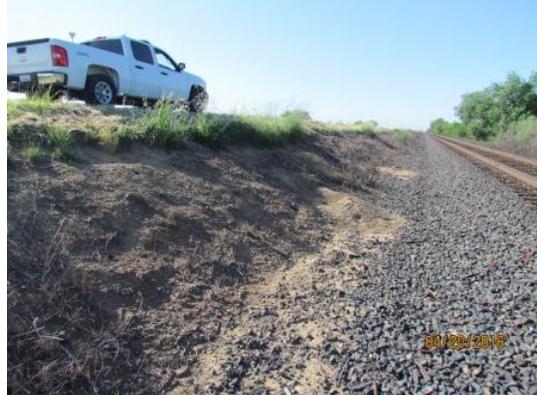
Photo 1 of 1 : SP_2020_RD0010_163_41_20200227_00009.jpg

View of multiple ground squirrel holes on landside slope looking downstream. There is no evidence of active squirrels.

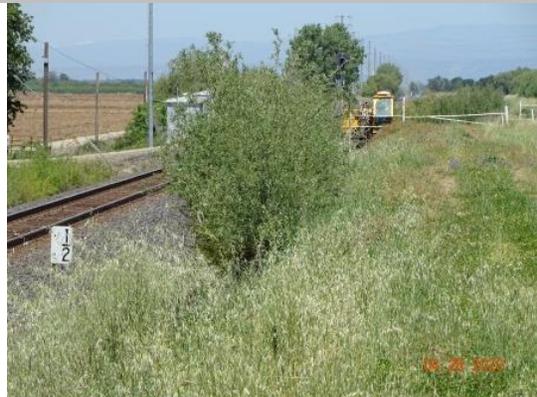
Photo 1 of 1 : SP_2020_RD0010_163_66_20200430_00100.jpg

View looking upstream landside at small starter tree on levee slope, Spring 2020.

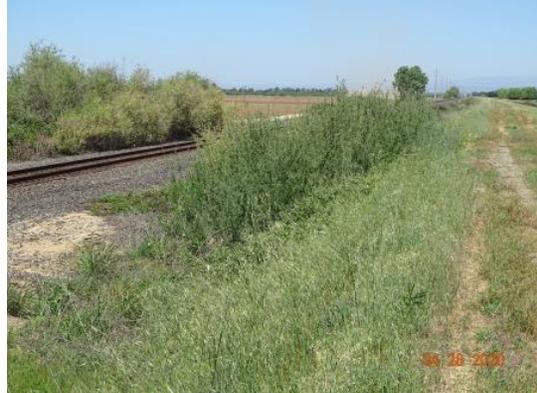
Photo 1 of 1 : SP_2020_RD0010_163_33_20200430_00102.jpg

View looking upstream landside at small starter trees on levee slope, Spring 2020.

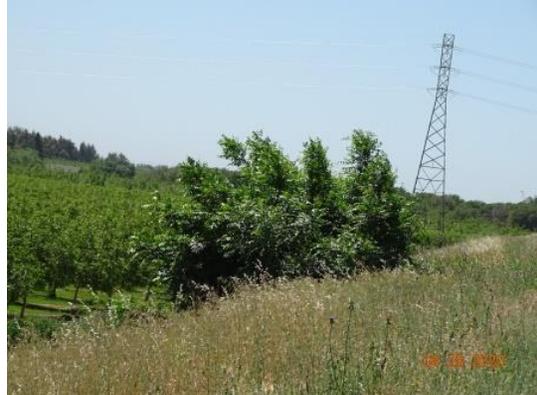
Photo 1 of 1 : SP_2020_RD0010_164_70_20200429_00111.jpg

View looking downstream landside at small starter tree on levee slope, Spring 2020.

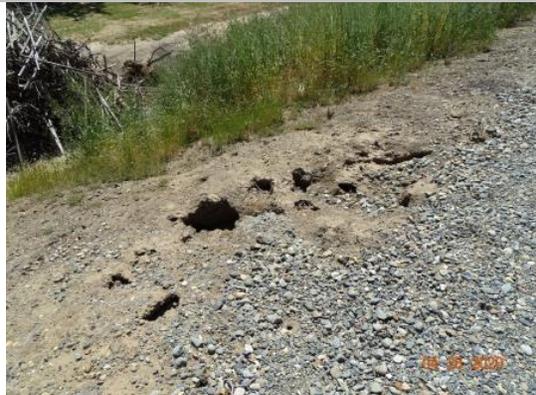
Photo 1 of 1 : SP_2020_RD0010_164_68_20200429_00108.jpg

View looking landside at squirrel activity on the levee slope, Spring 2020.

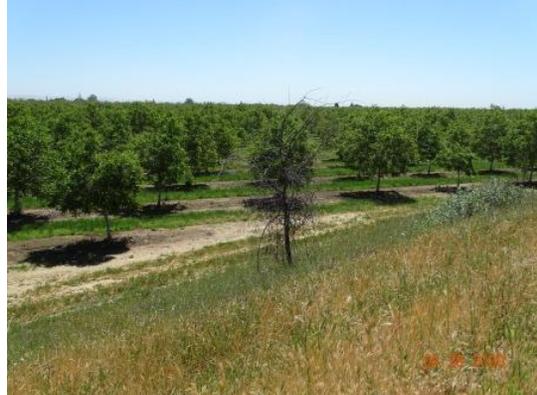
Photo 1 of 1 : SP_2020_RD0010_164_66_20200429_00107.jpg

View looking downstream landside at small starter tree on levee slope, Spring 2020.

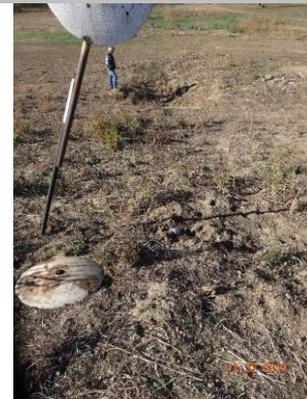
Photo 2 of 3 : UCIP_SP_2020_24825_44663.jpg

View of waterward slope--burrow activity present.

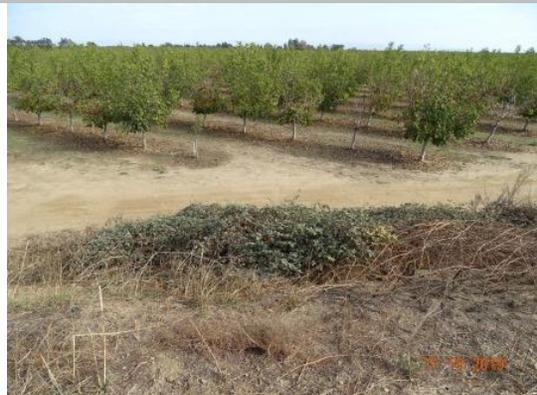
Photo 1 of 1 : SP_2020_RD0010_164_58_20200227_00018.jpg

View looking at blackberry bushes on the landside levee slope that need to be removed, Fall 2019.

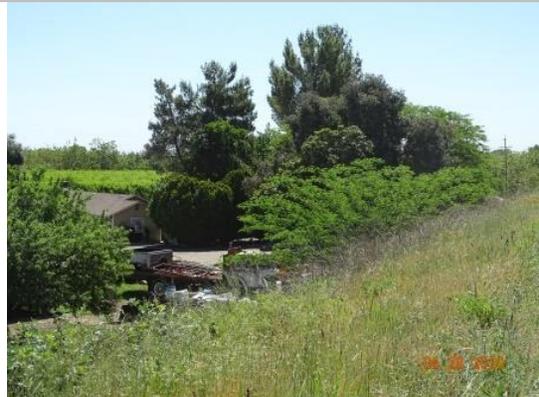
Photo 1 of 1 : SP_2020_RD0010_164_64_20200429_00105.jpg

View looking downstream landside at small starter trees on levee slope, Spring 2020.

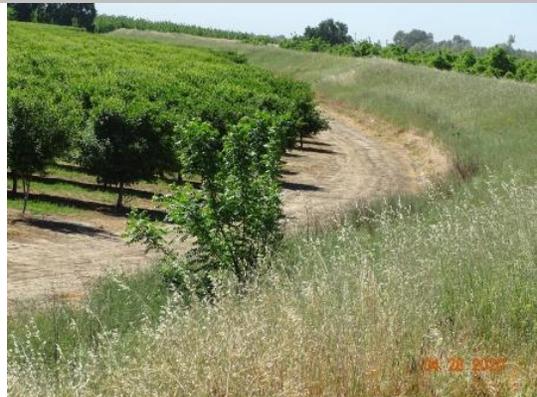
Photo 1 of 1 : SP_2020_RD0010_164_61_20200429_00102.jpg

View looking downstream landside at small starter tree on levee slope, Spring 2020.

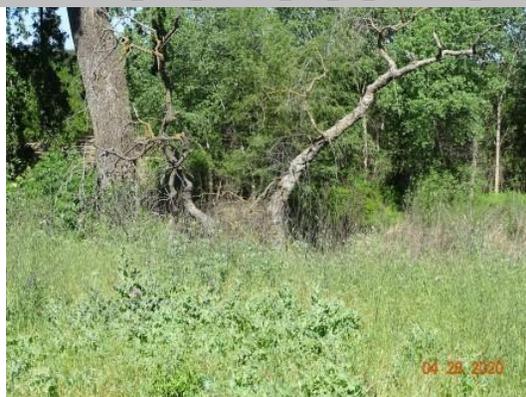
Photo 1 of 1 : SP_2020_RD0010_164_52_20200429_00099.jpg

View looking waterside at a downed tree on the levee slope, Spring 2020.

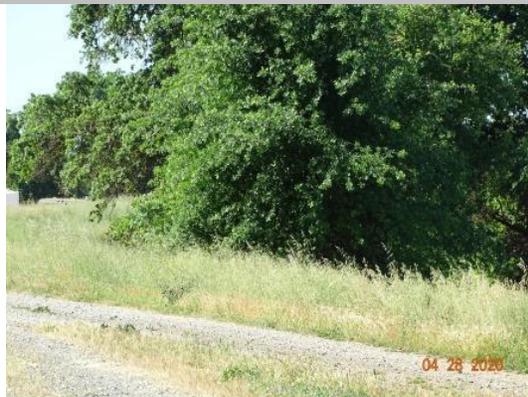
Photo 1 of 1 : SP_2020_RD0010_164_37_20200429_00097.jpg

View looking downstream waterside at a tree with low hanging limbs, Spring 2020.

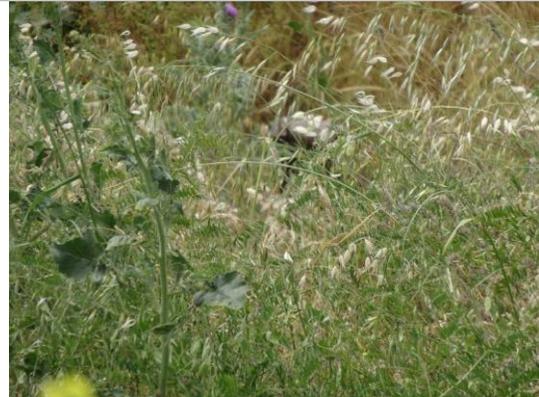
Photo 2 of 3 : UCIP_SP_2020_24768_44451.jpg

Dense vegetation on landward side.

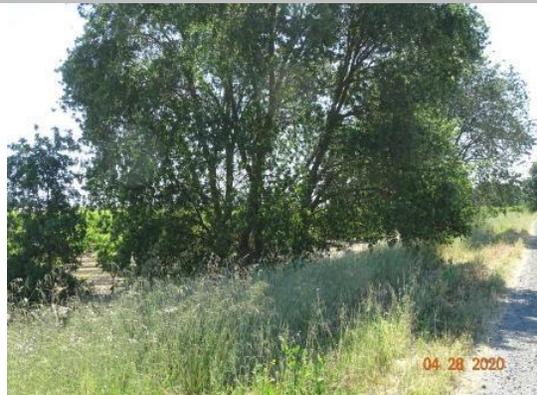
Photo 1 of 1 : SP_2020_RD0010_164_50_20200429_00096.jpg

View looking downstream landside at a tree with low hanging limbs, Spring 2020.

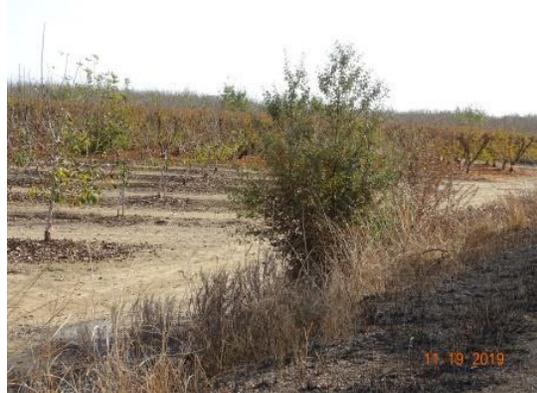
Photo 1 of 1 : SP_2020_RD0010_164_56_20200227_00016.jpg

View looking downstream landside at a small starter tree that needs to be removed.

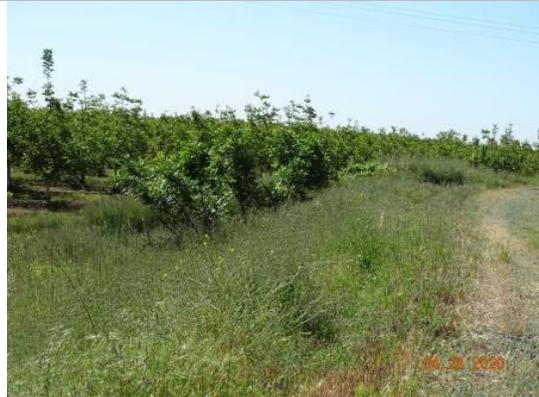
Photo 1 of 1 : SP_2020_RD0010_164_43_20200429_00093.jpg

View looking downstream landside at small starter tree on levee slope, Spring 2020.

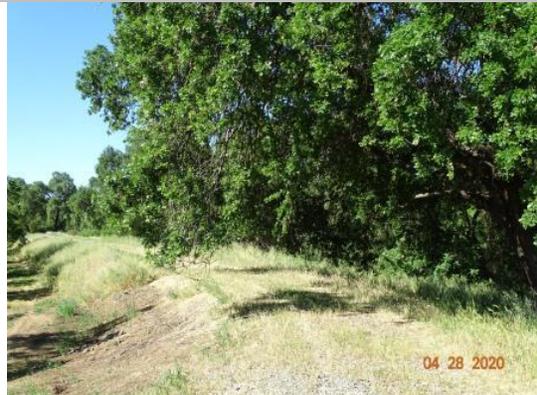
Photo 1 of 1 : SP_2020_RD0010_164_38_20200429_00092.jpg

View looking downstream at low hanging branches over the crown, Spring 2020.

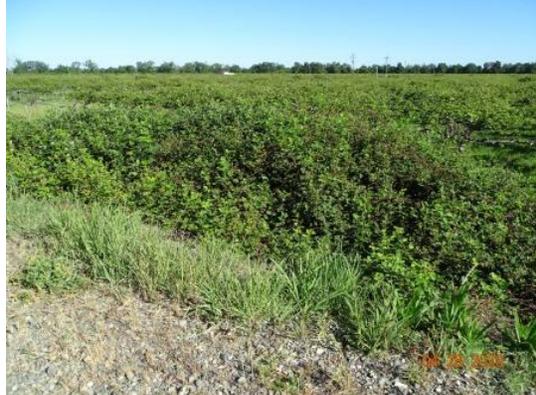
Photo 1 of 1 : SP_2020_RD0010_165_21_20200429_00026.jpg

View looking downstream waterside at blackberries on levee slope, Spring 2020.

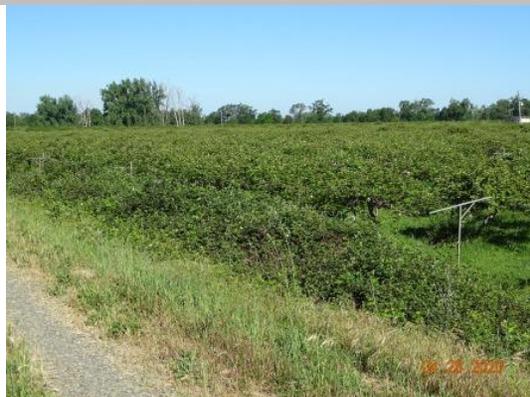
Photo 1 of 1 : SP_2020_RD0010_165_19_20200429_00024.jpg

View looking downstream waterside at black berries on the levee slope, Spring 2020.

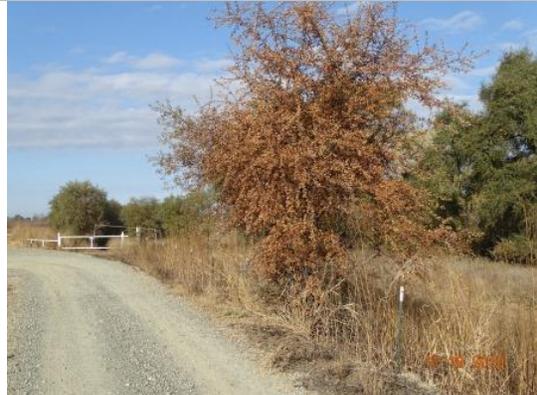
Photo 1 of 1 : SP_2020_RD0010_165_10_20200227_00004.jpg

View looking downstream waterside of a tree that needs to be trimmed for access and visibility.

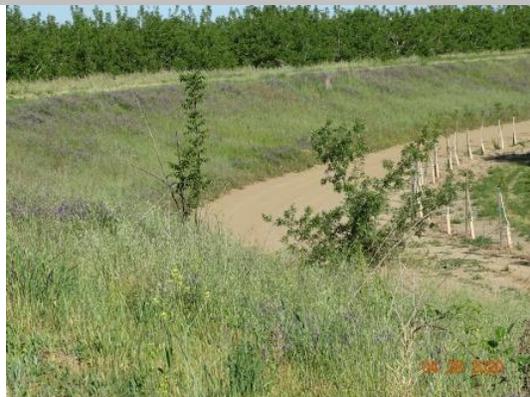
Photo 1 of 1 : SP_2020_RD0010_165_12_20200429_00017.jpg

View looking downstream waterside at small starter trees that need to be removed, Spring 2020.

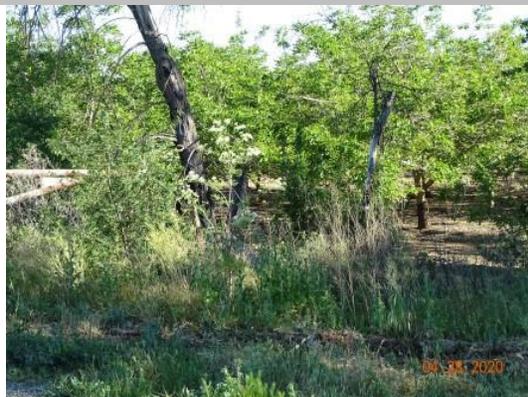
Photo 1 of 1 : SP_2020_RD0010_165_11_20200429_00016.jpg

View looking downstream waterside at a small starter tree that needs to be removed, Spring 2020.
