**Flood Control Project Maintenance
Levee Inspections**

Fall 2019 Levee Maintenance Deficiency Summary Report

San Joaquin River Basin

Reclamation District No. 0017 Mossdale

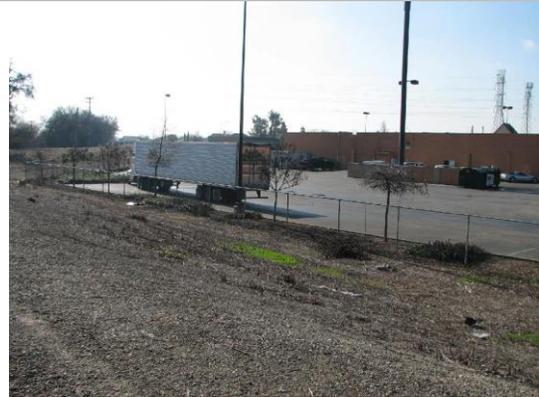
Photo 3 of 3 : UCIP_FA_2019_40603_38478.jpg

LM Start	0.03	Rating **	M	Issue No.	12 (cont)
LM End	0.03	Issue Type +	En	Location *	
Category	Supplemental			GPS Latitude/Longitude	
				Start	End
Item	DRAFT DWR UCIP Field Study			37.911561 °	37.911561 °
				-121.291441 °	-121.291441 °
DWR ID	1				
Comment Code					
Inspector Comment					
DS_ID:1 FS_ID:40603 EP_NO: 6623 Repair Type: Non-Urgent Crossing Status: Found UCIP Comments: Marker missing on landward side. Need to contact owner to determine status of crossing. Need date of last inspection and confirmation that crossing is still in operable condition. FIELD_STRUCT_DESC: 5.563-inch welded steel natural gas pipeline through the levees, 4.5 feet below the crown, across the channels and overflow area. (5-inch gas line authorized under Permit No. 6623, 1969 - Laymac Corporation) [Additional Reference(s): DWR Levee Logs, 1981, 2003]. FS Date: 2/3/2010

View of landward side.

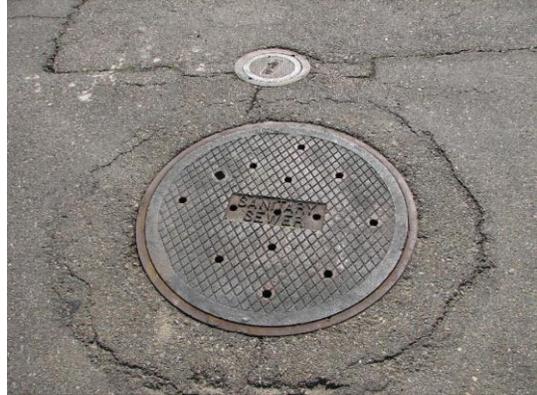
Photo 3 of 3 : UCIP_FA_2019_40604_38495.jpg

Comment Code					
Inspector Comment					
DS_ID:2 FS_ID:40604 EP_NO: 14992 Repair Type: Non-Urgent Crossing Status: Indicator Found UCIP Comments: Need to contact owner to determine status of crossing. Also need date of last inspection. FIELD_STRUCT_DESC: [Weston Ranch - French Camp Slough Crossings] 1 of 3. 30-inch high-density polyethylene (HDPE) sewer force main (SFM) through the levee, 32 feet below levee crown. All pipes encased in concrete. (two 30-inch force mains (originally issued as 27-inch) and one 12-inch pipe authorized under Permit No. 14992, 1989 - City of Stockton and Richard Blewett) [Additional Reference(s): DWR Levee Logs, 1981, 2003] FS Date: 2/3/2010

Manhole found on landward side.

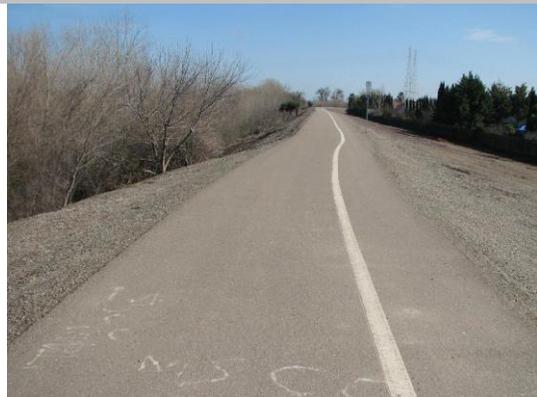
Photo 1 of 3 : UCIP_FA_2019_52614_38505.jpg

Comment Code					
Inspector Comment					
DS_ID:159 FS_ID:52614 EP_NO: 14992 Repair Type: Non-Urgent Crossing Status: Indicator Found UCIP Comments: Need to contact owner to determine status of crossing. Also need date of last inspection. FIELD_STRUCT_DESC: [Weston Ranch - French Camp Slough Crossings] 2 of 3. 30-inch high-density polyethylene (HDPE) sewer force main (SFM) through the levee, 32 feet below levee crown. All pipes encased in concrete. (two 30-inch force mains (originally issued as 27-inch) and one 12-inch pipe authorized under Permit No. 14992, 1989 - City of Stockton and Richard Blewett) [Additional Reference(s): DWR Levee Logs, 1981, 2003] FS Date: 2/3/2010

Overview of levee at crossing.

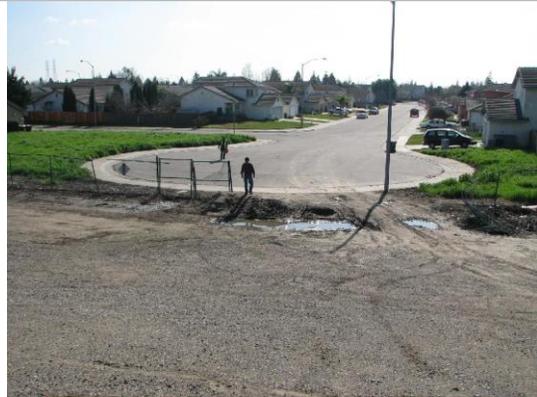
Photo 2 of 3 : UCIP_FA_2019_52614_38503.jpg

View of landward toe--established neighborhood.

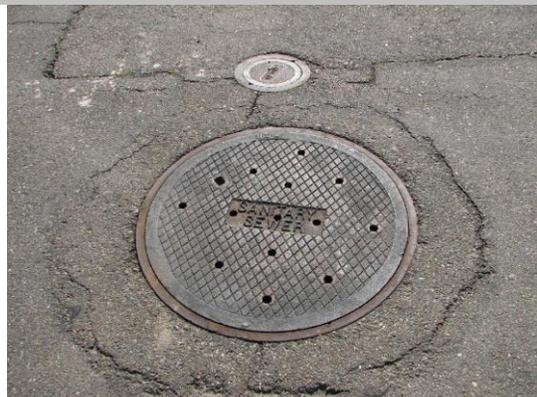
Photo 3 of 3 : UCIP_FA_2019_52614_38509.jpg

Manhole for sanitary sewer visible on landward side.

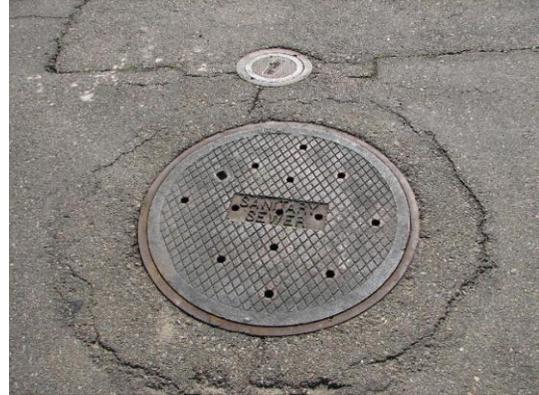
Photo 3 of 3 : UCIP_FA_2019_40606_71940.jpg

Comment Code						
Inspector Comment						
DS_ID:158 FS_ID:40606 EP_NO: 14992 Repair Type: Non-Urgent Crossing Status: Indicator Found UCIP Comments: Need to contact owner to determine status of crossing. Also need date of last inspection. FIELD_STRUCT_DESC: [Weston Ranch - French Camp Slough Crossings] 3 of 3. 12-inch high-density polyethylene (HDPE) sewer force main (SFM) through the levee, 32 feet below levee crown. All pipes encased in concrete. (two 30-inch force mains (originally issued as 27-inch) and one 12-inch pipe authorized under Permit No. 14992, 1989 - City of Stockton and Richard Blewett) [Additional Reference(s): DWR Levee Logs, 1981, 2003] FS Date: 2/3/2010

Manhole visible on landward side.

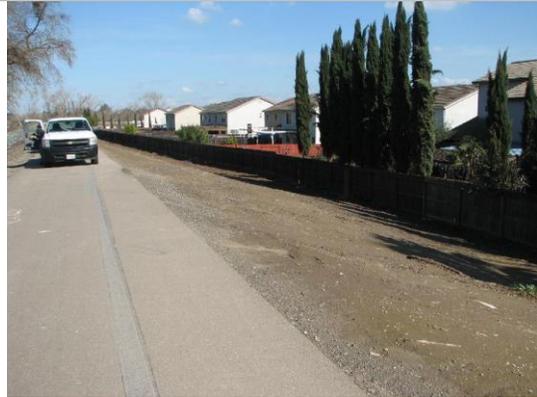
Photo 1 of 3 : UCIP_FA_2019_40628_38516.jpg

Comment Code					
Inspector Comment					
DS_ID:75 FS_ID:40628 EP_NO: 15093 Repair Type: Non-Urgent Crossing Status: Found UCIP Comments: Only appurtenances remaining at this location--4 pillings located on waterward side. According to records the pillings were to be removed under a completion maintenace contract. Need to coordinate with owner. FIELD_STRUCT_DESC: 14-inch-diameter pipeline through levee at unknown depth. Per inspector's notes "this crossing is abandoned almost all materials removed including pipes, conduit, and pump house. The only items left are 4 pilings which are to be removed under a completion maintenance contract. Approximately 200 feet of reinforced concrete pipe lateral removed in R/W south of crossing". FS Date: 2/3/2010

View of landward side.

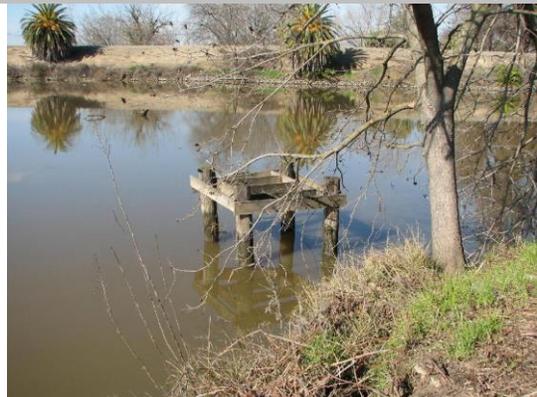
Photo 2 of 3 : UCIP_FA_2019_40628_38515.jpg

View of waterward side--pillings inside channel.

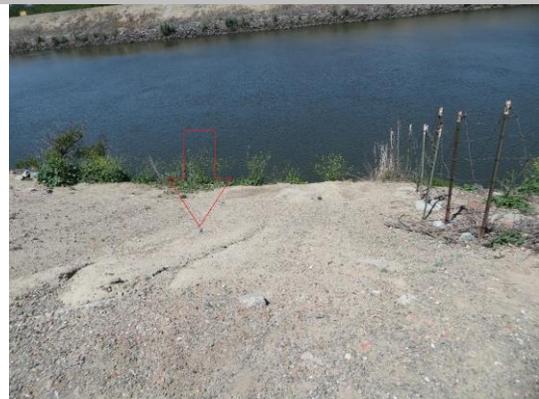
Photo 1 of 2 : UCIP_FA_2019_49637_74109.jpg

Comment Code					
Inspector Comment					
DS_ID:10 FS_ID:49637 EP_NO: 15098 Repair Type: Non-Urgent Crossing Status: Indicator Found UCIP Comments: 5/19/2015 Only signs of electrical conduit found. Need to contact owner to determine status of pipe as no record of removal has been found and only an electrical conduit was found at this location. (DWR UCIP - W. Wylie) FIELD_STRUCT_DESC: 8-inch steel irrigation pipe through the levee, 3.3 feet below levee crown. Electrical conduit through levee. Pump house located on waterside (WS) berm. Siphon breaker on WS shoulder, standpipe located 10 feet from landside (LS) toe. (8-inch pipe authorized under Permit No. 15098, 1989 - G. La Baume, permit also includes authorization of 12-inch pipe at different location). [Additional Reference(s): DWR Levee Logs, 1981, 2003] FS Date: 5/19/2015

View of WS slope with electrical conduit.

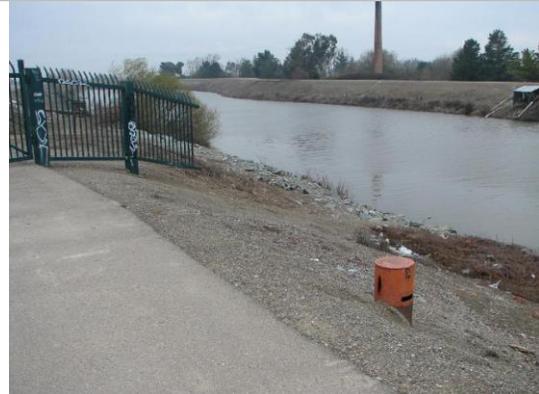
Photo 3 of 3 : UCIP_FA_2019_40639_38685.jpg

Comment Code					
Inspector Comment					
DS_ID:11 FS_ID:40639 EP_NO: 15316 Repair Type: Non-Urgent Crossing Status: Indicator Found UCIP Comments: Need to contact owner to determine status--pipe was not found only siphon breaker housing unit. FIELD_STRUCT_DESC: 8-inch steel drainage pipeline through levee, 3 feet below levee crown. Siphon breaker on the waterside (WS) shoulder. Pump is located inside ditch located approximately 75 feet landside (LS) of levee toe. (8-inch pipe authorized under Permit No. 15316, 1989 - W. Long and Reclamation No. 17 [RD0017], 10-inch pipe also installed) [Additional Reference(s): DWR Levee Logs, 1981, 2003, 8-inch pipe listed] FS Date: 2/4/2010

Siphon breaker located on waterward slope.

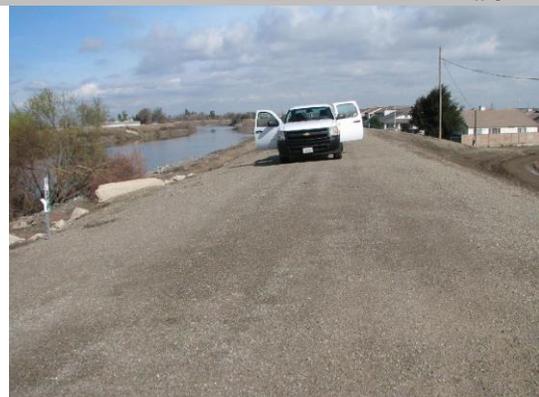
Photo 1 of 3 : UCIP_FA_2019_40640_71981.jpg

Comment Code					
Inspector Comment					
DS_ID:12 FS_ID:40640 EP_NO: 15099 Repair Type: Non-Urgent Crossing Status: Found UCIP Comments: Need to coordinate with owner to determine status of crossing. If crossing is no longer in use owner will need to contact the CVFPB to comply with Title 23. FIELD_STRUCT_DESC: 16-inch steel irrigation pipe through levee, 2.30 feet below levee crown. Siphon breaker on waterside (WS) shoulder. Pump house located on the WS berm. Standpipe located 15 feet from landside (LS) toe. Concrete stairway on WS slope. (16-inch pipe removed under Permit No. 15099, 1989 - W. Long, 12-inch pipe removed) [Additional Reference(s): DWR Levee Logs, 1981, 2003] FS Date: 2/4/2010

View of levee crown at crossing.

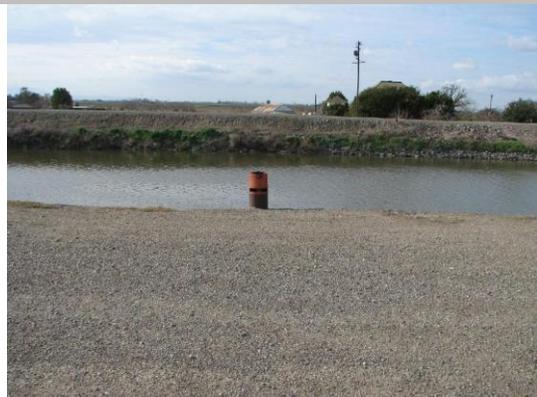
Photo 1 of 3 : UCIP_FA_2019_40642_38742.jpg

Comment Code					
Inspector Comment					
DS_ID:14 FS_ID:40642 EP_NO: 15317 Repair Type: Non-Urgent Crossing Status: Found UCIP Comments: Need to coordinate with owner to determine status of crossing. Need to find out if pipe located on landward side is tied to pipe through levee. Pipe found on waterward side is filled with concrete (non-functional). FIELD_STRUCT_DESC: 10-inch steel drainage pipe through levee, 3.91 feet below levee crown. Siphon breaker on waterside (WS) slope. Pump in ditch located 300 feet landside (LS) of toe. Ramp on LS slope. 10-inch pipe connects to an existing 16-inch discharge pipe on the LS. (10-inch installed under Permit No. 15317, 1990 - Calcagno Farms and Reclamation District 17 [RD0017], 16-inch section from levee removed; 10-pipe was installed during the levee work approved under Permit No. 15014, 1989 - RD0017). [Additional Reference(s): DWR Levee Logs, 1981, 2003] FS Date: 2/4/2010

View of waterward side--riser located on waterward shoulder.

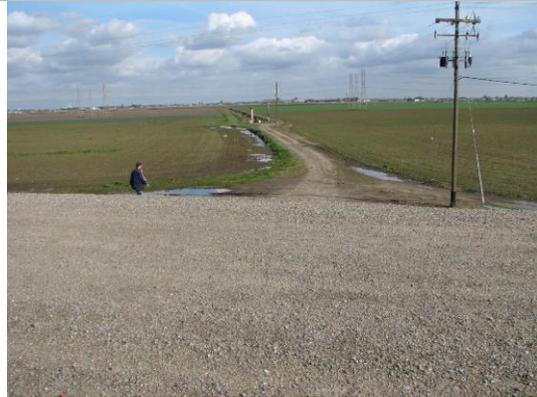
Photo 2 of 3 : UCIP_FA_2019_40642_38740.jpg

View of landward side.

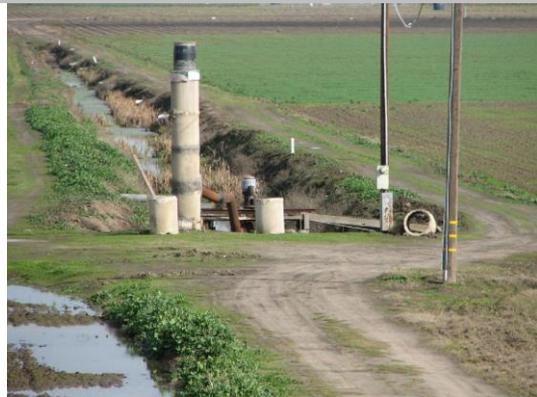
Photo 3 of 3 : UCIP_FA_2019_40642_38746.jpg

Unidentified appurtenances located on landward side-unable to confirm if pipe crosses levee.

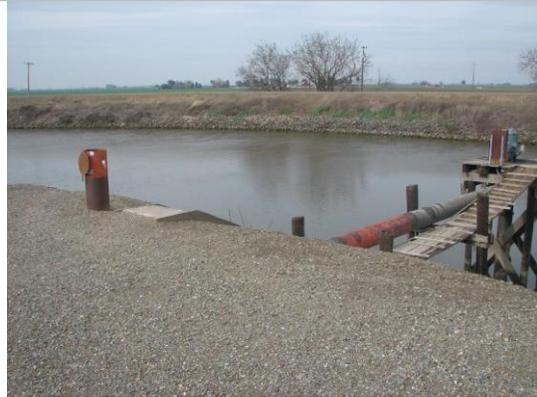
Photo 3 of 3 : UCIP_FA_2019_40645_72006.jpg

Comment Code					
Inspector Comment					
DS_ID:16 FS_ID:40645 EP_NO: 15102 Repair Type: Non-Urgent Crossing Status: Found UCIP Comments: Need to coordinate with owner to determine status of crossing. FIELD_STRUCT_DESC: 20-inch steel irrigation pipeline through levee. Invert of pipe is 2.8 feet below levee crown. Fill placed over the pipeline to provide 2.0 feet of cover. Siphon breaker on waterside (WS) shoulder. Pump on platform with walkway to shoulder, standpipe located 15 feet landside (LS) toe, concrete stairway en waterside (WS) slope. (20-inch pipe installed under Permit No. 15102, 1990 - Calcagno Farms Co-Partnership, also 24-inch pipe removed; 20-inch pipe was installed during the levee work approved under Permit No. 15014, 1989 - Reclamation District 17 [RD0017]). [Additional Reference(s): DWR Levee Logs, 1981, 2003] FS Date: 2/4/2010

Overview of waterward side.

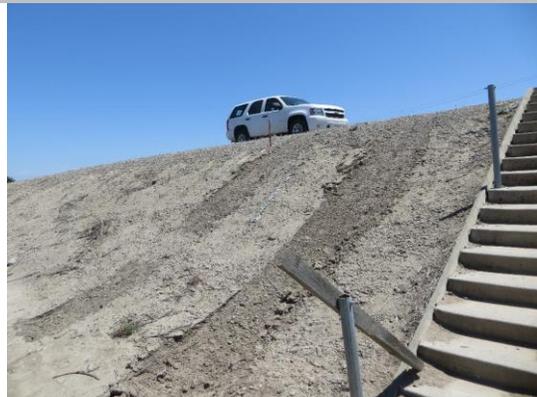
Photo 2 of 3 : UCIP_FA_2019_46009_74441.jpg

(2015) View of waterward slope--pipe removed.

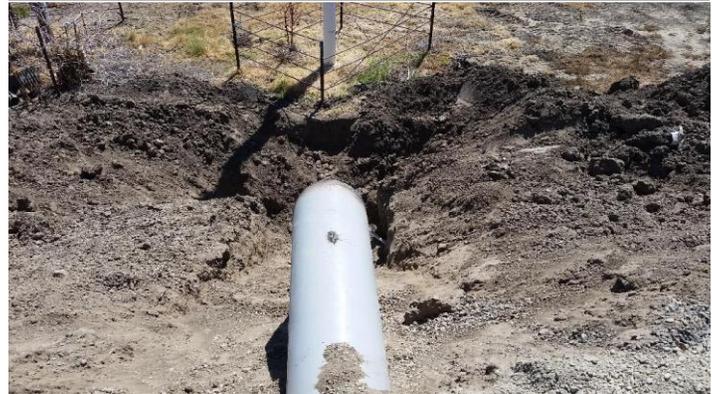
Photo 1 of 3 : UCIP_FA_2019_50004_75870.jpg

View of exposed pipe on LS--photo taken during install progress.

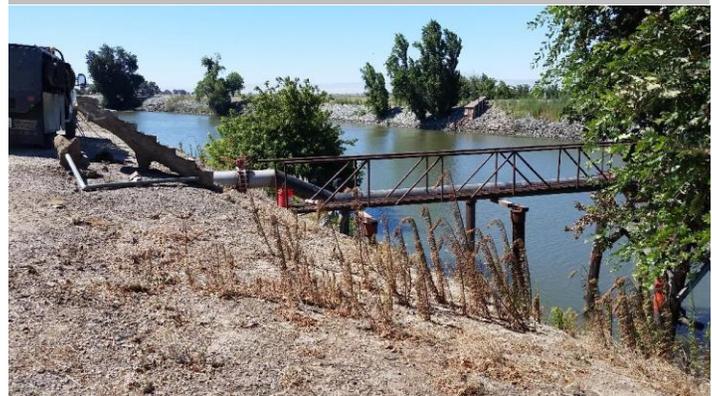
Photo 2 of 3 : UCIP_FA_2019_50004_75871.jpg

View of WS--coated pipe, walkway, and removal of concrete stairway. Construction in progress.

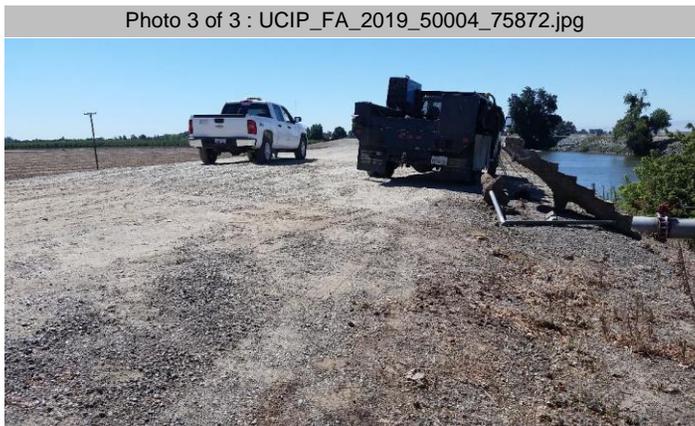
Comment Code					
Inspector Comment					
DS_ID:25466 FS_ID:50004 EP_NO: N/A Repair Type: Non-Urgent Crossing Status: Found UCIP Comments: 7/12/2016 Under Construction--Missing permit information and as-built drawings. New pipe installed 7/12/2016, as an emergency repair--owner in the process of obtaining permit from CVFPB. This pipe replaces DS_ID 22, pipe was removed July 2016. (DWR UCIP - omagana) FIELD_STRUCT_DESC: 16-inch steel irrigation pipe through the levee at an unknown depth below levee crown. Pump sits on the platform supported by steel piles located on the waterside (WS). Walkway extends from the pump platform to the WS. Positive closure device located on WS near walkway. (16-inch steel pipe installed under Permit No. XXXX, 2016 - XXXXX). FS Date: 7/12/2016

View of levee crown--construction on LS and WS in progress.

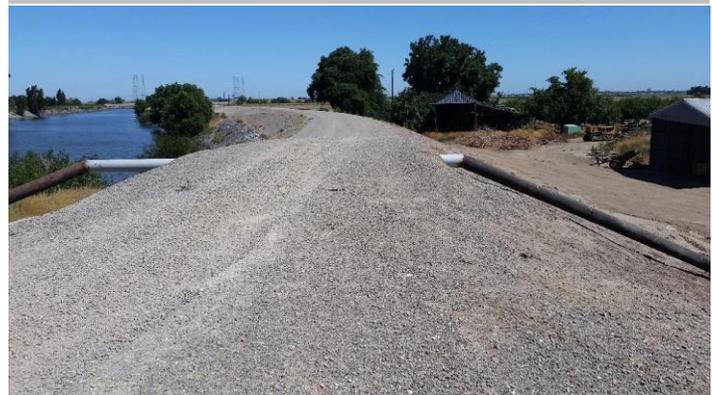
Photo 3 of 3 : UCIP_FA_2019_50005_75865.jpg

View of levee crown--levee section where pipe crosses is raised.

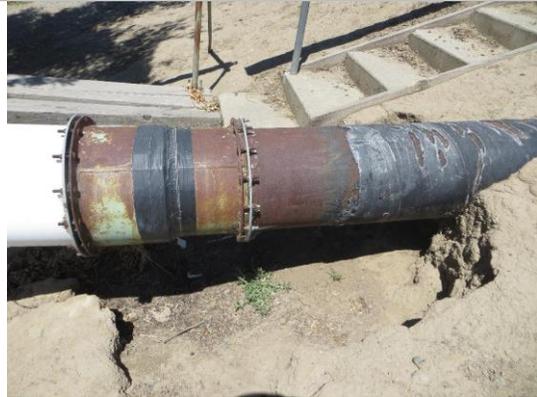
Photo 3 of 3 : UCIP_FA_2019_45998_74484.jpg

(2015) Erosion visible on waterward side.

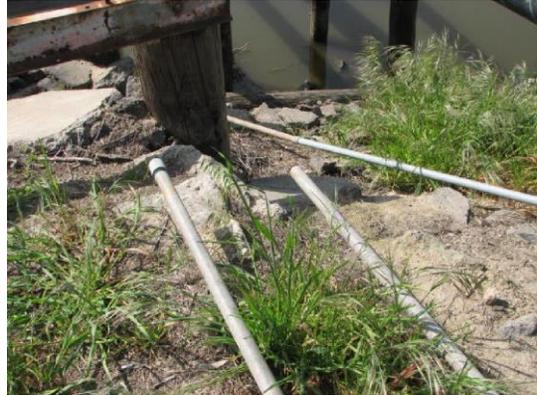
Photo 3 of 3 : UCIP_FA_2019_40688_72359.jpg

Conduits visible on waterward side--no connection.

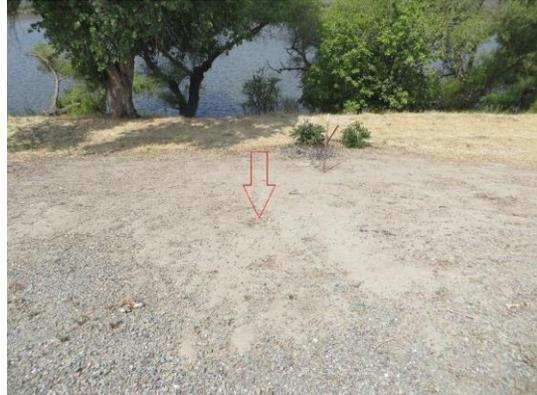
Photo 2 of 3 : UCIP_FA_2019_45463_74121.jpg

Vent visible on WS slope. Found partially burried.

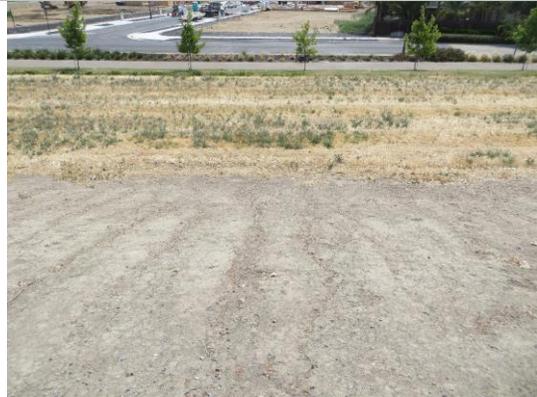
Photo 3 of 3 : UCIP_FA_2019_45463_74120.jpg

LS slope. No indication of pipe.

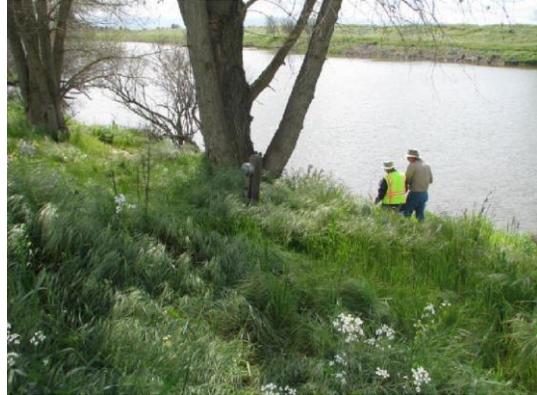
Photo 3 of 3 : UCIP_FA_2019_40702_72483.jpg

Dense vegetation along waterward slope--abandoned electrical box is visible through dense vegetation.

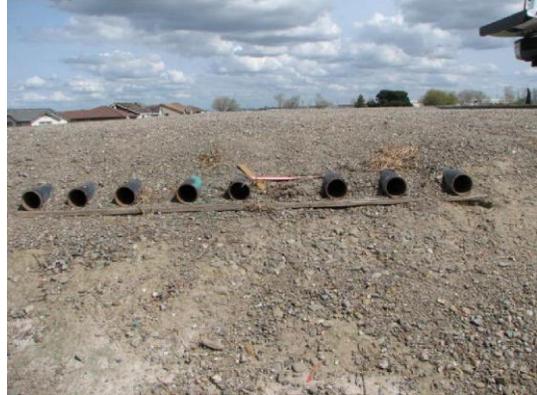
Photo 3 of 3 : UCIP_FA_2019_45993_72498.jpg

8-4 inch steel coated schedule 40 pipes with about 6 inch of cover.

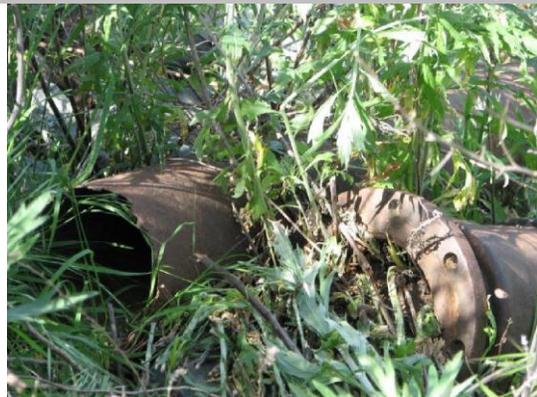
Photo 3 of 3 : UCIP_FA_2019_40706_72512.jpg

Non-functional crossing pipe disconnected.

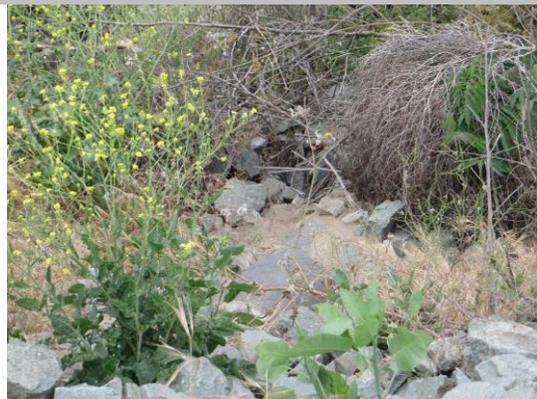
Photo 3 of 3 : UCIP_FA_2019_45466_74130.jpg

Pipe exposed in excavated area on WS slope.

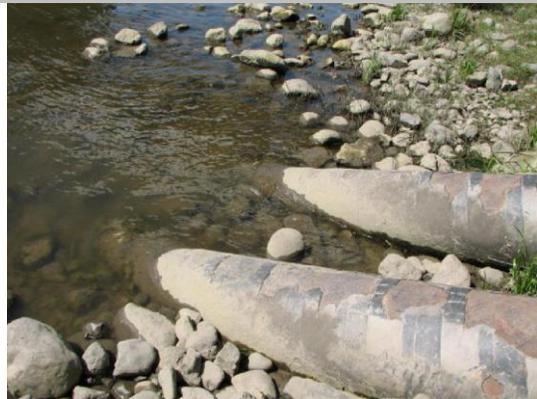
Photo 3 of 3 : UCIP_FA_2019_40713_72537.jpg

Sections of protective wrap missing near waterward toe.
