**Flood Control Project Maintenance
Levee Inspections**

Maintenance Issue Types Only, Levee Inspection Report By Mile - Fall 2019

Reclamation District No. 0017 Mossdale

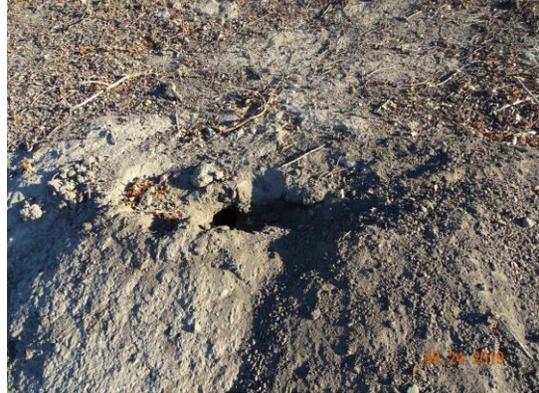
Photo 1 of 1 : FA_2019_RD0017_303_9_20191001_00016.jpg

LM Start	0.23	Rating **	M	Issue No.	9
LM End	0.23	Issue Type +	Ma	Location *	LS
Category	Earthen Levee		GPS Latitude/Longitude		
			Start	End	
Item	Animal Control		37.913438°	37.913438°	
			-121.294178°	-121.294178°	
DWR ID	DWR_RD0017_01_f_2019_9				
Comment Code					
A3 : No rodents visible, but rodent burrows visible; need to backfill and compact or grout burrows.					
Inspector Comment

View of rodent hole greater than 6 inches on landside slope. Fall 2019

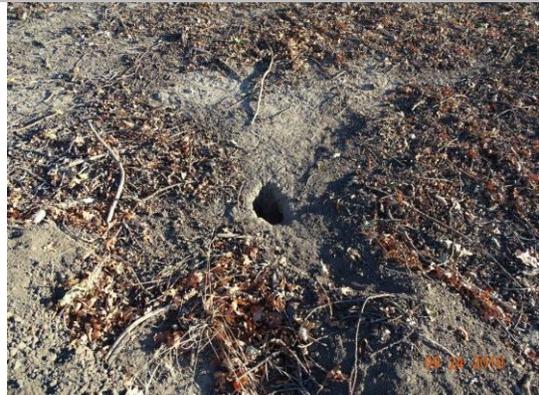
Photo 1 of 1 : FA_2019_RD0017_303_10_20191001_00017.jpg

LM Start	0.28	Rating **	M	Issue No.	10
LM End	0.28	Issue Type +	Ma	Location *	LS
Category	Earthen Levee		GPS Latitude/Longitude		
			Start	End	
Item	Animal Control		37.913466°	37.913466°	
			-121.295092°	-121.295092°	
DWR ID	DWR_RD0017_01_f_2019_10				
Comment Code					
A3 : No rodents visible, but rodent burrows visible; need to backfill and compact or grout burrows.					
Inspector Comment

View of rodent hole greater than 6 inches on landside slope. Fall 2019

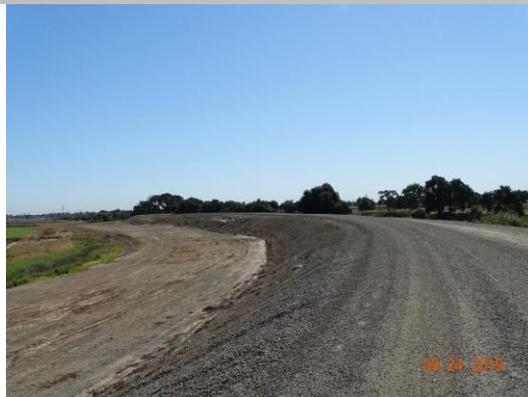
Photo 1 of 1 : FA_2019_RD0017_304_68_20191001_00196.jpg

LM Start	8.66	Rating **	A	Issue No.	68
LM End	8.66	Issue Type +	Ma	Location *	LS
Category	Earthen Levee		GPS Latitude/Longitude		
			Start	End	
Item	Vegetation		37.819715°	37.819715°	
			-121.319447°	-121.319447°	
DWR ID	DWR_RD0017_02_f_2019_68				
Comment Code					
V1 : Control annual grass and weeds on the levee slopes and easements.					
Inspector Comment					
Landside vegetation is well maintained.

Typical view of landside slope. Fall 2019

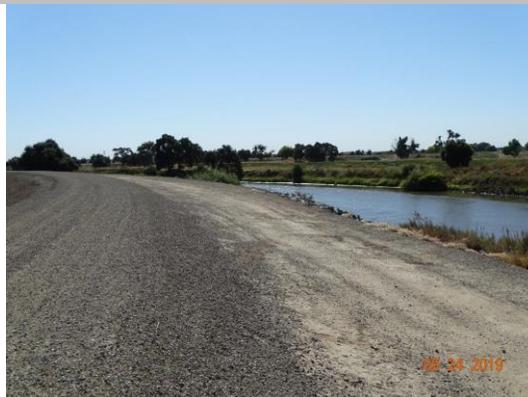
Photo 1 of 1 : FA_2019_RD0017_304_69_20191001_00197.jpg

LM Start	8.66	Rating **	A	Issue No.	69
LM End	8.66	Issue Type +	Ma	Location *	WS
Category	Earthen Levee		GPS Latitude/Longitude		
			Start	End	
Item	Vegetation		37.819715°	37.819715°	
			-121.319447°	-121.319447°	
DWR ID	DWR_RD0017_02_f_2019_69				
Comment Code					
V1 : Control annual grass and weeds on the levee slopes and easements.					
Inspector Comment					
Waterside vegetation is well maintained.

Typical view of waterside slope. Fall 2019

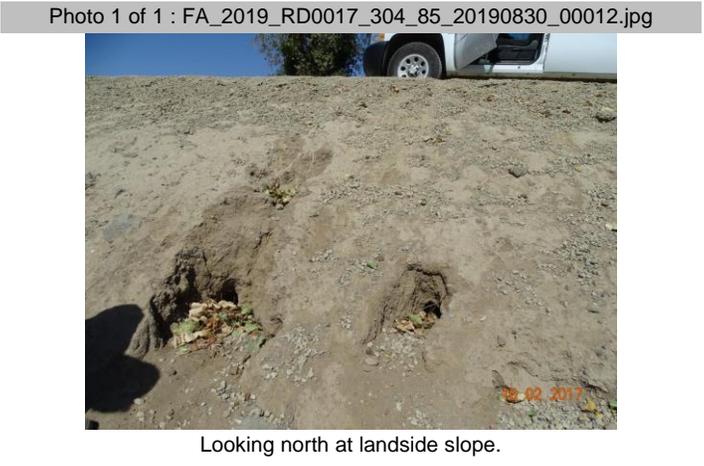
LM Start	9.24	Rating **	M	Issue No.	85
LM End	9.24	Issue Type +	Ma	Location *	LS
Category	Earthen Levee		GPS Latitude/Longitude		
			Start	End	
Item	Animal Control		37.815269 °	37.815269 °	
			-121.316805 °	-121.316805 °	
DWR ID	DWR_RD0017_02_f_2017_85				
Comment Code					
A3 : No rodents visible, but rodent burrows visible; need to backfill and compact or grout burrows.					
Inspector Comment

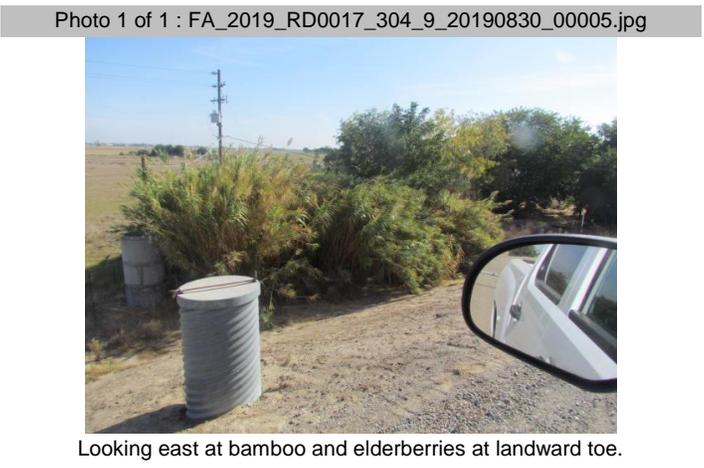
LM Start	9.29	Rating **	M	Issue No.	9
LM End	9.29	Issue Type +	Ma	Location *	LS
Category	Earthen Levee		GPS Latitude/Longitude		
			Start	End	
Item	Vegetation		37.815270 °	37.815270 °	
			-121.317692 °	-121.317692 °	
DWR ID	DWR_RD0017_02_s_2012_9				
Comment Code					
V4 : Elderberries are blocking visibility and flood fight capability.					
Inspector Comment					
Bamboo & elderberries at landside toe.

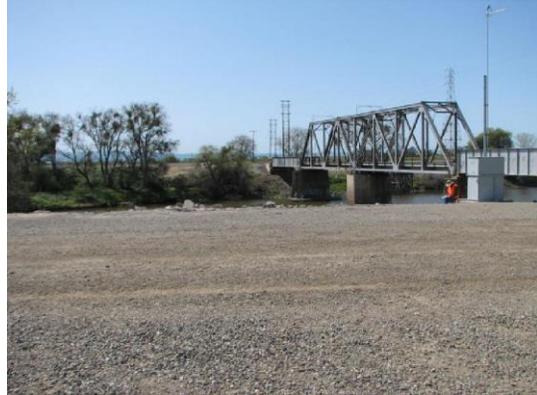
Photo 1 of 3 : UCIP_FA_2019_40715_72548.jpg

Comment Code					
Inspector Comment					
DS_ID:809 FS_ID:40715 EP_NO: N/A Repair Type: Non-Urgent Crossing Status: Found UCIP Comments: No information was obtained from desk study. This crossing was found during field visit. Need to contact owner to obtain additional details about crossing (installation date and permit) and status. FIELD_STRUCT_DESC: *ABANDONED* [Reclamation District No. 17 Drainage Plant] 18-inch drainage pipe of unknown material through the levee, 5.8 feet below the crown. Gate valve and siphon breaker on the waterside (WS) slope. Flap gate on the WS end. One CM cutoff wall. Pump on the landside (LS). (18-inch pipe Installed by USACE in 1961 -- no permit found; existing 18-inch pipe removed under Permit No. 14450, 1988 - R. H. Brown, two 18-inch pipes installed) [Additional Reference(s): DWR Levee Logs, 1981, 2003. USACE San Joaquin O&M Manual Unit No. 2, May 1963, (HLM 13.36)] FS Date: 2/4/2010

View of levee crown at crossing.

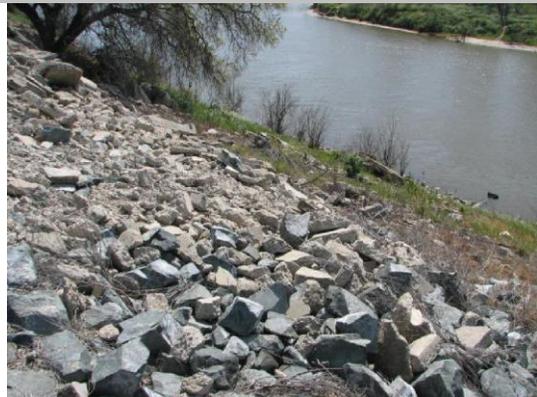
Photo 2 of 3 : UCIP_FA_2019_40715_72551.jpg

View of waterward side, photo 1 of 2.
