**Flood Control Project Maintenance
Levee Inspections**
LMA District Cover Sheet
Spring 2020 Levee Inspection Results

Reclamation District No. 0070 Meridian

Spring 2020 Levee Inspection Results

Waterway		Bank	Unit Miles
Unit No. 01 Sutter Bypass		Right	7.92

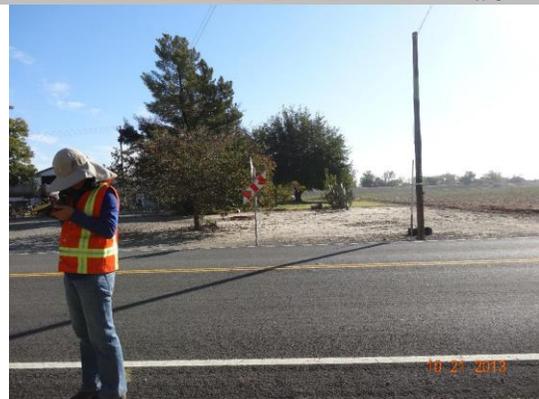
Photo 1 of 3 : UCIP_SP_2020_23384_40249.jpg

Comment Code					
Inspector Comment					
DS_ID:21415 FS_ID:23384 EP_NO: 15936 Repair Type: Non-Urgent Crossing Status: Indicator Found UCIP Comments: No markers visible on levee slope or levee toe to indicate line crosses levee. Need to contact PG&E to confirm location through levee. Also need to confirm the emergency contact person for this crossing. FIELD_STRUCT_DESC: 8-inch steel natural gas pipeline through the levee, 2.5 feet below the crown. Gas line markers on the landside (LS). (Plans to remove an existing 16-inch pipe and install an 8-inch natural gas pipe to existing pipe within the 10-foot LS limits of the levee authorized under Permit No. 15936, 1992 - Pacific Gas and Electric Company [PG&E]). FS Date: 10/21/2013

View of markers on the east side of S. Tarke Road.

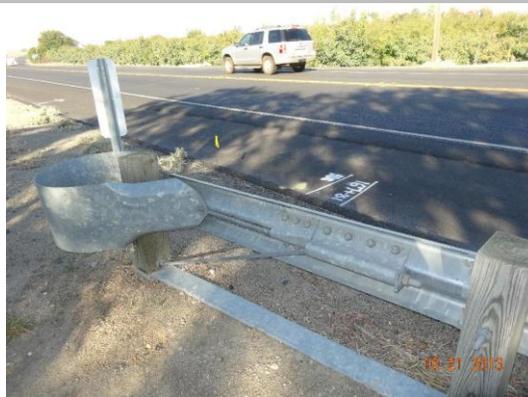
Photo 1 of 3 : UCIP_SP_2020_23467_40643.jpg

Underground Service Alert (USA) flag located at the end of Hwy 20 confirming gas line goes through.

Comment Code					
Inspector Comment					
DS_ID:21354 FS_ID:23467 EP_NO: 14802 Repair Type: Non-Urgent Crossing Status: Indicator Found UCIP Comments: Need to contact owner to determine status of crossing. Need date of last inspection and confirmation that crossing is still in operable condition. Markers found about 159 feet upstream of coordinates at the crossing of the ramp and S. Tarke Road (39.142684, -121.842685). FIELD_STRUCT_DESC: 4-inch steel natural gas pipeline through the levee, 2.5 feet below the crown. Aluminum pipe marker on the landside (LS) slope. Emergency contact information for Pacific Gas and Electric Company (PG&E): (800) 344-4749? or 4742? or (916) 742-3251. (Plans to replace an existing 3-inch natural gas main through the levee with a new 4-inch steel pipe authorized under Permit No. 14802, 1987 - PG&E). [Additional Reference(s): DWR Levee Log, 2007]. FS Date: 10/21/2013

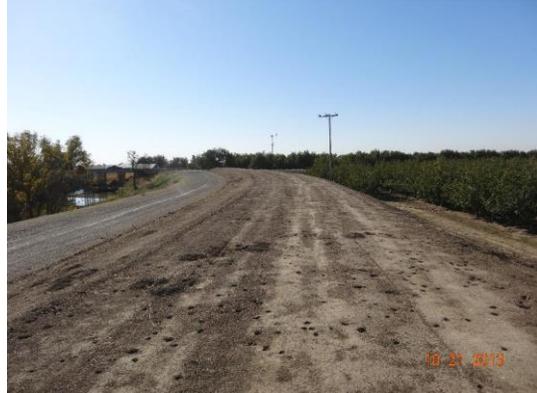
Photo 3 of 3 : UCIP_SP_2020_23526_40940.jpg

View of levee crown and waterward berm looking upstream from crossing.

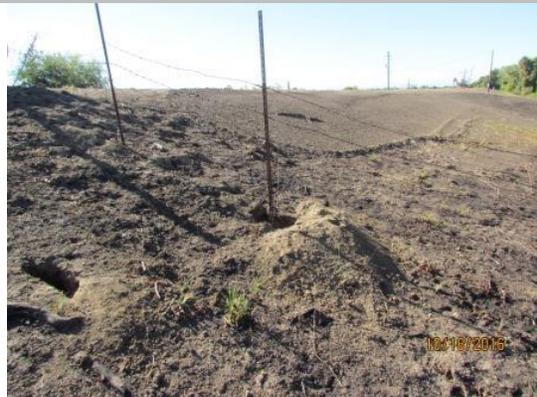
Photo 1 of 1 : SP_2020_RD0070_29_32_20200226_00003.jpg

View of the rodent holes along the waterside slope.

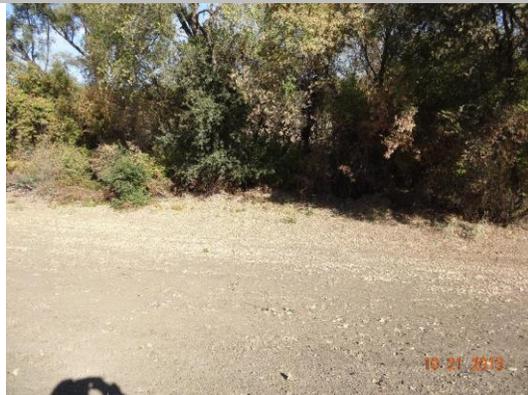
Photo 1 of 3 : UCIP_SP_2020_23530_40968.jpg

View of waterward side.

Comment Code					
Inspector Comment					
DS_ID:21322 FS_ID:23530 EP_NO: N/A Repair Type: Non-Urgent Crossing Status: Indicator Found UCIP Comments: Unable to determine if crossing exists need to coordinate with LMA to determine if more information is available about crossing. This crossing is referenced in the USACE Periodic Inspection as item USACE_CESPK_MRD1_2012_p_0208 for concrete ditch lined within 15 feet of LS toe, no water present, and no USACE recommendation letter available. FIELD_STRUCT_DESC: 12-inch steel irrigation discharge pipe through the levee, at an unknown depth. Cutoff wall around the pipe at the center of the levee. Slide gate on each end. Pump on the waterside (WS). Concrete distribution box on the landside (LS). [Additional Reference(s): USACE Sacramento O&M Manual 134, June 1953, (Station 142+70)]. FS Date: 10/21/2013

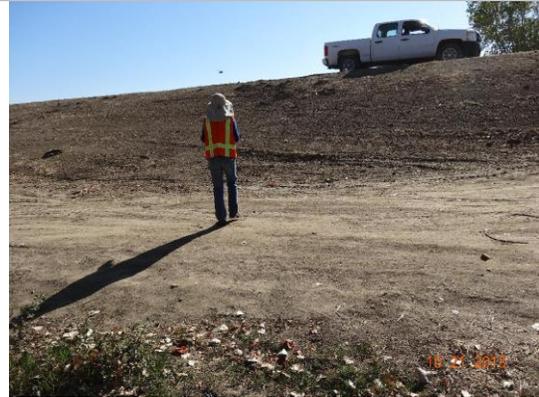
Photo 1 of 3 : UCIP_SP_2020_23506_40806.jpg

Comment Code					
Inspector Comment					
DS_ID:21361 FS_ID:23506 EP_NO: 9944 Repair Type: Non-Urgent Crossing Status: Found UCIP Comments: Burrow activity present on levee slopes. Multiple pipes found on landward side--are these pipes part of original crossing? This crossing is referenced in the USACE Periodic Inspection as item USACE_CESPK_MRD1_2012_p_0291--no USACE recommendation letter available. FIELD_STRUCT_DESC: 18-inch steel irrigation discharge pipe through the levee, 21.5 feet below the crown. Gate valve on the waterside (WS) end. Pipe discharges into a concrete box on the landside (LS). Rock revetment on the WS slope. (Retention of an 18-inch steel pipe through the levee, 21.5 feet below the crown, gate valve, and concrete box authorized under Automatic Board Order (ABO) issued as Permit No. 9944, 1974 - William J. and Marion D. Hankins). [Additional Reference(s): DWR Levee Log, 2007]. FS Date: 10/21/2013

View of waterward side slope and berm.

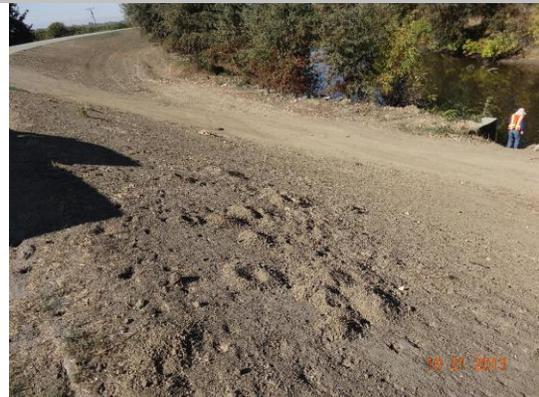
Photo 2 of 3 : UCIP_SP_2020_23506_40801.jpg

Recent burrow activity soil months next to holes.

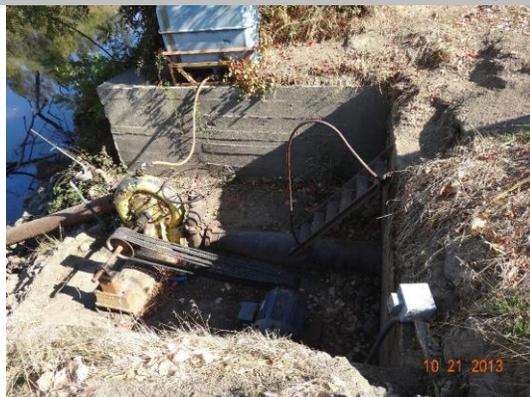
Photo 3 of 3 : UCIP_SP_2020_23506_40807.jpg

U shaped concrete box located on waterward side contains pump, motor, stairs, and pipe.

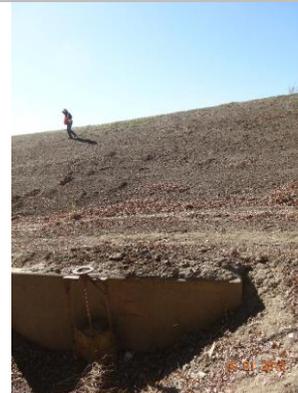
Photo 1 of 3 : UCIP_SP_2020_23510_40837.jpg

Comment Code					
Inspector Comment					
DS_ID:21362 FS_ID:23510 EP_NO: 9944 Repair Type: Non-Urgent Crossing Status: Found UCIP Comments: No pump connection. Need to coordinate with owner to determine status of crossing. If crossing is no longer in use owner will need to contact the CVFPB to comply with Title 23. This crossing is referenced in the USACE Periodic Inspection as item USACE_CESPK_MRD1_2012_p_0183 no USACE recommendation letter available. FIELD_STRUCT_DESC: 18-inch irrigation discharge pipe of an unknown material through the levee, 19.5 feet below the crown. Slide gate on the waterside (WS) end. Pump on the WS. Concrete distribution box on the landside (LS) slope. (Retention of an 18-inch pipe through the levee, 19.5 feet below the crown, and appurtenances authorized under Automatic Board Order (ABO) issued as Permit No. 9944, 1974 - William J. and Marion D. Hankins). [Additional Reference(s): DWR Levee Log, 2007. USACE Sacramento O&M Manual 134, June 1953, (Station 180+50)]. FS Date: 10/21/2013

Concrete head wall and screw gate at waterward toe.

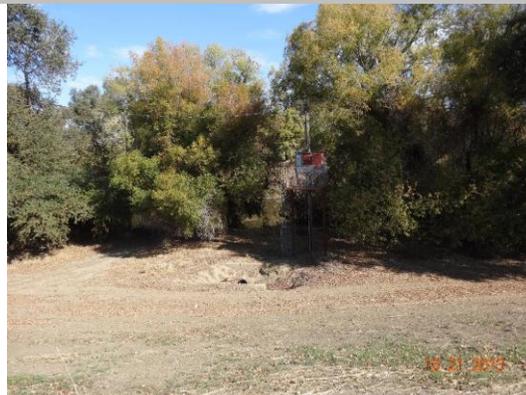
Photo 2 of 3 : UCIP_SP_2020_23510_40838.jpg

View of waterward side.

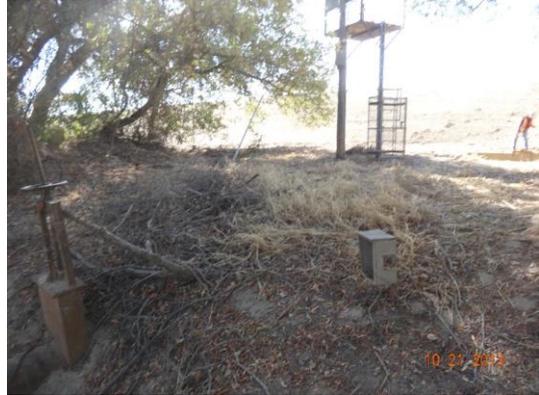
Photo 3 of 3 : UCIP_SP_2020_23510_40836.jpg

View of appurtenances located on waterward side.

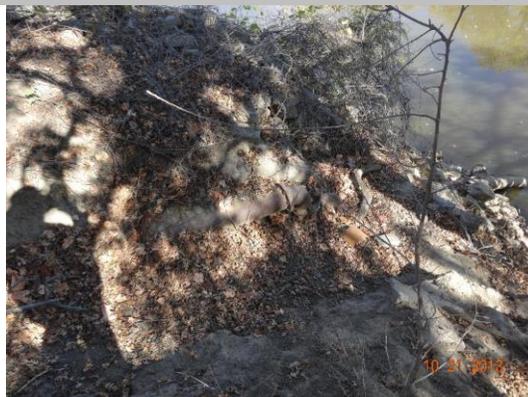
Photo 1 of 3 : UCIP_SP_2020_23516_40873.jpg

View of pipe located on waterward side.

Comment Code					
Inspector Comment					
DS_ID:21339 FS_ID:23516 EP_NO: 9951 Repair Type: Non-Urgent Crossing Status: Found UCIP Comments: Need to coordinate with owner to determine status of crossing. If crossing is no longer in use owner will need to contact the CVFPB to comply with Title 23. This crossing is referenced in the USACE Periodic Inspection as item USACE_CESPK_MRD1_2012_p_0144. FIELD_STRUCT_DESC: 10-inch steel irrigation pipe through the levee, 16.3 feet below the crown. Pipe crosses the levee at a 45 degree angle. Siphon breaker in a corrugated metal pipe (CMP) riser on the landside (LS) slope. Gate valve on the waterside (WS) end. Pipe discharges into a concrete discharge box. (Plans to retain a 10-inch steel pipe through the levee, 16.3 feet below the crown, a gate valve, a siphon breaker in a CMP riser, and a concrete discharge box authorized under Automatic Board Order (ABO) issued as Permit No. 9951, 1974 - Frank and Mischa Pirtle). [Additional Reference(s): DWR Levee Log, 2007]. FS Date: 10/21/2013

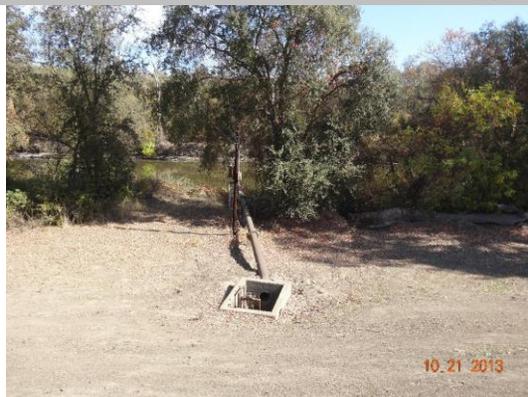
Photo 1 of 3 : UCIP_SP_2020_23518_40886.jpg

View of waterward side--pipe and concrete distribution box.

Comment Code					
Inspector Comment					
DS_ID:21338 FS_ID:23518 EP_NO: 9940 Repair Type: Non-Urgent Crossing Status: Found UCIP Comments: No connection present--need to contact owner to determine if owner plans to use. If crossing is no longer in use owner will need to coordinate with DWR inspector and CVFPB to remove according to Title 23 requirements. Unable to determine if crossing is in use. This crossing is referenced in the USACE Periodic Inspection as item USACE_CESPK_MRD1_2012_p_0125. FIELD_STRUCT_DESC: 18-inch steel irrigation discharge pipe through the levee, 19 feet below the crown. Cutoff wall around the pipe at the center of the levee. Slide gate in a concrete distribution box on the landside (LS). Pump on the waterside (WS). Pipe discharges into a concrete box on the LS. (Retention of an 18-inch steel pipe through the levee, 19 feet below the crown, a pump, a slide gate in a concrete distribution box, and a concrete box authorized under Automatic Board Order (ABO) issued as Permit No. 9940, 1974 - Pearl Clark, et al.). [Additional Reference(s): DWR Levee Log, 2007. USACE Sacramento O&M Manual 134, June 1953, (Station 251+30)]. FS Date: 10/21/2013

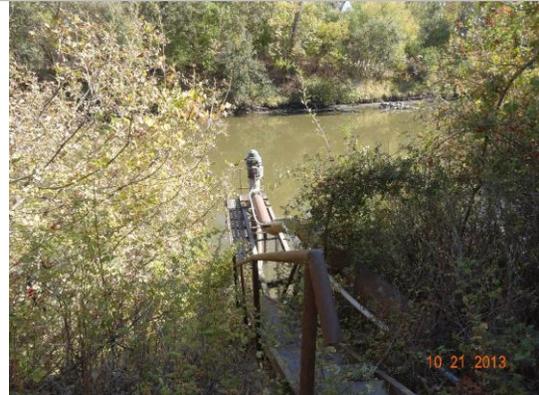
Photo 1 of 3 : UCIP_SP_2020_23519_40896.jpg

Comment Code					
Inspector Comment					
DS_ID:21357 FS_ID:23519 EP_NO: 9957 Repair Type: Non-Urgent Crossing Status: Found UCIP Comments: Burrow activity on slopes -- recommend addressing issue. This crossing is referenced in the USACE Periodic Inspection as item USACE_CESPK_MRD1_2012_p_0110. FIELD_STRUCT_DESC: 12-inch steel irrigation discharge pipe through the levee, 5.5 feet below the crown. Pump on the waterside (WS) slope. Siphon breaker in a corrugated metal pipe (CMP) riser on the landside (LS) slope. Pipe discharges into a concrete box at the LS toe. Service pole at the LS toe. (Plans to retain a 12-inch steel pipe through the levee, 5.5 feet below the crown, a siphon breaker in a CMP riser, a pump, and a concrete box authorized under Automatic Board Order (ABO) issued as Permit No. 9957, 1974 - James E. and Mattie Smith). [Additional Reference(s): DWR Levee Log, 2007]. FS Date: 10/21/2013

View of waterward side--pump, pipe, and walkway.

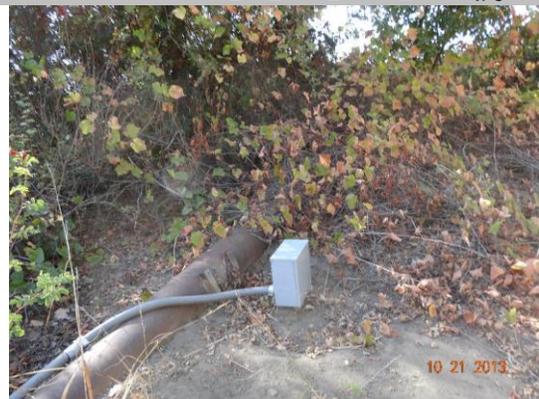
Photo 2 of 3 : UCIP_SP_2020_23519_40898.jpg

Pipe and electrical conduit exposed on levee berm.

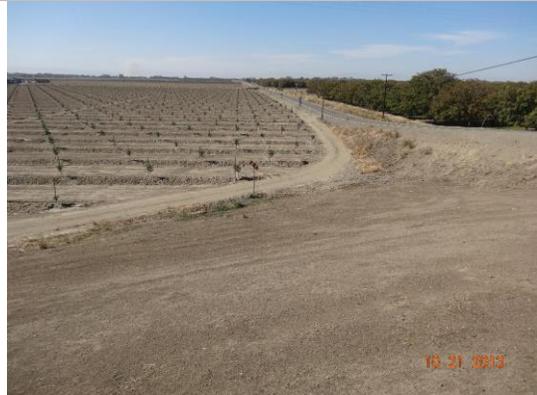
Photo 1 of 3 : UCIP_SP_2020_23479_40724.jpg

DS_ID:21360
 FS_ID:23479
 EP_NO: 4867
 Repair Type: Non-Urgent
 Crossing Status: Found
 UCIP Comments: Utility marker contact information includes Contact prior to Excavation call 1-800-227-2600 or Emergency Contact 1-800-811-4111. Need to contact owner to determine status of crossing. Need date of last inspection and confirmation that crossing is still in operable condition.
 FIELD_STRUCT_DESC: 6.5-inch coated steel natural gas pipeline through the levee, 4 feet below the crown. Concrete cutoff wall around the pipe at the center of the levee. Rock revetment on the waterside (WS) slope. (Plans for installing a gas line through the levee authorized under Permit No. 4867, 1965 - Pacific Gas and Electric Company [PG&E]). [Additional Reference(s): DWR Levee Log, 2007].
 FS Date: 10/21/2013

View of landward side.

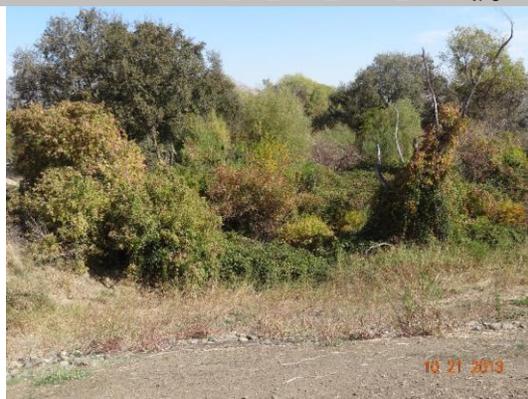
Photo 3 of 3 : UCIP_SP_2020_23479_40722.jpg

View of waterward side.

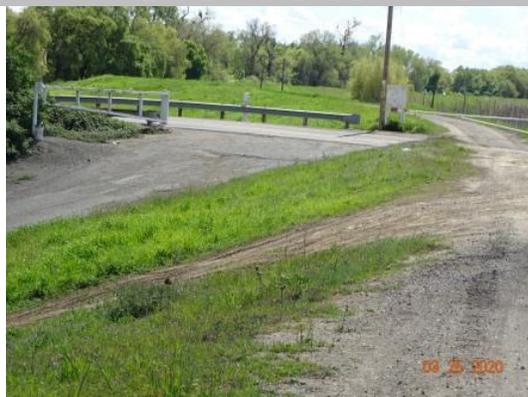
Photo 1 of 1 : SP_2020_RD0070_29_6_20200326_00066.jpg

LM Start	6.18	Rating **	M	Issue No.	6
LM End	6.18	Issue Type +	Ma	Location *	WS
Category	Earthen Levee			GPS Latitude/Longitude	
				Start	End
Item	Slope Stability			39.187481 °	39.187481 °
				-121.910852 °	-121.910852 °
DWR ID	DWR_RD0070_01_s_2012_6				
Comment Code					
S3 : Repair the levee slope damaged by vehicle traffic and prevent access where possible.					
Inspector Comment

View of vehicle erosion along the waterside slope. Spring 2020.

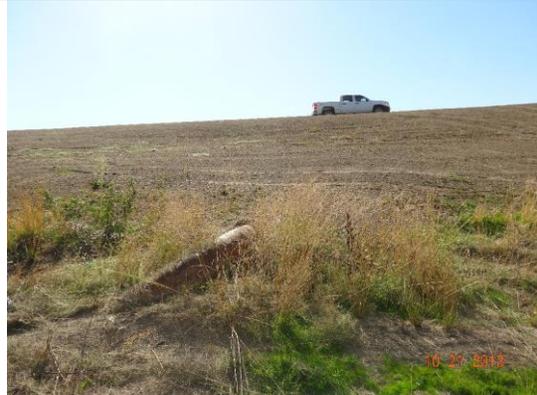
Photo 3 of 3 : UCIP_SP_2020_46422_40913.jpg

View of waterward slope and pipe at levee toe.

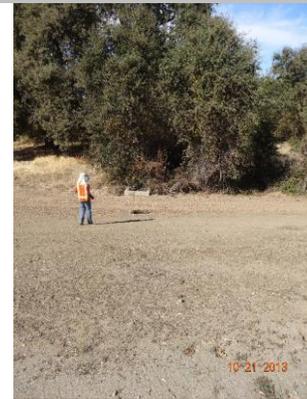
Photo 1 of 3 : UCIP_SP_2020_23529_40964.jpg

Comment Code					
Inspector Comment					
DS_ID:21345 FS_ID:23529 EP_NO: 9942 Repair Type: Non-Urgent Crossing Status: Found UCIP Comments: Dense vegetation limits the inspector's visibility to identify signs of pipe failure (leaks) along the slope. Recommend removing vegetation along pipe alignment to conduct proper inspection of structure and appurtenances. This crossing is referenced in the USACE Periodic Inspection as item USACE_CESPK_MRD1_2012_p_0005. FIELD_STRUCT_DESC: 24-inch corrugated metal irrigation discharge pipe through the levee, 16.5 feet below the crown. Incline pump on the waterside (WS). Slide gate in a corrugated metal pipe (CMP) riser on the WS slope. Pipe discharges into a concrete box at the landside (LS) toe. Service pole on the LS. (Retention of a 24-inch CMP through the levee, 16.5 feet below the crown, a slant pump, a slide gate in a CMP riser, a box, and a service pole authorized under Automatic Board Order (ABO) issued as Permit No. 9942, 1974 - R. W. and H. Evelyn Draper). [Additional Reference(s): DWR Levee Log, 2007. USACE Sacramento O&M Manual 134, June 1953, (Station 330+00)]. FS Date: 10/21/2013

View of waterward slope.

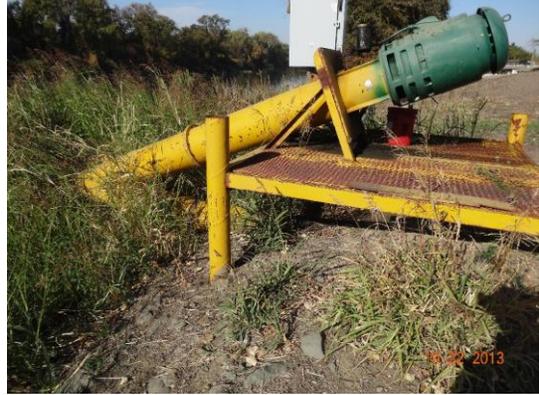
Photo 2 of 3 : UCIP_SP_2020_52618_42060.jpg

View of pump on waterward side.

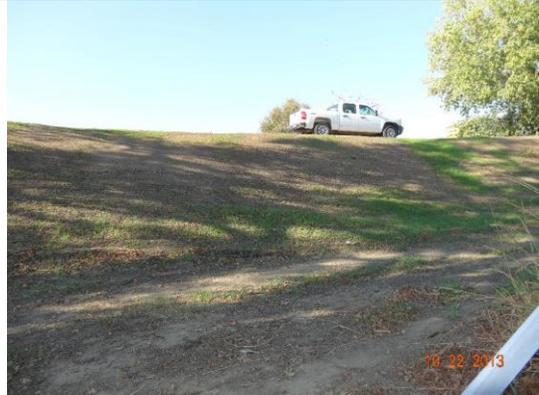
Photo 3 of 3 : UCIP_SP_2020_52618_42062.jpg

View of levee slope on landward side.

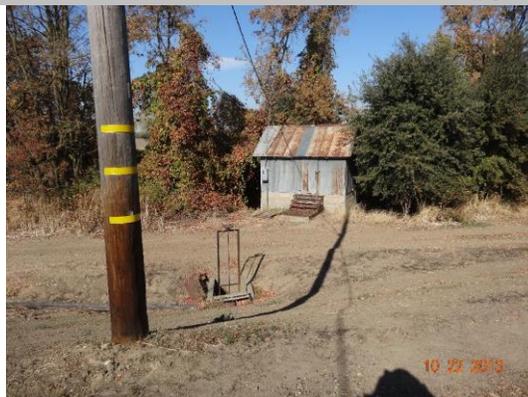
Photo 1 of 3 : UCIP_SP_2020_54252_42036.jpg

View of waterward side--appurtenances present pump house, concrete distribution box, screw gate, and power pole.

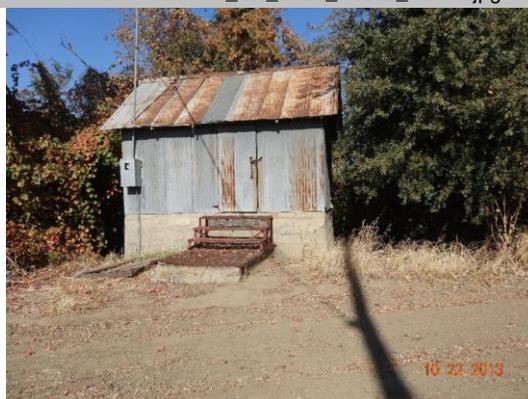
Photo 2 of 3 : UCIP_SP_2020_54252_42041.jpg

Pump station on waterward side.

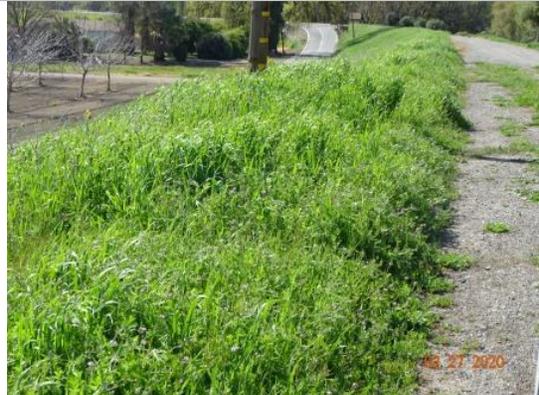
Photo 1 of 1 : SP_2020_RD0070_30_41_20200421_00119.jpg

View of vegetation along the landside slope. Spring 2020.

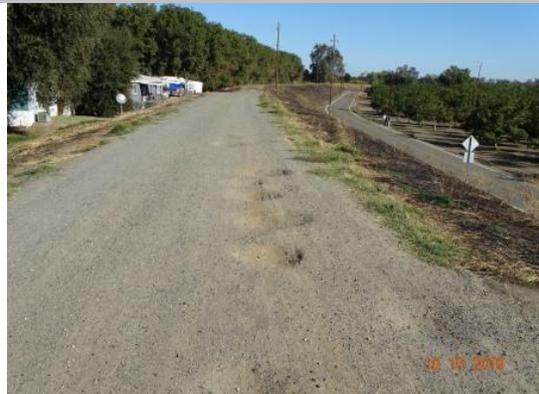
Photo 1 of 1 : SP_2020_RD0070_30_99_20200226_00019.jpg

View of the ruts in the crown surface. Fall 2019.

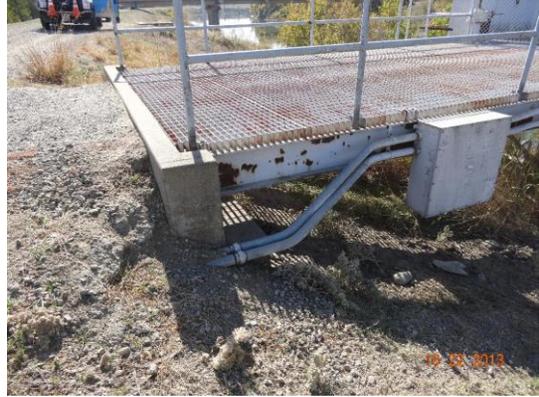
Photo 2 of 3 : UCIP_SP_2020_47030_42567.jpg

View of conduit pipes through levee.

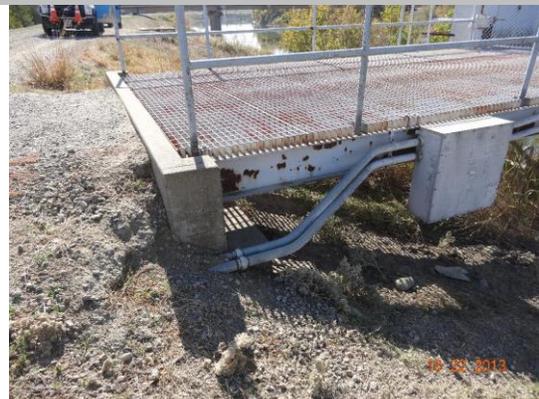
Photo 2 of 3 : UCIP_SP_2020_47032_42080.jpg

View of conduit pipes through levee.

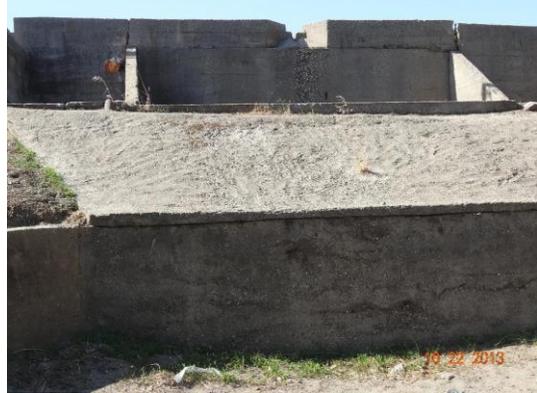
Photo 1 of 1 : UCIP_SP_2020_23961_42098.jpg

Concrete headwall located on landward side--no pipe. Only visible pipe is the pipe located at the far left (downstream end).

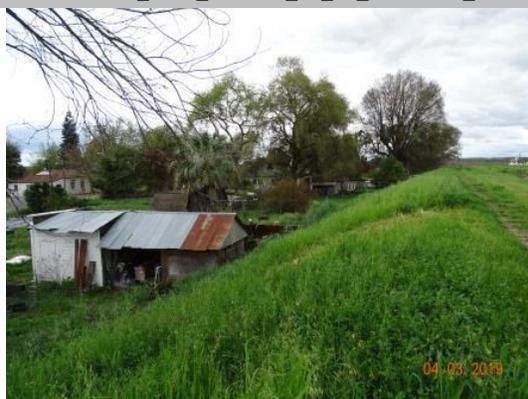
Photo 1 of 1 : SP_2020_RD0070_30_92_20200226_00018.jpg

View of the unpermitted outbuilding at the landside toe. Spring 2019.

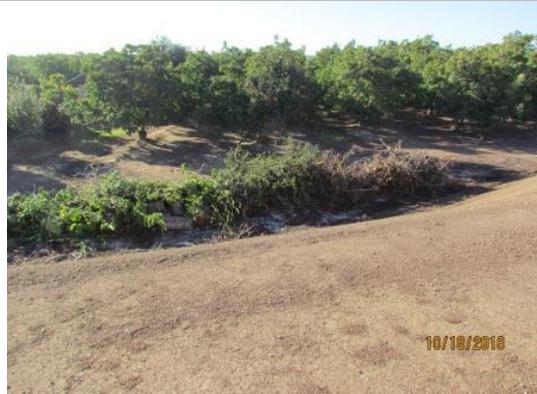
Photo 1 of 1 : SP_2020_RD0070_30_53_20200226_00003.jpg

View of the prunings along the landside toe.

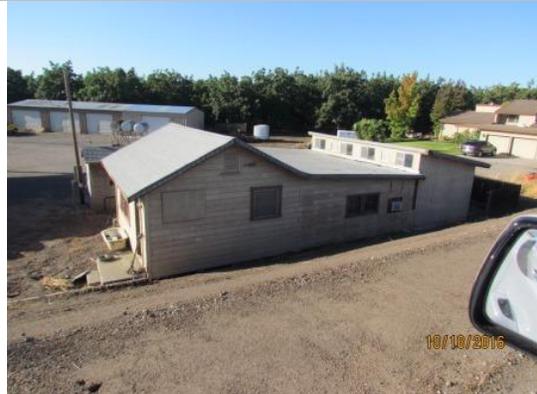
Photo 1 of 1 : SP_2020_RD0070_30_9_20200226_00002.jpg

View of a building within the easement of the levee.

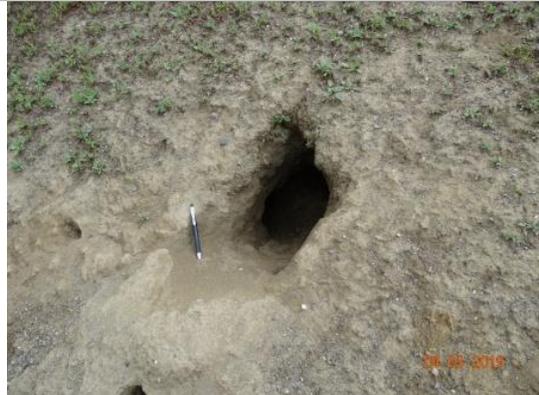
Photo 3 of 3 : SP_2020_RD0070_30_89_20200226_00017.jpg

Upclose view of a large rodent burrow. Spring 2019.

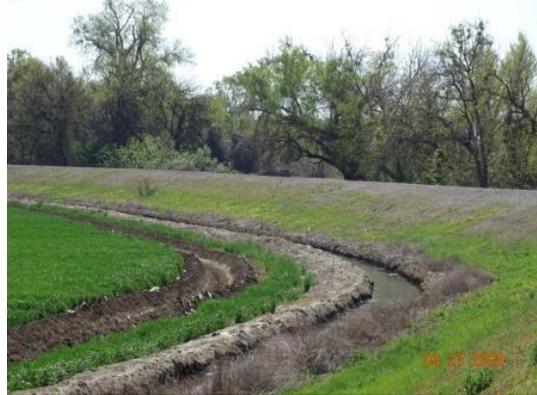
Photo 1 of 1 : SP_2020_RD0070_30_56_20200421_00120.jpg

View of the ditch along the landside toe. Spring 2020.

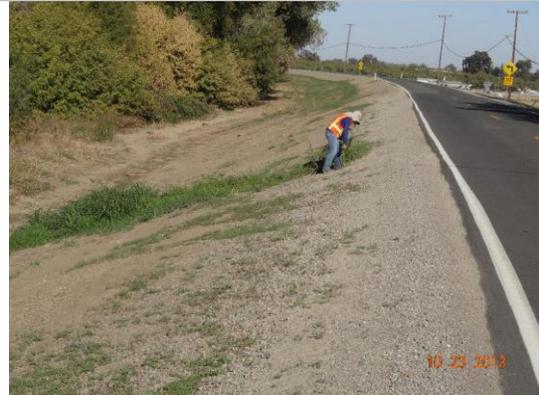
Photo 1 of 3 : UCIP_SP_2020_50007_42684.jpg

Vegetation on WS where leak found.

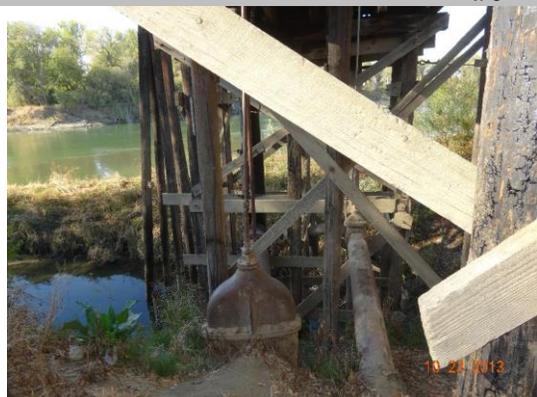
Photo 2 of 3 : UCIP_SP_2020_24108_42465.jpg

View of 16-inch pipe and 24-inch pipe with screw gate located on waterward side.

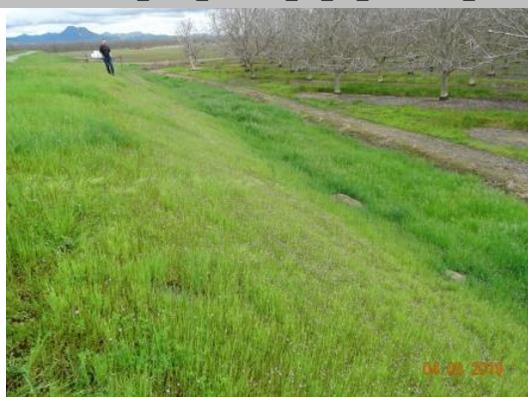
Photo 1 of 1 : SP_2020_RD0070_30_78_20200226_00014.jpg

View of the rodent burrows on the landside slope and toe. Spring 2019.

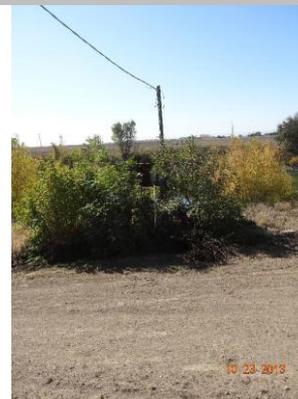
Photo 1 of 3 : UCIP_SP_2020_47033_42141.jpg

Crossing appurtenances located near brush and power pole on waterward side.

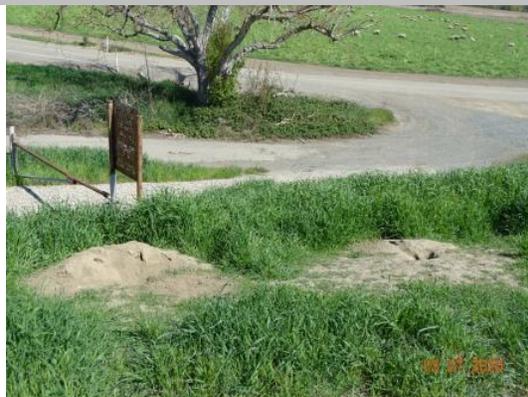
Photo 1 of 1 : SP_2020_RD0070_30_64_20200421_00121.jpg

View of rodent holes on the landside slope. Spring 2020.

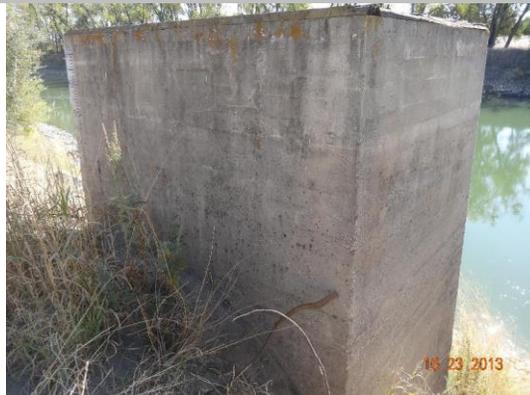
Photo 1 of 1 : UCIP_SP_2020_47039_42800.jpg

Remains of old gaging station associated with 24-inch iron pipe that extends into the river.

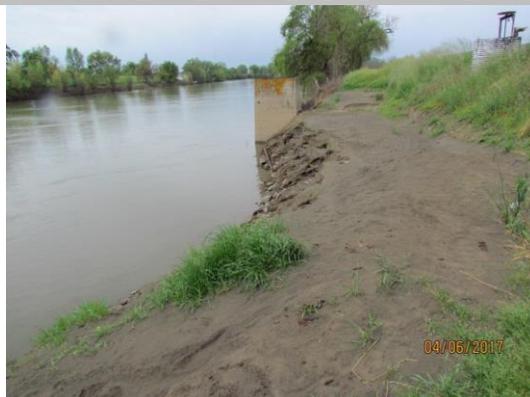
Photo 1 of 1 : SP_2020_RD0070_30_72_20200226_00010.jpg

View of the erosion along the waterside slope.
