**Flood Control Project Maintenance
Levee Inspections**

Maintenance Issue Types Only, Levee Inspection Report By Mile - Fall 2019

Reclamation District No. 0070 Meridian

Waterway	Bank	Unit Miles	Inspection Start/End	Inspector
Unit No. 01 Sutter Bypass	Right	7.92	10/09/2019 10/09/2019	Makar Sokol

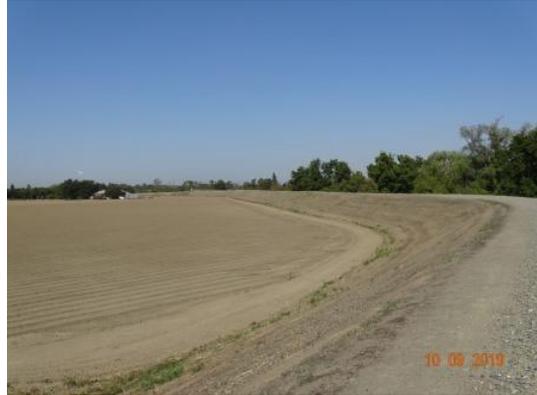
Photo 1 of 1 : FA_2019_RD0070_29_25_20191011_00071.jpg

LM Start	0.16	Rating **	A	Issue No.	25
LM End	0.16	Issue Type +	Ma	Location *	LS
Category	Earthen Levee			GPS Latitude/Longitude	
				Start	End
Item	Vegetation			39.138687°	39.138687°
				-121.836578°	-121.836578°
DWR ID	DWR_RD0070_01_f_2019_25				
Comment Code					
V1 : Control annual grass and weeds on the levee slopes and easements.					
Inspector Comment					
Good vegetation control is implemented on the landside and waterside slopes.

View of good vegetation control on the landside slope. Fall 2019.

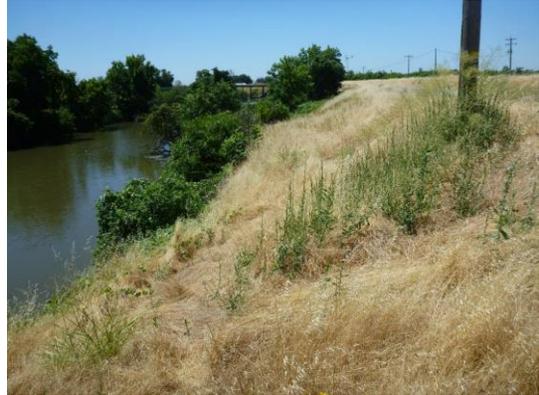
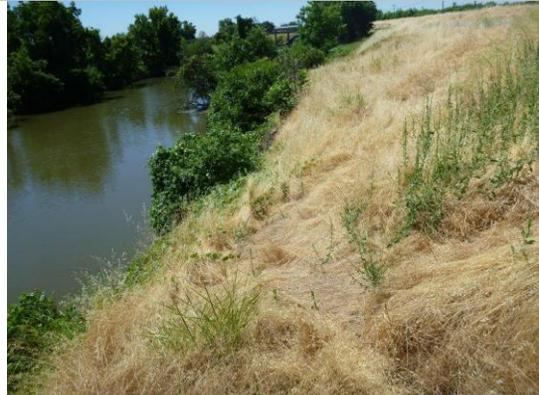
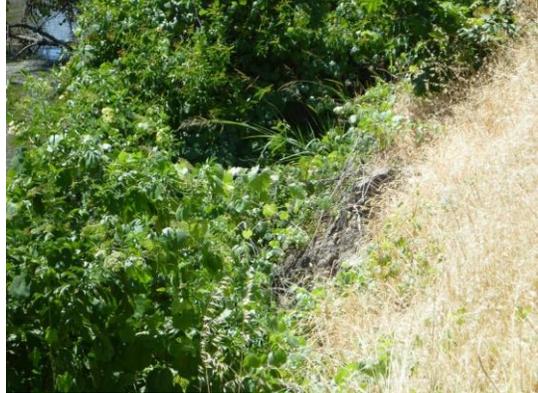
LM Start	0.76	Rating **	A/W	Issue No.	36
LM End	0.76	Issue Type +	Ma	Location *	WS
Category	Supplemental		GPS Latitude/Longitude		
			Start	End	
Item	2017 Storm Damage		39.145240°	39.145240°	
			-121.842650°	-121.842650°	
DWR ID	RD 70-03				
Comment Code					
Inspector Comment					
Levee Evaluation Comments					
Description:					
Site ID No:154					
Site Designation:RD 70-03					
Repair Type: Erosion					
Rating:Area of Concern					
Field Date:7/17/2017					
Notes:

LM Start	0.76	Rating **	A/W	Issue No.	36 (cont)
LM End	0.76	Issue Type +	Ma	Location *	WS
Category	Supplemental			GPS Latitude/Longitude	
				Start	End
Item	2017 Storm Damage			39.145240°	39.145240°
				-121.842650°	-121.842650°
DWR ID	RD 70-03				
Comment Code					
Inspector Comment					
Levee Evaluation Comments					
Description:					
Site ID No:154					
Site Designation:RD 70-03					
Repair Type: Erosion					
Rating:Area of Concern					
Field Date:7/17/2017					
Notes:

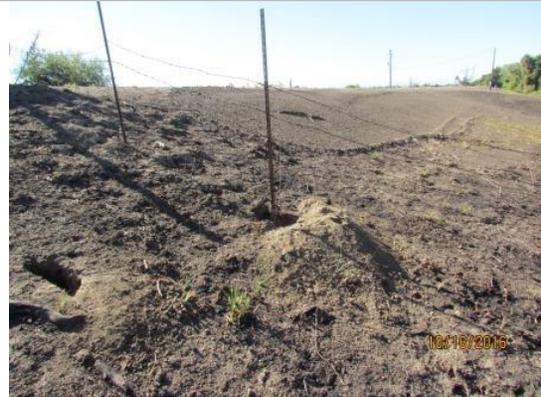
Photo 1 of 1 : FA_2019_RD0070_29_32_20190822_00006.jpg

LM Start	1.77	Rating **	M	Issue No.	32
LM End	1.77	Issue Type +	Ma	Location *	WS
Category	Earthen Levee			GPS Latitude/Longitude	
				Start	End
Item	Animal Control			39.151282°	39.151282°
				-121.855818°	-121.855818°
DWR ID	DWR_RD0070_01_f_2016_32				
Comment Code					
A3 : No rodents visible, but rodent burrows visible; need to backfill and compact or grout burrows.					
Inspector Comment

View of the rodent holes along the waterside slope.

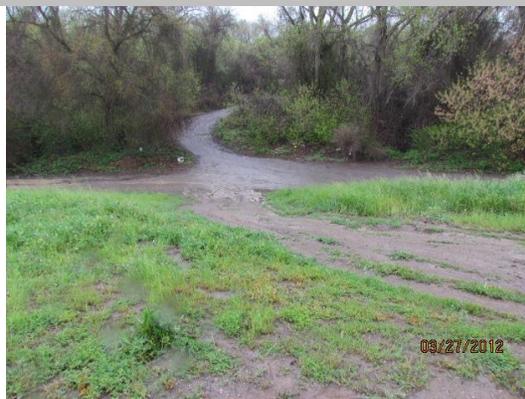
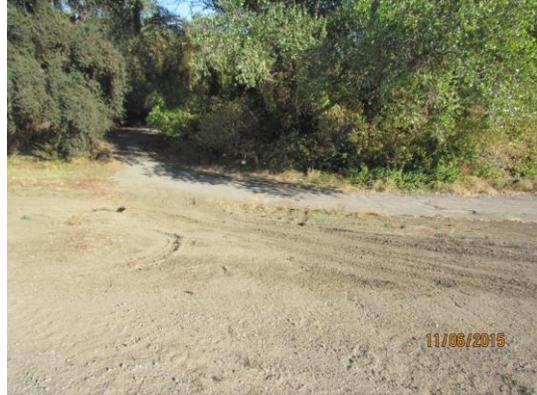
LM Start	6.18	Rating **	M	Issue No.	6
LM End	6.18	Issue Type +	Ma	Location *	WS
Category	Earthen Levee			GPS Latitude/Longitude	
				Start	End
Item	Slope Stability			39.187481 °	39.187481 °
				-121.910852 °	-121.910852 °
DWR ID	DWR_RD0070_01_s_2012_6				
Comment Code					
S3 : Repair the levee slope damaged by vehicle traffic and prevent access where possible.					
Inspector Comment

View of vehicle erosion along the waterside slope.

LM Start	6.18	Rating **	M	Issue No.	6 (cont)
LM End	6.18	Issue Type +	Ma	Location *	WS
Category	Earthen Levee			GPS Latitude/Longitude	
				Start	End
Item	Slope Stability			39.187481°	39.187481°
				-121.910852°	-121.910852°
DWR ID	DWR_RD0070_01_s_2012_6				
Comment Code					
S3 : Repair the levee slope damaged by vehicle traffic and prevent access where possible.					
Inspector Comment

View of the vehicle erosion along the waterside slope.

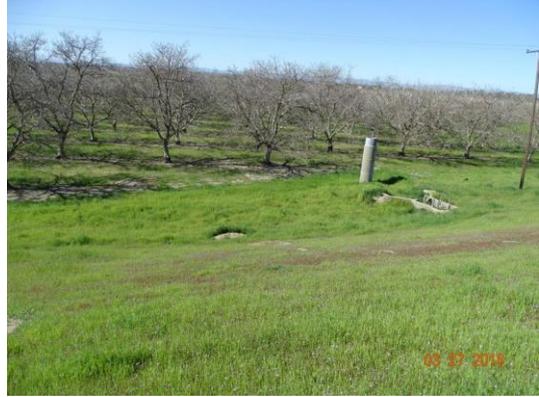
Photo 1 of 1 : FA_2019_RD0070_29_40_20190822_00016.jpg

LM Start	6.57	Rating **	U	Issue No.	40
LM End	6.57	Issue Type +	Ma	Location *	LS
Category	Earthen Levee		GPS Latitude/Longitude		
			Start	End	
Item	Animal Control		39.192283°	39.192283°	
			-121.914388°	-121.914388°	
DWR ID	DWR_RD0070_01_f_2018_40				
Comment Code					
A3 : No rodents visible, but rodent burrows visible; need to backfill and compact or grout burrows.					
Inspector Comment					
Several large rodent holes were observed in this area.

View of rodent holes along the landside slope.

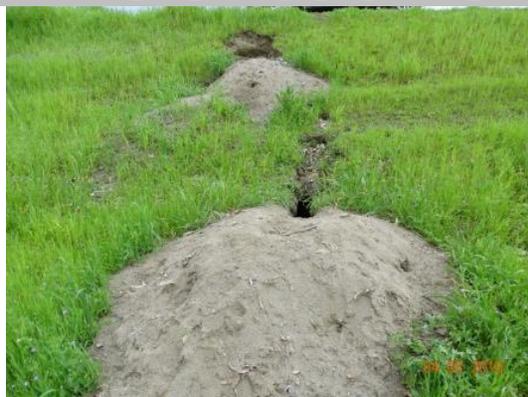
Photo 1 of 1 : FA_2019_RD0070_30_101_20190822_00030.jpg

LM Start	0.85	Rating **	U	Issue No.	101
LM End	0.85	Issue Type +	Ma	Location *	WS
Category	Earthen Levee			GPS Latitude/Longitude	
				Start	End
Item	Animal Control			39.185567°	39.185567°
				-121.941427°	-121.941427°
DWR ID	DWR_RD0070_02_s_2019_101				
Comment Code					
A3 : No rodents visible, but rodent burrows visible; need to backfill and compact or grout burrows.					
Inspector Comment

View of large rodent holes on the waterside slope. Spring 2019.

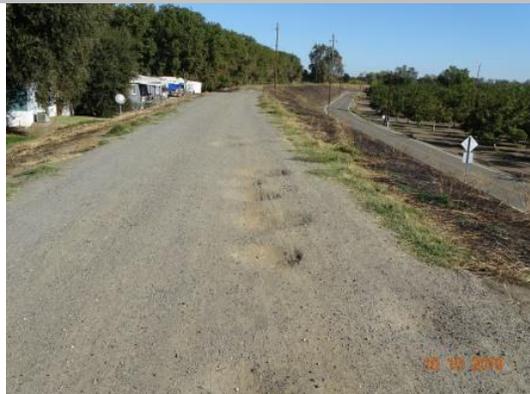
Photo 1 of 1 : FA_2019_RD0070_30_99_20191011_00131.jpg

LM Start	1.23	Rating **	M	Issue No.	99
LM End	1.23	Issue Type +	Ma	Location *	CR
Category	Earthen Levee		GPS Latitude/Longitude		
			Start	End	
Item	Crown Surface / Depressions / Rutting		39.180515 °	39.180515 °	
			-121.943885 °	-121.943885 °	
DWR ID	DWR_RD0070_02_s_2019_99				
Comment Code					
C2 : Repair depressions or ruts in the crown or slope.					
Inspector Comment

View of the ruts in the crown surface. Fall 2019.

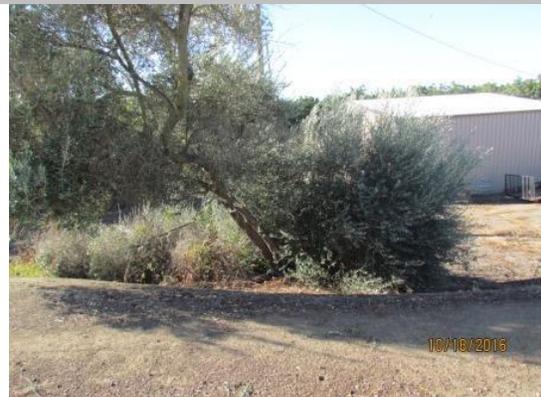
Photo 1 of 1 : FA_2019_RD0070_30_54_20190822_00005.jpg

LM Start	4.95	Rating **	M	Issue No.	54
LM End	4.95	Issue Type +	Ma	Location *	LS
Category	Earthen Levee		GPS Latitude/Longitude		
			Start	End	
Item	Trim / Thin Trees		39.142016°	39.142016°	
			-121.926214°	-121.926214°	
DWR ID	DWR_RD0070_02_f_2016_54				
Comment Code					
T1 : Trim trees to at least five feet above ground level.					
Inspector Comment

View of the trees blocking visibility.

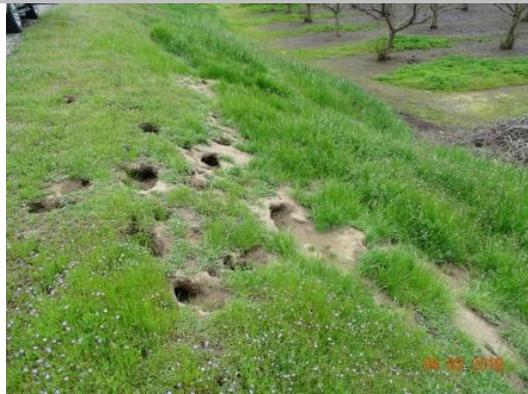
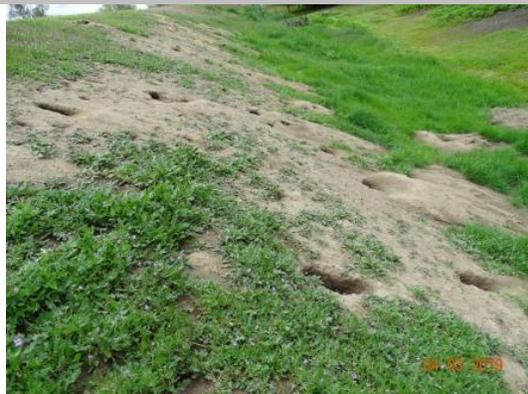
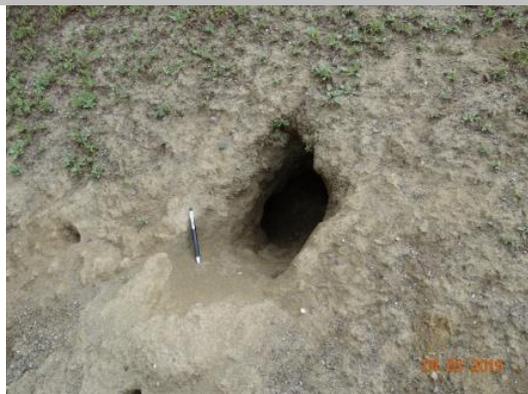
LM Start	5.03	Rating **	U	Issue No.	89
LM End	5.08	Issue Type +	Ma	Location *	LS
Category	Earthen Levee			GPS Latitude/Longitude	
				Start	End
Item	Animal Control			39.141997°	39.141905°
				-121.927776°	-121.928654°
DWR ID	DWR_RD0070_02_s_2019_89				
Comment Code					
A3 : No rodents visible, but rodent burrows visible; need to backfill and compact or grout burrows.					
Inspector Comment

View of the rodent burrows on the landside slope. Spring 2019.

Another view of the rodent burrows on the landside slope. Spring 2019.

Upclose view of a large rodent burrow. Spring 2019.

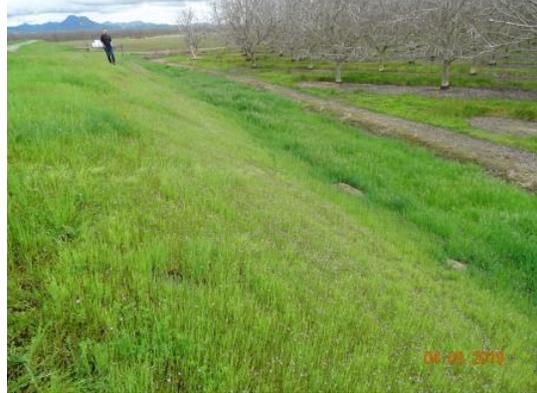
Photo 1 of 1 : FA_2019_RD0070_30_78_20190822_00020.jpg

LM Start	10.71	Rating **	U	Issue No.	78
LM End	10.71	Issue Type +	Ma	Location *	LS
Category	Earthen Levee			GPS Latitude/Longitude	
				Start	End
Item	Animal Control			39.089312 °	39.089312 °
				-121.893624 °	-121.893624 °
DWR ID	DWR_RD0070_02_s_2019_78				
Comment Code					
A3 : No rodents visible, but rodent burrows visible; need to backfill and compact or grout burrows.					
Inspector Comment

View of the rodent burrows on the landside slope and toe. Spring 2019.

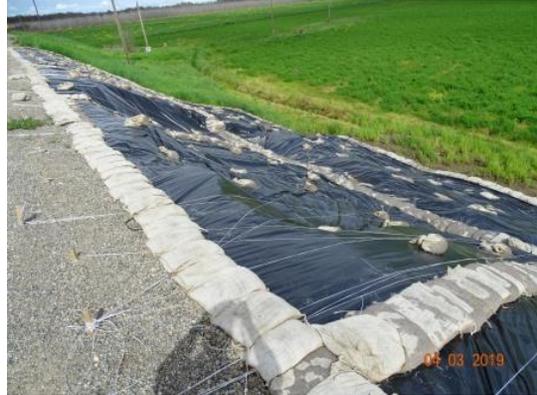
Photo 2 of 2 : FA_2019_RD0070_30_66_20190822_00013.jpg

LM Start	12.93	Rating **	U	Issue No.	66 (cont)
LM End	13.03	Issue Type +	Ma	Location *	LS
Category	Earthen Levee		GPS Latitude/Longitude		
			Start	End	
Item	Slope Stability		39.071323°	39.070900°	
			-121.877606°	-121.875728°	
DWR ID	DWR_RD0070_02_s_2019_66				
Comment Code					
S1 : Repair slope instability.					
Inspector Comment					
Sloughing on the landside slope occurred during the February 2019 storms. A temporary solution was used to address the issue. Permanent repairs should be completed to stabilize the slope.

View of the temporary solution used to address the sloughing. April 3, 2019.

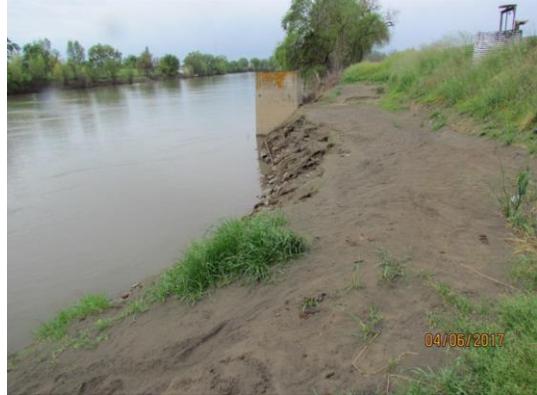
Photo 1 of 1 : FA_2019_RD0070_30_72_20190822_00014.jpg

LM Start	13.82	Rating **	A/W	Issue No.	72
LM End	13.82	Issue Type +	Ma	Location *	WS
Category	Earthen Levee		GPS Latitude/Longitude		
			Start	End	
Item	Erosion / Bank Caving		39.068370°	39.068370°	
			-121.862763°	-121.862763°	
DWR ID	DWR_RD0070_02_s_2017_72				
Comment Code					
E2 : Schedule repair of erosion site prior to the next inspection.					
Inspector Comment					
Repair the erosion along the waterside slope.

View of the erosion along the waterside slope.

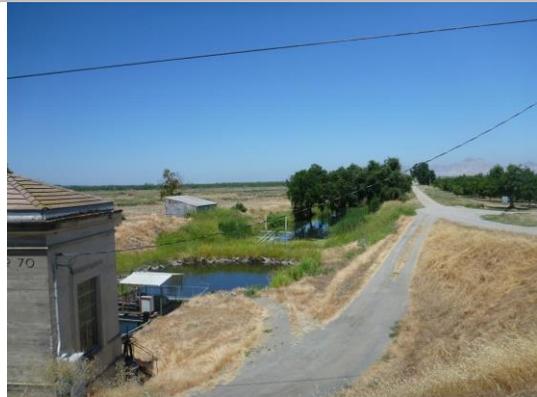
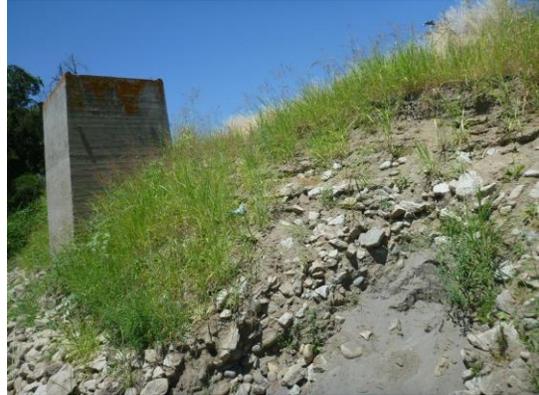
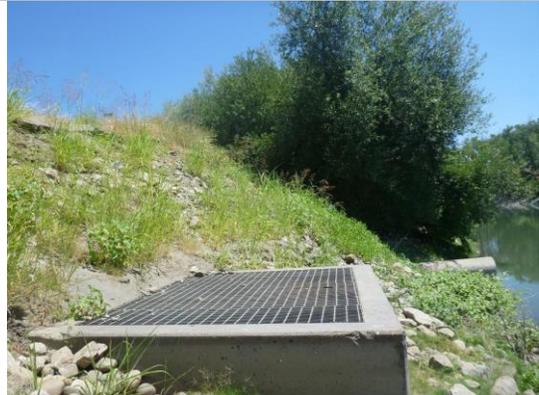
LM Start	13.83	Rating **	A/W	Issue No.	75
LM End	13.83	Issue Type +	Ma	Location *	
Category	Supplemental		GPS Latitude/Longitude		
			Start	End	
Item	2017 Storm Damage		39.068190°	39.068190°	
			-121.862700°	-121.862700°	
DWR ID	RD 70-01				
Comment Code					
Inspector Comment					
Levee Evaluation Comments					
Description:					
Site ID No:152					
Site Designation:RD 70-01					
Repair Type: Erosion					
Rating:Area of Concern					
Field Date:7/17/2017					
Notes: bank slope erosion around a drainage pipe/box

LM Start	13.83	Rating **	A/W	Issue No.	75 (cont)
LM End	13.83	Issue Type +	Ma	Location *	
Category	Supplemental		GPS Latitude/Longitude		
			Start	End	
Item	2017 Storm Damage		39.068190°	39.068190°	
			-121.862700°	-121.862700°	
DWR ID	RD 70-01				
Comment Code					
Inspector Comment					
Levee Evaluation Comments					
Description:					
Site ID No:152					
Site Designation:RD 70-01					
Repair Type: Erosion					
Rating:Area of Concern					
Field Date:7/17/2017					
Notes: bank slope erosion around a drainage pipe/box
