**Flood Control Project Maintenance
Levee Inspections**
LMA District Cover Sheet
Spring 2020 Levee Inspection Results

Reclamation District No. 0108 River Farms

Spring 2020 Levee Inspection Results

Waterway	Bank	Unit Miles
Unit No. 01 Colusa Basin Drain	Left	20.64

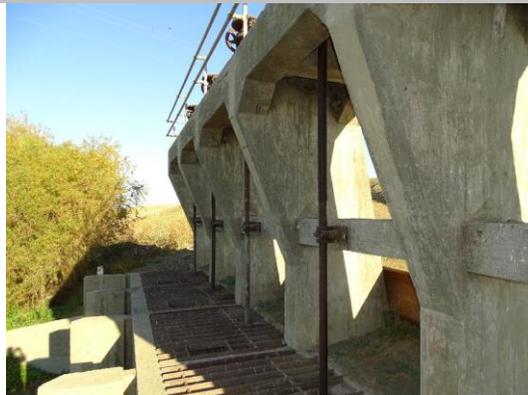
Photo 3 of 3 : UCIP_SP_2020_55919_83217.jpg

LM Start	0.06	Rating **	M	Issue No.	29 (cont)
LM End	0.06	Issue Type +	Ma	Location *	
Category	Supplemental			GPS Latitude/Longitude	
				Start	End
Item	DWR UCIP LMA Responsibility			38.822897 °	38.822897 °
				-121.797000 °	-121.797000 °
DWR ID	17943

Slide gate operating structure on WS shoulder

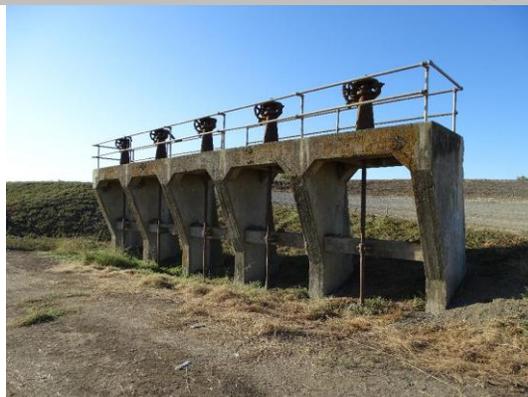
Photo 1 of 3 : UCIP_SP_2020_55920_83222.jpg

LM Start	0.06	Rating **	M	Issue No.	30
LM End	0.06	Issue Type +	Ma	Location *	
Category	Supplemental			GPS Latitude/Longitude	
				Start	End
Item	DWR UCIP LMA Responsibility			38.822919 °	38.822919 °
				-121.797046 °	-121.797046 °
DWR ID	22386

View of concrete structure located on landward side

Comment Code					
Inspector Comment					
DS_ID:22386 FS_ID:55920 EP_NO: 9396 Repair Type: Non-Urgent Crossing Status: Found UCIP Comments: 8/2/2019 Record remains Non-Urgent. In 2019 RD 108 took an attempt to bring structure to operable condition. Although this attempt was unsuccessful District will review other options. In the meantime crossing considered abandoned. Need to have CVFPB review ABO and determine current owner. (O.Yakimov - DWR UCIP) 06/10/2014 Need to contact owner to determine status of structure. Notes indicate crossing has been abandoned. Owner will need to coordinate with CVFPB and DWR inspector to determine how to properly abandon. (O.Magana - DWR UCIP) FIELD_STRUCT_DESC: *ABANDONED* 2 of 5: 72-inch reinforced concrete gravity drainage pipe or culvert through the levee, 31.6 feet below the crown. Slide gate on each end. (Retention of five 72-inch pipes through the levee [HLM 0.08] authorized under Automatic Board Order (ABO) issued as Permit No. 9736, 1974 - Reclamation District No. 108 [RD0108]). [Additional Reference(s): DWR Levee Log, 1991, (HLM 0.08). USACE Sacramento O&M Manual 132, October 1959, (HLM 0.08), referenced as five 6-foot by 8-foot concrete drainage culverts]. FS Date: 8/2/2019

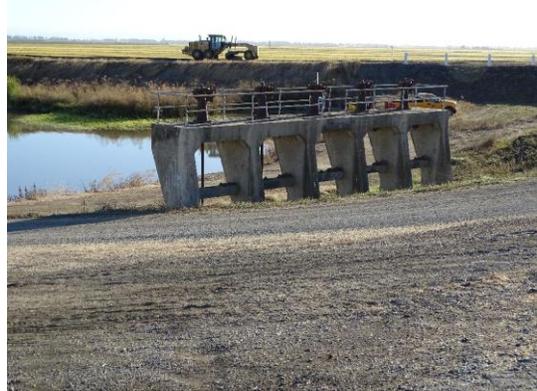
Photo 3 of 3 : UCIP_SP_2020_55921_83225.jpg

LM Start	0.06	Rating **	M	Issue No.	31 (cont)
LM End	0.06	Issue Type +	Ma	Location *	
Category	Supplemental			GPS Latitude/Longitude	
				Start	End
Item	DWR UCIP LMA Responsibility			38.822933 °	38.822933 °
				-121.797081 °	-121.797081 °
DWR ID	22387

Concrete structure located onlandward side

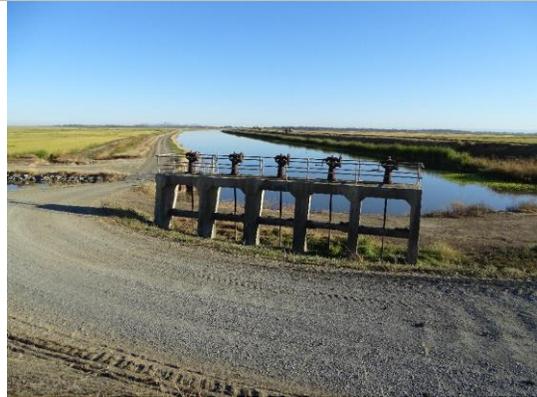
Photo 1 of 3 : UCIP_SP_2020_55922_83228.jpg

LM Start	0.06	Rating **	M	Issue No.	32
LM End	0.06	Issue Type +	Ma	Location *	
Category	Supplemental			GPS Latitude/Longitude	
				Start	End
Item	DWR UCIP LMA Responsibility			38.822897 °	38.822897 °
				-121.797000 °	-121.797000 °
DWR ID	22388

View of concrete structure located on landward side

Comment Code					
Inspector Comment					
DS_ID:22388 FS_ID:55922 EP_NO: 9396 Repair Type: Non-Urgent Crossing Status: Found UCIP Comments: 10/2/2019 Record remains Non-Urgent. In 2019 RD 108 took an attempt to bring structure to operable condition. Although this attempt was unsuccessful District will review other options. In the meantime crossing considered abandoned. Need to have CVFPB review ABO and determine current owner. (O.Yakimov - DWR UCIP)06/10/2014 Need to contact owner to determine status of structure. Notes indicate crossing has been abandoned. Owner will need to coordinate with CVFPB and DWR inspector to determine how to properly abandon. (O.Magana - DWR UCIP) FIELD_STRUCT_DESC: *ABANDONED* 4 of 5: 72-inch reinforced concrete gravity drainage pipe or culvert through the levee, 31.6 feet below the crown. Slide gate on each end. (Retention of five 72-inch pipes through the levee [HLM 0.08] authorized under Automatic Board Order (ABO) issued as Permit No. 9736, 1974 - Reclamation District No. 108 [RD0108]). [Additional Reference(s): DWR Levee Log, 1991, (HLM 0.08). USACE Sacramento O&M Manual 132, October 1959, (HLM 0.08), referenced as five 6-foot by 8-foot concrete drainage culverts]. FS Date: 10/2/2019 7:59:18 AM

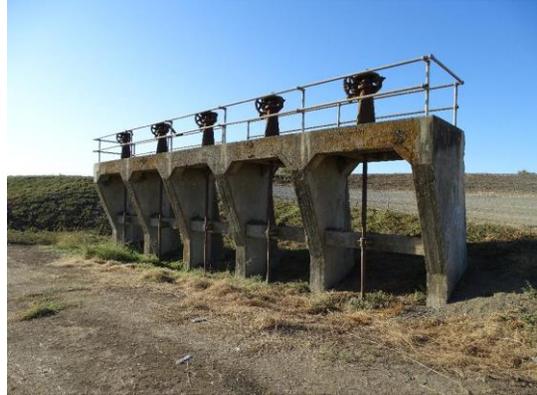
Photo 1 of 3 : UCIP_SP_2020_55923_83231.jpg

LM Start	0.07	Rating **	M	Issue No.	33
LM End	0.07	Issue Type +	Ma	Location *	
Category	Supplemental		GPS Latitude/Longitude		
			Start	End	
Item	DWR UCIP LMA Responsibility		38.822954 °	38.822954 °	
			-121.797135 °	-121.797135 °	
DWR ID	22389

Comment Code					
Inspector Comment					
DS_ID:22389 FS_ID:55923 EP_NO: 9396 Repair Type: Non-Urgent Crossing Status: Found UCIP Comments: 10/2/2019 Record remains Non-Urgent. In 2019 RD 108 took an attempt to bring structure to operable condition. Although this attempt was unsuccessful District will review other options. In the meantime crossing considered abandoned. Need to have CVFPB review ABO and determine current owner. (O.Yakimov - DWR UCIP)06/10/2014 Need to contact owner to determine status of structure. Notes indicate crossing has been abandoned. Owner will need to coordinate with CVFPB and DWR inspector to determine how to properly abandon. (O.Magana - DWR UCIP) FIELD_STRUCT_DESC: *ABANDONED* 5 of 5: 72-inch reinforced concrete gravity drainage pipe or culvert through the levee, 31.6 feet below the crown. Slide gate on each end. (Retention of five 72-inch pipes through the levee [HLM 0.08] authorized under Automatic Board Order (ABO) issued as Permit No. 9736, 1974 - Reclamation District No. 108 [RD0108]). [Additional Reference(s): DWR Levee Log, 1991. USACE Sacramento O&M Manual 132, October 1959, (HLM 0.08), referenced as five 6-foot by 8-foot concrete drainage culverts]. FS Date: 10/2/2019 8:01:09 AM

View of concrete structure located on landward side

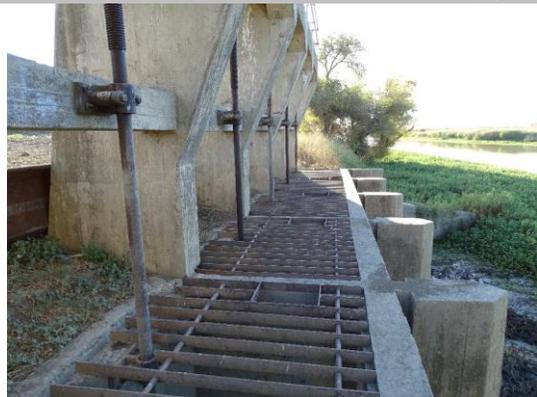
Photo 2 of 3 : UCIP_SP_2020_55923_83232.jpg

Slide gates on waterward side

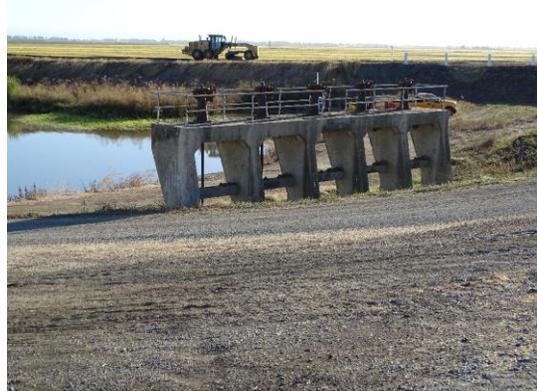
Photo 3 of 3 : UCIP_SP_2020_55923_83233.jpg

Concrete structure located on waterward side

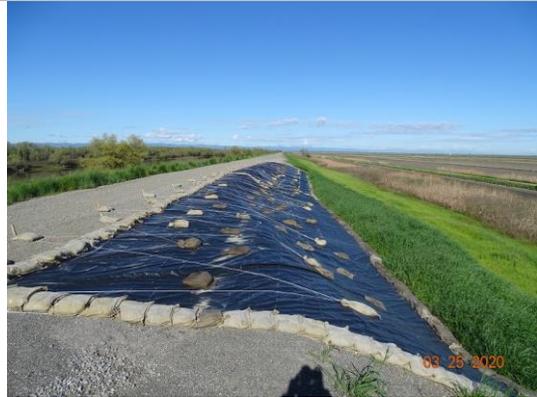
Photo 1 of 3 : SP_2020_RD0108_203_17_20200325_00040.jpg

LM Start	1.49	Rating **	M	Issue No.	17
LM End	1.51	Issue Type +	Ma	Location *	LS
Category	Earthen Levee		GPS Latitude/Longitude		
			Start	End	
Item	Slope Stability		38.830951 °	38.831043 °	
			-121.821574 °	-121.821847 °	
DWR ID	DWR_RD0108_01_s_2020_17				
Comment Code					
S1 : Repair slope instability.					
Inspector Comment					
There appears to be a 150' sloughing section that is a result of February 2019 storms. This site will be repaired by the USACE under PL84-99.

View of the sloughing site on the landside slope. Spring 2020.

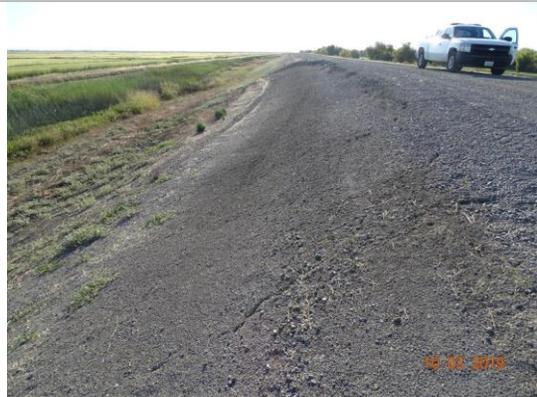
Photo 2 of 3 : SP_2020_RD0108_203_17_20200228_00006.jpg

View of the sloughing on the landside slope. Fall 2019.

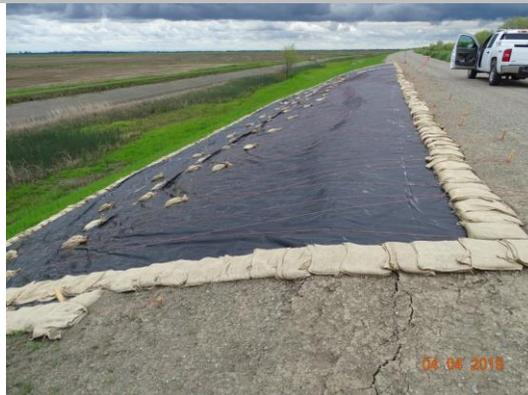
Photo 3 of 3 : SP_2020_RD0108_203_15_20200228_00003.jpg

LM Start	2.70	Rating **	M	Issue No.	15 (cont)
LM End	2.73	Issue Type +	Ma	Location *	LS
Category	Earthen Levee		GPS Latitude/Longitude		
			Start	End	
Item	Slope Stability		38.837568 °	38.837749 °	
			-121.842218 °	-121.842776 °	
DWR ID	DWR_RD0108_01_s_2019_15

View of sloughing on the landside slope. Spring 2019.

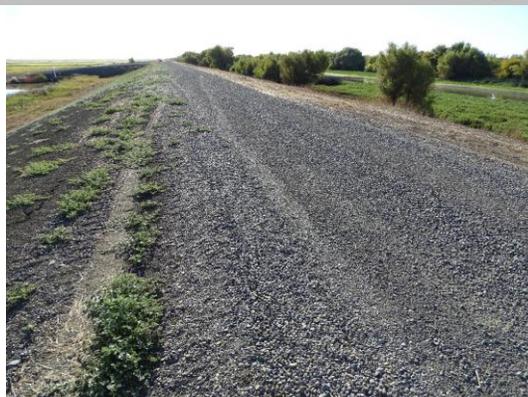
Photo 1 of 3 : UCIP_SP_2020_55925_83236.jpg

LM Start	2.91	Rating **	M	Issue No.	35
LM End	2.91	Issue Type +	En	Location *	
Category	Supplemental		GPS Latitude/Longitude		
			Start	End	
Item	DWR UCIP Field Study		38.838696 °	38.838696 °	
			-121.845843 °	-121.845843 °	
DWR ID	24875

View of levee crown at the crossing

DS_ID:24875
 FS_ID:55925
 EP_NO: N/A
 Repair Type: Non-Urgent
 Crossing Status: Indicator Found
 UCIP Comments: 10/2/2019 Record remains Non-Urgent. Geophysical results did not confirm presence of pipe through levee. Abandoned crossing. Needs to be removed or abandoned properly. (O.Yakimov - DWR UCIP)03/18/2014 No signs of pipe visible--need to contact owner to obtain permit number authorizing work. If crossing is no longer used by owner, the owner will need to coordinate with DWR Inspector and CVFPB to remove crossing according to Title 23 requirements. Dense vegetation limits the inspector's visibility to identify signs of pipe failure (leaks) along the slope. Recommend removing vegetation along pipe alignment to conduct proper inspection of structure. (O.Magana - DWR UCIP)
 FIELD_STRUCT_DESC: 44-inch corrugated metal pipe (CMP) riser on the waterside (WS). Riser is filled with trash and debris. Unable to determine if a crossing exists at this location. This riser was field discovered.

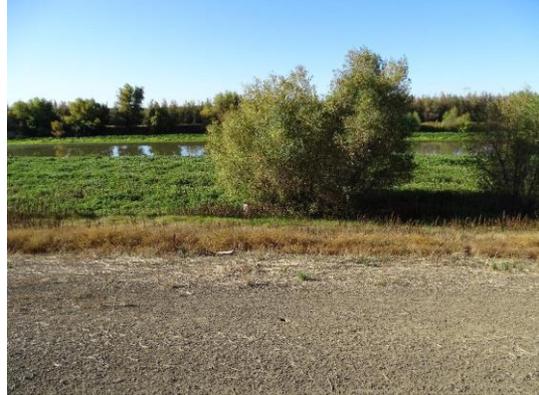
Photo 2 of 3 : UCIP_SP_2020_55925_83237.jpg

View of WS looking from levee crown

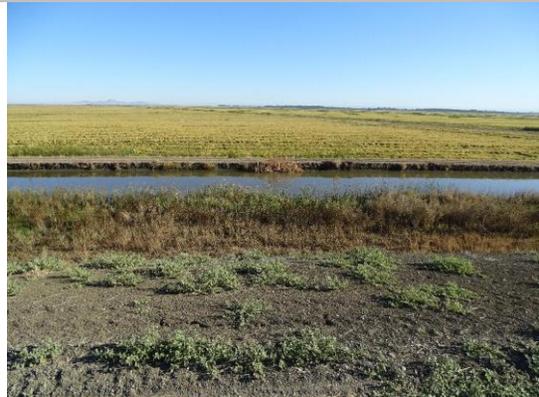
Photo 3 of 3 : UCIP_SP_2020_55925_83238.jpg

View of LS looking from levee crown

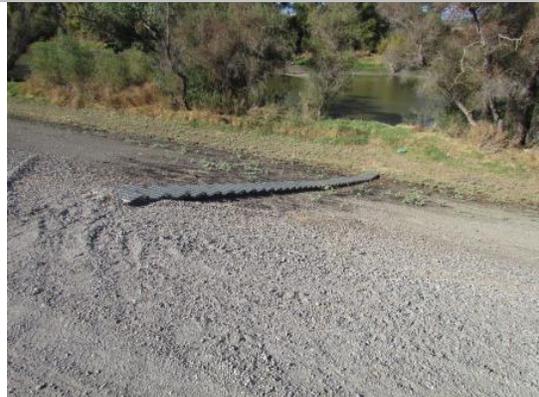
Photo 2 of 2 : SP_2020_RD0108_203_16_20200228_00005.jpg

View of a steel stairway on WS slope. Fall 2016 inspection.

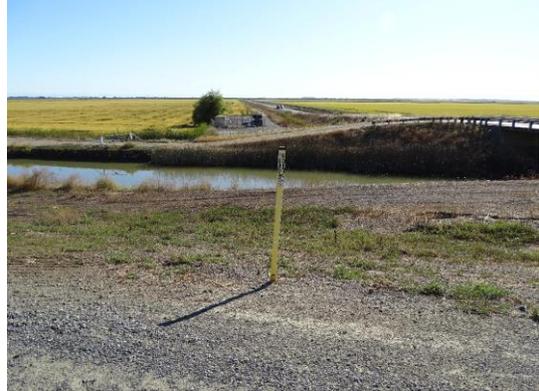
Photo 3 of 3 : UCIP_SP_2020_55926_83245.jpg

LM Start	11.24	Rating **	M	Issue No.	36 (cont)
LM End	11.24	Issue Type +	En	Location *	
Category	Supplemental			GPS Latitude/Longitude	
				Start	End
Item	DWR UCIP Field Study			38.925662 °	38.925662 °
				-121.914303 °	-121.914303 °
DWR ID	24876

View of LS looking from levee crown. Gas line marker installed on levee shoulder. PG&E facility on LS

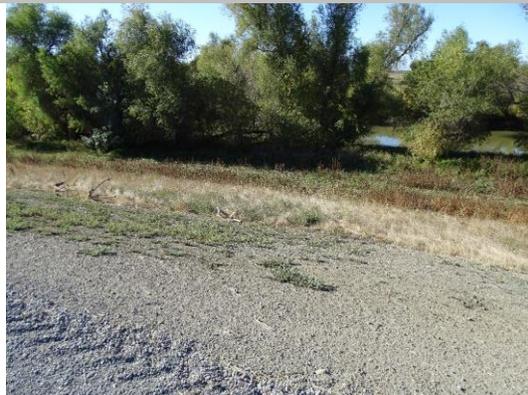
Photo 3 of 3 : UCIP_SP_2020_55927_83248.jpg

LM Start	14.94	Rating **	M	Issue No.	37 (cont)
LM End	14.94	Issue Type +	En	Location *	
Category	Supplemental			GPS Latitude/Longitude	
				Start	End
Item	DWR UCIP Field Study			38.971607 °	38.971607 °
				-121.929499 °	-121.929499 °
DWR ID	17942

View of waterward side. No marker visible on waterward side

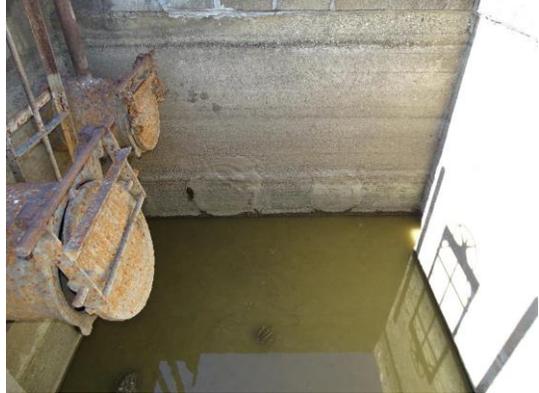
Photo 3 of 3 : UCIP_SP_2020_55932_83440.jpg

LM Start	18.73	Rating **	M	Issue No.	39 (cont)
LM End	18.73	Issue Type +	En	Location *	
Category	Supplemental			GPS Latitude/Longitude	
				Start	End
Item	DWR UCIP Field Study			39.011044 °	39.011044 °
				-121.978446 °	-121.978446 °
DWR ID	18659

Immured holes of 2 pipes towards levee in concrete box on LS

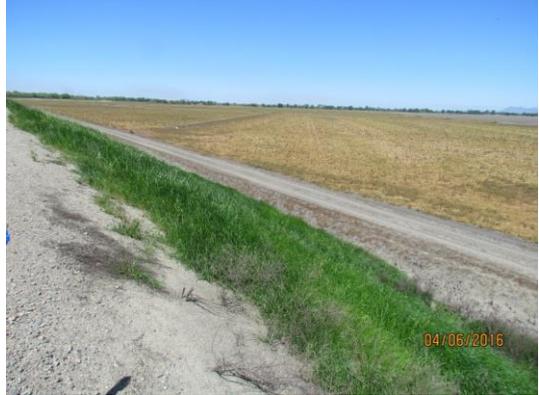
Photo 1 of 1 : SP_2020_RD0108_203_6_20200228_00001.jpg

LM Start	18.92	Rating **	M	Issue No.	6
LM End	19.28	Issue Type +	En	Location *	LS
Category	Earthen Levee			GPS Latitude/Longitude	
				Start	End
Item	Encroachments			39.013160 °	39.017000 °
				-121.980808 °	-121.985364 °
DWR ID	DWR_RD0108_01_s_2012_6				
Comment Code					
DT : Ditch					
Inspector Comment					
A ditch is located at the toe of the levee.

View of the ditch at the toe of the levee on the landward side looking upstream. Spring 2016.
