**Flood Control Project Maintenance
Levee Inspections**

Fall 2019 Levee Maintenance Deficiency Summary Report

Reclamation District No. 0150 Merrit Island

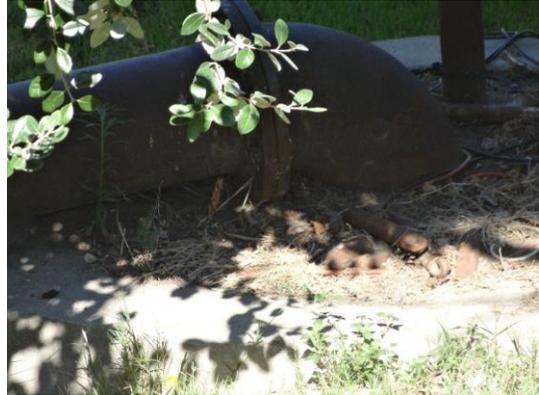
Photo 3 of 3 : UCIP_FA_2019_42700_34245.jpg

LS view: abandoned pipe and concrete box on landside toe.

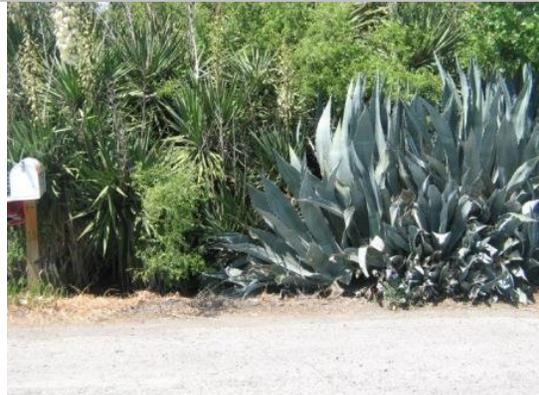
Photo 1 of 1 : FA_2019_RD0150_16_4_20190904_00001.jpg

Landscaping on landward slope of the levee.

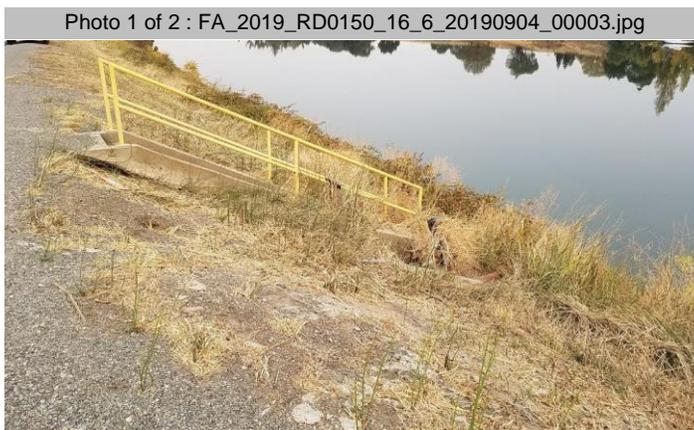
LM Start	0.38	Rating **	M	Issue No.	6
LM End	0.38	Issue Type +	Ma	Location *	WS
Category	Earthen Levee		GPS Latitude/Longitude		
			Start	End	
Item	Slope Stability		38.332598°	38.332598°	
			-121.572179°	-121.572179°	
DWR ID	DWR_RD0150_02_s_2012_6				
Comment Code					
S2 : Repair the levee slope damaged by foot traffic and prevent access where possible.					
Inspector Comment

View of slope instability around stairway. Fall 2018

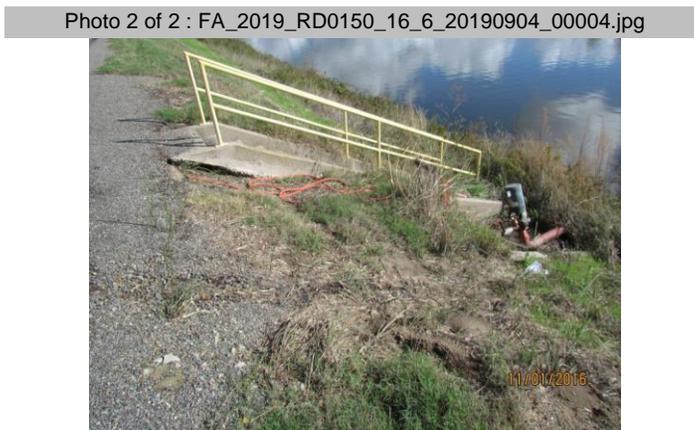
View of slope instability on the waterside of the levee. Fall 2016

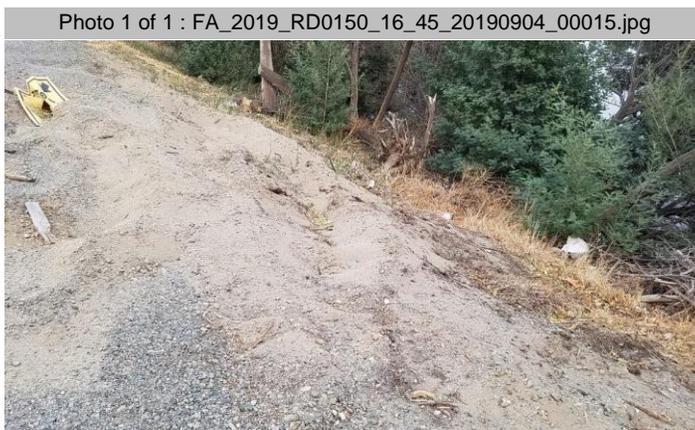
LM Start	0.59	Rating **	M	Issue No.	45
LM End	0.59	Issue Type +	Ma	Location *	WS
Category	Earthen Levee			GPS Latitude/Longitude	
				Start	End
Item	Slope Stability			38.334898 °	38.334898 °
				-121.569632 °	-121.569632 °
DWR ID	DWR_RD0150_02_f_2018_45				
Comment Code					
S3 : Repair the levee slope damaged by vehicle traffic and prevent access where possible.					
Inspector Comment

View of slope damage likely from vehicle traffic. Fall 2018

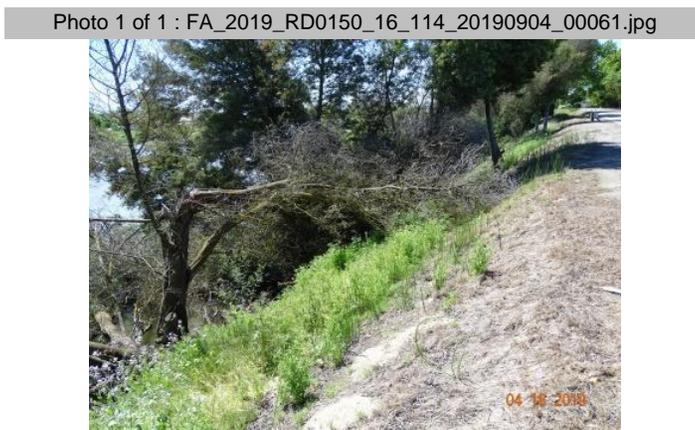
LM Start	0.60	Rating **	M	Issue No.	114
LM End	0.60	Issue Type +	Ma	Location *	WS
Category	Earthen Levee			GPS Latitude/Longitude	
				Start	End
Item	Encroachments			38.334998 °	38.334998 °
				-121.569468 °	-121.569468 °
DWR ID	DWR_RD0150_02_f_2019_114				
Comment Code					
TR : Tree or limb					
Inspector Comment					
Remove fallen tree from the levee slope.

View looking downstream at fallen tree on levee slope. Spring 2019

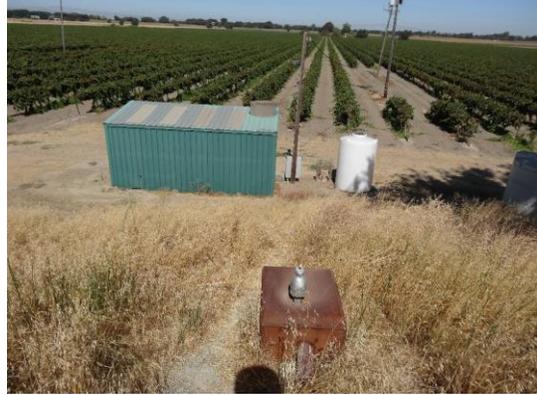
Photo 3 of 3 : UCIP_FA_2019_20303_34285.jpg

LS view: 10-inch pipe and air vent on levee slope. Concrete standpipe inside water filtration plant.

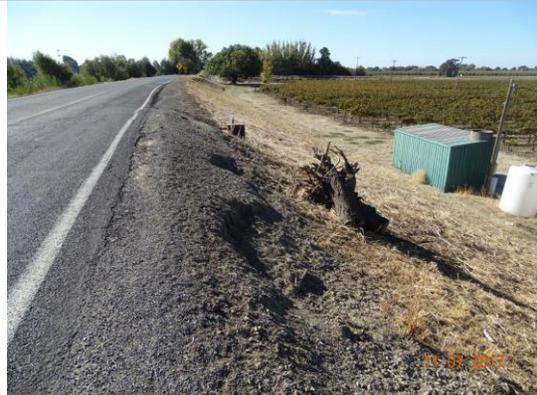
Photo 1 of 1 : FA_2019_RD0150_16_59_20190904_00038.jpg

LM Start	0.71	Rating **	U	Issue No.	59
LM End	0.71	Issue Type +	Ma	Location *	LS
Category	Earthen Levee			GPS Latitude/Longitude	
				Start	End
Item	Trim / Thin Trees			38.336291 °	38.336291 °
				-121.568260 °	-121.568260 °
DWR ID	DWR_RD0150_02_s_2016_59				
Comment Code					
T5 : Tree stumps.					
Inspector Comment					
Remove trees and repair slope damage.

View of the tree trunk on the landside of the levee. Fall 2017

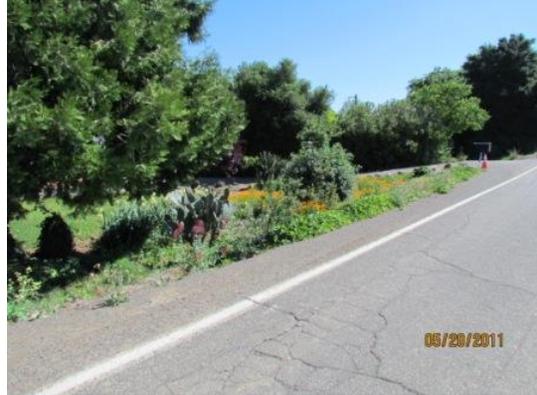
Photo 1 of 1 : FA_2019_RD0150_16_88_20190904_00055.jpg

Unpermitted landscaping was found on the landside slope of the levee. The picture was taken from the crown looking upstream. Spring 2011

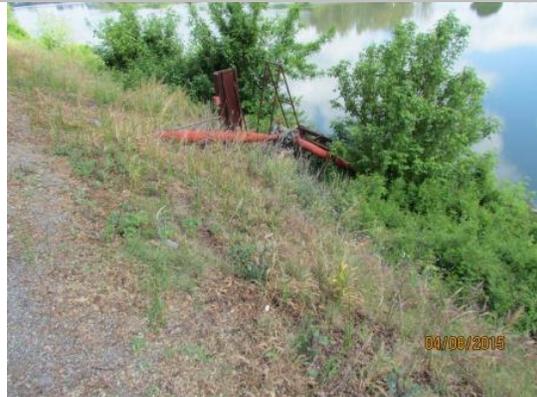
Photo 1 of 1 : FA_2019_RD0150_16_961_20190904_00063.jpg

View of the erosion on the waterside slope.

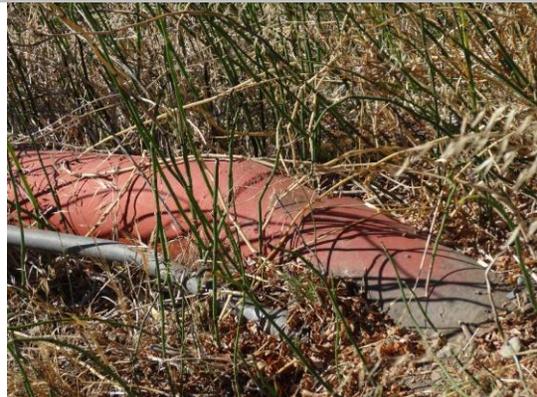
Photo 2 of 3 : UCIP_FA_2019_20736_34916.jpg

WS view: steel pipe and GI conduit on levee slope.

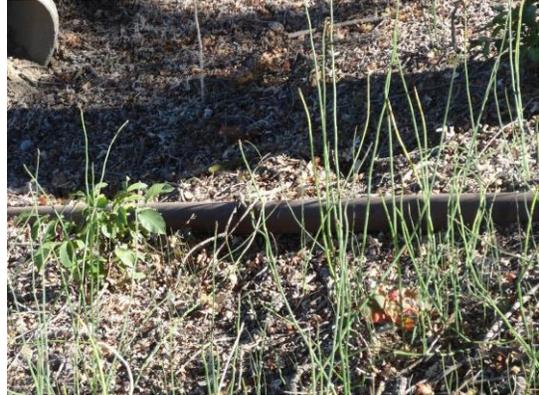
Photo 2 of 3 : UCIP_FA_2019_19848_33733.jpg

LS view: exposed 4-inch steel pipe on levee slope.

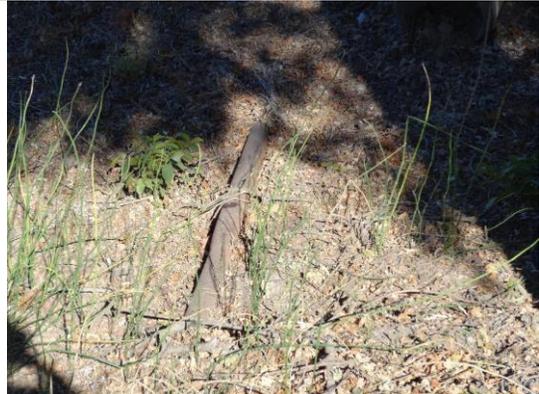
Photo 3 of 3 : UCIP_FA_2019_19848_33732.jpg

LS view: abandoned 4-inch steel pipe on levee slope.

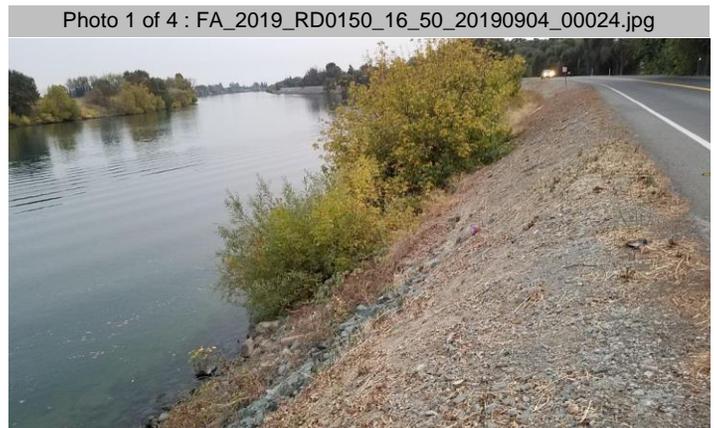
Comment Code					
Inspector Comment					
<p>Levee Evaluation Comments Description: The flood damage consists of a waterside erosion approximately 447 feet long on the west (right) bank of the Sacramento River. See attached pages for photos. Site ID No: 288 Site Designation: LMA-114 Repair Type: Erosion Rating: Area of Concern Field Date: 7/17/2017 Notes: Crown is a paved road. Much of site was not accessible because of thorny veg. Scarps were only about 1 ft deep where it was accessible so rated it a lower priority. Irrigation pipe within the site. A boat view would be helpful here. Fall 2018 DWR Inspector: Erosion along bank not visible from levee crown. Spring 2019 DWR Inspector: Slope appears to remain intact for at least 10' that is visible from the levee shoulder (portion without vegetation).</p>

View of waterside slope with some revetment. Fall 2018

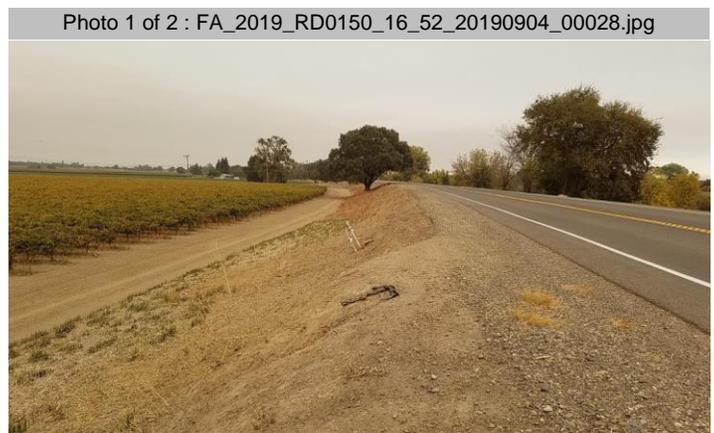
LM Start	5.90	Rating **	M	Issue No.	52
LM End	5.90	Issue Type +	Ma	Location *	LS
Category	Earthen Levee			GPS Latitude/Longitude	
				Start	End
Item	Erosion / Bank Caving			38.387915 °	38.387915 °
				-121.516002 °	-121.516002 °
DWR ID	DWR_RD0150_02_f_2016_52				
Comment Code					
E2 : Schedule repair of erosion site prior to the next inspection.					
Inspector Comment					
Repair erosion due to runoff.

View of erosion due to runoff. Fall 2018

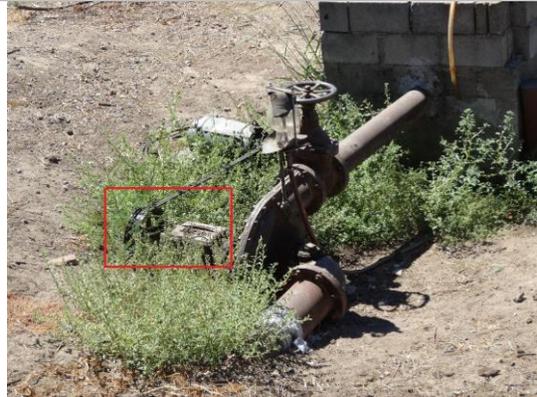
Photo 3 of 3 : UCIP_FA_2019_41646_34100.jpg

LS view: concrete masonry distribution box (top), steel pipe, gate valve, air vent, and pump (left) on levee toe.

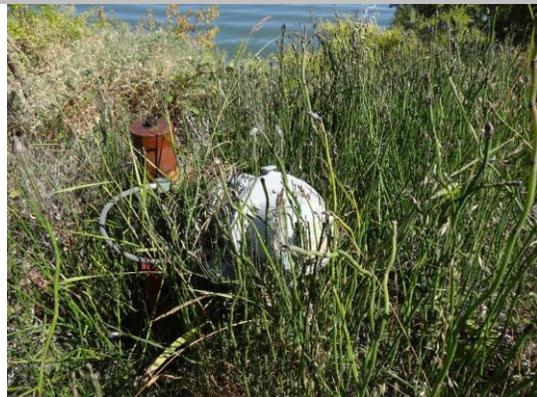
Photo 3 of 3 : UCIP_FA_2019_53333_34160.jpg

WS view: pump on levee slope. Dense vegetation on levee slope.

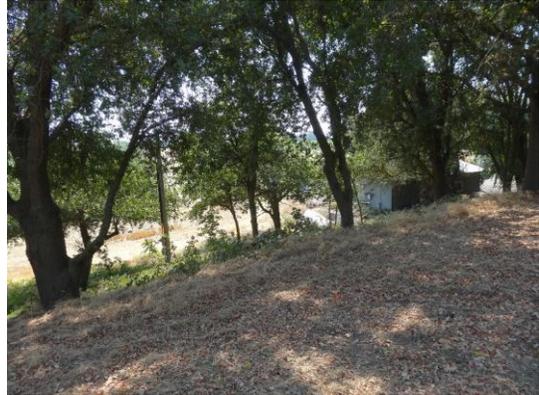
Photo 2 of 3 : UCIP_FA_2019_42693_31978.jpg

LS view: no pipe on levee slope.

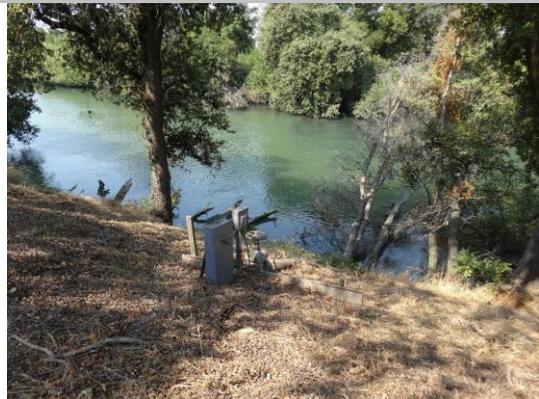
Photo 3 of 3 : UCIP_FA_2019_42693_31977.jpg

WS view: pipe and pump on levee slope.

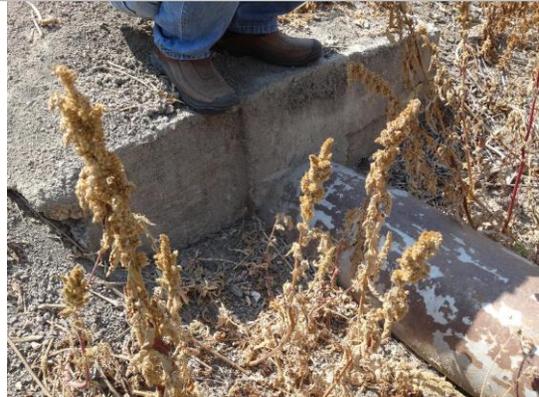
Photo 2 of 3 : UCIP_FA_2019_19112_32043.jpg

WS view: concrete headwall and exposed pipe on levee slope.

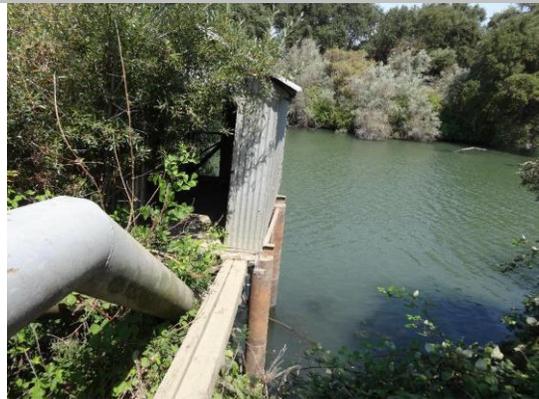
Photo 3 of 3 : UCIP_FA_2019_19112_32042.jpg

WS view: pipe, wooden walkway and pump house in channel.

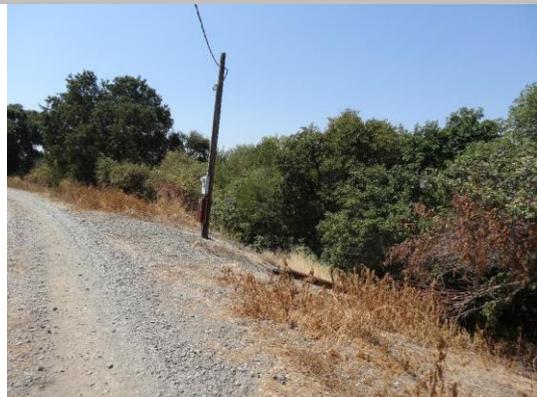
Photo 1 of 3 : UCIP_FA_2019_19137_32108.jpg

WS view: exposed pipe and power pole on levee slope.

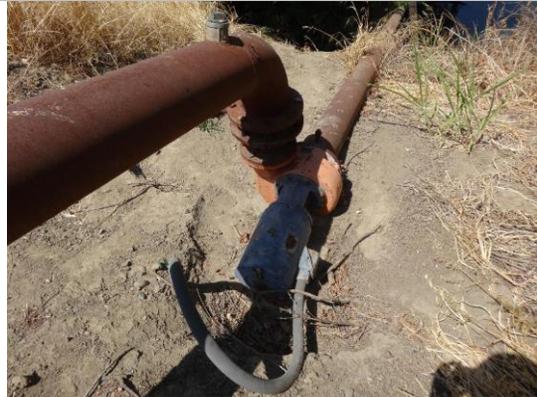
Photo 3 of 3 : UCIP_FA_2019_19137_32106.jpg

WS view: pipe and slant pump on levee slope.

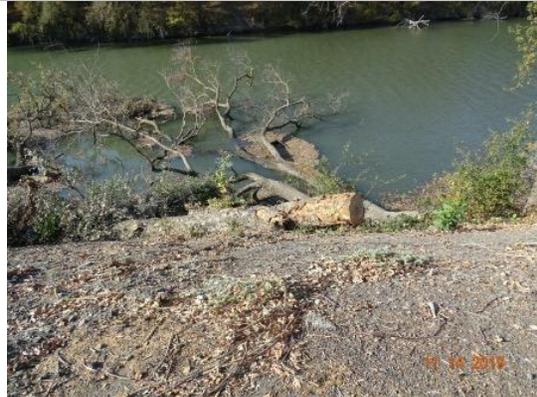
Photo 1 of 1 : FA_2019_RD0150_17_25_20191121_00162.jpg

View of a downed tree on the WS slope.

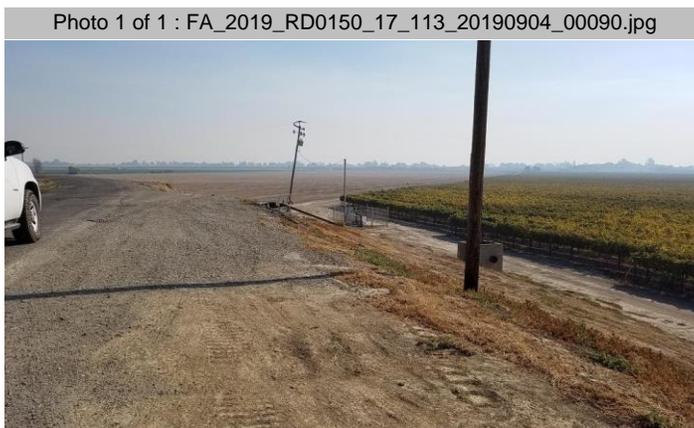
LM Start	3.28	Rating **	M	Issue No.	113
LM End	3.28	Issue Type +	En	Location *	LS
Category	Earthen Levee			GPS Latitude/Longitude	
				Start	End
Item	Encroachments			38.362992°	38.362992°
				-121.557275°	-121.557275°
DWR ID	DWR_RD0150_03_f_2013_113				
Comment Code					
PO : Pole					
Inspector Comment					
Pole on LS slope does not appear to be permitted by CVFPB and should be removed.

View of unauthorized pole on the LS slope.

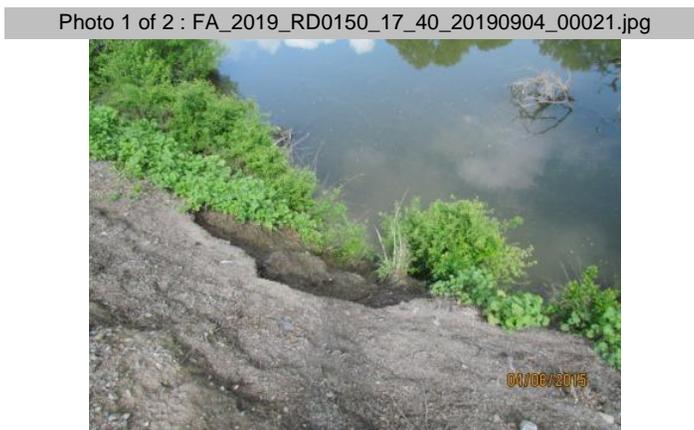
LM Start	3.31	Rating **	M	Issue No.	40
LM End	3.31	Issue Type +	Ma	Location *	WS
Category	Earthen Levee			GPS Latitude/Longitude	
				Start	End
Item	Erosion / Bank Caving			38.363008°	38.363008°
				-121.556751°	-121.556751°
DWR ID	DWR_RD0150_03_s_2013_40				
Comment Code					
E2 : Schedule repair of erosion site prior to the next inspection.					
Inspector Comment

View of erosion on the waterside of the levee during spring 2015 inspection.

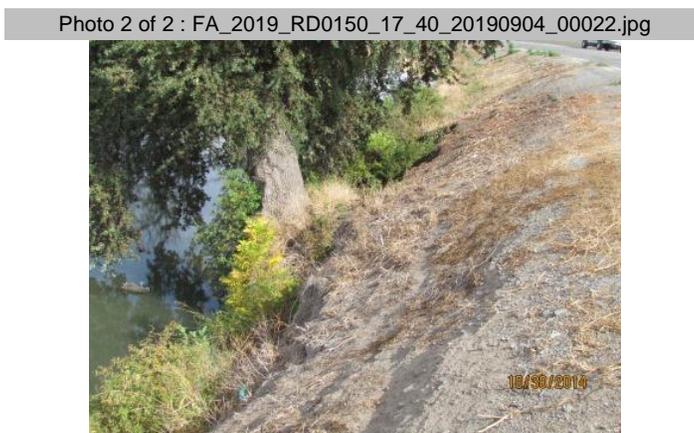
View of erosion on the waterside of the levee looking upstream during fall 2014 inspection.

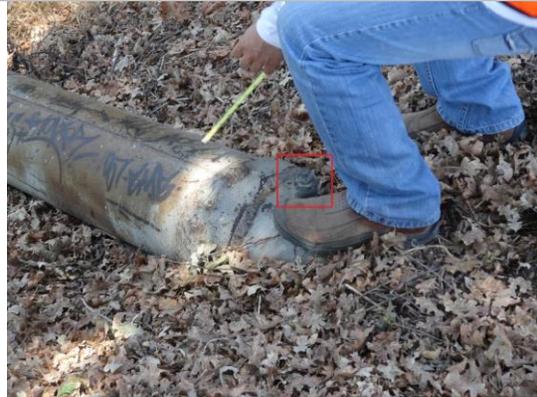
Photo 2 of 3 : UCIP_FA_2019_50202_35021.jpg

WS view: steel pipe with safety valve (marked) on levee slope.

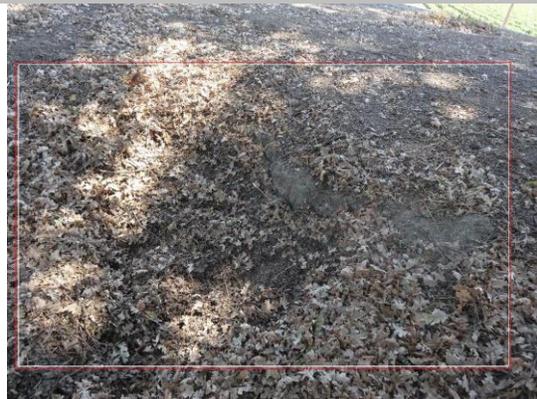
Photo 3 of 3 : UCIP_FA_2019_50202_35017.jpg

WS view: soil erosion (depression) on levee slope.

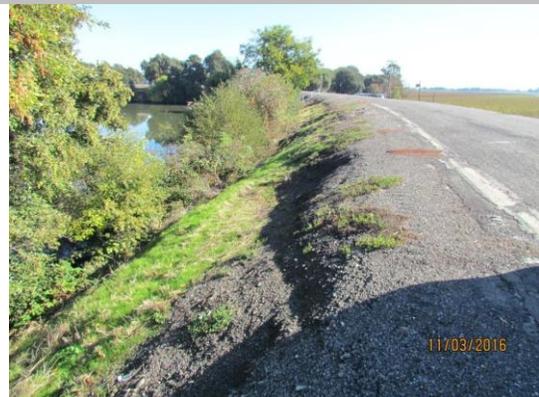
Photo 1 of 1 : FA_2019_RD0150_17_116_20190904_00097.jpg

View of slope instability on the waterside of the levee. Fall 2016

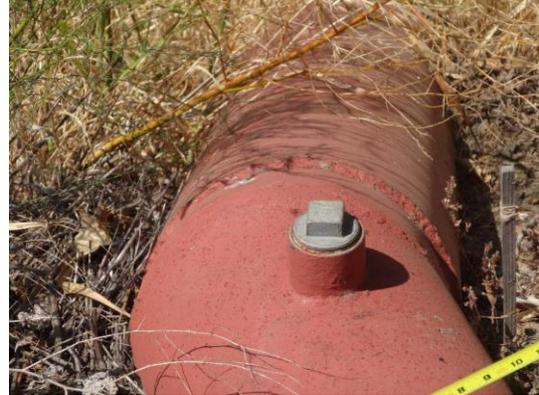
Photo 3 of 3 : UCIP_FA_2019_19281_32539.jpg

WS view: safety valve on steel pipe.

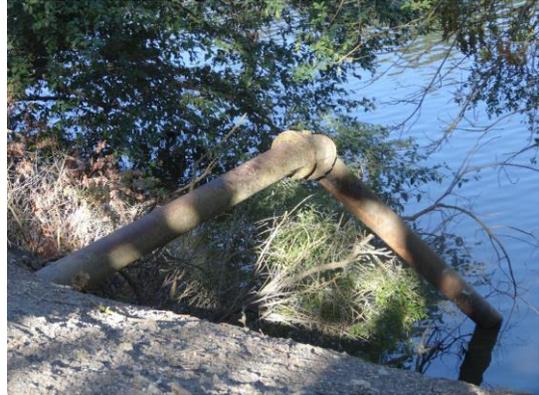
Photo 1 of 3 : UCIP_FA_2019_19283_32565.jpg

WS view: steel pipe on levee slope and in the stream.

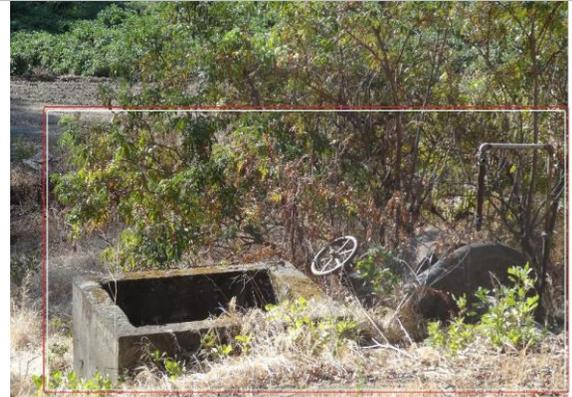
Photo 2 of 3 : UCIP_FA_2019_19283_32564.jpg

LS view: abandoned pump set and concrete box on levee slope.

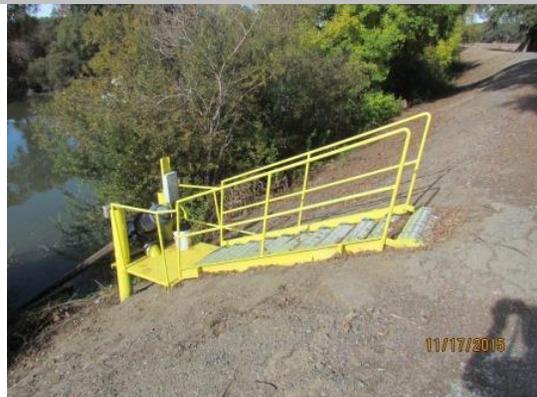
Photo 1 of 1 : FA_2019_RD0150_17_48_20190904_00030.jpg

View of a stairway on the waterside of the levee. Fall 2015

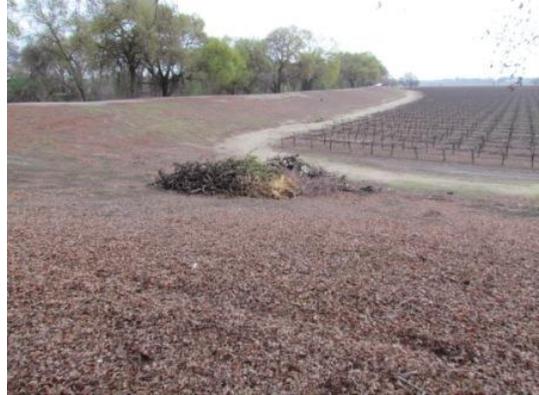
Photo 1 of 2 : FA_2019_RD0150_17_12_20190904_00001.jpg

Prunings were found on the landside toe of the levee looking upstream.

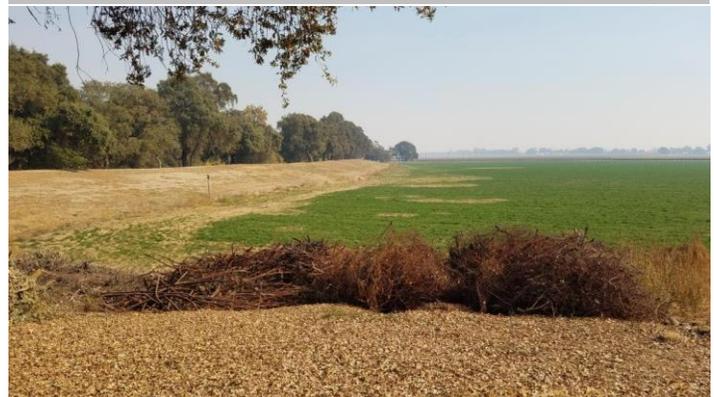
Photo 1 of 1 : FA_2019_RD0150_17_39_20190904_00020.jpg

View of landowner's metal debris at levee toe. Fall 2018

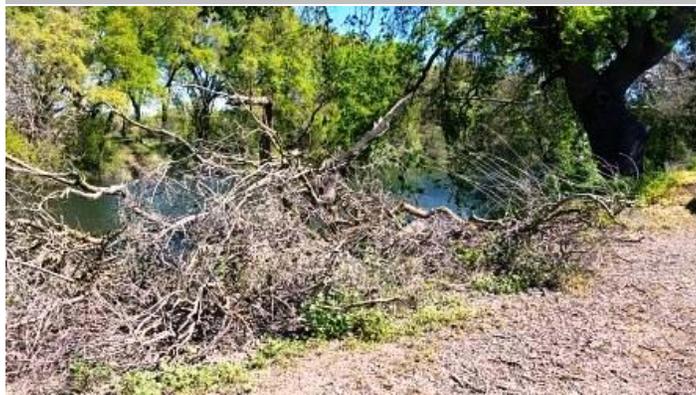
Photo 2 of 2 : FA_2019_RD0150_17_150_20190904_00112.jpg

View of tree debris on waterside slope. Spring 2019

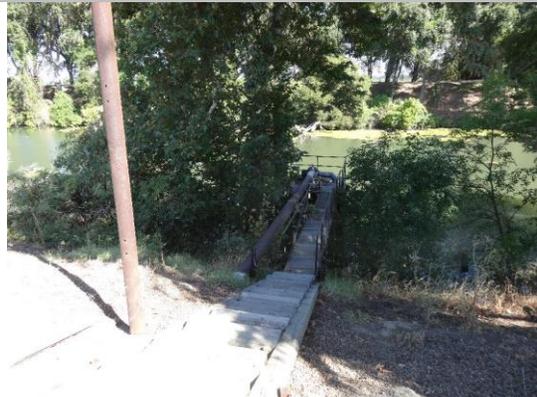
Photo 1 of 3 : UCIP_FA_2019_28265_51974.jpg

WS view: walkway, pipe, pump and support deck on river bank.

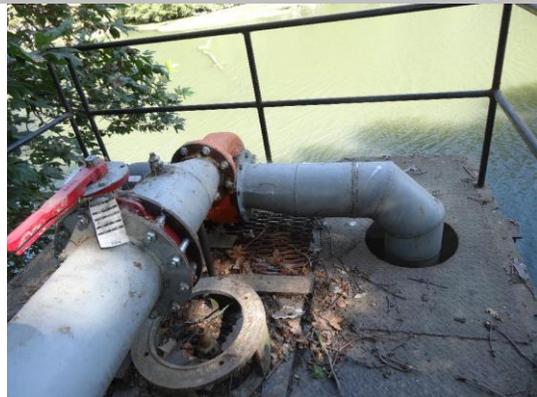
Photo 3 of 3 : UCIP_FA_2019_28265_51972.jpg

WS view: pipe, pump and gate valve on pump deck.

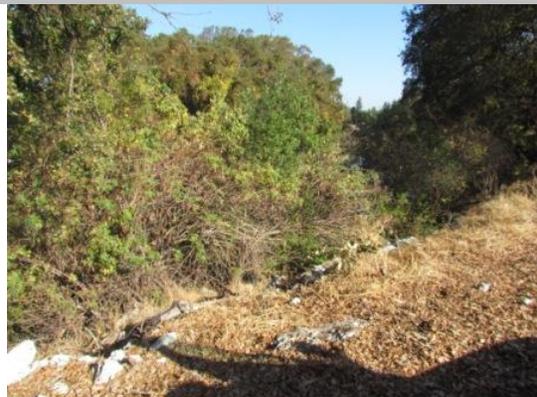
Photo 1 of 1 : FA_2019_RD0150_17_28_20190904_00007.jpg

Wild growth was found on the waterside slope of the levee looking upstream.

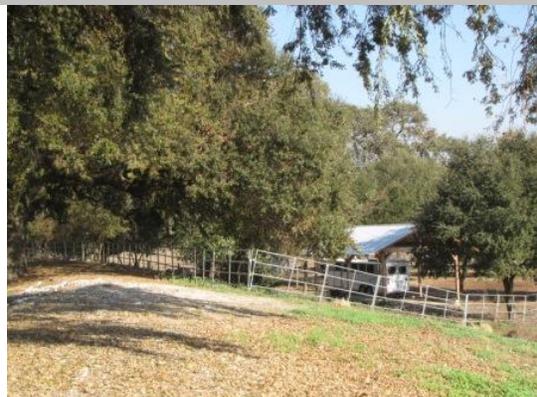
Photo 1 of 1 : FA_2019_RD0150_17_56_20190904_00039.jpg

View of fence around a horse pen along the shoulder of the levee and the landward slope.

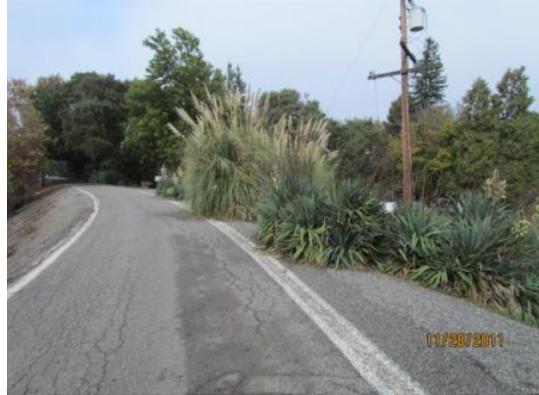
Photo 1 of 1 : FA_2019_RD0150_17_21_20190904_00004.jpg

Landscaping was found on the landside of the levee looking upstream. Fall 2011

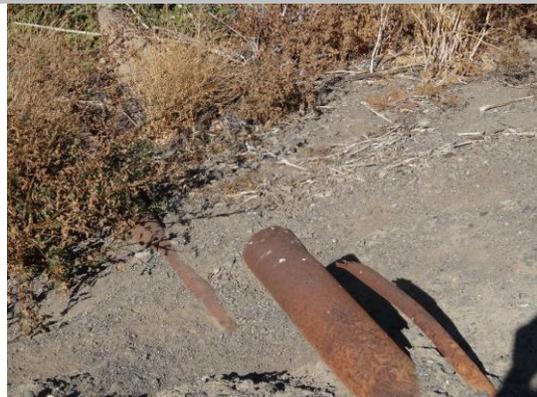
Photo 2 of 3 : UCIP_FA_2019_19403_32941.jpg

WS view: Abandoned concrete box (top). Open ended 6" steel pipe, 1" steel pipe, and another 6" steel pipe on levee slope.

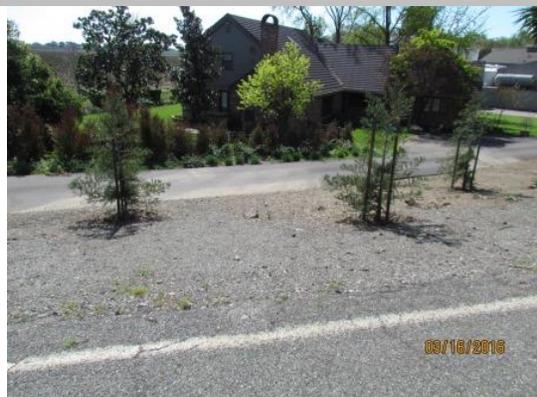
Photo 1 of 1 : FA_2019_RD0150_17_99_20190904_00081.jpg

View of planted trees on the landside slope of the levee. Spring 2016

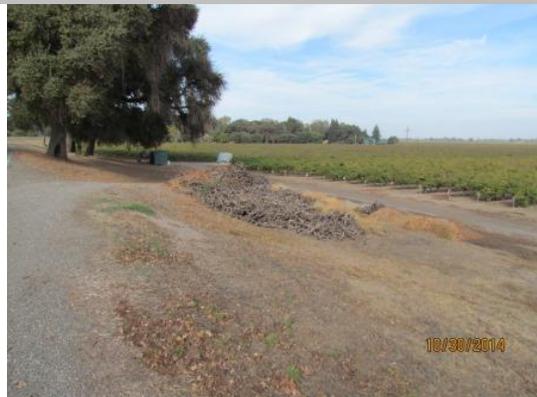
Photo 1 of 1 : FA_2019_RD0150_17_83_20190904_00064.jpg

Prunings were found on the landside toe of the levee looking upstream. Fall 2014

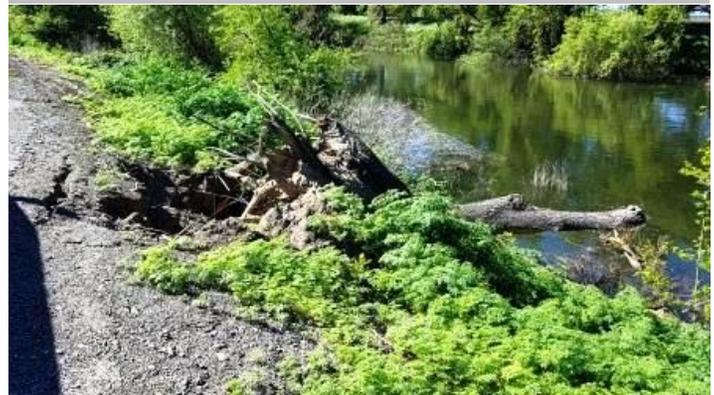
Photo 1 of 1 : FA_2019_RD0150_17_137_20190904_00110.jpg

View of fallen tree on waterside slope. Spring 2019

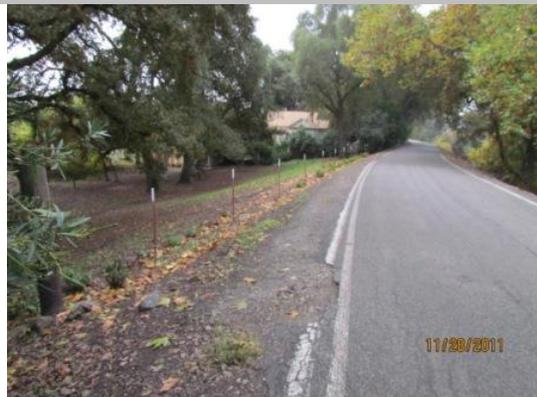
Photo 1 of 1 : FA_2019_RD0150_17_13_20190904_00003.jpg

Fence was found on the landside of the levee looking downstream. Fall 2011

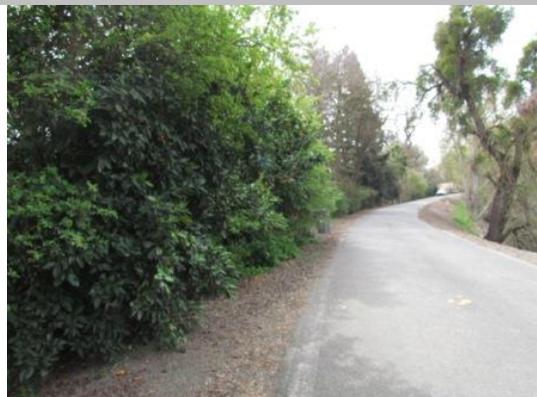
Photo 1 of 1 : FA_2019_RD0150_17_933_20190904_00115.jpg

View of the landscape on the landside shoulder of the levee looking downstream.

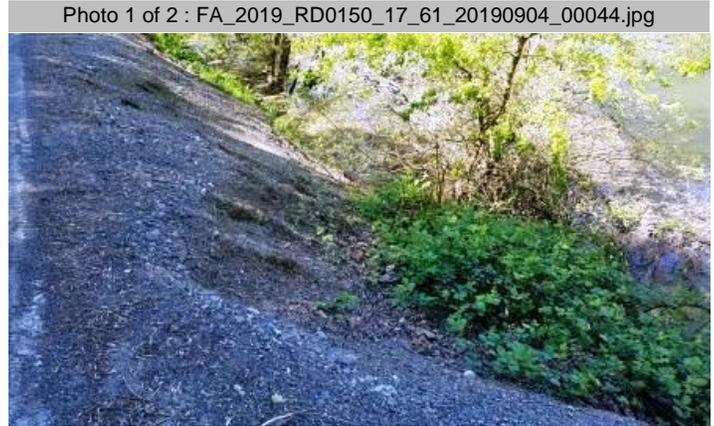
LM Start	6.90	Rating **	M	Issue No.	61
LM End	6.90	Issue Type +	Ma	Location *	WS
Category	Earthen Levee			GPS Latitude/Longitude	
				Start	End
Item	Erosion / Bank Caving			38.396655 °	38.396655 °
				-121.535485 °	-121.535485 °
DWR ID	DWR_RD0150_03_s_2012_61				
Comment Code					
E2 : Schedule repair of erosion site prior to the next inspection.					
Inspector Comment

View of erosion on waterside slope. Spring 2019

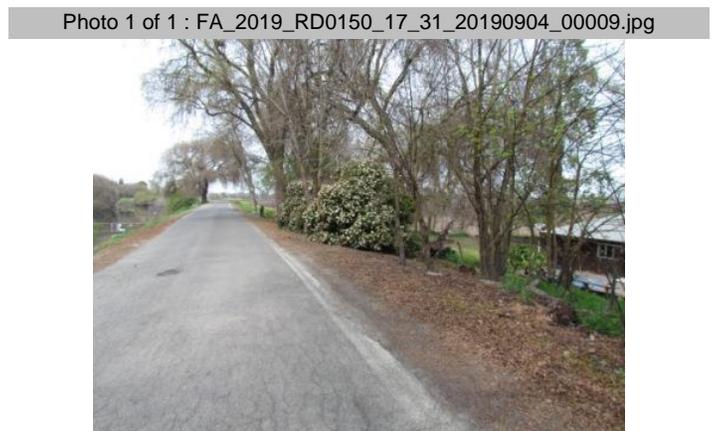
Landscaping was found on the landside shoulder of the levee looking upstream.

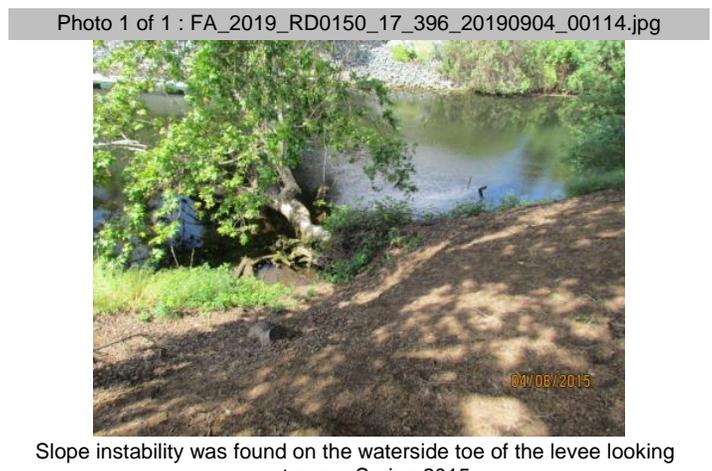
LM Start	7.74	Rating **	M	Issue No.	396
LM End	7.74	Issue Type +	Ma	Location *	WS
Category	Earthen Levee		GPS Latitude/Longitude		
			Start	End	
Item	Slope Stability		38.406098°	38.406098°	
			-121.543028°	-121.543028°	
DWR ID	DWR_RD0150_03_s_2015_396				
Comment Code					
S1 : Repair slope instability.					
Inspector Comment

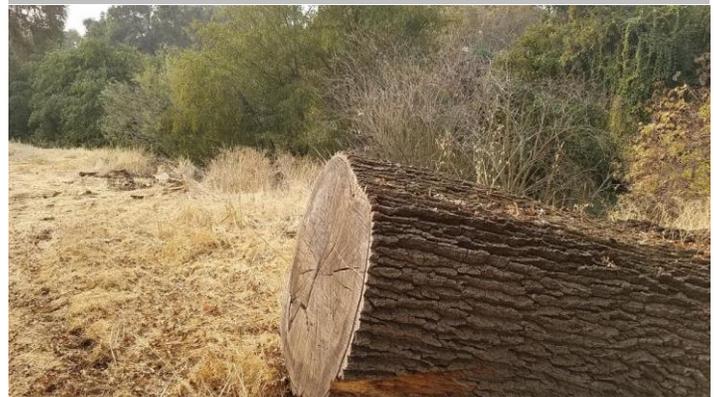
Photo 1 of 1 : FA_2019_RD0150_17_75_20190904_00059.jpg

View of downed tree on levee slope.

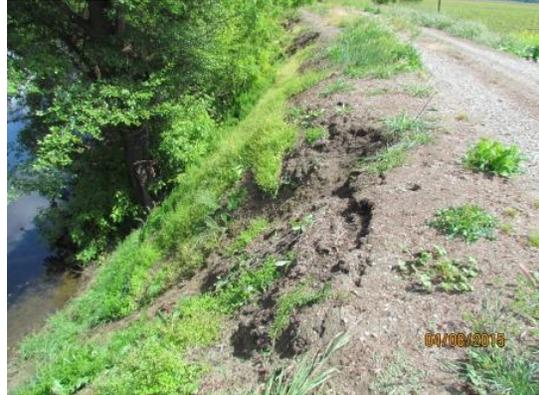
Photo 1 of 1 : FA_2019_RD0150_17_66_20190904_00050.jpg

View of erosion on the waterside of the levee. Spring 2015

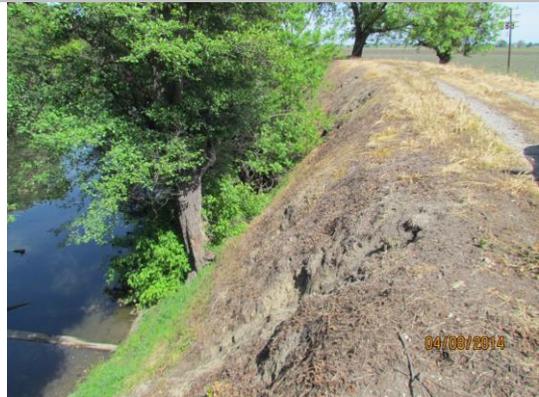
View of the erosion on the waterside shoulder looking upstream. Spring 2014

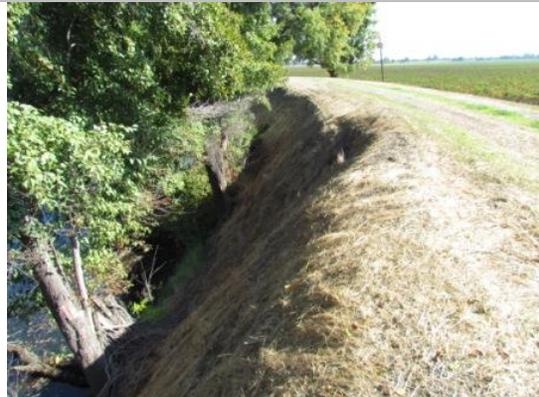
Erosion was found on the waterside shoulder of the levee looking upstream. This picture was taken during fall 2012 inspection.

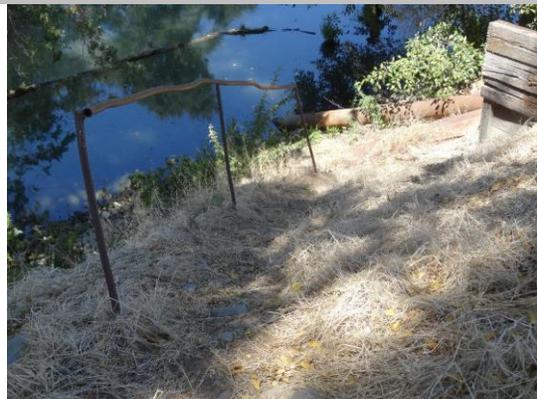
WS view: walkway and inlet pipe on levee slope.

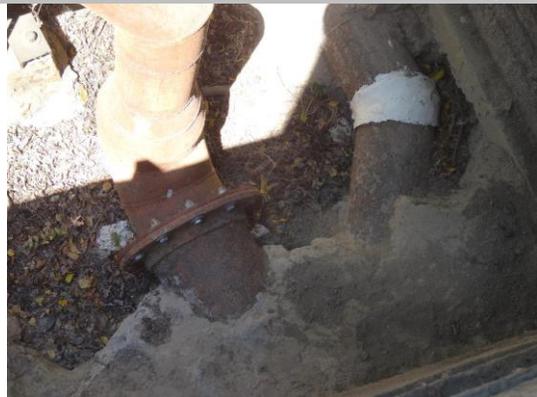
WS view: 8-inch steel pipe (right) next to 12" pipe (left). This 8" pipe might have merged with 12" pipe under the levee .

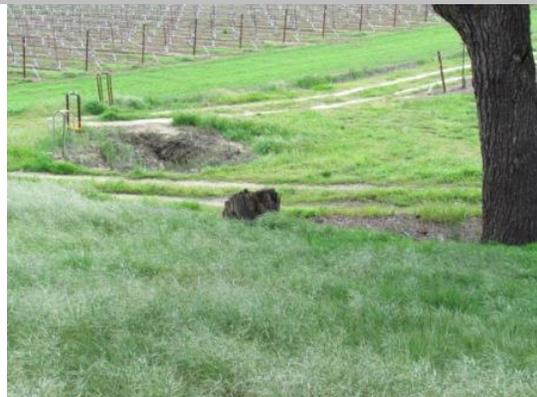
A tree stump was found on the landside of the levee looking upstream.

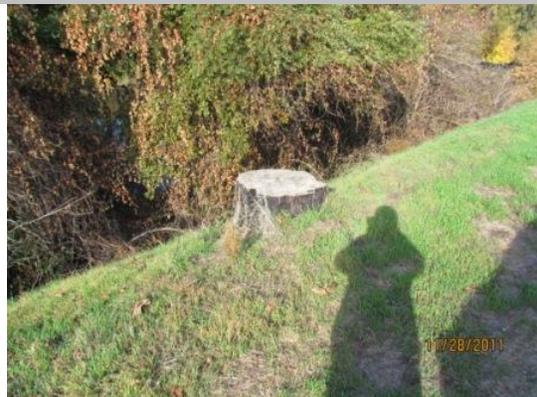
A tree stump was found on the waterside of the levee looking upstream.
Fall 2011
