**Flood Control Project Maintenance  
Levee Inspections**

**Maintenance Issue Types Only, Levee Inspection Report By Mile - Fall 2019**

**Reclamation District No. 0150 Merrit Island**

Waterway	Bank	Unit Miles	Inspection Start/End	Inspector
Unit No. 01 Sutter Slough	Left	0.52	11/14/2019 11/14/2019	Luz Dial

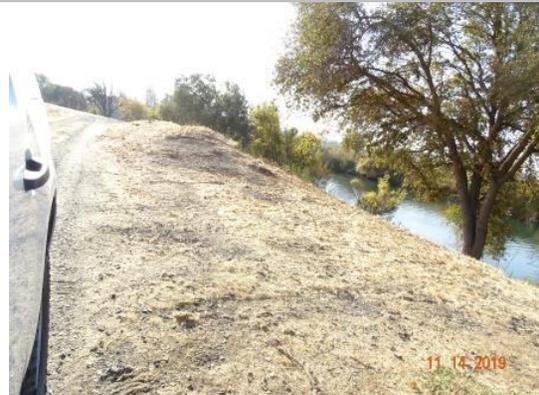
Photo 1 of 1 : FA\_2019\_RD0150\_15\_7\_20191121\_00003.jpg

View of fill material stored on the crown and shoulder. Fall 2019

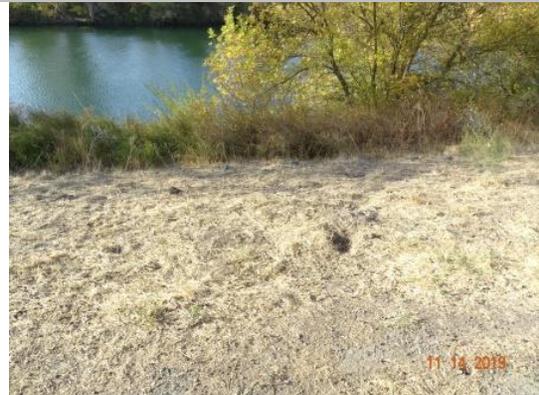
Photo 1 of 1 : FA\_2019\_RD0150\_15\_2\_20191121\_00002.jpg

View of animal holes on waterside slope. Fall 2019

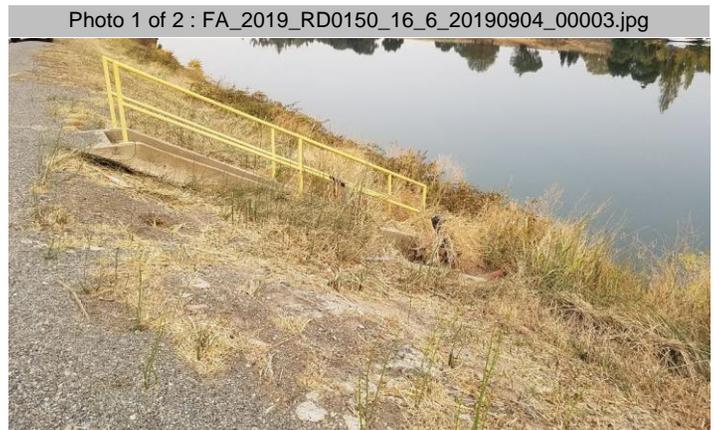
LM Start	<b>0.38</b>	Rating **	M	Issue No.	<b>6</b>
LM End	<b>0.38</b>	Issue Type +	Ma	Location *	WS
Category	Earthen Levee			GPS Latitude/Longitude	
				Start	End
Item	Slope Stability			38.332598°	38.332598°
				-121.572179°	-121.572179°
DWR ID	DWR_RD0150_02_s_2012_6				
Comment Code					
S2 : Repair the levee slope damaged by foot traffic and prevent access where possible.					
Inspector Comment

View of slope instability around stairway. Fall 2018

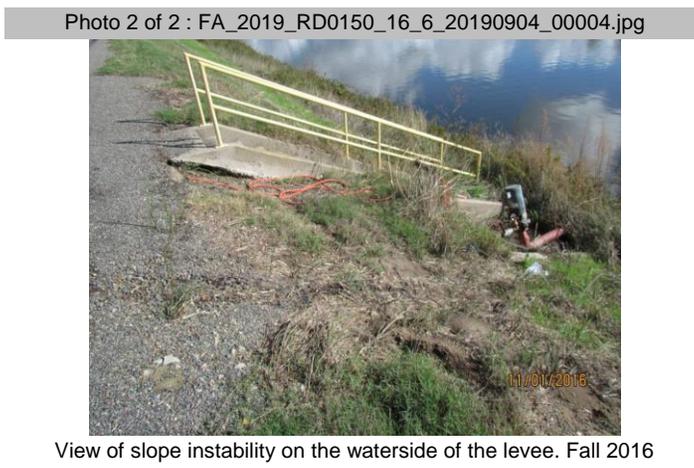
LM Start	<b>0.38</b>	Rating **	M	Issue No.	<b>6 (cont)</b>
LM End	<b>0.38</b>	Issue Type +	Ma	Location *	WS
Category	Earthen Levee			GPS Latitude/Longitude	
				Start	End
Item	Slope Stability			38.332598°	38.332598°
				-121.572179°	-121.572179°
DWR ID	DWR_RD0150_02_s_2012_6				
Comment Code					
S2 : Repair the levee slope damaged by foot traffic and prevent access where possible.					
Inspector Comment

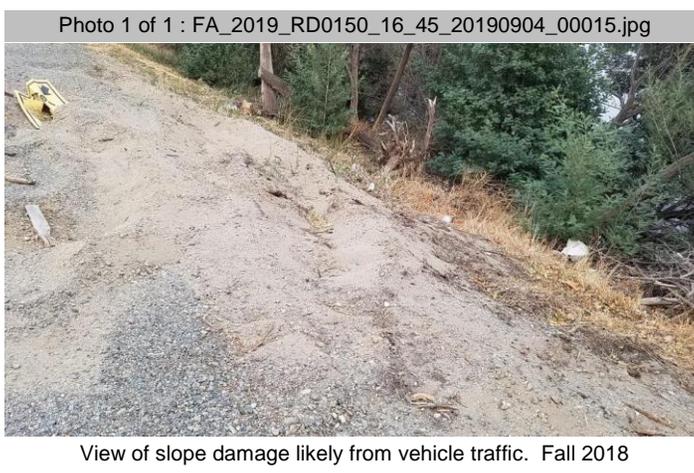
LM Start	<b>0.59</b>	Rating **	M	Issue No.	<b>45</b>
LM End	<b>0.59</b>	Issue Type +	Ma	Location *	WS
Category	Earthen Levee			GPS Latitude/Longitude	
				Start	End
Item	Slope Stability			38.334898°	38.334898°
				-121.569632°	-121.569632°
DWR ID	DWR_RD0150_02_f_2018_45				
Comment Code					
S3 : Repair the levee slope damaged by vehicle traffic and prevent access where possible.					
Inspector Comment

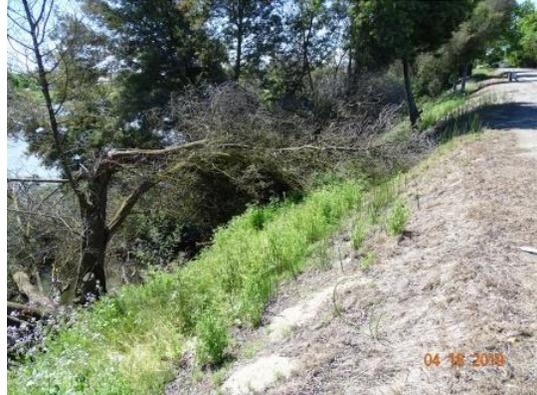
Photo 1 of 1 : FA\_2019\_RD0150\_16\_114\_20190904\_00061.jpg

View looking downstream at fallen tree on levee slope. Spring 2019

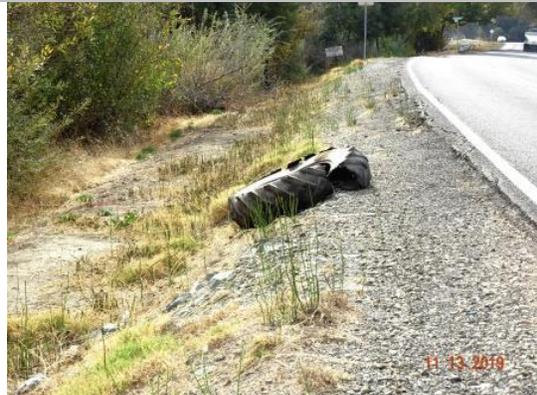
Photo 1 of 1 : FA\_2019\_RD0150\_16\_35\_20191121\_00121.jpg

View of tire on waterside slope. Fall 2019

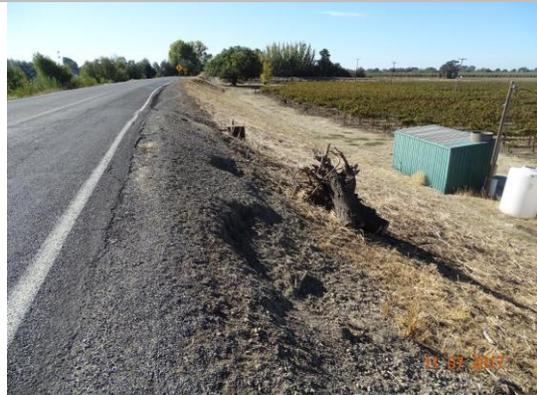
Photo 1 of 1 : FA\_2019\_RD0150\_16\_59\_20190904\_00038.jpg

LM Start	<b>0.71</b>	Rating **	<b>U</b>	Issue No.	<b>59</b>
LM End	<b>0.71</b>	Issue Type +	<b>Ma</b>	Location *	<b>LS</b>
Category	Earthen Levee			GPS Latitude/Longitude	
				Start	End
Item	Trim / Thin Trees			38.336291°	38.336291°
				-121.568260°	-121.568260°
DWR ID	DWR_RD0150_02_s_2016_59				
Comment Code					
T5 : Tree stumps.					
Inspector Comment					
Remove trees and repair slope damage.

View of the tree trunk on the landside of the levee. Fall 2017

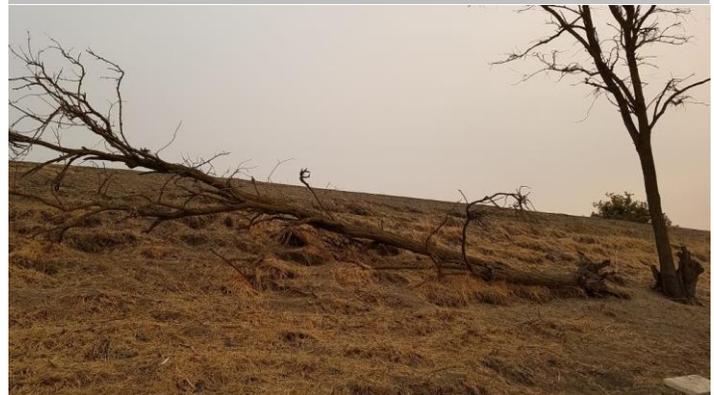
Photo 1 of 1 : FA\_2019\_RD0150\_16\_73\_20190904\_00045.jpg

View of fallen tree on landside levee slope. Fall 2018

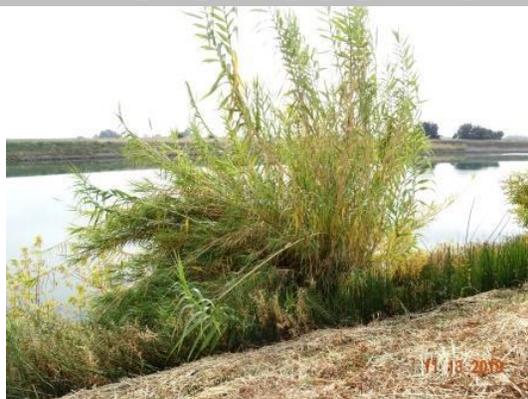
Photo 1 of 1 : FA\_2019\_RD0150\_16\_36\_20191121\_00122.jpg

View of Arundo growth. Fall 2019

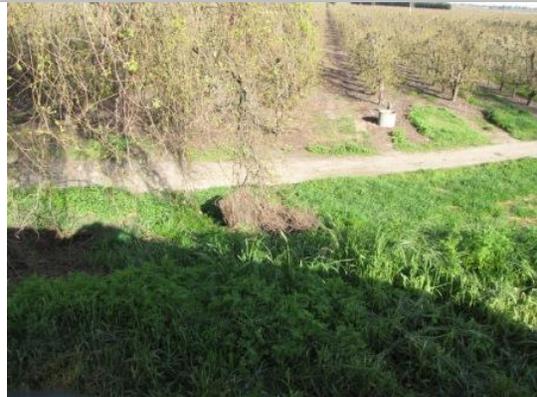
Photo 1 of 1 : FA\_2019\_RD0150\_16\_14\_20190904\_00006.jpg

View of a tree stump on the landward slope.

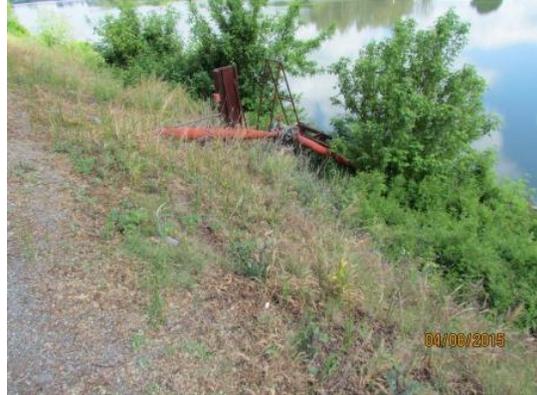
Photo 1 of 1 : FA\_2019\_RD0150\_16\_961\_20190904\_00063.jpg

LM Start	<b>3.24</b>	Rating **	M	Issue No.	<b>961</b>
LM End	<b>3.24</b>	Issue Type +	Ma	Location *	WS
Category	Earthen Levee		GPS Latitude/Longitude		
			Start	End	
Item	Erosion / Bank Caving		38.355321 °	38.355321 °	
			-121.530902 °	-121.530902 °	
DWR ID	DWR_RD0150_02_s_2012_961				
Comment Code					
E2 : Schedule repair of erosion site prior to the next inspection.					
Inspector Comment					
Depressions into the waterward slope can be seen along the waterward slope at this site. Also note the damaged pump support, pump, and pipe just upstream of the site.

View of the erosion on the waterside slope.

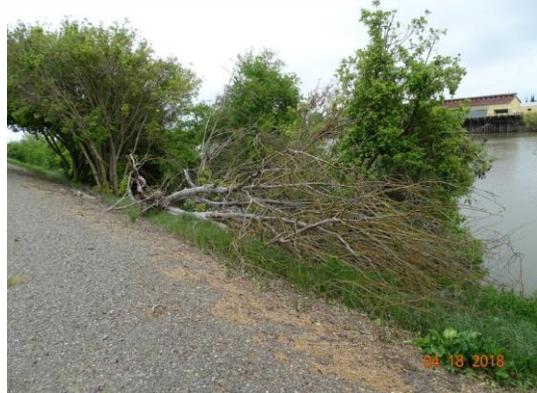
Photo 1 of 1 : FA\_2019\_RD0150\_16\_107\_20190904\_00060.jpg

View of fallen tree on waterside looking northeast. Spring 2018

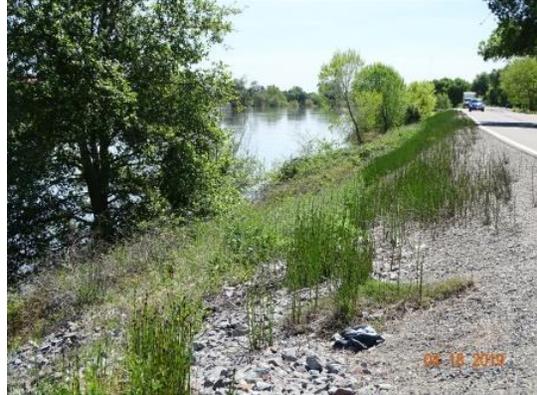
Photo 1 of 1 : FA\_2019\_RD0150\_16\_38\_20190904\_00012.jpg

LM Start	<b>4.50</b>	Rating **	U	Issue No.	<b>38</b>
LM End	<b>4.57</b>	Issue Type +	Ma	Location *	WS
Category	Supplemental			GPS Latitude/Longitude	
				Start	End
Item	2017 USACE Erosion Survey			38.370928 °	38.371909 °
				-121.523069 °	-121.523316 °
DWR ID	DWR_RD0150_02_s_2019_38				
Comment Code					
Inspector Comment					
2017 Site ID: SAC 38.5 R Status: Critical 2017 Field Notes: New erosion pocket. Vertical section along lower bank, and cracking. Upgraded to critical. Site History: 1999 - Downstream end (300 ft) repaired with rock. 2010 - Toe erosion, some vertical slopes lower down. 2011 - Failing rock repair. Slumping of the lower bank. Minor new erosion. 2013 - Tree at upstream end has exposed roots. Some new erosion.

View looking downstream at 2017 USACE Erosion Survey site. Spring 2019

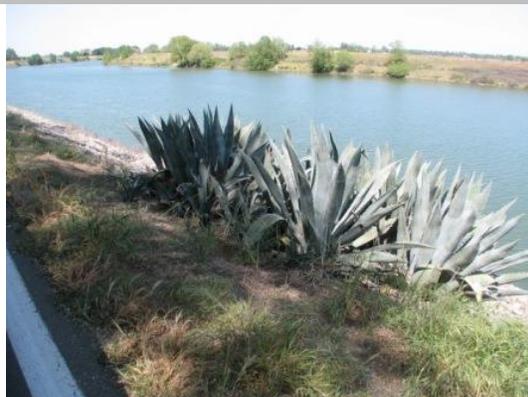
Photo 1 of 1 : FA\_2019\_RD0150\_16\_28\_20190904\_00009.jpg

View of century plants on waterward slope.

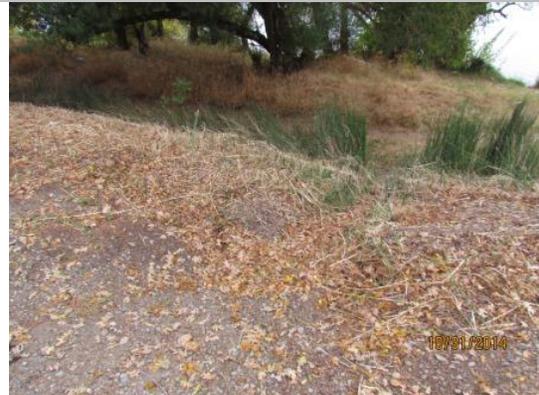
Photo 1 of 1 : FA\_2019\_RD0150\_16\_54\_20190904\_00035.jpg

LM Start	<b>5.33</b>	Rating **	M	Issue No.	<b>54</b>
LM End	<b>5.33</b>	Issue Type +	Ma	Location *	WS
Category	Earthen Levee		GPS Latitude/Longitude		
			Start	End	
Item	Slope Stability		38.382072°	38.382072°	
			-121.523220°	-121.523220°	
DWR ID	DWR_RD0150_02_f_2014_54				
Comment Code					
S2 : Repair the levee slope damaged by foot traffic and prevent access where possible.					
Inspector Comment

View of slope instability on the waterside of the levee looking towards the toe. Fall 2014

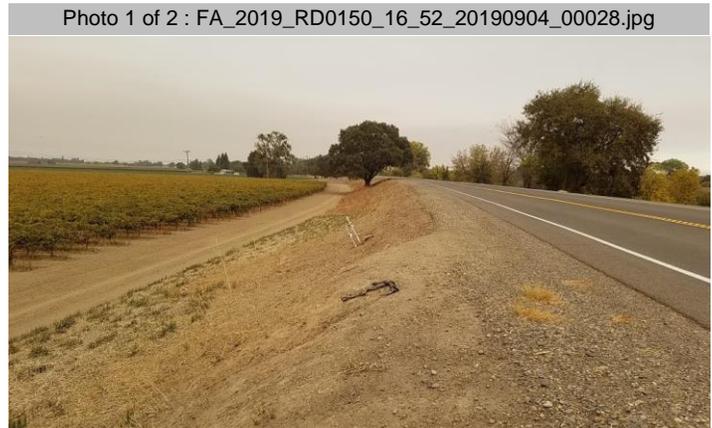
LM Start	<b>5.90</b>	Rating **	M	Issue No.	<b>52</b>
LM End	<b>5.90</b>	Issue Type +	Ma	Location *	LS
Category	Earthen Levee			GPS Latitude/Longitude	
				Start	End
Item	Erosion / Bank Caving			38.387915°	38.387915°
				-121.516002°	-121.516002°
DWR ID	DWR_RD0150_02_f_2016_52				
Comment Code					
E2 : Schedule repair of erosion site prior to the next inspection.					
Inspector Comment					
Repair erosion due to runoff.

View of erosion due to runoff. Fall 2018

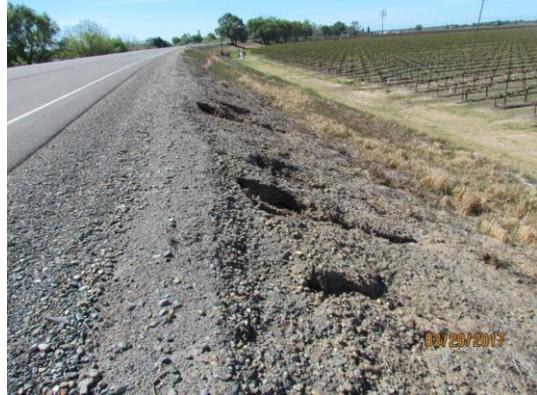
Photo 2 of 2 : FA\_2019\_RD0150\_16\_52\_20190904\_00029.jpg

LM Start	<b>5.90</b>	Rating **	M	Issue No.	<b>52 (cont)</b>
LM End	<b>5.90</b>	Issue Type +	Ma	Location *	LS
Category	Earthen Levee			GPS Latitude/Longitude	
				Start	End
Item	Erosion / Bank Caving			38.387915°	38.387915°
				-121.516002°	-121.516002°
DWR ID	DWR_RD0150_02_f_2016_52				
Comment Code					
E2 : Schedule repair of erosion site prior to the next inspection.					
Inspector Comment					
Repair erosion due to runoff.

View of the erosion on the landside of the levee during spring 2017 inspection.

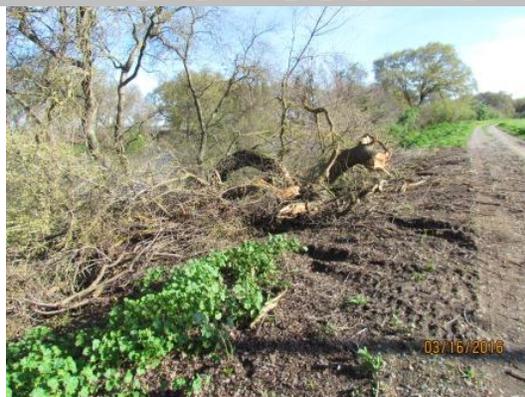
Photo 1 of 1 : FA\_2019\_RD0150\_17\_85\_20190904\_00066.jpg

View of broken tree trunk on the waterside slope of the levee. Spring 2016

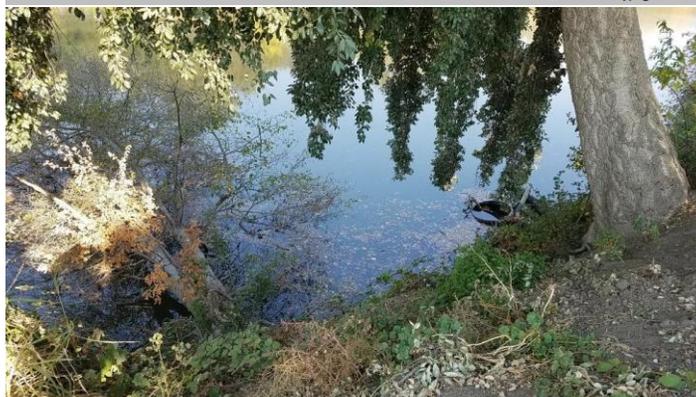
Photo 1 of 4 : FA\_2019\_RD0150\_17\_37\_20190904\_00016.jpg

View of slope damage near fallen tree. Fall 2018

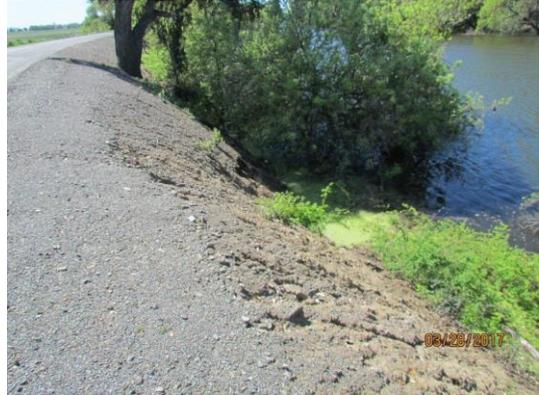
Photo 1 of 1 : FA\_2019\_RD0150\_17\_62\_20190904\_00046.jpg

View of erosion on the waterside slope of the levee looking downstream. Spring 2017

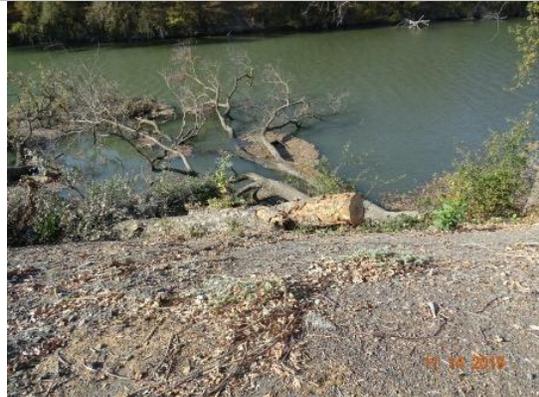
Photo 1 of 1 : FA\_2019\_RD0150\_17\_25\_20191121\_00162.jpg

View of a downed tree on the WS slope.

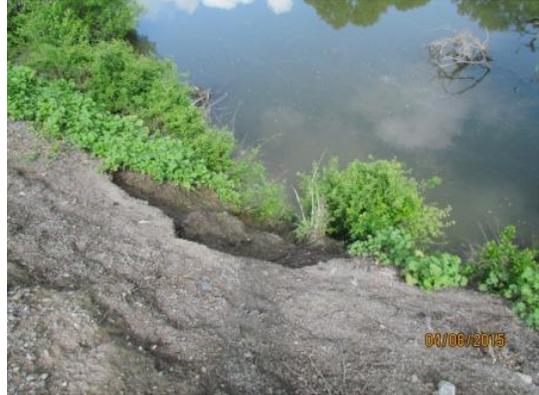
Photo 1 of 2 : FA\_2019\_RD0150\_17\_40\_20190904\_00021.jpg

View of erosion on the waterside of the levee during spring 2015 inspection.

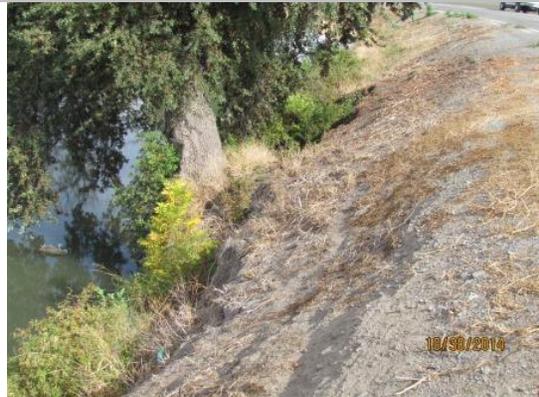
Photo 2 of 2 : FA\_2019\_RD0150\_17\_40\_20190904\_00022.jpg

View of erosion on the waterside of the levee looking upstream during fall 2014 inspection.

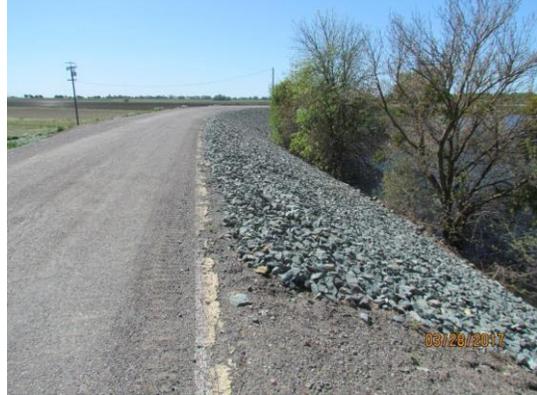
Photo 1 of 1 : FA\_2019\_RD0150\_17\_76\_20190904\_00060.jpg

View of the new riprap on the waterside slope of the levee looking downstream. Spring 2017

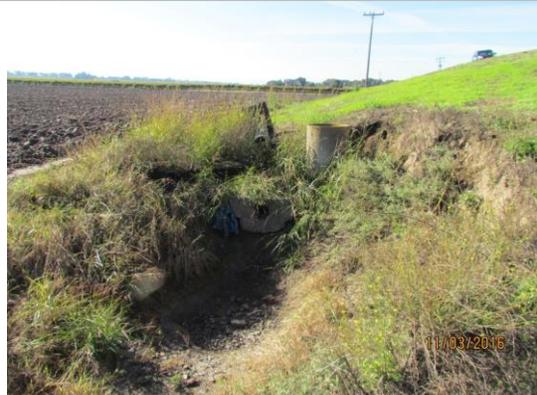
Photo 1 of 3 : FA\_2019\_RD0150\_17\_115\_20190904\_00094.jpg

View of the ditch on the landside toe of the levee. Fall 2016

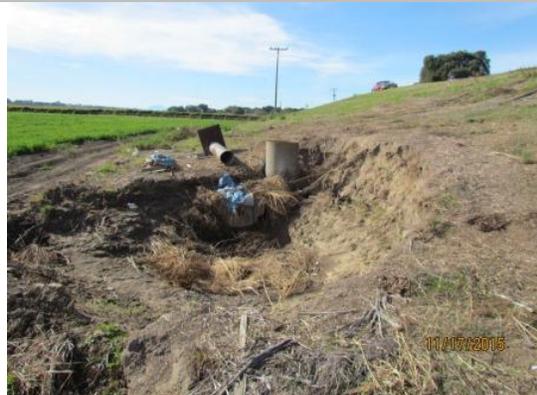
Photo 2 of 3 : FA\_2019\_RD0150\_17\_115\_20190904\_00095.jpg

View of the ditch on the landside toe of the levee during fall 2015 inspection.

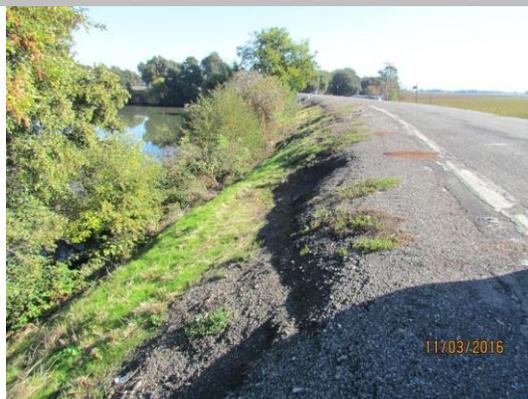
Photo 1 of 1 : FA\_2019\_RD0150\_17\_116\_20190904\_00097.jpg

View of slope instability on the waterside of the levee. Fall 2016

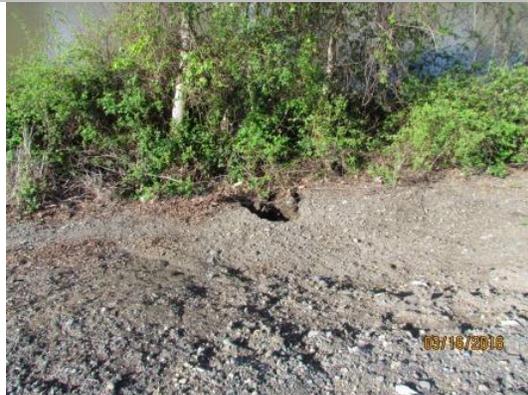
Photo 1 of 1 : FA\_2019\_RD0150\_17\_93\_20190904\_00074.jpg

Erosion was found on the waterside toe of the levee. Spring 2016

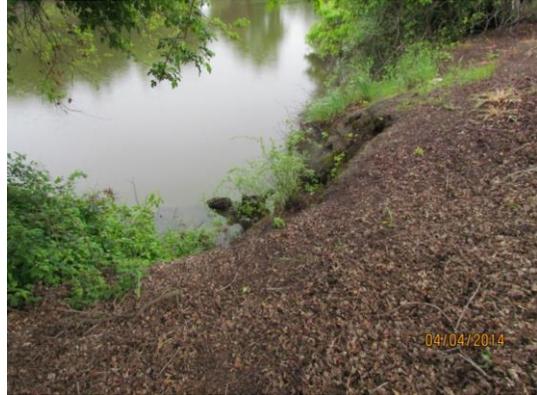
Photo 1 of 1 : FA\_2019\_RD0150\_17\_80\_20190904\_00061.jpg

View of an erosion site on the waterside toe of the levee looking upstream. Spring 2014

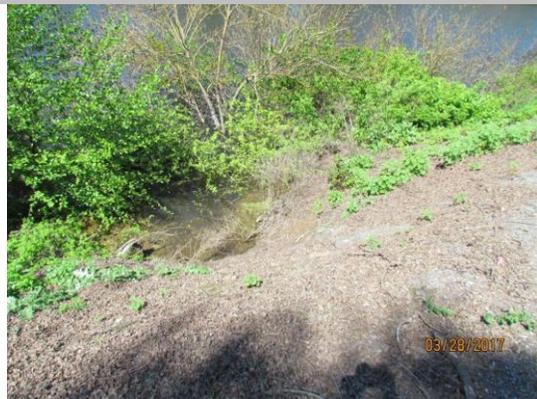
Photo 1 of 1 : FA\_2019\_RD0150\_17\_101\_20190904\_00082.jpg

View of an erosion on the waterside toe of the levee. Spring 2017

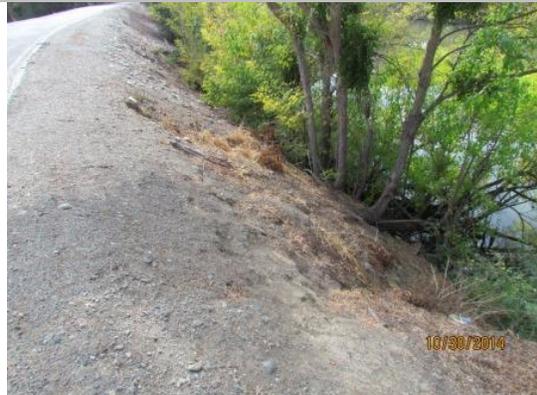
Photo 1 of 1 : FA\_2019\_RD0150\_17\_81\_20190904\_00062.jpg

View of erosion on the waterside of the levee looking downstream. Fall 2014

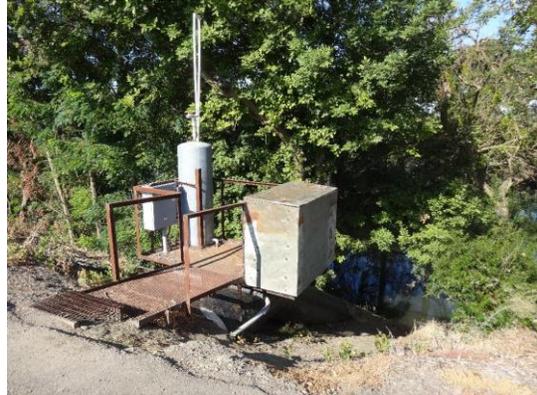
Photo 1 of 3 : UCIP\_FA\_2019\_49386\_63902.jpg

WS view: pipe, steel deck, pressure tank, electric control box on stream bank.

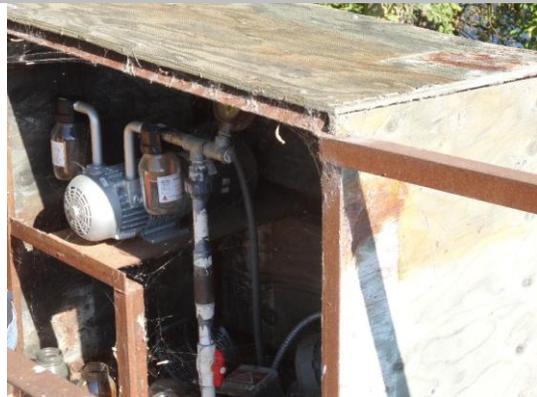
Photo 2 of 3 : UCIP\_FA\_2019\_49386\_63901.jpg

WS view: a smaller pump on steel deck. It was working during the survey.

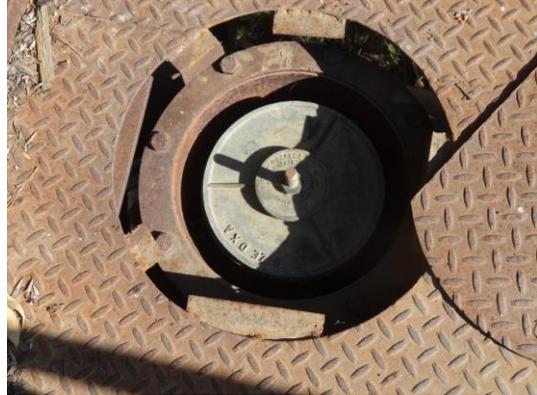
Photo 3 of 3 : UCIP\_FA\_2019\_49386\_63900.jpg

WS view: siphon breaker on pipe in steel deck on stream bank.

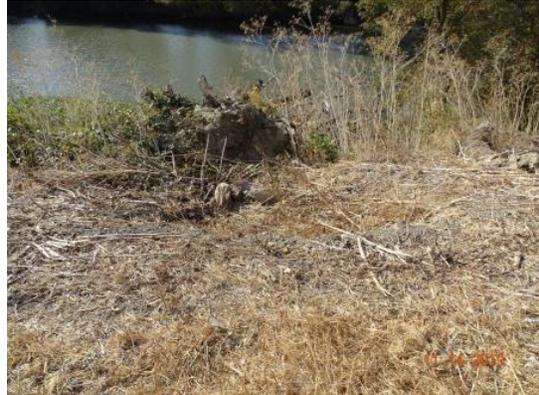
Photo 1 of 1 : FA\_2019\_RD0150\_17\_125\_20191121\_00164.jpg

View of fallen tree with exposed rootball. Fall 2019

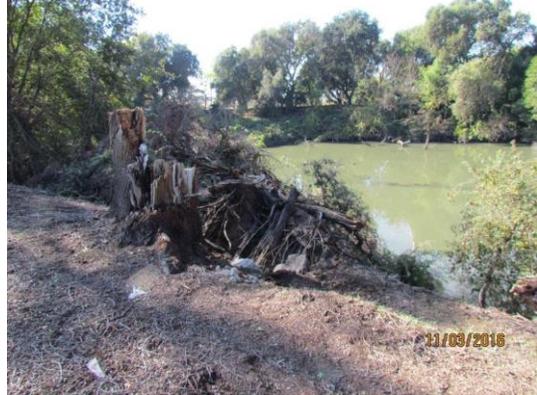
Photo 1 of 1 : FA\_2019\_RD0150\_17\_74\_20190904\_00058.jpg

View of stump and downed tree on the waterside slope of the levee.

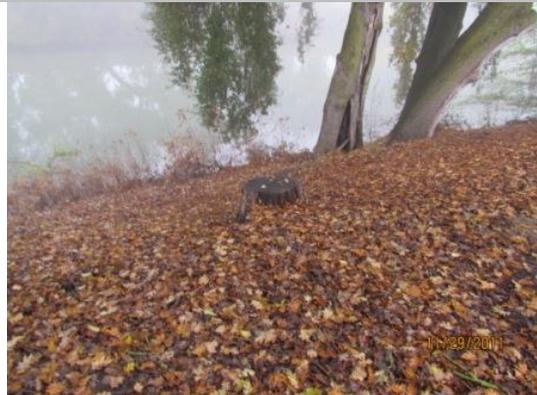
Photo 1 of 1 : FA\_2019\_RD0150\_17\_68\_20190904\_00053.jpg

Tree stump was found on the waterside of the levee looking upstream. Fall 2011

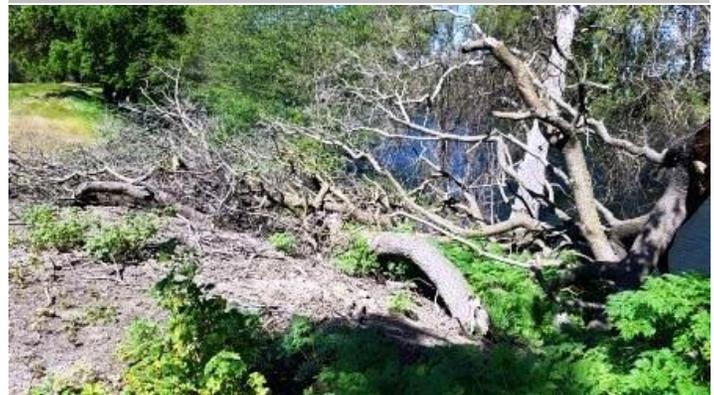
Photo 1 of 2 : FA\_2019\_RD0150\_17\_150\_20190904\_00111.jpg

View of tree debris on waterside slope. Spring 2019

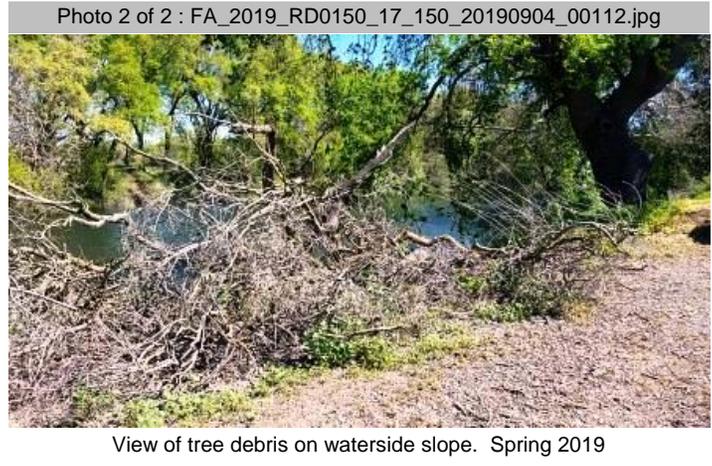
LM Start	<b>5.64</b>	Rating **	M	Issue No.	<b>150 (cont)</b>
LM End	<b>5.64</b>	Issue Type +	Ma	Location *	WS
Category	Earthen Levee			GPS Latitude/Longitude	
				Start	End
Item	Encroachments			38.383825 °	38.383825 °
				-121.543683 °	-121.543683 °
DWR ID	DWR_RD0150_03_s_2019_150				
Comment Code					
TR : Tree or limb					
Inspector Comment					
Remove tree debris from the levee shoulder and slope.

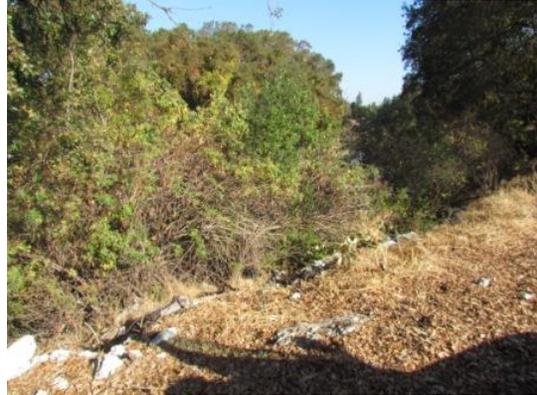
Photo 1 of 1 : FA\_2019\_RD0150\_17\_28\_20190904\_00007.jpg

Wild growth was found on the waterside slope of the levee looking upstream.

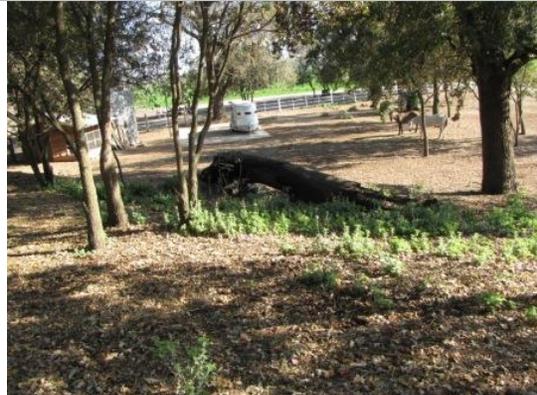
Photo 1 of 1 : FA\_2019\_RD0150\_17\_57\_20190904\_00040.jpg

View of downed tree on landward slope should be removed.

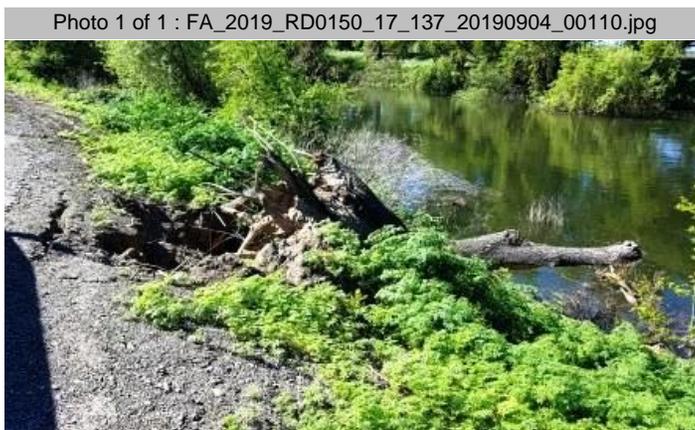
LM Start	<b>6.64</b>	Rating **	M	Issue No.	<b>137</b>
LM End	<b>6.64</b>	Issue Type +	Ma	Location *	WS
Category	Earthen Levee		GPS Latitude/Longitude		
			Start	End	
Item	Slope Stability		38.394332°	38.394332°	
			-121.538658°	-121.538658°	
DWR ID	DWR_RD0150_03_s_2019_137				
Comment Code					
S1 : Repair slope instability.					
Inspector Comment					
Remove the fallen tree and repair slope damaged by root ball.

View of fallen tree on waterside slope. Spring 2019

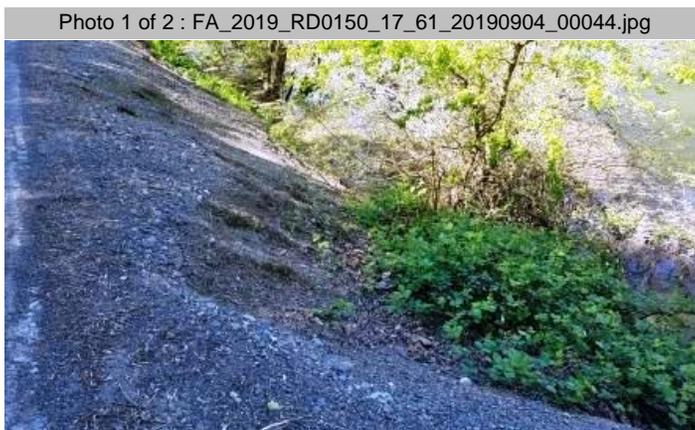
LM Start	<b>6.90</b>	Rating **	M	Issue No.	<b>61</b>
LM End	<b>6.90</b>	Issue Type +	Ma	Location *	WS
Category	Earthen Levee		GPS Latitude/Longitude		
			Start	End	
Item	Erosion / Bank Caving		38.396655°	38.396655°	
			-121.535485°	-121.535485°	
DWR ID	DWR_RD0150_03_s_2012_61				
Comment Code					
E2 : Schedule repair of erosion site prior to the next inspection.					
Inspector Comment

View of erosion on waterside slope. Spring 2019

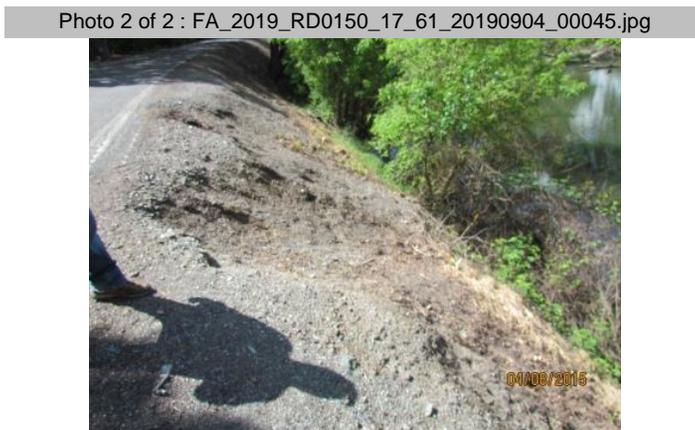
LM Start	<b>6.90</b>	Rating **	M	Issue No.	<b>61 (cont)</b>
LM End	<b>6.90</b>	Issue Type +	Ma	Location *	WS

View of erosion on the waterside of the levee during spring 2015 inspection.

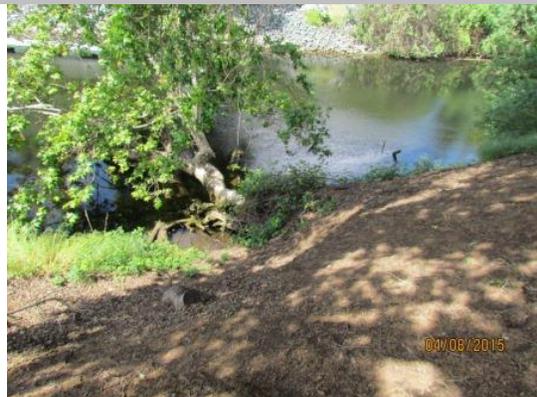
Photo 1 of 1 : FA\_2019\_RD0150\_17\_396\_20190904\_00114.jpg

Slope instability was found on the waterside toe of the levee looking upstream. Spring 2015

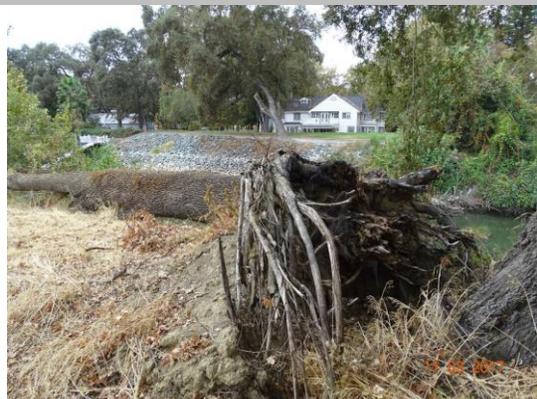
Photo 1 of 1 : FA\_2019\_RD0150\_17\_129\_20190904\_00108.jpg

View of a tree stump on the waterside shoulder of the levee. Fall 2017

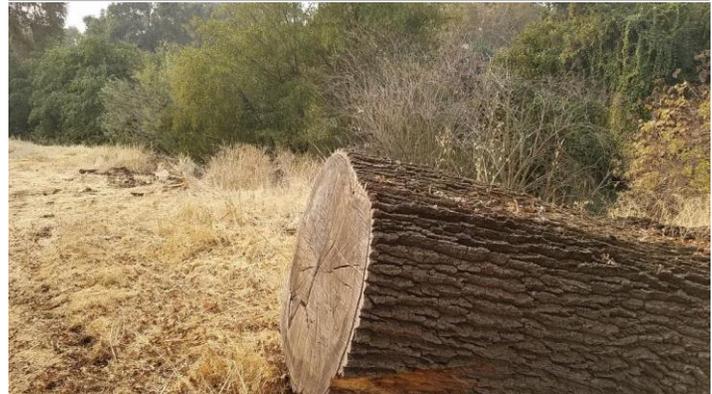
Photo 1 of 1 : FA\_2019\_RD0150\_17\_75\_20190904\_00059.jpg

View of downed tree on levee slope.

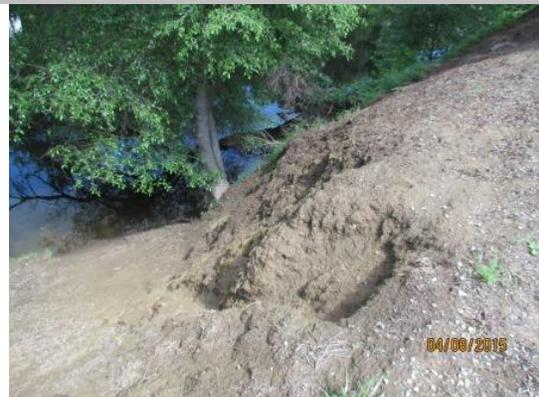
Photo 1 of 2 : FA\_2019\_RD0150\_17\_92\_20190904\_00072.jpg

View of slope instability on the waterside of the levee looking upstream during spring 2015 inspection.

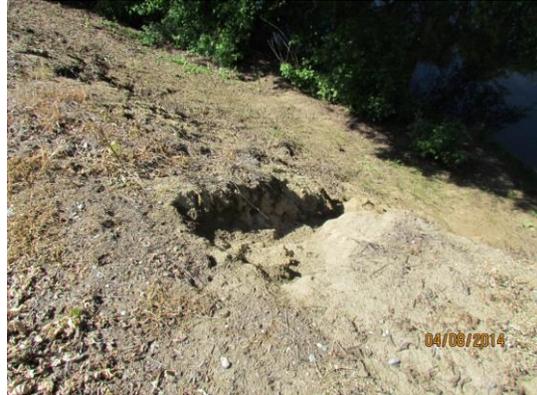
Photo 2 of 2 : FA\_2019\_RD0150\_17\_92\_20190904\_00073.jpg

Slope instability was found on the waterside of the levee looking downstream.

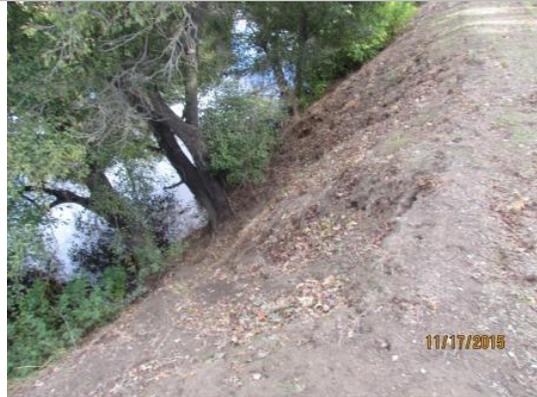
Photo 1 of 1 : FA\_2019\_RD0150\_17\_65\_20190904\_00049.jpg

View of erosion on the waterside of the levee. Fall 2015

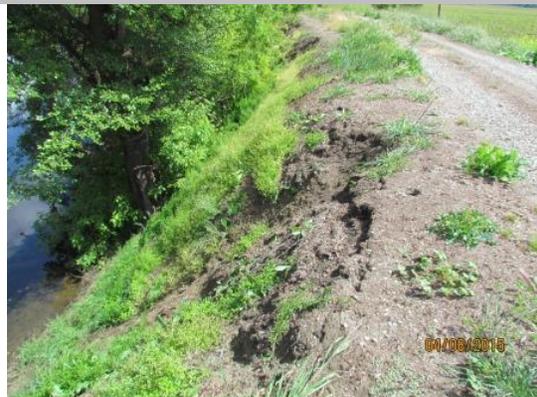
Photo 1 of 1 : FA\_2019\_RD0150\_17\_66\_20190904\_00050.jpg

View of erosion on the waterside of the levee. Spring 2015

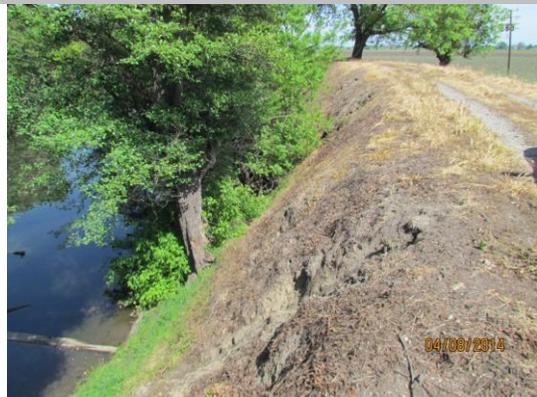
Photo 1 of 2 : FA\_2019\_RD0150\_17\_67\_20190904\_00051.jpg

View of the erosion on the waterside shoulder looking upstream. Spring 2014

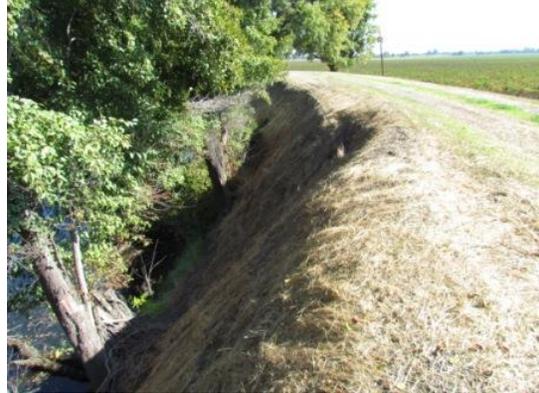
Photo 2 of 2 : FA\_2019\_RD0150\_17\_67\_20190904\_00052.jpg

Erosion was found on the waterside shoulder of the levee looking upstream. This picture was taken during fall 2012 inspection.

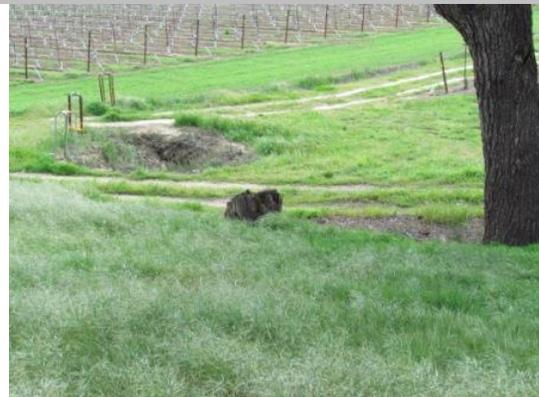
Photo 1 of 1 : FA\_2019\_RD0150\_17\_90\_20190904\_00068.jpg

LM Start	<b>8.46</b>	Rating **	N	Issue No.	<b>90</b>
LM End	<b>8.46</b>	Issue Type +	Ma	Location *	LS
Category	Earthen Levee			GPS Latitude/Longitude	
				Start	End
Item	Trim / Thin Trees			38.409220°	38.409220°
				-121.532801°	-121.532801°
DWR ID	DWR_RD0150_03_s_2012_90				
Comment Code					
T5 : Tree stumps.					
Inspector Comment

A tree stump was found on the landside of the levee looking upstream.

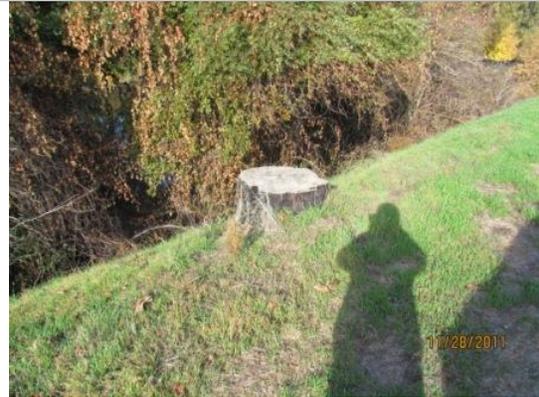
A tree stump was found on the waterside of the levee looking upstream. Fall 2011

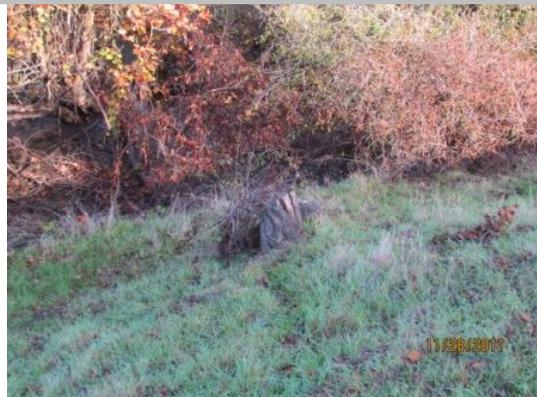
A tree stump was found on the waterside of the levee looking upstream.  
Fall 2011
