**Flood Control Project Maintenance
Levee Inspections**

Maintenance Issue Types Only, Levee Inspection Report By Mile - Fall 2019

Reclamation District No. 0341 Sherman Island

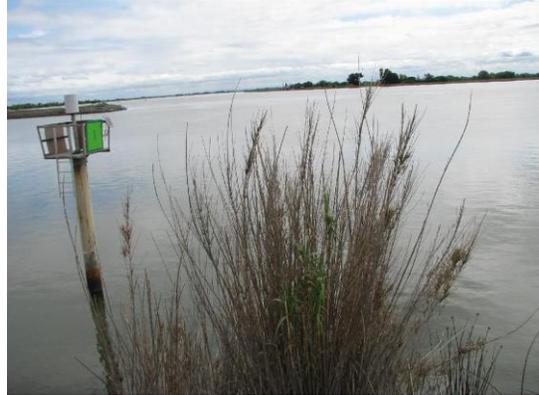
Photo 1 of 3 : UCIP_FA_2019_52252_37640.jpg

Comment Code					
Inspector Comment					
DS_ID:24215 FS_ID:52252 EP_NO: N/A Repair Type: Non-Urgent Crossing Status: Found UCIP Comments: 05/05/2009 Dense vegetation limits the inspector's visibility to identify signs of pipe failure (leaks) along the slopes. Recommend removing vegetation along pipe alignment to conduct proper inspection of structure and appurtenances. (DWR UCIP - O. Magana) FIELD_STRUCT_DESC: 30-inch steel drainage pipe through the levee, 11.1 feet below the crown. Corrugated metal cutoff wall around pipe at the center of the levee. Siphon breaker is located on both waterside (WS) and landside (LS). Pump is located on the LS approximately 300 feet from LS toe. Pipe is exposed on both levee slopes. Rock revetment present along WS slope. Marine Station number 1 located on WS with an attached small solar panel on top. [Additional Reference(s): DWR Levee Log, 1992. USACE Sacramento O&M Manual Unit No. 101, February 1962, (HLM 0.0). LMA encroachment station (STA) reference based on Map of Evacuation Route, Reclamation District 341 Sherman Island by Wagner Bonsignore Consulting Civil Engineers, A Corporation dated July 2012, STA 175+00]. FS Date: 5/5/2009

Marine station posts in river identified as Station 1 near crossing.

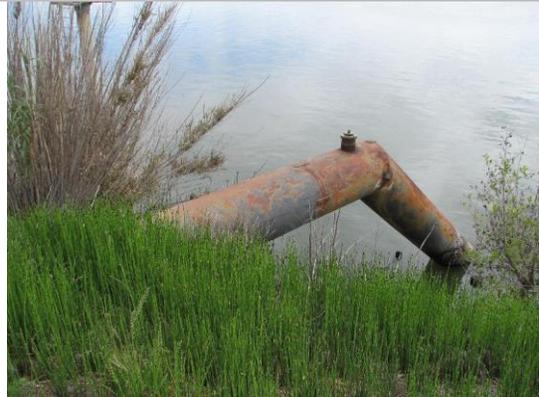
Photo 2 of 3 : UCIP_FA_2019_52252_37644.jpg

View of pipe and siphon breaker located on WS--dense vegetation on slope.

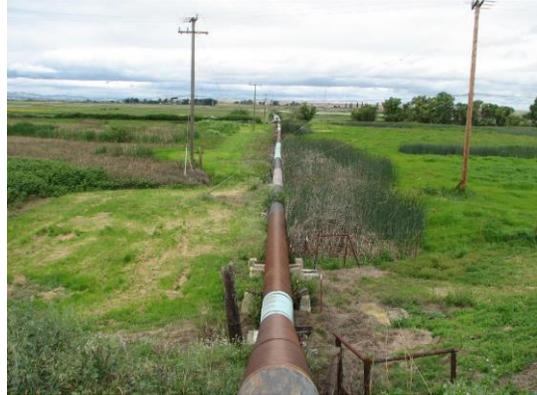
Photo 3 of 3 : UCIP_FA_2019_52252_37642.jpg

Overview of LS slope above ground once it exits levee. Pump is located approximately 300 feet from levee toe.

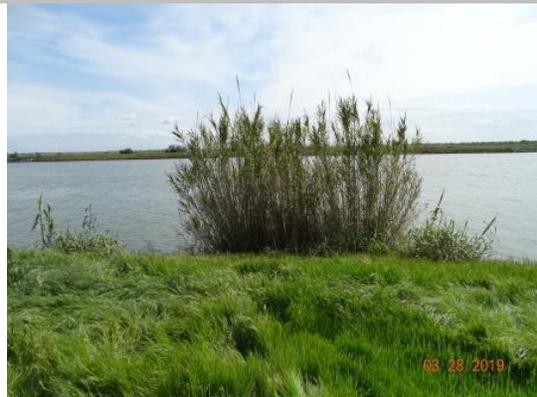
Photo 1 of 1 : FA_2019_RD0341_167_32_20190826_00008.jpg

LM Start	0.74	Rating **	M	Issue No.	32
LM End	0.74	Issue Type +	Ma	Location *	WS
Category	Earthen Levee			GPS Latitude/Longitude	
				Start	End
Item	Vegetation			38.096136°	38.096136°
				-121.686953°	-121.686953°
DWR ID	DWR_RD0341_01_s_2019_32				
Comment Code					
V2 : Remove the wild growth other than native grasses from the levee slopes.					
Inspector Comment					
Remove arundo from waterside slope.

View looking downslope at arundo on the waterside (Spring 2019).

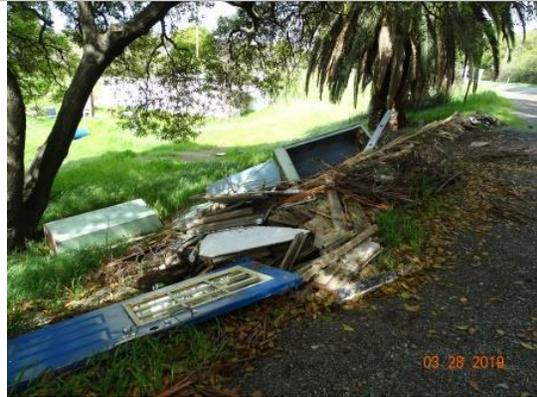
Photo 1 of 1 : FA_2019_RD0341_167_33_20190826_00009.jpg

LM Start	1.96	Rating **	M	Issue No.	33
LM End	1.96	Issue Type +	Ma	Location *	LS
Category	Earthen Levee		GPS Latitude/Longitude		
			Start	End	
Item	Encroachments		38.113663 °	38.113663 °	
			-121.684131 °	-121.684131 °	
DWR ID	DWR_RD0341_01_s_2019_33				
Comment Code					
GA : Garbage					
Inspector Comment					
Remove garbage from landside slope.

View looking upstream at garbage pile on the landside slope (Spring 2019).

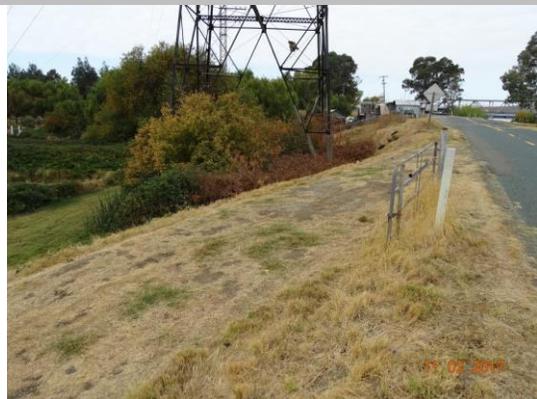
Photo 1 of 1 : FA_2019_RD0341_167_22_20190826_00003.jpg

LM Start	3.21	Rating **	M	Issue No.	22
LM End	3.21	Issue Type +	Ma	Location *	LS
Category	Earthen Levee		GPS Latitude/Longitude		
			Start	End	
Item	Vegetation		38.104677 °	38.104677 °	
			-121.700030 °	-121.700030 °	
DWR ID	DWR_RD0341_01_f_2017_22				
Comment Code					
V2 : Remove the wild growth other than native grasses from the levee slopes.					
Inspector Comment					
Remove or thin wild vegetation at base of electrical transmission tower to allow visibility and access to slope and toe.

View of wild vegetation at base of electrical transmission tower.

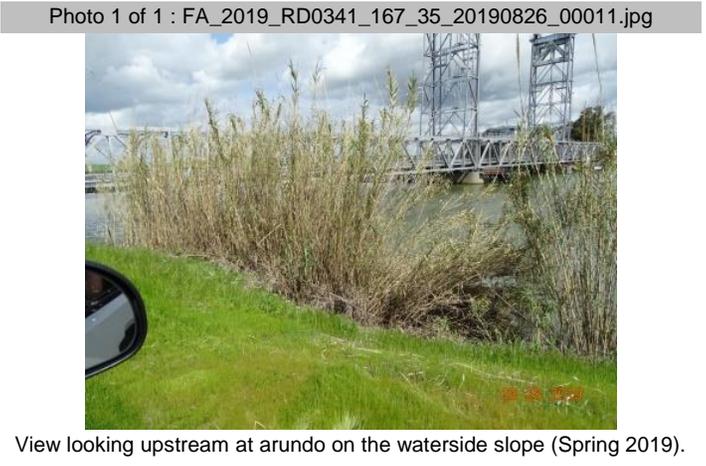
LM Start	3.27	Rating **	M	Issue No.	35
LM End	3.27	Issue Type +	Ma	Location *	WS
Category	Earthen Levee			GPS Latitude/Longitude	
				Start	End
Item	Vegetation			38.105058°	38.105058°
				-121.701046°	-121.701046°
DWR ID	DWR_RD0341_01_s_2019_35				
Comment Code					
V2 : Remove the wild growth other than native grasses from the levee slopes.					
Inspector Comment					
Remove arundo from the waterside slope.

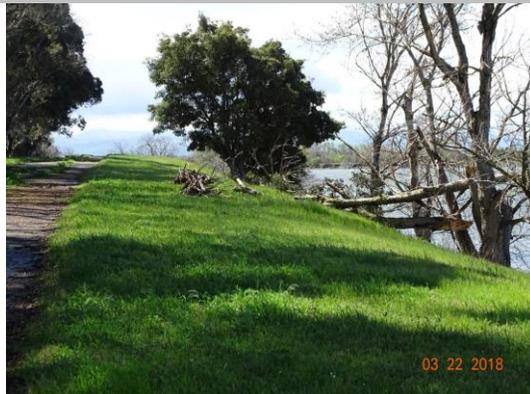
Photo 1 of 1 : FA_2019_RD0341_168_44_20190826_00013.jpg

LM Start	3.48	Rating **	M	Issue No.	44
LM End	3.48	Issue Type +	Ma	Location *	WS
Category	Earthen Levee		GPS Latitude/Longitude		
			Start	End	
Item	Encroachments		38.104454 °	38.104454 °	
			-121.704275 °	-121.704275 °	
DWR ID	DWR_RD0341_02_s_2018_44				
Comment Code					
TR : Tree or limb					
Inspector Comment					
Remove tree limbs from waterside shoulder.

Tree limbs on waterside shoulder should be removed.

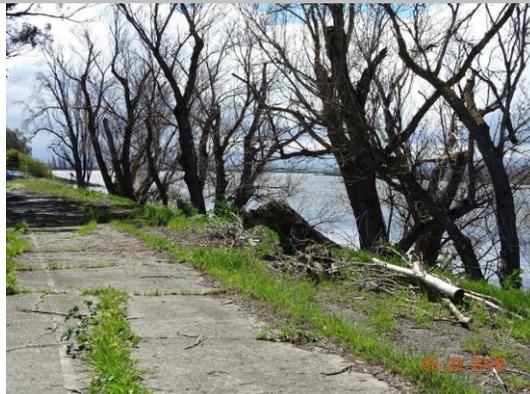
Photo 1 of 1 : FA_2019_RD0341_168_46_20190826_00014.jpg

LM Start	3.88	Rating **	M	Issue No.	46
LM End	3.93	Issue Type +	Ma	Location *	WS
Category	Earthen Levee		GPS Latitude/Longitude		
			Start	End	
Item	Encroachments		38.099054 °	38.098327 °	
			-121.706368 °	-121.706272 °	
DWR ID	DWR_RD0341_02_s_2018_46				
Comment Code					
TR : Tree or limb					
Inspector Comment					
Remove tree and limbs from waterside shoulder.

Tree trunk and limbs should be removed from waterside shoulder.

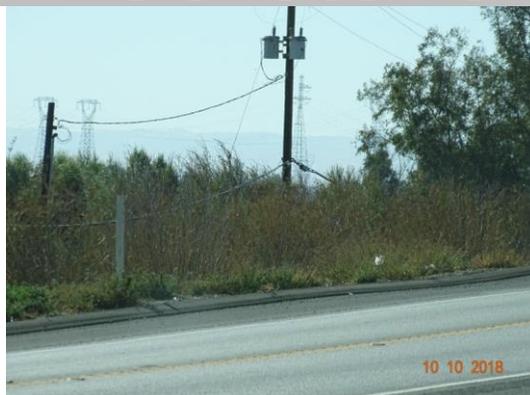
Photo 1 of 2 : FA_2019_RD0341_168_43_20190826_00011.jpg

LM Start	3.97	Rating **	M	Issue No.	43
LM End	6.03	Issue Type +	Ma	Location *	LS
Category	Earthen Levee		GPS Latitude/Longitude		
			Start	End	
Item	Vegetation		38.097782 °	38.080143 °	
			-121.706262 °	-121.728330 °	
DWR ID	DWR_RD0341_02_f_2017_43				
Comment Code					
V2 : Remove the wild growth other than native grasses from the levee slopes.					
Inspector Comment

View of vegetation on the land side slope where the levee is on Highway 160 (October 2018).

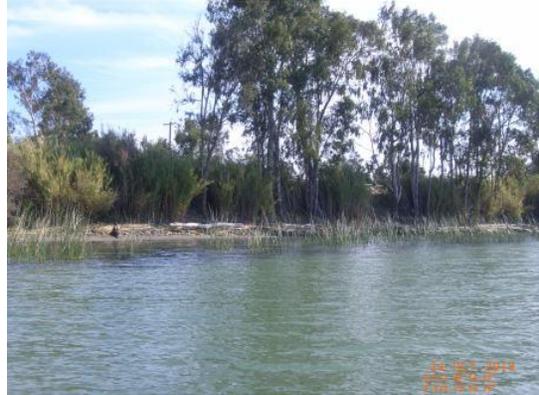
Photo 1 of 1 : FA_2019_RD0341_168_37_20190826_00004.jpg

LM Start	4.00	Rating **	M	Issue No.	37
LM End	4.19	Issue Type +	Ma	Location *	WS
Category	Supplemental			GPS Latitude/Longitude	
				Start	End
Item	2017 USACE Erosion Survey			38.097398 °	38.094590 °
				-121.706321 °	-121.706393 °
DWR ID	DWR_RD0341_02_f_2018_37				
Comment Code					
Inspector Comment					
2017 Site ID: SAC 8.2 L Status: Eroding 2017 Field Notes: Minor new erosion. Site History: 2011 - Large new erosion pocket probably hidden by vegetation in the past.

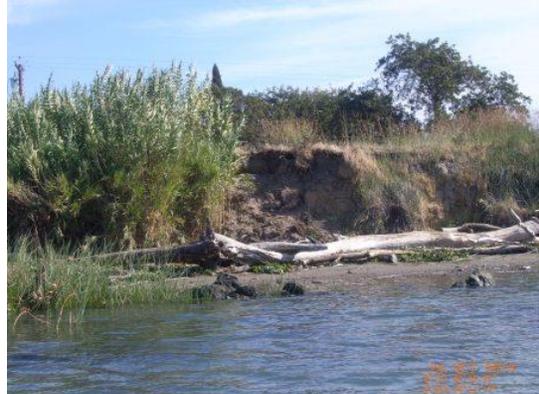
Photo 1 of 1 : FA_2019_RD0341_168_35_20190826_00003.jpg

LM Start	4.47	Rating **	U	Issue No.	35
LM End	4.70	Issue Type +	Ma	Location *	WS
Category	Supplemental			GPS Latitude/Longitude	
				Start	End
Item	2017 USACE Erosion Survey			38.090620 °	38.087425 °
				-121.706684 °	-121.707639 °
DWR ID	DWR_RD0341_02_f_2018_35				
Comment Code					
Inspector Comment					
2017 Site ID: SAC 8.0 L Status: Critical 2017 Field Notes: Site extended downstream Site History: 1999 - New small slump in eroded bank. 2005 - Reach extended because of vertical bank along the roadway upstream. 2011 - More slumping since last year. 2012 - Site upgraded to critical. Very steep slope which may be effecting the highway on top of the levee. 2015 - New erosion towards the downstream end of site.

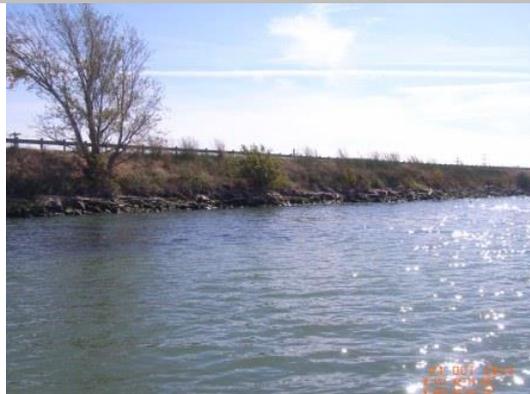
Photo 1 of 1 : FA_2019_RD0341_168_34_20190826_00002.jpg

LM Start	4.76	Rating **	A/W	Issue No.	34
LM End	5.01	Issue Type +	Ma	Location *	WS
Category	Supplemental		GPS Latitude/Longitude		
			Start	End	
Item	2017 USACE Erosion Survey		38.086603°	38.083954°	
			-121.707786°	-121.710589°	
DWR ID	DWR_RD0341_02_f_2018_34				
Comment Code					
Inspector Comment					
2017 Site ID: SAC 7.9 L Status: Critical 2017 Field Notes: Road base exposed in multiple locations. New tree popout observed. Site History: 2011 - Large slump section. 2012 - Site extended downstream, upgraded to critical, severe windwave. Slope is very steep and may be effecting the highway on top of the levee.

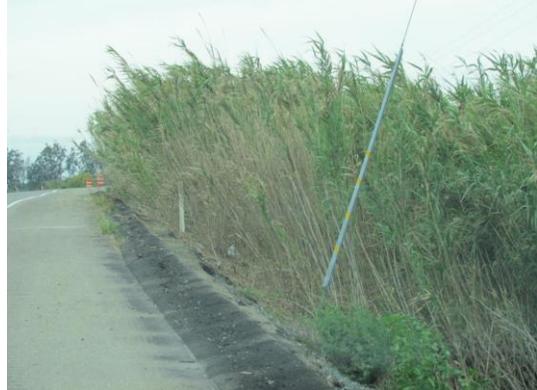
Photo 1 of 1 : FA_2019_RD0341_168_49_20190826_00016.jpg

LM Start	6.03	Rating **	U	Issue No.	49
LM End	6.10	Issue Type +	Ma	Location *	LS
Category	Earthen Levee		GPS Latitude/Longitude		
			Start	End	
Item	Vegetation		38.080143°	38.080125°	
			-121.728332°	-121.729662°	
DWR ID	DWR_RD0341_02_f_2016_49				
Comment Code					
V2 : Remove the wild growth other than native grasses from the levee slopes.					
Inspector Comment					
Remove the arundo from the landside slope

RD 341 Landside slope from levee mile 6.03-6.10 tall unwanted growth of Arundo present on the levee section.
