**Flood Control Project Maintenance
Levee Inspections**

Maintenance Issue Types Only, Levee Inspection Report By Mile - Spring 2020

Reclamation District No. 0501 Ryer Island

Waterway	Bank	Unit Miles	Inspection Start/End	Inspector
Unit No. 01 Steamboat Slough	Right	6.71	04/01/2020 04/01/2020	David Julian

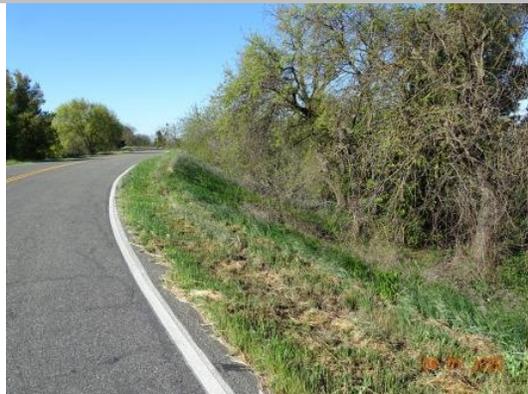
Photo 1 of 1 : SP_2020_RD0501_169_24_20200403_00077.jpg

LM Start	0.01	Rating **	M	Issue No.	24
LM End	6.71	Issue Type +	Ma	Location *	LS
Category	Earthen Levee		GPS Latitude/Longitude		
			Start	End	
Item	Vegetation		38.254354 °	38.184026 °	
			-121.601510 °	-121.657758 °	
DWR ID	DWR_RD0501_01_s_2020_24				
Comment Code					
V1 : Control annual grass and weeds on the levee slopes and easements.					
Inspector Comment

View looking downstream of annual vegetation on the landside slope (Spring 2020).

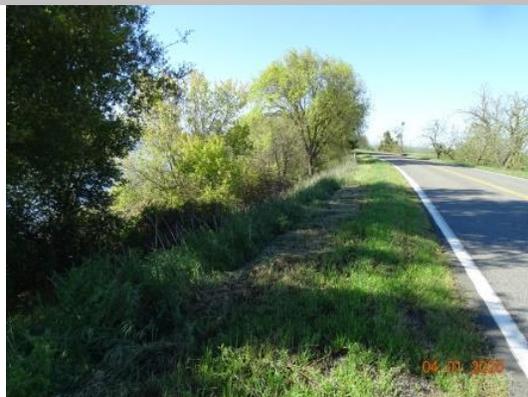
Photo 1 of 1 : SP_2020_RD0501_169_52_20200403_00079.jpg

LM Start	0.05	Rating **	M	Issue No.	52
LM End	1.24	Issue Type +	Ma	Location *	WS
Category	Earthen Levee		GPS Latitude/Longitude		
			Start	End	
Item	Vegetation		38.253964 °	38.236981 °	
			-121.601868 °	-121.604384 °	
DWR ID	DWR_RD0501_01_s_2020_52				
Comment Code					
V1 : Control annual grass and weeds on the levee slopes and easements.					
Inspector Comment

View looking downstream of annual vegetation on the waterside slope (Spring 2020).

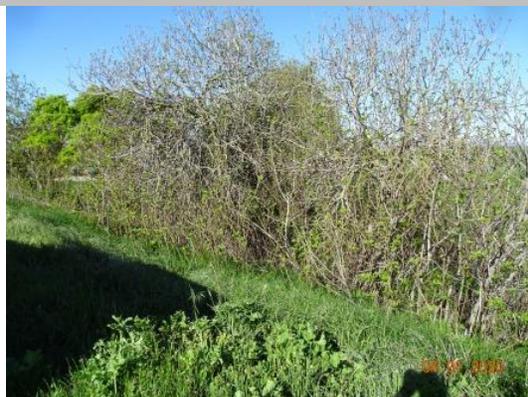
Photo 1 of 1 : SP_2020_RD0501_169_26_20200403_00078.jpg

LM Start	0.05	Rating **	U	Issue No.	26
LM End	0.05	Issue Type +	Ma	Location *	LS
Category	Earthen Levee		GPS Latitude/Longitude		
			Start	End	
Item	Trim / Thin Trees		38.253895 °	38.253895 °	
			-121.601937 °	-121.601937 °	
DWR ID	DWR_RD0501_01_f_2018_26				
Comment Code					
T2 : Thin trees to allow visibility of the ground and room to flood fight.					
Inspector Comment					
Trim fig tree to allow access and visibility down the landside slope.

View of fig tree on the landside slope (Spring 2020).

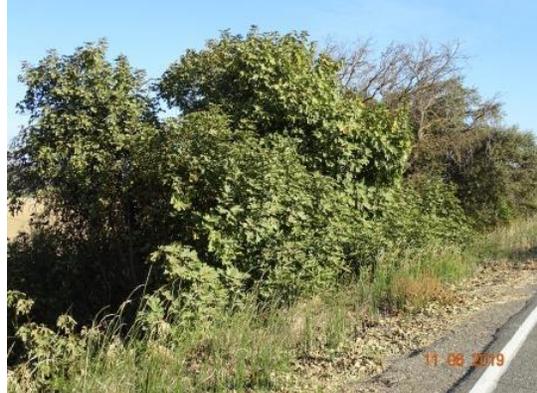
Photo 1 of 1 : SP_2020_RD0501_169_43_20200304_00016.jpg

LM Start	0.14	Rating **	M	Issue No.	43
LM End	0.16	Issue Type +	Ma	Location *	LS
Category	Earthen Levee			GPS Latitude/Longitude	
				Start	End
Item	Trim / Thin Trees			38.252790 °	38.252548 °
				-121.602705 °	-121.602805 °
DWR ID	DWR_RD0501_01_f_2018_43				
Comment Code					
T2 : Thin trees to allow visibility of the ground and room to flood fight.					
Inspector Comment

View looking upstream at fig trees on the landside slope (Fall 2019).

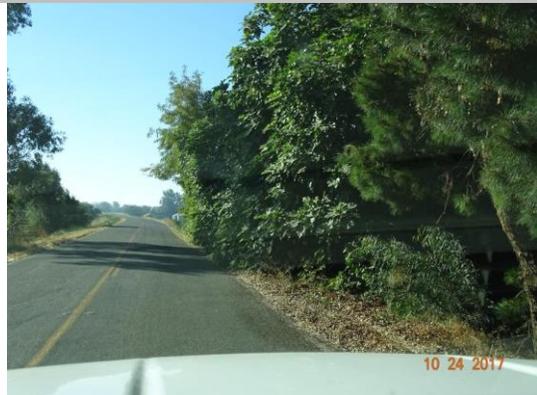
Photo 1 of 1 : SP_2020_RD0501_169_27_20200304_00005.jpg

LM Start	0.28	Rating **	M	Issue No.	27
LM End	0.28	Issue Type +	Ma	Location *	LS
Category	Earthen Levee			GPS Latitude/Longitude	
				Start	End
Item	Trim / Thin Trees			38.250809 °	38.250809 °
				-121.603119 °	-121.603119 °
DWR ID	DWR_RD0501_01_f_2017_27				
Comment Code					
T2 : Thin trees to allow visibility of the ground and room to flood fight.					
Inspector Comment					
Trim fig trees to allow inspection and access to landside slope and toe.

View of fig trees on the landside slope and toe.

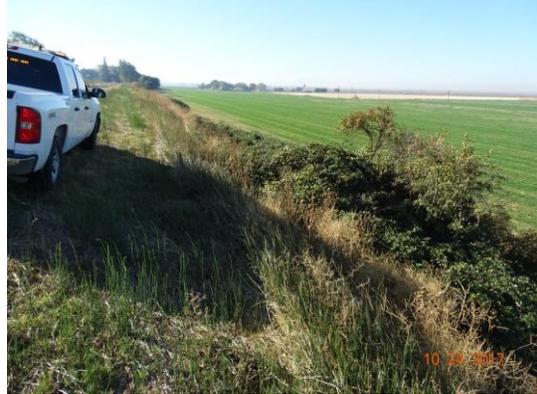
Photo 1 of 1 : SP_2020_RD0501_169_29_20200304_00007.jpg

LM Start	0.76	Rating **	M	Issue No.	29
LM End	1.01	Issue Type +	Ma	Location *	LS
Category	Earthen Levee			GPS Latitude/Longitude	
				Start	End
Item	Vegetation			38.243815 °	38.240257 °
				-121.603077 °	-121.603873 °
DWR ID	DWR_RD0501_01_f_2018_29				
Comment Code					
V2 : Remove the wild growth other than native grasses from the levee slopes.					
Inspector Comment					
Landside slope is covered in blackberry vines. Should be removed to allow inspection and access.

View of landside slope covered in blackberry vines.

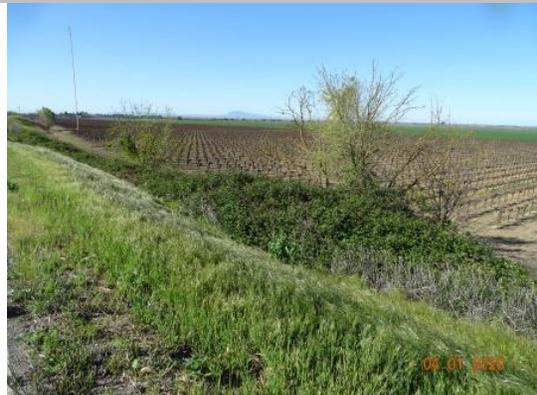
Photo 1 of 1 : SP_2020_RD0501_169_44_20200403_00081.jpg

LM Start	1.54	Rating **	U	Issue No.	44
LM End	1.68	Issue Type +	Ma	Location *	LS
Category	Earthen Levee			GPS Latitude/Longitude	
				Start	End
Item	Vegetation			38.232683 °	38.230700 °
				-121.603484 °	-121.603744 °
DWR ID	DWR_RD0501_01_f_2019_44				
Comment Code					
V2 : Remove the wild growth other than native grasses from the levee slopes.					
Inspector Comment

View of blackberries on the landside slope (Spring 2020).

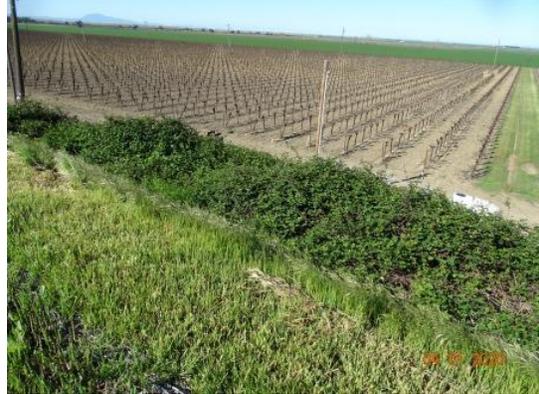
Photo 1 of 1 : SP_2020_RD0501_169_60_20200403_00082.jpg

View of blackberries on the landside toe (Spring 2020).

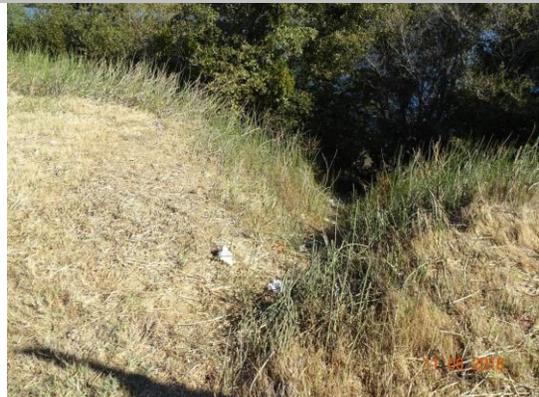
Photo 1 of 1 : SP_2020_RD0501_169_47_20200304_00018.jpg

LM Start	2.07	Rating **	U	Issue No.	47
LM End	2.07	Issue Type +	Ma	Location *	WS
Category	Earthen Levee			GPS Latitude/Longitude	
				Start	End
Item	Slope Stability			38.225070 °	38.225070 °
				-121.603827 °	-121.603827 °
DWR ID	DWR_RD0501_01_f_2018_47				
Comment Code					
S2 : Repair the levee slope damaged by foot traffic and prevent access where possible.					
Inspector Comment					
Deep gouges in the waterside slope due to heavy foot traffic.

View of foot path that is more than 1 foot deep into the waterside slope (November 2018).

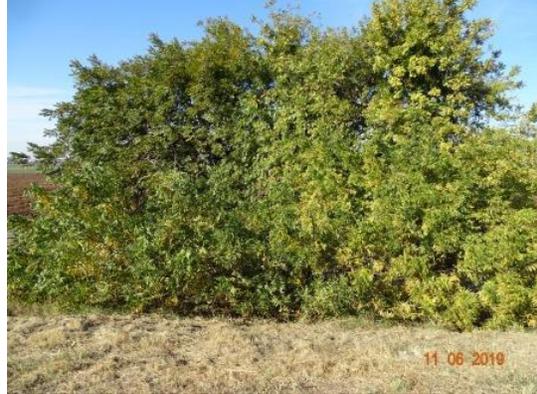
Photo 1 of 1 : SP_2020_RD0501_169_48_20200304_00020.jpg

View of thick trees on the landside slope (Fall 2019).

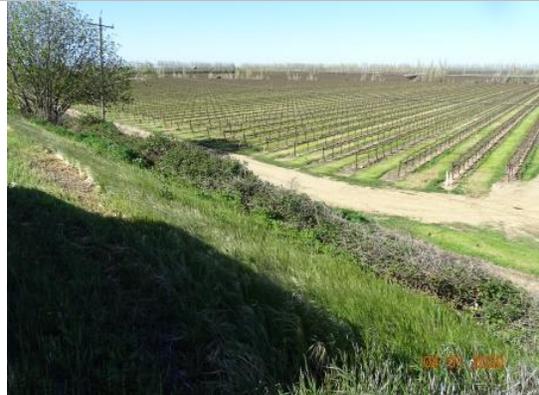
Photo 1 of 1 : SP_2020_RD0501_169_73_20200403_00084.jpg

View of blackberries on the landside toe (Spring 2020).

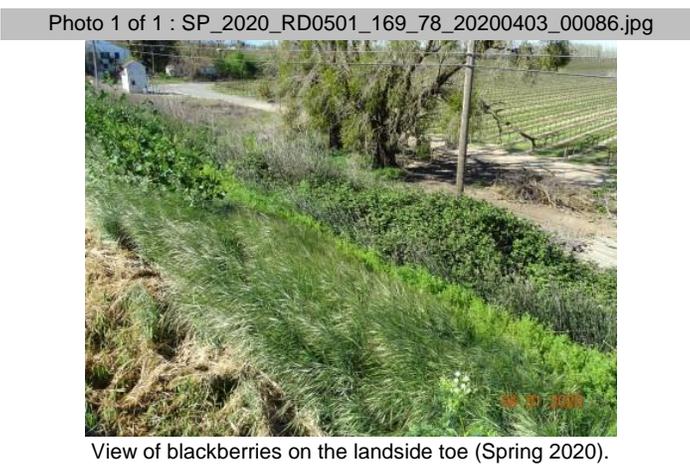
LM Start	3.65	Rating **	U	Issue No.	78
LM End	3.65	Issue Type +	Ma	Location *	LS
Category	Earthen Levee			GPS Latitude/Longitude	
				Start	End
Item	Vegetation			38.204116 °	38.204116 °
				-121.613091 °	-121.613091 °
DWR ID	DWR_RD0501_01_s_2020_78				
Comment Code					
V2 : Remove the wild growth other than native grasses from the levee slopes.					
Inspector Comment

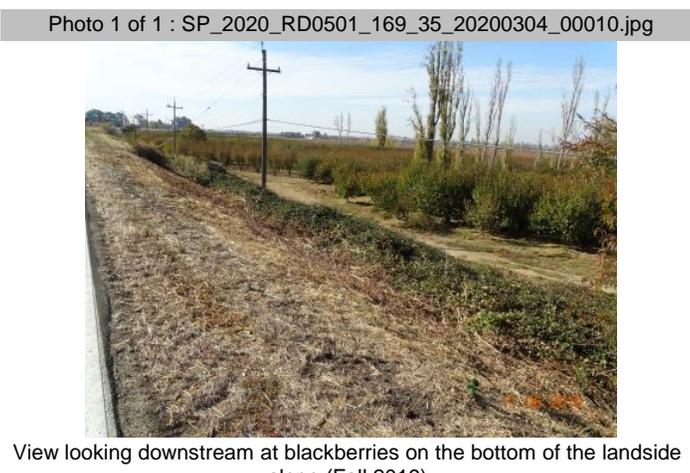
LM Start	3.79	Rating **	U	Issue No.	35
LM End	4.17	Issue Type +	Ma	Location *	LS
Category	Earthen Levee			GPS Latitude/Longitude	
				Start	End
Item	Vegetation			38.202172 °	38.197187 °
				-121.613737 °	-121.616620 °
DWR ID	DWR_RD0501_01_f_2019_35				
Comment Code					
V2 : Remove the wild growth other than native grasses from the levee slopes.					
Inspector Comment					
Blackberries at bottom of landside slope.

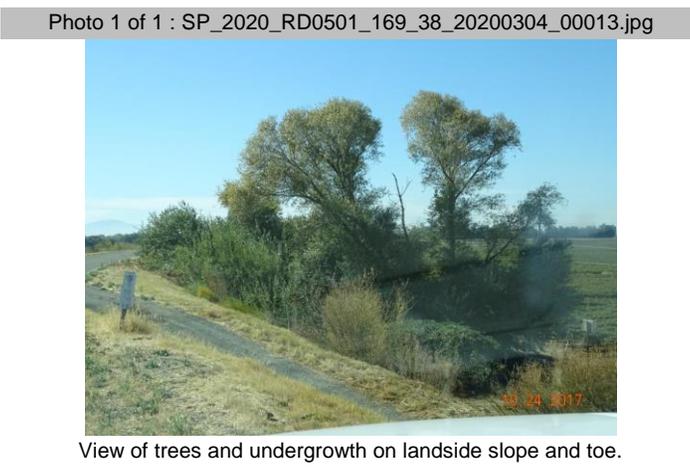
LM Start	5.89	Rating **	U	Issue No.	38
LM End	5.89	Issue Type +	Ma	Location *	LS
Category	Earthen Levee		GPS Latitude/Longitude		
			Start	End	
Item	Trim / Thin Trees		38.188870 °	38.188870 °	
			-121.644732 °	-121.644732 °	
DWR ID	DWR_RD0501_01_f_2017_38				
Comment Code					
T2 : Thin trees to allow visibility of the ground and room to flood fight.					
Inspector Comment

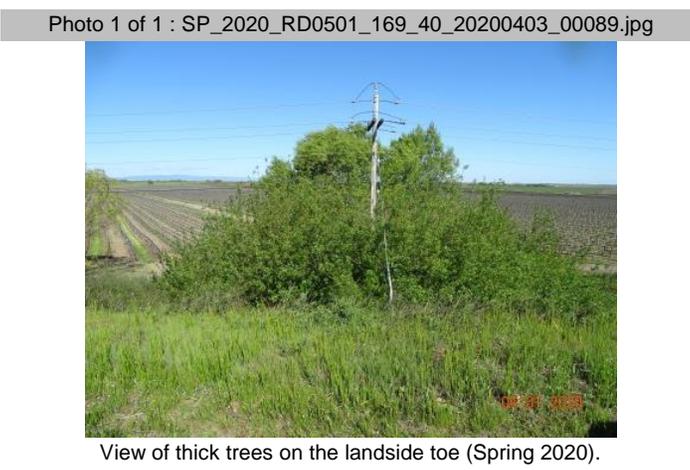
LM Start	6.15	Rating **	U	Issue No.	40
LM End	6.15	Issue Type +	Ma	Location *	LS
Category	Earthen Levee		GPS Latitude/Longitude		
			Start	End	
Item	Trim / Thin Trees		38.186090 °	38.186090 °	
			-121.648022 °	-121.648022 °	
DWR ID	DWR_RD0501_01_f_2017_40				
Comment Code					
T2 : Thin trees to allow visibility of the ground and room to flood fight.					
Inspector Comment

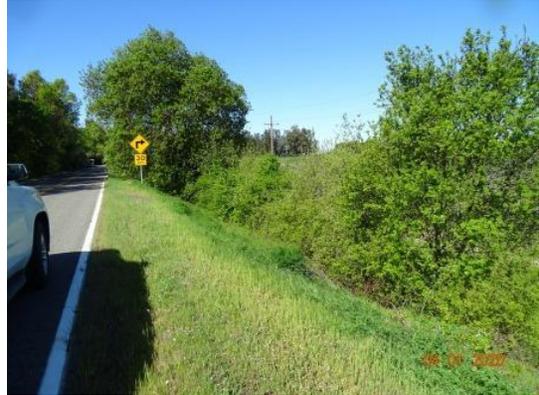
Photo 1 of 1 : SP_2020_RD0501_169_33_20200403_00090.jpg

View looking downstream at thick trees on the landside slope (Spring 2020).

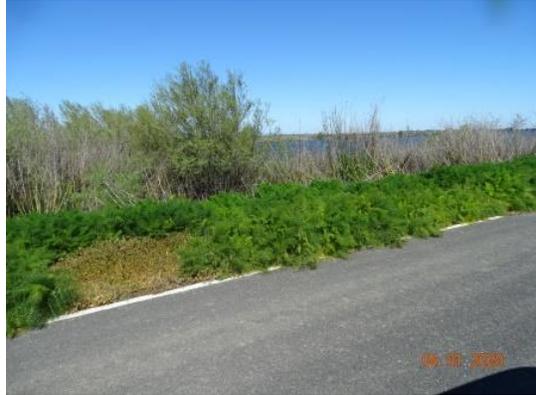
Photo 1 of 1 : SP_2020_RD0501_170_22_20200403_00046.jpg

View of thick annual vegetation on the waterside slope (Spring 2020).

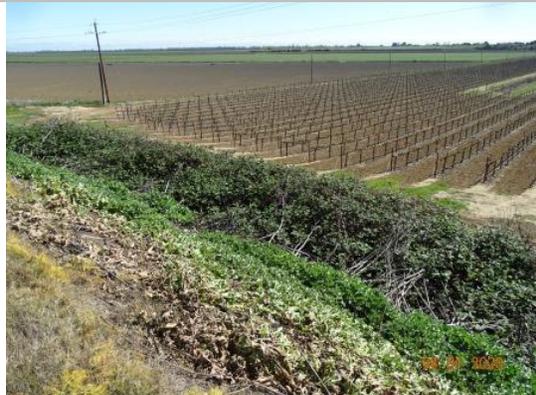
Photo 1 of 1 : SP_2020_RD0501_170_23_20200403_00047.jpg

LM Start	0.64	Rating **	U	Issue No.	23
LM End	0.64	Issue Type +	Ma	Location *	LS
Category	Earthen Levee		GPS Latitude/Longitude		
			Start	End	
Item	Vegetation		38.192469 °	38.192469 °	
			-121.655548 °	-121.655548 °	
DWR ID	DWR_RD0501_02_s_2020_23				
Comment Code					
V2 : Remove the wild growth other than native grasses from the levee slopes.					
Inspector Comment

View of thick blackberries on the landside toe (Spring 2020).

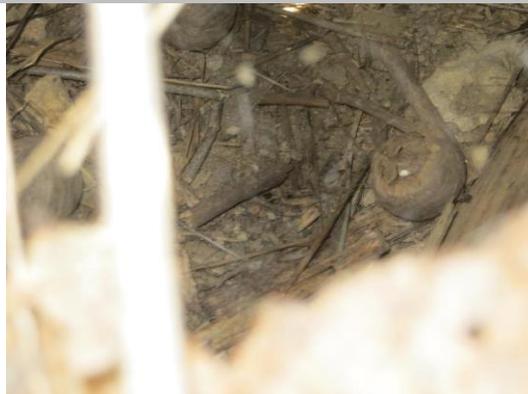
Photo 3 of 3 : UCIP_SP_2020_44753_73953.jpg

Inside hole in pipe at WS toe.

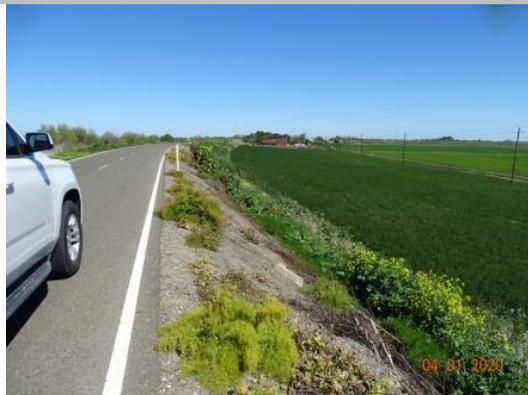
Photo 1 of 1 : SP_2020_RD0501_170_24_20200403_00048.jpg

LM Start	1.88	Rating **	U	Issue No.	24
LM End	3.34	Issue Type +	Ma	Location *	LS
Category	Earthen Levee			GPS Latitude/Longitude	
				Start	End
Item	Vegetation			38.209252 °	38.224813 °
				-121.656552 °	-121.672697 °
DWR ID	DWR_RD0501_02_s_2020_24				
Comment Code					
V1 : Control annual grass and weeds on the levee slopes and easements.					
Inspector Comment

View looking upstream at thick annual vegetation on the landside slope (Spring 2020).

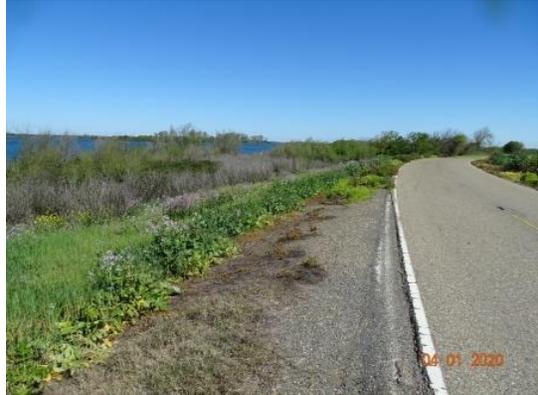
Photo 1 of 1 : SP_2020_RD0501_171_27_20200403_00081.jpg

View looking upstream at thick annual vegetation on the waterside slope (Spring 2020).

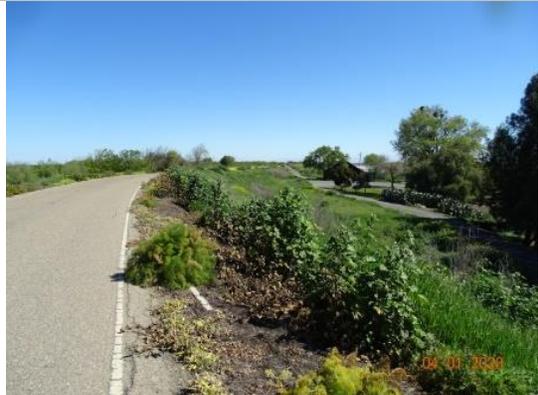
Photo 1 of 1 : SP_2020_RD0501_171_29_20200403_00080.jpg

LM Start	0.00	Rating **	U	Issue No.	29
LM End	1.68	Issue Type +	Ma	Location *	LS
Category	Earthen Levee		GPS Latitude/Longitude		
			Start	End	
Item	Vegetation		38.227996 °	38.247078 °	
			-121.673077 °	-121.658433 °	
DWR ID	DWR_RD0501_03_f_2019_29				
Comment Code					
V1 : Control annual grass and weeds on the levee slopes and easements.					
Inspector Comment

View looking upstream at thick annual vegetation on the landside slope (Spring 2020).

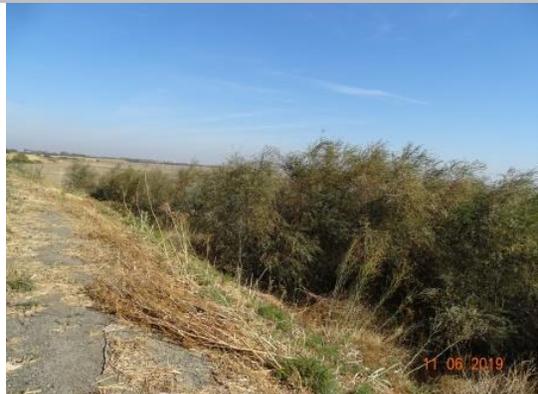
Photo 1 of 1 : SP_2020_RD0501_171_28_20200304_00001.jpg

LM Start	1.48	Rating **	M	Issue No.	28
LM End	1.48	Issue Type +	Ma	Location *	LS
Category	Earthen Levee		GPS Latitude/Longitude		
			Start	End	
Item	Trim / Thin Trees		38.244293 °	38.244293 °	
			-121.657843 °	-121.657843 °	
DWR ID	DWR_RD0501_03_f_2017_28				
Comment Code					
T2 : Thin trees to allow visibility of the ground and room to flood fight.					
Inspector Comment

View looking upstream at willows at the landside toe (Fall 2019).

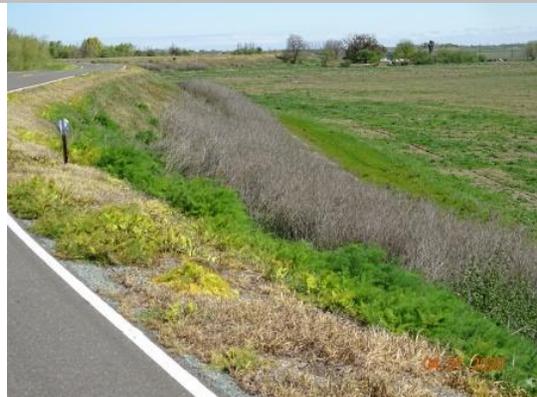
Photo 1 of 1 : SP_2020_RD0501_171_48_20200403_00083.jpg

View looking upstream at thick annual vegetation on the landside slope (Spring 2020).

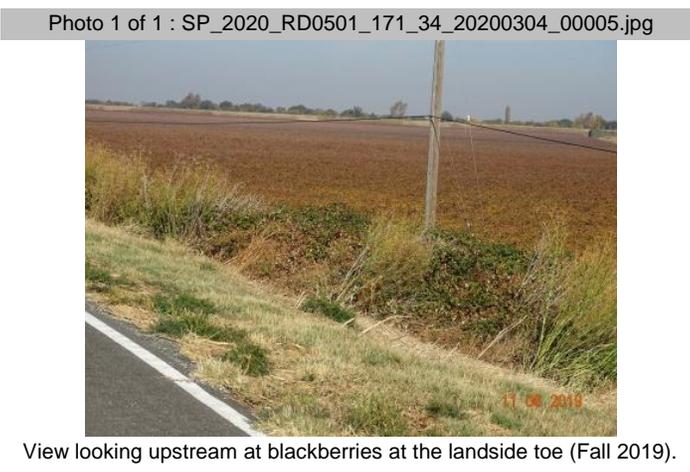
LM Start	4.47	Rating **	U	Issue No.	34
LM End	4.80	Issue Type +	Ma	Location *	LS
Category	Earthen Levee			GPS Latitude/Longitude	
				Start	End
Item	Vegetation			38.277918 °	38.281507 °
				-121.637670 °	-121.641595 °
DWR ID	DWR_RD0501_03_f_2017_34				
Comment Code					
V2 : Remove the wild growth other than native grasses from the levee slopes.					
Inspector Comment					
Blackberries at landside toe.

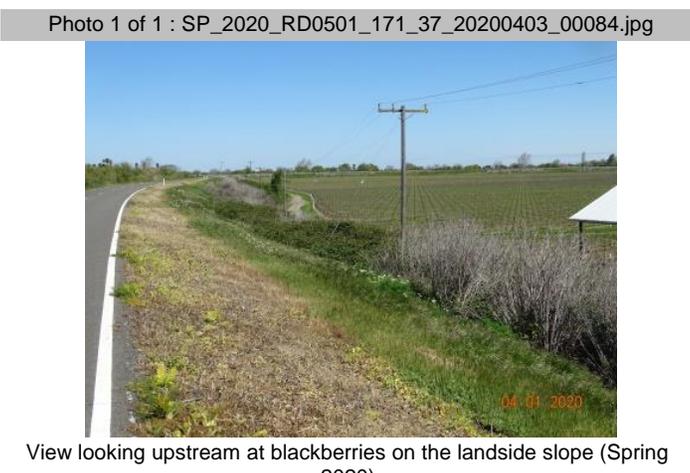
LM Start	4.95	Rating **	U	Issue No.	37
LM End	4.99	Issue Type +	Ma	Location *	LS
Category	Earthen Levee			GPS Latitude/Longitude	
				Start	End
Item	Vegetation			38.282816 °	38.283475 °
				-121.643242 °	-121.643310 °
DWR ID	DWR_RD0501_03_s_2019_37				
Comment Code					
V2 : Remove the wild growth other than native grasses from the levee slopes.					
Inspector Comment					
Remove blackberries from landside levee slope.

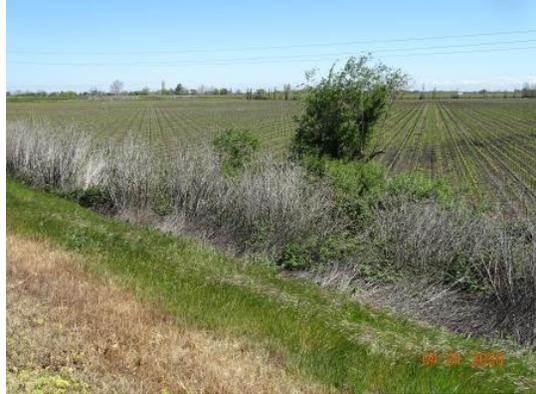
Photo 1 of 1 : SP_2020_RD0501_171_38_20200403_00085.jpg

View of thick blackberries on the landside slope (Spring 2020).

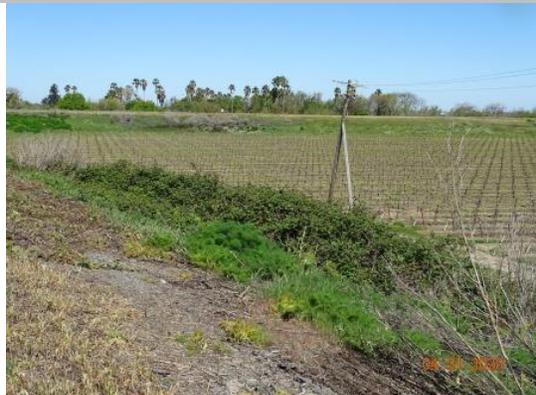
Photo 1 of 1 : SP_2020_RD0501_171_51_20200403_00086.jpg

View of blackberries on the landside slope (Spring 2020).

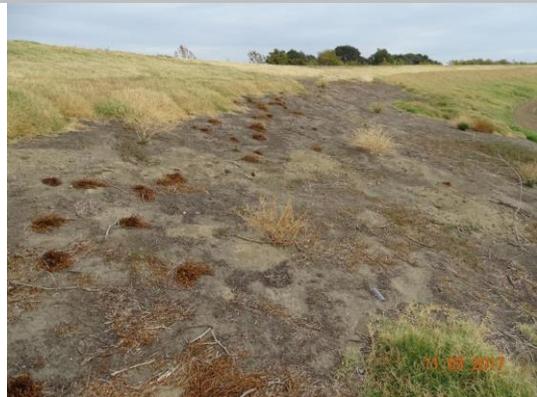
Photo 1 of 1 : SP_2020_RD0501_171_39_20200304_00007.jpg

Photo of evidence of significant rodent activity at this location.

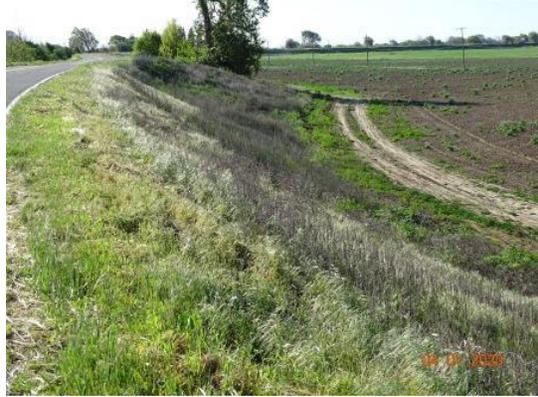
Photo 1 of 1 : SP_2020_RD0501_172_18_20200403_00036.jpg

View looking downstream at annual vegetation on the landside slope (Spring 2020).

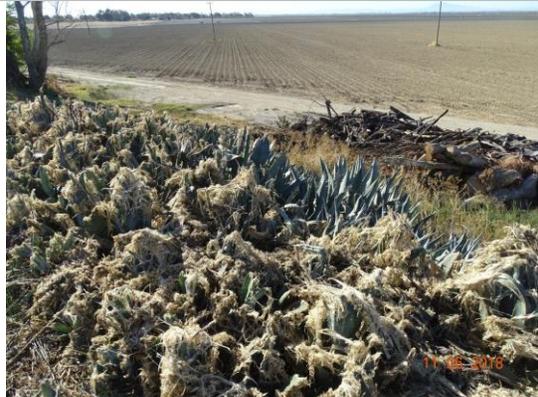
Photo 1 of 1 : SP_2020_RD0501_172_16_20200304_00004.jpg

View of cactus on the land side slope. LMA has chopped and sprayed cactus at the top of the slope and is in process of dealing with cactus along the entire slope (November 2018).

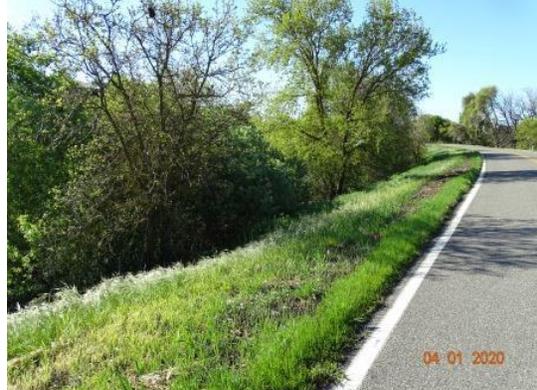
Photo 1 of 1 : SP_2020_RD0501_172_21_20200403_00037.jpg

View looking downstream at annual vegetation on the waterside slope (Spring 2020).

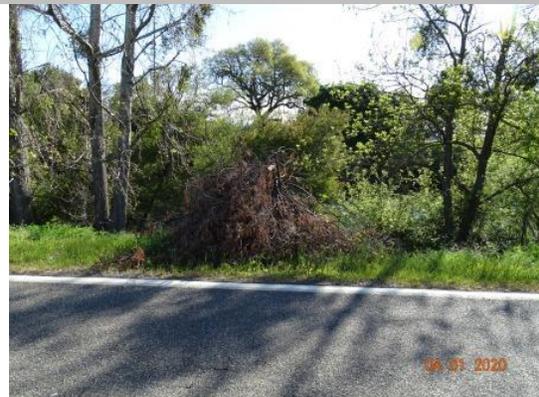
Photo 1 of 1 : SP_2020_RD0501_172_26_20200403_00038.jpg

View of pruning pile on the waterside hinge (Spring 2020).
