**Flood Control Project Maintenance
Levee Inspections**

Maintenance Issue Types Only, Levee Inspection Report By Mile - Spring 2020

Reclamation District No. 0524 Middle Roberts Island

Waterway	Bank	Unit Miles	Inspection Start/End	Inspector
Unit No. 01 San Joaquin River	Left	6.20	04/30/2020 04/30/2020	Alberto De Leon

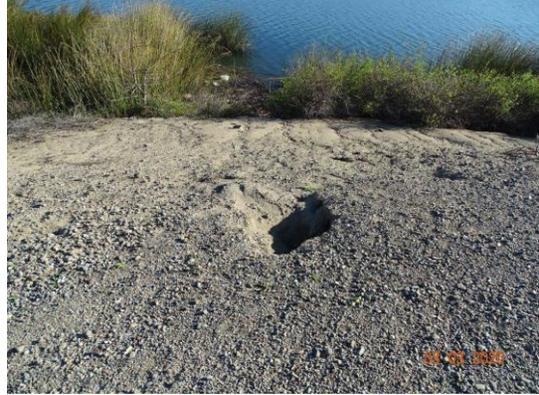
Photo 1 of 1 : SP_2020_RD0524_107_96_20200504_00340.jpg

LM Start	0.00	Rating **	U	Issue No.	96
LM End	0.00	Issue Type +	Ma	Location *	WS
Category	Earthen Levee			GPS Latitude/Longitude	
				Start	End
Item	Animal Control			37.941193 °	37.941193 °
				-121.346093 °	-121.346093 °
DWR ID	DWR_RD0524_01_s_2020_96				
Comment Code					
A1 : Exterminate rodents and backfill and compact or grout burrows.					
Inspector Comment

View of large animal burrow on waterside hinge. Spring 2020

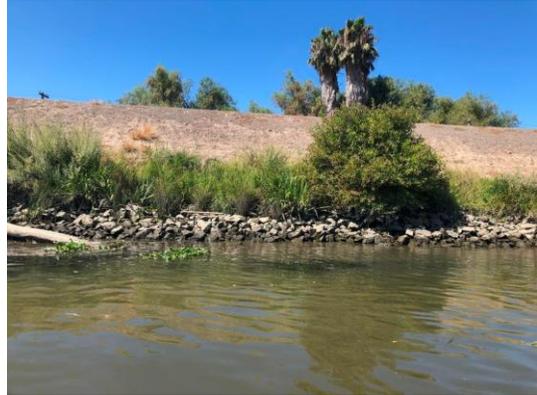
Photo 1 of 1 : SP_2020_RD0524_107_1_20200228_00002.jpg

LM Start	0.18	Rating **	U	Issue No.	1
LM End	0.18	Issue Type +	Ma	Location *	WS
Category	Supplemental		GPS Latitude/Longitude		
			Start	End	
Item	DWR Erosion Survey		37.939085 °	37.939085 °	
			-121.343917 °	-121.343917 °	
DWR ID	RD0524U01RM40.85				
Comment Code					
Inspector Comment					
Site ID: RD0524U01RM40.85 08/13/2019: No significant change observed. 09/13/2017: No significant change observed. 07/25/2016: No significant change observed. 06/24/2015: No significant change observed. 06/19/2014: No significant change observed. 08/13/2013: The erosion was discovered during 2013 spring levee inspection. Inspector comment: Erosion is located along the lower level of water-ward slope.

Front view of the erosion.

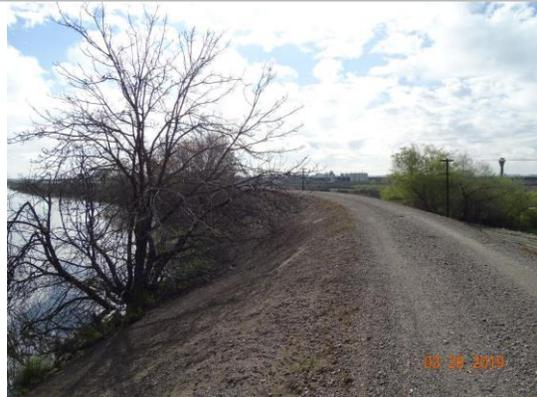
Photo 1 of 1 : SP_2020_RD0524_107_201_20200228_00168.jpg

LM Start	0.23	Rating **	M	Issue No.	201
LM End	0.23	Issue Type +	Ma	Location *	WS
Category	Earthen Levee		GPS Latitude/Longitude		
			Start	End	
Item	Trim / Thin Trees		37.938648 °	37.938648 °	
			-121.343480 °	-121.343480 °	
DWR ID	DWR_RD0524_01_f_2016_201				
Comment Code					
T1 : Trim trees to at least five feet above ground level.					
Inspector Comment

View of tree on waterside slope looking upstream. Spring 2019.

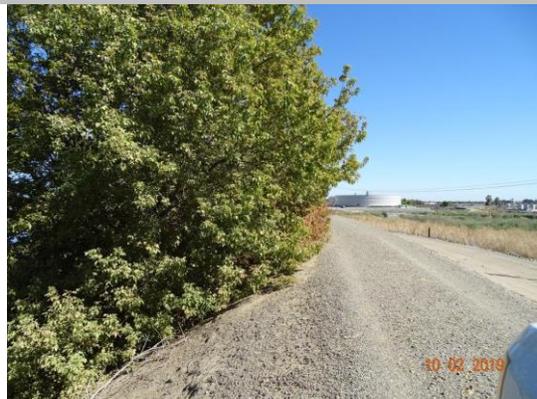
Photo 1 of 1 : SP_2020_RD0524_107_179_20200228_00144.jpg

View of trees on waterside slope. Fall 2019

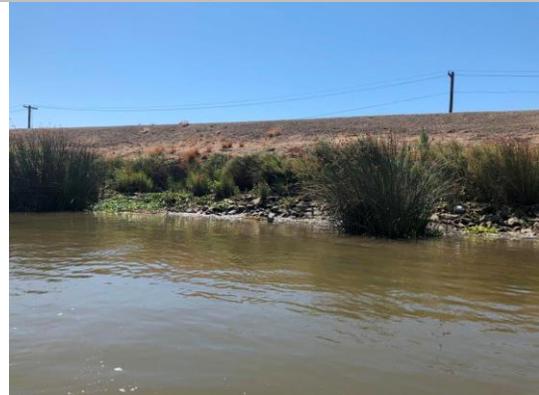
Photo 1 of 1 : SP_2020_RD0524_107_2_20200228_00005.jpg

LM Start	0.34	Rating **	M	Issue No.	2
LM End	0.34	Issue Type +	Ma	Location *	WS
Category	Supplemental			GPS Latitude/Longitude	
				Start	End
Item	DWR Erosion Survey			37.938461 °	37.938461 °
				-121.341526 °	-121.341526 °
DWR ID	RD0524U01RM40.93				
Comment Code					
Inspector Comment					
Site ID: RD0524U01RM40.93 08/13/2019: No significant change observed. 09/13/2017: There are two pocket erosions at the site; both erosions are around 10 ft long and 6 ft high.

Looking downstream of the erosion.

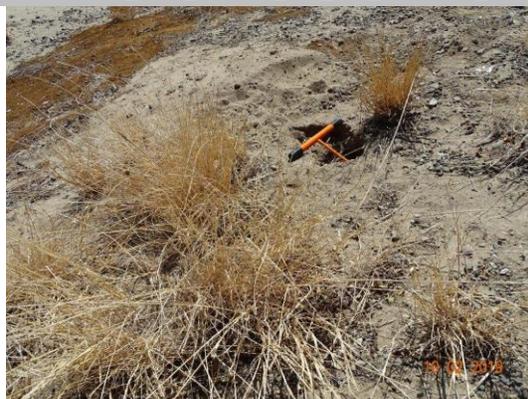
Photo 1 of 1 : SP_2020_RD0524_107_125_20200228_00113.jpg

View of large rodent hole on landside slope. Fall 2019

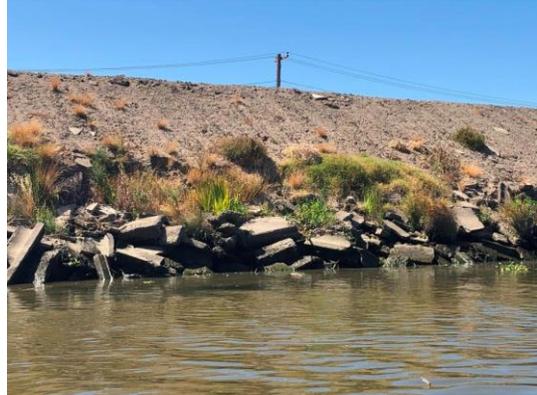
Photo 1 of 1 : SP_2020_RD0524_107_5_20200228_00008.jpg

LM Start	0.40	Rating **	U	Issue No.	5
LM End	0.40	Issue Type +	Ma	Location *	WS
Category	Supplemental			GPS Latitude/Longitude	
				Start	End
Item	DWR Erosion Survey			37.938870 °	37.938870 °
				-121.340460 °	-121.340460 °
DWR ID	RD0524U01RM40.99				
Comment Code					
Inspector Comment					
Site ID: RD0524U01RM40.99 08/13/2019: No significant change observed. 09/13/2017: No significant change observed. 07/25/2016: More vegetation observed at the site. 06/24/2015: No significant change observed. 06/19/2014: No significant change observed. 08/13/2013: No significant change at this site. 08/07/2012: The erosion is at the upper levee slope, and likely caused by slope slip. The lower levee slope is covered with dense vegetation.

Front view of the site.

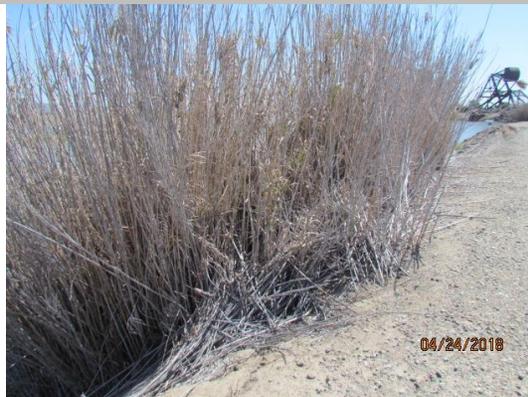
Photo 1 of 1 : SP_2020_RD0524_107_11_20200228_00011.jpg

Looking at bamboo on waterward slope. (Spring 2018)

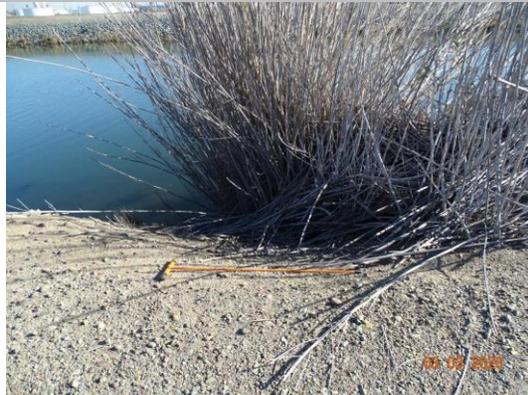
Photo 1 of 2 : SP_2020_RD0524_107_15_20200504_00345.jpg

LM Start	0.63	Rating **	U	Issue No.	15
LM End	0.63	Issue Type +	Ma	Location *	WS
Category	Supplemental		GPS Latitude/Longitude		
			Start	End	
Item	DWR Erosion Survey		37.938247 °	37.938247 °	
			-121.336503 °	-121.336503 °	
DWR ID	RD0524U01RM41.26				
Comment Code					
Inspector Comment					
Site ID: RD0524U01RM41.26 08/13/2019: No significant change observed. 09/13/2017: The erosion was discovered by levee inspection. The erosion site is immediately downstream of tall vegetation.

View of erosion on waterside slope. Spring 2020

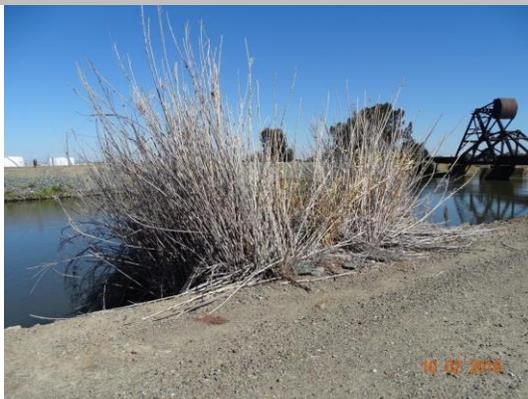
Photo 1 of 1 : SP_2020_RD0524_107_14_20200228_00013.jpg

View of bamboo on waterside slope. Fall 2019

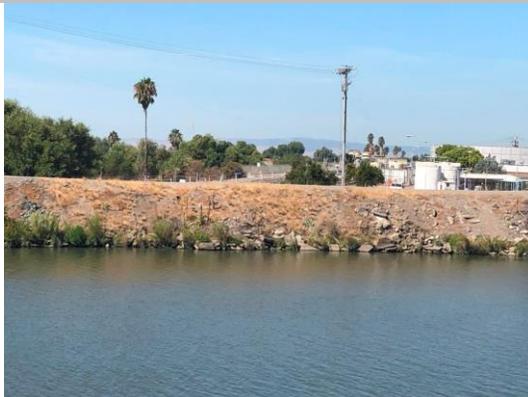
Photo 1 of 2 : SP_2020_RD0524_107_16_20200228_00018.jpg

Front view of the erosion.

Comment Code					
Inspector Comment					
Site ID: RD0524U01RM41.34 08/22/2019: No significant change observed. 09/13/2017: Pocket erosion above the protected levee toe.

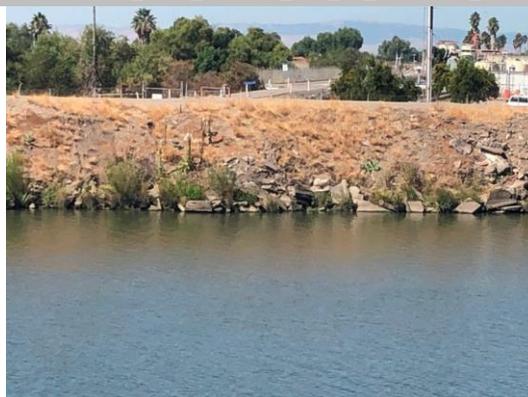
Photo 2 of 2 : SP_2020_RD0524_107_16_20200228_00019.jpg

Close-up view of the erosion.

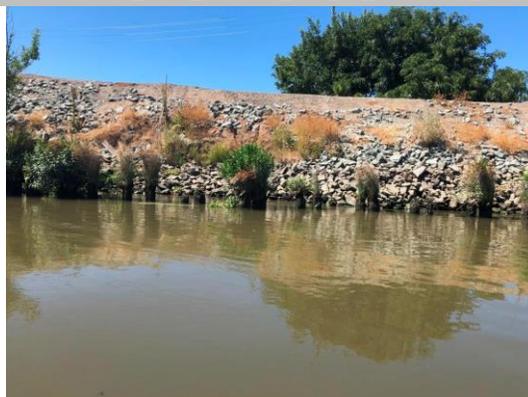
Photo 1 of 1 : SP_2020_RD0524_107_17_20200228_00020.jpg

Front view of the erosion.

Comment Code					
Inspector Comment					
Site ID: RD0524U01RM41.36 08/13/2019: No significant change observed. 09/13/2017: No significant change observed. 07/25/2016: No significant change observed. 06/24/2015: The erosion site is immediately downstream of the RR bridge.

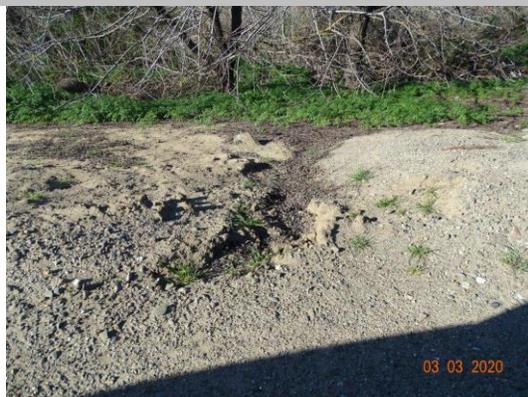
Photo 1 of 1 : SP_2020_RD0524_107_157_20200504_00349.jpg

View of erosion caused by surface runoff on landside slope. Spring 2020

Comment Code					
E2 : Schedule repair of erosion site prior to the next inspection.					
Inspector Comment					
Rills on landside slope appear to be caused by surface runoff.

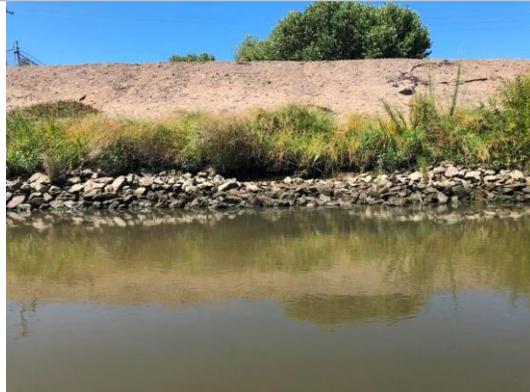
Photo 1 of 1 : SP_2020_RD0524_107_21_20200228_00025.jpg

LM Start	0.76	Rating **	U	Issue No.	21
LM End	0.77	Issue Type +	Ma	Location *	WS
Category	Supplemental			GPS Latitude/Longitude	
				Start	End
Item	DWR Erosion Survey			37.936821 °	37.936821 °
				-121.334582 °	-121.334582 °
DWR ID	RD0524U01RM41.39				
Comment Code					
Inspector Comment					
Site ID: RD0524U01RM41.39 08/13/2019: No significant change observed. 09/13/2017: No significant change observed. 07/25/2016: No significant change observed. 06/24/2015: No significant change observed. 06/19/2014: No significant change observed. 08/13/2013: No significant change at this site. 08/07/2012: The site has been visited by boat survey. No significant change observed. 08/23/2011: The site is located immediately upstream of a Railroad bridge. Dense vegetation at the water line blocks the view of erosion.

Front view of the erosion site.

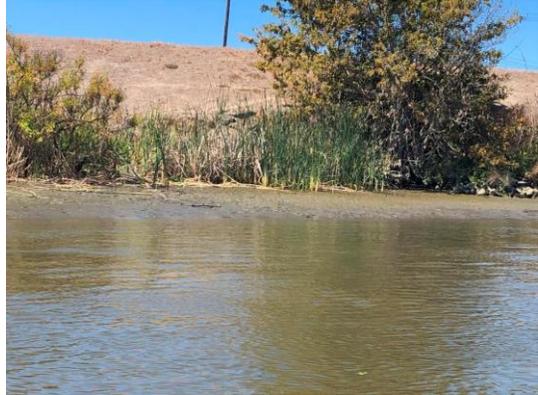
Photo 2 of 3 : SP_2020_RD0524_107_22_20200228_00029.jpg

Close-up view of the erosion site.

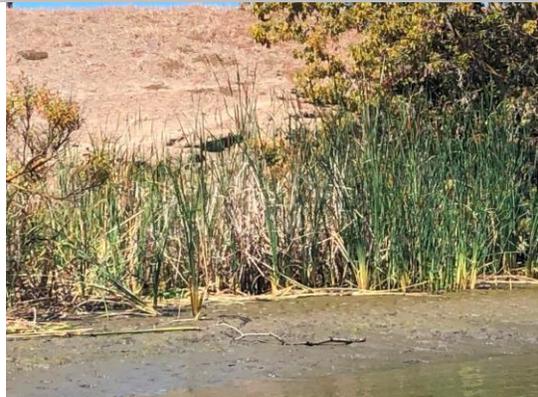
Photo 3 of 3 : SP_2020_RD0524_107_22_20200228_00030.jpg

Close-up view of the site.

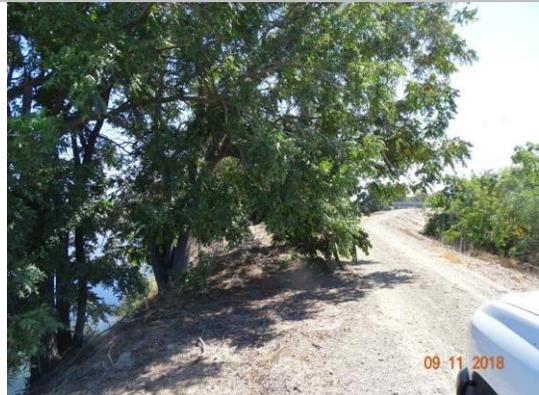
Photo 1 of 1 : SP_2020_RD0524_107_20_20200228_00024.jpg

Looking southeast at untrimmed tree on waterward slope.(Fall 2018)

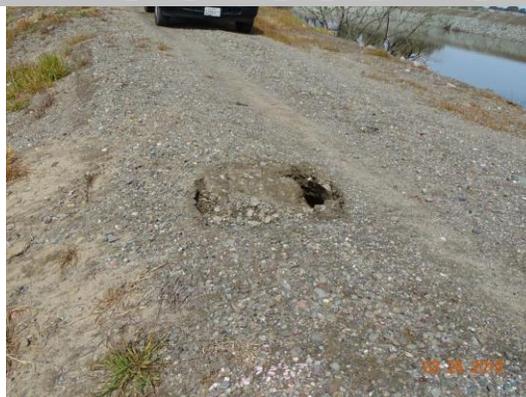
Photo 1 of 1 : SP_2020_RD0524_107_238_20200228_00216.jpg

Large rodent hole landside shoulder looking downstream. Spring 2019.

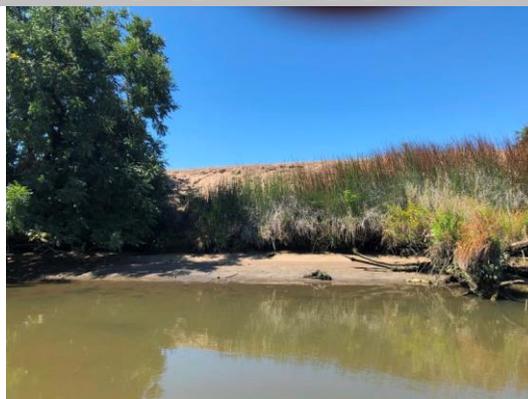
Photo 1 of 1 : SP_2020_RD0524_107_44_20200228_00046.jpg

Comment Code					
Inspector Comment					
Site ID: RD0524U01RM41.79 08/13/2019: No significant change observed. 09/13/2017: No significant change observed. 07/25/2016: No significant change observed. 06/24/2015: No significant change observed. 06/19/2014: No significant change observed. 08/13/2013: No significant change at this site. 08/07/2012: The site has been visited by boat survey. No significant change observed 08/23/2011: No significant change observed on site. 09/07/2010: No significant change observed on site. Vegetation is visible at the water line. There is an exposed pipe discharge partially hanging at the mid-slope, possibly still used for discharging irrigation/runoff water. There is minimal rip rap protection along the bank, and what's left of it is no longer adequately protecting the bank. 9/29/2009: Site consists of a 400-foot long eroding bank with minimal vegetation and protection; the existing rip rap has sloughed, rendering it useless; note that there is an exposed section of a pipe. 10/18/2006: There is extensive loss of rip rap on some sections; sewage disposal pond is on the landside of the levee; there is an exposed pipe outlet "hanging" from the upper slope.

Direct view of the site.

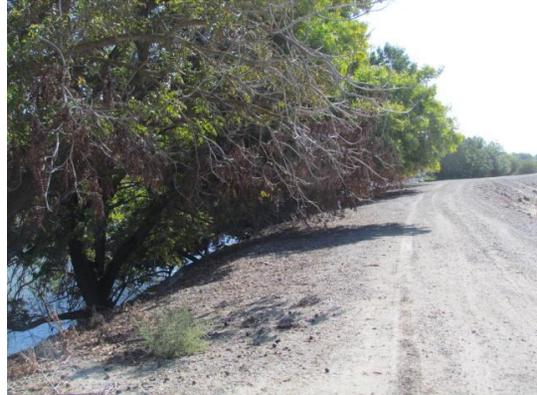
Photo 1 of 1 : SP_2020_RD0524_107_19_20200228_00023.jpg

Looking southeast at low hanging tree branches at waterside toe.

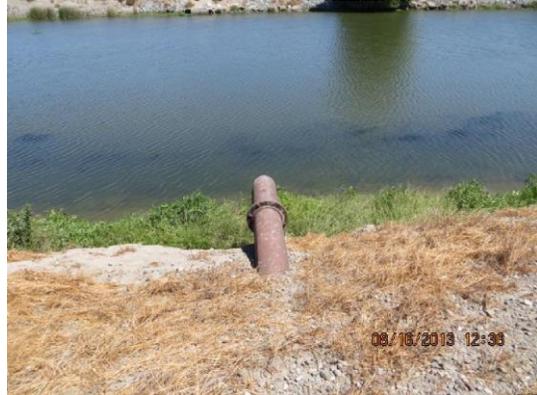
Photo 1 of 3 : UCIP_SP_2020_53162_29862.jpg

Comment Code					
Inspector Comment					
DS_ID:20602 FS_ID:53162 EP_NO: N/A Repair Type: Non-Urgent Crossing Status: Found UCIP Comments: 10/2/2018 Pipe appears abandoned, but both the pipe and levee appear in good condition; downgrading to Non-Urgent (D. Sanoski - DWR UCIP).11/16/2016 same as previous inspection both ends are open. This pipe does not appear in use. Need to contact owner to determine status of crossing. If the crossing is abandoned or in use, owner will need to coordinate with the CVFPB to comply with Title 23 requirements. (O. Magana - DWR UCIP)08/16/2013 Pipe appears to be open on both ends. Abandoned and should be done so properly. (W. Wylie - DWR UCIP) FIELD_STRUCT_DESC: *ABANDONED* 12-inch steel drainage pipe through the levee, 3.5 feet below the crown. Pipe is opened on the waterside (WS) and landside (LS) ends. The pump house referenced in O&M manual is missing from the LS (2013). [Additional Reference(s): DWR Levee Log, 2004. USACE San Joaquin O&M Manual 7, April 1964, (HLM 1.31)]. FS Date: 10/2/2018 1:10:16 PM

Pipe visible and open on WS slope.

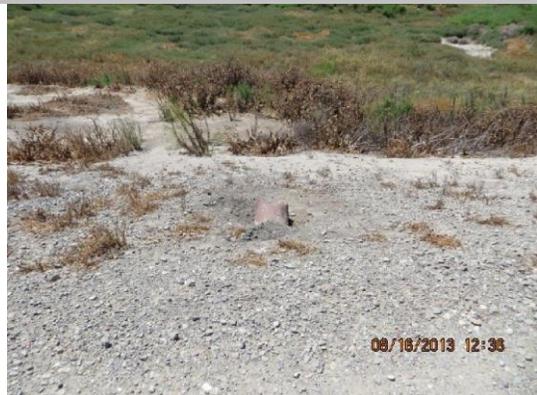
Photo 2 of 3 : UCIP_SP_2020_53162_29861.jpg

Pipe open and visible on LS slope.

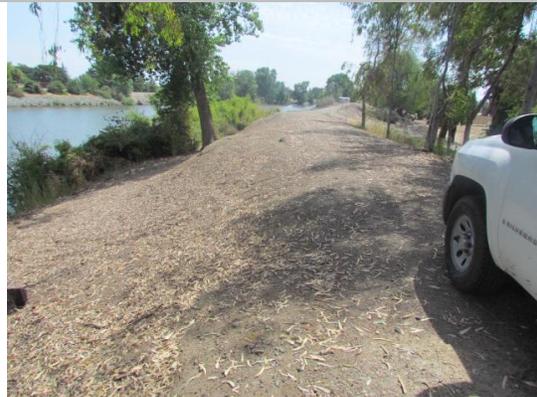
Photo 1 of 1 : SP_2020_RD0524_107_27_20200228_00034.jpg

Looking south at landward slope depression.

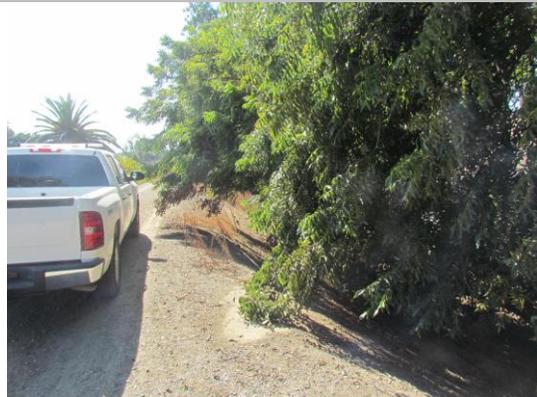
Photo 1 of 1 : SP_2020_RD0524_107_264_20200228_00231.jpg

Looking south at untrimmed trees on landward slope.

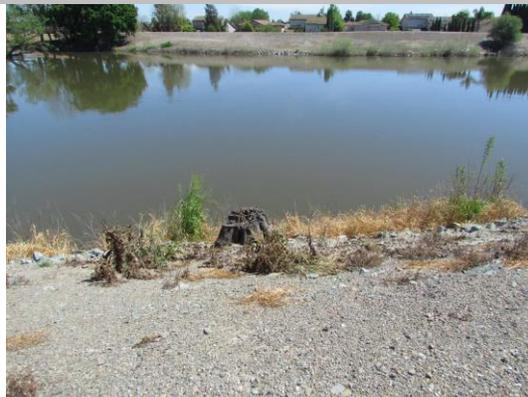
Photo 1 of 1 : SP_2020_RD0524_107_161_20200228_00139.jpg

Looking east at large tree stump on waterward shoulder.

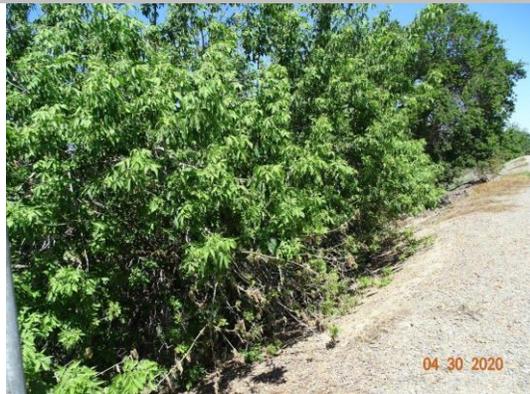
Photo 1 of 1 : SP_2020_RD0524_107_51_20200504_00386.jpg

View of trees that need to be trimmed and thinned on landside slope. Spring 2020

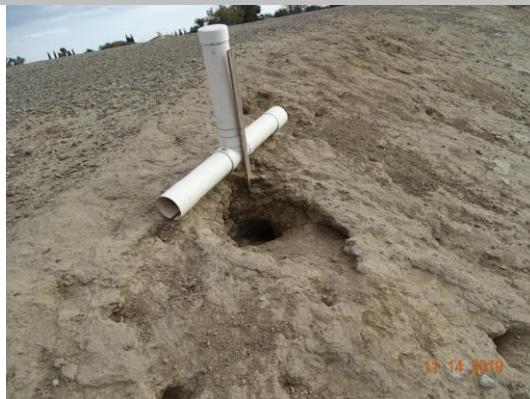
Photo 1 of 1 : SP_2020_RD0524_107_924_20200228_00238.jpg

LM Start	2.96	Rating **	U	Issue No.	924
LM End	3.04	Issue Type +	Ma	Location *	LS
Category	Earthen Levee		GPS Latitude/Longitude		
			Start	End	
Item	Animal Control		37.913023 °	37.911834 °	
			-121.324507 °	-121.324733 °	
DWR ID	DWR_RD0524_01_s_2012_924				
Comment Code					
A1 : Exterminate rodents and backfill and compact or grout burrows.					
Inspector Comment

View of large rodent holes on landside slope. Fall 2019

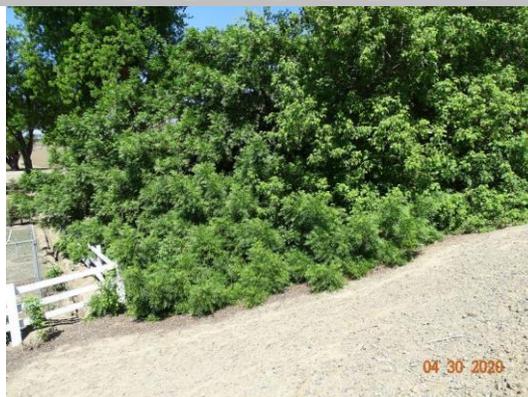
Photo 1 of 1 : SP_2020_RD0524_107_926_20200504_00381.jpg

View of trees that need to trimmed and thinned on landside slope. Spring 2020

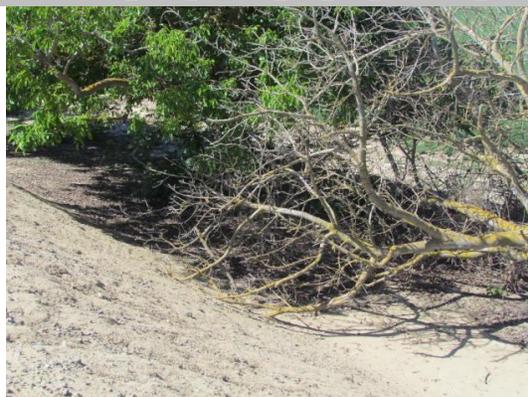
Photo 1 of 1 : SP_2020_RD0524_107_111_20200228_00107.jpg

Looking west at dead tree at landside toe.

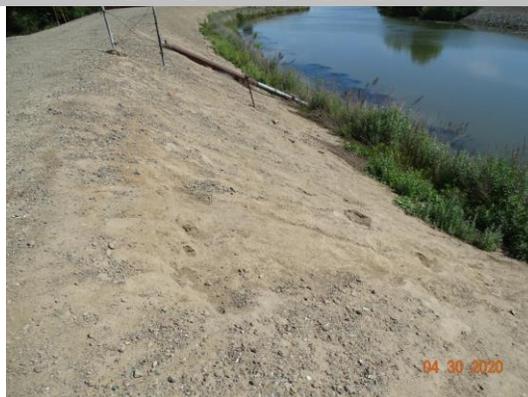
Photo 1 of 1 : SP_2020_RD0524_107_165_20200504_00371.jpg

View of multiple animal burrows on waterside slope. Spring 2020

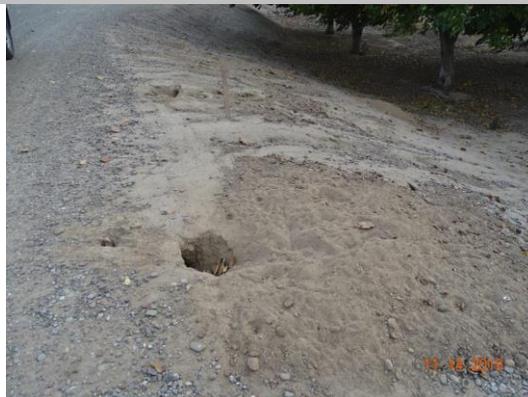
Photo 1 of 1 : SP_2020_RD0524_107_139_20200228_00116.jpg

View of large rodent holes on landside slope. Fall 2019

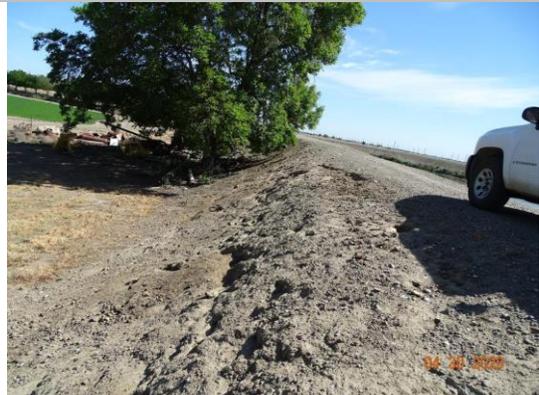
Photo 1 of 1 : SP_2020_RD0524_107_259_20200504_00369.jpg

View of multiple large animal burrows on the landside slope. Spring 2020

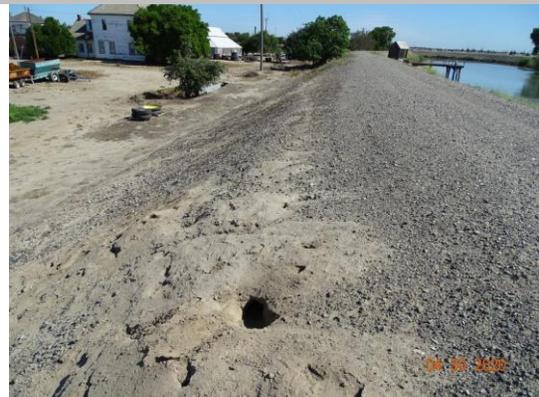
Photo 1 of 1 : SP_2020_RD0524_107_189_20200504_00366.jpg

View of multiple large animal burrows on the landside slope. Spring 2020

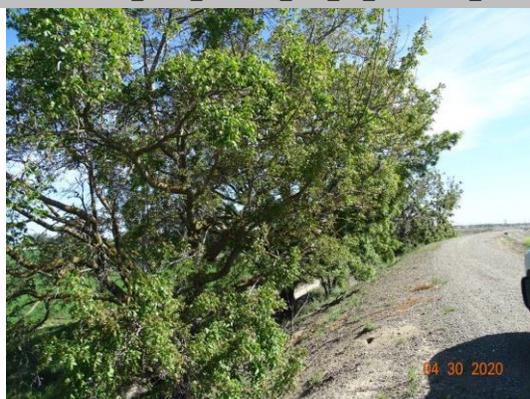
Photo 1 of 1 : SP_2020_RD0524_107_84_20200504_00363.jpg

View of trees that need to be trimmed on landside slope. Spring 2020

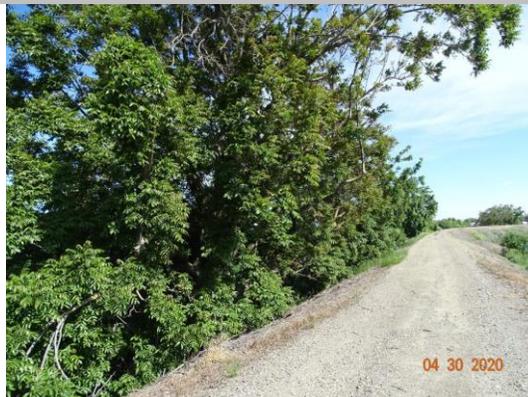
Photo 1 of 1 : SP_2020_RD0524_107_188_20200504_00362.jpg

View of trees that need to be trimmed and thinned on landside slope. Spring 2020

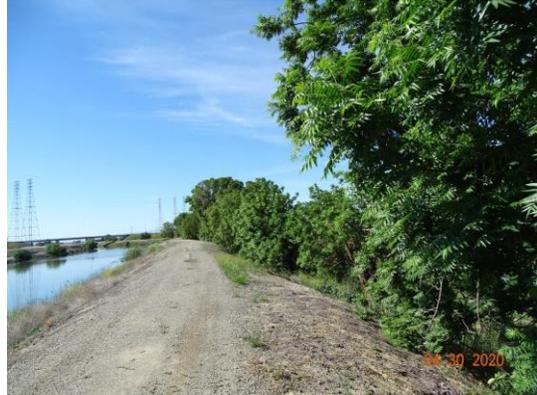
Photo 1 of 1 : SP_2020_RD0524_107_85_20200504_00360.jpg

View of trees that need to be trimmed and thinned on landside slope. Spring 2020

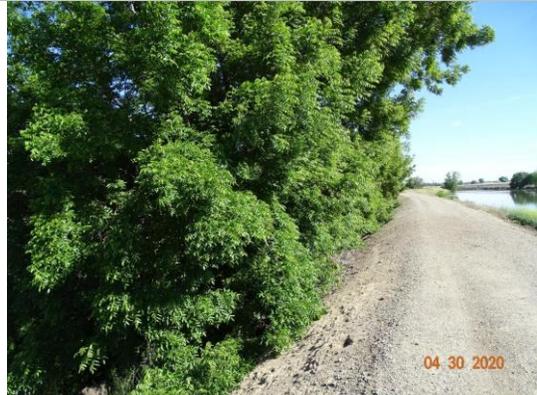
Photo 1 of 1 : SP_2020_RD0524_107_932_20200504_00359.jpg

View of trees that need to be trimmed and thinned on landside slope. Spring 2020

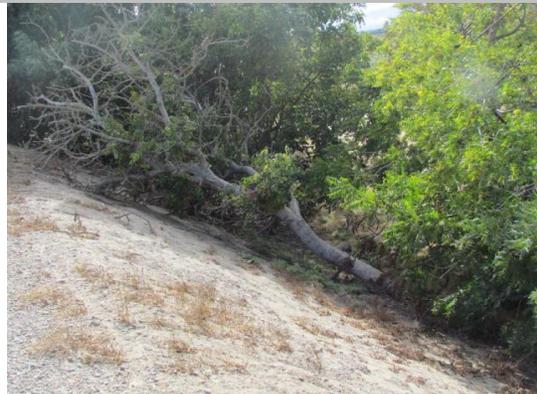
Photo 1 of 1 : SP_2020_RD0524_107_178_20200228_00143.jpg

Looking south at downed tree on landward slope.

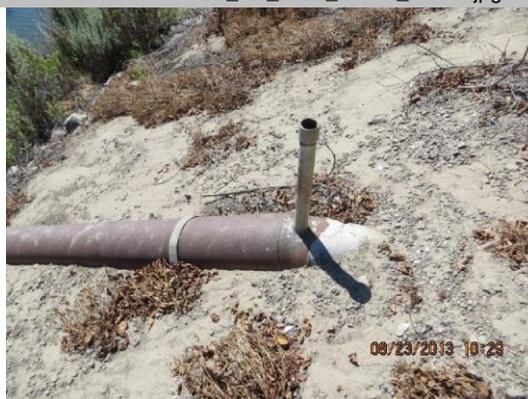
Photo 2 of 3 : UCIP_SP_2020_53358_30688.jpg

Vent on pipe on WS slope. Possible slurry standpipe that has not yet been used.

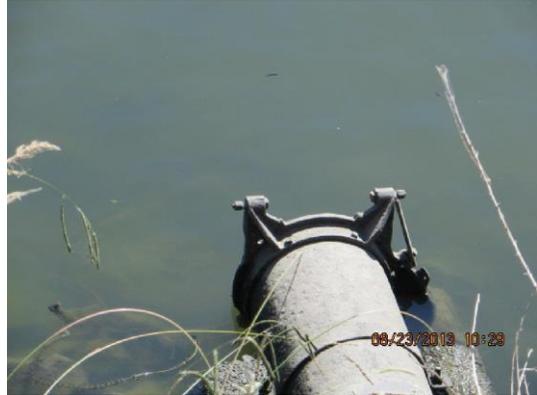
Photo 3 of 3 : UCIP_SP_2020_53358_30687.jpg

Broken flap gate at WS toe.

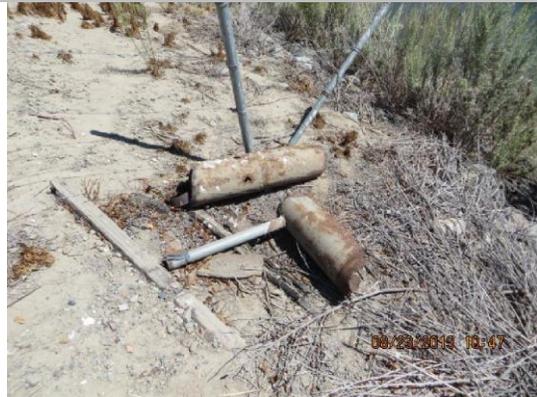
Photo 1 of 3 : UCIP_SP_2020_18348_30706.jpg

10-inch pipe debris on the WS slope.

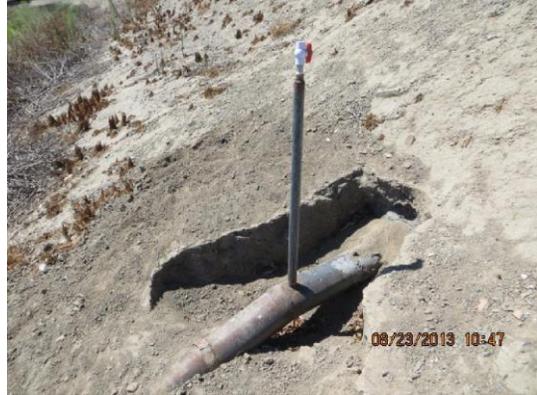
Photo 2 of 3 : UCIP_SP_2020_18348_30705.jpg

8-inch pipe sleeved through 10-inch pipe with vent on WS slope.

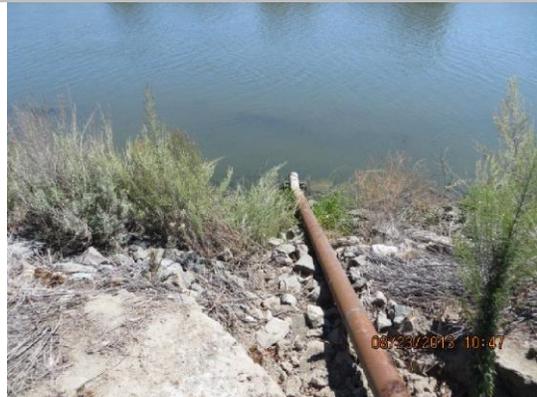
Photo 3 of 3 : UCIP_SP_2020_18348_30704.jpg

No flap gate on end of pipe at WS toe.

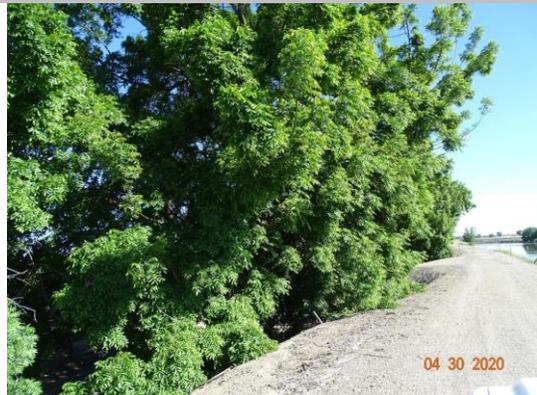
Photo 1 of 1 : SP_2020_RD0524_107_73_20200504_00357.jpg

View of trees that need to be trimmed and thinned on landside slope. Spring 2020

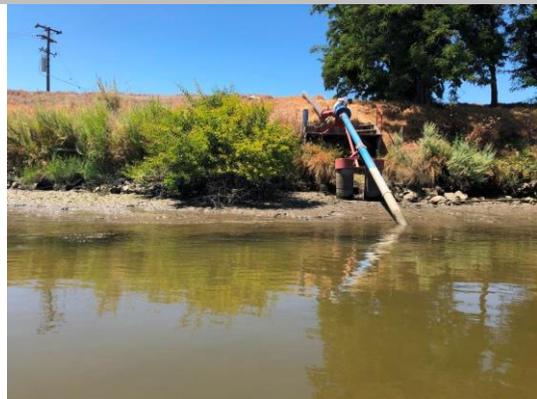
Photo 1 of 2 : SP_2020_RD0524_107_71_20200228_00081.jpg

Front view of the erosion.

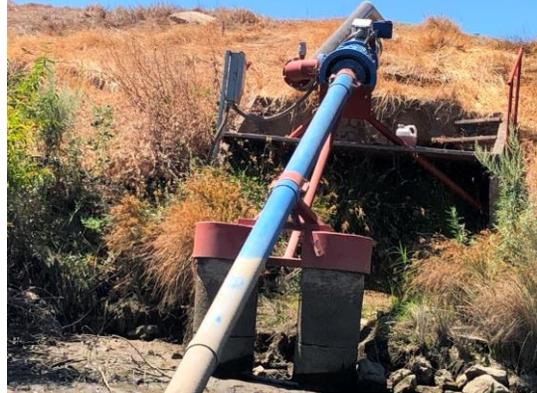
Photo 2 of 2 : SP_2020_RD0524_107_71_20200228_00082.jpg

Close-up view of the site.

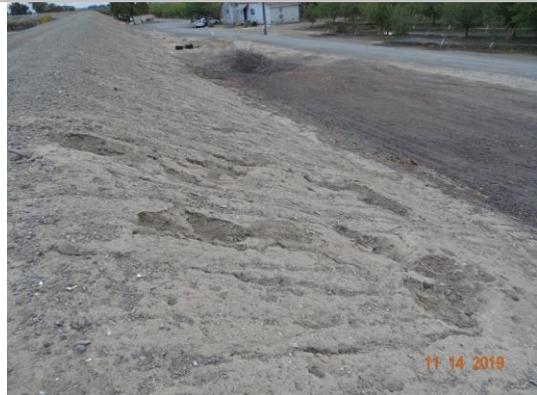
Photo 1 of 1 : SP_2020_RD0524_107_141_20200228_00117.jpg

View of multiple rodent holes on landside slope. Fall 2019

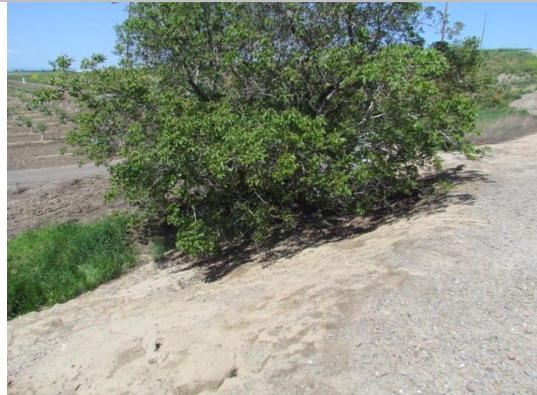
Photo 1 of 1 : SP_2020_RD0524_107_117_20200228_00109.jpg

Looking northwest at untrimmed tree on landward slope.

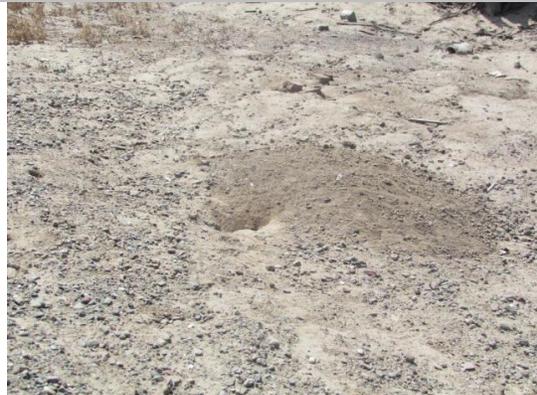
Photo 1 of 1 : SP_2020_RD0524_107_197_20200228_00161.jpg

Looking north at typical view of rodent holes on landward slope.

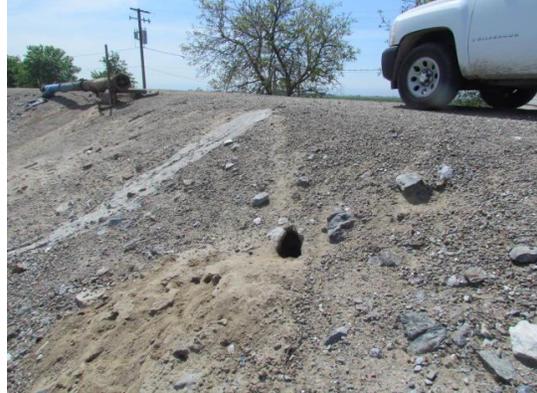
Photo 1 of 1 : SP_2020_RD0524_107_75_20200228_00085.jpg

View of rodent holes on waterside slope.

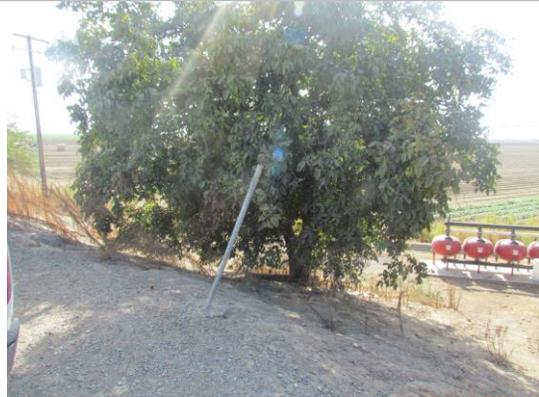
Photo 1 of 1 : SP_2020_RD0524_107_98_20200228_00101.jpg

Looking west at walnut tree on landward slope.

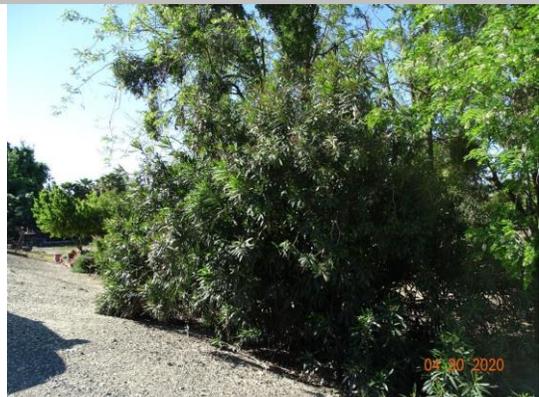
Photo 1 of 1 : SP_2020_RD0524_107_200_20200504_00354.jpg

View of oleander on landside slope. Spring 2020

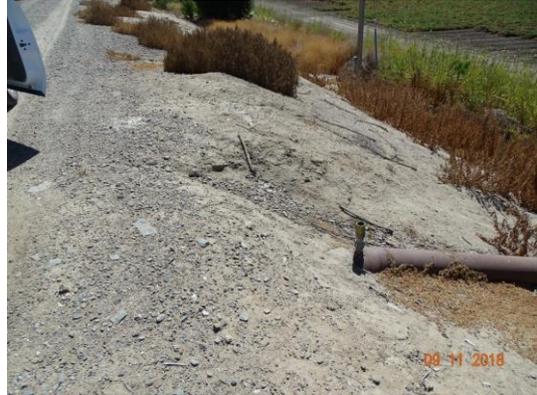
Photo 1 of 1 : SP_2020_RD0524_107_147_20200228_00121.jpg

Looking at landward erosion. (Fall 2018)

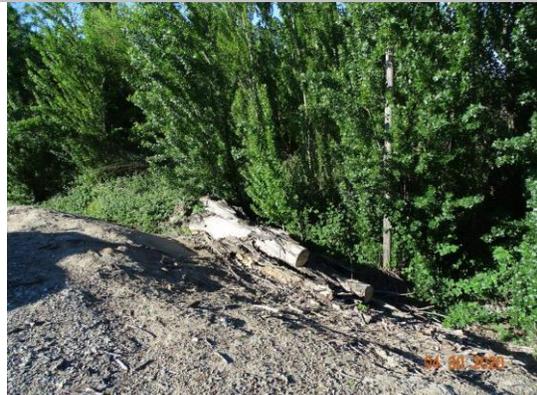
Photo 1 of 1 : SP_2020_RD0524_107_81_20200504_00352.jpg

View of tree branches on landside slope. Spring 2020

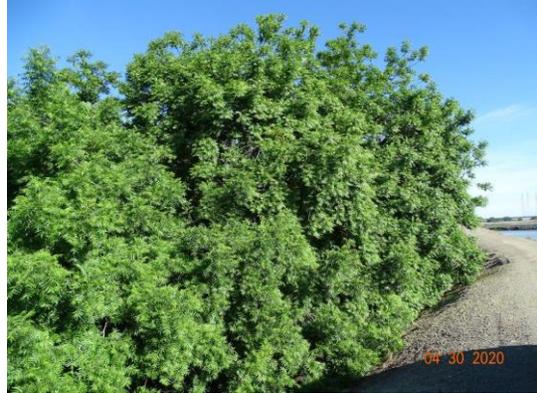
Photo 1 of 1 : SP_2020_RD0524_107_103_20200504_00351.jpg

View of trees on waterside slope that need to be trimmed and thinned. Spring 2020

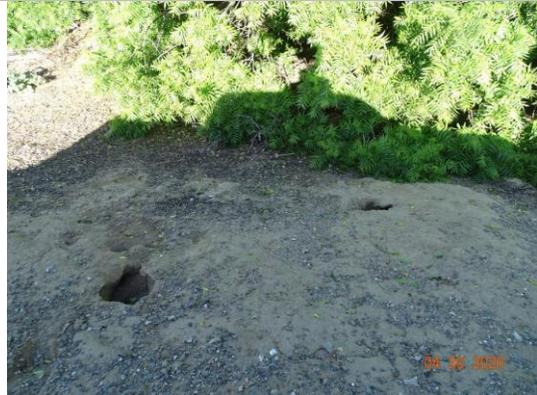
Photo 1 of 1 : SP_2020_RD0524_107_104_20200504_00350.jpg

View of large animal burrow on landside slope. Spring 2020
