**Flood Control Project Maintenance
Levee Inspections**

Fall 2019 Levee Maintenance Deficiency Summary Report

Reclamation District No. 0536 Egbert

Waterway	Bank	Unit Miles
Unit No. 01 Lindsey Slough	Right	5.58

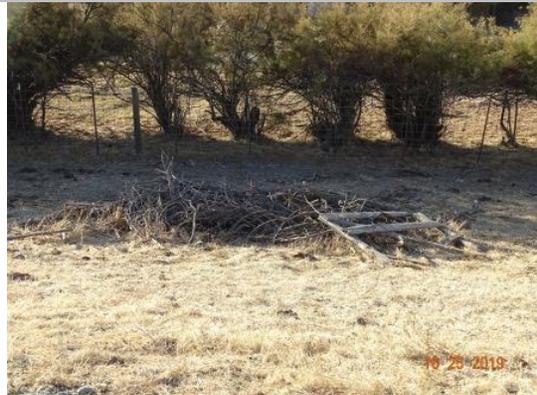
Photo 1 of 1 : FA_2019_RD0536_208_20_20191028_00061.jpg

View looking downslope at pile of tree limbs on the landside slope (Fall 2019).

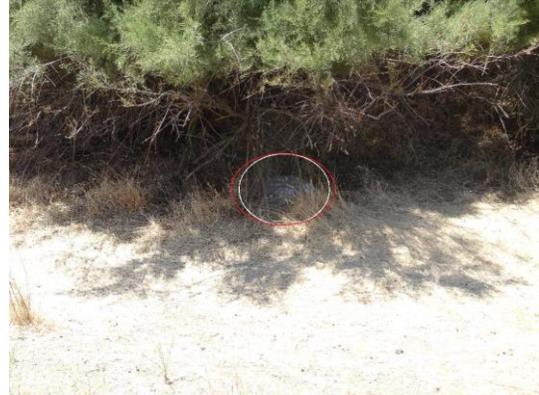
Photo 3 of 3 : UCIP_FA_2019_49313_34772.jpg

Comment Code					
Inspector Comment					
<p>DS_ID:22713 FS_ID:49313 EP_NO: 10114 Repair Type: No Action Needed Crossing Status: Found UCIP Comments: 06/01/2016 Debris cleared and flapgate is no longer blocked. 08/13/2013 Outlet was blocked by concrete debris and dirt. Needs cleaning of debris. FIELD_STRUCT_DESC: 24-inch corrugated metal gravity drainage pipe through the levee, 10.5 feet below the crown. Flap gate on the waterside (WS) end. Headwall on each end, not found in 2013 or 2016. No. 100 gate on the WS. Concrete debris on the WS slope. This crossing is also used for irrigation. 1-inch polyvinyl chloride (PVC) pipe sleeved through the 24-inch pipe, visible through the landside (LS) end. According to David Hearn, Reclamation District No. 536 (RD0536) president, the PVC pipe does not connect all the way through. Present landowner, as of 2016, is Solano Land Trust, and the pipe runs through the Jepson Prairie Reserve, managed by the University of California, Davis, (UC Davis). (Retention of a 24-inch drainage pipe through the levee, 10.5 feet below the crown, and a flap gate on the WS end authorized under Automatic Board Order (ABO) issued as Permit No. 10114, 1974 - H. E. Peterson). [Additional Reference(s): DWR Levee Log, 1992. USACE Sacramento O&M Manual 106, May 1953, (Station 274+00 "'A"'), invert elevation 15.8 feet]. FS Date: 6/1/2016</p>

LS view: open CM pipe end on levee slope.

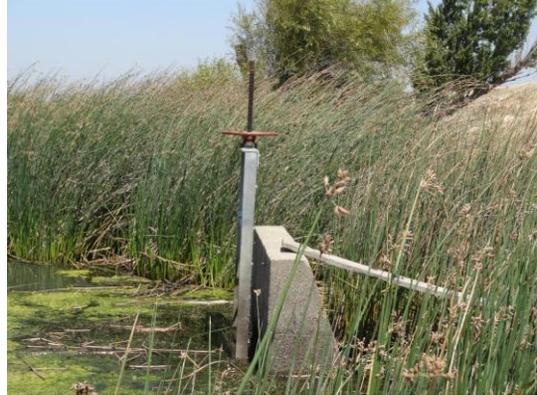
Photo 1 of 2 : UCIP_FA_2019_20444_34493.jpg

Comment Code					
Inspector Comment					
DS_ID:22715 FS_ID:20444 EP_NO: 10115 Repair Type: No Action Needed Crossing Status: Found UCIP Comments: Pipe was submerged into water and not visible. Steel bar fence on both sides of the levee. FIELD_STRUCT_DESC: 42-inch corrugated metal gravity drainage pipe through the levee, 22.5 feet below the crown. Concrete headwall on each end. Screw gate on the waterside (WS) end. (Retention of a 42-inch drainage pipe through the levee, 22.5 feet below the crown, and a slide gate on the WS end authorized under Automatic Board Order (ABO) issued as Permit No. 10115, 1974 - Petersen Estate Company, care of R. Moss). [Additional Reference(s): DWR Levee Log, 1992. USACE Sacramento O&M Manual 106, May 1953, (Station 238+36 ""A""), invert elevation 1.5 feet]. FS Date: 8/13/2013

WS view: slide gate, concrete headwall in the channel. Pipe submerged into water.

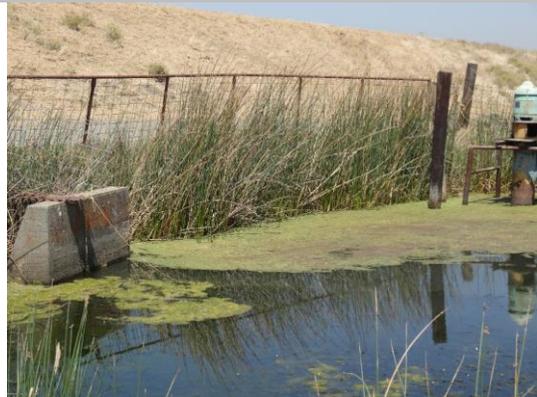
Photo 2 of 2 : UCIP_FA_2019_20444_34492.jpg

LS view: concrete headwall in the channel/irrigation ditch. Pipe submerged into water.

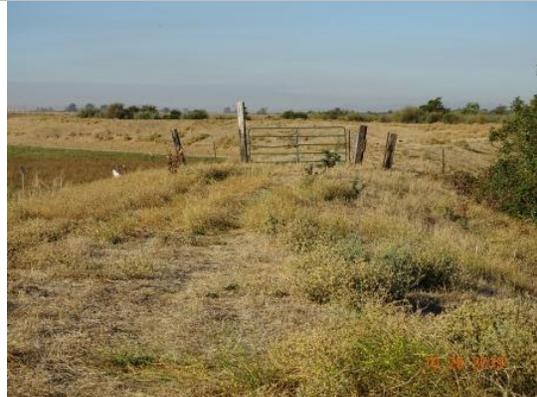
Photo 1 of 1 : FA_2019_RD0536_208_31_20191028_00063.jpg

View looking upstream at vegetation on the crown (Fall 2019).

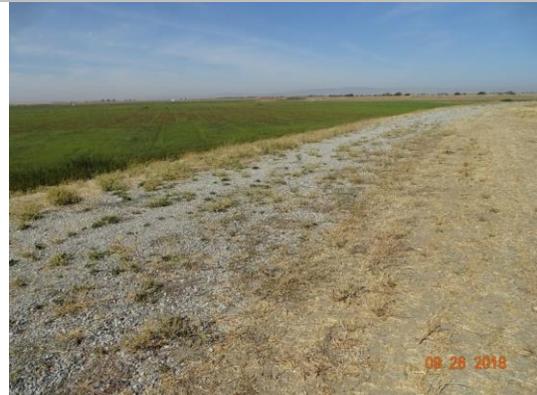
Photo 1 of 2 : FA_2019_RD0536_208_56_20190826_00026.jpg

LM Start	2.69	Rating **	A/W	Issue No.	56
LM End	2.71	Issue Type +	Ma	Location *	CR
Category	Earthen Levee		GPS Latitude/Longitude		
			Start	End	
Item	Crown Surface / Depressions / Rutting		38.255197°	38.254973°	
			-121.737932°	-121.737577°	
DWR ID	DWR_RD0536_01_f_2014_56				
Comment Code					
C2 : Repair depressions or ruts in the crown or slope.					
Inspector Comment					
Possible subsidence in this area has been repaired. Grade was restored and base rock was added to crown. Area looks good on 3/29/18. Should continue to monitor this site for possible future subsidence. 9/26/2018: Very minor subsidence present. Should be monitored.

View looking upstream at minor subsidence. (September 2018).

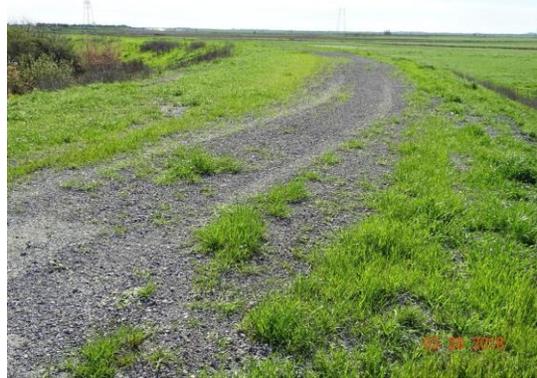
Photo 2 of 2 : FA_2019_RD0536_208_56_20190826_00027.jpg

3/29/2018: view of crown rutting and possible subsidence that has been repaired.

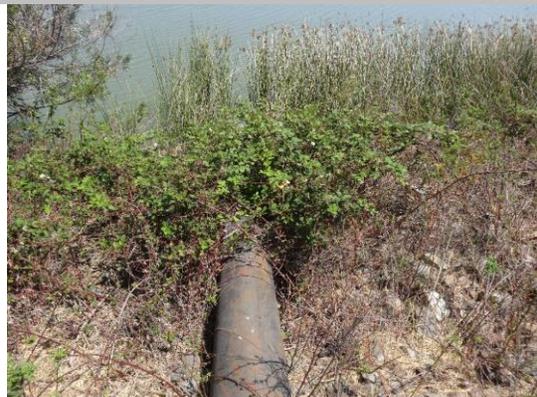
Photo 1 of 3 : UCIP_FA_2019_49314_34789.jpg

Comment Code					
Inspector Comment					
DS_ID:24023 FS_ID:49314 EP_NO: N/A Repair Type: Non-Urgent Crossing Status: Found UCIP Comments: 06/01/2016 Could not see flapggate in water. Pipes still in use. No cover over pressure relief valve on WS slope.08/13/2013:- Field discovered pipe.- Needs more information from the LMA/ DWR Inspector. - Dense vegetation on WS.- Pump feeds both pipes. FIELD_STRUCT_DESC: 2 of 2: 18-inch steel drainage discharge pipe through the levee, approximately 4 feet below the crown. Pump, called the Buddha Pump, in a pump house on the landside (LS) at the drainage ditch. Pressure breaker on the waterside (WS) slope. Pump and pipes are used by Reclamation District No. 536 (RD0536), per district president David Hearn, but could not identify permit information. Landowner is Dan Hearn per Solano County Assessor's Office (Parcel No. 0042-180-220). FS Date: 6/1/2016

WS view: exposed 18" steel pipe on levee slope.

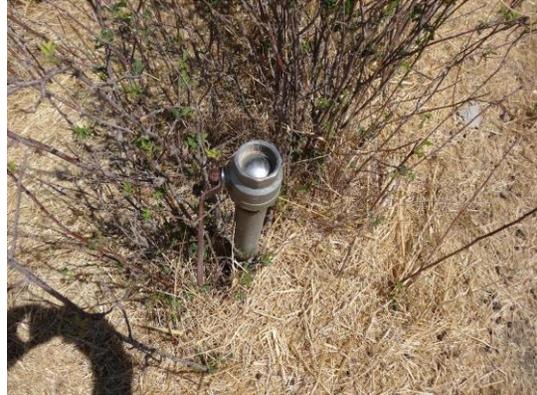
Photo 2 of 3 : UCIP_FA_2019_49314_34788.jpg

WS view: pressure breaker/valve on levee slope.

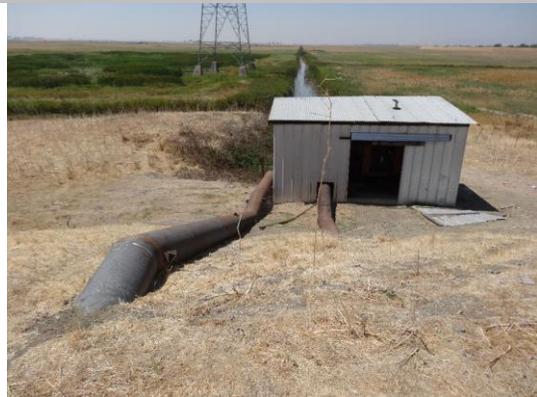
Photo 3 of 3 : UCIP_FA_2019_49314_34787.jpg

WS view: exposed 18" steel pipe (left) and 16" steel pipe (right) on levee slope. Pump house on bank of drainage ditch.

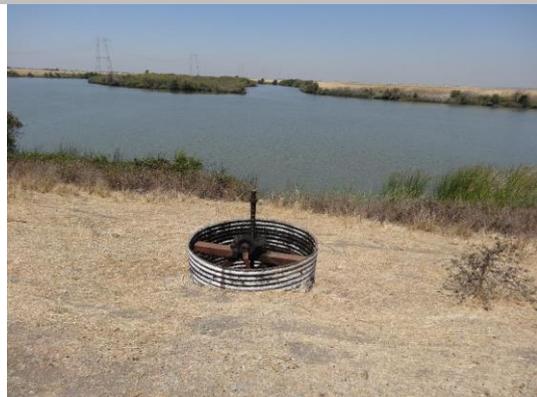
Photo 1 of 3 : UCIP_FA_2019_20503_34568.jpg

Comment Code					
Inspector Comment					
DS_ID:22718 FS_ID:20503 EP_NO: 10116 Repair Type: No Action Needed Crossing Status: Found UCIP Comments: Vortex seen on WS. Water flow seen on LS.Saddle, apron, and headwall not visible. Inlet and outlet pipe-ends are submerged into water. FIELD_STRUCT_DESC: 54-inch corrugated metal gravity drainage pipe through the levee, 30 feet below the crown. Screw gate in a pipe riser on the waterside (WS) slope. Saddle, apron, headwall, two corrugated metal cutoff walls, one No. 101 gate, and one No. 102 gate. (Retention of a 54-inch drainage pipe through the levee, 30 feet below the crown, and a slide gate on the WS slope authorized under Automatic Board Order (ABO) 10116, 1974 - Marion Sanchez Farms). [Additional Reference(s): DWR Levee Log, 1992. USACE Sacramento O&M Manual 106, May 1953, (Station 87+70 ""R""), invert elevation -2 feet]. FS Date: 8/13/2013

WS view: CMP riser with slide gate on levee slope. Water channel on background.

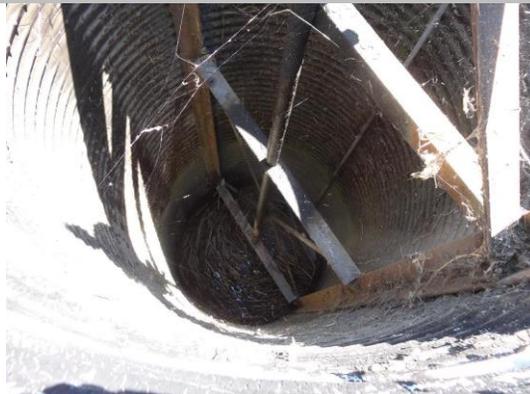
Photo 2 of 3 : UCIP_FA_2019_20503_34567.jpg

WS view: closer view of slide gate in CMP riser on levee slope.

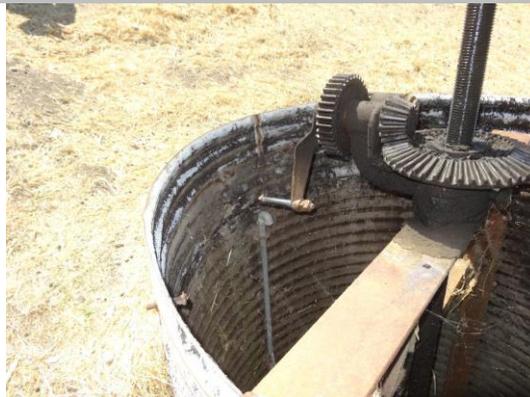
Photo 3 of 3 : UCIP_FA_2019_20503_34566.jpg

WS view: closer view of slide gate in CMP riser on levee slope. Air vent attached to the wall of CMP (left).

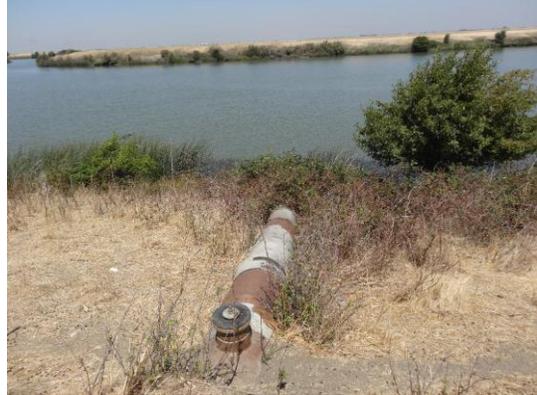
Photo 1 of 3 : UCIP_FA_2019_49317_34579.jpg

DS_ID:22719
 FS_ID:49317
 EP_NO: 2131
 Repair Type: Non-Urgent
 Crossing Status: Found
 UCIP Comments: 06/01/2016 New pump recently installed. Flapgate not visible though not required under condition of Permit No. 2131. No positive closure device found, which, if missing, is a violation of Condition 8 of Permit No. 2131. Need a name change permit for new owner RD0536. Siphon breaker missing cover.08/13/2013 Pump is missing at the time of inspection. May be taken out for repair.Flap gate on waterward end not found/visible as pipe was submerged into water.Pipe itself is a walkway with steel handrail.
 FIELD_STRUCT_DESC: 20-inch drainage discharge pipe of an unknown material through the levee, 1.5 feet below the crown. Pump, which was replaced recently, is on a steel platform in the drainage ditch on the landside (LS) toe. Siphon breaker on the waterside (WS) slope. Pipe is exposed on both slopes, but only found on the WS in 2016. Walkway over the pipe on the LS leads to the pump platform. Pipe and pump are now used by Reclamation District No. 536 [RD0536], per district president David Hearn. (Plans for construction of a 20-horsepower drainage pump installation and a 20-inch discharge pipe through the levee authorized under Permit No. 2131, 1955 - California Packing Corporation). [Additional Reference(s): DWR Levee Log, 1992]. FS Date: 6/1/2016

WS view: exposed steel pipe with siphon breaker on levee slope.

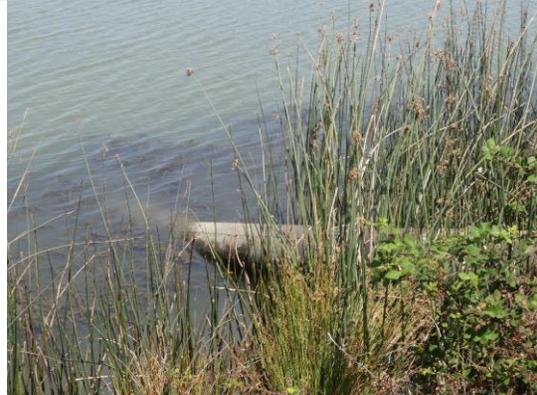
Photo 2 of 3 : UCIP_FA_2019_49317_34578.jpg

WS view: steel pipe submerged into water in the stream.

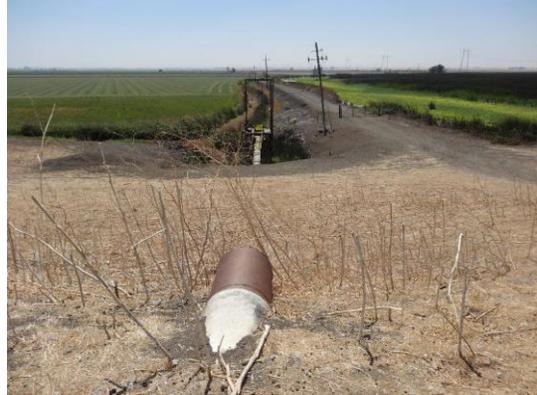
Photo 3 of 3 : UCIP_FA_2019_49317_34577.jpg

LS view: exposed steel pipe on levee slope and pump deck in drainage ditch.

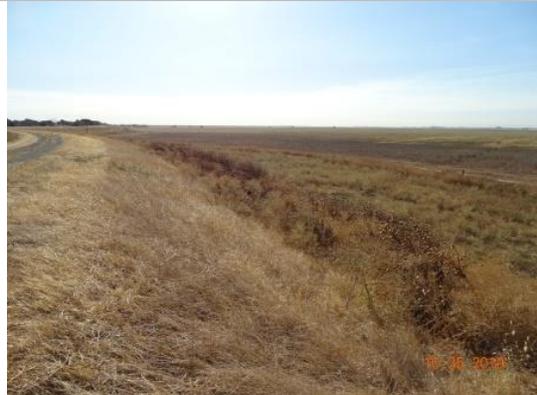
Photo 1 of 1 : FA_2019_RD0536_208_45_20191028_00064.jpg

View looking downstream at vegetation on the landside slope (Fall 2019).

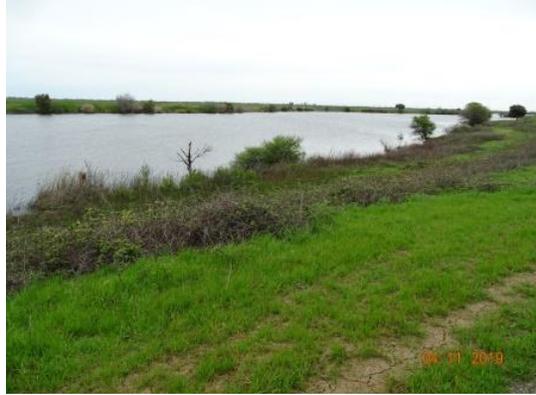
Photo 1 of 1 : FA_2019_RD0536_208_41_20190826_00023.jpg

View looking downstream at blackberries on the waterside slope (Spring 2019).

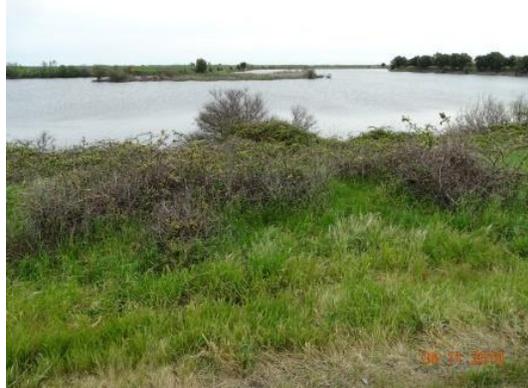
Photo 1 of 1 : FA_2019_RD0536_208_42_20190826_00024.jpg

View looking downslope at blackberries on the waterside slope (Spring 2019).

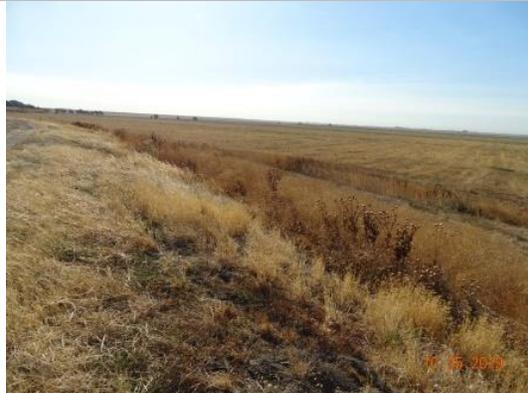
Photo 1 of 1 : FA_2019_RD0536_208_49_20191028_00065.jpg

View looking downstream at vegetation on the landside slope (Fall 2019).

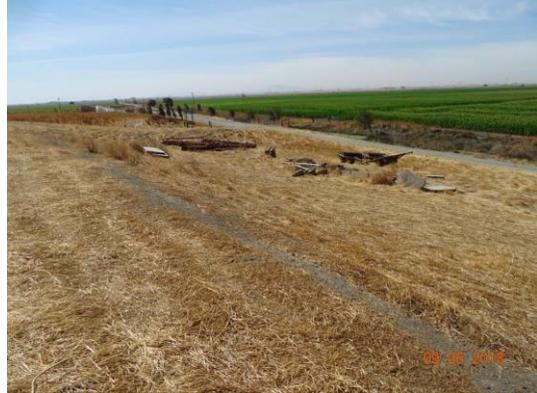
Photo 1 of 1 : FA_2019_RD0536_208_23_20190826_00012.jpg

View looking down slope of farm equipment on the landside slope (September 2018).

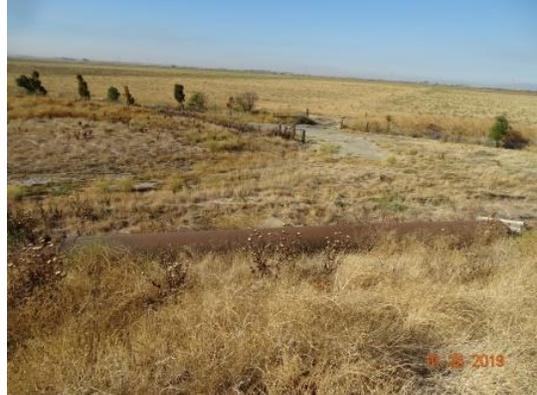
Photo 1 of 1 : FA_2019_RD0536_208_52_20191028_00067.jpg

View of large discarded pipe at the landside toe (Fall 2019).

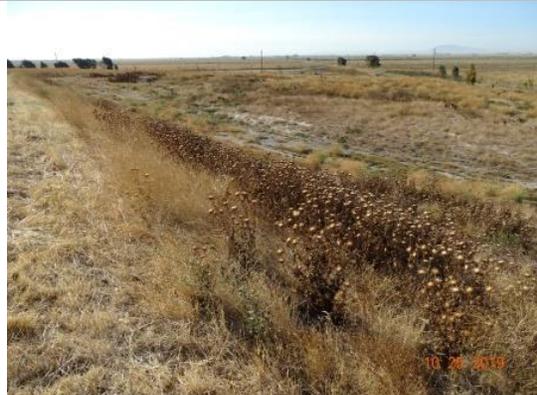
Photo 1 of 1 : FA_2019_RD0536_208_51_20191028_00066.jpg

View looking downstream at vegetation on the landside slope (Fall 2019).

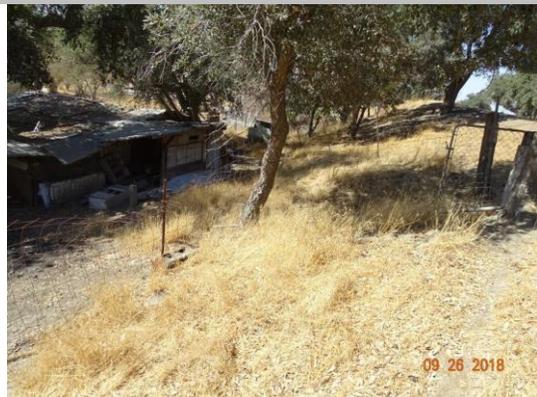
Photo 1 of 2 : FA_2019_RD0536_208_25_20190826_00014.jpg

View of fence on the landside slope (September 2018).

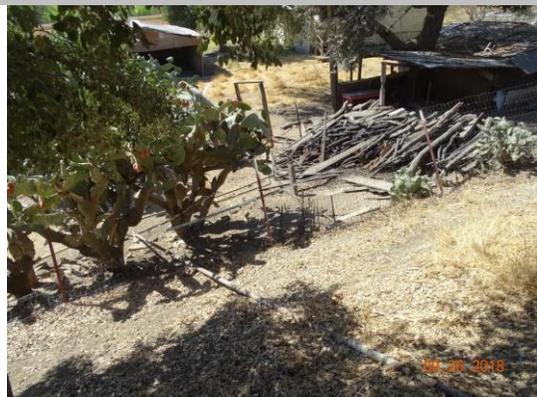
Photo 2 of 2 : FA_2019_RD0536_208_25_20190826_00015.jpg

Cactus, fence, and wood piles at the landside toe (September 2018).

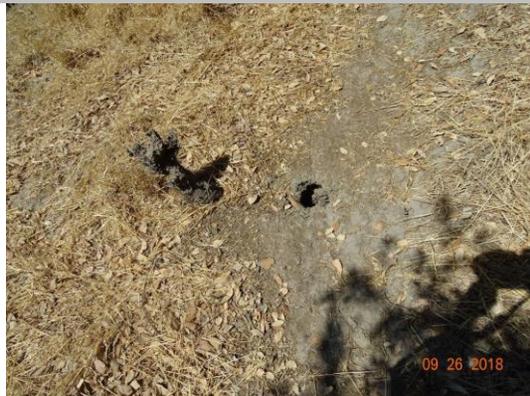
Photo 1 of 1 : FA_2019_RD0536_208_26_20190826_00016.jpg

View of squirrel hole on the landside slope (September 2018).

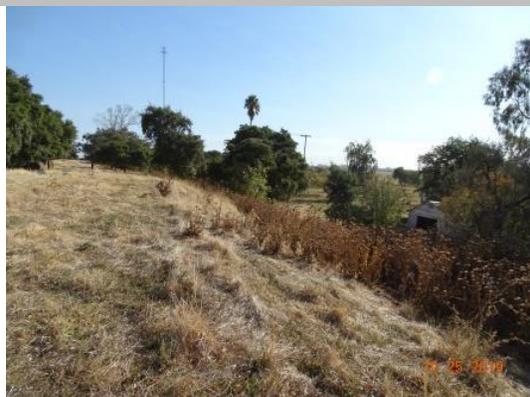
Photo 1 of 1 : FA_2019_RD0536_208_54_20191028_00068.jpg

View looking downstream at vegetation on the landside slope (Fall 2019).

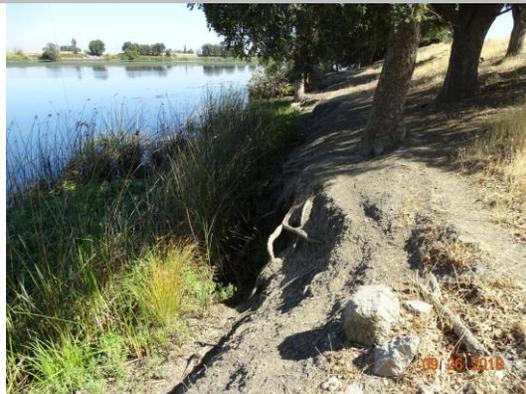
Photo 1 of 1 : FA_2019_RD0536_208_16_20190826_00006.jpg

Deeper erosion at the toe with roots exposed (September 2018).

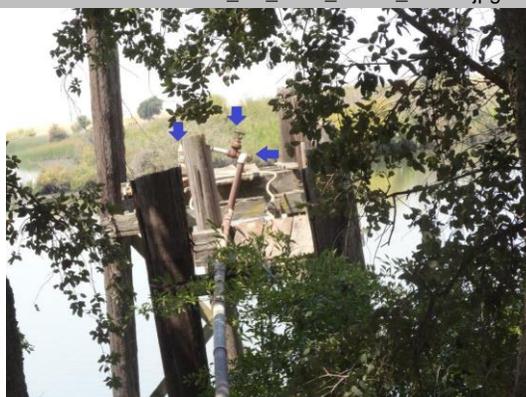
Photo 1 of 3 : UCIP_FA_2019_49318_34605.jpg

WS view: pump, pipe, gate valve, and wooden piling structure in the stream.

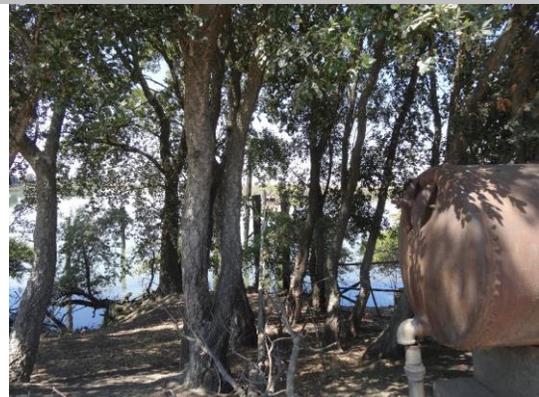
Photo 3 of 3 : UCIP_FA_2019_49318_34603.jpg

WS view: concrete cradle and abandoned steel tank on levee shoulder.

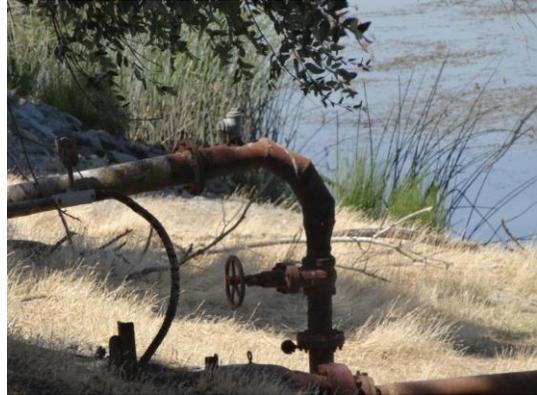
Photo 1 of 2 : UCIP_FA_2019_20543_34623.jpg

WS view: abandoned pipe, pump, conduit, and gate valve on levee slope.

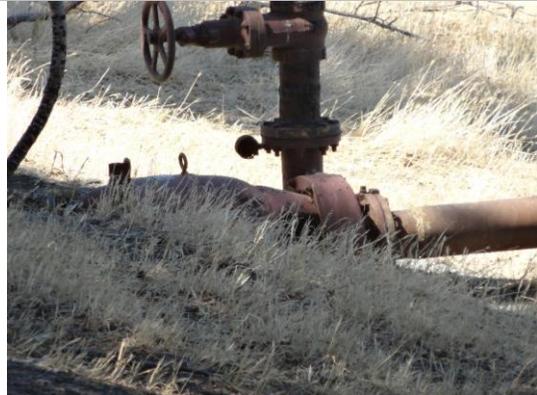
Photo 2 of 2 : UCIP_FA_2019_20543_34622.jpg

WS view: closer view of abandoned pipe, pump, and gate valve on levee slope.

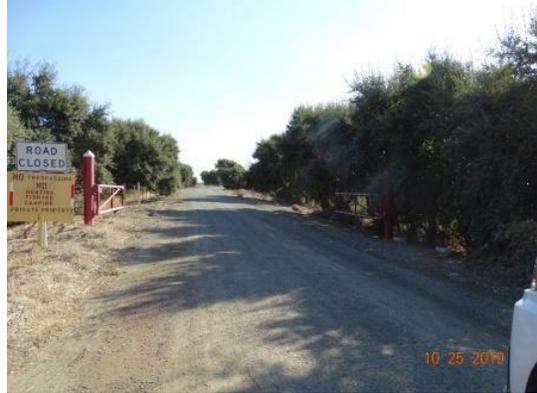
Photo 1 of 1 : FA_2019_RD0536_208_11_20191028_00069.jpg

View looking downstream at gate (Fall 2019).

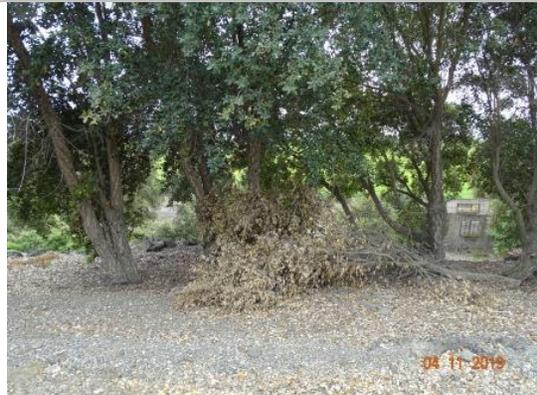
Photo 1 of 1 : FA_2019_RD0536_208_28_20190826_00018.jpg

View of tree limbs on the landside shoulder (Spring 2019).

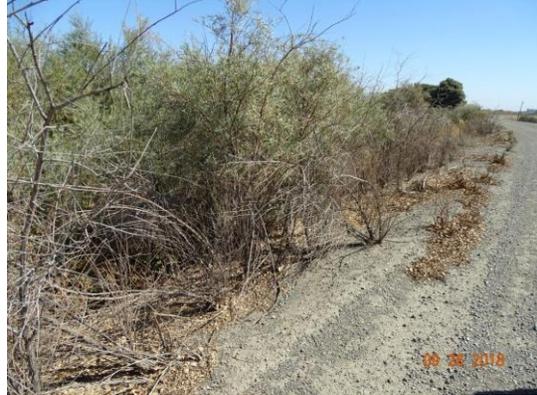
Photo 1 of 1 : FA_2019_RD0536_208_27_20190826_00017.jpg

View of vegetation on the waterside up to the crown that is blocking visibility (September 2018).

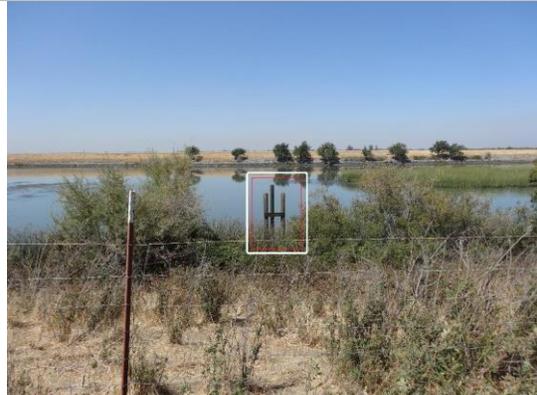
Photo 1 of 3 : UCIP_FA_2019_20563_34646.jpg

WS view: wooden & steel piles on the slough. Probably the supports are for pipe and flap gate. Not accessible due to fence.

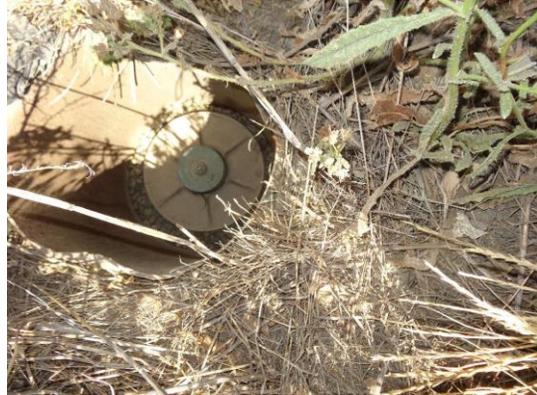
Photo 2 of 3 : UCIP_FA_2019_20563_34645.jpg

WS view: uncovered siphon breaker on levee shoulder. It needs protection.

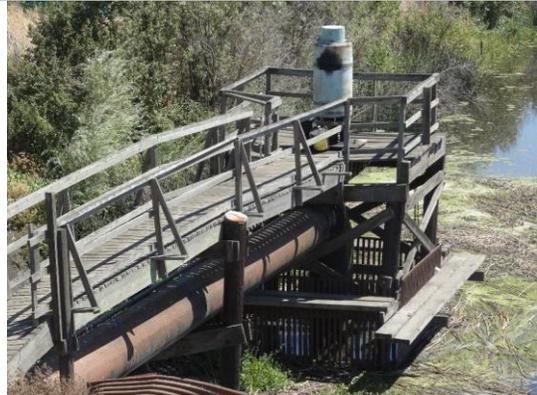
Photo 3 of 3 : UCIP_FA_2019_20563_34644.jpg

LS view: pipe under the wooden walkway and pump on wooden platform in drain ditch.

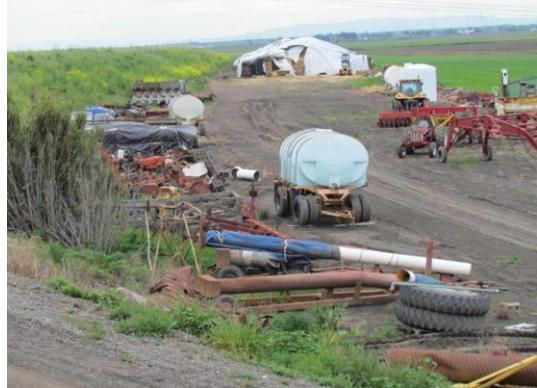
Photo 1 of 1 : FA_2019_RD0536_209_5_20190826_00001.jpg

View of equipment on the landside toe.

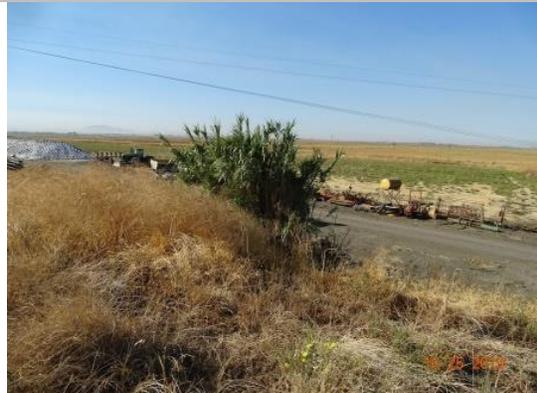
Photo 1 of 1 : FA_2019_RD0536_209_7_20191028_00022.jpg

View looking downslope at arundo on the landside slope (Fall 2019).

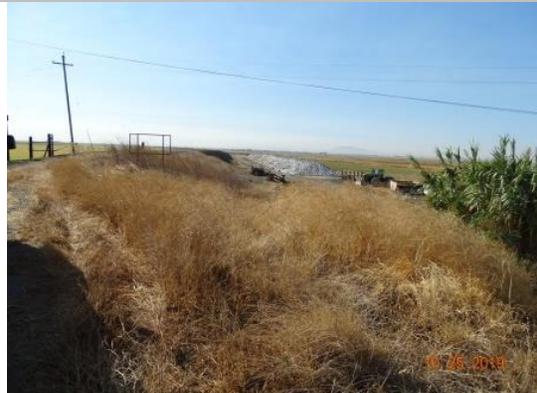
Photo 1 of 1 : FA_2019_RD0536_209_6_20191028_00021.jpg

View looking downstream at vegetation on the landside slope (Fall 2019).

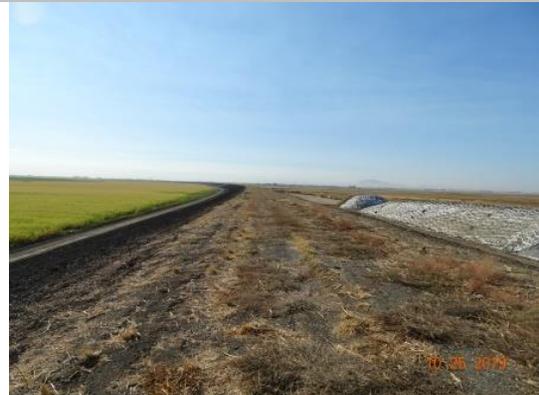
Photo 1 of 1 : FA_2019_RD0536_209_11_20191028_00023.jpg

View looking downstream at vegetation on the crown (Fall 2019).

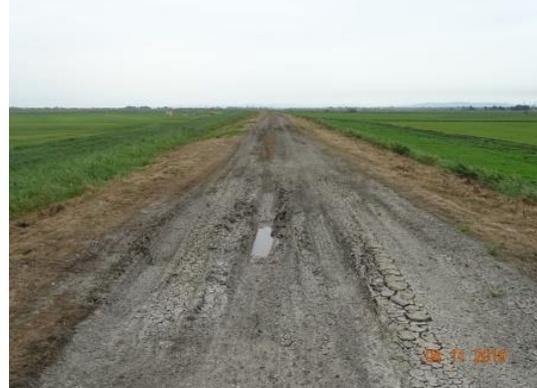
Photo 1 of 1 : FA_2019_RD0536_209_18_20190826_00005.jpg

View looking downstream at deep rut on the crown (Spring 2019).

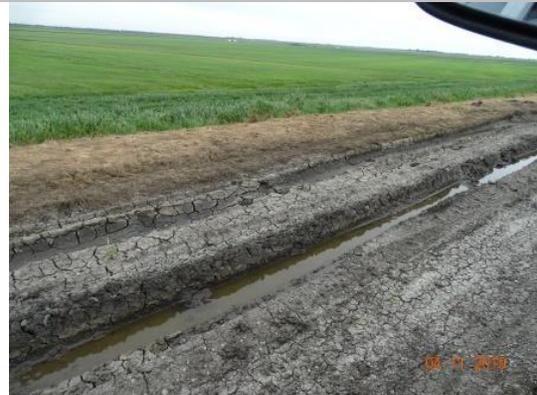
Photo 1 of 1 : FA_2019_RD0536_209_19_20190826_00006.jpg

View looking slightly downstream at deep rut on the crown (Spring 2019).

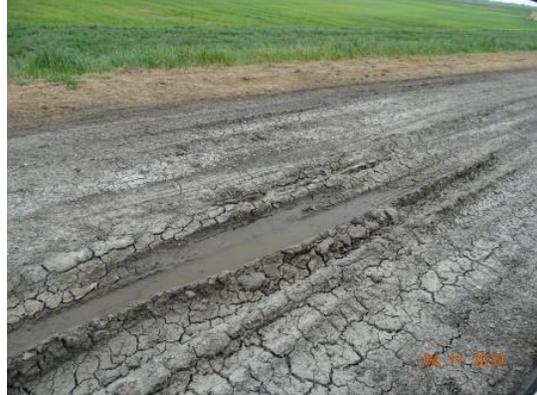
Photo 1 of 1 : FA_2019_RD0536_209_20_20190826_00007.jpg

View looking slightly downstream at deep rut on the crown (Spring 2019).

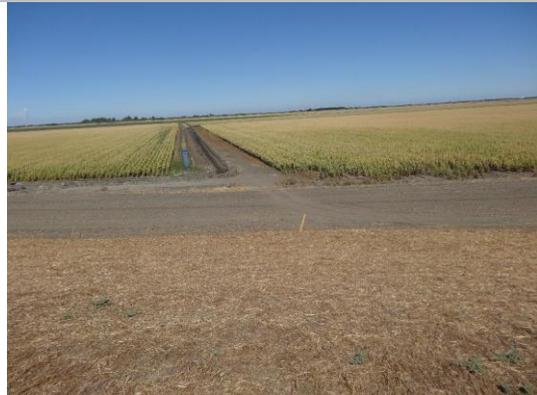
Photo 1 of 3 : UCIP_FA_2019_20664_34746.jpg

WS view: overview of levee slope and gasline indicator. The indicator is different than standard indicators.

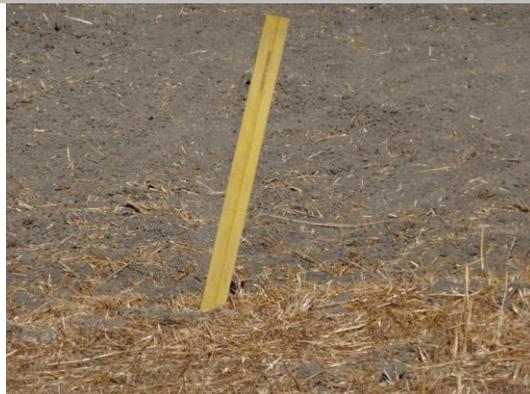
Photo 2 of 3 : UCIP_FA_2019_20664_34745.jpg

WS view: closer look at gasline indicator. The indicator is different than standard indicators.

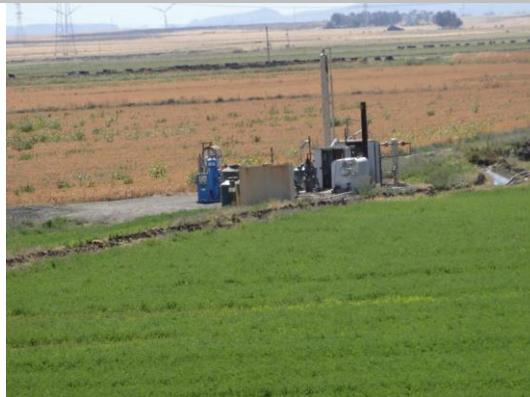
Photo 3 of 3 : UCIP_FA_2019_20664_34744.jpg

WS view: natural gas extraction plant near levee on the field.

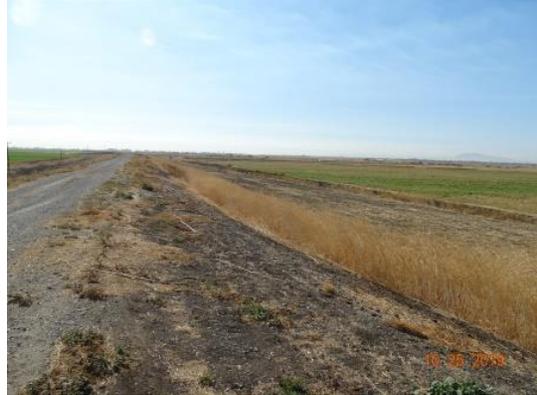
Photo 1 of 1 : FA_2019_RD0536_209_12_20191028_00024.jpg

View looking downstream at vegetation on the landside slope (Fall 2019).

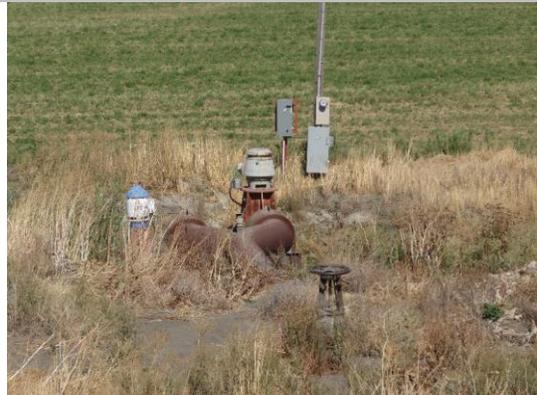
Photo 1 of 2 : UCIP_FA_2019_20647_34731.jpg

WS view: overview of pipe and pump (left). Big pump and appurtenances (right) for 24" steel pipe.

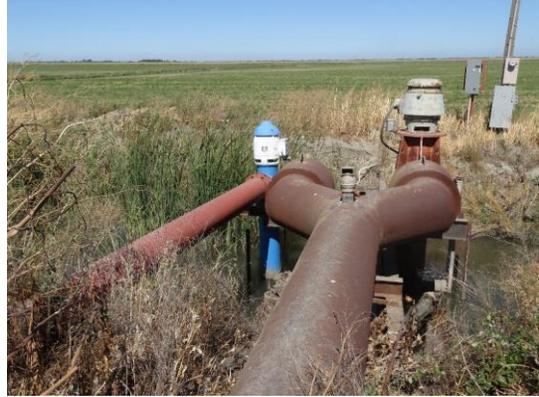
Photo 2 of 2 : UCIP_FA_2019_20647_34730.jpg

WS view: closer view of pipe and pump (left). Big pump and appurtenances (right) for 24" steel pipe.

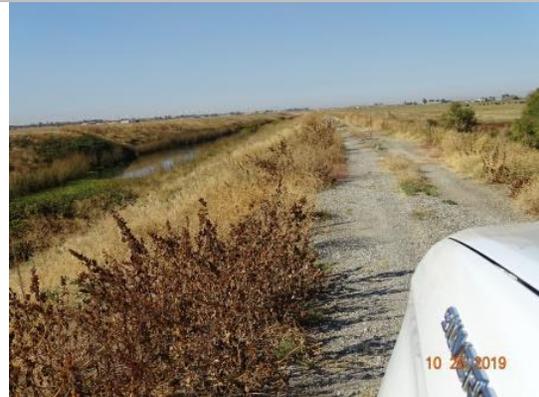
Photo 1 of 1 : FA_2019_RD0536_209_21_20191028_00026.jpg

View looking downstream at vegetation on the waterside slope (Fall 2019).

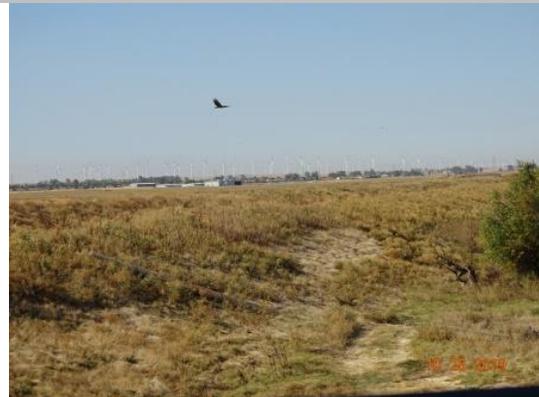
Photo 1 of 1 : FA_2019_RD0536_209_16_20191028_00025.jpg

View looking upstream at vegetation on the landside slope (Fall 2019).

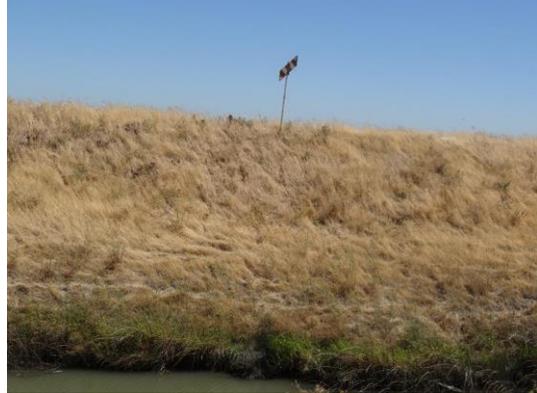
Photo 1 of 2 : UCIP_FA_2019_41845_34765.jpg

WS view: gasline indicator across the channel.

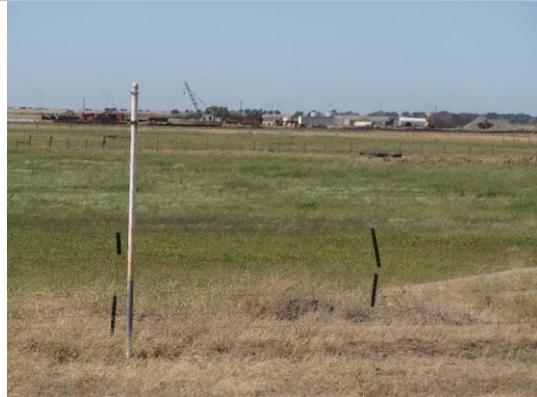
Photo 2 of 2 : UCIP_FA_2019_41845_34764.jpg

LS view: gasline indicator on levee toe.

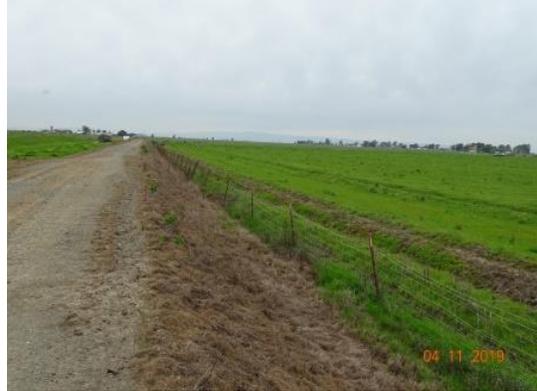
Photo 1 of 1 : FA_2019_RD0536_209_25_20190826_00008.jpg

View looking upstream at barbed wire fence at landside toe (Spring 2019).

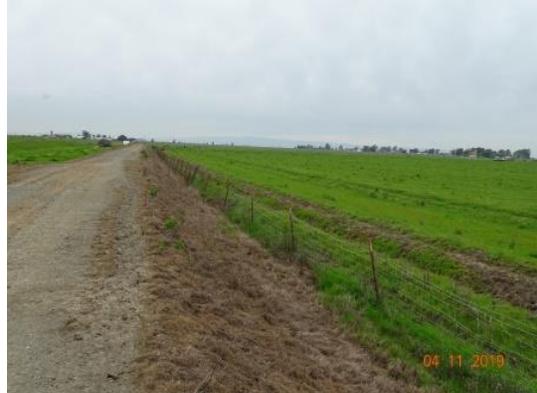
Photo 1 of 1 : FA_2019_RD0536_209_26_20190826_00009.jpg

View looking upstream at ditch on the landside toe (Spring 2019).

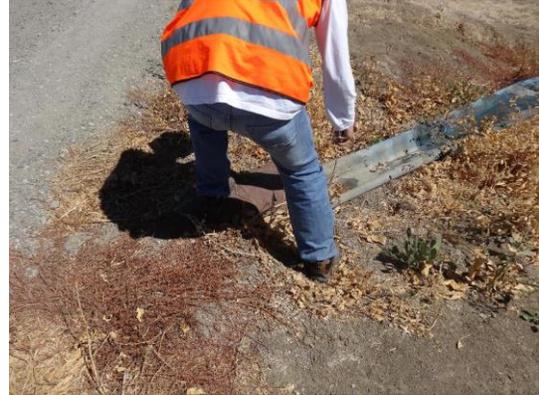
Photo 3 of 3 : UCIP_FA_2019_46813_34766.jpg

WS view: steel pipe on levee shoulder at 2-inch below the crown.
