**Flood Control Project Maintenance
Levee Inspections**

Maintenance Issue Types Only, Levee Inspection Report By Mile - Fall 2019

Reclamation District No. 0536 Egbert

Waterway	Bank	Unit Miles	Inspection Start/End	Inspector
Unit No. 01 Lindsey Slough	Right	5.58	10/25/2019 10/25/2019	David Julian

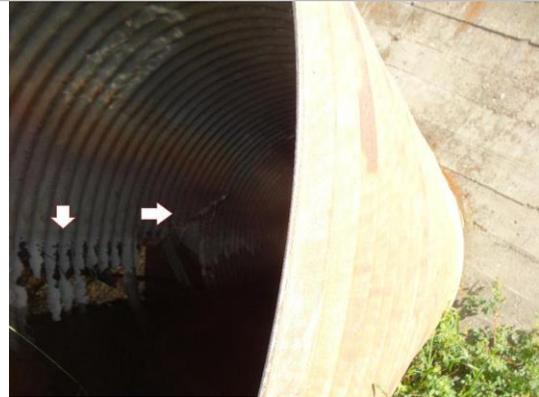
Photo 3 of 3 : UCIP_FA_2019_53359_34455.jpg

LM Start	0.00	Rating **	U	Issue No.	60 (cont)
LM End	0.00	Issue Type +	Ma	Location *	
Category	Supplemental			GPS Latitude/Longitude	
				Start	End
Item	DRAFT DWR UCIP LMA Responsibility			38.244963 °	38.244963 °
				-121.768960 °	-121.768960 °
DWR ID	22712

Comment Code					
Inspector Comment					
<p>DS_ID:22712 FS_ID:53359 EP_NO: 10114 Repair Type: Urgent Crossing Status: Found UCIP Comments: 10/2/2018 Holes present in pipe pose internal levee threat; keeping as Urgent (D. Sanoski - DWR UCIP).06/01/2016: Holes and heavy corrosion inside pipe on WS have gotten worse. Flapgates appear in good condition though vegetation blocks view of flapgate for 36-inch on WS. These pipes are still in use and necessary for drainage; pipes may be eligible for repair under DWR Deferred Maintenance Program. (K. Fazel - UCIP)08/13/2013:- Holes in pipe outlet due to heavy corrosion.- Needs detailed investigation of the pipe.- Headwall cracked and tilted on WS. (P. Amatya - DWR) FIELD_STRUCT_DESC: 1 of 2: 60-inch corrugated metal gravity drainage pipe through the levee, 10 feet below the crown. Flap gate on the waterside (WS). Headwall on each end. Culverts run under the road to provide drainage from agricultural fields via a landside (LS) ditch to Lindsey Slough. No. 100 gate in the LS drainage ditch. Reclamation District No. 536 (RD0536) president is David Hearn at hearnd5@gmail.com. (Retention of one 60-inch and one 36-inch drainage pipes through the levee, 10 feet and 6.5 feet below the crown, respectively, and flap gates on the WS ends authorized under Automatic Board Order (ABO) issued as Permit No. 10114, 1974 - H. E. Peterson). [Additional Reference(s): DWR Levee Log, 1992. USACE Sacramento O&M Manual 106, May 1953, (Station 294+49 ""A""), invert elevation 14.4 feet]. FS Date: 10/2/2018 1:53:00 PM</p>

LS view: holes & cracks on CM pipe due to heavy corrosion. Needs detailed investigation of the pipe.

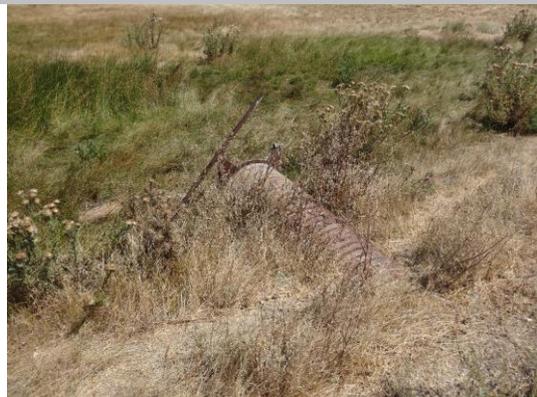
Photo 1 of 3 : UCIP_FA_2019_49313_34774.jpg

LM Start	0.31	Rating **	A/W	Issue No.	62
LM End	0.31	Issue Type +	Ma	Location *	
Category	Supplemental			GPS Latitude/Longitude	
				Start	End
Item	DRAFT DWR UCIP LMA Responsibility			38.245605°	38.245605°
				-121.763441°	-121.763441°
DWR ID	22713

Comment Code					
Inspector Comment					
<p>DS_ID:22713 FS_ID:49313 EP_NO: 10114 Repair Type: No Action Needed Crossing Status: Found UCIP Comments: 06/01/2016 Debris cleared and flapgate is no longer blocked. 08/13/2013 Outlet was blocked by concrete debris and dirt. Needs cleaning of debris. FIELD_STRUCT_DESC: 24-inch corrugated metal gravity drainage pipe through the levee, 10.5 feet below the crown. Flap gate on the waterside (WS) end. Headwall on each end, not found in 2013 or 2016. No. 100 gate on the WS. Concrete debris on the WS slope. This crossing is also used for irrigation. 1-inch polyvinyl chloride (PVC) pipe sleeved through the 24-inch pipe, visible through the landside (LS) end. According to David Hearn, Reclamation District No. 536 (RD0536) president, the PVC pipe does not connect all the way through. Present landowner, as of 2016, is Solano Land Trust, and the pipe runs through the Jepson Prairie Reserve, managed by the University of California, Davis, (UC Davis). (Retention of a 24-inch drainage pipe through the levee, 10.5 feet below the crown, and a flap gate on the WS end authorized under Automatic Board Order (ABO) issued as Permit No. 10114, 1974 - H. E. Peterson). [Additional Reference(s): DWR Levee Log, 1992. USACE Sacramento O&M Manual 106, May 1953, (Station 274+00 ""A""), invert elevation 15.8 feet]. FS Date: 6/1/2016</p>

WS view: overview of exposed CM pipe on levee slope.

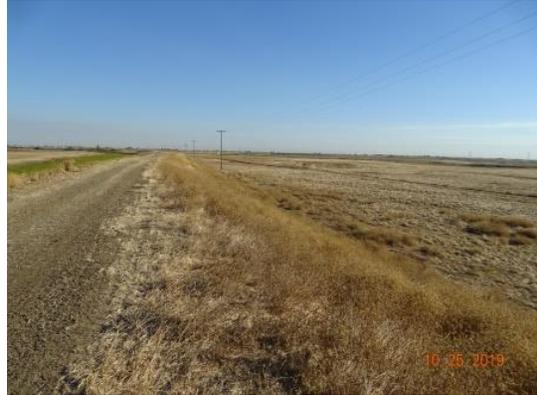
Photo 1 of 1 : FA_2019_RD0536_208_18_20191028_00062.jpg

LM Start	0.64	Rating **	M	Issue No.	18
LM End	1.33	Issue Type +	Ma	Location *	LS
Category	Earthen Levee		GPS Latitude/Longitude		
			Start	End	
Item	Vegetation		38.249125°	38.258775°	
			-121.760237°	-121.757365°	
DWR ID	DWR_RD0536_01_f_2019_18				
Comment Code					
V1 : Control annual grass and weeds on the levee slopes and easements.					
Inspector Comment

View looking downstream at vegetation on the landside slope (Fall 2019).

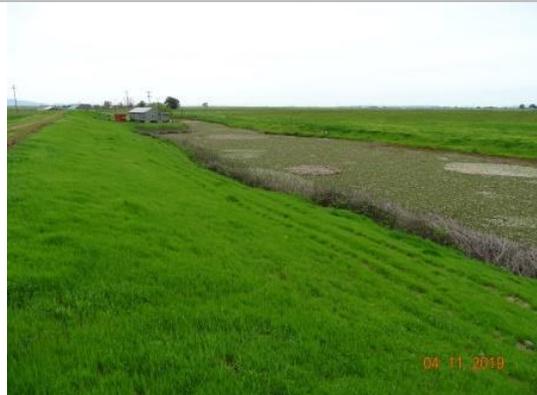
Photo 1 of 2 : FA_2019_RD0536_208_14_20190826_00003.jpg

LM Start	0.67	Rating **	M	Issue No.	14
LM End	0.98	Issue Type +	Ma	Location *	WS
Category	Supplemental		GPS Latitude/Longitude		
			Start	End	
Item	2017 USACE Erosion Survey		38.249615°	38.253717°	
			-121.760165°	-121.757979°	
DWR ID	DWR_RD0536_01_f_2018_14				
Comment Code					
Inspector Comment					
2017 Site ID: LDS 0.6 R Status: Eroding 2017 Field Notes: Appears to be cow paths along slope causing erosion. Site History: 2011 - Multiple sections of slumping bank. 2016 - Bank continues to erode.

View looking upstream at cow ruts on the waterside slope (Spring 2019).

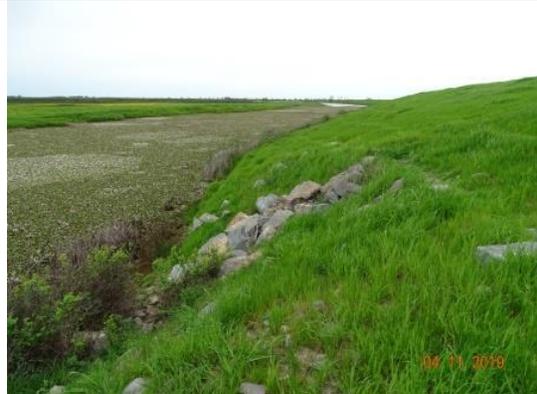
Photo 2 of 2 : FA_2019_RD0536_208_14_20190826_00004.jpg

View looking downstream at erosion spot with rock placed on it (Spring 2019).

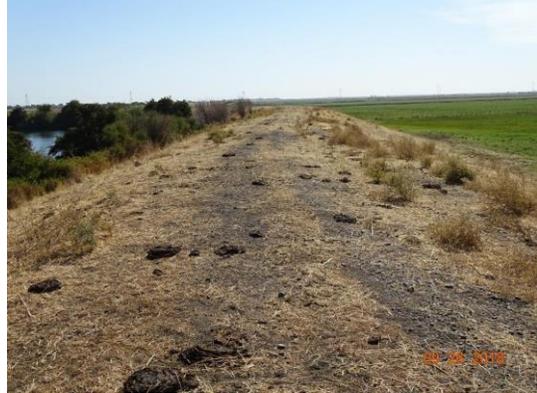
Photo 1 of 1 : FA_2019_RD0536_208_47_20190826_00025.jpg

LM Start	1.14	Rating **	M	Issue No.	47
LM End	1.55	Issue Type +	Ma	Location *	CR
Category	Earthen Levee		GPS Latitude/Longitude		
			Start	End	
Item	Crown Surface / Depressions / Rutting		38.256050°	38.258637°	
			-121.757582°	-121.753397°	
DWR ID	DWR_RD0536_01_f_2014_47				
Comment Code					
C2 : Repair depressions or ruts in the crown or slope.					
Inspector Comment					
Add appropriate gravel to the crown roadway.

View looking downstream of the crown. Gravel should be added to the roadway (September 2018).

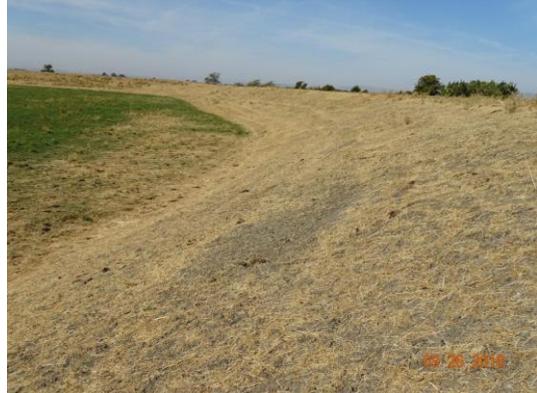
Photo 1 of 2 : FA_2019_RD0536_208_17_20190826_00007.jpg

LM Start	1.45	Rating **	M	Issue No.	17
LM End	1.45	Issue Type +	Ma	Location *	LS
Category	Earthen Levee		GPS Latitude/Longitude		
			Start	End	
Item	Slope Stability		38.259087°	38.259087°	
			-121.755133°	-121.755133°	
DWR ID	DWR_RD0536_01_f_2018_17				
Comment Code					
S2 : Repair the levee slope damaged by foot traffic and prevent access where possible.					
Inspector Comment					
Depressions in levee due to cows should be repaired to prevent deeper depressions into levee.

View looking upstream at divots in the slope created by cows. Divots are deep enough that they should be corrected (September 2018).

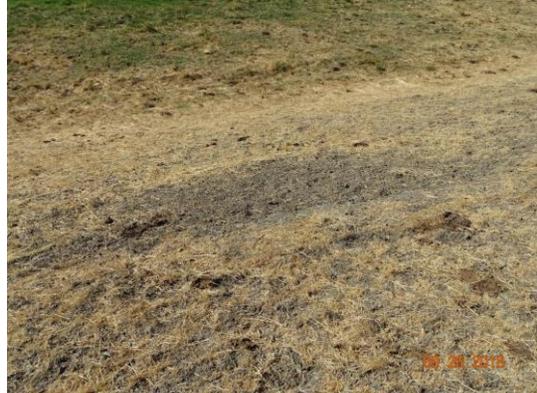
Photo 2 of 2 : FA_2019_RD0536_208_17_20190826_00008.jpg

Looking down slope at one of the cow divots (September 2018).

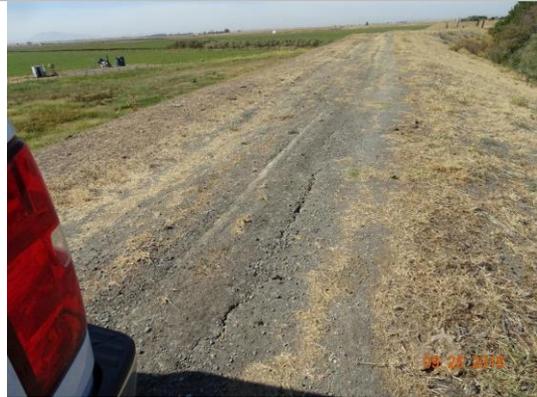
Photo 1 of 1 : FA_2019_RD0536_208_22_20190826_00011.jpg

LM Start	1.60	Rating **	M	Issue No.	22
LM End	2.17	Issue Type +	Ma	Location *	CR
Category	Earthen Levee		GPS Latitude/Longitude		
			Start	End	
Item	Crown Surface / Depressions / Rutting		38.258845°	38.258015°	
			-121.752675°	-121.744512°	
DWR ID	DWR_RD0536_01_f_2018_22				
Comment Code					
C1 : Add appropriate material and re-grade the levee to bring the crown above the design elevation.					
Inspector Comment					
Add appropriate gravel to the crown roadway.

View looking upstream at the crown. Surface cracks should be fixed and gravel added to roadway (September 2018).

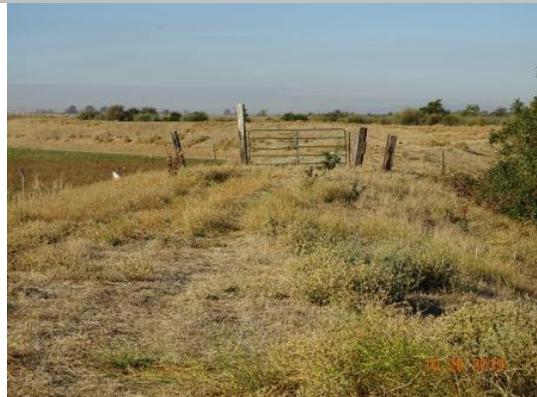
Photo 1 of 1 : FA_2019_RD0536_208_31_20191028_00063.jpg

LM Start	1.61	Rating **	M	Issue No.	31
LM End	1.80	Issue Type +	Ma	Location *	CR
Category	Earthen Levee		GPS Latitude/Longitude		
			Start	End	
Item	Vegetation		38.258960°	38.259690°	
			-121.752483°	-121.749481°	
DWR ID	DWR_RD0536_01_s_2019_31				
Comment Code					
V9 : Keep the crown roadway free of vegetation.					
Inspector Comment					
Remove annual vegetation from the crown road.

View looking upstream at vegetation on the crown (Fall 2019).

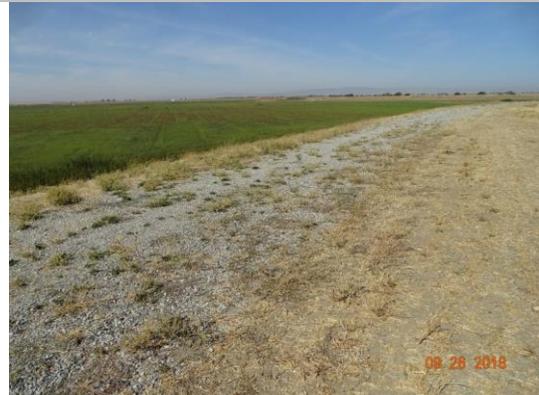
Photo 1 of 2 : FA_2019_RD0536_208_56_20190826_00026.jpg

LM Start	2.69	Rating **	A/W	Issue No.	56
LM End	2.71	Issue Type +	Ma	Location *	CR
Category	Earthen Levee		GPS Latitude/Longitude		
			Start	End	
Item	Crown Surface / Depressions / Rutting		38.255197°	38.254973°	
			-121.737932°	-121.737577°	
DWR ID	DWR_RD0536_01_f_2014_56				
Comment Code					
C2 : Repair depressions or ruts in the crown or slope.					
Inspector Comment					
Possible subsidence in this area has been repaired. Grade was restored and base rock was added to crown. Area looks good on 3/29/18. Should continue to monitor this site for possible future subsidence. 9/26/2018: Very minor subsidence present. Should be monitored.

View looking upstream at minor subsidence. (September 2018).

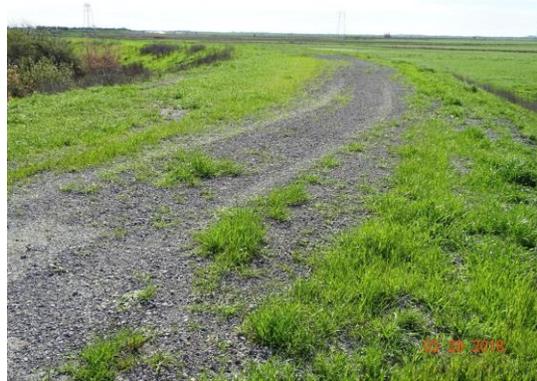
Photo 2 of 2 : FA_2019_RD0536_208_56_20190826_00027.jpg

LM Start	2.69	Rating **	A/W	Issue No.	56 (cont)
LM End	2.71	Issue Type +	Ma	Location *	CR
Category	Earthen Levee			GPS Latitude/Longitude	
				Start	End
Item	Crown Surface / Depressions / Rutting			38.255197°	38.254973°
				-121.737932°	-121.737577°
DWR ID	DWR_RD0536_01_f_2014_56				
Comment Code					
C2 : Repair depressions or ruts in the crown or slope.					
Inspector Comment					
Possible subsidence in this area has been repaired. Grade was restored and base rock was added to crown. Area looks good on 3/29/18. Should continue to monitor this site for possible future subsidence. 9/26/2018: Very minor subsidence present. Should be monitored.

3/29/2018: view of crown rutting and possible subsidence that has been repaired.

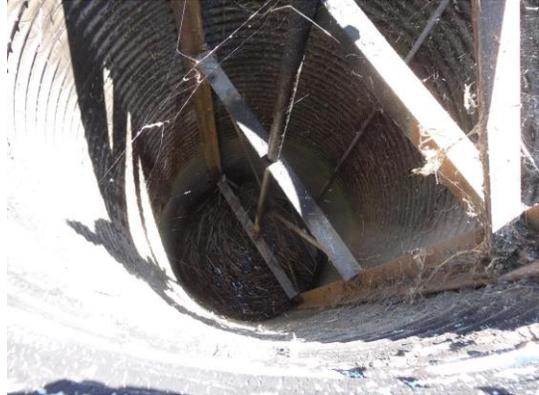
Photo 2 of 3 : UCIP_FA_2019_20503_34567.jpg

Comment Code					
Inspector Comment					
<p>DS_ID:22718 FS_ID:20503 EP_NO: 10116 Repair Type: No Action Needed Crossing Status: Found UCIP Comments: Vortex seen on WS. Water flow seen on LS.Saddle, apron, and headwall not visible. Inlet and outlet pipe-ends are submerged into water. FIELD_STRUCT_DESC: 54-inch corrugated metal gravity drainage pipe through the levee, 30 feet below the crown. Screw gate in a pipe riser on the waterside (WS) slope. Saddle, apron, headwall, two corrugated metal cutoff walls, one No. 101 gate, and one No. 102 gate. (Retention of a 54-inch drainage pipe through the levee, 30 feet below the crown, and a slide gate on the WS slope authorized under Automatic Board Order (ABO) 10116, 1974 - Marion Sanchez Farms). [Additional Reference(s): DWR Levee Log, 1992. USACE Sacramento O&M Manual 106, May 1953, (Station 87+70 ""R""), invert elevation -2 feet]. FS Date: 8/13/2013</p>

WS view: closer view of slide gate in CMP riser on levee slope.

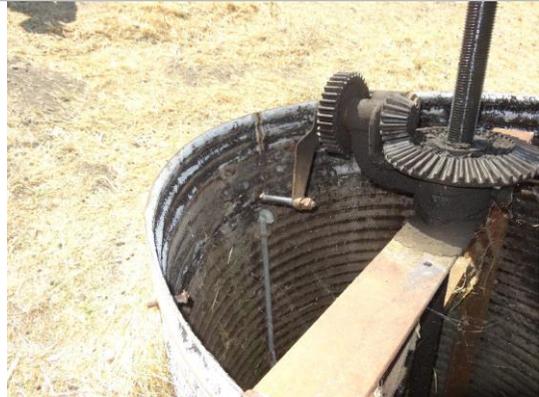
Photo 3 of 3 : UCIP_FA_2019_20503_34566.jpg

WS view: closer view of slide gate in CMP riser on levee slope. Air vent attached to the wall of CMP (left).

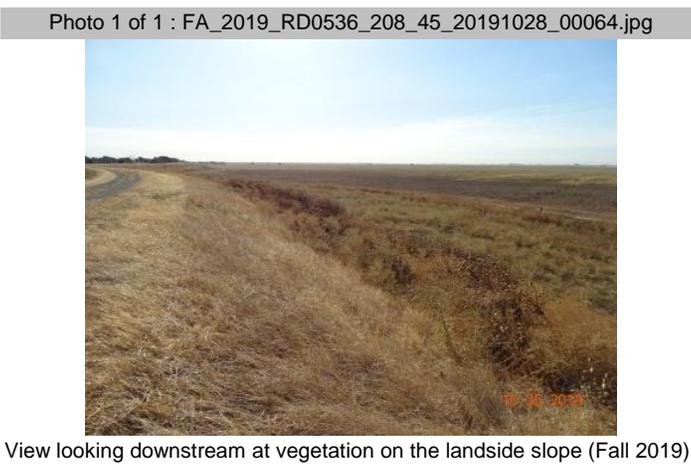
LM Start	3.96	Rating **	U	Issue No.	45
LM End	4.07	Issue Type +	Ma	Location *	LS
Category	Earthen Levee		GPS Latitude/Longitude		
			Start	End	
Item	Vegetation		38.250618°	38.250302°	
			-121.722550°	-121.720585°	
DWR ID	DWR_RD0536_01_f_2019_45				
Comment Code					
V1 : Control annual grass and weeds on the levee slopes and easements.					
Inspector Comment

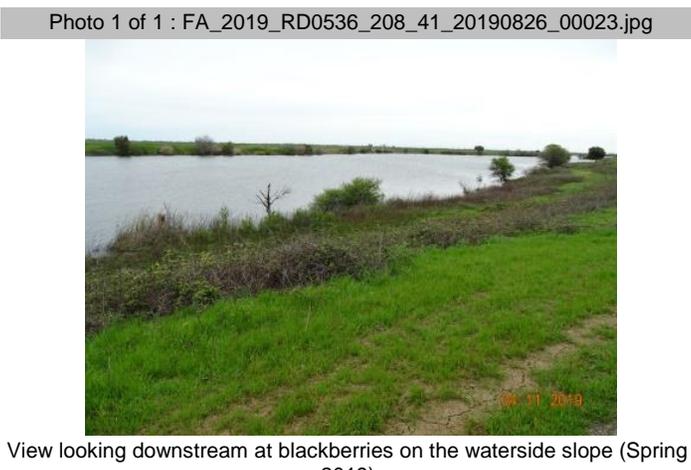
LM Start	3.98	Rating **	M	Issue No.	41
LM End	3.98	Issue Type +	Ma	Location *	WS
Category	Earthen Levee		GPS Latitude/Longitude		
			Start	End	
Item	Vegetation		38.250514°	38.250514°	
			-121.722303°	-121.722303°	
DWR ID	DWR_RD0536_01_s_2019_41				
Comment Code					
V2 : Remove the wild growth other than native grasses from the levee slopes.					
Inspector Comment					
Remove blackberries at least 20' from waterside shoulder.

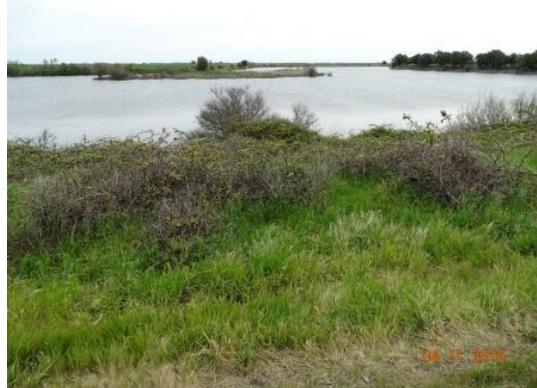
Photo 1 of 1 : FA_2019_RD0536_208_42_20190826_00024.jpg

View looking downslope at blackberries on the waterside slope (Spring 2019).

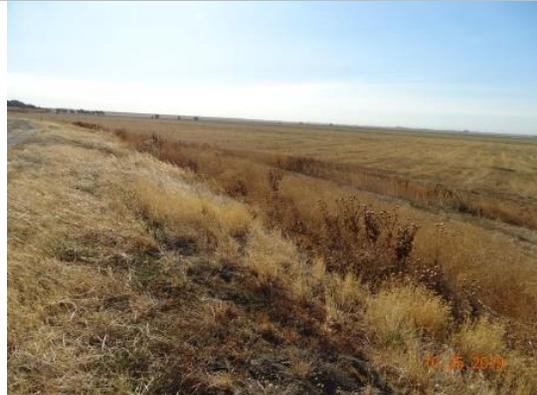
Photo 1 of 1 : FA_2019_RD0536_208_49_20191028_00065.jpg

LM Start	4.26	Rating **	U	Issue No.	49
LM End	4.64	Issue Type +	Ma	Location *	LS
Category	Earthen Levee		GPS Latitude/Longitude		
			Start	End	
Item	Vegetation		38.248763 °	38.248228 °	
			-121.717967 °	-121.712053 °	
DWR ID	DWR_RD0536_01_f_2019_49				
Comment Code					
V1 : Control annual grass and weeds on the levee slopes and easements.					
Inspector Comment

View looking downstream at vegetation on the landside slope (Fall 2019).

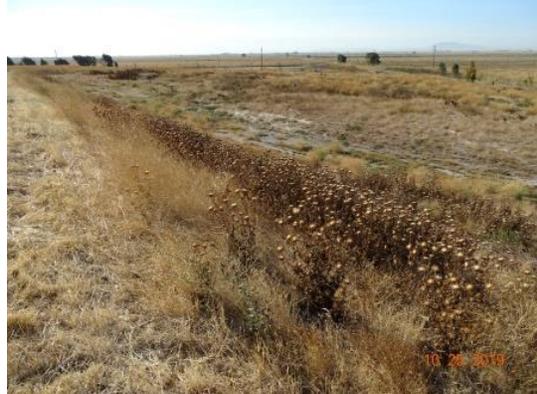
Photo 1 of 1 : FA_2019_RD0536_208_51_20191028_00066.jpg

View looking downstream at vegetation on the landside slope (Fall 2019).

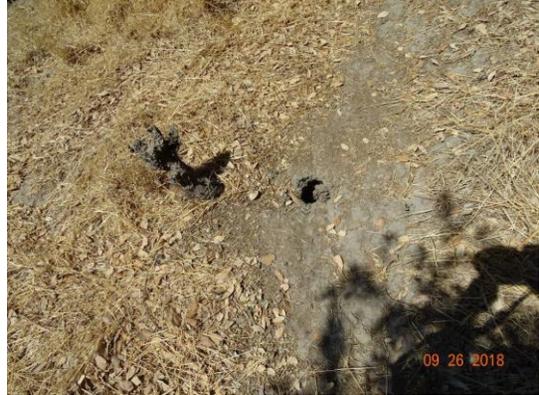
Photo 1 of 1 : FA_2019_RD0536_208_26_20190826_00016.jpg

View of squirrel hole on the landside slope (September 2018).

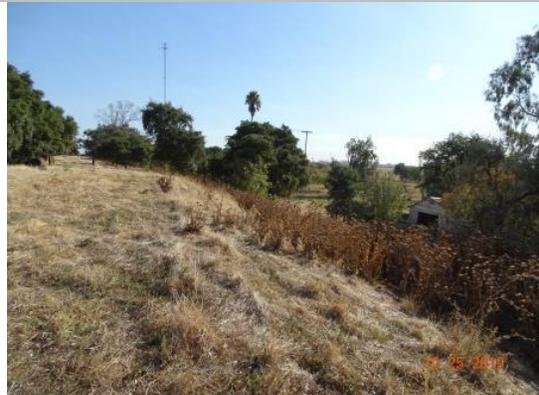
Photo 1 of 1 : FA_2019_RD0536_208_54_20191028_00068.jpg

View looking downstream at vegetation on the landside slope (Fall 2019).

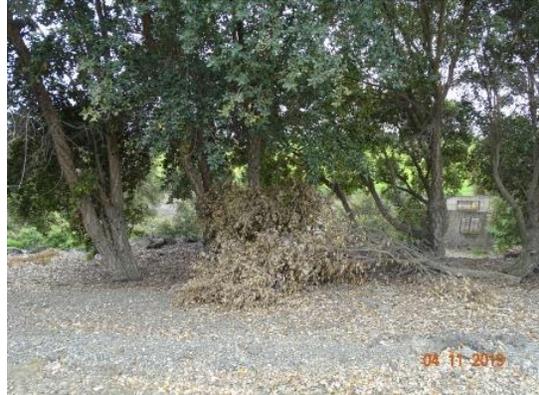
Photo 1 of 1 : FA_2019_RD0536_208_28_20190826_00018.jpg

View of tree limbs on the landside shoulder (Spring 2019).

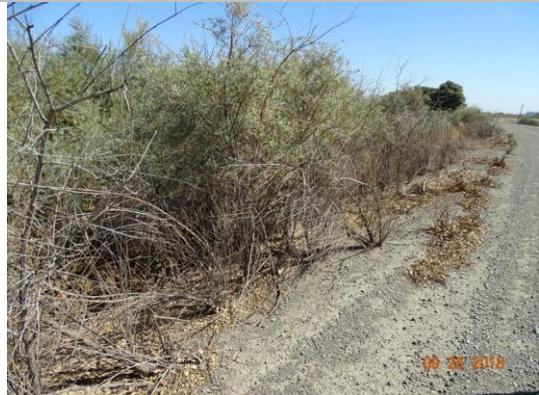
Photo 1 of 1 : FA_2019_RD0536_208_27_20190826_00017.jpg

View of vegetation on the waterside up to the crown that is blocking visibility (September 2018).

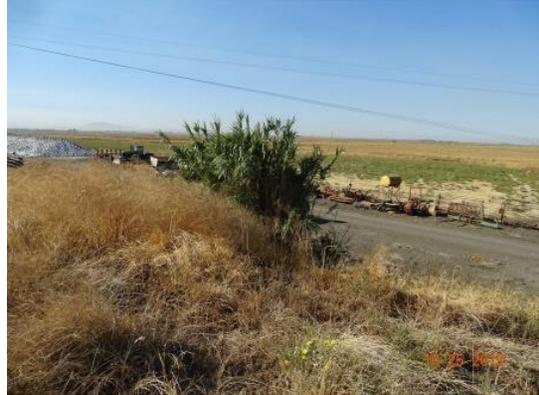
Photo 1 of 1 : FA_2019_RD0536_209_7_20191028_00022.jpg

View looking downslope at arundo on the landside slope (Fall 2019).

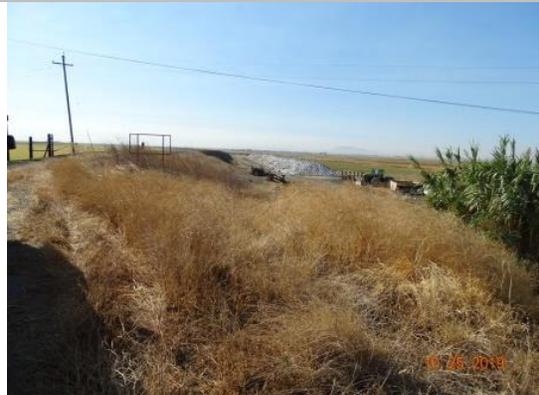
Photo 1 of 1 : FA_2019_RD0536_209_6_20191028_00021.jpg

LM Start	0.10	Rating **	U	Issue No.	6
LM End	0.12	Issue Type +	Ma	Location *	LS
Category	Earthen Levee		GPS Latitude/Longitude		
			Start	End	
Item	Vegetation		38.244162°	38.243828°	
			-121.696960°	-121.696922°	
DWR ID	DWR_RD0536_02_f_2019_6				
Comment Code					
V1 : Control annual grass and weeds on the levee slopes and easements.					
Inspector Comment

View looking downstream at vegetation on the landside slope (Fall 2019).

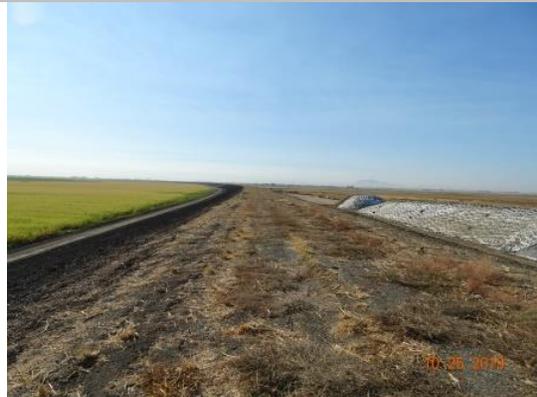
Photo 1 of 1 : FA_2019_RD0536_209_11_20191028_00023.jpg

View looking downstream at vegetation on the crown (Fall 2019).

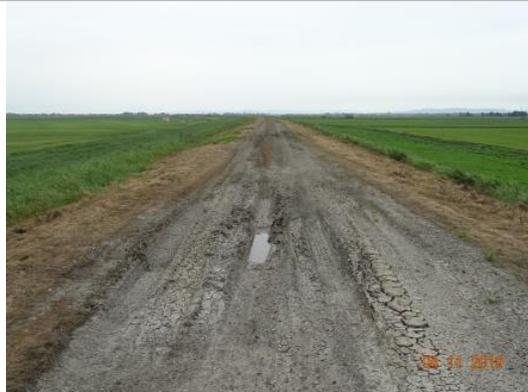
Photo 1 of 1 : FA_2019_RD0536_209_18_20190826_00005.jpg

LM Start	1.24	Rating **	M	Issue No.	18
LM End	1.24	Issue Type +	Ma	Location *	CR
Category	Earthen Levee		GPS Latitude/Longitude		
			Start	End	
Item	Crown Surface / Depressions / Rutting		38.227689 °	38.227689 °	
			-121.697644 °	-121.697644 °	
DWR ID	DWR_RD0536_02_s_2019_18				
Comment Code					
C2 : Repair depressions or ruts in the crown or slope.					
Inspector Comment

View looking downstream at deep rut on the crown (Spring 2019).

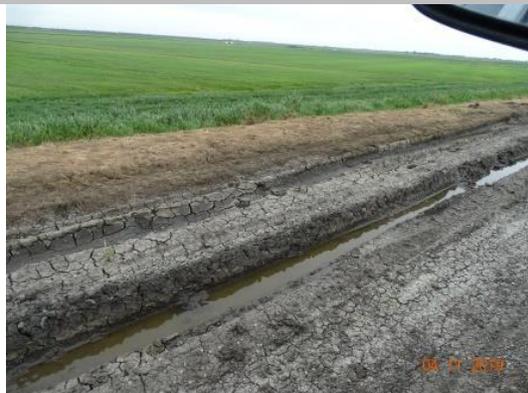
Photo 1 of 1 : FA_2019_RD0536_209_19_20190826_00006.jpg

LM Start	1.35	Rating **	U	Issue No.	19
LM End	1.35	Issue Type +	Ma	Location *	CR
Category	Earthen Levee		GPS Latitude/Longitude		
			Start	End	
Item	Crown Surface / Depressions / Rutting		38.226011 °	38.226011 °	
			-121.697401 °	-121.697401 °	
DWR ID	DWR_RD0536_02_s_2019_19				
Comment Code					
C2 : Repair depressions or ruts in the crown or slope.					
Inspector Comment

View looking slightly downstream at deep rut on the crown (Spring 2019).

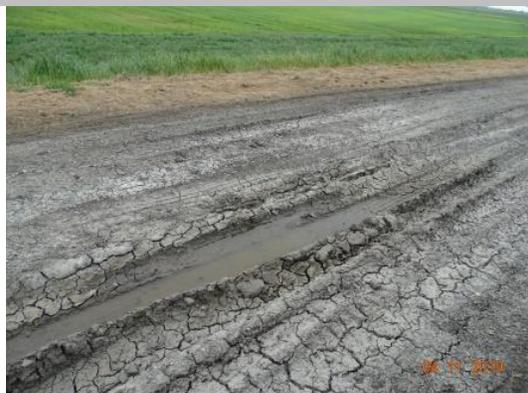
Photo 1 of 1 : FA_2019_RD0536_209_20_20190826_00007.jpg

LM Start	1.47	Rating **	U	Issue No.	20
LM End	1.47	Issue Type +	Ma	Location *	CR
Category	Earthen Levee		GPS Latitude/Longitude		
			Start	End	
Item	Crown Surface / Depressions / Rutting		38.224413 °	38.224413 °	
			-121.697100 °	-121.697100 °	
DWR ID	DWR_RD0536_02_s_2019_20				
Comment Code					
C2 : Repair depressions or ruts in the crown or slope.					
Inspector Comment

View looking slightly downstream at deep rut on the crown (Spring 2019).

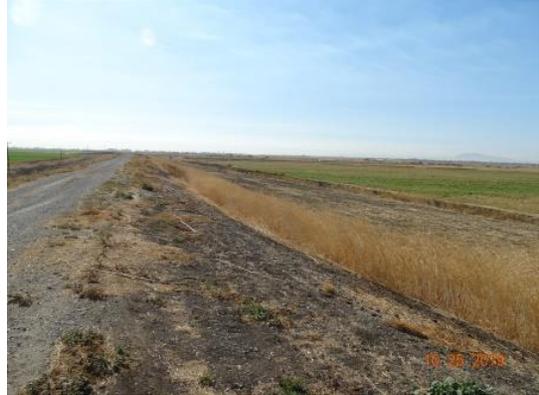
Photo 1 of 1 : FA_2019_RD0536_209_12_20191028_00024.jpg

View looking downstream at vegetation on the landside slope (Fall 2019).

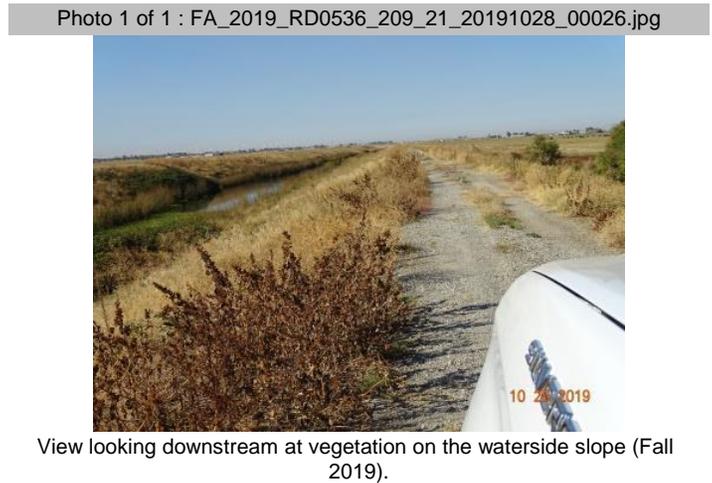
LM Start	3.51	Rating **	M	Issue No.	21
LM End	4.48	Issue Type +	Ma	Location *	WS
Category	Earthen Levee		GPS Latitude/Longitude		
			Start	End	
Item	Vegetation		38.197145°	38.197076°	
			-121.683912°	-121.701006°	
DWR ID	DWR_RD0536_02_f_2019_21				
Comment Code					
V1 : Control annual grass and weeds on the levee slopes and easements.					
Inspector Comment

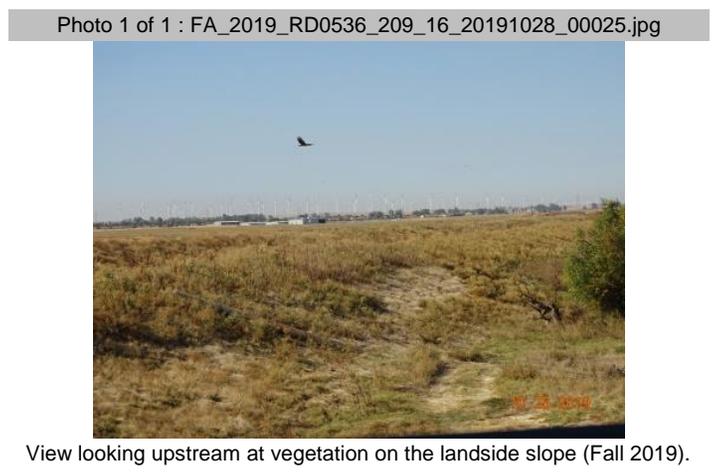
LM Start	3.51	Rating **	U	Issue No.	16
LM End	4.99	Issue Type +	Ma	Location *	LS
Category	Earthen Levee		GPS Latitude/Longitude		
			Start	End	
Item	Vegetation		38.197145°	38.198770°	
			-121.683912°	-121.710077°	
DWR ID	DWR_RD0536_02_f_2019_16				
Comment Code					
V1 : Control annual grass and weeds on the levee slopes and easements.					
Inspector Comment
