**Flood Control Project Maintenance
Levee Inspections**

Fall 2019 Levee Maintenance Deficiency Summary Report

Reclamation District No. 0544 Upper Roberts Island

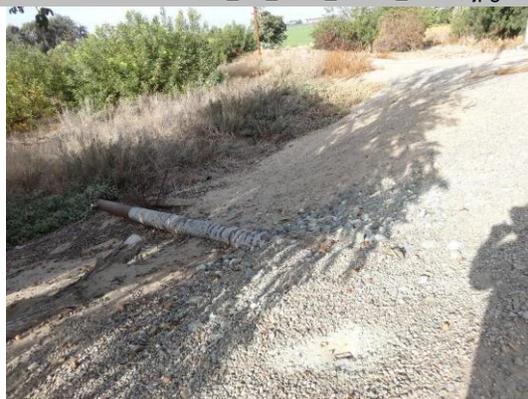
Photo 1 of 3 : UCIP_FA_2019_23851_41728.jpg

LM Start	0.01	Rating **	M	Issue No.	144
LM End	0.01	Issue Type +	En	Location *	
Category	Supplemental			GPS Latitude/Longitude	
				Start	End
Item	DRAFT DWR UCIP Field Study			37.870296°	37.870296°
				-121.329826°	-121.329826°
DWR ID	24713				
Comment Code					
Inspector Comment					
DS_ID:24713 FS_ID:23851 EP_NO: N/A Repair Type: Non-Urgent Crossing Status: Found UCIP Comments: Appears abandoned.May need proper abandonment.Pipe exposed on landside slope. FIELD_STRUCT_DESC: *ABANDONED* 12-inch steel pipe of an unknown purpose through the levee, 2 feet below the crown. Appears abandoned. Only visible on the landside (LS) slope. No pipe or other features visible on the waterside (WS). FS Date: 10/29/2013

LS view: exposed 12-inch steel pipe on levee slope. Appears abandoned.

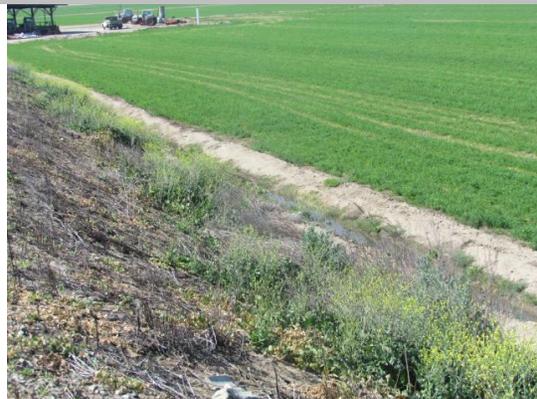
Photo 1 of 1 : FA_2019_RD0544_108_85_20190830_00048.jpg

Looking southwest at Irrigation ditch at landward toe.

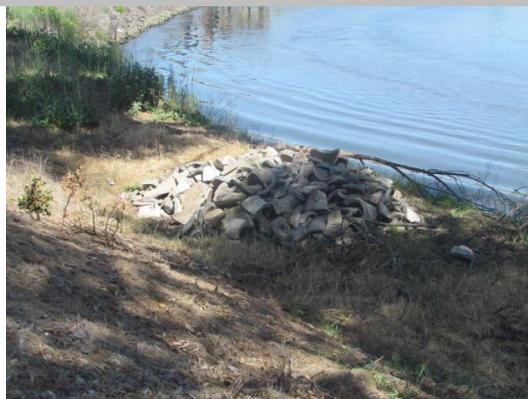
Photo 1 of 1 : FA_2019_RD0544_108_1_20190830_00001.jpg

LM Start	0.45	Rating **	M	Issue No.	1
LM End	0.45	Issue Type +	En	Location *	WS
Category	Earthen Levee		GPS Latitude/Longitude		
			Start	End	
Item	Encroachments		37.864713°	37.864713°	
			-121.326708°	-121.326708°	
DWR ID	DWR_RD0544_01_f_2013_1				
Comment Code					
MA : Material					
Inspector Comment					
Old broken concrete pipes were placed on the waterside berm.

Looking northeast at broken concrete piping on waterward berm.

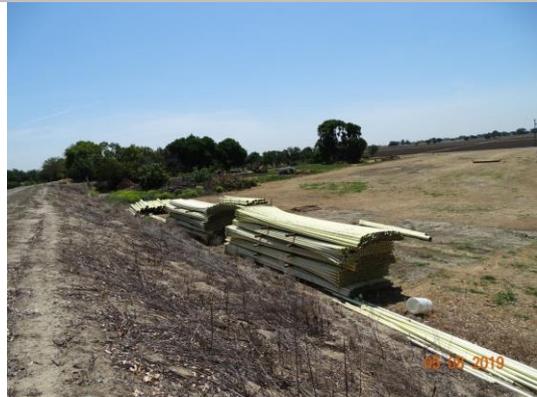
Photo 1 of 1 : FA_2019_RD0544_108_54_20190830_00030.jpg

View of irrigation pipes being stored in landside toe easement. (Spring 2019)

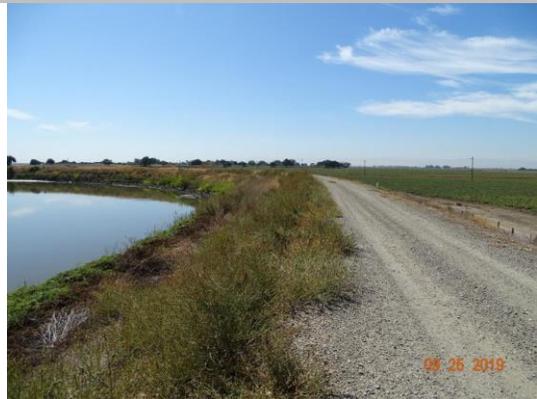
Photo 1 of 1 : FA_2019_RD0544_108_50_20191117_00156.jpg

Typical view of vegetation on waterside slope. Fall 2019

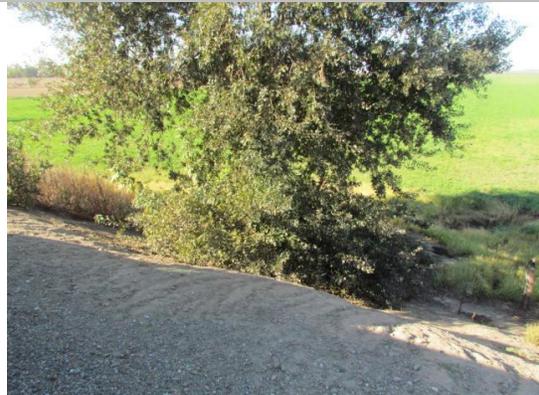
Photo 1 of 1 : FA_2019_RD0544_108_87_20190830_00050.jpg

Looking west at untrimmed tree at landward toe, Fall 2015.

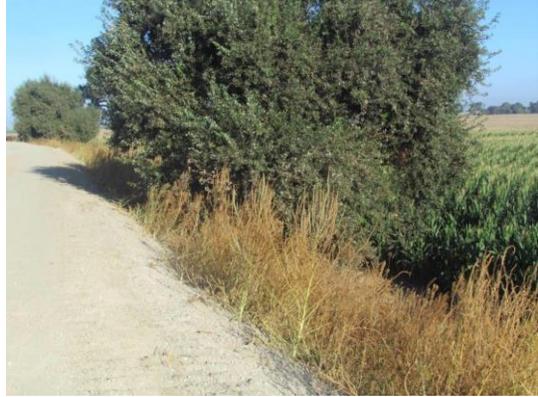
Photo 1 of 1 : FA_2019_RD0544_108_95_20190830_00056.jpg

Looking southwest at untrimmed tree on landward slope.

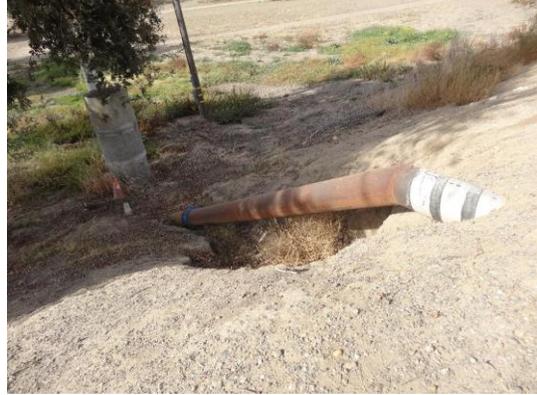
Photo 3 of 3 : UCIP_FA_2019_53362_42005.jpg

Comment Code					
Inspector Comment					
DS_ID:22650 FS_ID:53362 EP_NO: N/A Repair Type: Urgent Crossing Status: Found UCIP Comments: 10/2/2018 Severe erosion on LS slope so crossing remains Urgent (D. Sanoski - DWR UCIP).12/22/2016: Erosion of LS slope along pipe alignment. (K. Fazel - UCIP)10/29/2013:Siphon breaker on the landward slope not found. It has been removed and pipe plugged.Huge levee slope erosion on landside.2-inch electric conduit on waterside, service pole on landside. (P. Amatya - DWR) FIELD_STRUCT_DESC: 14-inch steel irrigation discharge pipe through the levee, 2 feet below the crown. Pump on a pile structure in the river. Steel walkway to the pump. 2-inch electrical conduit through the levee to the waterside (WS). Power pole on the landside (LS). [Additional Reference(s): DWR Levee Log, 2005, pipe referenced as 5 feet below the crown. USACE San Joaquin O&M Manual 7, April 1964, (HLM 2.26), pipe referenced as 5 feet below the crown]. FS Date: 10/2/2018 2:20:00 PM

LS view: exposed pipe, concrete standpipe (left), service pole (top right) and eroded slope.

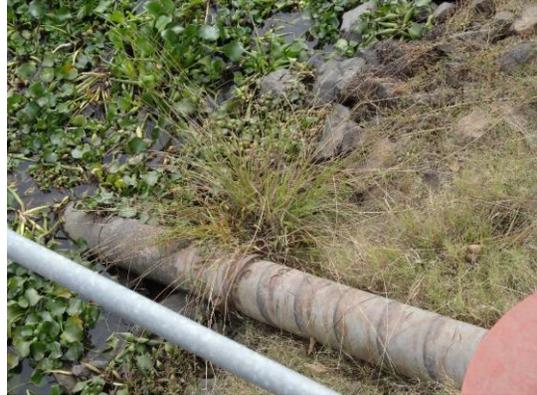
Photo 1 of 3 : UCIP_FA_2019_53363_44830.jpg

Comment Code					
Inspector Comment					
DS_ID:22652 FS_ID:53363 EP_NO: 13554 Repair Type: Urgent Crossing Status: Found UCIP Comments: 10/2/2018 Significant erosion on LS slope and around pipe, also noticed significant erosion on WS slope so crossing remains as Urgent (D. Sanoski - DWR UCIP).12/22/2016: Depression (hole) in levee in two places on the WS slope in alignment with this pipe. One of the holes is due to rodent activity. Crossing has been upgraded from Non-Urgent to Urgent. (K. Fazel - UCIP)10/29/2013:- levee slope erosion on landside.- needs cleaning of siphon breaker. (P. Amatya - DWR) FIELD_STRUCT_DESC: 12-inch coated steel drainage discharge pipe, 2 feet below the crown. Pump in a concrete standpipe in a drainage ditch at the landside (LS) toe. Siphon breaker in a steel riser on the waterside (WS). (Plans to install a 12-inch discharge pipe through the levee for removal of excess waters authorized under Permit No. 13554, 1982 - Lloyd Phelps Jr. [Additional Reference(s): DWR Levee Log, 2005, states that the pump is on a pier in the channel]. FS Date: 10/2/2018 2:34:00 PM

WS view: steel pipe immersed into the stream.

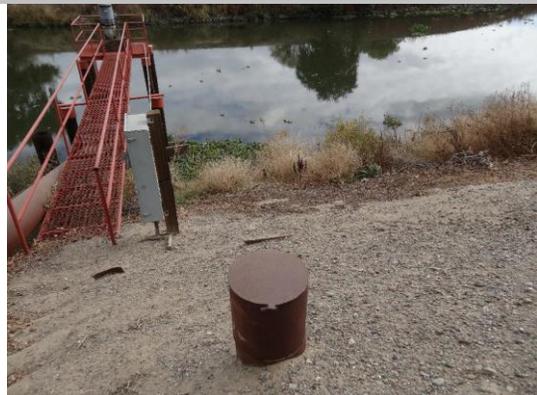
Photo 2 of 3 : UCIP_FA_2019_53363_44829.jpg

WS view: siphon breaker inside steel pipe riser (bottom) on levee slope.

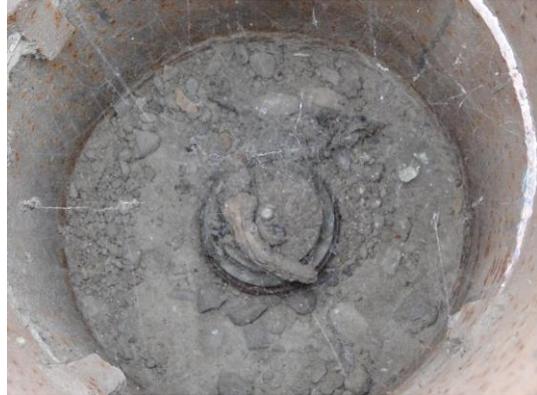
Photo 3 of 3 : UCIP_FA_2019_53363_44828.jpg

WS view: siphon breaker inside steel pipe riser on levee slope. Needs dirt cleaning/clearing.

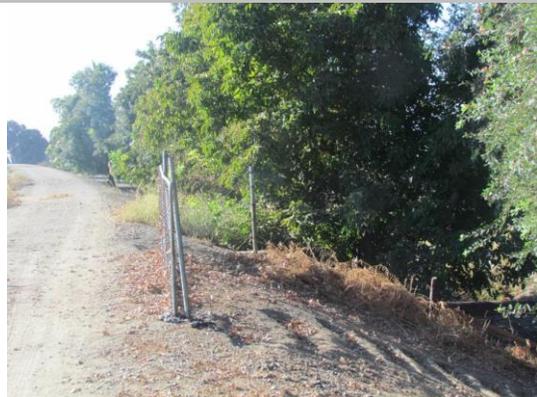
Photo 1 of 1 : FA_2019_RD0544_108_98_20190830_00057.jpg

Looking south at untrimmed trees on landward slope.

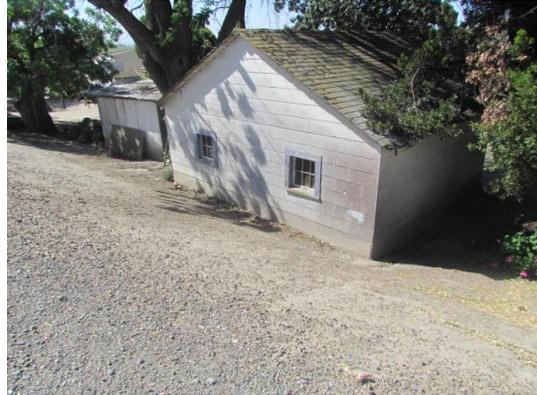
Photo 1 of 1 : FA_2019_RD0544_108_67_20190830_00034.jpg

Looking southeast at building at landward toe.

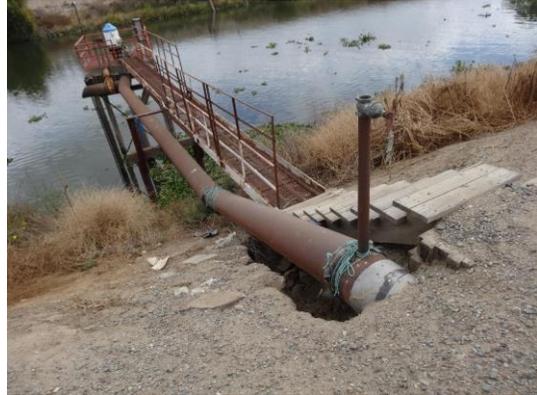
Photo 1 of 3 : UCIP_FA_2019_51361_44839.jpg

WS view: exposed pipe, walkway to pump, and pump on pile structure in the stream.

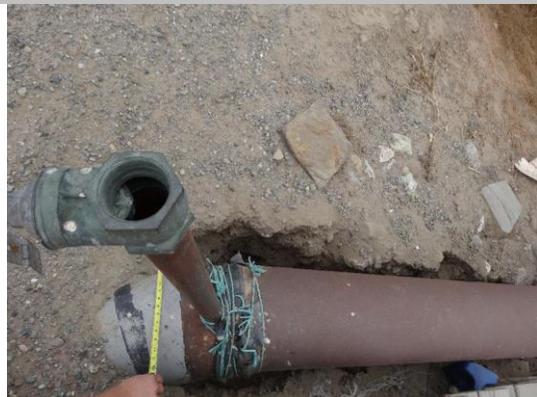
Photo 2 of 3 : UCIP_FA_2019_51361_44838.jpg

WS view: exposed pipe, air relief valve, and huge erosion on levee slope.

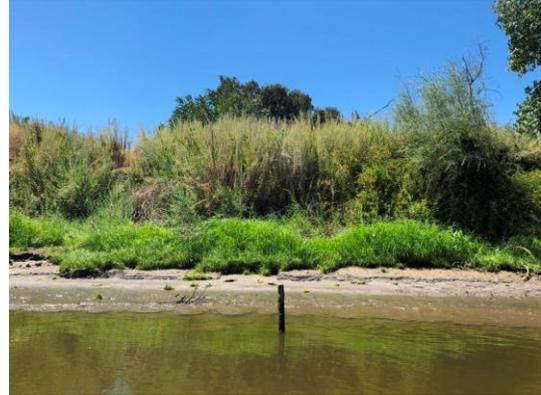
Photo 2 of 3 : SJR2019_RD0544U01RM49.67_2.jpg

Front view of the erosion.

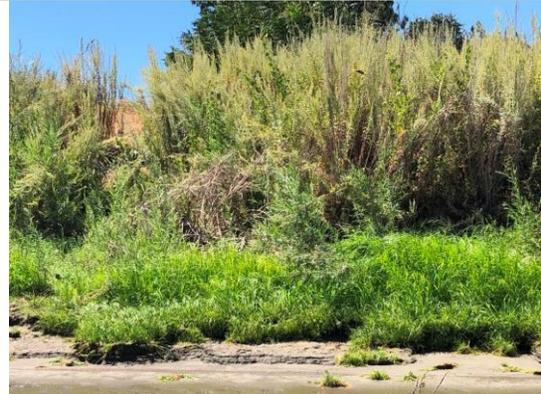
Photo 3 of 3 : SJR2019_RD0544U01RM49.67_3.jpg

Close-up view of the site.

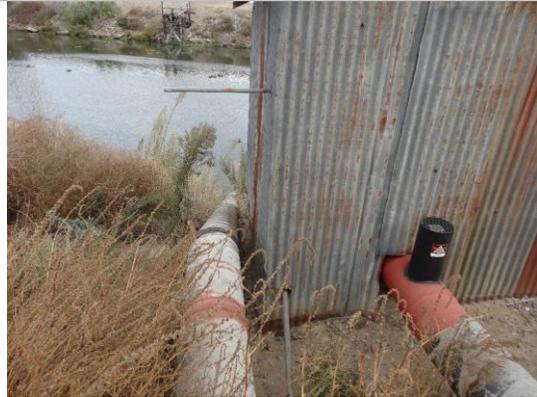
Photo 3 of 3 : UCIP_FA_2019_51366_44843.jpg

WS view: exposed steel pipe (right) with flow meter near pumphouse.

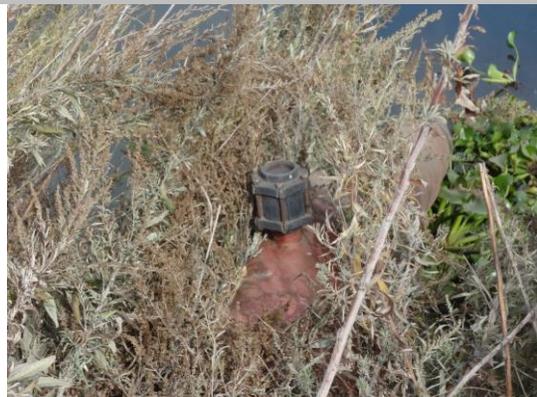
Photo 1 of 3 : UCIP_FA_2019_24892_44853.jpg

WS view: exposed steel pipe on bank of the channel.

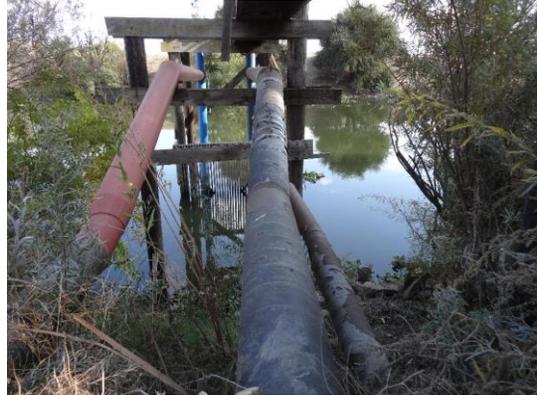
Photo 1 of 3 : UCIP_FA_2019_24893_44858.jpg

WS view: pipes, pumps, walkway to pump, and pile structure in the stream.

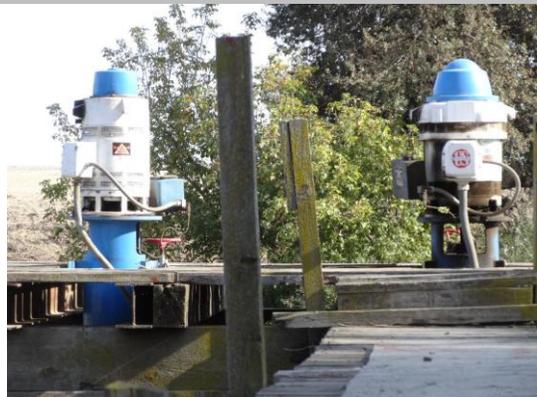
Photo 2 of 3 : UCIP_FA_2019_24893_44857.jpg

WS view: pumps, walkway to pump, and pile structure in the stream.

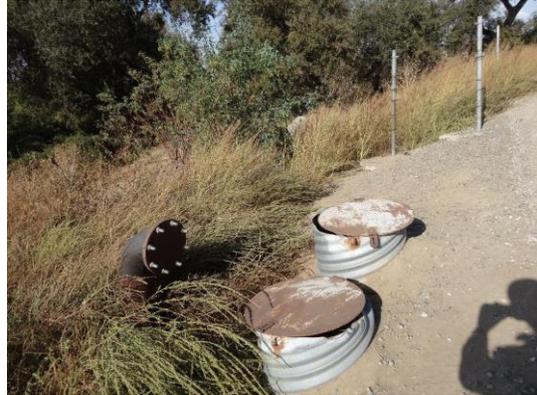
Photo 3 of 3 : UCIP_FA_2019_24893_44856.jpg

LS view: CMP riser (top- for 12" pipe), CMP riser (bottom- for 16" pipe), and capped steel pipe (left)

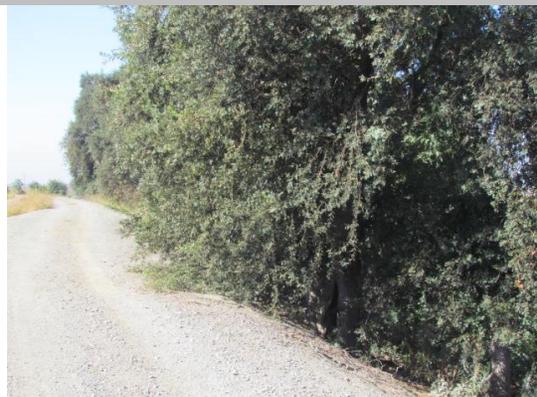
Photo 2 of 2 : FA_2019_RD0544_108_104_20190830_00058.jpg

Looking southwest at dense untrimmed trees on landward slope fall 2015.

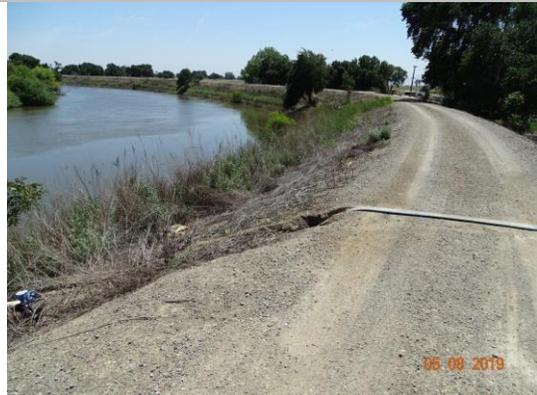
Photo 2 of 3 : FA_2019_RD0544_108_84_20190830_00046.jpg

View of 6 inch water line crossing the levee crown. (Spring 2019)

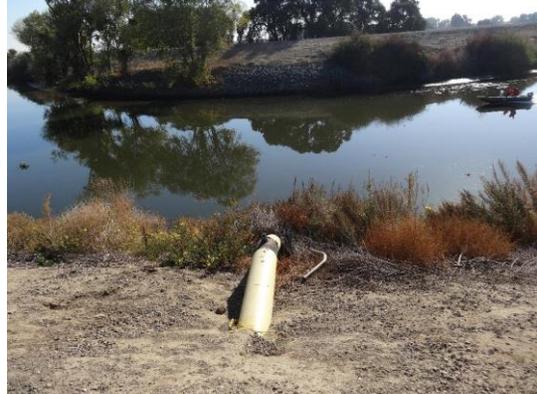
Photo 1 of 3 : UCIP_FA_2019_53364_44864.jpg

WS view: exposed steel pipe on levee slope.

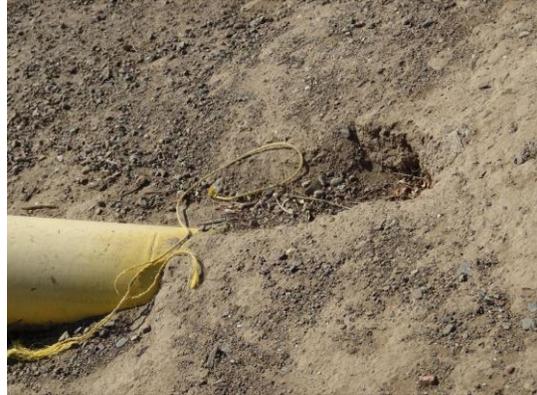
Photo 2 of 3 : UCIP_FA_2019_53364_44863.jpg

WS view: exposed steel pipe and a small depression on levee slope. May be due to leaky pipe.

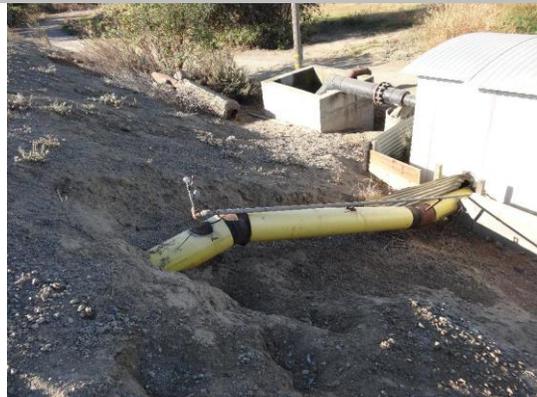
Photo 3 of 3 : UCIP_FA_2019_53364_44862.jpg

LS view: distribution box (top-left), pumphouse (right) and exposed leaky pipe on eroded levee slope.

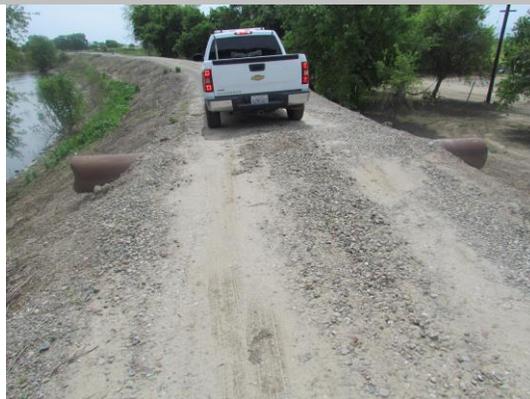
Photo 1 of 1 : FA_2019_RD0544_108_28_20190830_00016.jpg

Looking south at pipe across levee crown.

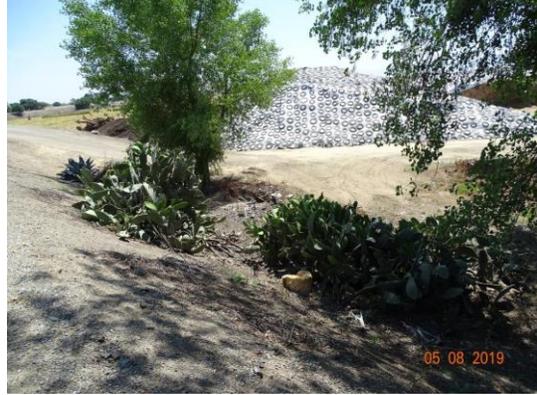
Photo 1 of 1 : FA_2019_RD0544_108_94_20190830_00055.jpg

View of cactus on landside slope. (Spring 2019)

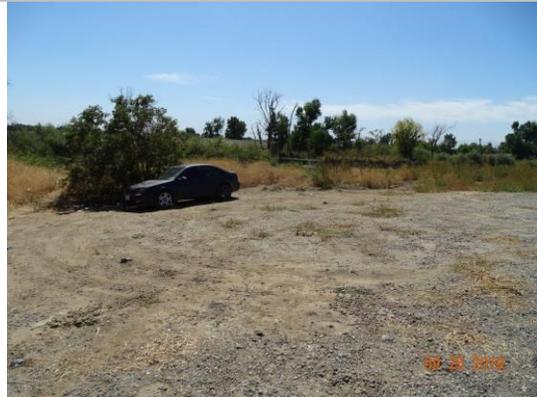
Photo 1 of 1 : FA_2019_RD0544_108_73_20191117_00160.jpg

View of abandoned vehicle on waterside easement. Fall 2019

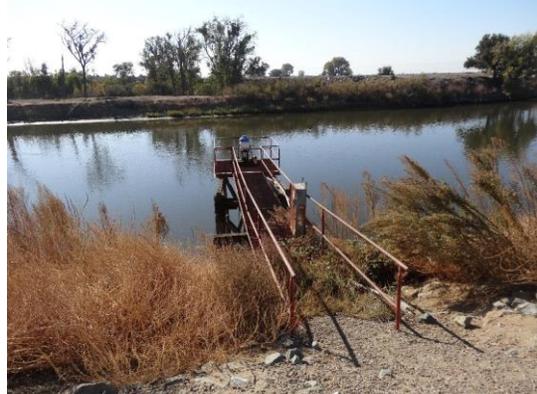
Photo 1 of 3 : UCIP_FA_2019_53365_42872.jpg

WS view: pump on pile structure, walkway to the pump on levee slope.

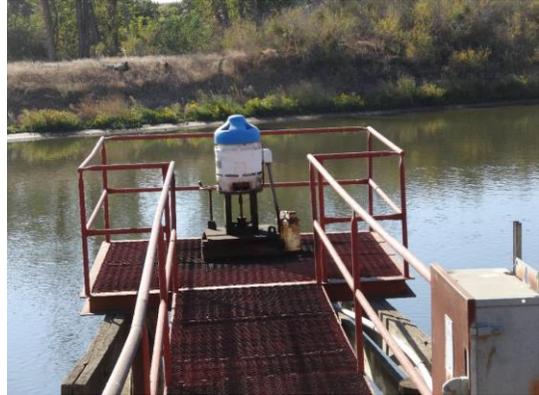
Photo 2 of 3 : UCIP_FA_2019_53365_42871.jpg

WS view: pump on pile structure in the stream. Oil leaking pump.

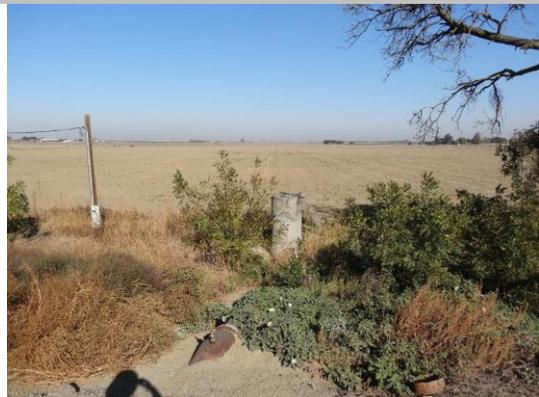
Photo 3 of 3 : UCIP_FA_2019_53365_42870.jpg

LS view: exposed pipe and pressure valve on levee slope. Two concrete standpipes on levee toe.

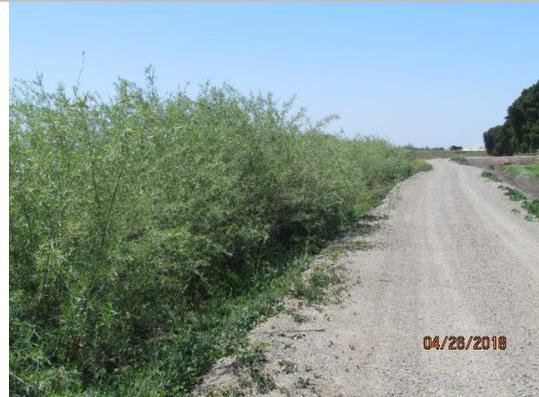
Photo 1 of 1 : FA_2019_RD0544_109_2_20190830_00002.jpg

View of vegetation on waterside slope. (Spring 2018)

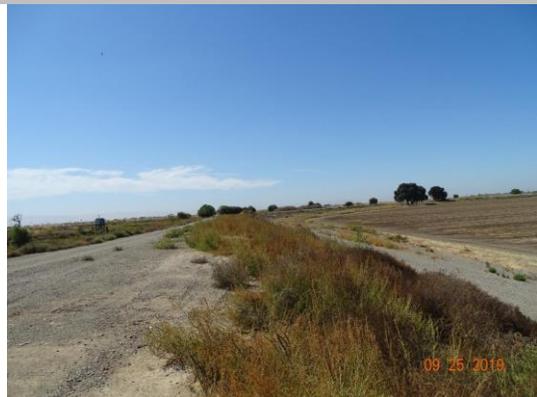
Photo 1 of 1 : FA_2019_RD0544_109_24_20191117_00111.jpg

Typical view of vegetation on landside slope. Fall 2019

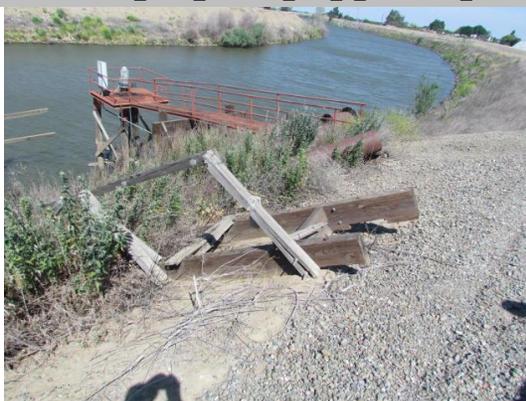
Photo 1 of 1 : FA_2019_RD0544_109_6_20190830_00003.jpg

Looking southeast at garbage on waterside shoulder and slope.

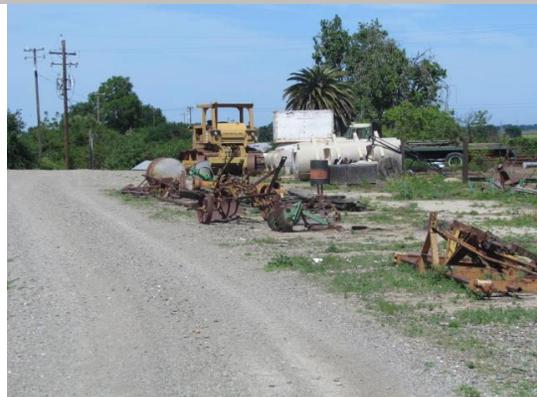
Photo 1 of 1 : FA_2019_RD0544_109_18_20190830_00009.jpg

LM Start	1.11	Rating **	M	Issue No.	18
LM End	1.22	Issue Type +	En	Location *	LS
Category	Earthen Levee			GPS Latitude/Longitude	
				Start	End
Item	Encroachments			37.819374°	37.820235°
				-121.333726°	-121.335268°
DWR ID	DWR_RD0544_02_s_2012_18				
Comment Code					
AV : Abandoned vehicles					
Inspector Comment					
Vehicles and farm equipment stored on landside for several years. Levee crown is an oversized width.

Looking southwest at farm equipment stored on landward landing. (spring 2016)

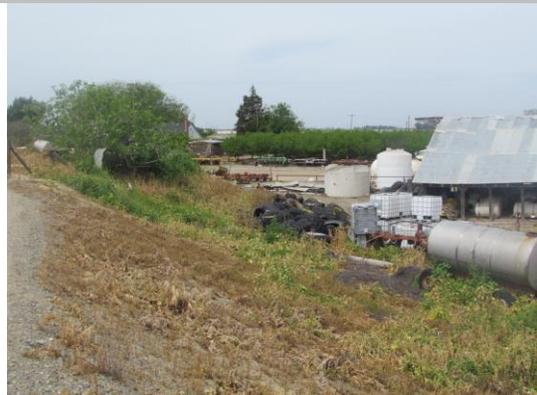
Photo 2 of 2 : FA_2019_RD0544_109_25_20190830_00014.jpg

Looking south at farm equipment stored on landward shoulder and slope.

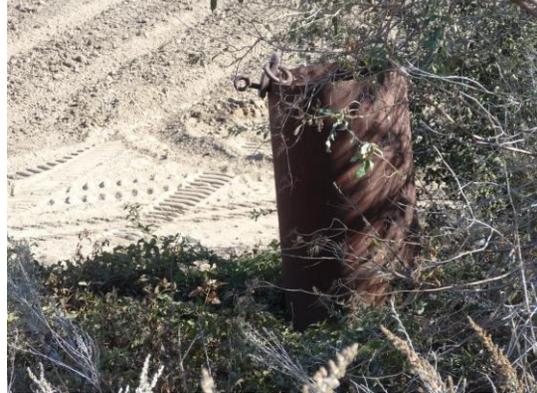
Photo 3 of 3 : UCIP_FA_2019_46674_44888.jpg

LS view: steel pipe riser off the levee toe.

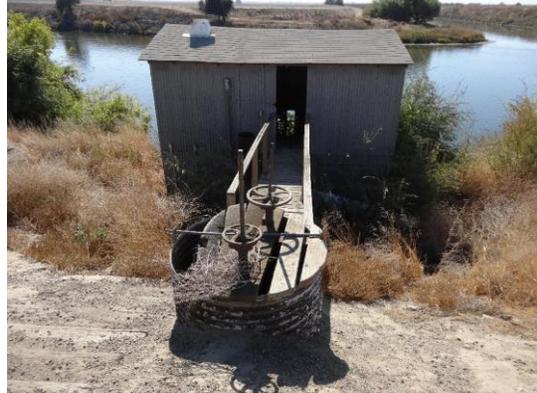
Photo 1 of 3 : UCIP_FA_2019_24288_42947.jpg

WS view: slide gate in CMP riser, walkway, and pumphouse on levee slope.

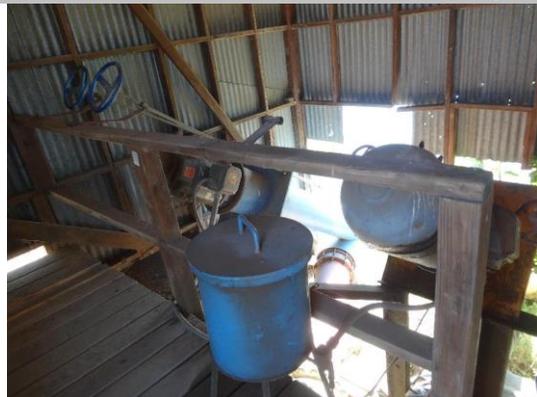
Photo 2 of 3 : UCIP_FA_2019_24288_42946.jpg

WS view: two pumps discharges water into CMP riser on levee slope.

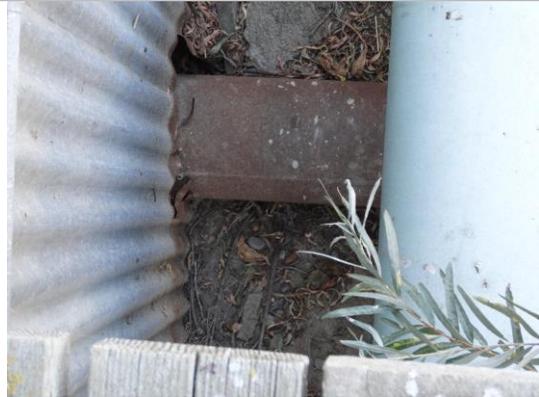
Photo 3 of 3 : UCIP_FA_2019_24288_42945.jpg

WS view: abandoned 10" steel pipe daylights on levee slope.

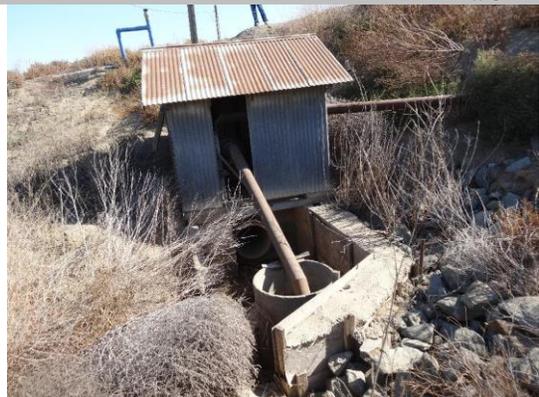
Photo 1 of 3 : UCIP_FA_2019_24907_44895.jpg

LS view: pipe, pump house, and appurtenances on levee slope.

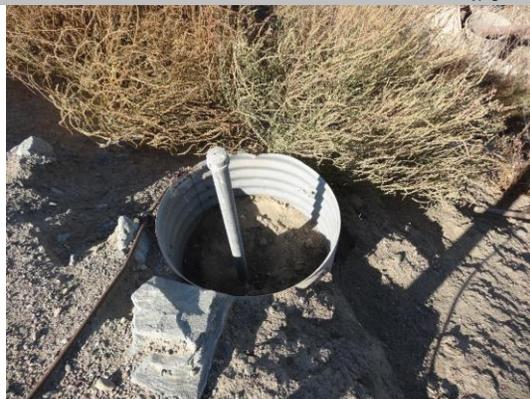
Photo 3 of 3 : UCIP_FA_2019_24907_44893.jpg

WS view: air vent on CMP riser on levee shoulder.

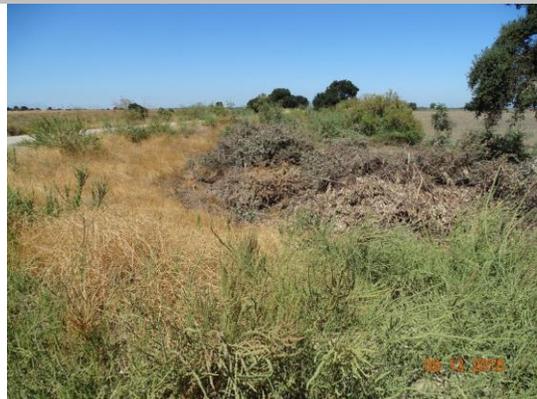
Photo 1 of 2 : FA_2019_RD0544_109_31_20190830_00018.jpg

Looking south at large pruning pile at landward toe. (Fall 2018)

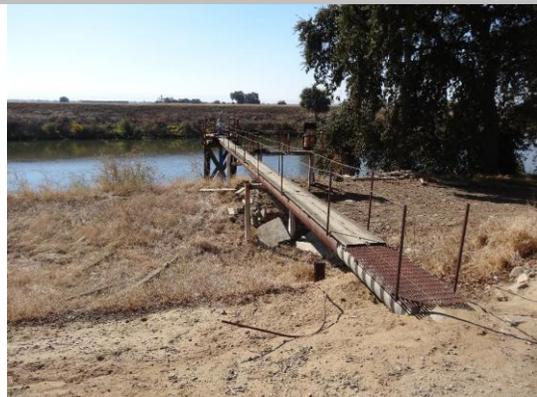
Photo 1 of 3 : UCIP_FA_2019_41731_42954.jpg

WS view: pipe, walkway, and pump on pile structure.

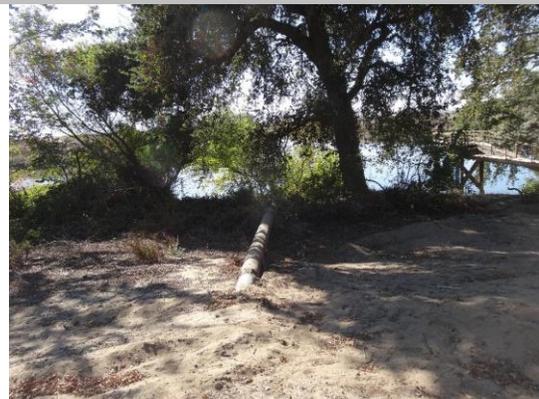
Photo 1 of 3 : UCIP_FA_2019_24293_42965.jpg

WS view: exposed steel pipe on berm.

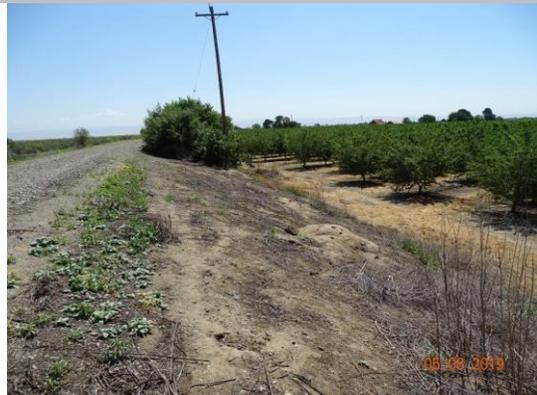
Photo 2 of 2 : FA_2019_RD0544_109_36_20190830_00023.jpg

View of landside slope with multiple animal burrows. (Spring 2019)

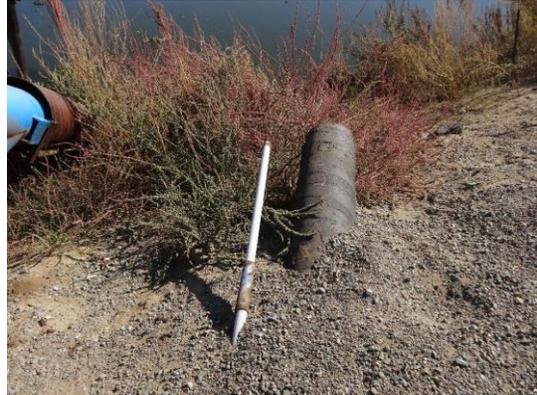
Photo 1 of 3 : UCIP_FA_2019_53173_42977.jpg

WS view: steel pipe and electric conduit on levee shoulder.

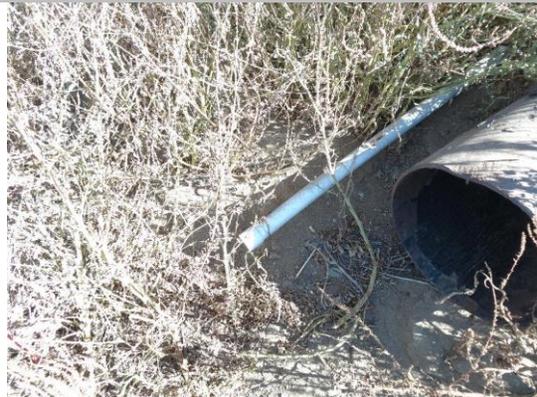
Photo 2 of 3 : UCIP_FA_2019_53173_42976.jpg

LS view: steel pipe and electric conduit on levee shoulder.

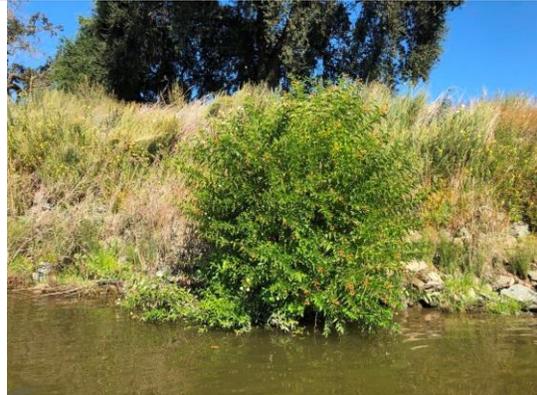
Photo 2 of 2 : SJR2019_RD0544U02RM32.91_2.jpg

Front view of the pocket erosion.

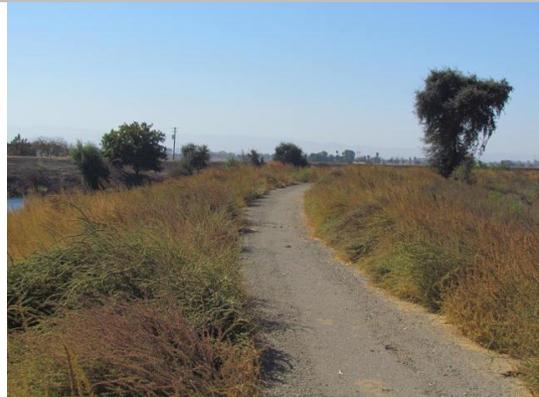
Photo 2 of 2 : FA_2019_RD0544_109_43_20190830_00028.jpg

Looking at dense vegetation on landward and waterward slope.

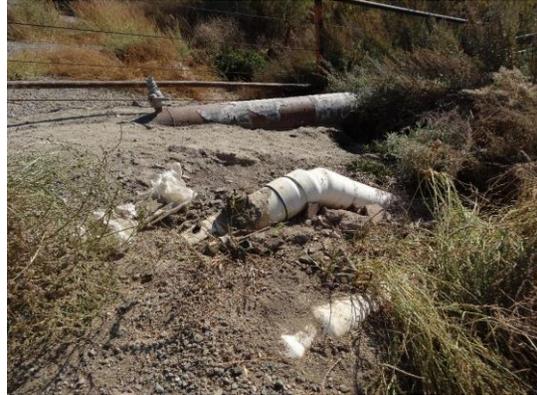
Photo 1 of 3 : UCIP_FA_2019_24908_44898.jpg

WS view: 12" steel pipe (top), two 8" white pvc pipes (bottom) on levee shoulder.

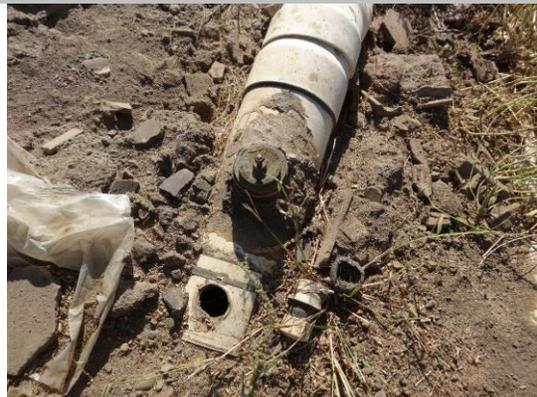
Photo 2 of 3 : UCIP_FA_2019_24908_44897.jpg

WS view: 8" white pvc pipe with siphon breaker on levee shoulder. An unplugged hole on the pipe.

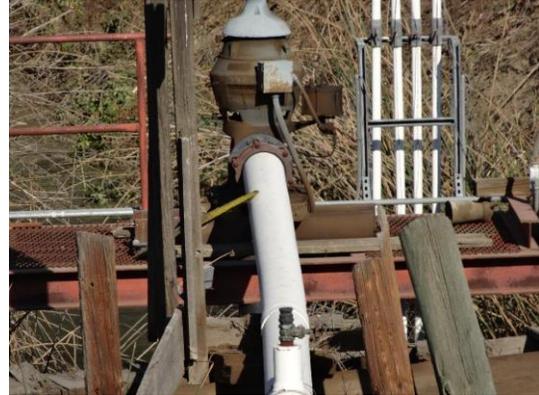
Photo 3 of 3 : UCIP_FA_2019_24908_44896.jpg

LS view: pump on steel platform over drainage ditch.

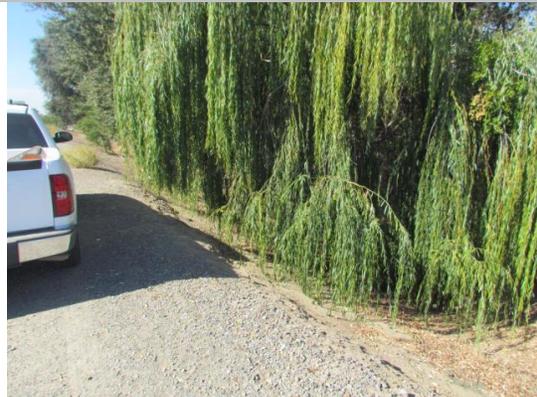
Photo 1 of 1 : FA_2019_RD0544_109_55_20190830_00030.jpg

Looking southwest at untrimmed trees on landward slope and toe, Fall 2015.

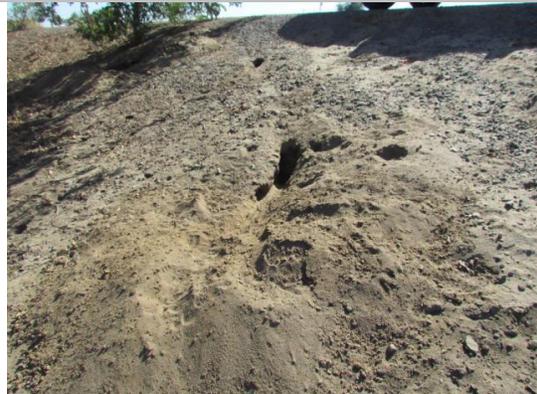
Photo 2 of 2 : FA_2019_RD0544_109_67_20190830_00033.jpg

Looking north at typical view of rodent holes on landward slope.
