**Flood Control Project Maintenance
Levee Inspections**

Maintenance Issue Types Only, Levee Inspection Report By Mile - Fall 2019

Reclamation District No. 0544 Upper Roberts Island

Waterway	Bank	Unit Miles	Inspection Start/End	Inspector
Unit No. 01 San Joaquin River	Left	6.05	09/25/2019 09/25/2019	Alberto De Leon

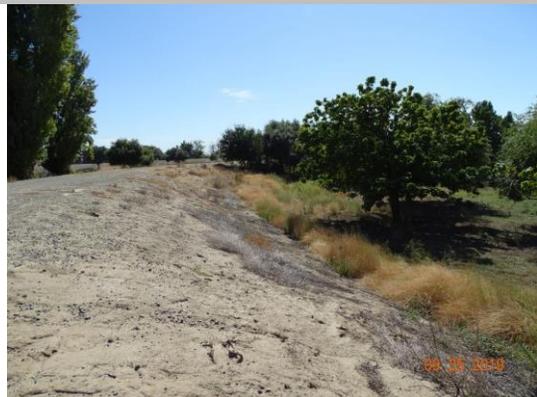
Photo 1 of 1 : FA_2019_RD0544_108_46_20191117_00153.jpg

Typical view of vegetation obstructing view of landside toe and easement. Fall 2019

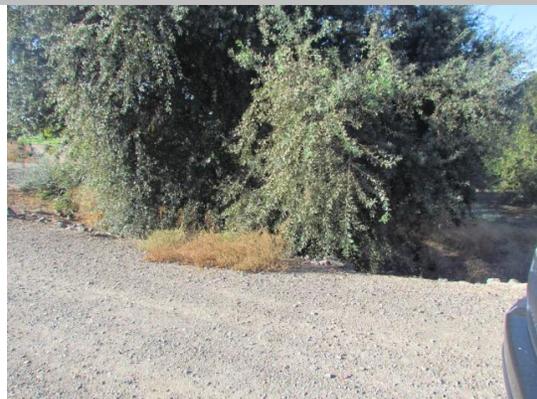
Photo 1 of 1 : FA_2019_RD0544_108_93_20190830_00054.jpg

LM Start	0.81	Rating **	M	Issue No.	93
LM End	0.81	Issue Type +	Ma	Location *	LS
Category	Earthen Levee			GPS Latitude/Longitude	
				Start	End
Item	Trim / Thin Trees			37.862694°	37.862694°
				-121.320887°	-121.320887°
DWR ID	DWR_RD0544_01_f_2014_93				
Comment Code					
T1 : Trim trees to at least five feet above ground level.					
Inspector Comment

Looking west at untrimmed trees on landward slope and toe, Fall 2015.

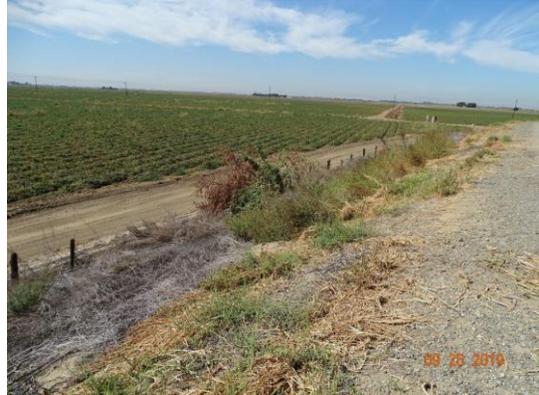
Photo 1 of 1 : FA_2019_RD0544_108_52_20191117_00154.jpg

Typical view of vegetation obstructing view of landside toe and easement. Fall 2019

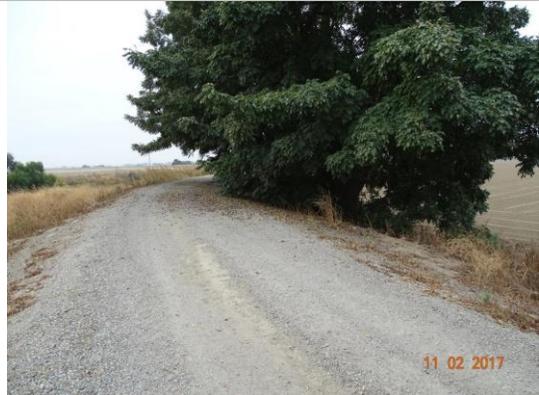
Photo 1 of 2 : FA_2019_RD0544_108_39_20190830_00021.jpg

LM Start	1.12	Rating **	M	Issue No.	39
LM End	1.12	Issue Type +	Ma	Location *	LS
Category	Earthen Levee		GPS Latitude/Longitude		
			Start	End	
Item	Trim / Thin Trees		37.859423°	37.859423°	
			-121.318328°	-121.318328°	
DWR ID	DWR_RD0544_01_s_2012_39				
Comment Code					
T1 : Trim trees to at least five feet above ground level.					
Inspector Comment					
There are untrimmed trees on the landside slope.

Looking southwest at landside slope.

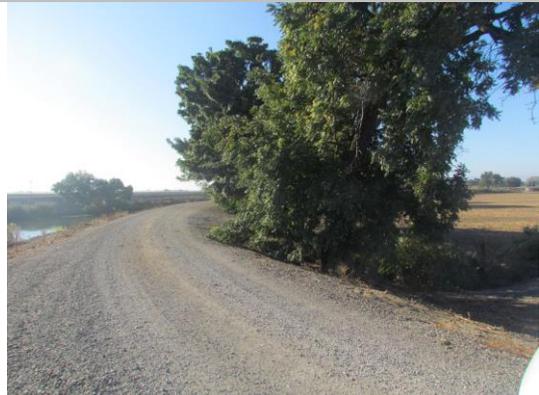
Photo 2 of 2 : FA_2019_RD0544_108_39_20190830_00022.jpg

Looking southwest at untrimmed tree on landward slope.

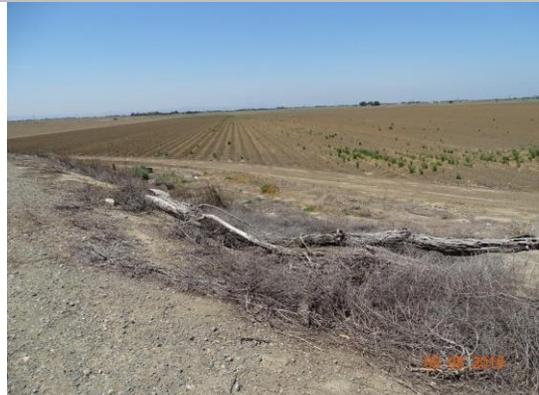
Photo 1 of 1 : FA_2019_RD0544_108_63_20190830_00033.jpg

View of tree limbs on landside slope. (Spring 2019)

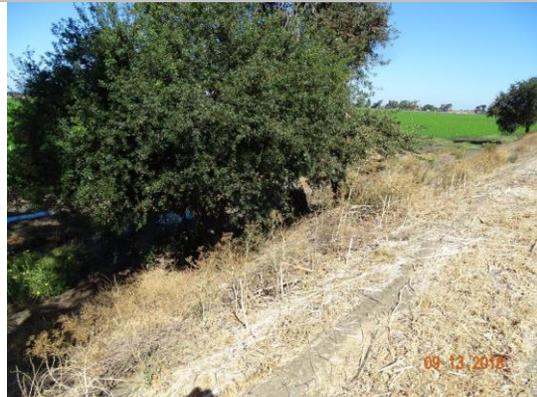
Photo 1 of 1 : FA_2019_RD0544_108_42_20190830_00023.jpg

Looking at untrimmed tree at landward toe. (Fall 2018)

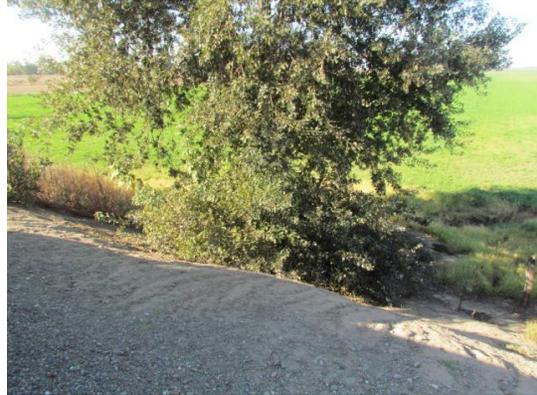
Photo 1 of 1 : FA_2019_RD0544_108_87_20190830_00050.jpg

Looking west at untrimmed tree at landward toe, Fall 2015.

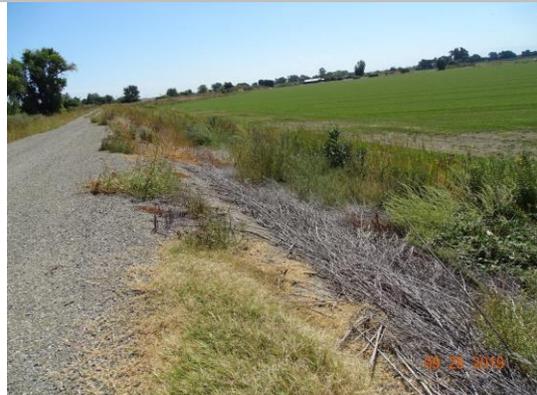
Photo 1 of 1 : FA_2019_RD0544_108_62_20191117_00155.jpg

LM Start	1.48	Rating **	M	Issue No.	62
LM End	6.04	Issue Type +	Ma	Location *	LS
Category	Earthen Levee		GPS Latitude/Longitude		
			Start	End	
Item	Vegetation		37.855049°	37.808780°	
			-121.321108°	-121.328154°	
DWR ID	DWR_RD0544_01_f_2019_62				
Comment Code					
V2 : Remove the wild growth other than native grasses from the levee slopes.					
Inspector Comment					
Visibility of the majority of the landside slope and easement is partially blocked due to tall grass and weeds.

Typical view of vegetation on landside slope and easement. Fall 2019

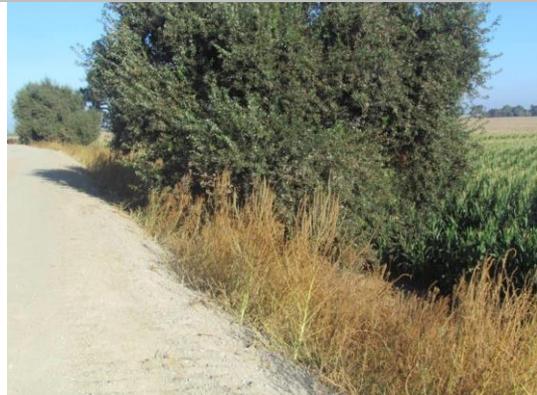
Photo 1 of 1 : FA_2019_RD0544_108_95_20190830_00056.jpg

LM Start	1.59	Rating **	M	Issue No.	95
LM End	1.59	Issue Type +	Ma	Location *	LS
Category	Earthen Levee		GPS Latitude/Longitude		
			Start	End	
Item	Trim / Thin Trees		37.854299°	37.854299°	
			-121.321865°	-121.321865°	
DWR ID	DWR_RD0544_01_s_2018_95				
Comment Code					
T1 : Trim trees to at least five feet above ground level.					
Inspector Comment					
There is an untrimmed tree on the landside slope.

Looking southwest at untrimmed tree on landward slope.

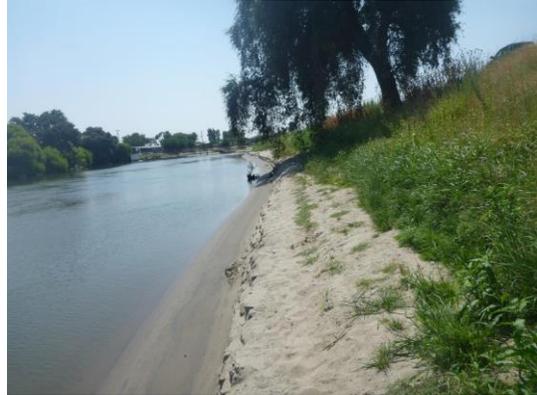
Photo 3 of 3 : LEVAL_FA_2019_569_4616.jpg

LM Start	1.89	Rating **	A/W	Issue No.	127 (cont)
LM End	1.91	Issue Type +	Ma	Location *	
Category	Supplemental			GPS Latitude/Longitude	
				Start	End
Item	2017 Storm Damage			37.852300°	37.852000°
				-121.323700°	-121.323600°
DWR ID	LMA-475				
Comment Code					
Inspector Comment					
Levee Evaluation Comments					
Description: Slope protection repairs are needed along the waterside slope due to erosion and riprap displacement from high water. Based upon levee inspections, it was determined the waterside levee slope is eroding, deteriorating, and degrading. The eroded levee sections need to be restored back to design standards to prevent further deterioration and damage.					
Site ID No: 569					
Site Designation: LMA-475					
Repair Type: Erosion					
Rating: Area of Concern					
Field Date: 8/10/2017					
Notes:

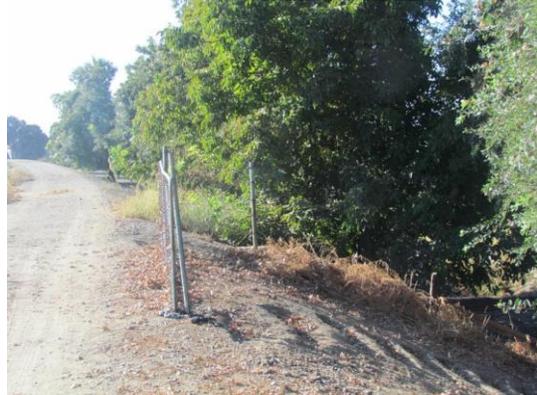
Photo 1 of 1 : FA_2019_RD0544_108_98_20190830_00057.jpg

Looking south at untrimmed trees on landward slope.

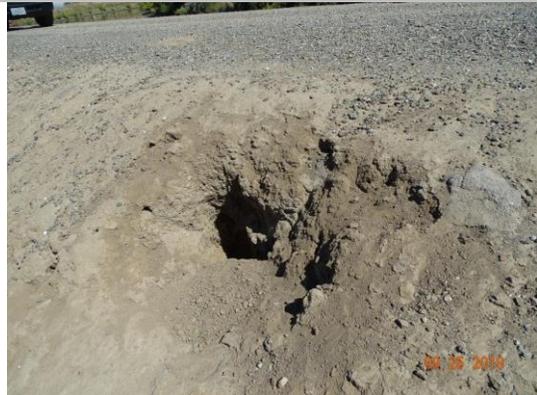
Photo 1 of 2 : FA_2019_RD0544_108_34_20191117_00158.jpg

LM Start	2.27	Rating **	U	Issue No.	34
LM End	2.36	Issue Type +	Ma	Location *	LS
Category	Earthen Levee		GPS Latitude/Longitude		
			Start	End	
Item	Animal Control		37.847973°	37.846743°	
			-121.324820°	-121.324336°	
DWR ID	DWR_RD0544_01_s_2012_34				
Comment Code					
A3 : No rodents visible, but rodent burrows visible; need to backfill and compact or grout burrows.					
Inspector Comment					
There are several rodent holes within this landside reach.

View of large rodent hole on landside slope. Fall 2019

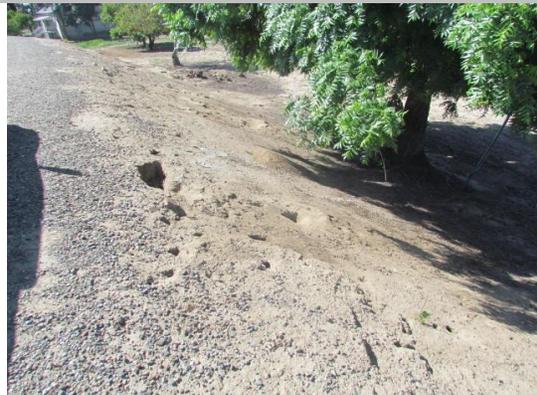
Photo 2 of 2 : FA_2019_RD0544_108_34_20190830_00018.jpg

Looking south at several rodent holes on landward shoulder and slope.

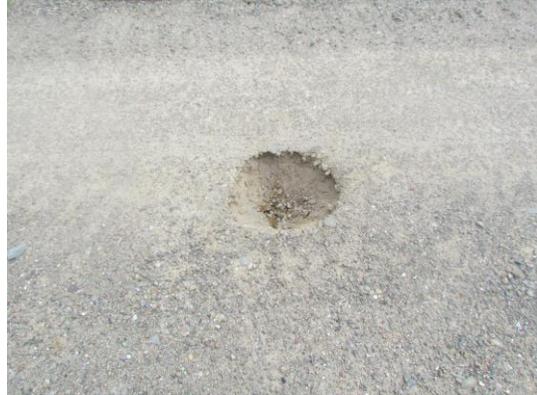
Photo 1 of 1 : FA_2019_RD0544_108_90_20190830_00052.jpg

LM Start	2.30	Rating **	M	Issue No.	90
LM End	2.30	Issue Type +	Ma	Location *	CR
Category	Earthen Levee			GPS Latitude/Longitude	
				Start	End
Item	Crown Surface / Depressions / Rutting			37.847542°	37.847542°
				-121.324732°	-121.324732°
DWR ID	DWR_RD0544_01_s_2019_90				
Comment Code					
C2 : Repair depressions or ruts in the crown or slope.					
Inspector Comment

Looking at pot hole on levee crown.

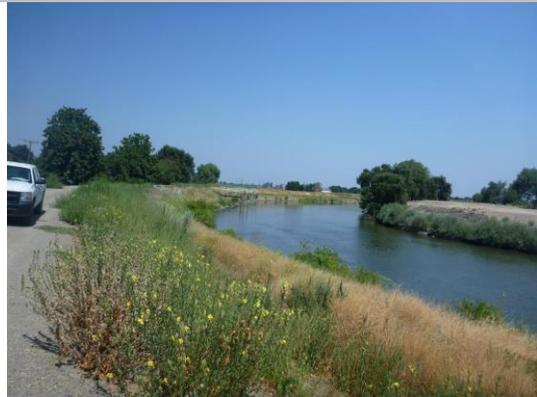
Photo 1 of 3 : LEVAL_FA_2019_568_4540.jpg

LM Start	2.31	Rating **	A/W	Issue No.	128
LM End	2.35	Issue Type +	Ma	Location *	
Category	Supplemental			GPS Latitude/Longitude	
				Start	End
Item	2017 Storm Damage			37.847300°	37.846800°
				-121.324700°	-121.324400°
DWR ID	LMA-474				
Comment Code					
Inspector Comment					
Levee Evaluation Comments					
Description:Slope protection repairs are needed along the waterside slope due to erosion and riprap displacement from high water. Based upon levee inspections, it was determined the waterside levee slope is eroding, deteriorating, and degrading. The eroded levee sections need to be restored back to design standards to prevent further deterioration and damage.					
Site ID No:568					
Site Designation:LMA-474					
Repair Type: Erosion					
Rating:Area of Concern					
Field Date:8/10/2017					
Notes:

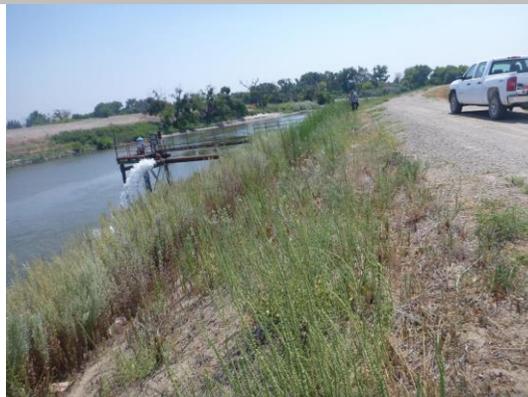
Photo 1 of 3 : LEVAL_FA_2019_567_4552.jpg

LM Start	2.53	Rating **	A/W	Issue No.	129
LM End	2.56	Issue Type +	Ma	Location *	
Category	Supplemental			GPS Latitude/Longitude	
				Start	End
Item	2017 Storm Damage			37.844900 °	37.844500 °
				-121.322300 °	-121.321900 °
DWR ID	LMA-473				
Comment Code					
Inspector Comment					
Levee Evaluation Comments					
Description:Slope protection repairs are needed along the waterside slope due to erosion and riprap displacement from high water. Based upon levee inspections, it was determined the waterside levee slope is eroding, deteriorating, and degrading. The eroded levee sections need to be restored back to design standards to prevent further deterioration and damage.					
Site ID No:567					
Site Designation:LMA-473					
Repair Type: Erosion					
Rating:Area of Concern					
Field Date:8/10/2017					
Notes: large rodent holes observed on landside slope.

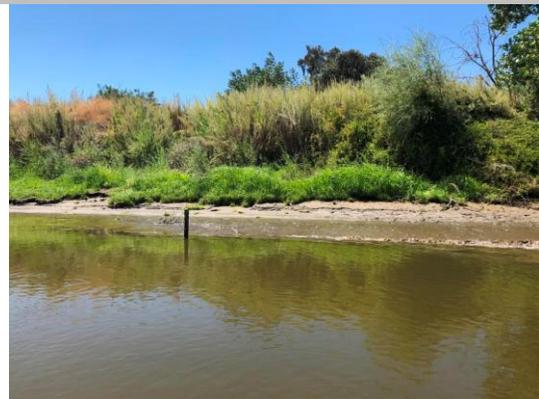
Photo 1 of 3 : SJR2019_RD0544U01RM49.67_1.jpg

LM Start	2.94	Rating **	M	Issue No.	5
LM End	2.94	Issue Type +	Ma	Location *	
Category	Supplemental		GPS Latitude/Longitude		
			Start	End	
Item	DWR Erosion Survey		37.840697°	37.840697°	
			-121.318252°	-121.318252°	
DWR ID	RD0544U01RM49.67				
Comment Code					
Inspector Comment					
Site ID: RD0544U01RM49.67 08/13/2019: No significant change observed. 09/13/2017: No significant change observed. 07/25/2016: No significant change observed. 06/24/2015: No significant change observed. 06/19/2014: No significant change observed. 08/13/2013: Pump has been removed. A larger pocket erosion has been found at the erosion site. 08/07/2012: The erosion is immediately upstream of a river bend. Dense vegetation is visible at the erosion site.

Front view of the erosion.

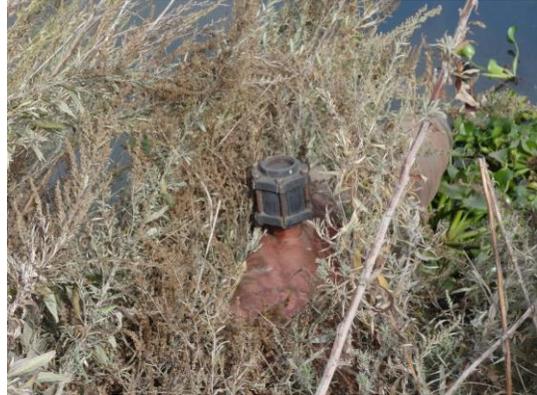
Photo 1 of 3 : UCIP_FA_2019_24892_44853.jpg

Comment Code					
Inspector Comment					
DS_ID:22658 FS_ID:24892 EP_NO: N/A Repair Type: No Action Needed Crossing Status: Found UCIP Comments: - pipe on channel bank looks comparatively new.- pump approximately 500 ft. from the levee center on landside in drainage ditch.- a tall concrete standpipe and service pole near the pump. FIELD_STRUCT_DESC: 12-inch steel drainage discharge pipe through the levee, 3 feet below the crown. Pump and concrete standpipe in a drainage ditch on the landside (LS). Air vent on the waterside (WS). [Additional Reference(s): DWR Levee Log, 2005. USACE San Joaquin O&M Manual 7, April 1964, (HLM 3.53)]. FS Date: 10/29/2013

WS view: exposed steel pipe on bank of the channel.

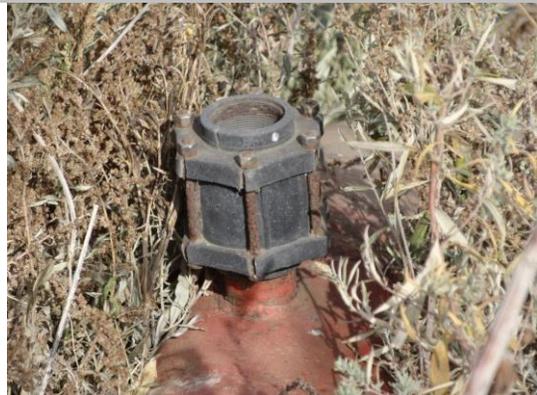
Photo 2 of 3 : UCIP_FA_2019_24892_44852.jpg

WS view: exposed steel pipe and air vent on the pipe.

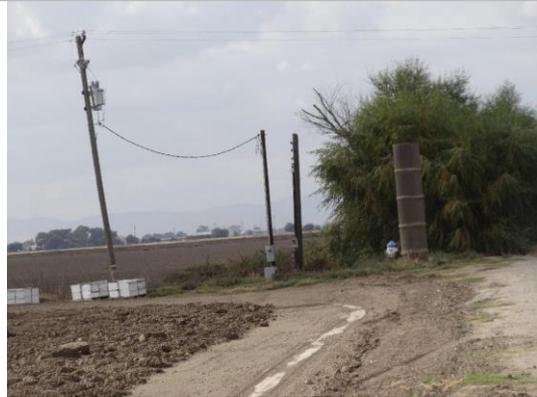
Photo 3 of 3 : UCIP_FA_2019_24892_44851.jpg

LS view: service pole, pump, and a concrete standpipe on bank of drainage ditch about 500 ft from the levee.

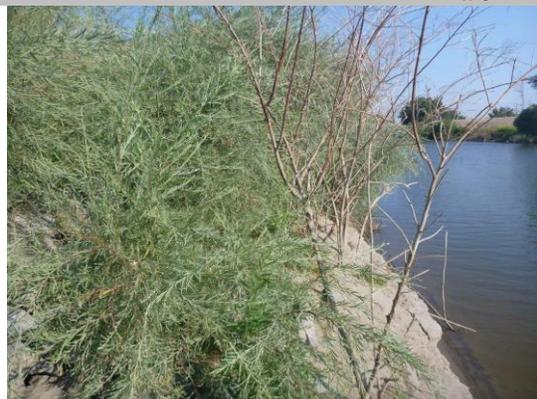
Photo 1 of 3 : LEVAL_FA_2019_565_4739.jpg

LM Start	3.65	Rating **	A/W	Issue No.	132
LM End	3.67	Issue Type +	Ma	Location *	
Category	Supplemental		GPS Latitude/Longitude		
			Start	End	
Item	2017 Storm Damage		37.831800°	37.831600°	
			-121.312700°	-121.312600°	
DWR ID	LMA-471				
Comment Code					
Inspector Comment					
Levee Evaluation Comments Description:Slope protection repairs are needed along the waterside slope due to erosion and riprap displacement from high water. Based upon levee inspections, it was determined the waterside levee slope is eroding, deteriorating, and degrading. The eroded levee sections need to be restored back to design standards to prevent further deterioration and damage. Site ID No:565 Site Designation:LMA-471 Repair Type: Erosion Rating:Area of Concern Field Date:8/11/2017 Notes: dense shrubs on levee slope

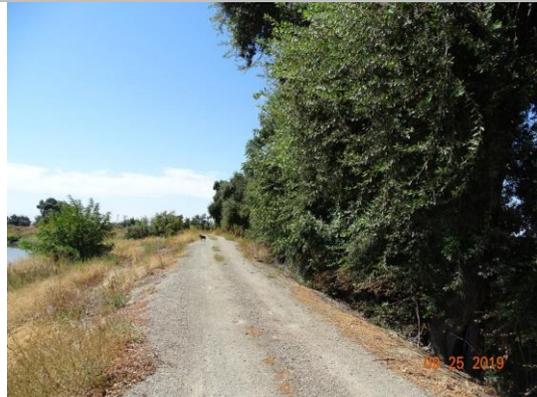
Photo 1 of 2 : FA_2019_RD0544_108_104_20191117_00164.jpg

View of untrimmed trees on landside slope. Fall 2019

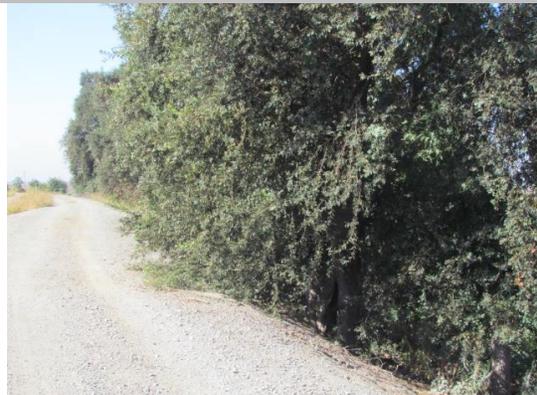
Photo 2 of 2 : FA_2019_RD0544_108_104_20190830_00058.jpg

Looking southwest at dense untrimmed trees on landward slope fall 2015.

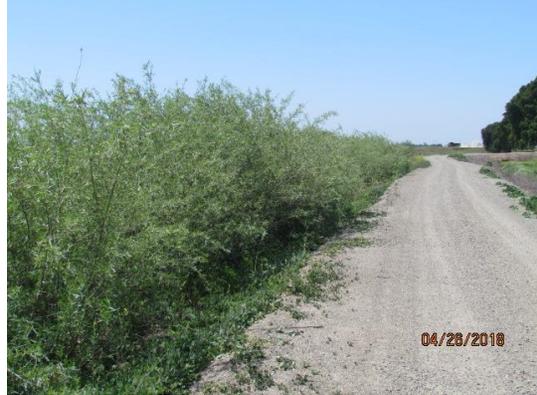
Photo 1 of 1 : FA_2019_RD0544_109_2_20190830_00002.jpg

View of vegetation on waterside slope. (Spring 2018)

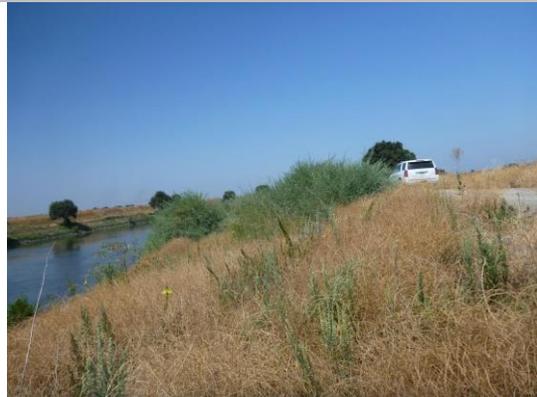
Photo 1 of 3 : LEVAL_FA_2019_556_4520.jpg

LM Start	0.21	Rating **	A/W	Issue No.	37
LM End	0.23	Issue Type +	Ma	Location *	
Category	Supplemental		GPS Latitude/Longitude		
			Start	End	
Item	2017 Storm Damage		37.808300 °	37.808400 °	
			-121.332000 °	-121.332200 °	
DWR ID	LMA-462				
Comment Code					
Inspector Comment					
Levee Evaluation Comments					
Description:Slope protection repairs are needed along the waterside slope due to erosion and riprap displacement from high water. Based upon levee inspections, it was determined the waterside levee slope is eroding, deteriorating, and degrading. The eroded levee sections need to be restored back to design standards to prevent further deterioration and damage.					
Site ID No:556					
Site Designation:LMA-462					
Repair Type: Erosion					
Rating:Area of Concern					
Field Date:8/16/2017					
Notes:

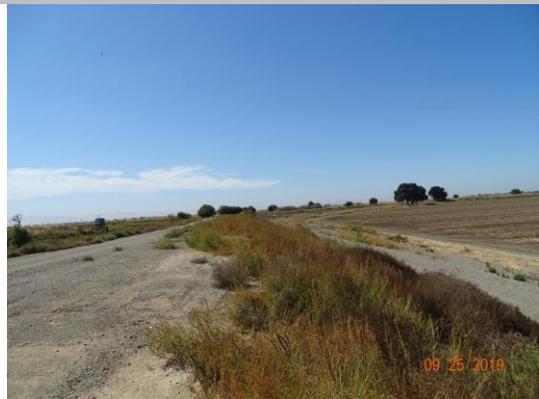
Photo 1 of 1 : FA_2019_RD0544_109_24_20191117_00111.jpg

Typical view of vegetation on landside slope. Fall 2019

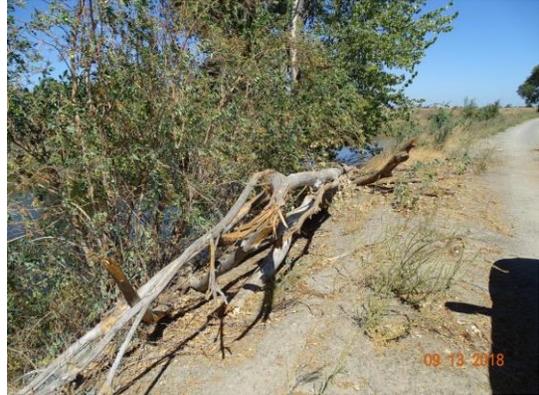
Photo 1 of 2 : FA_2019_RD0544_109_27_20190830_00016.jpg

Looking southeast at tree limbs on waterward shoulder. (Fall 2018)

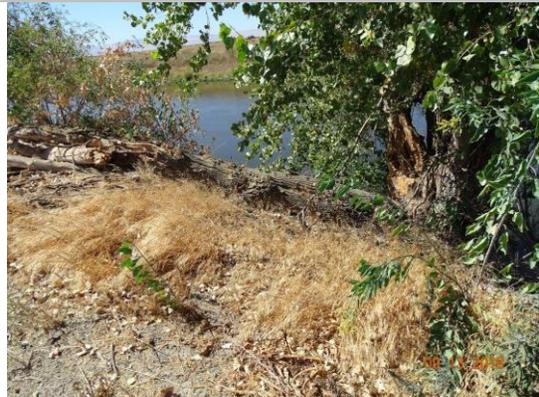
Photo 2 of 2 : FA_2019_RD0544_109_27_20190830_00017.jpg

Looking east at tree bank on waterside slope. (Fall 2018)

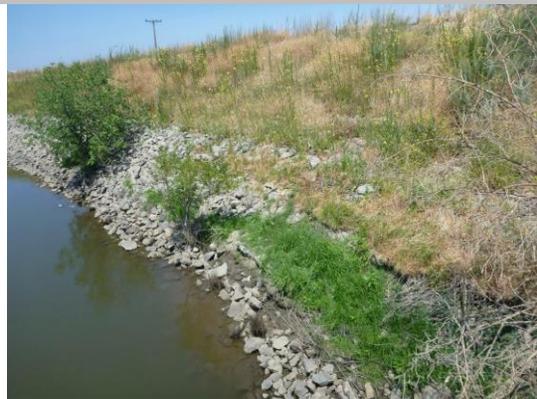
Photo 1 of 3 : LEVAL_FA_2019_552_4810.jpg

LM Start	1.01	Rating **	A/W	Issue No.	82
LM End	1.02	Issue Type +	Ma	Location *	
Category	Supplemental		GPS Latitude/Longitude		
			Start	End	
Item	2017 Storm Damage		37.818100°	37.818200°	
			-121.332800°	-121.332800°	
DWR ID	LMA-458				
Comment Code					
Inspector Comment					
Levee Evaluation Comments					
Description:Slope protection repairs are needed along the waterside slope due to erosion and riprap displacement from high water. Based upon levee inspections, it was determined the waterside levee slope is eroding, deteriorating, and degrading. The eroded levee sections need to be restored back to design standards to prevent further deterioration and damage.					
Site ID No:552					
Site Designation:LMA-458					
Repair Type: Erosion					
Rating:Area of Concern					
Field Date:8/16/2017					
Notes:

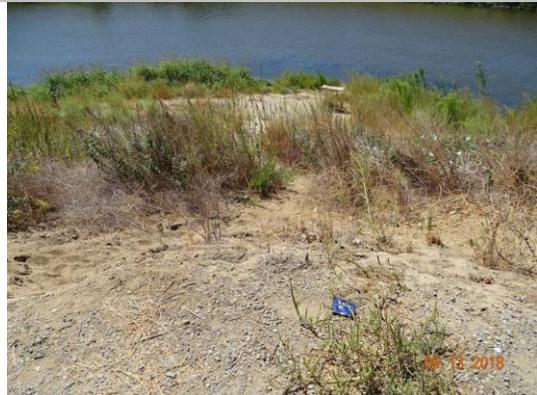
Photo 1 of 1 : FA_2019_RD0544_109_34_20190830_00021.jpg

LM Start	1.91	Rating **	A/W	Issue No.	34
LM End	1.91	Issue Type +	Ma	Location *	WS
Category	Earthen Levee		GPS Latitude/Longitude		
			Start	End	
Item	Slope Stability		37.817658°	37.817658°	
			-121.342097°	-121.342097°	
DWR ID	DWR_RD0544_02_f_2018_34				
Comment Code					
S2 : Repair the levee slope damaged by foot traffic and prevent access where possible.					
Inspector Comment					
Erosion is caused by foot traffic.

Looking east at foot erosion on waterward slope. (Fall 2018)

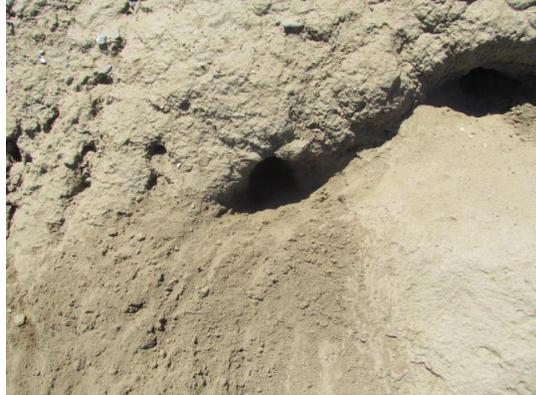
Photo 1 of 1 : FA_2019_RD0544_109_58_20190830_00031.jpg

Looking at typical rodent holes on landward slope.

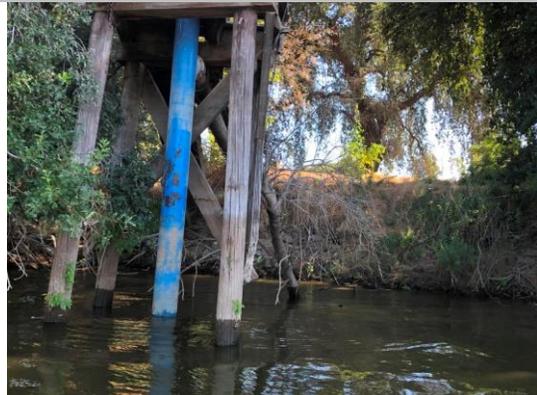
Photo 1 of 3 : SJR2019_RD0544U02RM33.21_1.jpg

LM Start	2.31	Rating **	M	Issue No.	7
LM End	2.31	Issue Type +	Ma	Location *	
Category	Supplemental		GPS Latitude/Longitude		
			Start	End	
Item	DWR Erosion Survey		37.821763°	37.821763°	
			-121.347275°	-121.347275°	
DWR ID	RD0544U02RM33.21				
Comment Code					
Inspector Comment					
Site ID: RD0544U02RM33.21 08/14/2019: No significant change observed. 09/13/2017: No significant change observed. 07/25/2016: No significant change observed. 06/25/2015: No significant change observed. 07/02/2014: No significant change observed. 08/20/2013: No significant change observed. 08/07/2012: The site was first reported in 2012 spring levee inspection report. The data were estimated as the site is underneath an irrigation pump station and is inaccessible by boat or land survey. It's possible the pump station played a role in the erosion.

Front view of the erosion site. View is partially blocked by the pump structure and vegetation at the site.

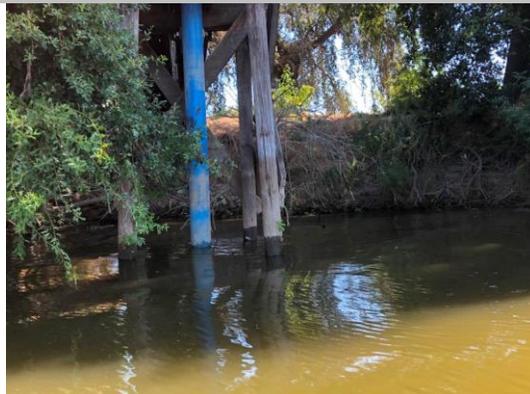
Photo 2 of 3 : SJR2019_RD0544U02RM33.21_2.jpg

Front view of the site.

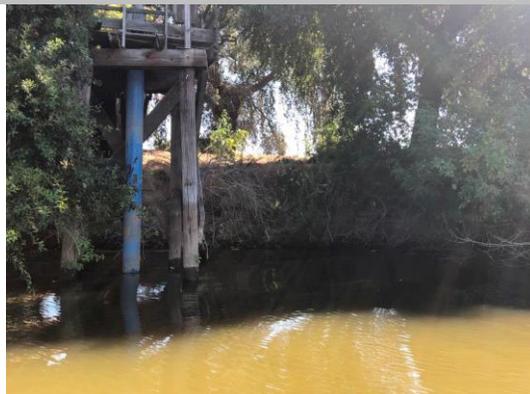
Photo 3 of 3 : SJR2019_RD0544U02RM33.21_3.jpg

Close-up view of the site.

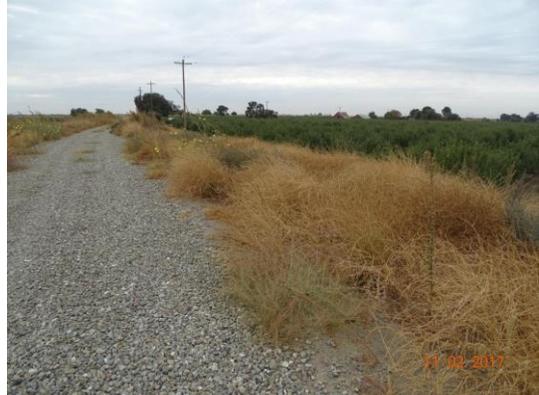
Photo 1 of 1 : FA_2019_RD0544_109_73_20190830_00042.jpg

LM Start	2.41	Rating **	U	Issue No.	73
LM End	2.59	Issue Type +	Ma	Location *	LS
Category	Earthen Levee			GPS Latitude/Longitude	
				Start	End
Item	Vegetation			37.821423 °	37.819153 °
				-121.348849 °	-121.350231 °
DWR ID	DWR_RD0544_02_f_2017_73				
Comment Code					
V2 : Remove the wild growth other than native grasses from the levee slopes.					
Inspector Comment

Looking southwest at the landside slope.

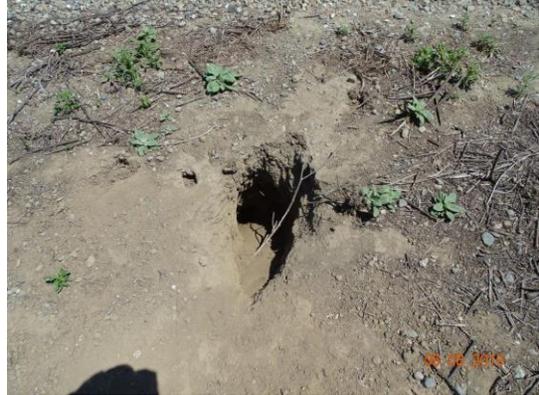
Photo 1 of 2 : FA_2019_RD0544_109_36_20190830_00022.jpg

View of animal burrow on landside slope. (Spring 2019)

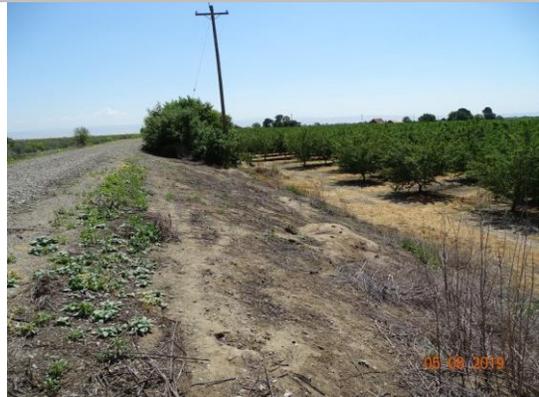
Photo 2 of 2 : FA_2019_RD0544_109_36_20190830_00023.jpg

View of landside slope with multiple animal burrows. (Spring 2019)

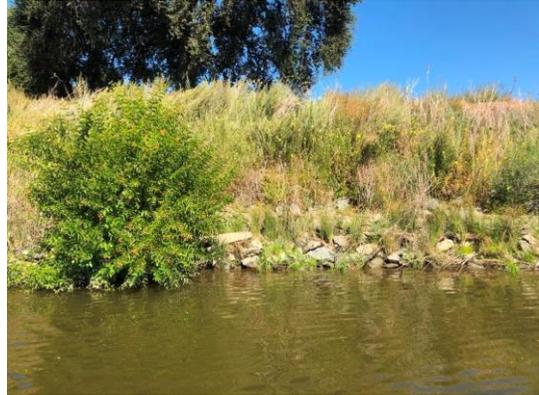
Photo 1 of 2 : SJR2019_RD0544U02RM32.91_1.jpg

Front view of the pocket erosion. Note vegetation and riprap at the site.

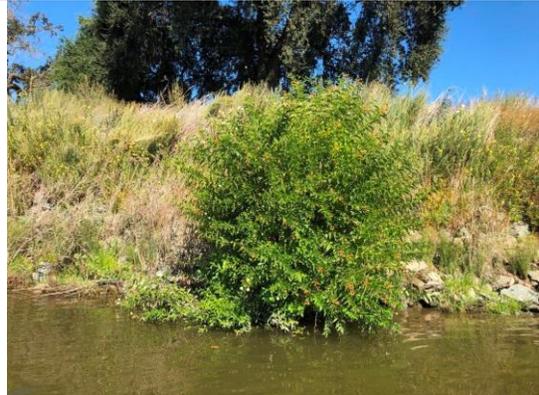
Photo 2 of 2 : SJR2019_RD0544U02RM32.91_2.jpg

Front view of the pocket erosion.

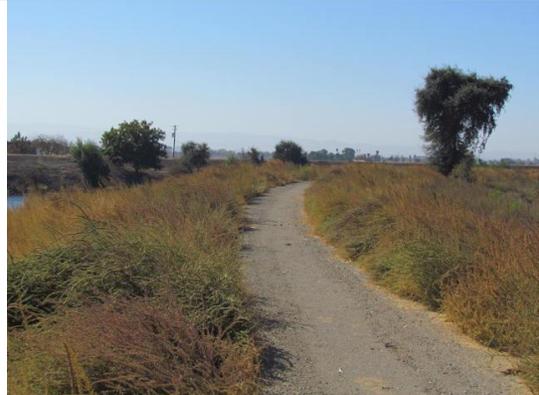
Photo 2 of 2 : FA_2019_RD0544_109_43_20190830_00028.jpg

Looking at dense vegetation on landward and waterward slope.

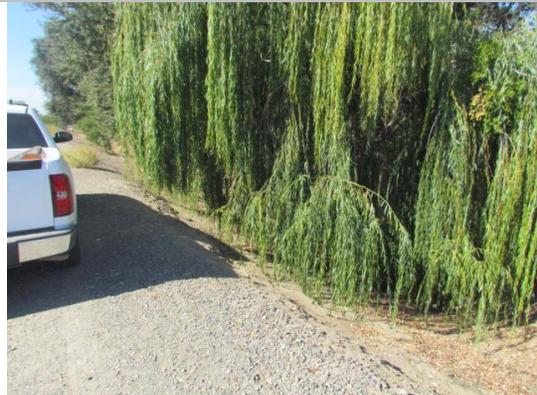
Photo 1 of 1 : FA_2019_RD0544_109_55_20190830_00030.jpg

Looking southwest at untrimmed trees on landward slope and toe, Fall 2015.

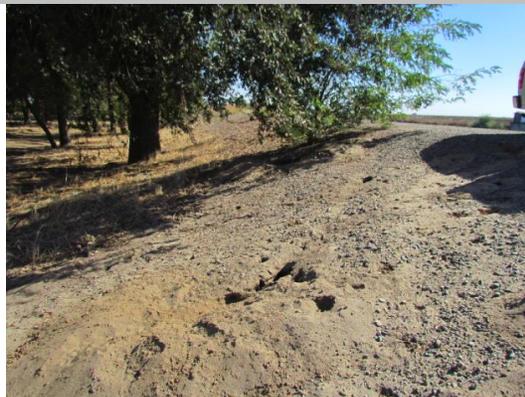
Photo 1 of 2 : FA_2019_RD0544_109_67_20190830_00032.jpg

LM Start	3.58	Rating **	M	Issue No.	67
LM End	3.58	Issue Type +	Ma	Location *	LS
Category	Earthen Levee			GPS Latitude/Longitude	
				Start	End
Item	Animal Control			37.819419 °	37.819419 °
				-121.365854 °	-121.365854 °
DWR ID	DWR_RD0544_02_f_2015_67				
Comment Code					
A3 : No rodents visible, but rodent burrows visible; need to backfill and compact or grout burrows.					
Inspector Comment					
Large rodent holes on landward slope.

Looking northeast at typical view of rodent holes on landward slope.

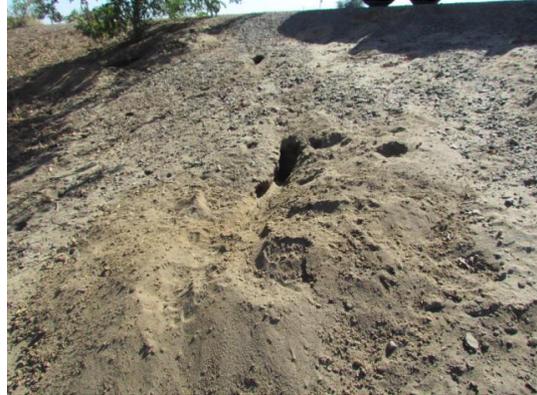
Photo 2 of 2 : FA_2019_RD0544_109_67_20190830_00033.jpg

Looking north at typical view of rodent holes on landward slope.
