**Flood Control Project Maintenance  
Levee Inspections**

**Fall 2019 Levee Maintenance Deficiency Summary Report**

**Sacramento River Basin**

**Reclamation District No. 0551 Pearson**

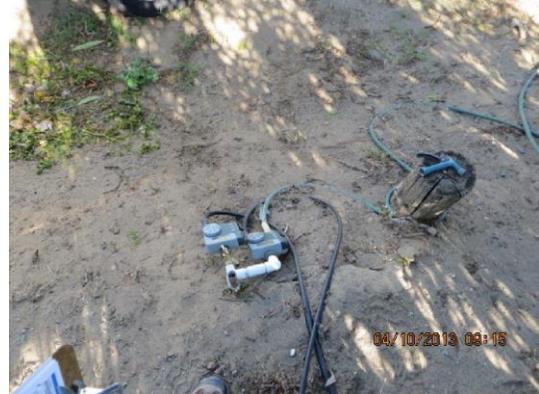
Photo 1 of 3 : UCIP\_FA\_2019\_11705\_19145.jpg

LM Start	<b>0.41</b>	Rating **	M	Issue No.	<b>70</b>
LM End	<b>0.41</b>	Issue Type +	En	Location *	
Category	Supplemental			GPS Latitude/Longitude	
				Start	End
Item	DRAFT DWR UCIP Field Study			38.332039°	38.332039°
				-121.569730°	-121.569730°
DWR ID	21982				
Comment Code					
Inspector Comment					
DS_ID:21982 FS_ID:11705 EP_NO: 2759 Repair Type: Non-Urgent Crossing Status: Found UCIP Comments: Unclear where exact crossing is located. FIELD_STRUCT_DESC: [Courtland Boating Facilities] 1-inch steel water line through the levee, at an unknown depth. Ramp and boating facilities on the waterside (WS). Pipe visible under buildings at concrete foundation on the landside (LS). Water service connections for irrigation located on the WS slope. (Permit No. 2759, 1958 - Courtland Dock). [Additional Reference(s): DWR Levee Log, 2005]. FS Date: 4/10/2013

Irrigation pipes on WS slope.

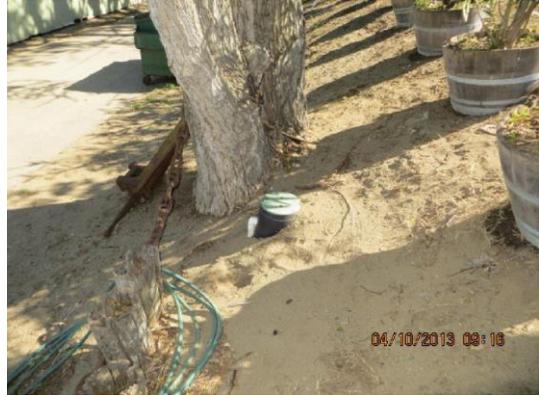
Photo 2 of 3 : UCIP\_FA\_2019\_11705\_19144.jpg

Irrigation pipes on WS slope.

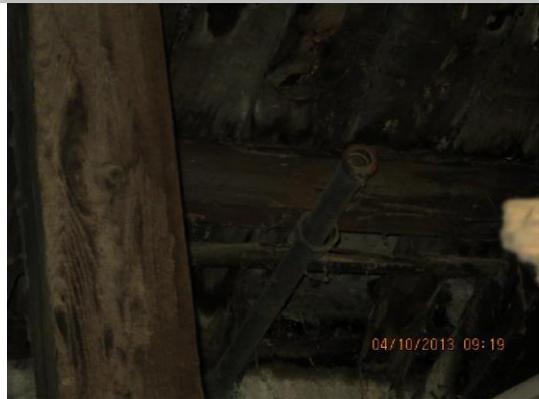
Photo 3 of 3 : UCIP\_FA\_2019\_11705\_19143.jpg

Various disconnected pipes visible at foundation/retaining wall under buildings on LS.

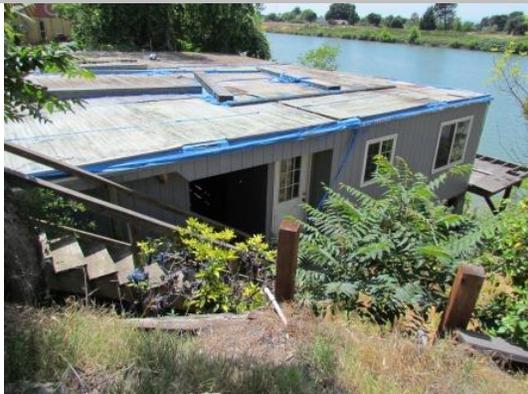
Photo 1 of 3 : FA\_2019\_RD0551\_175\_21\_20190826\_00006.jpg

Building and steps waterward. Photo taken 01-04-2014.

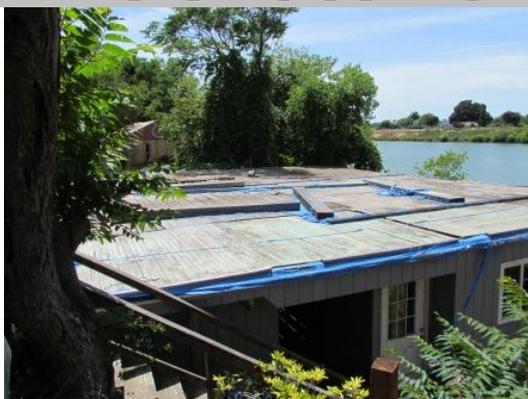
Photo 2 of 3 : FA\_2019\_RD0551\_175\_21\_20190826\_00007.jpg

Building remodeling project on waterside levee section. Photo taken 01-04-2014.

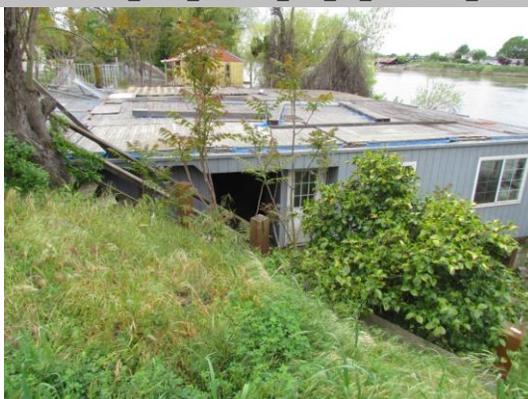
Photo 3 of 3 : FA\_2019\_RD0551\_175\_21\_20190826\_00008.jpg

Photo taken 4-06-2017 no change. No work done, no permit issued.

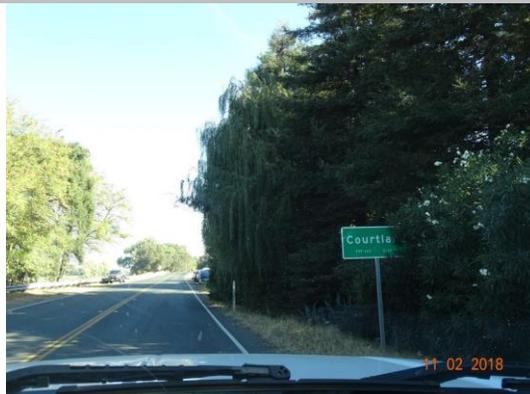
Photo 1 of 1 : FA\_2019\_RD0551\_175\_57\_20190826\_00077.jpg

View looking upstream at landscaping on the landside slope (November 2018).

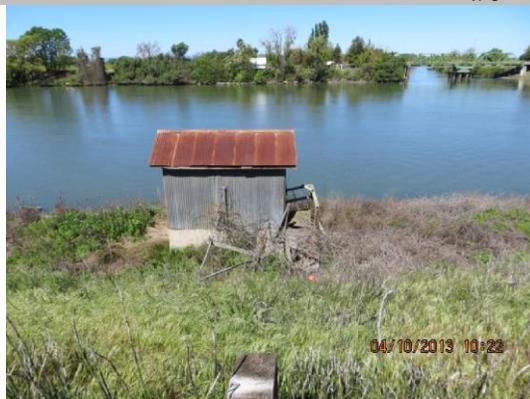
Photo 1 of 3 : UCIP\_FA\_2019\_11727\_19168.jpg

Item	DRAFT DWR UCIP Field Study			38.326088°	38.326088°
				-121.574525°	-121.574525°
DWR ID	21986				
Comment Code					
Inspector Comment					
DS_ID:21986 FS_ID:11727 EP_NO: 701 Repair Type: Non-Urgent Crossing Status: Found UCIP Comments: Pipe appears abandoned and should be done so properly. Good candidate for video inspection. FIELD_STRUCT_DESC: 14-inch steel irrigation pipe through the levee, 7.2 feet below the crown. Pump in pump house on the waterside (WS) slope. Service pole on the landside (LS) slope. 1-inch galvanized filler pipe, and a 2-inch electrical conduit at the same location. (Permit No. 701, 1937 - American Trust Company). [Additional Reference(s): DWR Levee Log, 2005. USACE Sacramento O&M Manual 111, May 1959, (RM 33.91)]. FS Date: 4/10/2013

Pump house and pipes visible on WS slope.

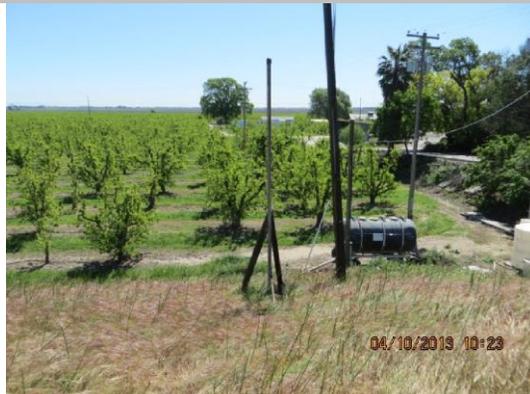
Photo 2 of 3 : UCIP\_FA\_2019\_11727\_19167.jpg

Pipe and JP visible on LS toe.

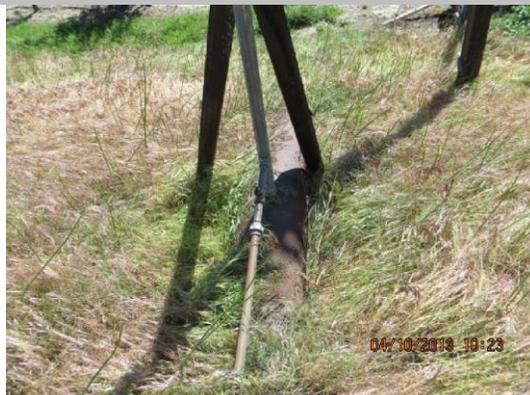
Photo 3 of 3 : UCIP\_FA\_2019\_11727\_19166.jpg

galvanized iron filler pipe and 16-inch pipe visible at LS toe.

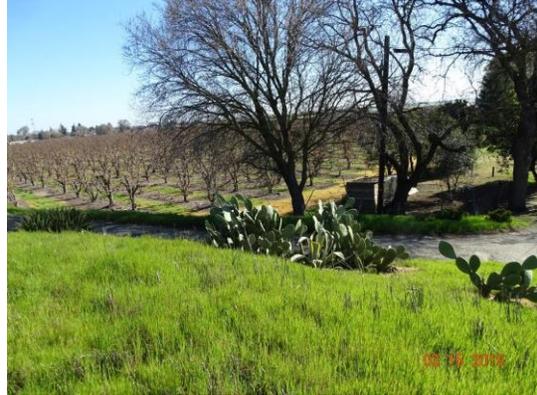
Photo 1 of 1 : FA\_2019\_RD0551\_175\_63\_20190826\_00083.jpg

View of cactus at the bottom of the landside slope (Spring 2019).

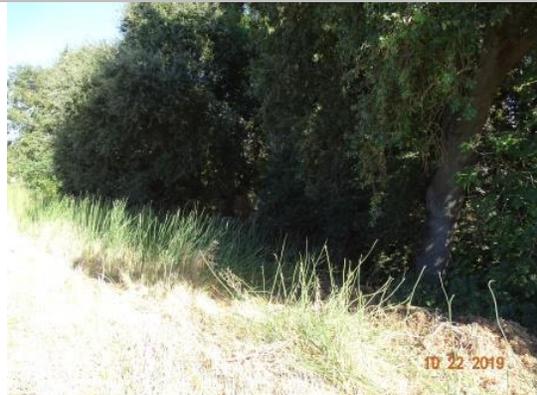
Photo 1 of 1 : FA\_2019\_RD0551\_175\_46\_20191024\_00127.jpg

LM Start	<b>1.36</b>	Rating **	U	Issue No.	<b>46</b>
LM End	<b>1.36</b>	Issue Type +	En	Location *	LS
Category	Earthen Levee			GPS Latitude/Longitude	
				Start	End
Item	Vegetation			38.319621 °	38.319621 °
				-121.576531 °	-121.576531 °
DWR ID	DWR_RD0551_01_f_2017_46				
Comment Code					
V6 : Landscaping					
Inspector Comment					
Landscaping should be maintained to allow inspection and access to landside slope and toe.

View looking upstream at landscaping on the landside slope (Fall 2019).

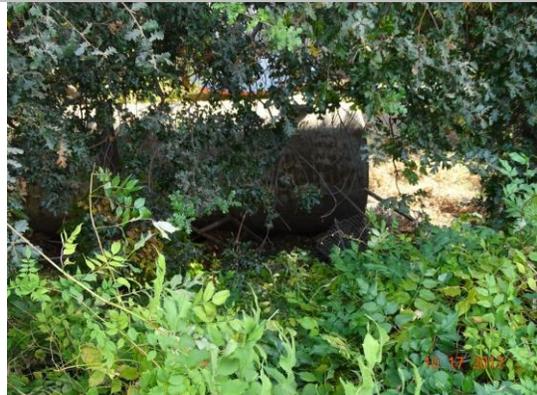
Photo 1 of 1 : FA\_2019\_RD0551\_175\_45\_20190826\_00068.jpg

LM Start	<b>1.36</b>	Rating **	M	Issue No.	<b>45</b>
LM End	<b>1.36</b>	Issue Type +	En	Location *	LS
Category	Earthen Levee			GPS Latitude/Longitude	
				Start	End
Item	Encroachments			38.319620 °	38.319620 °
				-121.576531 °	-121.576531 °
DWR ID	DWR_RD0551_01_f_2017_45				
Comment Code					
TA : Tank					
Inspector Comment					
Tank at landside toe should be removed to allow inspection and access.

Tank at landside toe should be removed to allow inspection and access.

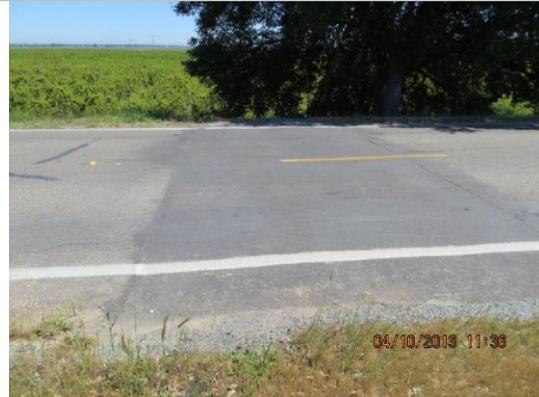
Photo 1 of 1 : UCIP\_FA\_2019\_11749\_19217.jpg

Item	DRAFT DWR UCIP Field Study			38.310237°	38.310237°
				-121.575470°	-121.575470°
DWR ID	22040				
Comment Code					
Inspector Comment					
DS_ID:22040 FS_ID:11749 EP_NO: 3676 Repair Type: Non-Urgent Crossing Status: Not Found UCIP Comments: Fresh cut through pavement on crown indicates recent work on pipes at this location. Need to determine if pipe was removed or abandoned in place. FIELD_STRUCT_DESC: 2 of 2: 8-inch coated steel irrigation pipe through the levee, 5 feet below the crown. 8-inch pipe sleeved through a 12-inch pipe. Pump on platform on the waterside (WS). (Permit No. 3676, 1961 - Runyon and Dorsey). [Additional Reference(s): DWR Levee Log, 2005. USACE Sacramento O&M Manual 111, May 1959, (RM 33.02)]. FS Date: 4/10/2013

Fresh cut through pavement at crown.

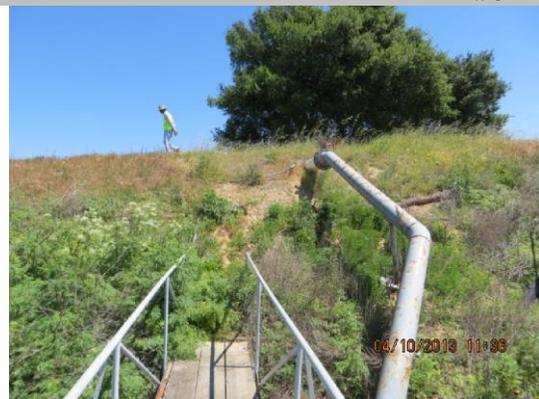
Photo 1 of 3 : UCIP\_FA\_2019\_11763\_19222.jpg

Item	DRAFT DWR UCIP Field Study			38.310223°	38.310223°
				-121.575458°	-121.575458°
DWR ID	21991				
Comment Code					
Inspector Comment					
DS_ID:21991 FS_ID:11763 EP_NO: 6551 Repair Type: Non-Urgent Crossing Status: Found UCIP Comments: Rodent activity undermining pipe on LS slope. FIELD_STRUCT_DESC: 1 of 2: 14-inch polyvinyl chloride (PVC) wrapped steel irrigation pipe through the levee, 3 feet below the crown. Butterfly valve on the waterside (WS) shoulder. 2-inch galvanized electrical conduit at the same location. Pump on pile structure on the WS toe. Pressure booster and pump on the landside (LS) toe. (Permit No. 6551, 1969 - John D. Wheeler). [Additional Reference(s): DWR Levee Log, 2005. USACE Sacramento O&M Manual 111, May 1959, (RM 32.78)]. FS Date: 4/10/2013

Pipe, butterfly valve, and electrical conduit 3-feet below the crown on the WS shoulder.

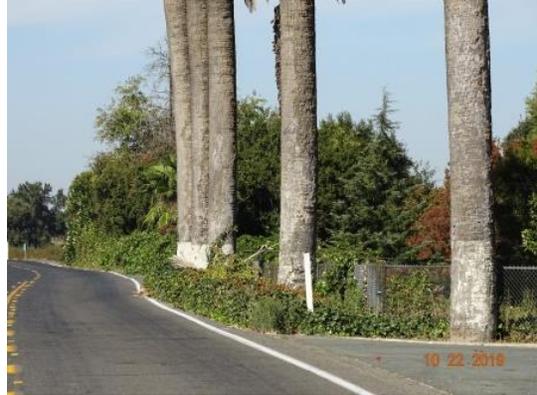
Photo 1 of 1 : FA\_2019\_RD0551\_175\_47\_20191024\_00126.jpg

View looking upstream at landscaping on the landside slope (Fall 2019).

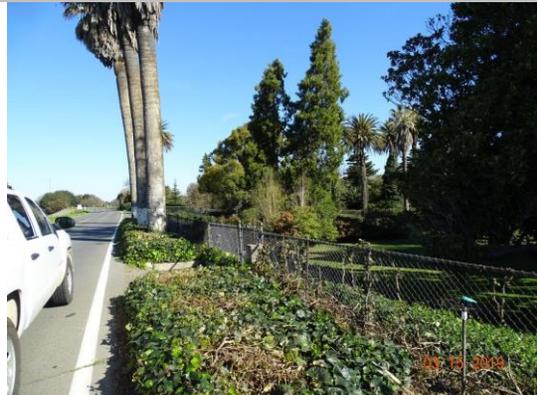
Photo 1 of 1 : FA\_2019\_RD0551\_175\_61\_20190826\_00081.jpg

View looking upstream at chainlink fence on the landside slope (Spring 2019).

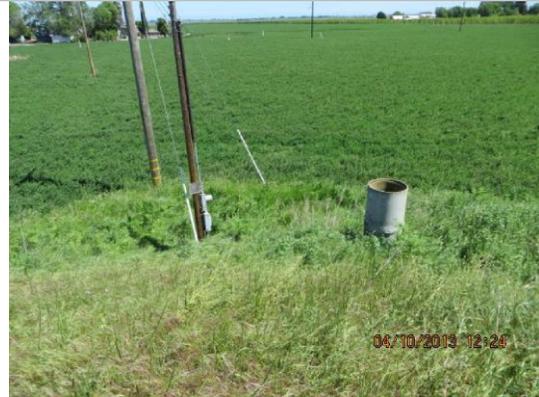
Photo 1 of 2 : UCIP\_FA\_2019\_11783\_19241.jpg

Item	DRAFT DWR UCIP Field Study			38.305189°	38.305189°
				-121.572012°	-121.572012°
DWR ID	21994				
Comment Code					
Inspector Comment					
DS_ID:21994 FS_ID:11783 EP_NO: 11141 Repair Type: Non-Urgent Crossing Status: Found UCIP Comments: Records indicate this pipe was abandoned, but it appears to be active. Verify status. FIELD_STRUCT_DESC: 10-inch steel irrigation pipe through the levee, 8 feet below the crown. Slant pump on the waterside (WS) slope. Service pole on the landside (LS) slope with a 1.5-inch galvanized iron electrical conduit through the levee at the same location. (Automatic Board Order (ABO) issued as Permit No. 11141, 1975 - Adele Runyon, et al.). [Additional Reference(s): DWR Levee Log, 2005. USACE Sacramento O&M Manual 111, May 1959, (RM 32.38), listed as a 12-inch pipe]. FS Date: 4/10/2013

JP and concrete standpipe on LS toe.

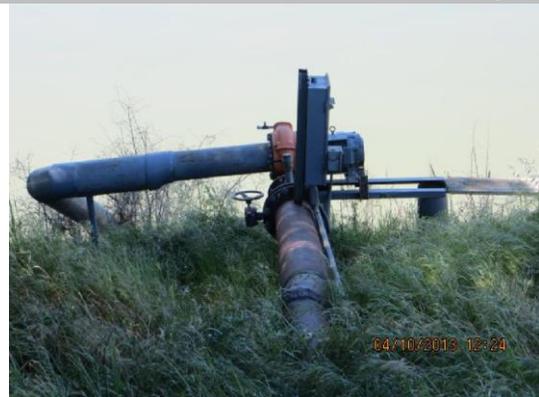
Photo 2 of 2 : UCIP\_FA\_2019\_11783\_19240.jpg

Pump, pipe, and butterfly valve on WS slope.

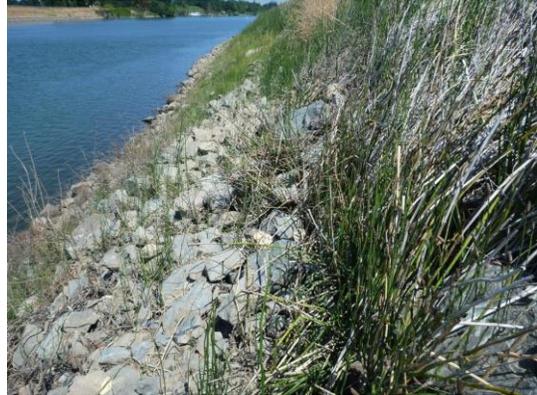
Photo 3 of 3 : FA\_2019\_RD0551\_175\_22\_20190826\_00011.jpg

Item	2017 Storm Damage			38.301258 °	38.300922 °
				-121.569550 °	-121.569258 °
DWR ID	LMA-159				
Comment Code					
Inspector Comment					
<p>Levee Evaluation Comments                  Description: District Station 142+31 to 143+80, Sec. 08, T. 5 N. R. 4 E., M.D.M. Approximately 149 linear-feet of erosion exists along the waterside slope of the Sacramento River. The erosion exists near the rip rap line about 3/4 of the way down the slope. Some existing rip rap has been pulled off in this section.                  Site ID No:332                  Site Designation:LMA-159                  Repair Type: Erosion                  Rating:Area of Concern                  Field Date:7/13/2017                  Notes: Crown is a paved road. Minor erosion right above and in the top of the rip rap.</p>

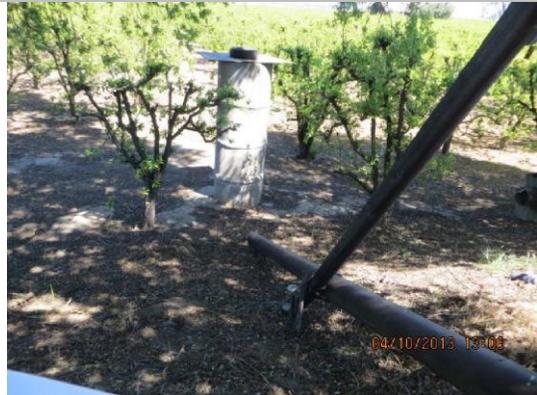
Photo 1 of 2 : UCIP\_FA\_2019\_11803\_19261.jpg

Item	DRAFT DWR UCIP Field Study			38.298323 °	38.298323 °
				-121.566941 °	-121.566941 °
DWR ID	22032				
Comment Code					
Inspector Comment					
<p>DS_ID:22032                  FS_ID:11803                  EP_NO: 1204                  Repair Type: Non-Urgent                  Crossing Status: Found                  UCIP Comments: Gap between sleeved pipes does not appear to be grouted on LS slope.                  FIELD_STRUCT_DESC: 12-inch steel irrigation conduit through the levee, 6 feet below the crown. 10-inch irrigation pipe sleeved through the 12-inch conduit. Pump on pile structure on the waterside (WS) toe. 48-inch concrete riser on the landside (LS) toe. (Permit No. 1204, 1947 - M. J. Barry Estate). [Additional Reference(s): USACE Sacramento O&amp;M Manual 111, May 1959, (RM 31.82)].                  FS Date: 4/10/2013</p>

48-inch concrete riser on LS toe.

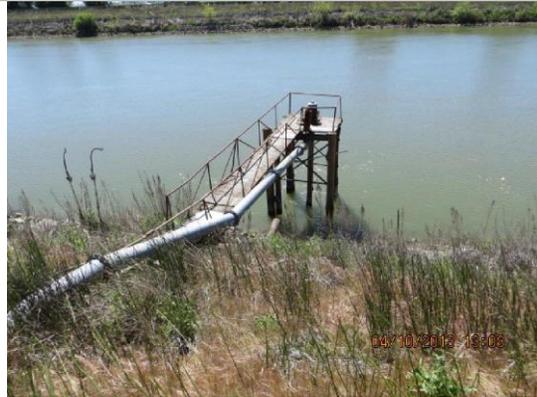
Photo 2 of 2 : UCIP\_FA\_2019\_11803\_19260.jpg

10-inch steel irrigation pipe and steel pump structure on WS toe.

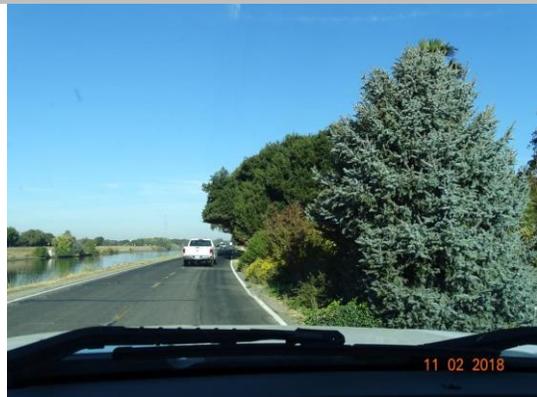
Photo 1 of 1 : FA\_2019\_RD0551\_175\_56\_20190826\_00076.jpg

View looking upstream at landscaping on the landside slope (November 2018).

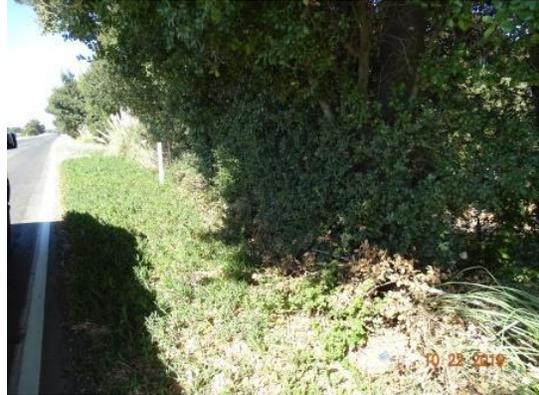
Photo 1 of 1 : FA\_2019\_RD0551\_175\_55\_20191024\_00125.jpg

View looking downstream at landscaping on the landside slope (Fall 2019).

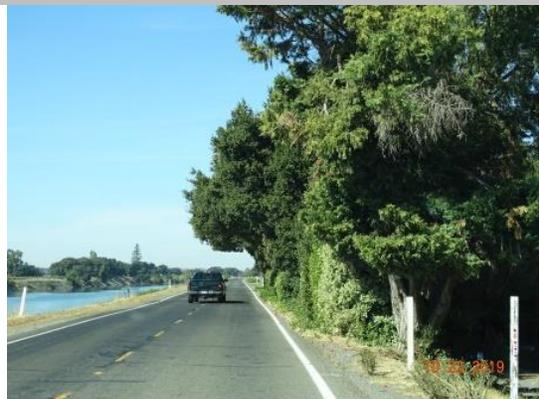
Photo 1 of 1 : FA\_2019\_RD0551\_175\_48\_20191024\_00124.jpg

View looking upstream at landscaping on the landside slope (Fall 2019).

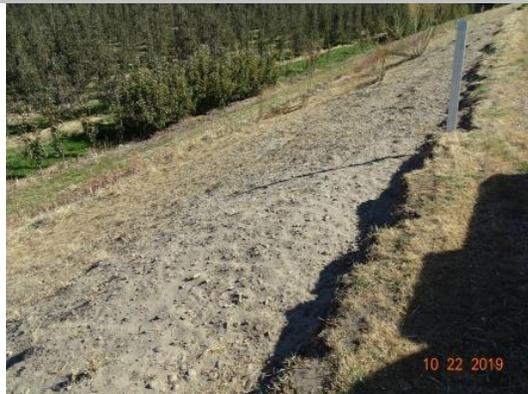
Photo 1 of 1 : FA\_2019\_RD0551\_175\_66\_20191024\_00123.jpg

LM Start	<b>3.91</b>	Rating **	M	Issue No.	<b>66</b>
LM End	<b>3.91</b>	Issue Type +	Ma	Location *	LS
Category	Earthen Levee			GPS Latitude/Longitude	
				Start	End
Item	Erosion / Bank Caving			38.287760°	38.287760°
				-121.555837°	-121.555837°
DWR ID	DWR_RD0551_01_f_2019_66				
Comment Code					
E2 : Schedule repair of erosion site prior to the next inspection.					
Inspector Comment

View looking downstream at erosion due to goats on the landside slope (Fall 2019).

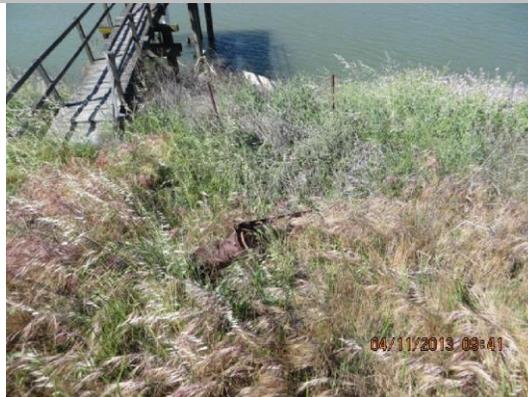
Photo 1 of 2 : UCIP\_FA\_2019\_11817\_19287.jpg

LM Start	<b>4.01</b>	Rating **	M	Issue No.	<b>78</b>
LM End	<b>4.01</b>	Issue Type +	En	Location *	
Category	Supplemental			GPS Latitude/Longitude	
				Start	End
Item	DRAFT DWR UCIP Field Study			38.286593°	38.286593°
				-121.554591°	-121.554591°
DWR ID	22034				
Comment Code					
Inspector Comment					
DS_ID:22034 FS_ID:11817 EP_NO: N/A Repair Type: Non-Urgent Crossing Status: Found UCIP Comments: Abandoned. Determine if pipe was removed or abandoned in place. FIELD_STRUCT_DESC: 8-inch irrigation pipe through the levee 6.7-feet below the crown. Abandoned slide gate at pad on WS slope. Originally included in O+M manual 1959. FS Date: 4/11/2013

Abandoned slide gate on WS slope.

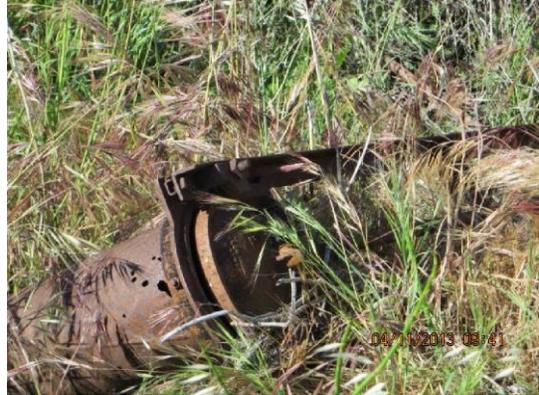
Photo 2 of 2 : UCIP\_FA\_2019\_11817\_19286.jpg

Abandoned slide gate on WS slope.

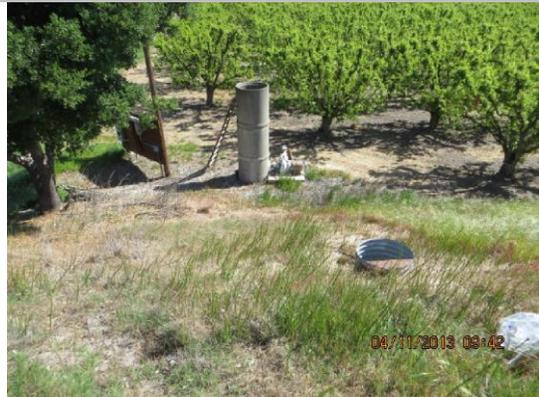
Photo 1 of 2 : UCIP\_FA\_2019\_11823\_19301.jpg

Comment Code					
Inspector Comment					
DS_ID:22018 FS_ID:11823 EP_NO: 11146 Repair Type: Non-Urgent Crossing Status: Found UCIP Comments: Wooden walkway in bad repair and presents a hazard to the public. FIELD_STRUCT_DESC: 14-inch irrigation pipe of an unknown material through the levee, 10.4 feet below the crown. Pump on pile structure in stream with wooden walkway. 48-inch concrete standpipe on the landside (LS) toe with booster pump and electrical panel. Siphon breaker in a 24-inch corrugated metal pipe (CMP) riser on the LS slope. 1.5-inch electrical conduit at the same location. (Automatic Board Order (ABO) issued as Permit No. 11146, 1975 - Edgar D. Turner, III). [Additional Reference(s): DWR Levee Log, 2005. USACE Sacramento O&M Manual 111, May 1959, (RM 30.75)]. FS Date: 4/11/2013

24-inch CMP riser and 48-inch concrete riser on LS slope.

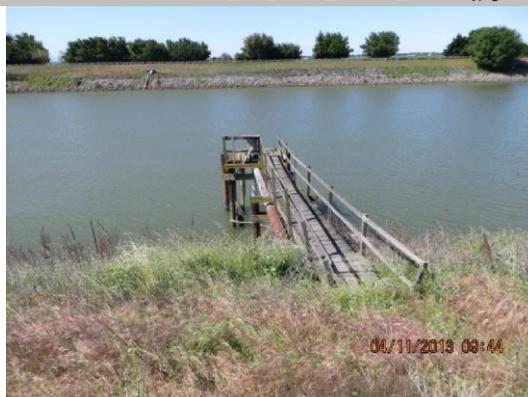
Photo 2 of 2 : UCIP\_FA\_2019\_11823\_19300.jpg

Pump on pier with wooden walkway on WS toe.

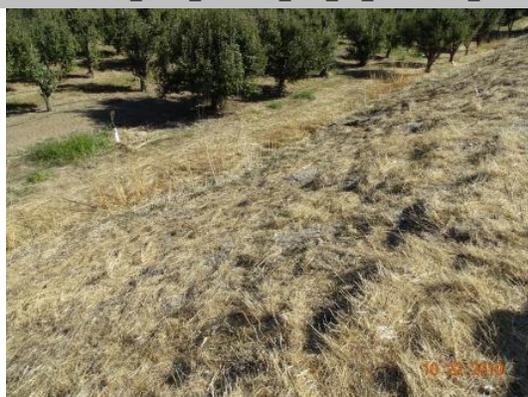
Photo 1 of 1 : FA\_2019\_RD0551\_175\_53\_20191024\_00122.jpg

View looking downstream at fresh rodent holes in the landside slope (Fall 2019).

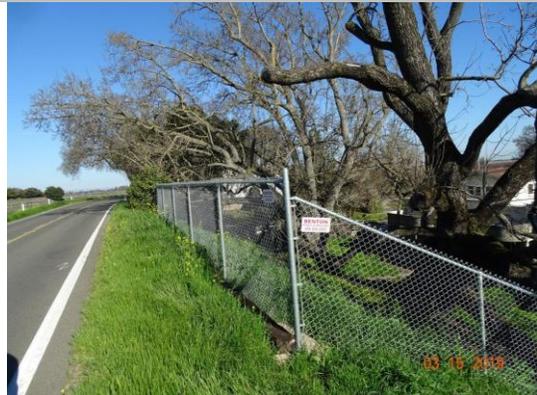
Photo 1 of 1 : FA\_2019\_RD0551\_175\_60\_20190826\_00080.jpg

View looking upstream at chainlink fence on the landside slope and shoulder (Spring 2019).

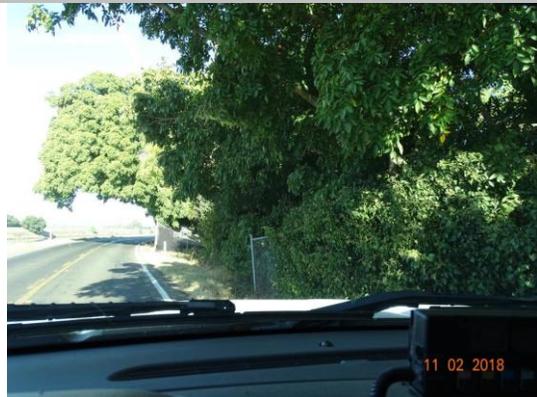
Photo 1 of 1 : FA\_2019\_RD0551\_175\_52\_20190826\_00075.jpg

View looking upstream at landscaping on the landside slope (November 2018).

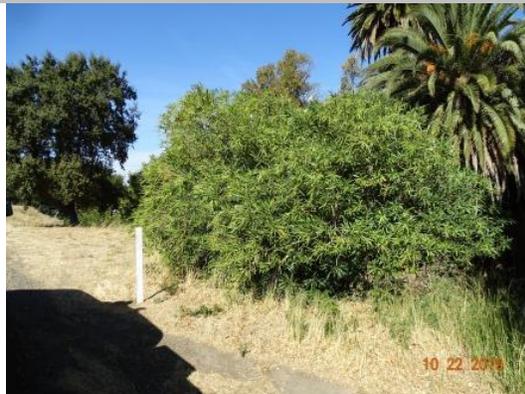
Photo 1 of 1 : FA\_2019\_RD0551\_175\_64\_20191024\_00121.jpg

View looking upstream at landscaping on the landside slope (Fall 2019).

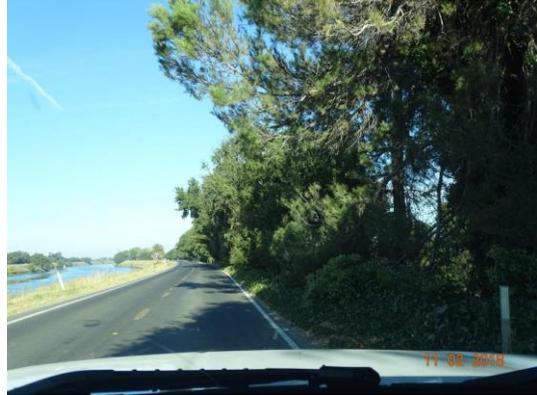
Photo 1 of 1 : FA\_2019\_RD0551\_175\_25\_20190826\_00013.jpg

View looking upstream at landscaping on the landside slope (November 2018).

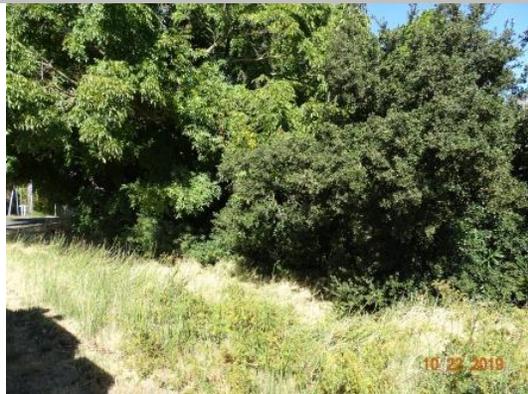
Photo 1 of 1 : FA\_2019\_RD0551\_175\_44\_20191024\_00120.jpg

View looking slightly upstream at landscaping on the landside slope (Fall 2019).

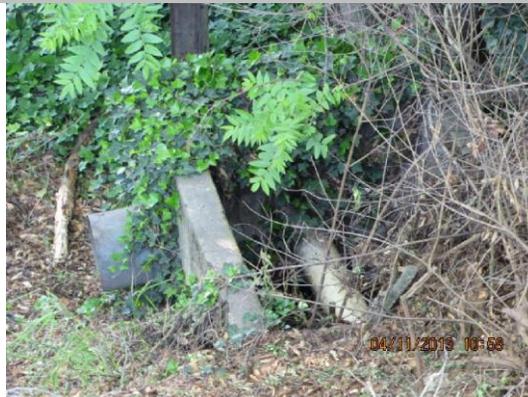
Photo 1 of 3 : UCIP\_FA\_2019\_12105\_19649.jpg

Pipe in distribution box at LS toe.

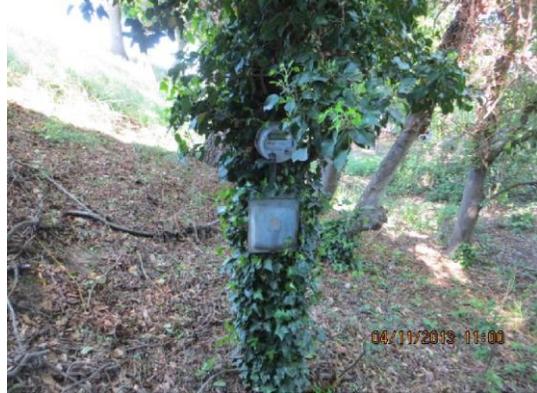
Photo 2 of 3 : UCIP\_FA\_2019\_12105\_19648.jpg

Meter on pole at LS toe.

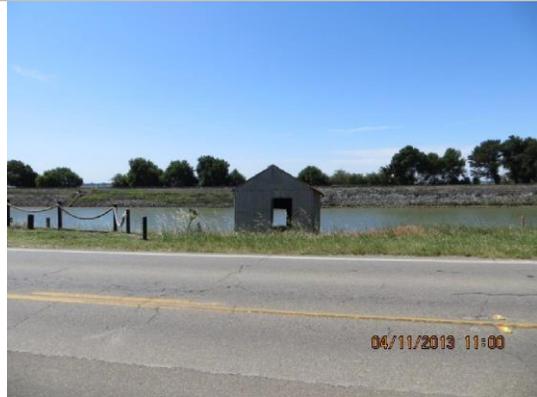
Photo 3 of 3 : UCIP\_FA\_2019\_12105\_19647.jpg

Relocated pumphouse on WS shoulder.

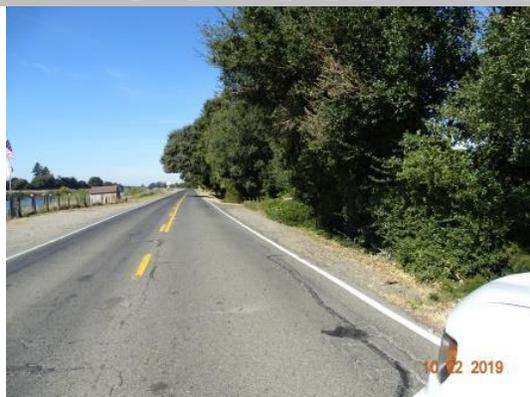
Photo 1 of 1 : FA\_2019\_RD0551\_175\_49\_20191024\_00119.jpg

LM Start	<b>5.08</b>	Rating **	M	Issue No.	<b>49</b>
LM End	<b>5.08</b>	Issue Type +	En	Location *	LS
Category	Earthen Levee			GPS Latitude/Longitude	
				Start	End
Item	Vegetation			38.275865°	38.275865°
				-121.540461°	-121.540461°
DWR ID	DWR_RD0551_01_f_2017_49				
Comment Code					
V6 : Landscaping					
Inspector Comment					
<p>Landscaping should be maintained to allow inspection and access to landside slope and toe.</p>

View looking upstream at landscaping on the landside slope (Fall 2019).

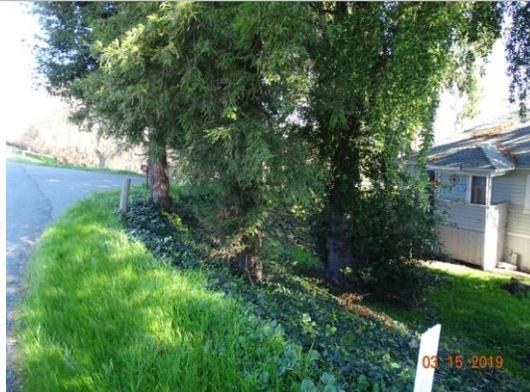
Photo 1 of 1 : FA\_2019\_RD0551\_175\_58\_20190826\_00078.jpg

View looking upstream at landscaping on the landside slope (Spring 2019).

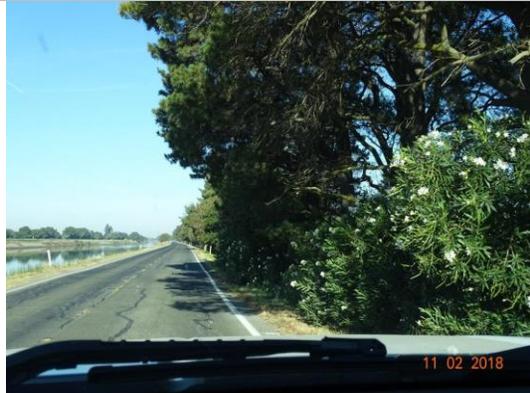
Photo 1 of 1 : FA\_2019\_RD0551\_175\_24\_20190826\_00012.jpg

View looking upstream at land scaping on the landside slope (November 2018).

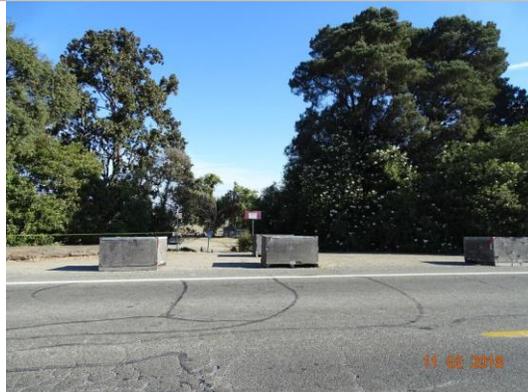
Photo 1 of 1 : FA\_2019\_RD0551\_175\_59\_20190826\_00079.jpg

View of boxes on the land side shoulder that landowner placed to block traffic from using driveway (November 2018).
