**Flood Control Project Maintenance
Levee Inspections**

Maintenance Issue Types Only, Levee Inspection Report By Mile - Spring 2020

Reclamation District No. 0551 Pearson

Waterway	Bank	Unit Miles	Inspection Start/End	Inspector
Unit No. 01 Sacramento River	Left	6.78	03/25/2020 03/25/2020	David Julian

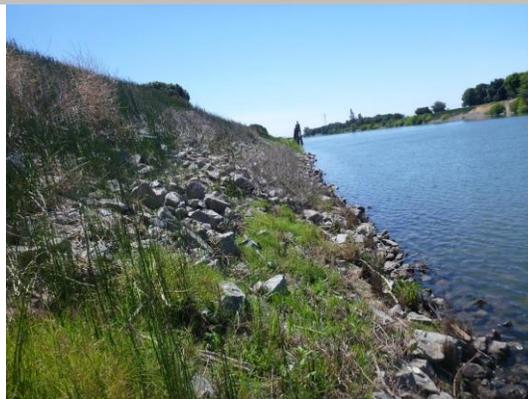
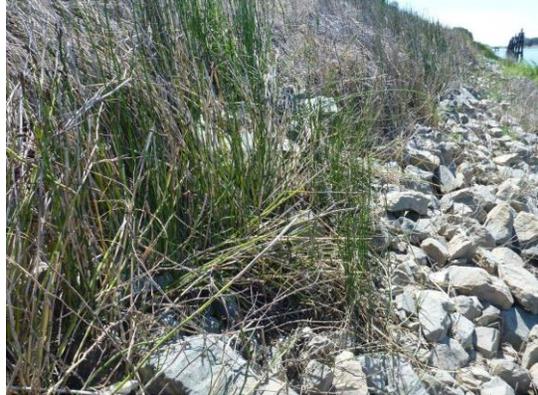
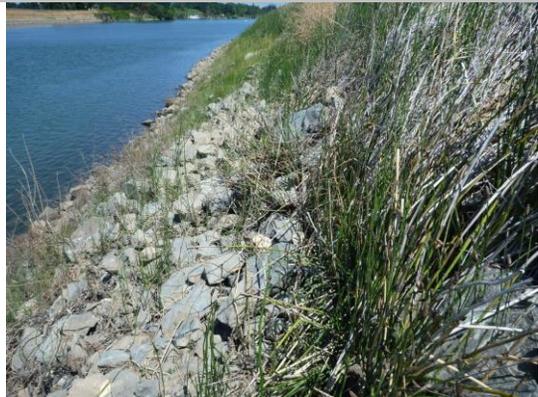
Photo 1 of 3 : SP_2020_RD0551_175_22_20200304_00009.jpg

LM Start	2.71	Rating **	A/W	Issue No.	22
LM End	2.74	Issue Type +	Ma	Location *	WS
Category	Earthen Levee		GPS Latitude/Longitude		
			Start	End	
Item	Erosion / Bank Caving		38.301258 °	38.300922 °	
			-121.569550 °	-121.569258 °	
DWR ID	LMA-159				
Comment Code					
E1 : Note and monitor erosion site.					
Inspector Comment					
<p>This was a 2017 Storm Damage site. Approximately 149 linear-feet of erosion. The erosion exists near the rip rap line about 3/4 of the way down the slope. Some existing rip rap has been pulled off in this section. Site ID No:332 Site Designation:LMA-159 3/25/2020 Field Notes: Do boat inspection to verify extent of erosion. Monitor.</p>

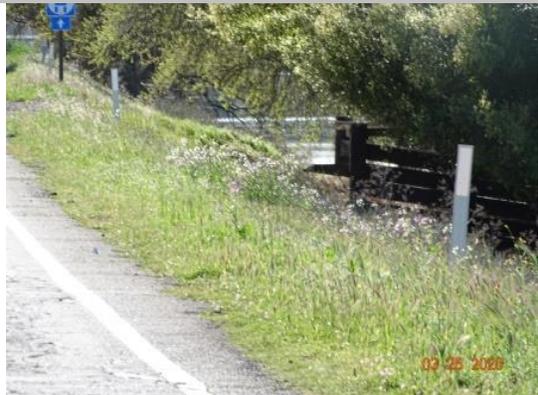
Photo 1 of 1 : SP_2020_RD0551_175_68_20200325_00124.jpg

LM Start	2.95	Rating **	M	Issue No.	68
LM End	6.02	Issue Type +	Ma	Location *	WS
Category	Earthen Levee			GPS Latitude/Longitude	
				Start	End
Item	Vegetation			38.298424 °	38.266581 °
				-121.567043 °	-121.527820 °
DWR ID	DWR_RD0551_01_s_2020_68

View looking upstream at annual vegetation on the landside slope.

Comment Code
V1 : Control annual grass and weeds on the levee slopes and easements.

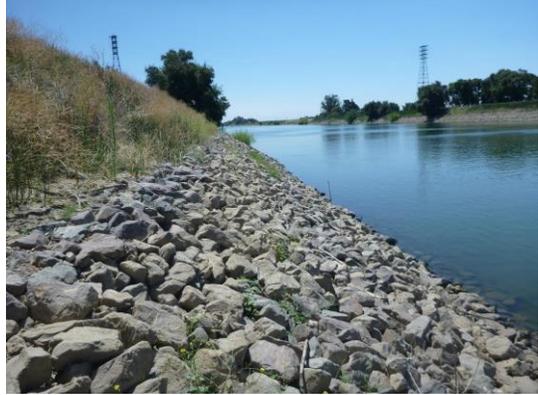
Photo 3 of 3 : SP_2020_RD0551_175_26_20200304_00016.jpg

LM Start	3.04	Rating **	A/W	Issue No.	26 (cont)
LM End	3.25	Issue Type +	Ma	Location *	WS
Category	Earthen Levee			GPS Latitude/Longitude	
				Start	End
Item	Erosion / Bank Caving			38.297258 °	38.294806 °
				-121.566231 °	-121.563958 °
DWR ID	DWR_RD0551_01_s_2020_26

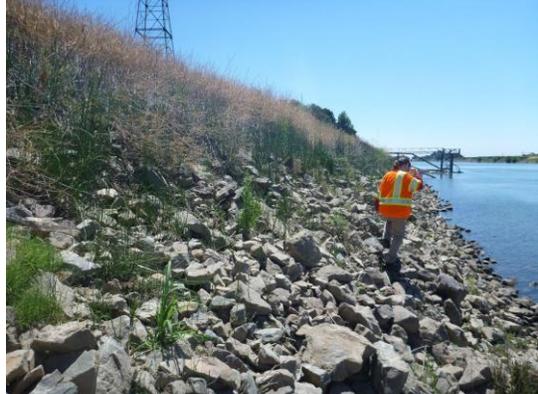
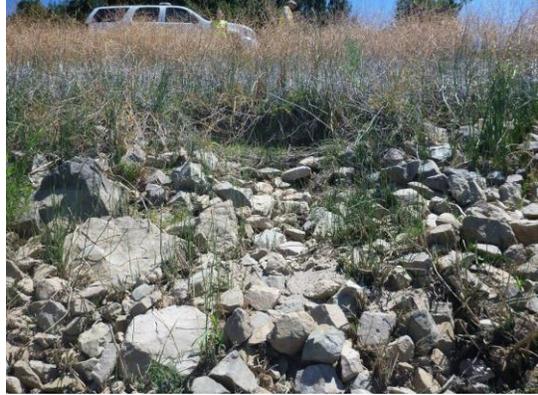
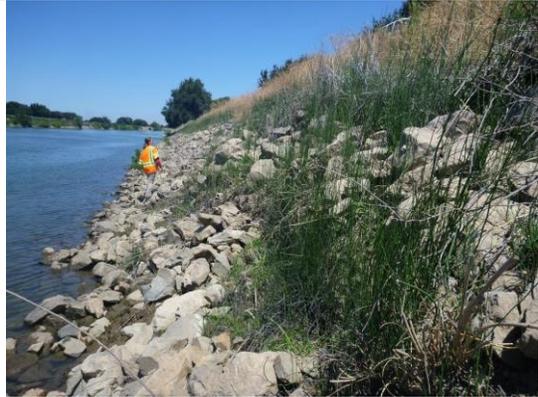
Photo 1 of 3 : SP_2020_RD0551_175_27_20200304_00017.jpg

Inspector Comment
This was a 2017 Storm Damage site. Approximately 94 linear-feet of erosion. The erosion occurs within the rip rap area near the waterline. Sloughing is exhibited in the in the bottom half of the slope. Some existing rip rap has been pulled off in this section.
Site ID No:334
Site Designation:LMA-161
3/25/2020 Field Notes: Do boat inspection to verify extent of erosion. Monitor.

Comment Code
E1 : Note and monitor erosion site.

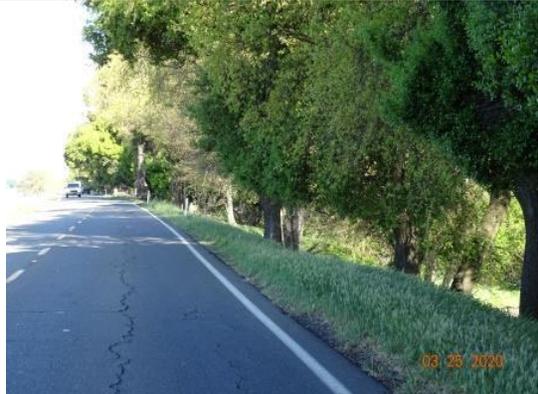
Photo 1 of 1 : SP_2020_RD0551_175_70_20200325_00125.jpg

LM Start	3.89	Rating **	M	Issue No.	70
LM End	6.72	Issue Type +	Ma	Location *	LS
Category	Earthen Levee			GPS Latitude/Longitude	
				Start	End
Item	Vegetation			38.287963 °	38.259511 °
				-121.556070 °	-121.518650 °
DWR ID	DWR_RD0551_01_s_2020_70				
Comment Code					
V1 : Control annual grass and weeds on the levee slopes and easements.					
Inspector Comment

View looking upstream at annual vegetation on the landside slope (Spring 2020).

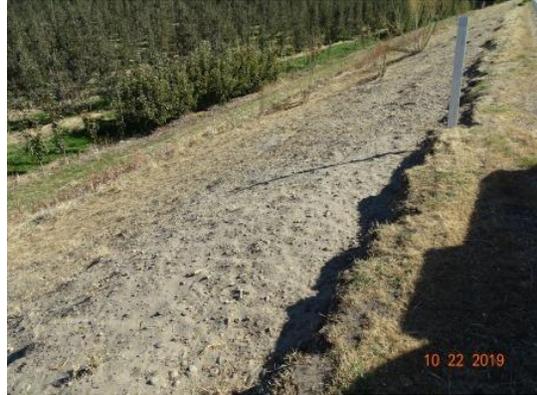
Photo 1 of 1 : SP_2020_RD0551_175_66_20200304_00088.jpg

LM Start	3.91	Rating **	M	Issue No.	66
LM End	3.91	Issue Type +	Ma	Location *	LS
Category	Earthen Levee		GPS Latitude/Longitude		
			Start	End	
Item	Erosion / Bank Caving		38.287760 °	38.287760 °	
			-121.555837 °	-121.555837 °	
DWR ID	DWR_RD0551_01_f_2019_66				
Comment Code					
E1 : Note and monitor erosion site.					
Inspector Comment

View looking downstream at erosion due to goats on the landside slope (Fall 2019).

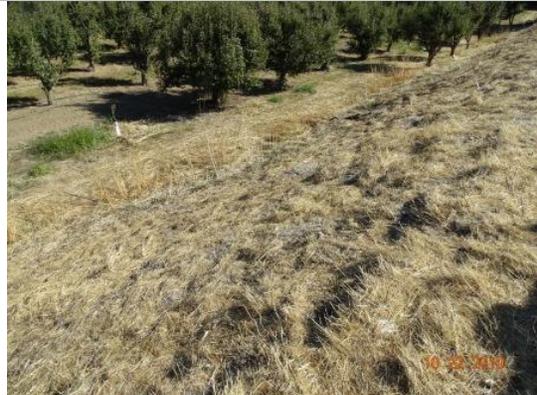
Photo 1 of 1 : SP_2020_RD0551_175_53_20200304_00077.jpg

LM Start	4.04	Rating **	M	Issue No.	53
LM End	4.04	Issue Type +	Ma	Location *	LS
Category	Earthen Levee		GPS Latitude/Longitude		
			Start	End	
Item	Animal Control		38.286255 °	38.286255 °	
			-121.554193 °	-121.554193 °	
DWR ID	DWR_RD0551_01_f_2018_53				
Comment Code					
A3 : No rodents visible, but rodent burrows visible; need to backfill and compact or grout burrows.					
Inspector Comment					
There are many fresh rodent holes on the slope.

View looking downstream at fresh rodent holes in the landside slope (Fall 2019).

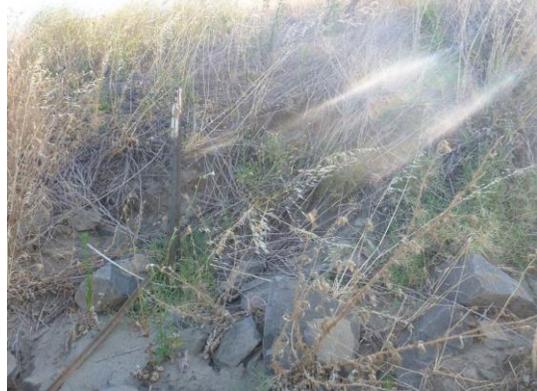
Photo 1 of 3 : SP_2020_RD0551_175_31_20200304_00029.jpg

LM Start	4.92	Rating **	A/W	Issue No.	31
LM End	4.95	Issue Type +	Ma	Location *	WS
Category	Earthen Levee		GPS Latitude/Longitude		
			Start	End	
Item	Erosion / Bank Caving		38.277589 °	38.277256 °	
			-121.542575 °	-121.542211 °	
DWR ID	LMA-166				
Comment Code					
E1 : Note and monitor erosion site.					
Inspector Comment					
<p>This was a 2017 Storm Damage site. Approximately 160 linear-feet of erosion. The erosion commences approximately halfway down the slope from the crown and extends to the rip rap. Some existing rip rap has been pulled off in this section. Site ID No:339 Site Designation:LMA-166 3/25/2020 Field Notes: Do boat inspection to verify extent of erosion. Monitor.</p>

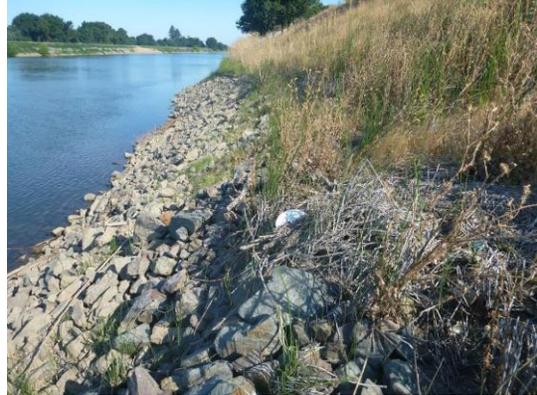
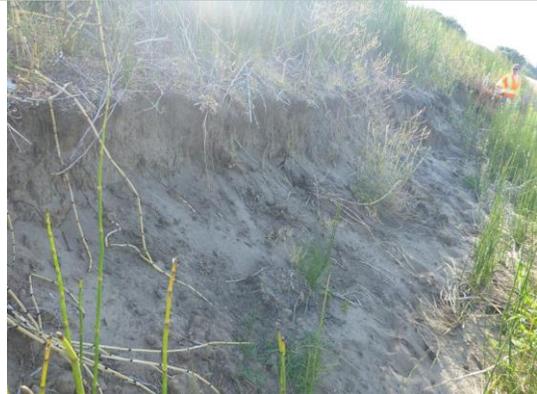
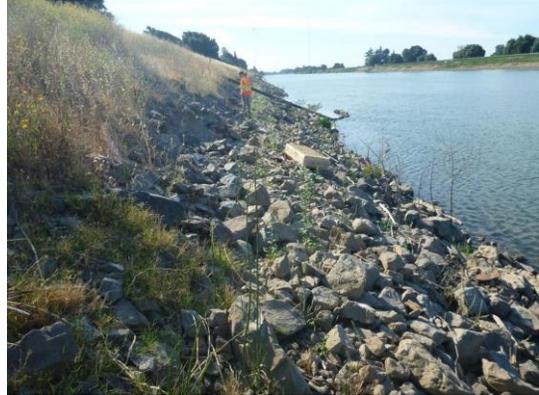
Photo 1 of 3 : SP_2020_RD0551_175_34_20200304_00038.jpg

Comment Code					
Inspector Comment					
<p>Planned For Repair. Levee Evaluation Comments Description: District Station 273+82 to 278+08, Sec. 21 and 22, T. 5 N. R. 4 E., M.D.M. Approximately 426 linear-feet of erosion exists along the waterside slope of the Sacramento River. The erosion commences approximately halfway down the slope and extends to the rip rap. Some existing rip rap has been pulled off in this section. Site ID No:342 Site Designation:LMA-169 Repair Type: Erosion Rating: Serious Field Date: 7/14/2017 Notes: there is a 7 ft scarp that extends for 40-60 ft in very sandy soil, scarps are 2-4 ft the rest of the length. Worst site in this RD so far. Serious because of the length of this deeper scarp and the weak soil here. Crown is a paved road.</p>

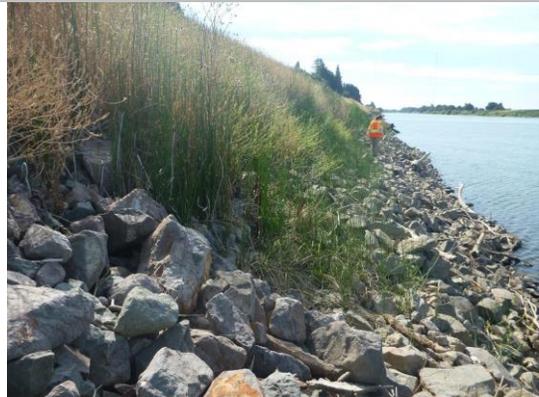
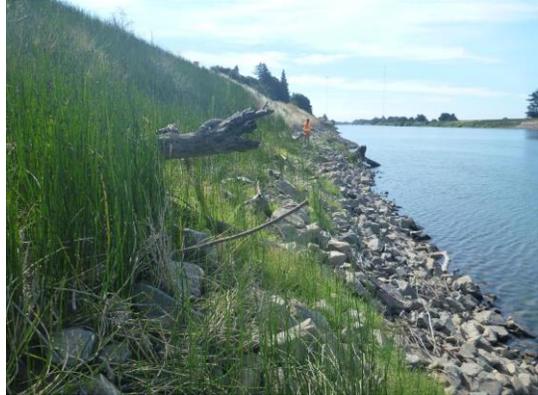
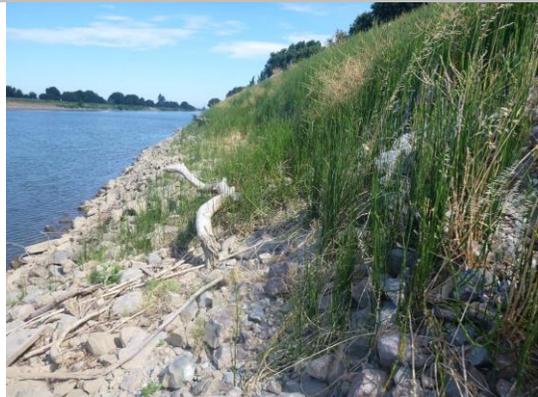
Photo 1 of 3 : SP_2020_RD0551_175_35_20200304_00041.jpg

Inspector Comment
This was the 2017 Storm Damage site. Approximately 241 linear-feet of erosion and sloughing. The erosion commences approximately 3/4 of the way down the slope and extends to the rip rap. Some existing rip rap has been pulled off in this section. Site ID No:343 Site Designation:LMA-170 3/25/2020 Field Notes: Do boat inspection to verify extent of erosion. Monitor.

Comment Code
E1 : Note and monitor erosion site.

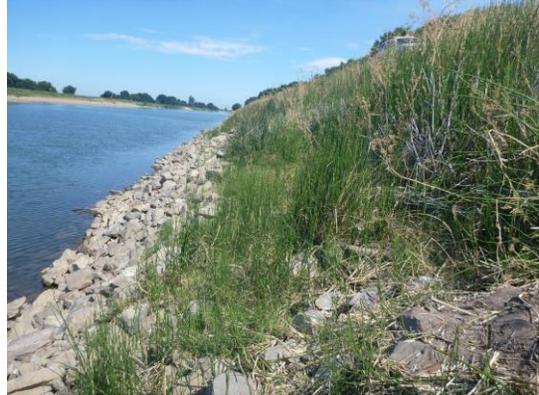
Photo 3 of 3 : SP_2020_RD0551_175_36_20200304_00046.jpg

LM Start	5.52	Rating **	A/W	Issue No.	36 (cont)
LM End	5.54	Issue Type +	Ma	Location *	WS
Category	Earthen Levee		GPS Latitude/Longitude		
			Start	End	
Item	Erosion / Bank Caving		38.271406 °	38.271208 °	
			-121.534644 °	-121.534381 °	
DWR ID	LMA-171

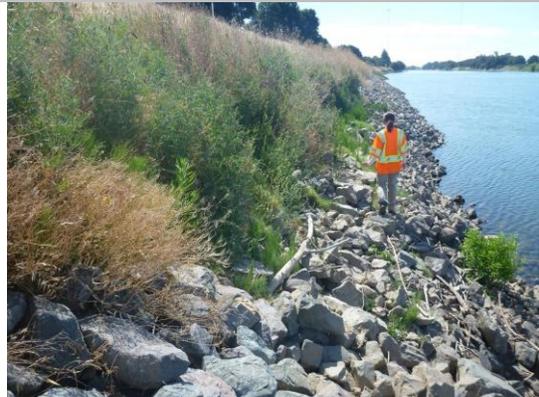
Photo 1 of 3 : SP_2020_RD0551_175_37_20200304_00047.jpg

Comment Code					
E1 : Note and monitor erosion site.					
Inspector Comment					
<p>This was a 2017 Storm Damage site. Approximately 115 linear-feet of erosion and sloughing. The erosion occurs just above the rip rap line. Some existing rip rap has been pulled off in this section. Site ID No:345 Site Designation:LMA-172 3/25/2020 Field Notes: Do boat inspection to verify extent of erosion. Monitor.</p>

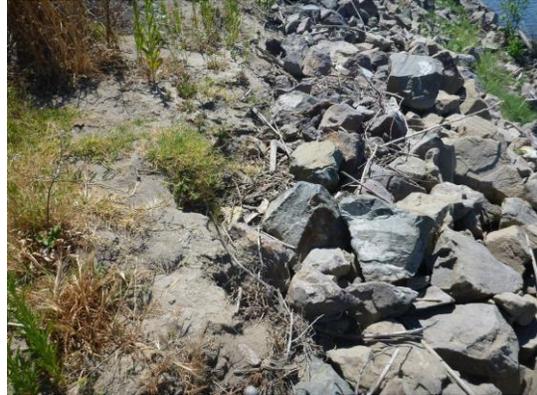
Photo 3 of 3 : SP_2020_RD0551_175_40_20200304_00058.jpg

LM Start	5.95	Rating **	A/W	Issue No.	40 (cont)
LM End	5.97	Issue Type +	Ma	Location *	WS
Category	Earthen Levee			GPS Latitude/Longitude	
				Start	End
Item	Erosion / Bank Caving			38.267286 °	38.267094 °
				-121.528886 °	-121.528642 °
DWR ID	LMA-176

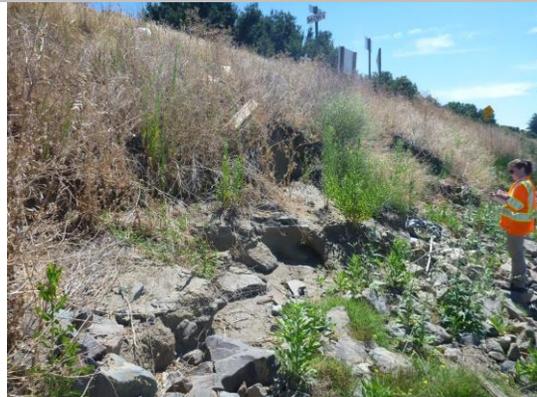
Photo 1 of 3 : SP_2020_RD0551_175_41_20200304_00059.jpg

Inspector Comment
This was a 2017 Storm Damage site. Approximately 388 linear-feet of erosion. The erosion commences approximately halfway down the slope and extends into the rip rap. Some existing rip rap has been pulled off in this section.
Site ID No:350
Site Designation:LMA-177
3/25/2020 Field Notes: Do boat inspection to verify extent of erosion. Monitor.

Comment Code
E1 : Note and monitor erosion site.

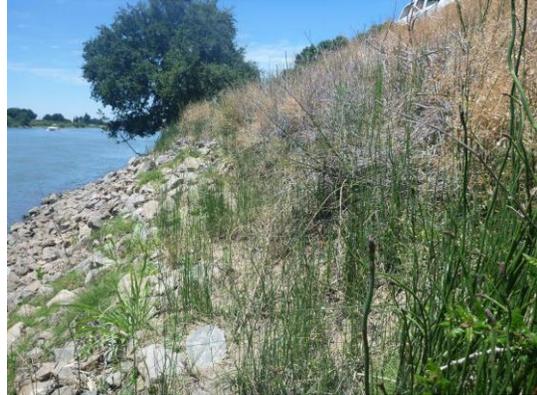
Photo 3 of 3 : SP_2020_RD0551_175_42_20200304_00064.jpg

LM Start	6.22	Rating **	A/W	Issue No.	42 (cont)
LM End	6.24	Issue Type +	Ma	Location *	WS
Category	Supplemental			GPS Latitude/Longitude	
				Start	End
Item	2017 Storm Damage			38.264436 °	38.264233 °
				-121.525472 °	-121.525219 °
DWR ID	LMA-178

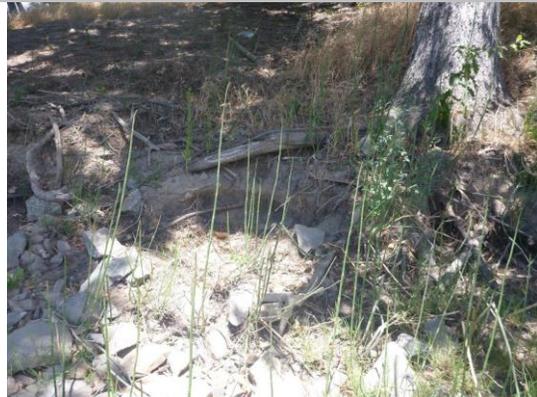
Photo 1 of 3 : SP_2020_RD0551_175_43_20200304_00065.jpg

Inspector Comment
This was a 2017 Storm Damage site. Approximately 80 linear-feet of erosion/sloughing and minor slippage. The erosion/sloughing commences approximately halfway down the slope and extends into the rip rap. Existing rip rap has been pulled off in this section.
Site ID No:352
Site Designation:LMA-179
3/25/2020 Field Notes: Do boat inspection to verify extent of erosion. Monitor.

Comment Code
E1 : Note and monitor erosion site.
