**Flood Control Project Maintenance
Levee Inspections**
LMA District Cover Sheet
Spring 2020 Levee Inspection Results

Reclamation District No. 0554 Walnut Grove

Spring 2020 Levee Inspection Results

Waterway		Bank	Unit Miles
Unit No. 01 Sacramento River		Left	1.13
	Spring (March - May)	Summer (June - August)	(September - November) Fall
Unit Maintenance Rating (Fall Only)			Winter (December - February)
Date of Inspection	3/25/2020 - 3/25/2020		
DWR Inspector	David Julian		
Accompanied By

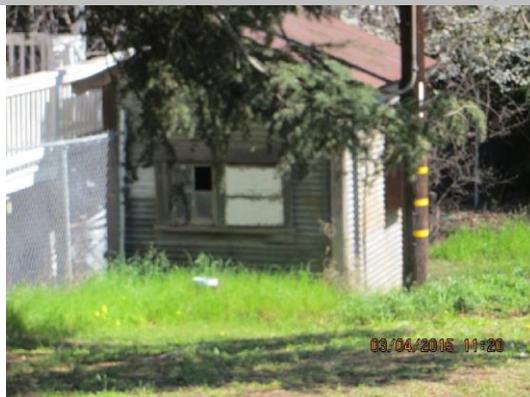
Photo 1 of 3 : UCIP_SP_2020_43726_73282.jpg

Comment Code					
Inspector Comment					
DS_ID:18976 FS_ID:43726 EP_NO: N/A Repair Type: Non-Urgent Crossing Status: Indicator Found UCIP Comments: Need to verify status of crossing with town of Locke. FIELD_STRUCT_DESC: 12-inch two water systems (a domestic and fire main) through the levee at unknown depth. Crosses levee just south of concrete block pumphouse on waterside (WS) shoulder and terminates at well house off landside (LS) toe. Gatevalve next to corner of pumphouse off LS toe. (12-inch pipe authorized under Permit No. 12944, 1980 - Sacramento Housing and Redevelopment Agency; transfer approval for Plans No. 12944 from Sacramento Housing and Redevelopment Agency to the Conty of Sacramento - Department of Public Works authorized under Permit No. 12944-A, 1982 - County of Sacramento Department of Public Works) FS Date: 3/4/2015 4:49:00 PM

Pumphouse off LS toe.

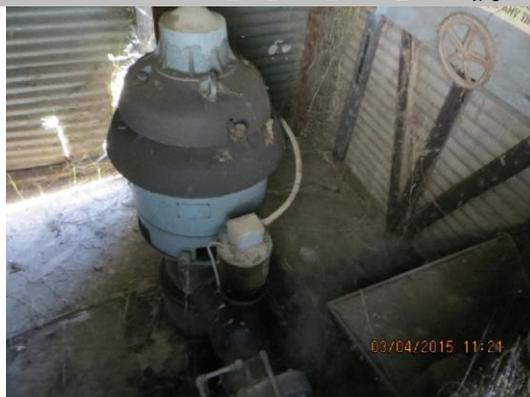
Photo 2 of 3 : UCIP_SP_2020_43726_73281.jpg

Pump over well inside pumphouse on LS toe.

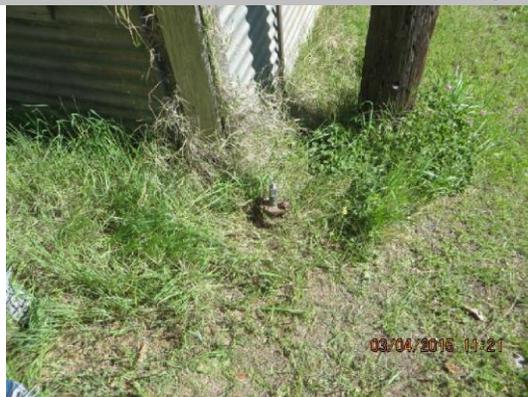
Photo 3 of 3 : UCIP_SP_2020_43726_73280.jpg

Gatevalve at corner of pumphouse on LS toe.

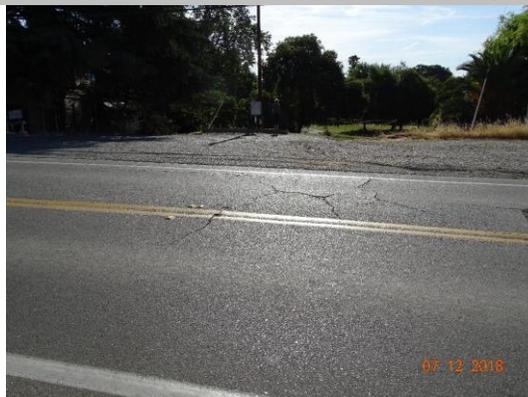
Photo 1 of 3 : UCIP_SP_2020_53405_77590.jpg

View of levee crown at the crossing toward LS.

Comment Code					
Inspector Comment					
DS_ID:20915 FS_ID:53405 EP_NO: 3360 Repair Type: Non-Urgent Crossing Status: Not Found UCIP Comments: 07/12/2018 No gas line markers at the crossing found. Need to contact PG&E. Crossing has been downgraded to "Non-Urgent" due to reclassification of gas lines. (O.Yakimov-DWR UCIP)7/25/2016 Coordinated with District Engineer, Gilbert Labrie with DCC Engineering. He will investigate the pipe and coordinate with PG&E to find out additional information regarding the fate of the pipe. (DWR UCIP - omagana)3/04/2015 No markers found. Need to contact owner to determine status of crossing. Recommend having owner install markers per CVFPB Title 23 for active pressure line. Owner will need to coordinate with CVFPB. (DWR UCIP - omagana) FIELD_STRUCT_DESC: Gas line along and through the levee, 3.5 feet below the crown. (gas line authorized under Permit No. 3360, 1962 - Pacific Gas and Electric Company [PG&E]) FS Date: 7/12/2018 7:28:04 AM

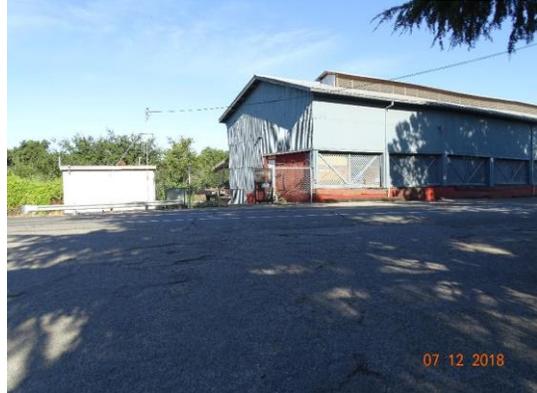
Photo 2 of 3 : UCIP_SP_2020_53405_77591.jpg

View of levee crown at the crossing toward WS.

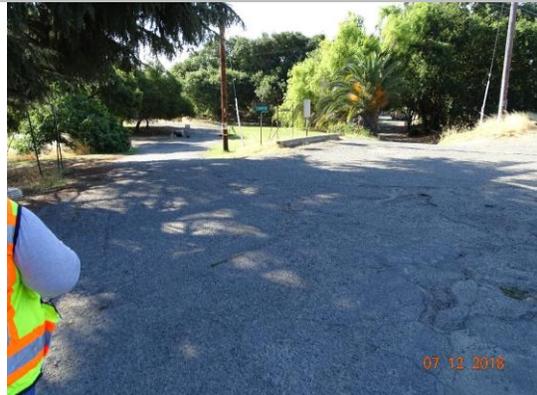
Photo 3 of 3 : UCIP_SP_2020_53405_77592.jpg

View of LS at the crossing.

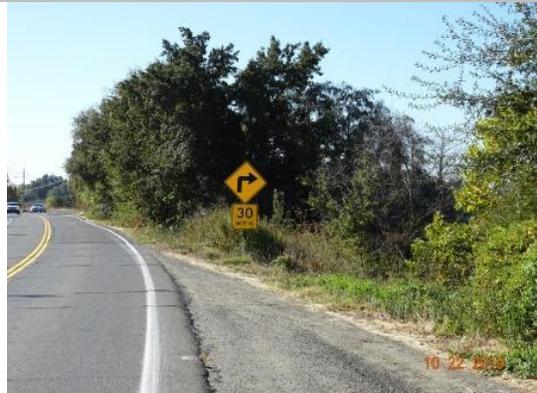
Photo 1 of 1 : SP_2020_RD0554_176_31_20200304_00013.jpg

LM Start	0.02	Rating **	M	Issue No.	31
LM End	0.17	Issue Type +	Ma	Location *	WS
Category	Earthen Levee			GPS Latitude/Longitude	
				Start	End
Item	Vegetation			38.249449 °	38.247375 °
				-121.510017 °	-121.509990 °
DWR ID	DWR_RD0554_01_f_2016_31				
Comment Code					
V2 : Remove the wild growth other than native grasses from the levee slopes.					
Inspector Comment

View looking downstream at vegetation on the waterside slope (Fall 2019).

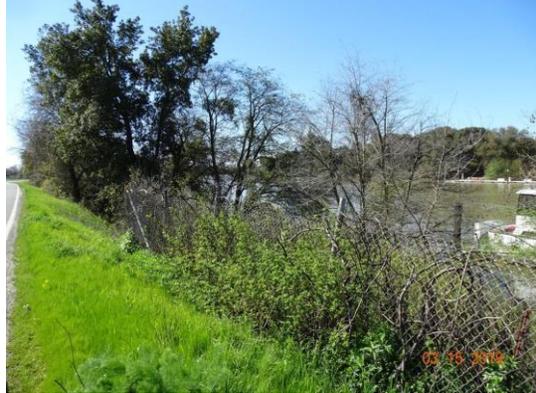
Photo 1 of 1 : SP_2020_RD0554_176_26_20200304_00008.jpg

View looking downstream at chainlink fence on the waterside slope (Spring 2019).

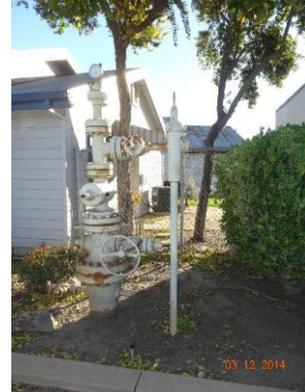
Photo 1 of 1 : UCIP_SP_2020_42146_58463.jpg

LM Start	0.08	Rating **	U	Issue No.	57
LM End	0.08	Issue Type +	En	Location *	
Category	Supplemental		GPS Latitude/Longitude		
			Start	End	
Item	DWR UCIP Field Study		38.248643 °	38.248643 °	
			-121.509850 °	-121.509850 °	
DWR ID	20946				
Comment Code					
Inspector Comment					
DS_ID:20946 FS_ID:42146 EP_NO: 5607 Repair Type: Urgent Crossing Status: Indicator Found UCIP Comments: No markers. Valves abandoned on landward side-- need to contact owner to determine status of crossing. FIELD_STRUCT_DESC: Abandoned three 4-inch steel petroleum pipes through the levee, 22.5 feet below the crown. Pipes placed in 8-inch pipe casing through the levee and plugged with concrete. Abandoned under Permit No. 5607 (1966). FS Date: 3/12/2014

Valves located on landward side.

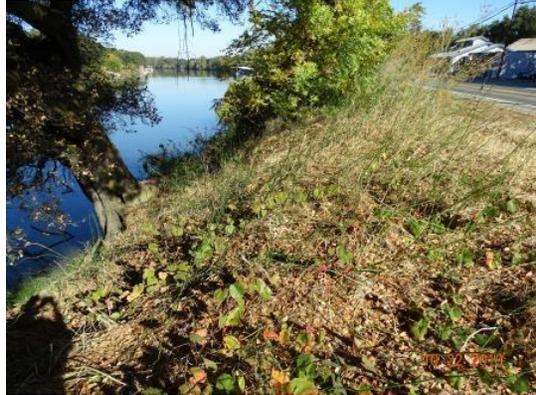
Photo 1 of 1 : SP_2020_RD0554_176_11_20200304_00001.jpg

LM Start	0.10	Rating **	M	Issue No.	11
LM End	0.10	Issue Type +	Ma	Location *	WS
Category	Earthen Levee		GPS Latitude/Longitude		
			Start	End	
Item	Erosion / Bank Caving		38.248262 °	38.248262 °	
			-121.509901 °	-121.509901 °	
DWR ID	DWR_RD0554_01_s_2014_11				
Comment Code					
E2 : Schedule repair of erosion site prior to the next inspection.					
Inspector Comment					
This is not a new erosion site, repairs are needed. One tree has fallen into the Sac River at the erosion site. This site can be seen better from the river by boat. The wild grapes block the view from the waterside shoulder looking down the slope. Rated as M because it is an oversized levee section.

View looking upstream at erosion site on the waterside (Fall 2019).

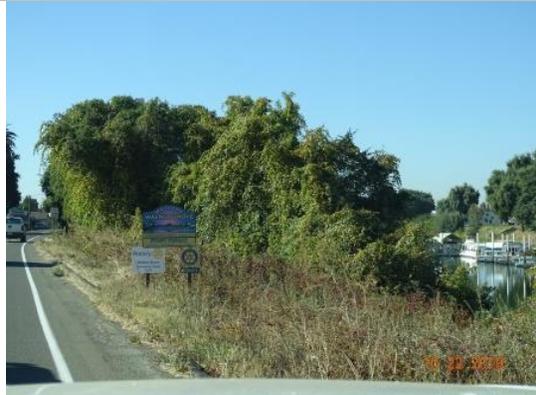
Photo 1 of 1 : SP_2020_RD0554_176_28_20200304_00010.jpg

LM Start	0.24	Rating **	U	Issue No.	28
LM End	0.35	Issue Type +	Ma	Location *	WS
Category	Earthen Levee		GPS Latitude/Longitude		
			Start	End	
Item	Vegetation		38.246473 °	38.244993 °	
			-121.510509 °	-121.511538 °	
DWR ID	DWR_RD0554_01_f_2017_28				
Comment Code					
V2 : Remove the wild growth other than native grasses from the levee slopes.					
Inspector Comment					
Also, remove annual grass from waterside slope.

View looking downstream at thick vegetation on the waterside slope (Fall 2019).

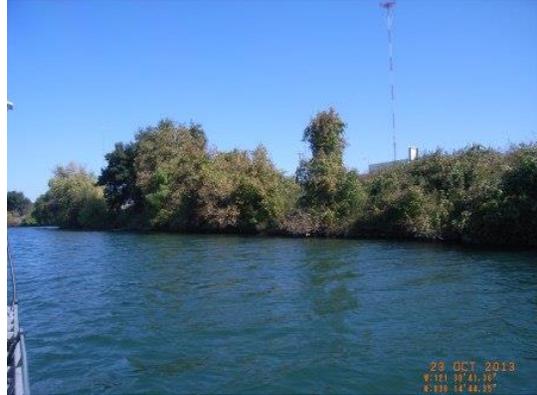
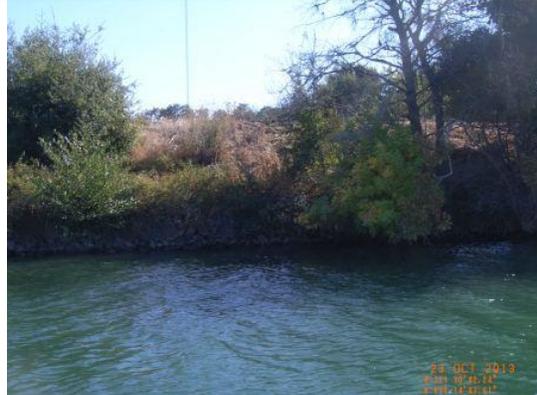
LM Start	0.26	Rating **	M	Issue No.	24
LM End	0.36	Issue Type +	Ma	Location *	WS
Category	Supplemental		GPS Latitude/Longitude		
			Start	End	
Item	2017 USACE Erosion Survey		38.246222 °	38.245017 °	
			-121.510878 °	-121.511740 °	
DWR ID	DWR_RD0554_01_f_2018_24				
Comment Code					
Inspector Comment					
2017 Site ID: SAC 27.0 L Status: Eroding 2017 Field Notes: Minor new erosion at toe. Site History: 2009 - Tension cracks on road on top of levee. Erosion into the levee slope and mass failure. 2013 - Short vertical sections at bank toe.

USACE 2013 Photo #1

USACE 2013 Photo #2

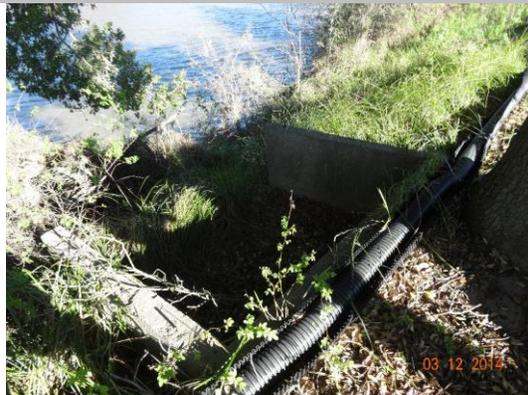
Photo 1 of 3 : UCIP_SP_2020_32018_58469.jpg

Comment Code					
Inspector Comment					
DS_ID:20897 FS_ID:32018 EP_NO: N/A Repair Type: Non-Urgent Crossing Status: Indicator Found UCIP Comments: Unable to determine status of crossing--was crossing removed during erosion repair site in 2007-2009? Need to coordinate with LMA or owner to obtain additional information about crossing. FIELD_STRUCT_DESC: *ABANDONED* 6-inch irrigation pipe of unknown material through the levee, 1.0-foot below the crown. Concrete pump pad on the waterside (WS) slope. [Additional Reference(s): DWR Levee Log, 1983 and 2005. USACE Sacramento O&M Manual Unit No. 111, May 1959, revised 29 Dec 2016, (River Mile [RM] 27.00)] FS Date: 3/12/2014

Concrete U wall located on waterward side.

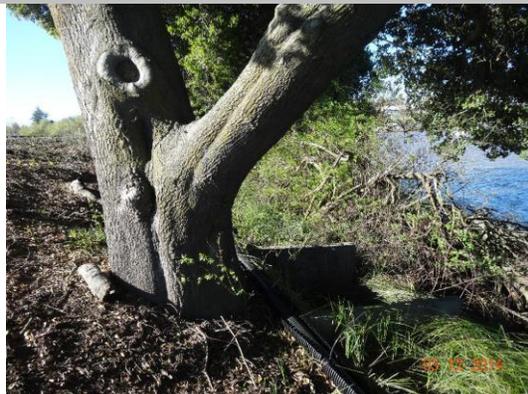
Photo 2 of 3 : UCIP_SP_2020_32018_58468.jpg

Concrete vault located on waterward side. Site is a erosion repair site.

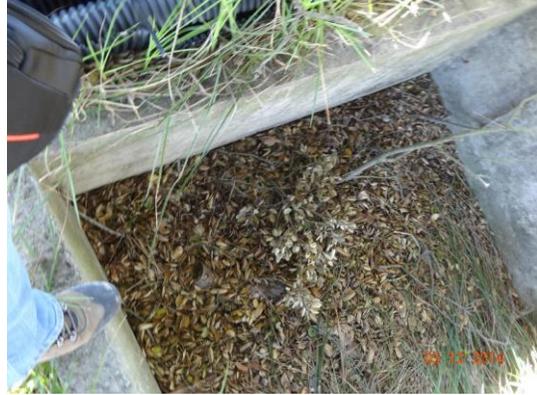
Photo 3 of 3 : UCIP_SP_2020_32018_58467.jpg

Concrete face no outlet visible on waterward side.

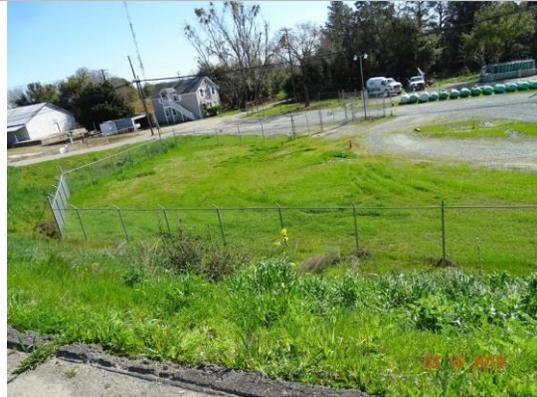
Photo 1 of 1 : SP_2020_RD0554_176_34_20200304_00016.jpg

LM Start	0.27	Rating **	M	Issue No.	34
LM End	0.32	Issue Type +	En	Location *	LS
Category	Earthen Levee			GPS Latitude/Longitude	
				Start	End
Item	Encroachments			38.246065 °	38.245397 °
				-121.510688 °	-121.511168 °
DWR ID	DWR_RD0554_01_s_2019_34				
Comment Code					
FE : Fence					
Inspector Comment					
A fence is located at the landside toe.

View of chainlink fence at the landside toe (Spring 2019).

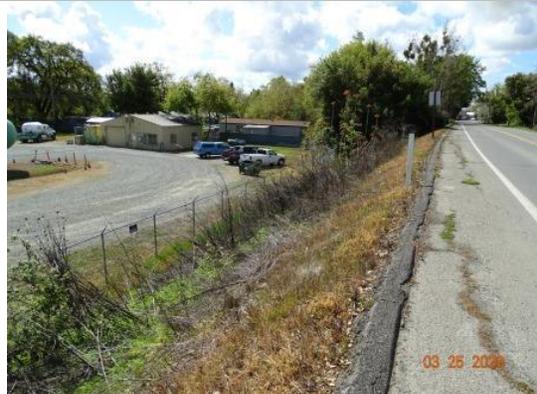
Photo 1 of 1 : SP_2020_RD0554_176_51_20200325_00082.jpg

LM Start	0.31	Rating **	M	Issue No.	51
LM End	0.35	Issue Type +	Ma	Location *	LS
Category	Earthen Levee			GPS Latitude/Longitude	
				Start	End
Item	Vegetation			38.245515 °	38.244950 °
				-121.511083 °	-121.511493 °
DWR ID	DWR_RD0554_01_f_2019_51				
Comment Code					
V2 : Remove the wild growth other than native grasses from the levee slopes.					
Inspector Comment

View looking downstream at vegetation on the landside slope (Spring 2020).

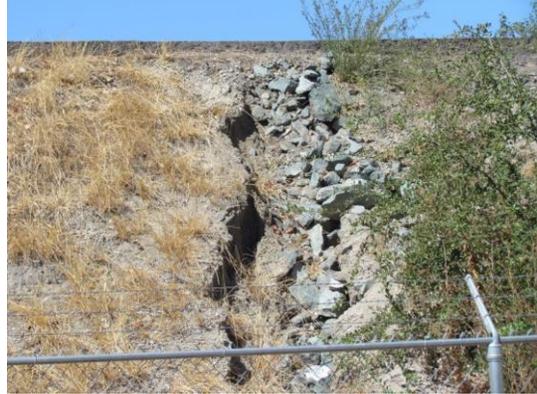
Photo 1 of 1 : SP_2020_RD0554_176_13_20200304_00002.jpg

LM Start	0.32	Rating **	U	Issue No.	13
LM End	0.32	Issue Type +	Ma	Location *	LS
Category	Earthen Levee			GPS Latitude/Longitude	
				Start	End
Item	Erosion / Bank Caving			38.245389 °	38.245389 °
				-121.511085 °	-121.511085 °
DWR ID	DWR_RD0554_01_s_2014_13				
Comment Code					
E2 : Schedule repair of erosion site prior to the next inspection.					
Inspector Comment					
This erosion isn't repaired to date. Large bush growing in eroded gully. Needs repairing.

View of eroded gully on the landside slope.

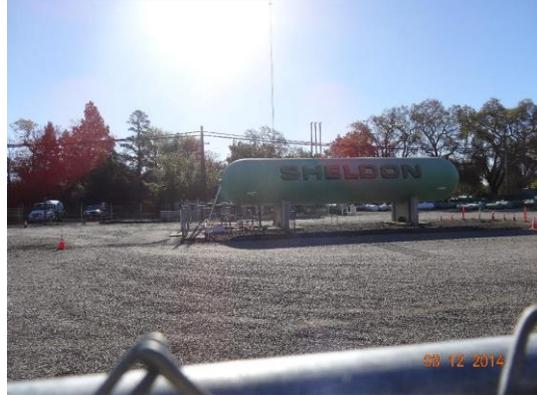
Photo 1 of 1 : UCIP_SP_2020_42143_60800.jpg

LM Start	0.33	Rating **	U	Issue No.	59
LM End	0.33	Issue Type +	En	Location *	
Category	Supplemental			GPS Latitude/Longitude	
				Start	End
Item	DWR UCIP Field Study			38.245295 °	38.245295 °
				-121.511274 °	-121.511274 °
DWR ID	20922				
Comment Code					
Inspector Comment					
DS_ID:20922 FS_ID:42143 EP_NO: N/A Repair Type: Urgent Crossing Status: Indicator Found UCIP Comments: No markers found. Need to contact owner to determine status of crossing. Unable to confirm if crossings are still active or if they cross levee. FIELD_STRUCT_DESC: 1 of 3: 3-inch steel fuel line through the levee, 2.7 feet below the crown. (USACE-1959). This entry matches the Drainage or Irrigation Structure referenced in O&M manual (RM 27.20). FS Date: 3/12/2014

Tank found on landward side.

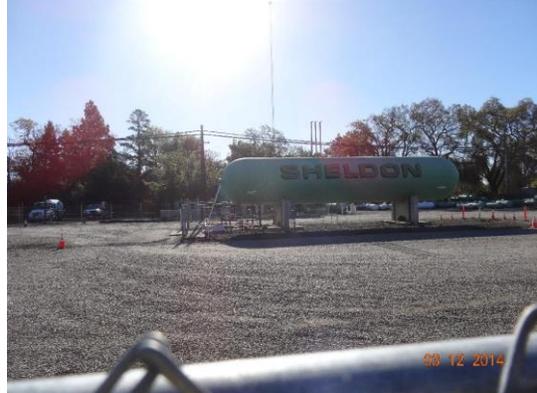
Photo 1 of 1 : UCIP_SP_2020_42144_60801.jpg

LM Start	0.33	Rating **	U	Issue No.	60
LM End	0.33	Issue Type +	En	Location *	
Category	Supplemental		GPS Latitude/Longitude		
			Start	End	
Item	DWR UCIP Field Study		38.245295 °	38.245295 °	
			-121.511274 °	-121.511274 °	
DWR ID	20932				
Comment Code					
Inspector Comment					
DS_ID:20932 FS_ID:42144 EP_NO: N/A Repair Type: Urgent Crossing Status: Indicator Found UCIP Comments: No markers found. Need to contact owner to determine status of crossing. Unable to confirm if crossings are still active or if they cross levee. FIELD_STRUCT_DESC: 2 of 3: 3-inch steel fuel line through the levee, 2.7 feet below the crown. (USACE-1959). This entry matches the Drainage or Irrigation Structure referenced in O&M manual (RM 27.20). FS Date: 3/12/2014

Fuel tank located on landward side.

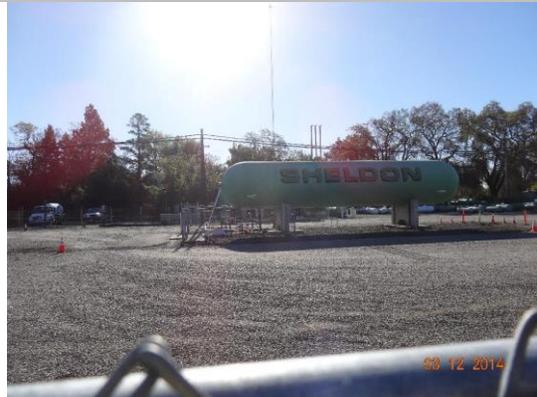
Photo 1 of 1 : UCIP_SP_2020_42145_60802.jpg

LM Start	0.33	Rating **	U	Issue No.	61
LM End	0.33	Issue Type +	En	Location *	
Category	Supplemental		GPS Latitude/Longitude		
			Start	End	
Item	DWR UCIP Field Study		38.245295 °	38.245295 °	
			-121.511274 °	-121.511274 °	
DWR ID	20933				
Comment Code					
Inspector Comment					
DS_ID:20933 FS_ID:42145 EP_NO: N/A Repair Type: Urgent Crossing Status: Indicator Found UCIP Comments: No markers. Need to contact owner to determine status of crossing. Unable to confirm if crossings are still active or if they cross levee. FIELD_STRUCT_DESC: 3 of 3: 3-inch steel fuel line through the levee, 2.7 feet below the crown. (USACE-1959). This entry matches the Drainage or Irrigation Structure referenced in O&M manual (RM 27.20). FS Date: 3/12/2014

Fuel tank located on landward side.

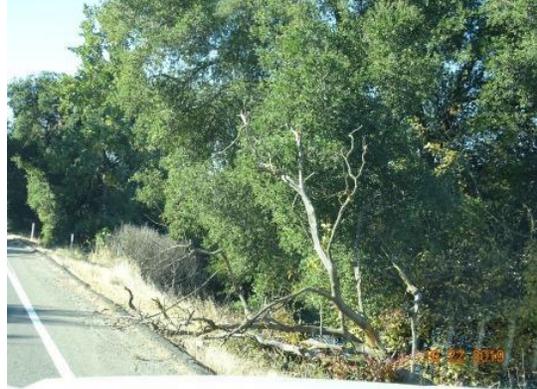
Photo 1 of 1 : SP_2020_RD0554_176_45_20200304_00018.jpg

View looking downstream at down tree on the waterside slope (Fall 2019).

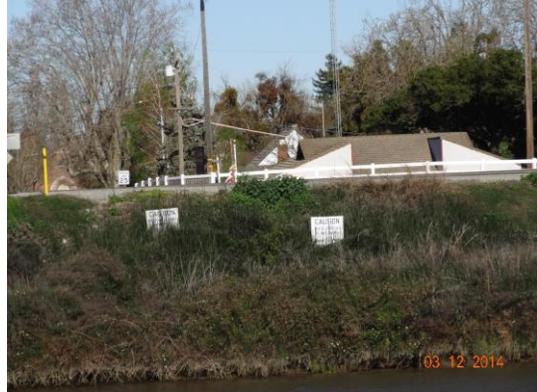
Photo 1 of 3 : UCIP_SP_2020_43694_58063.jpg

Comment Code					
Inspector Comment					
DS_ID:20899 FS_ID:43694 EP_NO: 5429 Repair Type: Non-Urgent Crossing Status: Indicator Found UCIP Comments: Signs of open cut along crossing--no markers visible on waterward or landward side. Large across channel on right bank berm indicating cable through levee. FIELD_STRUCT_DESC: Four 4-inch iron conduits through the levee, at various depths below the crown (3.0-4.9 feet). Each conduit encases a shielded telephone cable. Concrete cutoff wall around pipes on landward levee shoulder. Riser pole off the landward levee toe. (four 5-inch diameter AC ducts through a 18-inch pipe authorized under Permit No. 5429, 1967 - General Telephone Company of California; Replacement telephone conduits were pulled through iron conduits under Permit No. 13417, 1983 - General Telephone Company). [Additional Reference(s): DWR Levee Log, 1983 and 2005] FS Date: 3/4/2015

Signs for conduits visible on right bank across channel. Conduits cross left bank, channel, and right bank.

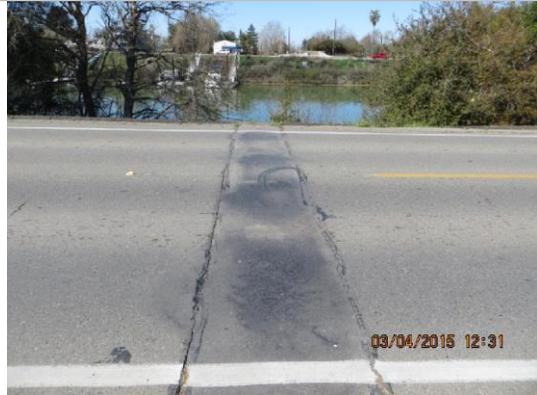
Photo 2 of 3 : UCIP_SP_2020_43694_73221.jpg

View of waterside from landside shoulder. Cuts in pavement indicate presence of pipe trench across levee.

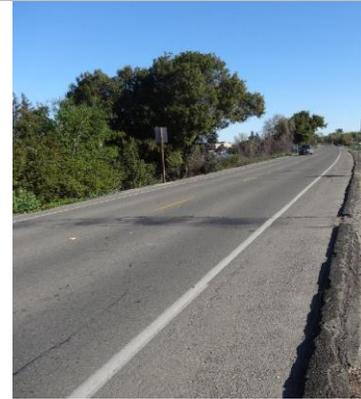
Photo 3 of 3 : UCIP_SP_2020_43694_58062.jpg

Signs of cut through levee at conduit.

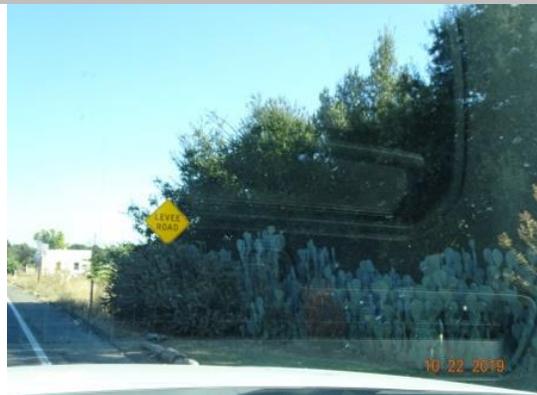
Photo 1 of 1 : SP_2020_RD0554_176_29_20200304_00011.jpg

View looking upstream at cactus and other landscaping on the landside slope (Fall 2019).

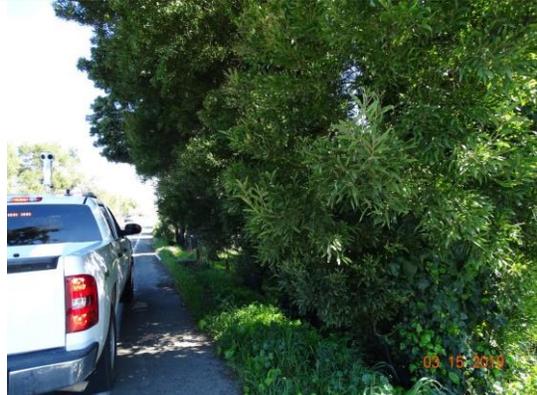
Photo 1 of 1 : SP_2020_RD0554_176_33_20200304_00015.jpg

View looking upstream at landscaping on the landside shoulder (Spring 2019).

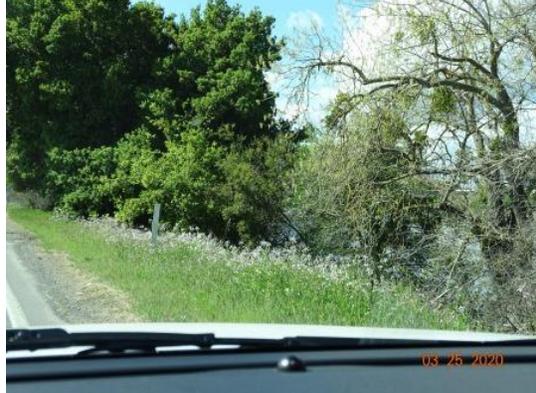
Photo 1 of 1 : SP_2020_RD0554_176_48_20200325_00078.jpg

View looking downstream at annual vegetation on the waterside slope (Spring 2020).

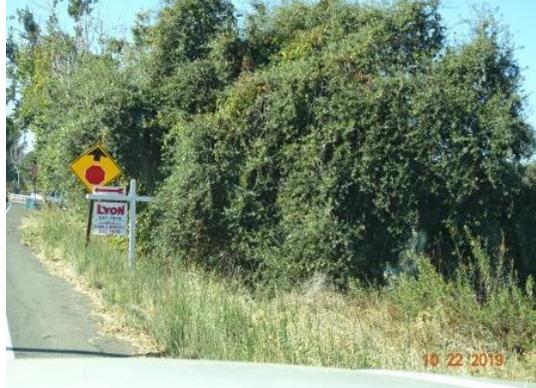
Photo 1 of 1 : SP_2020_RD0554_176_32_20200304_00014.jpg

View looking downstream at thick trees on the waterside slope (Fall 2019).

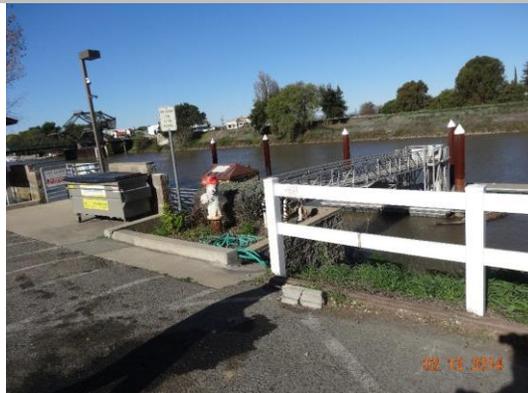
Photo 1 of 3 : UCIP_SP_2020_53525_58085.jpg

Comment Code					
Inspector Comment					
DS_ID:20901 FS_ID:53525 EP_NO: 11155 Repair Type: Non-Urgent Crossing Status: Not Found UCIP Comments: 05/17/2018 Pipe not found. See DS-ID 25532 for water supply line through the levee connected to fire hydrant on WS (UCIP-O.Yakimov) Multiple crossings at same location--unable to confirm if crossing matches details under permit 11155. Need to contact owner to obtain additional information about crossing status. FIELD_STRUCT_DESC: 1 of 3: 6-inch pipe of unknown material or purpose through the levee, 5.5 feet below the crown. Fire hydrant on waterside (WS) shoulder and valve in cut visible in roadway. Electrical utility box on landside (LS) shoulder. Electrical lines visible on WS at ramp. (three 6-inch pipe retained under Automatic Board Order (ABO) issued as Permit No. 11155, 1975 - Carol M. Dye et al) [Additional Reference(s): DWR Levee Log, 1983 and 2005. USACE Sacramento O&M Manual Unit No. 111, May 1959, revised 29 Dec 2016, (River Mile [RM] 26.75)] FS Date: 5/17/2018

Multiple lines through levee crown visible on waterward shoulder.

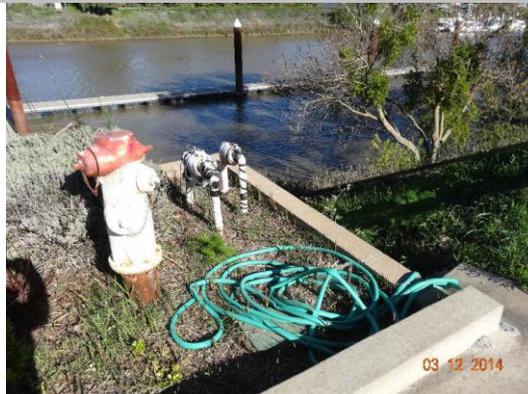
Photo 2 of 3 : UCIP_SP_2020_53525_58083.jpg

Lines visible on waterward side.

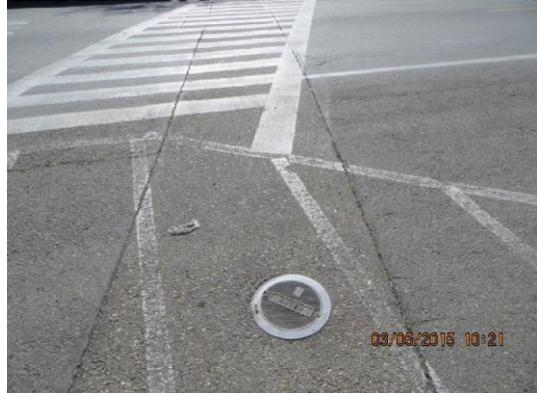
Photo 3 of 3 : UCIP_SP_2020_53525_73227.jpg

Cuts in pavement and lid for water valve visible from WS shoulder.

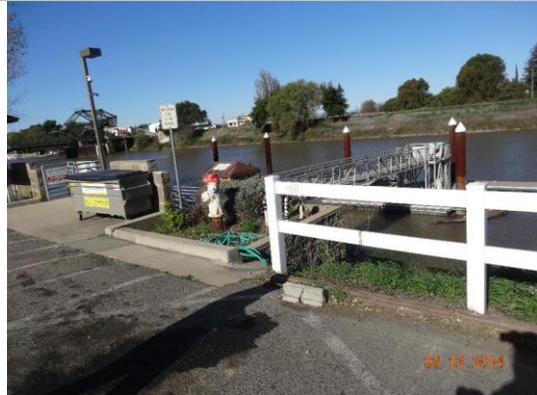
Photo 1 of 3 : UCIP_SP_2020_53526_58097.jpg

Multiple crossing visible on waterward shoulder.

Comment Code					
Inspector Comment					
DS_ID:20937 FS_ID:53526 EP_NO: 11155 Repair Type: Non-Urgent Crossing Status: Not Found UCIP Comments: 05/17/2018 Pipe not found. See DS-ID 25533 for water supply line through the levee visible as irrigation and dock cleaning pipes on WS (UCIP-O.Yakimov) Multiple crossings at same location--unable to confirm if crossing matches details under permit 11155. Need to contact owner to obtain additional information about crossing status. FIELD_STRUCT_DESC: 2 of 3: 6-inch pipe of unknown material or purpose through the levee, 5.5 feet below the crown. Fire hydrant on waterside (WS) shoulder and valve in cut visible in roadway. Electrical utility box on landside (LS) shoulder. Electrical lines visible on WS at ramp. (three 6-inch pipe retained under Automatic Board Order (ABO) issued as Permit No. 11155, 1975 - Carol M. Dye et al) [Additional Reference(s): DWR Levee Log, 1983 and 2005. USACE Sacramento O&M Manual Unit No. 111, May 1959, revised 29 Dec 2016, (River Mile [RM] 26.75)] FS Date: 5/17/2018 3:08:00 PM

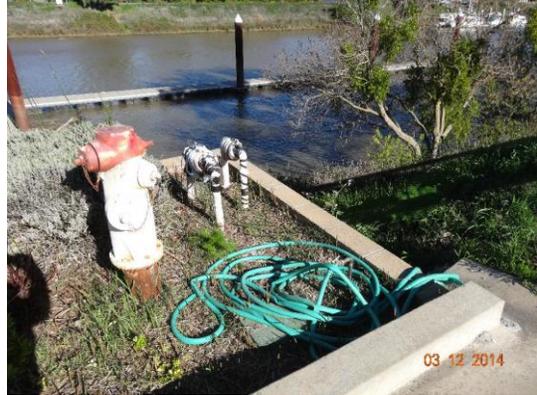
Photo 2 of 3 : UCIP_SP_2020_53526_58095.jpg

Crossings visible on waterward side.

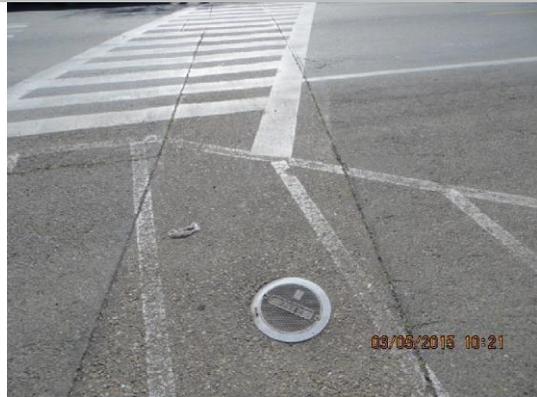
Photo 3 of 3 : UCIP_SP_2020_53526_73255.jpg

Cuts in pavement visible from WS shoulder. Valve visible in roadway.

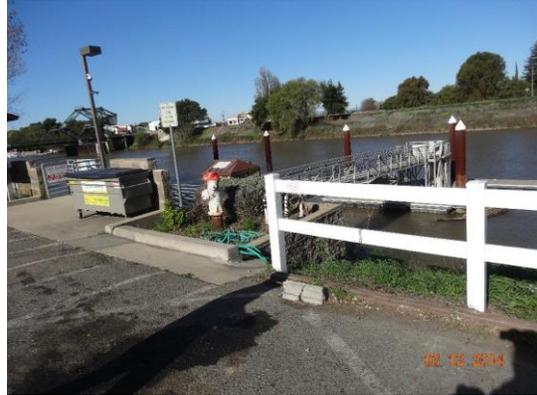
Photo 1 of 3 : UCIP_SP_2020_53527_58091.jpg

Comment Code					
Inspector Comment					
DS_ID:20938 FS_ID:53527 EP_NO: 11155 Repair Type: Non-Urgent Crossing Status: Not Found UCIP Comments: 05/17/2018 Pipe not found. See DS-ID 25534 for electrical conduit through the levee (UCIP-O.Yakimov) Multiple crossings at same location--unable to confirm if crossing matches details under permit 11155. Need to contact owner to obtain additional information about crossing status. FIELD_STRUCT_DESC: 3 of 3: 6-inch pipe of unknown material or purpose through the levee, 5.5 feet below the crown. Fire hydrant on waterside (WS) shoulder and valve in cut visible in roadway. Electrical utility box on landside (LS) shoulder. Electrical lines visible on WS at ramp. (three 6-inch pipe retained under Automatic Board Order (ABO) issued as Permit No. 11155, 1975 - Carol M. Dye et al) [Additional Reference(s): DWR Levee Log, 1983 and 2005. USACE Sacramento O&M Manual Unit No. 111, May 1959, revised 29 Dec 2016, (River Mile [RM] 26.75)] FS Date: 5/17/2018 3:09:00 PM

View of multiple crossings through levee.

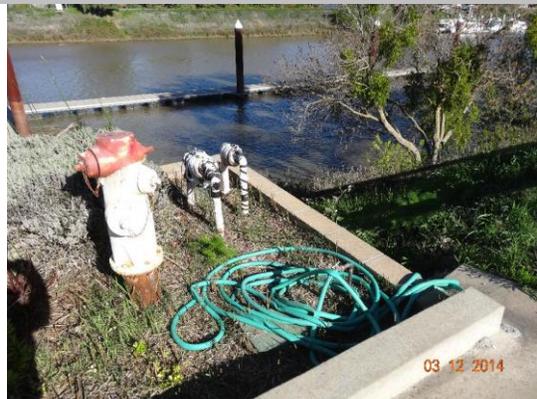
Photo 2 of 3 : UCIP_SP_2020_53527_58089.jpg

Crossings visible on waterward shoulder.

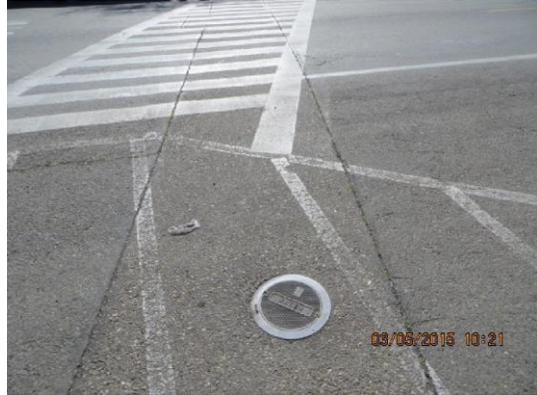
Photo 3 of 3 : UCIP_SP_2020_53527_73259.jpg

Cuts in pavement visible from WS shoulder. Valve visible in roadway.

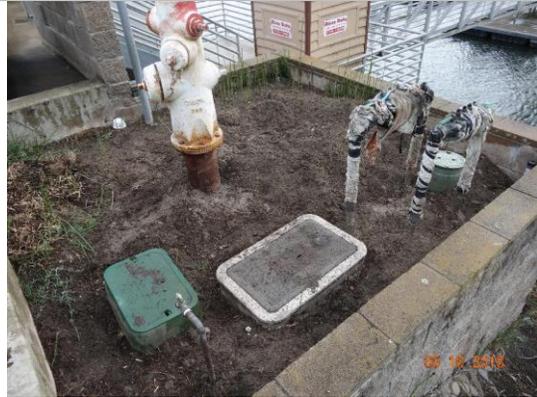
Photo 1 of 3 : UCIP_SP_2020_54267_80022.jpg

DS_ID:25532
 FS_ID:54267
 EP_NO: N/A
 Repair Type: Non-Urgent
 Crossing Status: Found
 UCIP Comments: 05/16/2018 No issues recorded during inspection (O.Yakimov - DWR UCIP)
 FIELD_STRUCT_DESC: 7-inch OD fire hydrant line through the levee, 2-feet blow crown. Installed as a part of Walnut Grove Community Dock project completed in 1998. No permit found for this crossing. [Additional Reference(s): Levee Log RD0544 Unit 1, LM 0.52, year 2015; Walnut Grove Community Dock Dwg No. 7127.01 sheet P-1]
 FS Date: 5/16/2018

Fire hydrant and irrigation lines at WS shoulder

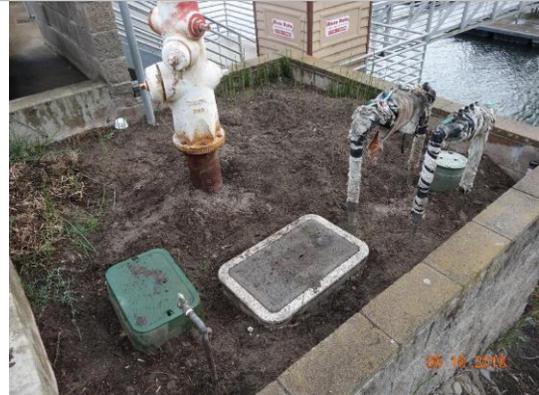
Photo 1 of 3 : UCIP_SP_2020_54268_80027.jpg

LM Start	0.52	Rating **	M	Issue No.	68
LM End	0.52	Issue Type +	En	Location *	
Category	Supplemental		GPS Latitude/Longitude		
			Start	End	
Item	DWR UCIP Field Study		38.243015 °	38.243015 °	
			-121.513278 °	-121.513278 °	
DWR ID	25533				
Comment Code					
Inspector Comment					
DS_ID:25533 FS_ID:54268 EP_NO: N/A Repair Type: Non-Urgent Crossing Status: Found UCIP Comments: 5/16/2018 No issues recorded during inspection (O.Yakimov - DWR UCIP) FIELD_STRUCT_DESC: Irrigation water supply pipe of unknown diameter, 2-feet blow crown. On waterside splits into irrigation and dock cleaning pipes. Installed as a part of Walnut Grove Community Dock project completed in 1998. No permit found for this crossing. [Additional Reference(s): Walnut Grove Community Dock Dwg No. 7127.01 sheet P-1] FS Date: 5/16/2018

Irrigation line on WS shoulder

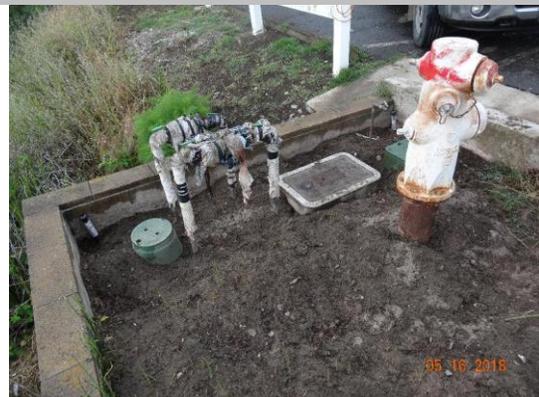
Photo 2 of 3 : UCIP_SP_2020_54268_80028.jpg

Irrigation line on WS shoulder

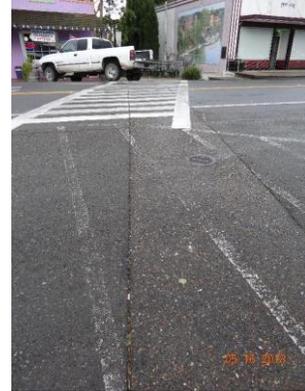
Photo 3 of 3 : UCIP_SP_2020_54268_80029.jpg

Cut in River Rd pavement

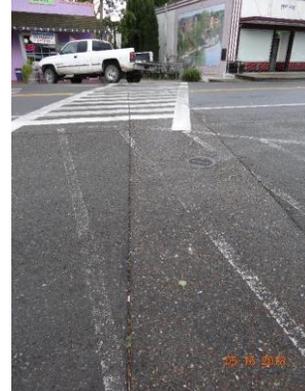
Photo 1 of 1 : UCIP_SP_2020_54269_80031.jpg

Cut in River Rd pavement

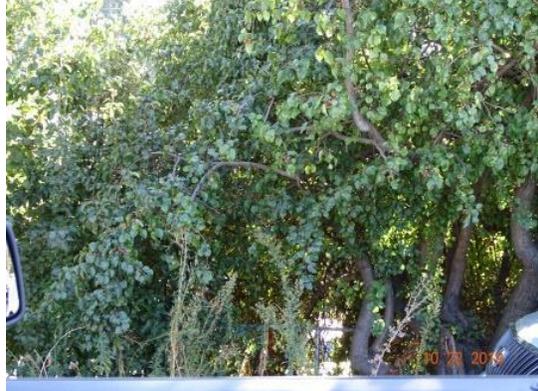
Photo 1 of 1 : SP_2020_RD0554_176_50_20200304_00021.jpg

View looking downslope at thick landscaping trees on the landside slope (Fall 2019).

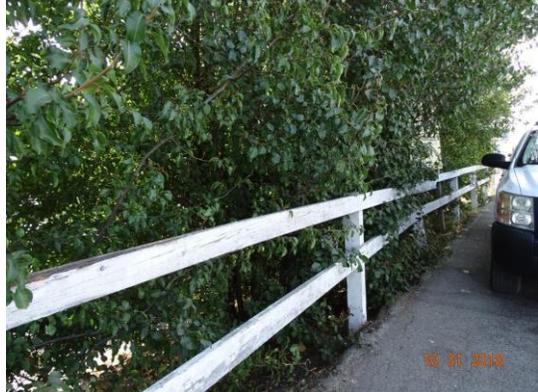
Photo 1 of 1 : SP_2020_RD0554_176_25_20200304_00007.jpg

View of thick trees on the landside slope (October 2018)

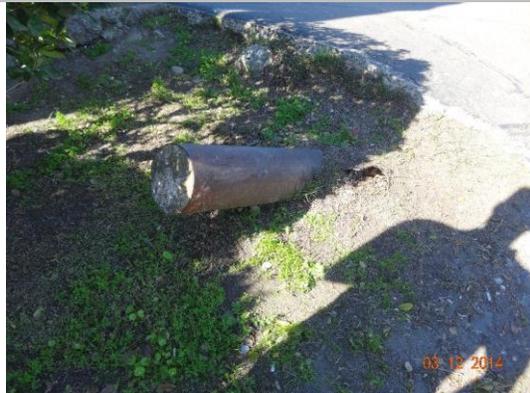
Photo 1 of 1 : UCIP_SP_2020_32020_58473.jpg

Steel pipe filled with concrete visible on landward shoulder.

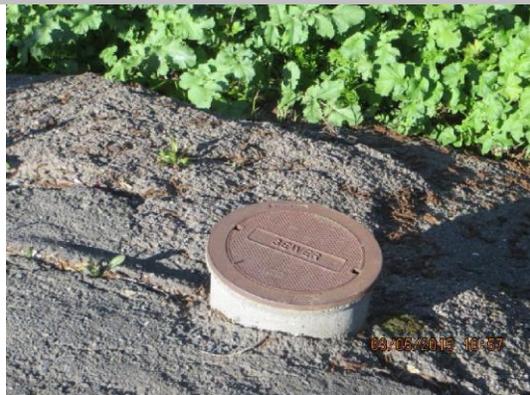
Photo 1 of 3 : UCIP_SP_2020_43805_73320.jpg

Sewer cleanout on WS shoulder.

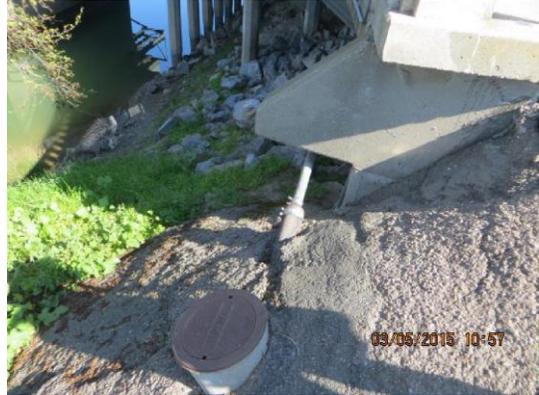
Photo 2 of 3 : UCIP_SP_2020_43805_73321.jpg

Pipe visible at bridge on WS shoulder.

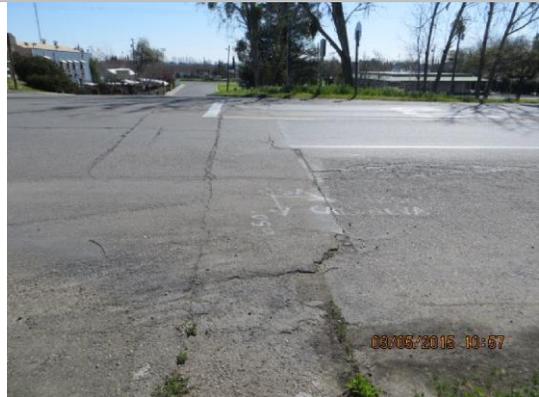
Photo 3 of 3 : UCIP_SP_2020_43805_73322.jpg

Cut in pavement at pipe alignment.

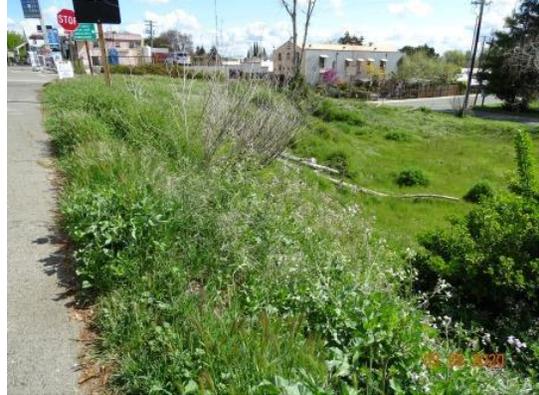
Photo 1 of 1 : SP_2020_RD0554_176_53_20200325_00079.jpg

View looking upstream at thick annual vegetation on the landside slope (Spring 2020).

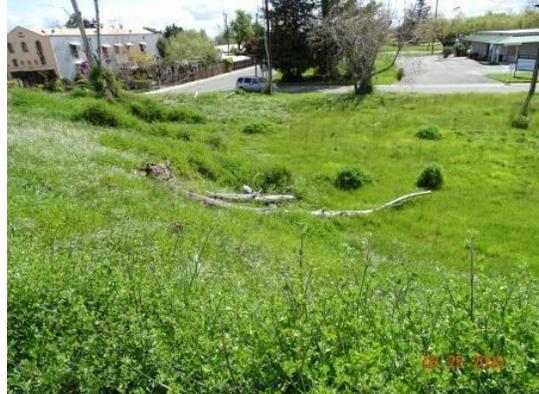
Photo 1 of 1 : SP_2020_RD0554_176_54_20200325_00081.jpg

View of large tree limb on the landside slope (Spring 2020).

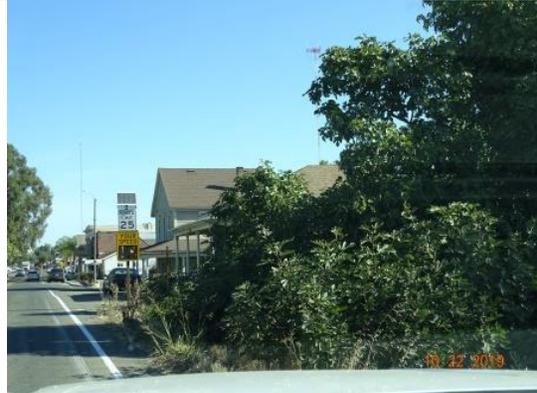
Photo 1 of 1 : SP_2020_RD0554_176_49_20200304_00020.jpg

View looking upstream at thick trees on the landside slope (Fall 2019).

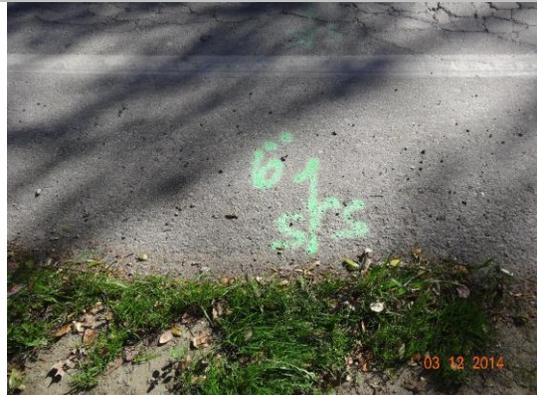
Photo 1 of 3 : UCIP_SP_2020_32021_58475.jpg

Underground service alert (USA) markers confirming sewer line.

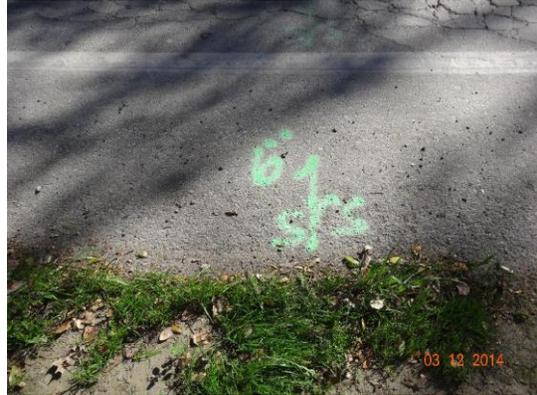
Photo 1 of 3 : UCIP_SP_2020_32022_58480.jpg

Underground service alert (USA) marker on waterward shoulder for sewer line.

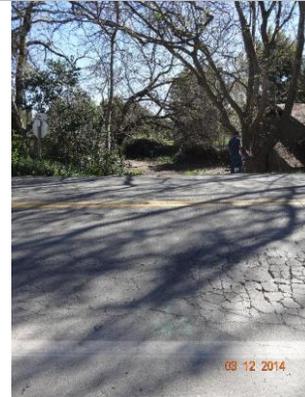
Photo 2 of 3 : UCIP_SP_2020_32022_58479.jpg

View of levee crown.

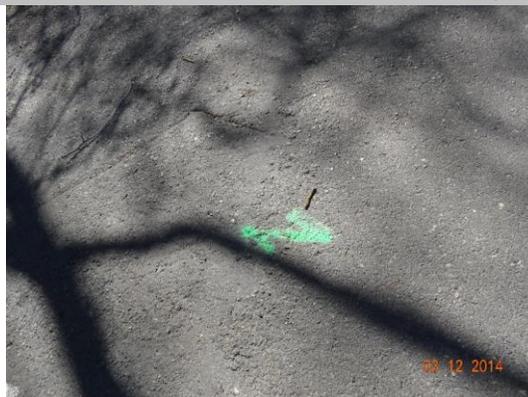
Photo 3 of 3 : UCIP_SP_2020_32022_58478.jpg

View of landward shoulder--USA marker.

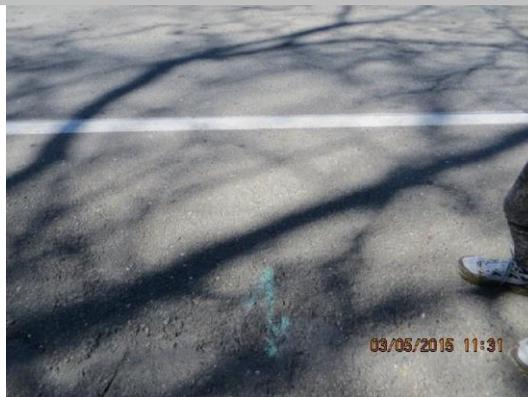
Photo 1 of 3 : UCIP_SP_2020_43804_73323.jpg

USAA SS marking on LS shoulder.

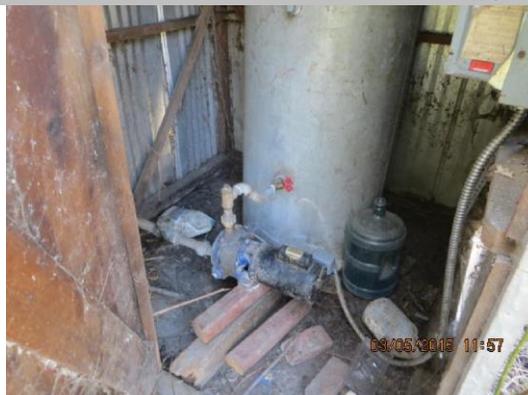
Photo 1 of 3 : UCIP_SP_2020_53406_73243.jpg

Pressurized tank, meter and pump in pumphouse on LS toe.

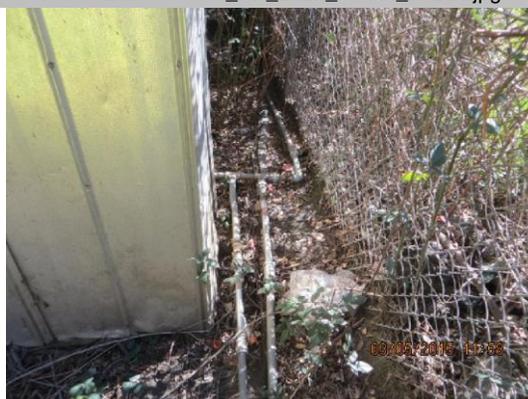
Photo 2 of 3 : UCIP_SP_2020_53406_73244.jpg

A 1-inch and a 1.5-inch galvanized iron drinking water pipe with shutoff valves at pumphouse on LS toe.

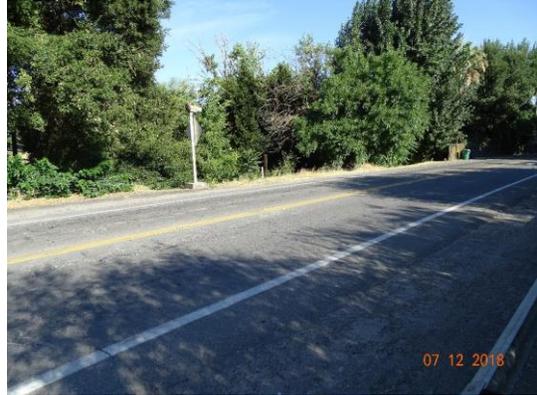
Photo 3 of 3 : UCIP_SP_2020_53406_77593.jpg

View of levee crown at the crossing.

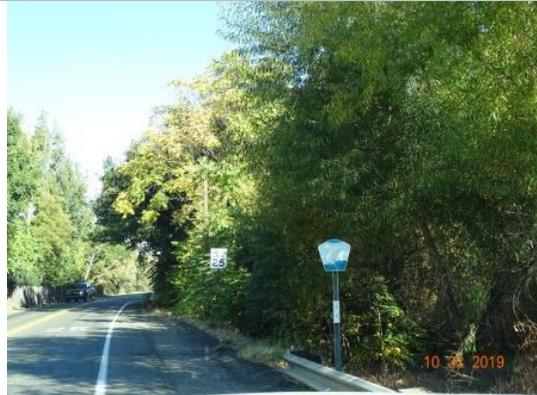
Photo 1 of 1 : SP_2020_RD0554_176_30_20200304_00012.jpg

View looking upstream at thick trees on the landside slope (Fall 2019).

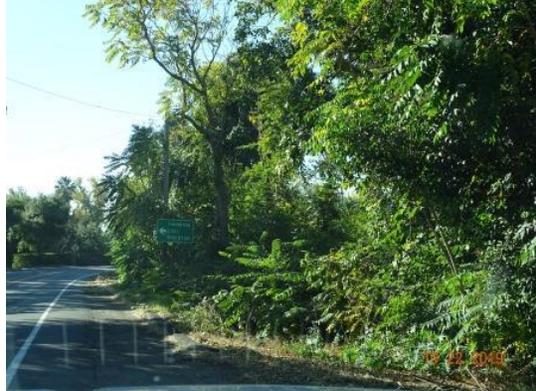
Photo 1 of 1 : SP_2020_RD0554_176_37_20200304_00017.jpg

View of looking downstream at thick trees on the waterside slope (Fall 2019).

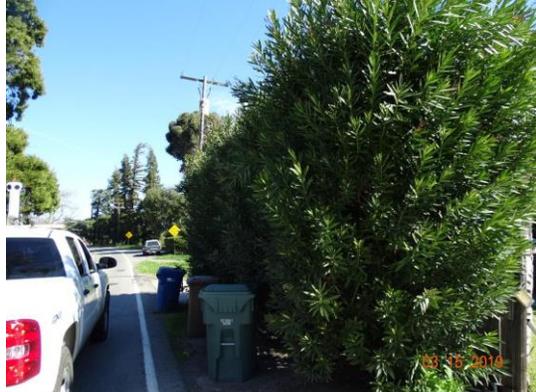
Photo 1 of 1 : SP_2020_RD0554_176_27_20200304_00009.jpg

View looking upstream at landscaping vegetation on the landside shoulder (Spring 2019).
