**Flood Control Project Maintenance
Levee Inspections**

Fall 2019 Levee Maintenance Deficiency Summary Report

Reclamation District No. 0563 Tyler Island

Waterway		Bank	Unit Miles
Unit No. 01 Georgiana Slough (Tyler Island)		Left	12.11
	Spring (March - May)	Summer (June - August)	(September - November) Fall Winter (December - February)
Unit Maintenance Rating (Fall Only)			U
Date of Inspection	4/5/2019 - 4/5/2019		11/8/2019 - 11/8/2019
DWR Inspector	David Julian		David Julian
Accompanied By	Steve Mello RD 563		Steve Mello RD 563

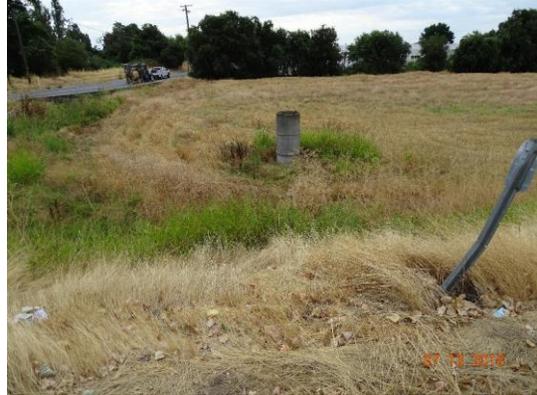
Photo 2 of 3 : UCIP_FA_2019_52739_77710.jpg

Standpipe located on LS.

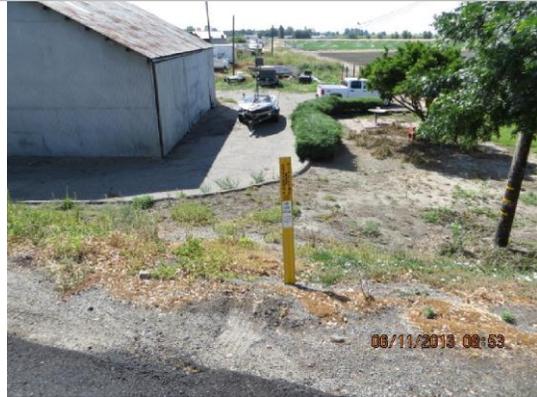
Photo 1 of 3 : UCIP_FA_2019_52740_24505.jpg

Gasline marker on LS shoulder.

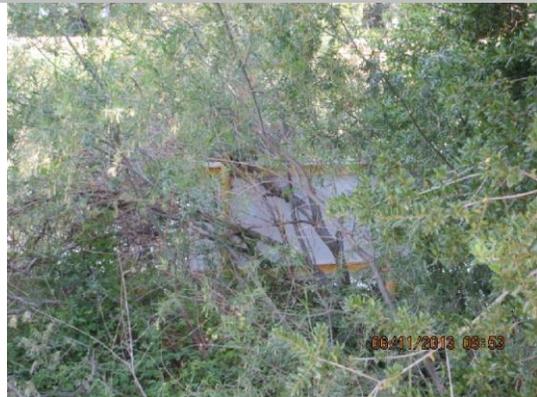
Photo 2 of 3 : UCIP_FA_2019_52740_24504.jpg

Gasline warning sign covered in vegetation on WS slope.

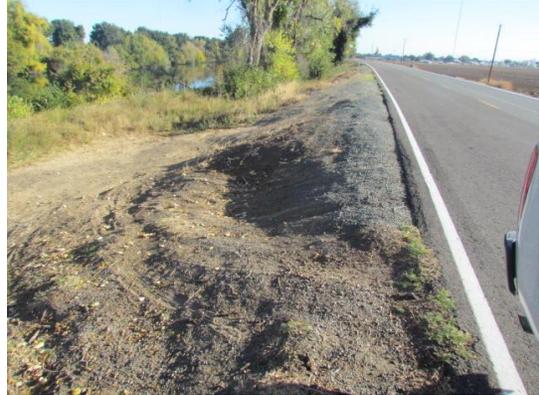
Photo 2 of 2 : FA_2019_RD0563_210_143_20190826_00094.jpg

LM Start	0.56	Rating **	M	Issue No.	143 (cont)
LM End	0.56	Issue Type +	Ma	Location *	WS
Category	Earthen Levee			GPS Latitude/Longitude	
				Start	End
Item	Slope Stability			38.228930 °	38.228930 °
				-121.523935 °	-121.523935 °
DWR ID	DWR_RD0563_01_f_2014_143				
Comment Code					
S3 : Repair the levee slope damaged by vehicle traffic and prevent access where possible.					
Inspector Comment					
Slope damage is due to vehicle traffic.

Looking northwest at slope damage on waterward slope.

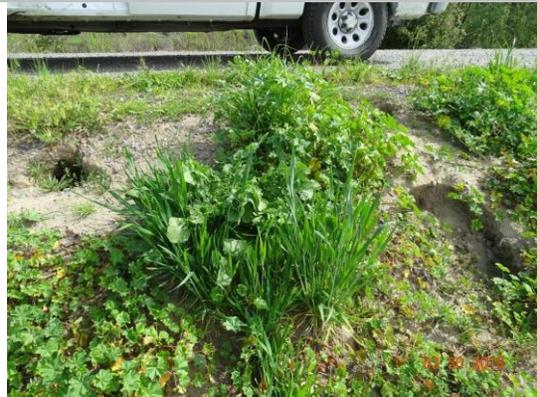
Photo 2 of 2 : FA_2019_RD0563_210_121_20190826_00081.jpg

3/30/2018: Rodent burrows on landside.

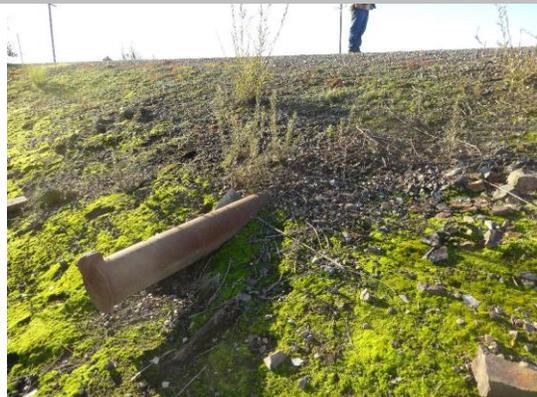
Photo 2 of 3 : UCIP_FA_2019_52745_76828.jpg

Pipe with flap visible on WS.

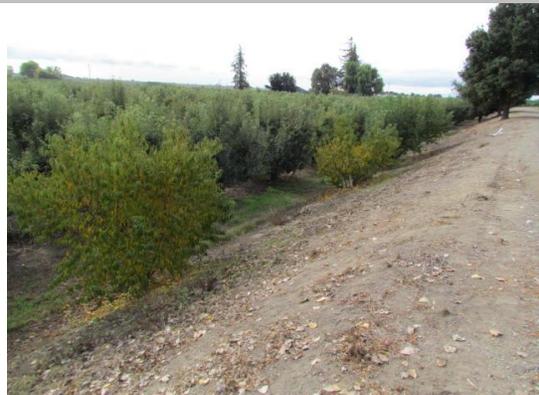
Photo 1 of 1 : FA_2019_RD0563_210_64_20190826_00022.jpg

Looking southeast at fruit trees on landside toe.

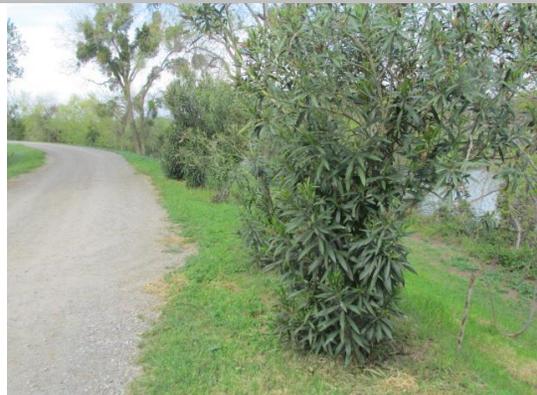
Photo 2 of 2 : FA_2019_RD0563_210_142_20190826_00092.jpg

Looking southwest at oleanders on waterward shoulder.

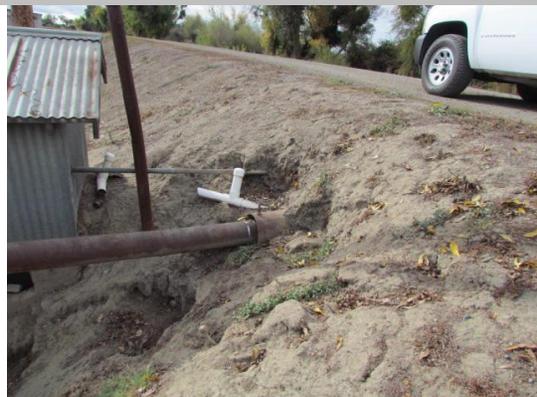
Photo 2 of 2 : FA_2019_RD0563_210_71_20190826_00030.jpg

Looking southwest at erosion around irrigation pipe on landside slope and toe.

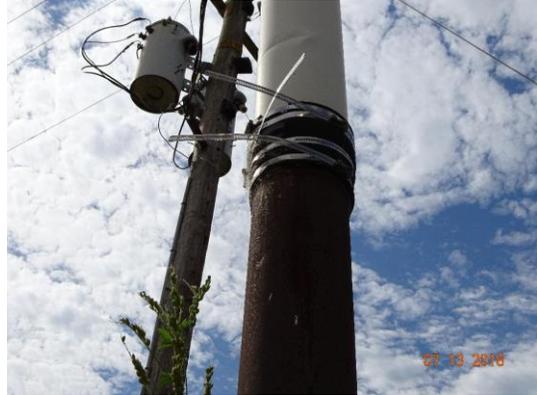
Photo 1 of 3 : UCIP_FA_2019_52732_77687.jpg

Leak at pipe join seems to be fixed with steel clamps.

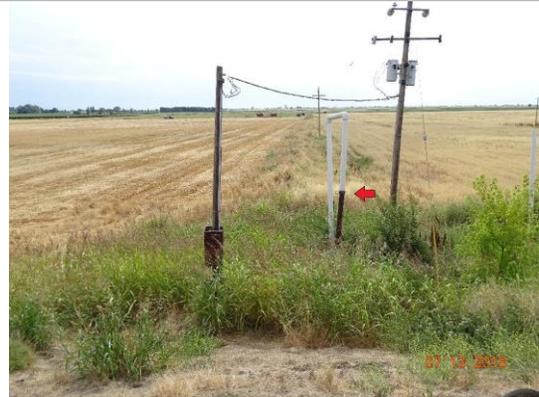
Photo 2 of 3 : UCIP_FA_2019_52732_77689.jpg

View of standpipe with dense vegetation around.

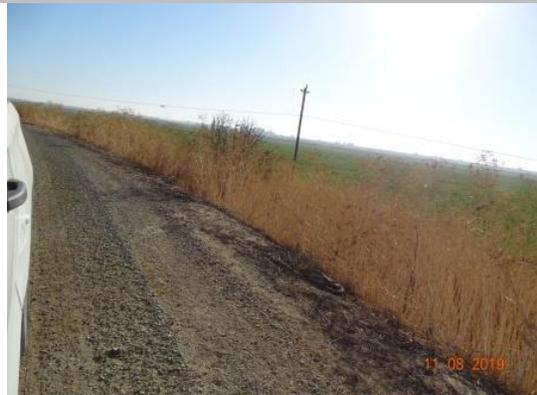
Photo 1 of 1 : FA_2019_RD0563_210_73_20191108_00227.jpg

View looking upstream at annual vegetation on the landside slope (Fall 2019).

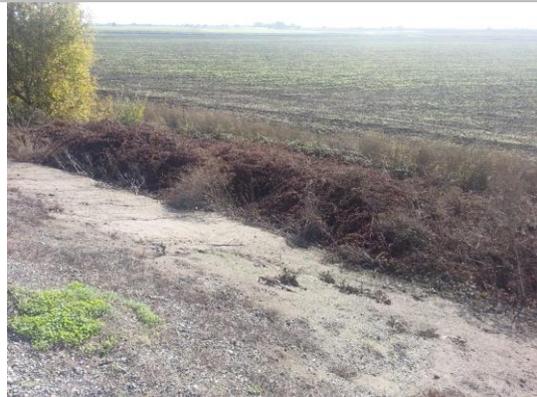
Photo 2 of 2 : FA_2019_RD0563_210_67_20190826_00025.jpg

Looking east at dead berryvines at landward toe. (Fall 2016)

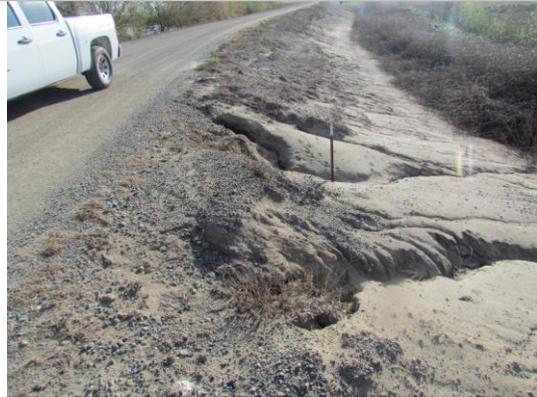
Photo 2 of 3 : FA_2019_RD0563_210_78_20190826_00042.jpg

Looking north at rain runoff erosion on landward slope. (Spring 2017)

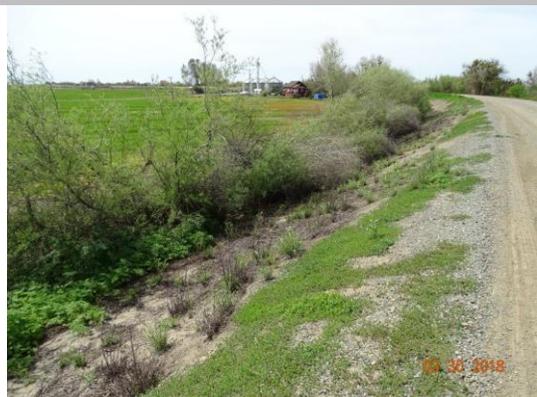
Photo 1 of 1 : FA_2019_RD0563_210_112_20190826_00075.jpg

Very dense woody vegetation preventing inspection and access to landside toe.

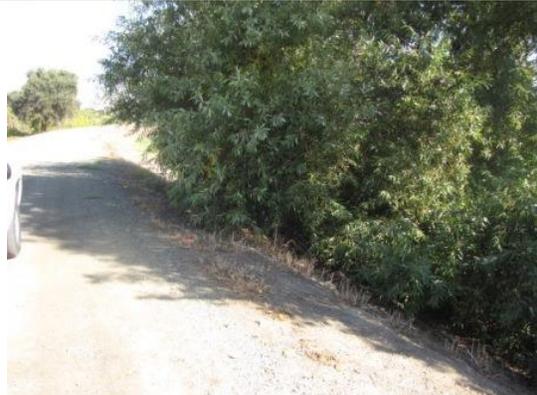
Photo 2 of 2 : FA_2019_RD0563_210_68_20190826_00027.jpg

Looking southeast at dense trees on landside slope and toe.

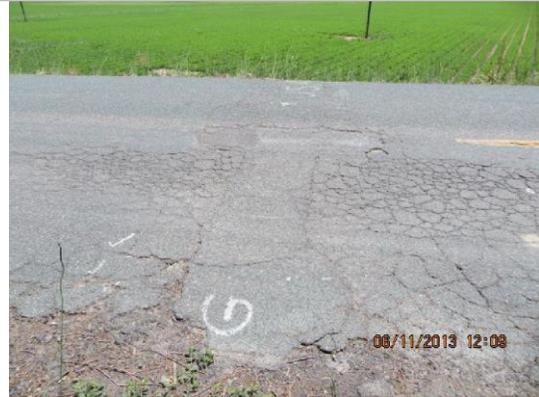
Photo 1 of 3 : UCIP_FA_2019_52758_27390.jpg

Cut in pavement with USAA markings for gasoline.

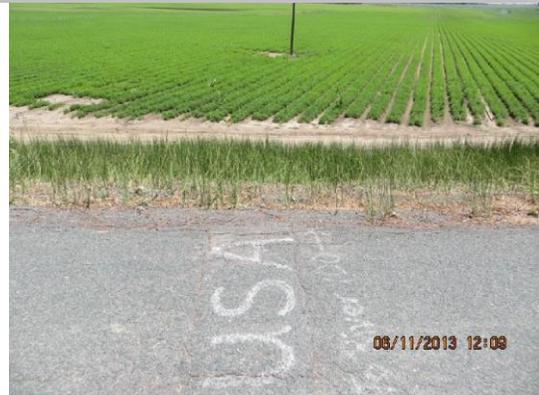
Photo 2 of 3 : UCIP_FA_2019_52758_27389.jpg

Cut in pavement with USAA markings for gasoline.

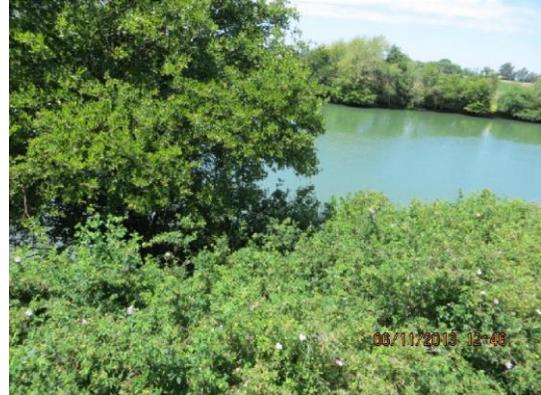
Photo 3 of 3 : UCIP_FA_2019_52763_24593.jpg

Unable to locate pump or other appurtances on WS toe due to vegetation.

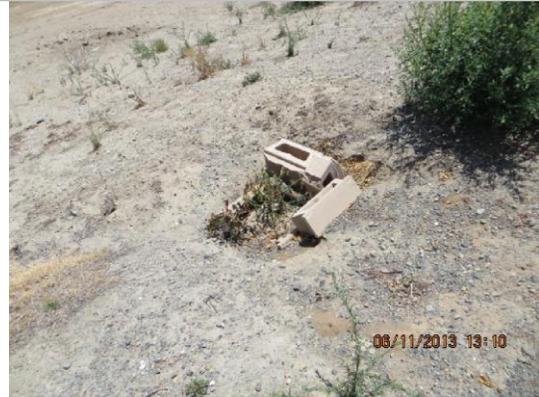
Photo 1 of 3 : UCIP_FA_2019_14950_24607.jpg

Vent/filler pipe exposed on LS shoulder.

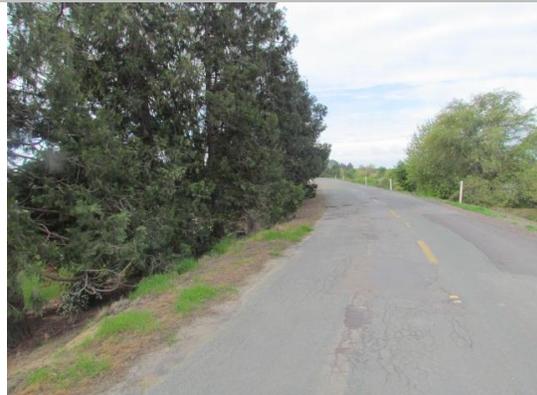
Photo 1 of 1 : FA_2019_RD0563_210_23_20190826_00011.jpg

Looking south at trees on landward shoulder.

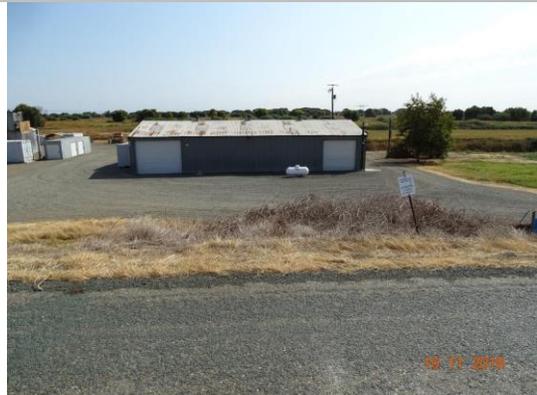
Photo 1 of 1 : FA_2019_RD0563_210_148_20190826_00098.jpg

View of prunings on landside slope (October 2018).

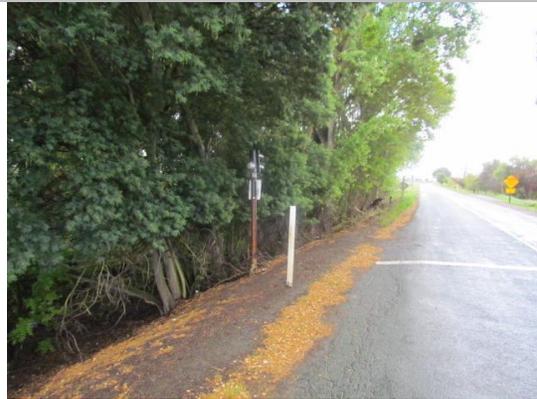
Photo 1 of 1 : FA_2019_RD0563_210_29_20190826_00012.jpg

Looking southeast at dense trees on landward slope and toe.

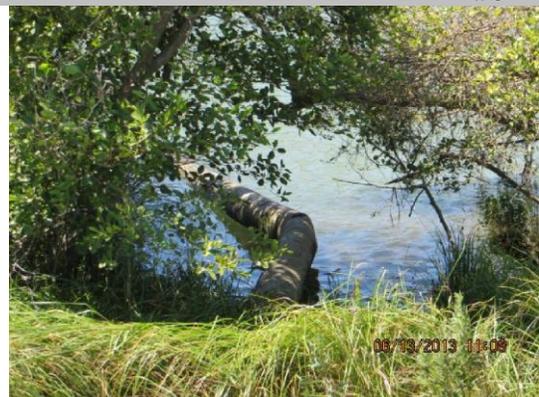
Photo 1 of 3 : UCIP_FA_2019_16292_27453.jpg

Pipe visible on WS toe. See damage to pipe at bend.

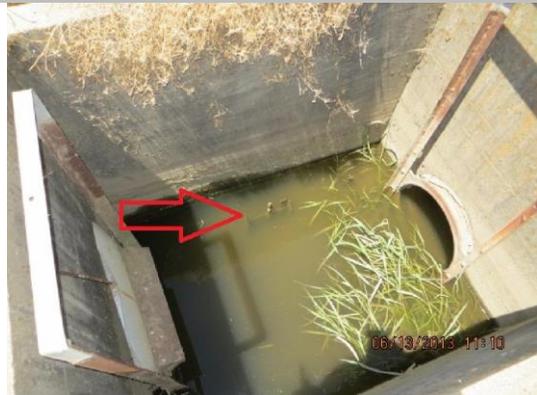
Photo 3 of 3 : UCIP_FA_2019_16292_27451.jpg

Broken slide gate in 7'X9' concrete distribution box on LS toe.

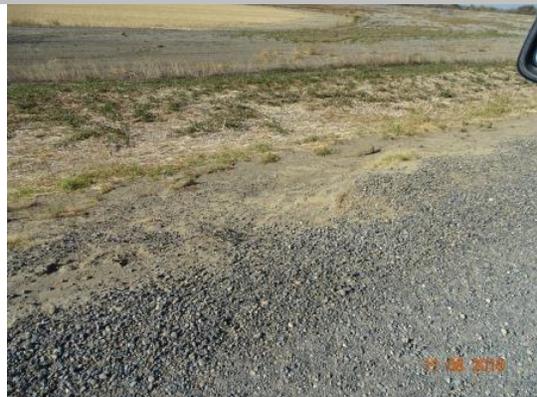
Photo 1 of 1 : FA_2019_RD0563_210_99_20191108_00235.jpg

View looking downslope of erosion at the top of the landside slope (Fall 2019).

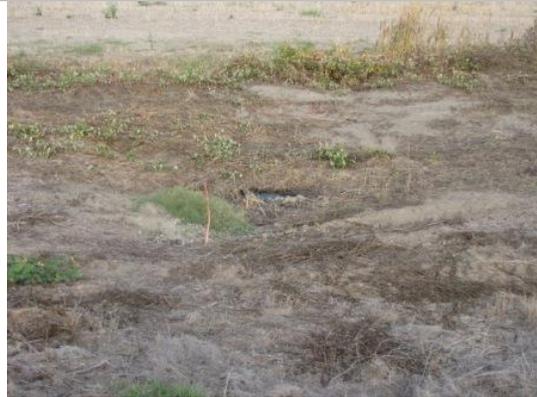
Photo 2 of 4 : FA_2019_RD0563_210_76_20190826_00038.jpg

Looking east at water ponding at landside toe just above 10" irrigation pipe.

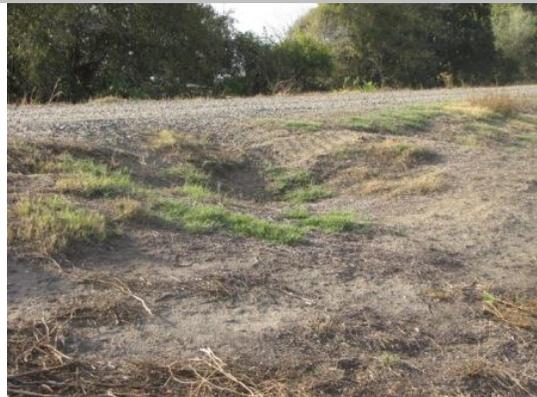
Photo 4 of 4 : FA_2019_RD0563_210_76_20190826_00040.jpg

Looking west at depression on landside shoulder and slope.

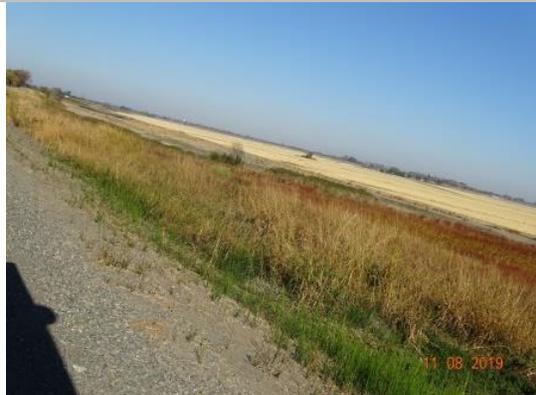
Photo 1 of 1 : FA_2019_RD0563_210_770_20191108_00238.jpg

View looking upstream at vegetation on the landside slope (Fall 2019).

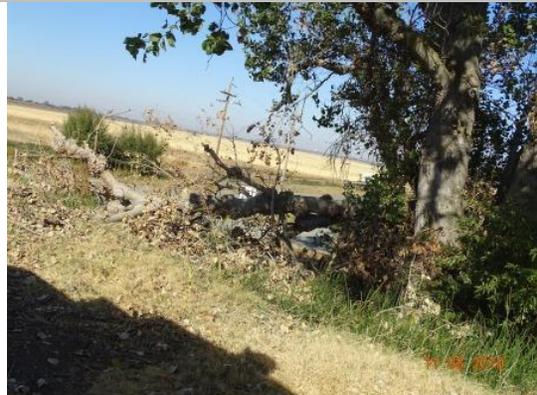
Photo 1 of 1 : FA_2019_RD0563_210_123_20191108_00239.jpg

View of large fallen tree limb on the landside slope (Fall 2019).
