**Flood Control Project Maintenance  
Levee Inspections**

**Maintenance Issue Types Only, Levee Inspection Report By Mile - Fall 2019**

**Reclamation District No. 0563 Tyler Island**

Waterway	Bank	Unit Miles	Inspection Start/End	Inspector
Unit No. 01 Georgiana Slough (Tyler Island)	Left	12.11	11/08/2019 11/08/2019	David Julian

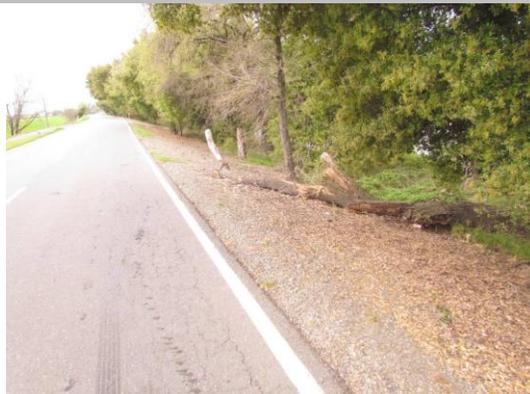
Photo 1 of 2 : FA\_2019\_RD0563\_210\_32\_20190826\_00014.jpg

Looking downstream at tree branch on waterward slope. (Spring 2017)

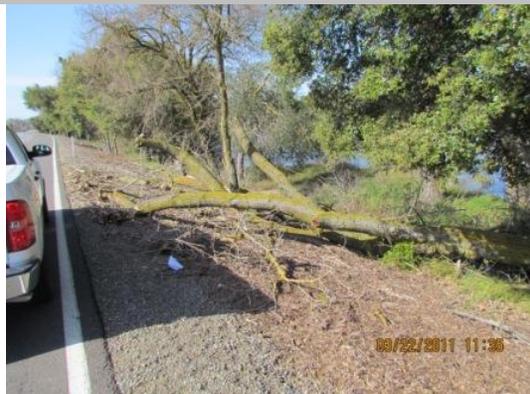
Photo 2 of 2 : FA\_2019\_RD0563\_210\_32\_20190826\_00015.jpg

Looking downstream at fallen tree limb on waterside slope. (Spring 2016)

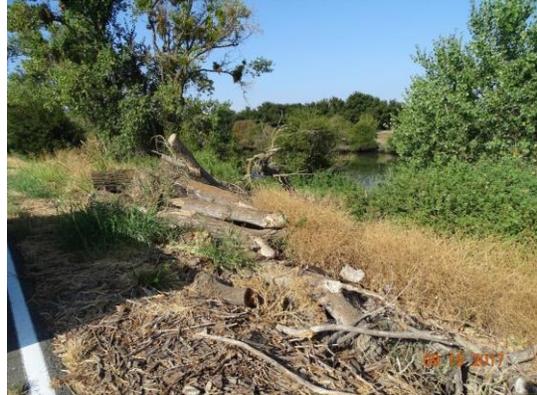
Photo 1 of 1 : FA\_2019\_RD0563\_210\_114\_20190826\_00076.jpg

Looking southwest at the waterside slope.

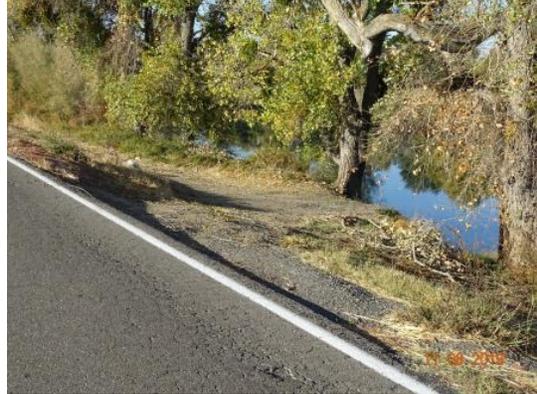
Photo 1 of 1 : FA\_2019\_RD0563\_210\_34\_20191108\_00221.jpg

LM Start	<b>0.53</b>	Rating **	M	Issue No.	<b>34</b>
LM End	<b>0.53</b>	Issue Type +	Ma	Location *	WS
Category	Earthen Levee			GPS Latitude/Longitude	
				Start	End
Item	Slope Stability			38.229232°	38.229232°
				-121.523538°	-121.523538°
DWR ID	DWR_RD0563_01_f_2018_34				
Comment Code					
S3 : Repair the levee slope damaged by vehicle traffic and prevent access where possible.					
Inspector Comment					
Slope damage due to vehicle traffic.

View looking downstream at slope damage from vehicle traffic (Fall 2019).

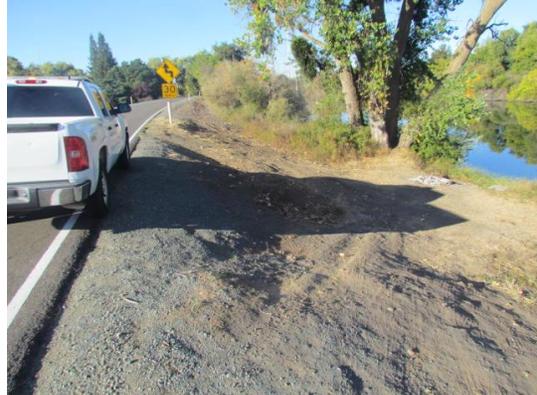
Photo 1 of 2 : FA\_2019\_RD0563\_210\_143\_20190826\_00093.jpg

LM Start	<b>0.56</b>	Rating **	M	Issue No.	<b>143</b>
LM End	<b>0.56</b>	Issue Type +	Ma	Location *	WS
Category	Earthen Levee			GPS Latitude/Longitude	
				Start	End
Item	Slope Stability			38.228930°	38.228930°
				-121.523935°	-121.523935°
DWR ID	DWR_RD0563_01_f_2014_143				
Comment Code					
S3 : Repair the levee slope damaged by vehicle traffic and prevent access where possible.					
Inspector Comment					
Slope damage is due to vehicle traffic.

Looking southeast at slope damage on waterward slope.

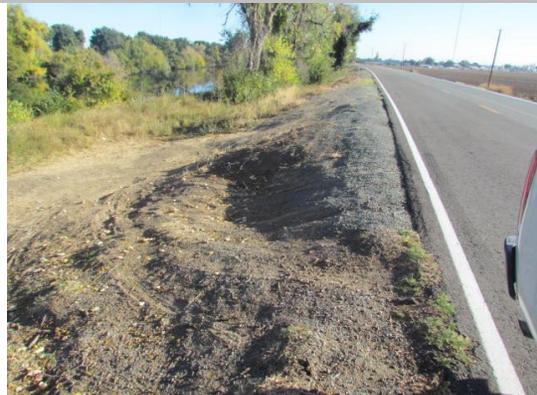
Photo 2 of 2 : FA\_2019\_RD0563\_210\_143\_20190826\_00094.jpg

Looking northwest at slope damage on waterward slope.

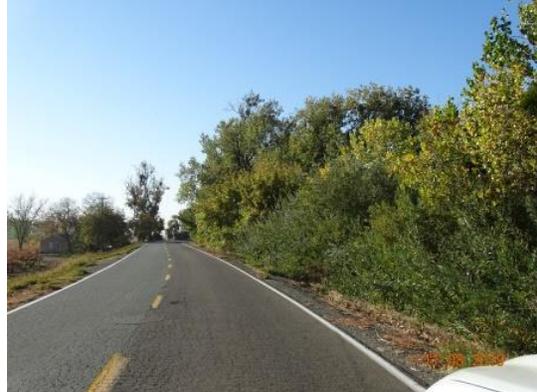
Photo 1 of 1 : FA\_2019\_RD0563\_210\_3\_20191108\_00222.jpg

View looking downstream at thick vegetation on the waterside slope (Fall 2019).

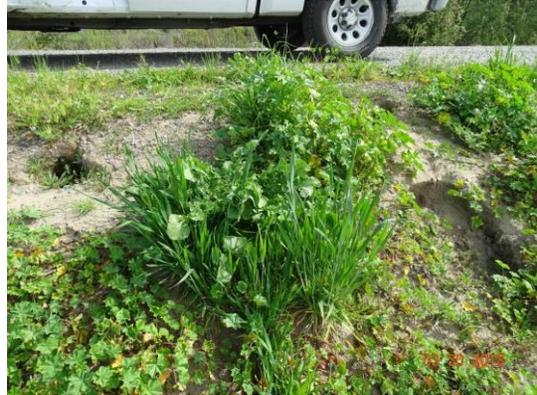
Photo 2 of 2 : FA\_2019\_RD0563\_210\_121\_20190826\_00081.jpg

3/30/2018: Rodent burrows on landside.

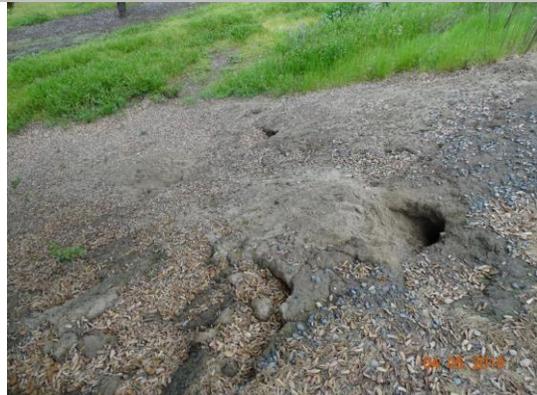
Photo 1 of 1 : FA\_2019\_RD0563\_210\_147\_20190826\_00097.jpg

View of squirrel holes with recent rodent activity (Spring 2019).

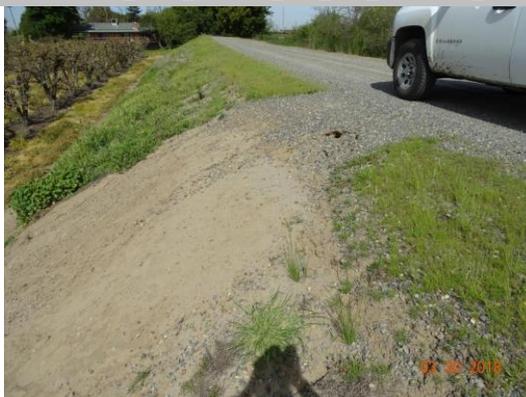
Photo 1 of 1 : FA\_2019\_RD0563\_210\_110\_20190826\_00074.jpg

LM Start	<b>1.03</b>	Rating **	U	Issue No.	<b>110</b>
LM End	<b>1.03</b>	Issue Type +	Ma	Location *	LS
Category	Earthen Levee			GPS Latitude/Longitude	
				Start	End
Item	Animal Control			38.226422°	38.226422°
				-121.529410°	-121.529410°
DWR ID	DWR_RD0563_01_s_2018_110				
Comment Code					
A3 : No rodents visible, but rodent burrows visible; need to backfill and compact or grout burrows.					
Inspector Comment					
A very large rodent burrow has caused the landside shoulder to collapse. The shoulder should be restored.

3/30/2018: Very large rodent burrow causing caving at landside shoulder.

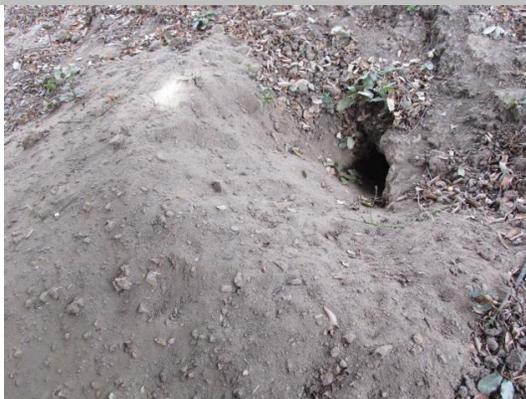
Photo 1 of 1 : FA\_2019\_RD0563\_210\_153\_20190826\_00103.jpg

LM Start	<b>1.15</b>	Rating **	U	Issue No.	<b>153</b>
LM End	<b>1.15</b>	Issue Type +	Ma	Location *	LS
Category	Earthen Levee			GPS Latitude/Longitude	
				Start	End
Item	Animal Control			38.226910°	38.226910°
				-121.531294°	-121.531294°
DWR ID	DWR_RD0563_01_f_2015_153				
Comment Code					
A3 : No rodents visible, but rodent burrows visible; need to backfill and compact or grout burrows.					
Inspector Comment					
Several large to medium rodent holes have been noted at this location.

Looking at typical view of several rodent holes on landward slope.

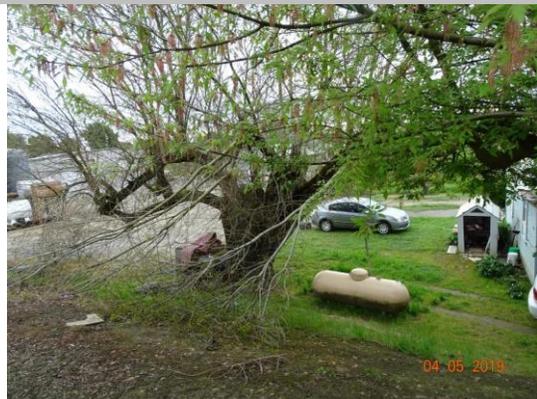
Photo 1 of 1 : FA\_2019\_RD0563\_210\_79\_20190826\_00046.jpg

View looking downslope of recently downed branches on landside slope (Spring 2019).

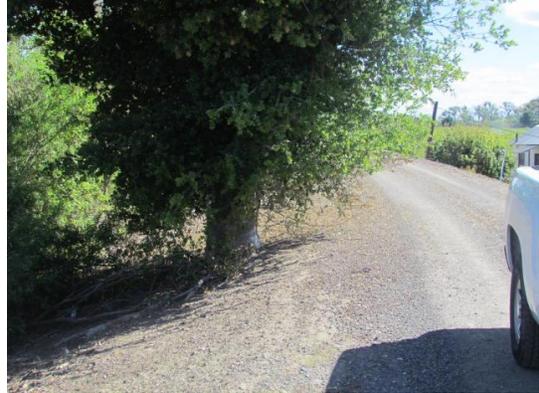
Photo 1 of 1 : FA\_2019\_RD0563\_210\_759\_20190826\_00111.jpg

Looking northwest at untrimmed trees on waterward slope and toe.

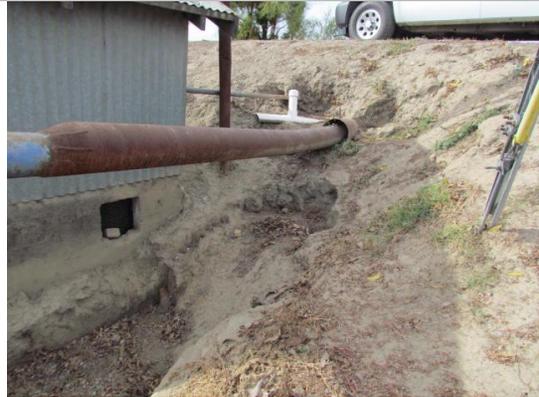
Photo 1 of 2 : FA\_2019\_RD0563\_210\_71\_20190826\_00029.jpg

Looking west at erosion at landside toe and slope next to pump house.

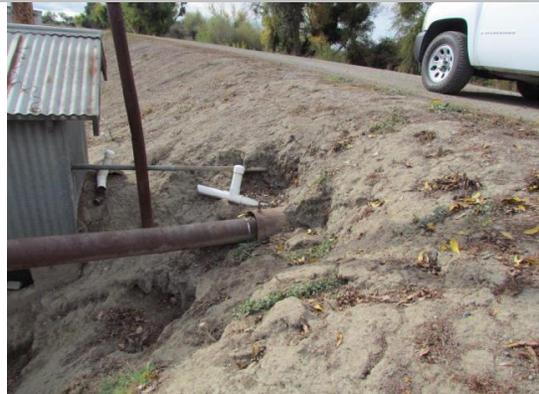
Photo 2 of 2 : FA\_2019\_RD0563\_210\_71\_20190826\_00030.jpg

Looking southwest at erosion around irrigation pipe on landside slope and toe.

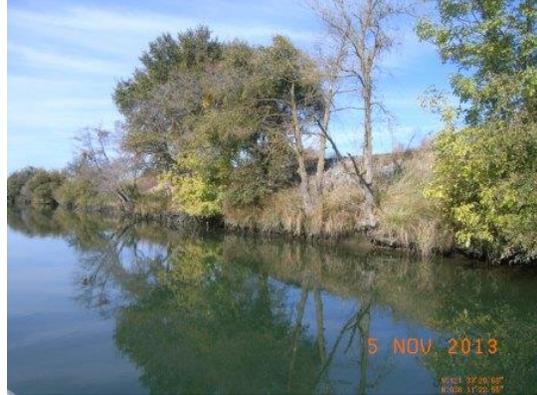
Photo 1 of 1 : FA\_2019\_RD0563\_210\_107\_20190826\_00073.jpg

Item	2017 USACE Erosion Survey			38.215405°	38.208046°
				-121.539764°	-121.540759°
DWR ID	DWR_RD0563_01_f_2018_107				
Comment Code					
Inspector Comment					
2017 Site ID: GEO 9.3 L Status: Critical 2017 Field Notes: Upgraded to critical. Pockets of erosion - subvertical. Areas of failed revetment, old rock is unraveling, and eminent tree popout outs expected. Site History: 1997 - Loss of rock at toe; pockets of upper berm erosion; very narrow berm width; toe rock problem; erosion pockets in rock. 2002 - New brush boxes at toe of the worst spots. 2005 - Upstream 200 ft removed because of the wide berm. 2006 - Some rock repair pockets behind the brush boxes at the upstream end. 2010 - Some new erosion. 2013 - New rock placed on the levee slope. 2016 - Fresh erosion along the toe.

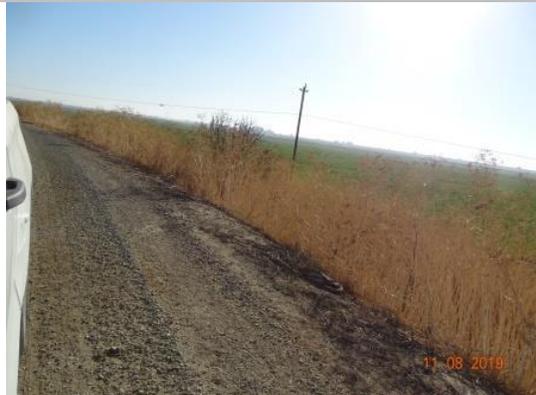
Photo 1 of 1 : FA\_2019\_RD0563\_210\_73\_20191108\_00227.jpg

View looking upstream at annual vegetation on the landside slope (Fall 2019).

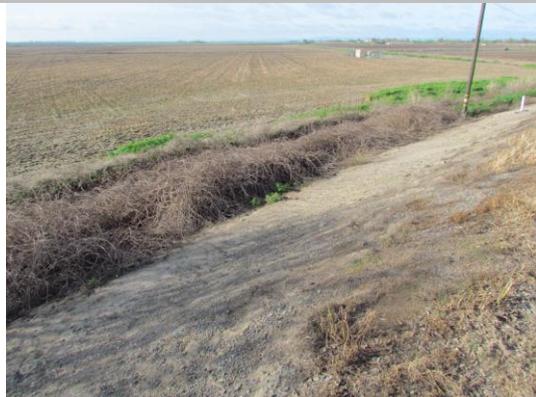
Photo 1 of 2 : FA\_2019\_RD0563\_210\_67\_20190826\_00024.jpg

Looking east at dead berryvines at landward toe. (Spring 2017)

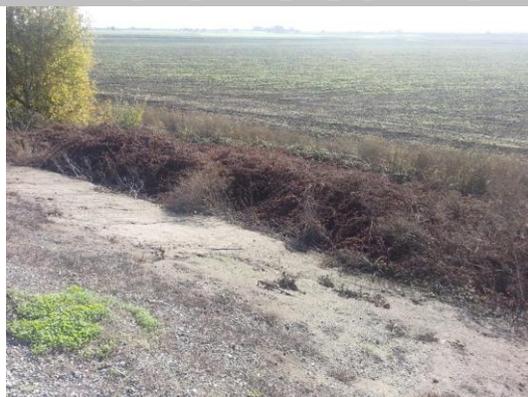
Photo 2 of 2 : FA\_2019\_RD0563\_210\_67\_20190826\_00025.jpg

Looking east at dead berryvines at landward toe. (Fall 2016)

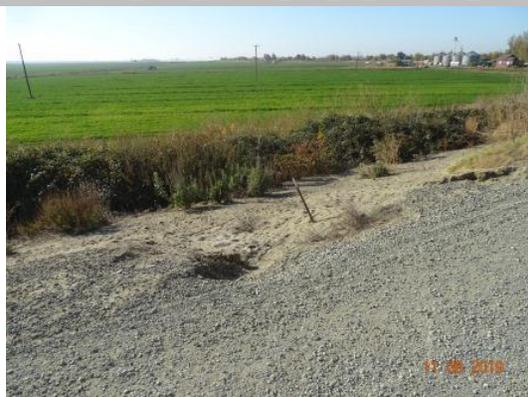
Photo 1 of 3 : FA\_2019\_RD0563\_210\_78\_20191108\_00228.jpg

LM Start	<b>3.06</b>	Rating **	U	Issue No.	<b>78</b>
LM End	<b>3.06</b>	Issue Type +	Ma	Location *	LS
Category	Earthen Levee			GPS Latitude/Longitude	
				Start	End
Item	Slope Stability			38.210240°	38.210240°
				-121.537517°	-121.537517°
DWR ID	DWR_RD0563_01_s_2012_78				
Comment Code					
S1 : Repair slope instability.					
Inspector Comment					
Slope damage on landside shoulder and slope has been in place for several inspection cycles. Proper drainage should be provided to prevent further erosion, and erosion should be repaired.

View looking downslope at erosion in the landside slope (Fall 2019).

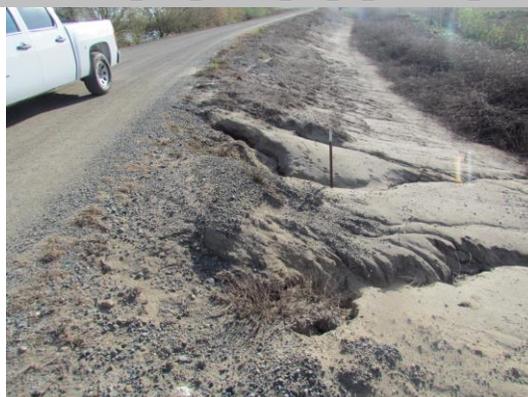
Photo 2 of 3 : FA\_2019\_RD0563\_210\_78\_20190826\_00042.jpg

Looking north at rain runoff erosion on landward slope. (Spring 2017)

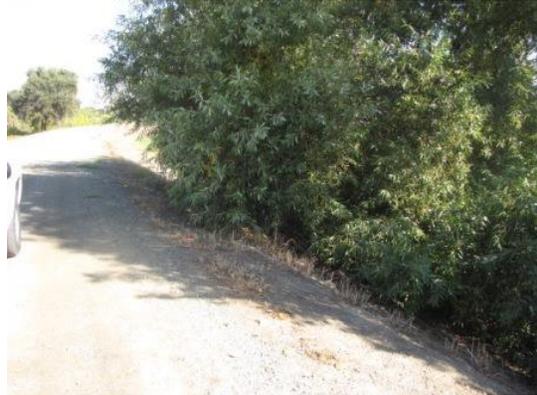
Photo 2 of 2 : FA\_2019\_RD0563\_210\_68\_20190826\_00027.jpg

Looking southeast at dense trees on landside slope and toe.

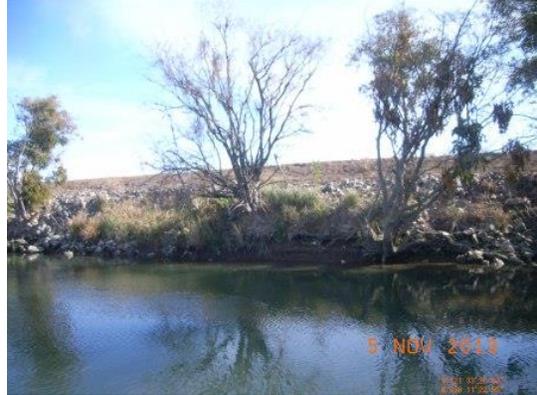
Photo 1 of 1 : FA\_2019\_RD0563\_210\_94\_20190826\_00062.jpg

LM Start	<b>3.42</b>	Rating **	M	Issue No.	<b>94</b>
LM End	<b>4.01</b>	Issue Type +	Ma	Location *	WS
Category	Supplemental			GPS Latitude/Longitude	
				Start	End
Item	2017 USACE Erosion Survey			38.206346°	38.199925°
				-121.540819°	-121.544249°
DWR ID	DWR_RD0563_01_f_2018_94				
Comment Code					
Inspector Comment					
2017 Site ID: GEO 8.3 L Status: Eroding 2017 Field Notes: New rock on levee in sections, failure of old rock in other sections, site extended upstream to account for new erosion pocket. Site History: 1997 - Narrow eroding berm upstream of existing rock. 2001 - Staked, low fascine walls at bankline. 2011 - Minor new erosion. Site extended downstream. 2012 - Rock repair failing in one erosion pocket. 2016 - Fresh erosion observed.

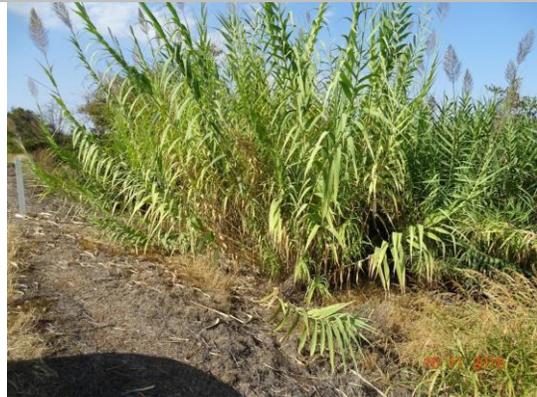
Photo 1 of 1 : FA\_2019\_RD0563\_210\_146\_20190826\_00096.jpg

View of arundo on waterside slope (October 2018).

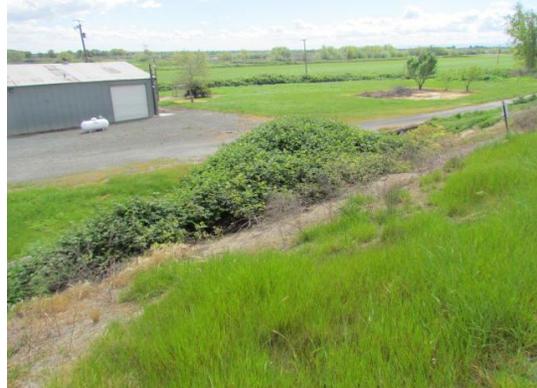
Photo 1 of 1 : FA\_2019\_RD0563\_210\_151\_20190826\_00102.jpg

Looking southeast at dense vegetation at landward toe.

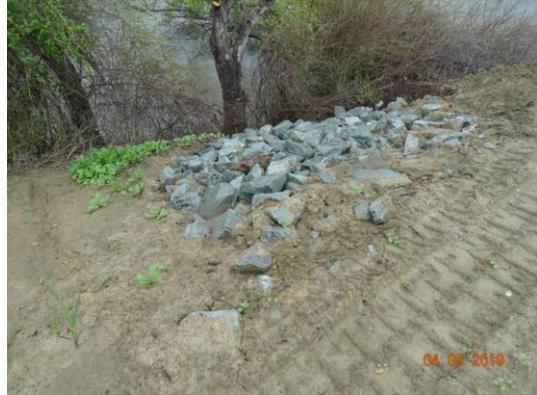
Photo 1 of 1 : FA\_2019\_RD0563\_210\_158\_20190826\_00106.jpg

LM Start	<b>7.71</b>	Rating **	A/W	Issue No.	<b>158</b>
LM End	<b>7.71</b>	Issue Type +	Ma	Location *	WS
Category	Earthen Levee		GPS Latitude/Longitude		
			Start	End	
Item	Slope Stability		38.162056°	38.162056°	
			-121.584043°	-121.584043°	
DWR ID	DWR_RD0563_01_s_2019_158				
Comment Code					
S1 : Repair slope instability.					
Inspector Comment					
The beaver hole was repaired by the LMA.

View of waterside slope repaired by LMA. A beaver hole was discovered on the waterside slope (Spring 2019).

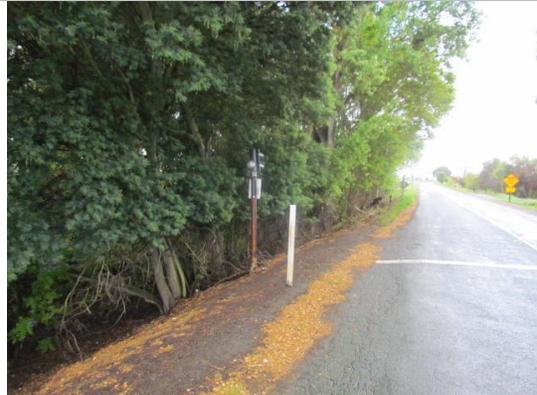
Photo 1 of 1 : FA\_2019\_RD0563\_210\_29\_20190826\_00012.jpg

Looking southeast at dense trees on landward slope and toe.

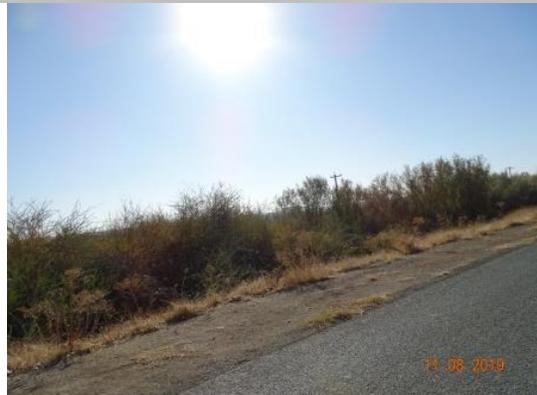
Photo 1 of 1 : FA\_2019\_RD0563\_210\_90\_20191108\_00233.jpg

View of thick vegetation at the landside toe (Fall 2019).

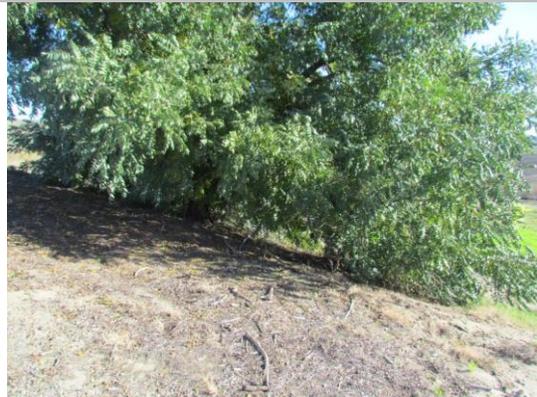
Photo 2 of 2 : FA\_2019\_RD0563\_210\_768\_20190826\_00114.jpg

Looking at untrimmed tree on landward slope.

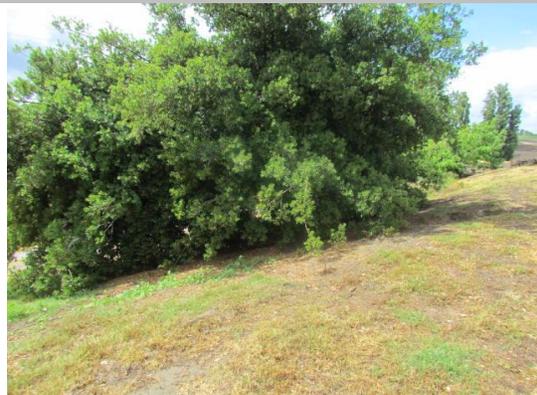
Photo 1 of 1 : FA\_2019\_RD0563\_210\_98\_20190826\_00065.jpg

Looking southeast at untrimmed trees on landward slope.

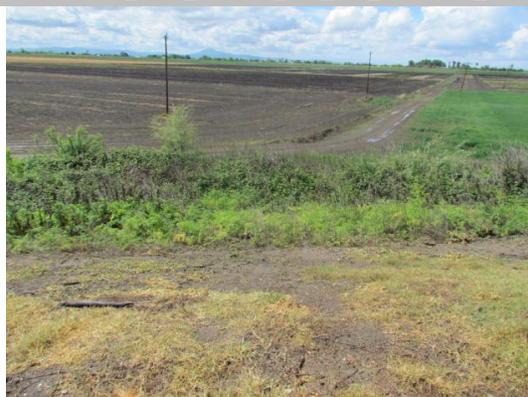
Photo 1 of 1 : FA\_2019\_RD0563\_210\_769\_20190826\_00115.jpg

Looking east at dense vegetation at landward toe. (Spring 2015)

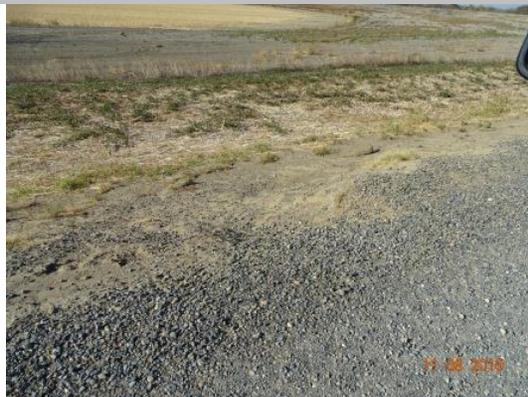
Photo 1 of 1 : FA\_2019\_RD0563\_210\_99\_20191108\_00235.jpg

View looking downslope of erosion at the top of the landside slope (Fall 2019).

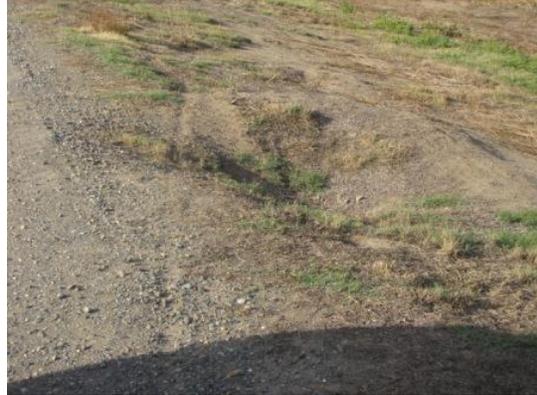
Photo 1 of 4 : FA\_2019\_RD0563\_210\_76\_20190826\_00037.jpg

Looking northeast a depression on landside shoulder and slope above 10" irrigation pipe four feet below crown.

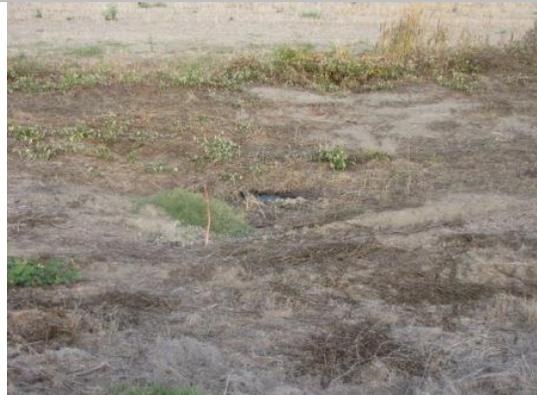
Photo 2 of 4 : FA\_2019\_RD0563\_210\_76\_20190826\_00038.jpg

Looking east at water ponding at landside toe just above 10" irrigation pipe.

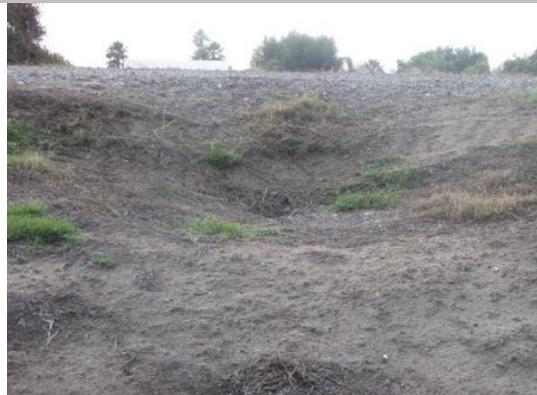
Photo 3 of 4 : FA\_2019\_RD0563\_210\_76\_20190826\_00039.jpg

Looking west at depression on landside shoulder and slope from landside toe.

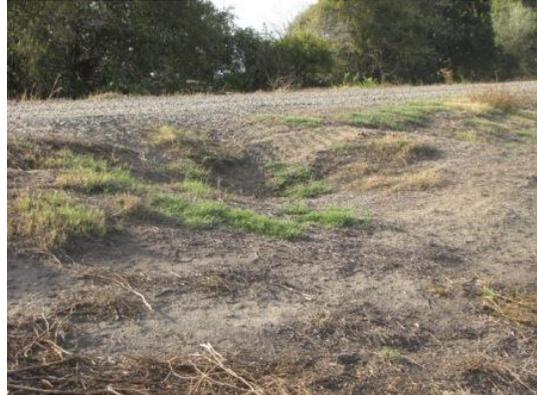
Photo 4 of 4 : FA\_2019\_RD0563\_210\_76\_20190826\_00040.jpg

Looking west at depression on landside shoulder and slope.

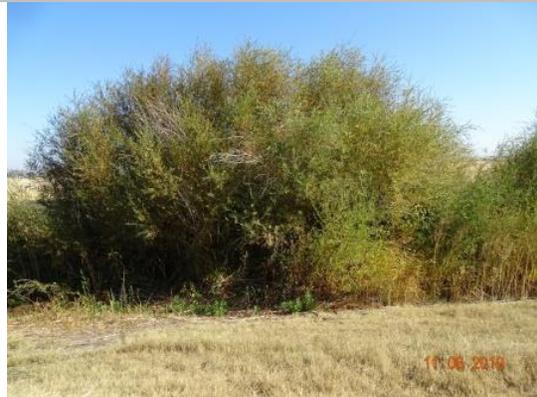
Photo 1 of 1 : FA\_2019\_RD0563\_210\_120\_20191108\_00236.jpg

View of thick tree on the landside slope (Fall 2019).

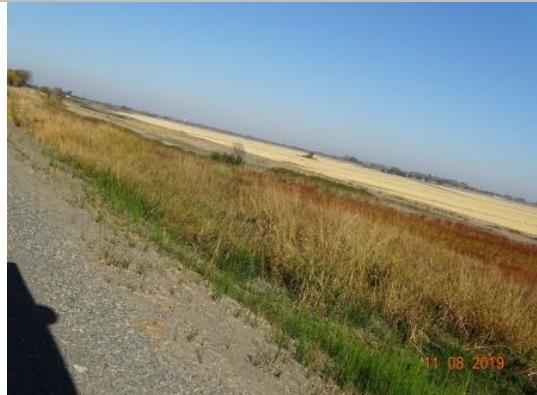
Photo 1 of 1 : FA\_2019\_RD0563\_210\_770\_20191108\_00238.jpg

View looking upstream at vegetation on the landside slope (Fall 2019).

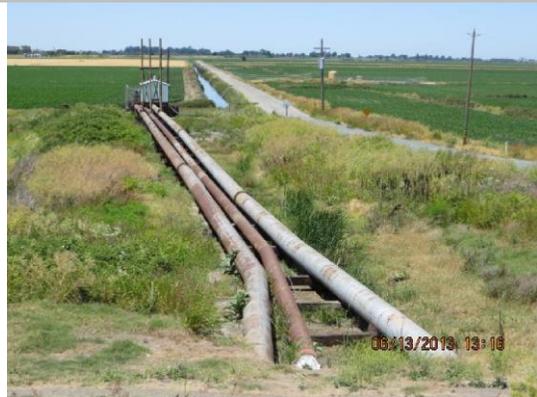
Photo 1 of 3 : UCIP\_FA\_2019\_52771\_24731.jpg

Pump and pipes off LS toe.

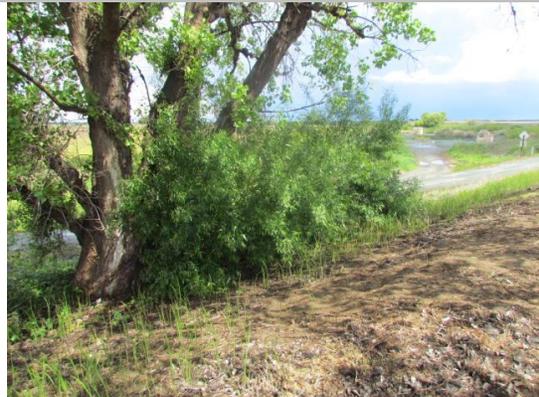
Photo 2 of 2 : FA\_2019\_RD0563\_210\_47\_20190826\_00018.jpg

Looking northeast at untrimmed tree at landward slope. (Spring 2015)
