**Flood Control Project Maintenance  
Levee Inspections**

**Fall 2019 Levee Maintenance Deficiency Summary Report**

**Reclamation District No. 0755 Randall**

**Levee Inspection Report By Mile - Fall 2019**

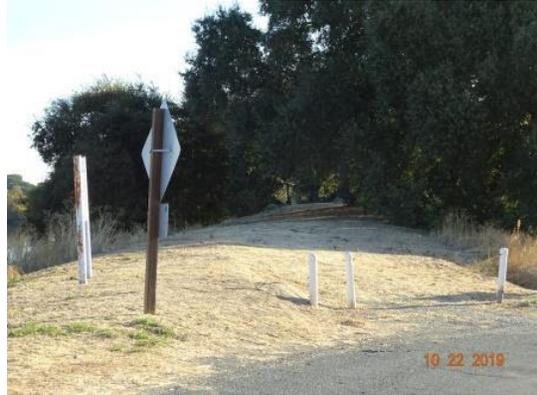
Photo 1 of 1 : FA\_2019\_RD0755\_177\_11\_20191024\_00049.jpg

LM Start	<b>0.00</b>	Rating **	M	Issue No.	<b>11</b>
LM End	<b>0.17</b>	Issue Type +	Ma	Location *	CR
Category	Earthen Levee		GPS Latitude/Longitude		
			Start	End	
Item	Vegetation		38.347123°	38.346773°	
			-121.537572°	-121.538687°	
DWR ID	DWR_RD0755_01_s_2017_11				
Comment Code					
V9 : Keep the crown roadway free of vegetation.					
Inspector Comment					
Crown vegetation should be mowed to allow inspection.

View looking upstream at vegetation on the crown (Fall 2019).

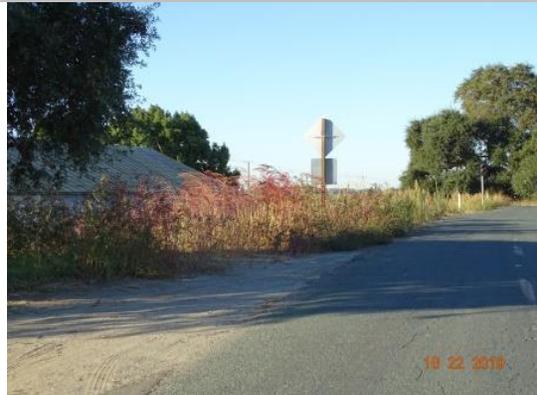
Photo 1 of 1 : FA\_2019\_RD0755\_177\_20\_20191024\_00050.jpg

LM Start	<b>0.17</b>	Rating **	U	Issue No.	<b>20</b>
LM End	<b>1.04</b>	Issue Type +	Ma	Location *	LS
Category	Earthen Levee		GPS Latitude/Longitude		
			Start	End	
Item	Vegetation		38.346757°	38.343637°	
			-121.538675°	-121.554030°	
DWR ID	DWR_RD0755_01_f_2016_20				
Comment Code					
V2 : Remove the wild growth other than native grasses from the levee slopes.					
Inspector Comment					
The vegetation should be removed/managed to allow inspection of landside slope and toe.

View looking downstream at thick vegetation on the landside slope (Fall 2019).

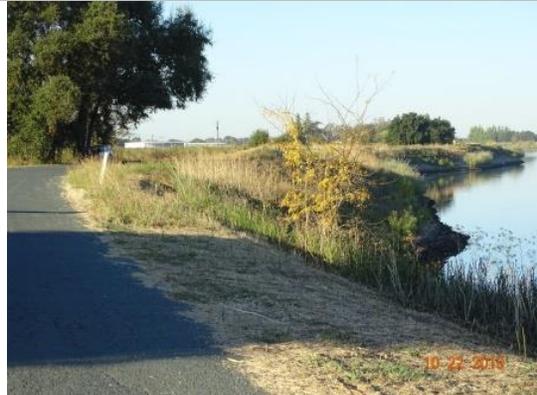
Photo 1 of 1 : FA\_2019\_RD0755\_177\_19\_20191024\_00051.jpg

LM Start	<b>0.17</b>	Rating **	M	Issue No.	<b>19</b>
LM End	<b>1.84</b>	Issue Type +	Ma	Location *	WS
Category	Earthen Levee		GPS Latitude/Longitude		
			Start	End	
Item	Vegetation		38.346757°	38.336409°	
			-121.538675°	-121.564813°	
DWR ID	DWR_RD0755_01_f_2016_19				
Comment Code					
V2 : Remove the wild growth other than native grasses from the levee slopes.					
Inspector Comment					
The tall weeds on the waterside slope should be removed/managed to allow inspection. Large cactus (Century Plants) at LM 1.07 should also be removed.

View looking downstream at thick vegetation on the waterside slope (Fall 2019).

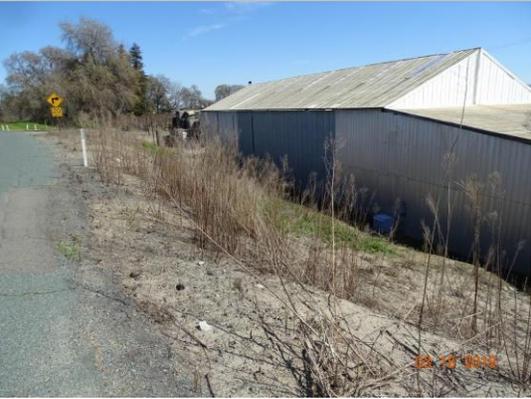
Photo 1 of 1 : FA\_2019\_RD0755\_177\_10\_20190826\_00001.jpg

LM Start	<b>0.21</b>	Rating **	M	Issue No.	<b>10</b>
LM End	<b>0.21</b>	Issue Type +	Ma	Location *	LS
Category	Earthen Levee			GPS Latitude/Longitude	
				Start	End
Item	Slope Stability			38.346428 °	38.346428 °
				-121.539400 °	-121.539400 °
DWR ID	DWR_RD0755_01_s_2019_10				
Comment Code					
S1 : Repair slope instability.					
Inspector Comment					
There is a 2" seperation between roadway and levee on the landside shoulder.

View looking upstream at small slip on the landside shoulder (Spring 2019).

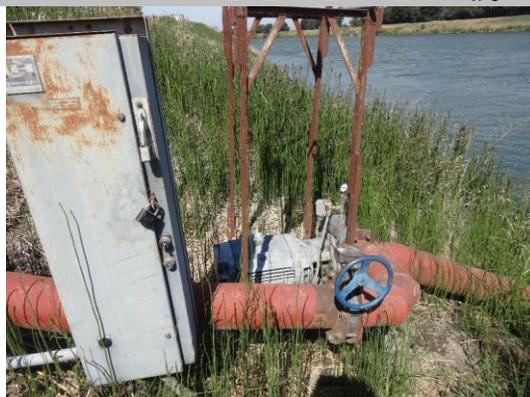
Photo 3 of 3 : UCIP\_FA\_2019\_17123\_29240.jpg

Item	DRAFT DWR UCIP Field Study			38.345640 °	38.345640 °
				-121.543277 °	-121.543277 °
DWR ID	18849				
Comment Code					
Inspector Comment					
DS_ID:18849 FS_ID:17123 EP_NO: 4302 Repair Type: Non-Urgent Crossing Status: Found UCIP Comments: FBC about 2 feet.Power conduit also through the levee.Wet ground on pump site/location. May need investigation about wet ground. FIELD_STRUCT_DESC: 8-inch coated steel irrigation discharge pipe through the levee, 2 feet below the crown. Pump, electrical box, and control valve on the waterside (WS) slope. Siphon breaker on the landside (LS) slope. Service pole at the LS toe. (Plans for placing an 8-inch irrigation pipe and pump authorized under Permit No. 4302, 1963 - E. C. Hemly). [Additional Reference(s): DWR Levee Log, 2005, referenced as 4 feet below the crown]. FS Date: 8/6/2013

WS view: pump, power switch box, butterfly valve and pipe.

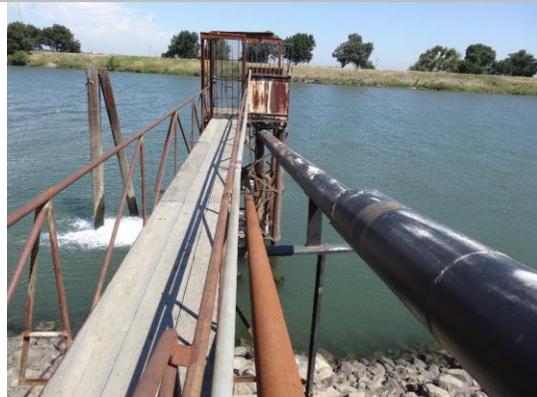
Photo 1 of 3 : UCIP\_FA\_2019\_41634\_29087.jpg

Item	DRAFT DWR UCIP Field Study		38.345113°	38.345113°	
			-121.547789°	-121.547789°	
DWR ID	18851				
Comment Code					
Inspector Comment					
DS_ID:18851 FS_ID:41634 EP_NO: 7357 Repair Type: Non-Urgent Crossing Status: Found UCIP Comments: An abandoned 12-in steel pipe lying on LS levee slope should be removed.A buried concrete headwall found on LS levee slope should be checked for any pipe or connection. FIELD_STRUCT_DESC: 2 of 2: 8-inch pipe sleeved through a 16-inch irrigation discharge pipe of an unknown material through the levee, 4.2 feet below the crown. Pump on the waterside (WS). (Plans to install an additional pump on an existing stand and to connect the discharge pipe to the existing pipe through the levee authorized under Permit No. 7357, 1971 - Green and Keown Farms, Inc). [Additional Reference(s): DWR Levee Log, 2005, 14-inch outer pipe referenced]. FS Date: 8/6/2013

WS view: pump structure on the stream, conduit, pipes, and walkway.

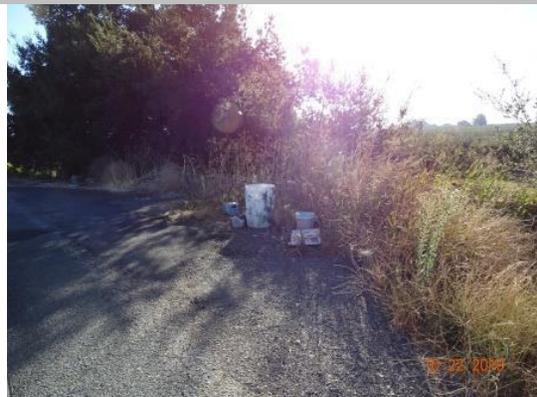
Photo 1 of 1 : FA\_2019\_RD0755\_177\_27\_20191024\_00060.jpg

View looking upstream at garbage on the landside shoulder. The barrel is a trash bin (Fall 2019).

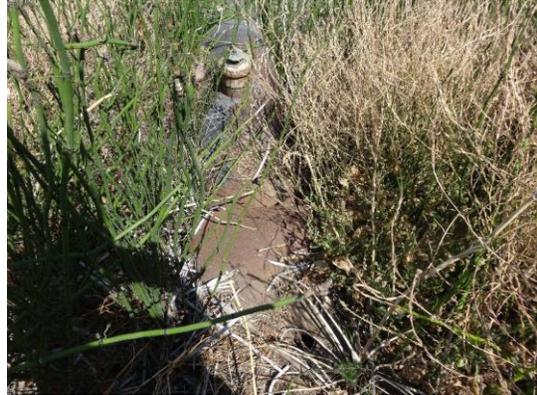
Photo 1 of 3 : UCIP\_FA\_2019\_17145\_29292.jpg

Item	DRAFT DWR UCIP LMA Responsibility			38.345057°	38.345057°
				-121.548050°	-121.548050°
DWR ID	18852				
Comment Code					
Inspector Comment					
DS_ID:18852 FS_ID:17145 EP_NO: 11222 Repair Type: No Action Needed Crossing Status: Found UCIP Comments: It was working during field survey. A pump found 150 ft from the levee. Not sure whether the pump belong to this drainage system. FIELD_STRUCT_DESC: *ABANDONED* 16-inch steel drainage pipe sleeved through a 24-inch steel drainage pipe through the levee, invert elevation 8 feet below the crown. (Retention of a 12-inch drainage pipe sleeved through a 24-inch pipe through the levee, 8 feet below the crown, authorized under Automatic Board Order (ABO) issued as Permit No. 11222, 1975 - Green McKeown, Inc). [Additional Reference(s): DWR Levee Log, 2005, 12-inch inner pipe referenced. USACE Sacramento O&M Manual 111, May 1959, (RM 35.89)]. FS Date: 8/6/2013

WS view: pipe and siphon breaker on levee slope

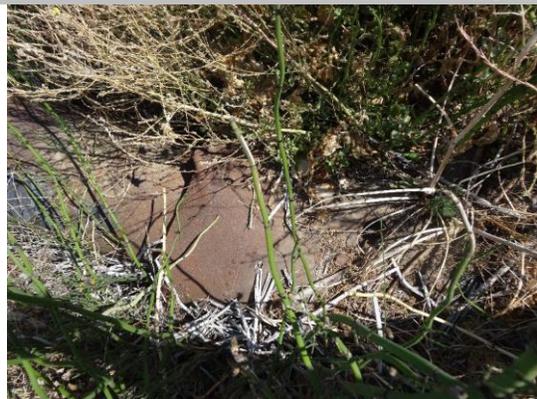
Photo 2 of 3 : UCIP\_FA\_2019\_17145\_29293.jpg

WS view: 16-inch pipe sleeved through 24-inch pipe.

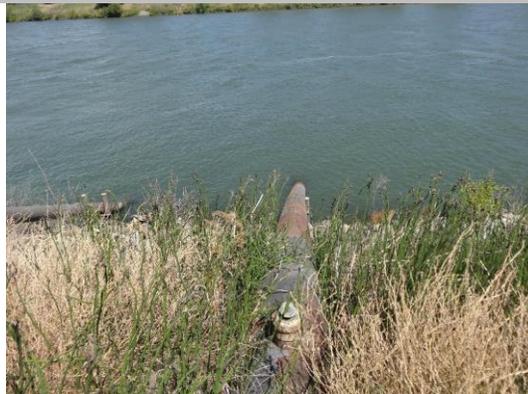
Photo 3 of 3 : UCIP\_FA\_2019\_17145\_29295.jpg

Item	DRAFT DWR UCIP LMA Responsibility			38.345057°	38.345057°
				-121.548050°	-121.548050°
DWR ID	18852				
Comment Code					
Inspector Comment					
DS_ID:18852 FS_ID:17145 EP_NO: 11222 Repair Type: No Action Needed Crossing Status: Found UCIP Comments: It was working during field survey. A pump found 150 ft from the levee. Not sure whether the pump belong to this drainage system. FIELD_STRUCT_DESC: *ABANDONED* 16-inch steel drainage pipe sleeved through a 24-inch steel drainage pipe through the levee, invert elevation 8 feet below the crown. (Retention of a 12-inch drainage pipe sleeved through a 24-inch pipe through the levee, 8 feet below the crown, authorized under Automatic Board Order (ABO) issued as Permit No. 11222, 1975 - Green McKeown, Inc). [Additional Reference(s): DWR Levee Log, 2005, 12-inch inner pipe referenced. USACE Sacramento O&M Manual 111, May 1959, (RM 35.89)]. FS Date: 8/6/2013

WS view: 16-inch drainage pipe on levee slope.

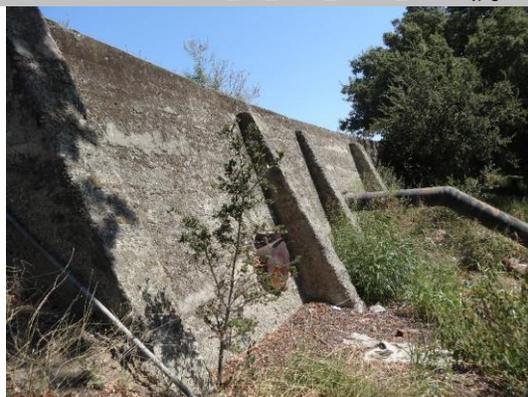
Photo 1 of 3 : UCIP\_FA\_2019\_17049\_29119.jpg

Item	DRAFT DWR UCIP Field Study			38.345036°	38.345036°
				-121.548141°	-121.548141°
DWR ID	18854				
Comment Code					
Inspector Comment					
DS_ID:18854 FS_ID:17049 EP_NO: 1716 Repair Type: Non-Urgent Crossing Status: Found UCIP Comments: Not found- a 4-inch pipe on waterward shoulder but a 2-inch GI pipe found on landside slope. FIELD_STRUCT_DESC: *ABANDONED* 18-inch drainage pipe of an unknown material through the levee, invert elevation 4.5 feet below the crown. (Plans for the replacement of an existing pipe through the levee authorized under Permit No. 1716, 1952 - Reclamation District No. 755 [RD0755]). [Additional Reference(s): DWR Levee Log, 2005. USACE Sacramento O&M Manual 111, May 1959, (RM 35.88)]. FS Date: 8/6/2013

LS view: concrete headwall and 2-inch conduit (left)

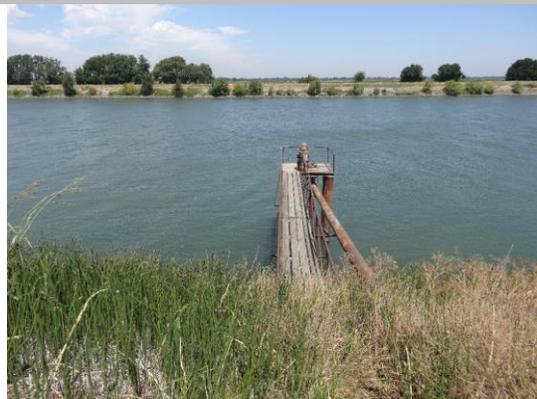
Photo 1 of 3 : UCIP\_FA\_2019\_17063\_29148.jpg

Item	DRAFT DWR UCIP Field Study			38.344103°	38.344103°
				-121.552119°	-121.552119°
DWR ID	18855				
Comment Code					
Inspector Comment					
DS_ID:18855 FS_ID:17063 EP_NO: 11225 Repair Type: Non-Urgent Crossing Status: Found UCIP Comments: Abandoned pipe and pump. Service pole, power box lying on LS slope. FIELD_STRUCT_DESC: *ABANDONED* 10-inch irrigation discharge pipe of an unknown material and a 1-inch electrical conduit through the levee, invert elevation 5.6 feet below the crown. Pump on a pile structure with a walkway to the pump. Abandoned service pole on the landside (LS) slope. (Retention of a 10-inch pipe through the levee, 5.6 feet below the crown, pump on a pile structure with a walkway to the pump, and a service pole on the LS slope Automatic Board Order (ABO) issued as Permit No. 11225, 1975 - Helen D. Wilson). [Additional Reference(s): DWR Levee Log, 2005. USACE Sacramento O&M Manual 111, May 1959, (RM 35.66)]. FS Date: 8/6/2013

WS view: overview of pipe and pump structure.

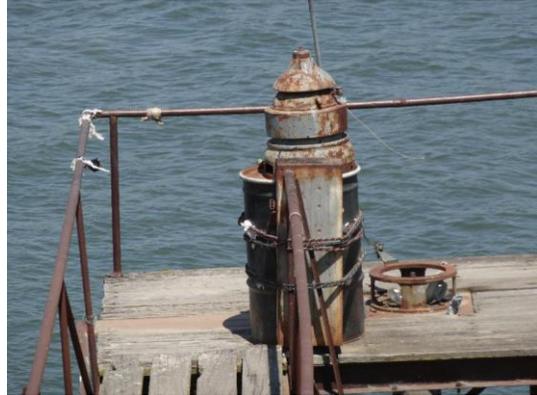
Photo 2 of 3 : UCIP\_FA\_2019\_17063\_29147.jpg

Item	DRAFT DWR UCIP Field Study			38.344103°	38.344103°
				-121.552119°	-121.552119°
DWR ID	18855				
Comment Code					
Inspector Comment					
DS_ID:18855 FS_ID:17063 EP_NO: 11225 Repair Type: Non-Urgent Crossing Status: Found UCIP Comments: Abandoned pipe and pump. Service pole, power box lying on LS slope. FIELD_STRUCT_DESC: *ABANDONED* 10-inch irrigation discharge pipe of an unknown material and a 1-inch electrical conduit through the levee, invert elevation 5.6 feet below the crown. Pump on a pile structure with a walkway to the pump. Abandoned service pole on the landside (LS) slope. (Retention of a 10-inch pipe through the levee, 5.6 feet below the crown, pump on a pile structure with a walkway to the pump, and a service pole on the LS slope Automatic Board Order (ABO) issued as Permit No. 11225, 1975 - Helen D. Wilson). [Additional Reference(s): DWR Levee Log, 2005. USACE Sacramento O&M Manual 111, May 1959, (RM 35.66)]. FS Date: 8/6/2013

WS view: an abandoned pump

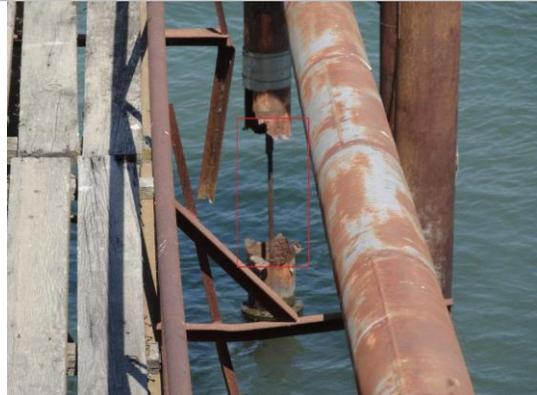
Photo 3 of 3 : UCIP\_FA\_2019\_17063\_29146.jpg

WS view: abandoned and discontinued vertical intake pipe

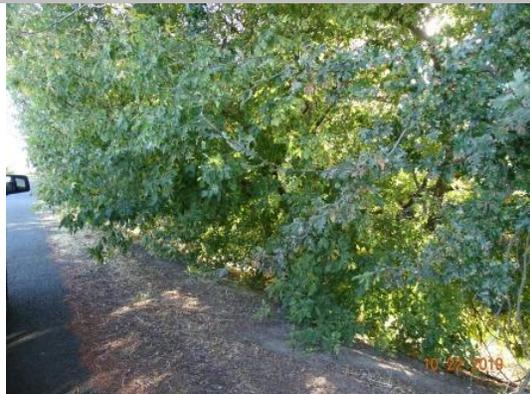
Photo 1 of 1 : FA\_2019\_RD0755\_177\_29\_20191024\_00059.jpg

View looking upstream at thick trees on the landside slope (Fall 2019).

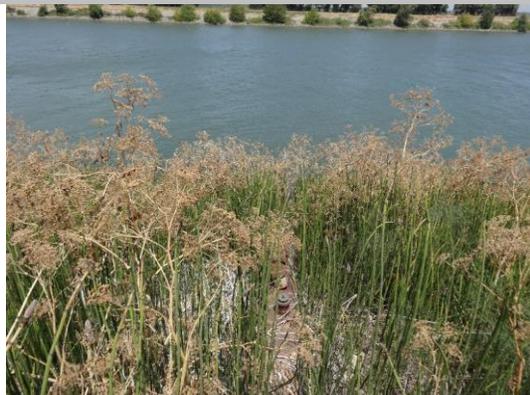
Photo 1 of 3 : UCIP\_FA\_2019\_46764\_29158.jpg

LM Start	<b>1.04</b>	Rating **	M	Issue No.	<b>54</b>
LM End	<b>1.04</b>	Issue Type +	En	Location *	
Category	Supplemental			GPS Latitude/Longitude	
				Start	End
Item	DRAFT DWR UCIP Field Study			38.343625 °	38.343625 °
				-121.554145 °	-121.554145 °
DWR ID	18856				
Comment Code					
Inspector Comment					
DS_ID:18856 FS_ID:46764 EP_NO: N/A Repair Type: Non-Urgent Crossing Status: Found UCIP Comments: Needs to be properly abandoned. FIELD_STRUCT_DESC: *ABANDONED* 12-inch pipe of an unknown material or purpose through the levee, invert elevation 5 feet below the crown. Siphon breaker on the waterside (WS). Pipe not found on the landside (LS). (Wilson). [Additional Reference(s): DWR Levee Log, 2005. USACE Sacramento O&M Manual 111, May 1959, (RM 35.55)]. FS Date: 8/6/2013

WS view: overview of steel pipe with siphon breaker on levee slope

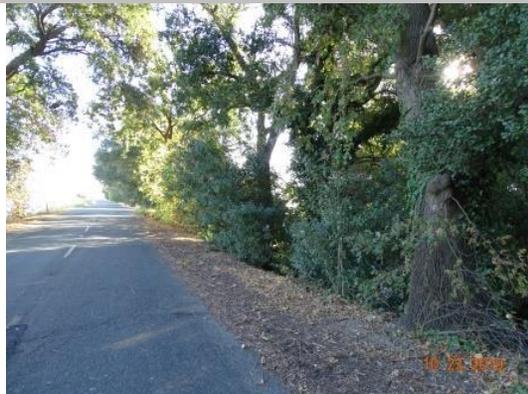
Photo 1 of 1 : FA\_2019\_RD0755\_177\_23\_20191024\_00057.jpg

View looking upstream at landscaping on the landside slope (Fall 2019).

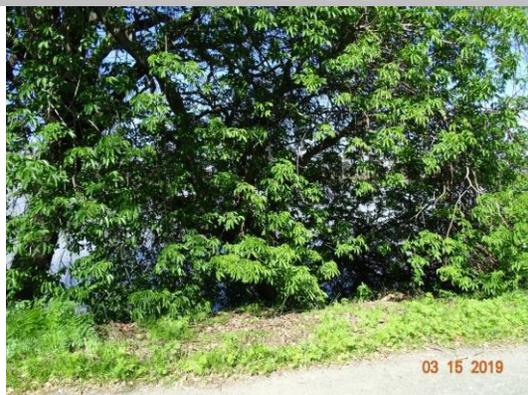
Photo 1 of 1 : FA\_2019\_RD0755\_177\_31\_20190826\_00020.jpg

LM Start	<b>1.06</b>	Rating **	M	Issue No.	<b>31</b>
LM End	<b>1.06</b>	Issue Type +	Ma	Location *	WS
Category	Earthen Levee		GPS Latitude/Longitude		
			Start	End	
Item	Trim / Thin Trees		38.343542 °	38.343542 °	
			-121.554487 °	-121.554487 °	
DWR ID	DWR_RD0755_01_s_2019_31				
Comment Code					
T1 : Trim trees to at least five feet above ground level.					
Inspector Comment					
Trees are blocking visibility down waterside slope.

View of tree at the top of the waterside shoulder (Spring 2019).

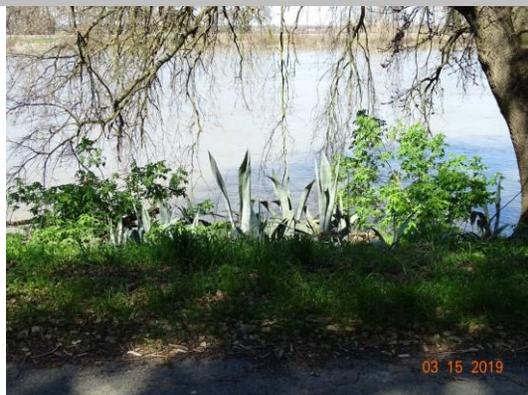
Photo 1 of 1 : FA\_2019\_RD0755\_177\_12\_20190826\_00003.jpg

LM Start	<b>1.06</b>	Rating **	M	Issue No.	<b>12</b>
LM End	<b>1.06</b>	Issue Type +	En	Location *	WS
Category	Earthen Levee		GPS Latitude/Longitude		
			Start	End	
Item	Vegetation		38.343543 °	38.343543 °	
			-121.554523 °	-121.554523 °	
DWR ID	DWR_RD0755_01_s_2018_12				
Comment Code					
V6 : Landscaping					
Inspector Comment					
Remove cactus on waterside slope.

View of cactus at the top of the waterside slope (Spring 2019).

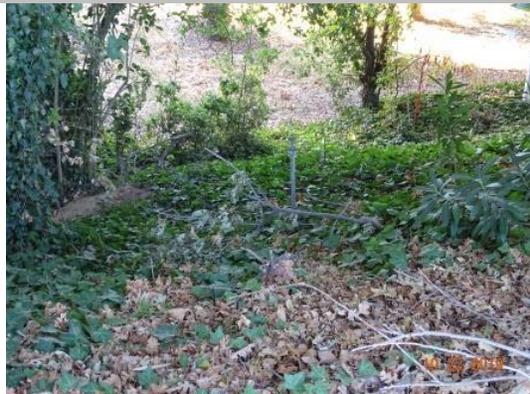
Photo 1 of 1 : FA\_2019\_RD0755\_177\_44\_20191024\_00058.jpg

View looking downslope at sprinkler emitter on the landside slope (Fall 2019).

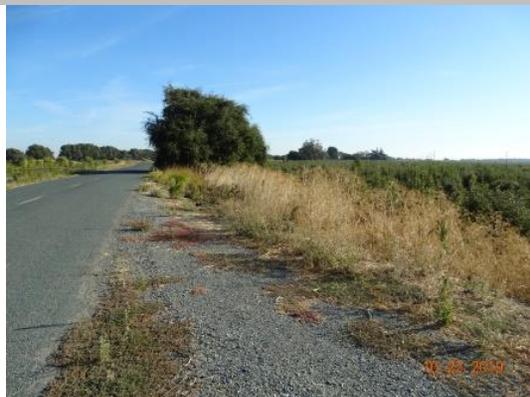
Photo 1 of 1 : FA\_2019\_RD0755\_177\_40\_20191024\_00056.jpg

View looking upstream at thick vegetation on the landside slope (Fall 2019).

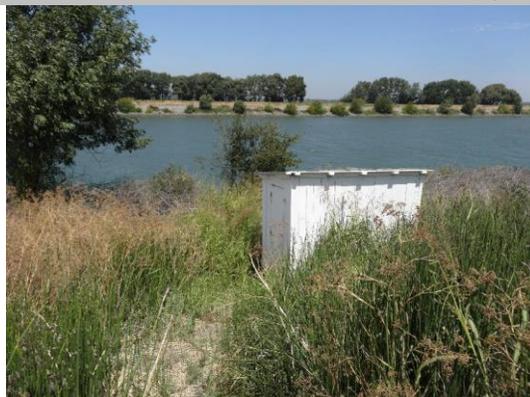
Photo 1 of 3 : UCIP\_FA\_2019\_17144\_29288.jpg

Item	DRAFT DWR UCIP Field Study			38.343305 °	38.343305 °
				-121.555538 °	-121.555538 °
DWR ID	18857				
Comment Code					
Inspector Comment					
DS_ID:18857 FS_ID:17144 EP_NO: 11219 Repair Type: Non-Urgent Crossing Status: Found UCIP Comments: - requires cleaning of siphon breaker box. FIELD_STRUCT_DESC: 8-inch irrigation discharge pipe of an unknown material through the levee, invert elevation 5.7 feet below the crown. Siphon breaker in a corrugated metal pipe (CMP) riser on the landside (LS) shoulder. Power pole on the LS. Pump and power box in a pump house on the waterside (WS) slope. Electrical conduit through the levee at the same location. (Retention of an 8-inch pipe through the levee, 5.7 feet below the crown, and a pump in a pump house on the WS slope authorized under Automatic Board Order (ABO) issued as Permit No. 11219, 1975 - David J. Jr and Bonnie Elliott. [Additional Reference(s): DWR Levee Log, 2005. USACE Sacramento O&M Manual 111, May 1959, (RM 35.47)]. FS Date: 8/6/2013

WS view: pump house on levee slope.

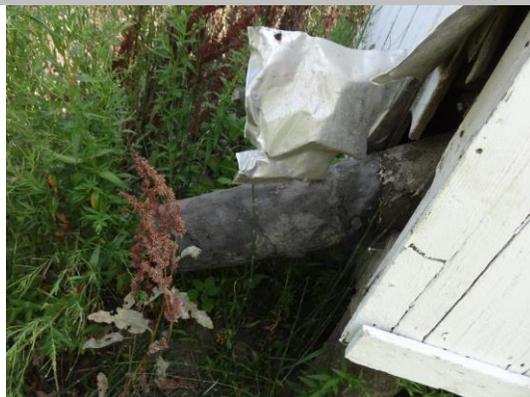
Photo 2 of 3 : UCIP\_FA\_2019\_17144\_29287.jpg

WS view: pipe daylight from pump house.

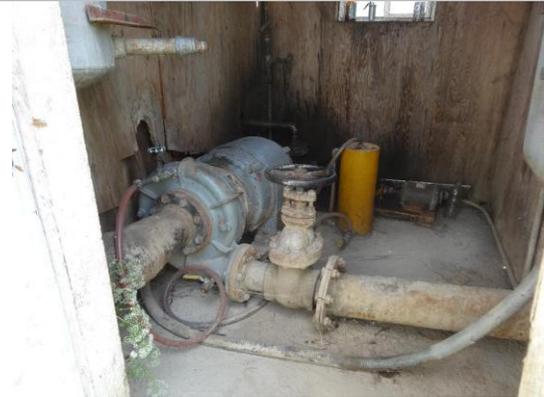
Photo 3 of 3 : UCIP\_FA\_2019\_17144\_29286.jpg

Item	DRAFT DWR UCIP Field Study			38.343305 °	38.343305 °
				-121.555538 °	-121.555538 °
DWR ID	18857				
Comment Code					
Inspector Comment					
DS_ID:18857 FS_ID:17144 EP_NO: 11219 Repair Type: Non-Urgent Crossing Status: Found UCIP Comments: - requires cleaning of siphon breaker box. FIELD_STRUCT_DESC: 8-inch irrigation discharge pipe of an unknown material through the levee, invert elevation 5.7 feet below the crown. Siphon breaker in a corrugated metal pipe (CMP) riser on the landside (LS) shoulder. Power pole on the LS. Pump and power box in a pump house on the waterside (WS) slope. Electrical conduit through the levee at the same location. (Retention of an 8-inch pipe through the levee, 5.7 feet below the crown, and a pump in a pump house on the WS slope authorized under Automatic Board Order (ABO) issued as Permit No. 11219, 1975 - David J. Jr and Bonnie Elliott). [Additional Reference(s): DWR Levee Log, 2005. USACE Sacramento O&M Manual 111, May 1959, (RM 35.47)]. FS Date: 8/6/2013

WS view: pumps, butterfly valve and pipe inside pump house.

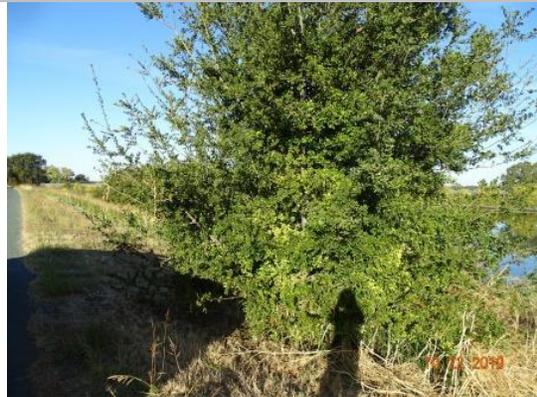
Photo 1 of 1 : FA\_2019\_RD0755\_177\_35\_20191024\_00052.jpg

View looking downstream at thick tree on the waterside slope (Fall 2019).

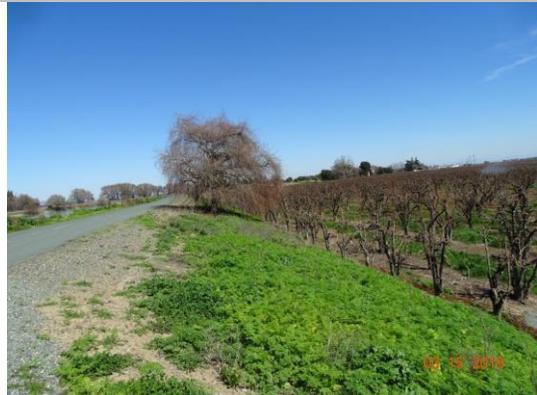
Photo 1 of 1 : FA\_2019\_RD0755\_177\_32\_20190826\_00021.jpg

LM Start	<b>1.30</b>	Rating **	M	Issue No.	<b>32</b>
LM End	<b>1.43</b>	Issue Type +	En	Location *	LS
Category	Earthen Levee		GPS Latitude/Longitude		
			Start	End	
Item	Encroachments		38.342412 °	38.341108 °	
			-121.558688 °	-121.560220 °	
DWR ID	DWR_RD0755_01_s_2019_32				
Comment Code					
CR : Crops					
Inspector Comment					
Orchard trees are on landside slope.

View looking upstream at orchard trees on the base of the landside slope (Spring 2019).

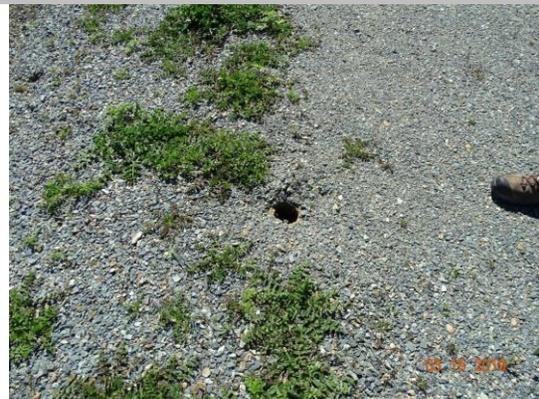
Photo 1 of 2 : FA\_2019\_RD0755\_177\_34\_20190826\_00023.jpg

View of 2 foot deep rodent hole on the landside of the crown (Spring 2019).

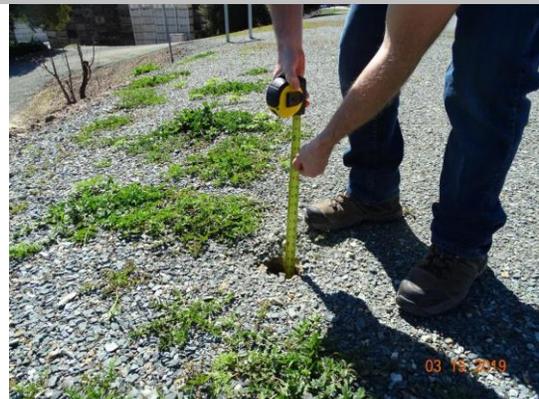
Photo 2 of 2 : FA\_2019\_RD0755\_177\_34\_20190826\_00024.jpg

Measuring tape showing rodent hole as being 2 feet deep on the landside of the crown (Spring 2019).

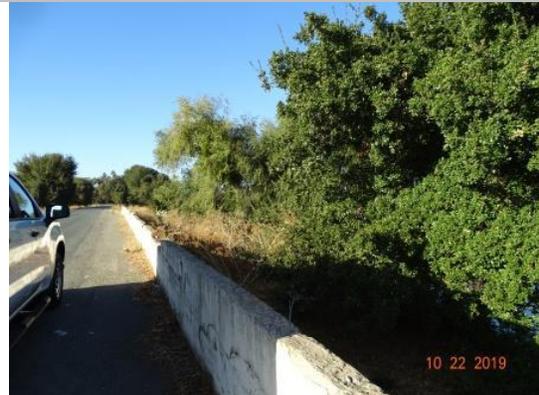
Photo 1 of 1 : FA\_2019\_RD0755\_177\_36\_20191024\_00053.jpg

View looking downstream at thick trees on the waterside slope (Fall 2019).

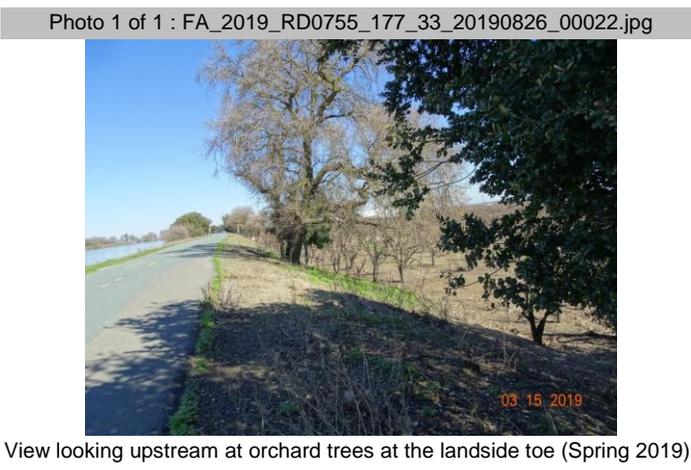
LM Start	<b>1.58</b>	Rating **	M	Issue No.	<b>33</b>
LM End	<b>1.72</b>	Issue Type +	En	Location *	LS
Category	Earthen Levee			GPS Latitude/Longitude	
				Start	End
Item	Encroachments			38.339360°	38.337767°
				-121.561855°	-121.563602°
DWR ID	DWR_RD0755_01_s_2019_33				
Comment Code					
CR : Crops					
Inspector Comment					
Trees are on the landside slope.

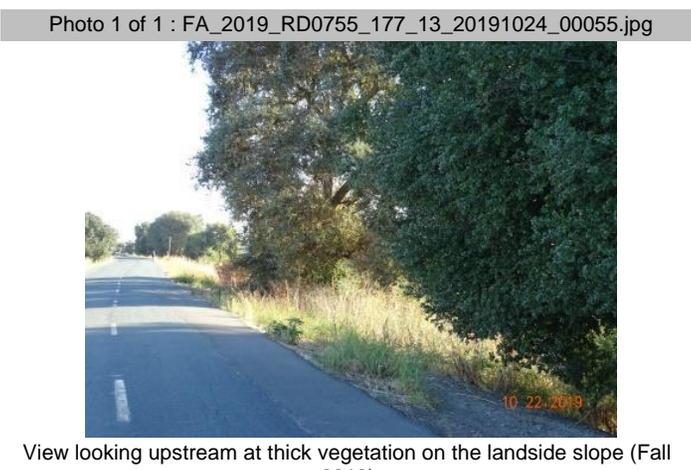
LM Start	<b>1.59</b>	Rating **	U	Issue No.	<b>13</b>
LM End	<b>1.73</b>	Issue Type +	Ma	Location *	LS
Category	Earthen Levee			GPS Latitude/Longitude	
				Start	End
Item	Vegetation			38.339210°	38.337755°
				-121.562058°	-121.563666°
DWR ID	DWR_RD0755_01_f_2018_13				
Comment Code					
V1 : Control annual grass and weeds on the levee slopes and easements.					
Inspector Comment
