**Flood Control Project Maintenance
Levee Inspections**

Fall 2019 Levee Maintenance Deficiency Summary Report

Reclamation District No. 0785 Driver

Waterway	Bank	Unit Miles
Unit No. 01 Sacramento River	Right	2.26

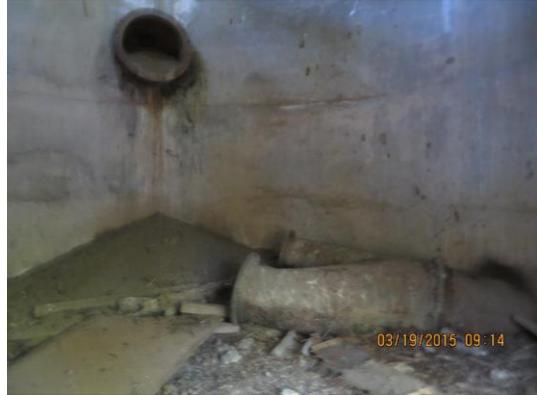
Photo 1 of 3 : UCIP_FA_2019_53407_73402.jpg

Comment Code					
Inspector Comment					
DS_ID:22974 FS_ID:53407 EP_NO: N/A Repair Type: Non-Urgent Crossing Status: Found UCIP Comments: 07/17/2018 Unable to acces pumphouse due to heavy vegetation. No integrity issue observed, therefore crossing downgraded to "Non-Urgent". Crossing is a part of DWR DMP Phase1 for internal video inspection. (O.Yakimov-DWR UCIP)07/18/2016 Same as last inspection. Pipe is silted in as visible through the LS pumphouse. (K. Fazel - UCIP)03/19/2015 Pipe appears to be abandoned and should be done so properly as it is open on the LS inside the pumphouse. Dense vegetation on both sides of the levee. (G. Wylie - FPIIB) FIELD_STRUCT_DESC: *ABANDONED* 30-inch steel pipe of an unknown purpose through the levee, 10 feet below the crown. Landside (LS) end open inside a concrete pump house on the LS shoulder. Unable to find the pipe on the waterside (WS). [Additional Reference(s): DWR Levee Log, 1988. USACE Sacramento O&M Manual 122.1, August 1955, (RM 70.05), 18-inch pipe referenced, invert elevation 33.4 feet]. FS Date: 7/17/2018 7:50:37 AM

Pipe open at base of concrete building on LS shoulder. No pump found.

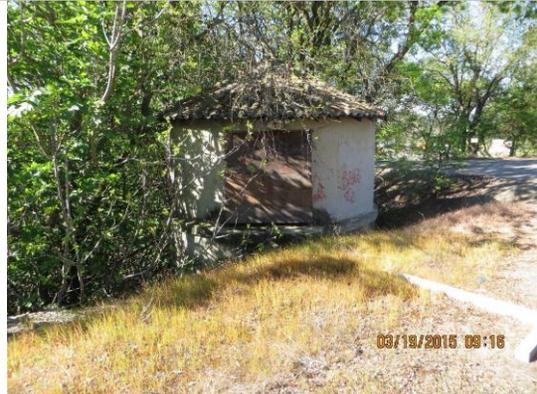
Photo 2 of 3 : UCIP_FA_2019_53407_73401.jpg

Pumphouse on LS shoulder.

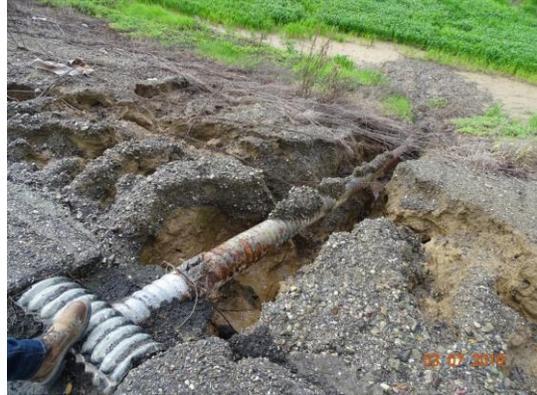
Photo 2 of 6 : FA_2019_RD0785_185_9_20190829_00004.jpg

LM Start	0.11	Rating **	U	Issue No.	9 (cont)
LM End	0.11	Issue Type +	Ma	Location *	LS
Category	Earthen Levee			GPS Latitude/Longitude	
				Start	End
Item	Erosion / Bank Caving			38.660211°	38.660211°
				-121.611748°	-121.611748°
DWR ID	DWR_RD0785_01_f_2017_9				
Comment Code					
E2 : Schedule repair of erosion site prior to the next inspection.					
Inspector Comment					
Significant runoff erosion on landside slope.

View of erosion on the landside slope. Spring 2019.

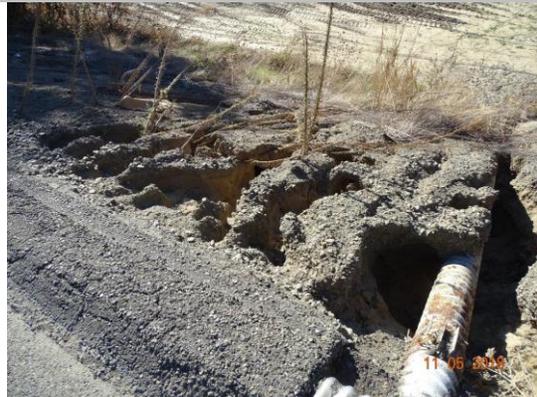
Photo 3 of 6 : FA_2019_RD0785_185_9_20190829_00005.jpg

View of erosion on the landside slope. Fall 2018.

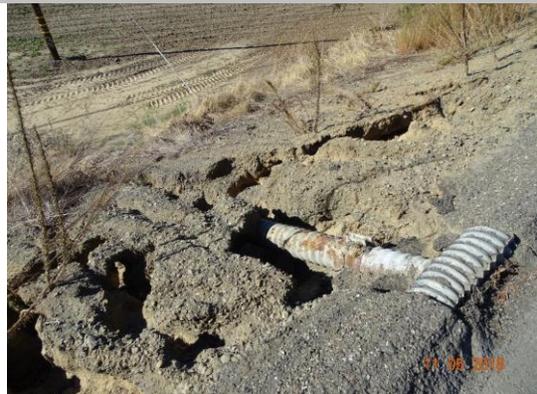
Photo 4 of 6 : FA_2019_RD0785_185_9_20190829_00006.jpg

Additional view of erosion on the landside slope. Fall 2018.

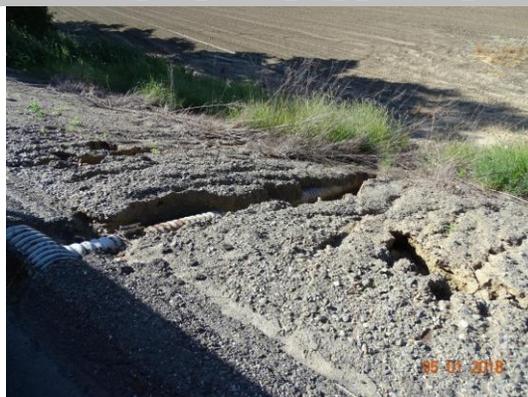
Photo 5 of 6 : FA_2019_RD0785_185_9_20190829_00007.jpg

LM Start	0.11	Rating **	U	Issue No.	9 (cont)
LM End	0.11	Issue Type +	Ma	Location *	LS
Category	Earthen Levee			GPS Latitude/Longitude	
				Start	End
Item	Erosion / Bank Caving			38.660211 °	38.660211 °
				-121.611748 °	-121.611748 °
DWR ID	DWR_RD0785_01_f_2017_9				
Comment Code					
E2 : Schedule repair of erosion site prior to the next inspection.					
Inspector Comment					
Significant runoff erosion on landside slope.

View of runoff on the landside slope. Spring 2018.

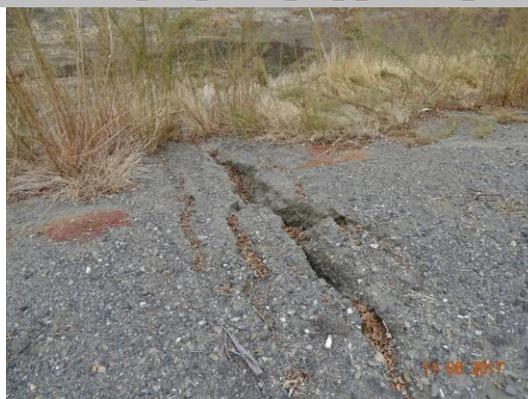
Photo 6 of 6 : FA_2019_RD0785_185_9_20190829_00008.jpg

View of runoff erosion on the landside slope. Fall 2017.

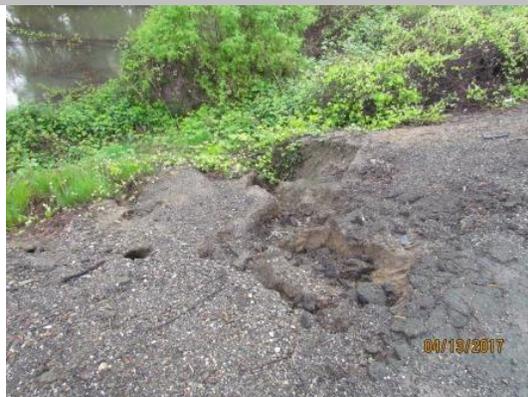
Photo 1 of 1 : FA_2019_RD0785_185_24_20190829_00019.jpg

LM Start	0.24	Rating **	M	Issue No.	24
LM End	0.24	Issue Type +	Ma	Location *	WS
Category	Earthen Levee			GPS Latitude/Longitude	
				Start	End
Item	Erosion / Bank Caving			38.658998 °	38.658998 °
				-121.610081 °	-121.610081 °
DWR ID	DWR_RD0785_01_s_2017_24				
Comment Code					
E2 : Schedule repair of erosion site prior to the next inspection.					
Inspector Comment					
Runoff erosion on waterside slope.

Runoff erosion on waterside levee slope. Spring 2017.

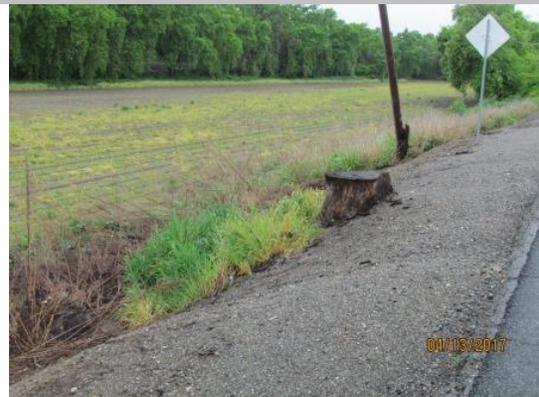
Photo 1 of 1 : FA_2019_RD0785_185_36_20190829_00024.jpg

View of stump on landside levee slope. Spring 2017.

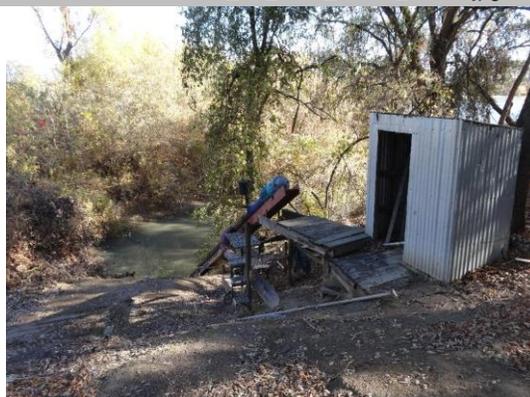
Photo 1 of 3 : UCIP_FA_2019_43963_45628.jpg

LM Start	0.63	Rating **	M	Issue No.	359
LM End	0.63	Issue Type +	En	Location *	
Category	Supplemental			GPS Latitude/Longitude	
				Start	End
Item	DRAFT DWR UCIP Field Study			38.654641 °	38.654641 °
				-121.605538 °	-121.605538 °
DWR ID	22982				
Comment Code					
Inspector Comment					
DS_ID:22982 FS_ID:43963 EP_NO: N/A Repair Type: Non-Urgent Crossing Status: Found UCIP Comments: Part of abandoned pipe also found on waterside that should be removed.No access to landside across the highway. FIELD_STRUCT_DESC: 2 of 2: 0.75-inch steel electrical conduit through the levee, 1 foot below the crown. [Additional Reference(s): DWR Levee Log, 1988]. FS Date: 11/21/2013

WS view: slant pump, walkway, and electric control box in shed on levee slope.

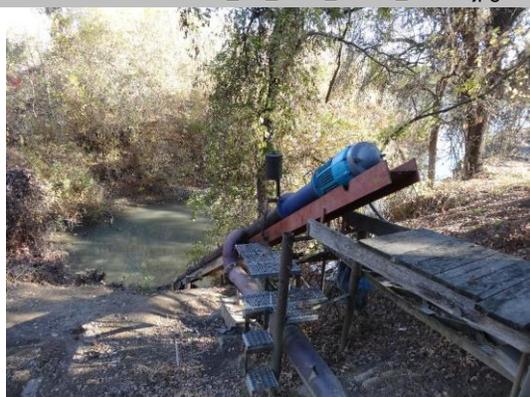
Photo 2 of 3 : UCIP_FA_2019_43963_45627.jpg

WS view: slant pump and walkway on levee slope.

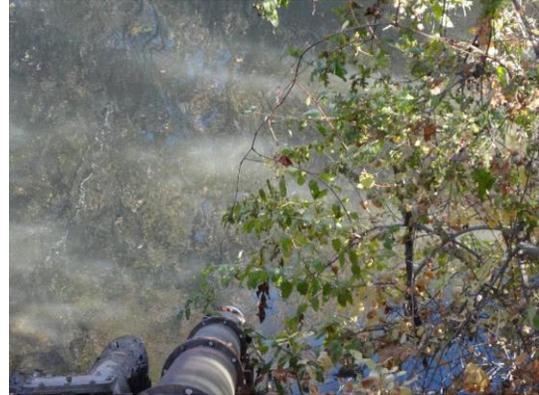
Photo 3 of 3 : UCIP_FA_2019_43963_45626.jpg

LM Start	0.63	Rating **	M	Issue No.	359 (cont)
LM End	0.63	Issue Type +	En	Location *	
Category	Supplemental			GPS Latitude/Longitude	
				Start	End
Item	DRAFT DWR UCIP Field Study			38.654641 °	38.654641 °
				-121.605538 °	-121.605538 °
DWR ID	22982				
Comment Code					
Inspector Comment					
DS_ID:22982 FS_ID:43963 EP_NO: N/A Repair Type: Non-Urgent Crossing Status: Found UCIP Comments: Part of abandoned pipe also found on waterside that should be removed.No access to landside across the highway. FIELD_STRUCT_DESC: 2 of 2: 0.75-inch steel electrical conduit through the levee, 1 foot below the crown. [Additional Reference(s): DWR Levee Log, 1988]. FS Date: 11/21/2013

WS view: two steel pipes on levee slope. Abandoned pipe on left.

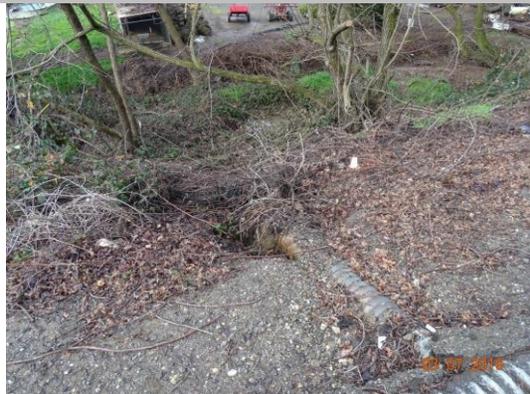
Photo 1 of 1 : FA_2019_RD0785_185_22_20190829_00018.jpg

LM Start	0.64	Rating **	M	Issue No.	22
LM End	0.64	Issue Type +	Ma	Location *	LS
Category	Earthen Levee			GPS Latitude/Longitude	
				Start	End
Item	Erosion / Bank Caving			38.654294 °	38.654294 °
				-121.605949 °	-121.605949 °
DWR ID	DWR_RD0785_01_s_2019_22				
Comment Code					
E2 : Schedule repair of erosion site prior to the next inspection.					
Inspector Comment					
Erosion around drainage pipe.

View of erosion on the landside slope. Spring 2019.

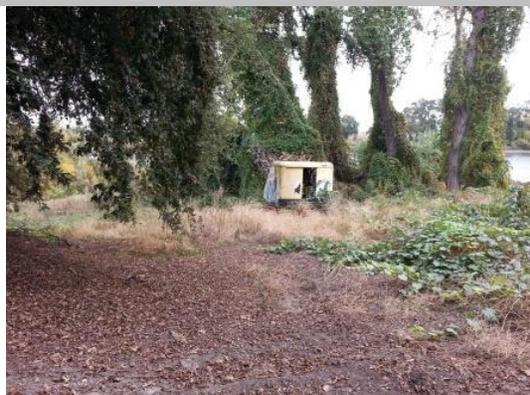
Photo 1 of 1 : FA_2019_RD0785_185_49_20190829_00025.jpg

LM Start	0.68	Rating **	M	Issue No.	49
LM End	0.68	Issue Type +	En	Location *	WS
Category	Earthen Levee			GPS Latitude/Longitude	
				Start	End
Item	Encroachments			38.654144 °	38.654144 °
				-121.605117 °	-121.605117 °
DWR ID	DWR_RD0785_01_f_2016_49				
Comment Code					
EQ : Equipment					
Inspector Comment					
Abandoned crane on waterward side.

View of an abandoned crane on waterward side of the levee. Fall 2016.

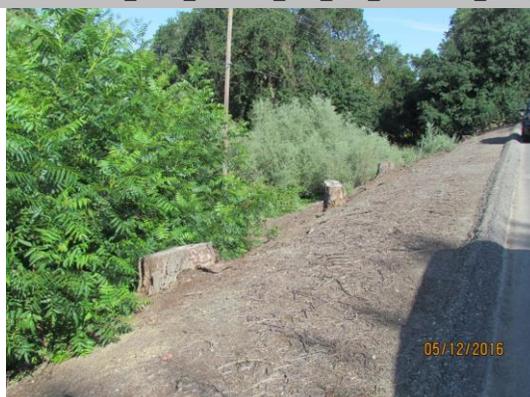
Photo 1 of 1 : FA_2019_RD0785_185_181_20190829_00027.jpg

LM Start	0.76	Rating **	N	Issue No.	181
LM End	0.76	Issue Type +	Ma	Location *	LS
Category	Earthen Levee			GPS Latitude/Longitude	
				Start	End
Item	Trim / Thin Trees			38.653003 °	38.653003 °
				-121.605061 °	-121.605061 °
DWR ID	DWR_RD0785_01_s_2014_181				
Comment Code					
T5 : Tree stumps.					
Inspector Comment

View of the tree stumps on the landward side of the levee looking upstream. Spring 2016.

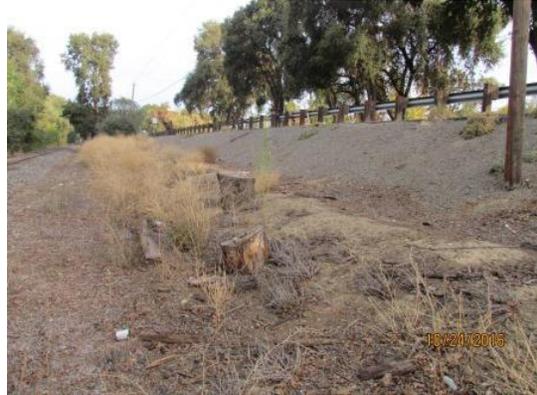
Photo 1 of 1 : FA_2019_RD0785_185_28_20190829_00020.jpg

Two tree stumps near levee toe on landside. Fall 2016.

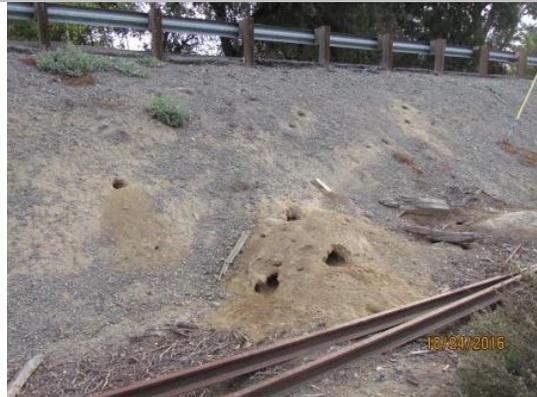
Photo 1 of 2 : FA_2019_RD0785_185_29_20190829_00021.jpg

LM Start	1.02	Rating **	M	Issue No.	29
LM End	1.02	Issue Type +	Ma	Location *	LS
Category	Earthen Levee			GPS Latitude/Longitude	
				Start	End
Item	Animal Control			38.649798°	38.649798°
				-121.602373°	-121.602373°
DWR ID	DWR_RD0785_01_f_2016_29				
Comment Code					
A3 : No rodents visible, but rodent burrows visible; need to backfill and compact or grout burrows.					
Inspector Comment					
Rodent holes on the landside slope.

View of rodent holes on LS slope. Fall 2016.

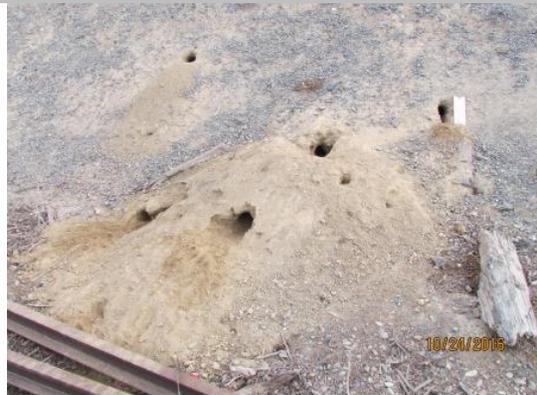
Photo 2 of 2 : FA_2019_RD0785_185_29_20190829_00022.jpg

Another view of rodent holes. Fall 2016.

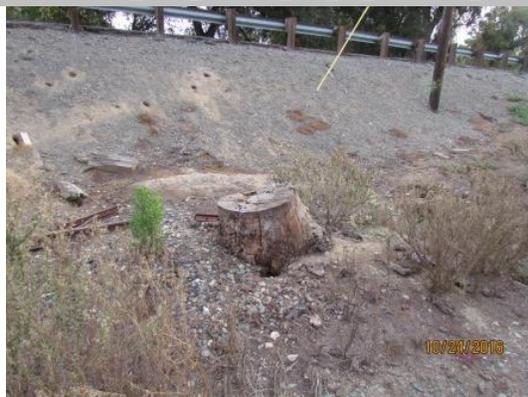
Photo 1 of 1 : FA_2019_RD0785_185_30_20190829_00023.jpg

View of a stump near levee toe on landside. Fall 2016.

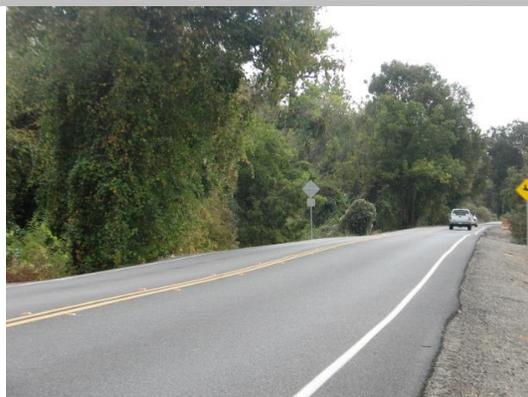
Photo 1 of 2 : FA_2019_RD0785_185_16_20190829_00014.jpg

LM Start	1.11	Rating **	M	Issue No.	16
LM End	1.21	Issue Type +	Ma	Location *	WS
Category	Earthen Levee			GPS Latitude/Longitude	
				Start	End
Item	Vegetation			38.648857°	38.647805°
				-121.601213°	-121.600076°
DWR ID	DWR_RD0785_01_f_2013_16				
Comment Code					
V2 : Remove the wild growth other than native grasses from the levee slopes.					
Inspector Comment

Brush and other vegetation partially blocks visibility or access to the levee slope. Fall 2013

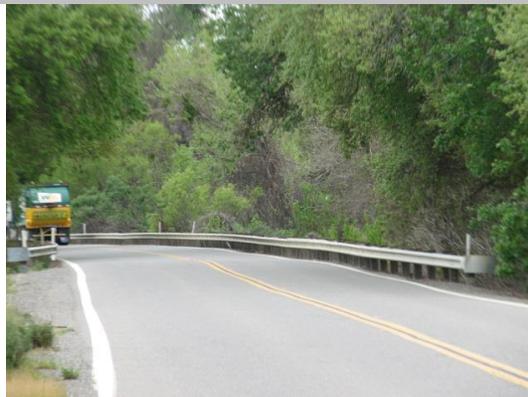
Photo 2 of 2 : FA_2019_RD0785_185_16_20190829_00015.jpg

Brush and other vegetation partially blocks visibility. Spring 2014

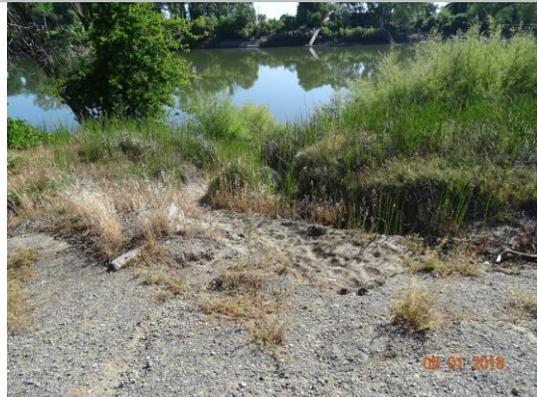
Photo 1 of 2 : FA_2019_RD0785_185_13_20190829_00009.jpg

LM Start	1.31	Rating **	M	Issue No.	13
LM End	1.31	Issue Type +	Ma	Location *	WS
Category	Earthen Levee		GPS Latitude/Longitude		
			Start	End	
Item	Erosion / Bank Caving		38.646652°	38.646652°	
			-121.598907°	-121.598907°	
DWR ID	DWR_RD0785_01_s_2013_13				
Comment Code					
E2 : Schedule repair of erosion site prior to the next inspection.					
Inspector Comment					
Rills on the waterside slope.

View of runoff on the waterside slope. Spring 2018.

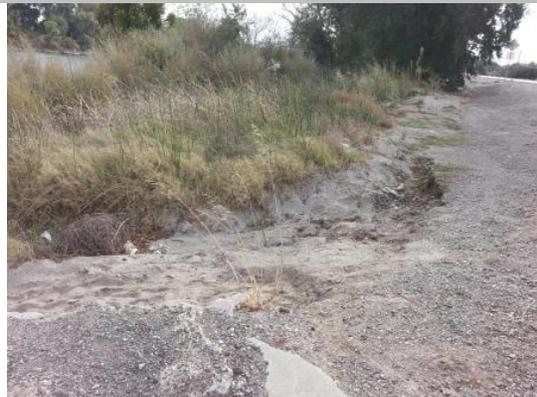
Photo 2 of 2 : FA_2019_RD0785_185_13_20190829_00010.jpg

View of the runoff on the waterside slope. Fall 2016.

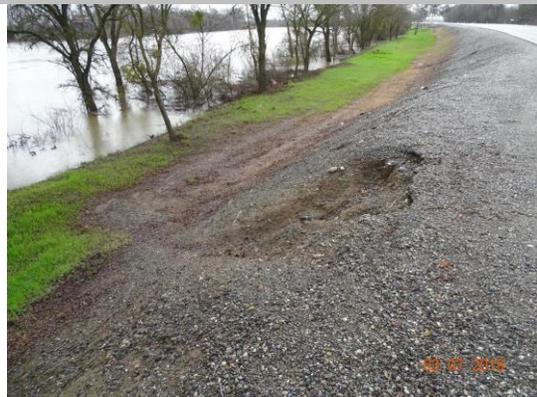
Photo 1 of 1 : FA_2019_RD0785_185_17_20190829_00016.jpg

LM Start	1.41	Rating **	M	Issue No.	17
LM End	1.41	Issue Type +	Ma	Location *	WS
Category	Earthen Levee		GPS Latitude/Longitude		
			Start	End	
Item	Erosion / Bank Caving		38.645424 °	38.645424 °	
			-121.597716 °	-121.597716 °	
DWR ID	DWR_RD0785_01_s_2019_17				
Comment Code					
E2 : Schedule repair of erosion site prior to the next inspection.					
Inspector Comment					
Runoff erosion on the waterside slope.

View of runoff erosion on the waterside slope. Spring 2019.

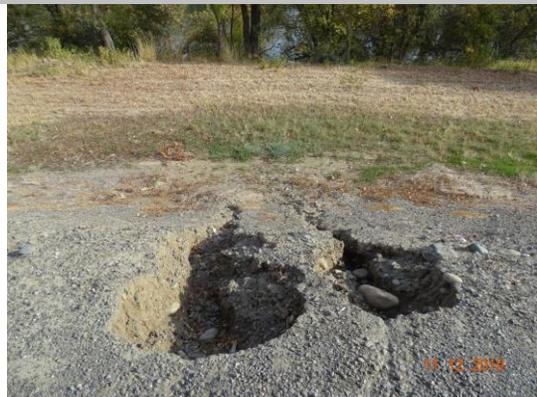
Photo 1 of 1 : FA_2019_RD0785_185_25_20191112_00040.jpg

LM Start	1.50	Rating **	M	Issue No.	25
LM End	1.50	Issue Type +	Ma	Location *	WS
Category	Earthen Levee		GPS Latitude/Longitude		
			Start	End	
Item	Erosion / Bank Caving		38.644482 °	38.644482 °	
			-121.596644 °	-121.596644 °	
DWR ID	DWR_RD0785_01_f_2019_25				
Comment Code					
E2 : Schedule repair of erosion site prior to the next inspection.					
Inspector Comment					
Rills on the waterside slope.

View of erosion on the waterside slope. Fall 2019.

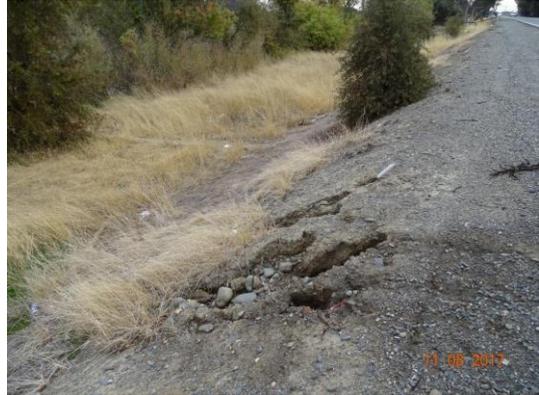
Photo 1 of 1 : FA_2019_RD0785_185_55_20190829_00026.jpg

LM Start	1.51	Rating **	M	Issue No.	55
LM End	1.51	Issue Type +	Ma	Location *	WS
Category	Earthen Levee			GPS Latitude/Longitude	
				Start	End
Item	Erosion / Bank Caving			38.644349°	38.644349°
				-121.596506°	-121.596506°
DWR ID	DWR_RD0785_01_f_2017_55				
Comment Code					
E2 : Schedule repair of erosion site prior to the next inspection.					
Inspector Comment					
Runoff on waterside slope.

View of the runoff erosion on the waterside slope. Fall 2017.

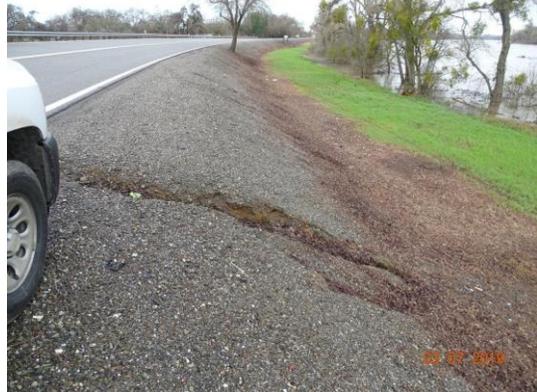
Photo 1 of 1 : FA_2019_RD0785_185_15_20190829_00013.jpg

LM Start	1.78	Rating **	M	Issue No.	15
LM End	1.78	Issue Type +	Ma	Location *	WS
Category	Earthen Levee			GPS Latitude/Longitude	
				Start	End
Item	Erosion / Bank Caving			38.642042 °	38.642042 °
				-121.592536 °	-121.592536 °
DWR ID	DWR_RD0785_01_s_2019_15				
Comment Code					
E2 : Schedule repair of erosion site prior to the next inspection.					
Inspector Comment					
Rills on the waterside slope.

View of rill on the waterside slope. Spring 2019.

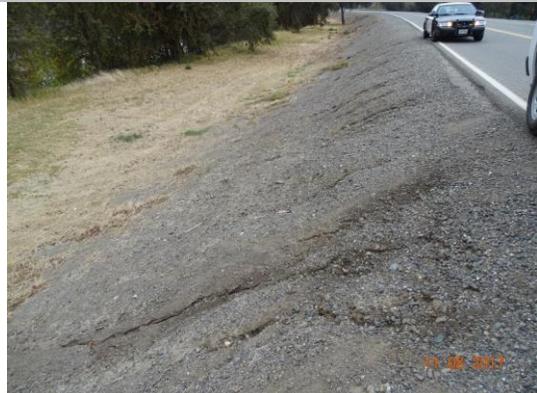
Photo 1 of 1 : FA_2019_RD0785_185_19_20190829_00017.jpg

LM Start	2.24	Rating **	M	Issue No.	19
LM End	2.24	Issue Type +	Ma	Location *	WS
Category	Earthen Levee			GPS Latitude/Longitude	
				Start	End
Item	Erosion / Bank Caving			38.642988 °	38.642988 °
				-121.584481 °	-121.584481 °
DWR ID	DWR_RD0785_01_s_2018_19				
Comment Code					
E1 : Note and monitor erosion site.					
Inspector Comment					
Runoff erosion on waterside slope.

View of runoff erosion on the waterside slope. Fall 2017.

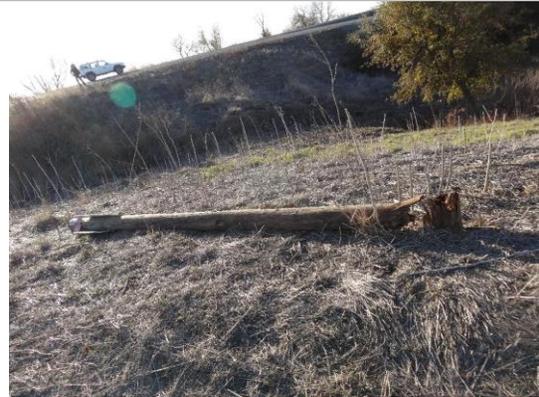
Photo 1 of 2 : UCIP_FA_2019_24750_44372.jpg

LM Start	0.01	Rating **	M	Issue No.	281
LM End	0.01	Issue Type +	En	Location *	
Category	Supplemental			GPS Latitude/Longitude	
				Start	End
Item	DRAFT DWR UCIP Field Study			38.641086°	38.641086°
				-121.620350°	-121.620350°
DWR ID	22985				
Comment Code					
Inspector Comment					
DS_ID:22985 FS_ID:24750 EP_NO: 16982 Repair Type: Non-Urgent Crossing Status: Indicator Found UCIP Comments: Only a damaged indicator post found on landside across the road. Damaged indicator needs to be fixed. FIELD_STRUCT_DESC: Three 2-inch-diameter and three 1.5-inch diameter HDPE conduits containing fiber optic cables across and under the east levee (County Road 124), 67 feet below the crown. HDPE pipes were pulled through an 8-inch bore hole and backfilled with bentonite. (App. No. 16982 - Pacific Fiber Link) FS Date: 12/2/2013

LS view: damaged indicator post across the levee road.

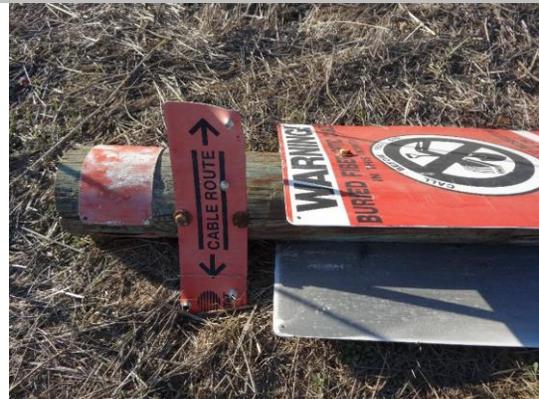
Photo 2 of 2 : UCIP_FA_2019_24750_44371.jpg

LS view: closer view of damaged indicator post.

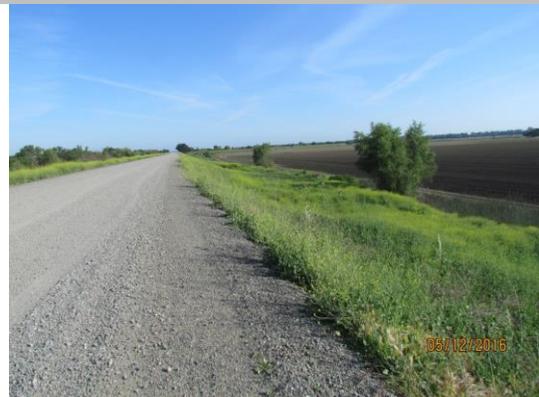
Photo 1 of 1 : FA_2019_RD0785_186_280_20190829_00006.jpg

LM Start	0.38	Rating **	A/W	Issue No.	280
LM End	0.38	Issue Type +	Ma	Location *	LS
Category	Earthen Levee		GPS Latitude/Longitude		
			Start	End	
Item	Slope Stability		38.636265 °	38.636265 °	
			-121.617422 °	-121.617422 °	
DWR ID	DWR_RD0785_02_s_2015_280				
Comment Code					
S1 : Repair slope instability.					
Inspector Comment					
Seems to be a bulge at the toe of the levee. Recommend monitoring.

View of the slope stability on the landward side of the levee looking upstream. Spring 2016.

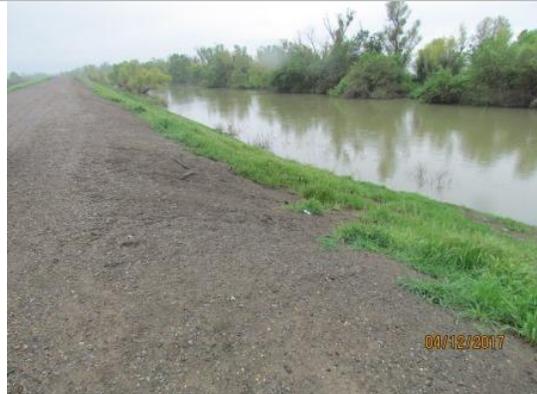
Photo 1 of 1 : FA_2019_RD0785_186_24_20190829_00005.jpg

View of slope stability on waterside levee slope. Spring 2017.

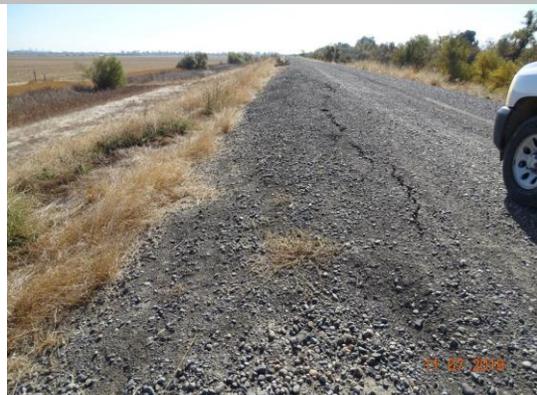
Photo 1 of 1 : FA_2019_RD0785_186_10_20191112_00009.jpg

View of cracking and settlement on the crown and landside shoulder. Fall 2019.

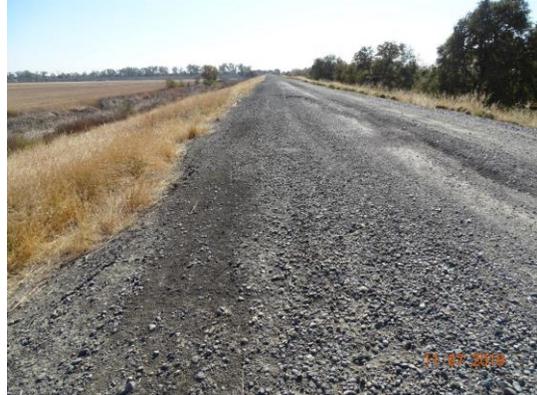
Photo 1 of 1 : FA_2019_RD0785_186_11_20191112_00010.jpg

View of cracking and settlement on the crown and landside shoulder. Fall 2019.

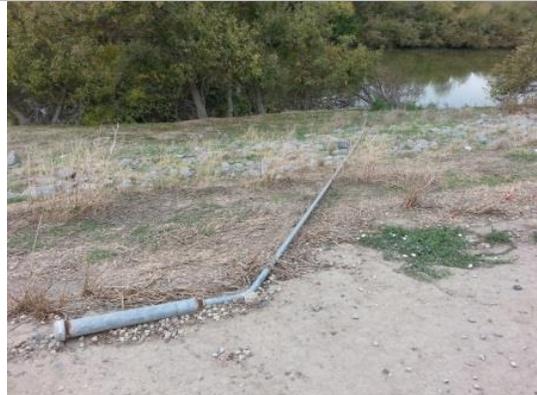
Photo 1 of 1 : FA_2019_RD0785_186_19_20190829_00004.jpg

LM Start	2.99	Rating **	M	Issue No.	19
LM End	2.99	Issue Type +	En	Location *	WS
Category	Earthen Levee		GPS Latitude/Longitude		
			Start	End	
Item	Encroachments		38.603503°	38.603503°	
			-121.593471°	-121.593471°	
DWR ID	DWR_RD0785_02_f_2016_19				
Comment Code					
PI : Pipe					
Inspector Comment					
Capped pipe on WS slope going down to the water. This is a pending CVFPB enforcement item.

View of a capped galvanized pipe on WS slope. Fall 2016.
