**Flood Control Project Maintenance
Levee Inspections**

Maintenance Issue Types Only, Levee Inspection Report By Mile - Fall 2019

Reclamation District No. 0817 Carlin

Waterway	Bank	Unit Miles	Inspection Start/End	Inspector
Unit No. 01 South Dry Creek	Left	3.81	10/28/2019 10/28/2019	Sterling York

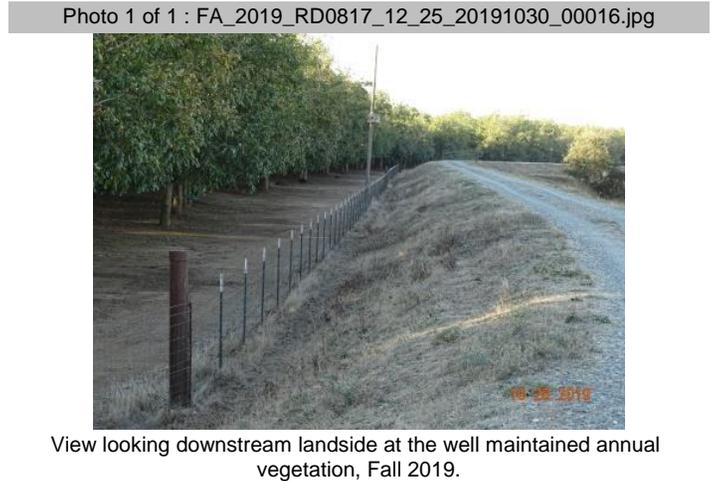
LM Start	0.01	Rating **	A	Issue No.	25
LM End	1.12	Issue Type +	Ma	Location *	LS
Category	Earthen Levee		GPS Latitude/Longitude		
			Start	End	
Item	Vegetation		38.984838°	38.995515°	
			-121.506067°	-121.491157°	
DWR ID	DWR_RD0817_01_f_2019_25				
Comment Code					
V1 : Control annual grass and weeds on the levee slopes and easements.					
Inspector Comment					
The annual vegetation is well maintained, Fall 2019.

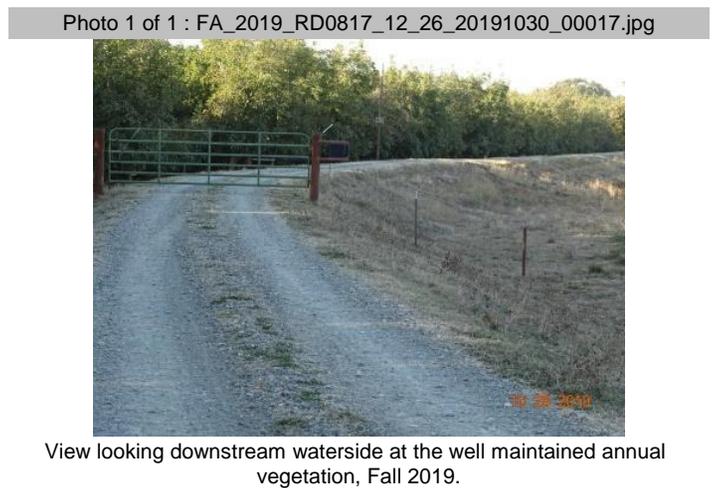
LM Start	0.01	Rating **	A	Issue No.	26
LM End	1.12	Issue Type +	Ma	Location *	WS
Category	Earthen Levee		GPS Latitude/Longitude		
			Start	End	
Item	Vegetation		38.984859°	38.995515°	
			-121.506056°	-121.491157°	
DWR ID	DWR_RD0817_01_f_2019_26				
Comment Code					
V1 : Control annual grass and weeds on the levee slopes and easements.					
Inspector Comment					
The annual vegetation is well maintained, Fall 2019.

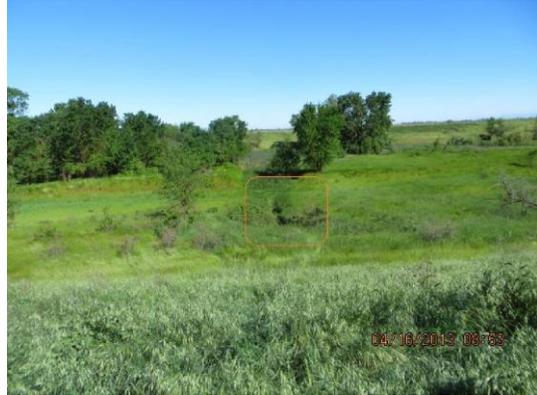
Photo 3 of 3 : UCIP_FA_2019_54440_19863.jpg

LM Start	0.29	Rating **	M	Issue No.	27 (cont)	
LM End	0.29	Issue Type +	Ma	Location *		
Category	Supplemental			GPS Latitude/Longitude		
				Start	End	
Item	DRAFT DWR UCIP LMA Responsibility			38.987813°	38.987813°	
				-121.502963°	-121.502963°	
DWR ID	18985

Comment Code						
Inspector Comment						
DS_ID:18985 FS_ID:54440 EP_NO: N/A Repair Type: Non-Urgent Crossing Status: Found UCIP Comments: 08/14/2019 DMP Internal Inspection Report shows minor defects in the pipe through the levee. This pipe is considered Non-Urgent: Low Priority. District Engineer, Tom Engler, recommends lining or removing/replacing pipe. The pipe is a critical pipe for the District since it handles a large portion of the drainage into Dry Creek. The pipe is responsible for draining most of the Wheatland basin into Dry Creek. Mr. Tom Engler recommends replacing the pipe to current standards including adding positive closure device on both sides of the levee so that the District has a backup if/when the flap gate located on the WS eventually fails. Supporting documentation submitted by the District Engineer has been forwarded to DMP. (O. Magana - DWR UCIP) 04/16/2013 Dense vegetation on waterward and landward slopes limit visual inspection of potential leaks along pipe alignment. Recommend having owner clear vegetation along slopes. (P. Amatya - DWR UCIP) FIELD_STRUCT_DESC: 48-inch corrugated metal gravity drainage pipe through the levee, 23.3 feet below the crown. Flap gate on the waterside (WS) end. [Additional Reference(s): DWR Levee Log, 2005. USACE Sacramento O&M Manual 146, November 1962, (HLM 0.28)]. FS Date: 4/16/2013

WS- dense vegetation on WS of the levee

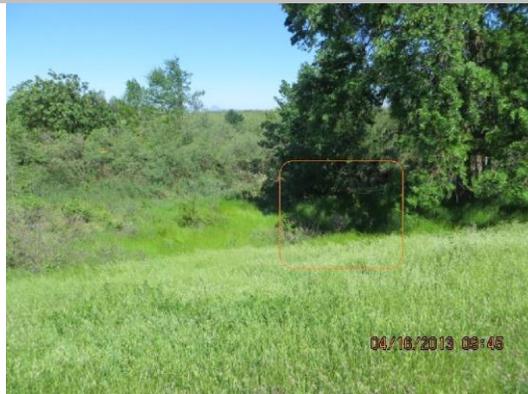
Photo 1 of 3 : UCIP_FA_2019_54435_19882.jpg

LM Start	1.34	Rating **	M	Issue No.	35
LM End	1.34	Issue Type +	Ma	Location *	
Category	Supplemental		GPS Latitude/Longitude		
			Start	End	
Item	DRAFT DWR UCIP LMA Responsibility		38.997961 °	38.997961 °	
			-121.488455 °	-121.488455 °	
DWR ID	18987

Comment Code					
Inspector Comment					
DS_ID:18987 FS_ID:54435 EP_NO: N/A Repair Type: Non-Urgent Crossing Status: Found UCIP Comments: 08/14/2019 No DMP Internal Inspection Report was completed for this pipe. Pipe was either completely buried or access to inlet/outlet was not feasible. Pipe has been abandoned and no longer needed per LMA District Engineer, Tom Engler. District Engineer recommends removal of this pipe. Supporting documentation submitted by the District Engineer has been forwarded to DMP. (O. Magana - DWR UCIP) 04/16/2013 Damaged slide gate on WS of the levee. Need to contact owner to determine status of crossing. If crossing is no longer in use owner will need to contact CVFPB to comply with Title 23. Dense vegetation on waterward and landward slopes limit visual inspection of potential leaks along pipe alignment. Recommend having owner clear vegetation along slopes. (P. Amatya - DWR UCIP) FIELD_STRUCT_DESC: *ABANDONED* 18-inch corrugated metal gravity drainage pipe through the levee, 14.9 feet below the crown. Slide gate on the waterside (WS) end. [Additional Reference(s): DWR Levee Log, 2005. USACE Sacramento O&M Manual 146, November 1962, (HLM 1.34)]. FS Date: 4/16/2013

WS- overview of WS area

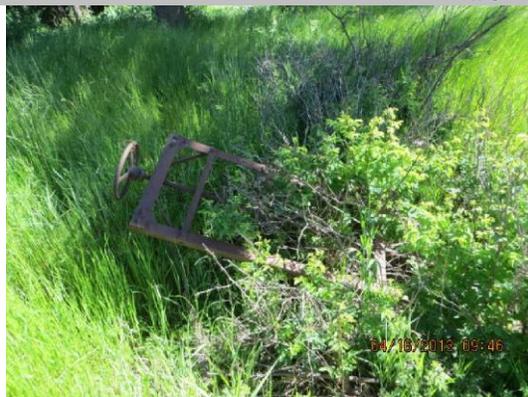
Photo 2 of 3 : UCIP_FA_2019_54435_19881.jpg

WS- closer look at damaged slide gate on WS

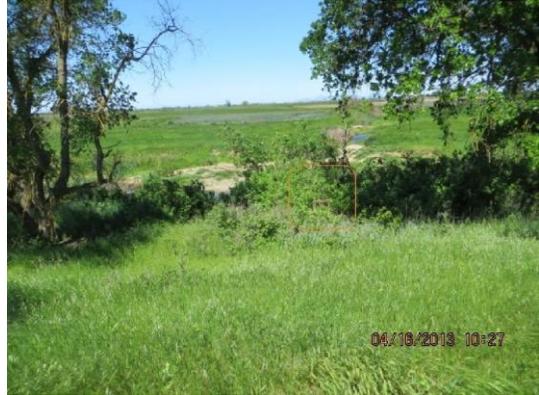
Photo 1 of 3 : UCIP_FA_2019_54436_19892.jpg

LM Start	1.62	Rating **	M	Issue No.	36
LM End	1.62	Issue Type +	Ma	Location *	
Category	Supplemental		GPS Latitude/Longitude		
			Start	End	
Item	DRAFT DWR UCIP LMA Responsibility		39.001340°	39.001340°	
			-121.485740°	-121.485740°	
DWR ID	18988

Comment Code					
Inspector Comment					
DS_ID:18988 FS_ID:54436 EP_NO: N/A Repair Type: Non-Urgent Crossing Status: Found UCIP Comments: 08/14/2019 No DMP Internal Inspection Report was completed for this pipe. Pipe was either completely buried or access to inlet/outlet was not feasible. Pipe has been abandoned and no longer needed per LMA District Engineer, Tom Engler. District Engineer recommends removal of this pipe. Supporting documentation submitted by the District Engineer has been forwarded to DMP. (O. Magana - DWR UCIP)04/16/2013 A burried slide gate on WS of the levee. Need to contact owner to determine status of crossing. If crossing is no longer in use owner will need to contact CVFPB to comply with Title 23. Dense vegetation on waterward and landward slopes limit visual inspection of potential leaks along pipe alignment. Recommend having owner clear vegetation along slopes. (P. Amatya - DWR UCIP) FIELD_STRUCT_DESC: *ABANDONED* 18-inch corrugated metal gravity drainage pipe through the levee, 13.8 feet below the crown. Slide gate on the waterside (WS) end. [Additional Reference(s): DWR Levee Log, 2005. USACE Sacramento O&M Manual 146, November 1962, (HLM 1.62)]. FS Date: 4/16/2013

WS- overview of WS berm

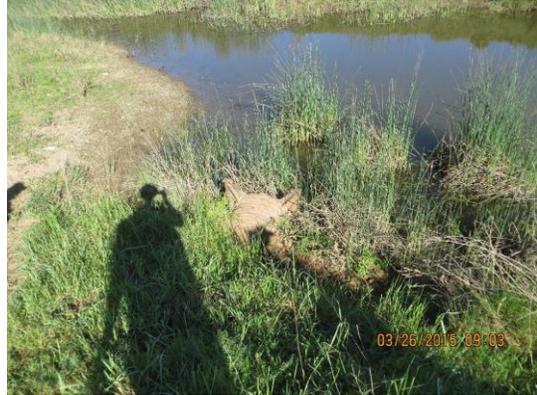
Photo 1 of 3 : UCIP_FA_2019_54438_73422.jpg

LM Start	2.96	Rating **	M	Issue No.	46
LM End	2.96	Issue Type +	Ma	Location *	
Category	Supplemental		GPS Latitude/Longitude		
			Start	End	
Item	DRAFT DWR UCIP LMA Responsibility		39.012552°	39.012552°	
			-121.466538°	-121.466538°	
DWR ID	18992

Comment Code					
Inspector Comment					
DS_ID:18992 FS_ID:54438 EP_NO: N/A Repair Type: Non-Urgent Crossing Status: Found UCIP Comments: 08/14/2019 No DMP Internal Inspection Report was completed for this pipe. Pipe was either completely buried or access to inlet/outlet was not feasible. Pipe has been abandoned and no longer needed per LMA District Engineer, Tom Engler. District Engineer recommends removal of this pipe. Supporting documentation submitted by the District Engineer has been forwarded to DMP. (O. Magana - DWR UCIP) 03/26/2015 Flapgate in closed position, but blocked from operation on WS toe. Pipe appears abandoned and should be verified as having been done so properly. (W. Wylie - DWR UCIP) FIELD_STRUCT_DESC: *ABANDONED* 36-inch corrugated metal gravity drainage pipe through the levee, 13.7 feet below the crown. Slide gate on the waterside (WS) end. Flap gate on the WS end. [Additional Reference(s): DWR Levee Log, 2005. USACE Sacramento O&M Manual 146, November 1962, (HLM 2.97)]. FS Date: 3/26/2015

Pipe and flapgate visible on WS toe.

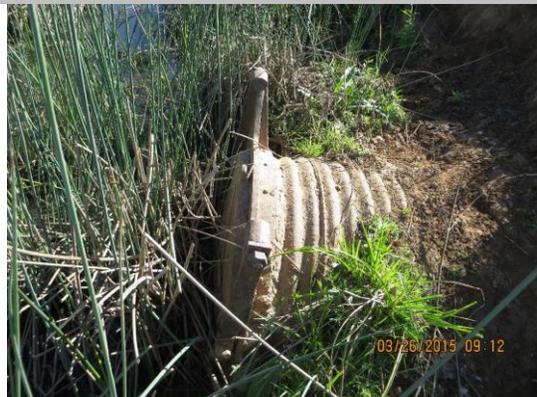
Photo 2 of 3 : UCIP_FA_2019_54438_73421.jpg

Pipe and flapgate visible on WS toe.

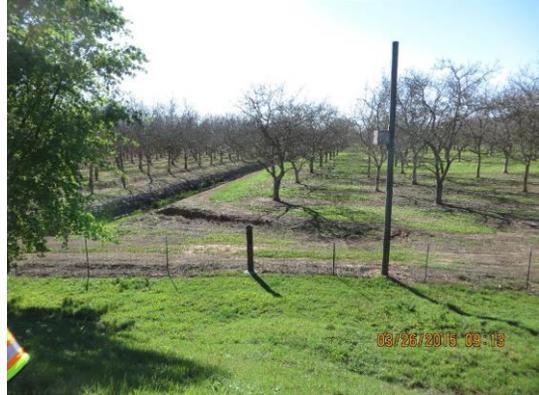
Photo 3 of 3 : UCIP_FA_2019_54438_73420.jpg

Comment Code					
Inspector Comment					
DS_ID:18992 FS_ID:54438 EP_NO: N/A Repair Type: Non-Urgent Crossing Status: Found UCIP Comments: 08/14/2019 No DMP Internal Inspection Report was completed for this pipe. Pipe was either completely buried or access to inlet/outlet was not feasible. Pipe has been abandoned and no longer needed per LMA District Engineer, Tom Engler. District Engineer recommends removal of this pipe. Supporting documentation submitted by the District Engineer has been forwarded to DMP. (O. Magana - DWR UCIP) 03/26/2015 Flapgate in closed position, but blocked from operation on WS toe. Pipe appears abandoned and should be verified as having been done so properly. (W. Wylie - DWR UCIP) FIELD_STRUCT_DESC: *ABANDONED* 36-inch corrugated metal gravity drainage pipe through the levee, 13.7 feet below the crown. Slide gate on the waterside (WS) end. Flap gate on the WS end. [Additional Reference(s): DWR Levee Log, 2005. USACE Sacramento O&M Manual 146, November 1962, (HLM 2.97)]. FS Date: 3/26/2015

LS of pipe burried but alignment would place LS outlet just left of telephone pole on LS toe.

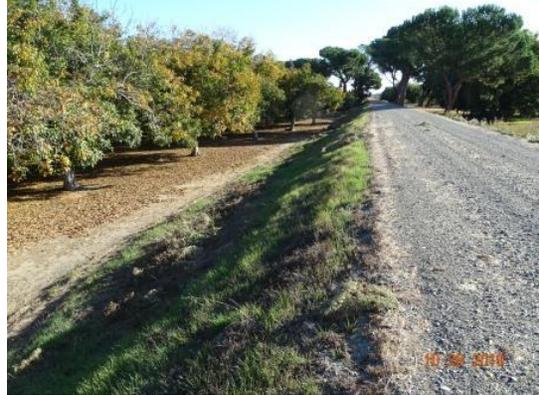
Photo 1 of 1 : FA_2019_RD0817_13_9_20191030_00024.jpg

LM Start	0.00	Rating **	A	Issue No.	9
LM End	3.25	Issue Type +	Ma	Location *	LS
Category	Earthen Levee		GPS Latitude/Longitude		
			Start	End	
Item	Vegetation		38.984722°	38.993891°	
			-121.506111°	-121.448154°	
DWR ID	DWR_RD0817_02_f_2019_9				
Comment Code					
V1 : Control annual grass and weeds on the levee slopes and easements.					
Inspector Comment					
The annual vegetation is well maintained, Fall 2019.

View looking upstream landside at the well maintained annual vegetation, Fall 2019.

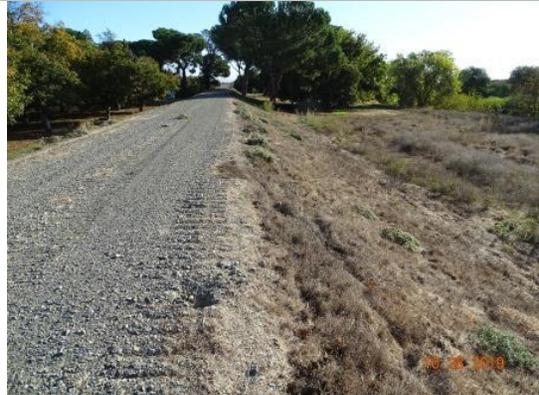
Photo 1 of 1 : FA_2019_RD0817_13_10_20191030_00025.jpg

LM Start	0.00	Rating **	A	Issue No.	10
LM End	3.25	Issue Type +	Ma	Location *	WS
Category	Earthen Levee		GPS Latitude/Longitude		
			Start	End	
Item	Vegetation		38.984722°	38.993891°	
			-121.506112°	-121.448154°	
DWR ID	DWR_RD0817_02_f_2019_10				
Comment Code					
V1 : Control annual grass and weeds on the levee slopes and easements.					
Inspector Comment					
The annual vegetation is well maintained, Fall 2019.

View looking upstream waterside at the well maintained annual vegetation, Fall 2019.

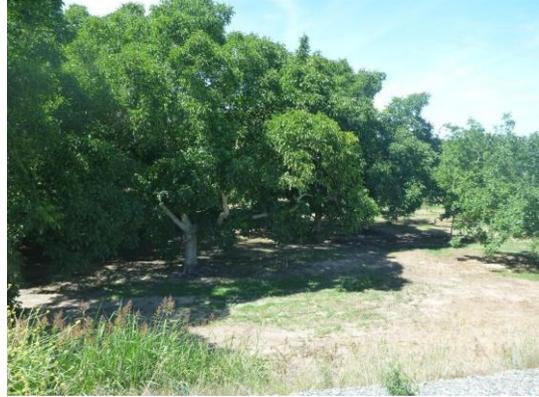
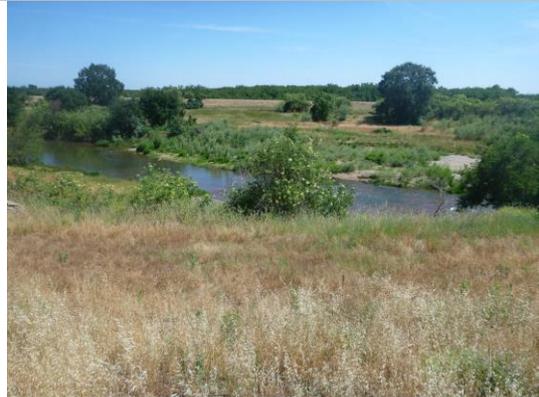
LM Start	2.08	Rating **	A/W	Issue No.	13
LM End	3.18	Issue Type +	Ma	Location *	
Category	Supplemental		GPS Latitude/Longitude		
			Start	End	
Item	2017 Storm Damage		38.989338°	38.994124°	
			-121.468640°	-121.449448°	
DWR ID	DWR_RD0817_02_s_2012_10				
Comment Code					
Inspector Comment					
Levee Evaluation Comments					
Description:					
Site ID No:162					
Site Designation:DWR_RD0817_02_s_2012_10					
Repair Type: Stability					
Rating:Area of Concern					
Field Date:6/5/2017					
Notes: Stability issues are due to levee geometry. Narrow steep slopes.

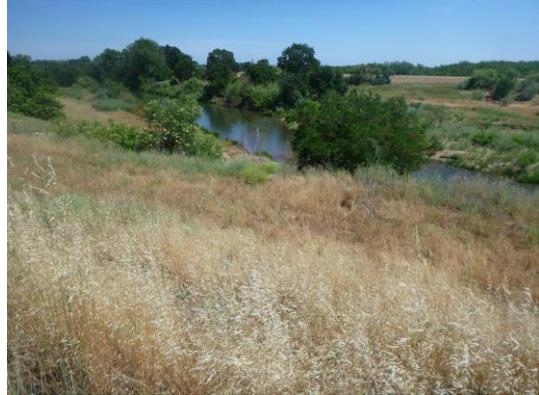
Photo 3 of 3 : LEVAL_FA_2019_162_289.jpg

LM Start	2.08	Rating **	A/W	Issue No.	13 (cont)
LM End	3.18	Issue Type +	Ma	Location *	
Category	Supplemental		GPS Latitude/Longitude		
			Start	End	
Item	2017 Storm Damage		38.989338°	38.994124°	
			-121.468640°	-121.449448°	
DWR ID	DWR_RD0817_02_s_2012_10				
Comment Code					
Inspector Comment					
Levee Evaluation Comments					
Description:					
Site ID No:162					
Site Designation:DWR_RD0817_02_s_2012_10					
Repair Type: Stability					
Rating:Area of Concern					
Field Date:6/5/2017					
Notes: Stability issues are due to levee geometry. Narrow steep slopes.

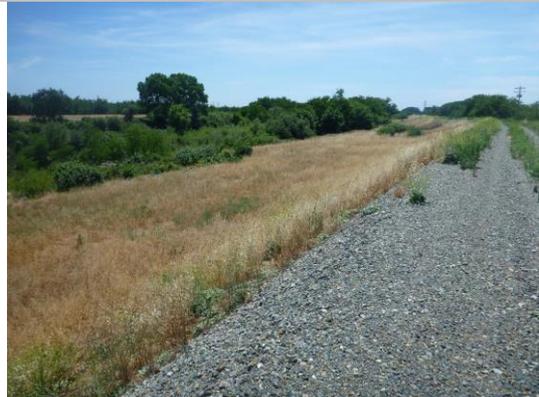
Photo 1 of 3 : LEVAL_FA_2019_161_1065.jpg

LM Start	2.72	Rating **	A/W	Issue No.	14
LM End	2.74	Issue Type +	Ma	Location *	
Category	Supplemental		GPS Latitude/Longitude		
			Start	End	
Item	2017 Storm Damage		38.992170°	38.992217°	
			-121.457332°	-121.456967°	
DWR ID	240-3				
Comment Code					
Inspector Comment					
Levee Evaluation Comments					
Description:					
Site ID No:161					
Site Designation:240-3					
Repair Type: Erosion					
Rating:Area of Concern					
Field Date:6/5/2017					
Notes: No issue found. Narrow levee with steep slopes. Did not investigate bench due to rattlesnake concerns. Possible alternate location at 38.993282; -121.451562.

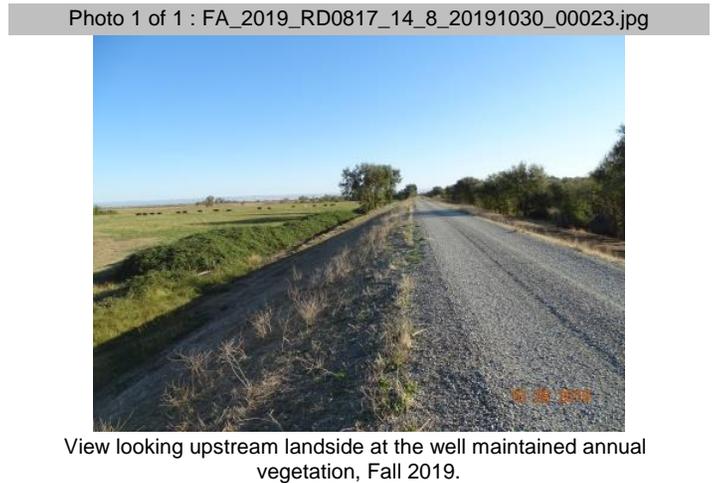
LM Start	0.25	Rating **	A	Issue No.	8
LM End	1.27	Issue Type +	Ma	Location *	LS
Category	Earthen Levee		GPS Latitude/Longitude		
			Start	End	
Item	Vegetation		38.987613°	38.996901°	
			-121.506580°	-121.491938°	
DWR ID	DWR_RD0817_03_f_2019_8				
Comment Code					
V1 : Control annual grass and weeds on the levee slopes and easements.					
Inspector Comment					
The annual vegetation is well maintained, Fall 2019.

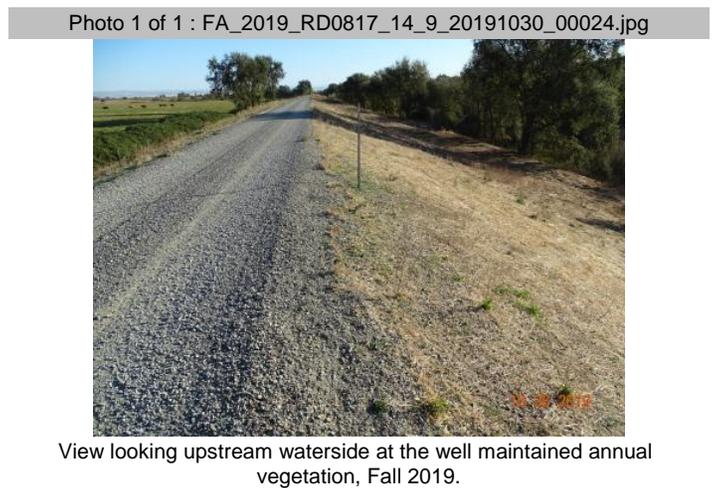
LM Start	0.26	Rating **	A	Issue No.	9
LM End	1.27	Issue Type +	Ma	Location *	WS
Category	Earthen Levee		GPS Latitude/Longitude		
			Start	End	
Item	Vegetation		38.987665°	38.996901°	
			-121.506479°	-121.491938°	
DWR ID	DWR_RD0817_03_f_2019_9				
Comment Code					
V1 : Control annual grass and weeds on the levee slopes and easements.					
Inspector Comment					
The annual vegetation is well maintained, Fall 2019.

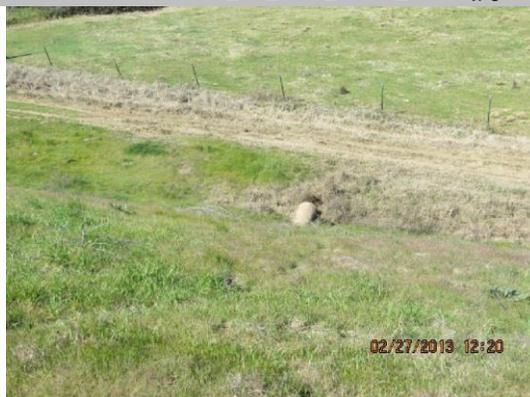
Photo 1 of 3 : UCIP_FA_2019_54258_54271.jpg

LM Start	0.27	Rating **	U	Issue No.	16
LM End	0.27	Issue Type +	Ma	Location *	
Category	Supplemental		GPS Latitude/Longitude		
			Start	End	
Item	DRAFT DWR UCIP LMA Responsibility		38.987762°	38.987762°	
			-121.506271°	-121.506271°	
DWR ID	22949

Comment Code					
Inspector Comment					
DS_ID:22949 FS_ID:54258 EP_NO: N/A Repair Type: Urgent Crossing Status: Found UCIP Comments: 07/25/2019 DMP Internal Inspection Report shows voids in pipe through the levee. This pipe is in failed condition and the record has been updated to Urgent: Pipe Integrity Issue. Tom Engler, District Engineer, recommends removal/replacement of pipe. Supporting documentation submitted by the District Engineer has been forward to DMP. The internal inspection of the pipe has been uploaded to database. (O. Magana – DWR UCIP)06/30/2016 Vegetation has been cleared at outlet enough to allow the flapgate to open by half a foot. Recommend rechecking WS outlet prior to flood season to ensure no overgrowth. Dense vegetation at LS but pipe still functional. Crossing has been downgraded from Urgent to Non-Urgent. (K. Fazel - UCIP)02/27/2013 Flap gate partially blocked by vegetation at outlet. (G. Wylie - FPIIB) FIELD_STRUCT_DESC: 18-inch corrugated metal gravity drainage pipe through the levee, 19.5 feet below the crown. Flap gate and headwall on the waterside (WS) end, headwall not found in 2016. (Due to a recent change in the levee alignment, this pipe is no longer in RD0784, Unit 6. Nevertheless, this pipe's original references remain in the RD0784 Levee Log and O&M Manual). [Additional Reference(s): DWR Levee Log, 2005. USACE Sacramento O&M Manual 145.1, August 1955, (Station 21+35), As-Built Drawing No. 2-4-106, Sheet 2, (Station 21+35)]. FS Date: 6/30/2016 9:02:00 AM

Pipe at LS toe

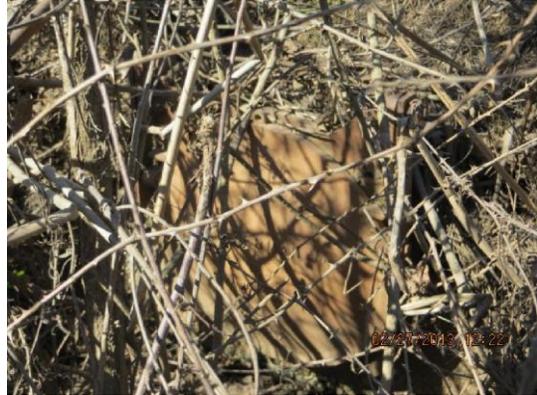
Photo 3 of 3 : UCIP_FA_2019_54258_54269.jpg

Comment Code					
Inspector Comment					
<p>DS_ID:22949 FS_ID:54258 EP_NO: N/A Repair Type: Urgent Crossing Status: Found UCIP Comments: 07/25/2019 DMP Internal Inspection Report shows voids in pipe through the levee. This pipe is in failed condition and the record has been updated to Urgent: Pipe Integrity Issue. Tom Engler, District Engineer, recommends removal/replacement of pipe. Supporting documentation submitted by the District Engineer has been forward to DMP. The internal inspection of the pipe has been uploaded to database. (O. Magana – DWR UCIP)06/30/2016 Vegetation has been cleared at outlet enough to allow the flapgate to open by half a foot. Recommend rechecking WS outlet prior to flood season to ensure no overgrowth. Dense vegetation at LS but pipe still functional. Crossing has been downgraded from Urgent to Non-Urgent. (K. Fazel - UCIP)02/27/2013 Flap gate partially blocked by vegetation at outlet. (G. Wylie - FPIIB) FIELD_STRUCT_DESC: 18-inch corrugated metal gravity drainage pipe through the levee, 19.5 feet below the crown. Flap gate and headwall on the waterside (WS) end, headwall not found in 2016. (Due to a recent change in the levee alignment, this pipe is no longer in RD0784, Unit 6. Nevertheless, this pipe's original references remain in the RD0784 Levee Log and O&M Manual). [Additional Reference(s): DWR Levee Log, 2005. USACE Sacramento O&M Manual 145.1, August 1955, (Station 21+35), As-Built Drawing No. 2-4-106, Sheet 2, (Station 21+35)]. FS Date: 6/30/2016 9:02:00 AM</p>

Flap gate blocked by vegetation on WS toe.

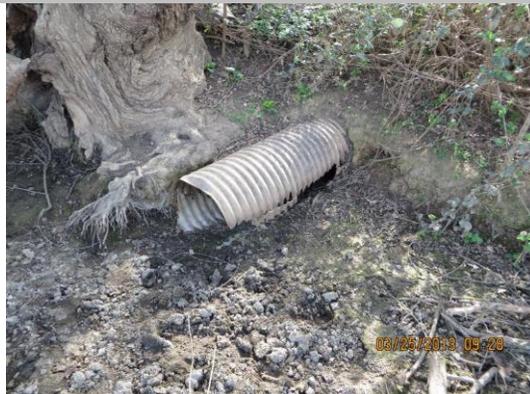
Photo 1 of 3 : UCIP_FA_2019_54254_53849.jpg

DS_ID:22950
 FS_ID:54254
 EP_NO: N/A
 Repair Type: Urgent
 Crossing Status: Found
 UCIP Comments: 07/25/2019 DMP Internal Inspection Report shows voids in pipe through the levee. This pipe is in failed condition and the record has been updated to Urgent: Pipe Integrity Issue and threat of Flood Risk. A section of the pipe material is missing on the WS which provides for water to enter the crossing and carry water to LS. Tom Engler, District Engineer, recommends lining or removal/replacement of pipe. Supporting documentation submitted by the District Engineer has been forward to DMP. The internal inspection of the pipe has been uploaded to database. (O. Magana – DWR UCIP)10/30/2018 Same as last inspection. Pipe has several sections of wall missing throughout the pipe length, and there is significant pipe deformation on the LS. Spoke with Tom Engler (MBK Engeers), District Engineer, and he mentioned that a video inspection has been completed at this site and that a report is in progress. LMA will be seeking funding for pipe repair under DWR's Deferred Maintenance Project (DMP). Crossing remains Urgent due to the deteriorated condition of the pipe. (O. Magana - DWR UCIP)06/30/2016 Holes still present through pipe on corroded landside (LS) end. Pipe still half full of debris as visible thru LS end. Good candidate for removal via DWR's Deferred Maintenance Program. WS vegetation cleared in the immediate vicinity of flapgate. Potential for overgrowth at WS end nevertheless imminent. Note that this pipe does not cause LS nuisance flooding per Tom Engler of MBK. (K. Fazel - UCIP)03/25/2013 Pipe heavily corroded and failing at inlet an outlet. (G. Wylie - FPIIB)

FIELD_STRUCT_DESC: 24-inch corrugated metal gravity drainage pipe through the levee, 20.5 feet below the crown. Flap gate and headwall on the waterside (WS) end. (Due to a recent change in the levee alignment, this pipe is no longer in RD0784, Unit 6. Nevertheless, this pipe's original references remain in the RD0784 Levee Log and O&M Manual). [Additional Reference(s): DWR Levee Log, 2005. USACE Sacramento O&M Manual 145.1, August 1955, (Station 35+57), As-Built Drawing No. 2-4-106, Sheet 4, (Station 35+57)].
 FS Date: 10/30/2018 1:50:00 PM

Pipe on LS toe corroded through.

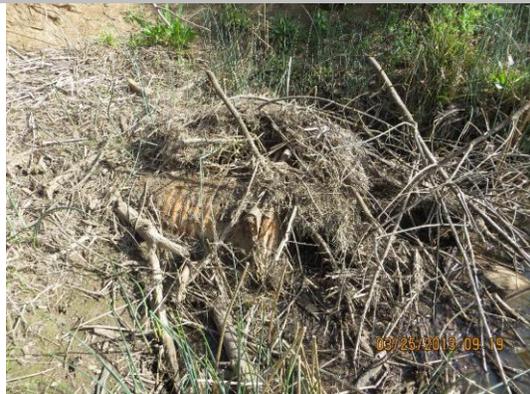
Photo 1 of 3 : UCIP_FA_2019_54257_53854.jpg

Comment Code					
Inspector Comment					
<p>DS_ID:22951 FS_ID:54257 EP_NO: N/A Repair Type: Urgent Crossing Status: Found UCIP Comments: 07/25/2019 DMP Internal Inspection Report shows ponding water along the pipe invert which prevented a full evaluation of the pipe floor and no holes were observed along the pipe section through the levee. However, the pipe wall has corroded significantly (pipe wall material missing) at the outlet. This pipe is in failed condition and the record has been updated to Urgent: Pipe Integrity Issue and threat of Flood Risk. A section of the pipe material is missing on the WS which provides for water to enter the crossing and carry water to LS. Tom Engler, District Engineer, recommends removal/replacement of pipe. The District Engineer also recommends upsizing the pipe since drainage has been diverted to this pipe. Supporting documentation submitted by the District Engineer has been forward to DMP. The internal inspection of the pipe has been uploaded to database. (O. Magana – DWR UCIP)10/30/2018 Same as last inspection. Pipe wall has corroded significantly (pipe wall missing) at the outlet. Spoke with Tom Engler (MBK Engineers), District Engineer, and he mentioned that a video inspection has been completed at this site and that a report is in progress. LMA will be seeking funding for pipe repair under DWR's Deferred Maintenance Project (DMP). Crossing remains Urgent due to the deteriorated condition of the pipe. (O. Magana - DWR UCIP)(O. Magana - DWR UCIP)06/30/2016 Corrosion still present on WS end. Inlet box was replaced 5 years ago and appears to be functioning properly due to the presence of a screen that prevents debris blockage. Flap gate functions properly only sometimes. WS heavily vegetated. (K. Fazel - UCIP) 03/25/2013 Corrosion holes on WS toe and flap gate is blocked by debris. Flap gate broken. Inlet partially blocked at concrete inlet. (G. Wylie - FPIIB) FIELD_STRUCT_DESC: 24-inch corrugated metal gravity drainage pipe through the levee, 20 feet below the crown. Flap gate and headwall on the waterside (WS) end. 56-inch by 34-inch concrete inlet box on the landside (LS) toe. (Due to a recent change in the levee alignment, this pipe is no longer in RD0784, Unit 6. Nevertheless, this pipe's original references remain in the RD0784 Levee Log and O&M Manual). [Additional Reference(s): DWR Levee Log, 2005, USACE Sacramento O&M Manual 145.1, August 1955, (Station 43+17), As-Built Drawing No. 2-4-106, Sheet 4, (Station 43+17)]. FS Date: 10/30/2018 1:51:00 PM</p>

Pipe and flapgate at WS toe blocked by debris.

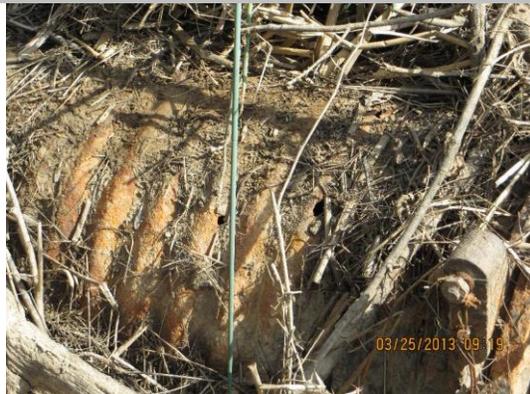
Photo 2 of 3 : UCIP_FA_2019_54257_53853.jpg

DS_ID:22951
 FS_ID:54257
 EP_NO: N/A
 Repair Type: Urgent
 Crossing Status: Found
 UCIP Comments: 07/25/2019 DMP Internal Inspection Report shows ponding water along the pipe invert which prevented a full evaluation of the pipe floor and no holes were observed along the pipe section through the levee. However, the pipe wall has corroded significantly (pipe wall material missing) at the outlet. This pipe is in failed condition and the record has been updated to Urgent: Pipe Integrity Issue and threat of Flood Risk. A section of the pipe material is missing on the WS which provides for water to enter the crossing and carry water to LS. Tom Engler, District Engineer, recommends removal/replacement of pipe. The District Engineer also recommends upsizing the pipe since drainage has been diverted to this pipe. Supporting documentation submitted by the District Engineer has been forward to DMP. The internal inspection of the pipe has been uploaded to database. (O. Magana – DWR UCIP)10/30/2018 Same as last inspection. Pipe wall has corroded significantly (pipe wall missing) at the outlet. Spoke with Tom Engler (MBK Engineers), District Engineer, and he mentioned that a video inspection has been completed at this site and that a report is in progress. LMA will be seeking funding for pipe repair under DWR's Deferred Maintenance Project (DMP). Crossing remains Urgent due to the deteriorated condition of the pipe. (O. Magana - DWR UCIP)(O. Magana - DWR UCIP)06/30/2016 Corrosion still present on WS end. Inlet box was replaced 5 years ago and appears to be functioning properly due to the presence of a screen that prevents debris blockage. Flap gate functions properly only sometimes. WS heavily vegetated. (K. Fazel - UCIP) 03/25/2013 Corrosion holes on WS toe and flap gate is blocked by debris. Flap gate broken. Inlet partially blocked at concrete inlet. (G. Wylie - FPIIB)

FIELD_STRUCT_DESC: 24-inch corrugated metal gravity drainage pipe through the levee, 20 feet below the crown. Flap gate and headwall on the waterside (WS) end. 56-inch by 34-inch concrete inlet box on the landside (LS) toe. (Due to a recent change in the levee alignment, this pipe is no longer in RD0784, Unit 6. Nevertheless, this pipe's original references remain in the RD0784 Levee Log and O&M Manual).
 [Additional Reference(s): DWR Levee Log, 2005. USACE Sacramento O&M Manual 145.1, August 1955, (Station 43+17), As-Built Drawing No. 2-4-106, Sheet 4, (Station 43+17)].
 FS Date: 10/30/2018 1:51:00 PM

Holes in pipe at broken flapgate on WS toe.

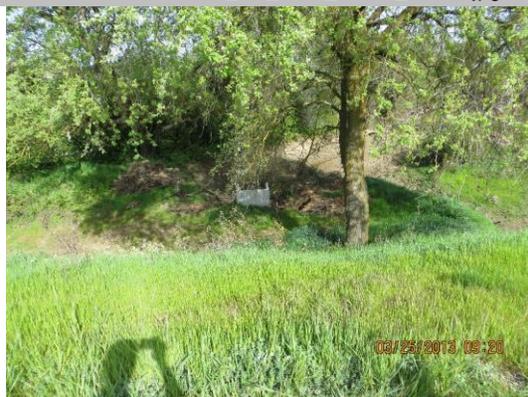
Photo 3 of 3 : UCIP_FA_2019_54257_53852.jpg

Improved concrete inlet on LS toe.

DS_ID:22951
 FS_ID:54257
 EP_NO: N/A
 Repair Type: Urgent
 Crossing Status: Found
 UCIP Comments: 07/25/2019 DMP Internal Inspection Report shows ponding water along the pipe invert which prevented a full evaluation of the pipe floor and no holes were observed along the pipe section through the levee. However, the pipe wall has corroded significantly (pipe wall material missing) at the outlet. This pipe is in failed condition and the record has been updated to Urgent: Pipe Integrity Issue and threat of Flood Risk. A section of the pipe material is missing on the WS which provides for water to enter the crossing and carry water to LS. Tom Engler, District Engineer, recommends removal/replacement of pipe. The District Engineer also recommends upsizing the pipe since drainage has been diverted to this pipe. Supporting documentation submitted by the District Engineer has been forward to DMP. The internal inspection of the pipe has been uploaded to database. (O. Magana – DWR UCIP)10/30/2018 Same as last inspection. Pipe wall has corroded significantly (pipe wall missing) at the outlet. Spoke with Tom Engler (MBK Engineers), District Engineer, and he mentioned that a video inspection has been completed at this site and that a report is in progress. LMA will be seeking funding for pipe repair under DWR's Deferred Maintenance Project (DMP). Crossing remains Urgent due to the deteriorated condition of the pipe. (O. Magana - DWR UCIP)(O. Magana - DWR UCIP)06/30/2016 Corrosion still present on WS end. Inlet box was replaced 5 years ago and appears to be functioning properly due to the presence of a screen that prevents debris blockage. Flap gate functions properly only sometimes. WS heavily vegetated. (K. Fazel - UCIP) 03/25/2013 Corrosion holes on WS toe and flap gate is blocked by debris. Flap gate broken. Inlet partially blocked at concrete inlet. (G. Wylie - FPIIB)

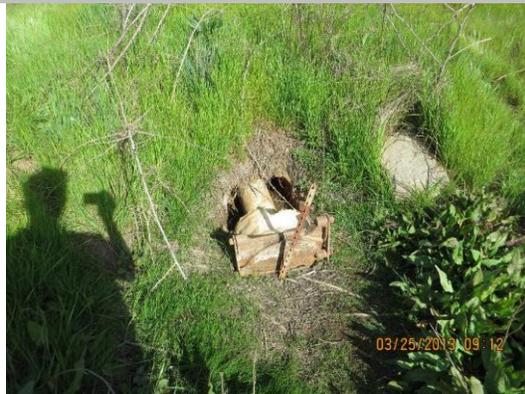
Photo 2 of 3 : UCIP_FA_2019_54266_53856.jpg

Pipe cut behind flap gate on WS toe with 8-inch PVC.

DS_ID:22952
 FS_ID:54266
 EP_NO: N/A
 Repair Type: Urgent
 Crossing Status: Found
 UCIP Comments: 07/25/2019 No DMP Internal Inspection Report was completed for this pipe. This pipe is in failed condition without the use of video inspection. The record has been updated to Urgent: Pipe Integrity Issue. Tom Engler, District Engineer, recommends removal of pipe. Supporting documentation submitted by the District Engineer has been forward to DMP. (O. Magana – DWR UCIP)10/30/2018 Same as last inspection. Pipe has deteriorated significantly and is no longer used as noted in the 2016 inspection. Spoke with Tom Engler with MBK, District Engineer, and he mentioned that a video inspection has been completed and that a report is in progress. LMA will be seeking funding to address pipe under DWR's Deferred Maintenance Project (DMP). Crossing remains Urgent due to the deteriorated condition of the pipe. (O. Magana - DWR UCIP)06/30/2016 Same as last inspection. Good candidate for removal via DWR's Deferred Maintenance Program. Pipe used to drain pastureland which have since been converted to rice fields that drain on opposite side of fields, rendering the drainage function of this pipe obsolete. This pipe is not needed and causes nuisance flooding at high water on landside (LS) per Tom Engler of MBK. As such, operation of flapgate is still blocked via a post at WS end. Pipe is sleeved but sleeve has grossly deteriorated. LS end of pipe appears bent. (K. Fazel - UCIP)03/25/2013 Pipe heavily corroded and damaged. 8-inch PVC pipe runs through pipe/possibly for irrigation. CMP heavily rusted on WS toe and debris blocking flap gate on WS toe. (G. Wylie - FPIIB) FIELD_STRUCT_DESC: *ABANDONED* 20-inch corrugated metal gravity drainage pipe through the levee, 16.5 feet below the crown. 8-inch polyvinyl chloride (PVC) pipe sleeved through the 20-inch corrugated metal pipe with the annular space left void. Flap gate on the waterside (WS) end. (Due to a recent change in the levee alignment, this pipe is no longer in RD0784, Unit 6. Nevertheless, this pipe's original references remain in the RD0784 Levee Log and O&M Manual). [Additional Reference(s): DWR Levee Log, 2005, 24-inch corrugated metal pipe (CMP) referenced. USACE Sacramento O&M Manual 145.1, August 1955, (Station 69+17), 18-inch CMP referenced, As-Built Drawing No. 2-4-106, Sheet 4, (Station 69+17)].

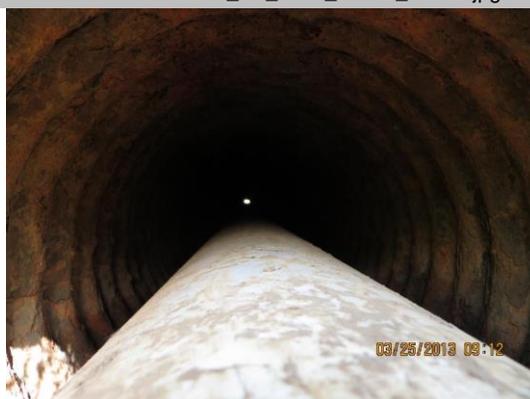
Photo 3 of 3 : UCIP_FA_2019_54266_53855.jpg

DS_ID:22952
 FS_ID:54266
 EP_NO: N/A
 Repair Type: Urgent
 Crossing Status: Found
 UCIP Comments: 07/25/2019 No DMP Internal Inspection Report was completed for this pipe. This pipe is in failed condition without the use of video inspection. The record has been updated to Urgent: Pipe Integrity Issue. Tom Engler, District Engineer, recommends removal of pipe. Supporting documentation submitted by the District Engineer has been forward to DMP. (O. Magana – DWR UCIP)10/30/2018 Same as last inspection. Pipe has deteriorated significantly and is no longer used as noted in the 2016 inspection. Spoke with Tom Engler with MBK, District Engineer, and he mentioned that a video inspection has been completed and that a report is in progress. LMA will be seeking funding to address pipe under DWR's Deferred Maintenance Project (DMP). Crossing remains Urgent due to the deteriorated condition of the pipe. (O. Magana - DWR UCIP)06/30/2016 Same as last inspection. Good candidate for removal via DWR's Deferred Maintenance Program. Pipe used to drain pastureland which have since been converted to rice fields that drain on opposite side of fields, rendering the drainage function of this pipe obsolete. This pipe is not needed and causes nuisance flooding at high water on landside (LS) per Tom Engler of MBK. As such, operation of flapgate is still blocked via a post at WS end. Pipe is sleeved but sleeve has grossly deteriorated. LS end of pipe appears bent. (K. Fazel - UCIP)03/25/2013 Pipe heavily corroded and damaged. 8-inch PVC pipe runs through pipe/possibly for irrigation. CMP heavily rusted on WS toe and debris blocking flap gate on WS toe. (G. Wylie - FPIIB) FIELD_STRUCT_DESC: *ABANDONED* 20-inch corrugated metal gravity drainage pipe through the levee, 16.5 feet below the crown. 8-inch polyvinyl chloride (PVC) pipe sleeved through the 20-inch corrugated metal pipe with the annular space left void. Flap gate on the waterside (WS) end. (Due to a recent change in the levee alignment, this pipe is no longer in RD0784, Unit 6. Nevertheless, this pipe's original references remain in the RD0784 Levee Log and O&M Manual). [Additional Reference(s): DWR Levee Log, 2005, 24-inch corrugated metal pipe (CMP) referenced. USACE Sacramento O&M Manual 145.1, August 1955, (Station 69+17), 18-inch CMP referenced, As-Built Drawing No. 2-4-106, Sheet 4, (Station 69+17)].

Pipe heavily corroded throughout.
