**Flood Control Project Maintenance
Levee Inspections**

Fall 2019 Levee Maintenance Deficiency Summary Report

Sacramento River Basin

Reclamation District No. 0900 West Sacramento

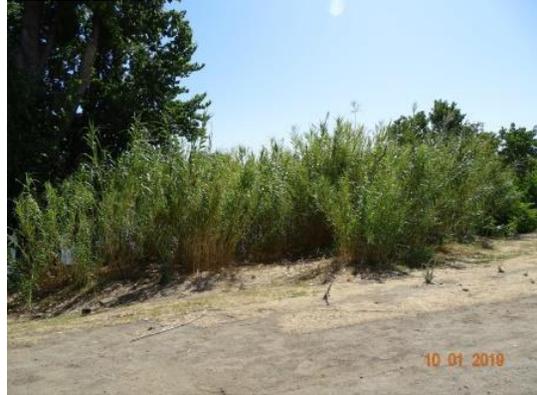
Photo 1 of 1 : FA_2019_RD0900_230_26_20191007_00018.jpg

View of Arundo growth on waterside berm. Fall 2019

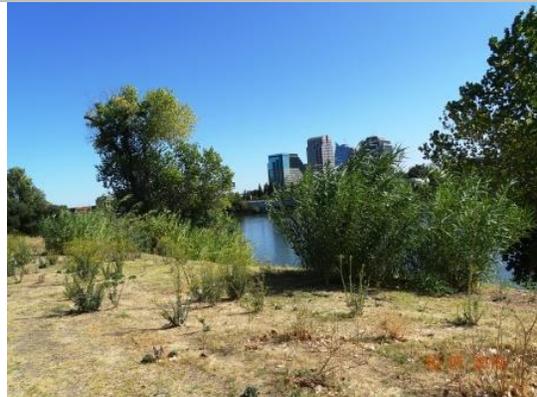
Photo 1 of 1 : FA_2019_RD0900_230_25_20191007_00017.jpg

LM Start	0.32	Rating **	M	Issue No.	25
LM End	0.32	Issue Type +	Ma	Location *	WS
Category	Earthen Levee			GPS Latitude/Longitude	
				Start	End
Item	Vegetation			38.576723°	38.576723°
				-121.511923°	-121.511923°
DWR ID	DWR_RD0900_01_f_2019_25				
Comment Code					
V2 : Remove the wild growth other than native grasses from the levee slopes.					
Inspector Comment					
Remove Arundo growth on the waterside slope.

View of Arundo on waterside berm. Fall 2019

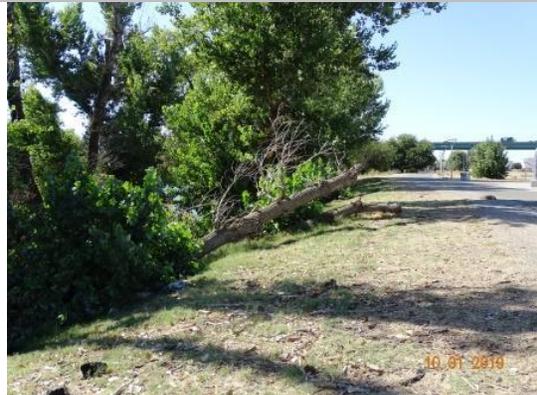
Photo 1 of 2 : FA_2019_RD0900_230_24_20191007_00015.jpg

LM Start	0.50	Rating **	M	Issue No.	24
LM End	0.50	Issue Type +	Ma	Location *	WS
Category	Earthen Levee			GPS Latitude/Longitude	
				Start	End
Item	Encroachments			38.574718°	38.574718°
				-121.514023°	-121.514023°
DWR ID	DWR_RD0900_01_f_2019_24				
Comment Code					
TR : Tree or limb					
Inspector Comment					
Remove a large tree on the waterside slope.

View of large tree debris on waterside slope. Fall 2019

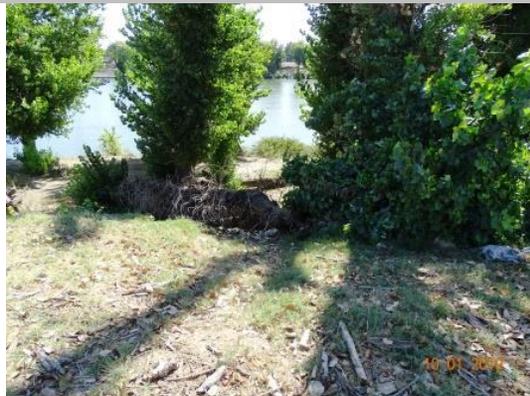
Photo 2 of 2 : FA_2019_RD0900_230_24_20191007_00016.jpg

View of large tree debris on waterside slope. Fall 2019

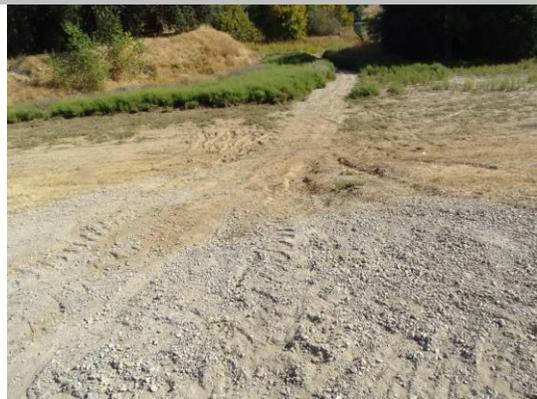
Photo 1 of 1 : FA_2019_RD0900_230_36_20190904_00005.jpg

LM Start	2.05	Rating **	A/W	Issue No.	36
LM End	2.05	Issue Type +	Ma	Location *	WS
Category	Earthen Levee			GPS Latitude/Longitude	
				Start	End
Item	Slope Stability			38.557865°	38.557865°
				-121.518175°	-121.518175°
DWR ID	DWR_RD0900_01_s_2018_36				
Comment Code					
S3 : Repair the levee slope damaged by vehicle traffic and prevent access where possible.					
Inspector Comment					
The LMA repaired slope damage, but vehicles continue to access river.

View of slope damage from vehicular traffic. Fall 2018

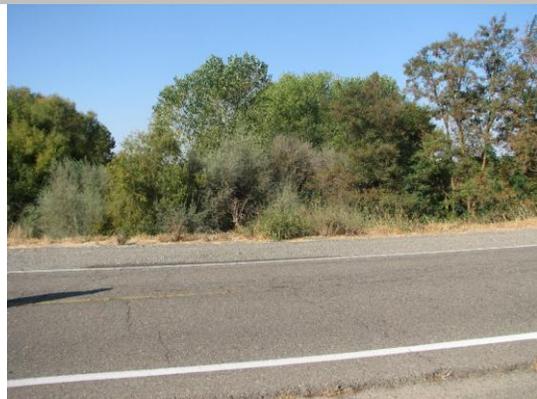
Photo 1 of 3 : UCIP_FA_2019_37665_68376.jpg

LM Start	2.15	Rating **	M	Issue No.	72
LM End	2.15	Issue Type +	En	Location *	
Category	Supplemental			GPS Latitude/Longitude	
				Start	End
Item	DRAFT DWR UCIP Field Study			38.556994°	38.556994°
				-121.516843°	-121.516843°
DWR ID	17772				
Comment Code					
Inspector Comment					
DS_ID:17772 FS_ID:37665 EP_NO: N/A Repair Type: Non-Urgent Crossing Status: Found UCIP Comments: Dense vegetation limits the inspector's visibility to identify signs of pipe failure (leaks) along the slope. Recommend removing vegetation along pipe alignment to conduct proper inspection of structure and appurtenances. FIELD_STRUCT_DESC: 42-inch drainage pipe of unknown material through the levee, 21.5 feet below the levee crown. Slide gate in concrete riser on the waterside (WS) slope. Flap gate on the WS end. [Additional Reference(s): DWR Levee Log, 2003] FS Date: 10/6/2009

View of levee crown at crossing.

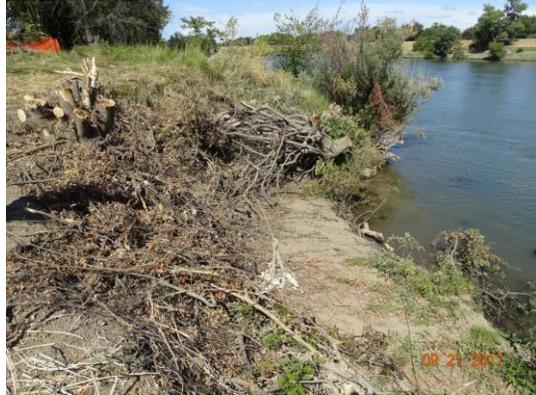
Photo 2 of 2 : FA_2019_RD0900_230_57_20190904_00007.jpg

LM Start	2.57	Rating **	A/W	Issue No.	57 (cont)
LM End	2.57	Issue Type +	Ob	Location *	WS
Category	Earthen Levee			GPS Latitude/Longitude	
				Start	End
Item	Erosion / Bank Caving			38.550965 °	38.550965 °
				-121.514795 °	-121.514795 °
DWR ID	DWR_RD0900_01_f_2017_57				
Comment Code					
E1 : Note and monitor erosion site.					
Inspector Comment					
The contractor (AECOM) is constructing the setback levee, and they cut down the trees in this area. Levee is repaired.

The contractor is planning on placing riprap in this area. This picture was taken from the waterside berm of the levee looking upstream. Fall 2017

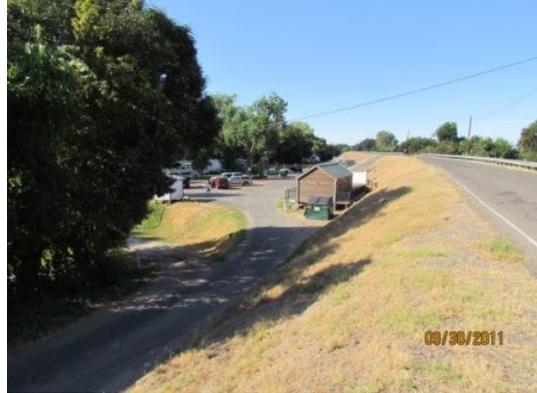
Photo 1 of 1 : FA_2019_RD0900_230_20_20190904_00003.jpg

LM Start	4.26	Rating **	A/W	Issue No.	20
LM End	4.26	Issue Type +	En	Location *	WS
Category	Earthen Levee		GPS Latitude/Longitude		
			Start	End	
Item	Encroachments		38.533274 °	38.533274 °	
			-121.528628 °	-121.528628 °	
DWR ID	DWR_RD0900_01_s_2012_20				
Comment Code					
BU : Building					
Inspector Comment					
Miscellaneous unpermitted encroachments at the Sherwood Harbor are located on the degraded levee.

View of Sherwood harbor's unpermitted properties on the waterside of the levee. The picture was taken from the crown looking upstream. Fall 2011

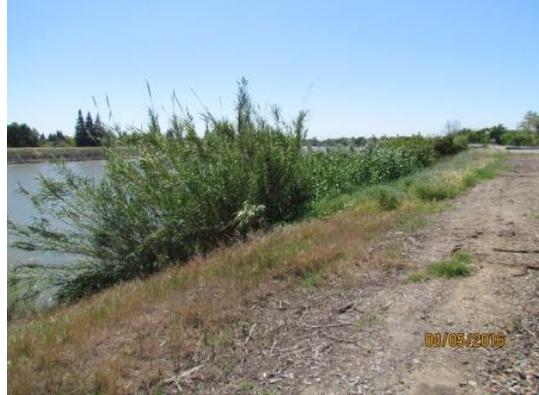
Photo 1 of 2 : FA_2019_RD0900_230_15_20190904_00001.jpg

Picture of the arundo on the waterside of the levee during spring 2016 inspection.

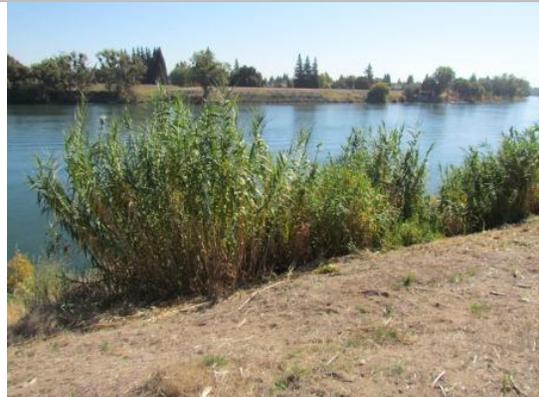
Photo 2 of 2 : FA_2019_RD0900_230_15_20190904_00002.jpg

LM Start	7.78	Rating **	M	Issue No.	15 (cont)
LM End	7.78	Issue Type +	Ma	Location *	WS

View of arundo on the waterside of the levee looking downstream.

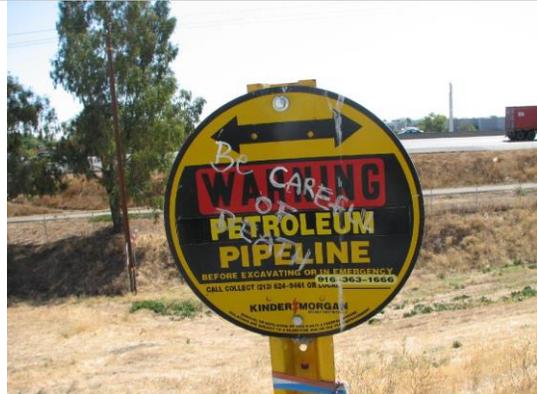
Photo 2 of 3 : UCIP_FA_2019_41825_72724.jpg

Marker of petroleum pipeline unable to confirm permit--there are 3 gas line in desk study records for gas line but none for Kinder Morgan.

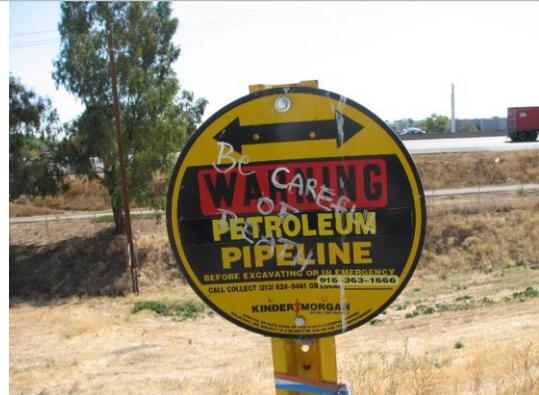
Photo 2 of 3 : UCIP_FA_2019_41826_72721.jpg

Marker of petroleum pipeline unable to confirm permit--there are 3 gas line in desk study records for gas line but none for Kinder Morgan.

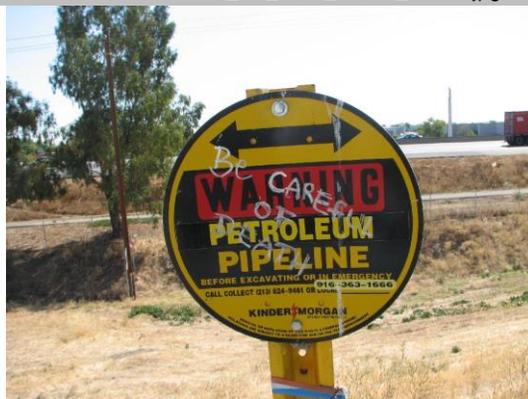
Photo 2 of 3 : UCIP_FA_2019_41824_72727.jpg

Marker of petroleum pipeline unable to confirm permit--there are 3 gas line in desk study records for gas line but none for Kinder Morgan.

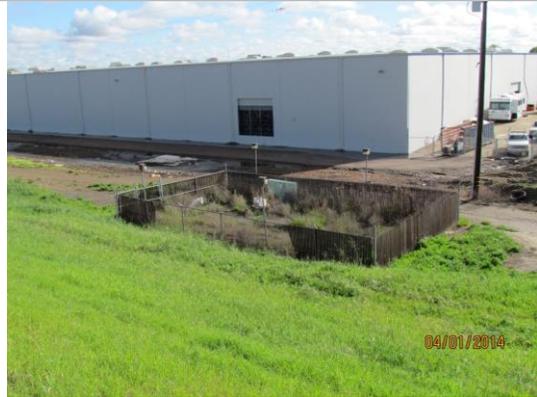
Photo 1 of 1 : FA_2019_RD0900_231_5_20190904_00001.jpg

View of the water well on the landside toe of the levee looking upstream. Spring 2014

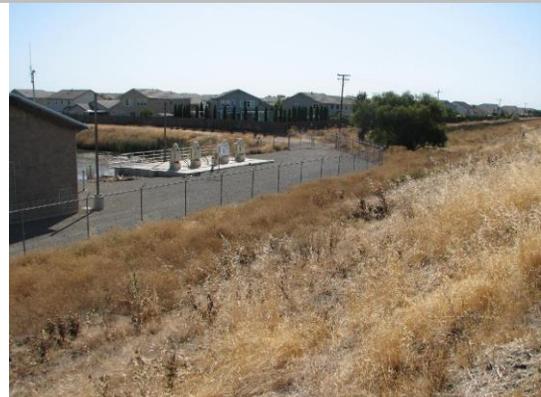
Photo 2 of 3 : UCIP_FA_2019_37770_68625.jpg

Pump station located on waterward side.

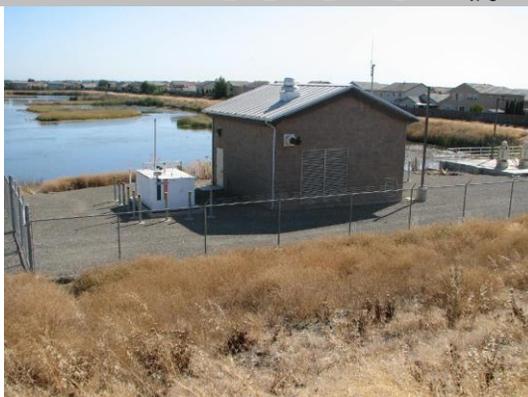
Photo 3 of 3 : UCIP_FA_2019_37778_68648.jpg

House structure located on landward side.

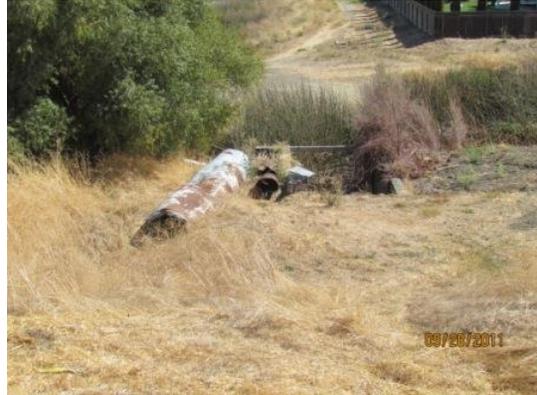
Photo 1 of 1 : FA_2019_RD0900_231_15_20190904_00002.jpg

Abandoned pipes and debris were found on the landside of the levee looking upstream. Fall 2011

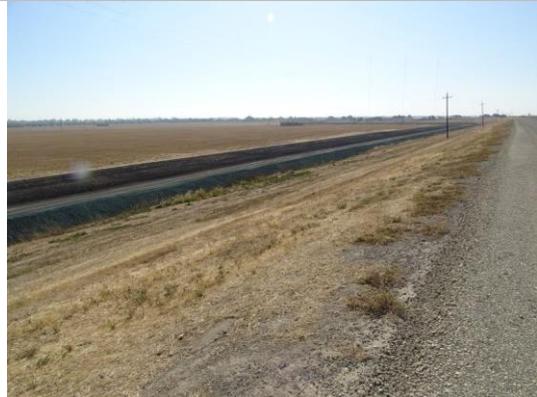
Photo 1 of 8 : FA_2019_RD0900_231_40_20190904_00004.jpg

LM Start	3.26	Rating **	A/W	Issue No.	40
LM End	5.47	Issue Type +	Ma	Location *	
Category	Supplemental		GPS Latitude/Longitude		
			Start	End	
Item	2017 Storm Damage		38.540928 °	38.508969 °	
			-121.581936 °	-121.581681 °	
DWR ID	RD 900-01

View of repaired slope instability site. Fall 2018

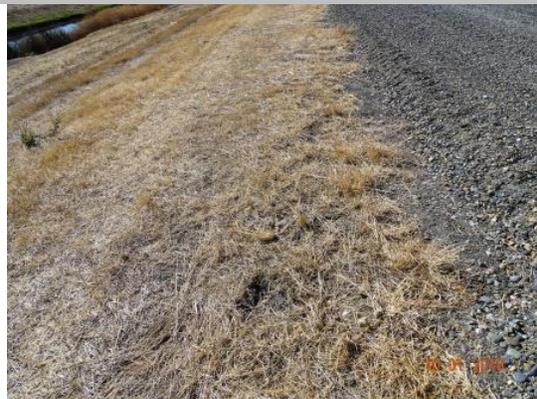
Photo 1 of 1 : FA_2019_RD0900_231_44_20191007_00056.jpg

View of small desiccation cracks along landside shoulder. Fall 2019

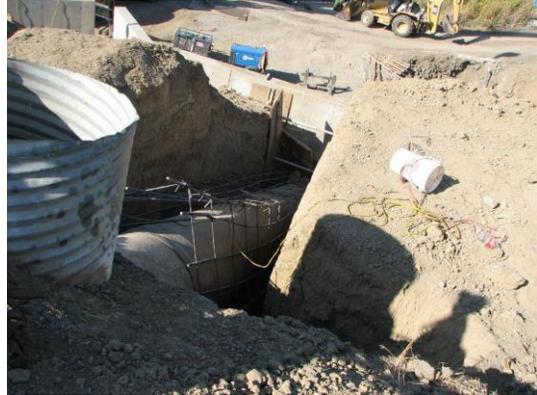
Photo 3 of 3 : UCIP_FA_2019_37894_68951.jpg

Construction of structures in Oct-2009, photo 3 of 3.

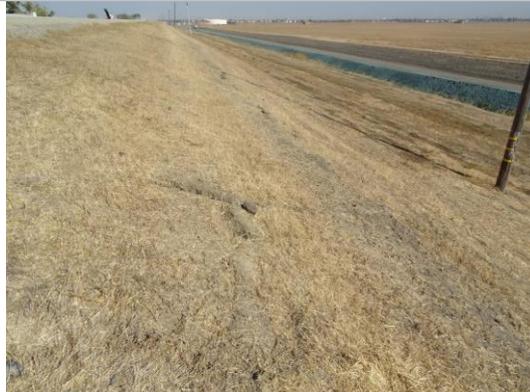
Photo 1 of 1 : FA_2019_RD0900_231_27_20190904_00003.jpg

View of desiccation cracks on levee. Fall 2018
