**Flood Control Project Maintenance  
Levee Inspections**  
**LMA District Cover Sheet**  
**Spring 2020 Levee Inspection Results**

**Reclamation District No. 0900 West Sacramento**

**Spring 2020 Levee Inspection Results**

Waterway	Bank	Unit Miles
Unit No. 01 Sacramento River	Right	7.70

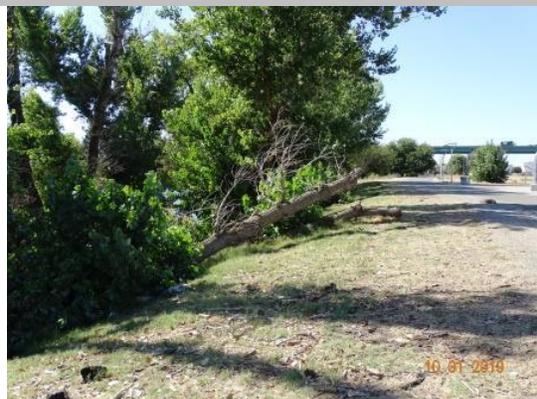
Photo 1 of 1 : SP\_2020\_RD0900\_230\_24\_20200302\_00004.jpg

LM Start	<b>0.50</b>	Rating **	M	Issue No.	<b>24</b>
LM End	<b>0.50</b>	Issue Type +	Ma	Location *	WS
Category	Earthen Levee		GPS Latitude/Longitude		
			Start	End	
Item	Encroachments		38.574718 °	38.574718 °	
			-121.514023 °	-121.514023 °	
DWR ID	DWR_RD0900_01_f_2019_24				
Comment Code					
TR : Tree or limb					
Inspector Comment					
Remove a large tree on the waterside slope.

View of large tree debris on waterside slope. Fall 2019

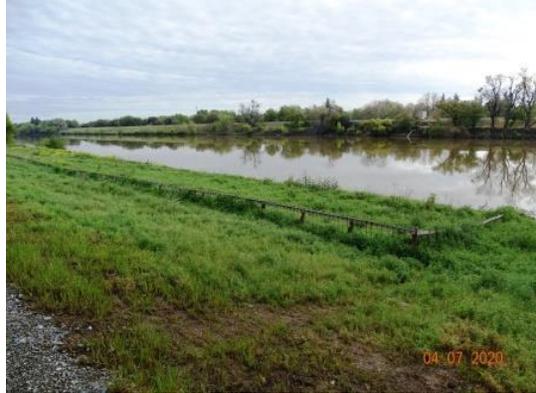
Photo 1 of 1 : SP\_2020\_RD0900\_230\_32\_20200407\_00019.jpg

LM Start	<b>2.55</b>	Rating **	A/W	Issue No.	<b>32</b>
LM End	<b>2.63</b>	Issue Type +	Ob	Location *	WS
Category	Earthen Levee		GPS Latitude/Longitude		
			Start	End	
Item	Vegetation		38.551280 °	38.550092 °	
			-121.514907 °	-121.514520 °	
DWR ID	DWR_RD0900_01_s_2019_32				
Comment Code					
V8 : Environmental Requirements.					
Inspector Comment					
The wooden fence with wire mesh delineates a former erosion site with environmental requirements.

View of a wooden barricade around a former erosion site to delineate an area with environmental requirements. Spring 2020

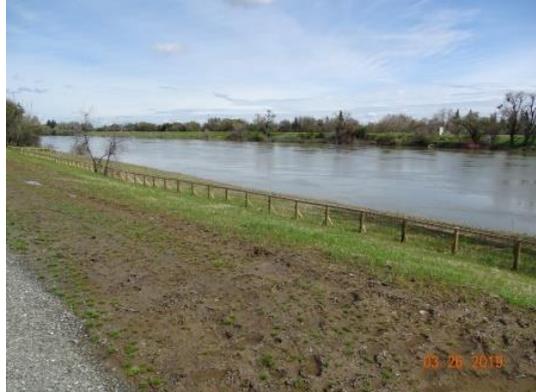
Photo 1 of 1 : SP\_2020\_RD0900\_230\_28\_20200302\_00008.jpg

LM Start	<b>2.55</b>	Rating **	A/W	Issue No.	<b>28</b>
LM End	<b>2.64</b>	Issue Type +	Ma	Location *	WS
Category	Supplemental		GPS Latitude/Longitude		
			Start	End	
Item	2017 USACE Erosion Survey		38.551319 °	38.550090 °	
			-121.514423 °	-121.513983 °	
DWR ID	DWR_RD0900_01_s_2019_28				
Comment Code					
Inspector Comment					
2017 Site ID: SAC 56.5 R Status: Eroding 2017 Field Notes: Fresh toe erosion. Site History: 1997 - Low berm is contributing to erosion. Old timber pile dikes above water parallel to bank. The upstream mitigation low berm causes a flow separation at the site. 1999 - Some new localized erosion with less than one foot of bank retreat. 2000 - Some new erosion at the upstream end. Fat toe deposits at toe. 2003 - Some new erosion upstream, but have a wide berm. 2011 - Minor new erosion at toe.

View looking upstream at repaired erosion site. Spring 2019

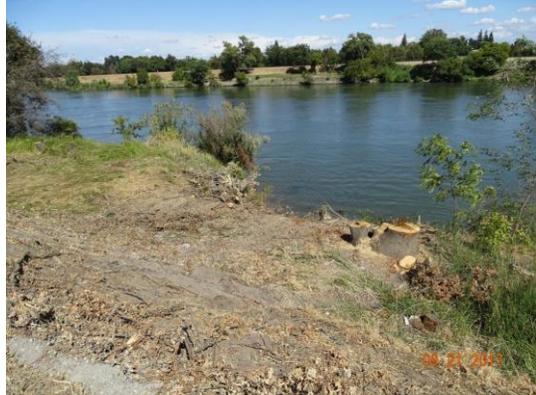
Photo 1 of 1 : SP\_2020\_RD0900\_230\_57\_20200302\_00010.jpg

LM Start	<b>2.57</b>	Rating **	A/W	Issue No.	<b>57</b>
LM End	<b>2.57</b>	Issue Type +	Ob	Location *	WS
Category	Earthen Levee		GPS Latitude/Longitude		
			Start	End	
Item	Erosion / Bank Caving		38.550965 °	38.550965 °	
			-121.514795 °	-121.514795 °	
DWR ID	DWR_RD0900_01_f_2017_57				
Comment Code					
E1 : Note and monitor erosion site.					
Inspector Comment					
The contractor (AECOM) is constructing the setback levee, and they cut down the trees in this area. Levee is repaired.

View of the existing erosion site on the waterside berm of the levee. Fall 2017

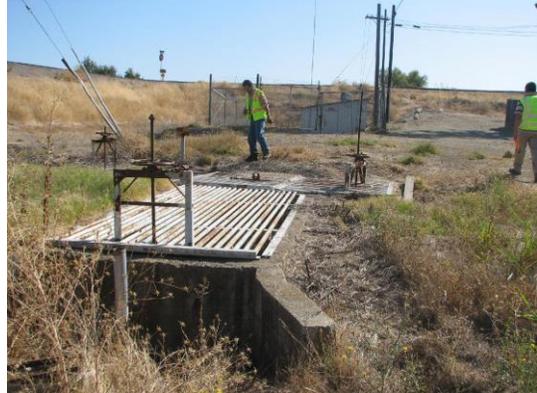
Photo 1 of 3 : UCIP\_SP\_2020\_37668\_68391.jpg

Item	DWR UCIP LMA Responsibility		38.540803 °	38.540803 °	
			-121.514255 °	-121.514255 °	
DWR ID	17769				
Comment Code					
Inspector Comment					
<p>DS_ID:17769                  FS_ID:37668                  EP_NO: N/A                  Repair Type: Non-Urgent                  Crossing Status: Found                  UCIP Comments: 02/26/2018 Pipe is located within the construction limits of the Levee Improvement Project for RD0900, As-built PENDING Project Completion. -- UNDER CONSTRUCTION Levee Improvement Project, construction schedule Summer 2016 to November 2018. Levee improvements address through seepage, underseepage and slope stability and include strengthen-in-place improvements and construction of a setback levee. Reference: [Issued FOR CONSTRUCTION] West Sacramento Area Flood Control Agency Southport Levee Improvement Project Early Implementation Program. Southport Sacramento River Levee: (Stat 3+90 to Station 287+57). Volume 3 (W.O. # 41164) December 2016 Conformed Submittal. HDR Engineering Inc. Folsom, CA – (DWR UCIP – O. Magana) 10/06/2009 Dense vegetation limits the inspector's visibility to identify signs of pipe failure (leaks) along the slope. Recommend removing vegetation along pipe alignment to conduct proper inspection of structure and appurtenances. (DWR UCIP - O. Magana) FIELD_STRUCT_DESC: 24-inch pipe through the levee, 22.0 feet below the crown. Pump house at the landside (LS) toe. Screw gate in LS of the levee. Additional Reference(s): USACE Sacramento O&amp;M Manual Unit No. 116, August 1955, revised 2011, (USGS River Mile [RM] 55.65), As-built drawing# 6-13-1100 page 3, January 1933] FS Date: 10/6/2009</p>

View of concrete structure located on landward side.

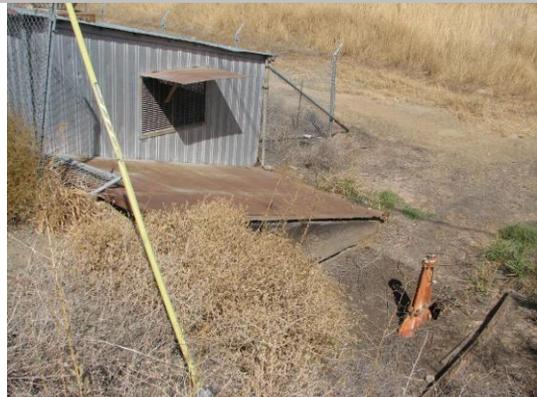
Photo 2 of 3 : UCIP\_SP\_2020\_37668\_68390.jpg

Pump house located on landward side.

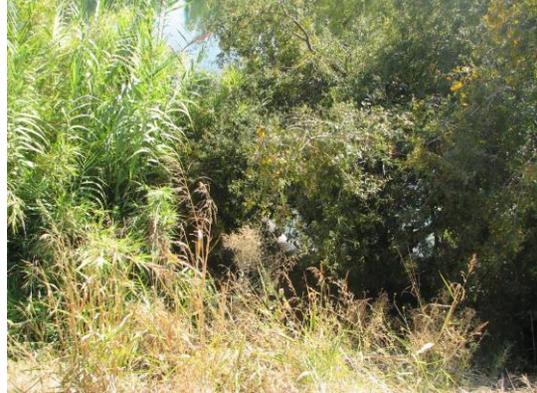
Photo 3 of 3 : UCIP\_SP\_2020\_37668\_68389.jpg

Pipe visible on waterward side visible through dense vegetation.

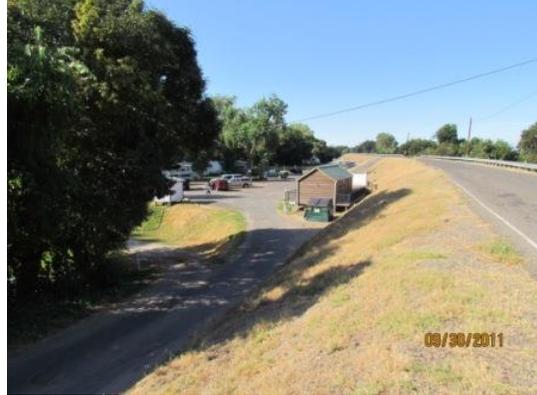
Photo 1 of 1 : SP\_2020\_RD0900\_230\_20\_20200302\_00003.jpg

LM Start	<b>4.26</b>	Rating **	A/W	Issue No.	<b>20</b>
LM End	<b>4.26</b>	Issue Type +	En	Location *	WS
Category	Earthen Levee			GPS Latitude/Longitude	
				Start	End
Item	Encroachments			38.533274 °	38.533274 °
				-121.528628 °	-121.528628 °
DWR ID	DWR_RD0900_01_s_2012_20				
Comment Code					
BU : Building					
Inspector Comment					
Miscellaneous unpermitted encroachments at the Sherwood Harbor are located on the degraded levee.

View of Sherwood harbor's unpermitted properties on the waterside of the levee. The picture was taken from the crown looking upstream. Fall 2011

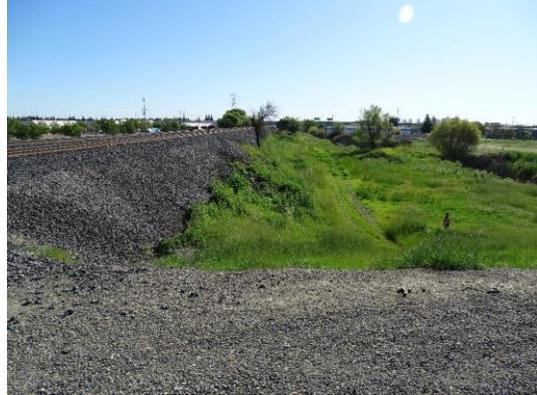
Photo 3 of 3 : UCIP\_SP\_2020\_56722\_84035.jpg

Land-Side: view of LS slope

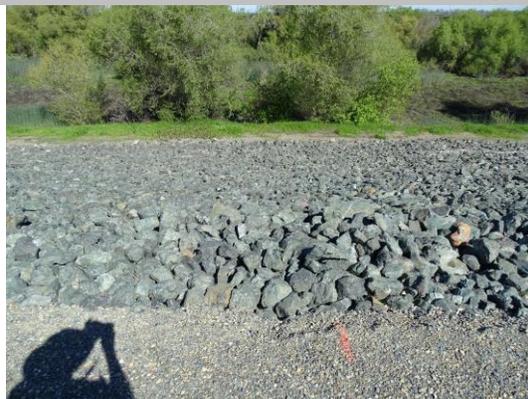
Photo 1 of 3 : UCIP\_SP\_2020\_56730\_83988.jpg

Item	DWR UCIP Field Study		38.574064 °	38.574064 °	
			-121.581406 °	-121.581406 °	
DWR ID	17862				
Comment Code					
Inspector Comment					
DS_ID:17862 FS_ID:56730 EP_NO: 2444 Repair Type: Non-Urgent Crossing Status: Indicator Found UCIP Comments: 04/14/2020 Record remains Non-Urgent. No inspection records were available to determine status of line through the levee. (D.Sanoski - DWR UCIP) 10/05/2009 Records show 3 gas lines in general area--unable to confirm alignment and status of crossing. Markers visible in general area are for Kinder Morgan and not the owner listed on permit. Need to contact owner to clarify if crossing is still present and if so determine status of crossing. Need date of last inspection and confirmation that crossing is still in operable condition. FIELD_STRUCT_DESC: 16-inch high pressure steel gas line through the levee, 3.0 feet below the levee crown. (16-inch pipe authorized under Permit No. 2444, 1956 - Pacific Gas and Electric Company [PG&E]). [Additional Reference(s): DWR Levee Log, 2003 (HLM 0.95)]. FS Date: 4/14/2020 10:10:00 AM

Water-Side: view of revetted WS slope

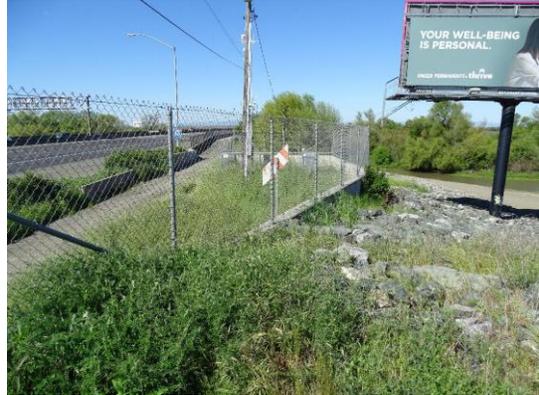
Photo 1 of 2 : UCIP\_SP\_2020\_56725\_84069.jpg

LM Start	<b>0.98</b>	Rating **	M	Issue No.	<b>56</b>
LM End	<b>0.98</b>	Issue Type +	En	Location *	
Category	Supplemental		GPS Latitude/Longitude		
			Start	End	
Item	DWR UCIP Field Study		38.573868 °	38.573868 °	
			-121.581800 °	-121.581800 °	
DWR ID	25603				
Comment Code					
Inspector Comment					
DS_ID:25603 FS_ID:56725 EP_NO: 1447 Repair Type: Non-Urgent Crossing Status: Indicator Found UCIP Comments: 04/14/2020 Record remains Non-Urgent. No inspection records were available to determine status of line through the levee. (D.Sanoski - DWR UCIP) FIELD_STRUCT_DESC: 12-3/4 inch O.D. gas main across the Yolo Bypass and the east levee immediately north of State Highway 80 at a minimum cover of three feet below the levee crown. (12-3/4 inch O.D. gas main authorized under Permit No. 1447, 1949 - Pacific Gas & Electric [PG&E]). FS Date: 4/14/2020

Top of Levee: view of Highway 80 and gas line marker

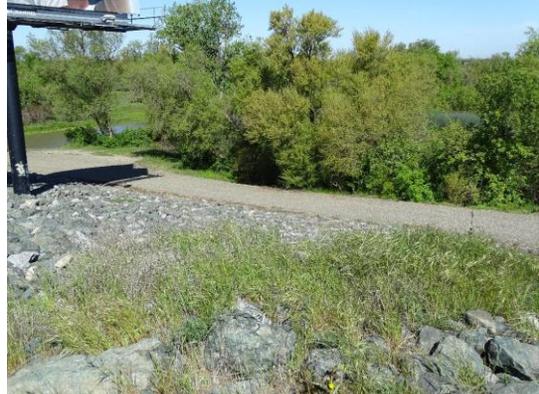
Photo 2 of 2 : UCIP\_SP\_2020\_56725\_84070.jpg

Water-Side: view of revetted WS slope

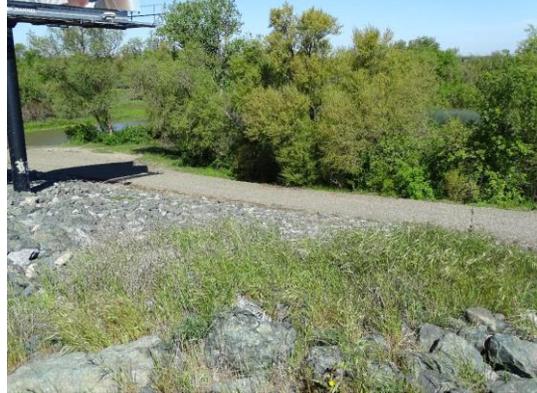
Photo 1 of 2 : UCIP\_SP\_2020\_56724\_84067.jpg

LM Start	<b>0.98</b>	Rating **	M	Issue No.	<b>57</b>
LM End	<b>0.98</b>	Issue Type +	En	Location *	
Category	Supplemental		GPS Latitude/Longitude		
			Start	End	
Item	DWR UCIP Field Study		38.573868 °	38.573868 °	
			-121.581800 °	-121.581800 °	
DWR ID	25602				
Comment Code					
Inspector Comment					
DS_ID:25602 FS_ID:56724 EP_NO: 570 Repair Type: Non-Urgent Crossing Status: Indicator Found UCIP Comments: 04/14/2020 Record remains Non-Urgent. No inspection records were available to determine status of line through the levee. (D.Sanoski - DWR UCIP) FIELD_STRUCT_DESC: 8-inch gas line along the north side of the State Highway along the Yolo Bypass; exact crossing location is unknown and the depth is unknown. (8-inch diameter gas line along north side of Highway 80 authorized under Permit No. 570, 1932 - Pacific Gas & Electric [PG&E]). FS Date: 4/14/2020

Water-Side: revetted WS slope

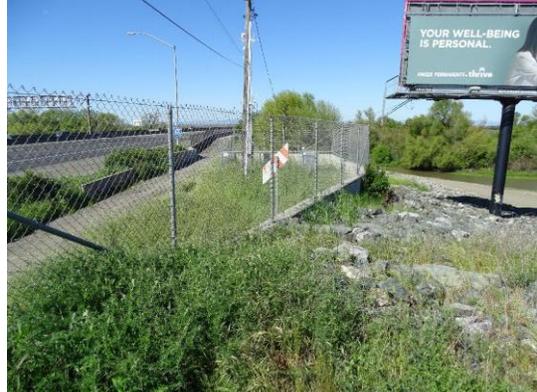
Photo 2 of 2 : UCIP\_SP\_2020\_56724\_84068.jpg

Top of Levee: view of Highway 80 and gas line marker

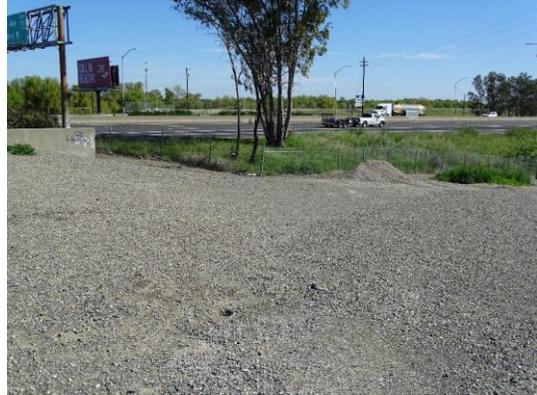
Photo 3 of 3 : UCIP\_SP\_2020\_56639\_83882.jpg

Land-Side: view of gravelled slope

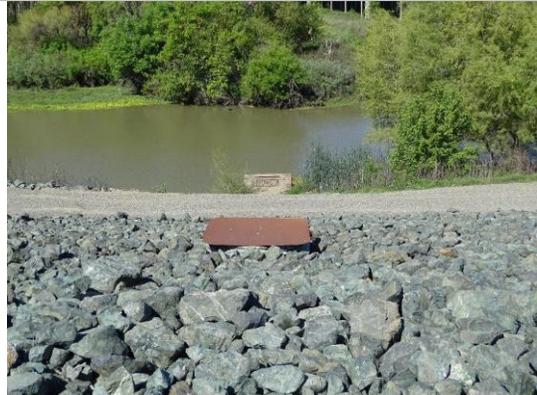
Photo 1 of 3 : UCIP\_SP\_2020\_56862\_83895.jpg

Water-Side: view of revetted WS slope with pipe riser valve box on slope and discharge platform at toe

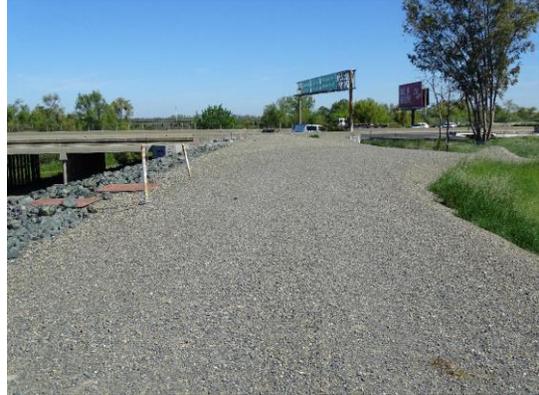
Photo 2 of 3 : UCIP\_SP\_2020\_56862\_83894.jpg

Top of Levee: view of levee crown

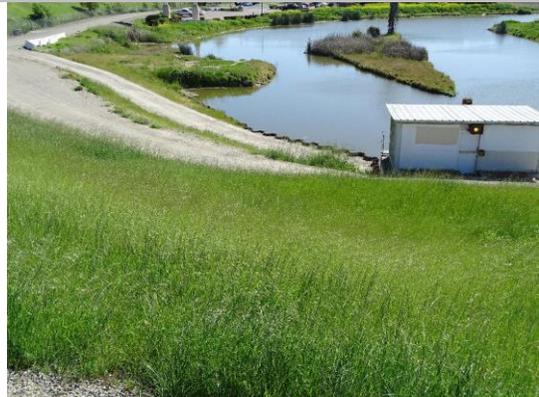
Photo 3 of 3 : UCIP\_SP\_2020\_56862\_83896.jpg

Land-Side: view of LS slope and no sign of pipe

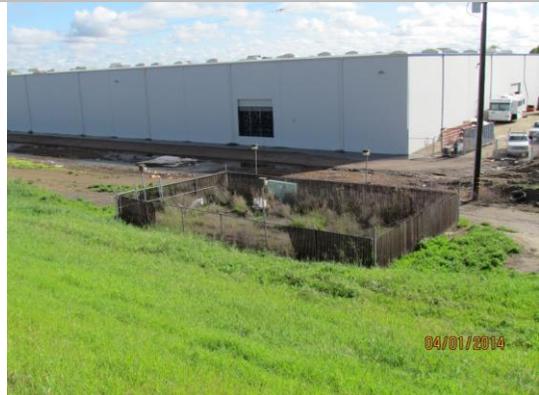
Photo 1 of 1 : SP\_2020\_RD0900\_231\_5\_20200302\_00001.jpg

LM Start	<b>1.31</b>	Rating **	M	Issue No.	<b>5</b>
LM End	<b>1.31</b>	Issue Type +	En	Location *	LS
Category	Earthen Levee			GPS Latitude/Longitude	
				Start	End
Item	Encroachments			38.569258 °	38.569258 °
				-121.582232 °	-121.582232 °
DWR ID	DWR_RD0900_02_s_2012_5				
Comment Code					
BU : Building					
Inspector Comment					
An abandoned city water well exists at the landward toe.

View of the water well on the landside toe of the levee looking upstream. Spring 2014

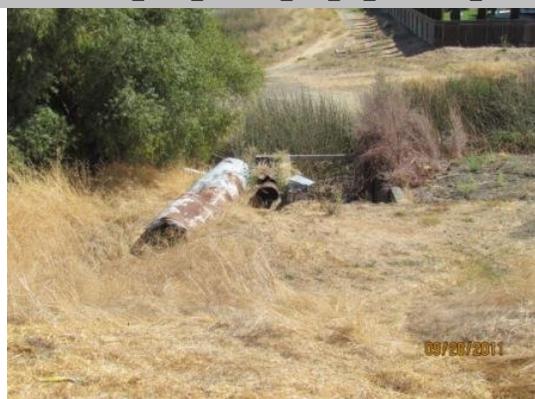
Photo 1 of 1 : SP\_2020\_RD0900\_231\_15\_20200302\_00002.jpg

Abandoned pipes and debris were found on the landside of the levee looking upstream. Fall 2011

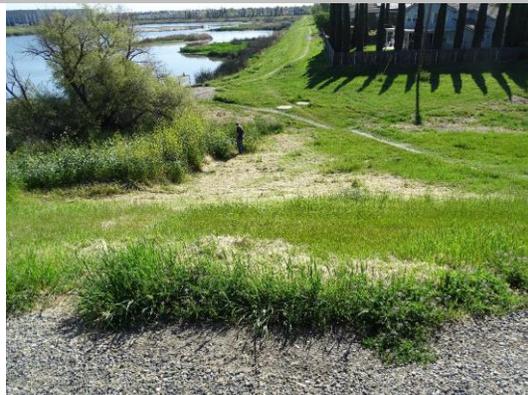
Photo 3 of 3 : UCIP\_SP\_2020\_56684\_83903.jpg

Land-Side: view of LS slope and abandoned concrete intake structure overgrown with vegetation

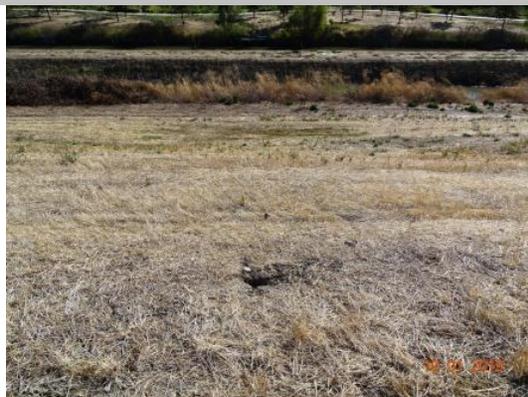
Photo 1 of 1 : SP\_2020\_RD0900\_231\_43\_20200302\_00012.jpg

View of desiccation crack 3" deep and 5' long. Fall 2019

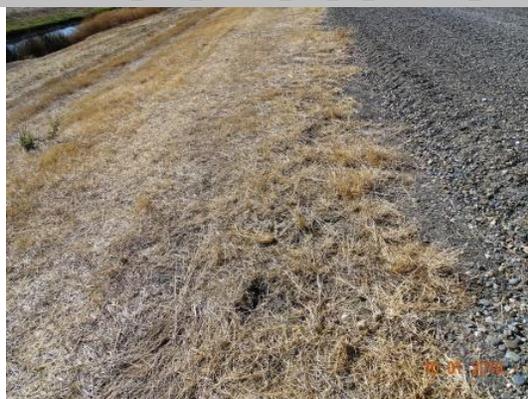
Photo 1 of 1 : SP\_2020\_RD0900\_231\_44\_20200302\_00013.jpg

LM Start	<b>4.46</b>	Rating **	A/W	Issue No.	<b>44</b>
LM End	<b>4.46</b>	Issue Type +	Ma	Location *	LS
Category	Earthen Levee		GPS Latitude/Longitude		
			Start	End	
Item	Cracking		38.523537 °	38.523537 °	
			-121.582130 °	-121.582130 °	
DWR ID	DWR_RD0900_02_f_2019_44				
Comment Code					
CR1 : Monitor and have inspected by geotechnical engineer.					
Inspector Comment					
Monitor small desiccation cracks.

View of small desiccation cracks along landside shoulder. Fall 2019

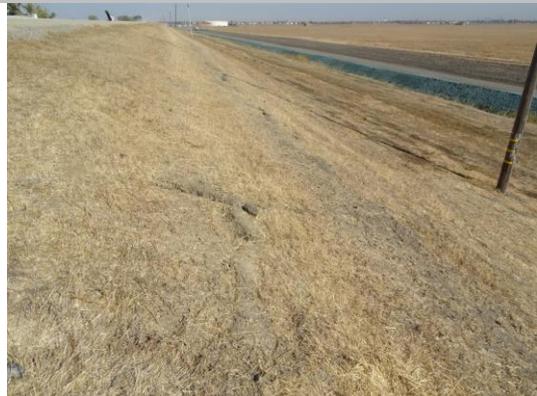
Photo 1 of 1 : SP\_2020\_RD0900\_231\_27\_20200302\_00003.jpg

View of desiccation cracks on levee. Fall 2018

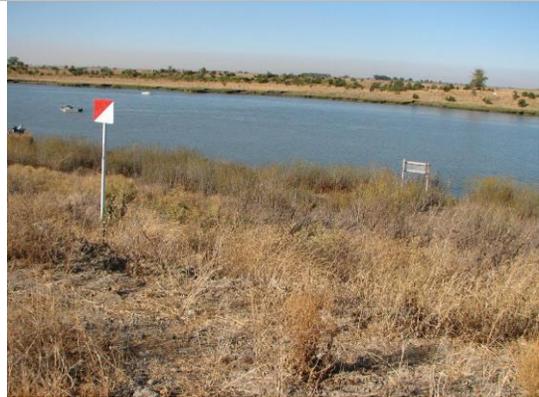
Photo 1 of 3 : UCIP\_SP\_2020\_56873\_68966.jpg

Water-Side: view of marker visible on WS near bank

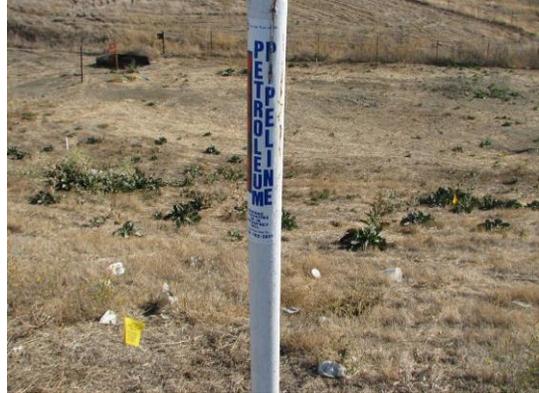
Photo 2 of 3 : UCIP\_SP\_2020\_56873\_68964.jpg

Land-Side: view of Petroleum pipeline labelled on LS slope

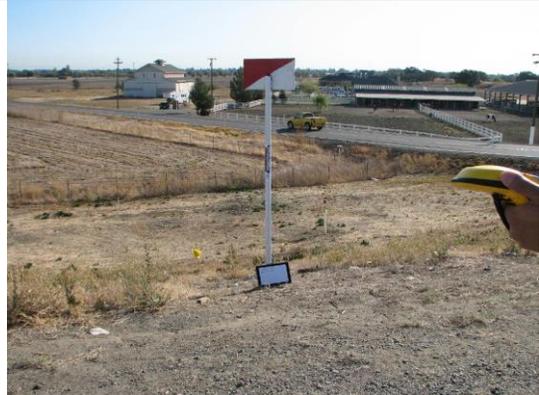
Photo 3 of 3 : UCIP\_SP\_2020\_56873\_68965.jpg

Land-Side: view of marker visible on LS slope
