**Flood Control Project Maintenance
Levee Inspections**

Fall 2019 Levee Maintenance Deficiency Summary Report

**Flood Control Project Maintenance
Levee Inspections**
LMA District Cover Sheet
Fall 2019 Levee Inspection Results

Reclamation District No. 0999 Netherlands

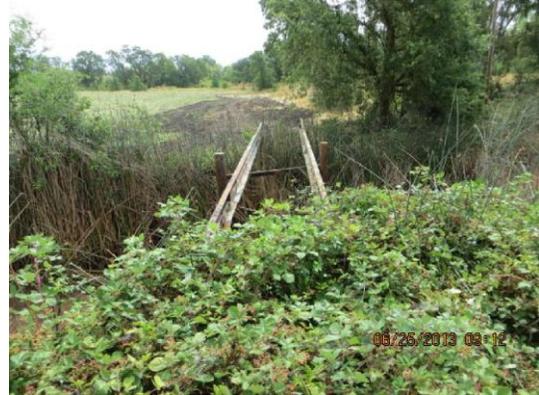
Photo 2 of 3 : UCIP_FA_2019_53368_25190.jpg

Comment Code					
Inspector Comment					
DS_ID:22743 FS_ID:53368 EP_NO: N/A Repair Type: Non-Urgent Crossing Status: Found UCIP Comments: 07/26/2018 Same as last inspection. Pipe open on WS, but no visual signs of pipe or levee integrity issues so downgrading crossing to Non-Urgent (D. Sanoski - DWR UCIP).07/07/2016 Condition largely unchanged from previous inspection. Pipe open on the WS, waterward of the siphon breaker. Dense vegetation and steep slope limited inspection of WS outlet into Ship Channel. (T. Hatch/UCIP) 06/25/2013 Pipe abandoned and open on WS slope. Pipe should be abandoned properly. (W. Wylie/UCIP) FIELD_STRUCT_DESC: *ABANDONED* 30-inch steel drainage pipe through the levee, 6.5 feet below the crown. Pump on a platform in the canal off the landside (LS) toe, not found. Flap gate on the waterside (WS), not found. Siphon breaker and an air vent on the WS shoulder. 1-inch galvanized iron filler pipe visible on the WS shoulder along same alignment. [Additional Reference(s): DWR Levee Log, 1992. USACE Sacramento O&M Manual 113 (Revised), October 1966, (HLM 1.73)]. FS Date: 7/26/2018 10:10:00 AM

Pump platform visible off LS toe, but no appurtances remain.

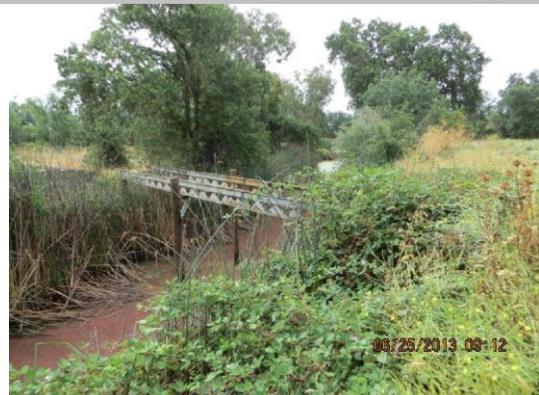
Photo 3 of 3 : UCIP_FA_2019_53368_25189.jpg

Pump platform visible off LS toe, but no appurtances remain.

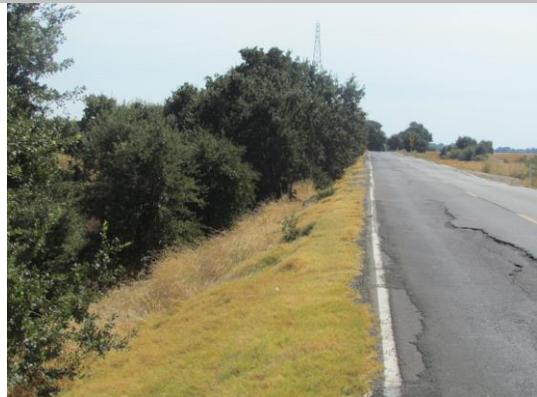
Photo 3 of 3 : FA_2019_RD0999_232_30_20190904_00013.jpg

Looking southeast at dense trees on landward slope. (Fall 2016)

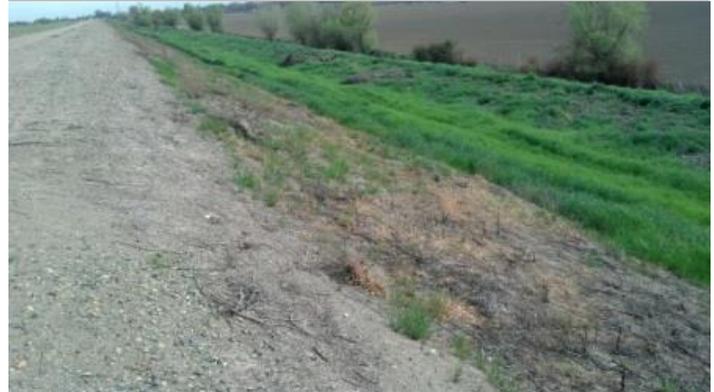
Photo 3 of 3 : FA_2019_RD0999_232_51_20190904_00035.jpg

LM Start	3.22	Rating **	M	Issue No.	51
LM End	3.22	Issue Type +	Ma	Location *	LS
Category	Earthen Levee		GPS Latitude/Longitude		
			Start	End	
Item	Slope Stability		38.459399°	38.459399°	
			-121.587523°	-121.587523°	
DWR ID	DWR_RD0999_01_s_2013_51				
Comment Code					
S1 : Repair slope instability.					
Inspector Comment					
Repair depression on landward shoulder and slope approximately 40' x 20'. Earthen material appears to be sliding toward levee toe.

Looking north at depression on landside shoulder and slope. Spring 2016

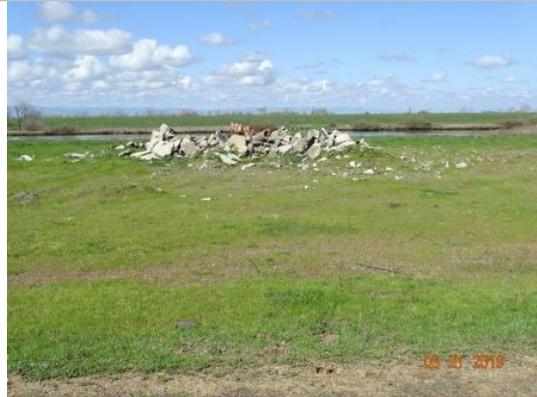
Photo 1 of 1 : FA_2019_RD0999_232_58_20190904_00038.jpg

LM Start	8.15	Rating **	M	Issue No.	58
LM End	8.15	Issue Type +	En	Location *	WS
Category	Earthen Levee		GPS Latitude/Longitude		
			Start	End	
Item	Encroachments		38.392225°	38.392225°	
			-121.618630°	-121.618630°	
DWR ID	DWR_RD0999_01_s_2019_58				
Comment Code					
DE : Debris					
Inspector Comment					
Remove broken concrete and abandoned equipment on the waterside berm.

View of broken concrete and equipment dumped on waterside berm. Spring 2019

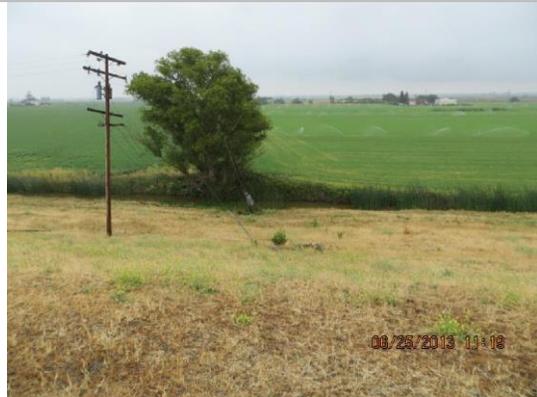
Photo 1 of 3 : UCIP_FA_2019_24413_43357.jpg

LM Start	9.50	Rating **	M	Issue No.	921
LM End	9.50	Issue Type +	En	Location *	
Category	Supplemental			GPS Latitude/Longitude	
				Start	End
Item	DRAFT DWR UCIP Field Study			38.373823°	38.373823°
				-121.627212°	-121.627212°
DWR ID	22750				
Comment Code					
Inspector Comment					
DS_ID:22750 FS_ID:24413 EP_NO: 13300 Repair Type: Non-Urgent Crossing Status: Found UCIP Comments: Pipe abandoned and should be done so properly. FIELD_STRUCT_DESC: 6-inch coated steel irrigation pipe through the levee, 3 feet below the crown. Joint pole (JP) and meter at abandoned pump location on the landside (LS) toe. (Permit No. 13300, 1981 - Eldon M. Studarus). [Additional Reference(s): DWR Levee Log, 1992]. FS Date: 6/25/2013

JP and meter at site of abandoned pump.

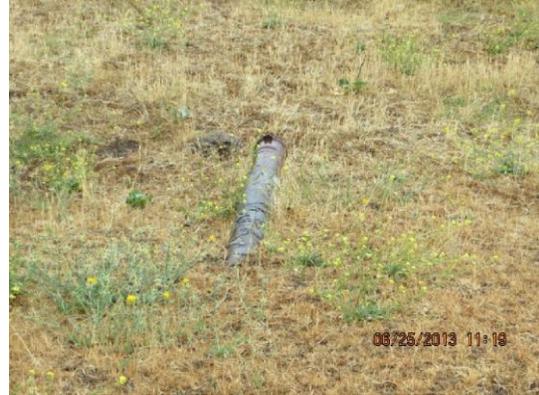
Photo 2 of 3 : UCIP_FA_2019_24413_43356.jpg

Pipe open on WS slope.

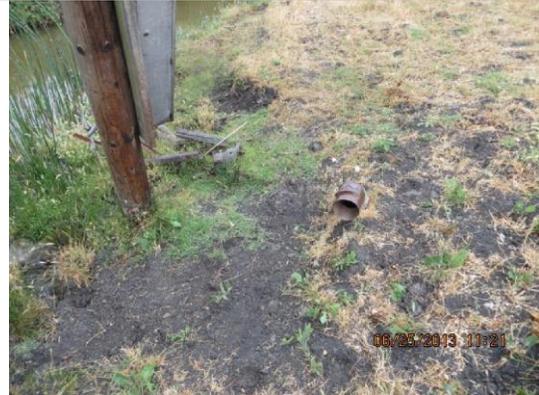
Photo 3 of 3 : UCIP_FA_2019_24413_43355.jpg

JP and meter at site of abandoned pump.

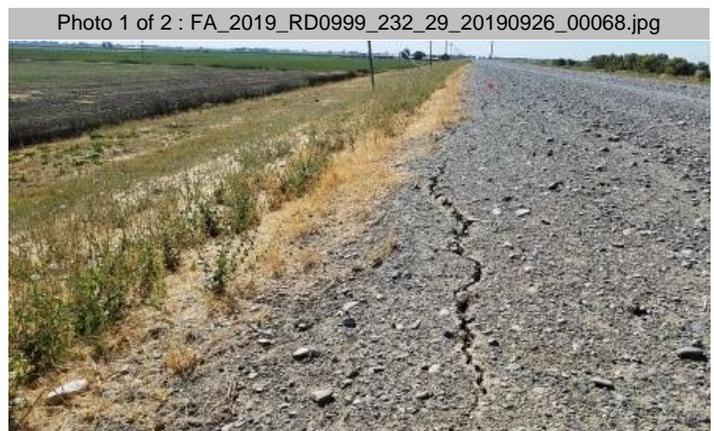
LM Start	13.17	Rating **	A/W	Issue No.	29
LM End	13.19	Issue Type +	Ma	Location *	CR
Category	Earthen Levee		GPS Latitude/Longitude		
			Start	End	
Item	Cracking		38.322938°	38.322690°	
			-121.644940°	-121.644953°	
DWR ID	DWR_RD0999_01_f_2019_29				
Comment Code					
CR1 : Monitor and have inspected by geotechnical engineer.					
Inspector Comment					
Monitor cracks as deep as 4" on the landside shoulder.

View of longitudinal cracks as deep as 4" on the landside shoulder. Fall 2019

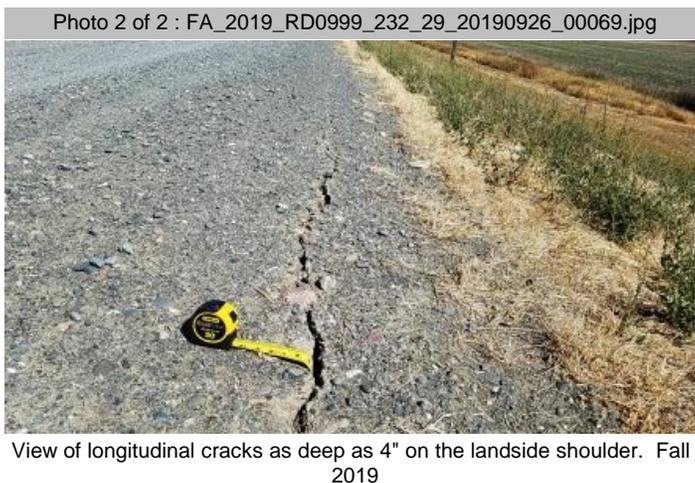
LM Start	13.17	Rating **	A/W	Issue No.	29 (cont)
LM End	13.19	Issue Type +	Ma	Location *	CR
Category	Earthen Levee		GPS Latitude/Longitude		
			Start	End	
Item	Cracking		38.322938°	38.322690°	
			-121.644940°	-121.644953°	
DWR ID	DWR_RD0999_01_f_2019_29				
Comment Code					
CR1 : Monitor and have inspected by geotechnical engineer.					
Inspector Comment					
Monitor cracks as deep as 4" on the landside shoulder.

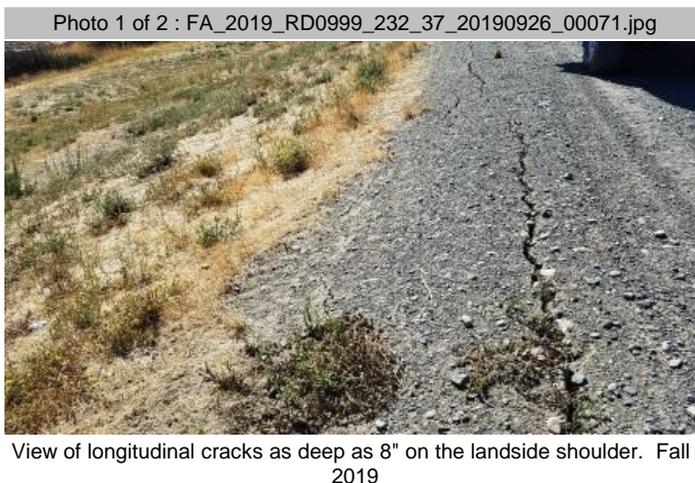
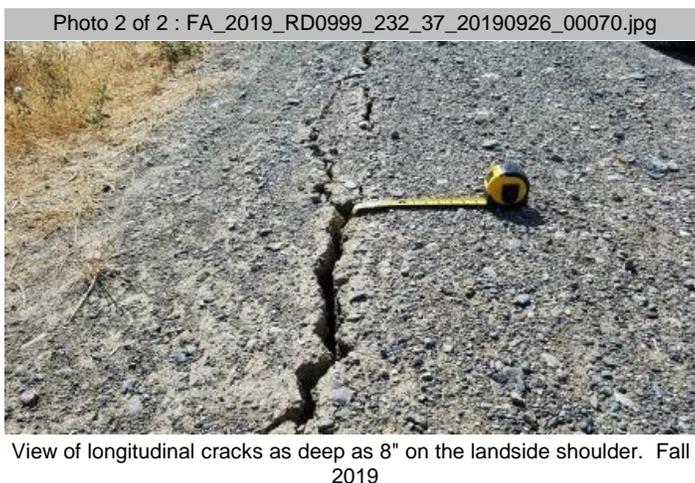
LM Start	13.26	Rating **	A/W	Issue No.	37
LM End	13.27	Issue Type +	Ma	Location *	CR
Category	Earthen Levee		GPS Latitude/Longitude		
			Start	End	
Item	Cracking		38.321620°	38.321490°	
			-121.644968°	-121.644968°	
DWR ID	DWR_RD0999_01_f_2019_37				
Comment Code					
CR1 : Monitor and have inspected by geotechnical engineer.					
Inspector Comment					
Monitor cracks as deep as 8" on the landside shoulder.

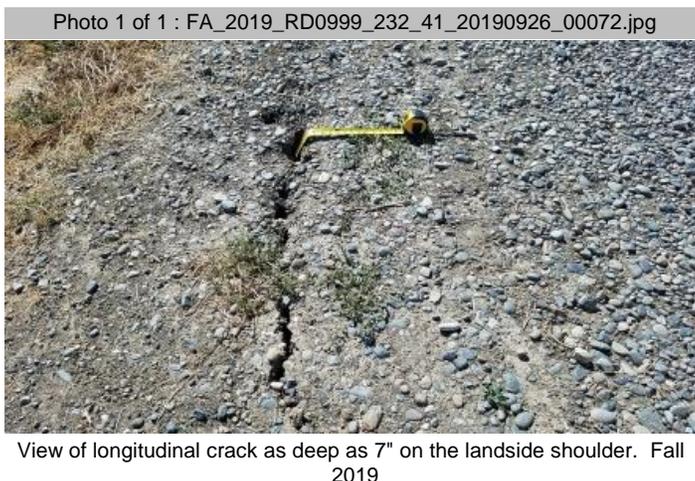
LM Start	14.00	Rating **	A/W	Issue No.	41
LM End	14.00	Issue Type +	Ma	Location *	CR
Category	Earthen Levee			GPS Latitude/Longitude	
				Start	End
Item	Cracking			38.310882°	38.310882°
				-121.644982°	-121.644982°
DWR ID	DWR_RD0999_01_f_2019_41				
Comment Code					
CR1 : Monitor and have inspected by geotechnical engineer.					
Inspector Comment					
Monitor a 5'-long crack as deep as 7" on the landside shoulder.

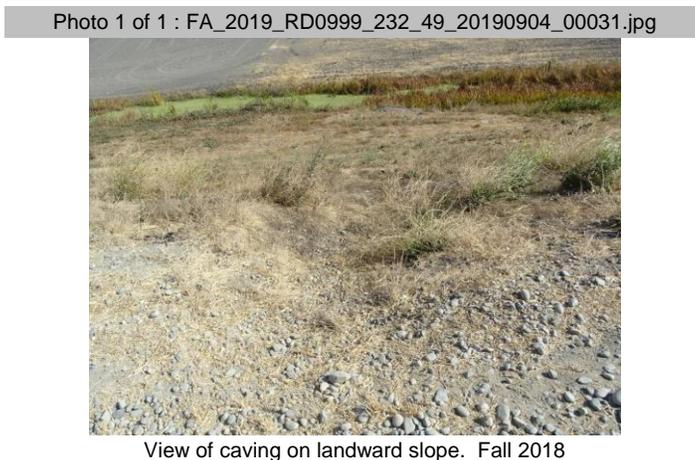
LM Start	14.04	Rating **	M	Issue No.	49
LM End	14.04	Issue Type +	Ma	Location *	LS
Category	Earthen Levee			GPS Latitude/Longitude	
				Start	End
Item	Erosion / Bank Caving			38.310347°	38.310347°
				-121.644955°	-121.644955°
DWR ID	DWR_RD0999_01_f_2012_49				
Comment Code					
E1 : Note and monitor erosion site.					
Inspector Comment					
Repair caving, 4' x 10', on the landside slope.

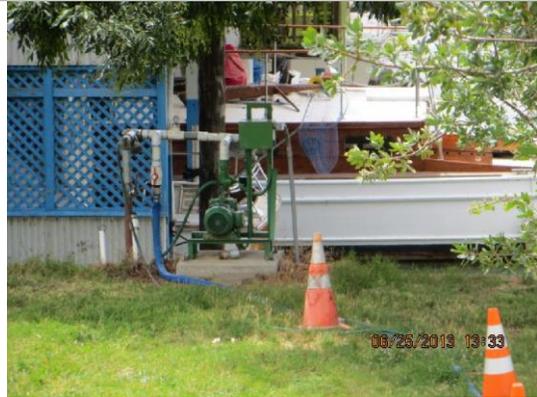
Photo 2 of 3 : UCIP_FA_2019_16330_27511.jpg

Possible pump visible off WS toe at waters edge.

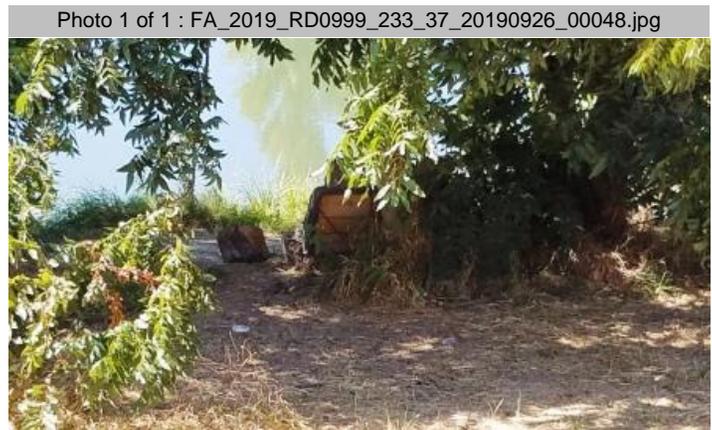
LM Start	2.14	Rating **	M	Issue No.	37
LM End	2.14	Issue Type +	Ma	Location *	WS
Category	Earthen Levee		GPS Latitude/Longitude		
			Start	End	
Item	Encroachments		38.288258°	38.288258°	
			-121.607925°	-121.607925°	
DWR ID	DWR_RD0999_02_s_2019_37				
Comment Code					
DE : Debris					
Inspector Comment					
Remove sofa debris on the waterside slope.

View looking southward at debris on the waterside slope. Fall 2019

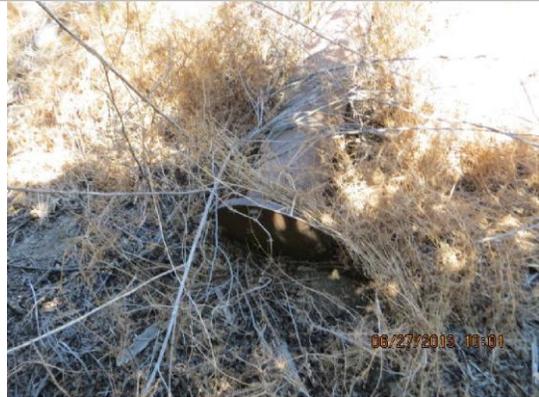
Photo 3 of 3 : UCIP_FA_2019_15389_25252.jpg

Steel plate on WS end of pipe.

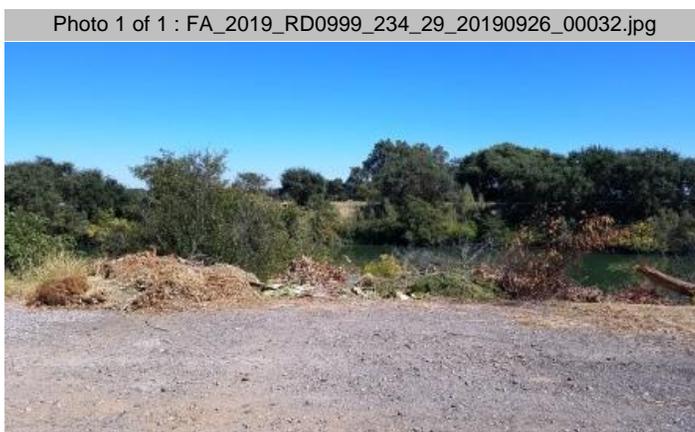
LM Start	1.61	Rating **	M	Issue No.	29
LM End	1.61	Issue Type +	Ma	Location *	WS
Category	Earthen Levee		GPS Latitude/Longitude		
			Start	End	
Item	Encroachments		38.307288°	38.307288°	
			-121.598100°	-121.598100°	
DWR ID	DWR_RD0999_03_s_2019_29				
Comment Code					
DE : Debris					
Inspector Comment					
Remove trash and pruning debris left at the turnout.

View of debris on the waterside turnout. Fall 2019

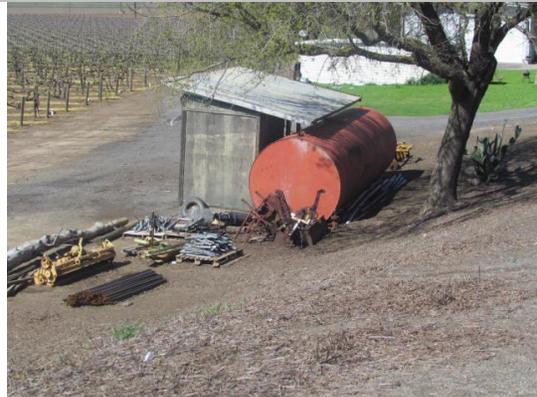
Photo 1 of 3 : FA_2019_RD0999_234_27_20190904_00016.jpg

Looking northwest at diesel tank and other farm equipment stored at landward toe. (Spring 2016)

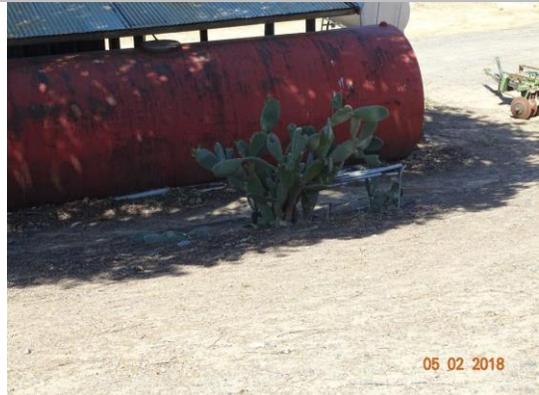
Photo 1 of 1 : FA_2019_RD0999_234_26_20190904_00015.jpg

Vegetation on landside toe looking west. Spring 2018

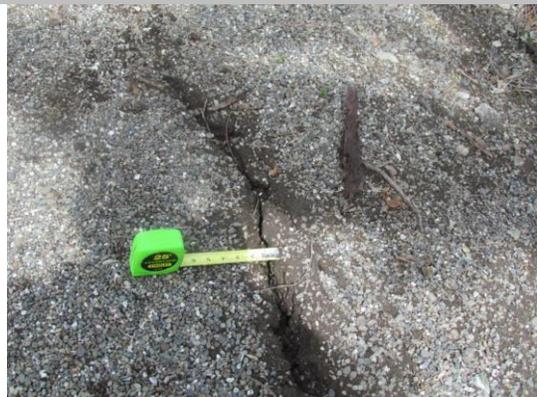
Photo 1 of 3 : FA_2019_RD0999_236_165_20190904_00069.jpg

Looking at two inch plus crack on waterward shoulder.

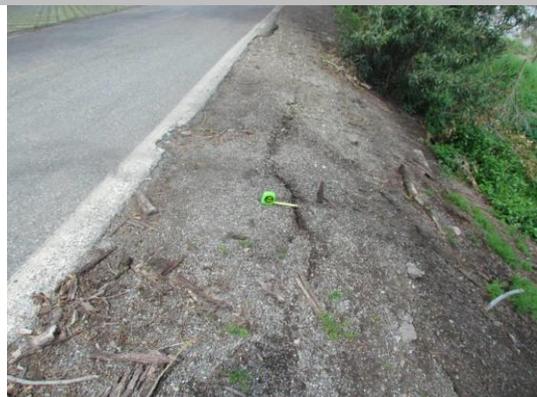
Photo 2 of 3 : FA_2019_RD0999_236_165_20190904_00070.jpg

Looking upstream at cracking along waterward shoulder.

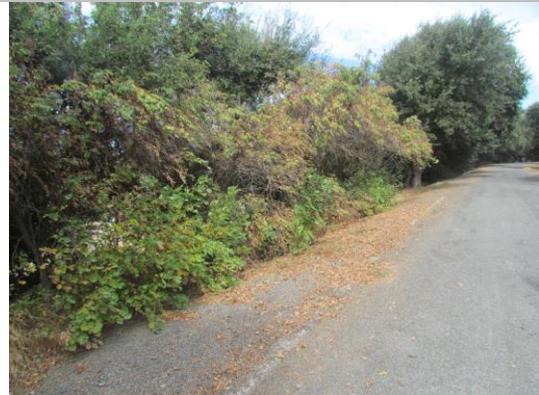
Photo 1 of 1 : FA_2019_RD0999_236_199_20190904_00089.jpg

Looking northwest at dense vegetation on landward slope.

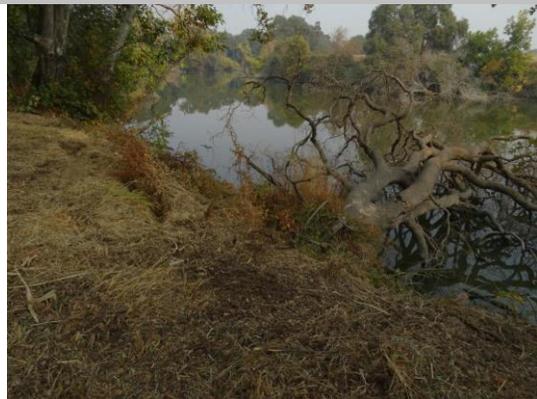
Photo 1 of 1 : FA_2019_RD0999_236_83_20190904_00033.jpg

View of a fallen tree and slope damage. Fall 2018

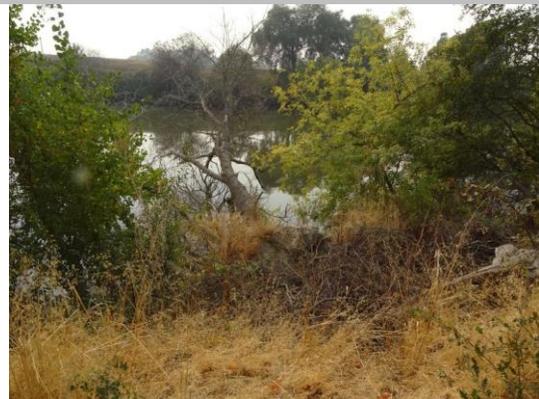
Photo 1 of 1 : FA_2019_RD0999_236_85_20190904_00034.jpg

View of fallen tree and slope damage. Fall 2018

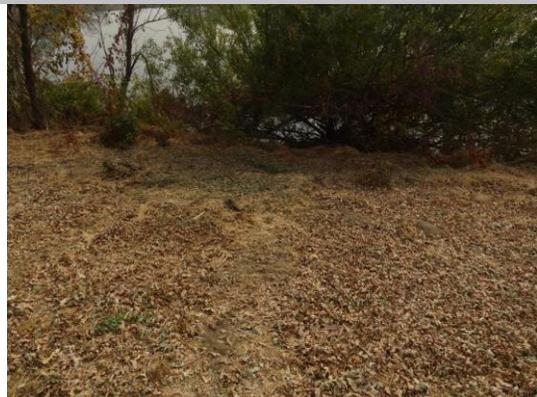
Photo 1 of 1 : FA_2019_RD0999_236_62_20190904_00026.jpg

View of tree stump on levee slope. Fall 2018

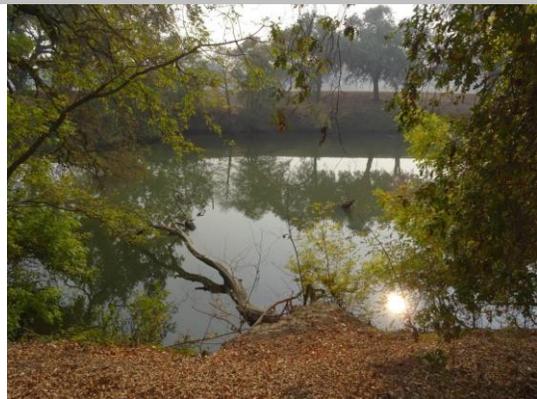
Photo 1 of 1 : FA_2019_RD0999_236_99_20190904_00045.jpg

View of fallen tree and slope damage. Fall 2018

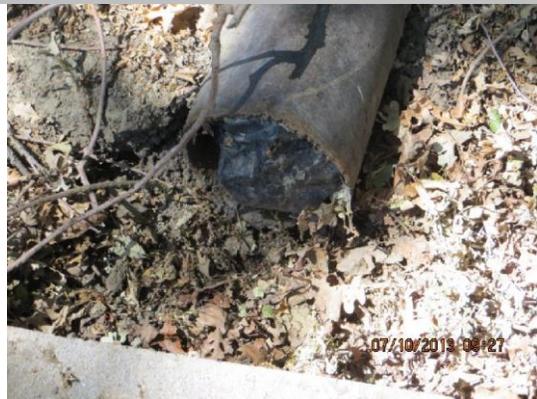
Photo 3 of 3 : UCIP_FA_2019_53372_25857.jpg

Pipe open on WS slope.

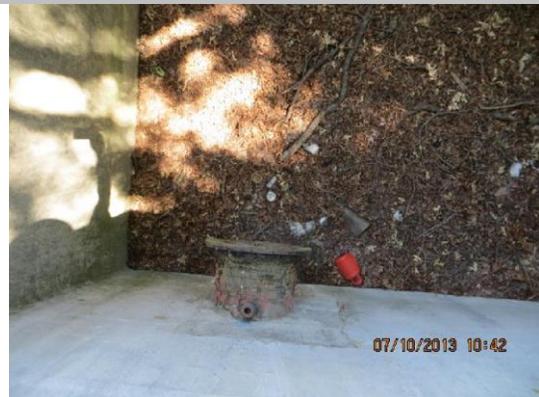
Photo 3 of 3 : UCIP_FA_2019_53373_25936.jpg

Pipe open at pump pit on WS toe.
