**Flood Control Project Maintenance
Levee Inspections**

Maintenance Issue Types Only, Levee Inspection Report By Mile - Fall 2019

Reclamation District No. 1000 Natomas

Waterway	Bank	Unit Miles	Inspection Start/End	Inspector
Unit No. 01 Sacramento River	Left	18.28	09/18/2019 09/18/2019	Sterling York

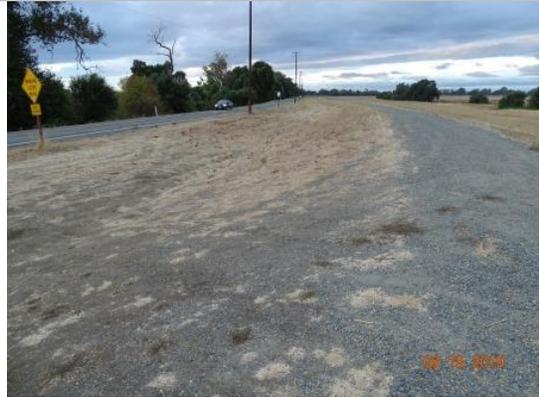
Photo 1 of 1 : FA_2019_RD1000_31_6_20190930_00054.jpg

LM Start	0.01	Rating **	A	Issue No.	6
LM End	11.94	Issue Type +	Ma	Location *	WS
Category	Earthen Levee			GPS Latitude/Longitude	
				Start	End
Item	Vegetation			38.780408°	38.649835°
				-121.603300°	-121.577853°
DWR ID	DWR_RD1000_01_f_2019_6				
Comment Code					
V1 : Control annual grass and weeds on the levee slopes and easements.					
Inspector Comment					
The annual vegetation is well maintained, Fall 2019.

View looking upstream waterside of the well maintained annual vegetation, Fall 2019.

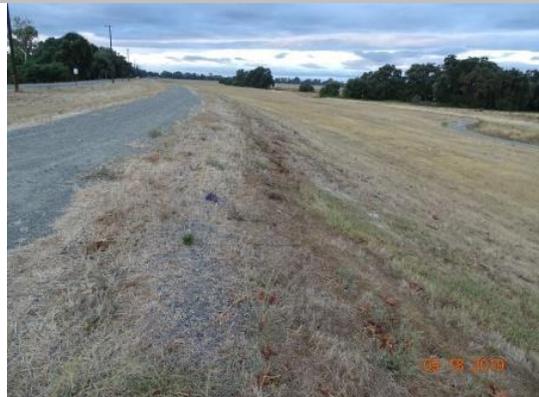
Photo 1 of 1 : FA_2019_RD1000_31_3_20190930_00055.jpg

LM Start	0.01	Rating **	A	Issue No.	3
LM End	11.97	Issue Type +	Ma	Location *	LS
Category	Earthen Levee			GPS Latitude/Longitude	
				Start	End
Item	Vegetation			38.780408°	38.650068°
				-121.603300°	-121.577248°
DWR ID	DWR_RD1000_01_f_2019_3				
Comment Code					
V1 : Control annual grass and weeds on the levee slopes and easements.					
Inspector Comment					
The annual vegetation is well maintained, Fall 2019.

View looking upstream landside of the well maintained annual vegetation, Fall 2019.

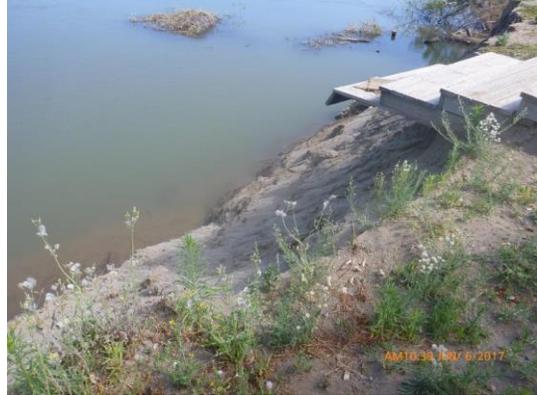
Photo 1 of 3 : LEVAL_FA_2019_45_1257.jpg

LM Start	5.21	Rating **	A/W	Issue No.	4
LM End	5.21	Issue Type +	Ma	Location *	
Category	Supplemental		GPS Latitude/Longitude		
			Start	End	
Item	2017 Storm Damage		38.710830°	38.710830°	
			-121.611100°	-121.611100°	
DWR ID	LMA-12				
Comment Code					
Inspector Comment					
Levee Evaluation Comments					
Description:					
Site ID No:45					
Site Designation:LMA-12					
Repair Type: Erosion					
Rating:Area of Concern					
Field Date:6/6/2017					
Notes: private residence

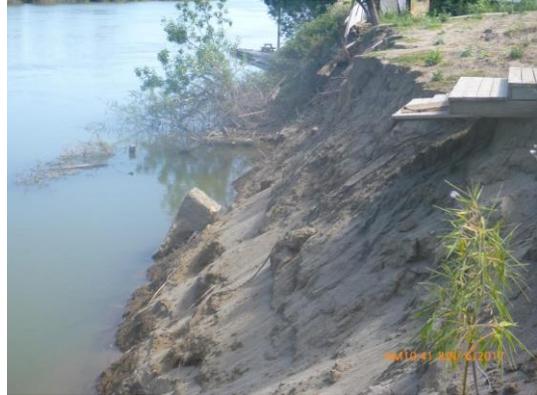
Photo 3 of 3 : LEVAL_FA_2019_45_1261.jpg

LM Start	5.21	Rating **	A/W	Issue No.	4 (cont)
LM End	5.21	Issue Type +	Ma	Location *	
Category	Supplemental			GPS Latitude/Longitude	
				Start	End
Item	2017 Storm Damage			38.710830 °	38.710830 °
				-121.611100 °	-121.611100 °
DWR ID	LMA-12				
Comment Code					
Inspector Comment					
Levee Evaluation Comments					
Description:					
Site ID No:45					
Site Designation:LMA-12					
Repair Type: Erosion					
Rating:Area of Concern					
Field Date:6/6/2017					
Notes: private residence

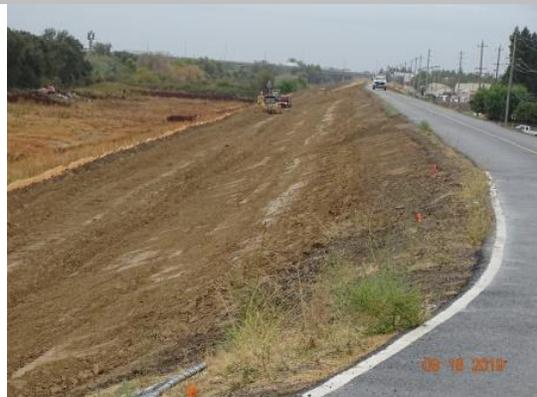
Photo 1 of 2 : FA_2019_RD1000_33_11_20190930_00014.jpg

LM Start	0.05	Rating **	A/W	Issue No.	11
LM End	4.20	Issue Type +	Ma	Location *	CR
Category	Earthen Levee		GPS Latitude/Longitude		
			Start	End	
Item	Slope Stability		38.606454°	38.665724°	
			-121.469943°	-121.477500°	
DWR ID	DWR_RD1000_03_f_2019_11				
Comment Code					
S1 : Repair slope instability.					
Inspector Comment					
Under construction, Reach H-Army Corp Project, Fall 2019.

View looking downstream waterside of the levee under construction, Reach H-Army Corp Project, Fall 2019.

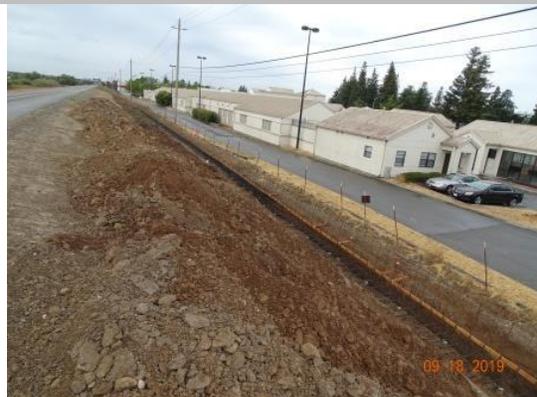
Photo 2 of 2 : FA_2019_RD1000_33_11_20190930_00015.jpg

View looking downstream landside of the levee under construction, Reach H-Army Corp Project, Fall 2019.

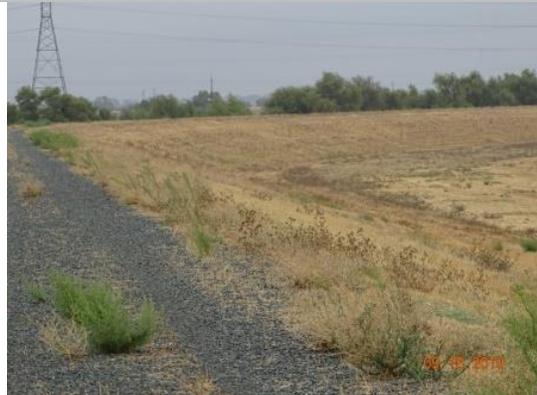
Photo 1 of 1 : FA_2019_RD1000_33_1_20190930_00016.jpg

LM Start	4.20	Rating **	A	Issue No.	1
LM End	16.85	Issue Type +	Ma	Location *	LS
Category	Earthen Levee			GPS Latitude/Longitude	
				Start	End
Item	Vegetation			38.665724°	38.821487°
				-121.477500°	-121.542591°
DWR ID	DWR_RD1000_03_f_2019_1				
Comment Code					
V1 : Control annual grass and weeds on the levee slopes and easements.					
Inspector Comment					
The annual vegetation is well maintained, Fall 2019.

View looking downstream landside at the well maintained annual vegetation, Fall 2019.

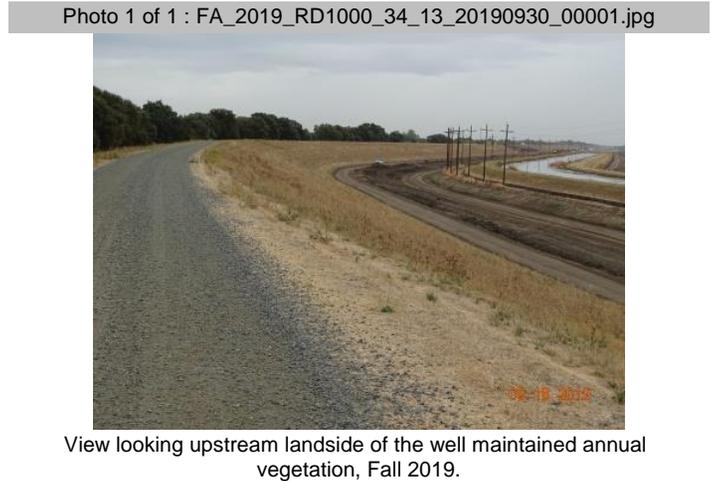
LM Start	0.01	Rating **	A	Issue No.	13
LM End	4.25	Issue Type +	Ma	Location *	LS
Category	Earthen Levee		GPS Latitude/Longitude		
			Start	End	
Item	Vegetation		38.820549°	38.781216°	
			-121.543915°	-121.603191°	
DWR ID	DWR_RD1000_04_f_2019_13				
Comment Code					
V1 : Control annual grass and weeds on the levee slopes and easements.					
Inspector Comment					
The annual vegetation is well maintained, Fall 2019.

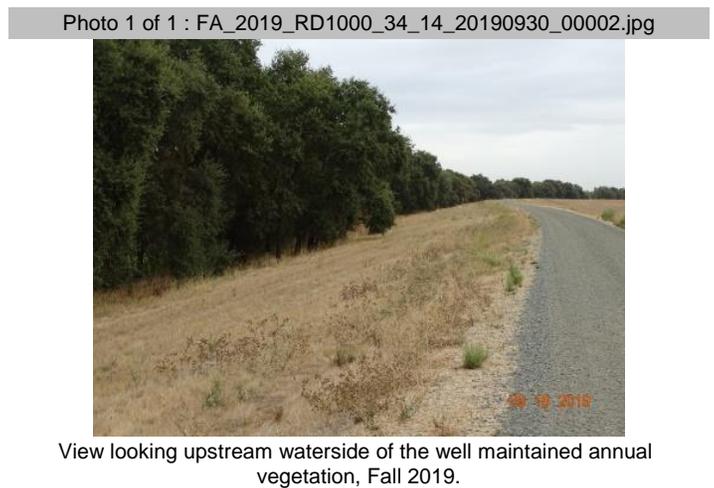
LM Start	0.01	Rating **	A	Issue No.	14
LM End	4.25	Issue Type +	Ma	Location *	WS
Category	Earthen Levee		GPS Latitude/Longitude		
			Start	End	
Item	Vegetation		38.820549°	38.781216°	
			-121.543915°	-121.603191°	
DWR ID	DWR_RD1000_04_f_2019_14				
Comment Code					
V1 : Control annual grass and weeds on the levee slopes and easements.					
Inspector Comment					
The annual vegetation is well maintained, Fall 2019.
