**Flood Control Project Maintenance  
Levee Inspections**

**Maintenance Issue Types Only, Levee Inspection Report By Mile - Spring 2020**

**Reclamation District No. 1001 Nicolaus**

Waterway	Bank	Unit Miles	Inspection Start/End	Inspector
Unit No. 01 Yankee Slough	Right	4.12	03/30/2020 03/30/2020	Sterling York

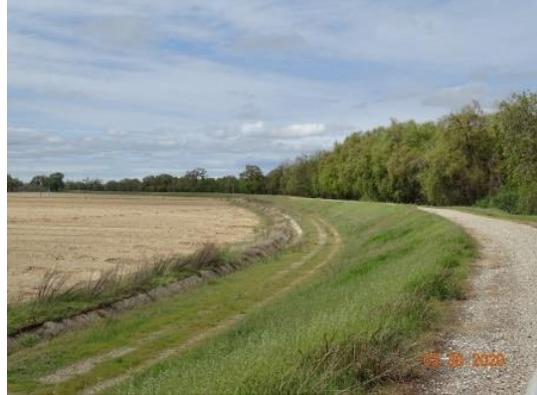
Photo 1 of 1 : SP\_2020\_RD1001\_36\_10\_20200406\_00017.jpg

LM Start	<b>0.01</b>	Rating **	A	Issue No.	<b>10</b>
LM End	<b>4.10</b>	Issue Type +	Ma	Location *	LS
Category	Earthen Levee		GPS Latitude/Longitude		
			Start	End	
Item	Vegetation		38.980182 °	38.970514 °	
			-121.470263 °	-121.534444 °	
DWR ID	DWR_RD1001_01_s_2020_10				
Comment Code					
V1 : Control annual grass and weeds on the levee slopes and easements.					
Inspector Comment					
The annual vegetation is well maintained, Spring 2020.

View looking upstream landside at the well maintained annual vegetation, Spring 2020.

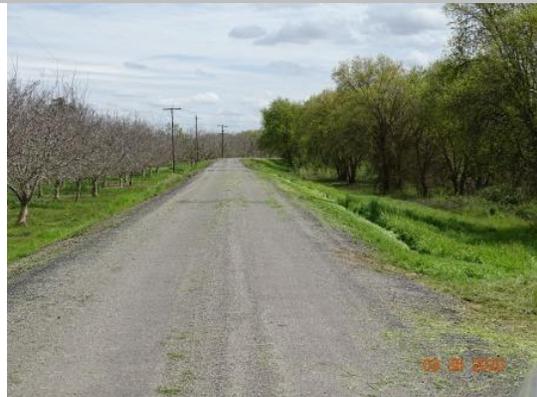
Photo 1 of 1 : SP\_2020\_RD1001\_36\_11\_20200406\_00016.jpg

LM Start	<b>0.01</b>	Rating **	A	Issue No.	<b>11</b>
LM End	<b>4.10</b>	Issue Type +	Ma	Location *	WS
Category	Earthen Levee		GPS Latitude/Longitude		
			Start	End	
Item	Vegetation		38.980182 °	38.970514 °	
			-121.470263 °	-121.534444 °	
DWR ID	DWR_RD1001_01_s_2020_11				
Comment Code					
V1 : Control annual grass and weeds on the levee slopes and easements.					
Inspector Comment					
The annual vegetation is well maintained, Spring 2020.

View looking upstream waterside at the well maintained annual vegetation, Spring 2020.

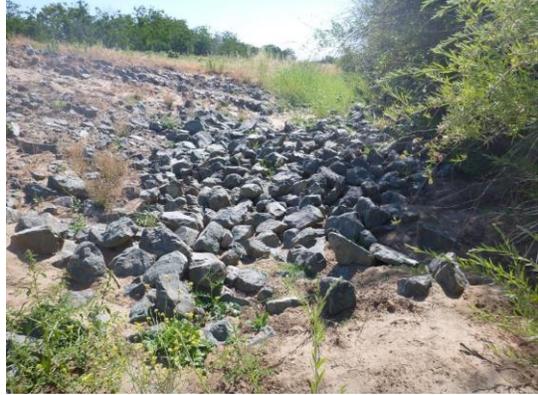
Photo 3 of 3 : LEVAL\_SP\_2020\_135\_303.jpg

LM Start	<b>0.73</b>	Rating **	A/W	Issue No.	<b>9 (cont)</b>
LM End	<b>0.75</b>	Issue Type +	Ma	Location *	
Category	Supplemental			GPS Latitude/Longitude	
				Start	End
Item	2017 Storm Damage			38.975046 °	38.975038 °
				-121.480938 °	-121.481151 °
DWR ID	LMA-15

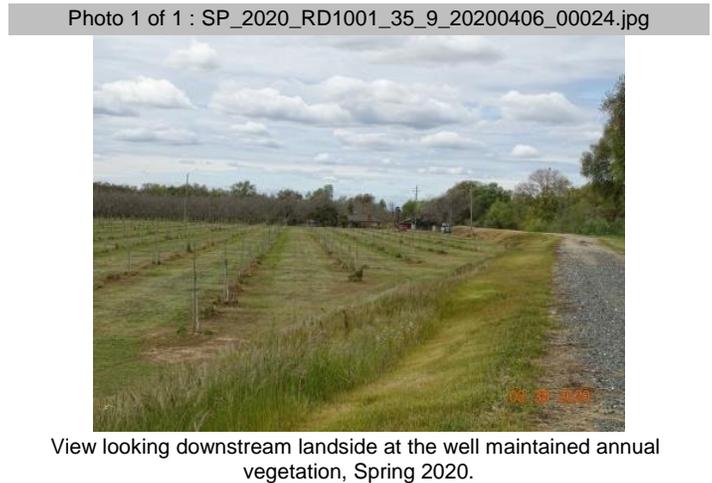
LM Start	<b>0.01</b>	Rating **	A	Issue No.	<b>9</b>
LM End	<b>3.62</b>	Issue Type +	Ma	Location *	LS
Category	Earthen Levee		GPS Latitude/Longitude		
			Start	End	
Item	Vegetation		38.971342 °	38.965658 °	
			-121.473997 °	-121.533276 °	
DWR ID	DWR_RD1001_02_s_2020_9				
Comment Code					
V1 : Control annual grass and weeds on the levee slopes and easements.					
Inspector Comment					
The annual vegetation is well maintained, Spring 2020.

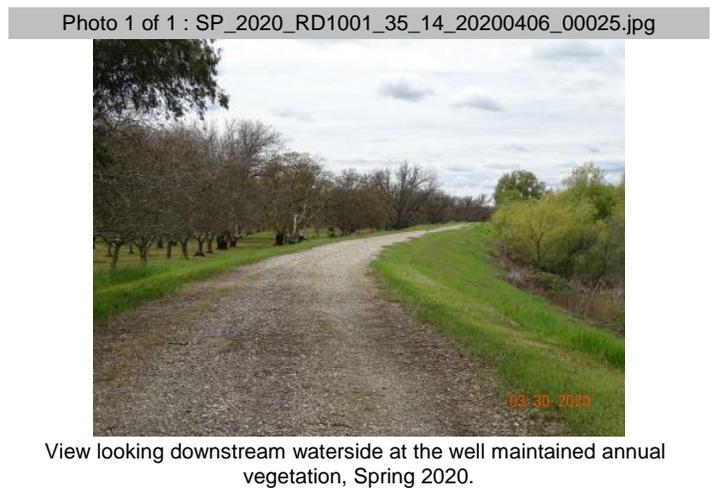
LM Start	<b>0.01</b>	Rating **	A	Issue No.	<b>14</b>
LM End	<b>3.62</b>	Issue Type +	Ma	Location *	WS
Category	Earthen Levee		GPS Latitude/Longitude		
			Start	End	
Item	Vegetation		38.971342 °	38.965658 °	
			-121.473997 °	-121.533276 °	
DWR ID	DWR_RD1001_02_s_2020_14				
Comment Code					
V1 : Control annual grass and weeds on the levee slopes and easements.					
Inspector Comment					
The annual vegetation is well maintained, Spring 2020.

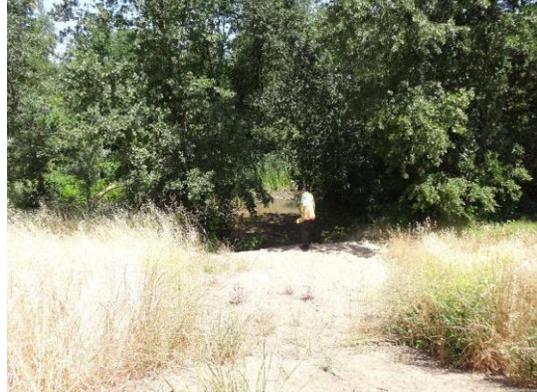
Photo 1 of 3 : UCIP\_SP\_2020\_14008\_23108.jpg

Item	DWR UCIP LMA Responsibility			38.967403 °	38.967403 °
				-121.510953 °	-121.510953 °
DWR ID	22543				
Comment Code					
Inspector Comment					
DS_ID:22543 FS_ID:14008 EP_NO: N/A Repair Type: Non-Urgent Crossing Status: Found UCIP Comments: 05/23/2013 - slide gate in inlet pipe on landside - pits on pipe due to corrosion (P. Amatya - DWR UCIP) FIELD_STRUCT_DESC: 36-inch corrugated metal gravity drainage pipe through the levee, 15 feet below the crown. Flap gate and concrete U-shaped headwall at outfall on the waterside (WS) end. Slide gate at inlet on the landside (LS) end. (Reclamation District No. 1001). [Additional Reference(s): DWR Levee Log, 1993. USACE Sacramento O&M Manual 141.1, August 1955, (Station 67+75)]. FS Date: 5/23/2013

WS- overview of waterside of the levee.

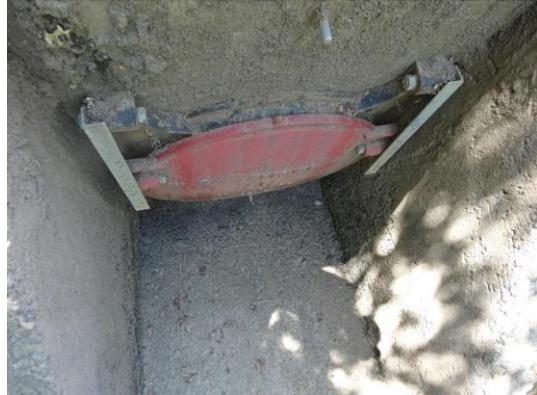
Photo 2 of 3 : UCIP\_SP\_2020\_14008\_23107.jpg

WS- outfall pipe with flap gate in concrete wing wall.

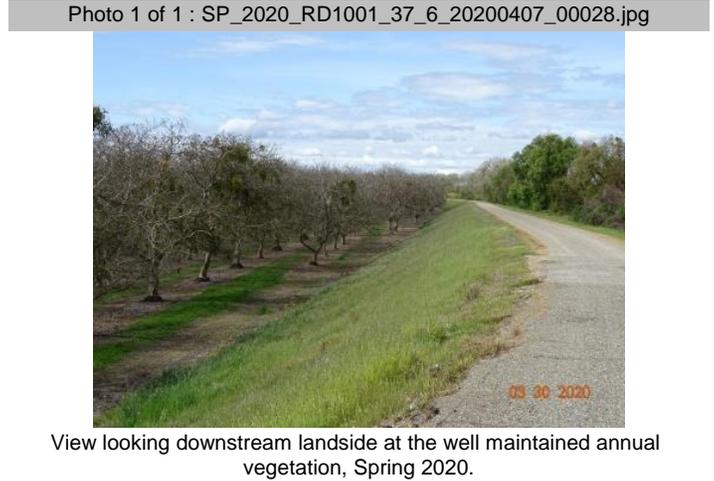
LM Start	<b>0.01</b>	Rating **	A	Issue No.	<b>6</b>
LM End	<b>12.54</b>	Issue Type +	Ma	Location *	LS
Category	Earthen Levee		GPS Latitude/Longitude		
			Start	End	
Item	Vegetation		39.006578 °	38.941648 °	
			-121.375132 °	-121.567352 °	
DWR ID	DWR_RD1001_03_s_2020_6				
Comment Code					
V1 : Control annual grass and weeds on the levee slopes and easements.					
Inspector Comment					
The annual vegetation is well maintained, Spring 2020.

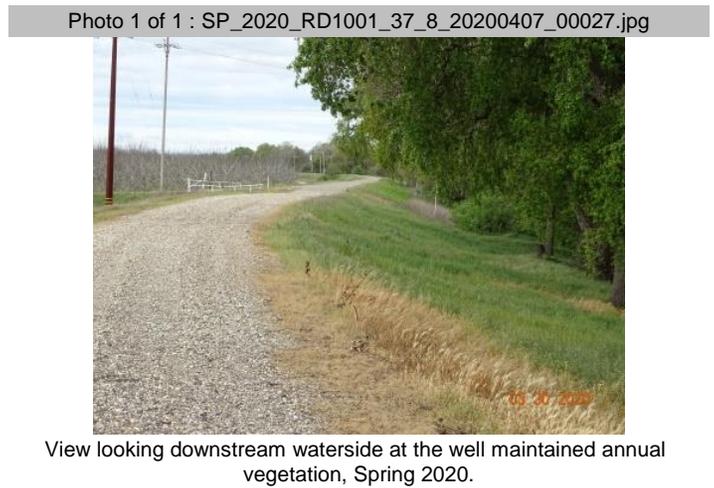
LM Start	<b>0.01</b>	Rating **	A	Issue No.	<b>8</b>
LM End	<b>12.54</b>	Issue Type +	Ma	Location *	WS
Category	Earthen Levee		GPS Latitude/Longitude		
			Start	End	
Item	Vegetation		39.006578 °	38.941648 °	
			-121.375132 °	-121.567352 °	
DWR ID	DWR_RD1001_03_s_2020_8				
Comment Code					
V1 : Control annual grass and weeds on the levee slopes and easements.					
Inspector Comment					
The annual vegetation is well maintained, Spring 2020.

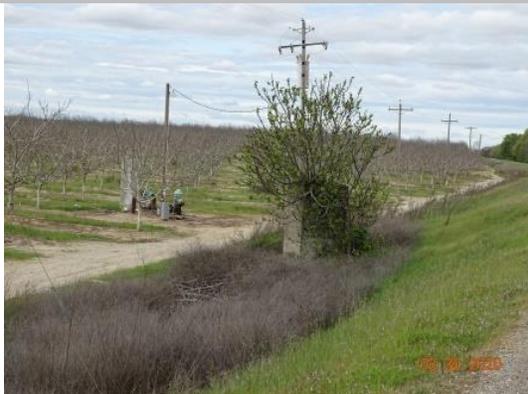
Photo 1 of 1 : SP\_2020\_RD1001\_37\_36\_20200407\_00030.jpg

View of a small starter tree on landside slope looking downstream that is less than 4" in diameter, Spring 2020.

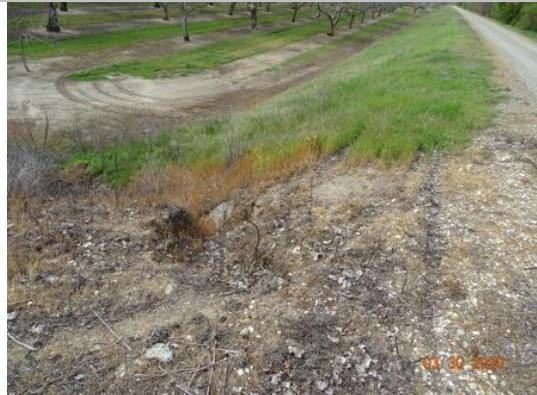
Photo 1 of 1 : SP\_2020\_RD1001\_37\_21\_20200408\_00041.jpg

LM Start	<b>6.51</b>	Rating **	M	Issue No.	<b>21</b>
LM End	<b>6.51</b>	Issue Type +	Ma	Location *	LS
Category	Earthen Levee		GPS Latitude/Longitude		
			Start	End	
Item	Erosion / Bank Caving		38.983953 °	38.983953 °	
			-121.488081 °	-121.488081 °	
DWR ID	DWR_RD1001_03_s_2020_21				
Comment Code					
E2 : Schedule repair of erosion site prior to the next inspection.					
Inspector Comment					
Repair the erosion reel down the levee slope, Spring 2020.

View looking downstream landside at a washout running down the levee slope, Spring 2020.

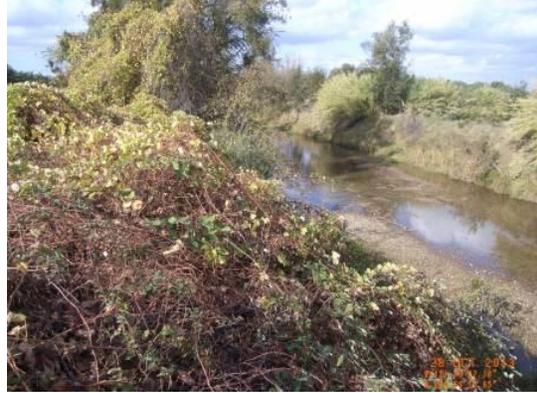
Photo 1 of 1 : SP\_2020\_RD1001\_37\_13\_20200227\_00009.jpg

LM Start	<b>7.22</b>	Rating **	A/W	Issue No.	<b>13</b>
LM End	<b>7.31</b>	Issue Type +	Ma	Location *	WS
Category	Supplemental		GPS Latitude/Longitude		
			Start	End	
Item	2017 USACE Erosion Survey		38.982737 °	38.982572 °	
			-121.501144 °	-121.502797 °	
DWR ID	DWR_RD1001_03_f_2018_13				
Comment Code					
Inspector Comment					
2017 Site ID: BER 5.7 L Status: Eroding 2017 Field Notes: Minor new erosion observed. Site History: 2008 - Sandy/silty banks with rotational slab failures creating near vertical bank with pop-outs due to tree failures. Narrow berm.

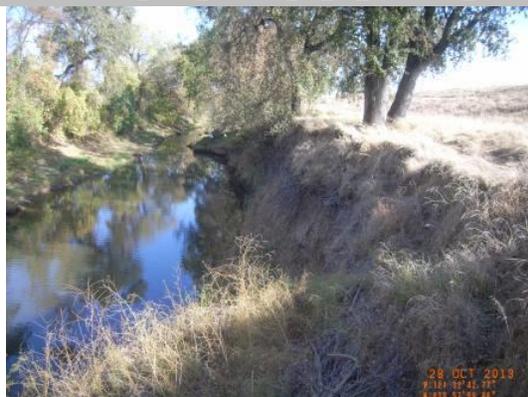
Photo 1 of 1 : SP\_2020\_RD1001\_37\_12\_20200227\_00008.jpg

LM Start	<b>10.36</b>	Rating **	A/W	Issue No.	<b>12</b>
LM End	<b>10.40</b>	Issue Type +	Ma	Location *	WS
Category	Supplemental		GPS Latitude/Longitude		
			Start	End	
Item	2017 USACE Erosion Survey		38.964583 °	38.964010 °	
			-121.544967 °	-121.545228 °	
DWR ID	DWR_RD1001_03_f_2018_12				
Comment Code					
Inspector Comment					
2017 Site ID: BER 2.5 L Status: Eroding 2017 Field Notes: Erosion pockets have expanded Site History: 2011 - Large section of bank has slumped off. RD has flagged and appears to be watching. 2012 - Slopes slightly steeper. 2013 - Minor new erosion observed.

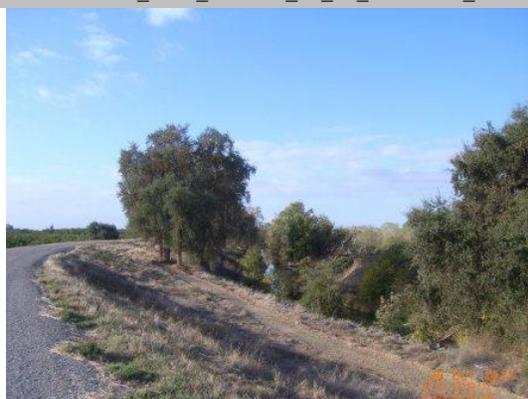
Photo 1 of 1 : SP\_2020\_RD1001\_37\_10\_20200227\_00006.jpg

LM Start	<b>11.08</b>	Rating **	A/W	Issue No.	<b>10</b>
LM End	<b>11.16</b>	Issue Type +	Ma	Location *	WS
Category	Supplemental		GPS Latitude/Longitude		
			Start	End	
Item	2017 USACE Erosion Survey		38.955070 °	38.954227 °	
			-121.549528 °	-121.550592 °	
DWR ID	DWR_RD1001_03_f_2018_10				
Comment Code					
Inspector Comment					
2017 Site ID: BER 1.9 L Status: Eroding 2017 Field Notes: Minor new erosion observed. Site History: 2011 - Large slumped sections of bank. 2012 - Slopes slightly steeper.

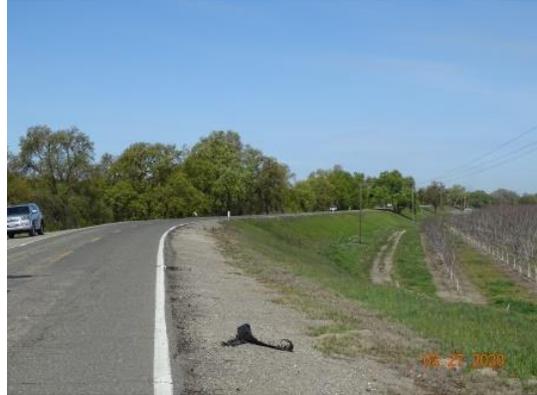
Photo 1 of 1 : SP\_2020\_RD1001\_38\_58\_20200406\_00069.jpg

View looking upstream landside at the well maintained annual vegetation, Spring 2020.

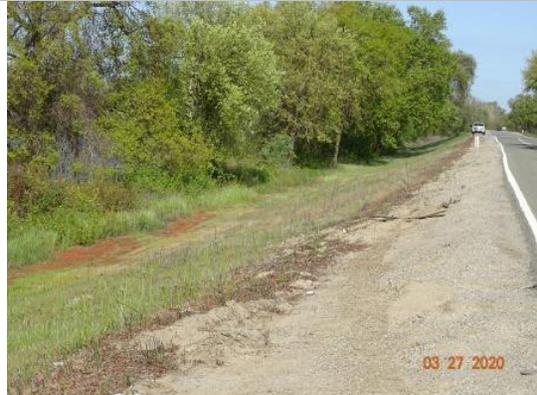
Photo 1 of 1 : SP\_2020\_RD1001\_38\_59\_20200406\_00070.jpg

LM Start	<b>0.01</b>	Rating **	A	Issue No.	<b>59</b>
LM End	<b>13.27</b>	Issue Type +	Ma	Location *	WS
Category	Earthen Levee		GPS Latitude/Longitude		
			Start	End	
Item	Vegetation		38.940950 °	38.781209 °	
			-121.567646 °	-121.605553 °	
DWR ID	DWR_RD1001_04_s_2020_59				
Comment Code					
V1 : Control annual grass and weeds on the levee slopes and easements.					
Inspector Comment					
The annual vegetation is well maintained, Spring 2020.

View looking upstream waterside at the well maintained annual vegetation, Spring 2020.

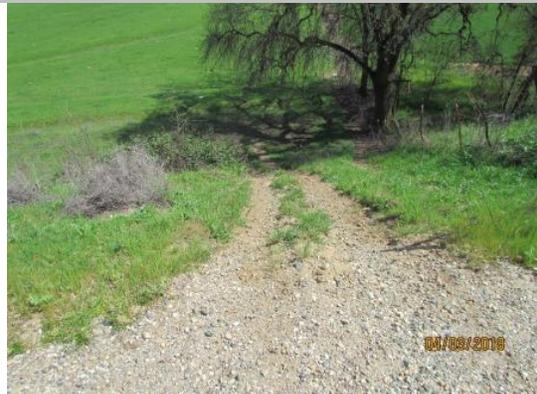
Photo 1 of 1 : SP\_2020\_RD1001\_38\_68\_20200227\_00025.jpg

LM Start	<b>0.55</b>	Rating **	M	Issue No.	<b>68</b>
LM End	<b>0.55</b>	Issue Type +	Ma	Location *	LS
Category	Earthen Levee		GPS Latitude/Longitude		
			Start	End	
Item	Slope Stability		38.933299 °	38.933299 °	
			-121.567069 °	-121.567069 °	
DWR ID	DWR_RD1001_04_s_2016_68				
Comment Code					
S3 : Repair the levee slope damaged by vehicle traffic and prevent access where possible.					
Inspector Comment					
Repair slope damage caused by ATV.

View of ruts caused by vehicle on the landside levee slope.

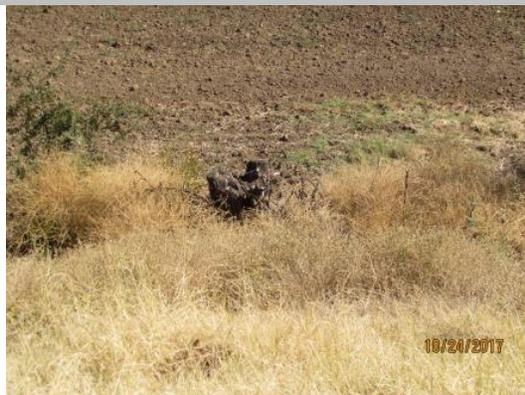
Photo 1 of 1 : SP\_2020\_RD1001\_38\_69\_20200227\_00026.jpg

View of landside toe of a stump that needs to be removed.

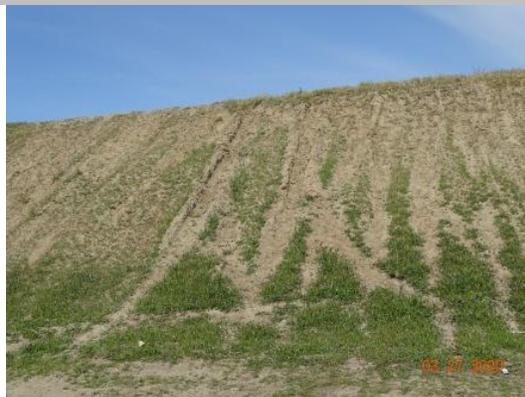
Photo 1 of 1 : SP\_2020\_RD1001\_38\_62\_20200407\_00071.jpg

LM Start	<b>4.06</b>	Rating **	M	Issue No.	<b>62</b>
LM End	<b>4.06</b>	Issue Type +	Ma	Location *	LS
Category	Earthen Levee			GPS Latitude/Longitude	
				Start	End
Item	Slope Stability			38.892633 °	38.892633 °
				-121.597945 °	-121.597945 °
DWR ID	DWR_RD1001_04_s_2020_62				
Comment Code					
S3 : Repair the levee slope damaged by vehicle traffic and prevent access where possible.					
Inspector Comment					
Repair the damage caused by the vehicle driving up the levee slope, Spring 2020.

View looking at the landside levee from the toe at the vehicle tire tracks on the slope, Spring 2020.

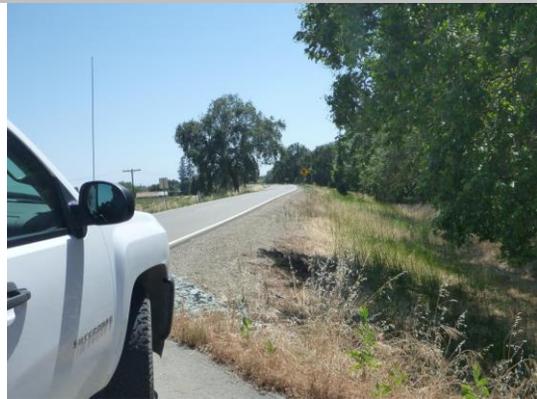
Photo 1 of 3 : LEVAL\_SP\_2020\_139\_1148.jpg

LM Start	<b>5.61</b>	Rating **	A/W	Issue No.	<b>35</b>
LM End	<b>5.61</b>	Issue Type +	Ma	Location *	WS
Category	Earthen Levee			GPS Latitude/Longitude	
				Start	End
Item	Erosion / Bank Caving			38.876390 °	38.876390 °
				-121.613476 °	-121.613476 °
DWR ID	LMA-19				
Comment Code					
E1 : Note and monitor erosion site.					
Inspector Comment					
This was a 2017 Storm Damage Site. Small erosion site that is not into levee prism. Site ID No:139 Site Designation:LMA-19

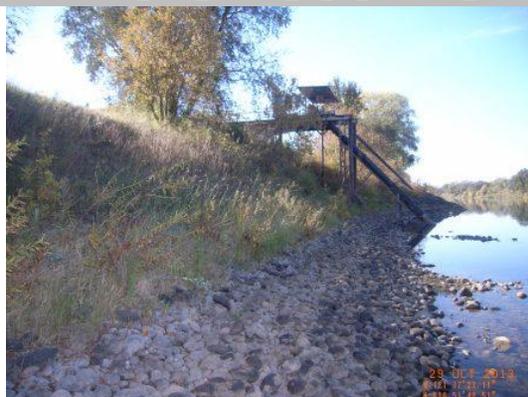
Photo 1 of 1 : SP\_2020\_RD1001\_38\_15\_20200227\_00005.jpg

LM Start	<b>6.57</b>	Rating **	A/W	Issue No.	<b>15</b>
LM End	<b>6.77</b>	Issue Type +	Ma	Location *	WS
Category	Supplemental		GPS Latitude/Longitude		
			Start	End	
Item	2017 USACE Erosion Survey		38.863946 °	38.861558 °	
			-121.621388 °	-121.623316 °	
DWR ID	DWR_RD1001_04_f_2018_15				
Comment Code					
Inspector Comment					
2017 Site ID: FHR 5.8 L Status: Eroding 2017 Field Notes: slope is not stable enough to maintain vegetation growth, new erosion Site History: 2011 - Large slumped sections on the lower bank. 2012 - New cracks observed.

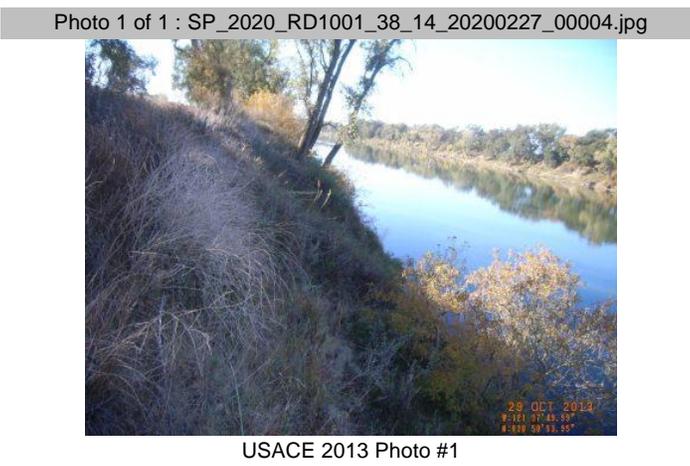
LM Start	<b>7.47</b>	Rating **	A/W	Issue No.	<b>14</b>
LM End	<b>7.79</b>	Issue Type +	Ma	Location *	WS
Category	Supplemental			GPS Latitude/Longitude	
				Start	End
Item	2017 USACE Erosion Survey			38.852394 °	38.848004 °
				-121.629231 °	-121.630873 °
DWR ID	DWR_RD1001_04_f_2018_14				
Comment Code					
Inspector Comment					
2017 Site ID: FHR 5.0 L Status: Critical 2017 Field Notes: Upgraded to critical, significant new erosion, entire bank slope is vertical with non cohesive soils. Site History: 2000 - Steep bank off berm with some slumps and fallen trees, continued erosion. 2002 - Site lengthened upstream and downstream due to vertical bank along most of the reach. 2010 - Site extended upstream. 2011 - Minimal new erosion. 2012 - Site extended on the upstream end, new tree pop-out, and bank erosion continues to worsen. 2013 - Minor new erosion at the toe and top of bank.

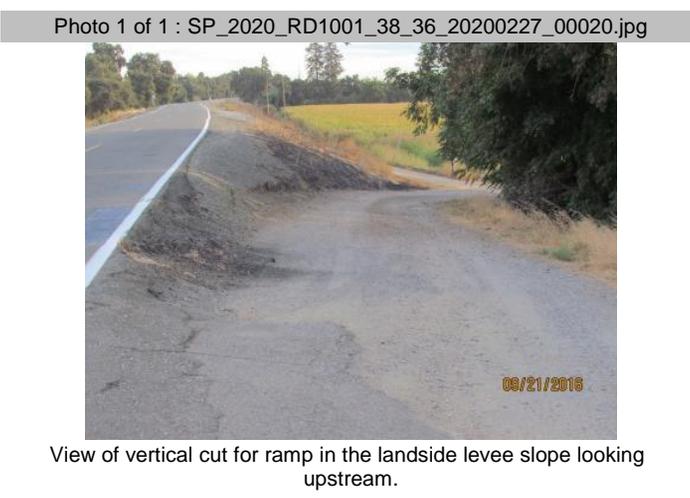
LM Start	<b>7.60</b>	Rating **	A/W	Issue No.	<b>36</b>
LM End	<b>7.60</b>	Issue Type +	Ma	Location *	LS
Category	Earthen Levee			GPS Latitude/Longitude	
				Start	End
Item	Crown Surface / Depressions / Rutting			38.850521 °	38.850521 °
				-121.629423 °	-121.629423 °
DWR ID	DWR_RD1001_04_f_2015_36				
Comment Code					
C2 : Repair depressions or ruts in the crown or slope.					
Inspector Comment					
Ramp has vertical cut into the levee prism.

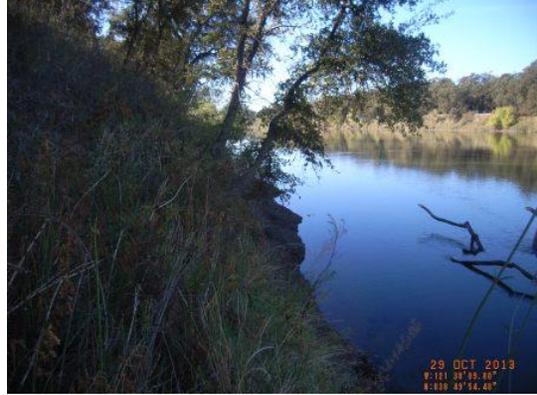
Photo 1 of 1 : SP\_2020\_RD1001\_38\_13\_20200227\_00003.jpg

LM Start	<b>8.59</b>	Rating **	A/W	Issue No.	<b>13</b>
LM End	<b>9.47</b>	Issue Type +	Ma	Location *	WS
Category	Supplemental		GPS Latitude/Longitude		
			Start	End	
Item	2017 USACE Erosion Survey		38.836601 °	38.824642 °	
			-121.633701 °	-121.639534 °	
DWR ID	DWR_RD1001_04_f_2018_13				
Comment Code					
Inspector Comment					
2017 Site ID: FHR 3.8 L Status: Eroding 2017 Field Notes: New erosion along lower slope Site History: 2006 - Sandy, silty bank with intermittent pockets of erosion. Rotational failure and tree pop outs are most of the problem. Some upper slope fluvial erosion. 2010 - Site extended upstream. The lower Feather may benefit from a regional repair. 2011 - Site combined with 3.6. Minimal new erosion. 2013 - New erosion observed at bank toe. Trees on site now have exposed roots.

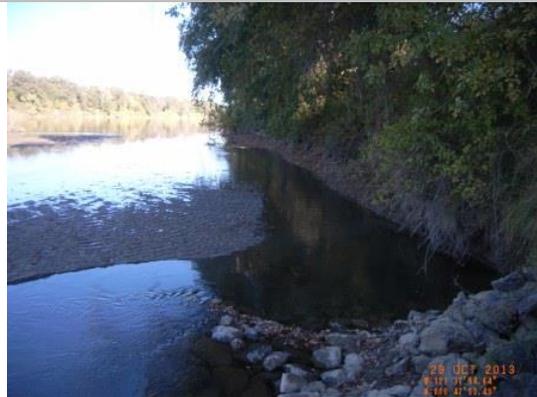
Photo 1 of 1 : SP\_2020\_RD1001\_38\_10\_20200227\_00002.jpg

LM Start	<b>11.18</b>	Rating **	A/W	Issue No.	<b>10</b>
LM End	<b>11.37</b>	Issue Type +	Ma	Location *	WS
Category	Supplemental		GPS Latitude/Longitude		
			Start	End	
Item	2017 USACE Erosion Survey		38.800920 °	38.798165 °	
			-121.633050 °	-121.631939 °	
DWR ID	DWR_RD1001_04_f_2018_10				
Comment Code					
Inspector Comment					
2017 Site ID: FHR 1.0 L Status: Eroding 2017 Field Notes: Significant new erosion along lower bank. Site History: 2000 - Site is relatively stable except for some toe erosion at the upstream end, recommend monitoring the upstream end. 2004 - Some new block failures (10ft deep) at the toe of the upstream end. 2007 - Some minor new slumping at the waterline. 2013 - Minor new erosion along the bank toe.

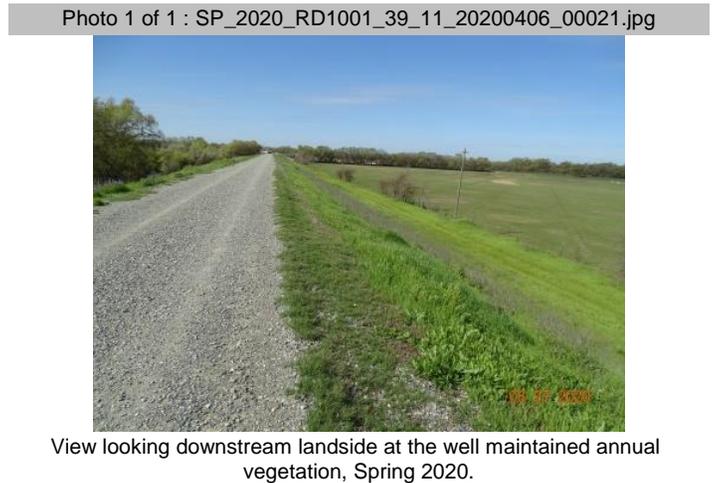
LM Start	<b>0.00</b>	Rating **	A	Issue No.	<b>11</b>
LM End	<b>5.39</b>	Issue Type +	Ma	Location *	LS
Category	Earthen Levee		GPS Latitude/Longitude		
			Start	End	
Item	Vegetation		38.781246 °	38.831097 °	
			-121.605437 °	-121.529738 °	
DWR ID	DWR_RD1001_05_s_2020_11				
Comment Code					
V1 : Control annual grass and weeds on the levee slopes and easements.					
Inspector Comment					
The annual vegetation is well maintained, Spring 2020.

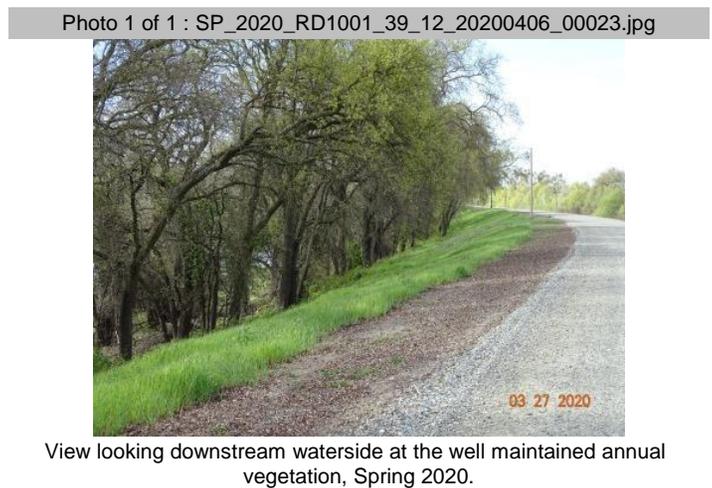
LM Start	<b>0.00</b>	Rating **	A	Issue No.	<b>12</b>
LM End	<b>5.39</b>	Issue Type +	Ma	Location *	WS
Category	Earthen Levee		GPS Latitude/Longitude		
			Start	End	
Item	Vegetation		38.781246 °	38.831097 °	
			-121.605436 °	-121.529738 °	
DWR ID	DWR_RD1001_05_s_2020_12				
Comment Code					
V1 : Control annual grass and weeds on the levee slopes and easements.					
Inspector Comment					
The annual vegetation is well maintained, Spring 2020.

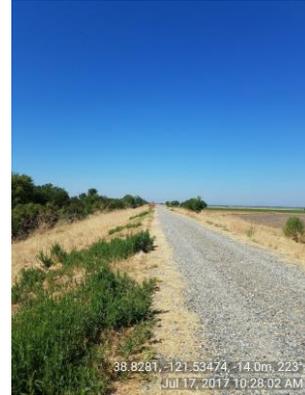
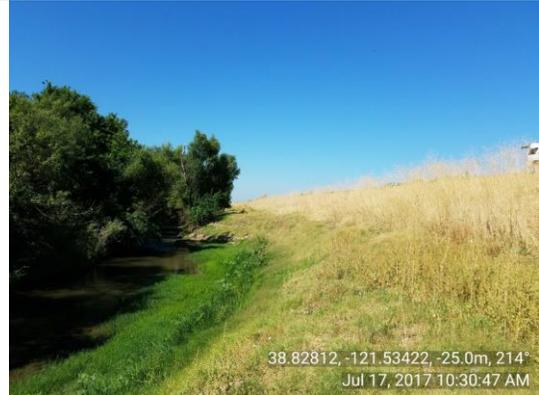
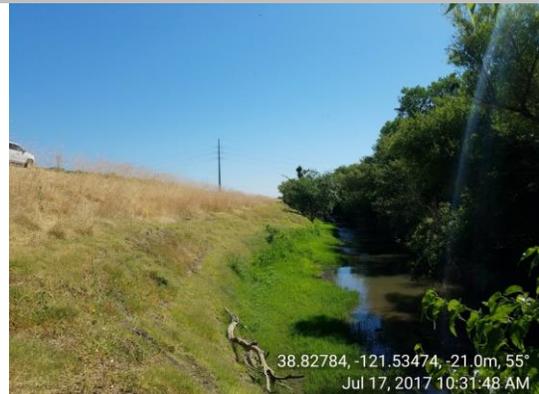
LM Start	<b>5.05</b>	Rating **	M	Issue No.	<b>8</b>
LM End	<b>5.06</b>	Issue Type +	Ma	Location *	WS
Category	Earthen Levee		GPS Latitude/Longitude		
			Start	End	
Item	Erosion / Bank Caving		38.828100 °	38.828188 °	
			-121.534740 °	-121.534625 °	
DWR ID	RD 1001-03				
Comment Code					
E2 : Schedule repair of erosion site prior to the next inspection.					
Inspector Comment					
This was a 2017 Storm Damage Site. Site ID No:493 Site Designation:RD 1001-03

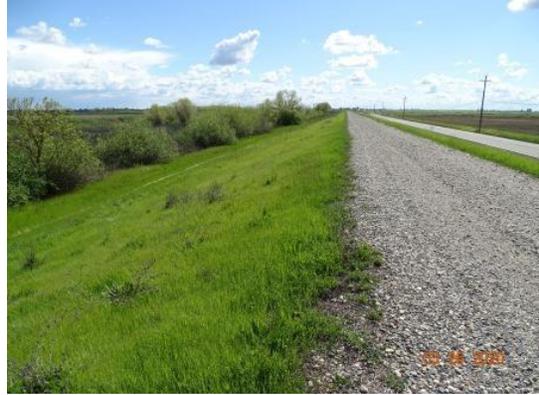
Photo 1 of 1 : SP\_2020\_RD1001\_40\_25\_20200406\_00054.jpg

View looking downstream waterside at the well maintained annual vegetation, Spring 2020.

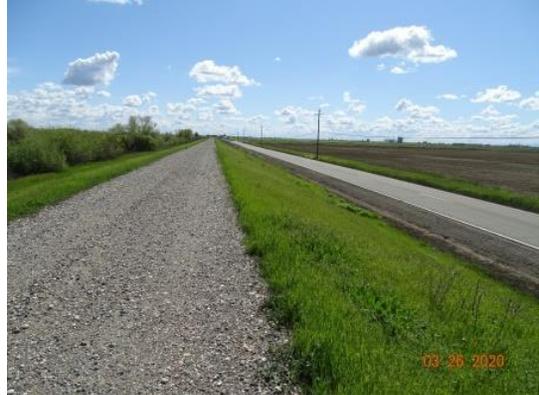
Photo 1 of 1 : SP\_2020\_RD1001\_40\_23\_20200406\_00053.jpg

View looking downstream landside at the well maintained annual vegetation, Spring 2020.

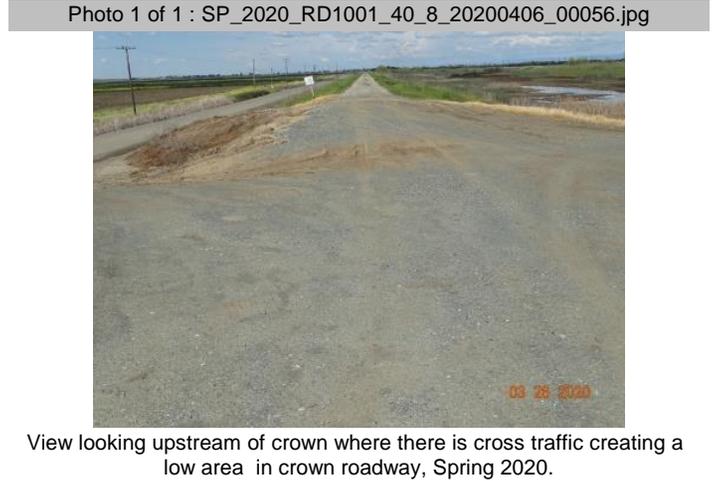
LM Start	<b>2.05</b>	Rating **	M	Issue No.	<b>8</b>
LM End	<b>2.05</b>	Issue Type +	Ma	Location *	CR
Category	Earthen Levee		GPS Latitude/Longitude		
			Start	End	
Item	Crown Surface / Depressions / Rutting		38.860002 °	38.860002 °	
			-121.524873 °	-121.524873 °	
DWR ID	DWR_RD1001_06_s_2012_8				
Comment Code					
C2 : Repair depressions or ruts in the crown or slope.					
Inspector Comment					
There are depressions on the crown where there is cross traffic. Fix low area, Spring 2020.

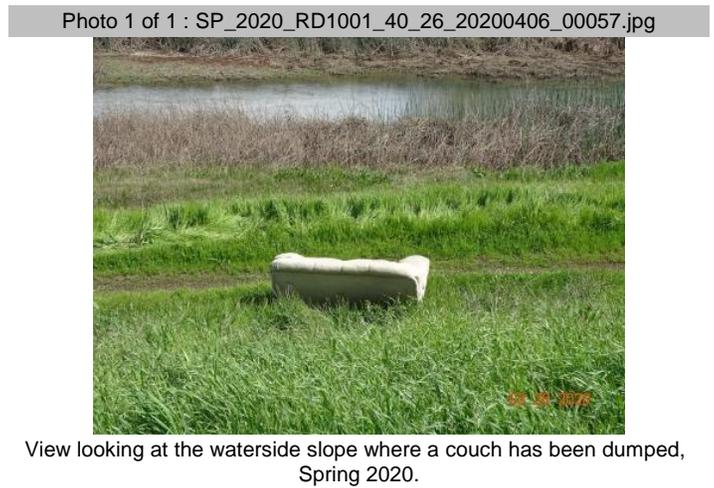
LM Start	<b>2.56</b>	Rating **	M	Issue No.	<b>26</b>
LM End	<b>2.56</b>	Issue Type +	Ma	Location *	WS
Category	Earthen Levee		GPS Latitude/Longitude		
			Start	End	
Item	Encroachments		38.867278 °	38.867278 °	
			-121.524843 °	-121.524843 °	
DWR ID	DWR_RD1001_06_s_2020_26				
Comment Code					
DE : Debris					
Inspector Comment

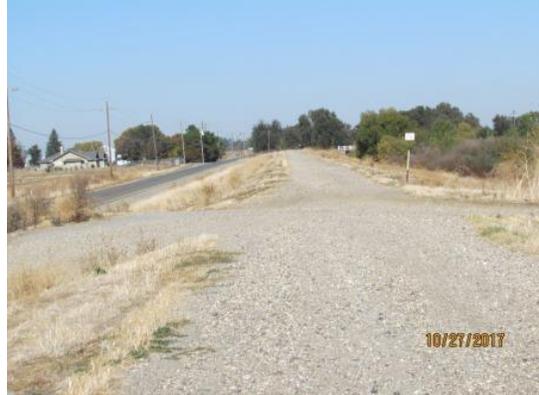
Photo 1 of 1 : SP\_2020\_RD1001\_40\_7\_20200227\_00002.jpg

LM Start	<b>4.04</b>	Rating **	A/W	Issue No.	<b>7</b>
LM End	<b>4.04</b>	Issue Type +	Ma	Location *	CR
Category	Earthen Levee		GPS Latitude/Longitude		
			Start	End	
Item	Crown Surface / Depressions / Rutting		38.888803 °	38.888803 °	
			-121.524738 °	-121.524738 °	
DWR ID	DWR_RD1001_06_s_2012_7				
Comment Code					
C2 : Repair depressions or ruts in the crown or slope.					
Inspector Comment					
There are depressions on the crown where there is cross traffic. Monitor this area and fix as needed.

View of crown where there is cross traffic looking upstream. Monitor this area and fix as needed.

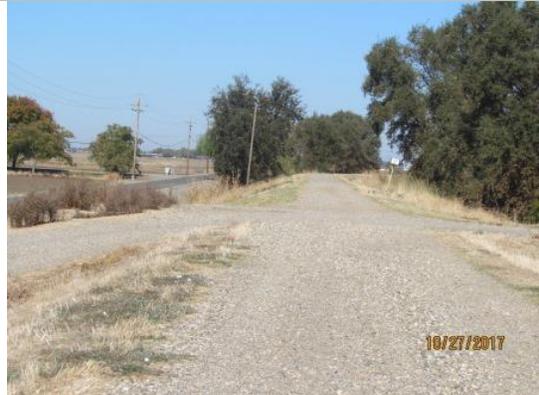
Photo 1 of 1 : SP\_2020\_RD1001\_40\_19\_20200227\_00006.jpg

LM Start	<b>4.33</b>	Rating **	A/W	Issue No.	<b>19</b>
LM End	<b>4.33</b>	Issue Type +	Ma	Location *	CR
Category	Earthen Levee		GPS Latitude/Longitude		
			Start	End	
Item	Crown Surface / Depressions / Rutting		38.892999 °	38.892999 °	
			-121.524711 °	-121.524711 °	
DWR ID	DWR_RD1001_06_f_2013_19				
Comment Code					
C2 : Repair depressions or ruts in the crown or slope.					
Inspector Comment					
There are depressions on the crown where there is cross traffic. Monitor this area and fix as needed.

View of crown where there is cross traffic looking upstream. Monitor this area and fix as needed.
