**Flood Control Project Maintenance
Levee Inspections**
LMA District Cover Sheet
Spring 2020 Levee Inspection Results

Reclamation District No. 1500 Sutter Basin

Spring 2020 Levee Inspection Results

Waterway	Bank	Unit Miles
Unit No. 01 Sacramento River	Left	33.15

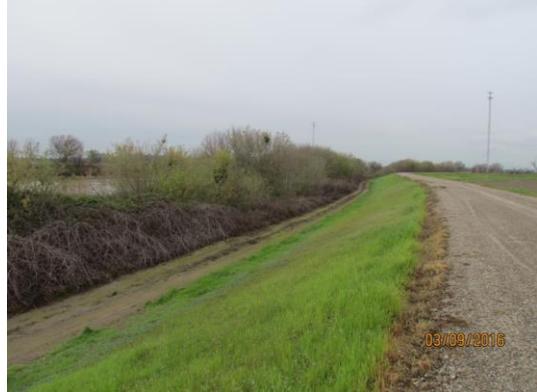
Photo 1 of 2 : SP_2020_RD1500_189_72_20200228_00025.jpg

View of the revegetation site on the waterward side toe of the levee looking upstream. Spring 2016.

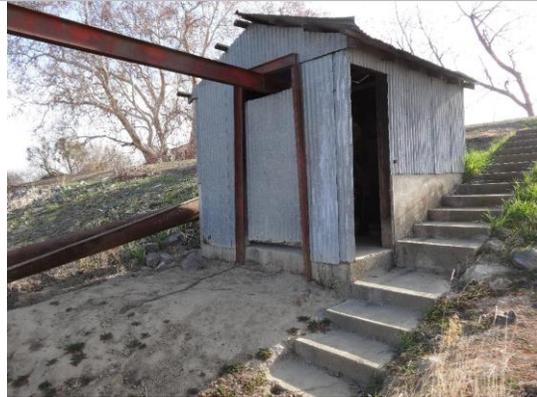
Photo 1 of 3 : UCIP_SP_2020_28903_53162.jpg

Comment Code					
Inspector Comment					
DS_ID:20094 FS_ID:28903 EP_NO: 10080 Repair Type: Non-Urgent Crossing Status: Found UCIP Comments: Pump removed from concrete pad and kept inside pump house (may be for storage purpose) on waterside. A 8-inch steel pipe inside 14-inch pipe. FIELD_STRUCT_DESC: 1 of 2: 14-inch steel irrigation discharge pipe through the levee, 5.2 feet below the crown. Pump in a corrugated metal pump house on the waterside (WS) slope. Butterfly valve on the WS. Concrete staircase on the WS slope. 1.75-inch galvanized iron water line with faucet exposed on the landside (LS) slope, 3.4 feet below the crown. 4-foot by 5.7-foot concrete distribution box at the LS toe. 1.25-inch conduit through levee, 2 feet below the crown. (14-inch steel irrigation discharge pipe through the levee and pump in a corrugated metal pump house on the WS slope authorized under Automatic Board Order (ABO) issued as Permit No. 10080, 1974 - Sebastian Yturralde). [Additional Reference(s): DWR Levee Log, 2005. USACE Sacramento O&M Manual 128, March 1960, (HLM 1.28)]. FS Date: 1/9/2014

WS view: pipe (left), pump house/store, and concrete steps.

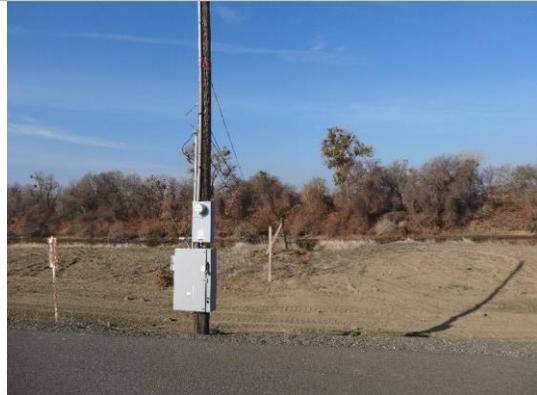
Photo 1 of 3 : UCIP_SP_2020_28204_51875.jpg

Comment Code					
Inspector Comment					
DS_ID:20033 FS_ID:28204 EP_NO: N/A Repair Type: Non-Urgent Crossing Status: Found UCIP Comments: - pump removed- erosion around pump station.- overhead electrical line. FIELD_STRUCT_DESC: 10-inch steel irrigation discharge pipe through the levee, 10 feet below the crown. Pump and gate valve on the riverbank. Service pole and switch panel on the waterside (WS) shoulder. Pipe crosses irrigation ditch and discharges into a steel distribution box in the field. (10-inch steel irrigation discharge pipe through the levee and pump on the riverbank authorized under Automatic Board Order (ABO) issued as Permit No. 10043, 1974 - Leo Giovanetti). [Additional Reference(s): DWR Levee Log, 2005. USACE Sacramento O&M Manual 128, March 1960, (HLM 1.63)]. FS Date: 1/9/2014

WS view: Service pole with control panel on levee shoulder.

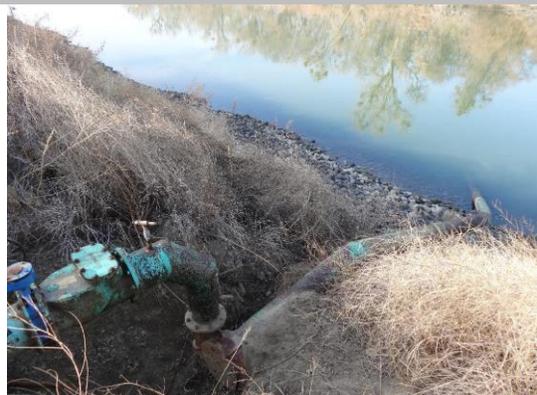
Photo 2 of 3 : UCIP_SP_2020_28204_51874.jpg

WS view: pump (removed) and inlet pipe on river bank.

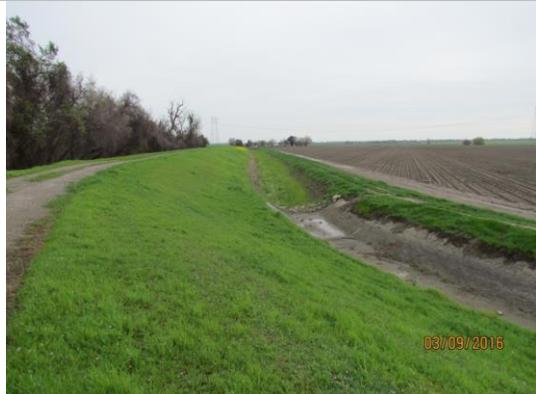
Photo 1 of 1 : SP_2020_RD1500_189_963_20200228_00060.jpg

View of the ditch at the toe of the landward side of the levee looking upstream. Spring 2016.

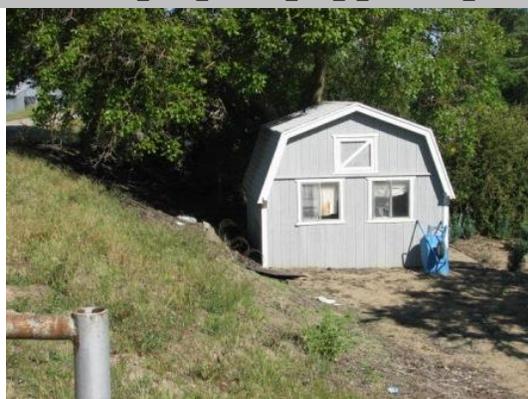
Photo 1 of 2 : SP_2020_RD1500_189_7_20200228_00002.jpg

A small building is encroaching into the landside levee toe.

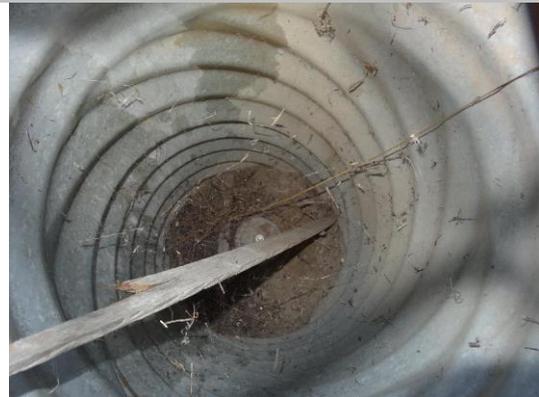
Photo 2 of 3 : UCIP_SP_2020_28912_53180.jpg

Comment Code					
Inspector Comment					
DS_ID:20040 FS_ID:28912 EP_NO: 5031 Repair Type: Non-Urgent Crossing Status: Found UCIP Comments: New butterfly valve in CMP riser on waterside slope. New pipe and pump.Needs cleaning and clearing of siphon breaker in CMP on landside.An abandoned 5x5 foot concrete distribution box on landside. Abandoned pipe found on both sides of the levee. FIELD_STRUCT_DESC: 12-inch steel irrigation discharge pipe through the levee at a slight angle, 4.2 feet below the crown. 2-inch conduit through the levee, 2 feet below the crown. Slant pump on a steel platform on the berm. (Slant pump authorized under Permit No. 5031, 1965 - Gladys Johnston and Helen Dixon). Pipe discharges into an irrigation ditch and an abandoned 5-foot by 5-foot concrete distribution box on the landside. (Pipe originally installed in 1950. 12-inch centrifugal irrigation pump and 14-inch, 12-gage welded steel pipe through the levee authorized under Permit No. 1466, 1950 - Estate of Caroline L. Knox. Pipe reinstalled by USACE in 1958). [Additional Reference(s): DWR Levee Log, 2005. USACE Sacramento O&M Manual 128, March 1960, (HLM 4.71)]. FS Date: 1/9/2014

LS view: obstructed siphon breaker in CMP riser.

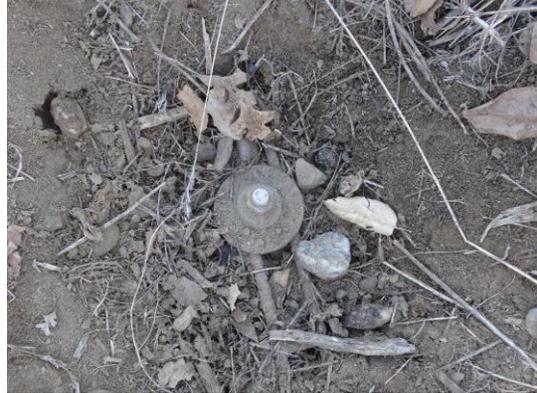
Photo 3 of 3 : UCIP_SP_2020_28913_53182.jpg

Comment Code					
Inspector Comment					
DS_ID:20041 FS_ID:28913 EP_NO: 10056 Repair Type: Non-Urgent Crossing Status: Found UCIP Comments: Depression on landside levee slope around siphon breaker due to leakage. Siphon breaker needs protection. FIELD_STRUCT_DESC: 18-inch steel irrigation discharge pipe through the levee, 4 feet below the crown. 1.5-inch conduit through the levee, 20 feet below the crown. Slant pump in a corrugated metal pump house on the waterside (WS). Wooden steps on the WS slope. Siphon breaker on the landside (LS) slope. 5-foot by 5-foot concrete distribution box at the LS toe. (18-inch steel irrigation discharge pipe and all other elements of this irrigation structure retained under Automatic Board Order (ABO) issued as Permit No. 10056, 1974 - Philip Leiser). [Additional Reference(s): DWR Levee Log, 2005. USACE Sacramento O&M Manual 128, March 1960, (HLM 5.23)]. FS Date: 1/9/2014

LS view: leaky and obstructed siphon breaker. Depression around siphon breaker due to leakage.

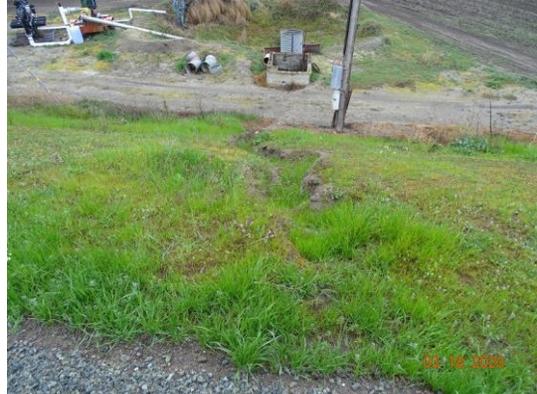
Photo 1 of 1 : SP_2020_RD1500_189_139_20200319_00204.jpg

LM Start	5.19	Rating **	M	Issue No.	139
LM End	5.19	Issue Type +	Ma	Location *	LS
Category	Earthen Levee			GPS Latitude/Longitude	
				Start	End
Item	Erosion / Bank Caving			38.802344 °	38.802344 °
				-121.712940 °	-121.712940 °
DWR ID	DWR_RD1500_01_s_2020_139				
Comment Code					
E2 : Schedule repair of erosion site prior to the next inspection.					
Inspector Comment					
Runoff erosion on the landside slope.

View of the erosion on the landside slope. Spring 2020.

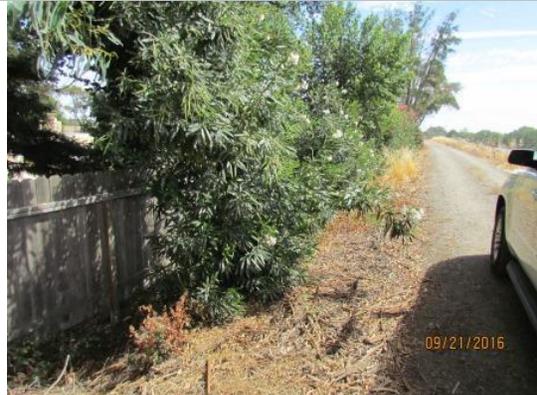
Photo 1 of 1 : SP_2020_RD1500_189_125_20200228_00051.jpg

View of fence and vegetation on LS slope. Fall 2016.

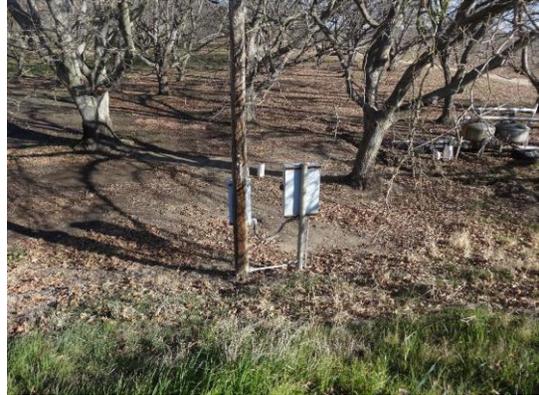
Photo 3 of 3 : UCIP_SP_2020_28923_53200.jpg

LS view: service pole and switch board on levee toe. No other apurtenances found on landside.

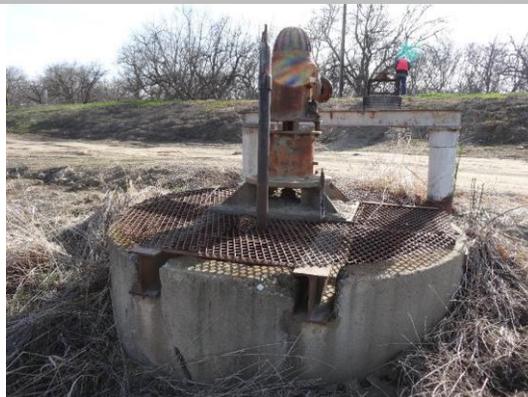
Photo 2 of 3 : UCIP_SP_2020_28324_52130.jpg

WS view: vertical pump on concrete sump on levee berm. Looks abandoned.

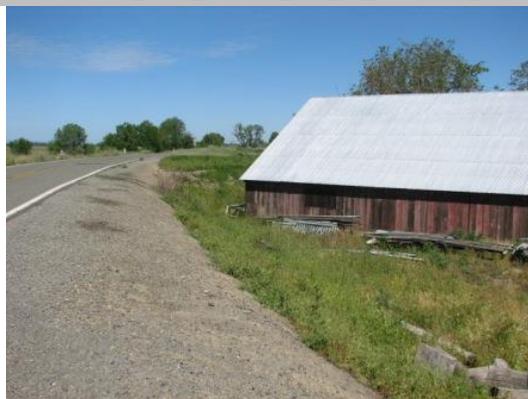
Photo 1 of 1 : SP_2020_RD1500_189_18_20200228_00006.jpg

The corner of the building has encroached into the toe.

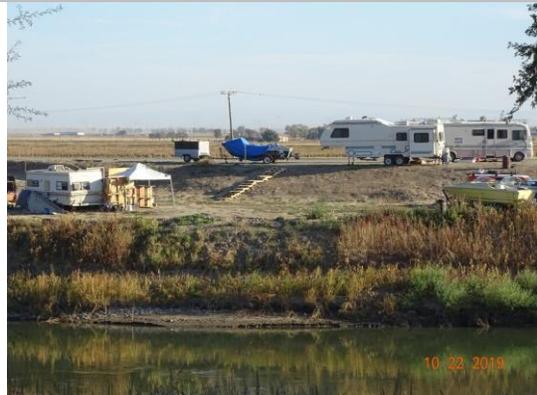
Photo 2 of 2 : SP_2020_RD1500_189_137_20200319_00203.jpg

View of the campers on the waterside berm. Fall 2019.

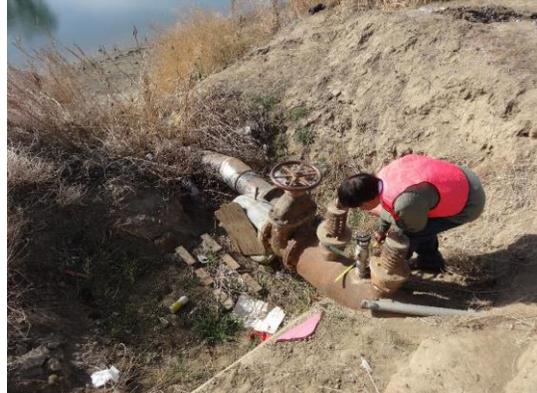
Photo 3 of 3 : UCIP_SP_2020_28365_52179.jpg

LS view: U type concrete headwall, pipe, gate valve, and pump (removed and plugged with plywood) on river bank.

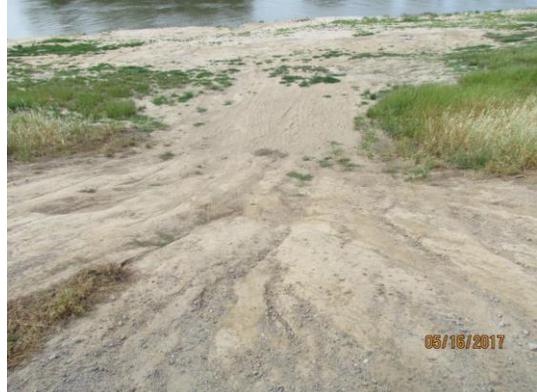
Photo 1 of 1 : SP_2020_RD1500_189_162_20200228_00059.jpg

View of slope stability on waterside slope. Spring 2017.

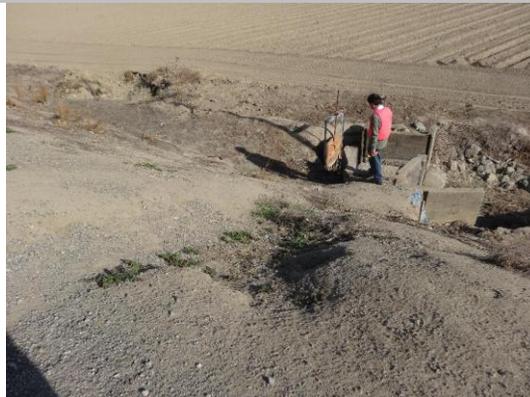
Photo 2 of 3 : UCIP_SP_2020_50069_52189.jpg

LS view: surface erosion along pipe alignment on landside.

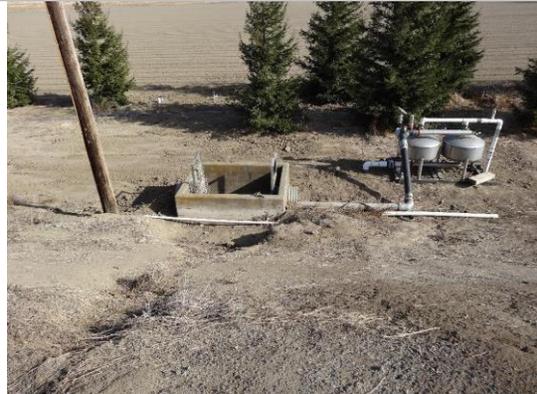
Photo 2 of 3 : UCIP_SP_2020_50198_52219.jpg

LS view: depressions along the pipe alignment on levee slope. It needs detailed investigation.

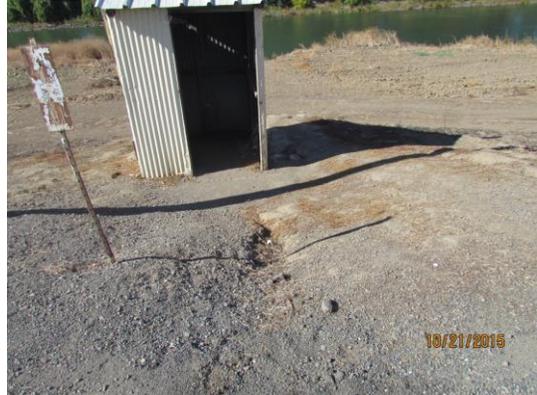
Photo 3 of 3 : SP_2020_RD1500_189_114_20200228_00045.jpg

There is slight erosion on the waterward side of the levee where the pipe seems to run through the levee. Fall 2015.

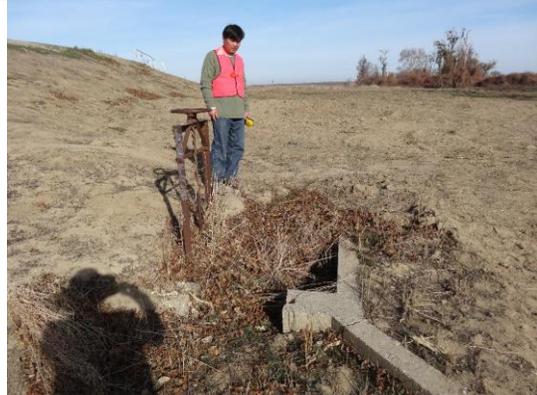
Photo 1 of 3 : UCIP_SP_2020_50197_52425.jpg

WS view: slide gate (left) in concrete box at levee toe. Slide gate and the box mostly buried.

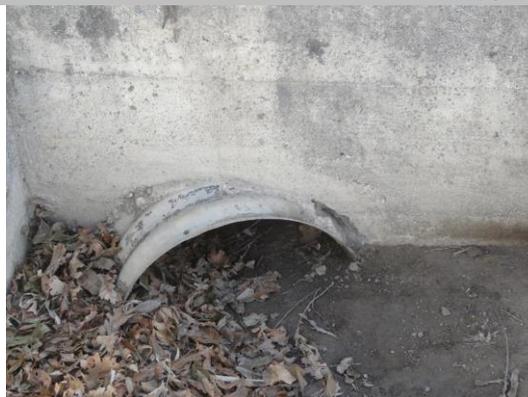
Photo 3 of 3 : UCIP_SP_2020_50197_52423.jpg

LS view: silted CMP in concrete intake box on levee toe.

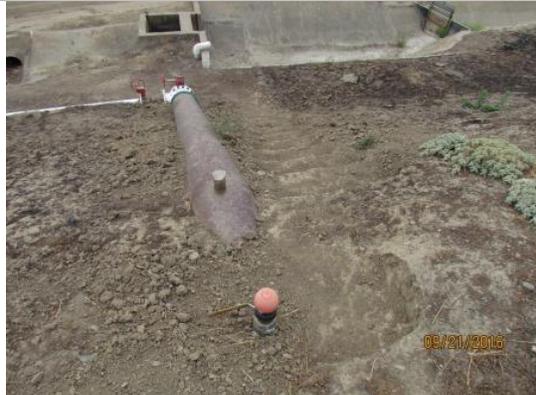
Photo 1 of 1 : SP_2020_RD1500_189_117_20200228_00047.jpg

View of stairs dug on landside levee slope. Fall 2016.

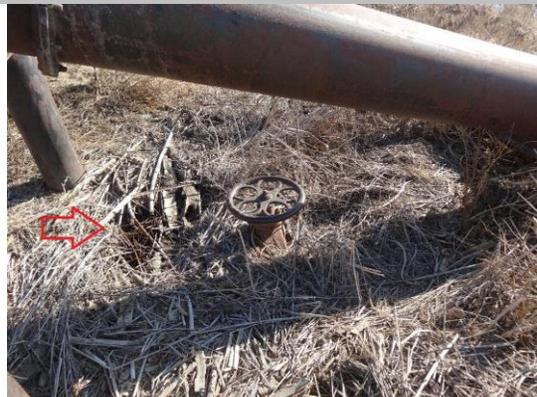
Photo 2 of 3 : UCIP_SP_2020_28583_52626.jpg

WS view: gate valve beneath slant pipe on levee berm. Water leaking from this pipe (marked).

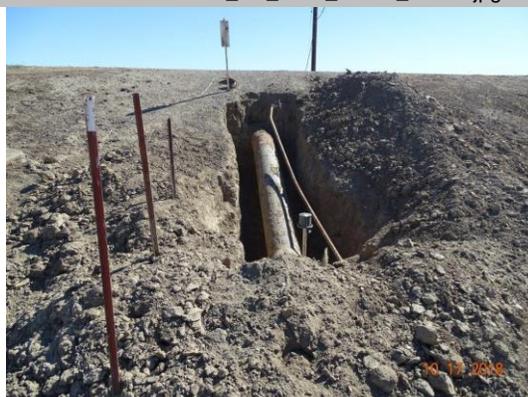
Photo 1 of 3 : UCIP_SP_2020_53023_78166.jpg

WS levee slope was excavated to do pipe maintenance, photo courtesy of Zach Jojola.

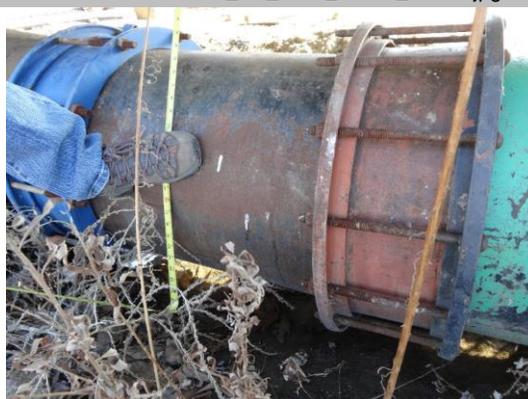
Photo 2 of 3 : UCIP_SP_2020_28603_52666.jpg

WS view: leaky pipe near pump platform. Pipe leaks from the joint.

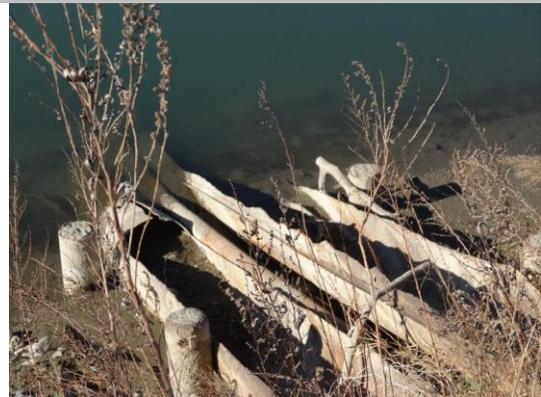
Photo 1 of 2 : UCIP_SP_2020_28629_52709.jpg

WS view: abandoned 24" and 30" steel pipe on river bank.

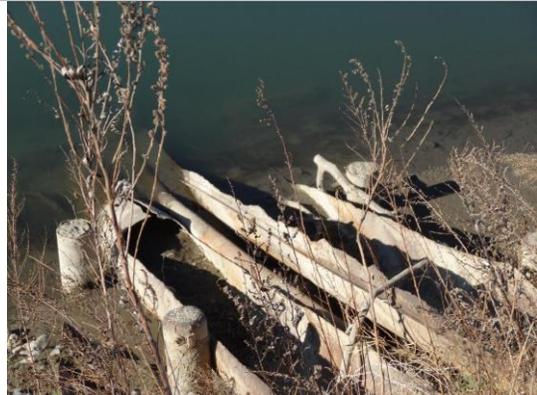
Photo 1 of 2 : UCIP_SP_2020_28628_52705.jpg

WS view: abandoned 24" and 30" steel pipe on river bank.

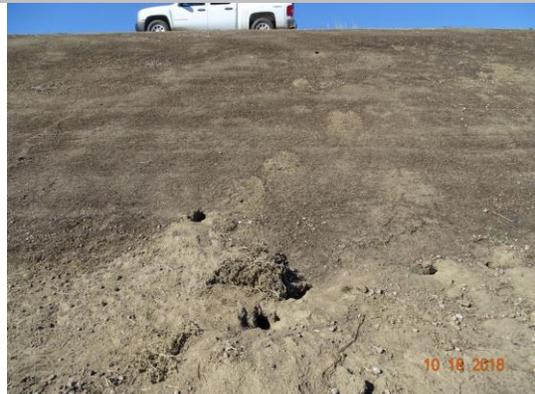
Photo 1 of 1 : SP_2020_RD1500_189_92_20200228_00036.jpg

View of rodent holes on the landside slope. Fall 2018.

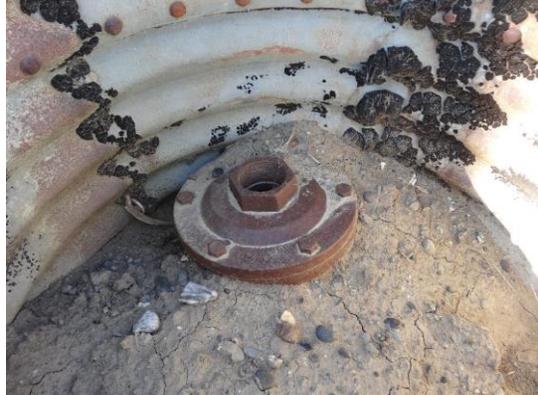
Photo 3 of 3 : UCIP_SP_2020_50201_52853.jpg

LS view: obstructed and leaky siphon breaker in CMP riser on levee slope.

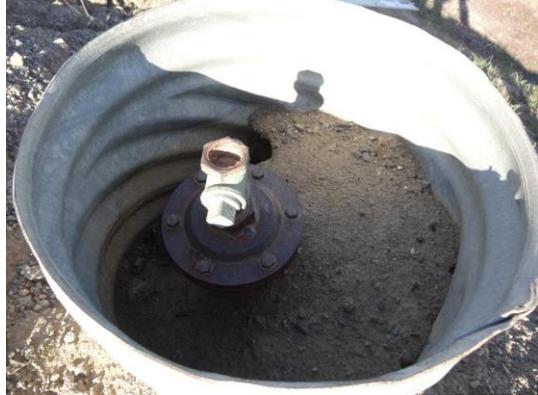
Photo 2 of 3 : UCIP_SP_2020_28144_51811.jpg

LS view: obstructed and leaked pressure breaker in CMP on levee slope.

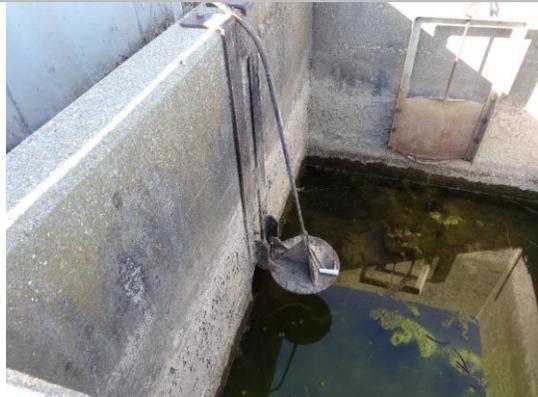
Photo 3 of 3 : UCIP_SP_2020_28144_51815.jpg

LS view: corroded flap gate in concrete distribution box.

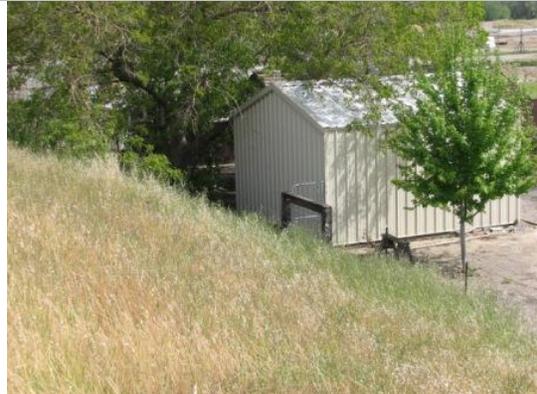
Photo 1 of 1 : SP_2020_RD1500_189_46_20200228_00020.jpg

The building is within the easement of the levee toe.

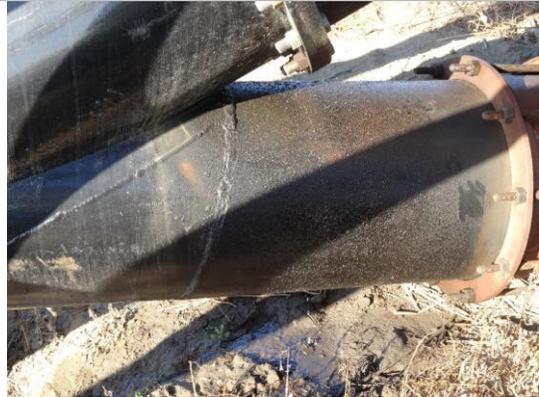
Photo 3 of 3 : UCIP_SP_2020_28953_53254.jpg

WS view: oil and water leaking from pipe near pump.

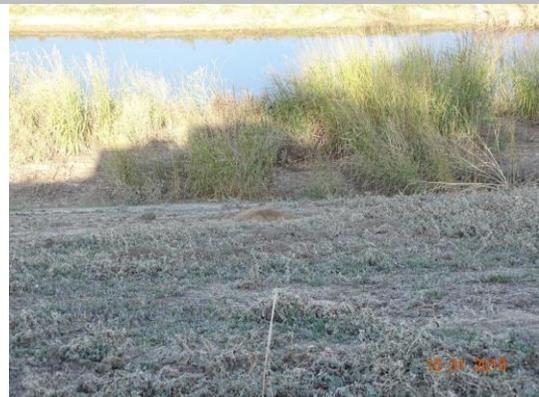
Photo 1 of 1 : SP_2020_RD1500_190_20_20200228_00010.jpg

View of rodent hole on the landside slope. Fall 2019.

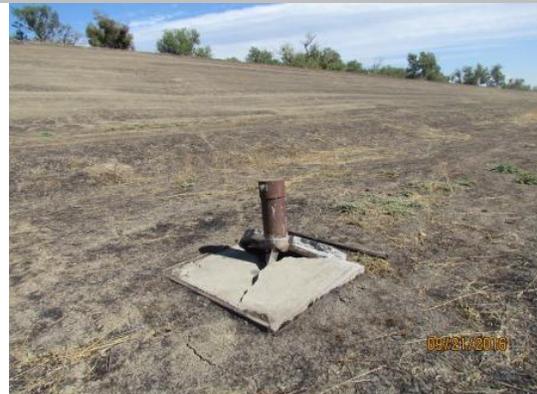
Photo 1 of 3 : SP_2020_RD1500_190_4_20200228_00001.jpg

View of underseepage relief well with destroyed concrete pad as well as PVC pipes. Fall 2016.

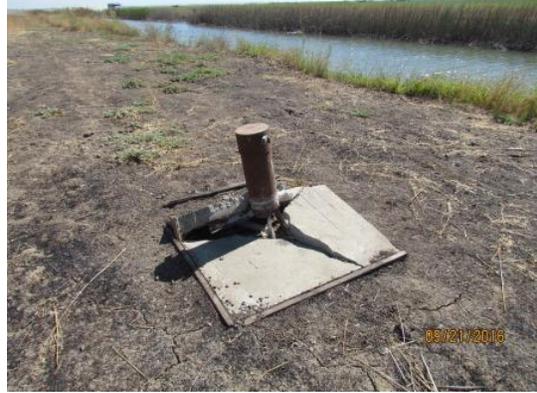
Photo 2 of 3 : SP_2020_RD1500_190_4_20200228_00002.jpg

Another view of damaged well. Fall 2016.
