**Flood Control Project Maintenance  
Levee Inspections**

**Maintenance Issue Types Only, Levee Inspection Report By Mile - Fall 2019**

**Reclamation District No. 1500 Sutter Basin**

Waterway	Bank	Unit Miles	Inspection Start/End	Inspector
Unit No. 01 Sacramento River	Left	33.15	10/30/2019 10/30/2019	Zach Jojola

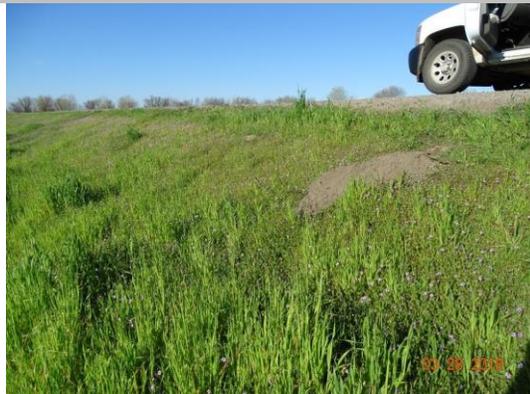
Photo 1 of 2 : FA\_2019\_RD1500\_189\_99\_20190829\_00042.jpg

View of rodent holes. Spring 2018

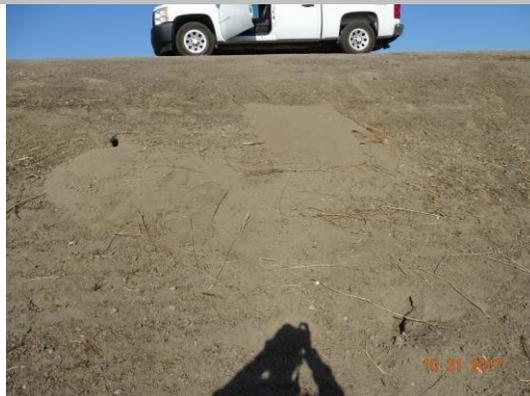
Photo 2 of 2 : FA\_2019\_RD1500\_189\_99\_20190829\_00043.jpg

View of holes and mounds on landside slope. Fall 2017.

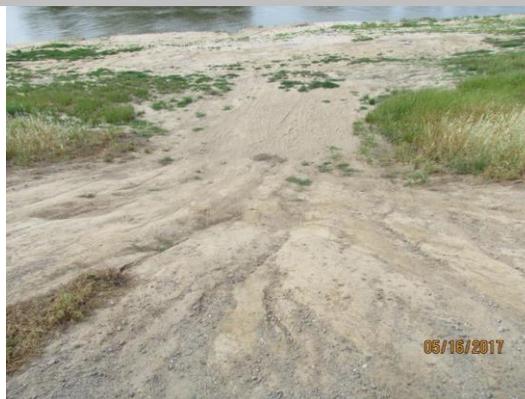
Photo 1 of 1 : FA\_2019\_RD1500\_189\_162\_20190829\_00071.jpg

LM Start	<b>9.71</b>	Rating **	A/W	Issue No.	<b>162</b>
LM End	<b>9.71</b>	Issue Type +	Ma	Location *	WS
Category	Earthen Levee		GPS Latitude/Longitude		
			Start	End	
Item	Slope Stability		38.853564 °	38.853564 °	
			-121.725379 °	-121.725379 °	
DWR ID	DWR_RD1500_01_s_2017_162				
Comment Code					
S3 : Repair the levee slope damaged by vehicle traffic and prevent access where possible.					
Inspector Comment					
The area is heavily accessed by trailer residents and fishermen. Recommend monitoring.

View of slope stability on waterside slope. Spring 2017.

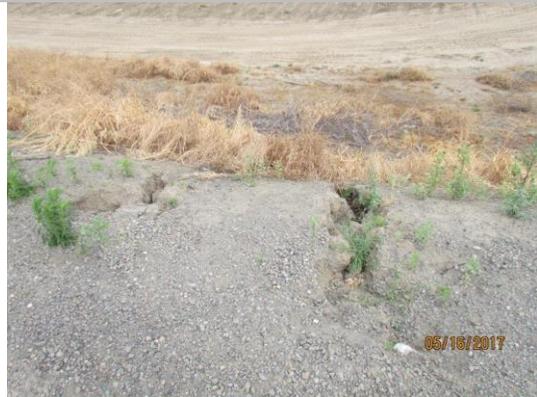
Photo 1 of 1 : FA\_2019\_RD1500\_189\_116\_20190829\_00052.jpg

LM Start	<b>12.01</b>	Rating **	M	Issue No.	<b>116</b>
LM End	<b>12.01</b>	Issue Type +	Ma	Location *	LS
Category	Earthen Levee			GPS Latitude/Longitude	
				Start	End
Item	Erosion / Bank Caving			38.870730°	38.870730°
				-121.752908°	-121.752908°
DWR ID	DWR_RD1500_01_s_2017_116				
Comment Code					
E2 : Schedule repair of erosion site prior to the next inspection.					
Inspector Comment					
There is runoff erosion on the landside levee slope.

View of erosion on landside slope. Spring 2017.

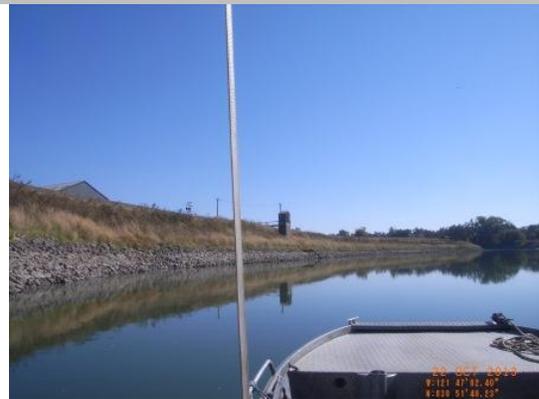
Photo 1 of 1 : FA\_2019\_RD1500\_189\_89\_20190829\_00036.jpg

LM Start	<b>13.98</b>	Rating **	A/W	Issue No.	<b>89</b>
LM End	<b>14.28</b>	Issue Type +	Ma	Location *	WS
Category	Supplemental		GPS Latitude/Longitude		
			Start	End	
Item	2017 USACE Erosion Survey		38.857239°	38.861899°	
			-121.783771°	-121.784057°	
DWR ID	DWR_RD1500_01_f_2018_89				
Comment Code					
Inspector Comment					
2017 Site ID: SAC 99.0 L Status: Eroding 2017 Field Notes: Rock continues to unravel. Site History: 1997 - Intermittent toe failure of the hand placed riprap; failure of toe materials.

USACE 2013 Photo #1

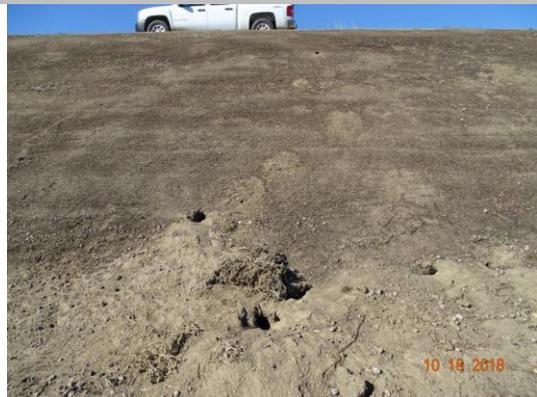
Photo 1 of 1 : FA\_2019\_RD1500\_189\_92\_20190829\_00037.jpg

View of rodent holes on the landside slope. Fall 2018.

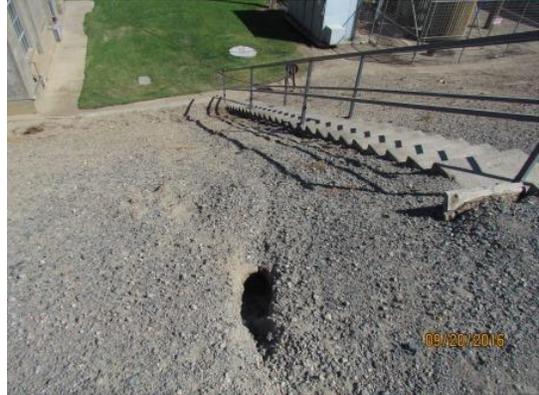
Photo 1 of 1 : FA\_2019\_RD1500\_189\_107\_20190829\_00046.jpg

View of rodent burrows on landside slope. Fall 2016.

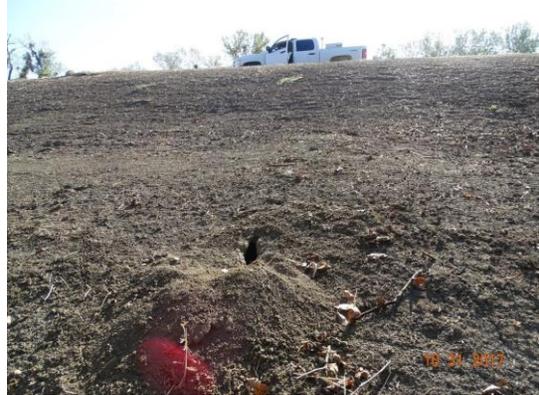
Photo 1 of 1 : FA\_2019\_RD1500\_190\_39\_20190829\_00011.jpg

View of rodent hole on landside slope. Fall 2017.

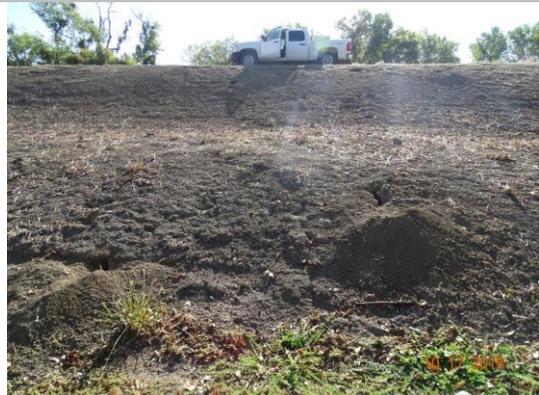
Photo 1 of 1 : FA\_2019\_RD1500\_190\_16\_20190829\_00009.jpg

LM Start	<b>0.14</b>	Rating **	M	Issue No.	<b>16</b>
LM End	<b>0.14</b>	Issue Type +	Ma	Location *	LS
Category	Earthen Levee		GPS Latitude/Longitude		
			Start	End	
Item	Animal Control		38.762564 °	38.762564 °	
			-121.672771 °	-121.672771 °	
DWR ID	DWR_RD1500_02_f_2018_16				
Comment Code					
A3 : No rodents visible, but rodent burrows visible; need to backfill and compact or grout burrows.					
Inspector Comment					
There are multiple holes on the landside slope.

View of rodent holes on the landside slope. Fall 2018.

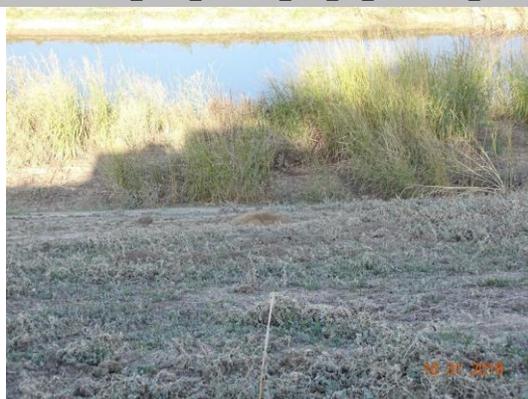
Photo 1 of 1 : FA\_2019\_RD1500\_190\_20\_20191104\_00042.jpg

LM Start	<b>8.31</b>	Rating **	A/W	Issue No.	<b>20</b>
LM End	<b>8.31</b>	Issue Type +	Ma	Location *	LS
Category	Earthen Levee		GPS Latitude/Longitude		
			Start	End	
Item	Animal Control		38.872391 °	38.872391 °	
			-121.642262 °	-121.642262 °	
DWR ID	DWR_RD1500_02_f_2019_20				
Comment Code					
A3 : No rodents visible, but rodent burrows visible; need to backfill and compact or grout burrows.					
Inspector Comment					
Rodent hole on the landside slope. Recommend monitoring.

View of rodent hole on the landside slope. Fall 2019.

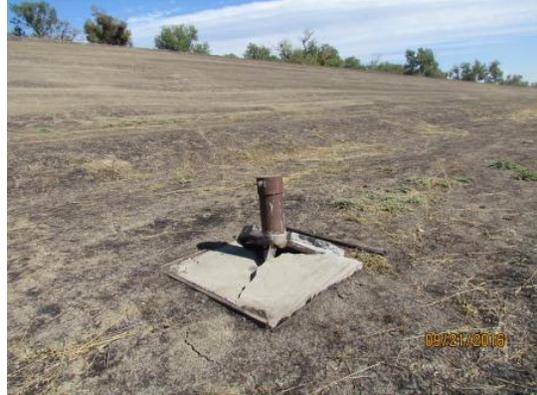
Photo 1 of 3 : FA\_2019\_RD1500\_190\_4\_20190829\_00001.jpg

View of underseepage relief well with destroyed concrete pad as well as PVC pipes. Fall 2016.

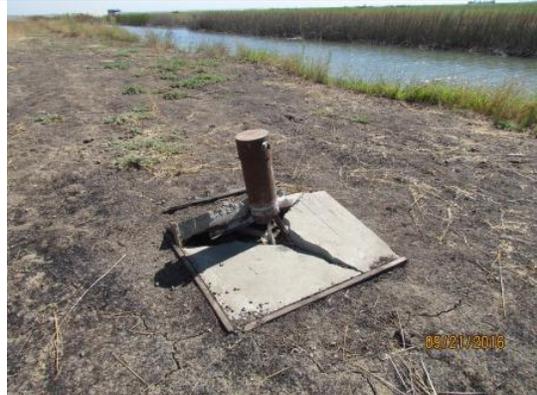
Photo 2 of 3 : FA\_2019\_RD1500\_190\_4\_20190829\_00002.jpg

Another view of damaged well. Fall 2016.

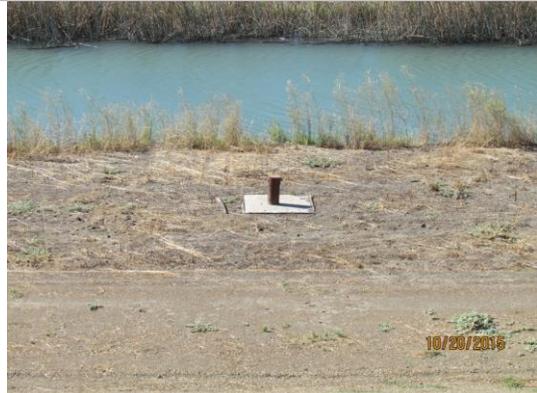
Photo 3 of 3 : FA\_2019\_RD1500\_190\_4\_20190829\_00003.jpg

View of the relief well at historical boil 12. Fall 2015.

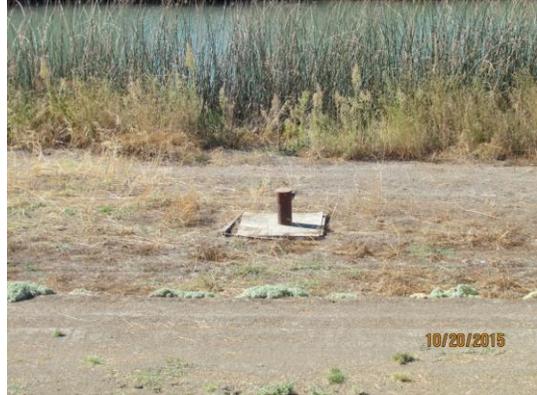
Photo 1 of 1 : FA\_2019\_RD1500\_190\_11\_20190829\_00004.jpg

A relief well at historical boil 16. Fall 2015.

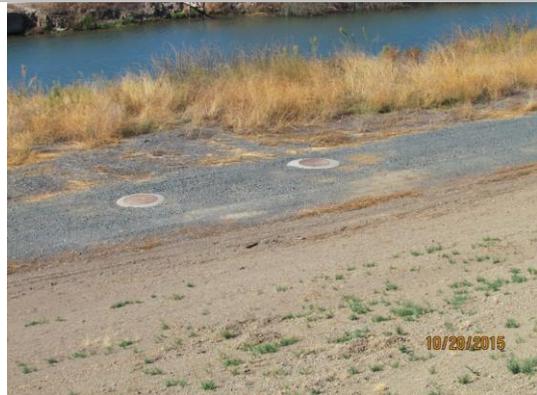
Photo 1 of 2 : FA\_2019\_RD1500\_190\_13\_20190829\_00006.jpg

View of two of four drains on the landward side of the levee. Fall 2015.

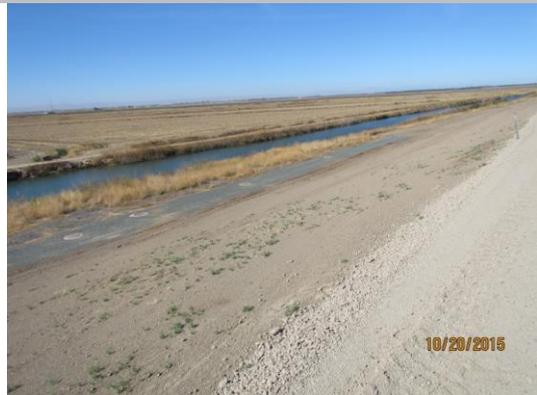
Photo 2 of 2 : FA\_2019\_RD1500\_190\_13\_20190829\_00007.jpg

View of the 4 drains at the levee toe on the landward side. Fall 2015.

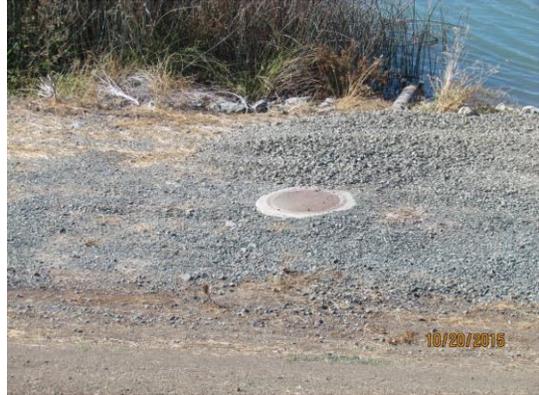
Photo 1 of 1 : FA\_2019\_RD1500\_190\_15\_20190829\_00008.jpg

View of the toe drainage at the landward toe berm. Fall 2015.
