**Flood Control Project Maintenance
Levee Inspections**
LMA District Cover Sheet
Spring 2020 Levee Inspection Results

Reclamation District No. 1600 Mull

Waterway	Bank	Unit Miles
Unit No. 01 Sacramento River	Right	10.46

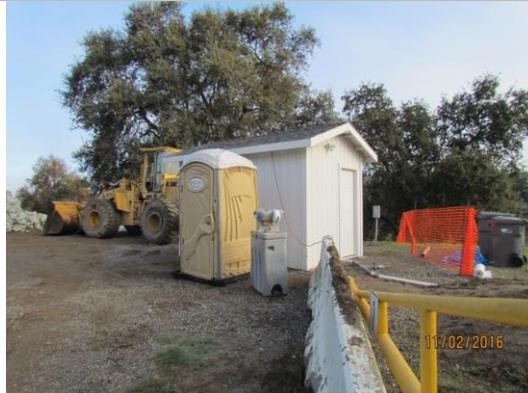
Photo 1 of 1 : SP_2020_RD1600_191_129_20200228_00033.jpg

View of the building. Fall 2016.

LM Start	0.11	Rating **	A/W	Issue No.	1
LM End	0.11	Issue Type +	Ma	Location *	WS
Category	Earthen Levee		GPS Latitude/Longitude		
			Start	End	
Item	Erosion / Bank Caving		38.676524 °	38.676524 °	
			-121.631243 °	-121.631243 °	
DWR ID	DWR_RD1600_01_f_2018_1				
Comment Code					
E1 : Note and monitor erosion site.					
Inspector Comment					
Rills forming on overbuilt section of levee. Not within the prism. Recommend monitoring.

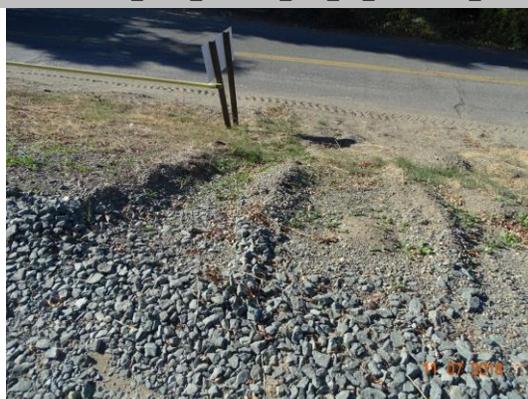
Photo 1 of 1 : SP_2020_RD1600_191_38_20200228_00017.jpg

LM Start	0.11	Rating **	A/W	Issue No.	38
LM End	0.11	Issue Type +	Ma	Location *	LS
Category	Earthen Levee		GPS Latitude/Longitude		
			Start	End	
Item	Slope Stability		38.676524 °	38.676524 °	
			-121.631245 °	-121.631245 °	
DWR ID	DWR_RD1600_01_f_2018_38				
Comment Code					
S3 : Repair the levee slope damaged by vehicle traffic and prevent access where possible.					
Inspector Comment					
Vehicle ruts on the landside slope.

View of ruts on the landside slope. Fall 2018.

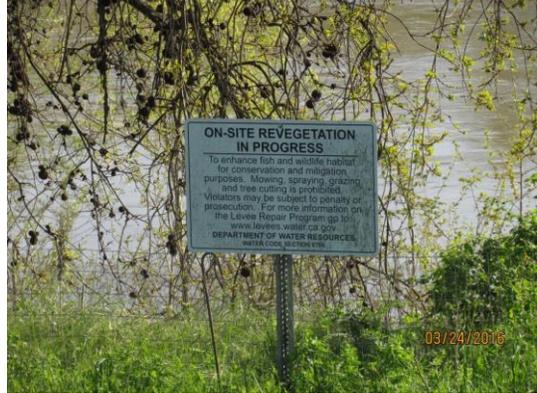
Photo 1 of 2 : SP_2020_RD1600_191_49_20200228_00022.jpg

Sign stating revegetation site. Spring 2016.

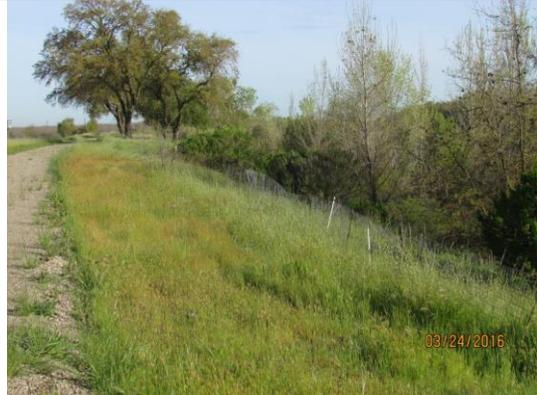
Photo 2 of 2 : SP_2020_RD1600_191_49_20200228_00023.jpg

View of the revegetation site and fence on the waterward side of the levee looking upstream. Spring 2016.

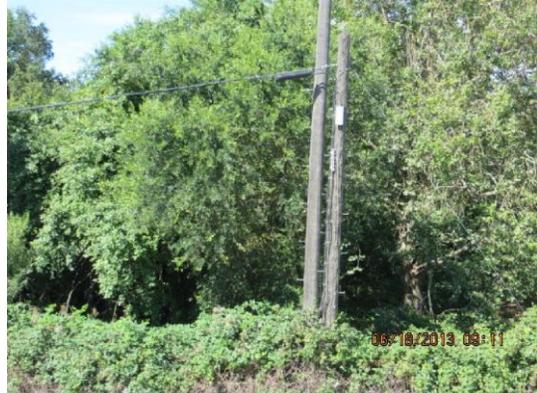
Photo 1 of 1 : UCIP_SP_2020_15087_24812.jpg

LM Start	0.13	Rating **	M	Issue No.	1203
LM End	0.13	Issue Type +	En	Location *	
Category	Supplemental		GPS Latitude/Longitude		
			Start	End	
Item	DWR UCIP Field Study		38.676802 °	38.676802 °	
			-121.631442 °	-121.631442 °	
DWR ID	21459				
Comment Code					
Inspector Comment					
DS_ID:21459 FS_ID:15087 EP_NO: 1929 Repair Type: Non-Urgent Crossing Status: Indicator Found UCIP Comments: Line should be located with carsonite signs on both sides of levee. FIELD_STRUCT_DESC: Telephone conduit of an unknown size or material through the levee, 3 feet below the crown. Telephone line at joint pole (JP) off the landside (LS) toe. (Permit No. 1929, 1954 - Pacific Telephone and Telegraph Company [PT&T]). [Additional Reference(s): DWR Levee Log, 1988]. FS Date: 6/18/2013

Line visible on JP off LS toe. Likely this is the source of crossing.

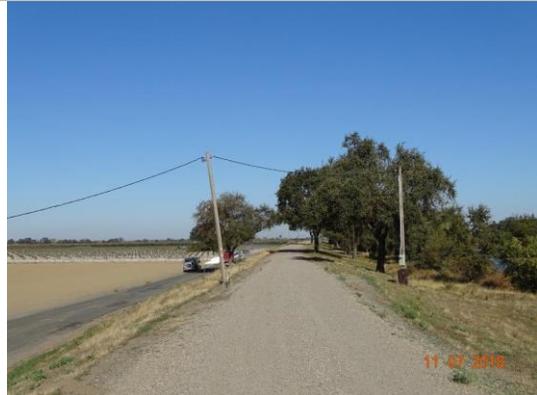
Photo 1 of 1 : SP_2020_RD1600_191_44_20200228_00020.jpg

View of telephone line over levee crown. Fall 2018.

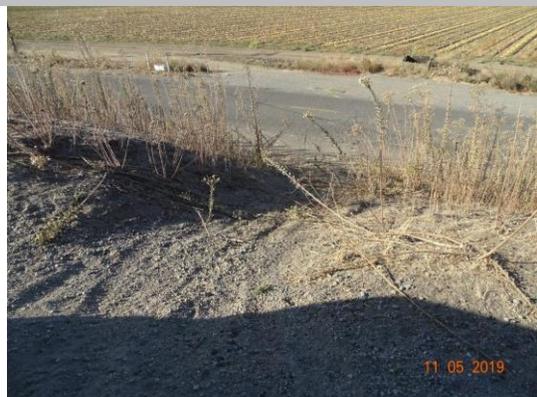
Photo 1 of 1 : SP_2020_RD1600_191_133_20200228_00034.jpg

LM Start	0.53	Rating **	M	Issue No.	133
LM End	0.53	Issue Type +	Ma	Location *	LS
Category	Earthen Levee		GPS Latitude/Longitude		
			Start	End	
Item	Slope Stability		38.682140 °	38.682140 °	
			-121.634083 °	-121.634083 °	
DWR ID	DWR_RD1600_01_f_2013_133				
Comment Code					
S2 : Repair the levee slope damaged by foot traffic and prevent access where possible.					
Inspector Comment					
There appears to be a footpath and settlement on landside slope over pipe crossing.

View of settlement and footpath on landside slope. Fall 2019.

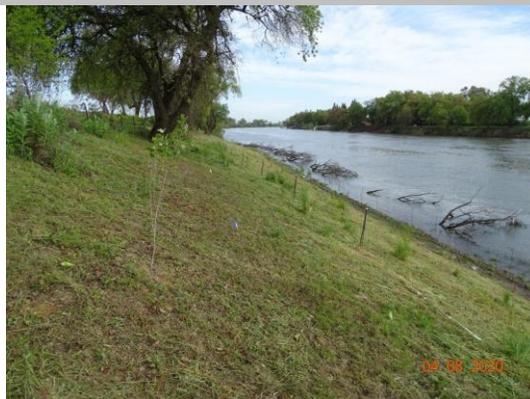
Photo 1 of 2 : SP_2020_RD1600_191_26_20200409_00061.jpg

View of revegetation site on the waterside berm. Spring 2020.

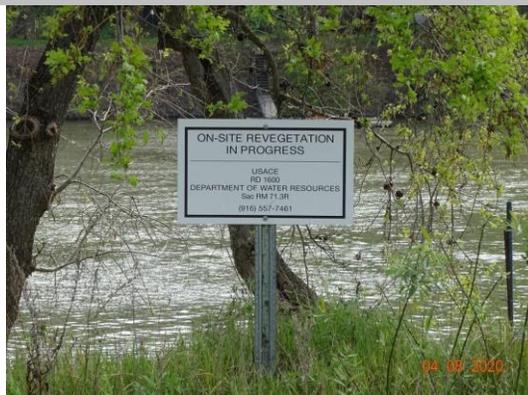
Photo 2 of 2 : SP_2020_RD1600_191_26_20200409_00062.jpg

View of revegetation sign on the waterside berm. Spring 2020.

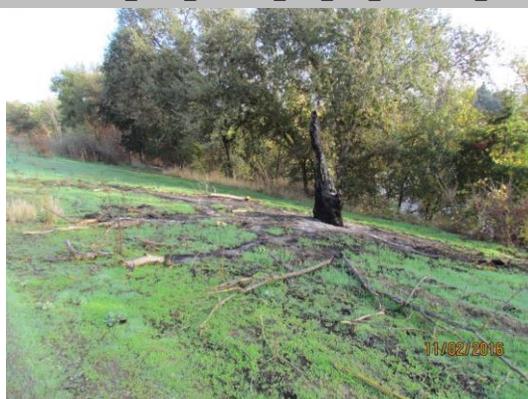
Photo 1 of 1 : SP_2020_RD1600_191_624_20200228_00036.jpg

LM Start	0.78	Rating **	N	Issue No.	624
LM End	0.78	Issue Type +	Ma	Location *	WS
Category	Earthen Levee			GPS Latitude/Longitude	
				Start	End
Item	Trim / Thin Trees			38.685713 °	38.685713 °
				-121.634985 °	-121.634985 °
DWR ID	DWR_RD1600_01_s_2017_624				
Comment Code					
T5 : Tree stumps.					
Inspector Comment					
Burnt stump on waterside slope.

View of burnt tree on waterside slope. Fall 2016.

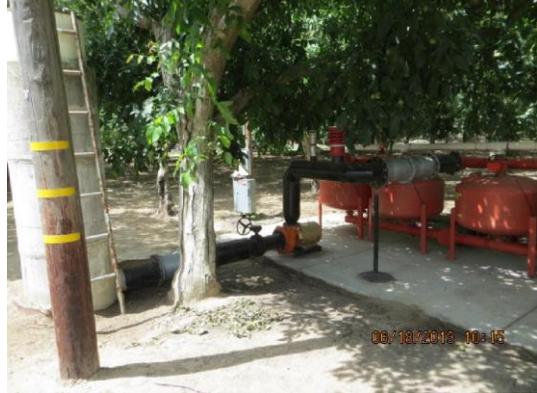
Photo 3 of 3 : UCIP_SP_2020_15285_25086.jpg

Filters, boost pump, and gate valve down stream from concrete standpipe off LS toe.

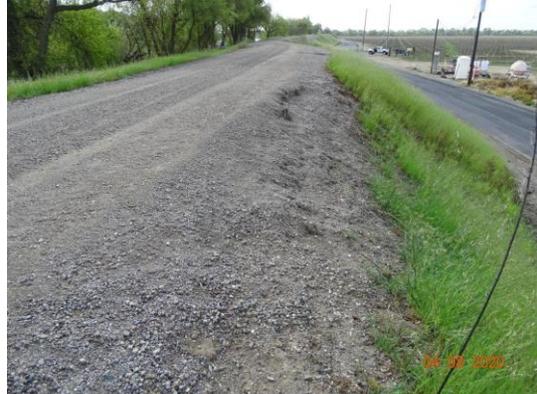
Photo 1 of 1 : SP_2020_RD1600_191_134_20200409_00059.jpg

LM Start	0.97	Rating **	M	Issue No.	134
LM End	0.97	Issue Type +	Ma	Location *	LS
Category	Earthen Levee			GPS Latitude/Longitude	
				Start	End
Item	Erosion / Bank Caving			38.688454 °	38.688454 °
				-121.635528 °	-121.635528 °
DWR ID	DWR_RD1600_01_f_2013_134				
Comment Code					
E2 : Schedule repair of erosion site prior to the next inspection.					
Inspector Comment					
Bank caving on the landside slope.

View of bank caving on the landside slope. Spring 2020.

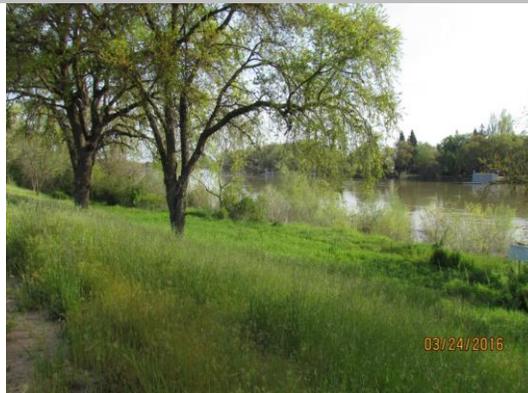
Photo 1 of 2 : SP_2020_RD1600_191_22_20200228_00012.jpg

View of the revegetation site at the berm edge on the waterward side of the levee looking upstream. Spring 2016.

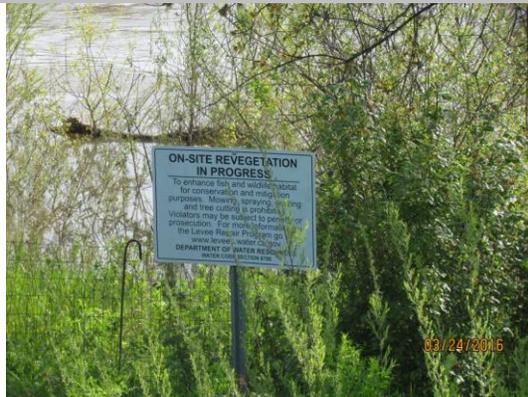
Photo 2 of 2 : SP_2020_RD1600_191_22_20200228_00013.jpg

Sign stating revegetation site. Spring 2016.

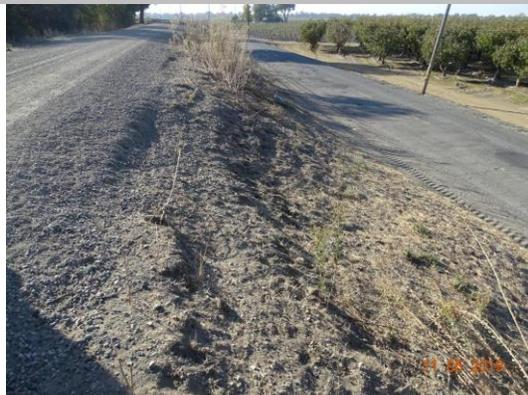
Photo 1 of 1 : SP_2020_RD1600_191_40_20200228_00018.jpg

LM Start	1.10	Rating **	M	Issue No.	40
LM End	1.10	Issue Type +	Ma	Location *	LS
Category	Earthen Levee		GPS Latitude/Longitude		
			Start	End	
Item	Erosion / Bank Caving		38.690393 °	38.690393 °	
			-121.635688 °	-121.635688 °	
DWR ID	DWR_RD1600_01_f_2019_40				
Comment Code					
E2 : Schedule repair of erosion site prior to the next inspection.					
Inspector Comment					
Bank caving on the landside slope.

View of bank caving on the landside slope. Fall 2019.

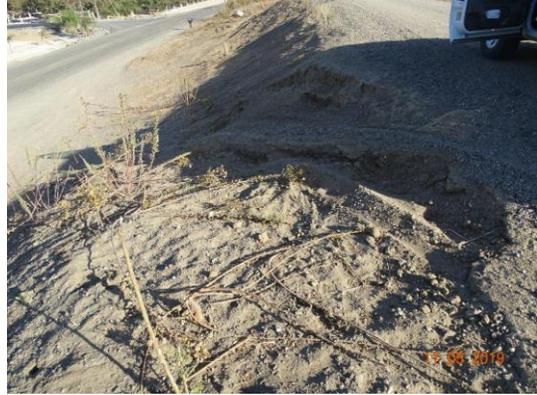
Photo 1 of 1 : SP_2020_RD1600_191_4_20200228_00001.jpg

LM Start	1.40	Rating **	M	Issue No.	4
LM End	1.40	Issue Type +	Ma	Location *	LS
Category	Earthen Levee		GPS Latitude/Longitude		
			Start	End	
Item	Erosion / Bank Caving		38.694452 °	38.694452 °	
			-121.634292 °	-121.634292 °	
DWR ID	DWR_RD1600_01_s_2017_4				
Comment Code					
E2 : Schedule repair of erosion site prior to the next inspection.					
Inspector Comment					
Erosion where tire ruts previously were formed.

View of erosion on the landside slope. Fall 2019.

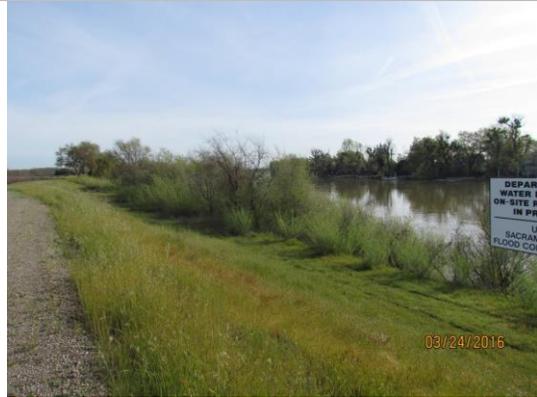
Photo 1 of 2 : SP_2020_RD1600_191_5_20200228_00003.jpg

LM Start	1.40	Rating **	A/W	Issue No.	5
LM End	1.40	Issue Type +	Ob	Location *	WS
Category	Earthen Levee		GPS Latitude/Longitude		
			Start	End	
Item	Vegetation		38.694469 °	38.694469 °	
			-121.634312 °	-121.634312 °	
DWR ID	DWR_RD1600_01_f_2012_5				
Comment Code					
V8 : Environmental Requirements.					
Inspector Comment

View of the revegetation site on the berm of the waterward side of the levee looking upstream. Spring 2016.

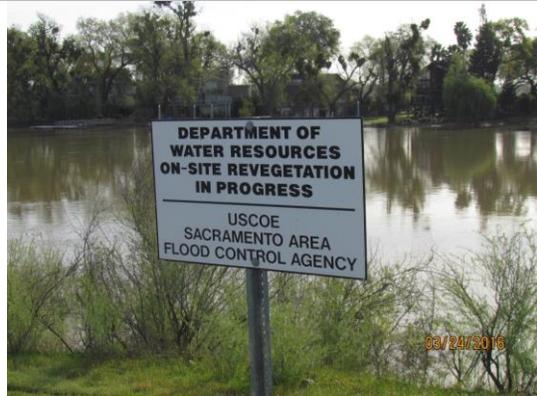
Photo 2 of 2 : SP_2020_RD1600_191_5_20200228_00004.jpg

DWR revegetation site. Spring 2016.

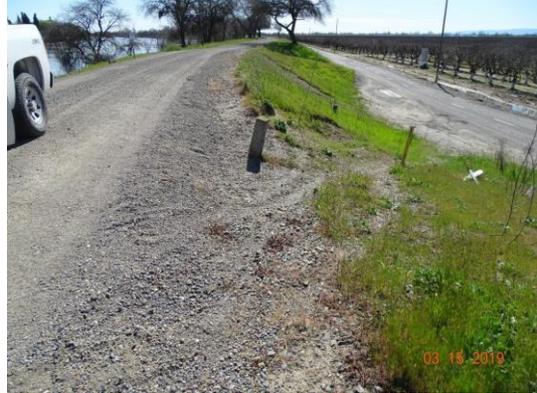
Photo 1 of 1 : SP_2020_RD1600_191_52_20200228_00024.jpg

LM Start	1.42	Rating **	A/W	Issue No.	52
LM End	1.42	Issue Type +	Ma	Location *	LS
Category	Earthen Levee		GPS Latitude/Longitude		
			Start	End	
Item	Slope Stability		38.694728 °	38.694728 °	
			-121.634224 °	-121.634224 °	
DWR ID	DWR_RD1600_01_f_2018_52				
Comment Code					
S3 : Repair the levee slope damaged by vehicle traffic and prevent access where possible.					
Inspector Comment					
Ruts on the landside slope from vehicles. Recommend monitoring for future activity.

View of ruts on landside shoulder. Spring 2019.

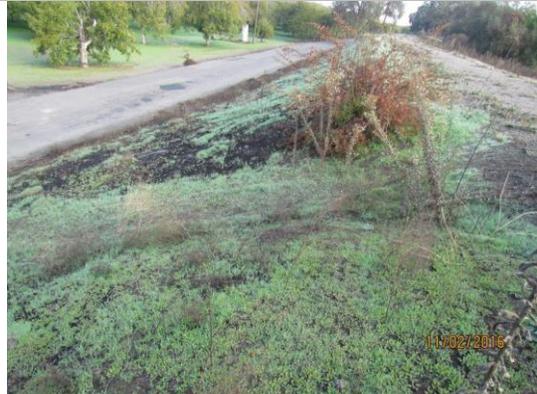
Photo 1 of 1 : SP_2020_RD1600_191_70_20200228_00029.jpg

LM Start	1.70	Rating **	A/W	Issue No.	70
LM End	1.70	Issue Type +	Ma	Location *	LS
Category	Earthen Levee		GPS Latitude/Longitude		
			Start	End	
Item	Slope Stability		38.698414 °	38.698414 °	
			-121.631874 °	-121.631874 °	
DWR ID	DWR_RD1600_01_f_2017_70				
Comment Code					
S3 : Repair the levee slope damaged by vehicle traffic and prevent access where possible.					
Inspector Comment					
Footpath and vehicle access on landside slope. Recommend monitoring.

View of slope instability. Fall 2016.

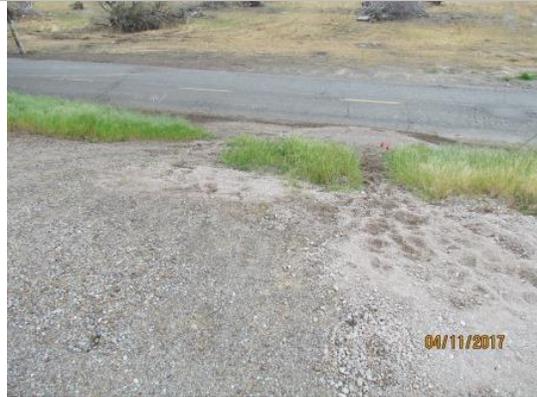
Photo 1 of 1 : SP_2020_RD1600_191_72_20200228_00030.jpg

LM Start	2.01	Rating **	M	Issue No.	72
LM End	2.01	Issue Type +	Ma	Location *	LS
Category	Earthen Levee		GPS Latitude/Longitude		
			Start	End	
Item	Erosion / Bank Caving		38.701605 °	38.701605 °	
			-121.627954 °	-121.627954 °	
DWR ID	DWR_RD1600_01_s_2018_72				
Comment Code					
E2 : Schedule repair of erosion site prior to the next inspection.					
Inspector Comment					
Bank caving on the landside slope.

View of the erosion site. Spring 2017.

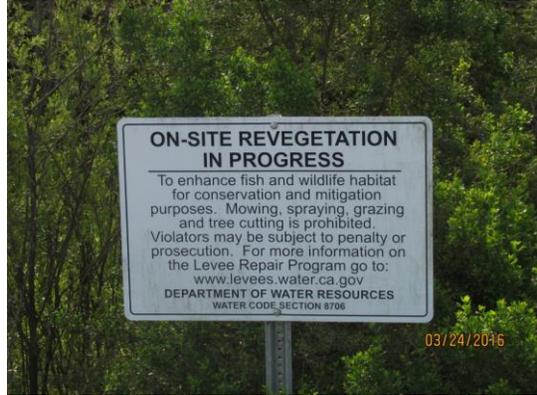
Photo 1 of 2 : SP_2020_RD1600_191_35_20200228_00015.jpg

Sign for revegetation site. Spring 2016.

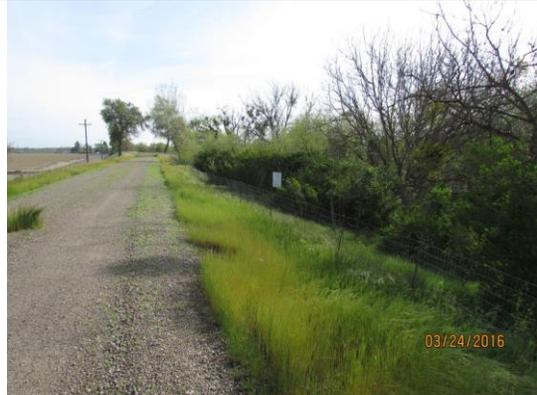
Photo 2 of 2 : SP_2020_RD1600_191_35_20200228_00016.jpg

View of the revegetation site on the waterward side of the levee looking upstream. Spring 2016.

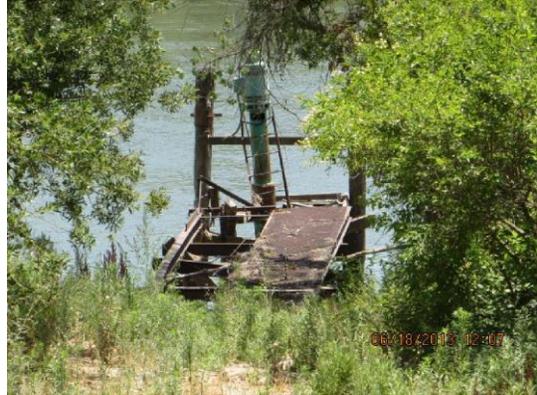
Photo 1 of 3 : UCIP_SP_2020_15108_24826.jpg

Comment Code					
Inspector Comment					
DS_ID:21467 FS_ID:15108 EP_NO: N/A Repair Type: Non-Urgent Crossing Status: Not Found UCIP Comments: Pipe removed and replaced with a pipe dsid 25565 - permit 18852. Appears abandoned and should be done so properly. Debris buildup on pier. Power cut to pump. FIELD_STRUCT_DESC: *REMOVED* 16-inch steel irrigation pipe through the levee, 2 feet below the crown. Walkway from berm to pump on pile structure in the stream. Siphon breaker on the landside (LS) slope. 12-inch polyvinyl chloride (PVC) standpipe off the LS toe. [Additional Reference(s): DWR Levee Log, 1988. USACE Sacramento O&M Manual 123, August 1955, (RM 73.4) (18-inch pipe listed)]. FS Date: 6/18/2013

Pump on metal platform off WS berm.

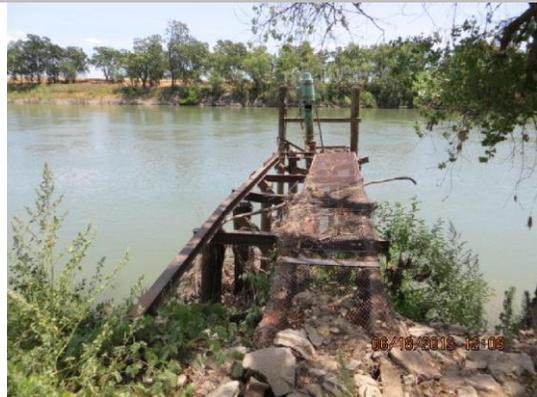
Photo 2 of 3 : UCIP_SP_2020_15108_24825.jpg

Debris buildup at metal platform waterline.

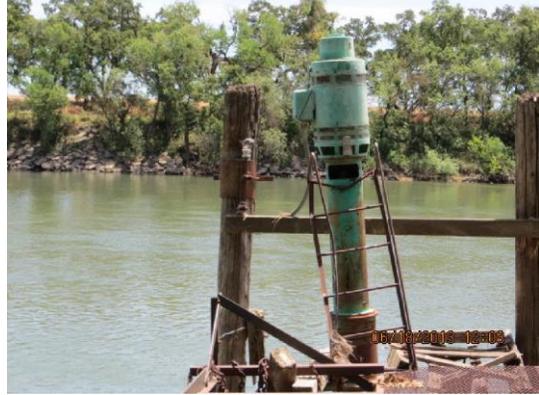
Photo 3 of 3 : UCIP_SP_2020_15108_24824.jpg

Electrical cut to pump.

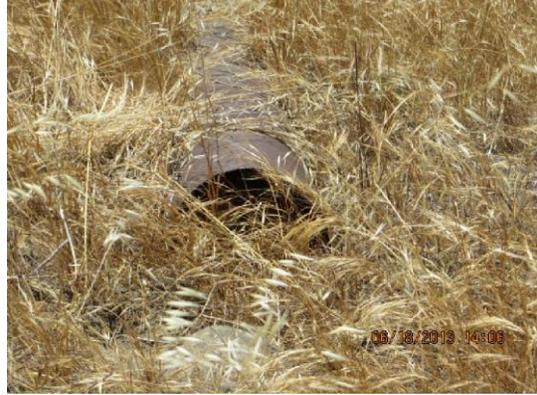
Photo 2 of 2 : UCIP_SP_2020_41563_27473.jpg

Pipe and remnants of grouted pipe on LS slope.

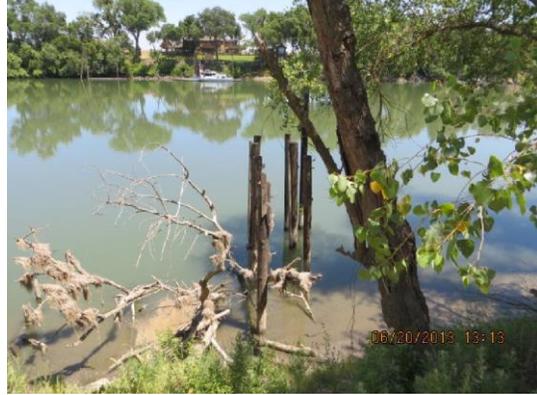
Photo 3 of 3 : UCIP_SP_2020_53410_25012.jpg

Pump missing from pier on WS toe.

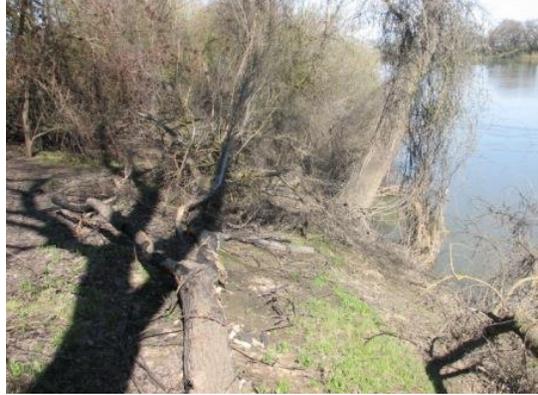
Photo 1 of 1 : SP_2020_RD1600_191_20_20200228_00007.jpg

View of erosion on the waterside berm.

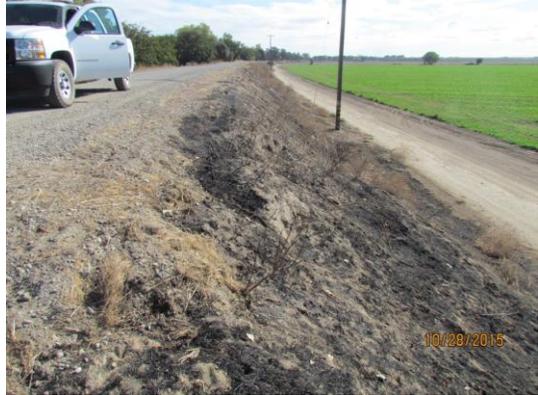
Photo 1 of 1 : SP_2020_RD1600_191_61_20200228_00026.jpg

View of the erosion on the landward side of the levee looking downstream. Fall 2015.

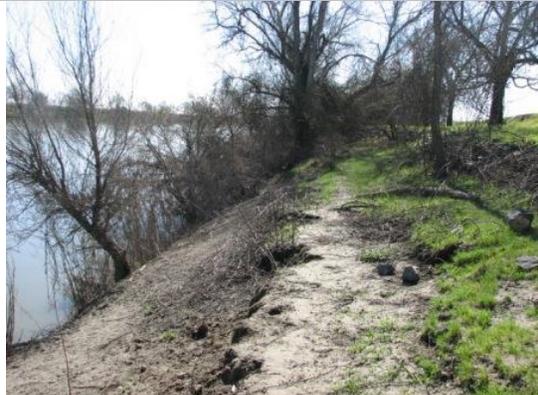
Photo 1 of 2 : SP_2020_RD1600_191_21_20200228_00009.jpg

The erosion is eroding away the berm area.

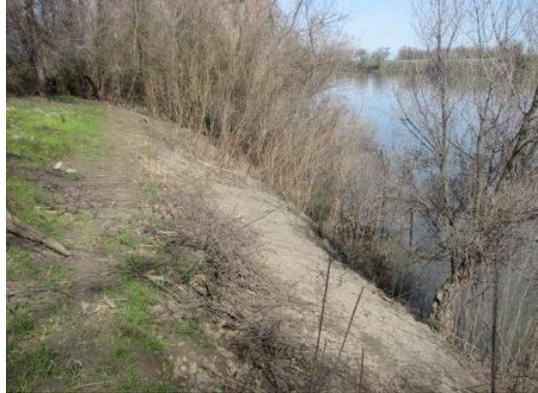
Photo 2 of 2 : SP_2020_RD1600_191_21_20200228_00010.jpg

The bank is eroding away and has become very steep.

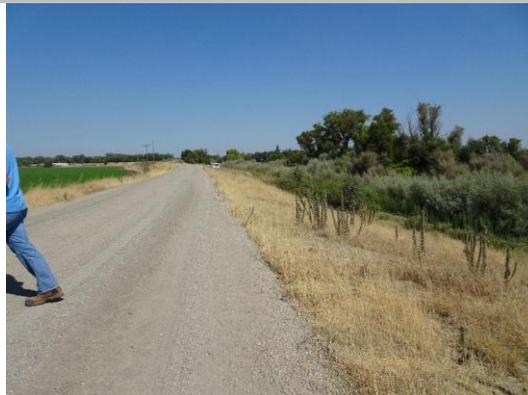
Photo 3 of 3 : UCIP_SP_2020_50169_75609.jpg

view of levee crown looking upstream from pipe location.

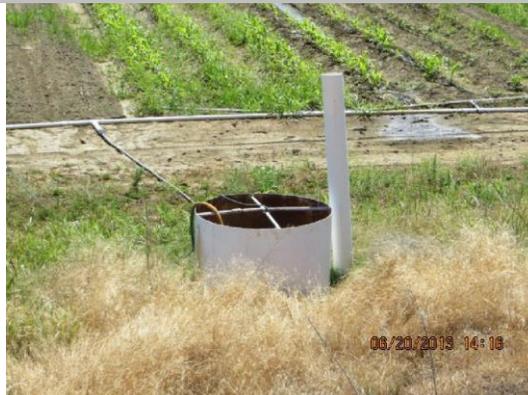
Photo 1 of 1 : UCIP_SP_2020_16310_27485.jpg

4-foot diameter steel standpipe at LS toe, may be indicator of pipe location.

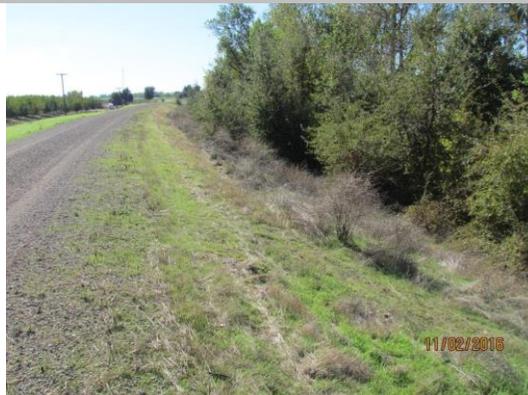
Photo 1 of 1 : SP_2020_RD1600_191_66_20200228_00028.jpg

Vegetation on WS slope has been cleared only about 10 ft. from the crown. Fall 2016.

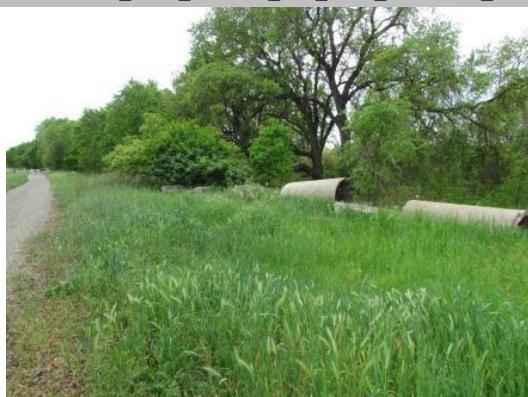
Photo 1 of 1 : SP_2020_RD1600_191_1202_20200228_00037.jpg

View of debris on the waterward side of the levee looking upstream. Spring 2015.

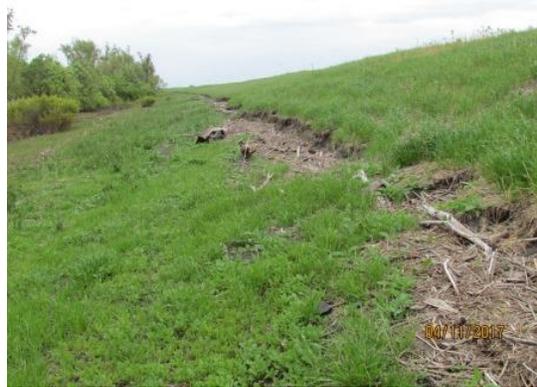
Photo 1 of 1 : SP_2020_RD1600_192_23_20200228_00017.jpg

View of wave wash damage on waterside levee slope. Spring 2017.

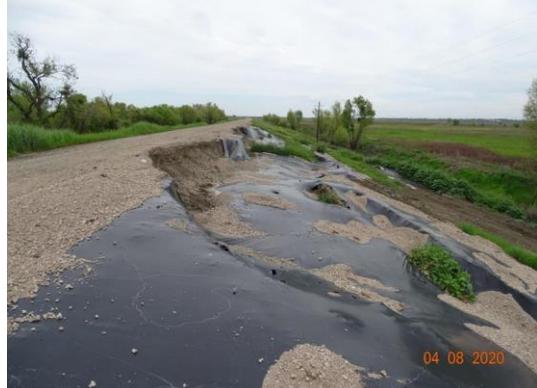
Photo 1 of 2 : SP_2020_RD1600_192_8_20200409_00025.jpg

View of sloughing on the landside slope. Spring 2020.

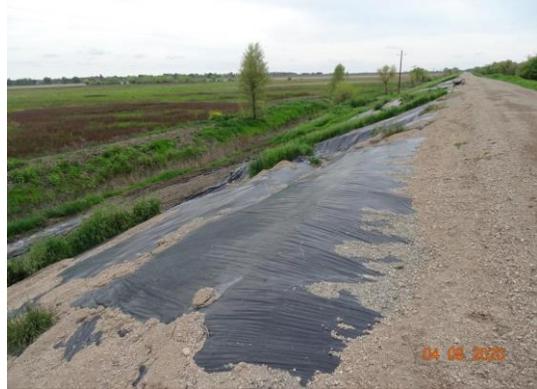
Photo 2 of 2 : SP_2020_RD1600_192_8_20200409_00024.jpg

View of sloughing on the landside slope. Spring 2020.

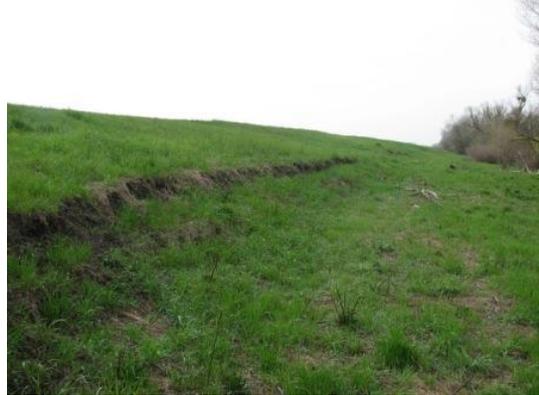
Photo 1 of 2 : SP_2020_RD1600_192_14_20200228_00007.jpg

A closer view of the wave wash damage along the bypass.

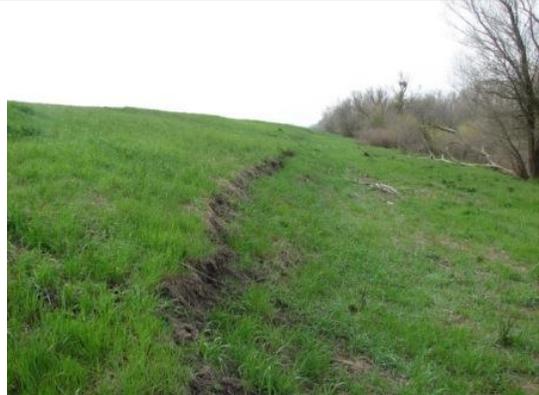
Photo 2 of 2 : SP_2020_RD1600_192_14_20200228_00008.jpg

Wave wash damage along the slope the cut is 1'-2'.

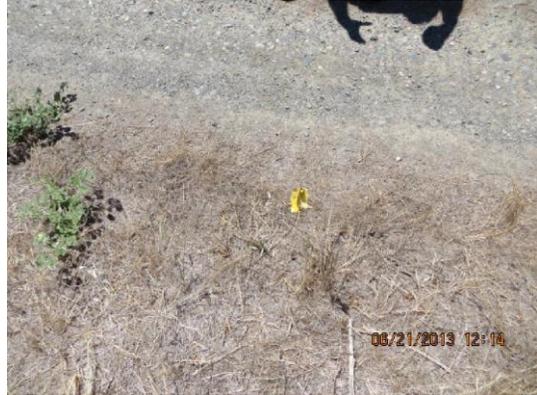
Photo 1 of 3 : UCIP_SP_2020_52738_27478.jpg

PG&E marker flag on Crown.

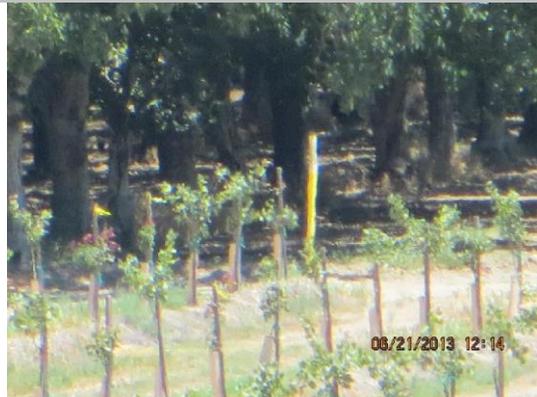
Photo 2 of 3 : UCIP_SP_2020_52738_27477.jpg

Carsonite gasline marker visible approximately 1,000-feet east of levee crown.

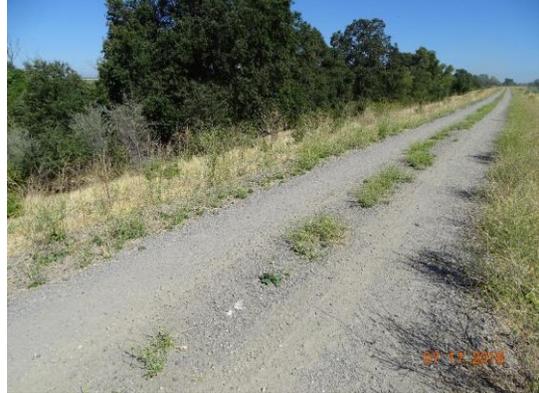
Photo 3 of 3 : UCIP_SP_2020_52738_77709.jpg

View of levee crown at potential crossing looking upstream.

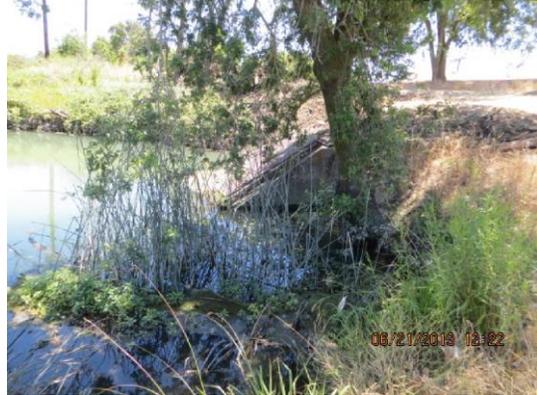
Photo 1 of 3 : UCIP_SP_2020_15303_25158.jpg

Concrete intake structure on LS.

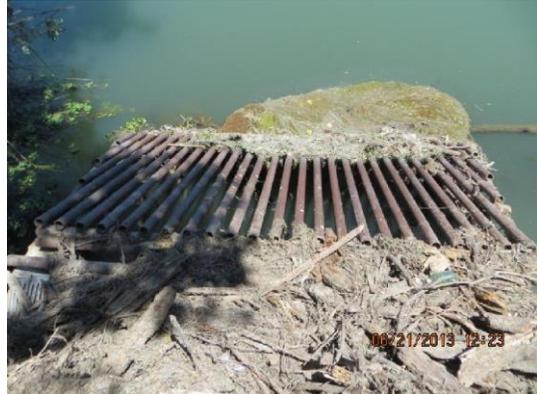
Photo 2 of 3 : UCIP_SP_2020_15303_25157.jpg

Concrete intake structure on LS.

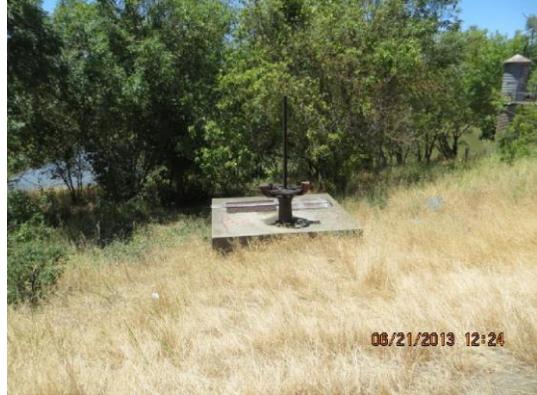
Photo 3 of 3 : UCIP_SP_2020_15303_25156.jpg

Slide gate in 9'X10' concrete box on WS slope.
