**Flood Control Project Maintenance  
Levee Inspections**

**Fall 2019 Levee Maintenance Deficiency Summary Report**

**Reclamation District No. 1660 Tisdale**

**Levee Inspection Report By Mile - Fall 2019**

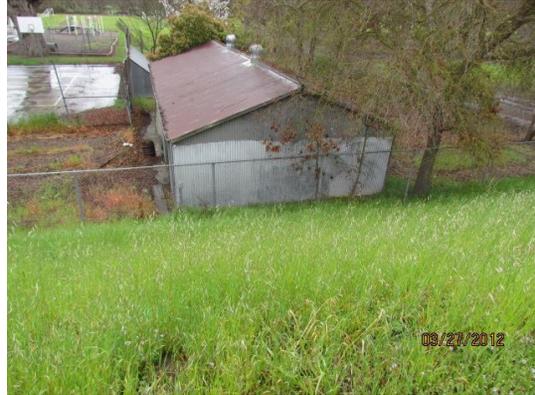
Photo 1 of 1 : FA\_2019\_RD1660\_8\_12\_20190822\_00005.jpg

LM Start	<b>0.05</b>	Rating **	M	Issue No.	<b>12</b>
LM End	<b>0.05</b>	Issue Type +	En	Location *	LS
Category	Earthen Levee			GPS Latitude/Longitude	
				Start	End
Item	Encroachments			39.062643°	39.062643°
				-121.837857°	-121.837857°
DWR ID	DWR_RD1660_01_s_2012_12				
Comment Code					
BU : Building					
Inspector Comment

View of the building and fence at the landside toe.

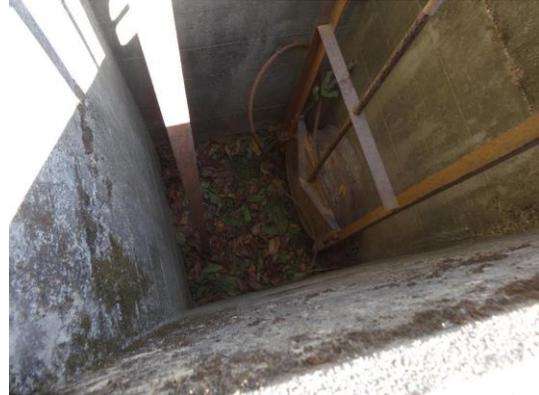
Photo 3 of 3 : UCIP\_FA\_2019\_46670\_38105.jpg

Item	DRAFT DWR UCIP LMA Responsibility			39.061322°	39.061322°
				-121.837993°	-121.837993°
DWR ID	22489				
Comment Code					
Inspector Comment					
DS_ID:22489 FS_ID:46670 EP_NO: N/A Repair Type: Non-Urgent Crossing Status: Found UCIP Comments: - needs proper abandonment.- opening of landside pipe almost burried. FIELD_STRUCT_DESC: *ABANDONED* 24-inch corrugated metal gravity drainage pipe through the levee, 16.4 feet below the crown. Two corrugated metal cutoff walls. Slide gate in a concrete well at the waterside (WS) toe. (IV A-Winship). USACE bench mark on the top of the headwall at the landside (LS) toe. [Additional Reference(s): DWR Levee Log, 2005. USACE Sacramento O&M Manual 133, August 1955, (Station 2+07.8)]. FS Date: 10/10/2013

WS view: closer view of two slide gates in concrete box on levee slope.

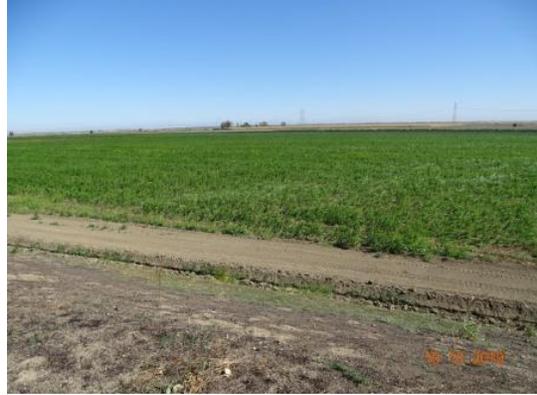
Photo 1 of 1 : FA\_2019\_RD1660\_8\_11\_20191011\_00020.jpg

LM Start	<b>0.68</b>	Rating **	M	Issue No.	<b>11</b>
LM End	<b>0.96</b>	Issue Type +	En	Location *	LS
Category	Earthen Levee		GPS Latitude/Longitude		
			Start	End	
Item	Encroachments		39.053604 °	39.049522 °	
			-121.839538 °	-121.839354 °	
DWR ID	DWR_RD1660_01_f_2019_11				
Comment Code					
DT : Ditch					
Inspector Comment

View of the ditch along the landside toe. Fall 2019.

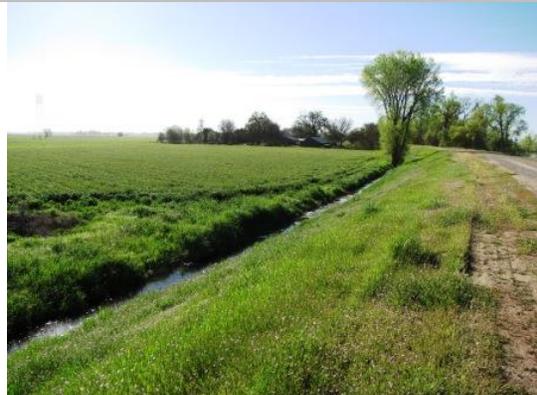
Photo 1 of 1 : FA\_2019\_RD1660\_8\_9\_20190822\_00004.jpg

LM Start	<b>1.10</b>	Rating **	M	Issue No.	<b>9</b>
LM End	<b>1.45</b>	Issue Type +	En	Location *	LS
Category	Earthen Levee		GPS Latitude/Longitude		
			Start	End	
Item	Encroachments		39.047610 °	39.043221 °	
			-121.838802 °	-121.835815 °	
DWR ID	DWR_RD1660_01_s_2012_9				
Comment Code					
DT : Ditch					
Inspector Comment

View of a ditch along the landside toe.

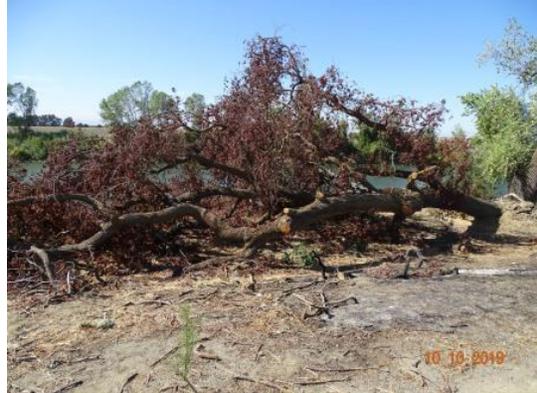
Photo 1 of 1 : FA\_2019\_RD1660\_8\_13\_20191011\_00021.jpg

LM Start	<b>1.22</b>	Rating **	U	Issue No.	<b>13</b>
LM End	<b>1.22</b>	Issue Type +	Ma	Location *	WS
Category	Earthen Levee		GPS Latitude/Longitude		
			Start	End	
Item	Encroachments		39.045932 °	39.045932 °	
			-121.838241 °	-121.838241 °	
DWR ID	DWR_RD1660_01_f_2019_13				
Comment Code					
TR : Tree or limb					
Inspector Comment					
The large fallen tree should be removed from the waterside slope.

View of the large fallen tree on the waterside slope. Fall 2019.

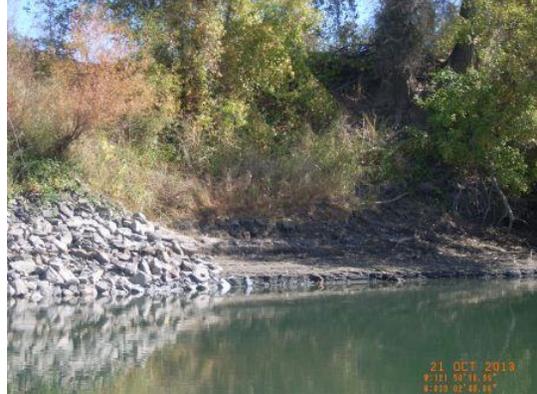
Photo 1 of 1 : FA\_2019\_RD1660\_8\_8\_20190822\_00003.jpg

LM Start	<b>1.33</b>	Rating **	A/W	Issue No.	<b>8</b>
LM End	<b>1.36</b>	Issue Type +	Ma	Location *	WS
Category	Supplemental		GPS Latitude/Longitude		
			Start	End	
Item	2017 USACE Erosion Survey		39.044361 °	39.043916 °	
			-121.837654 °	-121.837305 °	
DWR ID	DWR_RD1660_01_f_2018_8				
Comment Code					
Inspector Comment					
2017 Site ID: SAC 120.6 L Status: Eroding 2017 Field Notes: No observed change. Site History: 2009 - Erosion on levee toe where an old cobble site is failing. 2011 - Some new minor erosion. 2012 - Site extended downstream, bank is being impacted from the weight of the trees. 2013 - Minor new erosion at the toe. 2015 - Minor new erosion at toe.

USACE 2013 Photo #1

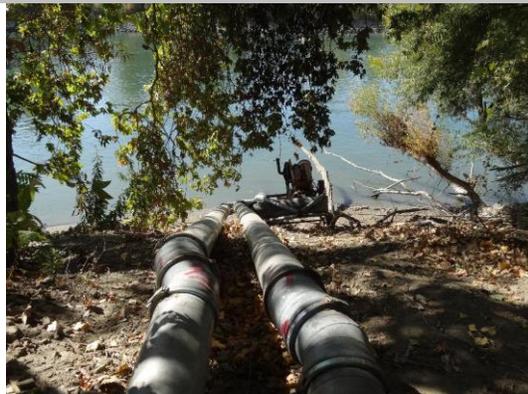
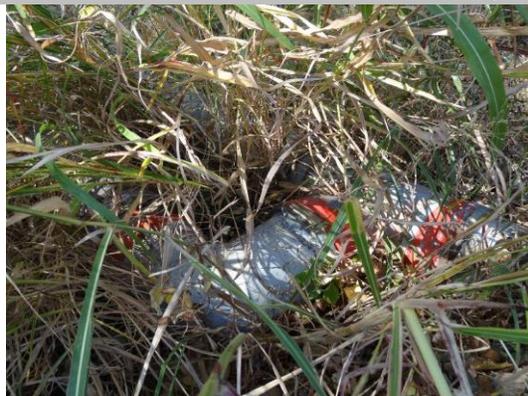
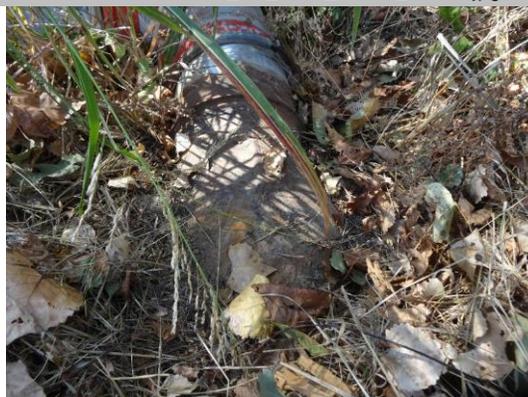
Item	DRAFT DWR UCIP Field Study			39.042304 °	39.042304 °
				-121.834783 °	-121.834783 °
DWR ID	22484				
Comment Code					
Inspector Comment					
DS_ID:22484 FS_ID:22543 EP_NO: 16476 Repair Type: Non-Urgent Crossing Status: Found UCIP Comments: - 16-inch old steel pipe abandoned. Abandoned pipe found on landside levee toe.- abandoned power pole on waterside.- mobile diesel pump on channel bank.- attached tin pipes exposed on levee surface. FIELD_STRUCT_DESC: 14-inch steel irrigation discharge pipe through the levee crown, at an unknown depth. Two 12-inch tin pipes on the surface of the levee slopes, attached to the existing 14-inch steel pipe. Pipe discharges into an irrigation ditch on the landside (LS). Air vent on the LS shoulder. (Plans to grout a 25-foot section of pipeline through the levee authorized under Permit No. 16476, 1995 - Reclamation District No. 1660 [RD1660]). FS Date: 10/10/2013

WS view: two exposed 12" tin pipes on levee slope. These pipes connected to the pump on river bank.

WS view: two exposed 12" tin pipes on levee slope.

WS view: two exposed tin pipes joined together and connected to 14-inch steel pipe on levee slope.

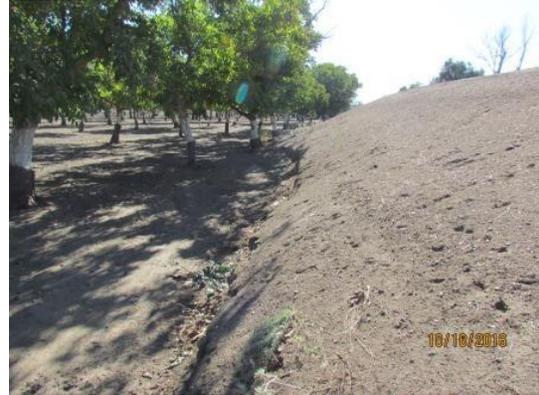
Photo 1 of 1 : FA\_2019\_RD1660\_8\_2\_20190822\_00001.jpg

LM Start	<b>2.37</b>	Rating **	M	Issue No.	<b>2</b>
LM End	<b>2.37</b>	Issue Type +	Ma	Location *	LS
Category	Earthen Levee			GPS Latitude/Longitude	
				Start	End
Item	Slope Stability			39.034107°	39.034107°
				-121.825152°	-121.825152°
DWR ID	DWR_RD1660_01_s_2012_2				
Comment Code					
S1 : Repair slope instability.					
Inspector Comment

View of the toe cut by the farmer on the landside.

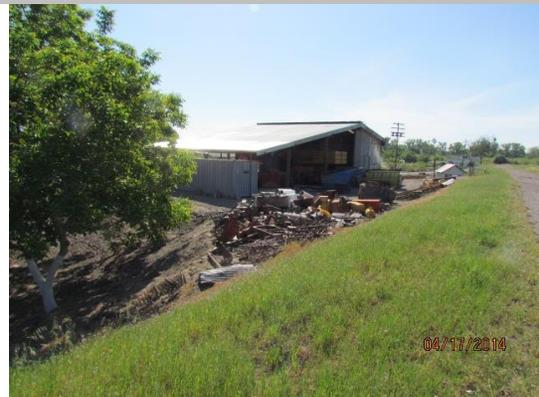
Photo 1 of 1 : FA\_2019\_RD1660\_8\_3\_20190822\_00002.jpg

LM Start	<b>2.58</b>	Rating **	M	Issue No.	<b>3</b>
LM End	<b>2.58</b>	Issue Type +	En	Location *	LS
Category	Earthen Levee			GPS Latitude/Longitude	
				Start	End
Item	Encroachments			39.031405 °	39.031405 °
				-121.823403 °	-121.823403 °
DWR ID	DWR_RD1660_01_s_2012_3				
Comment Code					
EQ : Equipment					
Inspector Comment

View of equipment along the landside slope.

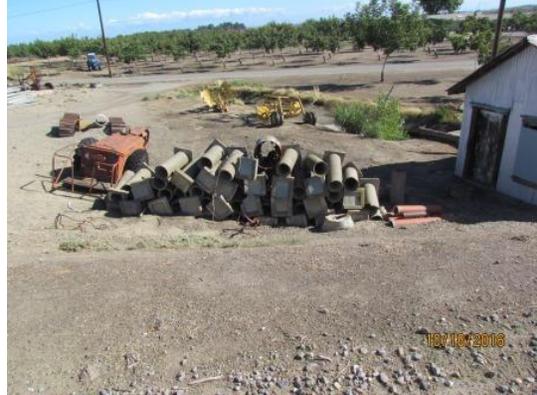
Photo 1 of 1 : FA\_2019\_RD1660\_8\_18\_20190822\_00006.jpg

LM Start	<b>2.61</b>	Rating **	M	Issue No.	<b>18</b>
LM End	<b>2.61</b>	Issue Type +	En	Location *	LS
Category	Earthen Levee			GPS Latitude/Longitude	
				Start	End
Item	Encroachments			39.031020°	39.031020°
				-121.823091°	-121.823091°
DWR ID	DWR_RD1660_01_f_2016_18				
Comment Code					
DE : Debris					
Inspector Comment					
The concrete pipes should be removed from the landside toe.

View of the concrete pipes within the levee easement.

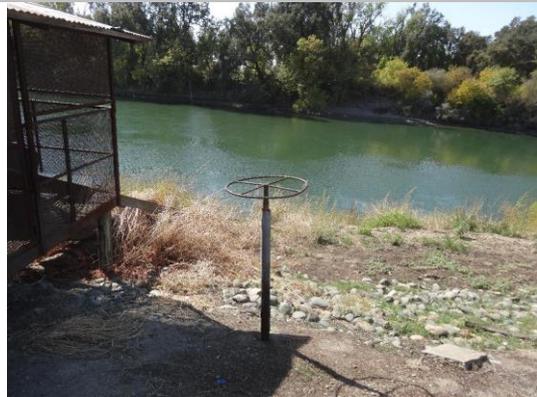
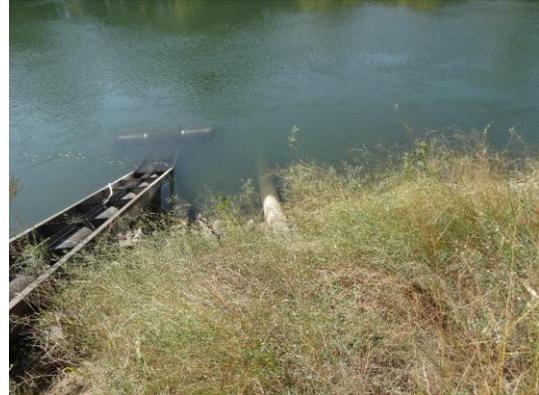
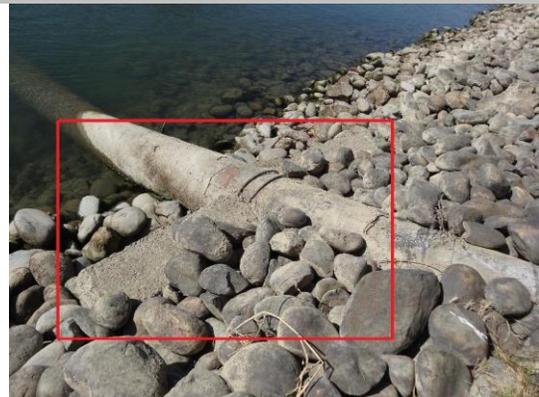
Item	DRAFT DWR UCIP Field Study			39.030935°	39.030935°
				-121.823022°	-121.823022°
DWR ID	22492				
Comment Code					
Inspector Comment					
DS_ID:22492 FS_ID:22632 EP_NO: 10012 Repair Type: Non-Urgent Crossing Status: Found UCIP Comments: - abandoned pumphouse on landside toe. Needs confirmation from LMA or DWR Inspector about abandonment of pumphouse.- headwall on channel bank. FIELD_STRUCT_DESC: 24-inch steel irrigation discharge pipe through the levee, 24 feet below the crown. Slide gate on the waterside (WS) shoulder. Abandoned pump house on the landside (LS) slope. (Retention of a 24-inch steel pipe through the levee, 24 feet below the crown, slide gate, and pump house authorized under Automatic Board Order (ABO) issued as Permit No. 10012, 1974 - Lawrence C. Harris). [Additional Reference(s): DWR Levee Log, 2005]. FS Date: 10/10/2013

WS view: gate valve handle (center) on levee slope.

WS view: inlet steel pipe (right) immersed into channel water.

WS view: closer view of inlet steel pipe immersed into channel water. Pipe was supported by concrete headwall.

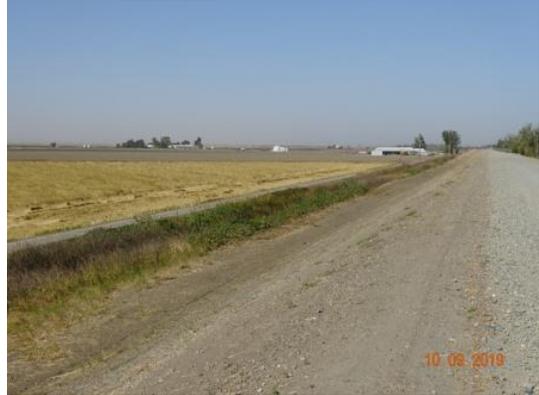
Photo 1 of 1 : FA\_2019\_RD1660\_9\_4\_20191011\_00015.jpg

View of good vegetation control on the landside slope. Fall 2019.

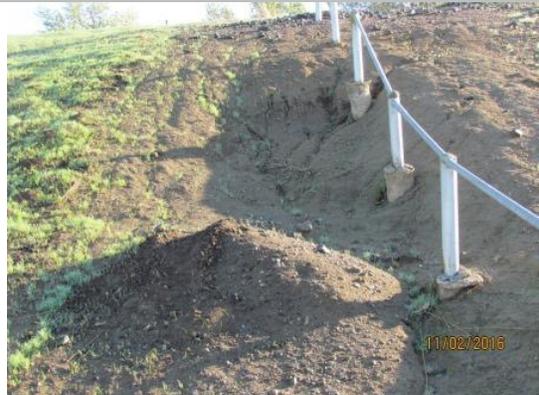
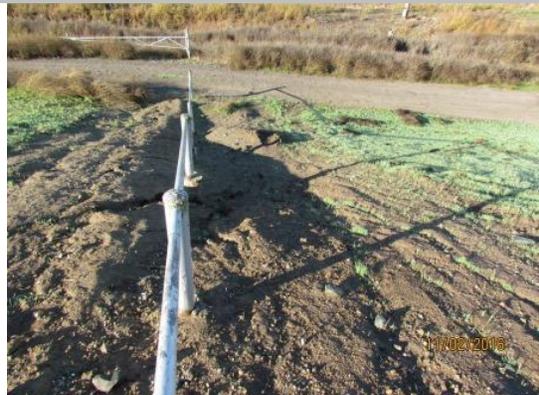
LM Start	<b>0.00</b>	Rating **	M	Issue No.	<b>6</b>
LM End	<b>0.00</b>	Issue Type +	Ma	Location *	LS
Category	Earthen Levee		GPS Latitude/Longitude		
			Start	End	
Item	Slope Stability		39.032910°	39.032910°	
			-121.743665°	-121.743665°	
DWR ID	DWR_RD1660_02_f_2016_6				
Comment Code					
S1 : Repair slope instability.					
Inspector Comment

View of the slope instability looking from the landside toe.

Another view of the slope instability looking from the levee crown.

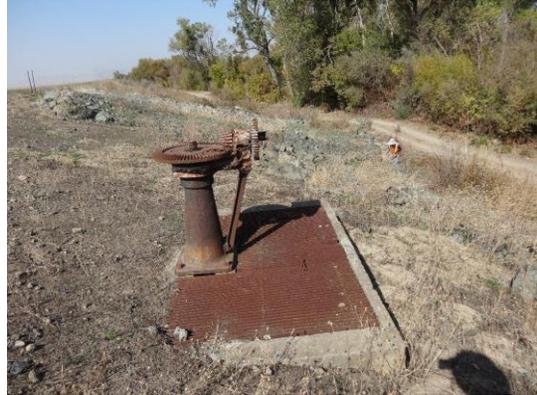
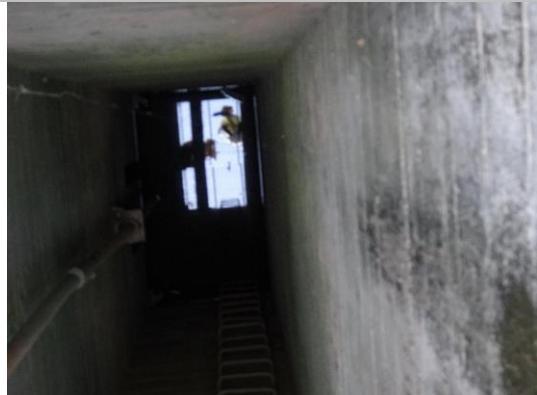
Item	DRAFT DWR UCIP LMA Responsibility		39.033214 °	39.033214 °	
			-121.743541 °	-121.743541 °	
DWR ID	22495				
Comment Code					
Inspector Comment					
DS_ID:22495 FS_ID:22663 EP_NO: 10020 Repair Type: No Action Needed Crossing Status: Found UCIP Comments: - pipe/opening not visible as it was submerged into water on both sides.- it seems that 36-inch concrete pipe through the levee. It needs confirmation from LMA/DWR Inspector.- USED bench mark on landside concrete vault. FIELD_STRUCT_DESC: [Reclamation District No. 1660 (RD1660 Drainage Pump] 48-inch by 84-inch reinforced concrete outfall structure through the levee, 34 feet below the crown. Slide gate in a 4-foot by 8-foot concrete riser on the waterside (WS) slope. (Retention of a 4-foot by 7-foot concrete culvert outfall drain through the levee, 34 feet below the crown, and a slide gate in a concrete well authorized under Automatic Board Order (ABO) issued as Permit No. 10020, 1974 - Leo Bandoni, care of John Digardi). [Additional Reference(s): DWR Levee Log, 2005. USACE Sacramento O&M Manual 133, August 1955, (Station 1044+60), two 4-foot by 7-foot concrete tunnels referenced]. FS Date: 10/10/2013

WS view: 4 ft. by 8 ft. concrete box with slide gate on levee slope. USED bench mark on top of the box.

WS view: inside view of concrete box on levee slope. Slide gate in concrete box.

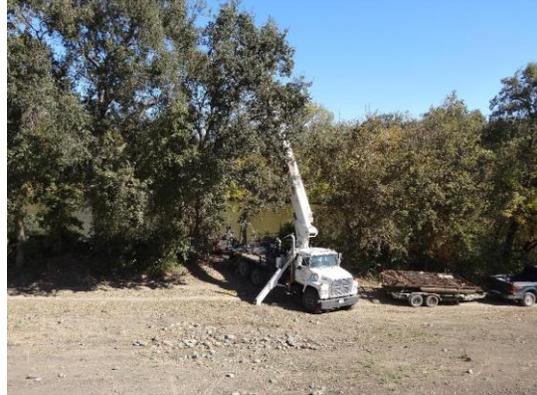
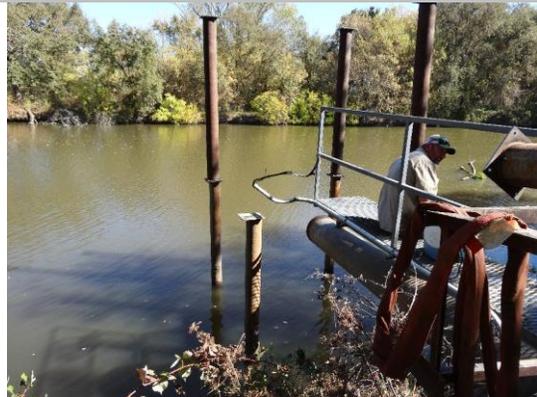
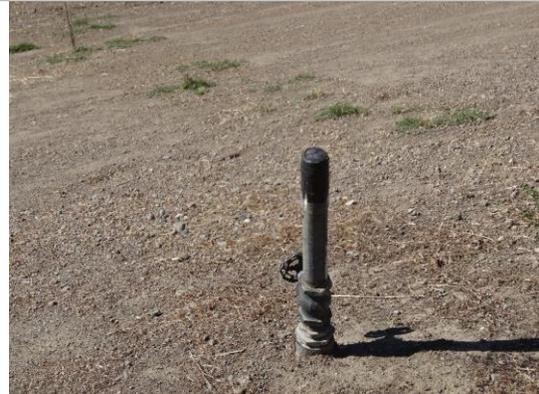
Item	DRAFT DWR UCIP Field Study			39.102512°	39.102512°
				-121.774960°	-121.774960°
DWR ID	22499				
Comment Code					
Inspector Comment					
DS_ID:22499 FS_ID:22705 EP_NO: N/A Repair Type: Non-Urgent Crossing Status: Found UCIP Comments: Pressure relief valve on landside levee slope.Pump platform under construction for upgrade (raising platform)Look for new upgrade/revision permit. FIELD_STRUCT_DESC: 18-inch steel irrigation discharge pipe through the levee, 5.8 feet below the crown. Pump in the channel. Gate valve on the landside (LS) berm. Pipe discharges into a 4-foot by 4-foot concrete box on the LS berm. 2-inch electrical conduit of an unknown material through the levee, 3 feet below the crown. (Plans for construction of a pumping plant with an 18-inch discharge pipe through the levee authorized under Permit No. 4215, 1963 - S. A. McKeehan). [Additional Reference(s): DWR Levee Log, 2005]. FS Date: 10/15/2013

WS view: pump platform under construction.

WS view: pump platform under construction. 18" steel pipe and 2" electric conduit under steel platform.

LS view: pressure relief valve on levee slope.

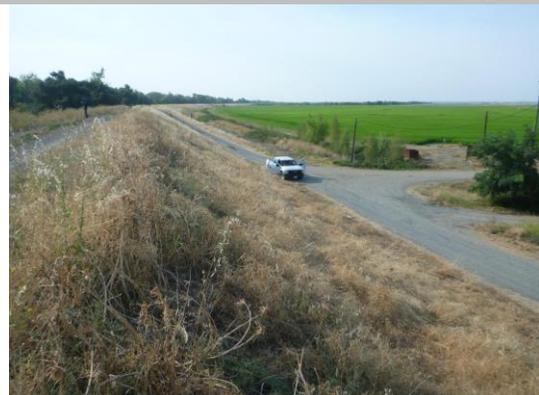
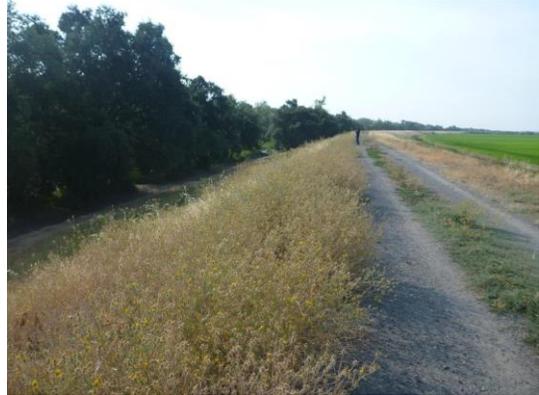
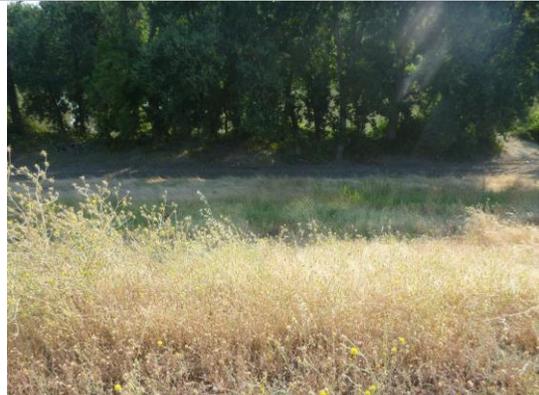
LM Start	<b>5.12</b>	Rating **	A/W	Issue No.	<b>9</b>
LM End	<b>5.12</b>	Issue Type +	Ob	Location *	
Category	Supplemental			GPS Latitude/Longitude	
				Start	End
Item	2017 Storm Damage			39.102537°	39.102537°
				-121.775390°	-121.775390°
DWR ID	RD 1660-01				
Comment Code					
Inspector Comment					
Levee Evaluation Comments Description: Site ID No:157 Site Designation:RD 1660-01 Repair Type: Seepage (B) Rating:Area of Concern Field Date:8/3/2017 Notes: small bulges, levee prone to seepage

LM Start	<b>5.12</b>	Rating **	A/W	Issue No.	<b>9 (cont)</b>
LM End	<b>5.12</b>	Issue Type +	Ob	Location *	
Category	Supplemental		GPS Latitude/Longitude		
			Start	End	
Item	2017 Storm Damage		39.102537°	39.102537°	
			-121.775390°	-121.775390°	
DWR ID	RD 1660-01				
Comment Code					
Inspector Comment					
Levee Evaluation Comments					
Description:					
Site ID No:157					
Site Designation:RD 1660-01					
Repair Type: Seepage (B)					
Rating:Area of Concern					
Field Date:8/3/2017					
Notes: small bulges, levee prone to seepage

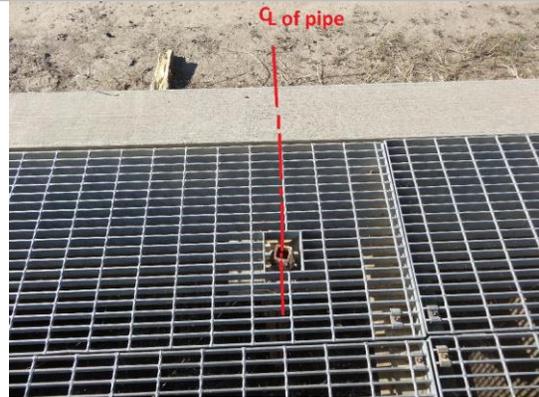
Photo 3 of 3 : UCIP\_FA\_2019\_22708\_38409.jpg

Item	DRAFT DWR UCIP LMA Responsibility			39.136861°	39.136861°	
				-121.833974°	-121.833974°	
DWR ID	22505					
Comment Code						
Inspector Comment						
DS_ID:22505 FS_ID:22708 EP_NO: N/A Repair Type: No Action Needed Crossing Status: Found UCIP Comments: - inlet structure 160 ft off the levee center on landside drainage ditch. FIELD_STRUCT_DESC: 48-inch steel gravity drainage pipe through the levee, 29 feet below the crown. Slide gate and concrete bulkhead on the riverbank. Staff gage on the waterside (WS) berm. (Retention of a 48-inch corrugated metal pipe (CMP) through the levee, 29 feet below the crown, a slide gate, and a concrete bulkhead authorized under Automatic Board Order (ABO) No. 10021, 1974 - Butte Slough Irrigation Company, care of Tarke Warehouse). [Additional Reference(s): DWR Levee Log, 2005. USACE Sacramento O&M Manual 133, August 1955, (Station 433+43), 48-inch CMP referenced]. FS Date: 10/15/2013

WS view: concrete box on channel bank. Pipe discharges into this box. A slide gate inside this box.
