**Flood Control Project Maintenance
Levee Inspections**
LMA District Cover Sheet
Spring 2020 Levee Inspection Results

Reclamation District No. 1660 Tisdale

Spring 2020 Levee Inspection Results

Levee Inspection Report By Mile - Spring 2020

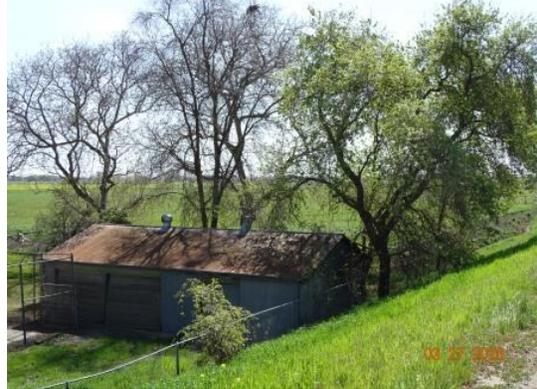
Photo 1 of 1 : SP_2020_RD1660_8_12_20200421_00018.jpg

LM Start	0.05	Rating **	M	Issue No.	12
LM End	0.05	Issue Type +	En	Location *	LS
Category	Earthen Levee		GPS Latitude/Longitude		
			Start	End	
Item	Encroachments		39.062643 °	39.062643 °	
			-121.837857 °	-121.837857 °	
DWR ID	DWR_RD1660_01_s_2012_12				
Comment Code					
BU : Building					
Inspector Comment

View of the building at the landside toe. Spring 2020.

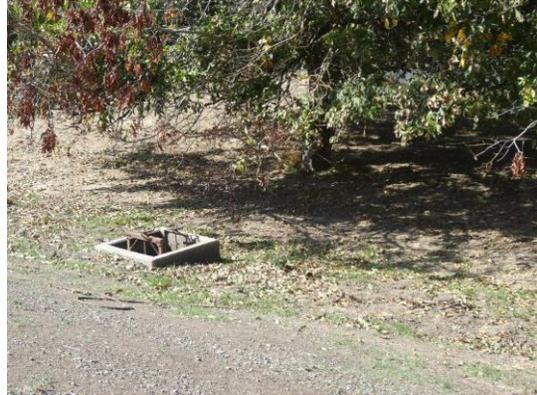
Photo 1 of 3 : UCIP_SP_2020_46670_38107.jpg

LM Start	0.14	Rating **	M	Issue No.	27
LM End	0.14	Issue Type +	Ma	Location *	
Category	Supplemental		GPS Latitude/Longitude		
			Start	End	
Item	DWR UCIP LMA Responsibility		39.061322 °	39.061322 °	
			-121.837993 °	-121.837993 °	
DWR ID	22489				
Comment Code					
Inspector Comment					
DS_ID:22489 FS_ID:46670 EP_NO: N/A Repair Type: Non-Urgent Crossing Status: Found UCIP Comments: - needs proper abandonment.- opening of landside pipe almost burried. FIELD_STRUCT_DESC: *ABANDONED* 24-inch corrugated metal gravity drainage pipe through the levee, 16.4 feet below the crown. Two corrugated metal cutoff walls. Slide gate in a concrete well at the waterside (WS) toe. (IV A-Winship). USACE bench mark on the top of the headwall at the landside (LS) toe. [Additional Reference(s): DWR Levee Log, 2005. USACE Sacramento O&M Manual 133, August 1955, (Station 2+07.8)]. FS Date: 10/10/2013

WS view: concrete box on levee slope. No pipe found on berm and river bank.

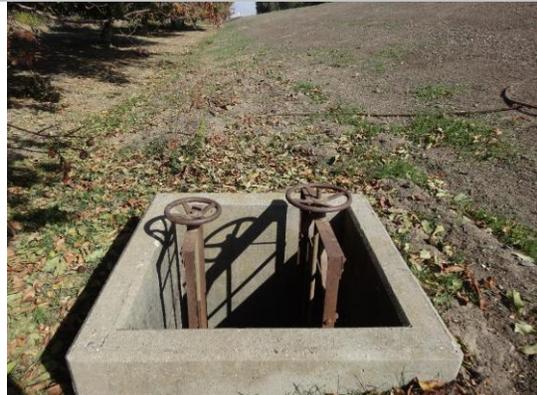
Photo 2 of 3 : UCIP_SP_2020_46670_38106.jpg

WS view: two slide gates in concrete box on levee slope.

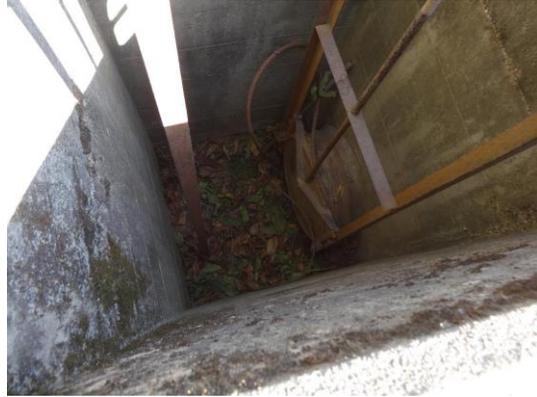
Photo 3 of 3 : UCIP_SP_2020_46670_38105.jpg

WS view: closer view of two slide gates in concrete box on levee slope.

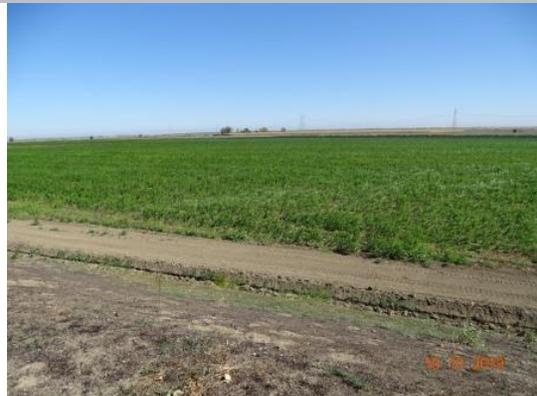
Photo 1 of 1 : SP_2020_RD1660_8_11_20200226_00005.jpg

LM Start	0.68	Rating **	M	Issue No.	11
LM End	0.96	Issue Type +	En	Location *	LS
Category	Earthen Levee			GPS Latitude/Longitude	
				Start	End
Item	Encroachments			39.053604 °	39.049522 °
				-121.839538 °	-121.839354 °
DWR ID	DWR_RD1660_01_f_2019_11				
Comment Code					
DT : Ditch					
Inspector Comment

View of the ditch along the landside toe. Fall 2019.

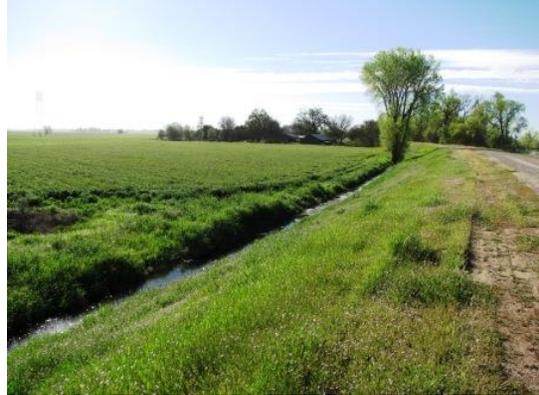
Photo 1 of 1 : SP_2020_RD1660_8_9_20200226_00004.jpg

LM Start	1.10	Rating **	M	Issue No.	9
LM End	1.45	Issue Type +	En	Location *	LS
Category	Earthen Levee		GPS Latitude/Longitude		
			Start	End	
Item	Encroachments		39.047610 °	39.043221 °	
			-121.838802 °	-121.835815 °	
DWR ID	DWR_RD1660_01_s_2012_9				
Comment Code					
DT : Ditch					
Inspector Comment

View of a ditch along the landside toe.

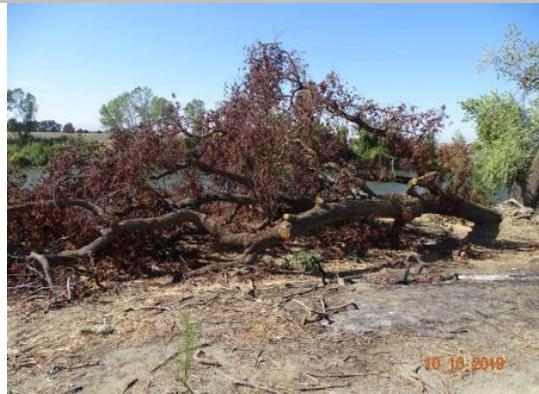
Photo 1 of 1 : SP_2020_RD1660_8_13_20200226_00007.jpg

LM Start	1.22	Rating **	U	Issue No.	13
LM End	1.22	Issue Type +	Ma	Location *	WS
Category	Earthen Levee		GPS Latitude/Longitude		
			Start	End	
Item	Encroachments		39.045932 °	39.045932 °	
			-121.838241 °	-121.838241 °	
DWR ID	DWR_RD1660_01_f_2019_13				
Comment Code					
TR : Tree or limb					
Inspector Comment					
The large fallen tree should be removed from the waterside slope.

View of the large fallen tree on the waterside slope. Fall 2019.

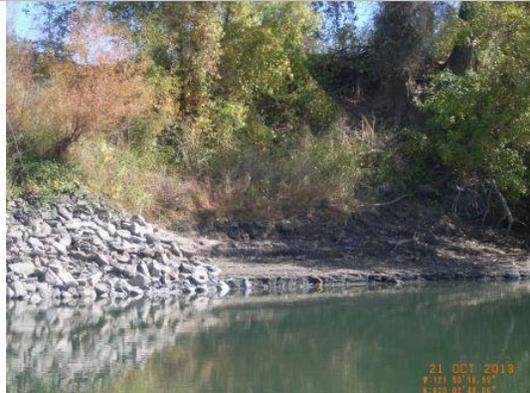
Photo 1 of 1 : SP_2020_RD1660_8_8_20200226_00003.jpg

LM Start	1.33	Rating **	A/W	Issue No.	8
LM End	1.36	Issue Type +	Ma	Location *	WS
Category	Supplemental			GPS Latitude/Longitude	
				Start	End
Item	2017 USACE Erosion Survey			39.044361 °	39.043916 °
				-121.837654 °	-121.837305 °
DWR ID	DWR_RD1660_01_f_2018_8				
Comment Code					
Inspector Comment					
2017 Site ID: SAC 120.6 L Status: Eroding 2017 Field Notes: No observed change. Site History: 2009 - Erosion on levee toe where an old cobble site is failing. 2011 - Some new minor erosion. 2012 - Site extended downstream, bank is being impacted from the weight of the trees. 2013 - Minor new erosion at the toe. 2015 - Minor new erosion at toe.

USACE 2013 Photo #1

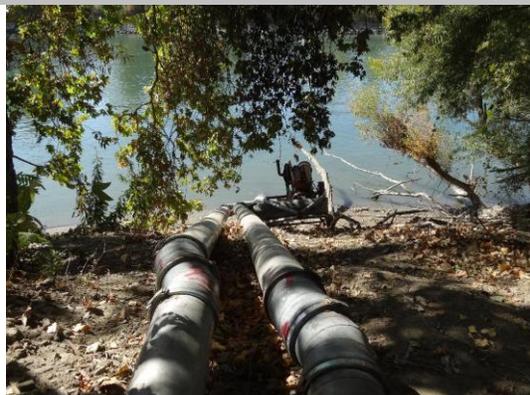
Photo 1 of 3 : UCIP_SP_2020_22543_38142.jpg

Comment Code					
Inspector Comment					
DS_ID:22484 FS_ID:22543 EP_NO: 16476 Repair Type: Non-Urgent Crossing Status: Found UCIP Comments: - 16-inch old steel pipe abandoned. Abandoned pipe found on landside levee toe.- abandoned power pole on waterside.- mobile diesel pump on channel bank.- attached tin pipes exposed on levee surface. FIELD_STRUCT_DESC: 14-inch steel irrigation discharge pipe through the levee crown, at an unknown depth. Two 12-inch tin pipes on the surface of the levee slopes, attached to the existing 14-inch steel pipe. Pipe discharges into an irrigation ditch on the landside (LS). Air vent on the LS shoulder. (Plans to grout a 25-foot section of pipeline through the levee authorized under Permit No. 16476, 1995 - Reclamation District No. 1660 [RD1660]). FS Date: 10/10/2013

WS view: two exposed 12" tin pipes on levee slope. These pipes connected to the pump on river bank.

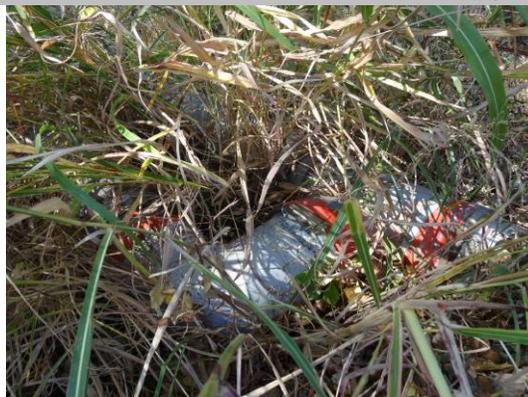
Photo 2 of 3 : UCIP_SP_2020_22543_38141.jpg

WS view: two exposed 12" tin pipes on levee slope.

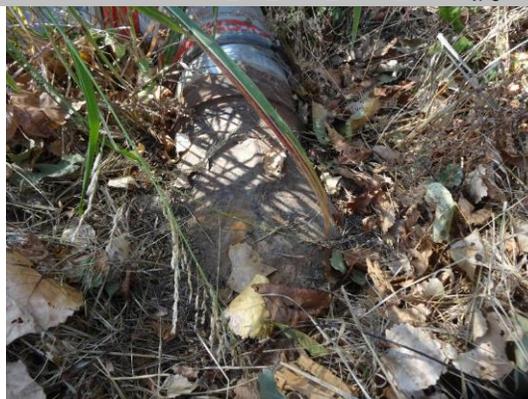
Photo 3 of 3 : UCIP_SP_2020_22543_38140.jpg

WS view: two exposed tin pipes joined together and connected to 14-inch steel pipe on levee slope.

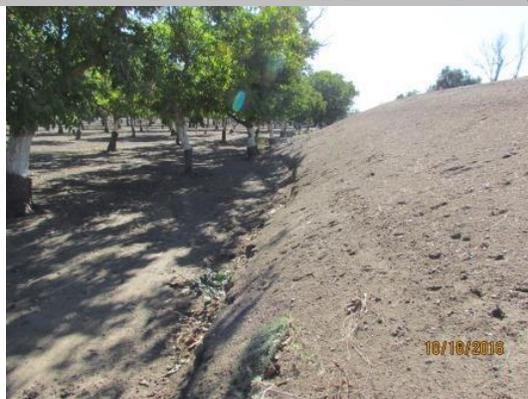
Photo 1 of 1 : SP_2020_RD1660_8_2_20200226_00001.jpg

LM Start	2.37	Rating **	M	Issue No.	2
LM End	2.37	Issue Type +	Ma	Location *	LS
Category	Earthen Levee			GPS Latitude/Longitude	
				Start	End
Item	Slope Stability			39.034107 °	39.034107 °
				-121.825152 °	-121.825152 °
DWR ID	DWR_RD1660_01_s_2012_2				
Comment Code					
S1 : Repair slope instability.					
Inspector Comment

View of the toe cut by the farmer on the landside.

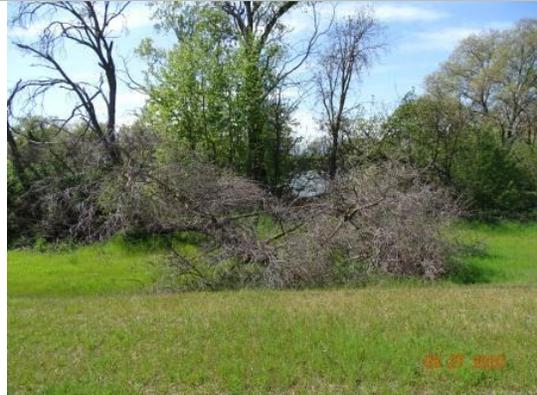
Photo 1 of 1 : SP_2020_RD1660_8_17_20200421_00019.jpg

LM Start	2.48	Rating **	M	Issue No.	17
LM End	2.48	Issue Type +	Ma	Location *	WS
Category	Earthen Levee		GPS Latitude/Longitude		
			Start	End	
Item	Encroachments		39.032688 °	39.032688 °	
			-121.824242 °	-121.824242 °	
DWR ID	DWR_RD1660_01_s_2020_17				
Comment Code					
TR : Tree or limb					
Inspector Comment					
The fallen tree should be removed from the waterside slope.

View of the fallen tree at the waterside toe. Spring 2020.

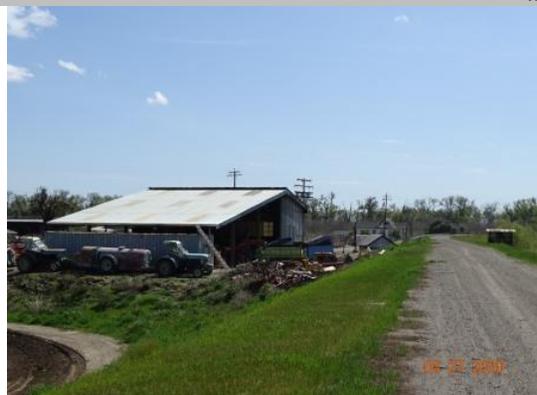
Photo 1 of 1 : SP_2020_RD1660_8_3_20200421_00020.jpg

LM Start	2.58	Rating **	M	Issue No.	3
LM End	2.58	Issue Type +	En	Location *	LS
Category	Earthen Levee		GPS Latitude/Longitude		
			Start	End	
Item	Encroachments		39.031405 °	39.031405 °	
			-121.823403 °	-121.823403 °	
DWR ID	DWR_RD1660_01_s_2012_3				
Comment Code					
EQ : Equipment					
Inspector Comment

View of equipment along the landside slope. Spring 2020.

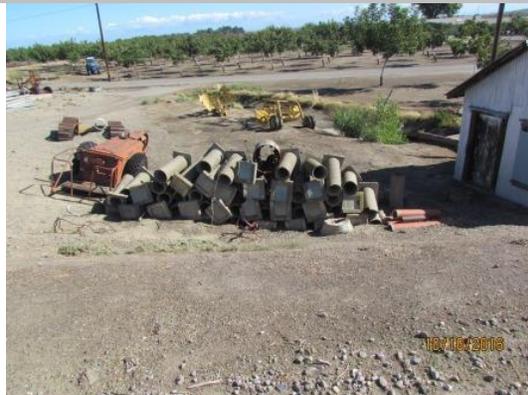
Photo 1 of 1 : SP_2020_RD1660_8_18_20200226_00008.jpg

View of the concrete pipes within the levee easement.

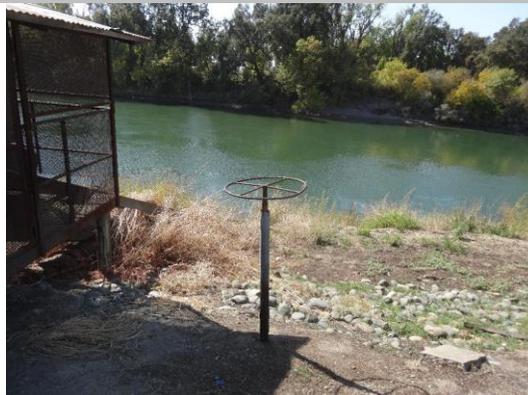
Photo 1 of 3 : UCIP_SP_2020_22632_38178.jpg

Comment Code					
Inspector Comment					
DS_ID:22492 FS_ID:22632 EP_NO: 10012 Repair Type: Non-Urgent Crossing Status: Found UCIP Comments: - abandoned pumphouse on landside toe. Needs confirmation from LMA or DWR Inspector about abandonment of pumphouse.- headwall on channel bank. FIELD_STRUCT_DESC: 24-inch steel irrigation discharge pipe through the levee, 24 feet below the crown. Slide gate on the waterside (WS) shoulder. Abandoned pump house on the landside (LS) slope. (Retention of a 24-inch steel pipe through the levee, 24 feet below the crown, slide gate, and pump house authorized under Automatic Board Order (ABO) issued as Permit No. 10012, 1974 - Lawrence C. Harris). [Additional Reference(s): DWR Levee Log, 2005]. FS Date: 10/10/2013

WS view: gate valve handle (center) on levee slope.

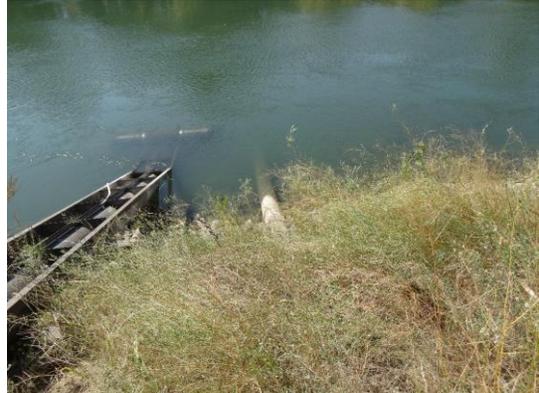
Photo 2 of 3 : UCIP_SP_2020_22632_38177.jpg

WS view: inlet steel pipe (right) immersed into channel water.

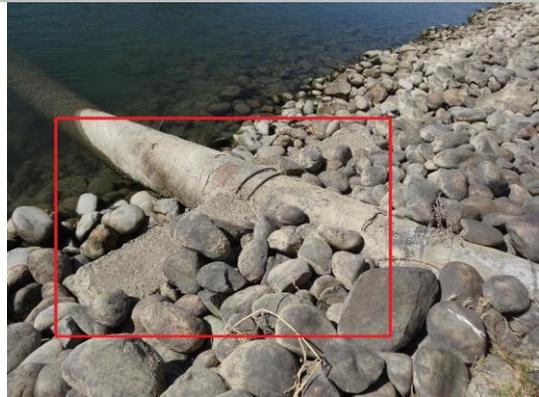
Photo 3 of 3 : UCIP_SP_2020_22632_38176.jpg

WS view: closer view of inlet steel pipe immersed into channel water. Pipe was supported by concrete headwall.

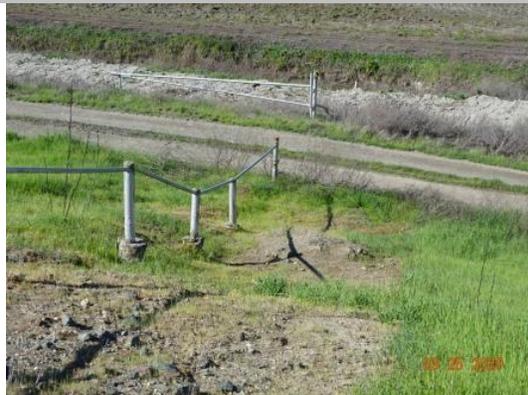
Photo 1 of 1 : SP_2020_RD1660_9_6_20200326_00015.jpg

LM Start	0.00	Rating **	M	Issue No.	6
LM End	0.00	Issue Type +	Ma	Location *	LS
Category	Earthen Levee		GPS Latitude/Longitude		
			Start	End	
Item	Slope Stability		39.032910 °	39.032910 °	
			-121.743665 °	-121.743665 °	
DWR ID	DWR_RD1660_02_f_2016_6				
Comment Code					
S1 : Repair slope instability.					
Inspector Comment

View of the slope instability along the landside slope. Spring 2020.

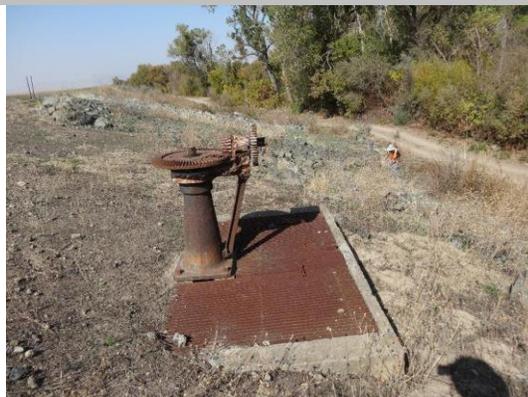
Photo 1 of 3 : UCIP_SP_2020_22663_38248.jpg

Comment Code					
Inspector Comment					
DS_ID:22495 FS_ID:22663 EP_NO: 10020 Repair Type: No Action Needed Crossing Status: Found UCIP Comments: - pipe/opening not visible as it was submerged into water on both sides.- it seems that 36-inch concrete pipe through the levee. It needs confirmation from LMA/DWR Inspector.- USED bench mark on landside concrete vault. FIELD_STRUCT_DESC: [Reclamation District No. 1660 (RD1660) Drainage Pump] 48-inch by 84-inch reinforced concrete outfall structure through the levee, 34 feet below the crown. Slide gate in a 4-foot by 8-foot concrete riser on the waterside (WS) slope. (Retention of a 4-foot by 7-foot concrete culvert outfall drain through the levee, 34 feet below the crown, and a slide gate in a concrete well authorized under Automatic Board Order (ABO) issued as Permit No. 10020, 1974 - Leo Bandoni, care of John Digardi). [Additional Reference(s): DWR Levee Log, 2005. USACE Sacramento O&M Manual 133, August 1955, (Station 1044+60), two 4-foot by 7-foot concrete tunnels referenced]. FS Date: 10/10/2013

WS view: 4 ft. by 8 ft. concrete box with slide gate on levee slope. USED bench mark on top of the box.

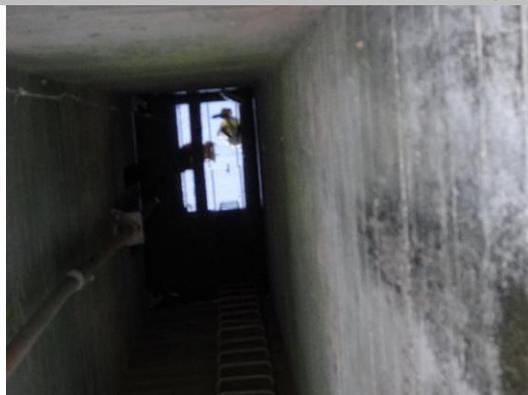
Photo 2 of 3 : UCIP_SP_2020_22663_38247.jpg

WS view: inside view of concrete box on levee slope. Slide gate in concrete box.

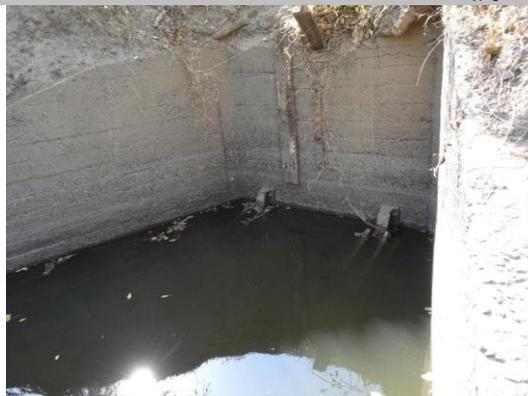
Photo 3 of 3 : UCIP_SP_2020_22663_38246.jpg

WS view: closer view of U shaped concrete headwall in bypass channel. Pipe not visible.

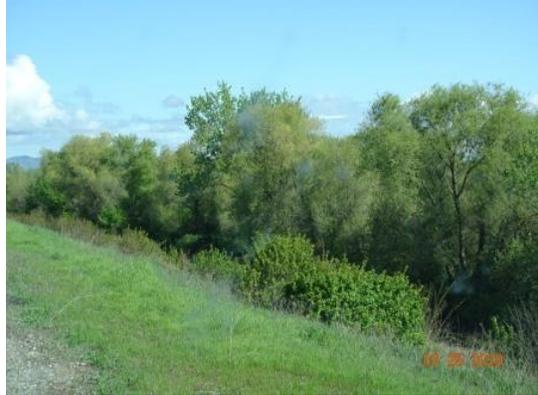
Photo 1 of 1 : SP_2020_RD1660_9_5_20200326_00016.jpg

View of wild growth along the waterside slope. Spring 2020.

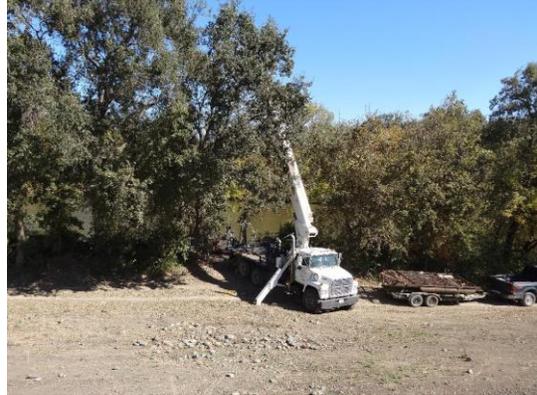
Photo 1 of 3 : UCIP_SP_2020_22705_38394.jpg

Comment Code					
Inspector Comment					
DS_ID:22499 FS_ID:22705 EP_NO: N/A Repair Type: Non-Urgent Crossing Status: Found UCIP Comments: Pressure relief valve on landside levee slope.Pump platform under construction for upgrade (raising platform)Look for new upgrade/revision permit. FIELD_STRUCT_DESC: 18-inch steel irrigation discharge pipe through the levee, 5.8 feet below the crown. Pump in the channel. Gate valve on the landside (LS) berm. Pipe discharges into a 4-foot by 4-foot concrete box on the LS berm. 2-inch electrical conduit of an unknown material through the levee, 3 feet below the crown. (Plans for construction of a pumping plant with an 18-inch discharge pipe through the levee authorized under Permit No. 4215, 1963 - S. A. McKeehan). [Additional Reference(s): DWR Levee Log, 2005]. FS Date: 10/15/2013

WS view: pump platform under construction.

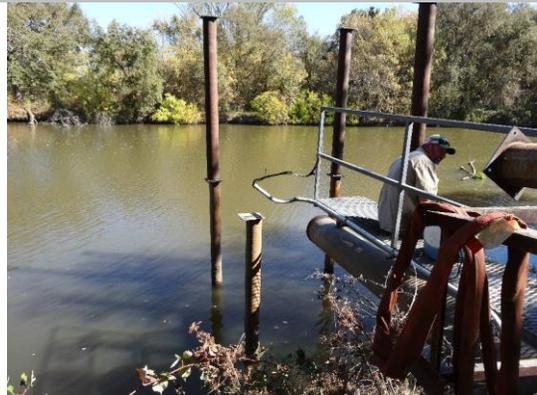
Photo 2 of 3 : UCIP_SP_2020_22705_38393.jpg

WS view: pump platform under construction. 18" steel pipe and 2" electric conduit under steel platform.

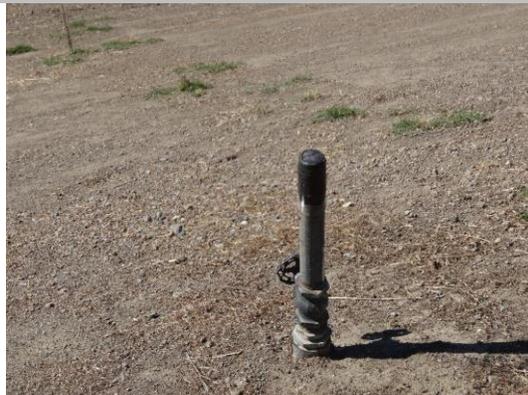
Photo 3 of 3 : UCIP_SP_2020_22705_38392.jpg

LS view: pressure relief valve on levee slope.

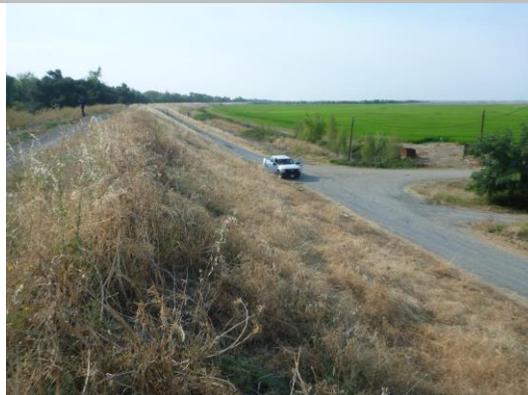
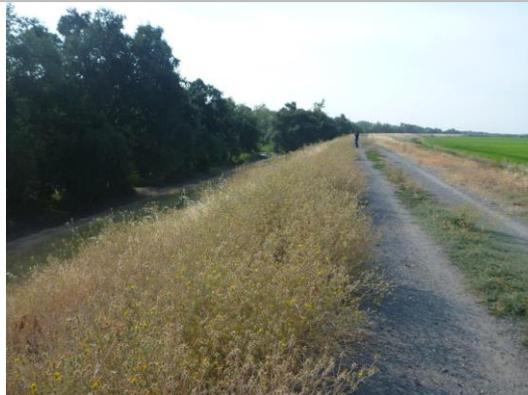
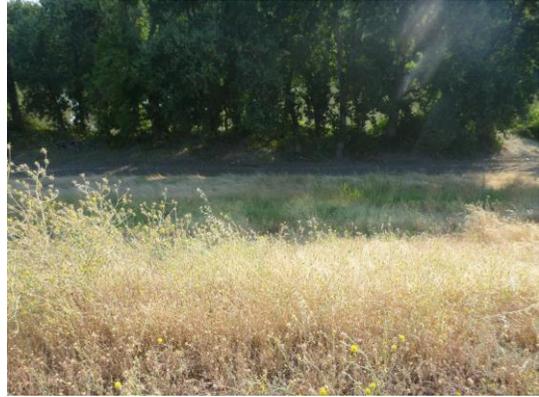
LM Start	5.12	Rating **	A/W	Issue No.	9
LM End	5.12	Issue Type +	Ob	Location *	LS
Category	Earthen Levee			GPS Latitude/Longitude	
				Start	End
Item	Seepage / Sandboils			39.102537 °	39.102537 °
				-121.775390 °	-121.775390 °
DWR ID	RD 1660-01				
Comment Code					
Inspector Comment					
Small bulges. Levee is prone to seepage. Site ID No:157 Site Designation:RD 1660-01

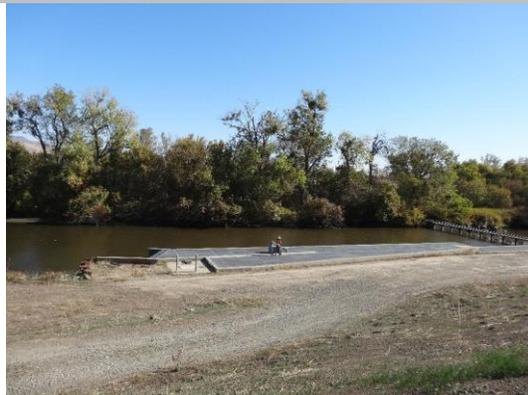
Photo 1 of 3 : UCIP_SP_2020_22708_38406.jpg

Comment Code					
Inspector Comment					
DS_ID:22505 FS_ID:22708 EP_NO: N/A Repair Type: No Action Needed Crossing Status: Found UCIP Comments: - inlet structure 160 ft off the levee center on landside drainage ditch. FIELD_STRUCT_DESC: 48-inch steel gravity drainage pipe through the levee, 29 feet below the crown. Slide gate and concrete bulkhead on the riverbank. Staff gage on the waterside (WS) berm. (Retention of a 48-inch corrugated metal pipe (CMP) through the levee, 29 feet below the crown, a slide gate, and a concrete bulkhead authorized under Automatic Board Order (ABO) No. 10021, 1974 - Butte Slough Irrigation Company, care of Tarke Warehouse). [Additional Reference(s): DWR Levee Log, 2005. USACE Sacramento O&M Manual 133, August 1955, (Station 433+43), 48-inch CMP referenced]. FS Date: 10/15/2013

WS view: overview of concrete box on channel bank. It looks like a fish ladder. Pipe discharges into this box.

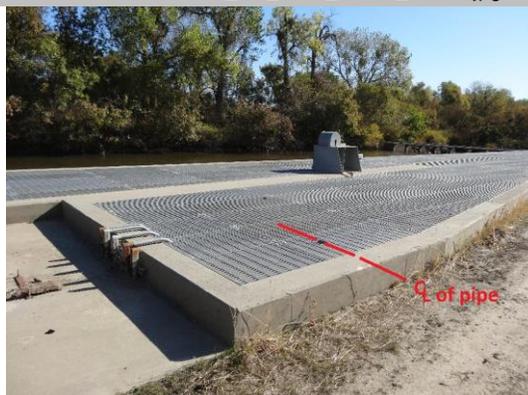
Photo 2 of 3 : UCIP_SP_2020_22708_38405.jpg

WS view: concrete box on channel bank. Pipe end with slide gate. Pipe discharges into this box.

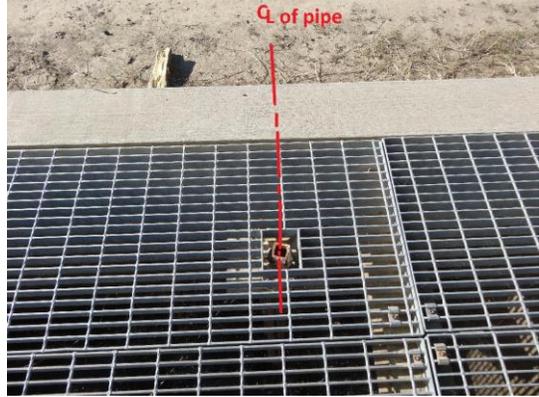
Photo 3 of 3 : UCIP_SP_2020_22708_38409.jpg

WS view: concrete box on channel bank. Pipe discharges into this box.
A slide gate inside this box.
