**Flood Control Project Maintenance
Levee Inspections**

Maintenance Issue Types Only, Levee Inspection Report By Mile - Fall 2019

Reclamation District No. 1660 Tisdale

Waterway	Bank	Unit Miles	Inspection Start/End	Inspector
Unit No. 01 Sacramento River	Left	2.94	10/10/2019 10/10/2019	Makar Sokol

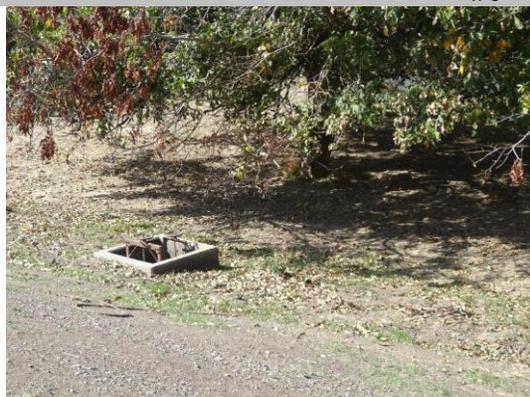
Photo 1 of 3 : UCIP_FA_2019_46670_38107.jpg

LM Start	0.14	Rating **	M	Issue No.	27
LM End	0.14	Issue Type +	Ma	Location *	
Category	Supplemental			GPS Latitude/Longitude	
				Start	End
Item	DRAFT DWR UCIP LMA Responsibility			39.061322°	39.061322°
				-121.837993°	-121.837993°
DWR ID	22489				
Comment Code					
Inspector Comment					
DS_ID:22489 FS_ID:46670 EP_NO: N/A Repair Type: Non-Urgent Crossing Status: Found UCIP Comments: - needs proper abandonment.- opening of landside pipe almost burried. FIELD_STRUCT_DESC: *ABANDONED* 24-inch corrugated metal gravity drainage pipe through the levee, 16.4 feet below the crown. Two corrugated metal cutoff walls. Slide gate in a concrete well at the waterside (WS) toe. (IV A-Winship). USACE bench mark on the top of the headwall at the landside (LS) toe. [Additional Reference(s): DWR Levee Log, 2005. USACE Sacramento O&M Manual 133, August 1955, (Station 2+07.8)]. FS Date: 10/10/2013

WS view: concrete box on levee slope. No pipe found on berm and river bank.

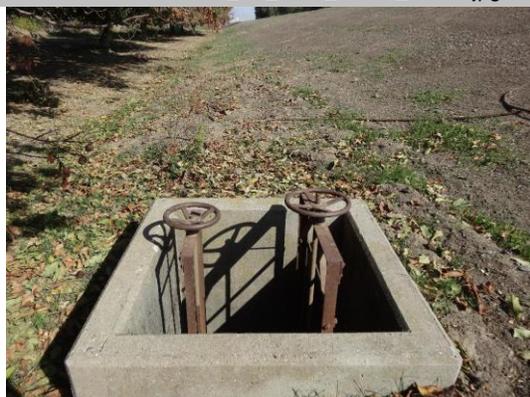
Photo 2 of 3 : UCIP_FA_2019_46670_38106.jpg

WS view: two slide gates in concrete box on levee slope.

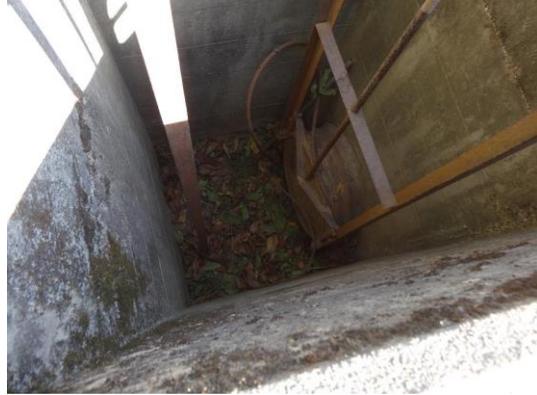
Photo 3 of 3 : UCIP_FA_2019_46670_38105.jpg

Comment Code					
Inspector Comment					
DS_ID:22489 FS_ID:46670 EP_NO: N/A Repair Type: Non-Urgent Crossing Status: Found UCIP Comments: - needs proper abandonment.- opening of landside pipe almost burried. FIELD_STRUCT_DESC: *ABANDONED* 24-inch corrugated metal gravity drainage pipe through the levee, 16.4 feet below the crown. Two corrugated metal cutoff walls. Slide gate in a concrete well at the waterside (WS) toe. (IV A-Winship). USACE bench mark on the top of the headwall at the landside (LS) toe. [Additional Reference(s): DWR Levee Log, 2005. USACE Sacramento O&M Manual 133, August 1955, (Station 2+07.8)]. FS Date: 10/10/2013

WS view: closer view of two slide gates in concrete box on levee slope.

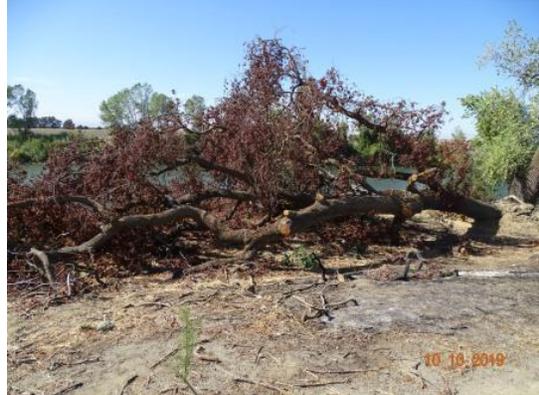
Photo 1 of 1 : FA_2019_RD1660_8_13_20191011_00021.jpg

LM Start	1.22	Rating **	U	Issue No.	13
LM End	1.22	Issue Type +	Ma	Location *	WS
Category	Earthen Levee		GPS Latitude/Longitude		
			Start	End	
Item	Encroachments		39.045932°	39.045932°	
			-121.838241°	-121.838241°	
DWR ID	DWR_RD1660_01_f_2019_13				
Comment Code					
TR : Tree or limb					
Inspector Comment					
The large fallen tree should be removed from the waterside slope.

View of the large fallen tree on the waterside slope. Fall 2019.

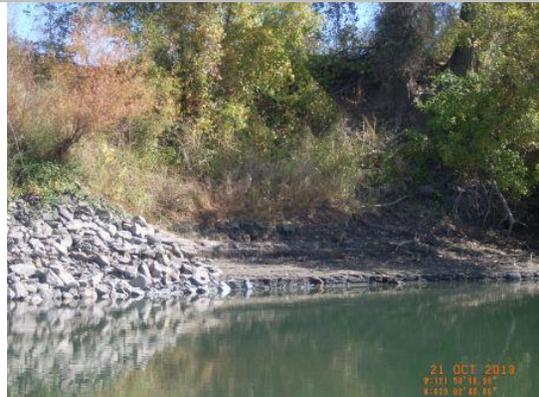
Photo 1 of 1 : FA_2019_RD1660_8_8_20190822_00003.jpg

LM Start	1.33	Rating **	A/W	Issue No.	8
LM End	1.36	Issue Type +	Ma	Location *	WS
Category	Supplemental		GPS Latitude/Longitude		
			Start	End	
Item	2017 USACE Erosion Survey		39.044361°	39.043916°	
			-121.837654°	-121.837305°	
DWR ID	DWR_RD1660_01_f_2018_8				
Comment Code					
Inspector Comment					
2017 Site ID: SAC 120.6 L Status: Eroding 2017 Field Notes: No observed change. Site History: 2009 - Erosion on levee toe where an old cobble site is failing. 2011 - Some new minor erosion. 2012 - Site extended downstream, bank is being impacted from the weight of the trees. 2013 - Minor new erosion at the toe. 2015 - Minor new erosion at toe.

USACE 2013 Photo #1

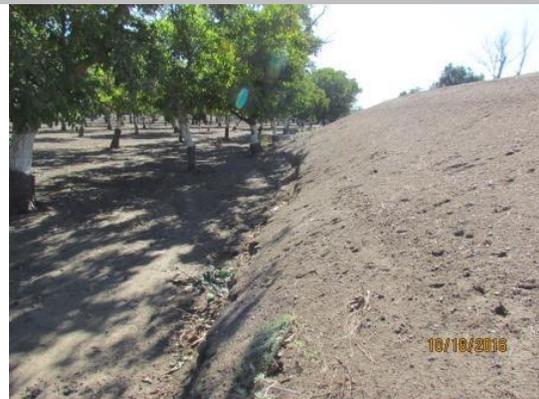
Photo 1 of 1 : FA_2019_RD1660_8_2_20190822_00001.jpg

LM Start	2.37	Rating **	M	Issue No.	2
LM End	2.37	Issue Type +	Ma	Location *	LS
Category	Earthen Levee			GPS Latitude/Longitude	
				Start	End
Item	Slope Stability			39.034107°	39.034107°
				-121.825152°	-121.825152°
DWR ID	DWR_RD1660_01_s_2012_2				
Comment Code					
S1 : Repair slope instability.					
Inspector Comment

View of the toe cut by the farmer on the landside.

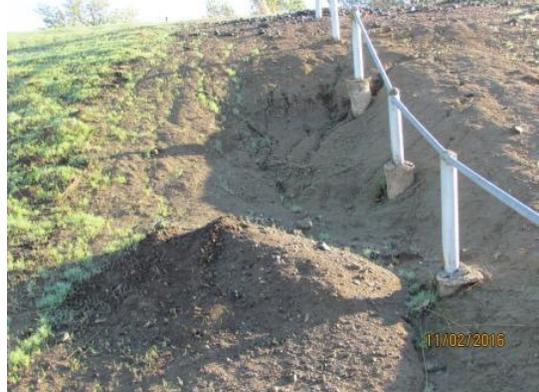
Photo 1 of 2 : FA_2019_RD1660_9_6_20190822_00001.jpg

LM Start	0.00	Rating **	M	Issue No.	6
LM End	0.00	Issue Type +	Ma	Location *	LS
Category	Earthen Levee		GPS Latitude/Longitude		
			Start	End	
Item	Slope Stability		39.032910°	39.032910°	
			-121.743665°	-121.743665°	
DWR ID	DWR_RD1660_02_f_2016_6				
Comment Code					
S1 : Repair slope instability.					
Inspector Comment

View of the slope instability looking from the landside toe.

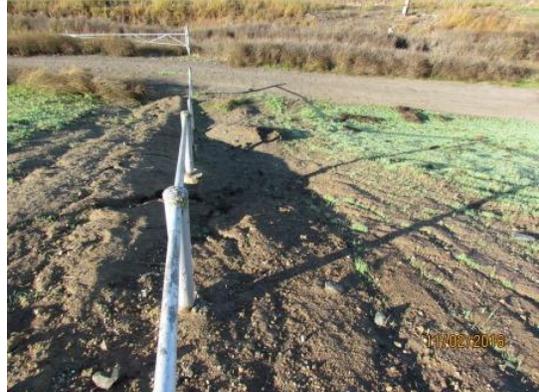
Photo 2 of 2 : FA_2019_RD1660_9_6_20190822_00002.jpg

Another view of the slope instability looking from the levee crown.

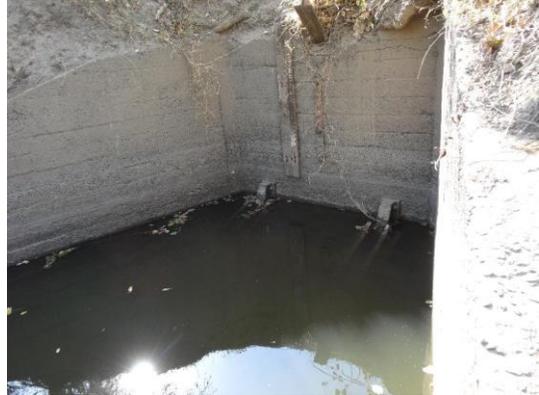
Photo 3 of 3 : UCIP_FA_2019_22663_38246.jpg

Comment Code					
Inspector Comment					
<p>DS_ID:22495 FS_ID:22663 EP_NO: 10020 Repair Type: No Action Needed Crossing Status: Found UCIP Comments: - pipe/opening not visible as it was submerged into water on both sides.- it seems that 36-inch concrete pipe through the levee. It needs confirmation from LMA/DWR Inspector.- USED bench mark on landside concrete vault. FIELD_STRUCT_DESC: [Reclamation District No. 1660 (RD1660) Drainage Pump] 48-inch by 84-inch reinforced concrete outfall structure through the levee, 34 feet below the crown. Slide gate in a 4-foot by 8-foot concrete riser on the waterside (WS) slope. (Retention of a 4-foot by 7-foot concrete culvert outfall drain through the levee, 34 feet below the crown, and a slide gate in a concrete well authorized under Automatic Board Order (ABO) issued as Permit No. 10020, 1974 - Leo Bandoni, care of John Digardi). [Additional Reference(s): DWR Levee Log, 2005. USACE Sacramento O&M Manual 133, August 1955, (Station 1044+60), two 4-foot by 7-foot concrete tunnels referenced]. FS Date: 10/10/2013</p>

WS view: closer view of U shaped concrete headwall in bypass channel. Pipe not visible.

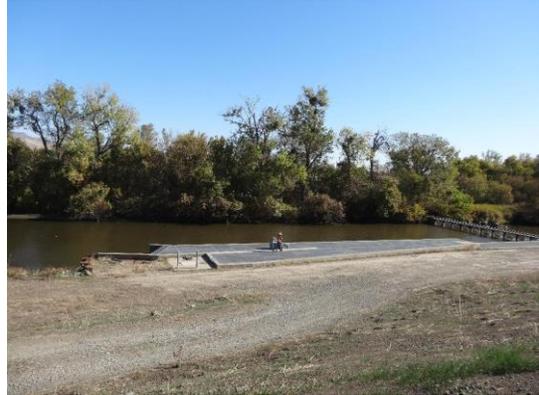
Photo 1 of 3 : UCIP_FA_2019_22708_38406.jpg

Comment Code					
Inspector Comment					
DS_ID:22505 FS_ID:22708 EP_NO: N/A Repair Type: No Action Needed Crossing Status: Found UCIP Comments: - inlet structure 160 ft off the levee center on landside drainage ditch. FIELD_STRUCT_DESC: 48-inch steel gravity drainage pipe through the levee, 29 feet below the crown. Slide gate and concrete bulkhead on the riverbank. Staff gage on the waterside (WS) berm. (Retention of a 48-inch corrugated metal pipe (CMP) through the levee, 29 feet below the crown, a slide gate, and a concrete bulkhead authorized under Automatic Board Order (ABO) No. 10021, 1974 - Butte Slough Irrigation Company, care of Tarke Warehouse). [Additional Reference(s): DWR Levee Log, 2005. USACE Sacramento O&M Manual 133, August 1955, (Station 433+43), 48-inch CMP referenced]. FS Date: 10/15/2013

WS view: overview of concrete box on channel bank. It looks like a fish ladder. Pipe discharges into this box.

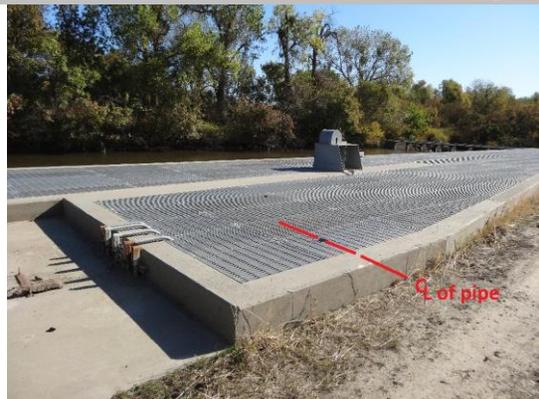
Photo 2 of 3 : UCIP_FA_2019_22708_38405.jpg

WS view: concrete box on channel bank. Pipe end with slide gate. Pipe discharges into this box.

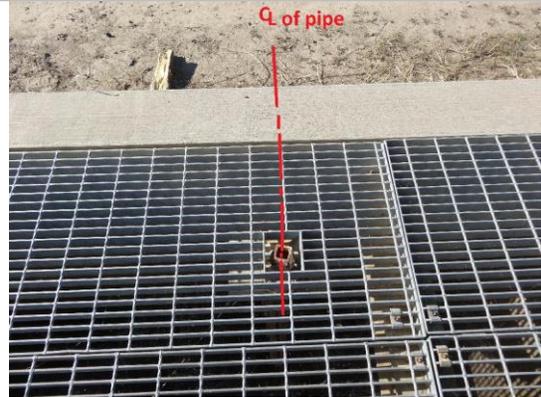
Photo 3 of 3 : UCIP_FA_2019_22708_38409.jpg

Comment Code					
Inspector Comment					
DS_ID:22505 FS_ID:22708 EP_NO: N/A Repair Type: No Action Needed Crossing Status: Found UCIP Comments: - inlet structure 160 ft off the levee center on landside drainage ditch. FIELD_STRUCT_DESC: 48-inch steel gravity drainage pipe through the levee, 29 feet below the crown. Slide gate and concrete bulkhead on the riverbank. Staff gage on the waterside (WS) berm. (Retention of a 48-inch corrugated metal pipe (CMP) through the levee, 29 feet below the crown, a slide gate, and a concrete bulkhead authorized under Automatic Board Order (ABO) No. 10021, 1974 - Butte Slough Irrigation Company, care of Tarke Warehouse). [Additional Reference(s): DWR Levee Log, 2005. USACE Sacramento O&M Manual 133, August 1955, (Station 433+43), 48-inch CMP referenced]. FS Date: 10/15/2013

WS view: concrete box on channel bank. Pipe discharges into this box. A slide gate inside this box.
