**Flood Control Project Maintenance
Levee Inspections**

Fall 2019 Levee Maintenance Deficiency Summary Report

Sacramento River Basin

Reclamation District No. 2060 Hastings

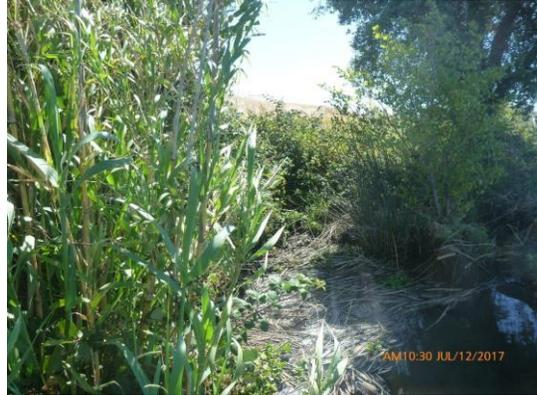
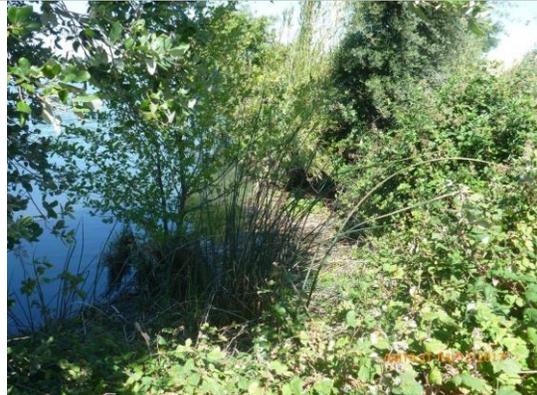
LM Start	0.40	Rating **	M	Issue No.	5
LM End	0.40	Issue Type +	Ma	Location *	WS
Category	Supplemental			GPS Latitude/Longitude	
				Start	End
Item	2017 Storm Damage			38.247894 °	38.247911 °
				-121.703492 °	-121.703539 °
DWR ID	LMA-185				
Comment Code					
Inspector Comment					
Levee Evaluation Comments					
Description: Erosion commences approximately 3/4 of the way down the slope, near the water line towards the waterside toe.					
Site ID No: 358					
Site Designation: LMA-185					
Repair Type: Erosion					
Rating: Area of Concern					
Field Date: 7/12/2017					
Notes: Small erosion into bank.

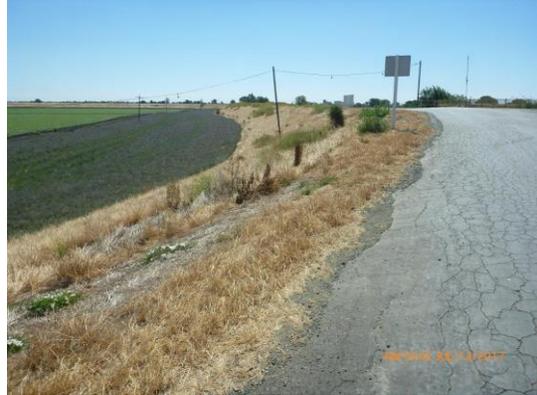
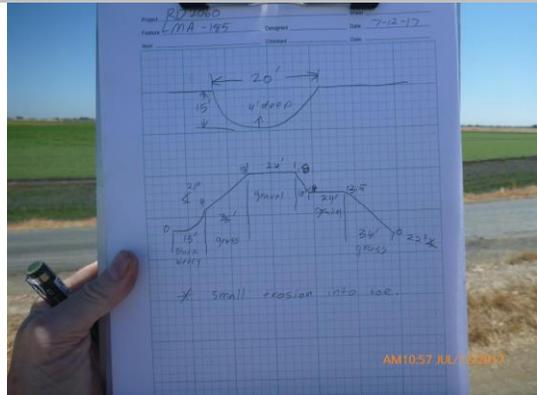
LM Start	0.40	Rating **	M	Issue No.	5 (cont)
LM End	0.40	Issue Type +	Ma	Location *	WS
Category	Supplemental			GPS Latitude/Longitude	
				Start	End
Item	2017 Storm Damage			38.247894 °	38.247911 °
				-121.703492 °	-121.703539 °
DWR ID	LMA-185				
Comment Code					
Inspector Comment					
Levee Evaluation Comments Description: Erosion commences approximately 3/4 of the way down the slope, near the water line towards the waterside toe. Site ID No: 358 Site Designation: LMA-185 Repair Type: Erosion Rating: Area of Concern Field Date: 7/12/2017 Notes: Small erosion into bank.

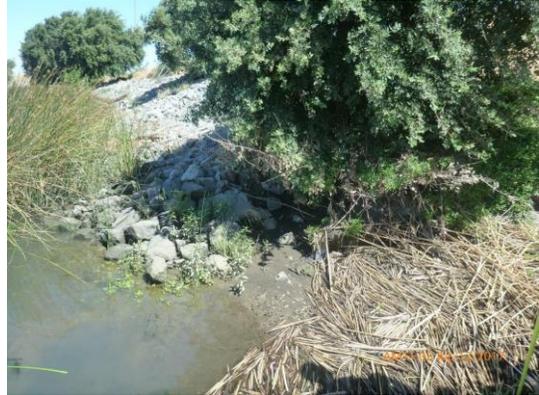
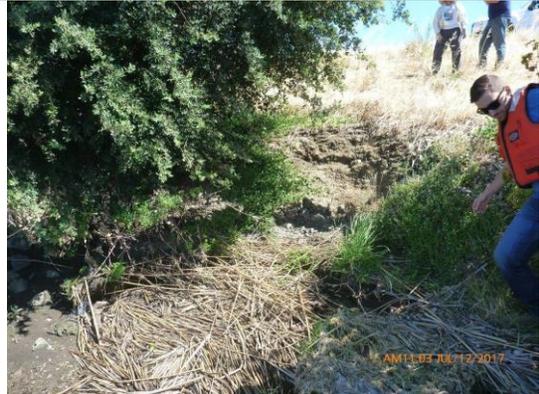
LM Start	0.41	Rating **	M	Issue No.	8
LM End	0.42	Issue Type +	Ma	Location *	WS
Category	Supplemental		GPS Latitude/Longitude		
			Start	End	
Item	2017 Storm Damage		38.248036°	38.248017°	
			-121.703539°	-121.703789°	
DWR ID	LMA-186

Levee Evaluation Comments
 Description: Erosion commences approximately halfway down the water side slope extending in to existing rip rap. Existing rip rap appears to have been pulled off in this section.
 Site ID No: 359
 Site Designation: LMA-186
 Repair Type: Erosion
 Rating: Area of Concern
 Field Date: 7/12/2017
 Notes: Site had riprap but is eroded away. Minor erosion in toe of levee.

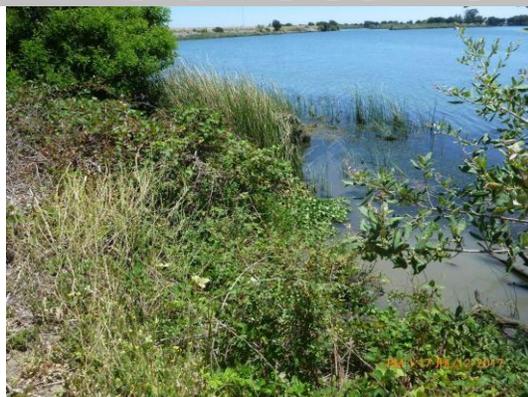
LM Start	1.04	Rating **	M	Issue No.	15 (cont)
LM End	1.08	Issue Type +	Ma	Location *	WS
Category	Supplemental			GPS Latitude/Longitude	
				Start	End
Item	2017 Storm Damage			38.251058 °	38.250872 °
				-121.714050 °	-121.714792 °
DWR ID	LMA-189				
Comment Code					
Inspector Comment					
Levee Evaluation Comments Description: Erosion commences approximately 3/4 of the way down the water side slope concentrated at the waterline. Site ID No: 362 Site Designation: LMA-189 Repair Type: Erosion Rating: Area of Concern Field Date: 7/12/2017 Notes: Erosion due to lack of revetment. Erosion ends at riprap downstream. Vertical cut at summer wse.

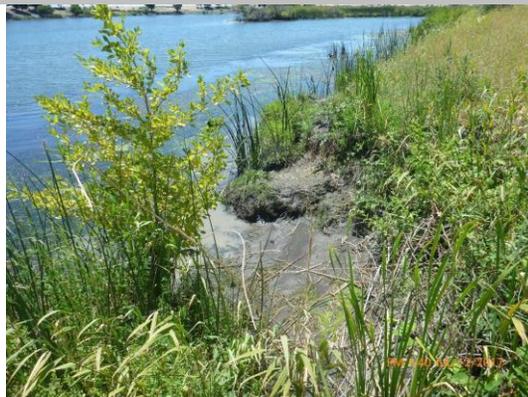
LM Start	1.09	Rating **	M	Issue No.	16
LM End	1.10	Issue Type +	Ma	Location *	WS
Category	Supplemental			GPS Latitude/Longitude	
				Start	End
Item	2017 Storm Damage			38.250844 °	38.250833 °
				-121.714944 °	-121.714994 °
DWR ID	LMA-190				
Comment Code					
Inspector Comment					
Levee Evaluation Comments Description: Erosion commences approximately halfway down the water side slope extending to the toe. Site ID No: 363 Site Designation: LMA-190 Repair Type: Erosion Rating: Area of Concern Field Date: 7/12/2017 Notes: Small erosion up to high water line. Cuts into slope with 6' vertical cut.

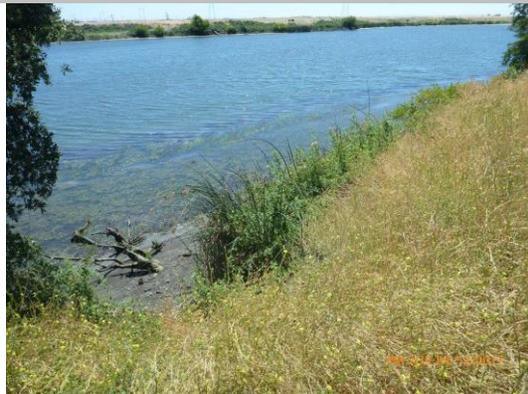
LM Start	1.39	Rating **	A/W	Issue No.	20 (cont)
LM End	1.56	Issue Type +	Ma	Location *	WS
Category	Supplemental			GPS Latitude/Longitude	
				Start	End
Item	2017 Storm Damage			38.251886°	38.252619°
				-121.719933°	-121.722842°
DWR ID	LMA-192				
Comment Code					
Inspector Comment					
Levee Evaluation Comments Description: Erosion commences approximately halfway down the water side slope extending to the toe. Site ID No: 365 Site Designation: LMA-192 Repair Type: Erosion Rating: Serious Field Date: 7/12/2017 Notes: Several deep narrow cuts into levee, but mostly minor erosion at highwater line.

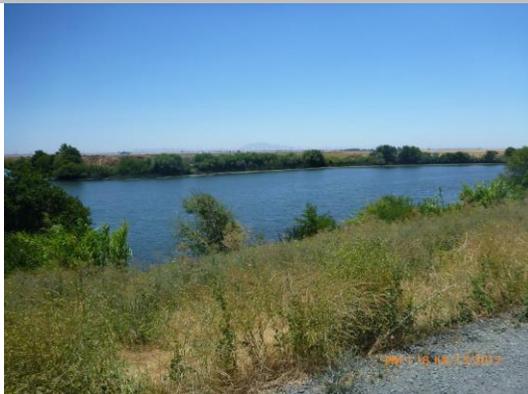
LM Start	3.60	Rating **	M	Issue No.	27 (cont)
LM End	3.61	Issue Type +	Ma	Location *	WS
Category	Supplemental			GPS Latitude/Longitude	
				Start	End
Item	2017 Storm Damage			38.261469 °	38.261464 °
				-121.748389 °	-121.748442 °
DWR ID	LMA-200				
Comment Code					
Inspector Comment					
Levee Evaluation Comments Description: Erosion commences halfway down the slope and extends to the toe. Erosion is concentrated at the water line. Site ID No: 373 Site Designation: LMA-200 Repair Type: Erosion Rating: Area of Concern Field Date: 7/13/2017 Notes: Small erosion with a narrow deep cut. Heavy veg is protecting the slope.

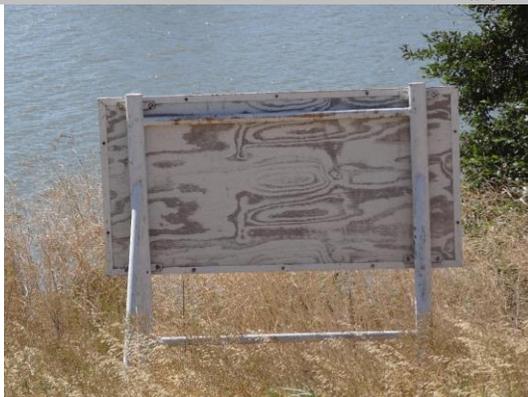
Comment Code					
Inspector Comment					
DS_ID: 22050 FS_ID: 41908 EP_NO: 10119 Repair Type: Non-Urgent Crossing Status: Indicator Found UCIP Comments: 09/19/2018 Updated record to reflect correct permit, historic levee log showed Permit No. 10119 correct Permit No. is 12784. Permit No. 10119 was issued for overhead lines. (O. Magana - DWR UCIP) 08/15/2013 Need to contact owner and verify status of crossing. (P. Amatya - DWR UCIP) FIELD_STRUCT_DESC: 8.625-inch steel natural gas pipeline through the levee, at an unknown depth. Gas line marker on the landside (LS). Sign board on the waterside (WS). (8.625-inch pipeline installed across the channel and both levees of Lindsey Slough authorized under Permit No. 12784, 1979 - Pacific Gas and Electric Company [PG&E]; 8.625-inch line referenced incorrectly as part of Permit No. 10119, 1975 - PG&E, correct Permit No. is 12784). [Additional Reference(s): DWR Levee Log, 2005]. FS Date: 8/15/2013

WS view: gasoline sign board on levee slope.

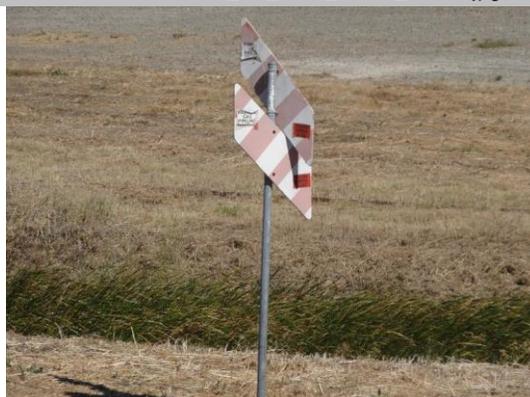
Comment Code					
Inspector Comment					
<p>DS_ID:22050 FS_ID:41908 EP_NO: 10119 Repair Type: Non-Urgent Crossing Status: Indicator Found UCIP Comments: 09/19/2018 Updated record to reflect correct permit, historic levee log showed Permit No. 10119 correct Permit No. is 12784. Permit No. 10119 was issued for overhead lines. (O. Magana - DWR UCIP) 08/15/2013 Need to contact owner and verify status of crossing. (P. Amatya - DWR UCIP) FIELD_STRUCT_DESC: 8.625-inch steel natural gas pipeline through the levee, at an unknown depth. Gas line marker on the landside (LS). Sign board on the waterside (WS). (8.625-inch pipeline installed across the channel and both levees of Lindsey Slough authorized under Permit No. 12784, 1979 - Pacific Gas and Electric Company [PG&E]; 8.625-inch line referenced incorrectly as part of Permit No. 10119, 1975 - PG&E, correct Permit No. is 12784). [Additional Reference(s): DWR Levee Log, 2005]. FS Date: 8/15/2013</p>

LS view: gasline indicator across the road from levee toe.

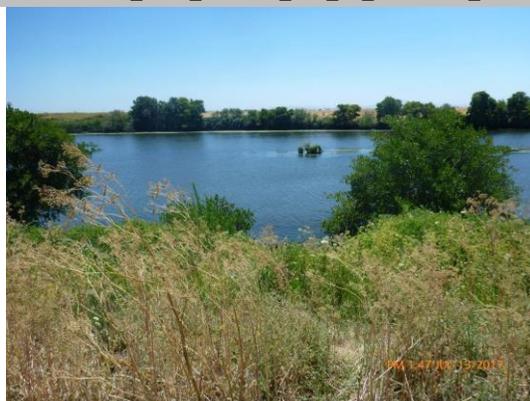
LM Start	3.67	Rating **	M	Issue No.	28
LM End	3.67	Issue Type +	Ma	Location *	WS
Category	Supplemental			GPS Latitude/Longitude	
				Start	End
Item	2017 Storm Damage			38.261181 °	38.261167 °
				-121.749542 °	-121.749592 °
DWR ID	LMA-201				
Comment Code					
Inspector Comment					
<p>Levee Evaluation Comments Description: Erosion is concentrated near the water line. Site ID No: 374 Site Designation: LMA-201 Repair Type: Erosion Rating: Area of Concern Field Date: 7/13/2017 Notes: Small narrow and deep cut. May have been caused by a collapsed beaver den.</p>

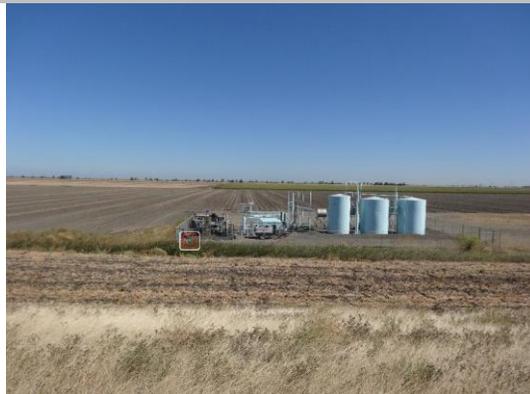
Comment Code					
Inspector Comment					
DS_ID:22045 FS_ID:41878 EP_NO: 12784 Repair Type: Non-Urgent Crossing Status: Indicator Found UCIP Comments: 09/19/2018 Based on permit number 12784 review, 8.625-inch line should cross at RD2060U1 CLM 3.756 however, the markers for this crossing show the line crosses at RD2060U1 CLM 3.648 instead. Need to request line alignment for this crossing and update record. This could be a duplicate record of dsid 22050. (O. Magana - DWR UCIP) 08/15/2013 Need to contact owner to determine status and install signs if appropriate. (P. Amatya - DWR UCIP) FIELD_STRUCT_DESC: 8.625-inch steel natural gas pipeline through the levee, 4 feet below the crown. Gas line marker off the landside (LS) toe. (To construct an 8.625-inch pipeline across the channel and both levees of Lindsey Slough authorized under Permit No. 12784, 1979 - Pacific Gas and Electric Company [PG&E]). FS Date: 8/15/2013

LS view: a gas plant and gasline indicator found on LS.

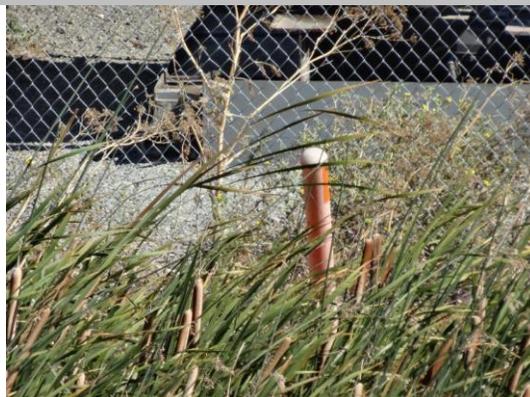
LS view: closer view of gasline indicator found on LS.

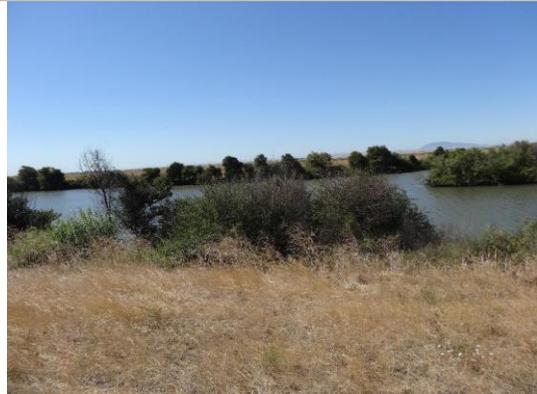
Comment Code					
Inspector Comment					
<p>DS_ID:22045 FS_ID:41878 EP_NO: 12784 Repair Type: Non-Urgent Crossing Status: Indicator Found UCIP Comments: 09/19/2018 Based on permit number 12784 review, 8.625-inch line should cross at RD2060U1 CLM 3.756 however, the markers for this crossing show the line crosses at RD2060U1 CLM 3.648 instead. Need to request line alignment for this crossing and update record. This could be a duplicate record of dsid 22050. (O. Magana - DWR UCIP) 08/15/2013 Need to contact owner to determine status and install signs if appropriate. (P. Amatya - DWR UCIP) FIELD_STRUCT_DESC: 8.625-inch steel natural gas pipeline through the levee, 4 feet below the crown. Gas line marker off the landside (LS) toe. (To construct an 8.625-inch pipeline across the channel and both levees of Lindsey Slough authorized under Permit No. 12784, 1979 - Pacific Gas and Electric Company [PG&E]). FS Date: 8/15/2013</p>

WS view: no indicators found on WS.

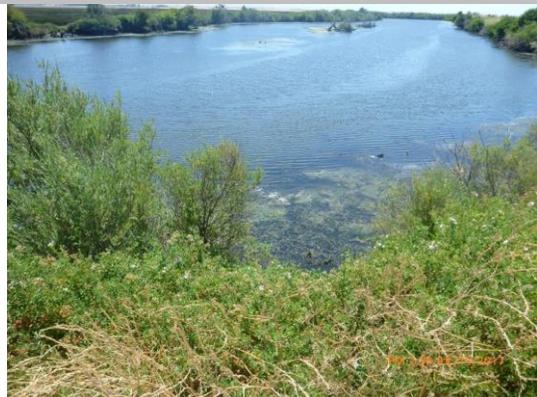
LM Start	4.28	Rating **	A/W	Issue No.	29
LM End	4.28	Issue Type +	Ma	Location *	WS
Category	Supplemental			GPS Latitude/Longitude	
				Start	End
Item	2017 Storm Damage			38.260992 °	38.261017 °
				-121.759806 °	-121.759847 °
DWR ID	LMA-203				
Comment Code					
Inspector Comment					
<p>Levee Evaluation Comments Description: Erosion commences halfway down the slope and extends to the toe. Erosion is concentrated at the water line. Site ID No: 376 Site Designation: LMA-203 Repair Type: Erosion Rating: Area of Concern Field Date: 7/13/2017 Notes: Could not get to erosion due to dense veg. Possibly a deep narrow cut.</p>

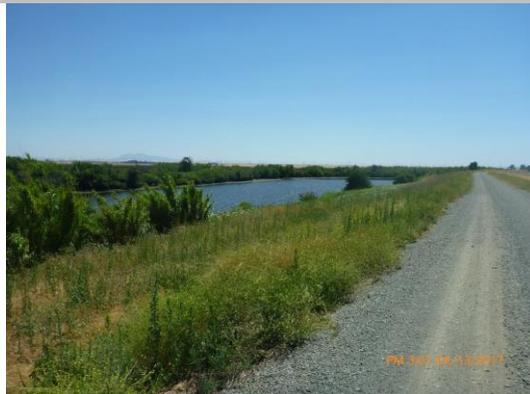
LM Start	4.40	Rating **	M	Issue No.	30 (cont)
LM End	4.46	Issue Type +	Ma	Location *	WS
Category	Supplemental			GPS Latitude/Longitude	
				Start	End
Item	2017 Storm Damage			38.260850 °	38.260425 °
				-121.761875 °	-121.762861 °
DWR ID	LMA-204				
Comment Code					
Inspector Comment					
Levee Evaluation Comments Description: Erosion/sloughing commences approximately halfway down the slope. Erosion is concentrated mostly near the water line and has resulting in slippage of the slope. Site ID No: 377 Site Designation: LMA-204 Repair Type: Erosion Rating: Area of Concern Field Date: 7/13/2017 Notes: large cut is 100' of 320' site. Large cut is 12' vertical and the rest is 6'.

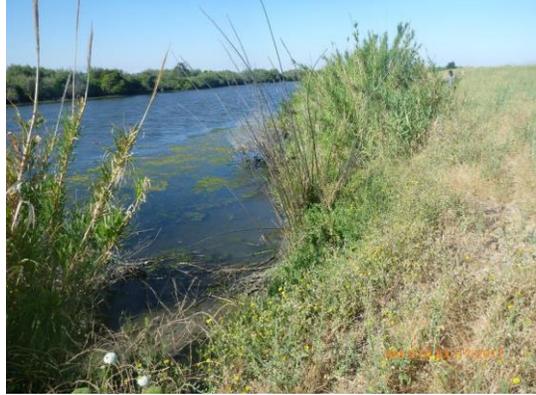
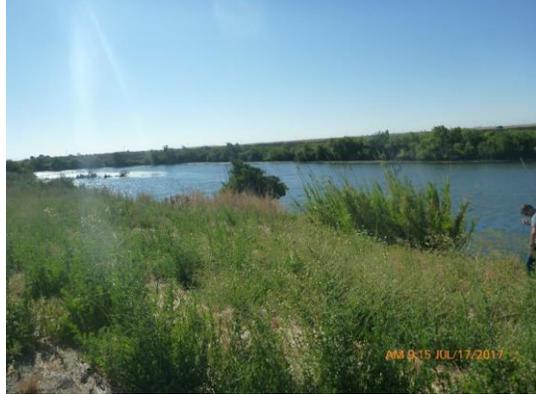
LM Start	4.50	Rating **	A/W	Issue No.	31
LM End	4.53	Issue Type +	Ma	Location *	WS
Category	Supplemental		GPS Latitude/Longitude		
			Start	End	
Item	2017 Storm Damage		38.260150°	38.259939°	
			-121.763556°	-121.764064°	
DWR ID	LMA-205				
Comment Code					
Inspector Comment					
Levee Evaluation Comments					
Description: Erosion commences approximately 3/4 of the way down the slope. It has resulted in some sloughing.					
Site ID No: 378					
Site Designation: LMA-205					
Repair Type: Erosion					
Rating: Serious					
Field Date: 7/17/2017					
Notes: Deep, wide, vertical cut into slope almost 1/2 way into sope.

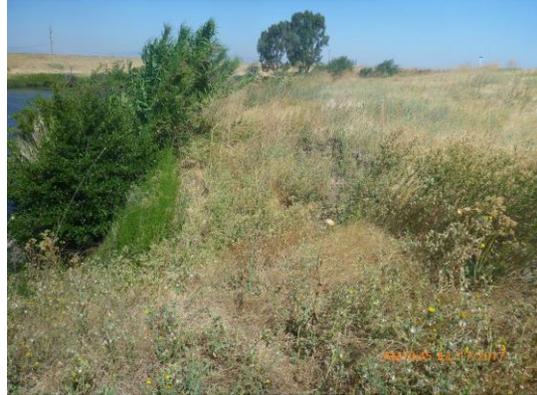
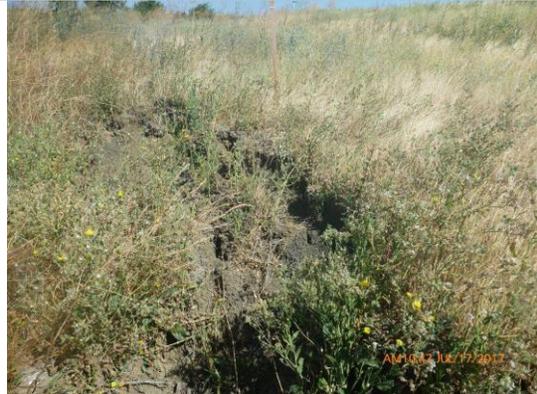
LM Start	5.00	Rating **	M	Issue No.	34 (cont)
LM End	5.01	Issue Type +	Ma	Location *	WS
Category	Supplemental			GPS Latitude/Longitude	
				Start	End
Item	2017 Storm Damage			38.262636°	38.262658°
				-121.770503°	-121.770547°
DWR ID	LMA-208				
Comment Code					
Inspector Comment					
Levee Evaluation Comments Description: Erosion is concentrated mostly near the water line and has resulting in slippage of the slope into the toe. Site ID No: 381 Site Designation: LMA-208 Repair Type: Erosion Rating: Area of Concern Field Date: 7/17/2017 Notes: Extended site from 15' to 75' to include LMA-209. Small erosions will become 1 site next high water due to sloughing between them.

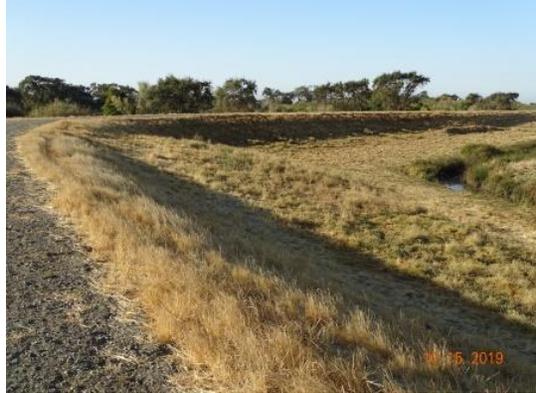
View of annual vegetation on the landside slope (Fall 2019).

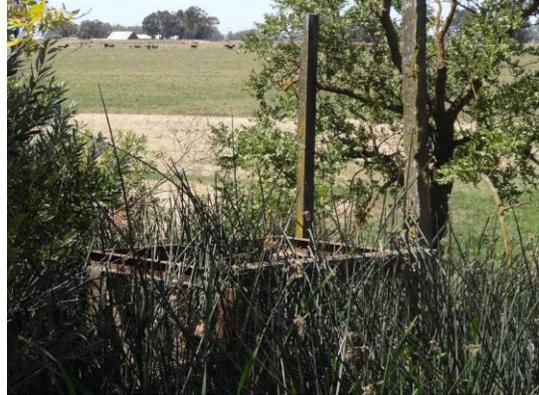
LM Start	0.00	Rating **	M	Issue No.	10
LM End	0.00	Issue Type +	En	Location *	
Category	Supplemental			GPS Latitude/Longitude	
				Start	End
Item	DRAFT DWR UCIP Field Study			38.289474 °	38.289474 °
				-121.775914 °	-121.775914 °
DWR ID	22059				
Comment Code					
Inspector Comment					
DS_ID:22059 FS_ID:46769 EP_NO: N/A Repair Type: Non-Urgent Crossing Status: Indicator Found UCIP Comments: - Abandoned pump structure in stream needs proper abandonment- Not accessible due to wired fence FIELD_STRUCT_DESC: *ABANDONED* Pump structure in stream. Concrete distribution box on the landside (LS) slope. Not accessible due to a wire fence. [Additional Reference(s): DWR Levee Log, 2005]. FS Date: 8/15/2013

WS view: abandoned pump support in stream/channel. Not accessible due to vegetation.

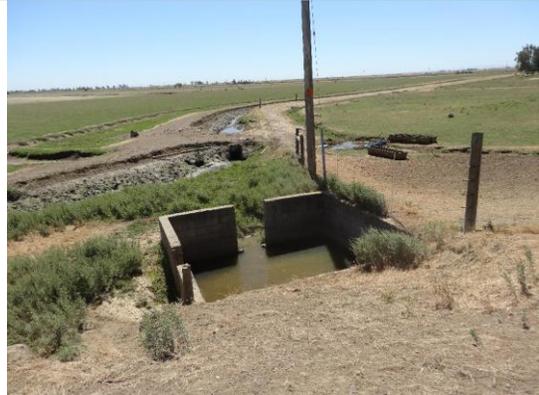
LS view: abandoned concrete distribution box. Not accessible due to wire fence.

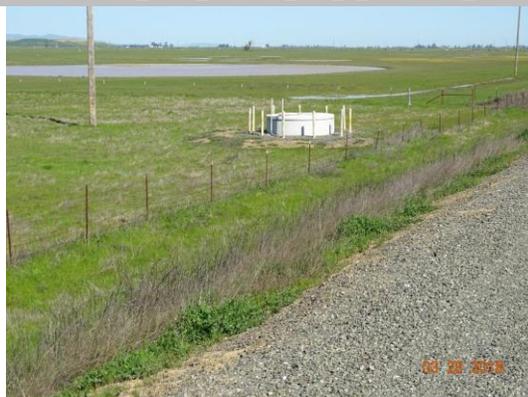
Barbed wire fence on waterside has no permit.

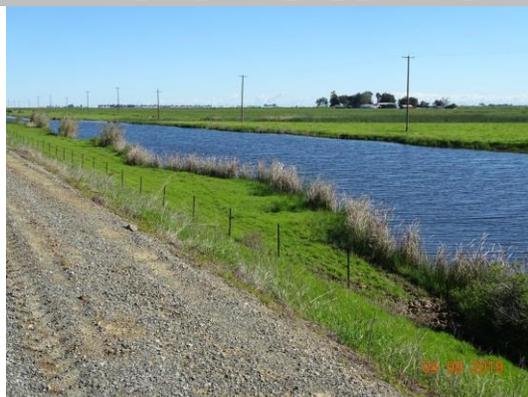
View looking upstream at fence at the landside toe (Spring 2019).

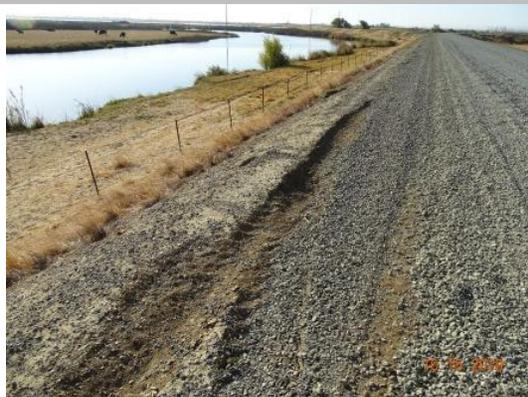
View of deep rut on the waterside shoulder of the crown (Fall 2019).

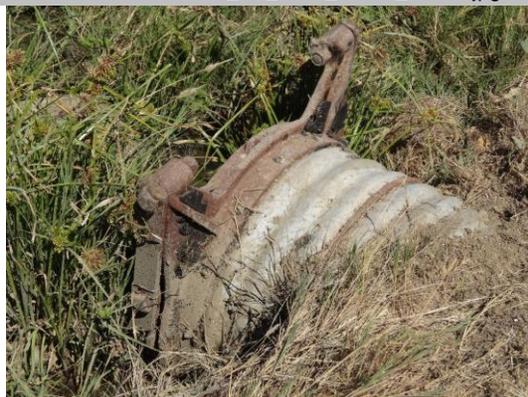
WS view: CM pipe with flap gate. Not accessible. Vegetation is partially blocking outlet pipe.

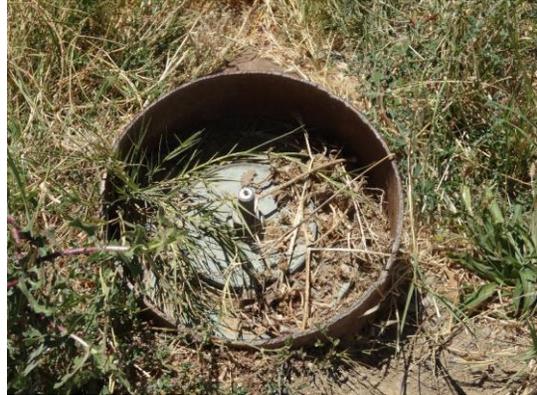
LS view: obstructed siphon breaker in steel riser on levee slope.

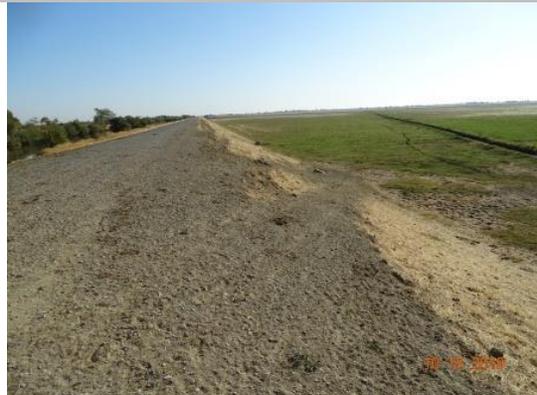
View looking downstream at cow path on the landside slope (Fall 2019).

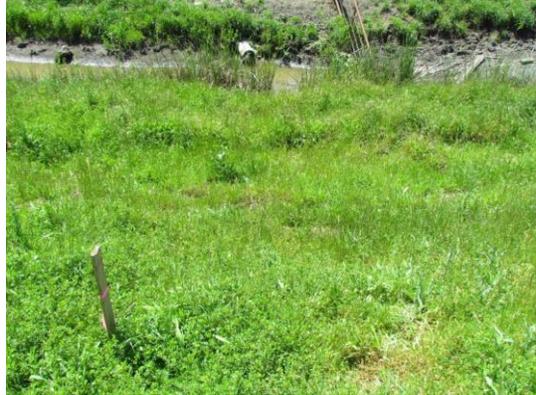
Looking down from the shoulder at the sloughing in the slope towards the irrigation ditch at toe.

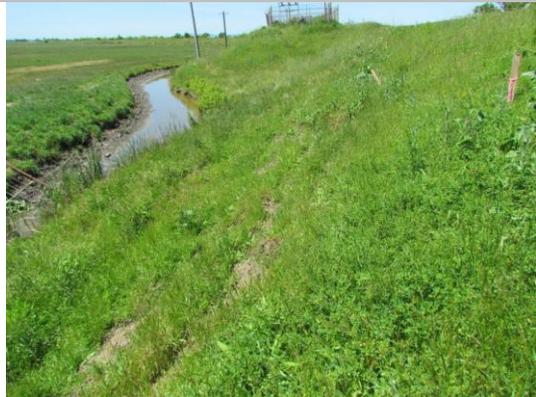
Standing on the slope looking upstream at the slough.

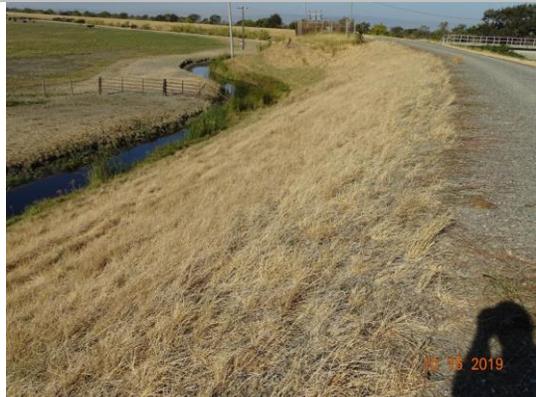
View looking upstream at minor slump on the lower half of the landside slope (Fall 2019).

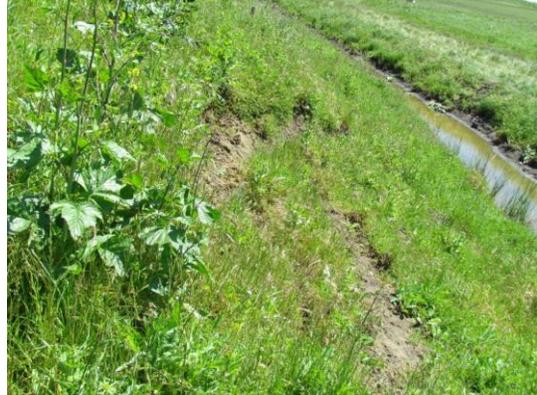
Standing at levee mile 0.15 looking downstream from the landside slope.

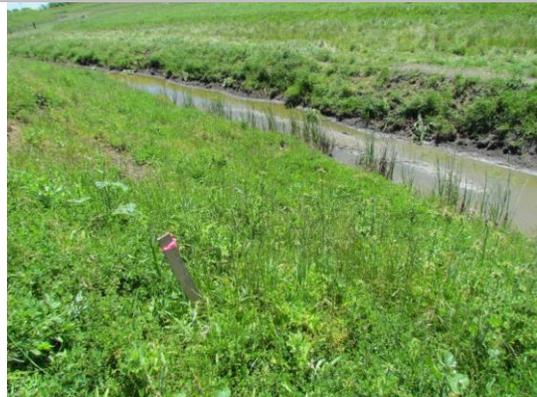
Just upstream of the erosion site looking downstream from the landside slope.

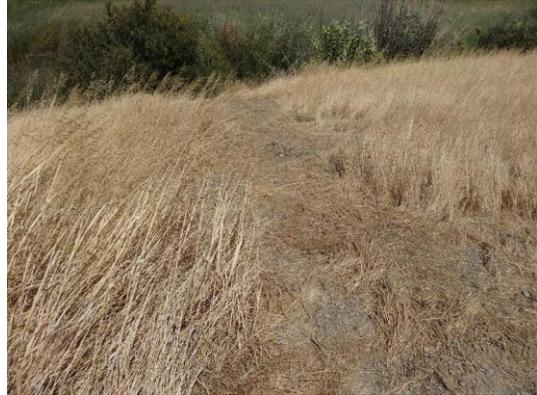
Waterside view: levee slope.

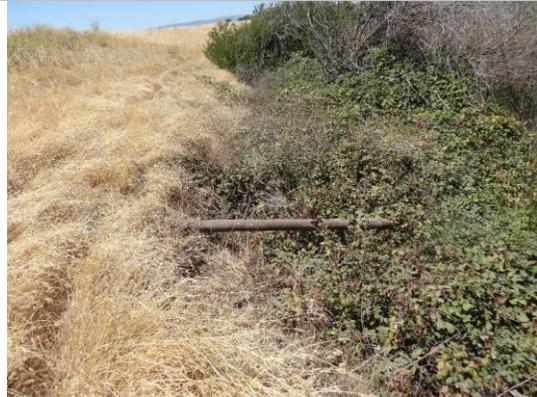
Waterside view: levee slope and a steel pipe.

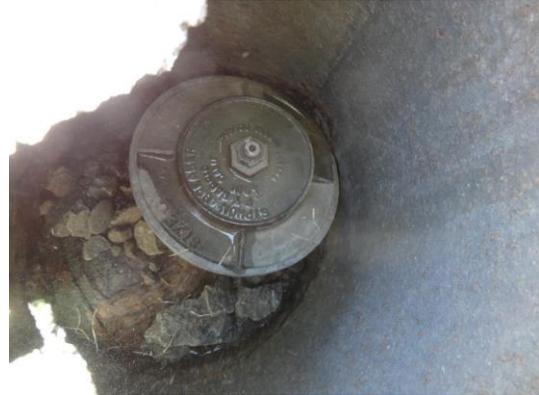
Waterside view: only leaky siphon breaker found.

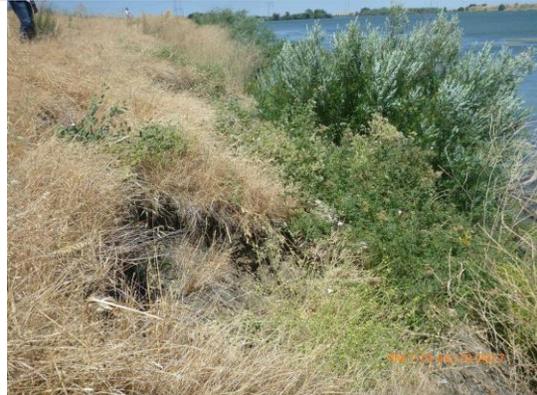
LM Start	2.12	Rating **	A/W	Issue No.	27
LM End	2.15	Issue Type +	Ma	Location *	WS
Category	Supplemental			GPS Latitude/Longitude	
				Start	End
Item	2017 Storm Damage			38.282733 °	38.282403 °
				-121.717683 °	-121.717428 °
DWR ID	LMA-224				
Comment Code					
Inspector Comment					
Levee Evaluation Comments Description: Erosion commences approximately 1/4 of the way down the slope and results in slippage into the waterside toe. Site ID No: 397 Site Designation: LMA-224 Repair Type: Erosion Rating: Serious Field Date: 7/18/2017 Notes: Benched erosion with large cracks on slope above. Light veg in erosion.

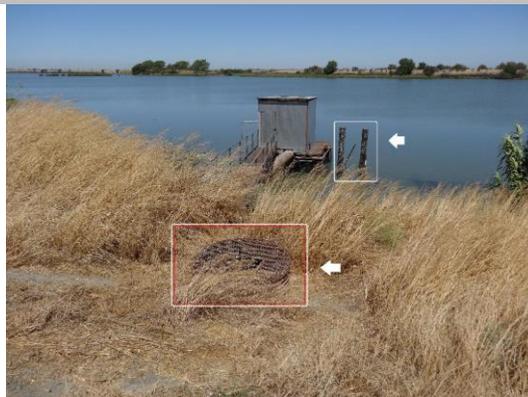
LM Start	3.24	Rating **	M	Issue No.	74
LM End	3.24	Issue Type +	En	Location *	
Category	Supplemental			GPS Latitude/Longitude	
				Start	End
Item	DRAFT DWR UCIP Field Study			38.270151 °	38.270151 °
				-121.705782 °	-121.705782 °
DWR ID	22064				
Comment Code					
Inspector Comment					
DS_ID: 22064 FS_ID: 18723 EP_NO: N/A Repair Type: Non-Urgent Crossing Status: Indicator Found UCIP Comments: Only a CMP riser was found on WS. FIELD_STRUCT_DESC: 36-inch asbestos bonded steel irrigation discharge pipe through the levee, 15 feet below the crown, not found. Slide gate in a corrugated metal pipe (CMP) riser on the waterside (WS) slope, found. Pump in pump house on a pile structure in the stream, not found. Service pole and anchor on the landside (LS) slope, not found. FS Date: 8/15/2013

WS view: slide gate in CMP riser (bottom- marked) and may be abandoned pile for pump support (marked- right).
