**Flood Control Project Maintenance
Levee Inspections**

Maintenance Issue Types Only, Levee Inspection Report By Mile - Spring 2020

Reclamation District No. 2060 Hastings

Waterway	Bank	Unit Miles	Inspection Start/End	Inspector
Unit No. 01 Lindsey Slough	Left	6.97	04/17/2020 04/17/2020	David Julian

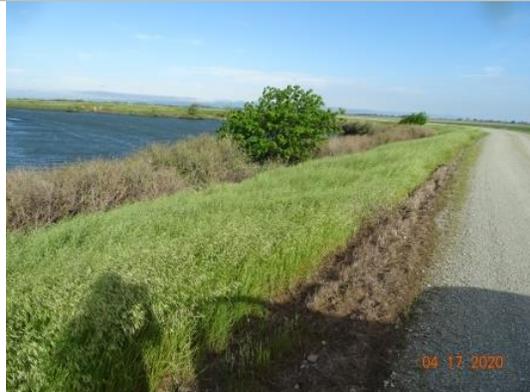
Photo 1 of 1 : SP_2020_RD2060_241_19_20200417_00074.jpg

LM Start	0.08	Rating **	M	Issue No.	19
LM End	5.08	Issue Type +	Ma	Location *	WS
Category	Earthen Levee		GPS Latitude/Longitude		
			Start	End	
Item	Vegetation		38.247305 °	38.263296 °	
			-121.697734 °	-121.771525 °	
DWR ID	DWR_RD2060_01_s_2020_19				
Comment Code					
V1 : Control annual grass and weeds on the levee slopes and easements.					
Inspector Comment

View looking upstream at vegetation on the waterside slope (Spring 2020).

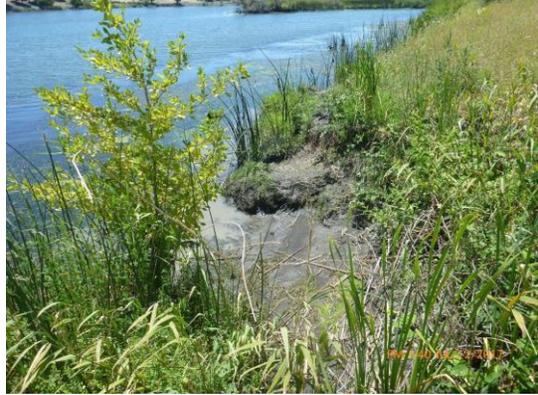
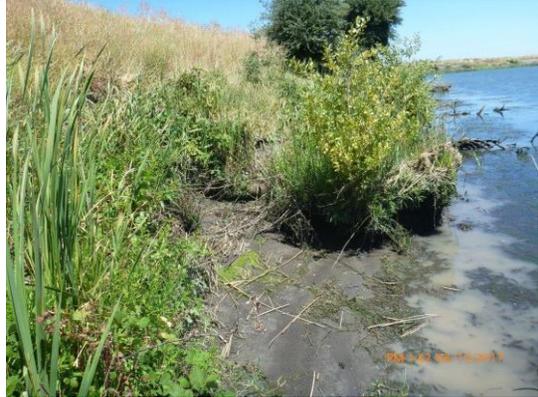
LM Start	1.09	Rating **	A/W	Issue No.	16
LM End	1.10	Issue Type +	Ma	Location *	WS
Category	Earthen Levee		GPS Latitude/Longitude		
			Start	End	
Item	Erosion / Bank Caving		38.250844 °	38.250833 °	
			-121.714944 °	-121.714994 °	
DWR ID	LMA-190				
Comment Code					
E1 : Note and monitor erosion site.					
Inspector Comment					
This was a 2017 Storm Damage site. Erosion at the waterside toe. Site ID No:363 Site Designation:LMA-190 4/17/2020 Field Notes: Unable to view erosion due to thick vegetation. Verify using a boat survey. Monitor.

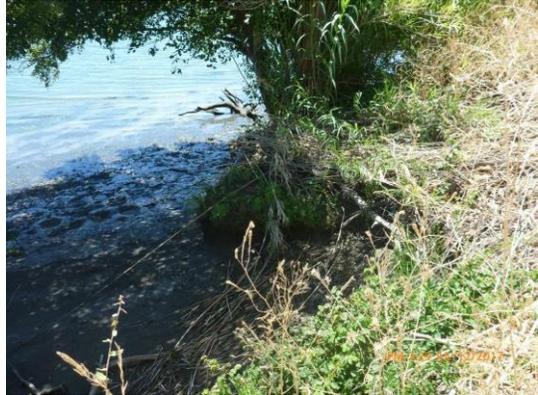
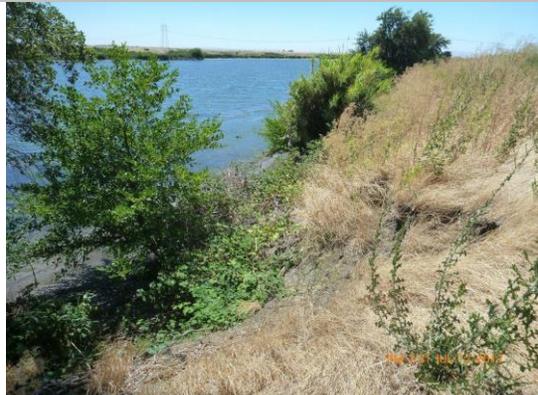
LM Start	1.39	Rating **	A/W	Issue No.	20
LM End	1.43	Issue Type +	Ma	Location *	WS
Category	Earthen Levee		GPS Latitude/Longitude		
			Start	End	
Item	Erosion / Bank Caving		38.251886 °	38.251910 °	
			-121.719933 °	-121.720620 °	
DWR ID	LMA-192				
Comment Code					
E1 : Note and monitor erosion site.					
Inspector Comment					
This was a 2017 Storm Damage site. Erosion commences approximately halfway down the water side slope extending to the toe. Site ID No:365 Site Designation:LMA-192 4/17/2020 Field Notes: Do a boat inspection to get a better view of erosion.

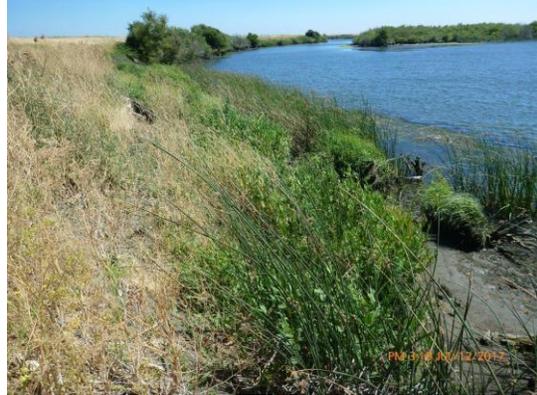
Photo 1 of 1 : SP_2020_RD2060_241_21_20200304_00027.jpg

LM Start	1.81	Rating **	A/W	Issue No.	21
LM End	1.84	Issue Type +	Ma	Location *	WS
Category	Earthen Levee		GPS Latitude/Longitude		
			Start	End	
Item	Erosion / Bank Caving		38.255972 °	38.256247 °	
			-121.724197 °	-121.724464 °	
DWR ID	LMA-193				
Comment Code					
E1 : Note and monitor erosion site.					
Inspector Comment					
<p>This was a 2017 Storm Damage site. Erosion commences approximately halfway down the water side slope extending to the toe. Some slipping into the toe has occurred due to deep erosion. Site ID No:366 Site Designation:LMA-193 4/17/2020 Field Notes: Do a boat inspection to get a better view of erosion.</p>

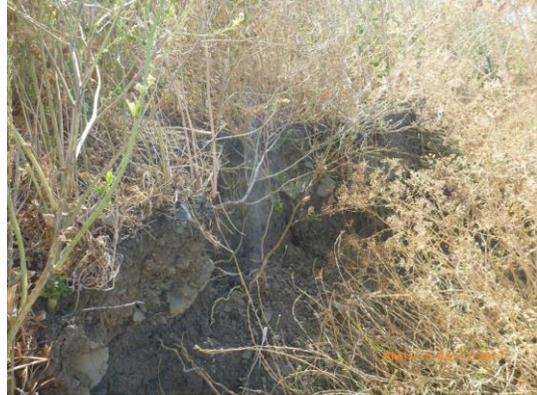
Photo 1 of 1 : SP_2020_RD2060_241_23_20200304_00033.jpg

LM Start	2.10	Rating **	A/W	Issue No.	23
LM End	2.13	Issue Type +	Ma	Location *	WS
Category	Earthen Levee		GPS Latitude/Longitude		
			Start	End	
Item	Erosion / Bank Caving		38.259317 °	38.259258 °	
			-121.726314 °	-121.726939 °	
DWR ID	LMA-195				
Comment Code					
E1 : Note and monitor erosion site.					
Inspector Comment					
This was a 2017 Storm Damage site. Erosion commences approximately halfway down the water side slope extending to the rip rap. Site ID No:368 Site Designation:LMA-195 4/17/2020 Field Notes: Do a boat inspection to get a better view of erosion.

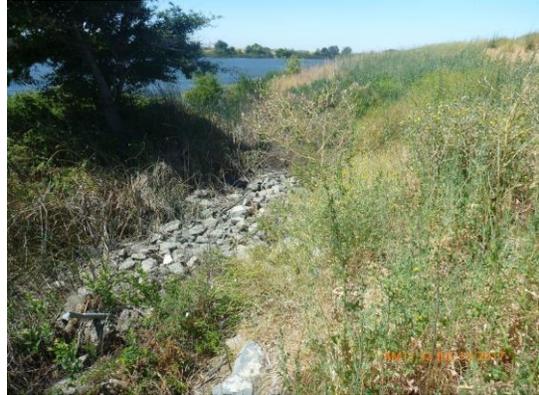
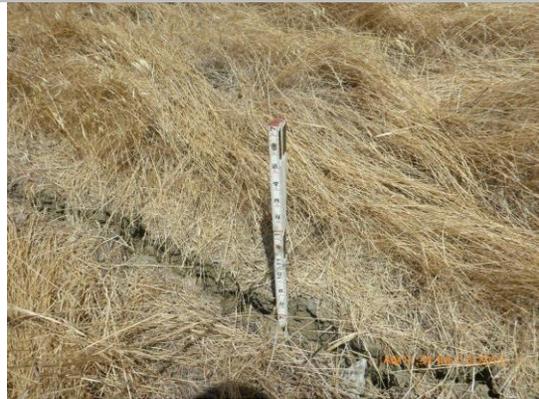
LM Start	3.07	Rating **	U	Issue No.	25
LM End	3.10	Issue Type +	Ma	Location *	WS
Category	Earthen Levee			GPS Latitude/Longitude	
				Start	End
Item	Erosion / Bank Caving			38.260772 °	38.260569 °
				-121.740817 °	-121.741194 °
DWR ID	LMA-197				
Comment Code					
E2 : Schedule repair of erosion site prior to the next inspection.					
Inspector Comment					
This was a 2017 Storm Damage Site Large erosion halfway into levee. Horizontal cracking on slope almost 24" deep. Site ID No:370 Site Designation:LMA-197

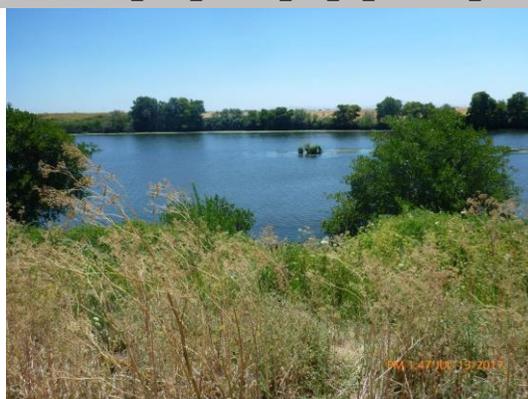
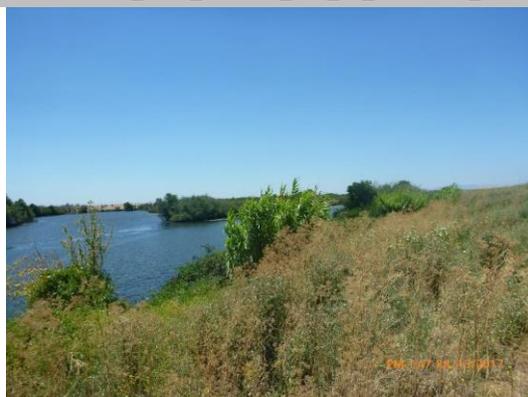
LM Start	3.67	Rating **	A/W	Issue No.	28
LM End	3.67	Issue Type +	Ma	Location *	WS
Category	Earthen Levee		GPS Latitude/Longitude		
			Start	End	
Item	Erosion / Bank Caving		38.261181 °	38.261167 °	
			-121.749542 °	-121.749592 °	
DWR ID	LMA-201

Inspector Comment
Erosion is concentrated near the water line.
Site ID No:374
Site Designation:LMA-201
4/6/2020 Notes: Planned for repair.

Comment Code
E1 : Note and monitor erosion site.

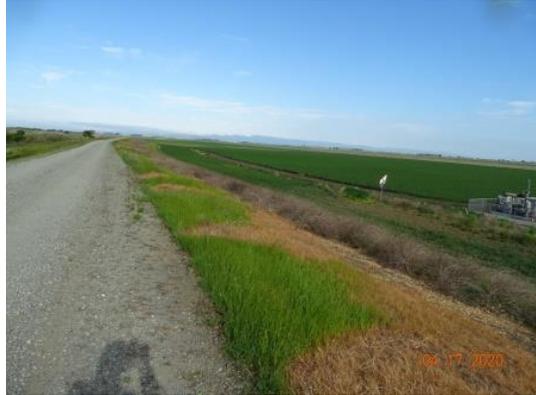
Photo 1 of 1 : SP_2020_RD2060_241_17_20200417_00075.jpg

View looking upstream at vegetation on the landside slope (Spring 2020).

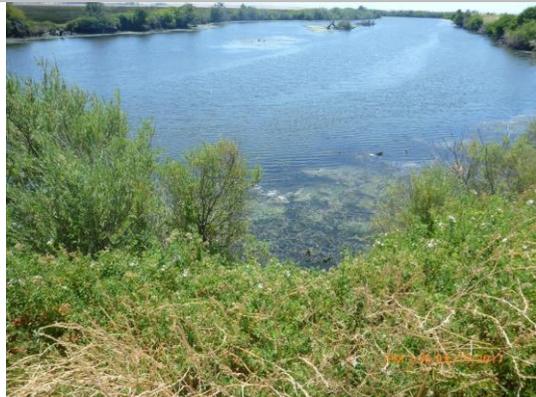
Photo 1 of 1 : SP_2020_RD2060_241_29_20200304_00051.jpg

LM Start	4.28	Rating **	A/W	Issue No.	29
LM End	4.28	Issue Type +	Ma	Location *	WS
Category	Earthen Levee		GPS Latitude/Longitude		
			Start	End	
Item	Erosion / Bank Caving		38.260992 °	38.261017 °	
			-121.759806 °	-121.759847 °	
DWR ID	LMA-203				
Comment Code					
E1 : Note and monitor erosion site.					
Inspector Comment					
This was a 2017 Storm Damage site. Erosion commences halfway down the slope and extends to the toe. Erosion is concentrated at the water line. Site ID No:376 4/17/2020 Field Notes: Could not get to erosion due to dense vegetation. A boat survey will allow for a better inspection.

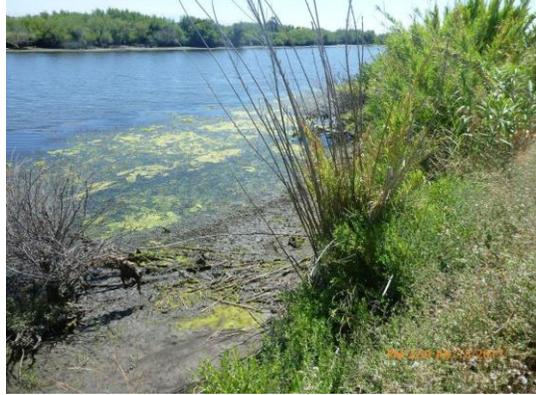
Photo 1 of 1 : SP_2020_RD2060_241_30_20200304_00054.jpg

LM Start	4.40	Rating **	A/W	Issue No.	30
LM End	4.46	Issue Type +	Ma	Location *	WS
Category	Earthen Levee		GPS Latitude/Longitude		
			Start	End	
Item	Erosion / Bank Caving		38.260850 °	38.260425 °	
			-121.761875 °	-121.762861 °	
DWR ID	LMA-204				
Comment Code					
E1 : Note and monitor erosion site.					
Inspector Comment					
This was a 2017 Storm Damage site. Erosion/sloughing commences approximately halfway down the slope. Erosion is concentrated mostly near the water line and has resulting in slippage of the slope. Site ID No:377 Site Designation:LMA-204 4/17/2020 Field Notes: Vegetation thick to properly rate. A boat survey will provide a better inspection.

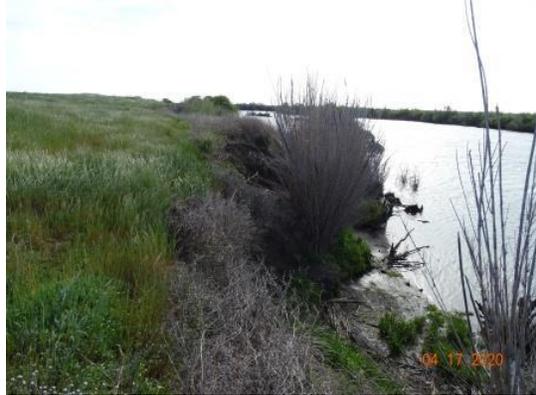
Photo 1 of 2 : SP_2020_RD2060_241_31_20200417_00076.jpg

LM Start	4.50	Rating **	U	Issue No.	31
LM End	4.53	Issue Type +	Ma	Location *	WS
Category	Earthen Levee		GPS Latitude/Longitude		
			Start	End	
Item	Erosion / Bank Caving		38.260150 °	38.259939 °	
			-121.763556 °	-121.764064 °	
DWR ID	LMA-205				
Comment Code					
E2 : Schedule repair of erosion site prior to the next inspection.					
Inspector Comment					
This was a 2017 Storm Damage site. Deep, wide, vertical cut into slope almost 1/2 way into sope. Site ID No:378 Site Designation:LMA-205

View looking downstream at erosion into the waterside slope (Spring 2020).

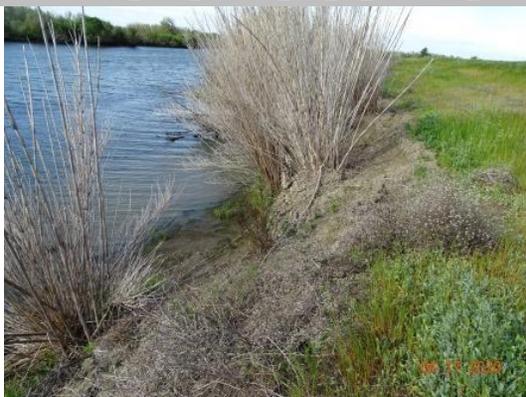
Photo 2 of 2 : SP_2020_RD2060_241_31_20200417_00077.jpg

View looking upstream at erosion into the waterside slope (Spring 2020).

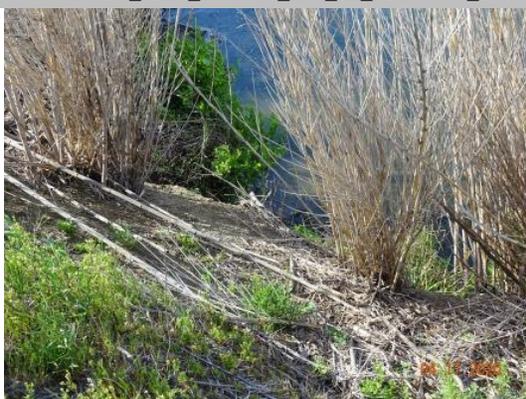
Photo 1 of 1 : SP_2020_RD2060_241_32_20200417_00078.jpg

LM Start	4.88	Rating **	M	Issue No.	32
LM End	4.88	Issue Type +	Ma	Location *	WS
Category	Earthen Levee		GPS Latitude/Longitude		
			Start	End	
Item	Erosion / Bank Caving		38.261769 °	38.261769 °	
			-121.768504 °	-121.768504 °	
DWR ID	LMA-206

View of erosion into the waterside toe (Spring 2020).

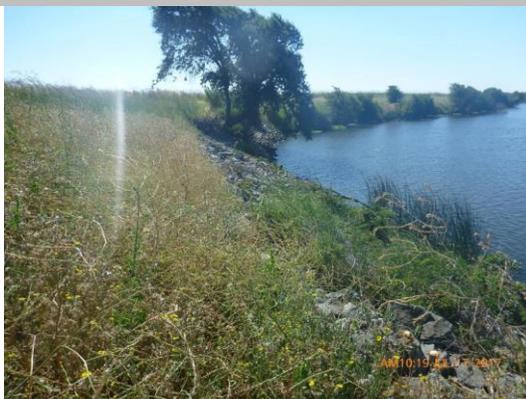
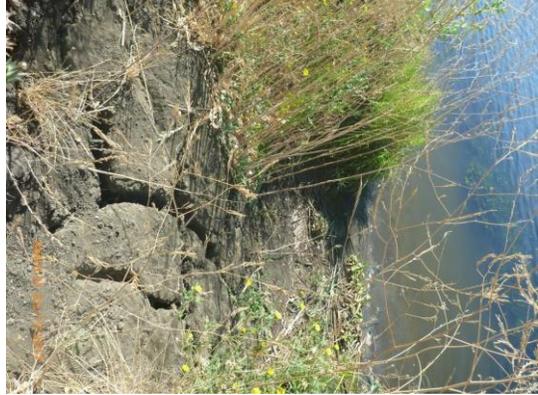
LM Start	4.92	Rating **	M	Issue No.	33
LM End	4.92	Issue Type +	Ma	Location *	WS
Category	Earthen Levee		GPS Latitude/Longitude		
			Start	End	
Item	Erosion / Bank Caving		38.262128 °	38.262128 °	
			-121.769175 °	-121.769175 °	
DWR ID	LMA-207

Comment Code					
E2 : Schedule repair of erosion site prior to the next inspection.					
Inspector Comment					
This was a 2017 Storm Damage site. Erosion on the waterside toe. Site ID No:380 Site Designation:LMA-207

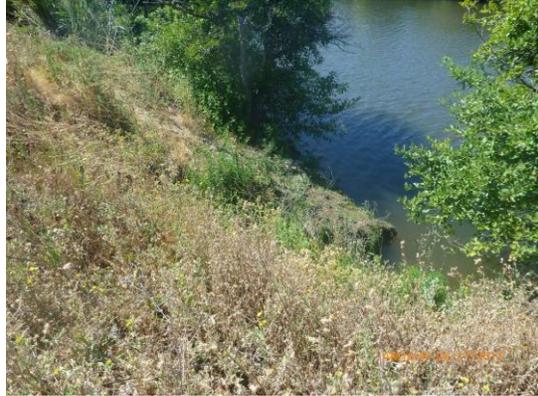
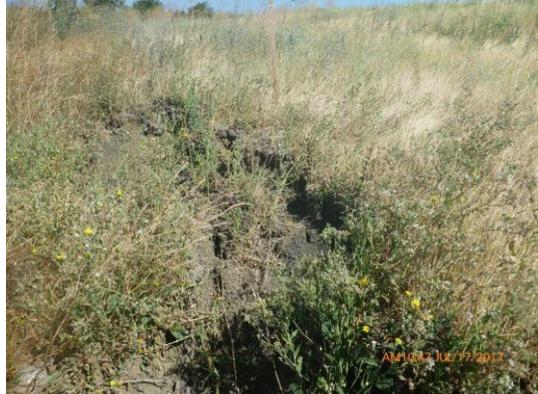
LM Start	5.00	Rating **	M	Issue No.	34
LM End	5.00	Issue Type +	Ma	Location *	WS
Category	Earthen Levee			GPS Latitude/Longitude	
				Start	End
Item	Erosion / Bank Caving			38.262636 °	38.262636 °
				-121.770503 °	-121.770503 °
DWR ID	LMA-208

Inspector Comment
This was a 2017 Storm Damage site.
Erosion into the waterside toe.
Site ID No:381
Site Designation:LMA-208

Comment Code
E2 : Schedule repair of erosion site prior to the next inspection.

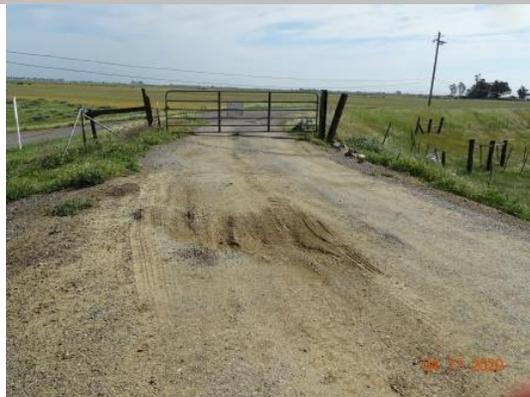
Photo 1 of 1 : SP_2020_RD2060_242_11_20200420_00014.jpg

LM Start	0.71	Rating **	U	Issue No.	11
LM End	0.71	Issue Type +	Ma	Location *	CR
Category	Earthen Levee		GPS Latitude/Longitude		
			Start	End	
Item	Crown Surface / Depressions / Rutting		38.284945 °	38.284945 °	
			-121.795743 °	-121.795743 °	
DWR ID	DWR_RD2060_02_s_2020_11				
Comment Code					
C2 : Repair depressions or ruts in the crown or slope.					
Inspector Comment

View of large rut on the crown (Spring 2020).

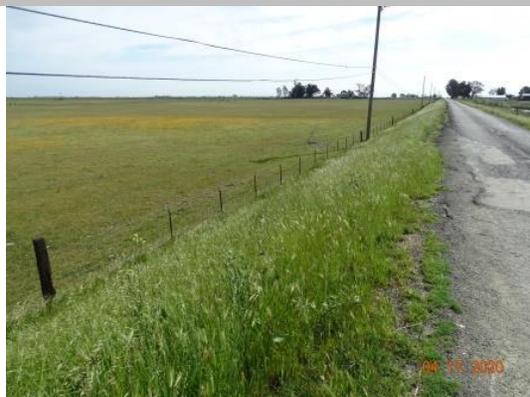
Photo 1 of 1 : SP_2020_RD2060_242_10_20200420_00015.jpg

View looking downstream of annual vegetation on the waterside slope (Spring 2020).

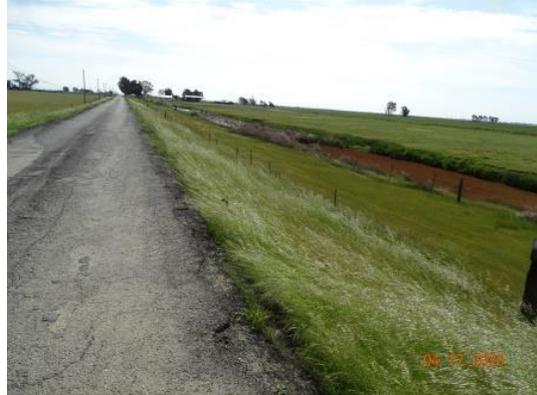
Photo 1 of 1 : SP_2020_RD2060_242_7_20200420_00016.jpg

View looking downstream at annual vegetation on the landside slope (Spring 2020).

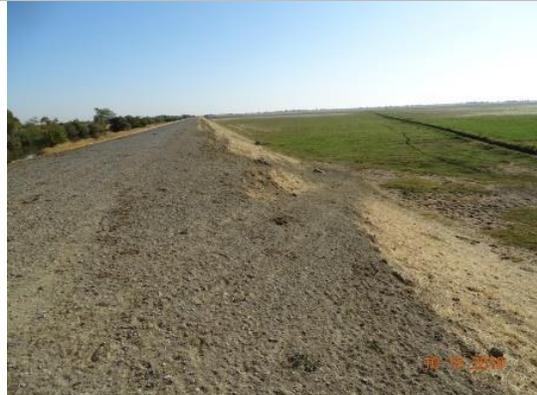
Photo 1 of 1 : SP_2020_RD2060_242_8_20200304_00004.jpg

LM Start	2.52	Rating **	M	Issue No.	8
LM End	2.52	Issue Type +	Ma	Location *	LS
Category	Earthen Levee		GPS Latitude/Longitude		
			Start	End	
Item	Animal Control		38.290866 °	38.290866 °	
			-121.768068 °	-121.768068 °	
DWR ID	DWR_RD2060_02_f_2019_8				
Comment Code					
A2 : Repair the levee slope damaged by livestock and prevent large animal access.					
Inspector Comment					
Cow path is located on the landside slope.

View looking downstream at cow path on the landside slope (Fall 2019).

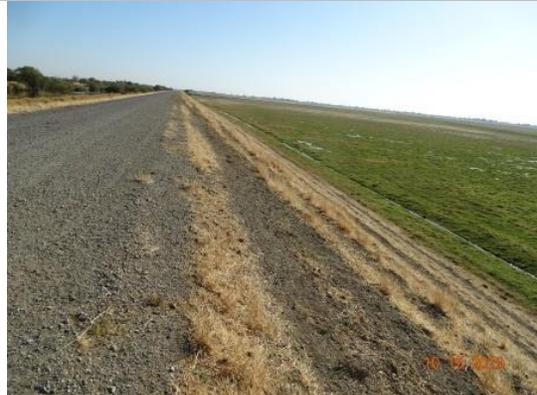
Photo 1 of 1 : SP_2020_RD2060_242_9_20200304_00005.jpg

LM Start	2.60	Rating **	M	Issue No.	9
LM End	2.99	Issue Type +	Ma	Location *	LS
Category	Earthen Levee		GPS Latitude/Longitude		
			Start	End	
Item	Animal Control		38.291315 °	38.293390 °	
			-121.766569 °	-121.760008 °	
DWR ID	DWR_RD2060_02_f_2019_9				
Comment Code					
A2 : Repair the levee slope damaged by livestock and prevent large animal access.					
Inspector Comment					
Terracing on the levee due to cows.

View looking downstream at terracing in the levee due to cows (Fall 2019).

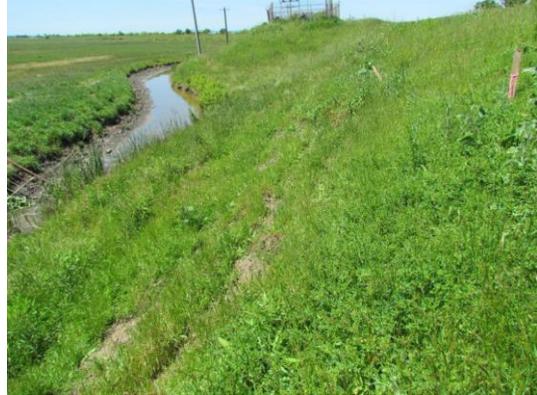
Photo 1 of 1 : SP_2020_RD2060_243_16_20200304_00009.jpg

LM Start	0.07	Rating **	M	Issue No.	16
LM End	0.07	Issue Type +	Ma	Location *	LS
Category	Earthen Levee		GPS Latitude/Longitude		
			Start	End	
Item	Slope Stability		38.296350 °	38.296302 °	
			-121.747642 °	-121.747565 °	
DWR ID	DWR_RD2060_03_s_2017_16				
Comment Code					
S1 : Repair slope instability.					
Inspector Comment					
Sloughing is occurring on the LS slope.

Standing on the slope looking upstream at the slough.

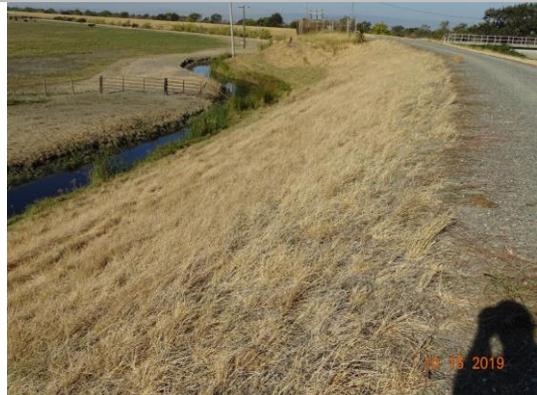
Photo 1 of 1 : SP_2020_RD2060_243_71_20200304_00073.jpg

LM Start	0.10	Rating **	A/W	Issue No.	71
LM End	0.10	Issue Type +	Ma	Location *	LS
Category	Earthen Levee		GPS Latitude/Longitude		
			Start	End	
Item	Slope Stability		38.296084 °	38.296084 °	
			-121.747052 °	-121.747052 °	
DWR ID	DWR_RD2060_03_s_2018_71				
Comment Code					
S1 : Repair slope instability.					
Inspector Comment					
Minor slump at toe likely due to cattle should be repaired.

View looking upstream at minor slump on the lower half of the landside slope (Fall 2019).

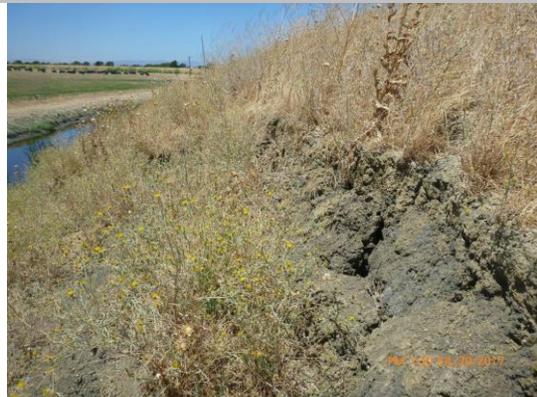
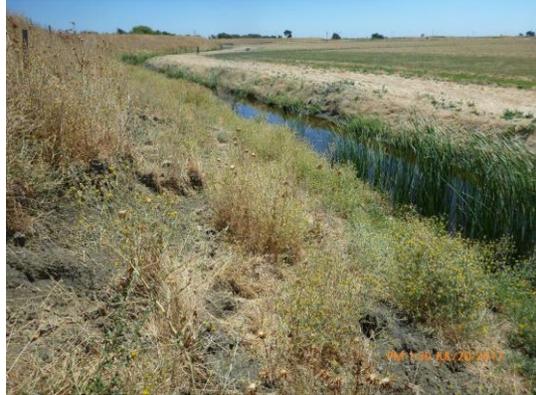
LM Start	0.12	Rating **	A/W	Issue No.	13
LM End	0.18	Issue Type +	Ma	Location *	LS
Category	Earthen Levee		GPS Latitude/Longitude		
			Start	End	
Item	Slope Stability		38.295919 °	38.295611 °	
			-121.746700 °	-121.745742 °	
DWR ID	LMA-212				
Comment Code					
S1 : Repair slope instability.					
Inspector Comment					
This was a 2017 Storm Damage site. Sloughing and seepage occurs near the land side toe. Site ID No:385 Site Designation:LMA-212

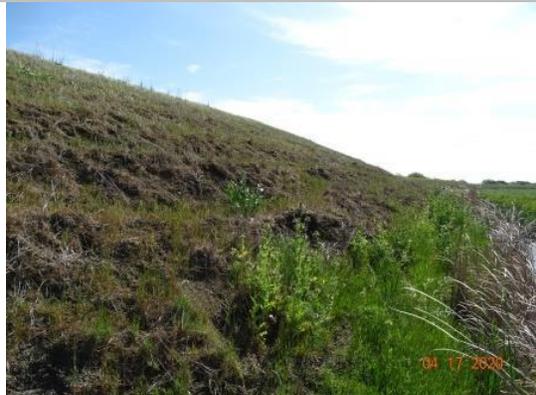
Photo 1 of 1 : SP_2020_RD2060_243_19_20200420_00082.jpg

LM Start	0.13	Rating **	M	Issue No.	19
LM End	0.19	Issue Type +	Ma	Location *	LS
Category	Earthen Levee			GPS Latitude/Longitude	
				Start	End
Item	Animal Control			38.295915 °	38.295559 °
				-121.746683 °	-121.745583 °
DWR ID	DWR_RD2060_03_f_2019_19

View looking downstream at terracing due to cows on the landside slope (Spring 2020).

Comment Code					
A2 : Repair the levee slope damaged by livestock and prevent large animal access.					
Inspector Comment					
Terracing due to cows walking on the landside slope.

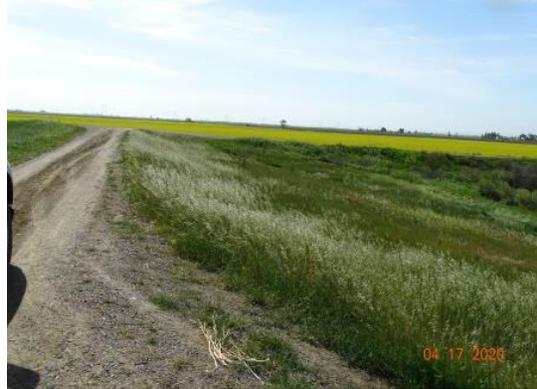
Photo 1 of 1 : SP_2020_RD2060_243_8_20200420_00083.jpg

View looking downstream at annual vegetation on the landside slope (Spring 2020).

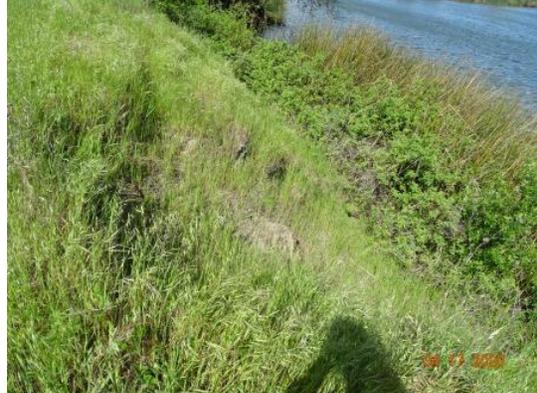
Photo 1 of 1 : SP_2020_RD2060_243_14_20200420_00084.jpg

LM Start	0.64	Rating **	U	Issue No.	14
LM End	0.64	Issue Type +	Ma	Location *	WS
Category	Earthen Levee		GPS Latitude/Longitude		
			Start	End	
Item	Erosion / Bank Caving		38.292197 °	38.292208 °	
			-121.739661 °	-121.739611 °	
DWR ID	LMA-213				
Comment Code					
E2 : Schedule repair of erosion site prior to the next inspection.					
Inspector Comment					
This was a 2017 Storm Damage site. Relatively deep erosion spot into waterside slope Site ID No:386 Site Designation:LMA-213

View looking upstream at erosion into the waterside slope (Spring 2020).

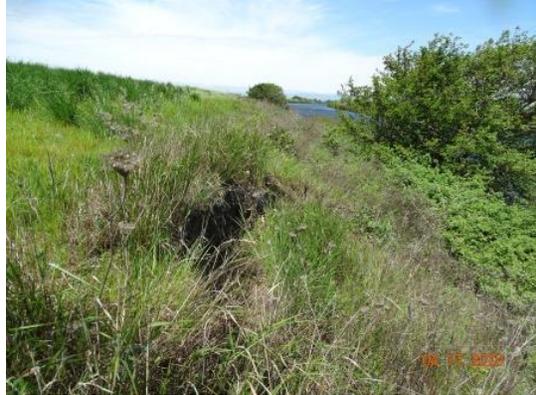
Photo 1 of 1 : SP_2020_RD2060_243_20_20200420_00085.jpg

LM Start	1.22	Rating **	U	Issue No.	20
LM End	1.22	Issue Type +	Ma	Location *	WS
Category	Earthen Levee		GPS Latitude/Longitude		
			Start	End	
Item	Erosion / Bank Caving		38.290511 °	38.290511 °	
			-121.729828 °	-121.729828 °	
DWR ID	LMA-217				
Comment Code					
E2 : Schedule repair of erosion site prior to the next inspection.					
Inspector Comment					
This was a 2017 Storm Damage site. Erosion about halfway down the waterside slope. Site ID No:390 Site Designation:LMA-217

View looking upstream at erosion into the waterside slope (Spring 2020).

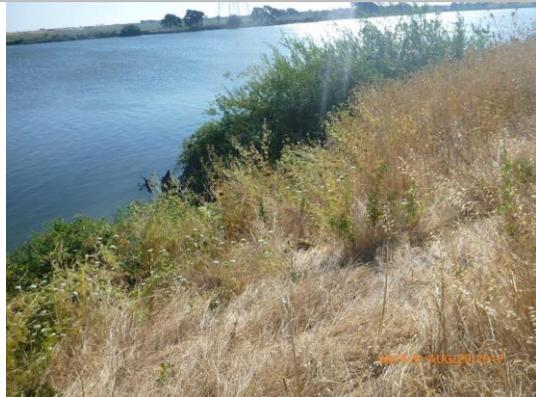
Photo 1 of 1 : SP_2020_RD2060_243_21_20200304_00016.jpg

LM Start	1.38	Rating **	A/W	Issue No.	21
LM End	1.42	Issue Type +	Ma	Location *	WS
Category	Earthen Levee		GPS Latitude/Longitude		
			Start	End	
Item	Erosion / Bank Caving		38.290067 °	38.289608 °	
			-121.726839 °	-121.726344 °	
DWR ID	LMA-320				
Comment Code					
E1 : Note and monitor erosion site.					
Inspector Comment					
This was a 2017 Storm Damage site. MBK Delta Erosion Sites_6-29-2017 Site ID No:482 Site Designation:LMA-320 Field Date:8/29/2017 4/17/2020 Notes: Did not see any erosion. Do boat inspection to verify. Monitor.

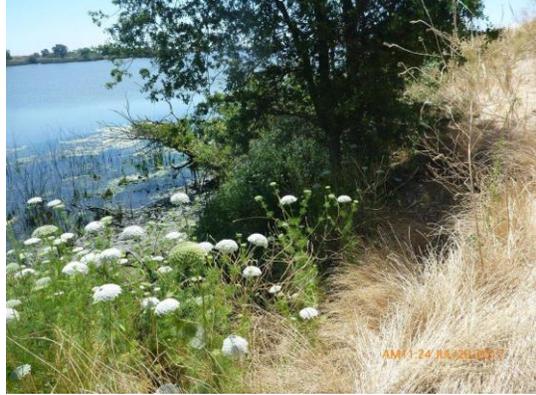
Photo 1 of 1 : SP_2020_RD2060_243_22_20200304_00021.jpg

LM Start	1.45	Rating **	A/W	Issue No.	22
LM End	1.59	Issue Type +	Ma	Location *	WS
Category	Earthen Levee		GPS Latitude/Longitude		
			Start	End	
Item	Erosion / Bank Caving		38.289256 °	38.287689 °	
			-121.726050 °	-121.724658 °	
DWR ID	LMA-219				
Comment Code					
E1 : Note and monitor erosion site.					
Inspector Comment					
2017 Storm Damage Site Erosion commences halfway down the slope and results in slippage into the waterside toe. Site ID No:392 Site Designation:LMA-219 4/17/2020 Field Notes: Unable to see erosion. Verify with boat inspection. Monitor.

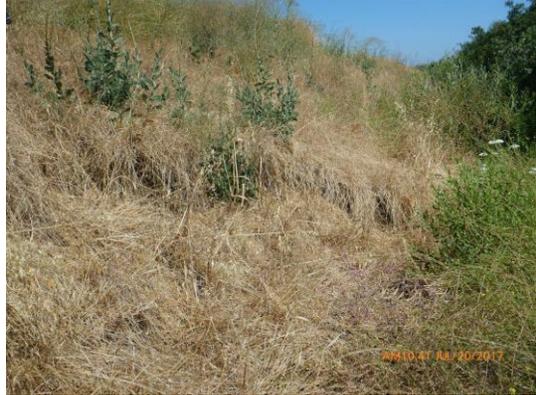
Photo 1 of 1 : SP_2020_RD2060_243_23_20200304_00023.jpg

LM Start	1.62	Rating **	A/W	Issue No.	23
LM End	1.63	Issue Type +	Ma	Location *	WS
Category	Earthen Levee		GPS Latitude/Longitude		
			Start	End	
Item	Erosion / Bank Caving		38.287336 °	38.287222 °	
			-121.724364 °	-121.724253 °	
DWR ID	LMA-220				
Comment Code					
E1 : Note and monitor erosion site.					
Inspector Comment					
This was a 2017 Storm Damage site. Erosion commences halfway down the slope and results in slippage into the waterside toe. Existing rip rap has sloughed into the water side toe. Site ID No:393 Site Designation:LMA-220 4/17/2020 Notes: Swarm of bees did not allow for inspection. Verify with boat inspection. Monitor.

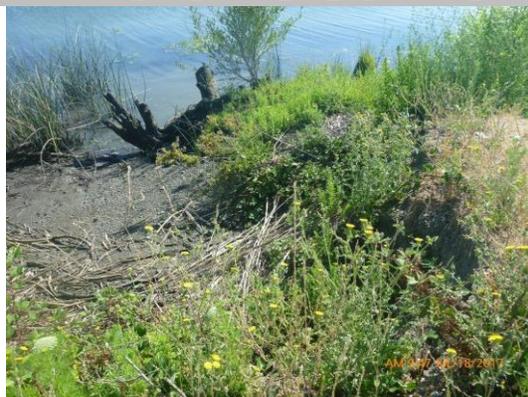
Photo 1 of 1 : SP_2020_RD2060_243_36_20200304_00057.jpg

LM Start	2.69	Rating **	A/W	Issue No.	36
LM End	2.73	Issue Type +	Ma	Location *	WS
Category	Earthen Levee			GPS Latitude/Longitude	
				Start	End
Item	Erosion / Bank Caving			38.276608 °	38.276133 °
				-121.710811 °	-121.710394 °
DWR ID	LMA-232

Comment Code
E1 : Note and monitor erosion site.

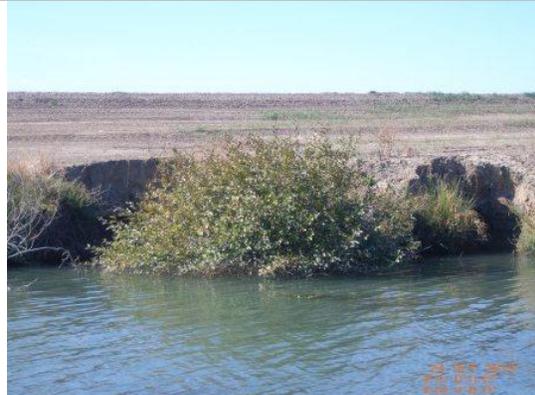
Photo 1 of 1 : SP_2020_RD2060_243_4_20200304_00001.jpg

LM Start	3.78	Rating **	A/W	Issue No.	4
LM End	4.09	Issue Type +	Ma	Location *	WS
Category	Supplemental			GPS Latitude/Longitude	
				Start	End
Item	2017 USACE Erosion Survey			38.264585 °	38.260593 °
				-121.698868 °	-121.696403 °
DWR ID	DWR_RD2060_03_f_2018_4				
Comment Code					
Inspector Comment					
2017 Site ID: CHS 21.1 R Status: Eroding 2017 Field Notes: Significant toe erosion within last year. Site History: 2011 - Several pockets of erosion from rotational failure and slumping toe. 2013 - Site extended downstream to include new erosion pockets. 2016 - New rock in one of the erosion spots. 2020 - erosion extent includes several 2017 storm damage sites. Site Numbers - 410, 411, 412. LMA Site IDs - LMA-237, LMA-238, LMA-239.
