**Flood Control Project Maintenance
Levee Inspections**

Fall 2019 Levee Maintenance Deficiency Summary Report

San Joaquin River Basin

Reclamation District No. 2062 Stewart

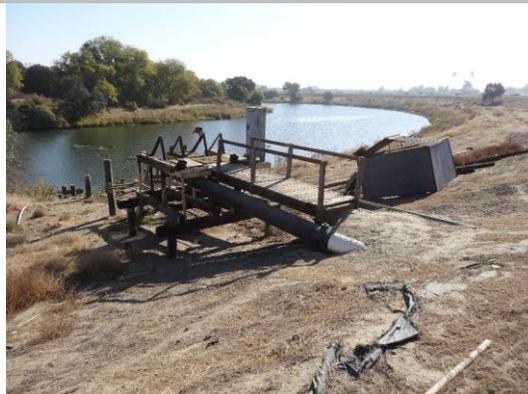
Photo 1 of 3 : UCIP_FA_2019_22807_38905.jpg

Comment Code					
Inspector Comment					
DS_ID:19177 FS_ID:22807 EP_NO: 12679 Repair Type: Non-Urgent Crossing Status: Found UCIP Comments: - All 3 pipes on landside looks new.- Pumps, pump house, and pipes removed from waterside.- Land development activities going on in this area.- Needs to confirm from LMA or DWR Inspector about the crossing. FIELD_STRUCT_DESC: 1 of 3: 16-inch steel irrigation discharge pipe through the levee, 5 feet below the crown. Electrical conduit through the levee. Slant pump in a pump house on the waterside (WS) slope. Siphon breaker on the landside (LS) slope. Service pole and concrete gate valve box at the landside (LS) toe. Installed by USACE in 1961. (Plans to replace rusted portions of two 16-inch irrigation pipes through the levee authorized under Permit No. 16124, 1993 - Reclamation District No. 2062). [Additional Reference(s): DWR Levee Log, 2007. USACE San Joaquin O&M Manual 9, April 1964, (HLM 1.65)]. FS Date: 10/22/2013

WS view: pipes, walkway, and dismantled pump house (right).

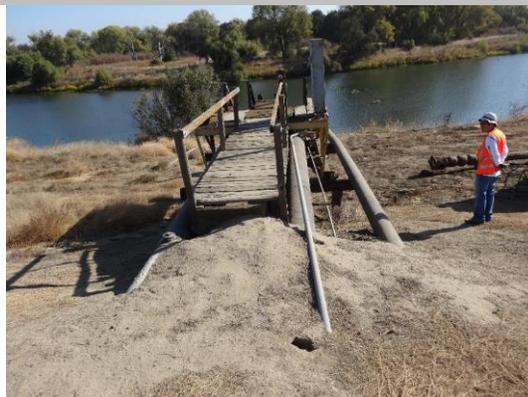
Photo 2 of 3 : UCIP_FA_2019_22807_38904.jpg

WS view: 16-inch pipes on both sides of walkway and 10-inch pipe (on right) away from walkway.

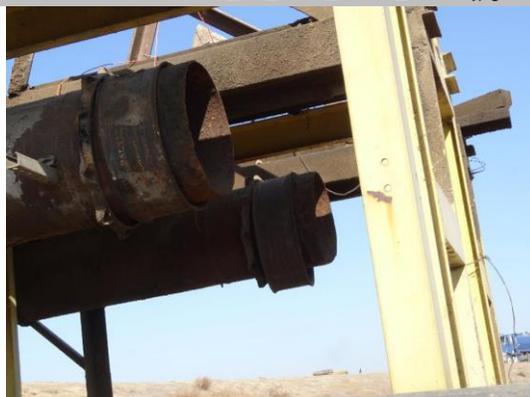
Photo 3 of 3 : UCIP_FA_2019_22807_38903.jpg

Comment Code						
Inspector Comment						
DS_ID:19177 FS_ID:22807 EP_NO: 12679 Repair Type: Non-Urgent Crossing Status: Found UCIP Comments: - All 3 pipes on landside looks new.- Pumps, pump house, and pipes removed from waterside.- Land development activities going on in this area.- Needs to confirm from LMA or DWR Inspector about the crossing. FIELD_STRUCT_DESC: 1 of 3: 16-inch steel irrigation discharge pipe through the levee, 5 feet below the crown. Electrical conduit through the levee. Slant pump in a pump house on the waterside (WS) slope. Siphon breaker on the landside (LS) slope. Service pole and concrete gate valve box at the landside (LS) toe. Installed by USACE in 1961. (Plans to replace rusted portions of two 16-inch irrigation pipes through the levee authorized under Permit No. 16124, 1993 - Reclamation District No. 2062). [Additional Reference(s): DWR Levee Log, 2007. USACE San Joaquin O&M Manual 9, April 1964, (HLM 1.65)]. FS Date: 10/22/2013

WS view: two 16-inch pipes. Pumps were removed. Pumphouse dismantled.

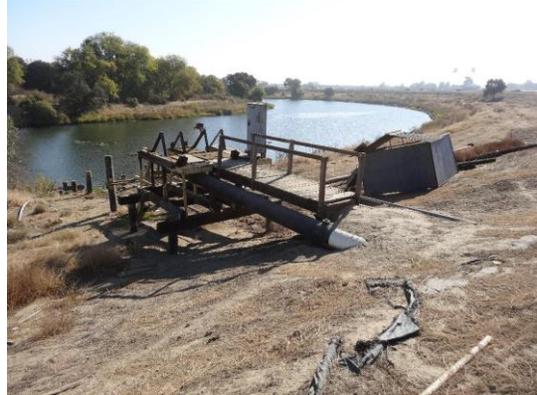
Photo 1 of 3 : UCIP_FA_2019_22809_38913.jpg

Comment Code					
Inspector Comment					
DS_ID:19183 FS_ID:22809 EP_NO: 12679 Repair Type: Non-Urgent Crossing Status: Found UCIP Comments: - All 3 pipes on landside looks new.- Pumps, pump house, and pipes removed from waterside.- Land development activities going on in this area.- Needs to confirm from LMA or DWR Inspector about the crossing. FIELD_STRUCT_DESC: 2 of 3: 16-inch steel irrigation discharge pipe through the levee, 5 feet below the crown. Electrical conduit through the levee. Slant pump in a pump house on the waterside (WS) slope. Siphon breaker on the landside (LS) slope. Service pole and concrete gate valve box at the landside (LS) toe. Installed by USACE in 1961. (Plans to replace rusted portions of two 16-inch irrigation pipes through the levee authorized under Permit No. 16124, 1993 - Reclamation District No. 2062). [Additional Reference(s): DWR Levee Log, 2007. USACE San Joaquin O&M Manual 9, April 1964, (HLM 1.65)]. FS Date: 10/22/2013

WS view: pipes, walkway, and dismantled pump house (right).

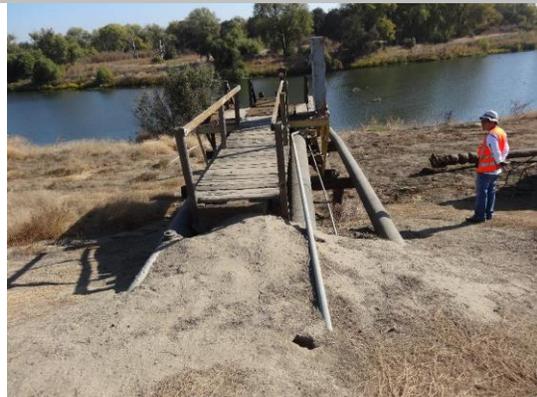
Photo 2 of 3 : UCIP_FA_2019_22809_38912.jpg

WS view: 16-inch pipes on both sides of walkway and 10-inch pipe (on right) away from walkway.

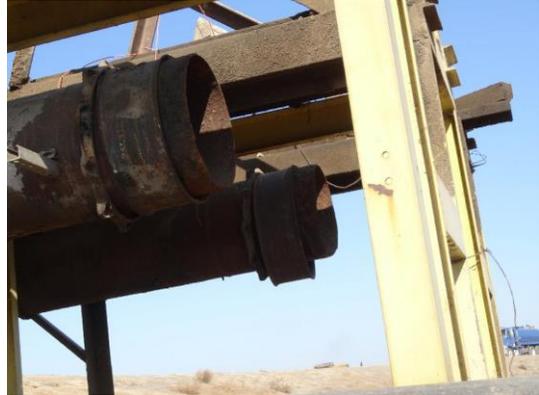
Photo 3 of 3 : UCIP_FA_2019_22809_38911.jpg

Comment Code					
Inspector Comment					
DS_ID:19183 FS_ID:22809 EP_NO: 12679 Repair Type: Non-Urgent Crossing Status: Found UCIP Comments: - All 3 pipes on landside looks new.- Pumps, pump house, and pipes removed from waterside.- Land development activities going on in this area.- Needs to confirm from LMA or DWR Inspector about the crossing. FIELD_STRUCT_DESC: 2 of 3: 16-inch steel irrigation discharge pipe through the levee, 5 feet below the crown. Electrical conduit through the levee. Slant pump in a pump house on the waterside (WS) slope. Siphon breaker on the landside (LS) slope. Service pole and concrete gate valve box at the landside (LS) toe. Installed by USACE in 1961. (Plans to replace rusted portions of two 16-inch irrigation pipes through the levee authorized under Permit No. 16124, 1993 - Reclamation District No. 2062). [Additional Reference(s): DWR Levee Log, 2007. USACE San Joaquin O&M Manual 9, April 1964, (HLM 1.65)]. FS Date: 10/22/2013

WS view: two 16-inch pipes under walkway; pumps were removed.

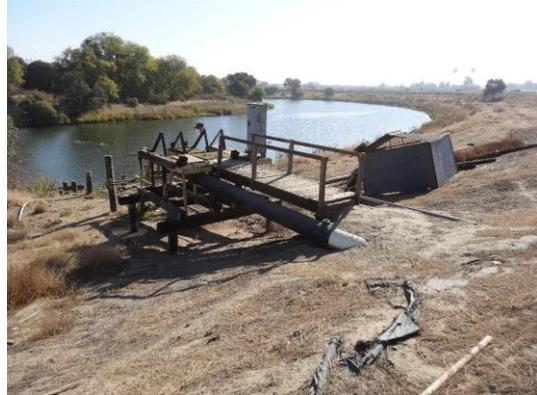
Photo 1 of 3 : UCIP_FA_2019_22810_38918.jpg

Comment Code					
Inspector Comment					
DS_ID:19184 FS_ID:22810 EP_NO: 12679 Repair Type: Non-Urgent Crossing Status: Found UCIP Comments: - All 3 pipes on landside looks new. No pump associated with 8-inch pipe.- Pumps, pump house, and pipes removed from waterside.- Land development activities going on in this area.- Needs to confirm from LMA or DWR Inspector about the crossing. FIELD_STRUCT_DESC: 3 of 3: 8-inch steel irrigation discharge pipe through the levee, 8 feet below the crown. Electrical conduit through the levee. Slant pump in a pump house on the waterside (WS) slope. Siphon breaker on the landside (LS) slope. Service pole and concrete gate valve box at the landside (LS) toe. (Plans to install a 75-horsepower pump on the bank with a 10-inch steel discharge pipe through the levee authorized under Permit No. 12679, 1979 - Reclamation District No. 2062). [Additional Reference(s): DWR Levee Log, 2007]. FS Date: 10/22/2013

WS view: pipes, walkway, and dismantled pumphouse (right).

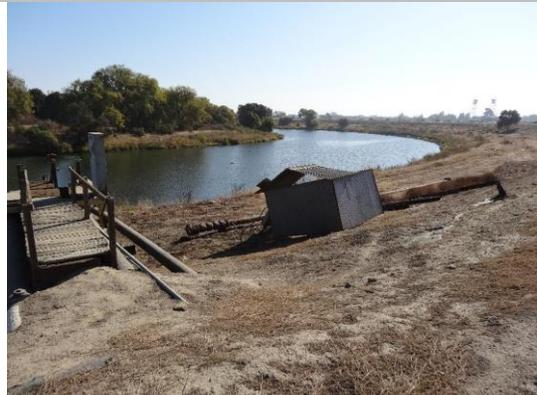
Photo 2 of 3 : UCIP_FA_2019_22810_38917.jpg

WS view: electric conduit and 10-inch pipe (right). Dismantled/removed pipe and pump house (far right).

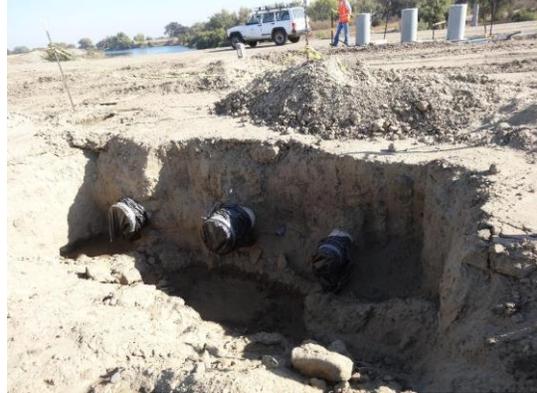
Photo 3 of 3 : UCIP_FA_2019_22810_38916.jpg

Comment Code					
Inspector Comment					
DS_ID:19184 FS_ID:22810 EP_NO: 12679 Repair Type: Non-Urgent Crossing Status: Found UCIP Comments: - All 3 pipes on landside looks new. No pump associated with 8-inch pipe.- Pumps, pump house, and pipes removed from waterside.- Land development activities going on in this area.- Needs to confirm from LMA or DWR Inspector about the crossing. FIELD_STRUCT_DESC: 3 of 3: 8-inch steel irrigation discharge pipe through the levee, 8 feet below the crown. Electrical conduit through the levee. Slant pump in a pump house on the waterside (WS) slope. Siphon breaker on the landside (LS) slope. Service pole and concrete gate valve box at the landside (LS) toe. (Plans to install a 75-horsepower pump on the bank with a 10-inch steel discharge pipe through the levee authorized under Permit No. 12679, 1979 - Reclamation District No. 2062). [Additional Reference(s): DWR Levee Log, 2007]. FS Date: 10/22/2013

LS view: two 16-inch pipes (left) and one 10-inch pipe (right) in ditch. Concrete box removed.

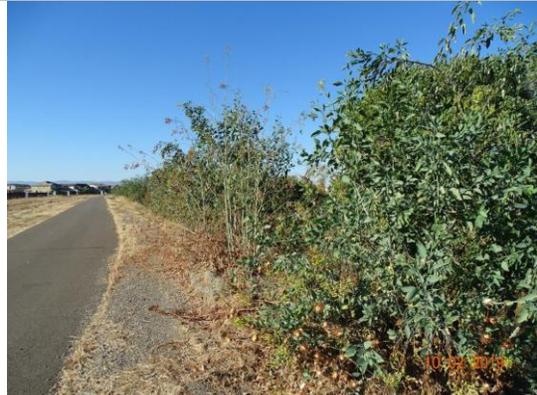
Photo 1 of 1 : FA_2019_RD2062_309_9_20191027_00010.jpg

LM Start	2.01	Rating **	U	Issue No.	9
LM End	2.09	Issue Type +	Ma	Location *	WS
Category	Earthen Levee			GPS Latitude/Longitude	
				Start	End
Item	Vegetation			37.793068°	37.794010°
				-121.310008°	-121.309373°
DWR ID	DWR_RD2062_01_f_2019_9				
Comment Code					
V2 : Remove the wild growth other than native grasses from the levee slopes.					
Inspector Comment

View of vegetation on waterside slope. Fall 2019

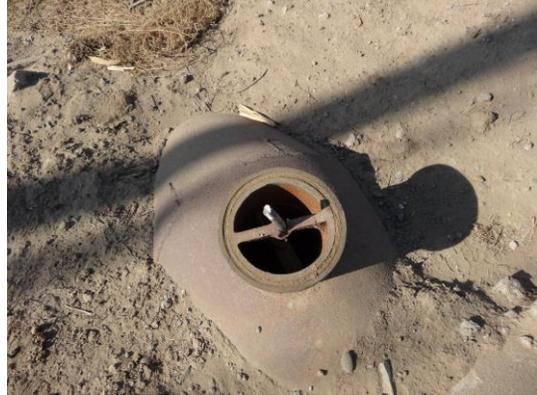
Photo 2 of 3 : UCIP_FA_2019_23110_39397.jpg

LM Start	0.56	Rating **	M	Issue No.	28 (cont)
LM End	0.56	Issue Type +	En	Location *	
Category	Supplemental			GPS Latitude/Longitude	
				Start	End
Item	DRAFT DWR UCIP Field Study			37.784380°	37.784380°
				-121.338985°	-121.338985°
DWR ID	24697				
Comment Code					
Inspector Comment					
DS_ID:24697 FS_ID:23110 EP_NO: N/A Repair Type: Non-Urgent Crossing Status: Found UCIP Comments: Found on field with the help of USACE 2012 PI Report. Needs proper abandonment. FIELD_STRUCT_DESC: *ABANDONED* 24-inch steel irrigation discharge pipe through the levee, at an unknown depth. Damaged siphon breaker on the waterside (WS) slope. Pump on a concrete sump in an irrigation ditch on the landside (LS). Service pole on the LS slope. Pump disconnected from the service pole. FS Date: 10/23/2013

WS view: exposed steel pipe and damaged siphon breaker on levee slope.

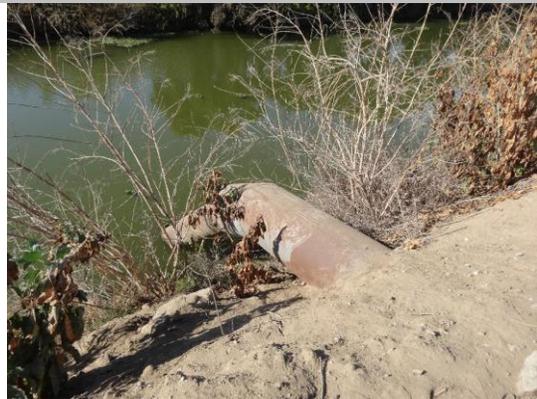
Photo 3 of 3 : UCIP_FA_2019_23110_39396.jpg

WS view: exposed steel pipe on channel bank and also immersed into channel water.

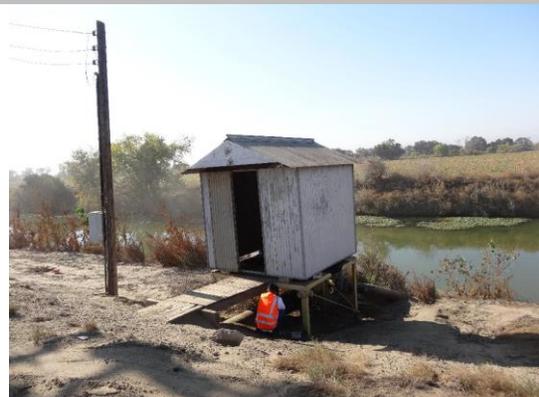
Photo 1 of 3 : UCIP_FA_2019_23181_39792.jpg

Comment Code					
Inspector Comment					
DS_ID:19192 FS_ID:23181 EP_NO: 12427 Repair Type: Non-Urgent Crossing Status: Found UCIP Comments: - no siphon breaker found- levee toe erosion under walkway on waterside.- erosion around concrete standpipe on landside- may be base of the standpipe was leaking. FIELD_STRUCT_DESC: 18-inch irrigation discharge pipe of an unknown material through the levee, 4.4 feet below the crown. Pump house on the waterside (WS) slope. Metal walkway from the pump house to the crown. Service pole on the WS. Flap gate, siphon breaker, and concrete distribution box on the landside (LS) slope. (Emergency plans to replace an existing 18-inch discharge pipe through the levee authorized under Permit No. 12427, 1978 - Reclamation District No. 2062). [Additional Reference(s): DWR Levee Log, 2007, 16-inch pipe referenced. USACE San Joaquin O&M Manual 9, April 1964, (HLM 0.76)]. FS Date: 10/23/2013

WS view: pipe, walkway, service pole, and pumphouse on levee slope.

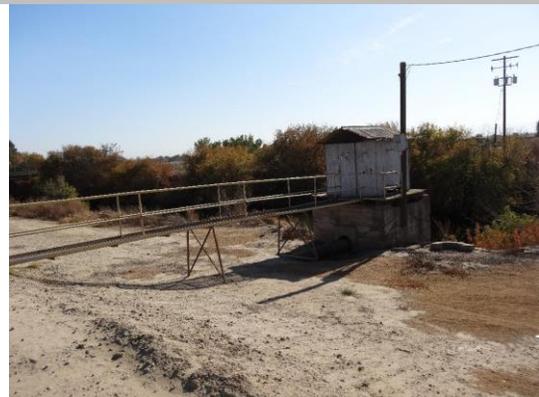
Photo 1 of 3 : UCIP_FA_2019_51468_39195.jpg

Comment Code					
Inspector Comment					
DS_ID:19193 FS_ID:51468 EP_NO: N/A Repair Type: Non-Urgent Crossing Status: Found UCIP Comments: 04/05/2017:Pipe has been plugged as a flood fight measure and is likely to be replaced under a permit. MBK (Michael Moncrief) is working on the permit. Photo and update courtesy of Max Khashchuk as part of his 2017 Spring Inspection. (K. Fazel - UCIP)10/22/2013:- pumphouse on concrete sump in the channel.- erosion under walkway on waterside. (P. Amatya - DWR) FIELD_STRUCT_DESC: 20-inch steel irrigation discharge pipe through the levee, 8 feet below the crown. Pump house on the waterside (WS) slope. Metal walkway from the pump house to the crown. Flap gate, siphon breaker, and concrete distribution box on the landside (LS) slope. [Additional Reference(s): DWR Levee Log, 2007, 18-inch pipe referenced. USACE San Joaquin O&M Manual 9, April 1964, (HLM 1.40), 18-inch pipe referenced]. FS Date: 4/6/2017

WS view: pipe, walkway, and pumphouse on levee berm. Service pole on waterside.

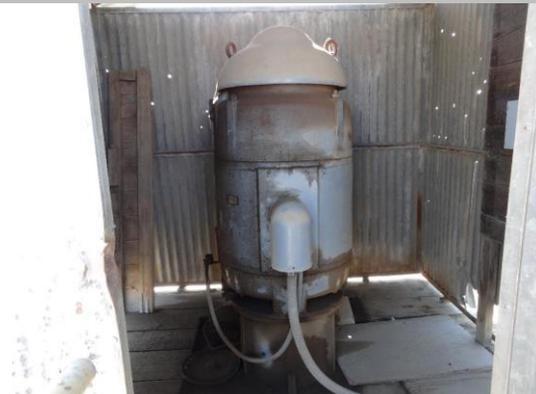
Photo 2 of 3 : UCIP_FA_2019_51468_39194.jpg

Comment Code					
Inspector Comment					
DS_ID:19193 FS_ID:51468 EP_NO: N/A Repair Type: Non-Urgent Crossing Status: Found UCIP Comments: 04/05/2017:Pipe has been plugged as a flood fight measure and is likely to be replaced under a permit. MBK (Michael Moncrief) is working on the permit. Photo and update courtesy of Max Khashchuk as part of his 2017 Spring Inspection. (K. Fazel - UCIP)10/22/2013:- pumphouse on concrete sump in the channel.- erosion under walkway on waterside. (P. Amatya - DWR) FIELD_STRUCT_DESC: 20-inch steel irrigation discharge pipe through the levee, 8 feet below the crown. Pump house on the waterside (WS) slope. Metal walkway from the pump house to the crown. Flap gate, siphon breaker, and concrete distribution box on the landside (LS) slope. [Additional Reference(s): DWR Levee Log, 2007, 18-inch pipe referenced. USACE San Joaquin O&M Manual 9, April 1964, (HLM 1.40), 18-inch pipe referenced]. FS Date: 4/6/2017

WS view: leaky pump and control box in pumphouse.

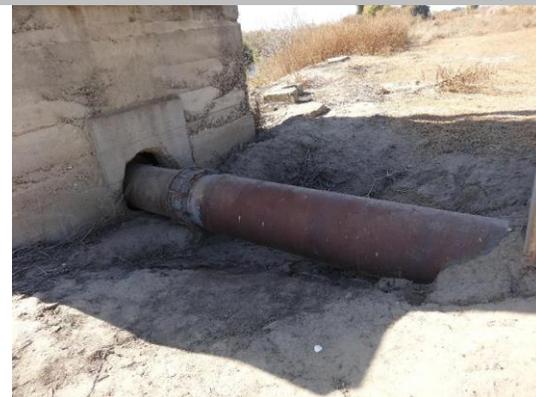
Photo 3 of 3 : UCIP_FA_2019_51468_39193.jpg

WS view: exposed steel pipe under walkway. Soil erosion under walkway. This may be due to leaky pipe joint.

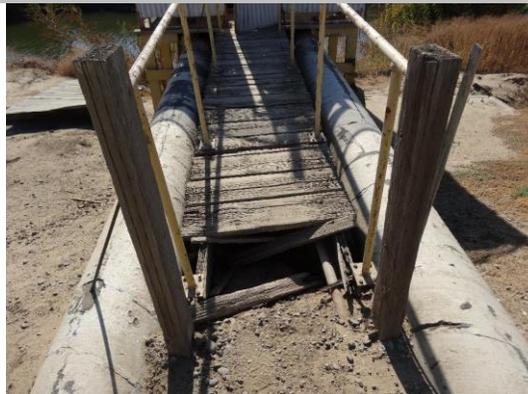
Photo 2 of 3 : UCIP_FA_2019_53375_39186.jpg

Comment Code					
Inspector Comment					
DS_ID:19194 FS_ID:53375 EP_NO: 4305 Repair Type: Urgent Crossing Status: Found UCIP Comments: 10/10/2018 Extremely overgrown vegetation did not allow visual inspection of WS levee erosion; however, there are indications based on vegetation growth patterns that the erosion is still present, so keeping crossing as Urgent (D. Sanoski - DWR UCIP).08/31/2016: Heavy sloughing and sink hole remains at the WS slope in alignment with pipe. Though sloughing is not affecting levee prism, it is still an indication of a pipe integrity problem. Oil leak at the pump but does not appear to impact the levee. (K. Fazel - UCIP)10/22/2013:- missing roof in pump house.- no protection for siphon breaker- huge erosion under pumphouse and levee slope on waterside. (P. Amatya - DWR) FIELD_STRUCT_DESC: 1 of 2: 18-inch steel irrigation discharge pipe through the levee, 4.8 feet below the crown. Pump house on the waterside (WS) slope. Siphon breaker on the landside (LS) shoulder. Service pole on the LS shoulder. Concrete distribution box at the LS toe. (Plans for installation of two irrigation pumps on the bank to replace an old centrifugal pumping plant at the same location authorized under Permit No. 4305, 1963 - Reclamation District No. 2062) [Additional Reference(s): DWR Levee Log, 2007. USACE San Joaquin O&M Manual 9, April 1964, (HLM 1.67)]. FS Date: 10/10/2018 11:02:00 AM

WS view: walkway to pumphouse. Walkway in poor condition.

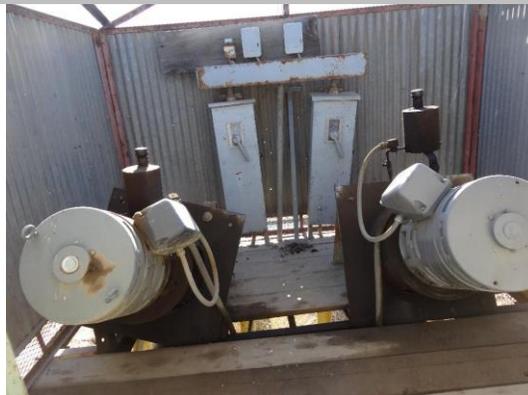
Photo 3 of 3 : UCIP_FA_2019_53375_39185.jpg

WS view: two leaky slant pumps in pumphouse with missing roof.

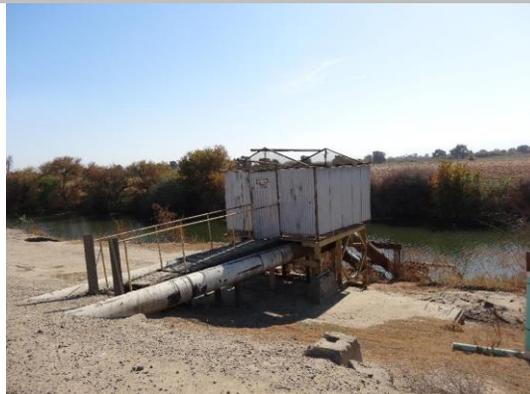
Photo 1 of 3 : UCIP_FA_2019_53376_39176.jpg

DS_ID:19197
 FS_ID:53376
 EP_NO: 4305
 Repair Type: Urgent
 Crossing Status: Found
 UCIP Comments: 10/10/2018 Extremely overgrown vegetation did not allow visual inspection of WS levee erosion; however, there are indications based on vegetation growth patterns that the erosion is still present, so keeping crossing as Urgent (D. Sanoski - DWR UCIP).08/31/2016: Heavy sloughing and sink hole remains at the WS slope in alignment with pipes. Though sloughing is not affecting levee prism, it is still an indication of a pipe integrity problem. Oil leak at the pump but does not appear to impact levee. (K. Fazel - UCIP)10/22/2013:- missing roof in pump house.- no protection for siphon breaker- huge erosion under pumphouse and levee slope on waterside. (P. Amatya - DWR)
 FIELD_STRUCT_DESC: 2 of 2: 18-inch steel irrigation discharge pipe through the levee, 4.8 feet below the crown. Pump house on the waterside (WS) slope. Siphon breaker on the landside (LS) shoulder. Service pole on the LS shoulder. Concrete distribution box at the LS toe. (Plans for installation of two irrigation pumps on the bank to replace an old centrifugal pumping plant at the same location authorized under Permit No. 4305, 1963 - Reclamation District No. 2062) [Additional Reference(s): DWR Levee Log, 2007. USACE San Joaquin O&M Manual 9, April 1964, (HLM 1.67)].

WS view: pipes, walkway, and pumphouse with missing roof (right).

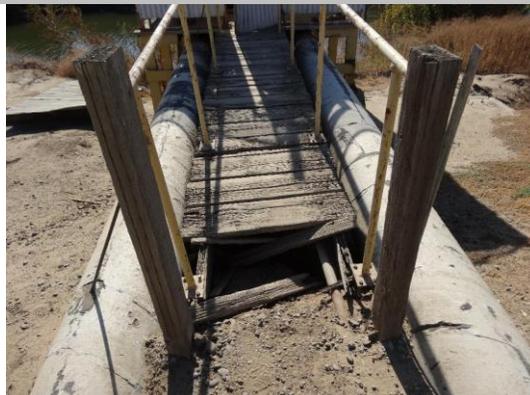
Photo 2 of 3 : UCIP_FA_2019_53376_39175.jpg

WS view: walkway in poor condition, to pumphouse.

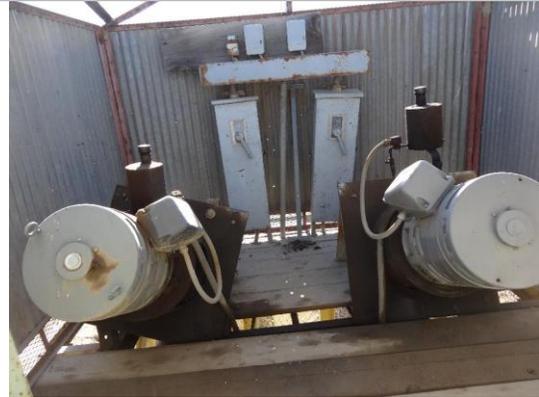
Photo 3 of 3 : UCIP_FA_2019_53376_39174.jpg

Comment Code					
Inspector Comment					
DS_ID:19197 FS_ID:53376 EP_NO: 4305 Repair Type: Urgent Crossing Status: Found UCIP Comments: 10/10/2018 Extremely overgrown vegetation did not allow visual inspection of WS levee erosion; however, there are indications based on vegetation growth patterns that the erosion is still present, so keeping crossing as Urgent (D. Sanoski - DWR UCIP).08/31/2016: Heavy sloughing and sink hole remains at the WS slope in alignment with pipes. Though sloughing is not affecting levee prism, it is still an indication of a pipe integrity problem. Oil leak at the pump but does not appear to impact levee. (K. Fazel - UCIP)10/22/2013:- missing roof in pump house.- no protection for siphon breaker- huge erosion under pumphouse and levee slope on waterside. (P. Amatya - DWR) FIELD_STRUCT_DESC: 2 of 2: 18-inch steel irrigation discharge pipe through the levee, 4.8 feet below the crown. Pump house on the waterside (WS) slope. Siphon breaker on the landside (LS) shoulder. Service pole on the LS shoulder. Concrete distribution box at the LS toe. (Plans for installation of two irrigation pumps on the bank to replace an old centrifugal pumping plant at the same location authorized under Permit No. 4305, 1963 - Reclamation District No. 2062) [Additional Reference(s): DWR Levee Log, 2007. USACE San Joaquin O&M Manual 9, April 1964, (HLM 1.67)]. FS Date: 10/10/2018 11:20:00 AM

WS view: two leaky slant pumps in pumphouse with missing roof.

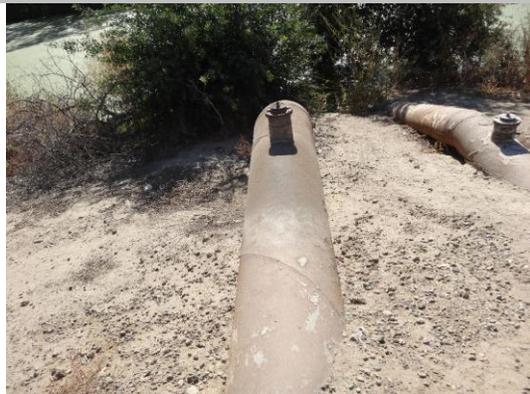
Photo 1 of 3 : UCIP_FA_2019_23304_40147.jpg

Comment Code					
Inspector Comment					
DS_ID:19199 FS_ID:23304 EP_NO: 11524 Repair Type: Non-Urgent Crossing Status: Found UCIP Comments: - waterside pipe immersed into channel water.- most of the pipe on landside exposed and siphon breaker on waterside not protected. FIELD_STRUCT_DESC: 1 of 3: 24-inch coated steel drainage discharge pipe through the levee, 2 feet below the crown. Siphon breaker on the waterside (WS) slope. Pump on a steel platform in a drainage ditch, 350 feet from the levee centerline off the landward berm. (Plans to install a drainage pump and 24-inch discharge line through the levee at existing main drainage pump authorized under Permit No. 11524, 1976 - Reclamation District No. 2062). [Additional Reference(s): DWR Levee Log, 2007. USACE San Joaquin O&M Manual 9, April 1964, (HLM 3.29)]. FS Date: 10/22/2013

WS view: 24-inch steel pipe (left) with siphon breaker on levee slope. 18-inch pipe on right.

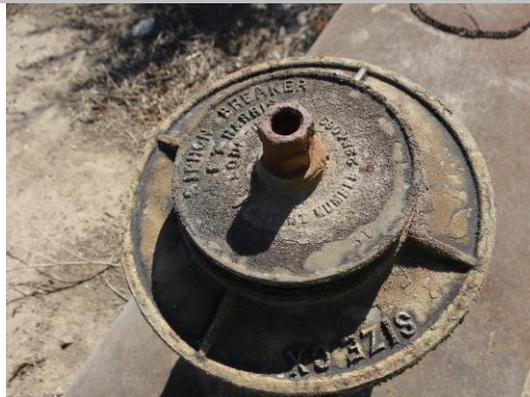
Photo 2 of 3 : UCIP_FA_2019_23304_40146.jpg

WS view: leaky siphon breaker on levee slope.

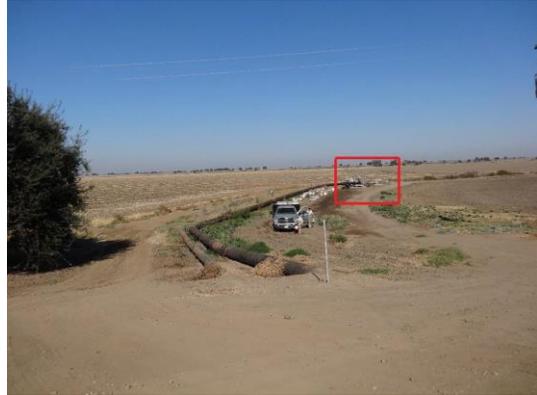
Photo 3 of 3 : UCIP_FA_2019_23304_40148.jpg

Comment Code					
Inspector Comment					
DS_ID:19199 FS_ID:23304 EP_NO: 11524 Repair Type: Non-Urgent Crossing Status: Found UCIP Comments: - waterside pipe immersed into channel water.- most of the pipe on landside exposed and siphon breaker on waterside not protected. FIELD_STRUCT_DESC: 1 of 3: 24-inch coated steel drainage discharge pipe through the levee, 2 feet below the crown. Siphon breaker on the waterside (WS) slope. Pump on a steel platform in a drainage ditch, 350 feet from the levee centerline off the landward berm. (Plans to install a drainage pump and 24-inch discharge line through the levee at existing main drainage pump authorized under Permit No. 11524, 1976 - Reclamation District No. 2062). [Additional Reference(s): DWR Levee Log, 2007. USACE San Joaquin O&M Manual 9, April 1964, (HLM 3.29)]. FS Date: 10/22/2013

LS view: overview of pipes on levee berm and pump platform (marked - right) off the berm 350 ft from the levee.

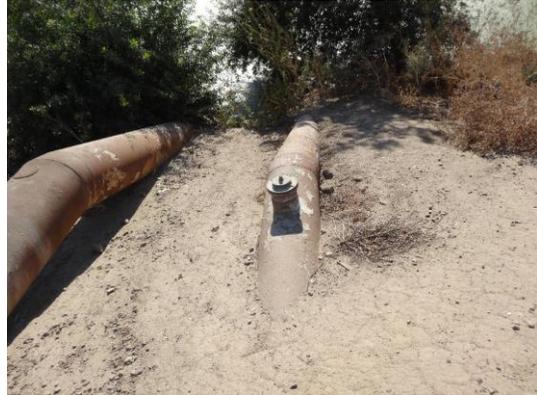
Photo 1 of 3 : UCIP_FA_2019_23023_39082.jpg

Comment Code					
Inspector Comment					
DS_ID:19198 FS_ID:23023 EP_NO: 11524 Repair Type: Non-Urgent Crossing Status: Found UCIP Comments: - 18-inch pipe bifurcated near the pump and two gate valves installed.- waterside pipe immersed into channel water.- most of the pipe on landside exposed and siphon breaker on waterside not protected. FIELD_STRUCT_DESC: 2 of 3: 18-inch coated steel drainage discharge pipe through the levee, 4 feet below the crown. Siphon breaker on the waterside (WS) slope. Pump on a steel platform in a drainage ditch, 350 feet from the levee centerline off the landward berm. (Plans to install a drainage pump and 24-inch discharge line through the levee at existing main drainage pump authorized under Permit No. 11524, 1976 - Reclamation District No. 2062). [Additional Reference(s): DWR Levee Log, 2007. USACE San Joaquin O&M Manual 9, April 1964, (HLM 3.29), 16-inch pipe referenced]. FS Date: 10/22/2013

WS view: exposed 18-inch pipe with siphon breaker on levee slope. Exposed 24-inch pipe (left).

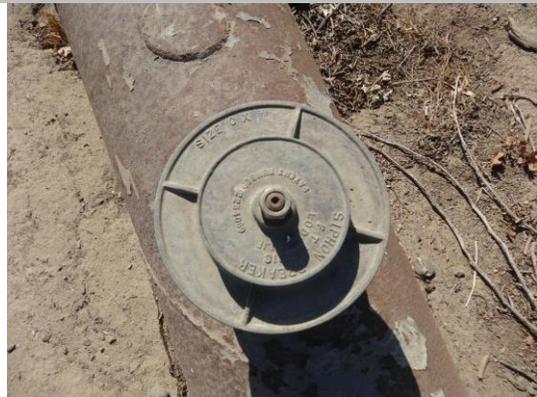
Photo 2 of 3 : UCIP_FA_2019_23023_39081.jpg

WS view: closer view of 18-inch pipe with siphon breaker on levee slope.

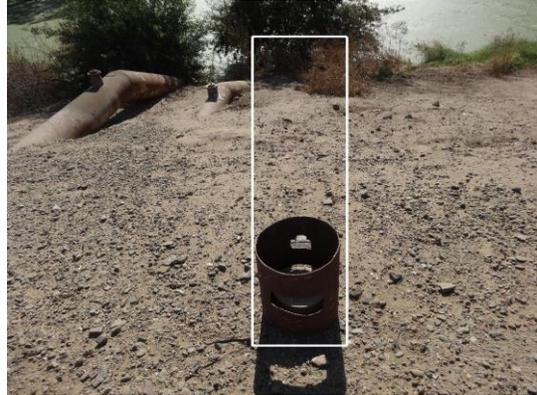
Photo 1 of 3 : UCIP_FA_2019_23305_40153.jpg

WS view: siphon breaker in steel pipe riser on levee slope.

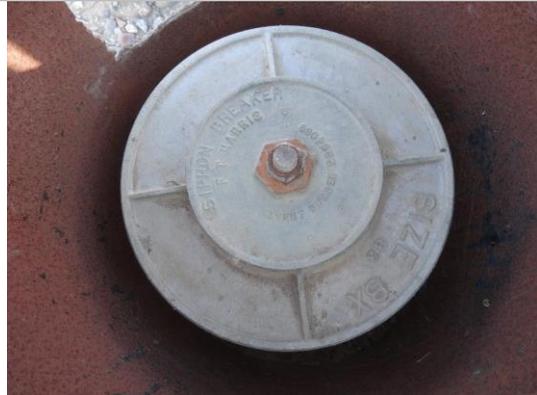
Photo 2 of 3 : UCIP_FA_2019_23305_40152.jpg

WS view: closer view of siphon breaker in steel pipe riser on levee slope.

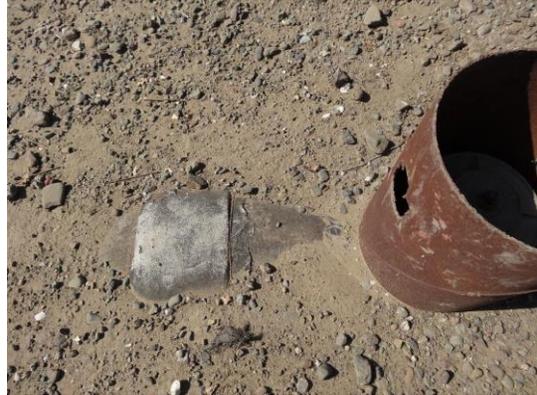
Photo 3 of 3 : UCIP_FA_2019_23305_40151.jpg

WS view: exposed pipe and steel pipe riser on levee slope.

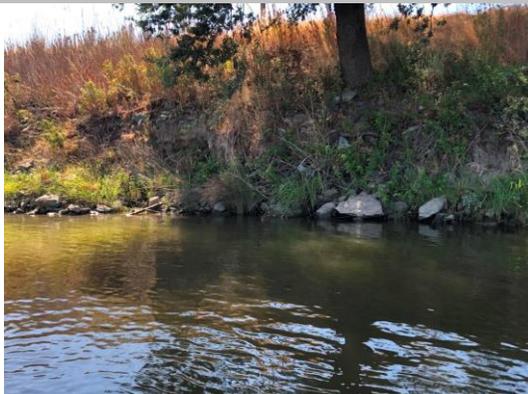
Photo 1 of 3 : SJR2019_RD2062U03RM29.94_4.jpg

Front view of the erosion site. Note the large tree above the erosion.

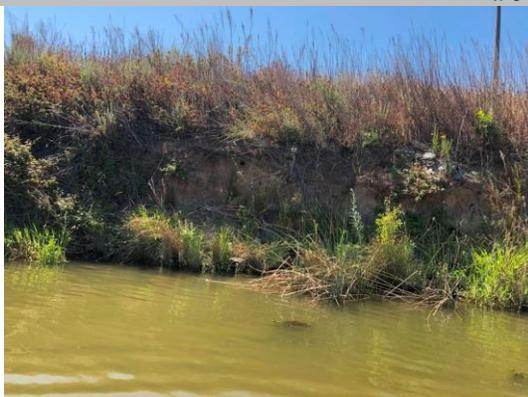
Photo 2 of 3 : SJR2019_RD2062U03RM29.94_10.jpg

Close-up view of the erosion.

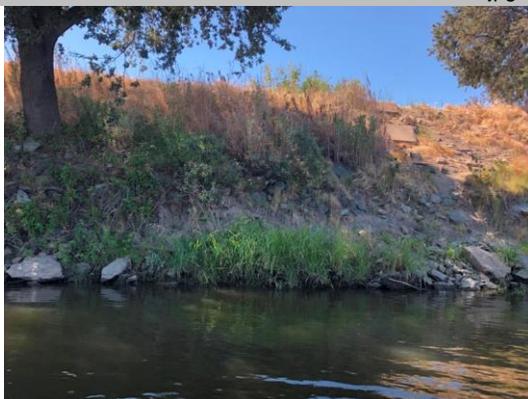
Photo 3 of 3 : SJR2019_RD2062U03RM29.94_3.jpg

Close-up view of the erosion.

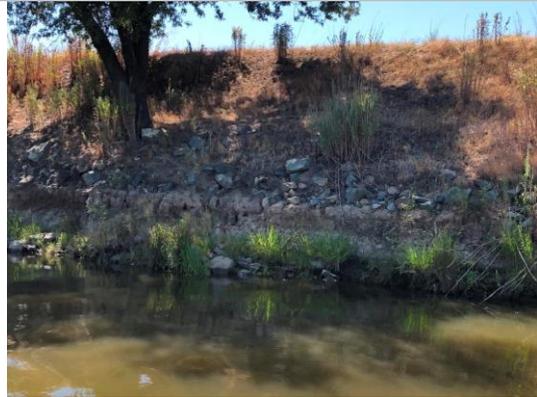
Photo 3 of 3 : SJR2019_RD2062U03RM30.02_4.jpg

Close-up view of the erosion.

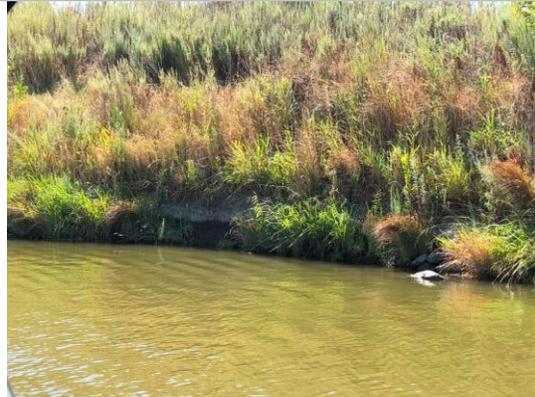
Photo 3 of 3 : SJR2019_RD2062U03RM30.19_10.jpg

Front view of the site with dense vegetation.

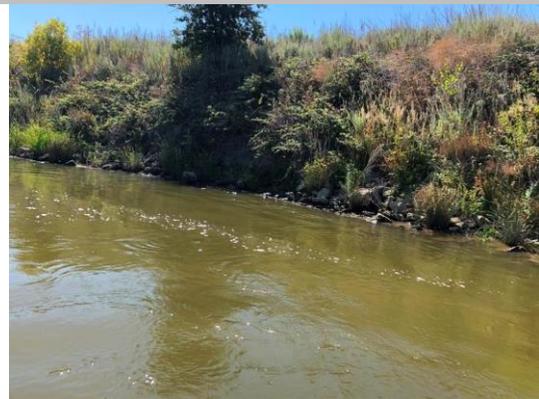
Photo 1 of 3 : SJR2019_RD2062U03RM30.27_10.jpg

Front view of the erosion.

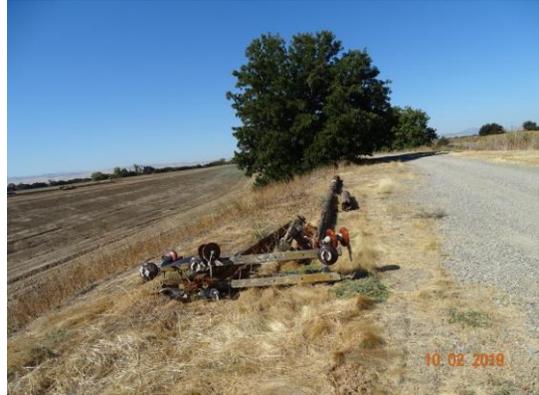
Photo 1 of 1 : FA_2019_RD2062_311_42_20191027_00055.jpg

View of utility company debris on landside slope. Fall 2019

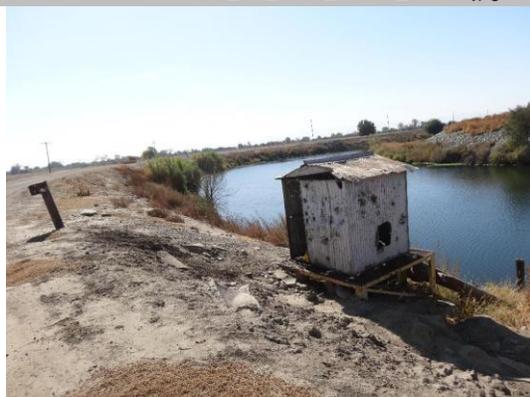
Photo 1 of 3 : UCIP_FA_2019_53377_40158.jpg

WS view: pump house on levee slope and soil erosion on levee slope.

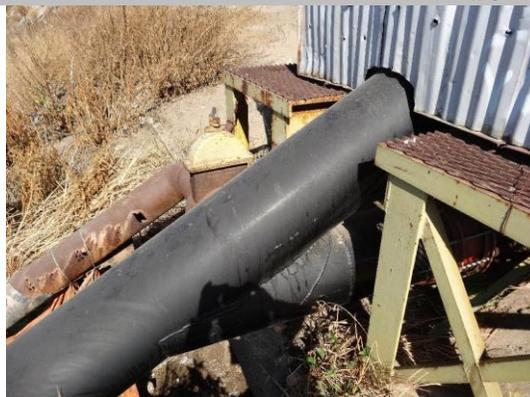
Photo 2 of 3 : UCIP_FA_2019_53377_40157.jpg

WS view: pump house on levee slope and holes-pits on corroded overflow pipe (left).

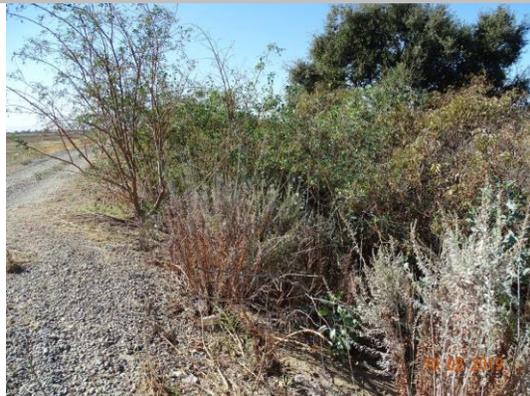
Photo 1 of 1 : FA_2019_RD2062_311_22_20191111_00058.jpg

View of vegetation on waterside slope. Fall 2019

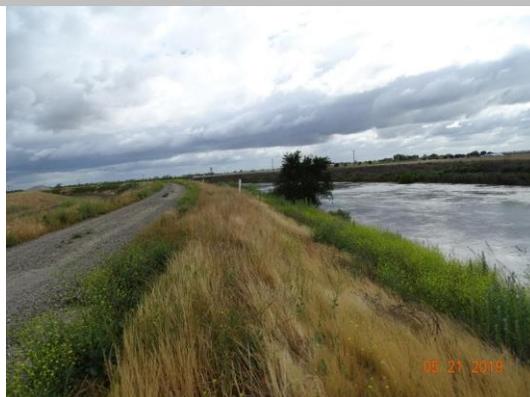
Photo 1 of 1 : FA_2019_RD2062_311_15_20190830_00032.jpg

Typical view of vegetation on waterside slope. (Spring 2019)

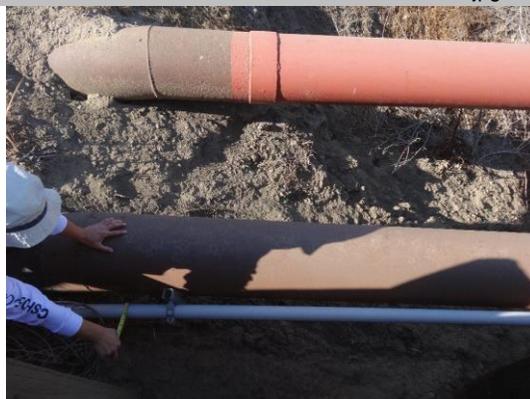
Photo 2 of 3 : UCIP_FA_2019_23311_40174.jpg

WS view: exposed steel pipes and an electric conduit on levee slope.

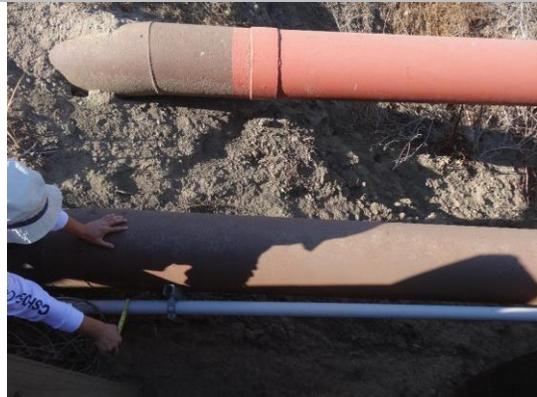
Photo 2 of 3 : UCIP_FA_2019_23312_40179.jpg

WS view: exposed steel pipes and a electric conduit on levee slope.

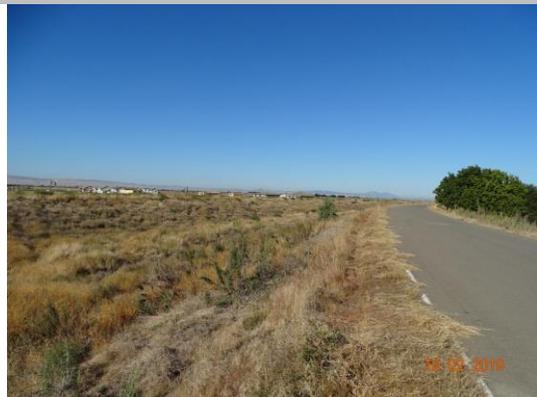
Photo 1 of 1 : FA_2019_RD2062_311_19_20191111_00057.jpg

View of vegetation on landside slope and easement. Fall 2019

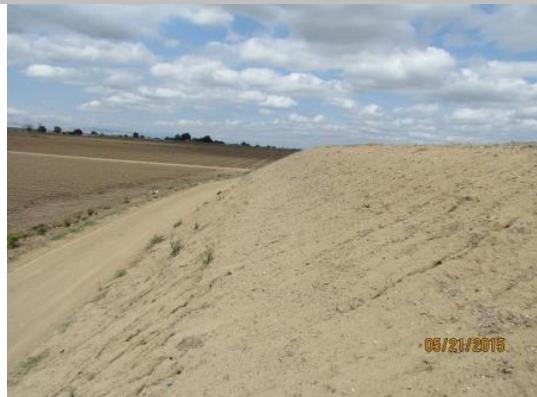
Photo 1 of 1 : FA_2019_RD2062_311_31_20190830_00037.jpg

View of the eroded landside levee toe.

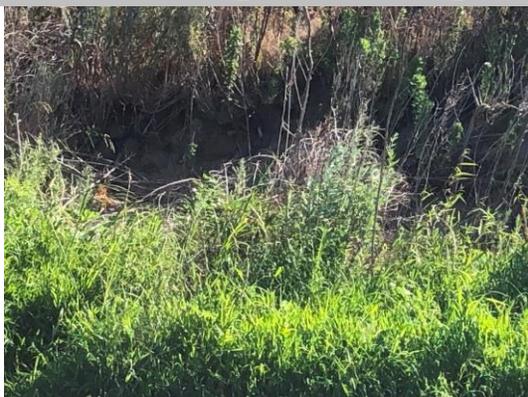
Photo 2 of 3 : SJR2019_RD2062U03RM33.92_3.JPG

Close-up view of the erosion.

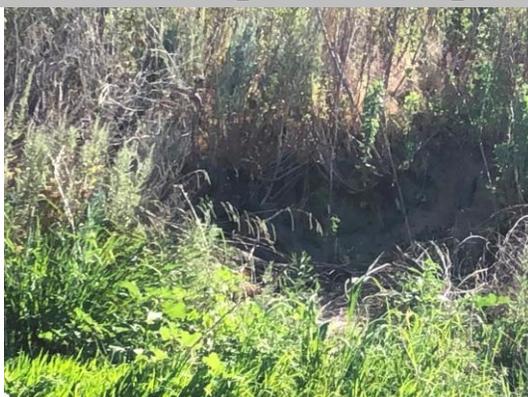
Photo 3 of 3 : SJR2019_RD2062U03RM33.92_6.JPG

Close-up view of the erosion. Note the sandy material of the river bank at the erosion site.

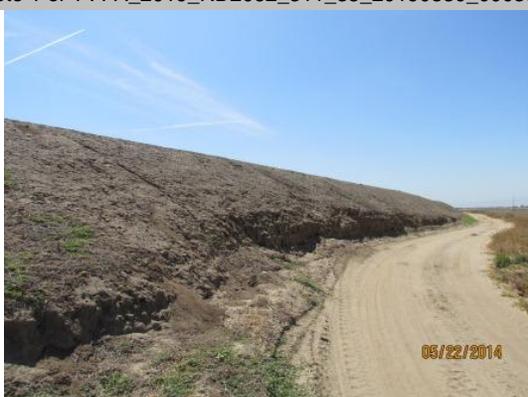
Photo 1 of 1 : FA_2019_RD2062_311_35_20190830_00038.jpg

View of a 2-3 feet vertical cut at the landside levee toe.

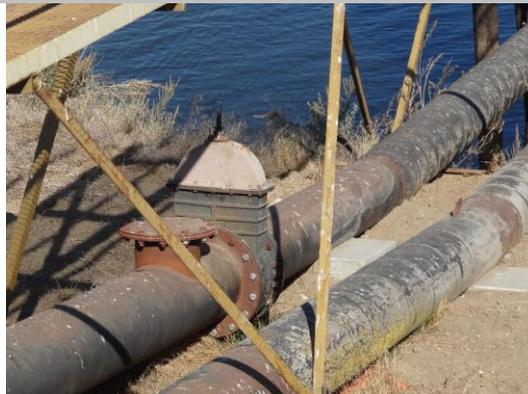
Photo 2 of 3 : UCIP_FA_2019_23140_39530.jpg

WS view: two 16-inch pipes under walkway. Gate valve without handle on one of the pipes.
