**Flood Control Project Maintenance  
Levee Inspections**

**Maintenance Issue Types Only, Levee Inspection Report By Mile - Fall 2019**

**Reclamation District No. 2062 Stewart**

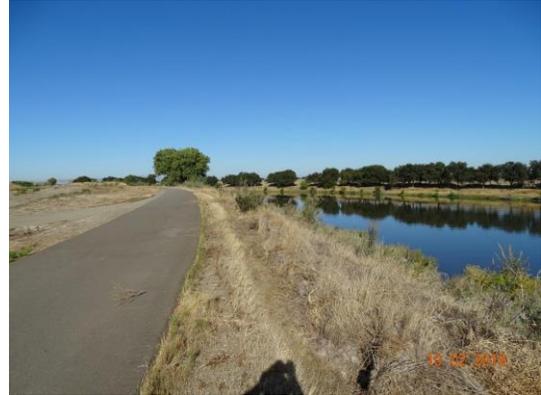
Photo 1 of 1 : FA\_2019\_RD2062\_309\_11\_20191111\_00011.jpg

LM Start	<b>0.00</b>	Rating **	M	Issue No.	<b>11</b>
LM End	<b>0.76</b>	Issue Type +	Ma	Location *	WS
Category	Earthen Levee		GPS Latitude/Longitude		
			Start	End	
Item	Vegetation		37.807461°	37.804875°	
			-121.328057°	-121.315880°	
DWR ID	DWR_RD2062_01_f_2019_11				
Comment Code					
V2 : Remove the wild growth other than native grasses from the levee slopes.					
Inspector Comment

View of vegetation on waterside slope. Fall 2019

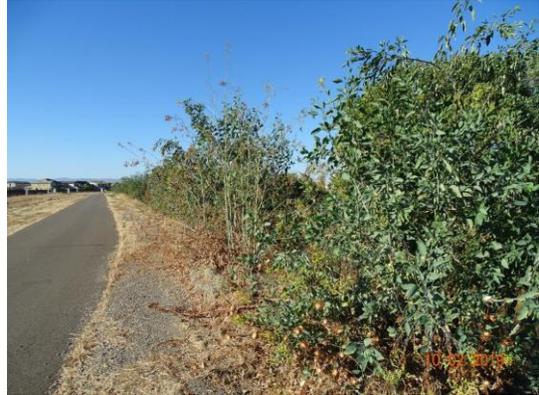
Photo 1 of 1 : FA\_2019\_RD2062\_309\_9\_20191027\_00010.jpg

LM Start	<b>2.01</b>	Rating **	U	Issue No.	<b>9</b>
LM End	<b>2.09</b>	Issue Type +	Ma	Location *	WS
Category	Earthen Levee		GPS Latitude/Longitude		
			Start	End	
Item	Vegetation		37.793068°	37.794010°	
			-121.310008°	-121.309373°	
DWR ID	DWR_RD2062_01_f_2019_9				
Comment Code					
V2 : Remove the wild growth other than native grasses from the levee slopes.					
Inspector Comment

View of vegetation on waterside slope. Fall 2019

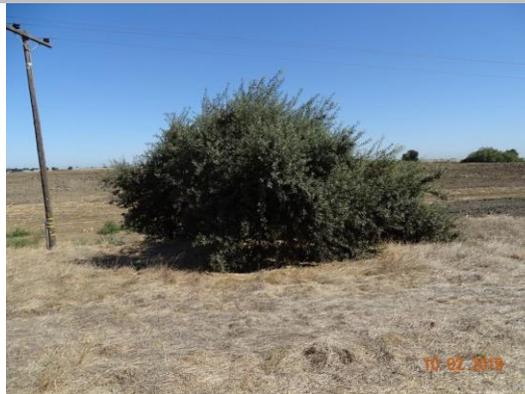
Photo 1 of 1 : FA\_2019\_RD2062\_310\_23\_20191027\_00030.jpg

LM Start	<b>1.51</b>	Rating **	U	Issue No.	<b>23</b>
LM End	<b>1.51</b>	Issue Type +	Ma	Location *	LS
Category	Earthen Levee			GPS Latitude/Longitude	
				Start	End
Item	Trim / Thin Trees			37.793014 °	37.793014 °
				-121.352582 °	-121.352582 °
DWR ID	DWR_RD2062_02_f_2019_23				
Comment Code					
T3 : Trim and thin trees to allow visibility of the ground and room to flood fight.					
Inspector Comment

View of tree on landside slope. Fall 2019

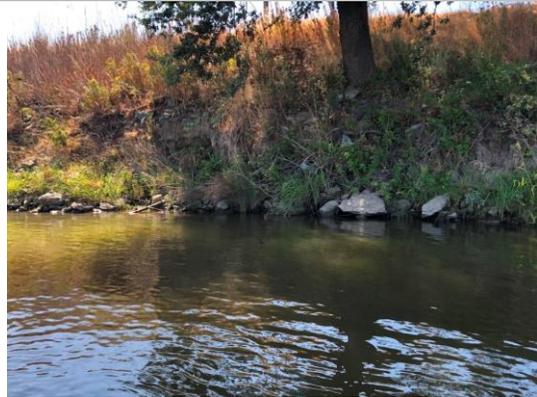
Photo 1 of 3 : SJR2019\_RD2062U03RM29.94\_4.jpg

LM Start	<b>-0.03</b>	Rating **	M	Issue No.	<b>1</b>
LM End	<b>0.07</b>	Issue Type +	Ma	Location *	
Category	Supplemental		GPS Latitude/Longitude		
			Start	End	
Item	DWR Erosion Survey		37.809514 °	37.809514 °	
			-121.390125 °	-121.390125 °	
DWR ID	RD2062U03RM29.94				
Comment Code					
Inspector Comment					
Site ID: RD2062U03RM29.94 08/14/2019: No significant change observed. 09/13/2017: The erosion site has expanded significantly along the river bank. 11/09/2016: No significant change observed. 06/25/2015: The erosion is below a large oak tree. Vegetation is visible around the erosion site.

Front view of the erosion site. Note the large tree above the erosion.

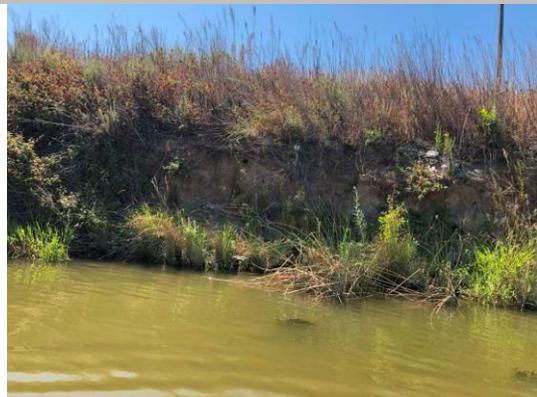
Photo 2 of 3 : SJR2019\_RD2062U03RM29.94\_10.jpg

Close-up view of the erosion.

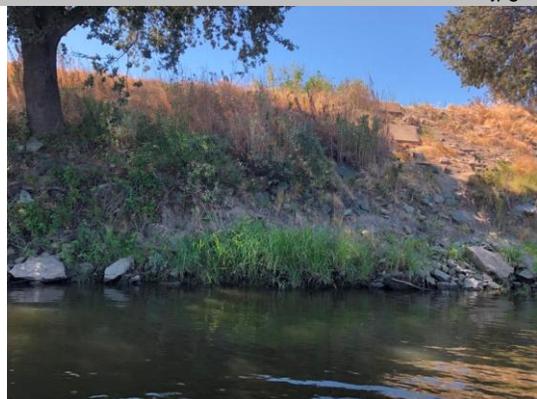
Photo 3 of 3 : SJR2019\_RD2062U03RM29.94\_3.jpg

Close-up view of the erosion.

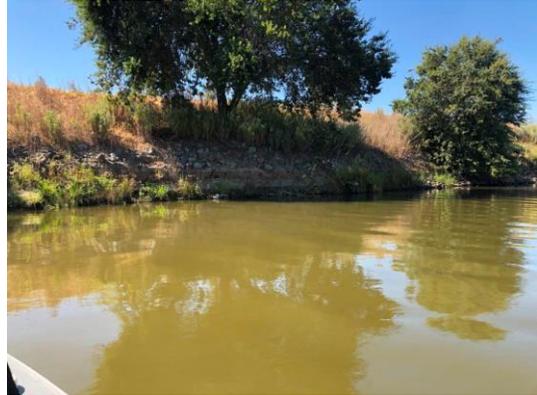
Photo 1 of 3 : SJR2019\_RD2062U03RM30.02\_1.jpg

Item	DWR Erosion Survey		37.809932°	37.809932°	
			-121.388788°	-121.388788°	
DWR ID	RD2062U03RM30.02				
Comment Code					
Inspector Comment					
Site ID: RD2062U03RM30.02					
08/14/2019: The erosion has extended downstream by approximately 60 ft.					
09/13/2017: The erosion site has expanded significantly with the erosion length increased to approximately 90 ft from 40 ft. Signs of animal activities have been found at the site.					
07/25/2016: No significant change observed.					
06/25/2015: No significant change observed.					
07/02/2014: No significant change observed.					
08/13/2013: No significant change observed.					
08/07/2012: The site has been visited by boat survey. No significant change observed					
08/23/2011: Hard to view the erosion because of the dense vegetation and trees on site. The site is under the bush, close to the tree.

Front view of the site.

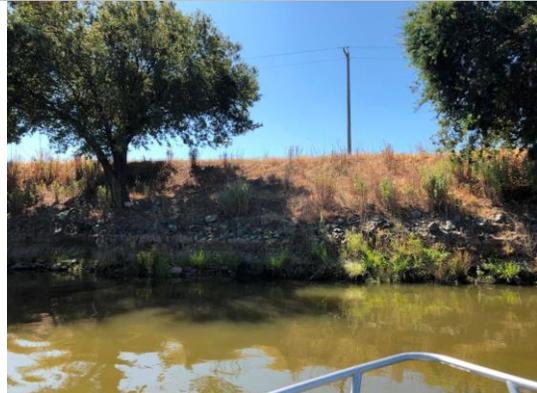
Photo 2 of 3 : SJR2019\_RD2062U03RM30.02\_3.jpg

Close-up view of the erosion. Note signs of animal activities at the site..

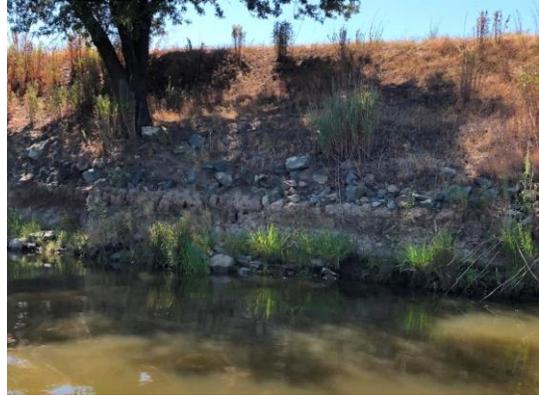
Photo 3 of 3 : SJR2019\_RD2062U03RM30.02\_4.jpg

Item	DWR Erosion Survey			37.809932°	37.809932°
				-121.388788°	-121.388788°
DWR ID	RD2062U03RM30.02				
Comment Code					
Inspector Comment					
Site ID: RD2062U03RM30.02 08/14/2019: The erosion has extended downstream by approximately 60 ft. 09/13/2017: The erosion site has expanded significantly with the erosion length increased to approximately 90 ft from 40 ft. Signs of animal activities have been found at the site. 07/25/2016: No significant change observed. 06/25/2015: No significant change observed. 07/02/2014: No significant change observed. 08/13/2013: No significant change observed. 08/07/2012: The site has been visited by boat survey. No significant change observed 08/23/2011: Hard to view the erosion because of the dense vegetation and trees on site. The site is under the bush, close to the tree.

Close-up view of the erosion.

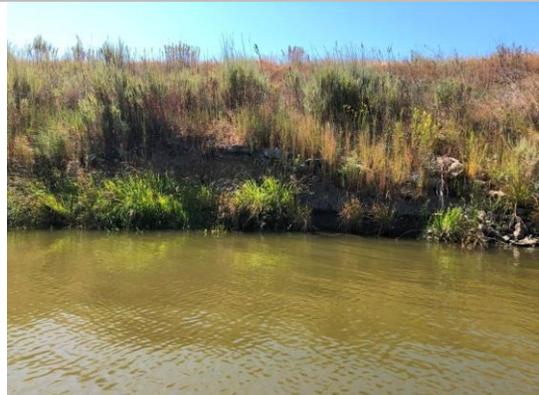
Photo 1 of 3 : SJR2019\_RD2062U03RM30.10\_3.jpg

LM Start	<b>0.17</b>	Rating **	M	Issue No.	<b>3</b>
LM End	<b>0.17</b>	Issue Type +	Ma	Location *	
Category	Supplemental			GPS Latitude/Longitude	
				Start	End
Item	DWR Erosion Survey			37.810268°	37.810268°
				-121.387495°	-121.387495°
DWR ID	RD2062U03RM30.1				
Comment Code					
Inspector Comment					
Site ID: RD2062U03RM30.1 08/14/2019: No significant change observed. 09/13/2017: No significant change observed. 07/25/2016: No significant change observed. 06/25/2015: No significant change observed. 07/02/2014: No significant change observed. 08/13/2013: No significant change observed. 08/07/2012: The site has been visited by boat survey. No significant change observed 08/23/2011: The protection at the levee toe has been washed away.

Direct view of the site.

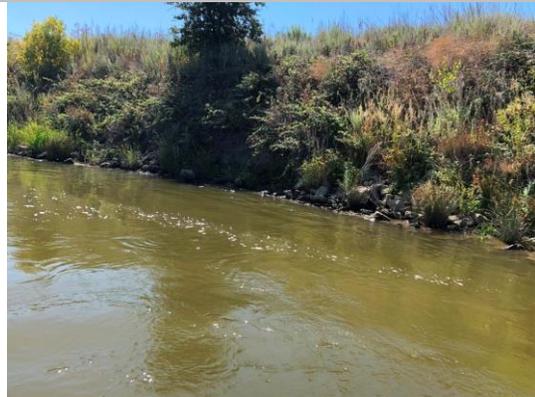
Photo 1 of 3 : SJR2019\_RD2062U03RM30.27\_10.jpg

LM Start	<b>0.35</b>	Rating **	M	Issue No.	<b>5</b>
LM End	<b>0.35</b>	Issue Type +	Ma	Location *	
Category	Supplemental		GPS Latitude/Longitude		
			Start	End	
Item	DWR Erosion Survey		37.811101°	37.811101°	
			-121.384402°	-121.384402°	
DWR ID	RD2062U03RM30.27				
Comment Code					
Inspector Comment					
Site ID: RD2062U03RM30.27					
08/14/2019: No significant change observed.					
09/13/2017: No significant change observed.					
07/25/2016: No significant change observed.					
06/25/2015: No significant change observed.					
07/02/2014: No significant change observed.					
08/13/2013: No significant change observed.					
08/07/2012: The site has been visited by boat survey. No significant change observed					
08/23/2011: The site is right at the downstream of a river bend.

Front view of the erosion.

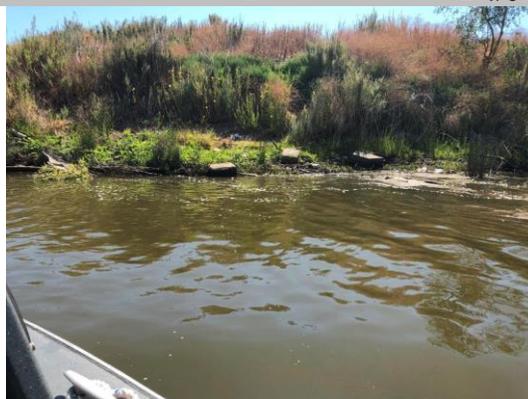
Photo 1 of 3 : SJR2019\_RD2062U03RM30.43\_3.jpg

Item	DWR Erosion Survey			37.813070°	37.813070°
				-121.383100°	-121.383100°
DWR ID	RD2062U03RM30.43				
Comment Code					
Inspector Comment					
<p>Site ID: RD2062U03RM30.43                      08/14/2019: No significant change observed.                      09/13/2017: No significant change observed.                      07/25/2016: No significant change observed.                      06/25/2015: No significant change observed.                      07/02/2014: No significant change observed.                      08/13/2013: No significant change observed.                      08/07/2012: The site has been visited by boat survey. No significant change observed.                      08/23/2011: No significant change observed on site.                      09/07/2010: No significant change observed on site. Much of the placed rip rap revetment has slid. It is no longer adequately protecting the slope.                      08/06/2010: Recommended as local maintenance issue, per CLRO Report.                      03/09/2010: As discussed with Michael Moncrief of MBK, site will be 'addressed' this year.                      09/29/2009: No major change observed since last visit; a section of the rip rap has slipped, exposing a levee section that has eroded; recommended as local maintenance issue, per CLRO CES Evaluation 2008 Report; Site # is the same as RM30.43,LM0.63; previously rated "U".                      11/05/2008: Site is located inside of a bend; scarp looks to be into the levee prism; piles of concrete chunks placed on the slope, with some of them already starting to slide.</p>

Close-up view of the site.

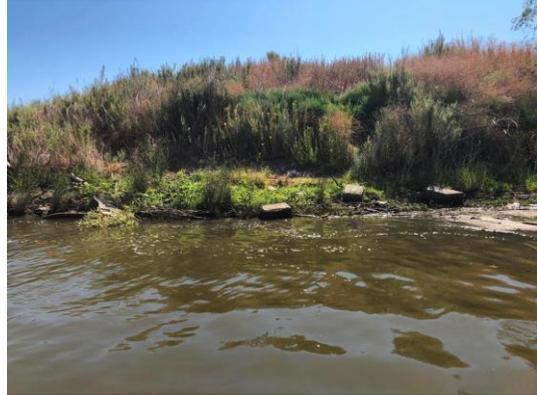
Photo 2 of 3 : SJR2019\_RD2062U03RM30.43\_2.jpg

Item	DWR Erosion Survey			37.813070°	37.813070°
				-121.383100°	-121.383100°
DWR ID	RD2062U03RM30.43				
Comment Code					
Inspector Comment					
<p>Site ID: RD2062U03RM30.43                  08/14/2019: No significant change observed.                  09/13/2017: No significant change observed.                  07/25/2016: No significant change observed.                  06/25/2015: No significant change observed.                  07/02/2014: No significant change observed.                  08/13/2013: No significant change observed.                  08/07/2012: The site has been visited by boat survey. No significant change observed.                  08/23/2011: No significant change observed on site.                  09/07/2010: No significant change observed on site. Much of the placed rip rap revetment has slid. It is no longer adequately protecting the slope.                  08/06/2010: Recommended as local maintenance issue, per CLRO Report.                  03/09/2010: As discussed with Michael Moncrief of MBK, site will be 'addressed' this year.                  09/29/2009: No major change observed since last visit; a section of the rip rap has slipped, exposing a levee section that has eroded; recommended as local maintenance issue, per CLRO CES Evaluation 2008 Report; Site # is the same as RM30.43,LM0.63; previously rated "U".                  11/05/2008: Site is located inside of a bend; scarp looks to be into the levee prism; piles of concrete chunks placed on the slope, with some of them already starting to slide.</p>

Front view of the site.

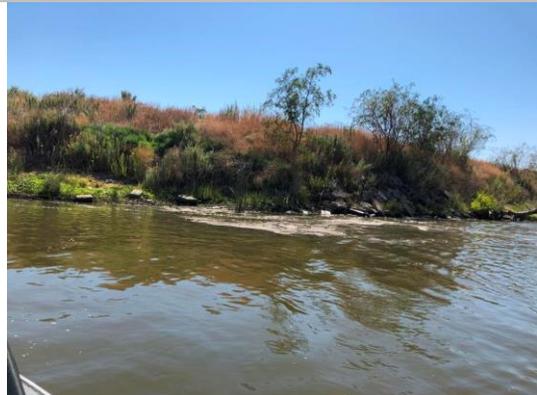
Photo 3 of 3 : SJR2019\_RD2062U03RM30.43\_4.jpg

Front view of the site.

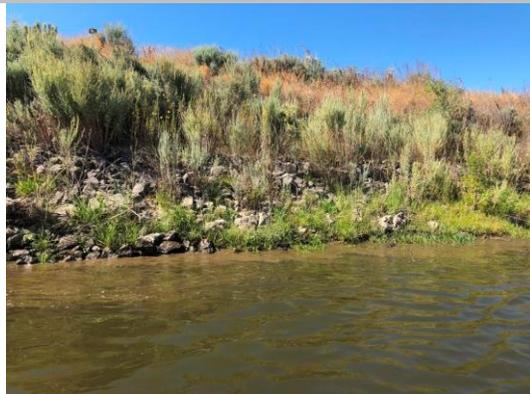
Photo 3 of 3 : SJR2019\_RD2062U03RM31.12\_1.jpg

Item	DWR Erosion Survey			37.819290 °	37.819290 °
				-121.378880 °	-121.378880 °
DWR ID	RD2062U03RM31.12				
Comment Code					
Inspector Comment					
Site ID: RD2062U03RM31.12 08/14/2019: No significant change observed. 09/13/2017: No significant change observed. 07/25/2016: No significant change observed. 06/25/2015: No significant change observed. 07/02/2014: No significant change observed. 08/13/2013: No significant change observed. 08/07/2012: The site has been visited by boat survey. No significant change observed 08/23/2011: No significant change observed on site. 09/07/2010: No significant change observed on site. Much of the seasonal grass along the slope was cleared. Site consists of an existing scalloped erosion approximately 30 feet long by 5 feet wide at its widest opening. The lateral crack is extended outwards along the middle slope. There is a 1 to 2 feet of differential settlement that could further develop into a shallow slide. 08/06/2010: Recommended as local maintenance issue, per CLRO. 03/09/2010: As discussed with Michael Moncrief of MBK Engineer, site will be 'addressed' this year. 09/28/2009: No major change observed; section of rip rap has slipped, creating a terraced effect; dense vegetation growth; recommended as a local maintenance issue, per CLRO CES Evaluation 2008 Report; Site # is the same as RM31.12,LM1.25; previously rated "U". 09/14/2006: 1-2' into prism.

Close-up view of the site.

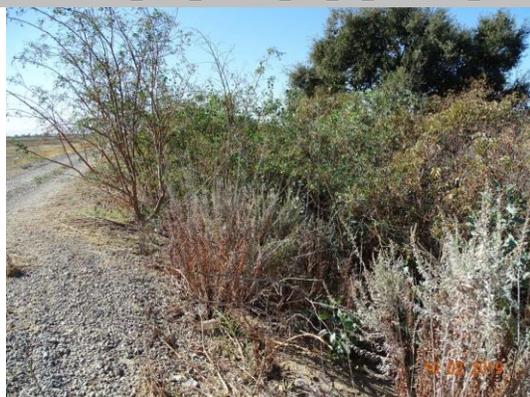
Photo 1 of 1 : FA\_2019\_RD2062\_311\_22\_20191111\_00058.jpg

LM Start	<b>1.31</b>	Rating **	U	Issue No.	<b>22</b>
LM End	<b>1.36</b>	Issue Type +	Ma	Location *	WS
Category	Earthen Levee			GPS Latitude/Longitude	
				Start	End
Item	Vegetation			37.820322 °	37.821072 °
				-121.377146 °	-121.377031 °
DWR ID	DWR_RD2062_03_s_2018_22				
Comment Code					
V2 : Remove the wild growth other than native grasses from the levee slopes.					
Inspector Comment

View of vegetation on waterside slope. Fall 2019

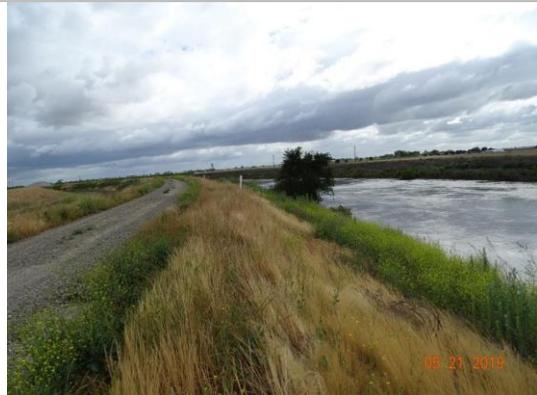
Photo 1 of 1 : FA\_2019\_RD2062\_311\_15\_20190830\_00032.jpg

LM Start	<b>1.36</b>	Rating **	M	Issue No.	<b>15</b>
LM End	<b>5.53</b>	Issue Type +	Ma	Location *	WS
Category	Earthen Levee		GPS Latitude/Longitude		
			Start	End	
Item	Vegetation		37.821032°	37.807536°	
			-121.377046°	-121.328314°	
DWR ID	DWR_RD2062_03_s_2019_15				
Comment Code					
V2 : Remove the wild growth other than native grasses from the levee slopes.					
Inspector Comment

Typical view of vegetation on waterside slope. (Spring 2019)

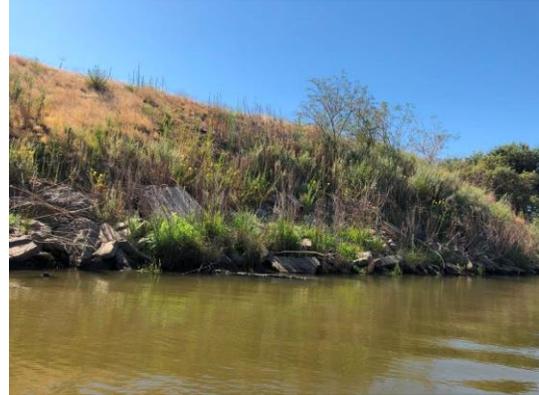
Photo 1 of 3 : SJR2019\_RD2062U03RM31.28\_9.jpg

Item	DWR Erosion Survey		37.821380 °	37.821380 °	
			-121.376900 °	-121.376900 °	
DWR ID	RD2062U03RM31.28				
Comment Code					
Inspector Comment					
<p>Site ID: RD2062U03RM31.28                  08/14/2019: No significant change observed.                  09/13/2017: No significant change observed.                  07/25/2016: No significant change observed.                  06/25/2015: No significant change observed.                  07/02/2014: No significant change observed.                  08/13/2013: No significant change observed.                  08/07/2012: The site has been visited by boat survey. No significant change observed                  08/23/2011: No significant change observed on site.                  09/07/2010: No significant change observed on site. There is a small- to medium sized Oak tree on the mid-slope just above rip rap. Some of the rip rap has collapsed, creating a pocket erosion just above the existing toe rip rap and upstream of the Oak tree.                  08/06/2010: Recommended as local maintenance issue, per CLRO.                  03/09/2010: As discussed with Michael Moncrief of MBK Engineer, site will be 'addressed' in 2010.                  09/29/2009: No major change since last visit; sliding of the rip rap at the base of the lone tree; there is noticeable man-made trail and foot traffic extending from the crown to the toe; much of the broken concrete used as temporary rip rap has slid, exposing portion of the bare levee slope; recommended as local maintenance issue, per CLRO CES Evaluation 2008 Report; Site # is the same as RM31.3, LM1.45; previously rated "M".                  11/05/2008: Portion of rip rap collapsing.                  09/14/2006: Portion of rip rap along the slope has collapsed; exposed levee section is starting to erode, exposing roots from the nearby tree.</p>

Front view of the erosion site.

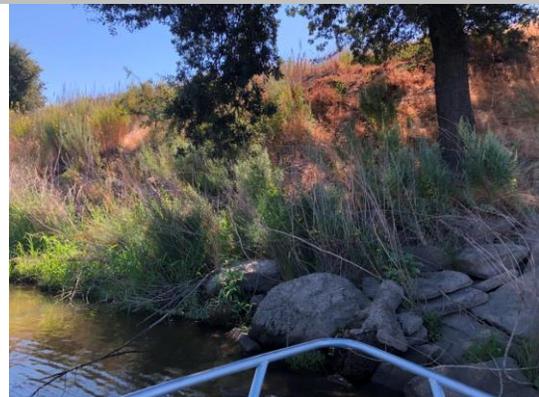
Photo 2 of 3 : SJR2019\_RD2062U03RM31.28\_3.jpg

Close-up view of the site.

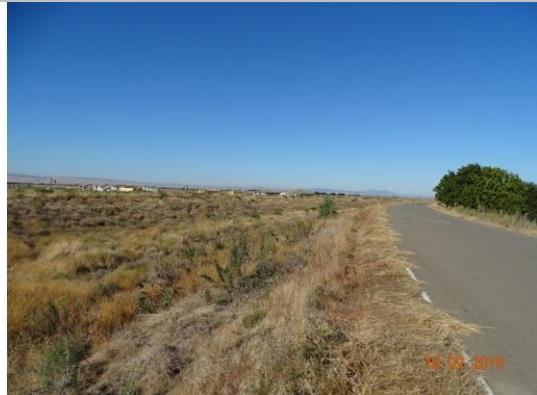
Photo 1 of 1 : FA\_2019\_RD2062\_311\_19\_20191111\_00057.jpg

LM Start	<b>3.31</b>	Rating **	U	Issue No.	<b>19</b>
LM End	<b>5.42</b>	Issue Type +	Ma	Location *	LS
Category	Earthen Levee		GPS Latitude/Longitude		
			Start	End	
Item	Vegetation		37.819898°	37.807428°	
			-121.346864°	-121.330299°	
DWR ID	DWR_RD2062_03_f_2019_19				
Comment Code					
V2 : Remove the wild growth other than native grasses from the levee slopes.					
Inspector Comment

View of vegetation on landside slope and easement. Fall 2019

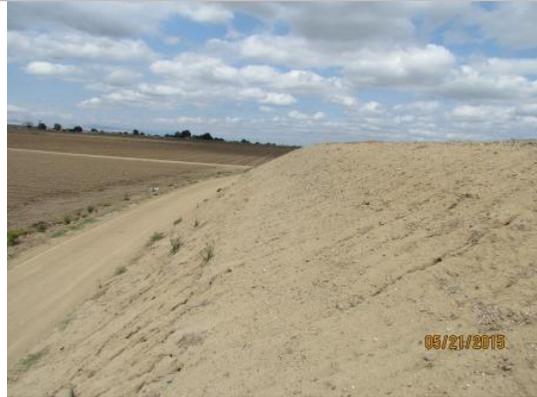
Photo 1 of 1 : FA\_2019\_RD2062\_311\_31\_20190830\_00037.jpg

LM Start	<b>3.61</b>	Rating **	M	Issue No.	<b>31</b>
LM End	<b>3.66</b>	Issue Type +	Ma	Location *	LS
Category	Earthen Levee		GPS Latitude/Longitude		
			Start	End	
Item	Erosion / Bank Caving		37.816982°	37.816541°	
			-121.342939°	-121.342191°	
DWR ID	DWR_RD2062_03_s_2015_31				
Comment Code					
E2 : Schedule repair of erosion site prior to the next inspection.					
Inspector Comment					
There is about a 3 ft vertical cut at the levee toe into the levee prism.

View of the eroded landside levee toe.

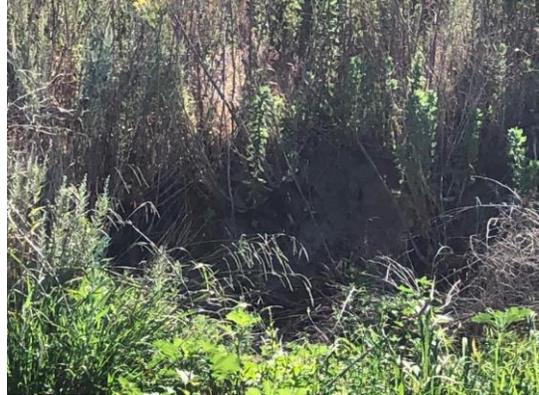
Photo 1 of 3 : SJR2019\_RD2062U03RM33.92\_1.JPG

LM Start	<b>3.99</b>	Rating **	A/W	Issue No.	<b>10</b>
LM End	<b>4.01</b>	Issue Type +	Ma	Location *	
Category	Supplemental			GPS Latitude/Longitude	
				Start	End
Item	DWR Erosion Survey			37.820834 °	37.820834 °
				-121.340314 °	-121.340314 °
DWR ID	RD2062U03RM33.92				
Comment Code					
Inspector Comment					
Site ID: RD2062U03RM33.92 08/14/2019: No significant change observed. 09/13/2017: The erosion site is immediately downstream of a sharp river bend.

Close-up view of the erosion located at the inside of a sharp river bend.

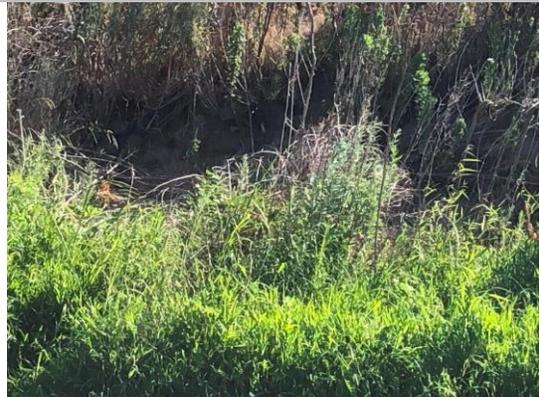
Photo 2 of 3 : SJR2019\_RD2062U03RM33.92\_3.JPG

Close-up view of the erosion.

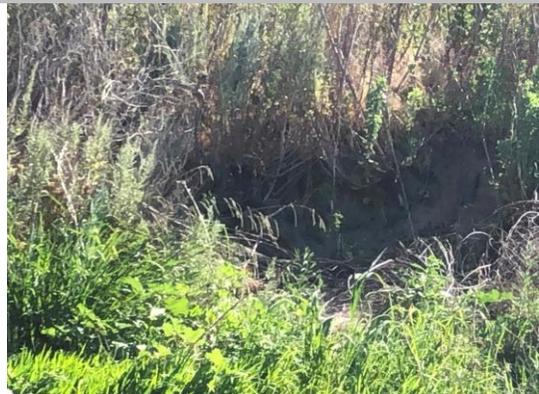
Photo 3 of 3 : SJR2019\_RD2062U03RM33.92\_6.JPG

Close-up view of the erosion. Note the sandy material of the river bank at the erosion site.

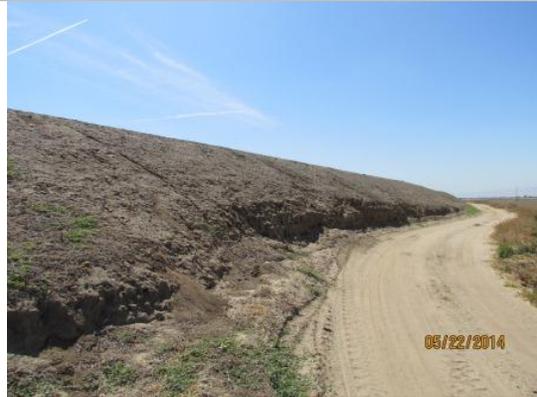
Photo 1 of 1 : FA\_2019\_RD2062\_311\_35\_20190830\_00038.jpg

LM Start	<b>4.83</b>	Rating **	M	Issue No.	<b>35</b>
LM End	<b>4.91</b>	Issue Type +	Ma	Location *	LS
Category	Earthen Levee		GPS Latitude/Longitude		
			Start	End	
Item	Erosion / Bank Caving		37.812849°	37.811682°	
			-121.336116°	-121.336271°	
DWR ID	DWR_RD2062_03_f_2014_35				
Comment Code					
E2 : Schedule repair of erosion site prior to the next inspection.					
Inspector Comment					
There is a 2 to 3 feet vertical cut at the landside toe.

View of a 2-3 feet vertical cut at the landside levee toe.
