**Flood Control Project Maintenance  
Levee Inspections**

**Maintenance Issue Types Only, Levee Inspection Report By Mile - Spring 2020**

**Reclamation District No. 2062 Stewart**

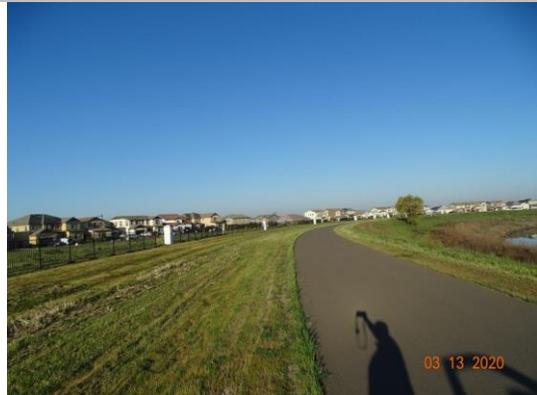
Photo 1 of 1 : SP\_2020\_RD2062\_309\_13\_20200318\_00012.jpg

LM Start	<b>1.84</b>	Rating **	A	Issue No.	<b>13</b>
LM End	<b>1.84</b>	Issue Type +	Ma	Location *	LS
Category	Earthen Levee			GPS Latitude/Longitude	
				Start	End
Item	Vegetation			37.791821 °	37.791821 °
				-121.312488 °	-121.312488 °
DWR ID	DWR_RD2062_01_s_2020_13				
Comment Code					
V1 : Control annual grass and weeds on the levee slopes and easements.					
Inspector Comment

Typical view of well maintained vegetation on landside slope. Spring 2020

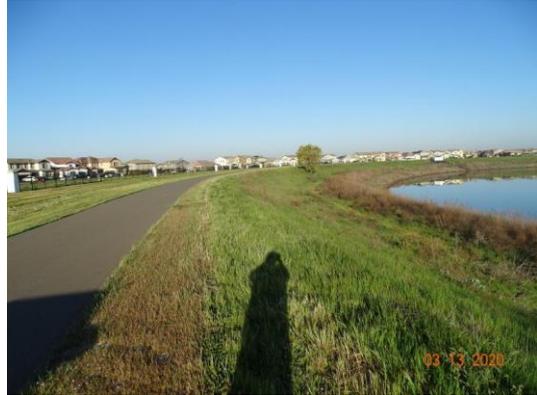
Photo 1 of 1 : SP\_2020\_RD2062\_309\_12\_20200318\_00013.jpg

LM Start	<b>1.84</b>	Rating **	A	Issue No.	<b>12</b>
LM End	<b>1.84</b>	Issue Type +	Ma	Location *	WS
Category	Earthen Levee		GPS Latitude/Longitude		
			Start	End	
Item	Vegetation		37.791821 °	37.791821 °	
			-121.312487 °	-121.312487 °	
DWR ID	DWR_RD2062_01_s_2020_12				
Comment Code					
V1 : Control annual grass and weeds on the levee slopes and easements.					
Inspector Comment

Typical view of well maintained vegetation on waterside slope. Spring 2020

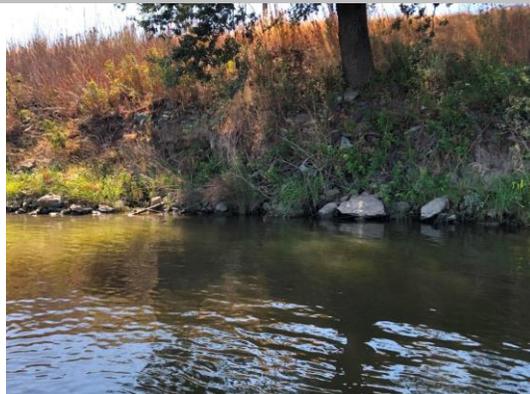
Photo 1 of 3 : SP\_2020\_RD2062\_311\_1\_20200228\_00001.jpg

LM Start	<b>-0.03</b>	Rating **	M	Issue No.	<b>1</b>
LM End	<b>0.07</b>	Issue Type +	Ma	Location *	WS
Category	Supplemental			GPS Latitude/Longitude	
				Start	End
Item	DWR Erosion Survey			37.809514 °	37.809514 °
				-121.390125 °	-121.390125 °
DWR ID	RD2062U03RM29.94				
Comment Code					
Inspector Comment					
Site ID: RD2062U03RM29.94 08/14/2019: No significant change observed. 09/13/2017: The erosion site has expanded significantly along the river bank. 11/09/2016: No significant change observed. 06/25/2015: The erosion is below a large oak tree. Vegetation is visible around the erosion site.

Front view of the erosion site. Note the large tree above the erosion.

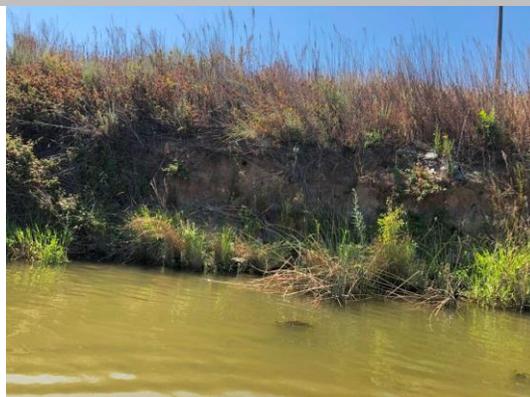
Photo 2 of 3 : SP\_2020\_RD2062\_311\_1\_20200228\_00002.jpg

Close-up view of the erosion.

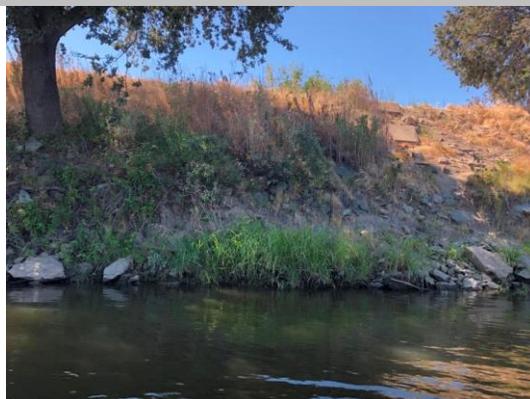
Photo 3 of 3 : SP\_2020\_RD2062\_311\_1\_20200228\_00003.jpg

Close-up view of the erosion.

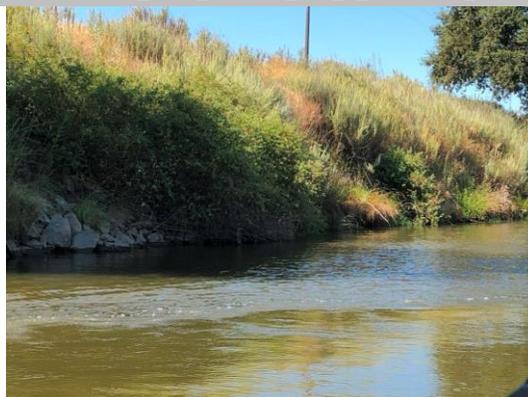
Photo 2 of 3 : SP\_2020\_RD2062\_311\_4\_20200228\_00011.jpg

LM Start	<b>0.22</b>	Rating **	U	Issue No.	<b>4 (cont)</b>
LM End	<b>0.31</b>	Issue Type +	Ma	Location *	WS
Category	Supplemental			GPS Latitude/Longitude	
				Start	End
Item	DWR Erosion Survey			37.810609 °	37.810609 °
				-121.385879 °	-121.385879 °
DWR ID	RD2062U03RM30.19

Close-up view of the pocket erosion. Note the dense vegetation at the site.

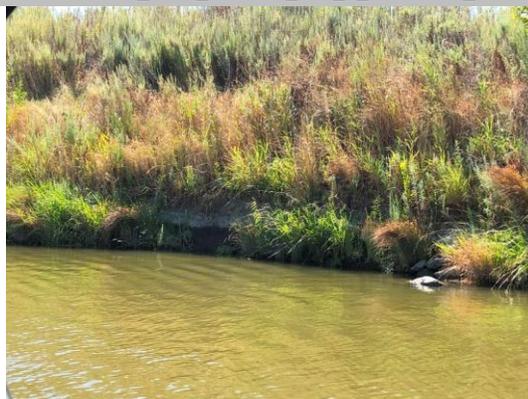
Photo 3 of 3 : SP\_2020\_RD2062\_311\_4\_20200228\_00012.jpg

Front view of the site with dense vegetation.

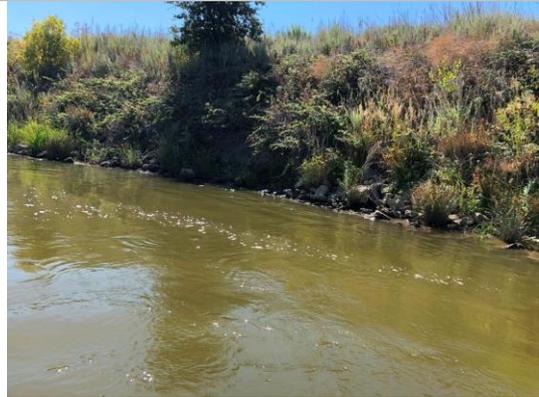
Photo 1 of 3 : SP\_2020\_RD2062\_311\_5\_20200228\_00013.jpg

Site ID: RD2062U03RM30.27  
 08/14/2019: No significant change observed.  
 09/13/2017: No significant change observed.  
 07/25/2016: No significant change observed.  
 06/25/2015: No significant change observed.  
 07/02/2014: No significant change observed.  
 08/13/2013: No significant change observed.  
 08/07/2012: The site has been visited by boat survey. No significant change observed  
 08/23/2011: The site is right at the downstream of a river bend.

Front view of the erosion.

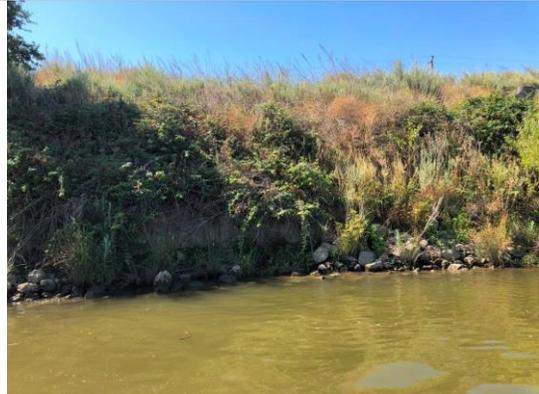
Photo 2 of 3 : SP\_2020\_RD2062\_311\_5\_20200228\_00014.jpg

Close-up view of the site. Note the dense vegetation at the site.

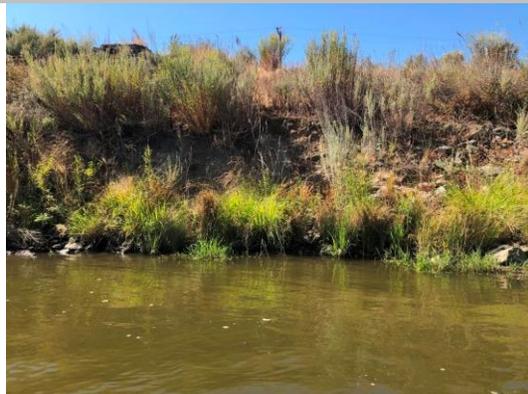
Photo 3 of 3 : SP\_2020\_RD2062\_311\_5\_20200228\_00015.jpg

Close-up view of the erosion.

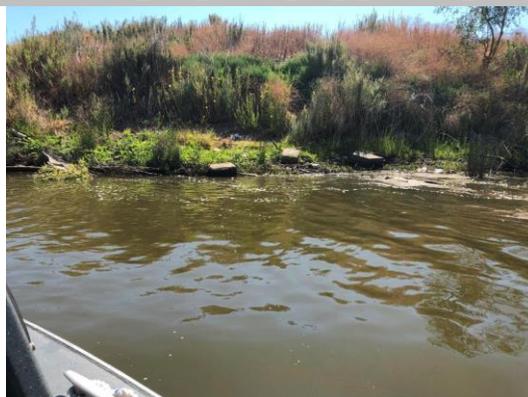
Photo 1 of 3 : SP\_2020\_RD2062\_311\_7\_20200228\_00016.jpg

LM Start	<b>0.55</b>	Rating **	M	Issue No.	<b>7</b>
LM End	<b>0.56</b>	Issue Type +	Ma	Location *	WS
Category	Supplemental			GPS Latitude/Longitude	
				Start	End
Item	DWR Erosion Survey			37.813070 °	37.813070 °
				-121.383100 °	-121.383100 °
DWR ID	RD2062U03RM30.43

Close-up view of the site.

<b>Comment Code</b>					
<b>Inspector Comment</b>					
<p>Site ID: RD2062U03RM30.43                  08/14/2019: No significant change observed.                  09/13/2017: No significant change observed.                  07/25/2016: No significant change observed.                  06/25/2015: No significant change observed.                  07/02/2014: No significant change observed.                  08/13/2013: No significant change observed.                  08/07/2012: The site has been visited by boat survey. No significant change observed.                  08/23/2011: No significant change observed on site.                  09/07/2010: No significant change observed on site. Much of the placed rip rap revetment has slid. It is no longer adequately protecting the slope.                  08/06/2010: Recommended as local maintenance issue, per CLRO Report.                  03/09/2010: As discussed with Michael Moncrief of MBK, site will be 'addressed' this year.                  09/29/2009: No major change observed since last visit; a section of the rip rap has slipped, exposing a levee section that has eroded; recommended as local maintenance issue, per CLRO CES Evaluation 2008 Report; Site # is the same as RM30.43, LM0.63; previously rated "U".                  11/05/2008: Site is located inside of a bend; scarp looks to be into the levee prism; piles of concrete chunks placed on the slope, with some of them already starting to slide.</p>

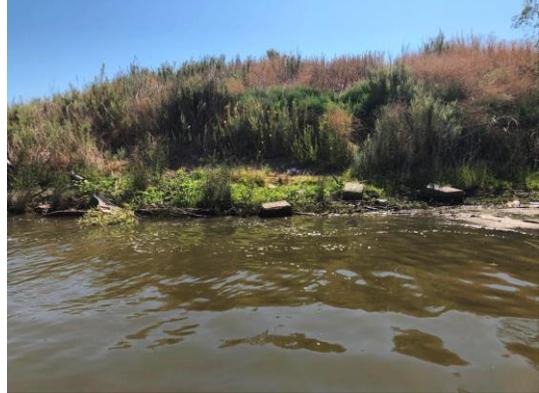
Photo 2 of 3 : SP\_2020\_RD2062\_311\_7\_20200228\_00017.jpg

Front view of the site.

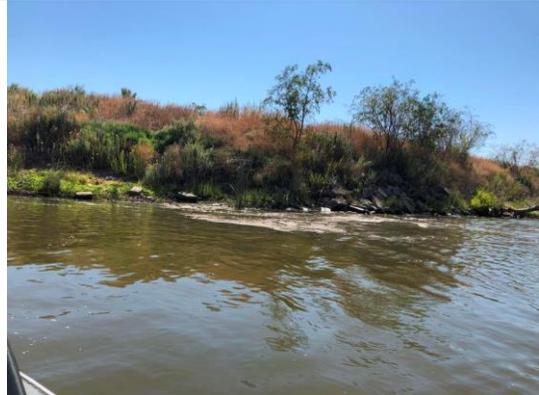
Photo 3 of 3 : SP\_2020\_RD2062\_311\_7\_20200228\_00018.jpg

Front view of the site.

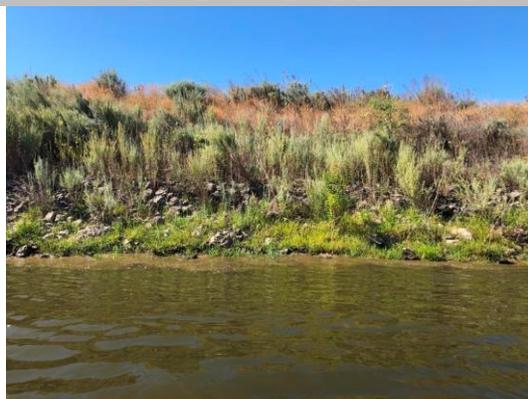
Photo 1 of 3 : SP\_2020\_RD2062\_311\_8\_20200228\_00019.jpg

Item	DWR Erosion Survey			37.819290 °	37.819290 °
				-121.378880 °	-121.378880 °
DWR ID	RD2062U03RM31.12				
Comment Code					
Inspector Comment					
<p>Site ID: RD2062U03RM31.12                  08/14/2019: No significant change observed.                  09/13/2017: No significant change observed.                  07/25/2016: No significant change observed.                  06/25/2015: No significant change observed.                  07/02/2014: No significant change observed.                  08/13/2013: No significant change observed.                  08/07/2012: The site has been visited by boat survey. No significant change observed                  08/23/2011: No significant change observed on site.                  09/07/2010: No significant change observed on site. Much of the seasonal grass along the slope was cleared. Site consists of an existing scalloped erosion approximately 30 feet long by 5 feet wide at its widest opening. The lateral crack is extended outwards along the middle slope. There is a 1 to 2 feet of differential settlement that could further develop into a shallow slide.                  08/06/2010: Recommended as local maintenance issue, per CLRO.                  03/09/2010: As discussed with Michael Moncrief of MBK Engineer, site will be 'addressed' this year.                  09/28/2009: No major change observed; section of rip rap has slipped, creating a terraced effect; dense vegetation growth; recommended as a local maintenance issue, per CLRO CES Evaluation 2008 Report; Site # is the same as RM31.12,LM1.25; previously rated "U".                  09/14/2006: 1-2' into prism.</p>

Front view of the site.

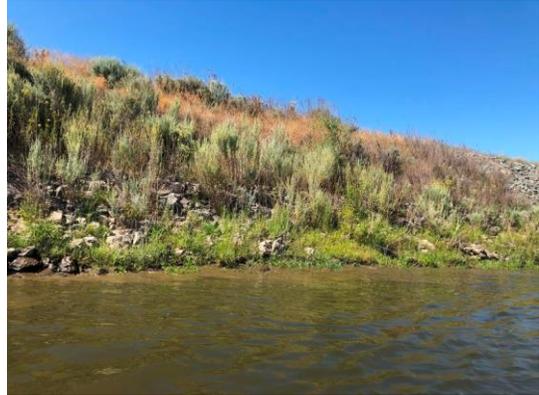
Photo 2 of 3 : SP\_2020\_RD2062\_311\_8\_20200228\_00020.jpg

Front view of the site.

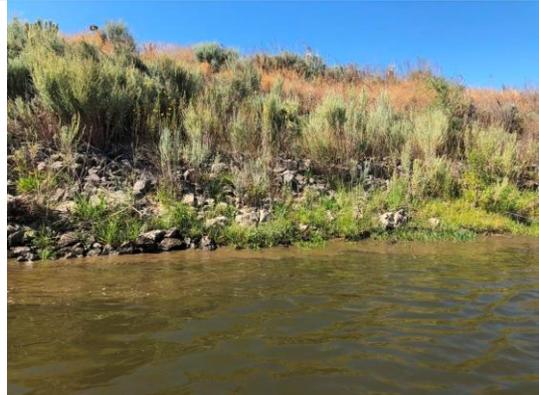
Photo 3 of 3 : SP\_2020\_RD2062\_311\_8\_20200228\_00021.jpg

Close-up view of the site.

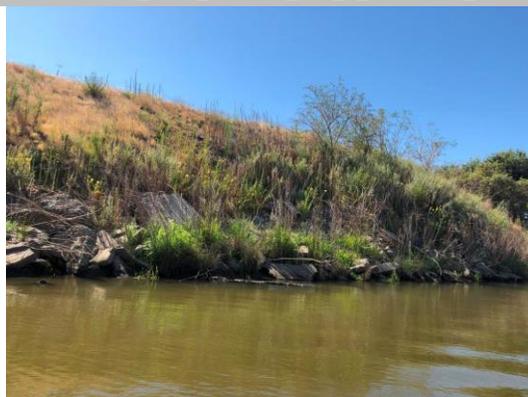
Photo 1 of 3 : SP\_2020\_RD2062\_311\_9\_20200228\_00022.jpg

Site ID: RD2062U03RM31.28  
 08/14/2019: No significant change observed.  
 09/13/2017: No significant change observed.  
 07/25/2016: No significant change observed.  
 06/25/2015: No significant change observed.  
 07/02/2014: No significant change observed.  
 08/13/2013: No significant change observed.  
 08/07/2012: The site has been visited by boat survey. No significant change observed  
 08/23/2011: No significant change observed on site.  
 09/07/2010: No significant change observed on site. There is a small-to medium sized Oak tree on the mid-slope just above rip rap. Some of the rip rap has collapsed, creating a pocket erosion just above the existing toe rip rap and upstream of the Oak tree.  
 08/06/2010: Recommended as local maintenance issue, per CLRO.  
 03/09/2010: As discussed with Michael Moncrief of MBK Engineer, site will be 'addressed' in 2010.  
 09/29/2009: No major change since last visit; sliding of the rip rap at the base of the lone tree; there is noticeable man-made trail and foot traffic extending from the crown to the toe; much of the broken concrete used as temporary rip rap has slid, exposing portion of the bare levee slope; recommended as local maintenance issue, per CLRO CES Evaluation 2008 Report; Site # is the same as RM31.3, LM1.45; previously rated "M".

Front view of the erosion site.

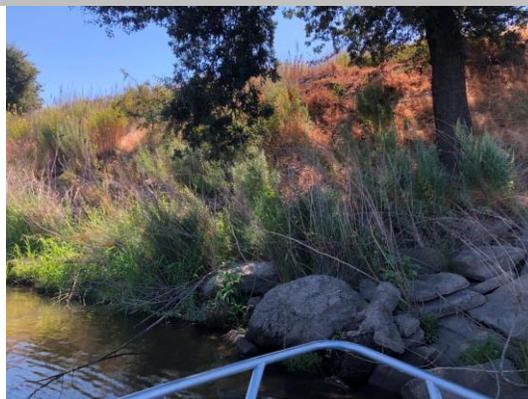
Photo 2 of 3 : SP\_2020\_RD2062\_311\_9\_20200228\_00023.jpg

Close-up view of the site.

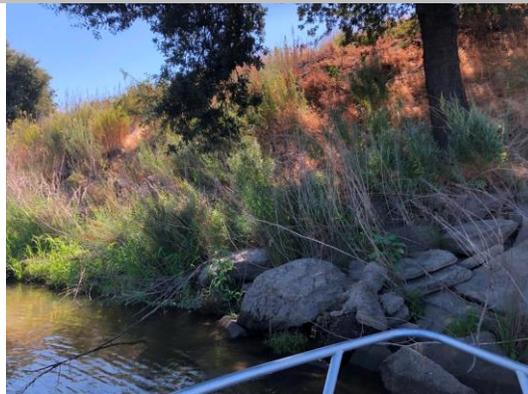
Photo 3 of 3 : SP\_2020\_RD2062\_311\_9\_20200228\_00024.jpg

Close-up view of the site. Note the existing broken concrete on levee slope and at the levee toe.

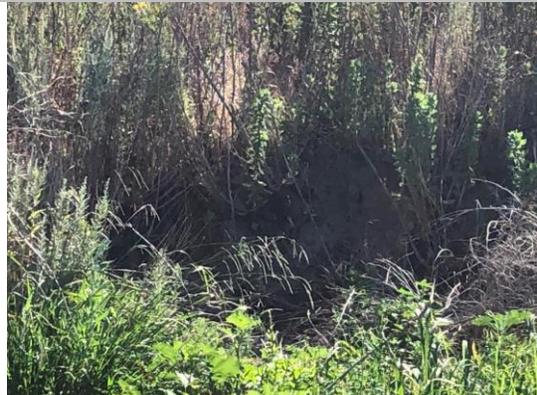
Photo 1 of 3 : SP\_2020\_RD2062\_311\_10\_20200228\_00025.jpg

LM Start	<b>3.99</b>	Rating **	A/W	Issue No.	<b>10</b>
LM End	<b>4.01</b>	Issue Type +	Ma	Location *	WS
Category	Supplemental		GPS Latitude/Longitude		
			Start	End	
Item	DWR Erosion Survey		37.820834 °	37.820834 °	
			-121.340314 °	-121.340314 °	
DWR ID	RD2062U03RM33.92				
Comment Code					
Inspector Comment					
Site ID: RD2062U03RM33.92 08/14/2019: No significant change observed. 09/13/2017: The erosion site is immediately downstream of a sharp river bend.

Close-up view of the erosion located at the inside of a sharp river bend.

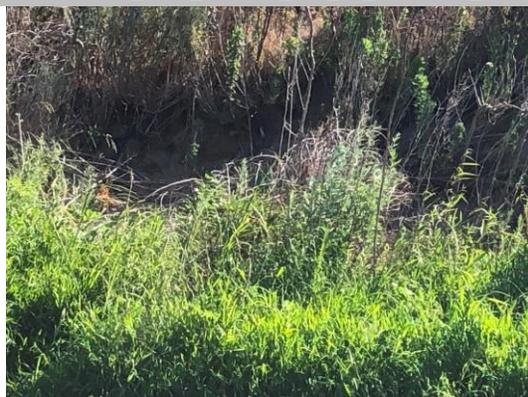
Photo 2 of 3 : SP\_2020\_RD2062\_311\_10\_20200228\_00026.jpg

Close-up view of the erosion.

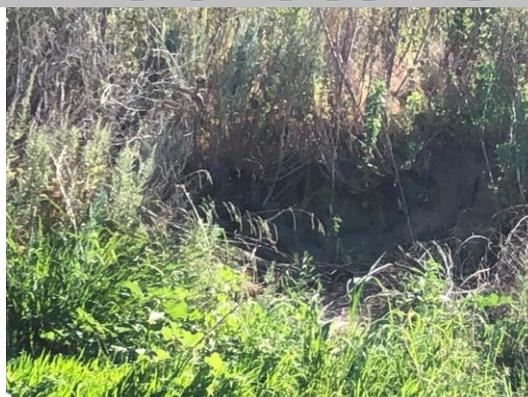
Photo 3 of 3 : SP\_2020\_RD2062\_311\_10\_20200228\_00027.jpg

Close-up view of the erosion. Note the sandy material of the river bank at the erosion site.

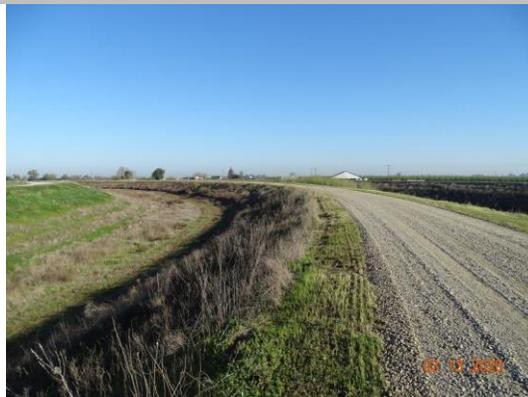
Photo 1 of 1 : SP\_2020\_RD2062\_311\_17\_20200318\_00051.jpg

LM Start	<b>4.48</b>	Rating **	A	Issue No.	<b>17</b>
LM End	<b>4.48</b>	Issue Type +	Ma	Location *	LS
Category	Earthen Levee			GPS Latitude/Longitude	
				Start	End
Item	Vegetation			37.817491 °	37.817491 °
				-121.333689 °	-121.333689 °
DWR ID	DWR_RD2062_03_s_2020_17				
Comment Code					
V1 : Control annual grass and weeds on the levee slopes and easements.					
Inspector Comment

Typical view of well maintained vegetation on landside slope. Spring 2020
