**Flood Control Project Maintenance
Levee Inspections**

Fall 2019 Levee Maintenance Deficiency Summary Report

San Joaquin River Basin

Reclamation District No. 2063 Crows Landing

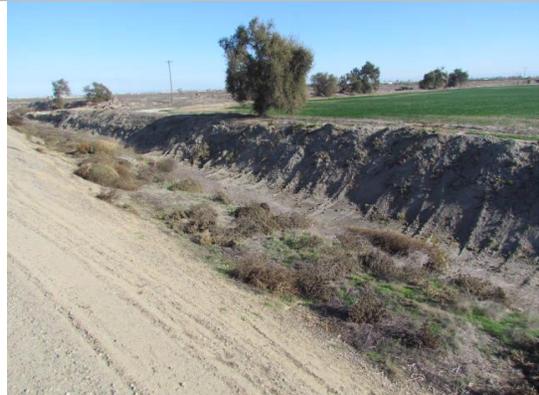
Photo 3 of 4 : FA_2019_RD2063_112_18_20190912_00002.jpg

Looking northeast at canal-ditch on landside berm.

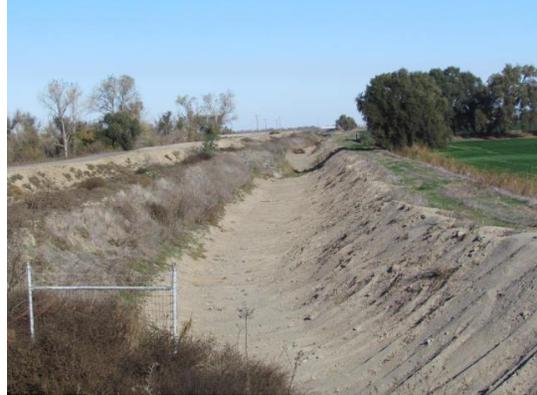
Photo 4 of 4 : FA_2019_RD2063_112_18_20190912_00003.jpg

Looking south at canal-ditch at landside berm and toe.

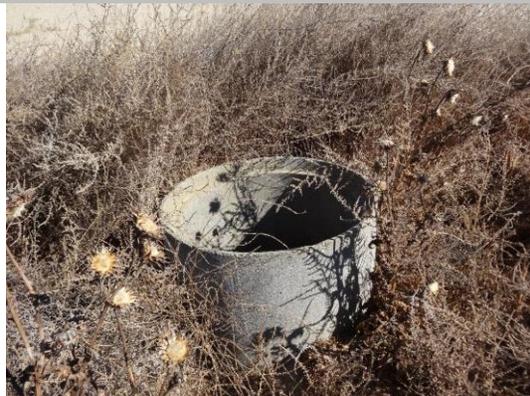
Photo 3 of 3 : UCIP_FA_2019_50216_43160.jpg

Comment Code					
Inspector Comment					
<p>DS_ID:22075 FS_ID:50216 EP_NO: N/A Repair Type: Non-Urgent Crossing Status: Indicator Found UCIP Comments: 08/23/2016: Could not locate pipe during inspection, though it was very prominently visible on the WS bank and LS ditch as per 2013 photos. I confirmed with RD2063 president Joe Sallaberry that the pipe was filled with concrete through the levee but removed at the LS ditch. Could not locate pipe's ends during inspection. No permit exists for this work. Crossing has been downgraded from Urgent to Non-Urgent since we lack documentation verifying proper abandonment. (K. Fazel - DWR UCIP) 11/05/2013:- Pipe has visible holes throughout both and WS along with pipe deformation. - looks abandoned. Needs proper abandonment.- alfalfa valve on concrete pipe riser on waterside toe.- no slide gate found on waterside. No pump and pile structure found in river. (P. Amatya - DWR UCIP) FIELD_STRUCT_DESC: *ABANDONED* 24-inch corrugated metal irrigation discharge pipe through the levee, 10 feet below the crown, not found during 2016 inspection. Slide gate in a corrugated metal pipe (CMP) riser on the waterside (WS) slope, not found during 2016 inspection. Pipe supported on two timber pile bents across a drainage ditch on the landside (LS), only pile remnants found during 2016 inspection. Pump on a pile structure in the river, not found during 2016 inspection. Two concrete standpipes on the WS berm, one of which was found during the 2016 inspection. Installed by USACE in 1961. [Additional Reference(s): DWR Levee Log, 1992. USACE San Joaquin O&M Manual 6, September 1961, (HLM 1.29)]. FS Date: 8/23/2016</p>

WS view: concrete riser with alfalfa valve on levee berm.

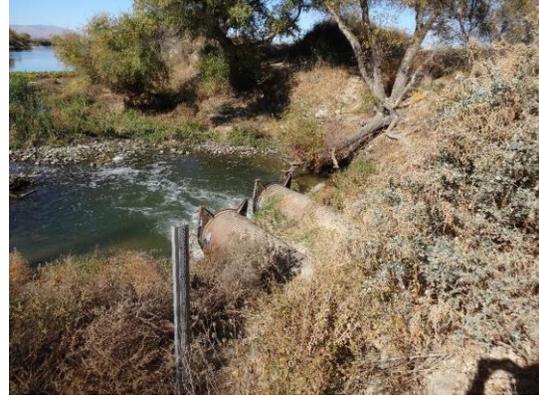
Photo 1 of 3 : UCIP_FA_2019_50218_43204.jpg

Comment Code					
Inspector Comment					
DS_ID:22076 FS_ID:50218 EP_NO: N/A Repair Type: No Action Needed Crossing Status: Found UCIP Comments: 08/23/2016: WS flapgates were held open by a piece of wood. Pipes may be used temporarily for irrigation. (K. Fazel - UCIP)11/05/2013: working during the inspection. (P. Amatya - DWR) FIELD_STRUCT_DESC: [Lateral Drain No. 5] 1 of 2: 48-inch corrugated metal gravity drainage pipe through the levee, 25.5 feet below the crown. Slide gate in a corrugated metal pipe (CMP) riser on the waterside (WS) slope. Flap gate on the WS end. 70-foot-long cobble spillway to river. Installed by USACE in 1961. [Additional Reference(s): DWR Levee Log, 1992. USACE San Joaquin O&M Manual 6, September 1961, (HLM 1.35)]. FS Date: 11/5/2013

WS view: two outfall CMP pipes on levee slope.

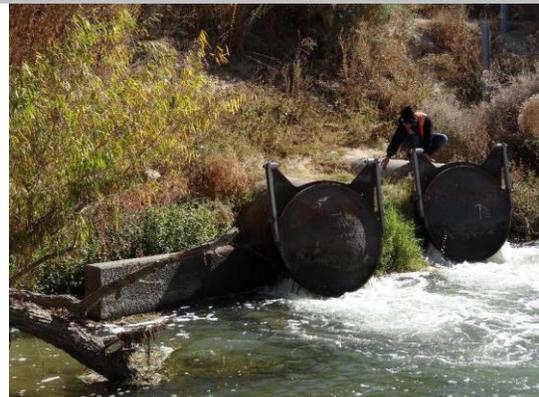
Photo 2 of 3 : UCIP_FA_2019_50218_43203.jpg

WS view: two outfall CMP pipes with flap gates on concrete headwall.

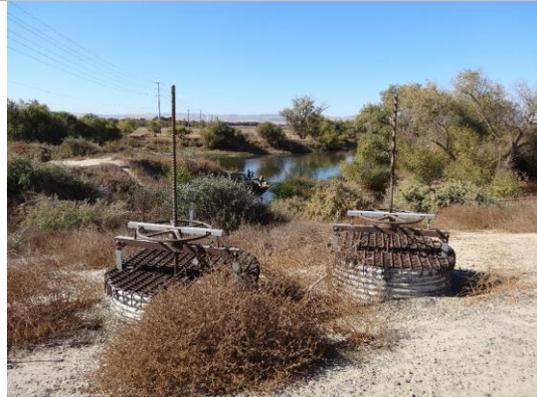
Photo 3 of 3 : UCIP_FA_2019_50218_43202.jpg

Comment Code					
Inspector Comment					
DS_ID:22076 FS_ID:50218 EP_NO: N/A Repair Type: No Action Needed Crossing Status: Found UCIP Comments: 08/23/2016: WS flapgates were held open by a piece of wood. Pipes may be used temporarily for irrigation. (K. Fazel - UCIP)11/05/2013: working during the inspection. (P. Amatya - DWR) FIELD_STRUCT_DESC: [Lateral Drain No. 5] 1 of 2: 48-inch corrugated metal gravity drainage pipe through the levee, 25.5 feet below the crown. Slide gate in a corrugated metal pipe (CMP) riser on the waterside (WS) slope. Flap gate on the WS end. 70-foot-long cobble spillway to river. Installed by USACE in 1961. [Additional Reference(s): DWR Levee Log, 1992. USACE San Joaquin O&M Manual 6, September 1961, (HLM 1.35)]. FS Date: 11/5/2013

WS view: two slide gates in CMP risers on levee slope.

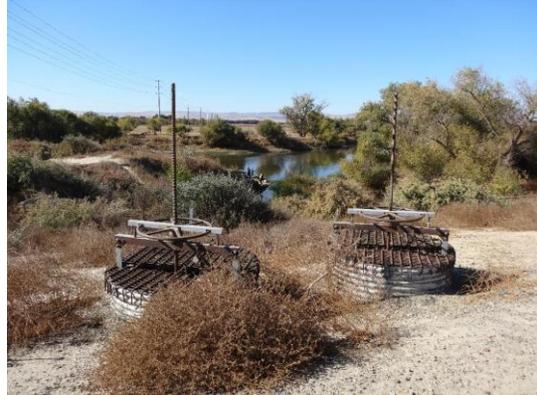
Photo 1 of 3 : UCIP_FA_2019_50217_43217.jpg

Comment Code					
Inspector Comment					
DS_ID:22119 FS_ID:50217 EP_NO: N/A Repair Type: No Action Needed Crossing Status: Found UCIP Comments: 08/23/2016: WS flapgates were held open by a piece of wood. Pipes may be used temporarily for irrigation. (K. Fazel - UCIP)11/05/2013: working during field inspection. (P. Amatya - DWR) FIELD_STRUCT_DESC: [Lateral Drain No. 5] 2 of 2: 48-inch corrugated metal gravity drainage pipe through the levee, 25.5 feet below the crown. Slide gate in a corrugated metal pipe (CMP) riser on the waterside (WS) slope. Flap gate on the WS end. 70-foot-long cobble spillway to river. Installed by USACE in 1961. [Additional Reference(s): DWR Levee Log, 1992. USACE San Joaquin O&M Manual 6, September 1961, (HLM 1.35)]. FS Date: 11/5/2013

WS view: two CMP risers with slide gates on levee slope.

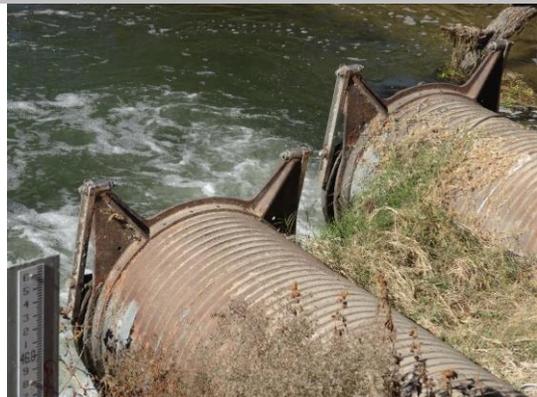
Photo 2 of 3 : UCIP_FA_2019_50217_43216.jpg

WS view: two CMP outfall pipes with flap gates on levee slope.

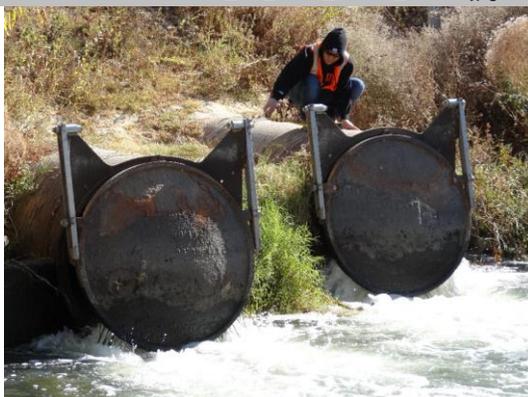
Photo 3 of 3 : UCIP_FA_2019_50217_43215.jpg

Comment Code					
Inspector Comment					
DS_ID:22119 FS_ID:50217 EP_NO: N/A Repair Type: No Action Needed Crossing Status: Found UCIP Comments: 08/23/2016: WS flapgates were held open by a piece of wood. Pipes may be used temporarily for irrigation. (K. Fazel - UCIP)11/05/2013: working during field inspection. (P. Amatya - DWR) FIELD_STRUCT_DESC: [Lateral Drain No. 5] 2 of 2: 48-inch corrugated metal gravity drainage pipe through the levee, 25.5 feet below the crown. Slide gate in a corrugated metal pipe (CMP) riser on the waterside (WS) slope. Flap gate on the WS end. 70-foot-long cobble spillway to river. Installed by USACE in 1961. [Additional Reference(s): DWR Levee Log, 1992. USACE San Joaquin O&M Manual 6, September 1961, (HLM 1.35)]. FS Date: 11/5/2013

WS view: front view of two CMP outfall pipes with flap gates on levee slope.

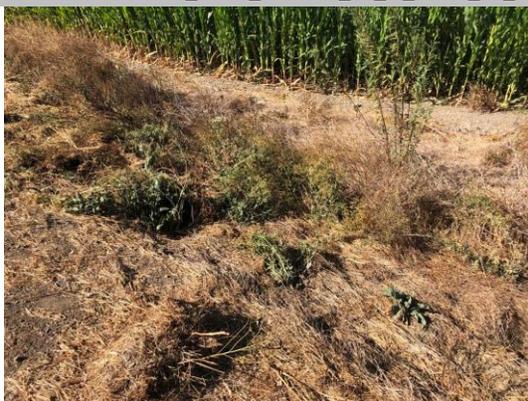
Photo 1 of 3 : SJR2019_DWR_RD2063_01_s_2017_59_1.JPG

LM Start	1.82	Rating **	M	Issue No.	38
LM End	1.84	Issue Type +	Ma	Location *	
Category	Supplemental			GPS Latitude/Longitude	
				Start	End
Item	DWR Erosion Survey			37.457653 °	37.457653 °
				-121.033728 °	-121.033728 °
DWR ID	RD2063U01RM100.79				
Comment Code					
Inspector Comment					
Site ID: RD2063U01RM100.79 09/12/2019: Erosion has developed into the lower levee slope.

Looking down at the erosion pocket.

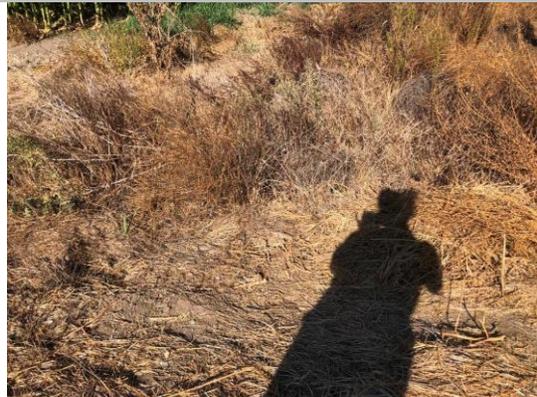
Photo 3 of 3 : SJR2019_DWR_RD2063_01_s _ 2017_59_2.JPG

Close-up view of the erosion.

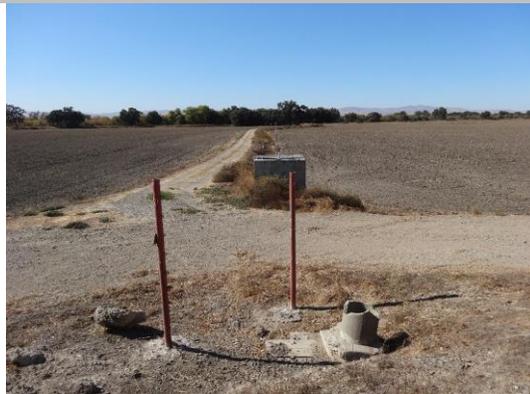
Photo 1 of 3 : UCIP_FA_2019_24404_43345.jpg

Comment Code					
Inspector Comment					
DS_ID:22078 FS_ID:24404 EP_NO: N/A Repair Type: Non-Urgent Crossing Status: Found UCIP Comments: 11/05/2013 Concrete distribution box with alfalfa valve not found at the waterward toe. Two steel standpipes and dismantled concrete standpipe on waterside levee toe. Concrete distribution box 50 ft off the levee center. (P. Amatya - DWR UCIP) FIELD_STRUCT_DESC: 30-inch corrugated metal irrigation discharge pipe through the levee, 16.5 feet below the crown. Slide gate in a concrete distribution box, 50 feet off the levee. Underground irrigation system. Installed by USACE in 1961. [Additional Reference(s): DWR Levee Log, 1992. USACE San Joaquin O&M Manual 6, September 1961, (HLM 2.11)]. FS Date: 11/5/2013

WS view: concrete box (top), and a dismantled concrete pipe on levee toe.

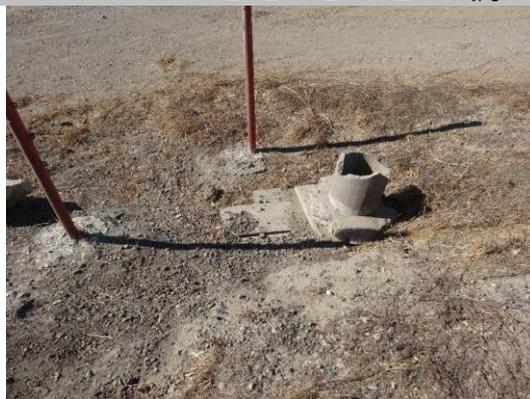
Photo 2 of 3 : UCIP_FA_2019_24404_43344.jpg

WS view: a dismantled concrete pipe on levee toe.

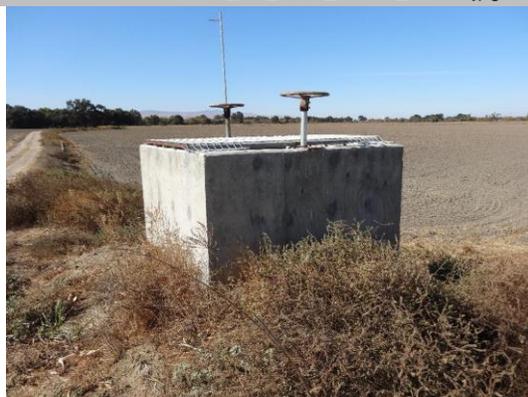
Photo 3 of 3 : UCIP_FA_2019_24404_43343.jpg

Comment Code					
Inspector Comment					
DS_ID:22078 FS_ID:24404 EP_NO: N/A Repair Type: Non-Urgent Crossing Status: Found UCIP Comments: 11/05/2013 Concrete distribution box with alfalfa valve not found at the waterward toe. Two steel standpipes and dismantled concrete standpipe on waterside levee toe. Concrete distribution box 50 ft off the levee center. (P. Amatya - DWR UCIP) FIELD_STRUCT_DESC: 30-inch corrugated metal irrigation discharge pipe through the levee, 16.5 feet below the crown. Slide gate in a concrete distribution box, 50 feet off the levee. Underground irrigation system. Installed by USACE in 1961. [Additional Reference(s): DWR Levee Log, 1992. USACE San Joaquin O&M Manual 6, September 1961, (HLM 2.11)]. FS Date: 11/5/2013

WS view: concrete distribution box with slide gate off the levee toe.

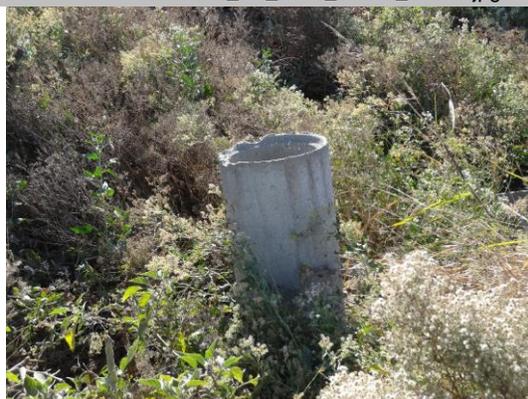
Photo 1 of 3 : UCIP_FA_2019_51823_43348.jpg

Comment Code					
Inspector Comment					
DS_ID:22081 FS_ID:51823 EP_NO: N/A Repair Type: No Action Needed Crossing Status: Found UCIP Comments: 11/05/2013 - concrete standpipe on waterside toe.- concrete distribution box on landside.- an alfalfa valve on waterside toe. (P. Amatya - DWR UCIP) FIELD_STRUCT_DESC: 30-inch corrugated metal gravity drainage pipe through the levee, 12 feet below the crown. Flap gate on the waterside (WS) end. Slide gate in a concrete distribution box on the landside (LS) end. Concrete U-shaped headwall on the WS end. [Additional Reference(s): DWR Levee Log, 1992. USACE San Joaquin O&M Manual 6, September 1961, (HLM 2.29)]. FS Date: 11/5/2013

WS view: concrete standpipe on levee toe.

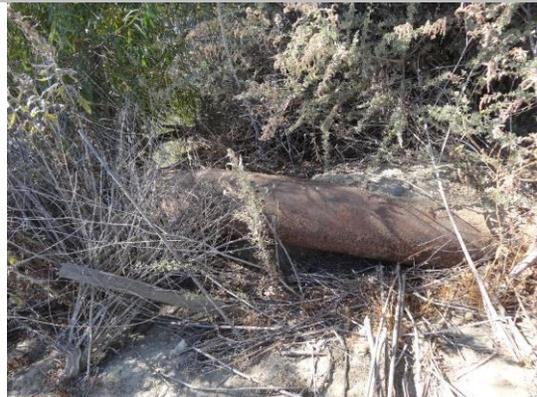
Photo 1 of 3 : UCIP_FA_2019_24427_43439.jpg

Comment Code					
Inspector Comment					
DS_ID:22085 FS_ID:24427 EP_NO: N/A Repair Type: Non-Urgent Crossing Status: Found UCIP Comments: 11/05/2013 Abandoned steel pipe and service pole on waterside. Pump not found on river bank. CMP riser on waterside slope. Slide gate not found in CMP riser. Steel pipe riser on waterside berm. Damaged PVC standpipe on waterside slope. (P. Amaty - DWR UCIP) FIELD_STRUCT_DESC: *ABANDONED* 24-inch corrugated metal irrigation discharge pipe through the levee, 10 feet below the crown. Slide gate in a corrugated metal pipe (CMP) riser on the waterside (WS) slope. 20-inch standpipe 3 feet from the landside (LS) toe. 12-inch pipe across the berm and into a CMP riser on the WS slope. Pump on riverbank. Installed by USACE in 1961. [Additional Reference(s): DWR Levee Log, 1992. USACE San Joaquin O&M Manual 6, September 1961, (HLM 2.46)]. FS Date: 11/5/2013

WS view: abandoned steel pipe on river bank. No pump found on river bank.

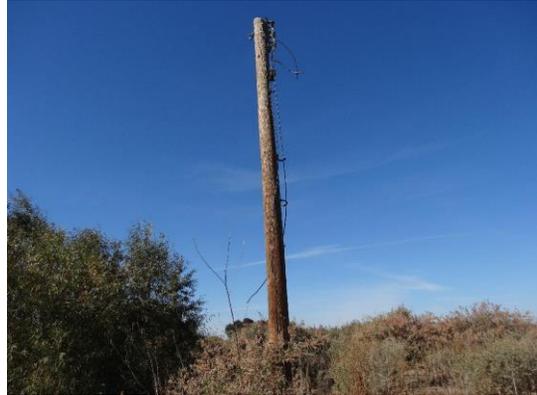
Photo 2 of 3 : UCIP_FA_2019_24427_43438.jpg

Comment Code					
Inspector Comment					
DS_ID:22085 FS_ID:24427 EP_NO: N/A Repair Type: Non-Urgent Crossing Status: Found UCIP Comments: 11/05/2013 Abandoned steel pipe and service pole on waterside. Pump not found on river bank. CMP riser on waterside slope. Slide gate not found in CMP riser. Steel pipe riser on waterside berm. Damaged PVC standpipe on waterside slope. (P. Amatya - DWR UCIP) FIELD_STRUCT_DESC: *ABANDONED* 24-inch corrugated metal irrigation discharge pipe through the levee, 10 feet below the crown. Slide gate in a corrugated metal pipe (CMP) riser on the waterside (WS) slope. 20-inch standpipe 3 feet from the landside (LS) toe. 12-inch pipe across the berm and into a CMP riser on the WS slope. Pump on riverbank. Installed by USACE in 1961. [Additional Reference(s): DWR Levee Log, 1992. USACE San Joaquin O&M Manual 6, September 1961, (HLM 2.46)]. FS Date: 11/5/2013

WS view: abandoned power pole on levee berm.

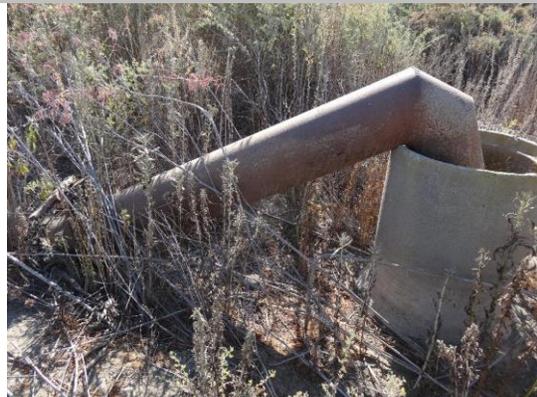
Photo 3 of 3 : UCIP_FA_2019_24427_43437.jpg

WS view: steel pipe and concrete riser on levee berm.

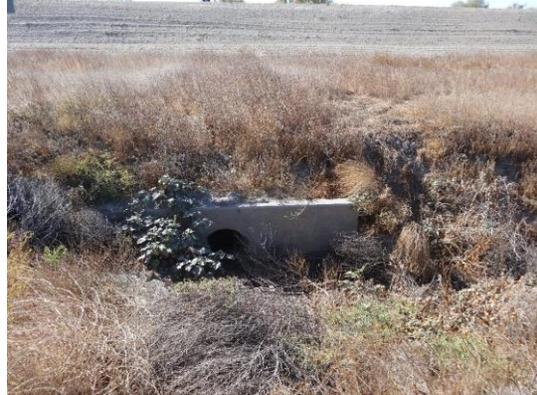
Photo 3 of 3 : UCIP_FA_2019_24435_43482.jpg

LM Start	2.62	Rating **	M	Issue No.	63 (cont)
LM End	2.62	Issue Type +	Ma	Location *	
Category	Supplemental			GPS Latitude/Longitude	
				Start	End
Item	DRAFT DWR UCIP LMA Responsibility			37.448233 °	37.448233 °
				-121.026521 °	-121.026521 °
DWR ID	22086				
Comment Code					
Inspector Comment					
DS_ID:22086 FS_ID:24435 EP_NO: N/A Repair Type: Non-Urgent Crossing Status: Found UCIP Comments: 11/05/2013 Both pipe ends 70 ft off the levee center. Clearing and cleaning of inlet/outlet pipe needed. (P. Amatya - DWR UCIP) FIELD_STRUCT_DESC: 24-inch corrugated metal gravity drainage pipe through the levee, 12 feet below the crown. Flap gate on the waterside (WS) end. Concrete headwall on each end. Installed by USACE in 1961. [Additional Reference(s): DWR Levee Log, 1992. USACE San Joaquin O&M Manual 6, September 1961, (HLM 2.65)]. FS Date: 11/5/2013

LS view: concrete headwall with CMP 70 ft off the levee center.

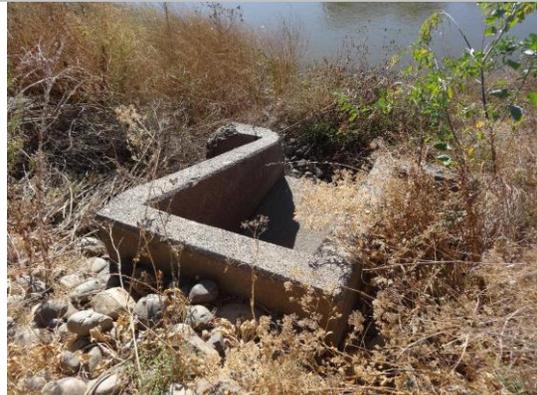
Photo 1 of 3 : UCIP_FA_2019_25023_45102.jpg

LM Start	2.68	Rating **	A/W	Issue No.	64
LM End	2.68	Issue Type +	Ma	Location *	
Category	Supplemental			GPS Latitude/Longitude	
				Start	End
Item	DRAFT DWR UCIP LMA Responsibility			37.447475 °	37.447475 °
				-121.026017 °	-121.026017 °
DWR ID	22087				
Comment Code					
Inspector Comment					
DS_ID:22087 FS_ID:25023 EP_NO: N/A Repair Type: No Action Needed Crossing Status: Found UCIP Comments: 11/05/2013 Both pipe ends about 85 feet off the levee center. (P. Amatya - DWR UCIP) FIELD_STRUCT_DESC: 24-inch corrugated metal gravity drainage pipe through the levee, 20.3 feet below the crown. Flap gate on the waterside (WS) end. Concrete headwall on each end. Installed by USACE in 1961. [Additional Reference(s): DWR Levee Log, 1992. USACE San Joaquin O&M Manual 6, September 1961, (HLM 2.71)]. FS Date: 11/5/2013

WS view: U typed concrete headwall on river bank.

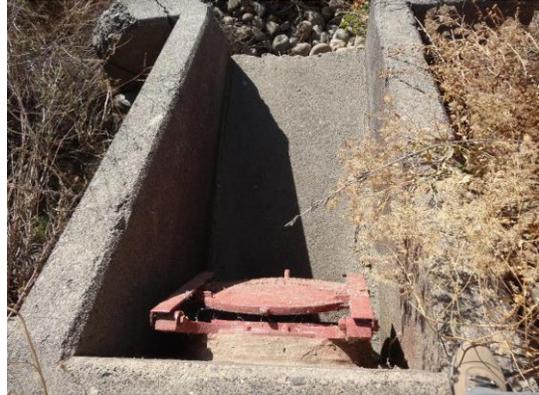
Photo 2 of 3 : UCIP_FA_2019_25023_45101.jpg

LM Start	2.68	Rating **	A/W	Issue No.	64 (cont)
LM End	2.68	Issue Type +	Ma	Location *	
Category	Supplemental			GPS Latitude/Longitude	
				Start	End
Item	DRAFT DWR UCIP LMA Responsibility			37.447475°	37.447475°
				-121.026017°	-121.026017°
DWR ID	22087				
Comment Code					
Inspector Comment					
DS_ID:22087 FS_ID:25023 EP_NO: N/A Repair Type: No Action Needed Crossing Status: Found UCIP Comments: 11/05/2013 Both pipe ends about 85 feet off the levee center. (P. Amatya - DWR UCIP) FIELD_STRUCT_DESC: 24-inch corrugated metal gravity drainage pipe through the levee, 20.3 feet below the crown. Flap gate on the waterside (WS) end. Concrete headwall on each end. Installed by USACE in 1961. [Additional Reference(s): DWR Levee Log, 1992. USACE San Joaquin O&M Manual 6, September 1961, (HLM 2.71)]. FS Date: 11/5/2013

WS view: pipe, flap gate, and concrete headwall on river bank.

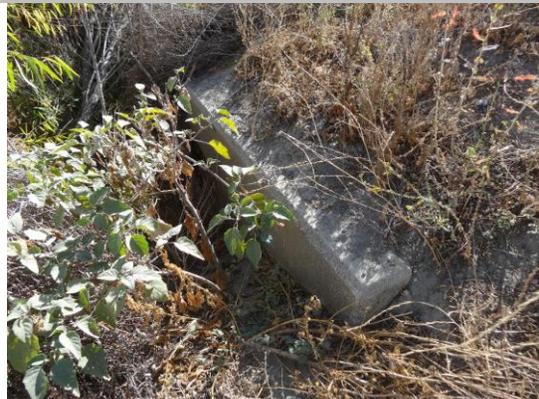
Photo 3 of 3 : UCIP_FA_2019_25023_45100.jpg

LS view: pipe and concrete headwall off the levee toe.

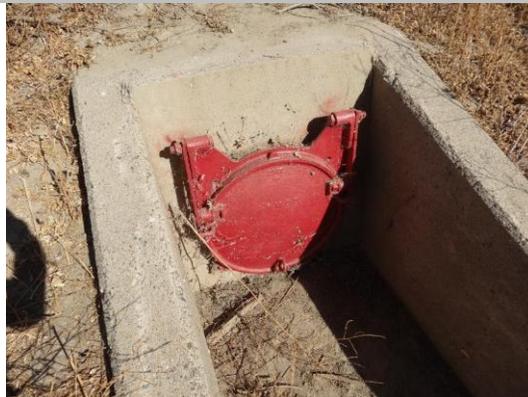
Photo 2 of 3 : UCIP_FA_2019_24469_43644.jpg

LM Start	3.29	Rating **	M	Issue No.	66
LM End	3.29	Issue Type +	Ma	Location *	
Category	Supplemental			GPS Latitude/Longitude	
				Start	End
Item	DRAFT DWR UCIP LMA Responsibility			37.441213°	37.441213°
				-121.021130°	-121.021130°
DWR ID	22089				
Comment Code					
Inspector Comment					
DS_ID:22089 FS_ID:24469 EP_NO: N/A Repair Type: Non-Urgent Crossing Status: Found UCIP Comments: 11/05/2013 - cleaning required in inlet pipe.- new flap gate (P. Amatya - DWR UCIP) FIELD_STRUCT_DESC: *ABANDONED* 24-inch corrugated metal gravity drainage pipe through the levee, 12.5 feet below the crown. Flap gate on the waterside (WS) end. Concrete headwall on each end. [Additional Reference(s): DWR Levee Log, 1992. USACE San Joaquin O&M Manual 6, September 1961, (HLM 3.33)]. FS Date: 11/5/2013

WS view: new flap gate, and U typed concrete headwall.

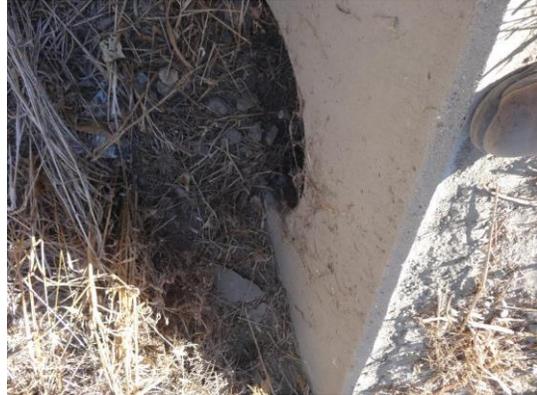
Photo 3 of 3 : UCIP_FA_2019_24469_43643.jpg

LM Start	3.29	Rating **	M	Issue No.	66 (cont)
LM End	3.29	Issue Type +	Ma	Location *	
Category	Supplemental			GPS Latitude/Longitude	
				Start	End
Item	DRAFT DWR UCIP LMA Responsibility			37.441213°	37.441213°
				-121.021130°	-121.021130°
DWR ID	22089				
Comment Code					
Inspector Comment					
DS_ID:22089 FS_ID:24469 EP_NO: N/A Repair Type: Non-Urgent Crossing Status: Found UCIP Comments: 11/05/2013 - cleaning required in inlet pipe.- new flap gate (P. Amatya - DWR UCIP) FIELD_STRUCT_DESC: *ABANDONED* 24-inch corrugated metal gravity drainage pipe through the levee, 12.5 feet below the crown. Flap gate on the waterside (WS) end. Concrete headwall on each end. [Additional Reference(s): DWR Levee Log, 1992. USACE San Joaquin O&M Manual 6, September 1961, (HLM 3.33)]. FS Date: 11/5/2013

LS view: CM pipe and concrete headwall on levee slope. Debris blocking inlet pipe.

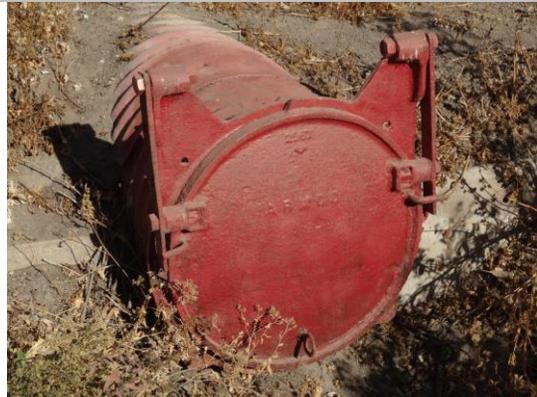
Photo 1 of 3 : UCIP_FA_2019_24485_43667.jpg

LM Start	3.64	Rating **	M	Issue No.	67
LM End	3.64	Issue Type +	Ma	Location *	
Category	Supplemental			GPS Latitude/Longitude	
				Start	End
Item	DRAFT DWR UCIP LMA Responsibility			37.436845°	37.436845°
				-121.017826°	-121.017826°
DWR ID	22093				
Comment Code					
Inspector Comment					
DS_ID:22093 FS_ID:24485 EP_NO: N/A Repair Type: Non-Urgent Crossing Status: Found UCIP Comments: 11/05/2013 - new flap gate on waterside.- cleaning and clearing of inlet box needed. (P. Amatya - DWR UCIP) FIELD_STRUCT_DESC: 24-inch corrugated metal gravity drainage pipe through the levee, 12 feet below the crown. Flap gate and concrete saddle on the waterside (WS) end. Concrete drop inlet box on the landside (LS) end. Installed by USACE in 1961. [Additional Reference(s): DWR Levee Log, 1992. USACE San Joaquin O&M Manual 6, September 1961, (HLM 3.69)]. FS Date: 11/5/2013

WS view: pipe, flap gate, and concrete saddle on levee slope

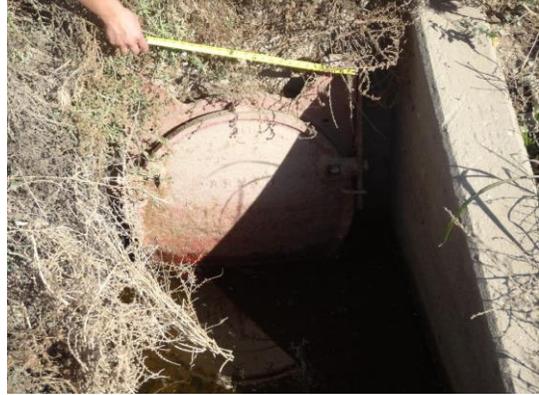
Photo 1 of 3 : UCIP_FA_2019_51821_43842.jpg

WS view: pipe, flap gate, and concrete headwall on drainage ditch.

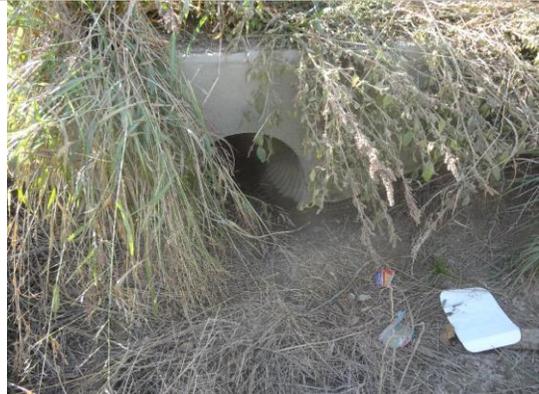
Photo 2 of 3 : UCIP_FA_2019_51821_43841.jpg

LS view: CM pipe and concrete headwall on levee toe.

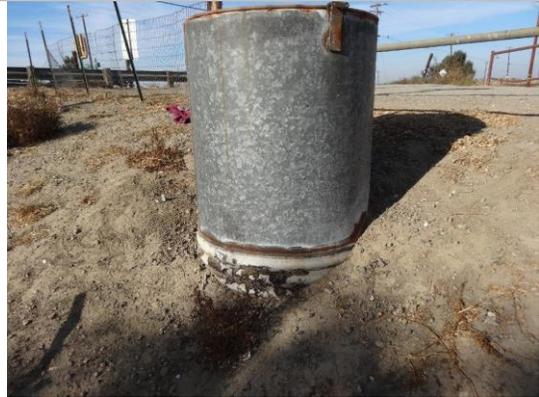
Photo 1 of 3 : UCIP_FA_2019_41746_43850.jpg

WS view: CMP riser on levee slope. Steel riser on top of CMP.

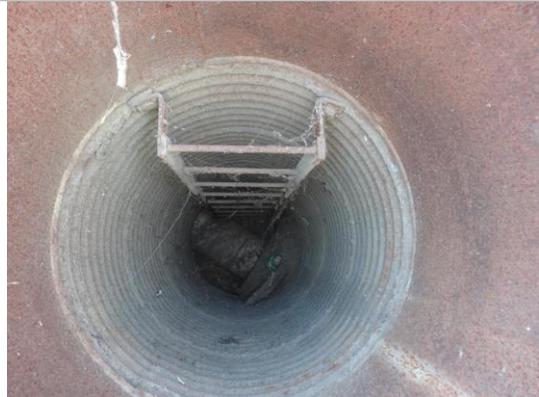
Photo 2 of 3 : UCIP_FA_2019_41746_43849.jpg

WS view: inside view of CMP riser on levee slope. Steel pipe and 24" CMP visible inside the riser.

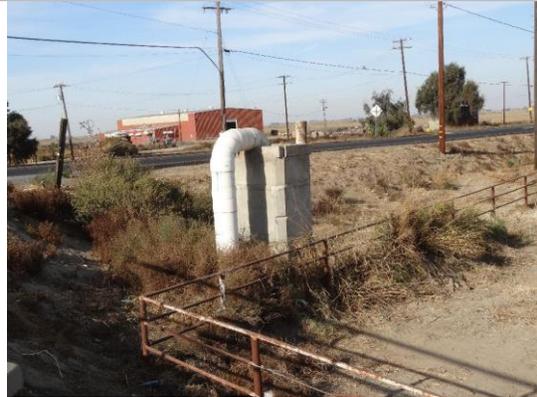
Photo 3 of 3 : UCIP_FA_2019_41746_43848.jpg

LS view: discharge pipe and concrete distribution box on levee toe.

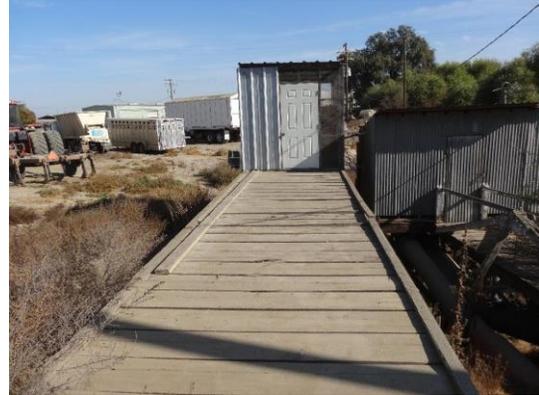
Photo 3 of 3 : UCIP_FA_2019_25025_45108.jpg

LS view: walkway to pump and pump house on levee slope.

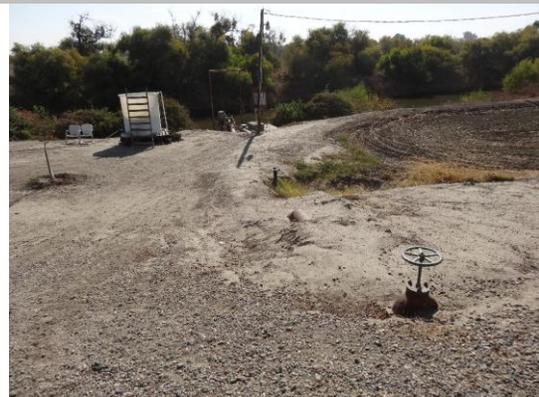
Photo 1 of 3 : UCIP_FA_2019_25028_45125.jpg

WS view: overview of waterside- gate valve and power pole on levee slope.

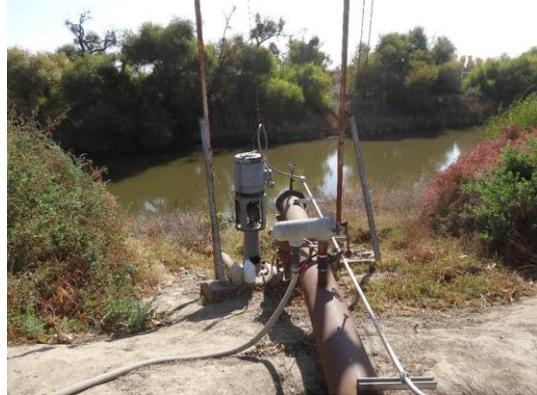
Photo 2 of 3 : UCIP_FA_2019_25028_45124.jpg

WS view: pump, pipe and other appurtenances on levee toe.

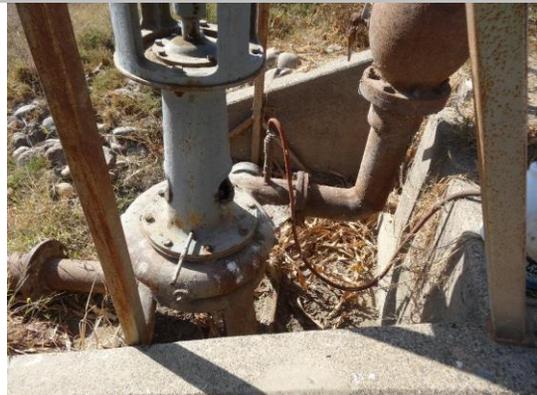
Photo 3 of 3 : UCIP_FA_2019_25028_45123.jpg

WS view: U type headwall and pump on river bank.

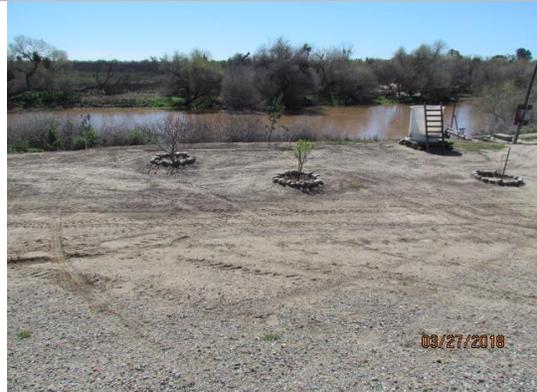
Photo 3 of 3 : FA_2019_RD2063_112_31_20190912_00006.jpg

Looking west at trees with retaining wall around trees. (Spring 2018)

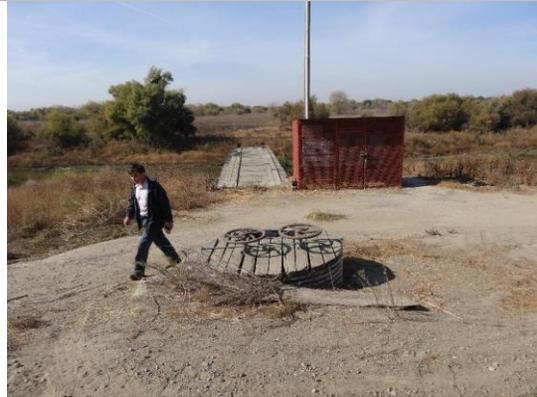
Photo 1 of 3 : UCIP_FA_2019_41669_45131.jpg

WS view: CMP riser, abandoned walkway, power pole on levee slope.

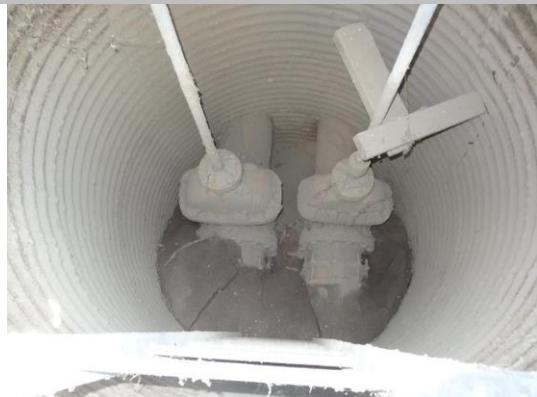
Photo 2 of 3 : UCIP_FA_2019_41669_45130.jpg

WS view: two gate valves inside CMP riser on levee slope.

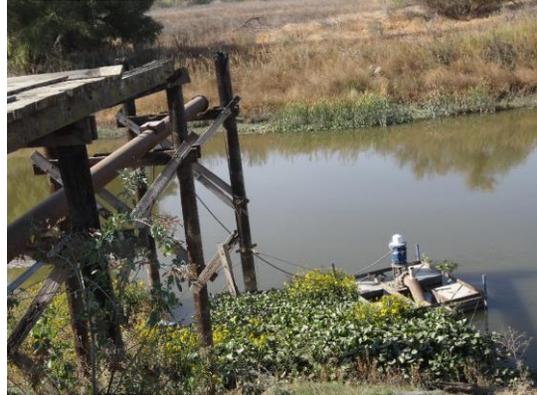
Photo 3 of 3 : UCIP_FA_2019_41669_45129.jpg

WS view: abandoned walkway, pipe (left) and pump on floating structure in the river.

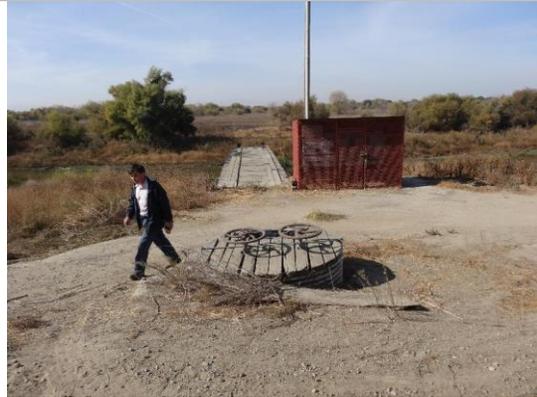
Photo 1 of 3 : UCIP_FA_2019_41670_43905.jpg

WS view: CMP riser, abandoned walkway, power pole on levee slope.

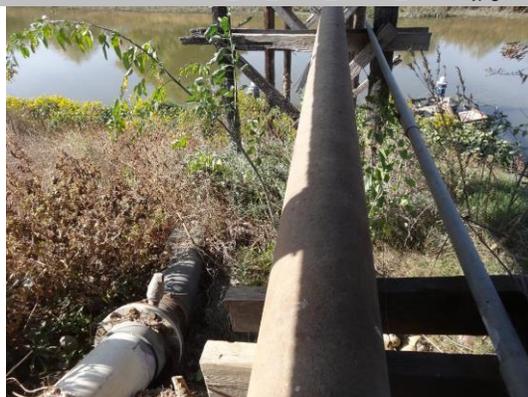
Photo 3 of 3 : UCIP_FA_2019_41670_43903.jpg

WS view: abandoned steel pipe (right), rubber pipe attached to steel pipe to pump on floating structure in the river.

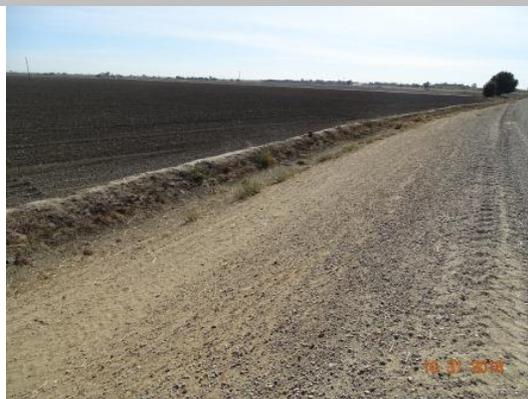
Photo 1 of 1 : FA_2019_RD2063_112_48_20190912_00010.jpg

View of ditch along levee toe. (Fall 2018)

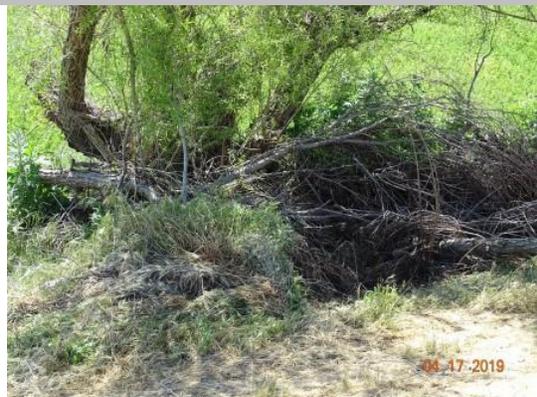
Photo 2 of 2 : FA_2019_RD2063_112_49_20190912_00012.jpg

View of prunings piled under a tree on landside toe. (Spring 2019)

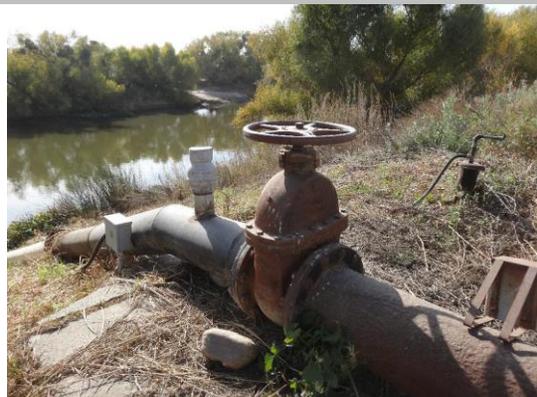
Photo 1 of 3 : UCIP_FA_2019_24628_43938.jpg

WS view: steel pipe, gate valve, air vent on levee berm.

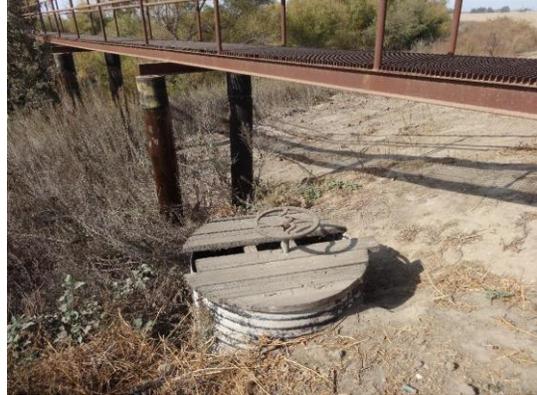
Photo 3 of 3 : UCIP_FA_2019_24629_43944.jpg

WS view: gate valve in CMP riser. Soil erosion around CMP riser.

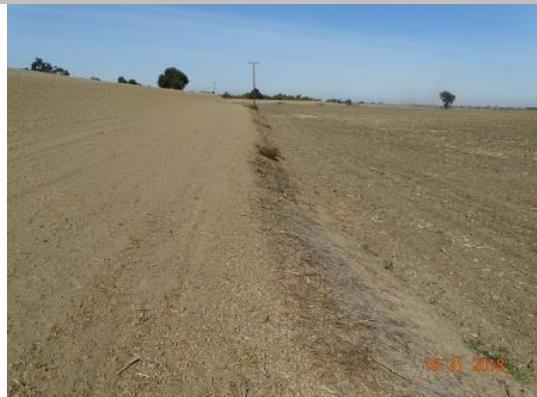
Photo 1 of 1 : FA_2019_RD2063_112_51_20190912_00013.jpg

View of cut into levee slope from agricultural equipment. (Fall 2018)

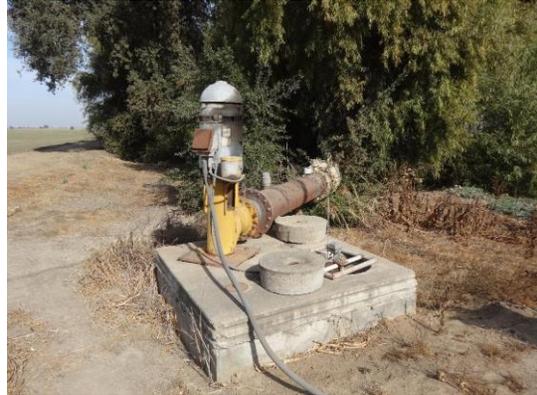
Photo 3 of 3 : UCIP_FA_2019_24632_43951.jpg

LS view: concrete distribution box on levee toe. Pump on the box discharges water into irrigation ditch.

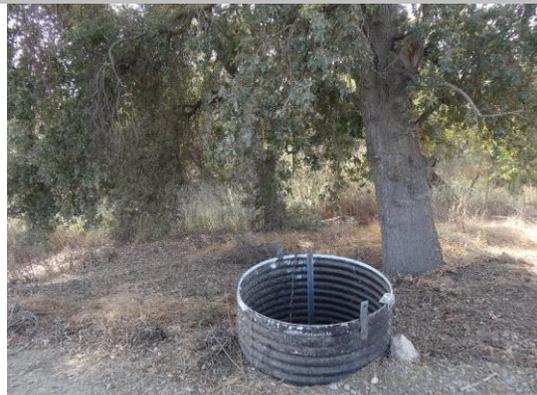
Photo 1 of 3 : UCIP_FA_2019_25031_45141.jpg

WS view: CMP riser with slide gate. Missing slide gate handwheel.

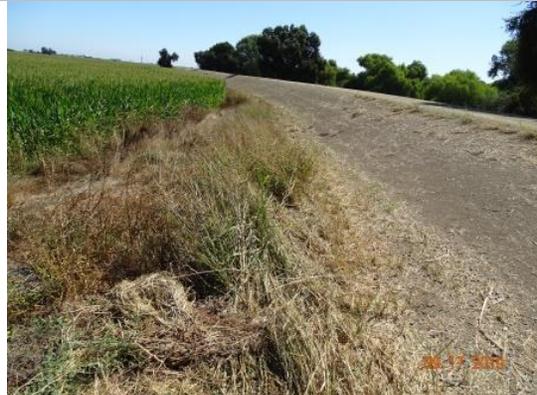
Photo 1 of 1 : FA_2019_RD2063_112_43_20190920_00113.jpg

Vegetation along landside slope looking upstream. (Fall 2019)

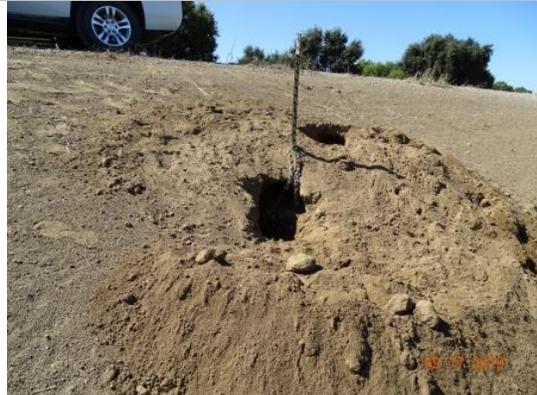
Photo 1 of 2 : FA_2019_RD2063_112_45_20190920_00114.jpg

View of animal burrow in landside slope. (Fall 2019)

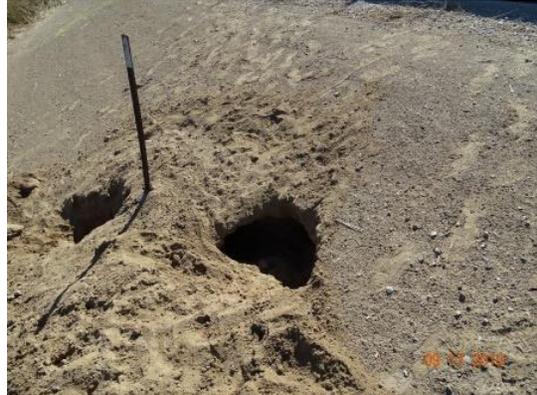
Photo 2 of 2 : FA_2019_RD2063_112_45_20190920_00116.jpg

View of animal burrow in landside slope. (Fall 2019)

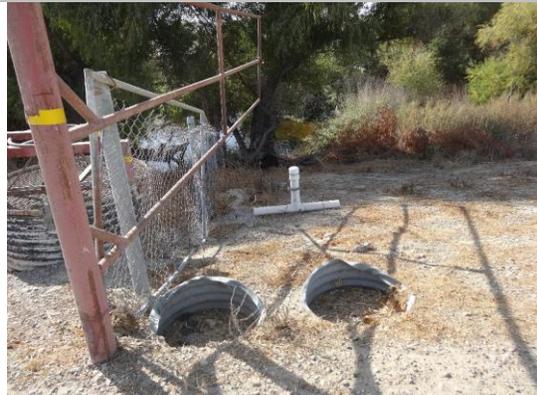
Photo 1 of 3 : UCIP_FA_2019_24651_44005.jpg

WS view: two siphon breakers in CMP risers on levee slope.

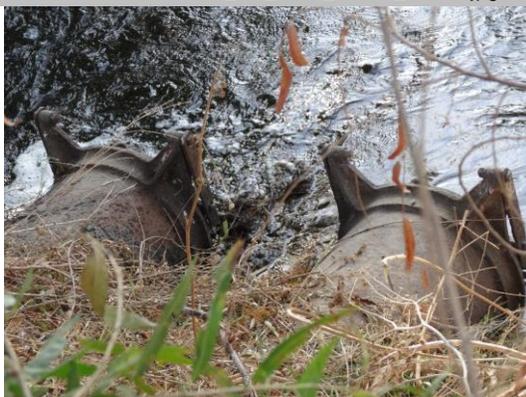
Photo 2 of 3 : UCIP_FA_2019_24651_44004.jpg

WS view: two flap gates on outfall pipe ends.

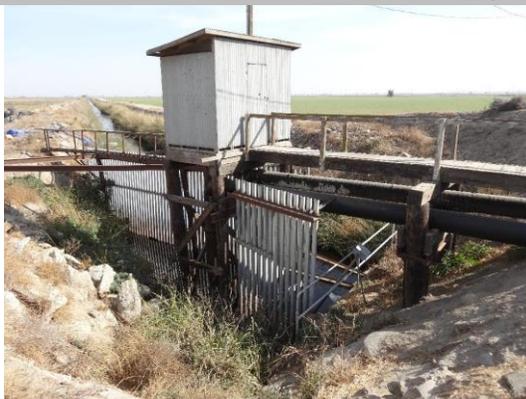
Photo 3 of 3 : UCIP_FA_2019_24651_44003.jpg

LS view: pipes under walkway to pump house.

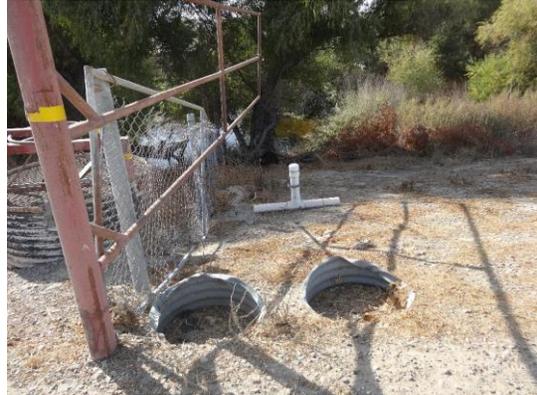
Photo 1 of 3 : UCIP_FA_2019_24652_44008.jpg

WS view: two siphon breakers in CMP risers on levee slope.

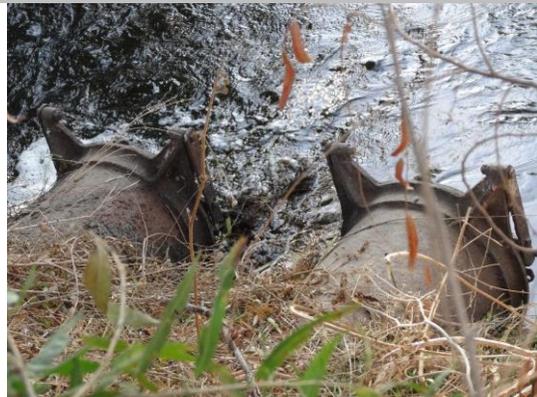
Photo 2 of 3 : UCIP_FA_2019_24652_44007.jpg

WS view: two flap gates on outfall pipe ends.

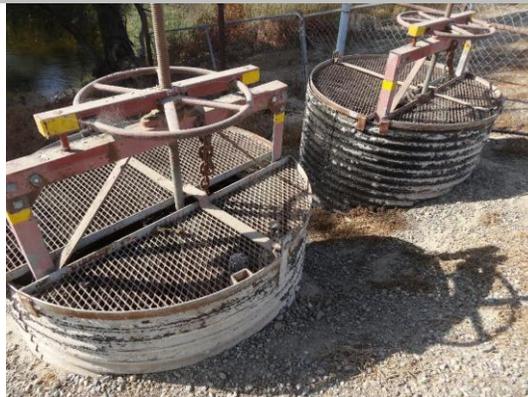
Photo 2 of 3 : UCIP_FA_2019_24650_44001.jpg

WS view: two slide gates in CMP risers on levee slope.

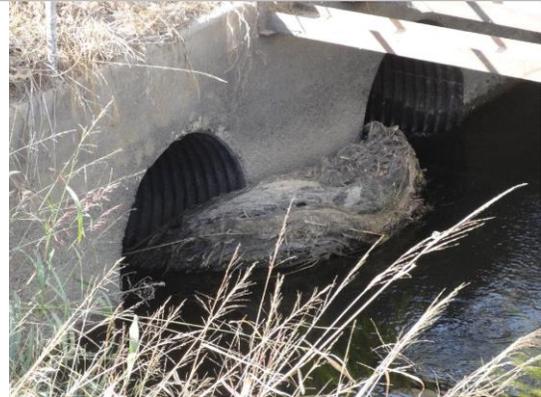
Photo 3 of 3 : UCIP_FA_2019_24650_44000.jpg

LS view: drainage pipes under walkway in drainage ditch.

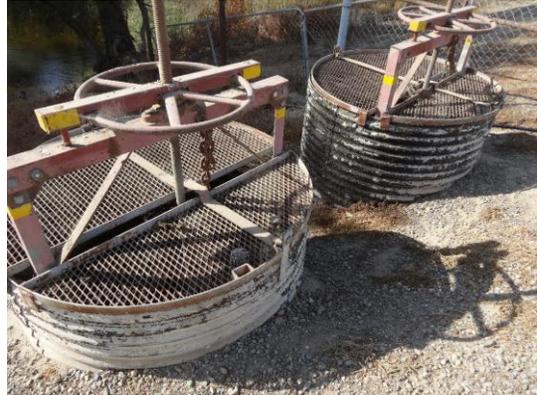
Photo 1 of 3 : UCIP_FA_2019_24636_43965.jpg

WS view: two slide gates in CMP risers on levee slope

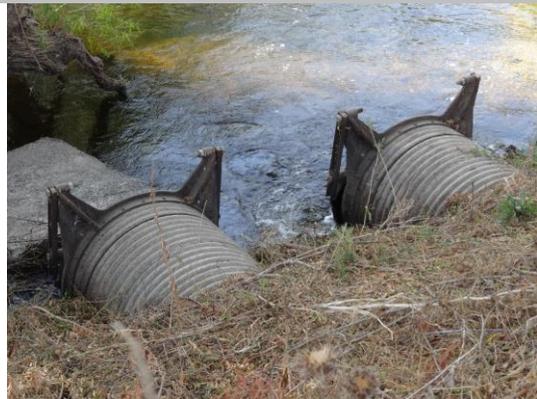
Photo 2 of 3 : UCIP_FA_2019_24636_43964.jpg

WS view: two flap gates on outfall pipe ends.

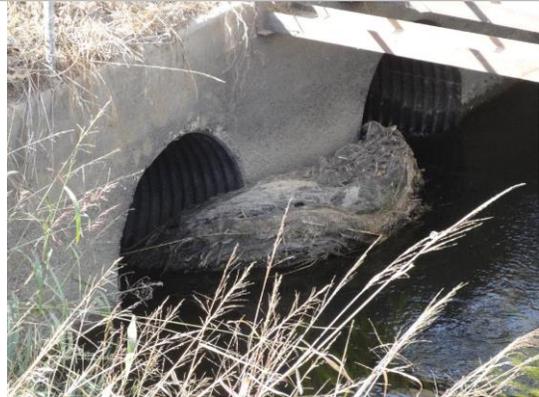
Photo 3 of 3 : UCIP_FA_2019_24636_43963.jpg

LS view: drainage pipes under walkway in drainage ditch.

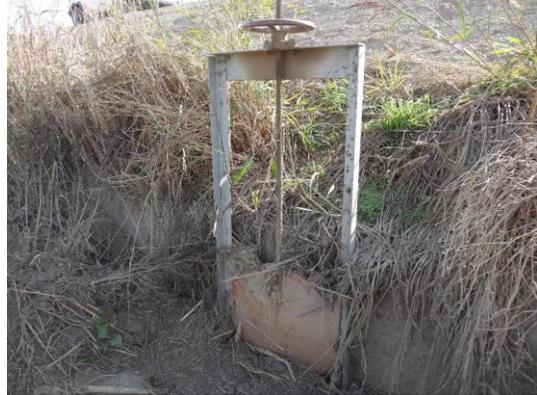
Photo 1 of 2 : UCIP_FA_2019_24638_43967.jpg

WS view: concrete headwall on levee end. Slide gate on pipe end.

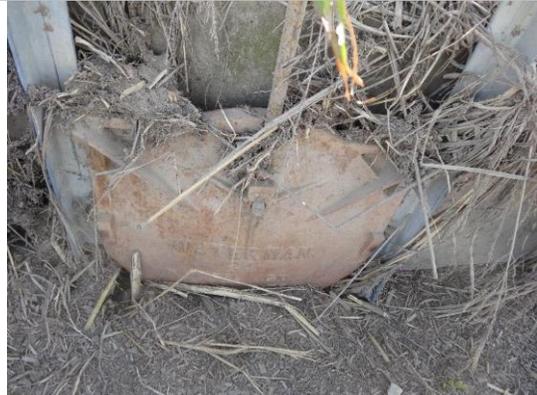
Photo 2 of 2 : UCIP_FA_2019_24638_43966.jpg

WS view: close view of slide gate on pipe end.

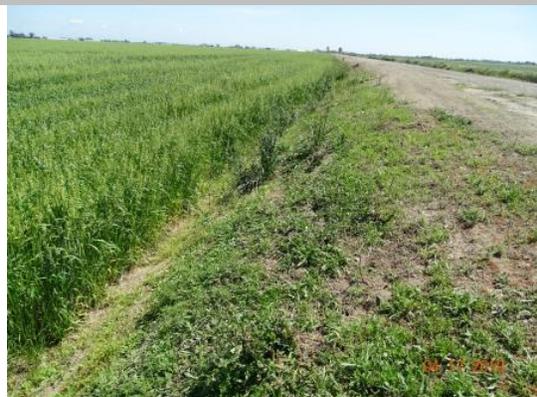
Photo 2 of 2 : FA_2019_RD2063_112_55_20190912_00017.jpg

Crops planted on landside toe up against the slope. (Spring 2019)

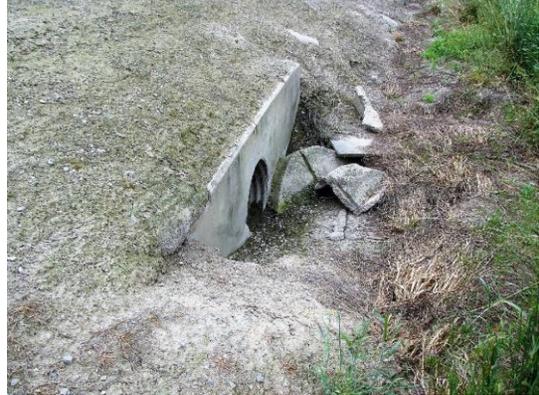
Photo 1 of 3 : UCIP_FA_2019_51825_77044.jpg

LS inlet as of 4/11/2017 levee inspection. Photo courtesy of DWR inspector Richard Willoughby.

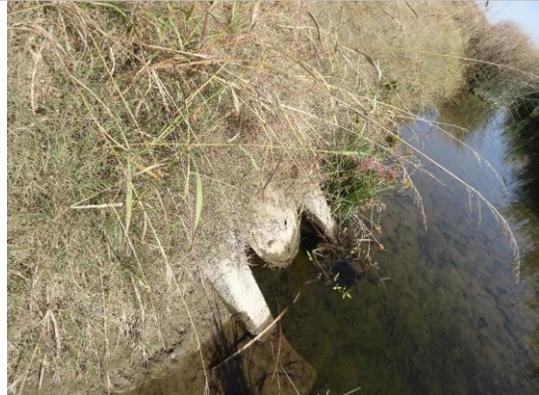
Photo 2 of 3 : UCIP_FA_2019_51825_43983.jpg

WS view: U type headwall and flap gate visible on the bank of the water channel.

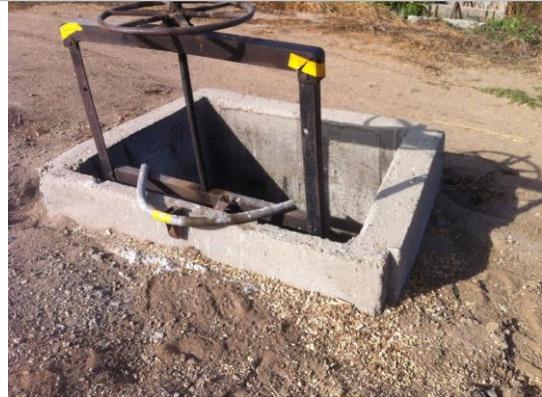
Photo 2 of 3 : UCIP_FA_2019_24644_43985.jpg

LS view: CM pipe with slide gate on inlet concrete box.

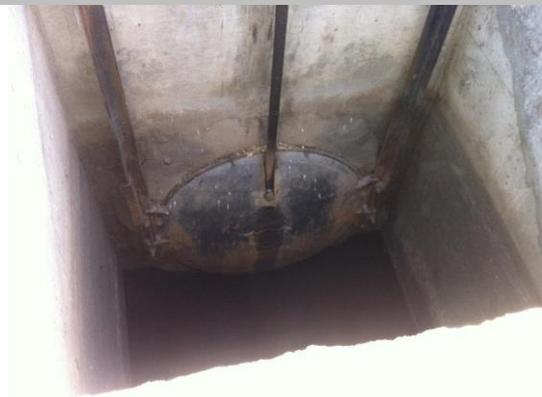
Photo 3 of 3 : UCIP_FA_2019_24644_43984.jpg

LS view: inside view of slide gate in concrete box.

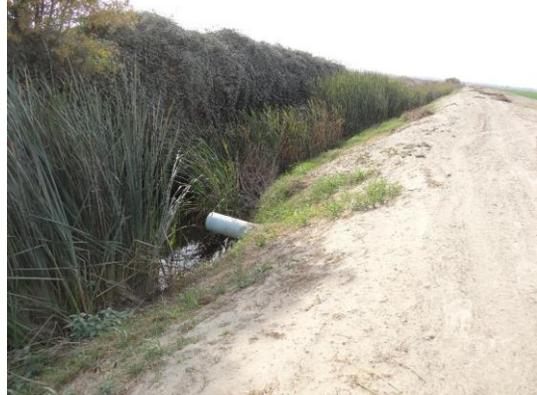
Photo 1 of 3 : UCIP_FA_2019_53095_43990.jpg

WS view: PVC pipe with open end on levee slope.

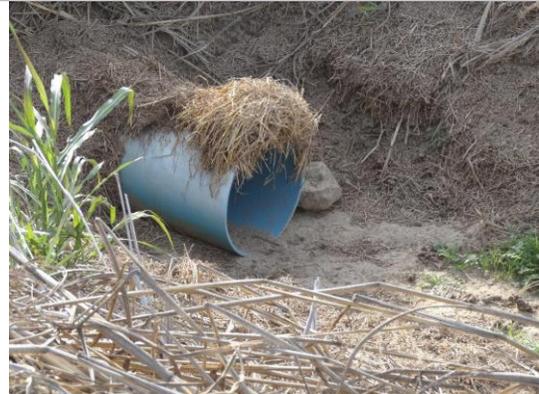
Photo 2 of 3 : UCIP_FA_2019_53095_43989.jpg

LS view: PVC pipe with open end on levee toe.

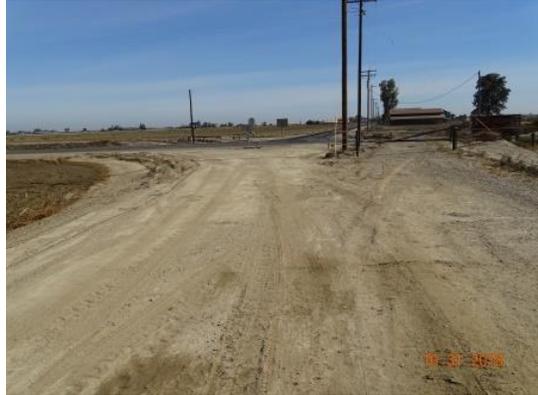
Photo 1 of 1 : FA_2019_RD2063_112_54_20190912_00015.jpg

View of unpermitted ramp coming off of street. (Fall 2018)
