**Flood Control Project Maintenance  
Levee Inspections**  
**LMA District Cover Sheet**  
**Spring 2020 Levee Inspection Results**

**Reclamation District No. 2063 Crows Landing**

**Spring 2020 Levee Inspection Results**

Waterway	Bank	Unit Miles
Unit No. 01 San Joaquin River	Right	10.44

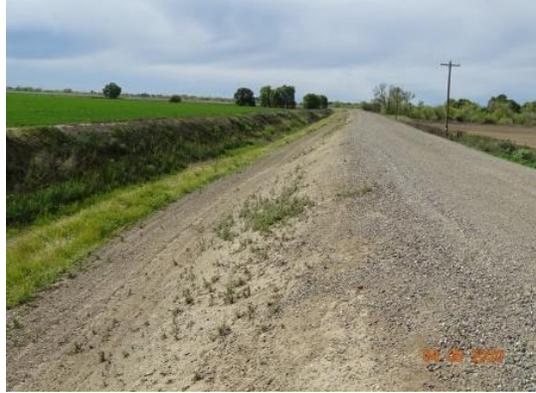
Photo 1 of 2 : SP\_2020\_RD2063\_112\_18\_20200409\_00117.jpg

Looking southeast at ditch running along the landside toe. (Spring 2020)

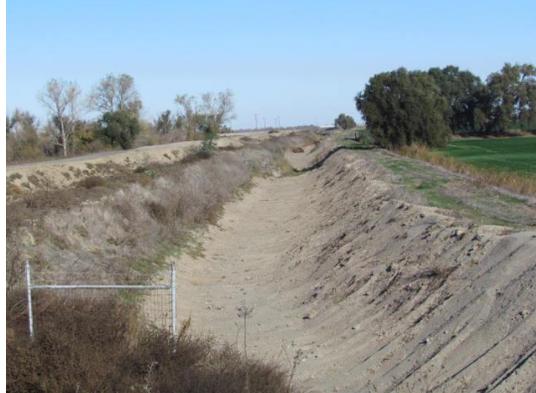
Photo 2 of 2 : SP\_2020\_RD2063\_112\_18\_20200225\_00004.jpg

Looking south at canal-ditch at landside berm and toe.

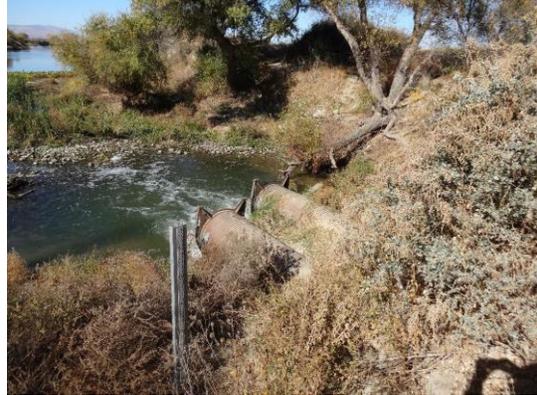
Photo 1 of 3 : UCIP\_SP\_2020\_50218\_43204.jpg

WS view: two outfall CMP pipes on levee slope.

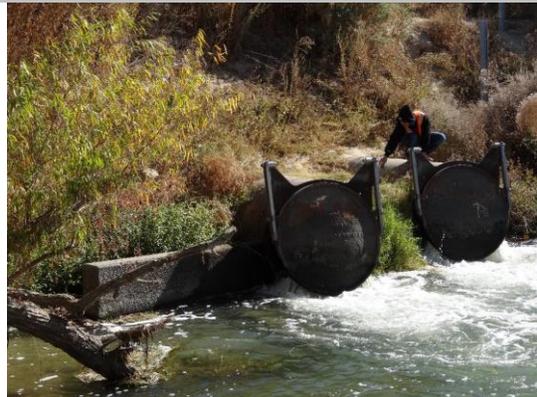
Photo 2 of 3 : UCIP\_SP\_2020\_50218\_43203.jpg

WS view: two outfall CMP pipes with flap gates on concrete headwall.

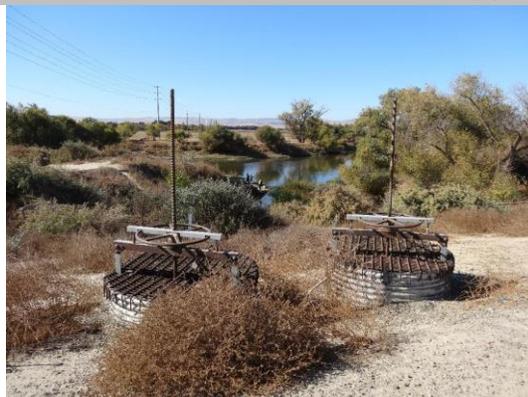
Photo 1 of 3 : UCIP\_SP\_2020\_50217\_43217.jpg

WS view: two CMP risers with slide gates on levee slope.

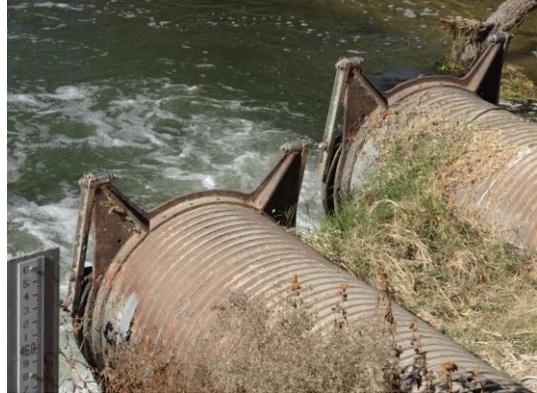
Photo 2 of 3 : UCIP\_SP\_2020\_50217\_43216.jpg

WS view: two CMP outfall pipes with flap gates on levee slope.

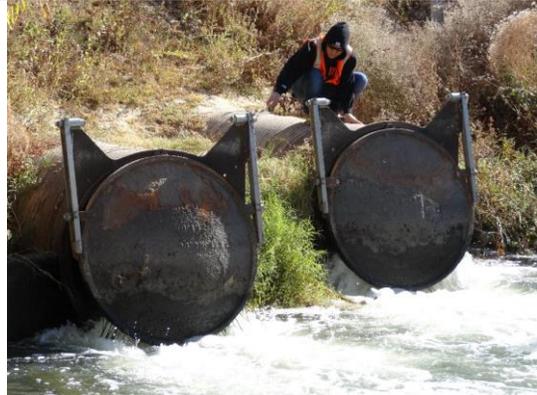
Photo 3 of 3 : UCIP\_SP\_2020\_50217\_43215.jpg

WS view: front view of two CMP outfall pipes with flap gates on levee slope.

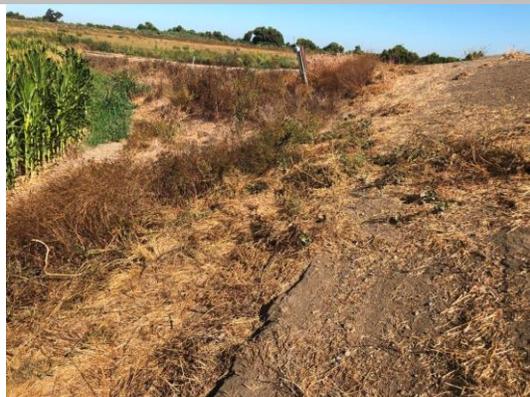
Photo 2 of 3 : SP\_2020\_RD2063\_112\_38\_20200225\_00009.jpg

Close view of the erosion.

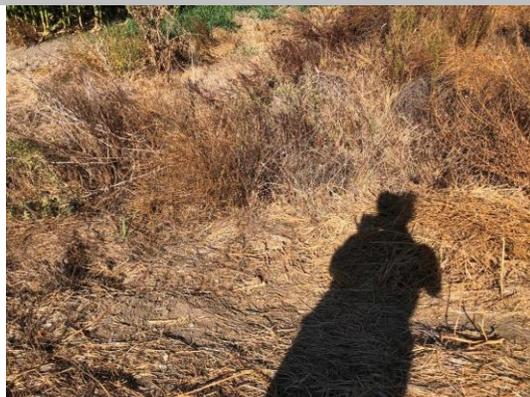
Photo 3 of 3 : SP\_2020\_RD2063\_112\_38\_20200225\_00010.jpg

Close-up view of the erosion.

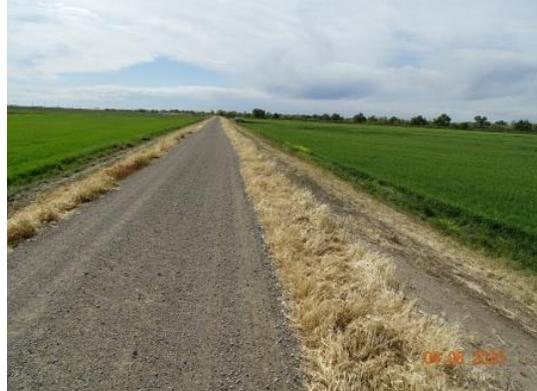
Photo 1 of 1 : SP\_2020\_RD2063\_112\_40\_20200409\_00118.jpg

View of waterside slope and shoulder looking upstream. (Spring 2020)

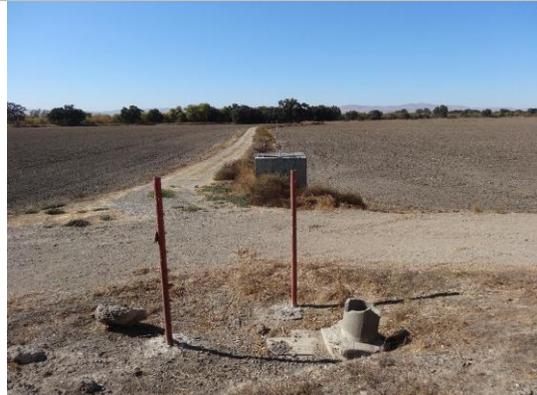
Photo 1 of 3 : UCIP\_SP\_2020\_24404\_43345.jpg

Item	DWR UCIP Field Study		37.454125 °	37.454125 °	
			-121.032240 °	-121.032240 °	
DWR ID	22078				
Comment Code					
Inspector Comment					
DS_ID:22078 FS_ID:24404 EP_NO: N/A Repair Type: Non-Urgent Crossing Status: Found UCIP Comments: 11/05/2013 Concrete distribution box with alfalfa valve not found at the waterward toe. Two steel standpipes and dismantled concrete standpipe on waterside levee toe. Concrete distribution box 50 ft off the levee center. (P. Amatya - DWR UCIP) FIELD_STRUCT_DESC: 30-inch corrugated metal irrigation discharge pipe through the levee, 16.5 feet below the crown. Slide gate in a concrete distribution box, 50 feet off the levee. Underground irrigation system. Installed by USACE in 1961. [Additional Reference(s): DWR Levee Log, 1992. USACE San Joaquin O&M Manual 6, September 1961, (HLM 2.11)]. FS Date: 11/5/2013

WS view: concrete box (top), and a dismantled concrete pipe on levee toe.

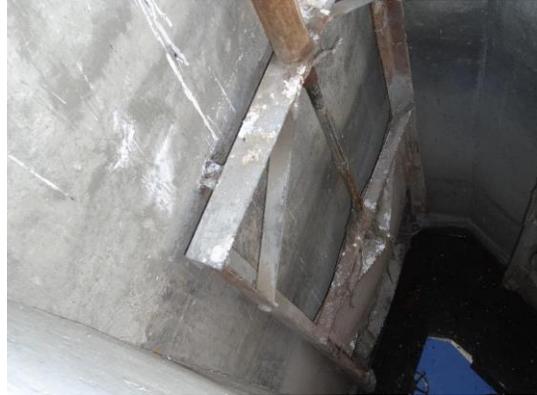
Photo 3 of 3 : UCIP\_SP\_2020\_51823\_43346.jpg

LS view: slide gate in concrete distribution box.

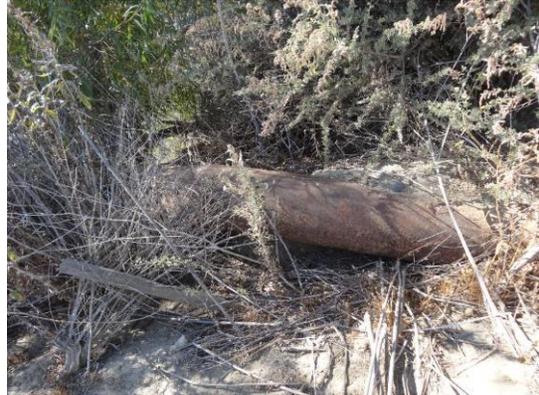
Photo 1 of 3 : UCIP\_SP\_2020\_24427\_43439.jpg

Item	DWR UCIP Field Study		37.450330 °	37.450330 °	
			-121.028674 °	-121.028674 °	
DWR ID	22085				
Comment Code					
Inspector Comment					
DS_ID:22085 FS_ID:24427 EP_NO: N/A Repair Type: Non-Urgent Crossing Status: Found UCIP Comments: 11/05/2013 Abandoned steel pipe and service pole on waterside. Pump not found on river bank. CMP riser on waterside slope. Slide gate not found in CMP riser. Steel pipe riser on waterside berm. Damaged PVC standpipe on waterside slope. (P. Amatya - DWR UCIP) FIELD_STRUCT_DESC: *ABANDONED* 24-inch corrugated metal irrigation discharge pipe through the levee, 10 feet below the crown. Slide gate in a corrugated metal pipe (CMP) riser on the waterside (WS) slope. 20-inch standpipe 3 feet from the landside (LS) toe. 12-inch pipe across the berm and into a CMP riser on the WS slope. Pump on riverbank. Installed by USACE in 1961. [Additional Reference(s): DWR Levee Log, 1992. USACE San Joaquin O&M Manual 6, September 1961, (HLM 2.46)]. FS Date: 11/5/2013

WS view: abandoned steel pipe on river bank. No pump found on river bank.

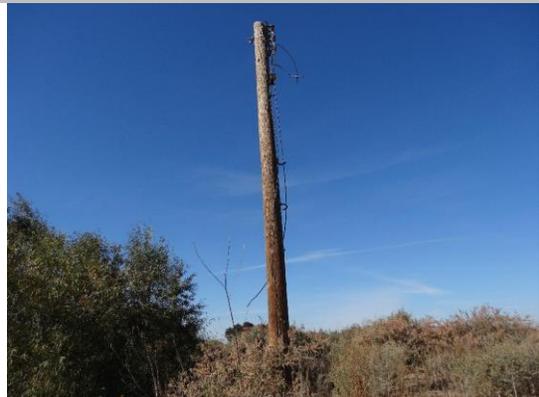
Photo 2 of 3 : UCIP\_SP\_2020\_24427\_43438.jpg

WS view: abandoned power pole on levee berm.

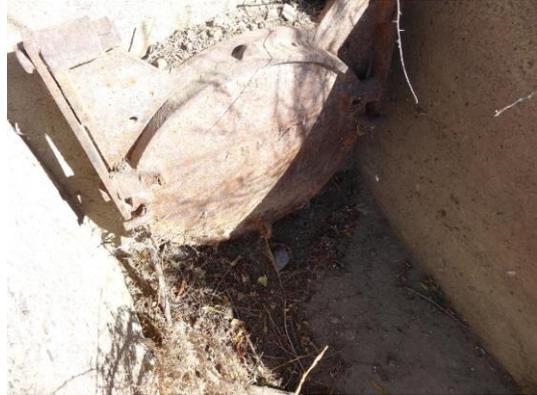
Photo 2 of 3 : UCIP\_SP\_2020\_24435\_43483.jpg

WS view: U shaped headwall outlet structure and pipe with flap gate.

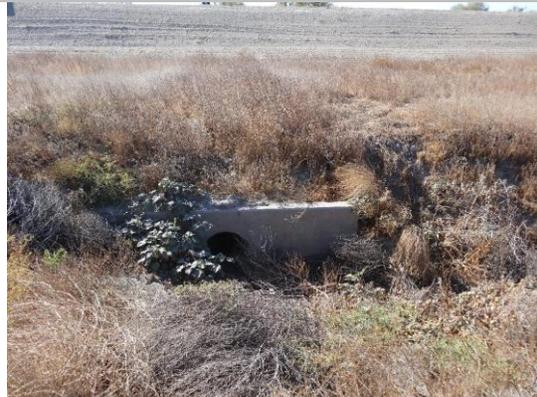
Photo 3 of 3 : UCIP\_SP\_2020\_24435\_43482.jpg

LS view: concrete headwall with CMP 70 ft off the levee center.

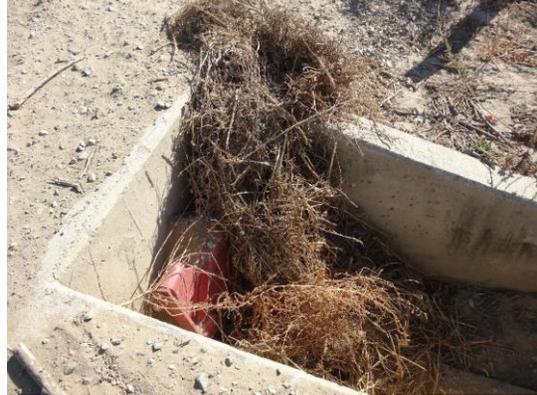
Photo 1 of 3 : UCIP\_SP\_2020\_24443\_43522.jpg

WS view: U typed concrete headwall on levee slope.

Comment Code					
Inspector Comment					
DS_ID:22088 FS_ID:24443 EP_NO: N/A Repair Type: Non-Urgent Crossing Status: Found UCIP Comments: 11/05/2013 - clear and clean debris (P. Amatya - DWR UCIP) FIELD_STRUCT_DESC: *ABANDONED* 24-inch corrugated metal gravity drainage pipe through the levee, 9.5 feet below the crown. Flap gate on the waterside (WS) end. Pipe open on the landside (LS) end. Concrete headwall on each end. [Additional Reference(s): DWR Levee Log, 1992. USACE San Joaquin O&M Manual 6, September 1961, (HLM 2.97)]. FS Date: 11/5/2013

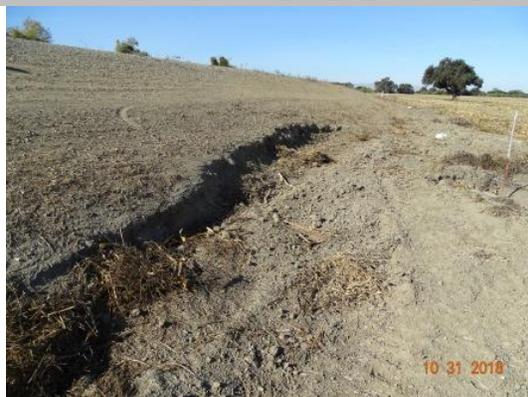
Photo 1 of 1 : SP\_2020\_RD2063\_112\_41\_20200225\_00011.jpg

View of agricultural equipment cutting into the levee slope. (Fall 2018)

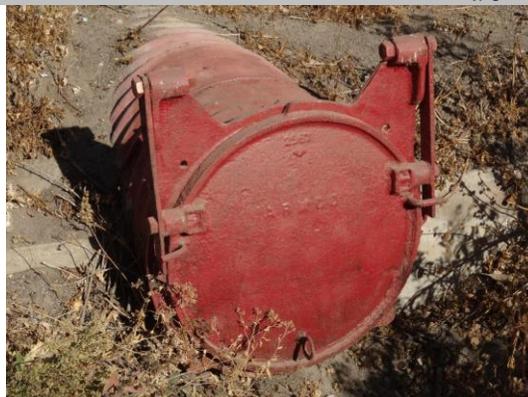
Photo 1 of 3 : UCIP\_SP\_2020\_24485\_43667.jpg

WS view: pipe, flap gate, and concrete saddle on levee slope

Comment Code					
Inspector Comment					
DS_ID:22093 FS_ID:24485 EP_NO: N/A Repair Type: Non-Urgent Crossing Status: Found UCIP Comments: 11/05/2013 - new flap gate on waterside.- cleaning and clearing of inlet box needed. (P. Amatya - DWR UCIP) FIELD_STRUCT_DESC: 24-inch corrugated metal gravity drainage pipe through the levee, 12 feet below the crown. Flap gate and concrete saddle on the waterside (WS) end. Concrete drop inlet box on the landside (LS) end. Installed by USACE in 1961. [Additional Reference(s): DWR Levee Log, 1992. USACE San Joaquin O&M Manual 6, September 1961, (HLM 3.69)]. FS Date: 11/5/2013

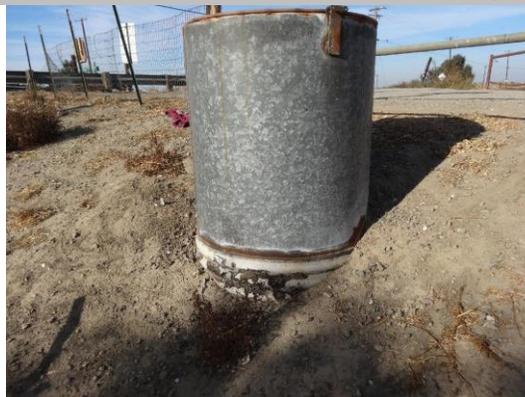
Photo 1 of 3 : UCIP\_SP\_2020\_41746\_43850.jpg

DS\_ID:22099  
 FS\_ID:41746  
 EP\_NO: N/A  
 Repair Type: Non-Urgent  
 Crossing Status: Found  
 UCIP Comments: 11/05/2013 Need to determine if annular space has been grouted or if repair/sleeving was done in accordance with a permit or Title 23. Slide gate not found in CM pipe riser on the waterward slope. Dense vegetation on waterside. Pipe only visible in CMP riser on waterside slope. (P. Amatya - DWR UCIP)  
 FIELD\_STRUCT\_DESC: 24-inch corrugated metal irrigation discharge pipe through the levee, 10 feet below the crown. Smaller pipe sleeved through the 24-inch pipe. Slide gate in a corrugated metal pipe (CMP) riser on the waterside (WS) slope. Connects to a concrete pipe irrigation system. Installed by USACE in 1961. [Additional Reference(s): DWR Levee Log, 1992. USACE San Joaquin O&M Manual 6, September 1961, (HLM 4.16)].  
 FS Date: 11/5/2013

WS view: CMP riser on levee slope. Steel riser on top of CMP.

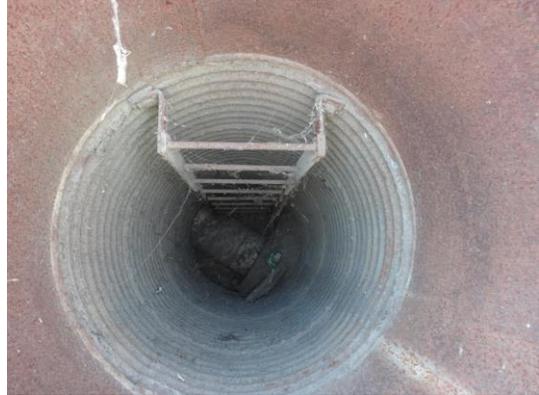
Photo 2 of 3 : UCIP\_SP\_2020\_41746\_43849.jpg

WS view: inside view of CMP riser on levee slope. Steel pipe and 24" CMP visible inside the riser.

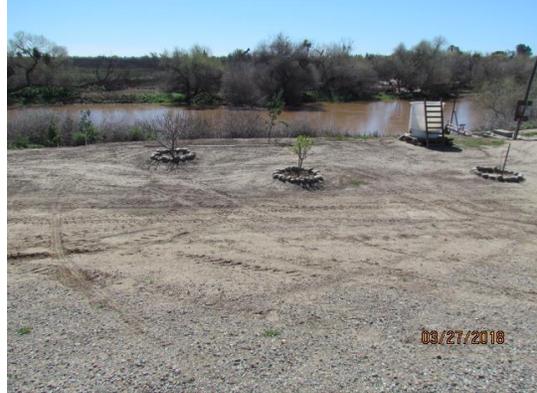
Photo 3 of 3 : SP\_2020\_RD2063\_112\_31\_20200225\_00007.jpg

Looking west at trees with retaining wall around trees. (Spring 2018)

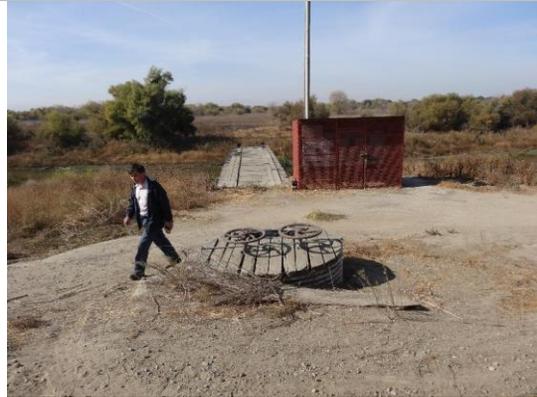
Photo 1 of 3 : UCIP\_SP\_2020\_41669\_45131.jpg

DS\_ID:22105  
 FS\_ID:41669  
 EP\_NO: N/A  
 Repair Type: Non-Urgent  
 Crossing Status: Found  
 UCIP Comments: 11/06/2013 Abandoned pipe should be done so properly.- rubber pipe attached to steel pipe on waterside.- a concrete standpipe on landside too.- overhead power line.- abandoned pipe and pile structure. Abandoned timber walkway on waterside. (P. Amatya - DWR UCIP)  
 FIELD\_STRUCT\_DESC: 1 of 2: 12-inch concrete encased steel irrigation discharge pipe through the levee, 9 feet below the crown. Two pumps on a floating structure in the river. Two slide gates in a 72-inch corrugated metal pipe (CMP) riser on the waterside (WS) slope. Pipe discharges into a concrete distribution box on the landside (LS) toe. Installed by USACE in 1961. [Additional Reference(s): DWR Levee Log, 1992, 14-inch and 16-inch pipes referenced. USACE San Joaquin O&M Manual 6, September 1961, (HLM 5.13), 14-inch and 16-inch pipes referenced].

WS view: CMP riser, abandoned walkway, power pole on levee slope.

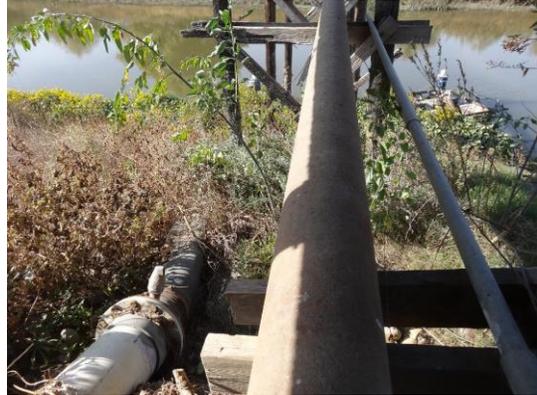
Photo 3 of 3 : UCIP\_SP\_2020\_41670\_43903.jpg

WS view: abandoned steel pipe (right), rubber pipe attached to steel pipe to pump on floating structure in the river.

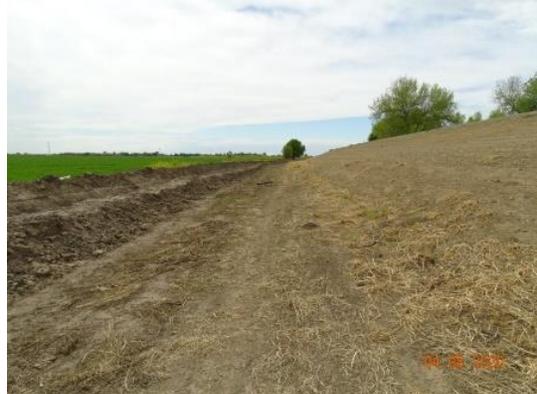
Photo 1 of 1 : SP\_2020\_RD2063\_112\_48\_20200409\_00120.jpg

Looking upstream at a ditch along the landside toe. (Spring 2020)

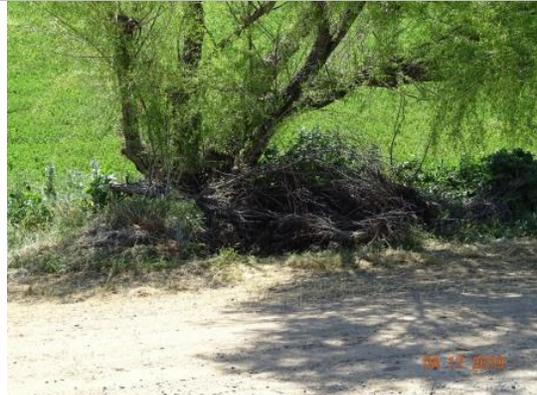
Photo 1 of 2 : SP\_2020\_RD2063\_112\_49\_20200225\_00018.jpg

View of prunings looking down landside slope. (Spring 2019)

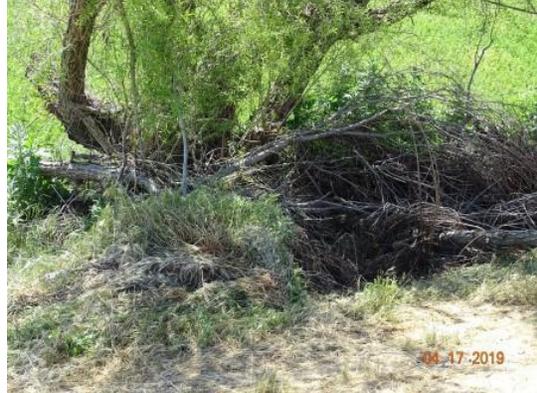
Photo 2 of 2 : SP\_2020\_RD2063\_112\_49\_20200225\_00019.jpg

View of prunings piled under a tree on landside toe. (Spring 2019)

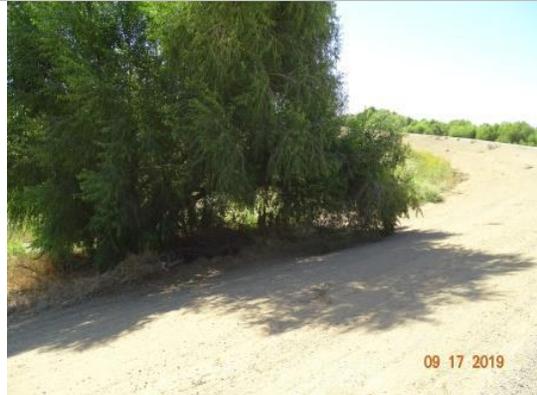
Photo 1 of 1 : SP\_2020\_RD2063\_112\_42\_20200225\_00012.jpg

Tree on landside toe should be trimmed. (2019)

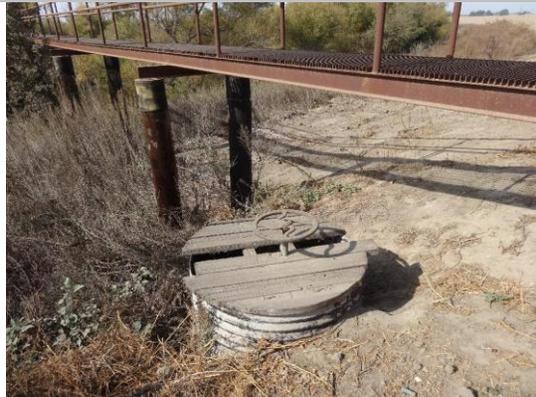
Photo 3 of 3 : UCIP\_SP\_2020\_24629\_43944.jpg

WS view: gate valve in CMP riser. Soil erosion around CMP riser.

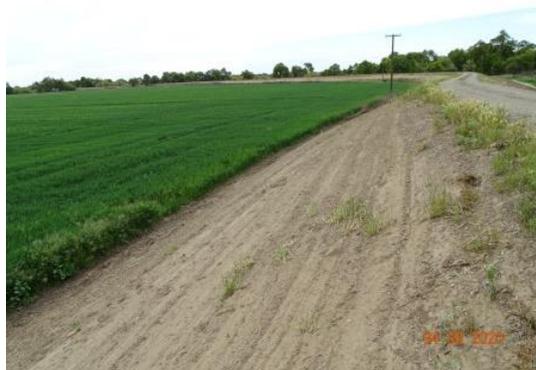
Photo 1 of 1 : SP\_2020\_RD2063\_112\_47\_20200409\_00119.jpg

View of crops planted along landside toe. (Spring 2020)

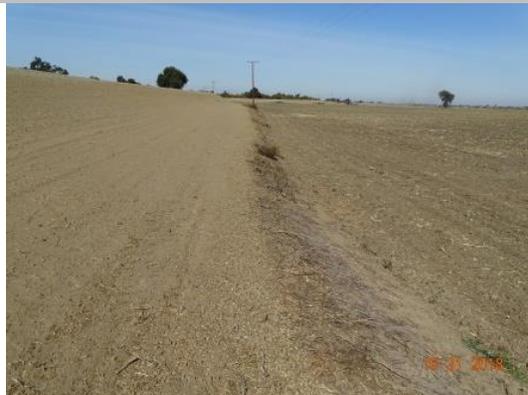
Photo 1 of 1 : SP\_2020\_RD2063\_112\_51\_20200225\_00020.jpg

View of cut into levee slope from agricultural equipment. (Fall 2018)

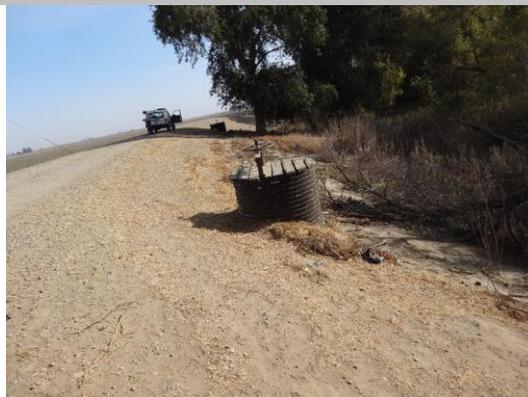
Photo 1 of 3 : UCIP\_SP\_2020\_24632\_43953.jpg

WS view: CMP riser on levee slope. No pipe visible on levee slope.

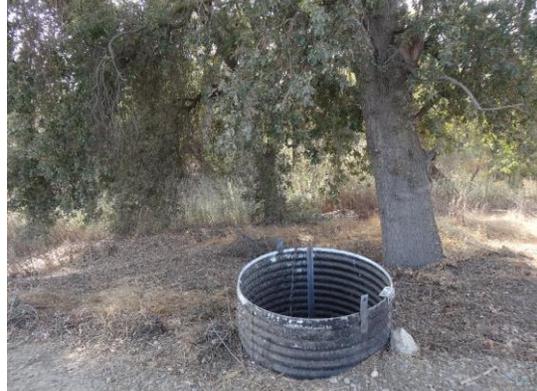
Photo 1 of 3 : UCIP\_SP\_2020\_25031\_45141.jpg

WS view: CMP riser with slide gate. Missing slide gate handwheel.

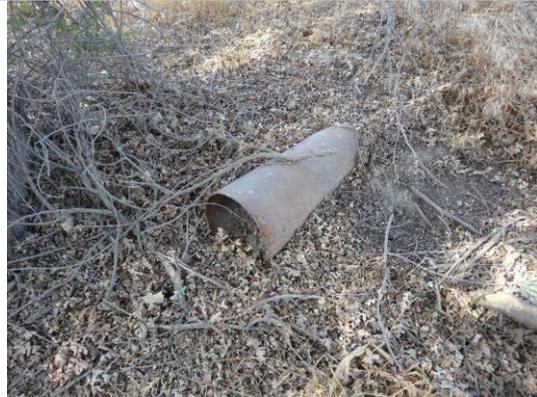
Photo 2 of 3 : UCIP\_SP\_2020\_25031\_45140.jpg

WS view: steel pipe with open-end on waterside slope.

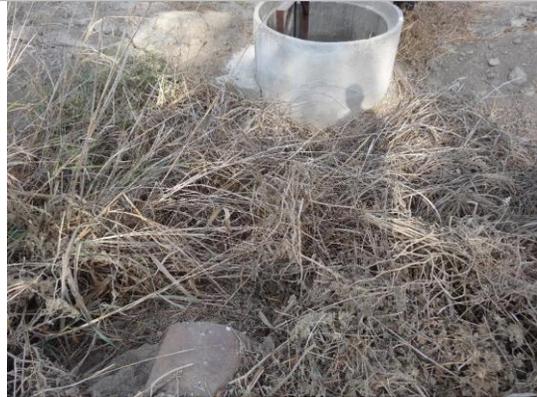
Photo 3 of 3 : UCIP\_SP\_2020\_25031\_45139.jpg

LS view: open-ended steel pipe on levee slope (bottom).

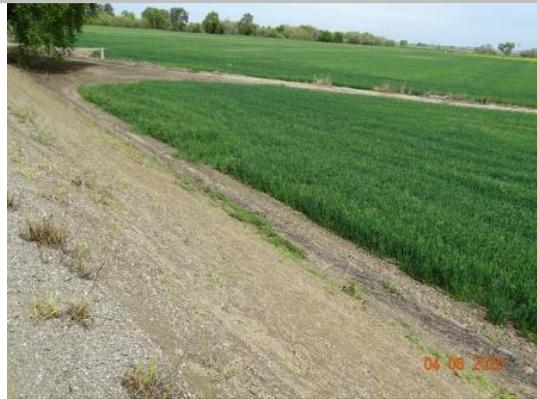
Photo 1 of 1 : SP\_2020\_RD2063\_112\_52\_20200409\_00121.jpg

View of crops planted up to the levee toe on the landside. (Spring 2020)

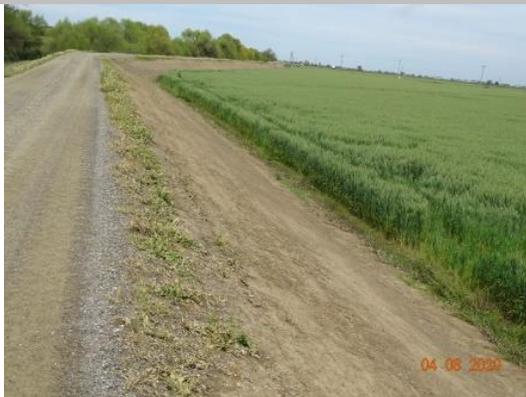
Photo 1 of 1 : SP\_2020\_RD2063\_112\_50\_20200409\_00122.jpg

View of crops planted in the landside toe looking downstream. (Spring 2020)

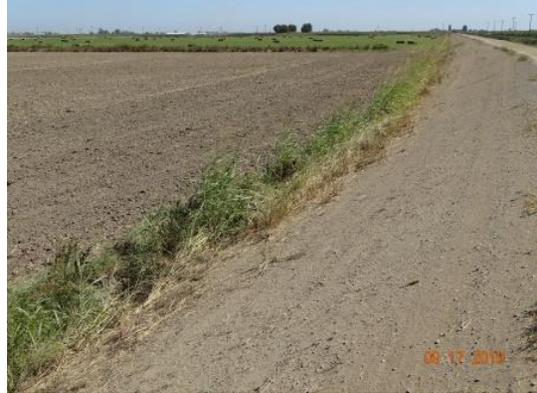
Photo 1 of 1 : SP\_2020\_RD2063\_112\_46\_20200225\_00016.jpg

Small ditch dug along landside toe. (Fall 2019)

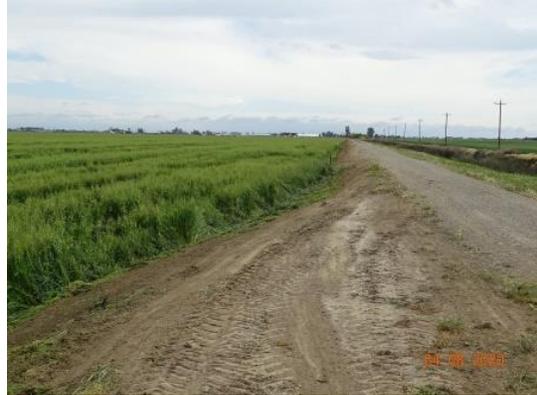
Photo 1 of 1 : SP\_2020\_RD2063\_112\_55\_20200409\_00123.jpg

Crops planted on landside toe. (Spring 2020)

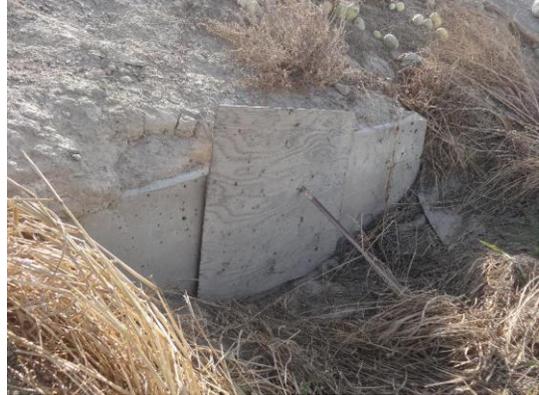
Photo 3 of 3 : UCIP\_SP\_2020\_51825\_43982.jpg

LS view: concrete headwall on levee end. Pipe opening blocked by plywood.

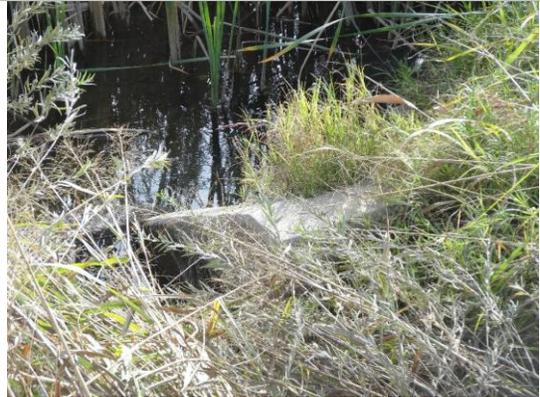
Photo 1 of 2 : UCIP\_SP\_2020\_24645\_43988.jpg

WS view: concrete U type headwall on channel bank. Not accessible.

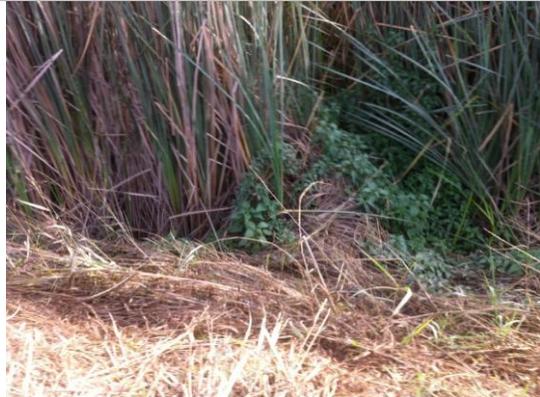
Photo 3 of 3 : UCIP\_SP\_2020\_53096\_43991.jpg

WS view: dense vegetation, no pipe visible.
