**Flood Control Project Maintenance
Levee Inspections**
LMA District Cover Sheet
Spring 2020 Levee Inspection Results

Reclamation District No. 2064 River Junction

Spring 2020 Levee Inspection Results

Waterway	Bank	Unit Miles
Unit No. 01 San Joaquin River	Right	5.56

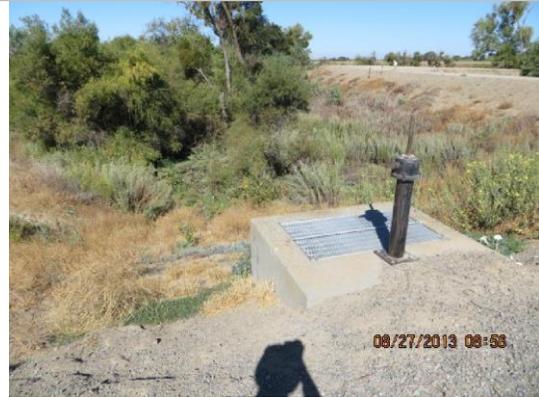
Photo 1 of 3 : UCIP_SP_2020_43603_31258.jpg

LM Start	0.06	Rating **	A/W	Issue No.	52
LM End	0.06	Issue Type +	Ma	Location *	
Category	Supplemental		GPS Latitude/Longitude		
			Start	End	
Item	DWR UCIP LMA Responsibility		37.709804 °	37.709804 °	
			-121.267559 °	-121.267559 °	
DWR ID	20511				
Comment Code					
Inspector Comment					
DS_ID:20511 FS_ID:43603 EP_NO: N/A Repair Type: No Action Needed Crossing Status: Found UCIP Comments: Debris removed from flap gate on waterside tow FIELD_STRUCT_DESC: 36-inch by 36-inch reinforced concrete box drainage culvert through the levee, 21 feet below the crown. Concrete U-shaped headwalls on both ends. Slide gate in a 6-foot by 7-foot concrete riser on the waterside (WS) slope. Flap gate on the WS end. Flashboard slots on the landside (LS) headwall. [Additional Reference(s): DWR Levee Log, 2005. USACE San Joaquin O&M Manual 3, December 1968, (HLM 0.07)]. FS Date: 3/2/2015

Slide gate in concrete riser on WS shoulder.

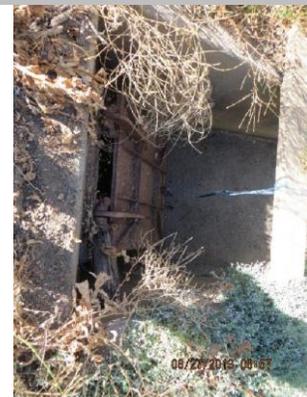
Photo 2 of 3 : UCIP_SP_2020_43603_31257.jpg

Flap gate and U shaped headwall on WS toe. Debris blocking closure of gate.

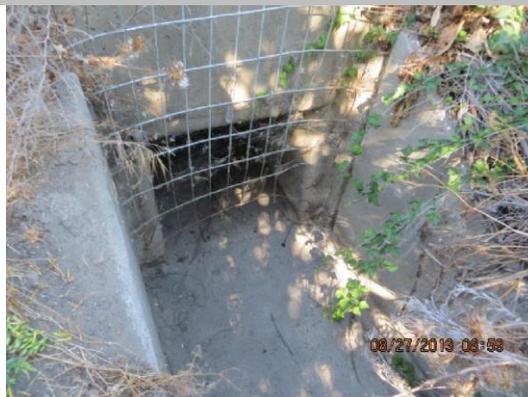
Photo 3 of 3 : UCIP_SP_2020_43603_31256.jpg

Concrete headwall at inlet on LS toe.

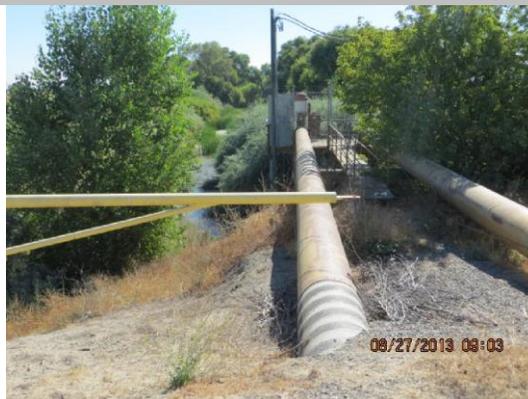
Photo 1 of 3 : UCIP_SP_2020_18718_31286.jpg

Steel storm drain pipe with pump on pier in background.

Comment Code					
Inspector Comment					
DS_ID:20512 FS_ID:18718 EP_NO: 13907 Repair Type: Non-Urgent Crossing Status: Found UCIP Comments: This pipe has less than 1-foot of cover. FIELD_STRUCT_DESC: 1 of 3: 24-inch coated steel drainage discharge pipe through the levee, 2 feet below the crown. Two 100-horsepower and one 75-horsepower pumps on the landside (LS) toe. Siphon breaker on the waterside (WS) shoulder. (Permit No. 13907, 1985 - Reclamation District No. 2064). [Additional Reference(s): DWR Levee Log, 2005]. FS Date: 8/27/2013

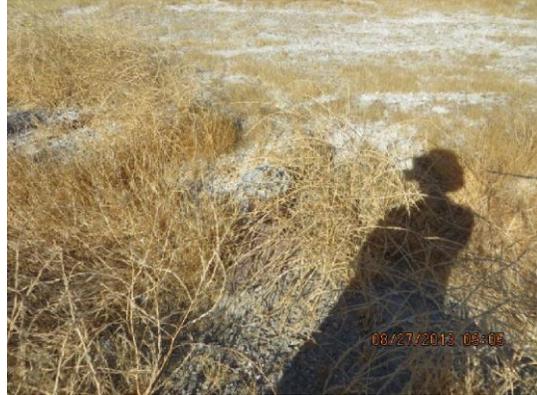
Photo 2 of 3 : UCIP_SP_2020_18720_31293.jpg

Siphon breaker visible on WS shoulder.

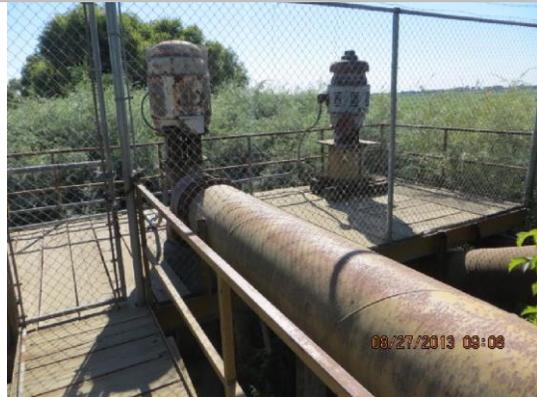
Photo 3 of 3 : UCIP_SP_2020_18720_31292.jpg

Pump on pier on LS.

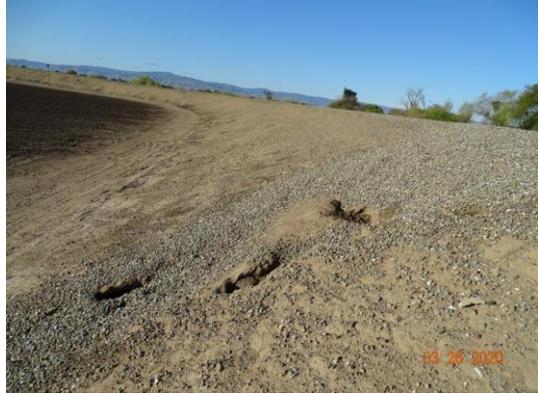
Photo 1 of 2 : SP_2020_RD2064_313_27_20200327_00058.jpg

View of large rodent burrows on landside slope. Spring 2020

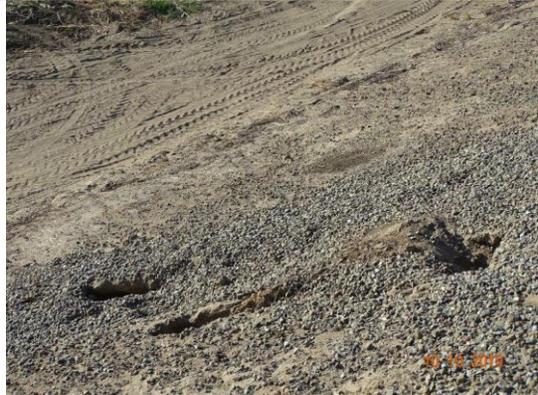
Photo 2 of 2 : SP_2020_RD2064_313_27_20200228_00008.jpg

View of large rodent burrows on landside slope. Fall 2019

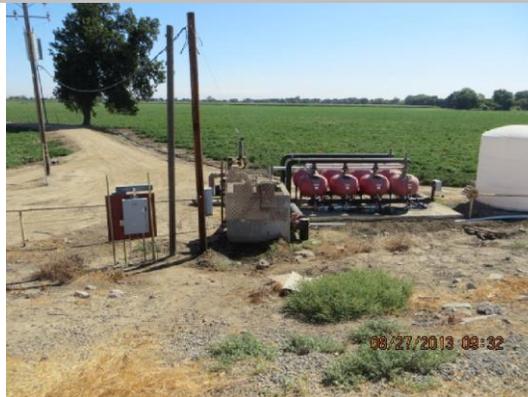
Photo 2 of 3 : UCIP_SP_2020_53378_38461.jpg

Concrete distribution box on LS toe with filter plant.

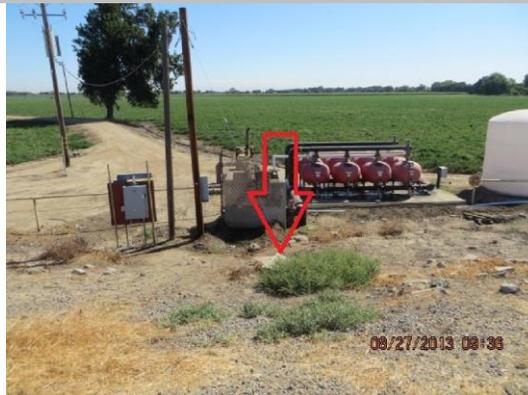
Photo 3 of 3 : UCIP_SP_2020_53378_38460.jpg

Leakage along pipe alignment on LS toe.

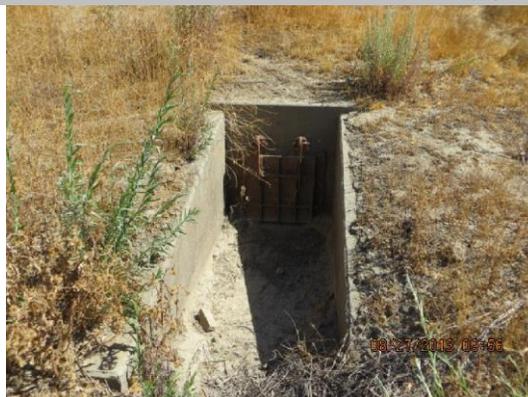
Photo 3 of 3 : UCIP_SP_2020_18748_31378.jpg

Flap gate on WS toe.

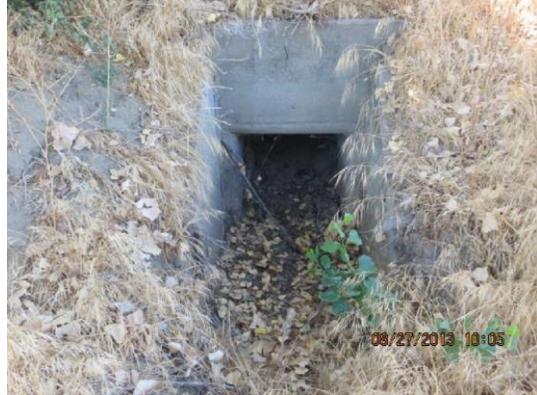
Photo 3 of 3 : UCIP_SP_2020_18763_31400.jpg

Concrete U-shaped headwall on LS toe.

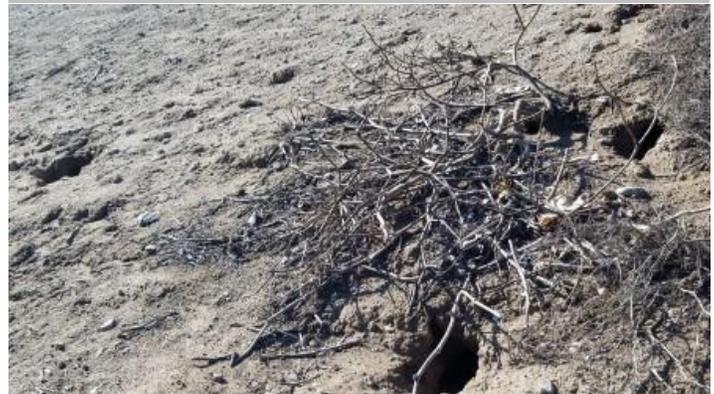
Photo 1 of 1 : SP_2020_RD2064_313_31_20200228_00009.jpg

LM Start	2.02	Rating **	M	Issue No.	32
LM End	2.02	Issue Type +	Ma	Location *	LS
Category	Earthen Levee			GPS Latitude/Longitude	
				Start	End
Item	Animal Control			37.689603 °	37.689603 °
				-121.263398 °	-121.263398 °
DWR ID	DWR_RD2064_01_s_2020_32				
Comment Code					
A3 : No rodents visible, but rodent burrows visible; need to backfill and compact or grout burrows.					
Inspector Comment

View of animal holes on levee slope. Fall 2018

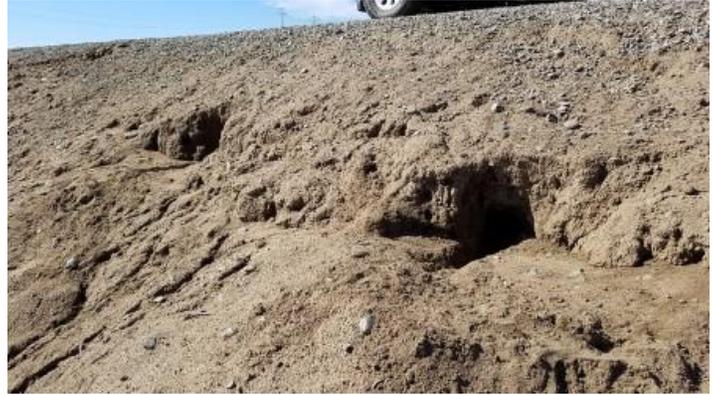
Photo 1 of 1 : SP_2020_RD2064_313_10_20200228_00001.jpg

LM Start	3.31	Rating **	M	Issue No.	10
LM End	3.45	Issue Type +	Ma	Location *	LS
Category	Earthen Levee			GPS Latitude/Longitude	
				Start	End
Item	Animal Control			37.678708 °	37.676786 °
				-121.263415 °	-121.264207 °
DWR ID	DWR_RD2064_01_f_2017_10				
Comment Code					
A3 : No rodents visible, but rodent burrows visible; need to backfill and compact or grout burrows.					
Inspector Comment

View of animal holes on levee slope. Fall 2018

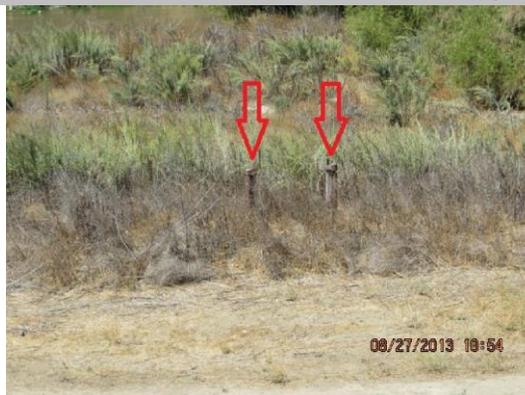
Photo 1 of 1 : UCIP_SP_2020_22731_38463.jpg

LM Start	3.46	Rating **	M	Issue No.	60
LM End	3.46	Issue Type +	En	Location *	
Category	Supplemental		GPS Latitude/Longitude		
			Start	End	
Item	DWR UCIP Field Study		37.676751 °	37.676751 °	
			-121.264193 °	-121.264193 °	
DWR ID	20517				
Comment Code					
Inspector Comment					
DS_ID:20517 FS_ID:22731 EP_NO: N/A Repair Type: Non-Urgent Crossing Status: Indicator Found UCIP Comments: Neet to verify status of pipeline. FIELD_STRUCT_DESC: Underground gas line crossing; depth through the levee and size unknown. Found possible sign posts on WS toe. FS Date: 8/27/2013

Possible sign posts on WS toe.

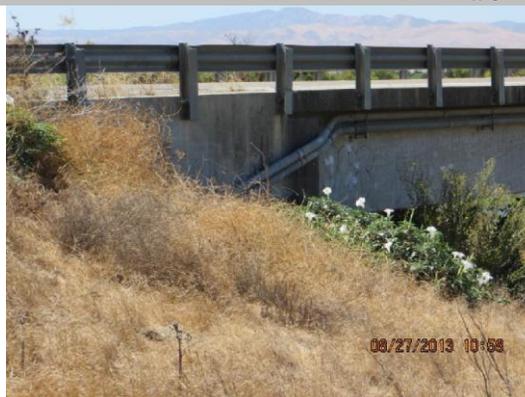
Photo 1 of 1 : UCIP_SP_2020_22085_37702.jpg

LM Start	3.49	Rating **	M	Issue No.	61
LM End	3.49	Issue Type +	En	Location *	
Category	Supplemental		GPS Latitude/Longitude		
			Start	End	
Item	DWR UCIP Field Study		37.676276 °	37.676276 °	
			-121.264104 °	-121.264104 °	
DWR ID	24059				
Comment Code					
Inspector Comment					
DS_ID:24059 FS_ID:22085 EP_NO: N/A Repair Type: Non-Urgent Crossing Status: Found UCIP Comments: Unable to identify purpose or permit for this crossing. FIELD_STRUCT_DESC: 1 of 2: 4-inch galvanized iron conduit of an unknown purpose through the levee, at an unknown depth. Visible on downstream side of the bridge. 3.5-foot by 6-foot steel vault on crown. FS Date: 8/27/2013

Upper conduit visible on DS side of bridge.

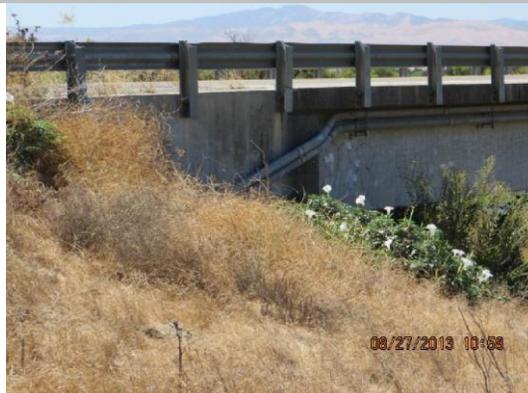
Photo 1 of 1 : UCIP_SP_2020_22790_38826.jpg

LM Start	3.49	Rating **	M	Issue No.	62
LM End	3.49	Issue Type +	En	Location *	
Category	Supplemental			GPS Latitude/Longitude	
				Start	End
Item	DWR UCIP Field Study			37.676276 °	37.676276 °
				-121.264104 °	-121.264104 °
DWR ID	24060				
Comment Code					
Inspector Comment					
DS_ID:24060 FS_ID:22790 EP_NO: N/A Repair Type: Non-Urgent Crossing Status: Found UCIP Comments: Unable to identify purpose or permit for this crossing. FIELD_STRUCT_DESC: 2 of 2: 4-inch galvanized iron conduit through the levee at unknown depth below the crown. Visible on downstream side of the bridge. 3.5-foot by 6-foot steel vault on crown. FS Date: 8/27/2013

Lower conduit visible on DS side of bridge at WS slope.

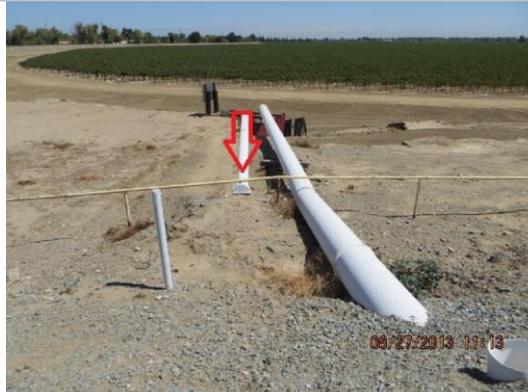
Photo 1 of 3 : UCIP_SP_2020_19044_31844.jpg

LM Start	3.57	Rating **	M	Issue No.	63
LM End	3.57	Issue Type +	En	Location *	
Category	Supplemental			GPS Latitude/Longitude	
				Start	End
Item	DWR UCIP Field Study			37.675267 °	37.675267 °
				-121.263426 °	-121.263426 °
DWR ID	20519				
Comment Code					
Inspector Comment					
DS_ID:20519 FS_ID:19044 EP_NO: 6450 Repair Type: Non-Urgent Crossing Status: Found UCIP Comments: Appears abandoned and if so should be done so properly. FIELD_STRUCT_DESC: *ABANDONED* 18-inch steel discharge pipe through the levee, 2 feet below the crown. Crown roadway padded over the pipe. Pipe exposed on both slopes. Gate valve on the landside (LS) toe. Pump missing from sump with sheet pile siding in ditch on the LS. Siphon breaker on the waterside (WS). (Permit No. 6450, 1969 - Reclamation District No. 2064). [Additional Reference(s): DWR Levee Log, 2005]. FS Date: 8/27/2013

Pipe and gate valve on LS toe.

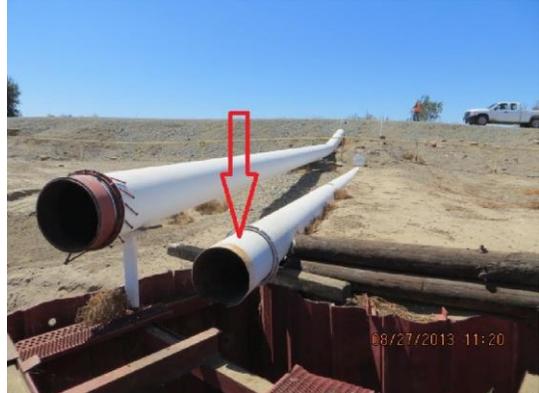
Photo 2 of 3 : UCIP_SP_2020_19044_31843.jpg

Pipe visible at sump off LS toe. No pump or appurtances.

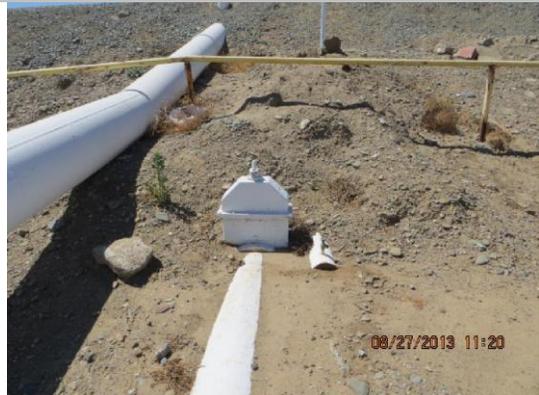
Photo 3 of 3 : UCIP_SP_2020_19044_31842.jpg

Gate valve on LS toe.

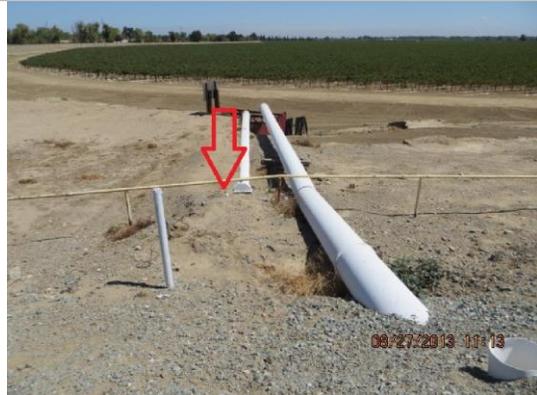
Photo 1 of 2 : UCIP_SP_2020_22732_38465.jpg

LM Start	3.57	Rating **	M	Issue No.	64
LM End	3.57	Issue Type +	Ma	Location *	
Category	Supplemental		GPS Latitude/Longitude		
			Start	End	
Item	DWR UCIP LMA Responsibility		37.675266 °	37.675266 °	
			-121.263421 °	-121.263421 °	
DWR ID	20525				
Comment Code					
Inspector Comment					
DS_ID:20525 FS_ID:22732 EP_NO: N/A Repair Type: Non-Urgent Crossing Status: Found UCIP Comments: Need to determine if pipe was actually removed from levee. FIELD_STRUCT_DESC: 12-inch steel drainage pipe through the levee, at an unknown depth. Steel plate welded over the landside (LS) end at the LS toe. (Permit No. 6450, 1969 - Reclamation District No. 2064, states it was removed in 1973, but it remains visible on the LS toe). [Additional Reference(s): USACE San Joaquin O&M Manual 3, December 1968, (HLM 3.55)]. FS Date: 8/27/2013

Pipe visible on LS toe.

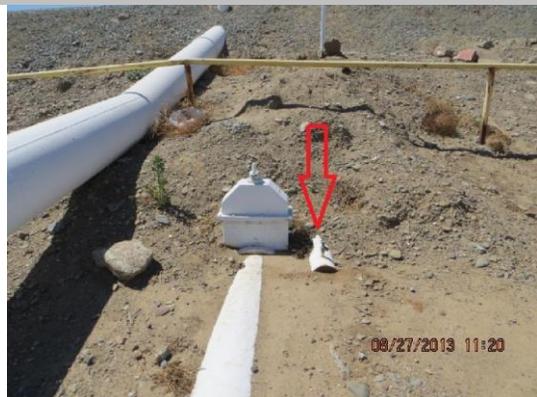
Photo 2 of 2 : UCIP_SP_2020_22732_38464.jpg

Pipe with welded steel plate over LS end at LS toe.

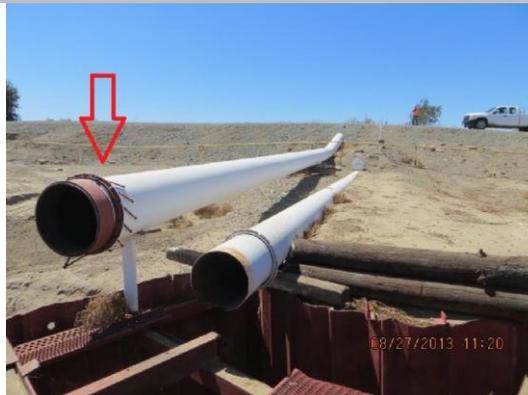
Photo 3 of 3 : UCIP_SP_2020_22733_38466.jpg

Pipe open at pump sump off LS toe.

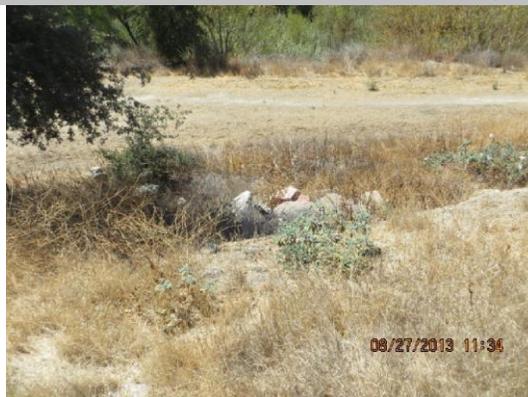
Photo 1 of 2 : UCIP_SP_2020_19046_31849.jpg

DS_ID:20534
 FS_ID:19046
 EP_NO: 13609
 Repair Type: Non-Urgent
 Crossing Status: Indicator Found
 UCIP Comments: Pipes should be abandoned properly.
 FIELD_STRUCT_DESC: *REMOVED* 2 of 2: 24-inch steel drainage pipe through the levee, 12.67 feet below the crown. Approximately 75 feet upstream of first 24-inch pipe. According to notes in permit, concrete rubble was placed over the pipe on the waterside (WS) slope. (Permit No. 13609, 1983 - Reclamation District No. 2064).
 FS Date: 8/27/2013

Concrete rubble on WS slope possible indicator of abandoned pipe location.

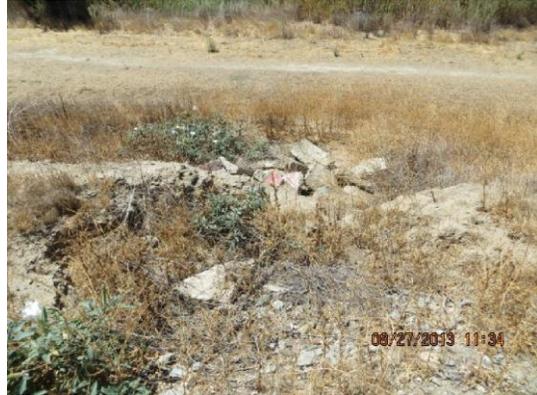
Photo 2 of 2 : UCIP_SP_2020_19046_31848.jpg

Concrete rubble on WS slope possible indicator of abandoned pipe location.

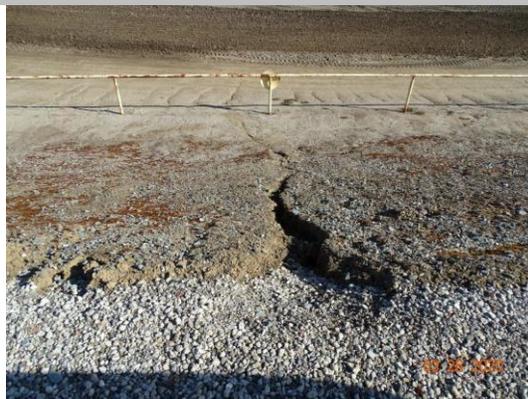
Photo 1 of 1 : SP_2020_RD2064_313_48_20200402_00060.jpg

LM Start	4.43	Rating **	M	Issue No.	48
LM End	4.43	Issue Type +	Ma	Location *	LS
Category	Earthen Levee		GPS Latitude/Longitude		
			Start	End	
Item	Erosion / Bank Caving		37.668809 °	37.668809 °	
			-121.250846 °	-121.250846 °	
DWR ID	DWR_RD2064_01_s_2020_48				
Comment Code					
E2 : Schedule repair of erosion site prior to the next inspection.					
Inspector Comment					
Landside slope separation/rill caused by surface runoff. Scheduled for repair Spring 2020.

View of landside slope separation/rill caused by surface runoff. Spring 2020

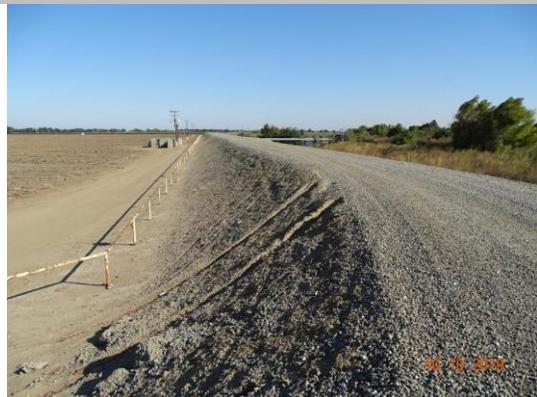
Photo 1 of 1 : SP_2020_RD2064_313_43_20200228_00011.jpg

LM Start	4.64	Rating **	M	Issue No.	43
LM End	4.64	Issue Type +	Ma	Location *	LS
Category	Earthen Levee			GPS Latitude/Longitude	
				Start	End
Item	Slope Stability			37.669079 °	37.669079 °
				-121.247102 °	-121.247102 °
DWR ID	DWR_RD2064_01_f_2019_43				
Comment Code					
S3 : Repair the levee slope damaged by vehicle traffic and prevent access where possible.					
Inspector Comment					
There are tire ruts on landside slope caused by farm equipment.

View of tire ruts on landside slope caused by farm equipment accessing levee crown. Fall 2019

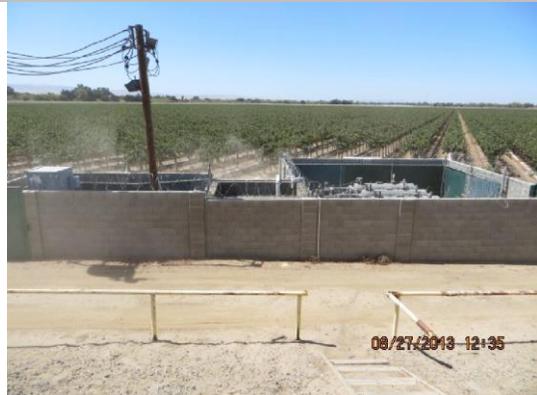
Photo 1 of 2 : UCIP_SP_2020_19063_31861.jpg

Comment Code					
Inspector Comment					
DS_ID:20520 FS_ID:19063 EP_NO: 3359 Repair Type: Non-Urgent Crossing Status: Indicator Found UCIP Comments: Pipe not found. Need to determine disposition of pipe as all other appurtenances remain. FIELD_STRUCT_DESC: 1 of 2: 24-inch irrigation pipe of an unknown material through the levee, 3.5 feet below the crown. Pump mounted on pipe structure in the river. Protective fender in the stream. Wooden walkway to the pump structure. Siphon breaker on the landside (LS). (Permit No. 3359, 1960 - Cook Land and Cattle Company). [Additional Reference(s): DWR Levee Log, 2005. USACE San Joaquin O&M Manual 3, December 1968, (HLM 4.69)]. FS Date: 8/27/2013

Concrete distribution box remains in center of structure on LS toe.

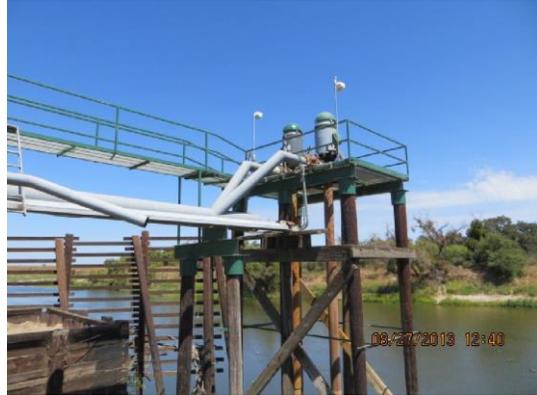
Photo 2 of 2 : UCIP_SP_2020_19063_31860.jpg

Pump platform, walkway, and fender remain in stream. No 24-inch pipe found.

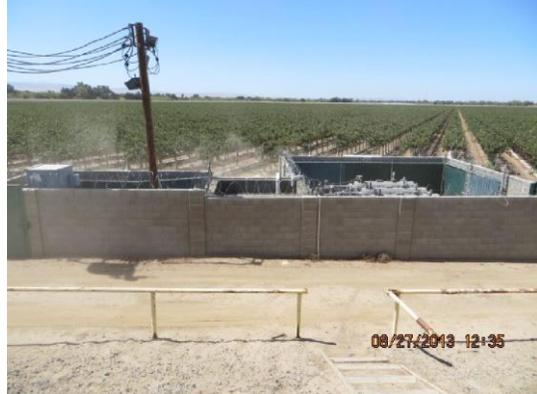
Photo 1 of 2 : UCIP_SP_2020_19064_31863.jpg

DS_ID:20530
 FS_ID:19064
 EP_NO: 3359
 Repair Type: Non-Urgent
 Crossing Status: Indicator Found
 UCIP Comments: Pipe not found. Need to determine disposition of pipe as all other appurtenances remain.
 FIELD_STRUCT_DESC: 2 of 2: 18-inch irrigation pipe of an unknown material through the levee, 3.5 feet below the crown. Pump mounted on pipe structure in the river. Protective fender in the stream. Wooden walkway to the pump structure. Siphon breaker on the landside (LS). (Permit No. 3359, 1960 - Cook Land and Cattle Company). [Additional Reference(s): DWR Levee Log, 2005. USACE San Joaquin O&M Manual 3, December 1968, (HLM 4.69)].
 FS Date: 8/27/2013

Concrete distribution box in center of structure on LS toe.

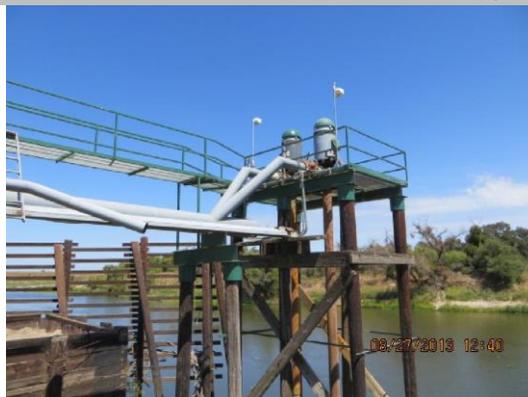
Photo 2 of 2 : UCIP_SP_2020_19064_31862.jpg

Pump platform and fender visible on WS toe.

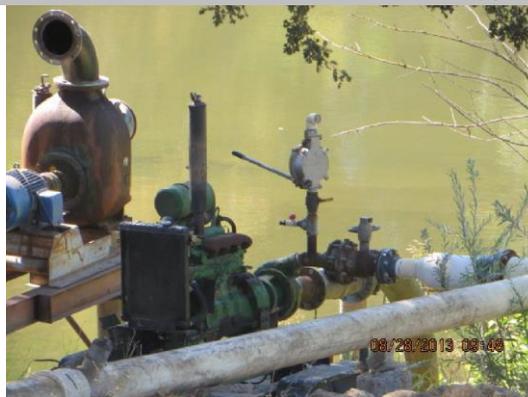
Photo 3 of 3 : UCIP_SP_2020_44653_37713.jpg

Portable pump on WS berm.

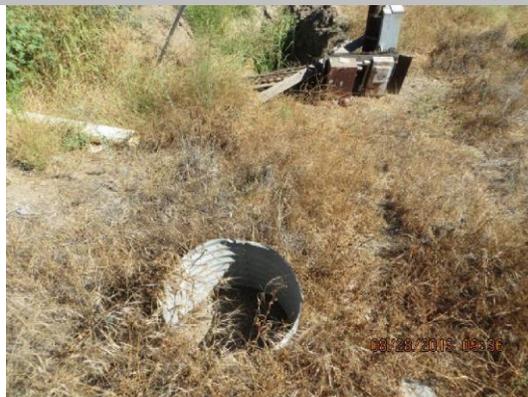
Photo 1 of 3 : UCIP_SP_2020_51385_31892.jpg

Siphon breaker in 24-inch CMP riser on LS shoulder.

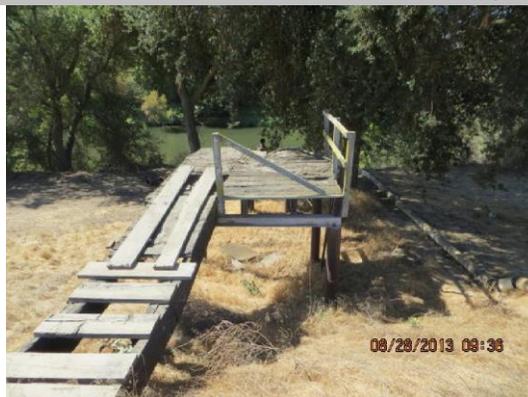
Photo 2 of 3 : UCIP_SP_2020_51385_31891.jpg

Deteriated wooded pump platform on WS shoulder.

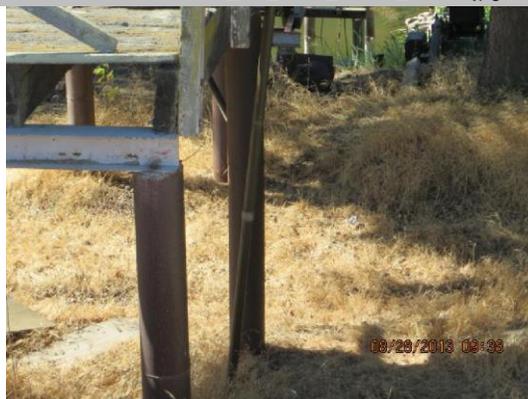
Photo 3 of 3 : UCIP_SP_2020_51385_31890.jpg

2-inch galvanized iron electrical conduit at same location.

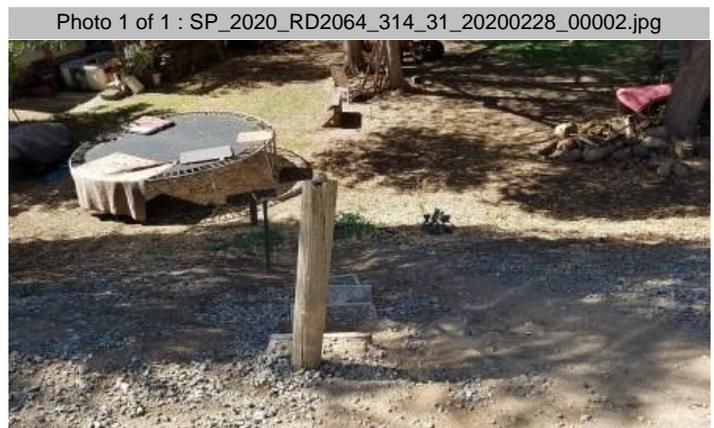
LM Start	1.78	Rating **	M	Issue No.	31
LM End	1.78	Issue Type +	En	Location *	LS
Category	Earthen Levee		GPS Latitude/Longitude		
			Start	End	
Item	Encroachments		37.673827 °	37.673827 °	
			-121.222411 °	-121.222411 °	
DWR ID	DWR_RD2064_02_f_2018_31				
Comment Code					
ST : Stairway					
Inspector Comment

View of stairway with railing that appears to be without a permit. Fall 2018

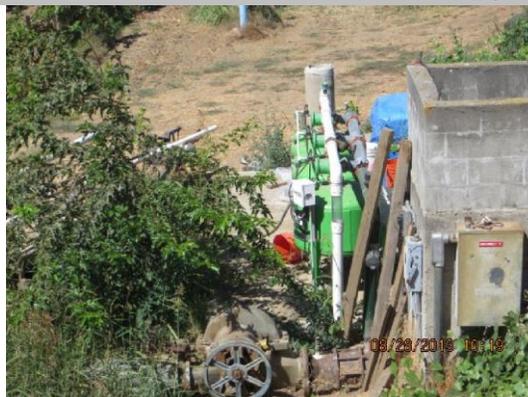
Photo 3 of 3 : UCIP_SP_2020_22095_37720.jpg

Filterplant visible on LS toe.

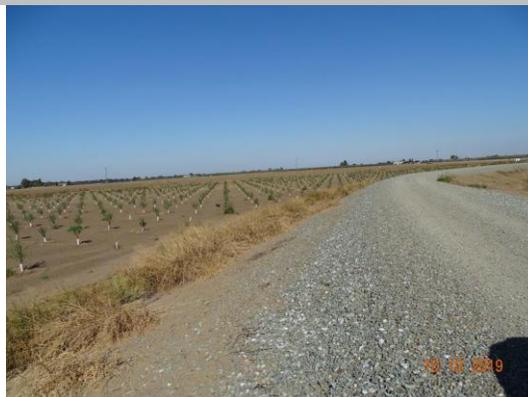
Photo 1 of 1 : SP_2020_RD2064_314_32_20200228_00003.jpg

View of vegetation on landside slope. Fall 2019

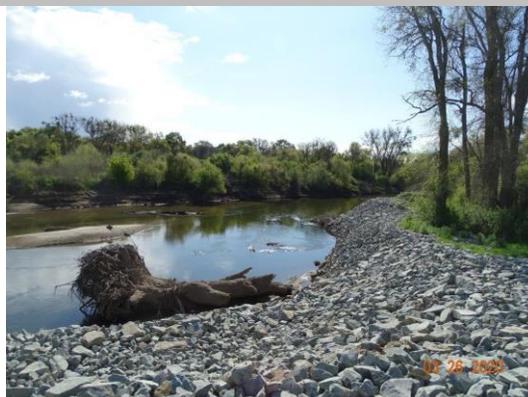
Photo 1 of 1 : SP_2020_RD2064_314_23_20200402_00052.jpg

View of waterside erosion repair looking downstream. Spring 2020

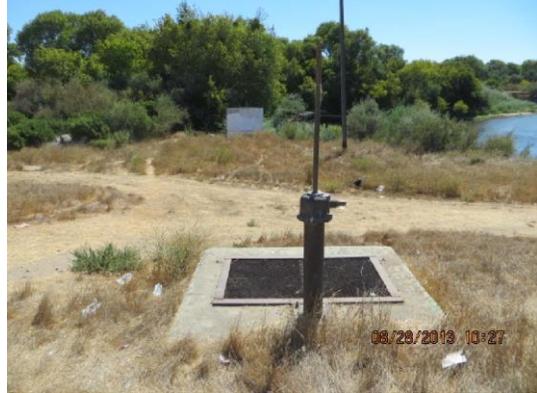
Photo 1 of 3 : UCIP_SP_2020_19086_31954.jpg

Gate valve on WS shoulder. Pump next to concrete riser in background.

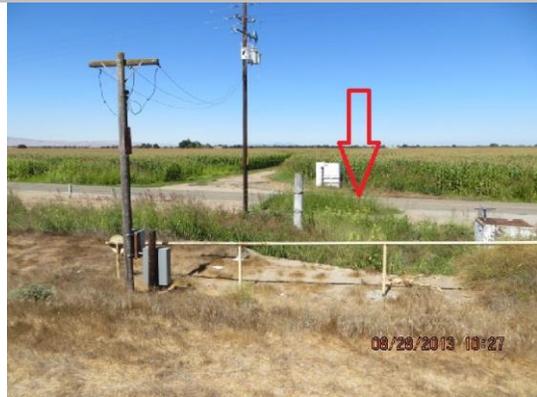
Photo 2 of 3 : UCIP_SP_2020_19086_31953.jpg

Wet area next to roadway off LS toe may indicate a leak. Power pole and meter on LS toe.

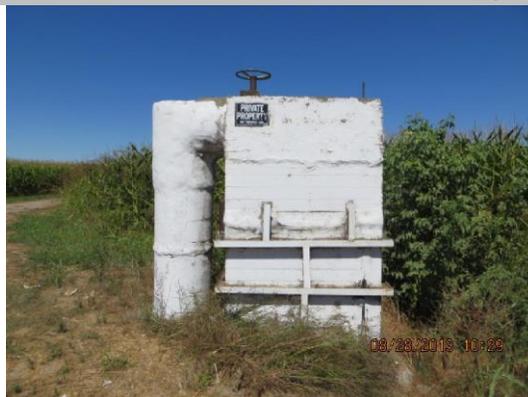
Photo 3 of 3 : UCIP_SP_2020_19086_31952.jpg

Concrete riser in field north of levee likely outlet for cox culvert.

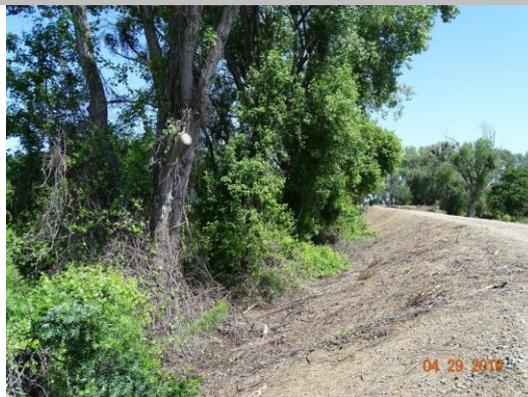
Photo 1 of 1 : SP_2020_RD2064_314_34_20200228_00004.jpg

View of fence with ivy obstructing the visibility of the landside toe. (Spring 2019)

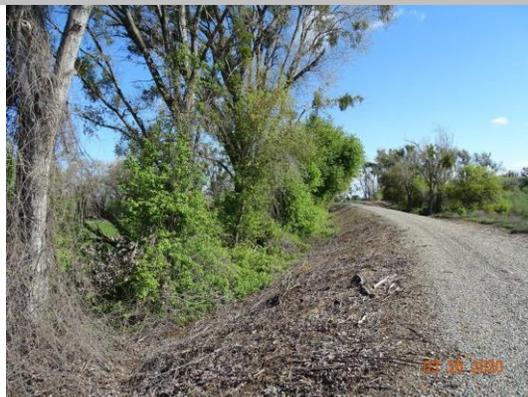
Photo 1 of 1 : SP_2020_RD2064_314_24_20200402_00053.jpg

View of vegetation on landside slope. Spring 2020

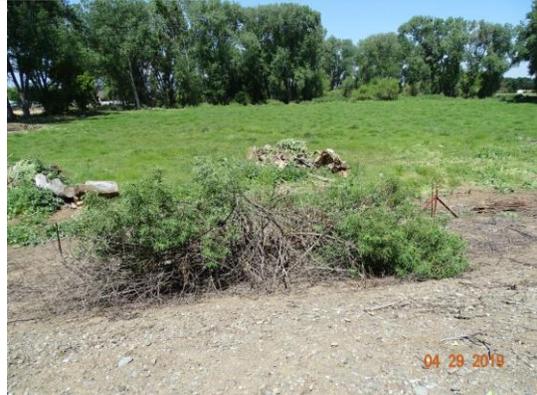
Photo 1 of 1 : SP_2020_RD2064_314_38_20200228_00005.jpg

View of pruning pile on landside shoulder obstructing visibility. (Spring 2019)

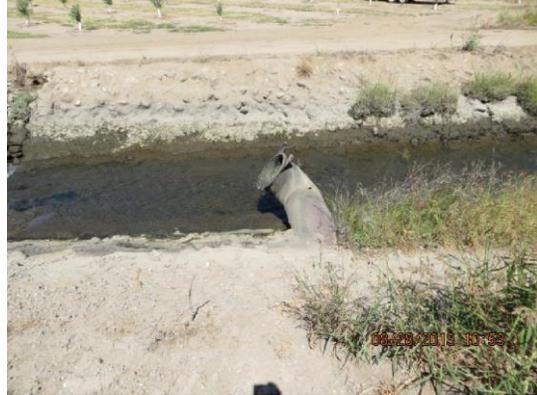
Photo 3 of 3 : UCIP_SP_2020_41075_31961.jpg

Pipe with missing flapgates on LS at concrete ditch.

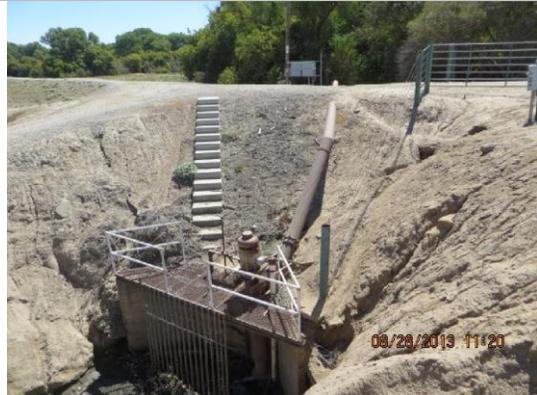
Photo 1 of 2 : UCIP_SP_2020_22107_37736.jpg

Pump for pipe on concrete headwall at LS toe.

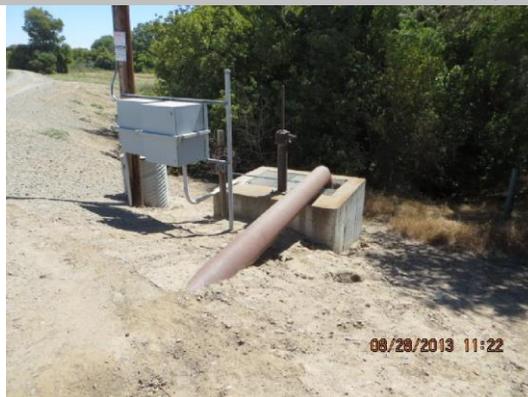
Photo 2 of 2 : UCIP_SP_2020_22107_37735.jpg

Pipe discharges into concrete riser on WS slope.

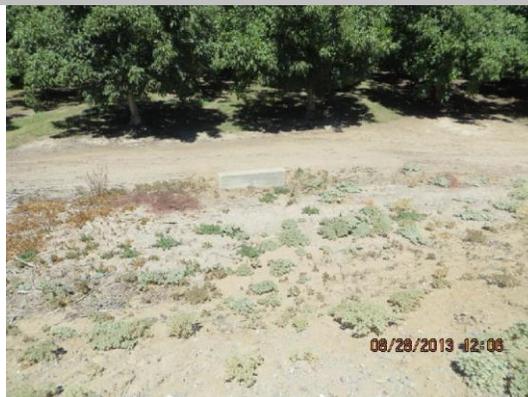
Photo 1 of 3 : UCIP_SP_2020_19117_32069.jpg

Headwall on LS toe.

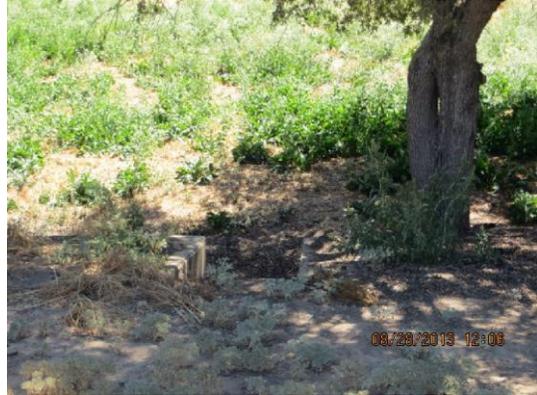
Photo 2 of 3 : UCIP_SP_2020_19117_32068.jpg

Headwall on WS toe.

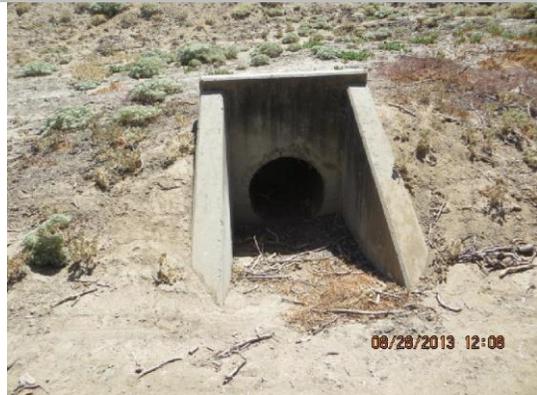
Photo 3 of 3 : UCIP_SP_2020_19117_32067.jpg

Headwall on LS toe.

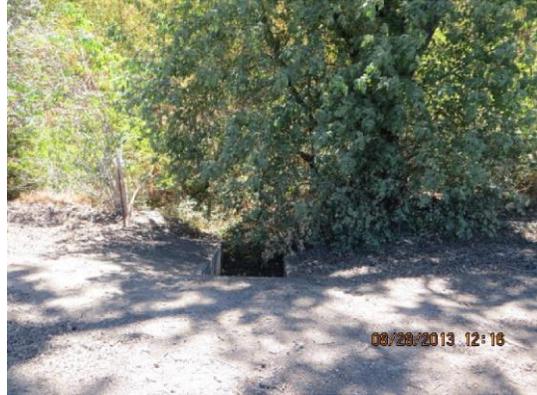
Photo 2 of 3 : UCIP_SP_2020_19120_32078.jpg

Concrete headwall on WS toe.

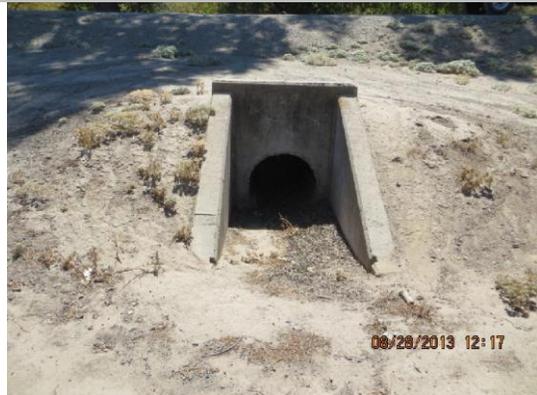
Photo 3 of 3 : UCIP_SP_2020_19120_32077.jpg

Concrete headwall on LS toe.

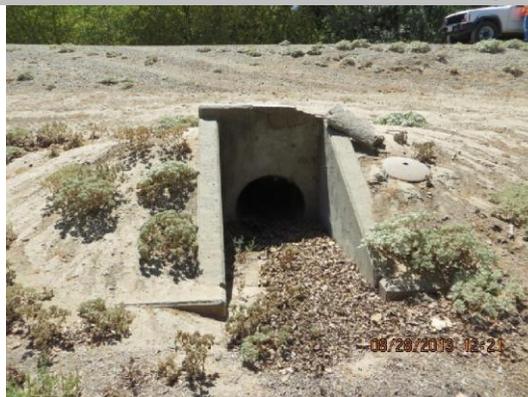
Photo 3 of 3 : UCIP_SP_2020_19122_32081.jpg

Concrete headwall on LS toe.

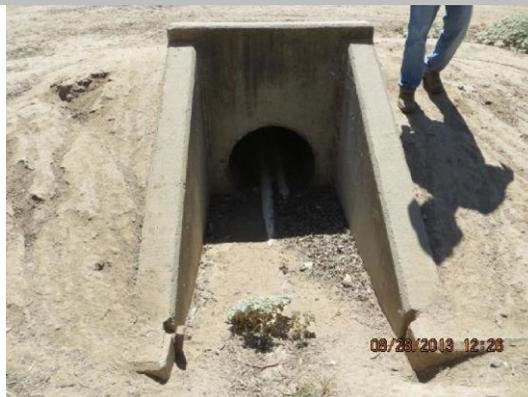
Photo 1 of 3 : UCIP_SP_2020_22108_37739.jpg

PVC pipe at right inside stormdrain on LS toe.

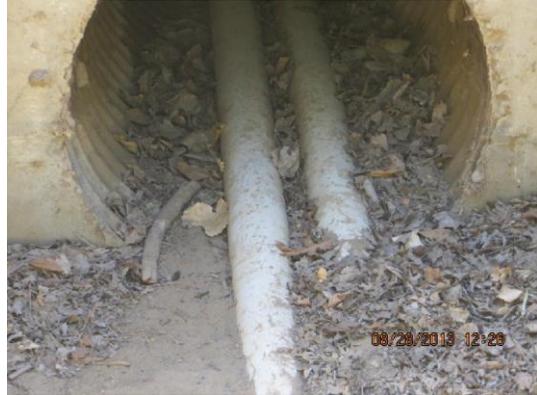
Photo 2 of 3 : UCIP_SP_2020_22108_37738.jpg

PVC pipe at right inside stormdrain on LS toe.

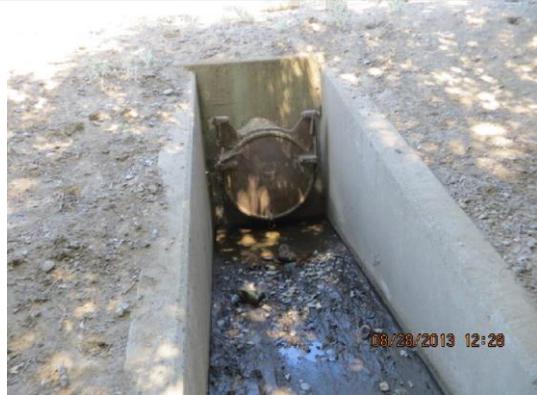
Photo 3 of 3 : UCIP_SP_2020_22108_37737.jpg

Evidence of discharge through PVC conduit on WS toe.

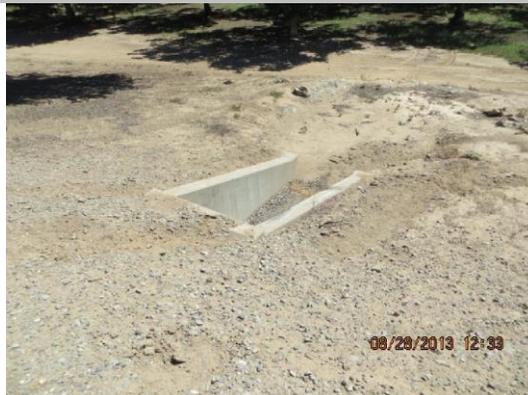
Photo 1 of 3 : UCIP_SP_2020_22794_38851.jpg

Concrete U shaped headwall on WS toe.

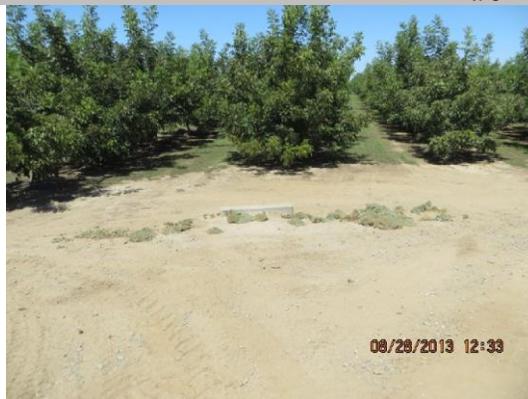
Photo 2 of 3 : UCIP_SP_2020_22794_38850.jpg

Concrete headwall on LS toe.

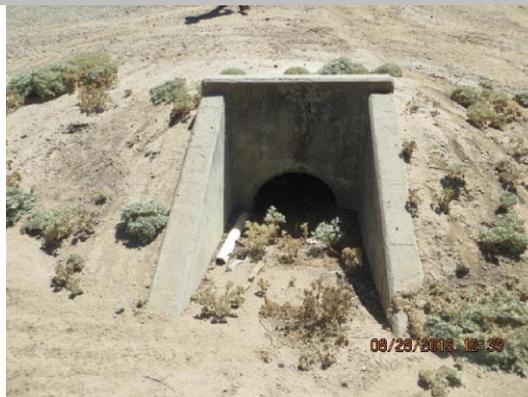
Photo 3 of 3 : UCIP_SP_2020_22794_38853.jpg

Concrete headwall on LS toe.

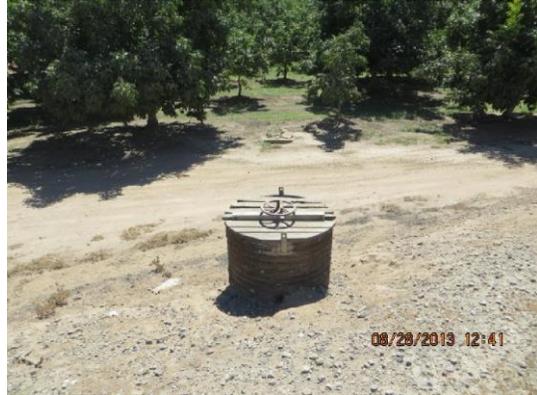
Photo 1 of 2 : UCIP_SP_2020_19145_32126.jpg

Slide gate in CMP riser on WS slope

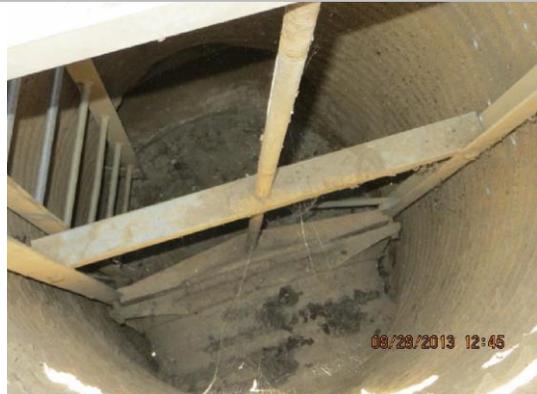
Photo 2 of 2 : UCIP_SP_2020_19145_32125.jpg

Pipe in CMP riser on WS slope.

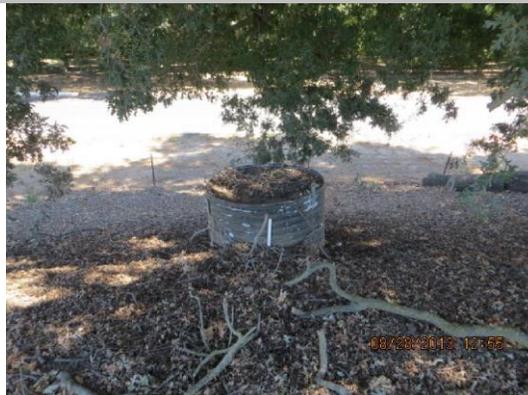
Photo 1 of 1 : UCIP_SP_2020_19146_32127.jpg

CMP riser for slide gate filled with soil.
