**Flood Control Project Maintenance
Levee Inspections**

Fall 2019 Levee Maintenance Deficiency Summary Report

Sacramento River Basin

Reclamation District No. 2068 Yolano

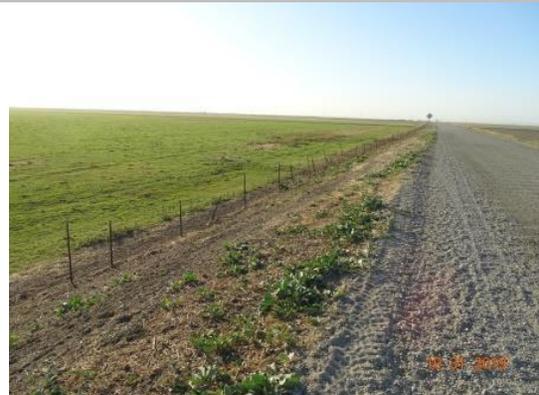
Photo 1 of 1 : FA_2019_RD2068_193_9_20191031_00017.jpg

LM Start	0.51	Rating **	A	Issue No.	9
LM End	5.45	Issue Type +	Ma	Location *	WS
Category	Earthen Levee			GPS Latitude/Longitude	
				Start	End
Item	Vegetation			38.401153°	38.329513°
				-121.693832°	-121.694075°
DWR ID	DWR_RD2068_01_f_2019_9				
Comment Code					
V1 : Control annual grass and weeds on the levee slopes and easements.					
Inspector Comment					
Annual vegetation is well maintained.

View looking downstream at well maintained vegetation on the waterside slope (Fall 2019).

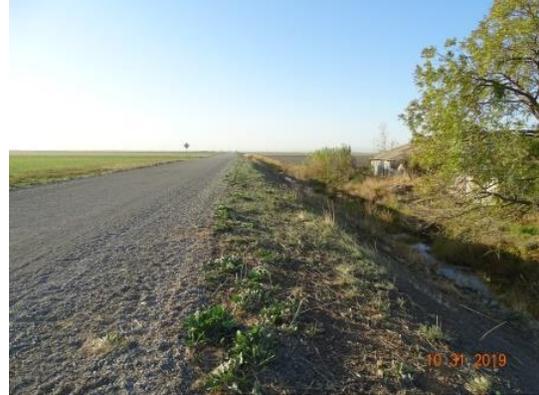
Photo 1 of 1 : FA_2019_RD2068_193_10_20191031_00018.jpg

LM Start	0.51	Rating **	A	Issue No.	10
LM End	5.45	Issue Type +	Ma	Location *	LS
Category	Earthen Levee			GPS Latitude/Longitude	
				Start	End
Item	Vegetation			38.401153°	38.329513°
				-121.693832°	-121.694075°
DWR ID	DWR_RD2068_01_f_2019_10				
Comment Code					
V1 : Control annual grass and weeds on the levee slopes and easements.					
Inspector Comment					
Annual vegetation is well maintained.

View looking downstream at well maintained annual vegetation on the landside slope (Fall 2019).

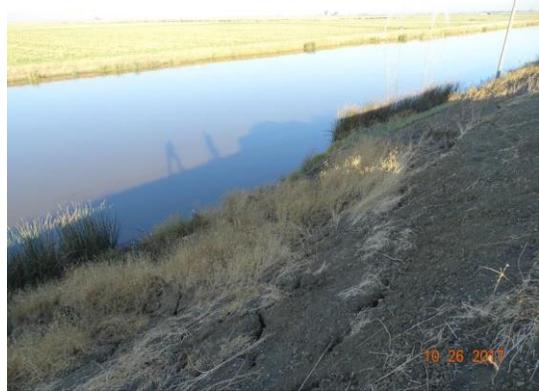
Photo 1 of 2 : FA_2019_RD2068_193_20_20190826_00003.jpg

LM Start	3.16	Rating **	A/W	Issue No.	20
LM End	3.19	Issue Type +	Ma	Location *	LS
Category	Earthen Levee		GPS Latitude/Longitude		
			Start	End	
Item	Slope Stability		38.362765°	38.362278°	
			-121.694040°	-121.694050°	
DWR ID	DWR_RD2068_01_f_2018_20				
Comment Code					
S1 : Repair slope instability.					
Inspector Comment					
Repair the slope instability.

View of slope instability on the landside.

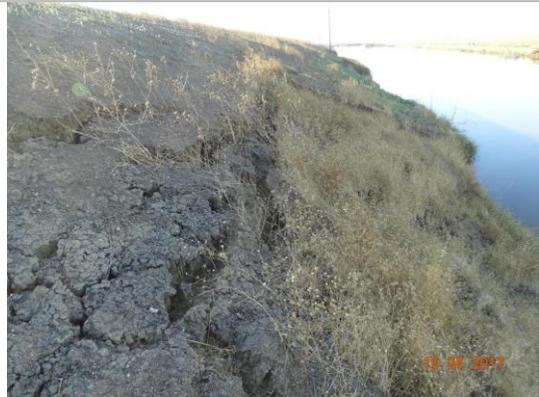
Photo 2 of 2 : FA_2019_RD2068_193_20_20190826_00004.jpg

View of the slope instability.

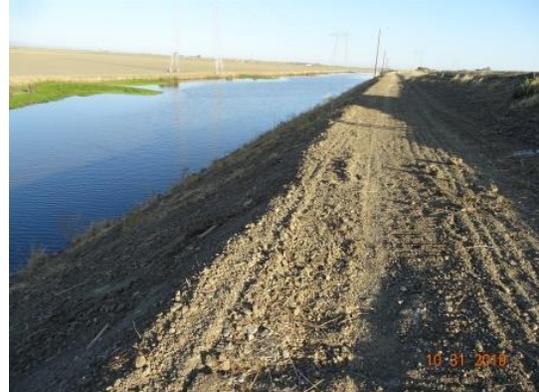
Photo 1 of 3 : FA_2019_RD2068_193_11_20191031_00019.jpg

LM Start	3.27	Rating **	A/W	Issue No.	11
LM End	3.48	Issue Type +	Ma	Location *	LS
Category	Earthen Levee			GPS Latitude/Longitude	
				Start	End
Item	Erosion / Bank Caving			38.361087 °	38.358140 °
				-121.694055 °	-121.694057 °
DWR ID	DWR_RD2068_01_s_2019_11				
Comment Code					
E1 : Note and monitor erosion site.					
Inspector Comment					
District graded the levee to fix the erosion spots. Monitor to see if rainwater erodes the slope again.

View looking upstream at erosion spots that LMA repaired (Fall 2019).

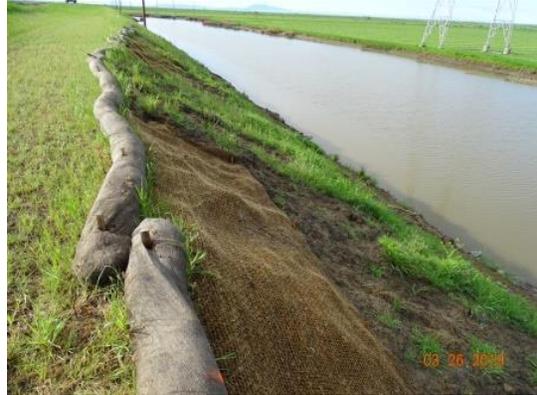
Photo 2 of 3 : FA_2019_RD2068_193_11_20190826_00001.jpg

LM Start	3.27	Rating **	A/W	Issue No.	11 (cont)
LM End	3.48	Issue Type +	Ma	Location *	LS
Category	Earthen Levee			GPS Latitude/Longitude	
				Start	End
Item	Erosion / Bank Caving			38.361087°	38.358140°
				-121.694055°	-121.694057°
DWR ID	DWR_RD2068_01_s_2019_11				
Comment Code					
E1 : Note and monitor erosion site.					
Inspector Comment					
District graded the levee to fix the erosion spots. Monitor to see if rainwater erodes the slope again.

View looking downstream at erosion due to rainfall on the landside slope (Spring 2019).

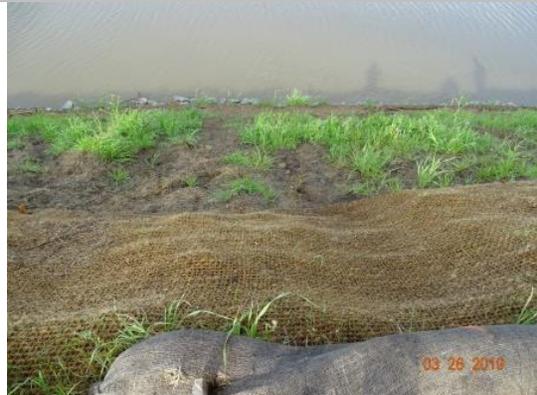
Photo 3 of 3 : FA_2019_RD2068_193_11_20190826_00002.jpg

View looking downslope at erosion due to rainfall on the landside slope (Spring 2019).

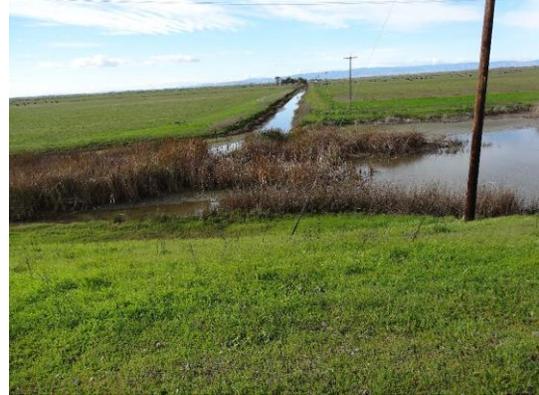
Photo 1 of 3 : UCIP_FA_2019_51451_76850.jpg

Comment Code					
Inspector Comment					
DS_ID:19335 FS_ID:51451 EP_NO: 7220 Repair Type: Non-Urgent Crossing Status: Indicator Found UCIP Comments: 12/06/2016 Line is abandoned according to a map obtained by the LMA. Gas line is labelled abandoned according to the map labelled "California Gas Transmission, Gas System Maintenance and Technical Support, Geographic Information Services", 5/10/2000 4:20 pm, City Solano, Division Sacramento, Zone 2, Wallmap #2-2649. Crossing has been downgraded from "Urgent" to "Non-Urgent" due to the supporting documentation provided by LMA to indicate gas line is abandoned. Need to contact owner to obtain as-builts for line abandonment. (O. Magana - DWR UCIP)08/08/2013 Pipe needs to have markers installed on both sides of levee. (W. Wylie - DWR UCIP) FIELD_STRUCT_DESC: 6.625-inch gas line of an unknown material through the levee, 3 feet below the crown. (Permit No. 7220, 1970 - Pacific Gas and Electric Company [PG&E]). [Additional Reference(s): DWR Levee Log, 1992]. FS Date: 12/6/2016

View of WS.

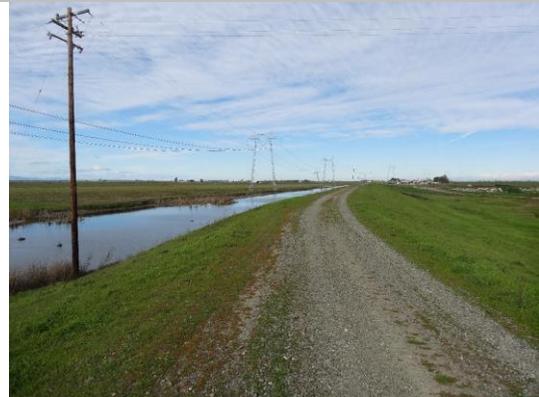
Photo 2 of 3 : UCIP_FA_2019_51451_76851.jpg

Overview of levee crown where crossing should be.

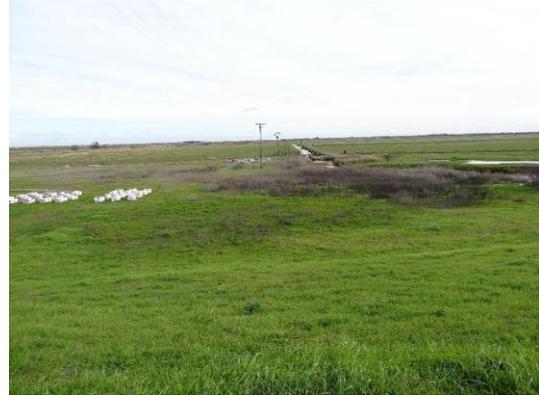
Photo 3 of 3 : UCIP_FA_2019_51451_76852.jpg

Comment Code					
Inspector Comment					
DS_ID:19335 FS_ID:51451 EP_NO: 7220 Repair Type: Non-Urgent Crossing Status: Indicator Found UCIP Comments: 12/06/2016 Line is abandoned according to a map obtained by the LMA. Gas line is labelled abandoned according to the map labelled "California Gas Transmission, Gas System Maintenance and Technical Support, Geographic Information Services", 5/10/2000 4:20 pm, City Solano, Division Sacramento, Zone 2, Wallmap #2-2649. Crossing has been downgraded from "Urgent" to "Non-Urgent" due to the supporting documentation provided by LMA to indicate gas line is abandoned. Need to contact owner to obtain as-builts for line abandonment. (O. Magana - DWR UCIP)08/08/2013 Pipe needs to have markers installed on both sides of levee. (W. Wylie - DWR UCIP) FIELD_STRUCT_DESC: 6.625-inch gas line of an unknown material through the levee, 3 feet below the crown. (Permit No. 7220, 1970 - Pacific Gas and Electric Company [PG&E]). [Additional Reference(s): DWR Levee Log, 1992]. FS Date: 12/6/2016

View of LS.

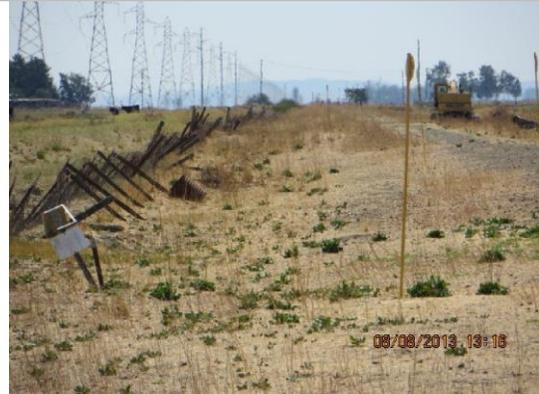
Photo 1 of 2 : UCIP_FA_2019_17531_29641.jpg

Comment Code					
Inspector Comment					
DS_ID:19355 FS_ID:17531 EP_NO: 8151 Repair Type: Non-Urgent Crossing Status: Indicator Found UCIP Comments: 12/22/2016 Met with Mike Hadesty, LMA Superintendent, and Brian Bush, LMA General Manager, to go over the list of pipes in RD2068. Per LMA records, line is an active line. New owner is Calpine. Need to coordinate with Calpine to update permit and obtain records to confirm line integrity. (O. Magana - DWR UCIP) 08/08/2013 Appears abandoned. Need to verify with pipeline owner. (W. Wylie - DWR UCIP) FIELD_STRUCT_DESC: 8-inch coated steel gas line through the levee, 3 feet below the crown. Gas line markers visible on the east toe of the levee at the intersection of the levee and Delhi Road. (Permit No. 8151, 1972 - Dow Chemical). [Additional Reference(s): DWR Levee Log, 1992]. FS Date: 8/8/2013

Gasline markers next to old rail road grade, looking south.

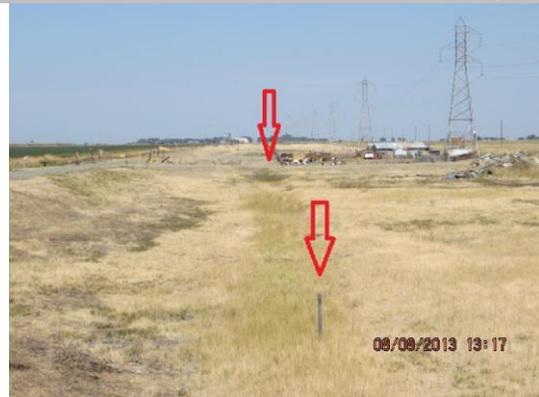
Photo 2 of 2 : UCIP_FA_2019_17531_29640.jpg

Gasline markers on east side of levee toe looking North.

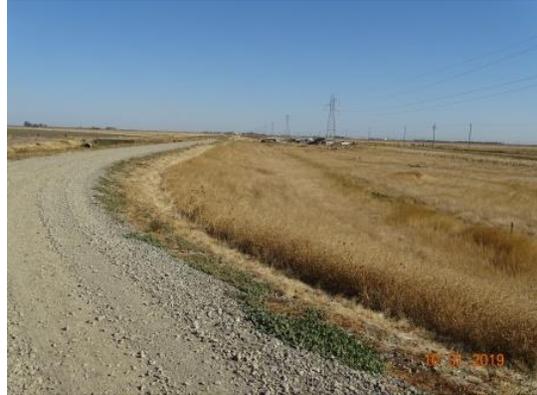
Photo 1 of 1 : FA_2019_RD2068_194_10_20191031_00007.jpg

LM Start	0.91	Rating **	M	Issue No.	10
LM End	1.01	Issue Type +	Ma	Location *	LS
Category	Earthen Levee		GPS Latitude/Longitude		
			Start	End	
Item	Vegetation		38.371395°	38.372627°	
			-121.740157°	-121.739170°	
DWR ID	DWR_RD2068_02_f_2019_10				
Comment Code					
V1 : Control annual grass and weeds on the levee slopes and easements.					
Inspector Comment

View looking upstream at annual vegetation on the landside slope (Fall 2019).

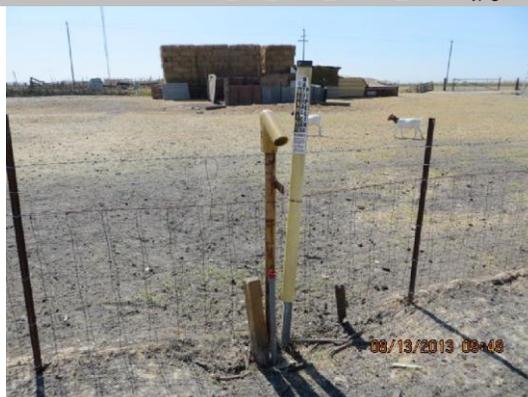
Photo 3 of 3 : UCIP_FA_2019_17532_29642.jpg

LM Start	1.07	Rating **	M	Issue No.	21 (cont)
LM End	1.07	Issue Type +	En	Location *	
Category	Supplemental			GPS Latitude/Longitude	
				Start	End
Item	DRAFT DWR UCIP Field Study			38.373330 °	38.373330 °
				-121.738530 °	-121.738530 °
DWR ID	19354				
Comment Code					
Inspector Comment					
DS_ID:19354 FS_ID:17532 EP_NO: 13028 Repair Type: Non-Urgent Crossing Status: Indicator Found UCIP Comments: 08/13/2013 Need improved signage on LS and WS shoulders. (W. Wylie - DWR UCIP) FIELD_STRUCT_DESC: 10-inch coated steel pipe through the levee, 2 feet below the crown. 4-inch gas line sleeved through the 10-inch pipe. Sign missing from marker post on east slope. 2-inch vent pipe with identification sign off the west bank of the levee and off the toe of the east side of the levee at the fence. (Permit No. 13028, 1980 - Shell Oil Company). FS Date: 8/13/2013

Vent and signage off WS toe.
