**Flood Control Project Maintenance
Levee Inspections**

Fall 2019 Levee Maintenance Deficiency Summary Report

San Joaquin River Basin

| RD2089 Reclamation District No. 2089 Stark | Overall LMA Rating | Total LMA Miles | | | | | | |

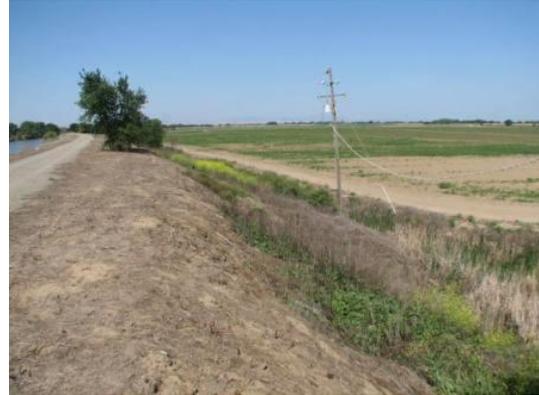
Photo 1 of 1 : FA_2019_RD2089_316_9_20190830_00010.jpg

Ditch flows parallel with the utility line shown in the photo. 05/24/2011

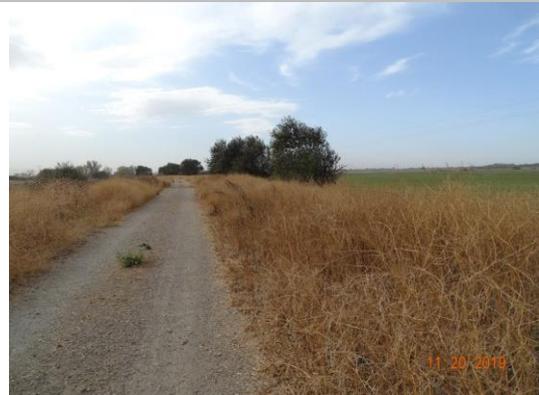
Photo 1 of 2 : FA_2019_RD2089_316_24_20191121_00055.jpg

View of vegetation on landside slope. Fall 2019

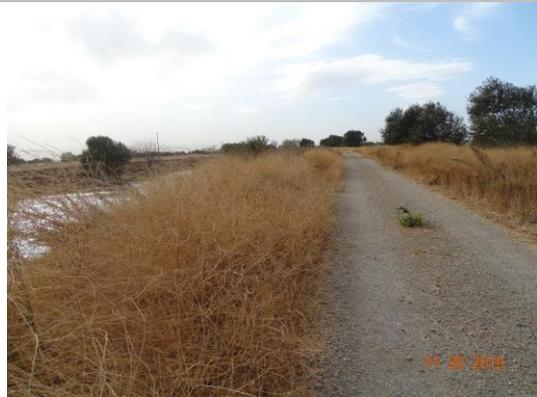
Photo 1 of 2 : FA_2019_RD2089_316_16_20191121_00054.jpg

View of vegetation on waterside slope. Fall 2019

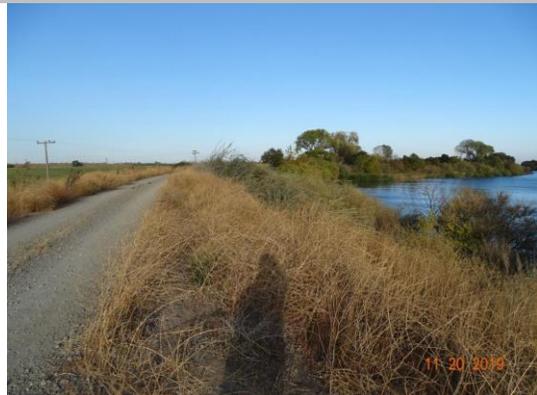
Photo 2 of 2 : FA_2019_RD2089_316_16_20191121_00062.jpg

View of vegetation on waterside slope. Fall 2019

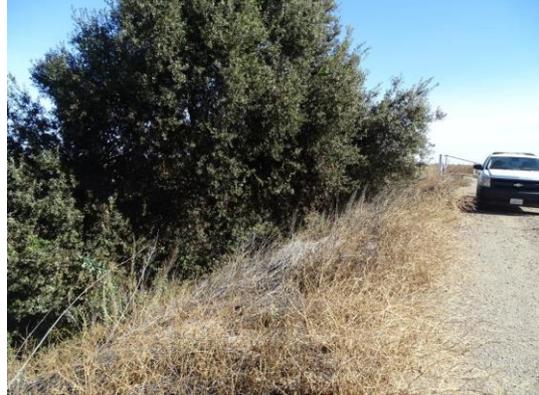
Photo 1 of 1 : FA_2019_RD2089_316_18_20190830_00016.jpg

Looking west at untrimmed trees on landward slope. (Fall 2018)

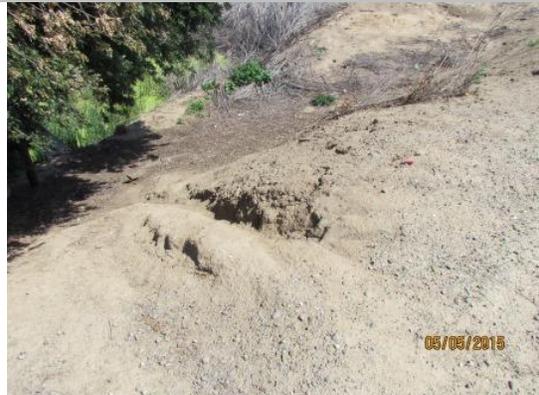
Photo 1 of 2 : FA_2019_RD2089_316_1_20190830_00001.jpg

View of the stairs eroding into the landside levee slope.

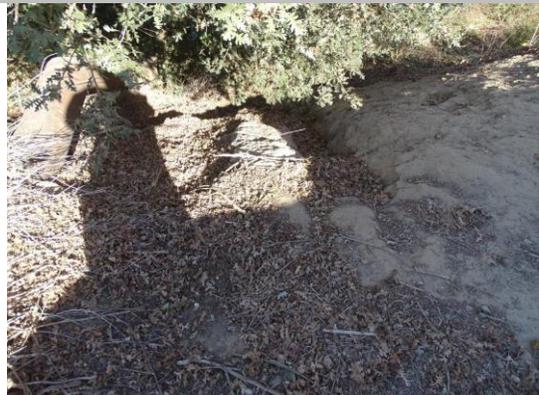
Photo 2 of 2 : FA_2019_RD2089_316_1_20190830_00002.jpg

View of the stairs eroding into the landside levee slope. (Fall 2018)

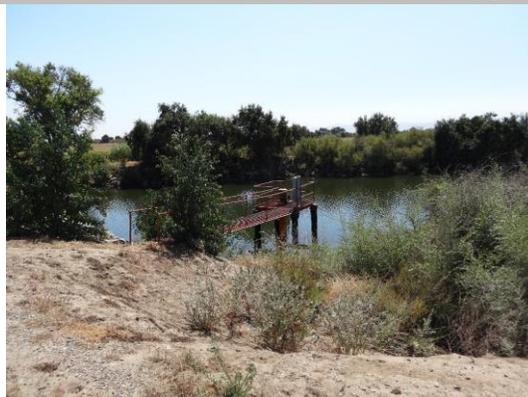
Photo 1 of 3 : UCIP_FA_2019_21635_36742.jpg

| DS_ID:23042 FS_ID:21635 EP_NO: 5641 Repair Type: Non-Urgent Crossing Status: Found UCIP Comments: - damaged siphon breaker.- most of the pipe on landside exposed on levee slope. FIELD_STRUCT_DESC: 20-inch steel irrigation discharge pipe and electrical conduit through the levee, 5.8 feet below the crown. Pump on a pile structure in the stream. Siphon breaker on the landside (LS) slope. (Plans to replace a rusted out irrigation discharge pipe through the levee authorized under Permit No. 5641, 1967 - Theodore Stark). [Additional Reference(s): DWR Levee Log, 1991. USACE San Joaquin O&M Manual 8, 1968, (HLM 0.46), 21-inch pipe referenced]. FS Date: 9/12/2013 | | | | | |

WS view: walkway to pump platform and pump on steel piling structure in the channel.

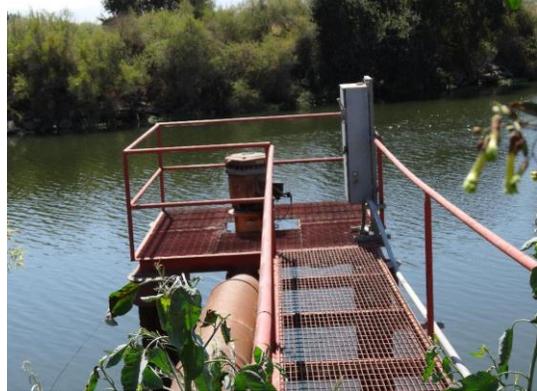
Photo 2 of 3 : UCIP_FA_2019_21635_36741.jpg

| LM Start | 0.46 | Rating ** | M | Issue No. | 50 (cont) |
|--|---|---|---|---|---|
| DS_ID:23042 FS_ID:21635 EP_NO: 5641 Repair Type: Non-Urgent Crossing Status: Found UCIP Comments: - damaged siphon breaker.- most of the pipe on landside exposed on levee slope. FIELD_STRUCT_DESC: 20-inch steel irrigation discharge pipe and electrical conduit through the levee, 5.8 feet below the crown. Pump on a pile structure in the stream. Siphon breaker on the landside (LS) slope. (Plans to replace a rusted out irrigation discharge pipe through the levee authorized under Permit No. 5641, 1967 - Theodore Stark). [Additional Reference(s): DWR Levee Log, 1991. USACE San Joaquin O&M Manual 8, 1968, (HLM 0.46), 21-inch pipe referenced]. FS Date: 9/12/2013 | | | | | |

WS view: steel walkway, electric control box, and pump on steel piling structure in the channel.

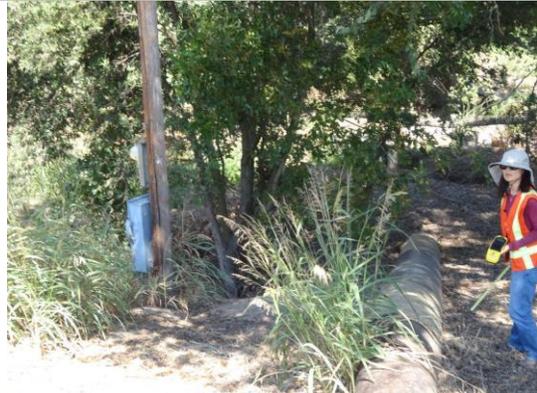
Photo 3 of 3 : UCIP_FA_2019_21635_36740.jpg

LS view: overview of exposed steel pipe (right) on levee slope and service pole (left).

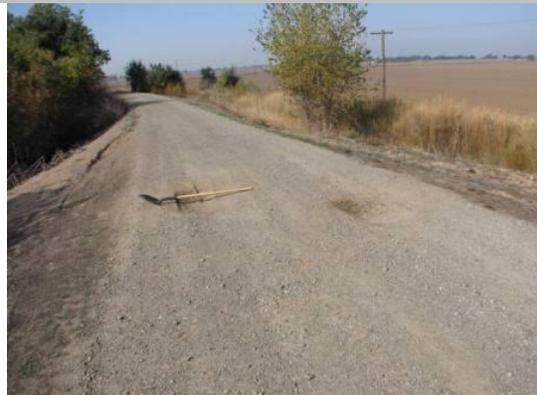
Photo 1 of 1 : FA_2019_RD2089_316_14_20190830_00013.jpg

11/10/2011 Depressions in crown.

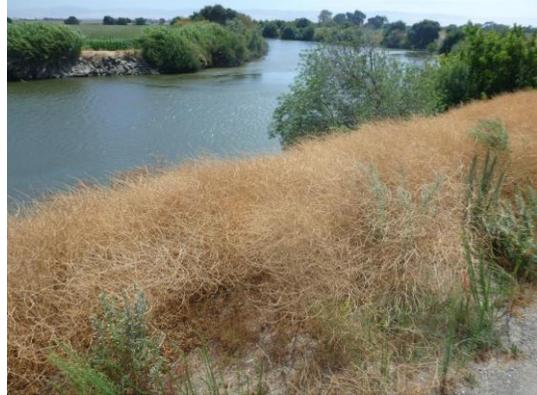
Photo 1 of 3 : LEVAL_FA_2019_512_4457.jpg

| Levee Evaluation Comments Description: Slope protection repairs are needed along the waterside slope due to erosion and riprap displacement from high water. Based upon levee inspections, it was determined the waterside levee slope is eroding, deteriorating, and degrading. The eroded levee sections need to be restored back to design standards to prevent further deterioration and damage. Site ID No: 512 Site Designation: LMA-418 Repair Type: Erosion Rating: Serious Field Date: 8/14/2017 Notes: deep erosion more than half way up slope. | | | | | |

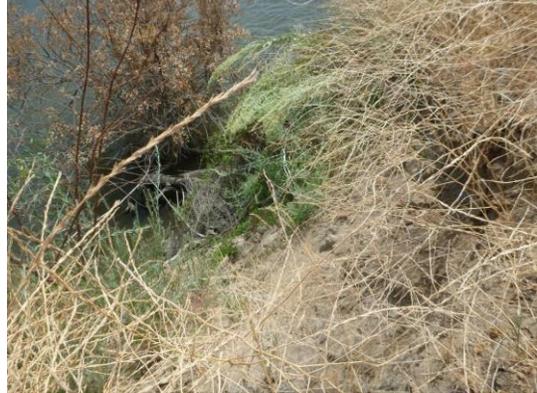
Photo 3 of 3 : LEVAL_FA_2019_512_4464.jpg

| <p>Levee Evaluation Comments</p> <p>Description: Slope protection repairs are needed along the waterside slope due to erosion and riprap displacement from high water. Based upon levee inspections, it was determined the waterside levee slope is eroding, deteriorating, and degrading. The eroded levee sections need to be restored back to design standards to prevent further deterioration and damage.</p> <p>Site ID No: 512</p> <p>Site Designation: LMA-418</p> <p>Repair Type: Erosion</p> <p>Rating: Serious</p> <p>Field Date: 8/14/2017</p> <p>Notes: deep erosion more than half way up slope.</p> | | | | | |

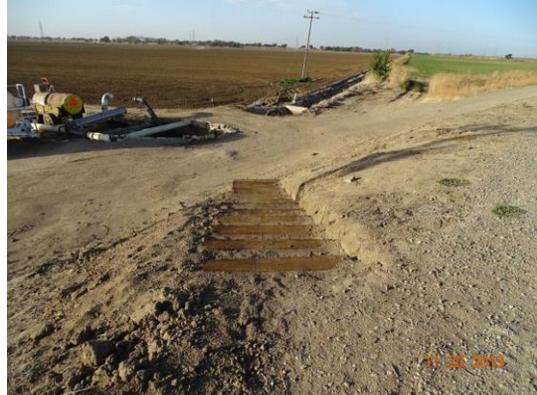
Photo 1 of 2 : FA_2019_RD2089_316_22_20191121_00064.jpg

View of steps on landside slope. Fall 2019

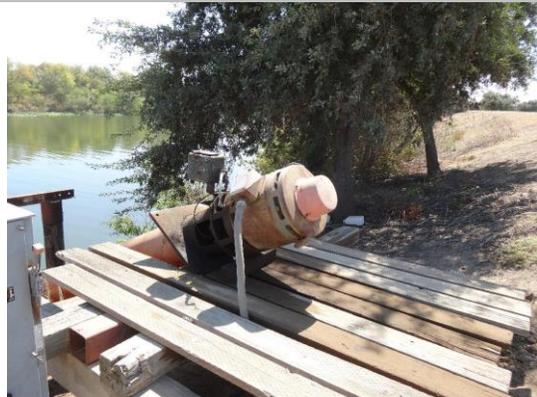
Photo 1 of 3 : UCIP_FA_2019_21587_36635.jpg

| DS_ID:23043 FS_ID:21587 EP_NO: 3385 Repair Type: Non-Urgent Crossing Status: Found UCIP Comments: - powerline on landside.- electric control box on waterside.- waterside slope erosion under pump platform. FIELD_STRUCT_DESC: 16-inch irrigation discharge pipe of an unknown material through the levee, 5.5 feet below the crown. Two cutoff walls. Slant pump in a pump house on the waterside (WS) slope. Siphon breaker on the landside (LS) slope. (Plans for installation of a pumping plant on the riverbank and a pipe that crosses the levee authorized under Permit No. 3385, 1960 - Eleanor M. Lawrence). [Additional Reference(s): DWR Levee Log, 1991. USACE San Joaquin O&M Manual 8, 1968, (HLM 0.81)]. FS Date: 9/12/2013 | | | | | |

WS view: slant pump on wooden platform. Oil leaks from the pump.

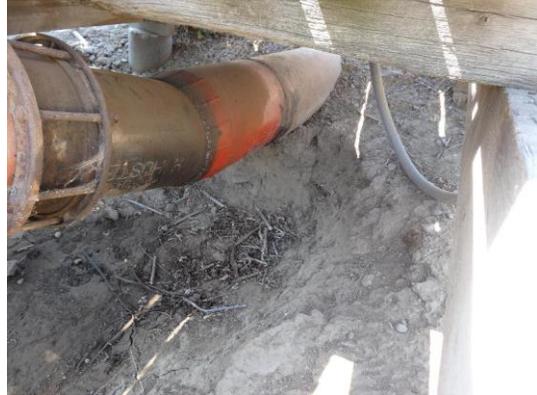
Photo 2 of 3 : UCIP_FA_2019_21587_36634.jpg

| DS_ID:23043 FS_ID:21587 EP_NO: 3385 Repair Type: Non-Urgent Crossing Status: Found UCIP Comments: - powerline on landside.- electric control box on waterside.- waterside slope erosion under pump platform. FIELD_STRUCT_DESC: 16-inch irrigation discharge pipe of an unknown material through the levee, 5.5 feet below the crown. Two cutoff walls. Slant pump in a pump house on the waterside (WS) slope. Siphon breaker on the landside (LS) slope. (Plans for installation of a pumping plant on the riverbank and a pipe that crosses the levee authorized under Permit No. 3385, 1960 - Eleanor M. Lawrence). [Additional Reference(s): DWR Levee Log, 1991. USACE San Joaquin O&M Manual 8, 1968, (HLM 0.81)]. FS Date: 9/12/2013 | | | | | |

WS view: soil erosion under pump platform. Needs mitigation measures to stop erosion.

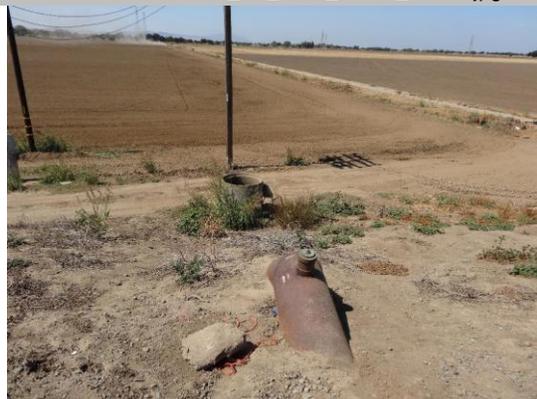
Photo 3 of 3 : UCIP_FA_2019_21587_36633.jpg

LS view: exposed pipe with siphon breaker on levee slope. Concrete standpipe on levee toe.

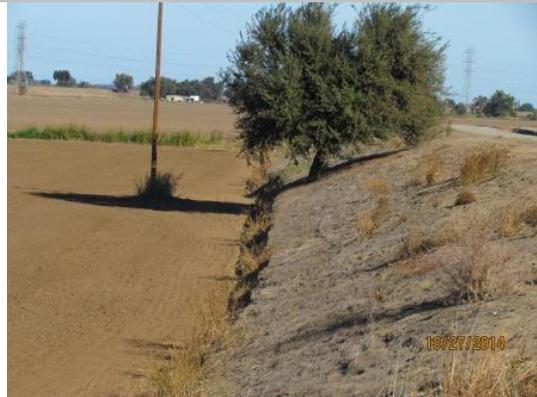
Photo 2 of 2 : FA_2019_RD2089_316_17_20190830_00014.jpg

View of the vertical cut along the landside levee toe.

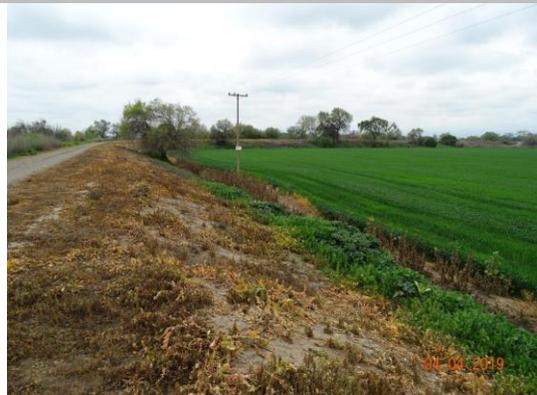
Photo 1 of 1 : FA_2019_RD2089_316_27_20190830_00025.jpg

View of vegetation on landside slope. (spring 2019)

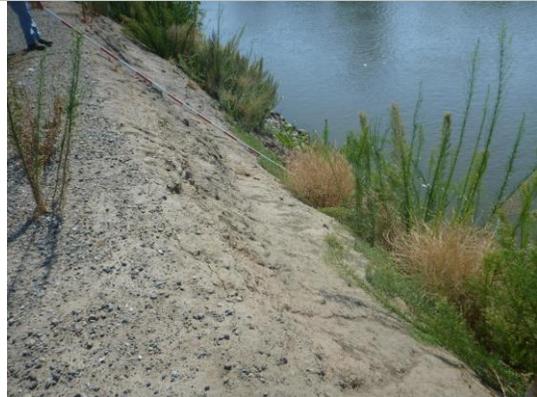
Photo 2 of 3 : LEVAL_FA_2019_511_4303.jpg

| LM Start | 1.16 | Rating ** | A/W | Issue No. | 30 |
|---|---|---|---|---|---|
| Description:Slope protection repairs are needed along the waterside slope due to erosion and riprap displacement from high water. Based upon levee inspections, it was determined the waterside levee slope is eroding, deteriorating, and degrading. The eroded levee sections need to be restored back to design standards to prevent further deterioration and damage. | | | | | |

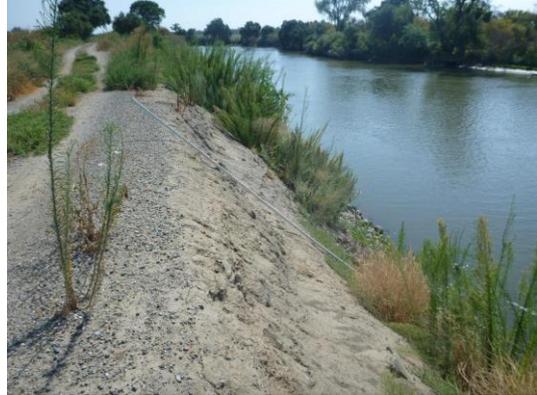
Photo 3 of 3 : LEVAL_FA_2019_511_4305.jpg

| Levee Evaluation Comments Description: Slope protection repairs are needed along the waterside slope due to erosion and riprap displacement from high water. Based upon levee inspections, it was determined the waterside levee slope is eroding, deteriorating, and degrading. The eroded levee sections need to be restored back to design standards to prevent further deterioration and damage. Site ID No: 511 Site Designation: LMA-417 Repair Type: Erosion Rating: Critical Field Date: 8/16/2017 Notes: Narrow levee with over steep slope | | | | | |

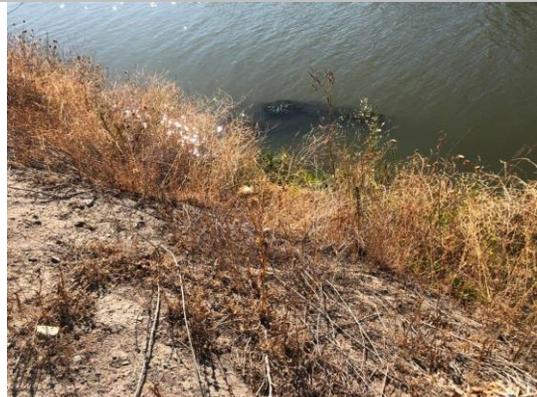
Photo 1 of 2 : SJR2019_RD2089U01RM29.10_1.jpg

| Site ID: RD2089U01RM29.1 09/26/2019: No significant change observed. 09/13/2017: The erosion is at the upstream of a small tree, inside of a slight river bend. | | | | | |

Looking at the erosion from levee top.

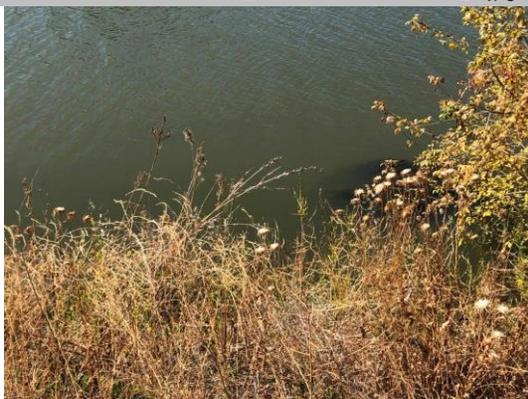
Photo 2 of 2 : SJR2019_RD2089U01RM29.10_4.jpg

| LM Start | 1.17 | Rating ** | A/W | Issue No. | 3 (cont) |
|---|---|---|---|---|---|
| Site ID: RD2089U01RM29.1 09/26/2019: No significant change observed. 09/13/2017: The erosion is at the upstream of a small tree, inside of a slight river bend. | | | | | |

Close-up view of the erosion. Note the trees next to the erosion site.

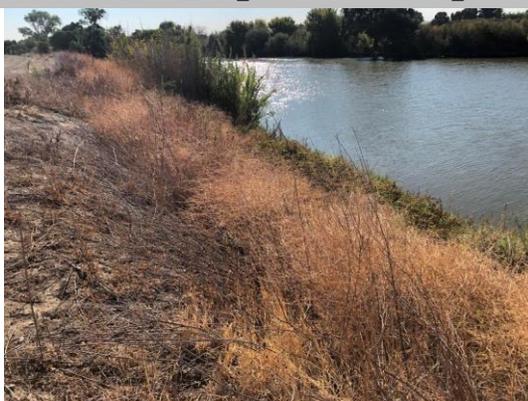
Photo 1 of 2 : SJR2019_RD2089U01RM29.04_2.JPG

| LM Start | 1.22 | Rating ** | M | Issue No. | 2 |
|---|---|---|---|---|---|
| Site ID: RD2089U01RM29.04 09/26/2019: No significant change observed. 09/13/2017: No significant change observed. More vegetation observed at the site. 09/16/2016: The river was not navigable near the site due to the dense water grass, so the site was visited by land survey. No significant change observed. 06/25/2015: No significant change observed. 07/02/2014: No significant change observed. 08/13/2013: The erosion is around a tree at the levee toe. Dense vegetation is visible. | | | | | |

Looking at the erosion from levee top.

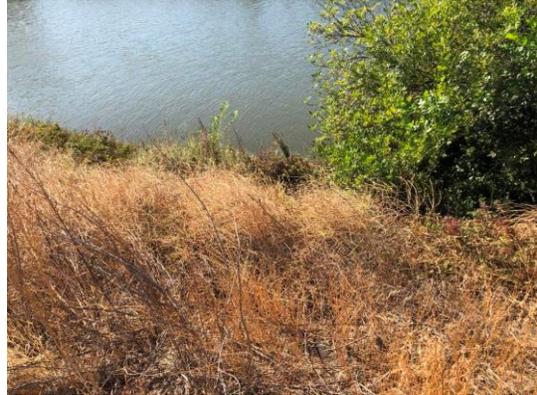
Photo 2 of 2 : SJR2019_RD2089U01RM29.04_3.JPG

| Site ID: RD2089U01RM29.04 09/26/2019: No significant change observed. 09/13/2017: No significant change observed. More vegetation observed at the site. 09/16/2016: The river was not navigable near the site due to the dense water grass, so the site was visited by land survey. No significant change observed. 06/25/2015: No significant change observed. 07/02/2014: No significant change observed. 08/13/2013: The erosion is around a tree at the levee toe. Dense vegetation is visible. | | | | | |

Close-up view of the erosion.

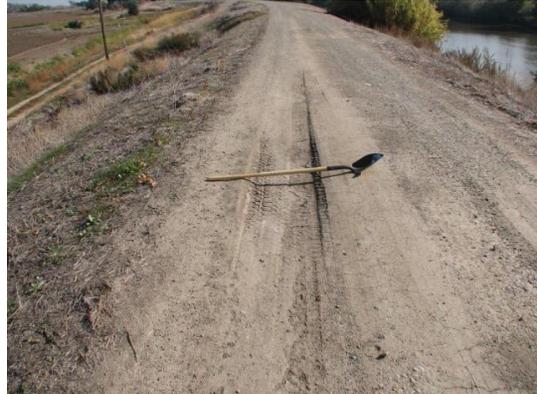
Photo 1 of 1 : FA_2019_RD2089_316_43_20190830_00033.jpg

View of depression in roadway. 11/10/2011

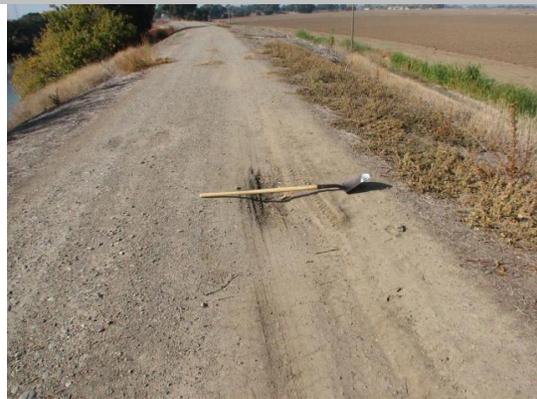
Photo 1 of 1 : FA_2019_RD2089_316_44_20190830_00034.jpg

View of roadway depression. 11/10/2011

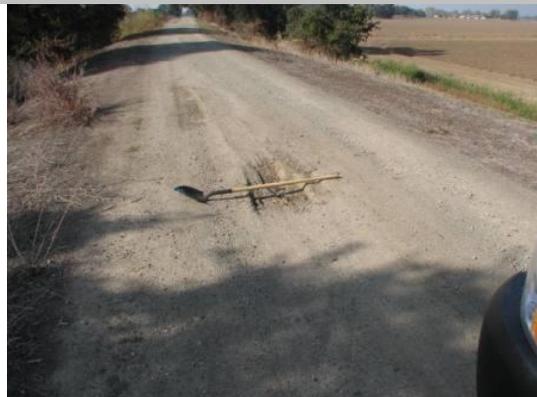
Photo 1 of 1 : FA_2019_RD2089_316_45_20190830_00035.jpg

View of roadway depression. 11/10/2011

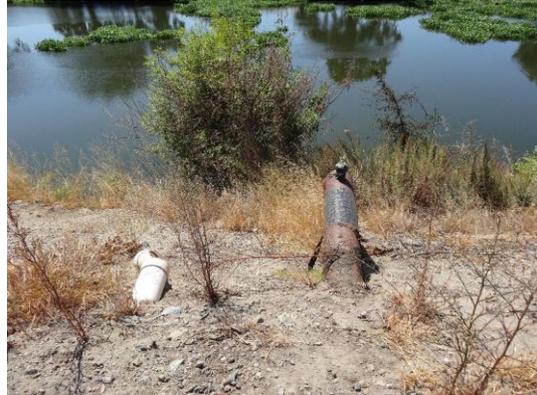
Photo 1 of 3 : UCIP_FA_2019_53379_36611.jpg

WS view: 6-inch pvc pipe on levee slope. Pipe end open and damaged.

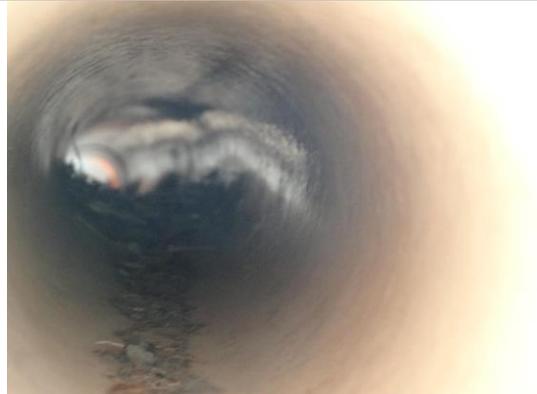
Photo 2 of 3 : UCIP_FA_2019_53379_36610.jpg

WS view: inside view of pvc pipe. Sediments found inside the pipe.

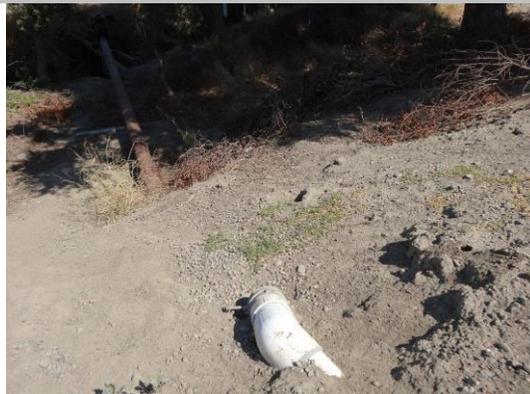
Photo 3 of 3 : UCIP_FA_2019_53379_36609.jpg

LS view: 6-inch pvc pipe on levee slope. Pipe end open.

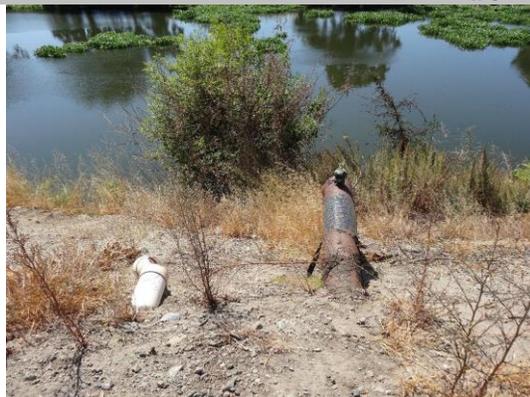
Photo 1 of 3 : UCIP_FA_2019_21585_36624.jpg

WS view: exposed steel pipe on levee slope. A pvc pipe on left.

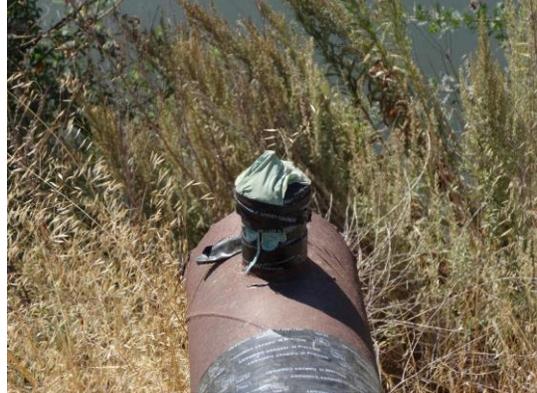
Photo 2 of 3 : UCIP_FA_2019_21585_36623.jpg

WS view: exposed steel pipe with siphon breaker. Looks siphon breaker needs repair.

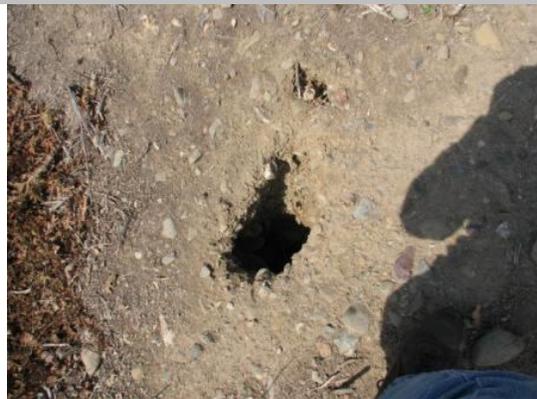
Photo 1 of 1 : FA_2019_RD2089_316_49_20190830_00037.jpg

View of deep burrow on waterside. 11/10/2011

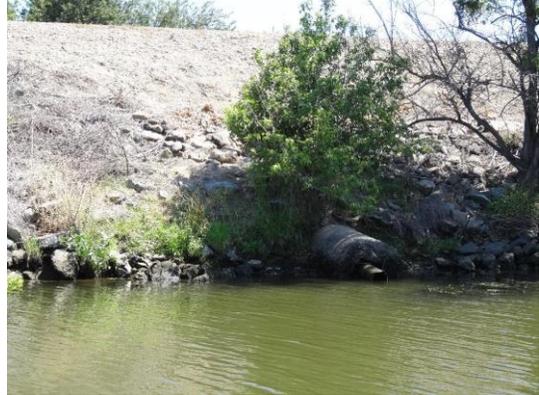
Photo 1 of 3 : UCIP_FA_2019_53182_74506.jpg

View up WS slope from water. Pipe does not cross channel.

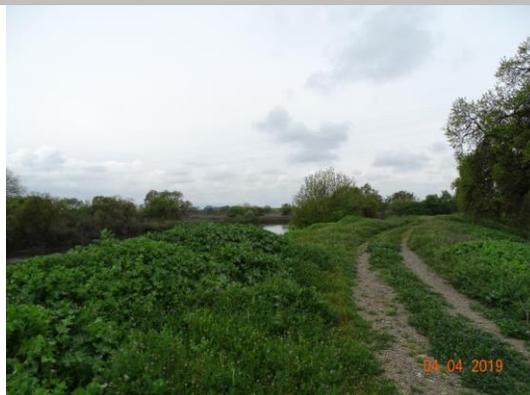
Photo 2 of 2 : FA_2019_RD2089_317_58_20190830_00067.jpg

Typical view of vegetation on waterside slope. (Spring 2019)

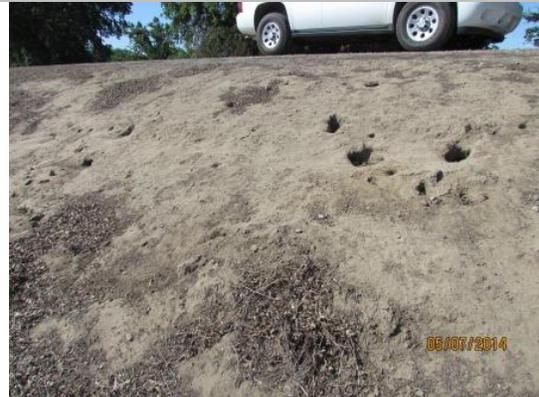
Photo 1 of 1 : FA_2019_RD2089_317_49_20190830_00052.jpg

View of the multiple rodent burrows on the landside levee hinge and slope.

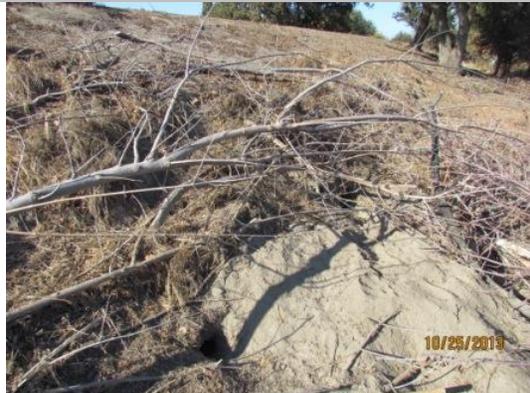
Photo 1 of 1 : FA_2019_RD2089_317_51_20190830_00056.jpg

View of the rodent burrow on the landside levee toe.

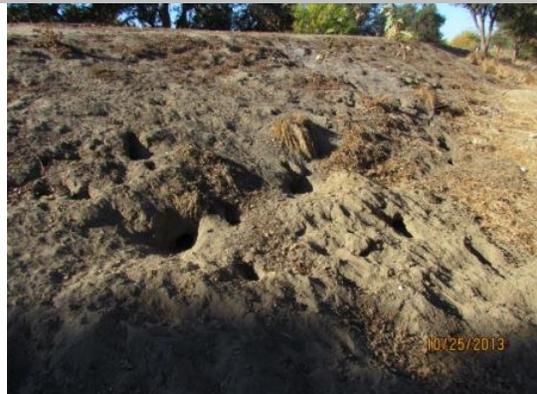
Photo 3 of 3 : FA_2019_RD2089_317_53_20190830_00060.jpg

Another view of the multiple rodent burrows on the landside levee slope.

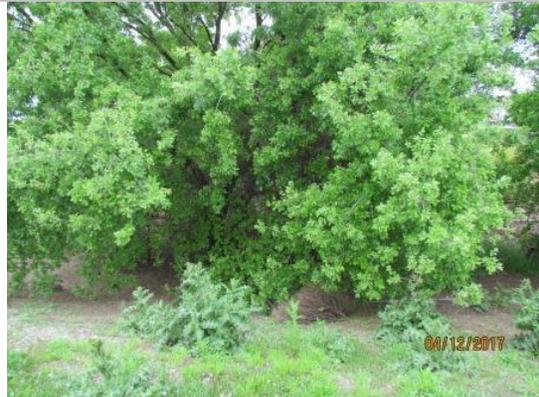
Photo 1 of 1 : FA_2019_RD2089_317_55_20190830_00062.jpg

View of the overgrown tree on the levee slope.

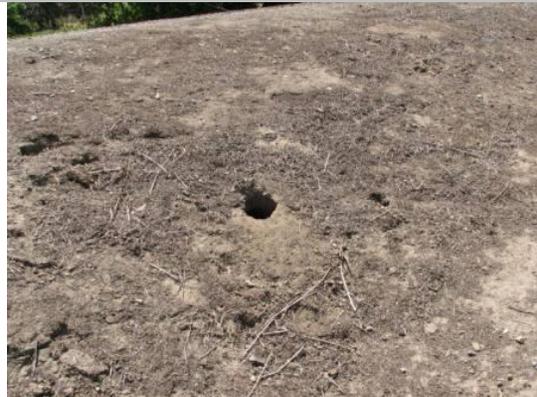
Photo 1 of 1 : FA_2019_RD2089_317_26_20190830_00027.jpg

View of active rodent burrow. 05/24/2011

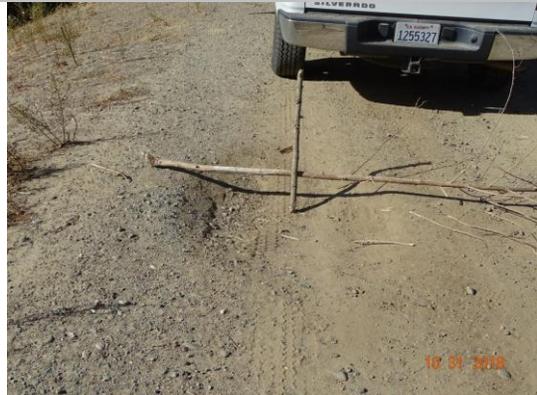
Photo 1 of 1 : FA_2019_RD2089_317_7_20190830_00007.jpg

View of depression greater than six inches on levee crown. (Fall 2018)

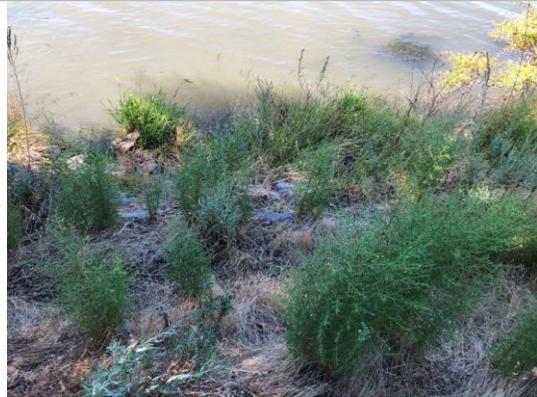
Photo 1 of 3 : SJR2019_RD2089U02RM28.35_1.jpg

Looking at the erosion from levee top.

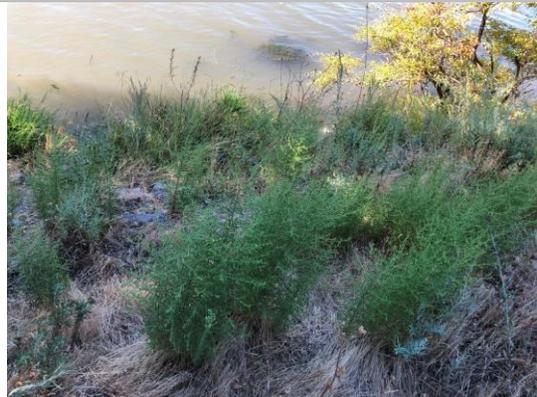
Photo 2 of 3 : SJR2019_RD2089U02RM28.35_4.jpg

Close-up view of the erosion.

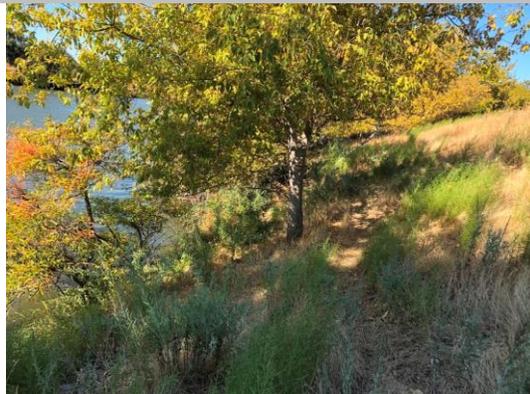
Photo 3 of 3 : SJR2019_RD2089U02RM28.35_5.jpg

Close-up view of the erosion.

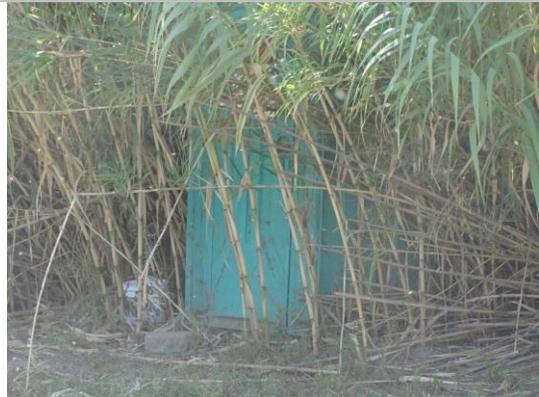
Photo 2 of 3 : FA_2019_RD2089_317_27_20190830_00029.jpg

Close-up view of portable toilet at water's edge. (Fall 2018)

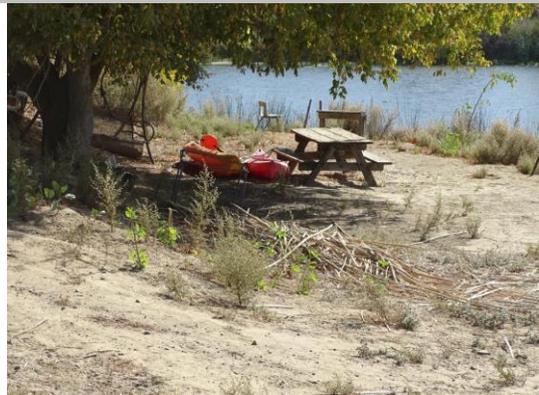
Photo 3 of 3 : FA_2019_RD2089_317_27_20190830_00030.jpg

View of picnic table and other items on waterward berm. (Fall 2018)

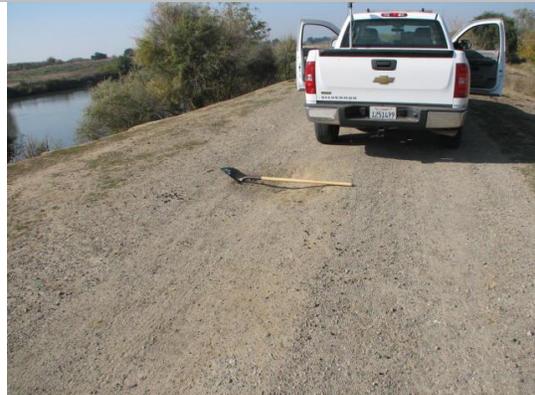
Photo 1 of 1 : FA_2019_RD2089_317_10_20190830_00011.jpg

Depression in crown needs to be filled. 11/10/2011

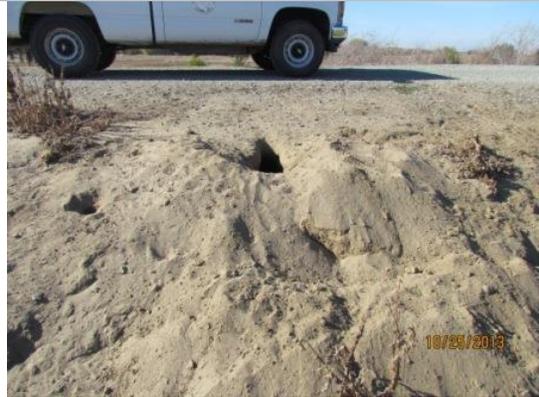
Photo 1 of 1 : FA_2019_RD2089_317_54_20190830_00061.jpg

View of the rodent burrow on the landside levee slope.

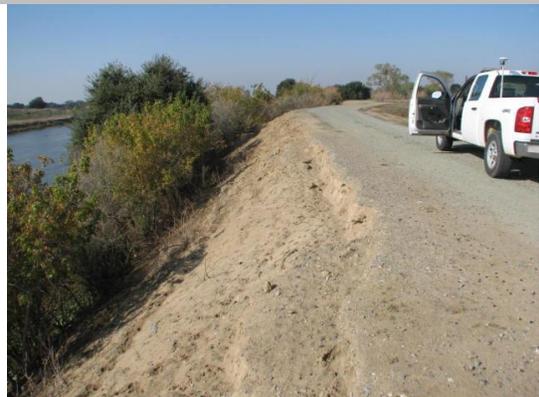
Photo 1 of 1 : FA_2019_RD2089_317_14_20190830_00016.jpg

View of the approximately 1' scarp that has been created by livestock travel. 11/10/2011

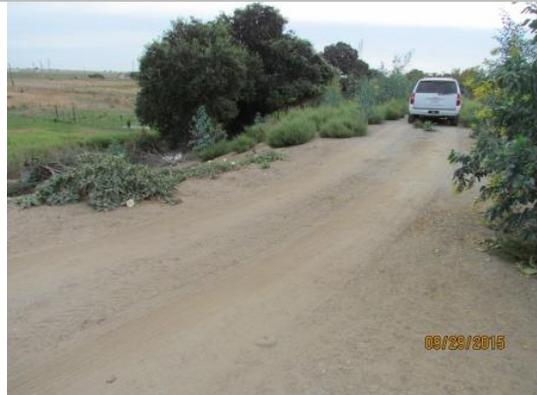
Photo 1 of 4 : FA_2019_RD2089_317_35_20190830_00034.jpg

View of the levee crown depression looking upstream.

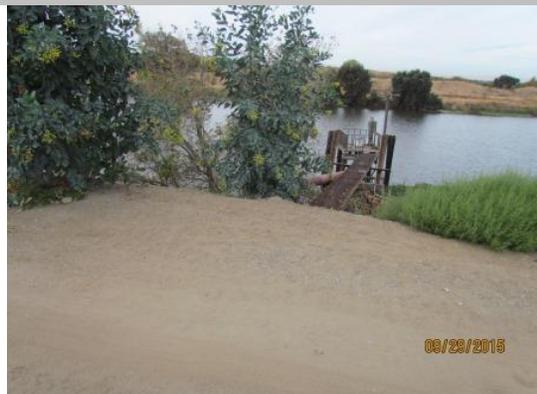
Photo 4 of 4 : FA_2019_RD2089_317_35_20190830_00037.jpg

View of the levee crown depression looking to the waterside.

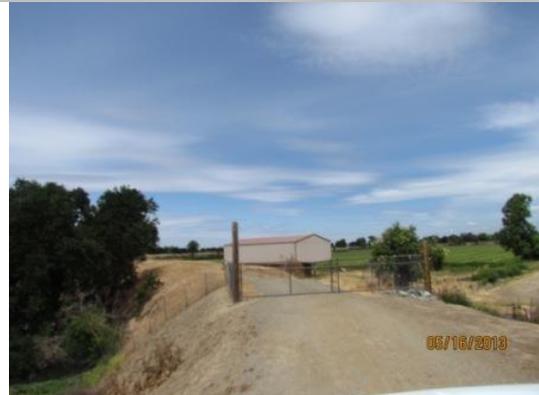
Photo 1 of 1 : FA_2019_RD2089_317_9_20190830_00010.jpg

View of the fence gate across levee crown.

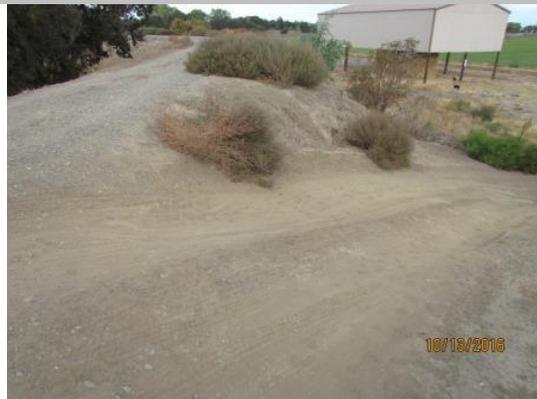
Photo 1 of 1 : FA_2019_RD2089_317_42_20190830_00044.jpg

View of the ramp on the landside levee slope.

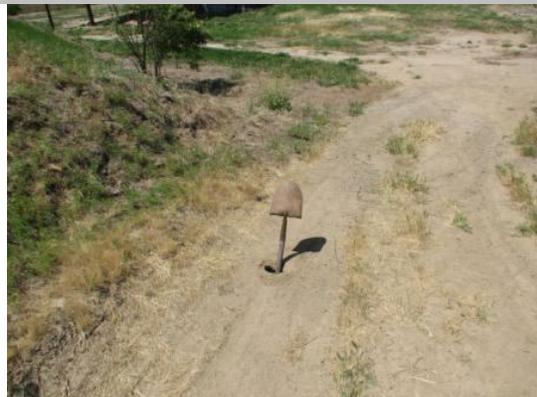
Photo 1 of 3 : FA_2019_RD2089_317_40_20190830_00040.jpg

View of deep vertical burrow in ramp on landside of levee. 05/24/2011

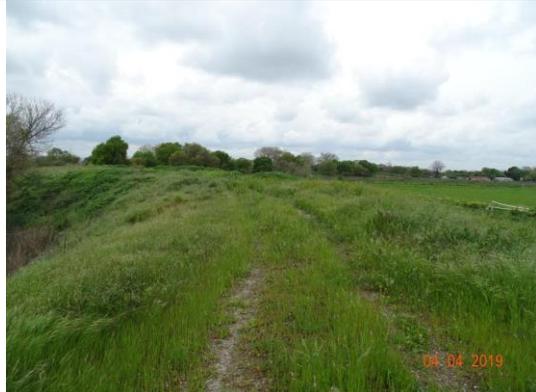
Photo 1 of 1 : FA_2019_RD2089_317_36_20190830_00038.jpg

View of vegetation on levee crown. (Spring 2019)

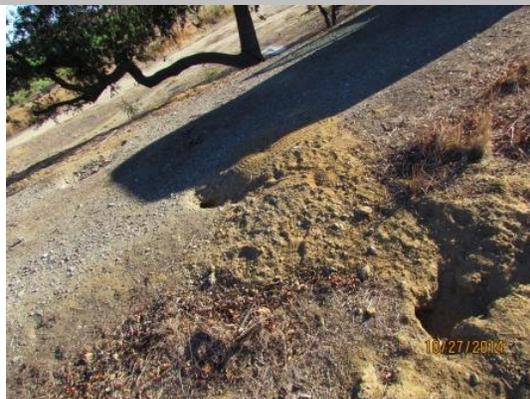
Photo 1 of 2 : FA_2019_RD2089_317_12_20190830_00013.jpg

View of several large rodent holes on the levee crown.

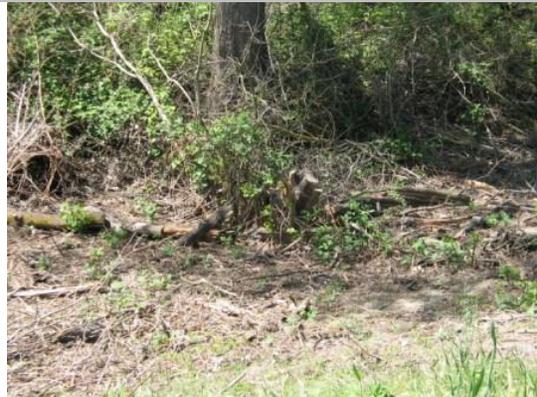
Photo 1 of 1 : FA_2019_RD2089_317_29_20190830_00032.jpg

View of tree stump left after vegetation and tree removal.

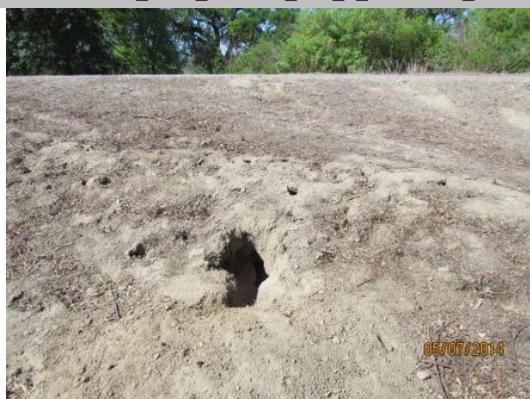
Photo 1 of 1 : FA_2019_RD2089_317_6_20190830_00006.jpg

View of the large rodent hole on the landside levee slope.

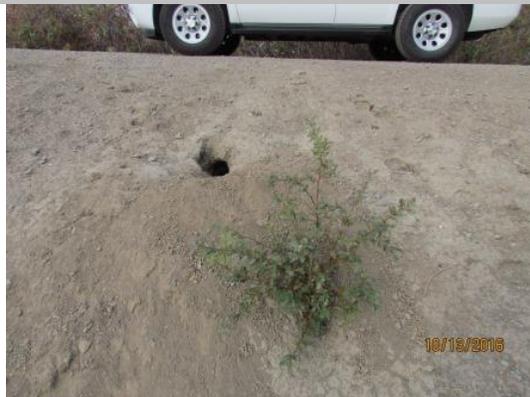
Photo 1 of 1 : FA_2019_RD2089_317_28_20190830_00031.jpg

View of the rodent burrow in the landside levee slope.

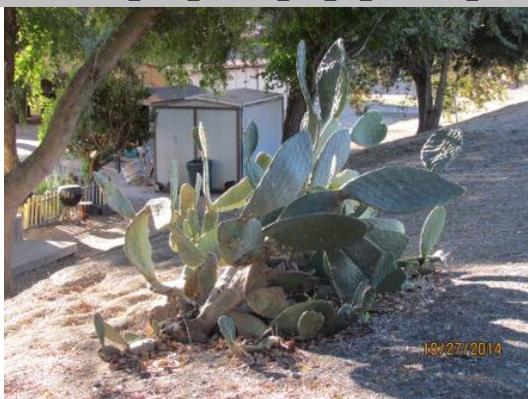
Photo 1 of 1 : FA_2019_RD2089_317_57_20190830_00066.jpg

View of the cactus on the crown at the landside levee shoulder.

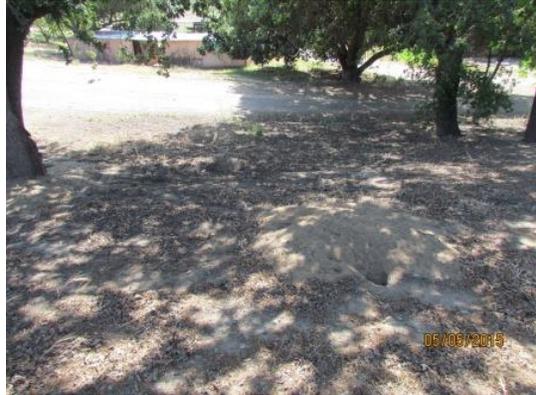
Photo 1 of 1 : FA_2019_RD2089_317_11_20190830_00012.jpg

View of the multiple rodent burrows on the landside levee slope.
