**Flood Control Project Maintenance
Levee Inspections**

Maintenance Issue Types Only, Levee Inspection Report By Mile - Spring 2020

Reclamation District No. 2091 Chase

Waterway	Bank	Unit Miles	Inspection Start/End	Inspector
Unit No. 01 San Joaquin River	Right	7.46	03/26/2020 03/26/2020	Corey Fujitani

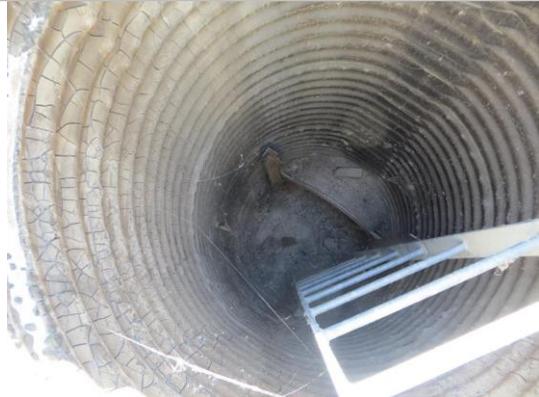
Photo 2 of 3 : UCIP_SP_2020_53094_38149.jpg

LM Start	0.10	Rating **	M	Issue No.	46 (cont)
LM End	0.10	Issue Type +	Ma	Location *	
Category	Supplemental			GPS Latitude/Longitude	
				Start	End
Item	DWR UCIP LMA Responsibility			37.542030 °	37.542030 °
				-121.094370 °	-121.094370 °
DWR ID	23156

Slide gate missing from open end of pipe at WS slope.

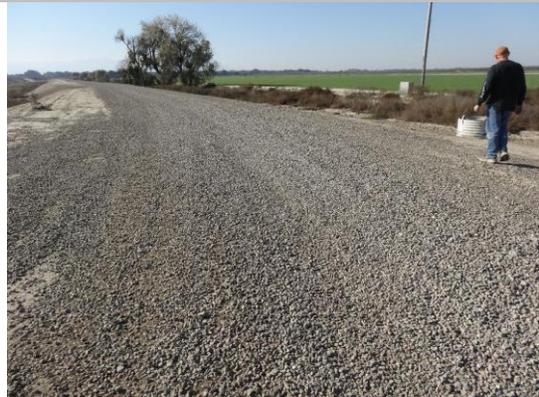
Photo 3 of 3 : UCIP_SP_2020_53094_76669.jpg

Overview of levee crown at pipe crossing.

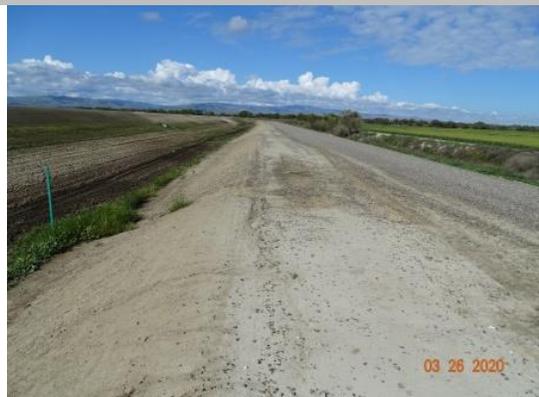
Photo 1 of 2 : SP_2020_RD2091_318_15_20200327_00030.jpg

LM Start	0.23	Rating **	A/W	Issue No.	15
LM End	0.23	Issue Type +	Ma	Location *	LS
Category	Earthen Levee			GPS Latitude/Longitude	
				Start	End
Item	Erosion / Bank Caving			37.541550 °	37.541550 °
				-121.096742 °	-121.096742 °
DWR ID	DWR_RD2091_01_s_2016_15				
Comment Code					
E1 : Note and monitor erosion site.					
Inspector Comment					
Caving on landward shoulder noted in 2017 possible collapsed pipe. Monitor for potential reoccurrence.

Looking west along the landside shoulder. (Spring 2020)

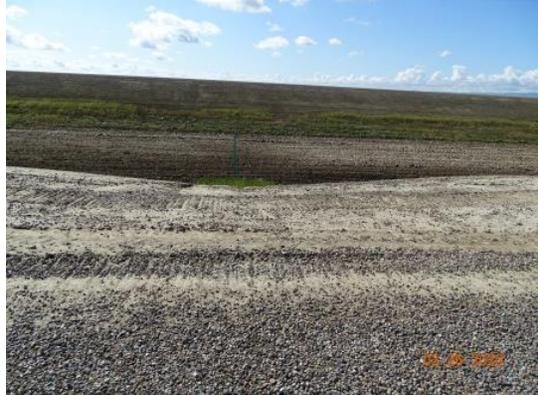
Photo 2 of 2 : SP_2020_RD2091_318_15_20200327_00031.jpg

Looking down the landside slope from the crown. (Spring 2020)

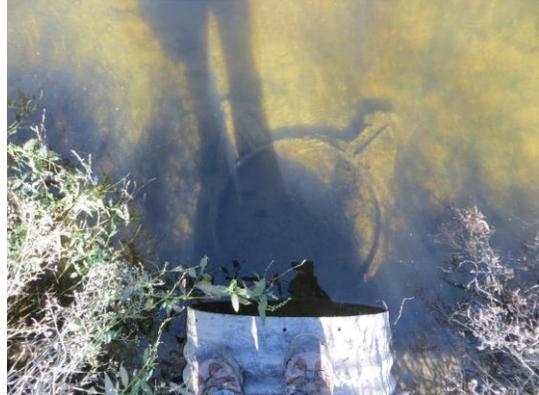
Photo 2 of 3 : UCIP_SP_2020_53431_38155.jpg

LM Start	0.24	Rating **	M	Issue No.	47 (cont)
LM End	0.24	Issue Type +	Ma	Location *	
Category	Supplemental			GPS Latitude/Longitude	
				Start	End
Item	DWR UCIP LMA Responsibility			37.541564 °	37.541564 °
				-121.096792 °	-121.096792 °
DWR ID	23158

Flapgate has fallen off at WS toe.

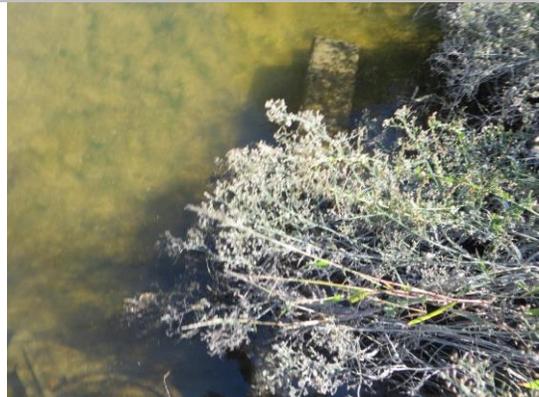
Photo 3 of 3 : UCIP_SP_2020_53431_38154.jpg

Concrete headwall under pipe at WS toe.

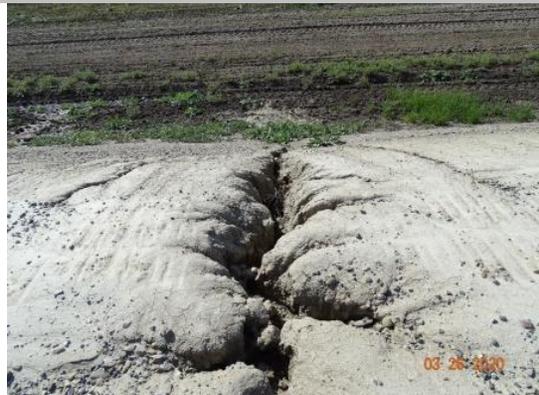
Photo 1 of 2 : SP_2020_RD2091_318_16_20200327_00034.jpg

LM Start	0.25	Rating **	M	Issue No.	16
LM End	0.28	Issue Type +	Ma	Location *	LS
Category	Earthen Levee			GPS Latitude/Longitude	
				Start	End
Item	Erosion / Bank Caving			37.541492 °	37.541408 °
				-121.097052 °	-121.097453 °
DWR ID	DWR_RD2091_01_s_2016_16

Looking down the landside slope at representative rill. (Spring 2020)

Comment Code					
E1 : Note and monitor erosion site.					
Inspector Comment					
Several sites of rill erosion and possible rodent holes along landward shoulder and slope.

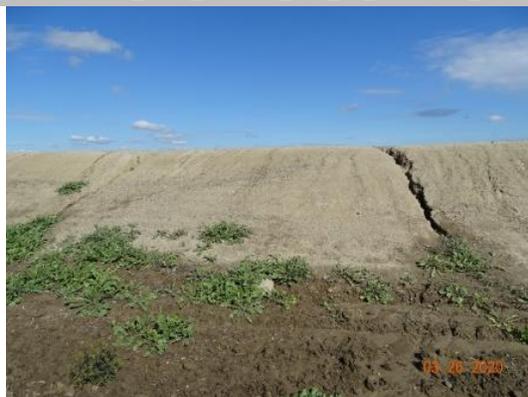
Photo 2 of 2 : SP_2020_RD2091_318_16_20200327_00035.jpg

Looking at rills in landside slope from the toe. (Spring 2020)

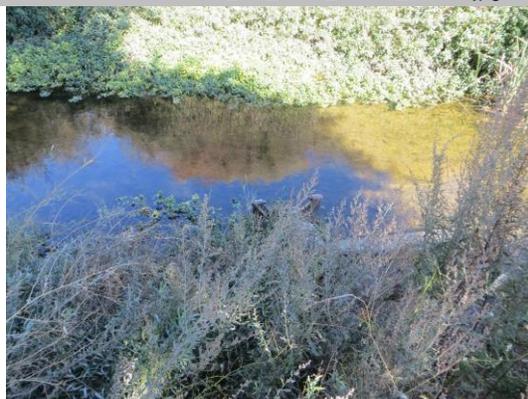
Photo 1 of 3 : UCIP_SP_2020_51639_38158.jpg

LM Start	0.63	Rating **	M	Issue No.	48
LM End	0.63	Issue Type +	Ma	Location *	
Category	Supplemental			GPS Latitude/Longitude	
				Start	End
Item	DWR UCIP LMA Responsibility			37.541220 °	37.541220 °
				-121.103880 °	-121.103880 °
DWR ID	23161

24-inch CMP on concrete headwall with flapgate on WS toe.

Comment Code					
Inspector Comment					
DS_ID:23161 FS_ID:51639 EP_NO: N/A Repair Type: Non-Urgent Crossing Status: Found UCIP Comments: 11/18/2016 Crossing has been downgraded from Urgent to Non-Urgent since the flap gate appears to fully close. According to Mike Alvez, this crossing is abandoned and the City of Modesto is working with CVFPB to authorize proper abandonment/removal. The City is working at finding funds to pay for proper abandonment/removal of all the drainage structures through this levee. (O. Magana - DWR UCIP)10/15/2013 Appears abandoned and if so should be done so properly. (W. Wylie - DWR UCIP) FIELD_STRUCT_DESC: *ABANDONED* 24-inch corrugated metal drainage pipe through the levee, 12 feet below the crown. Flap gate and concrete headwall on the waterside (WS) end. [Additional Reference(s): DWR Levee Log, 1992. USACE San Joaquin O&M Manual 6, September 1961, (HLM 0.64)]. FS Date: 11/18/2016

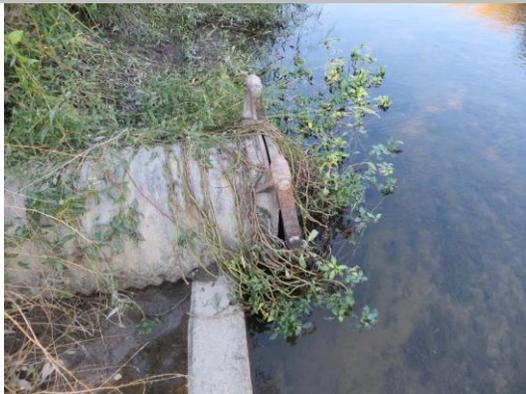
Photo 2 of 3 : UCIP_SP_2020_51639_38157.jpg

24-inch CMP on concrete headwall with flapgate on WS toe.

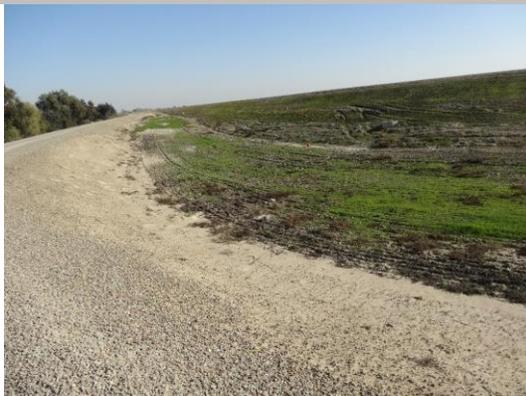
Photo 3 of 3 : UCIP_SP_2020_51639_76677.jpg

View of LS.

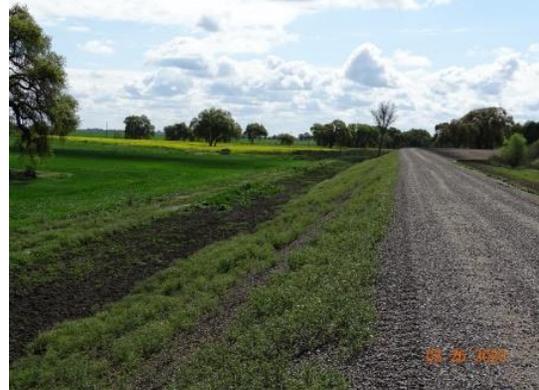
Photo 1 of 1 : SP_2020_RD2091_318_11_20200327_00036.jpg

LM Start	3.31	Rating **	M	Issue No.	11
LM End	3.44	Issue Type +	Ma	Location *	LS
Category	Earthen Levee			GPS Latitude/Longitude	
				Start	End
Item	Vegetation			37.512762 °	37.511583 °
				-121.089860 °	-121.087920 °
DWR ID	DWR_RD2091_01_s_2020_11				
Comment Code					
V1 : Control annual grass and weeds on the levee slopes and easements.					
Inspector Comment

View of landside slope looking upstream. (Spring 2020)

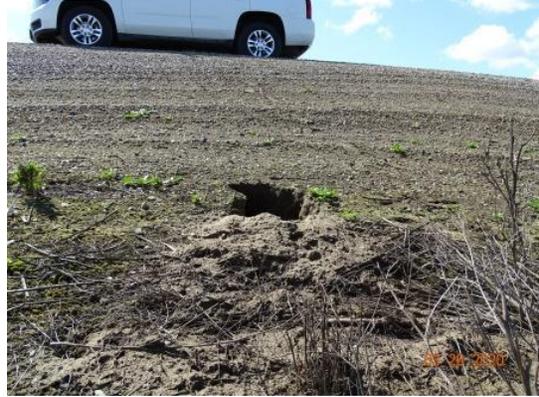
Photo 1 of 2 : SP_2020_RD2091_318_14_20200327_00038.jpg

LM Start	6.07	Rating **	M	Issue No.	14
LM End	6.07	Issue Type +	Ma	Location *	LS
Category	Earthen Levee			GPS Latitude/Longitude	
				Start	End
Item	Animal Control			37.486852 °	37.486852 °
				-121.060915 °	-121.060915 °
DWR ID	DWR_RD2091_01_s_2020_14				
Comment Code					
A3 : No rodents visible, but rodent burrows visible; need to backfill and compact or grout burrows.					
Inspector Comment

View of animal burrow from landside toe. (Spring 2020)

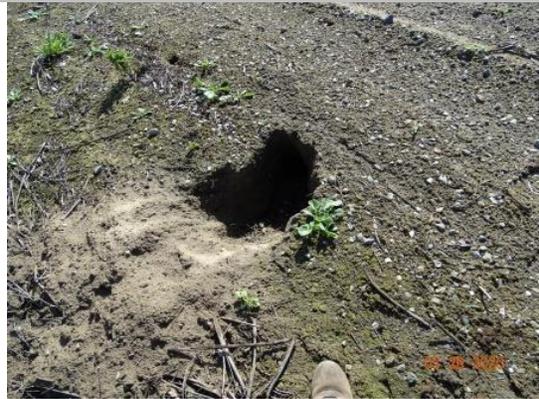
Photo 2 of 2 : SP_2020_RD2091_318_14_20200327_00037.jpg

View of animal burrow in landside slope. (Spring 2020)

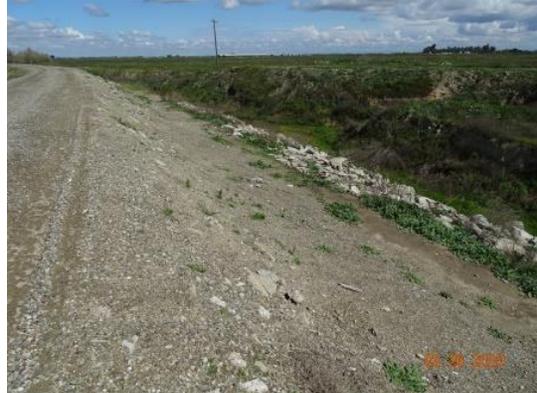
Photo 1 of 3 : SP_2020_RD2091_318_8_20200327_00039.jpg

LM Start	7.42	Rating **	U	Issue No.	8
LM End	7.45	Issue Type +	Ma	Location *	LS
Category	Earthen Levee		GPS Latitude/Longitude		
			Start	End	
Item	Erosion / Bank Caving		37.479308 °	37.478998 °	
			-121.044708 °	-121.044660 °	
DWR ID	DWR_RD2091_01_s_2017_8				
Comment Code					
E2 : Schedule repair of erosion site prior to the next inspection.					
Inspector Comment					
Repaired area with concrete containing rebar. Need to remove rebar.

Looking east at repaired site on waterward slope and toe. (Spring 2020)

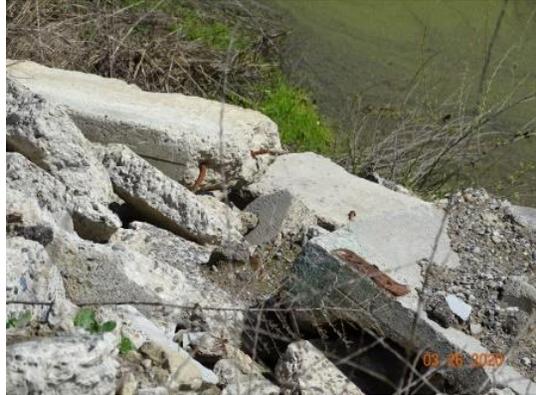
Photo 2 of 3 : SP_2020_RD2091_318_8_20200327_00045.jpg

View of rebar and other steel in the concrete rubble along the landside toe. (Spring 2020)

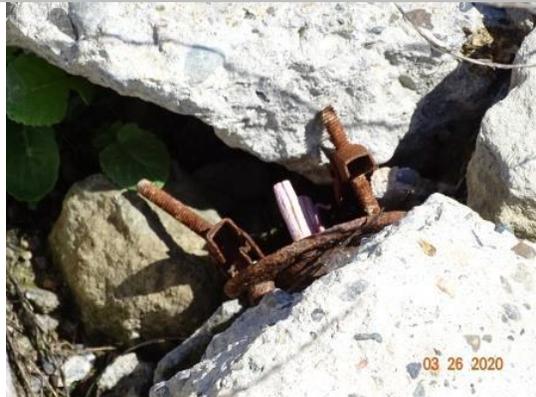
Photo 3 of 3 : SP_2020_RD2091_318_8_20200327_00042.jpg

View of rebar within the concrete rubble. (Spring 2020)
